TESTING AND EVALUATION OF WORK ZONE

TRAFFIC CONTROL DEVICES

PROVIDED BY FLASHER EQUIPMENT COMPANY

Project No. 71770

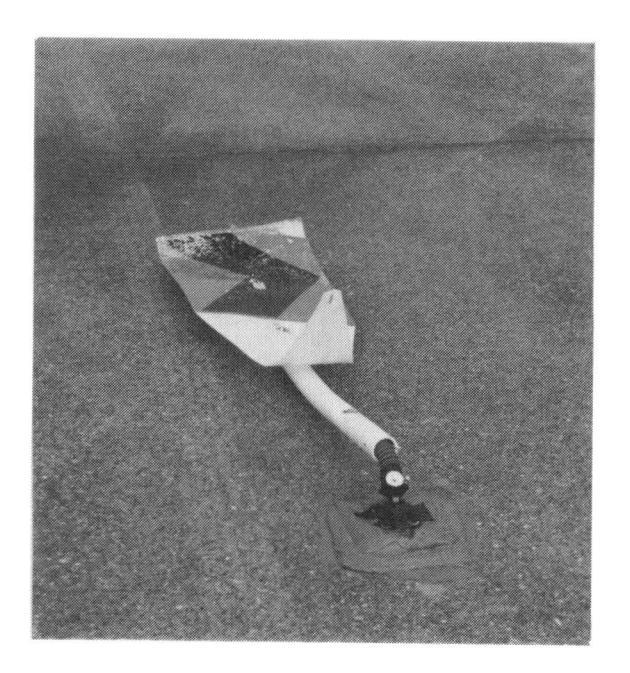
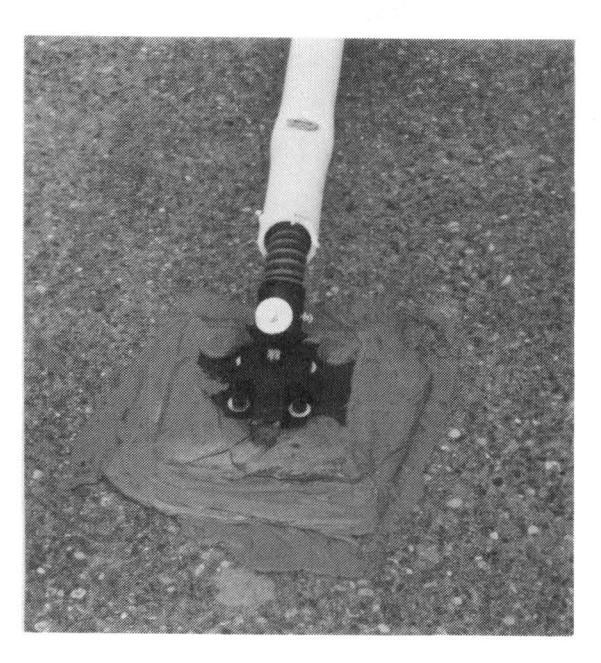
Figure 79. Damage to first device, test 7177-14.

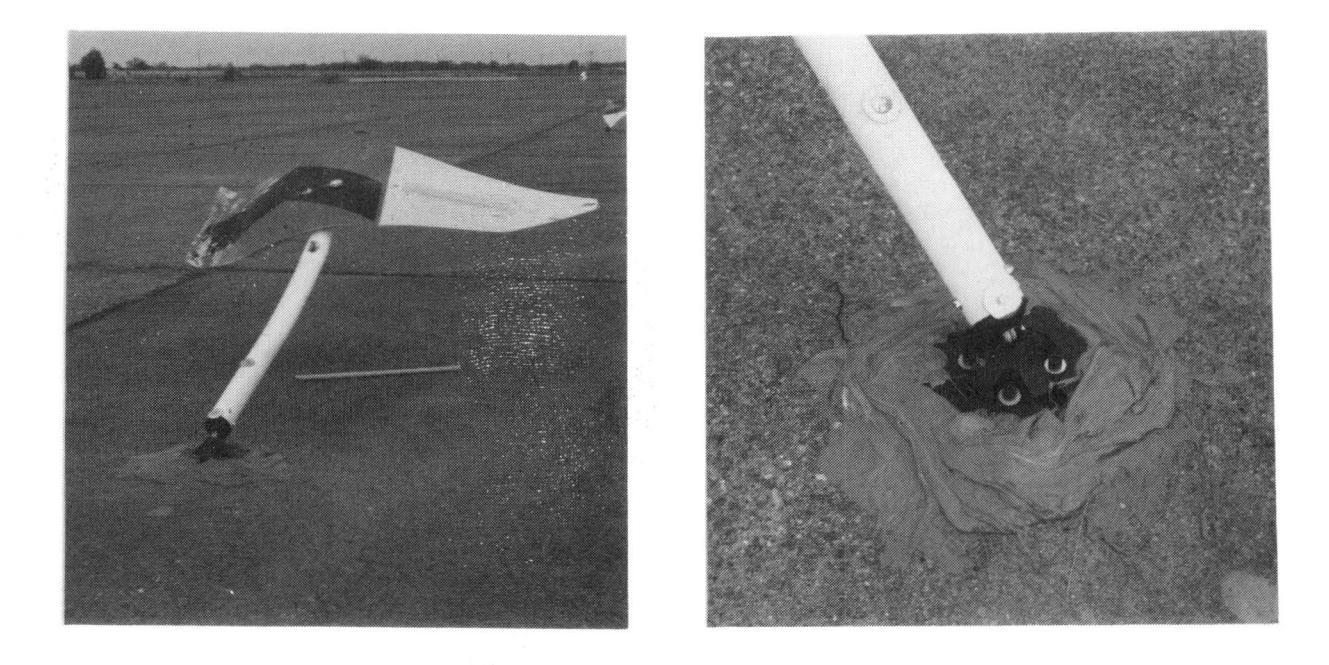
Figure 80. Damage to second device, test 7177-14.

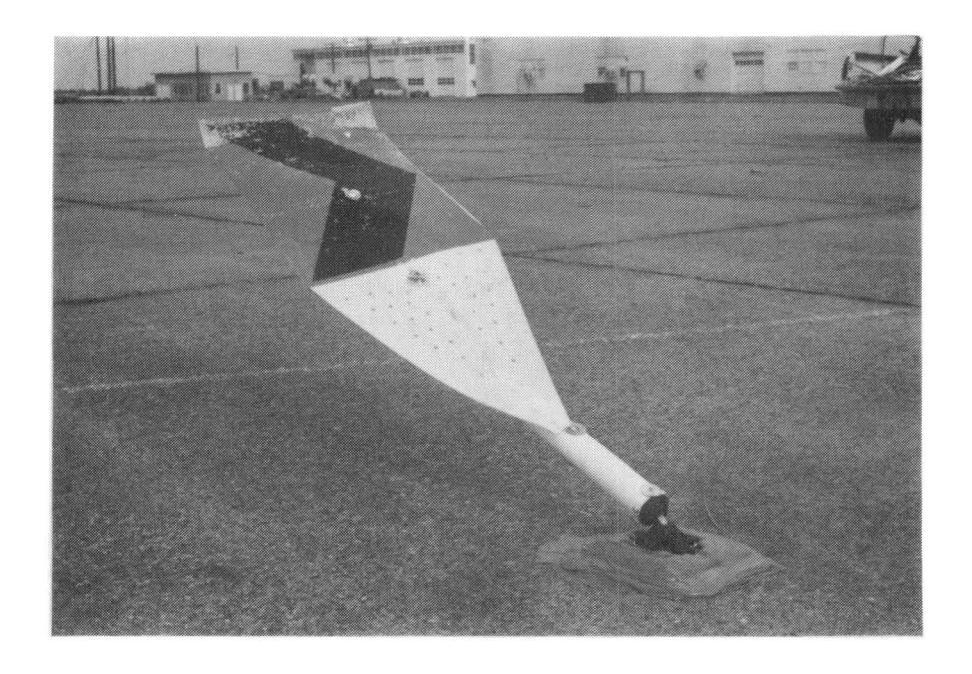
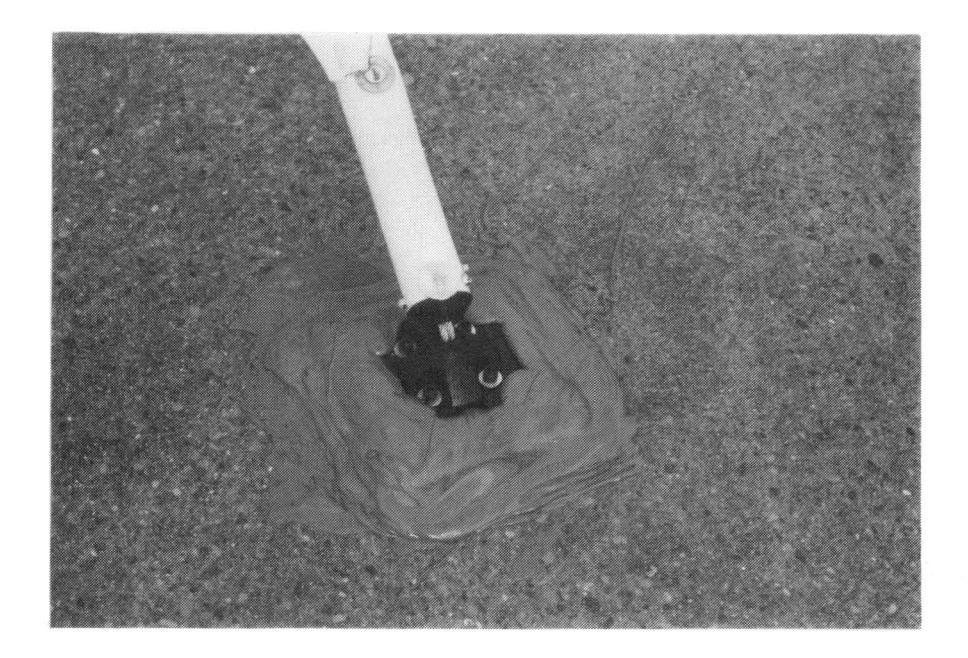
Figure 81. Damage to third device, test 7177-14.

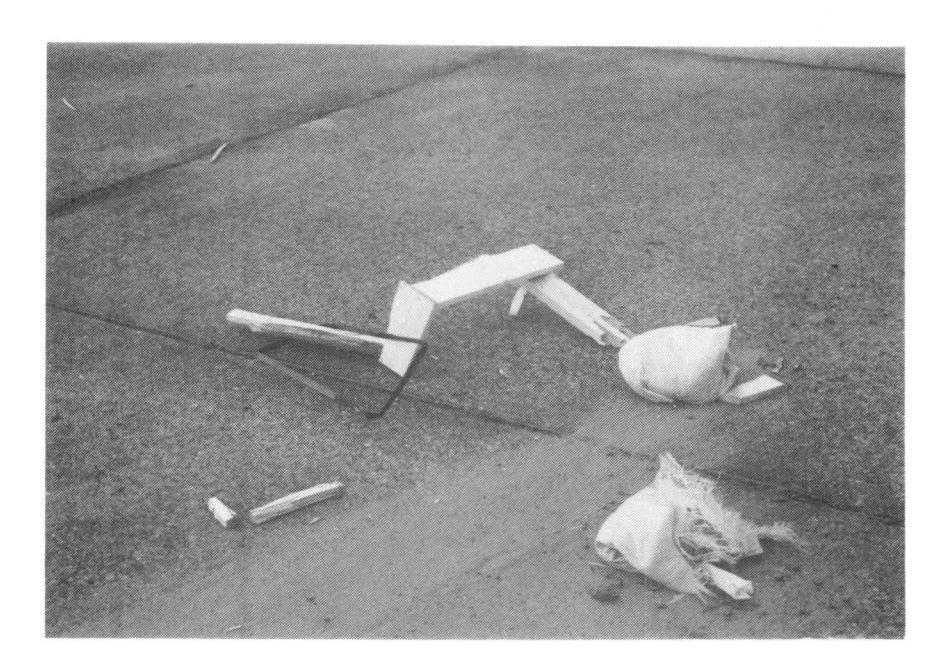
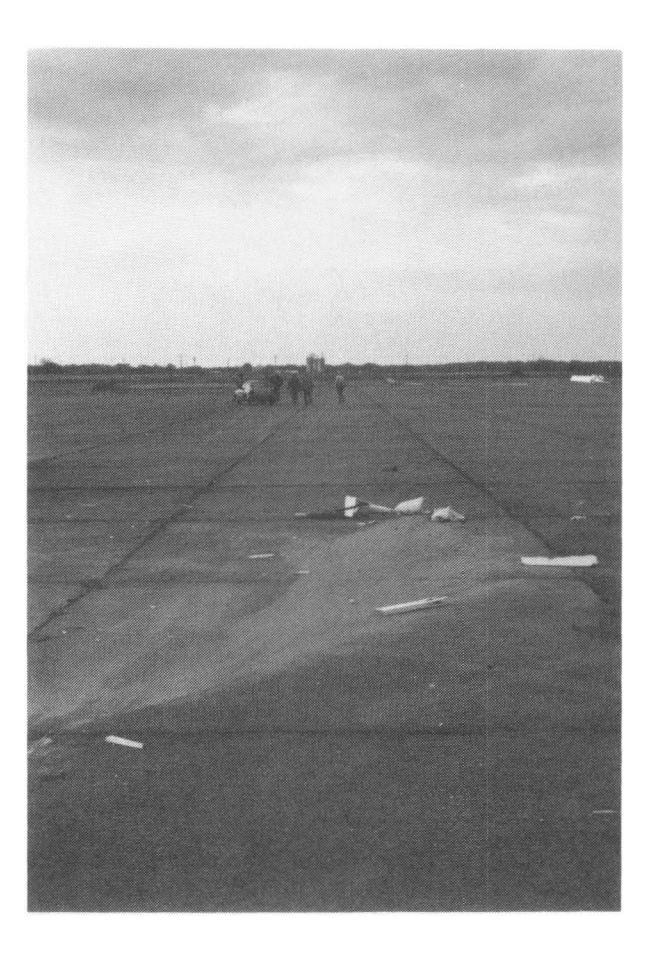
Figure 84. Damage to device, test 7177-15.

throughout the test sequence. The device came completely apart upon impact and debris was strewn along the vehicle path over a wide area.
