# DEVELOPING GUIDELINES FOR REPAIRING SEVERE EDGE FAILURES: TECHNICAL REPORT

### Report 0-6271-2-1 Project 0-6271 Project Title: Developing Guidelines for Repairing Severe Edge Failures

Published: April 2014

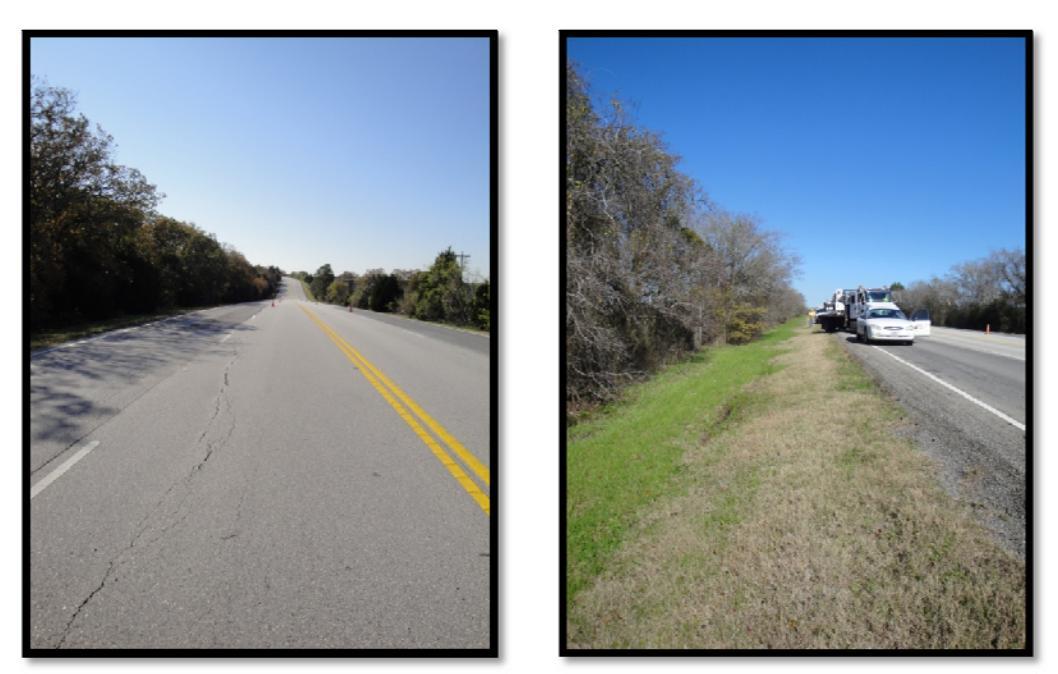
The Austin District recently completed two projects on SH 21 involving mitigation techniques for edge cracking. Figure 1 shows example cracking and steep front slopes typical of the SH 21 project. Figure 2 shows other pavements in the Austin District with severe edge failures.

Figure 1. Cracking and Steep Front Slopes on SH 21.

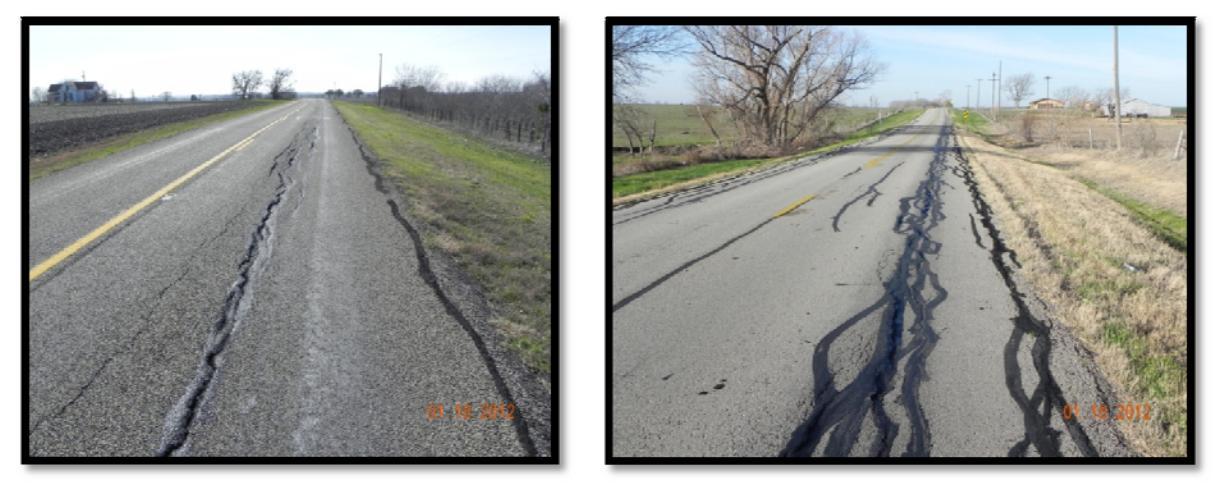
Figure 2. Edge Failures on Other Pavements in the Austin District. Images courtesy of Mike Arellano.

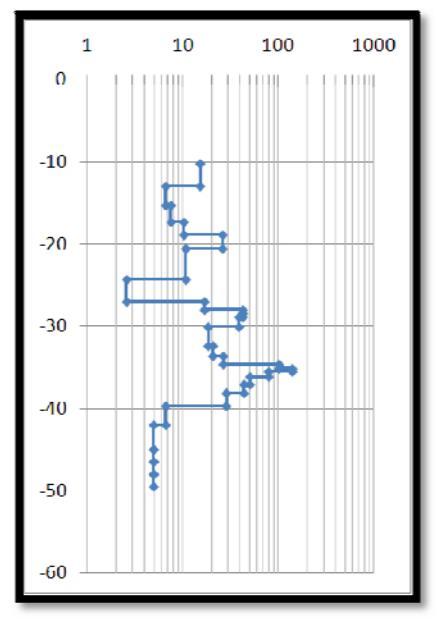
The Austin District also recently performed a project on SH 21 from US 290 to 0.8 mi east of FM 1441. The existing pavement had a lot of structure; however steep front slopes and soils with a plasticity index as high as 59 resulted in consistent maintenance requirements for cracking and roughness. Additionally, DCP profiles, illustrated in Figure 5, suggested a slip plane existed from about 24 to 28 inches from the pavement surface.

Figure 5. Slip Plane Evident in DCP Profile.

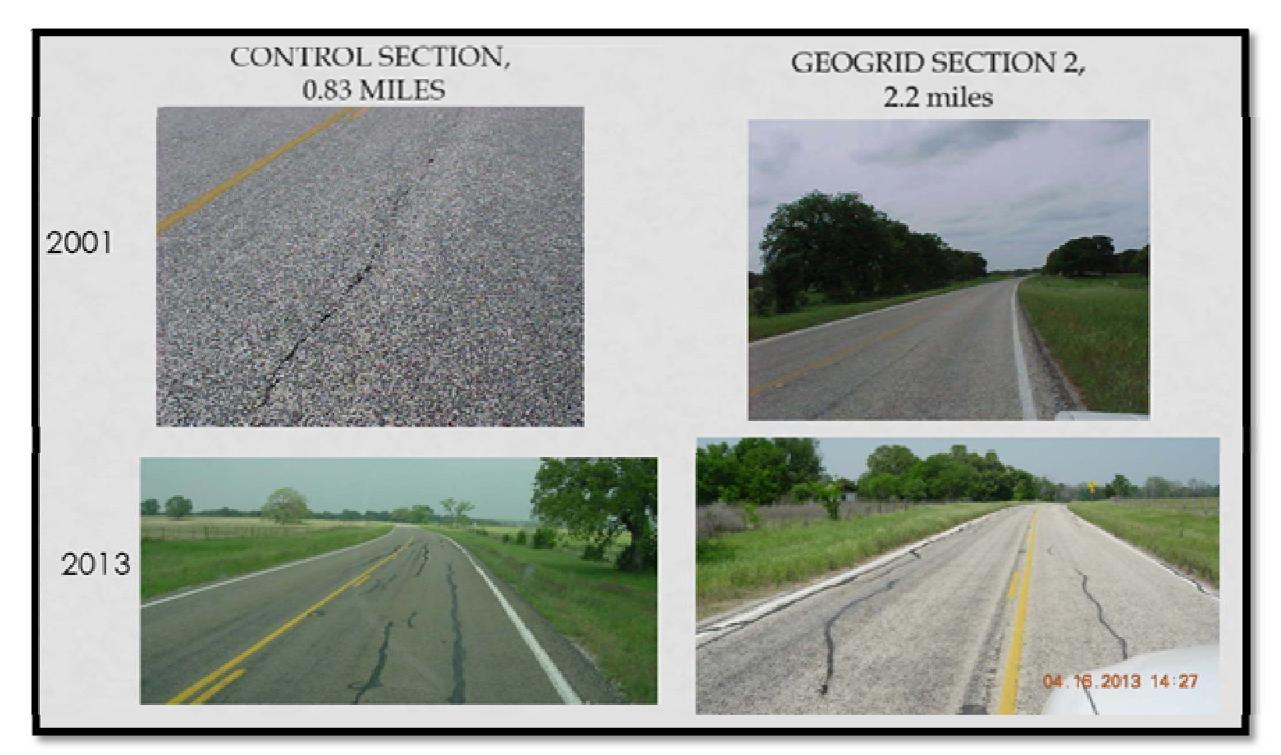
The first major test of using the FDR technique with geogrid reinforcement in the Bryan District occurred on FM 1915. Constructed in 1997, Figure 8 illustrates that in general the sections reinforced with the geogrid do not have as much cracking distress as the control sections.

Figure 8. FM 1915 Sections 5 and 16 Years after Repair. Images Courtesy of Darlene Goehl.

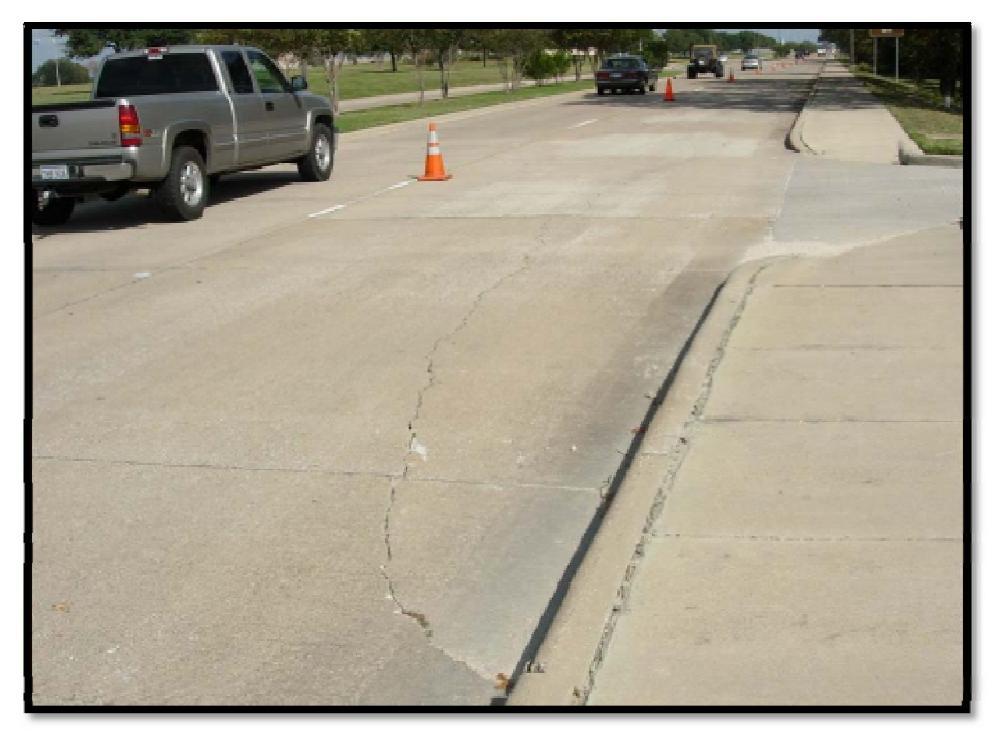
The Bryan District also has one of the few well documented cases of edge repair of concrete pavement. The distress shown in Figure 9 occurred shortly after construction. The subgrade plasticity index ranged from 14 to 49. Figure 10 presents the typical existing section. Figure 11 presents the repair details, which used a continuously reinforced concrete pavement (CRCP) repair tied to the existing concrete pavement contraction design (CPCD). As Figure 12 illustrates, although the crack did recur, the crack severity is much less than before.

**Figure 9. Edge Failure of Concrete Pavement.** *Image Courtesy of Darlene Goehl.*

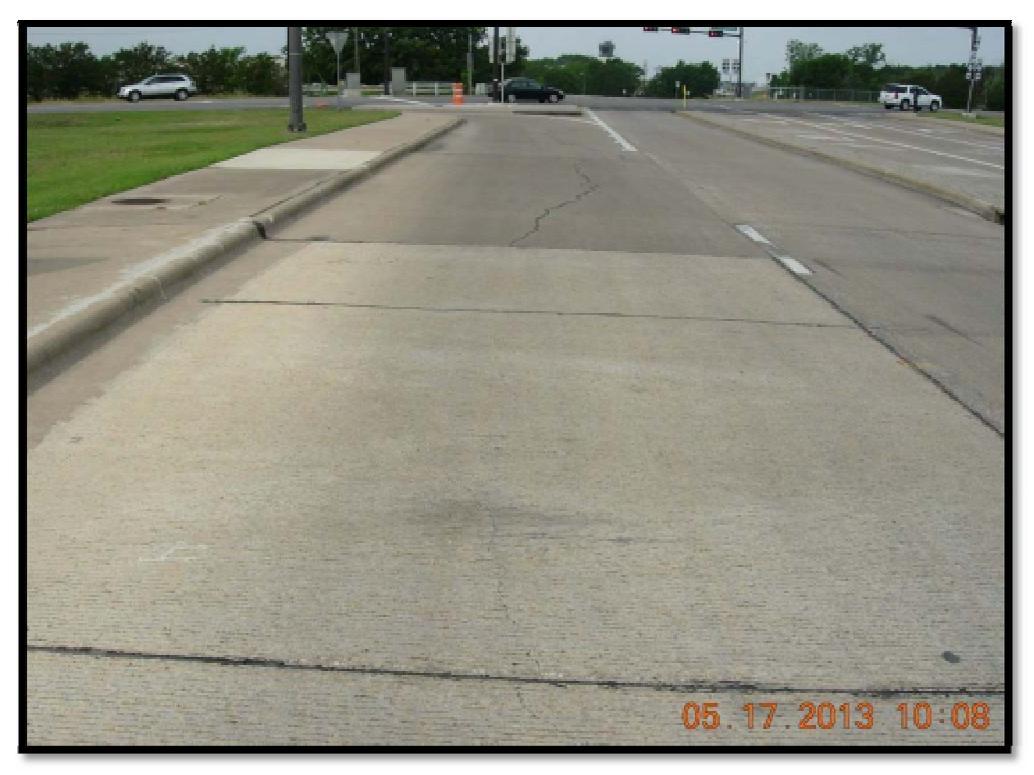
Figure 12. Concrete Pavement Edge Distress 7 Years after Repair. Image Courtesy of Darlene Goehl.

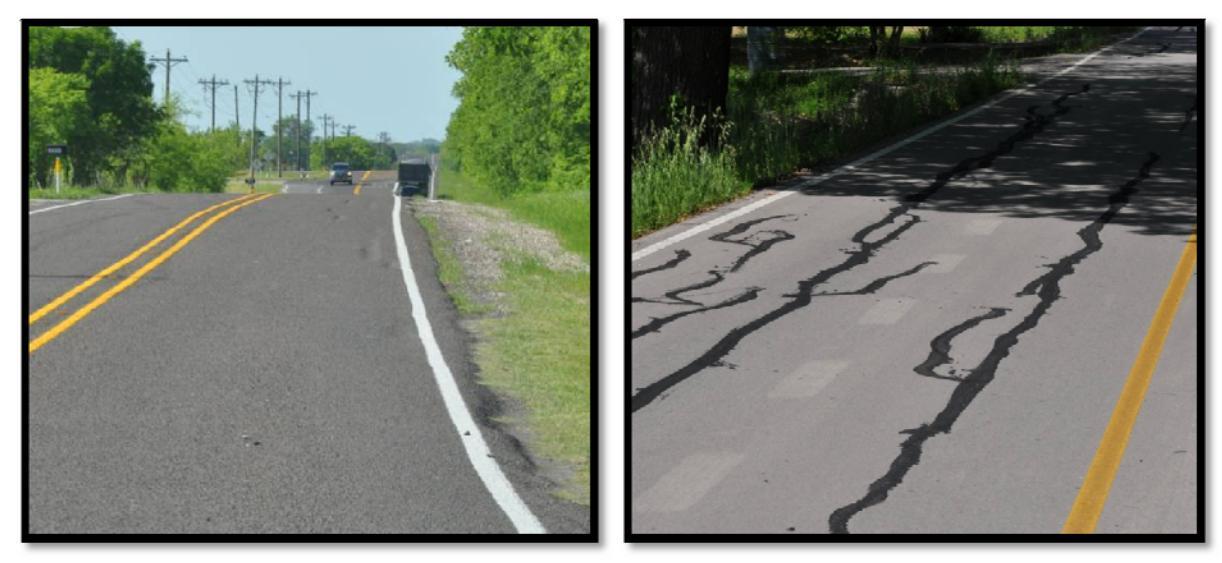
Figure 14 contrasts FM 549 and FM 1827, both after 3 years of service. While FM 549 has edge failures with roughness continuing to occur on the project, on FM 1827 the ride is still good although cracking has recurred.

Figure 14. FM 549 (Left) and FM 1827 (Right) after 3 Years of Service.

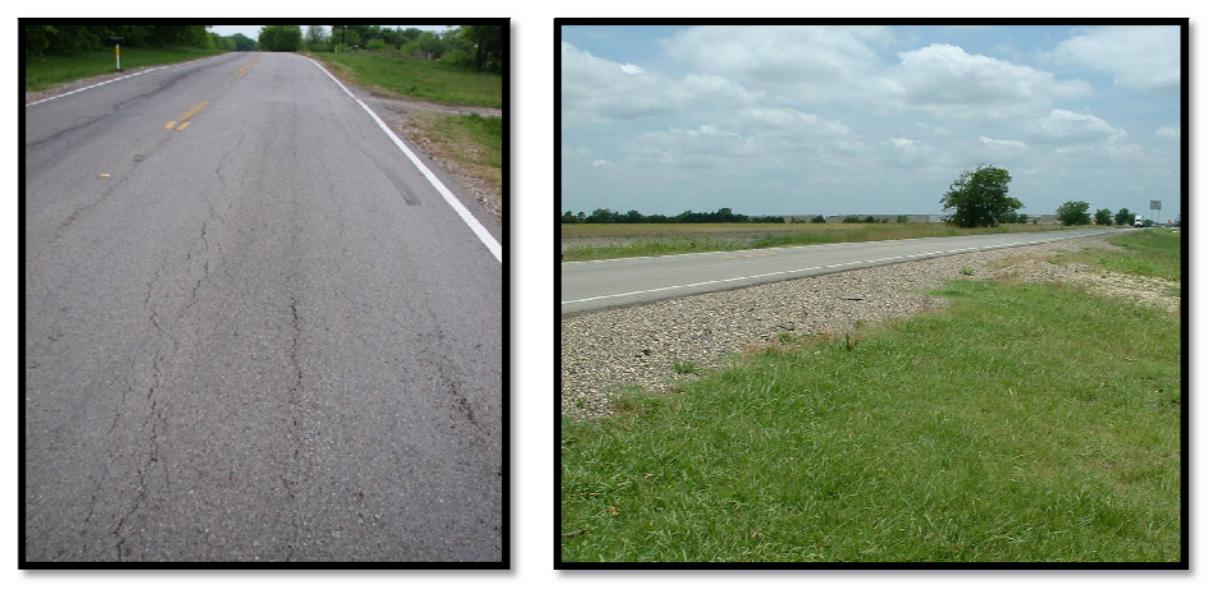
The Dallas District also constructed several projects where FDR employed dual treatment with cement and asphalt emulsion. The results were mixed, where on two projects, pavement distress recurred rapidly; on the third project, results were substantially improved. Figure 17 shows FM 429 and FM 548 after about 3 years of service, where distress has recurred on the former while the latter exhibited excellent overall condition.

Figure 17. Contrast of Performance on Projects with Cement/Asphalt Emulsion Treatment (L: FM 429; R: FM 548).

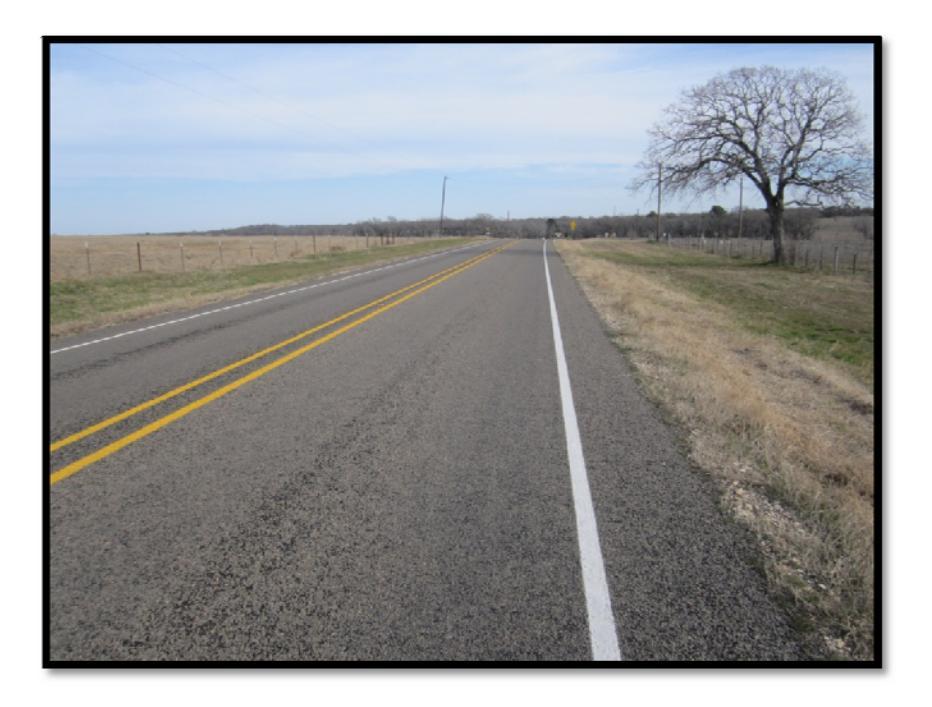
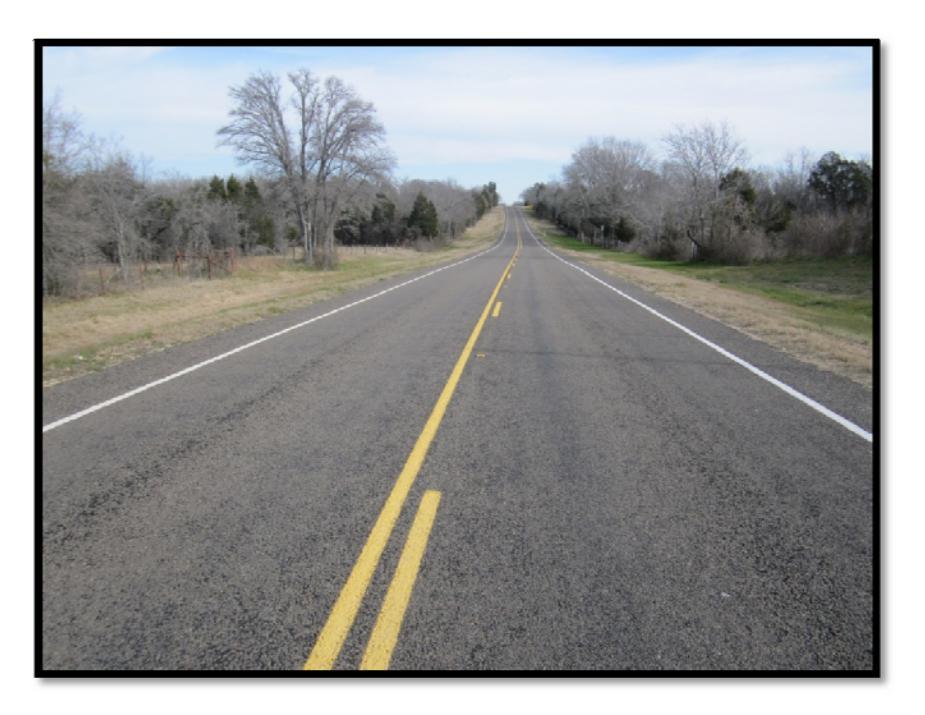
Figure 19. Representative Condition of FM 1712.

Figure 19. Representative Condition of FM 1712 (Cont.).

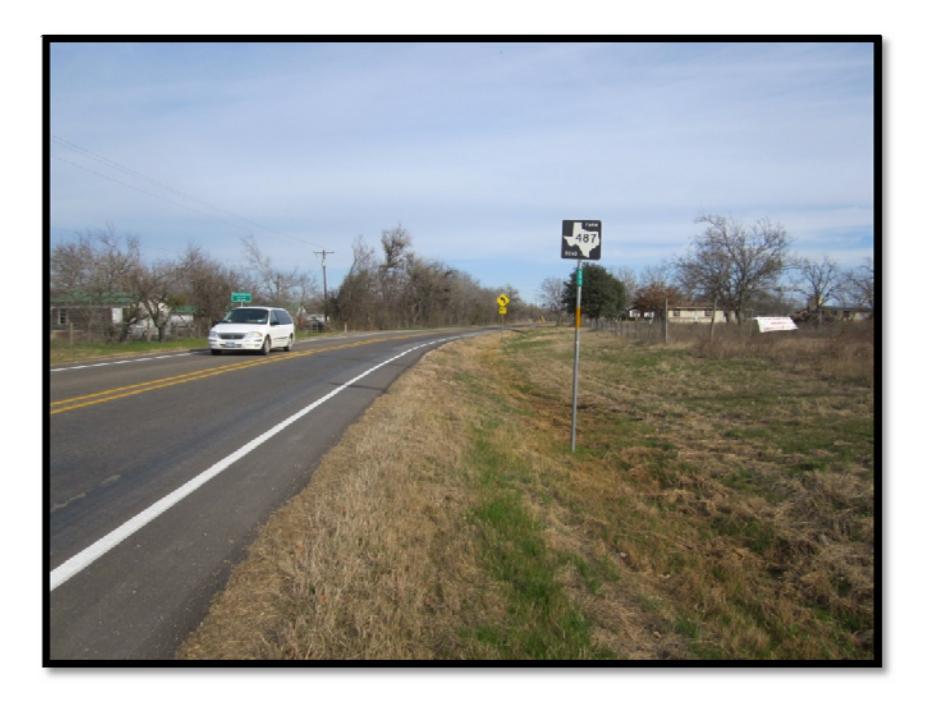
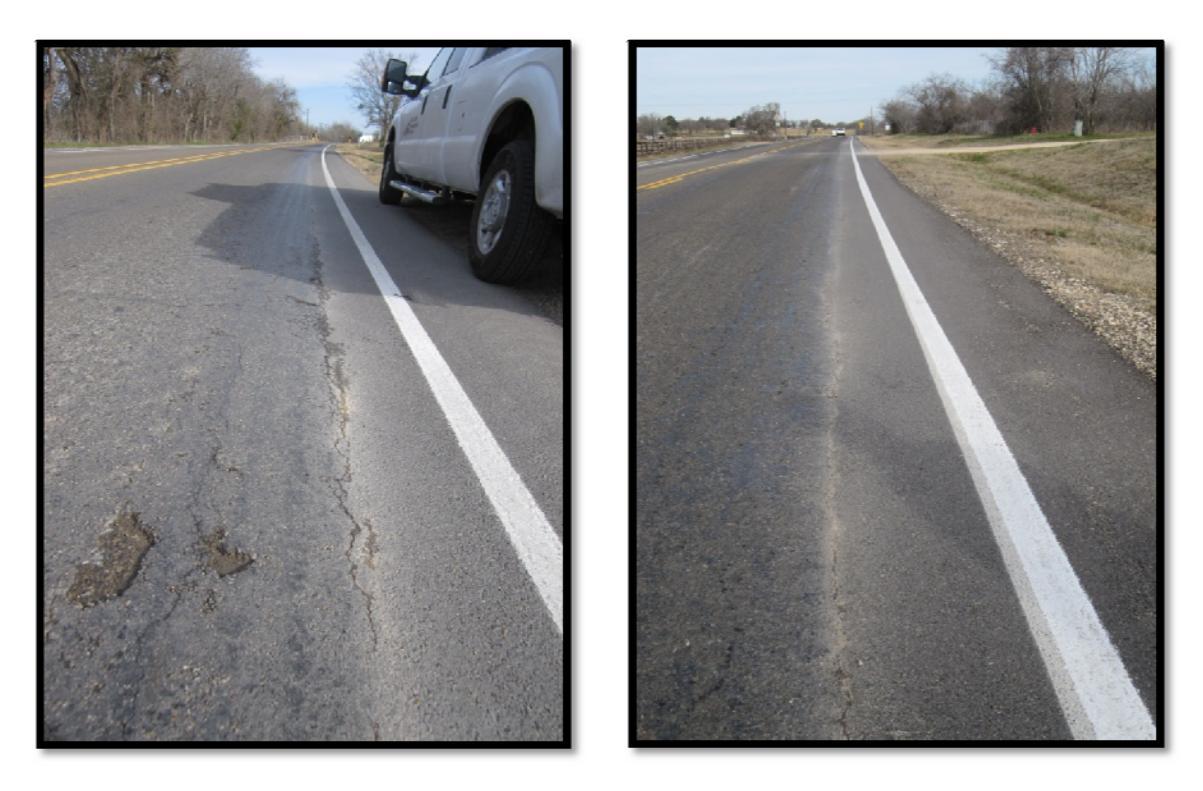
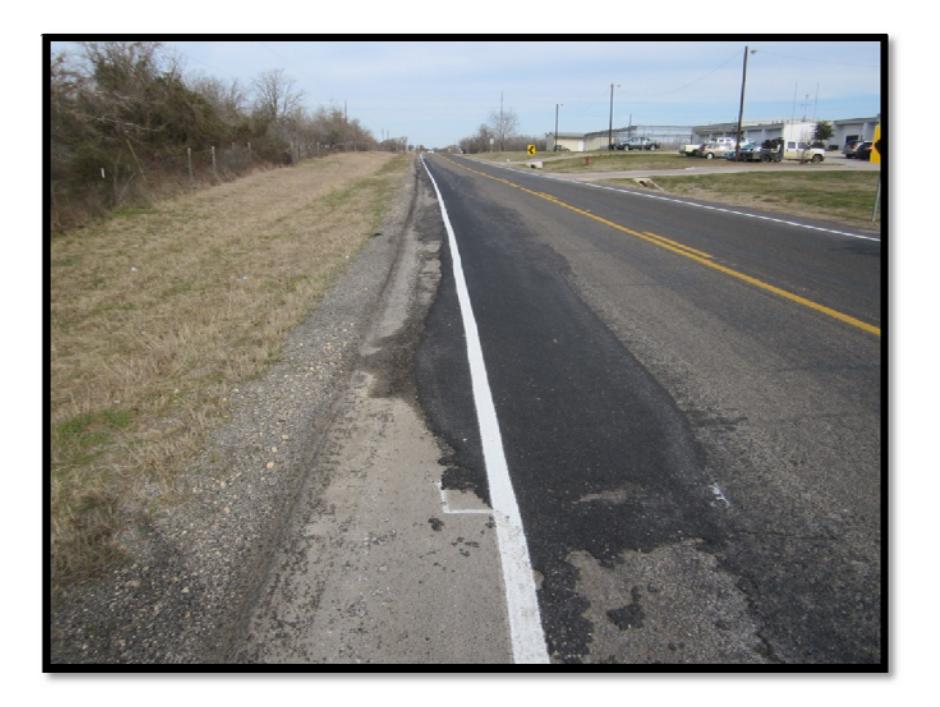
Figure 21 shows current conditions on FM 487. Problems exist at the longitudinal construction joint between the added shoulder and the existing pavement. In many locations a crack exists at the joint, resulting in pumping of fines and initiation of additional cracking in the vicinity. Several locations already exist where surface patches have been applied at the joint and shoulder.

Figure 21. Representative Condition of FM 487.

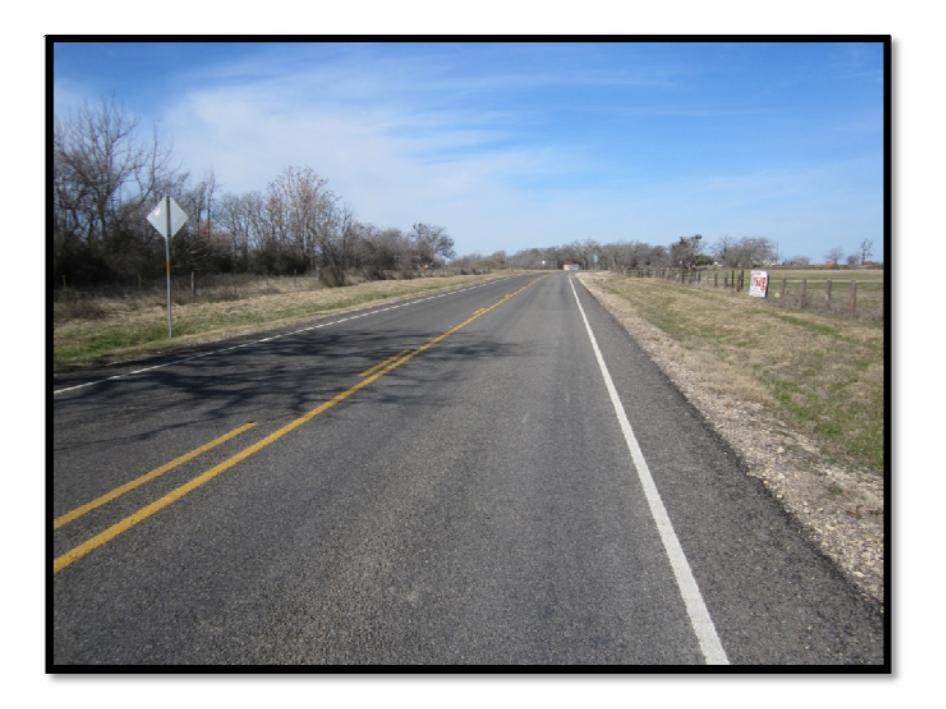
Figure 23 shows the representative current condition of the majority of the project, which shows no distress. However, localized edge distress exists near reference marker 404. Figure 24 illustrates the edge failure, where steep front slopes exist and longitudinal cracking and settlement have occurred at the pavement edge.

Figure 23. Representative Condition on FM 1600.

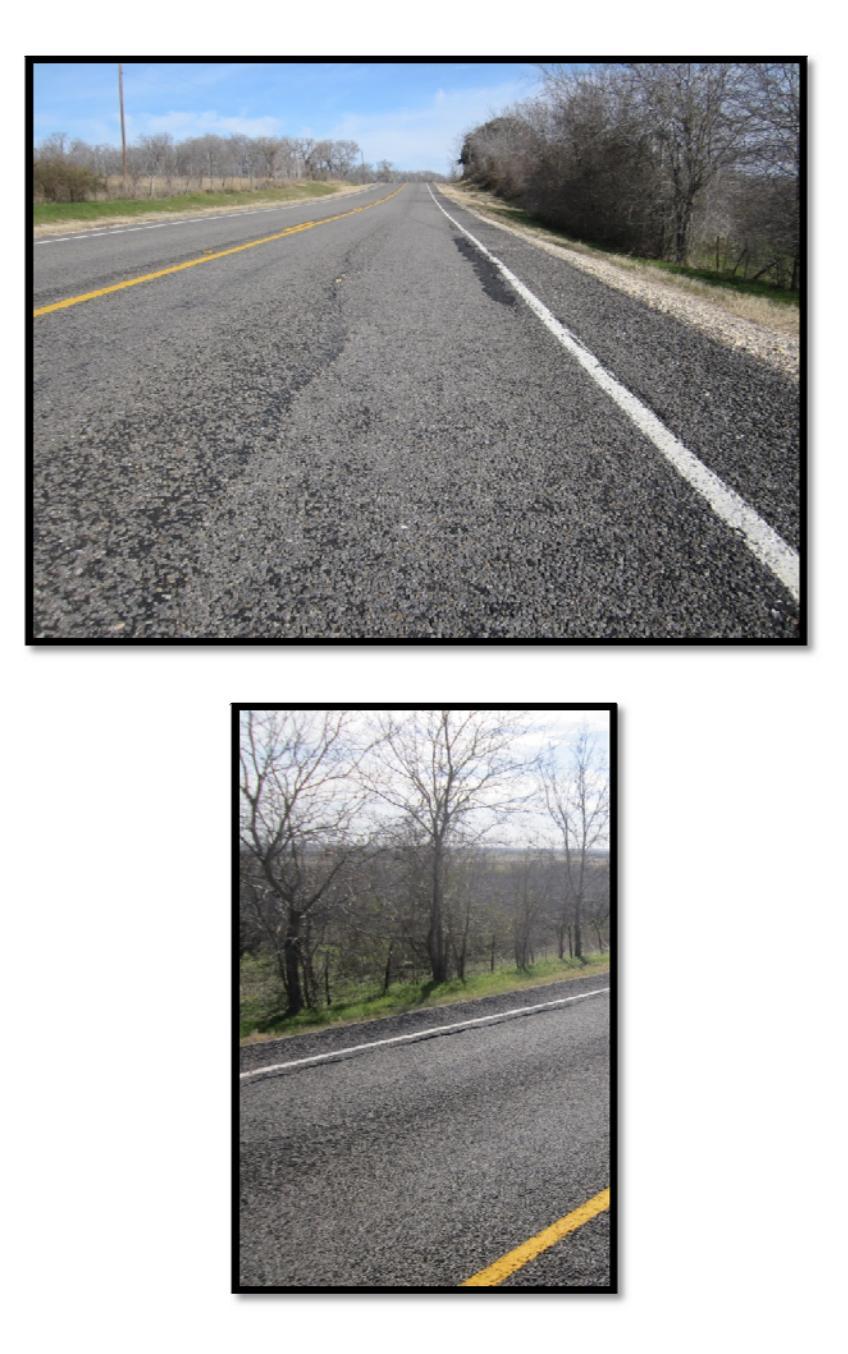
Figure 24. Localized Edge Distress on FM 1600.

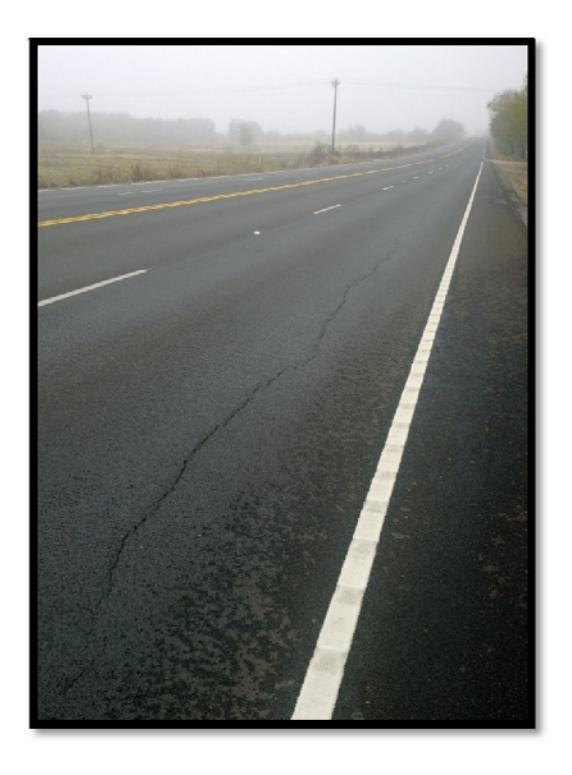
Currently, the section on SH 21 appears to be performing well with the exception of one crack shown in in Figure 26. Based on the distance of the crack from the pavement edge, it is uncertain whether the geogrid reinforcement extends under the pavement to the location of the crack.

Figure 26. Longitudinal Crack on SH 21.

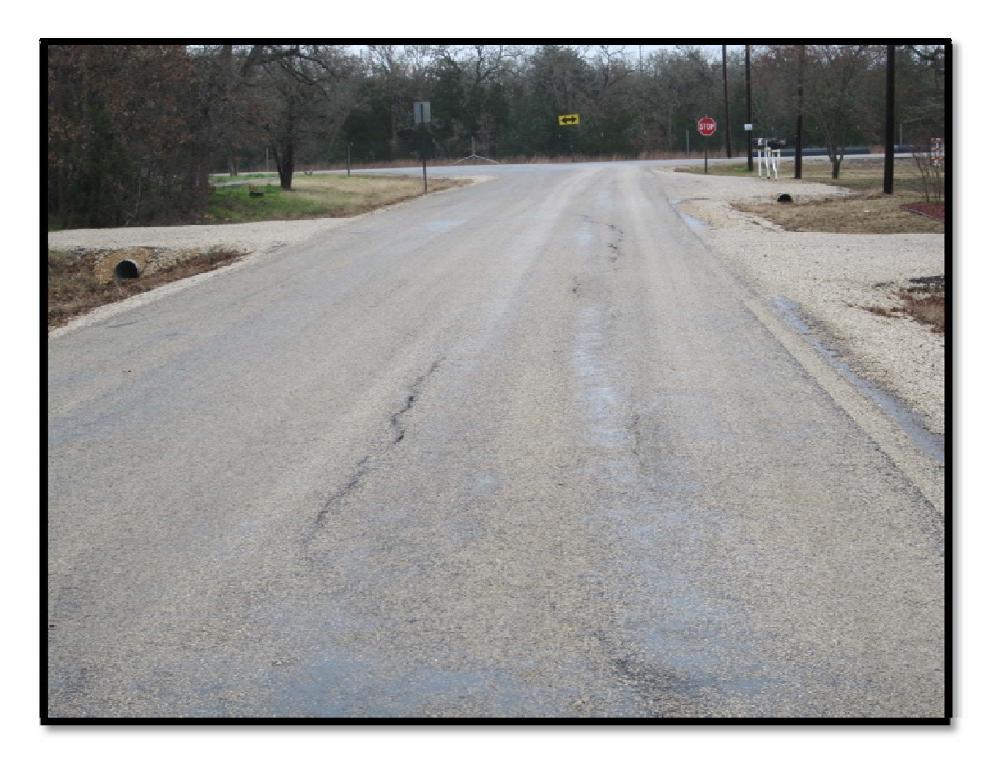
Figure 28. Section on Benchley Dr. without Geogrid.

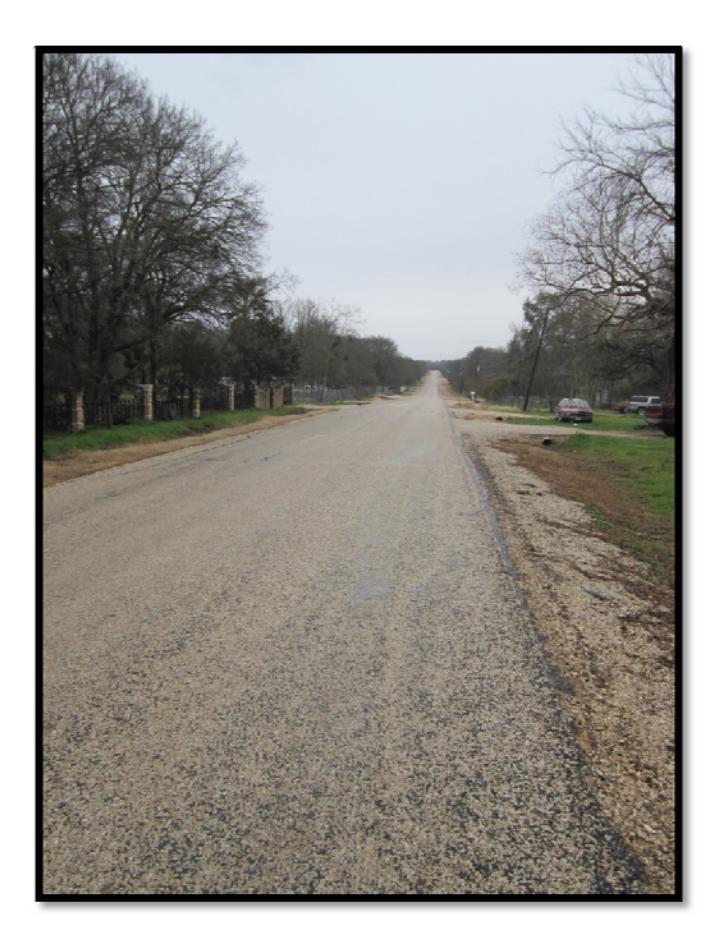
Figure 29. Representative Section on Benchley Dr. with Geogrid.

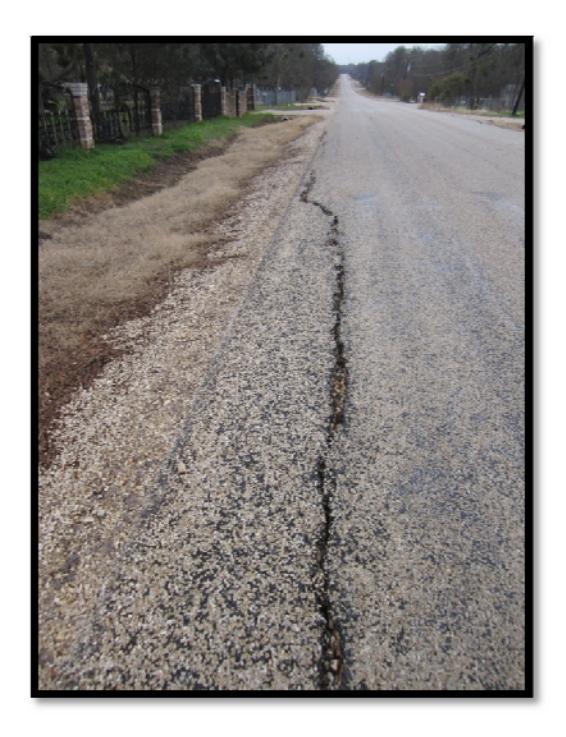
# Figure 30. Longitudinal Crack Observed in Section on Benchley Dr. with Geogrid.

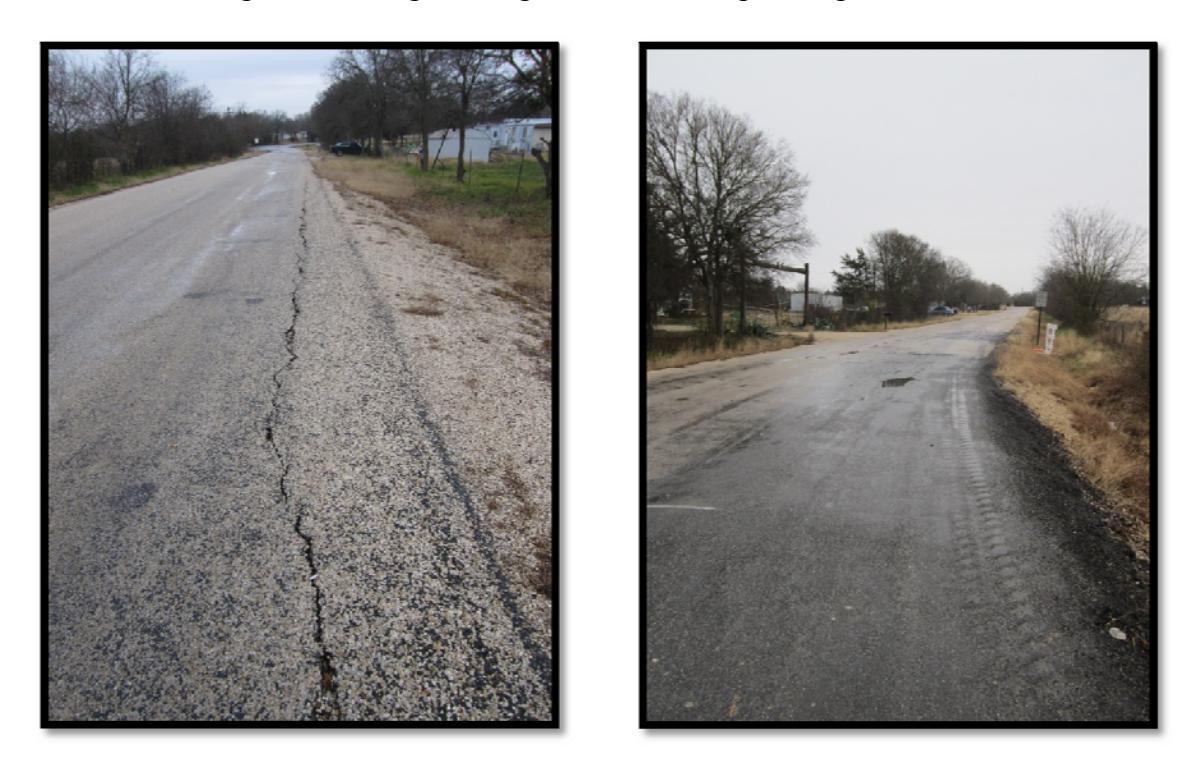
Figure 31 shows the current condition of Mumford Rd. reconstructed without geogrid in 2011. Substantial cracking exists, along with significant surface patching.

Figure 31. Current Condition of Mumford Rd.
