# Riprap Filters and Stability of Riprap-Covered Slopes: Technical Report

Technical Report 0-7091-R1

TEXAS A&M TRANSPORTATION INSTITUTE  
COLLEGE STATION, TEXAS

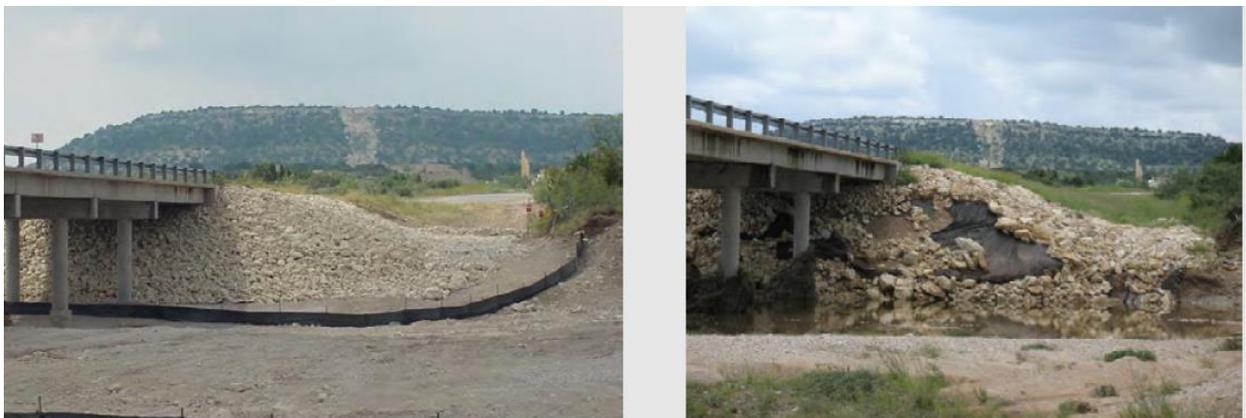
**Particle erosion** is considered the most common type of riprap-covered slope failure. Erosion (displacement) of the riprap stones at the toe of the slope will eventually lead to a failure of the riprap along the slope until the stream velocity is not high enough to move the remaining riprap stones lying near the channel (Figure 10). Figure 11 shows a riprap-covered slope failure due to toe erosion in Texas.

**Figure 11. Toe Erosion Slope Failure (Delphia, 2018).**

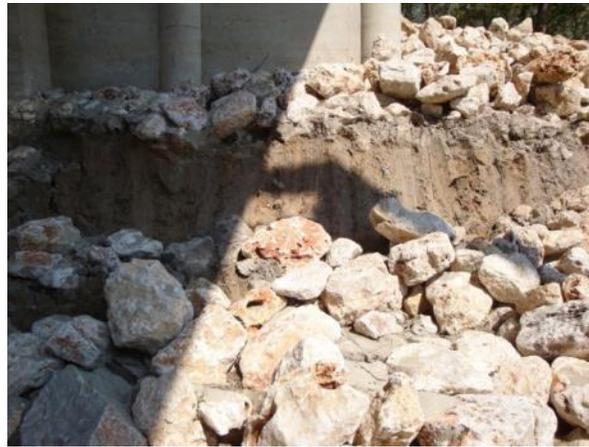
**Figure 67. Riprap-Covered Slope Failure (Briaud et al., 2010).**

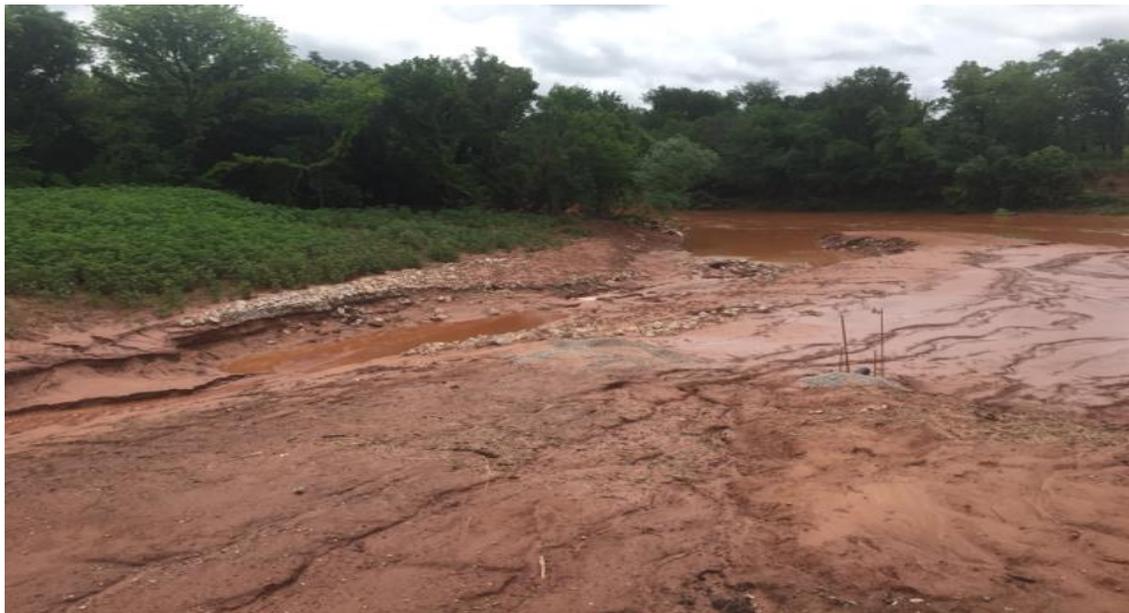
**Figure 85. Riprap-Covered Slope Failure (Courtesy of Oklahoma DOT).**

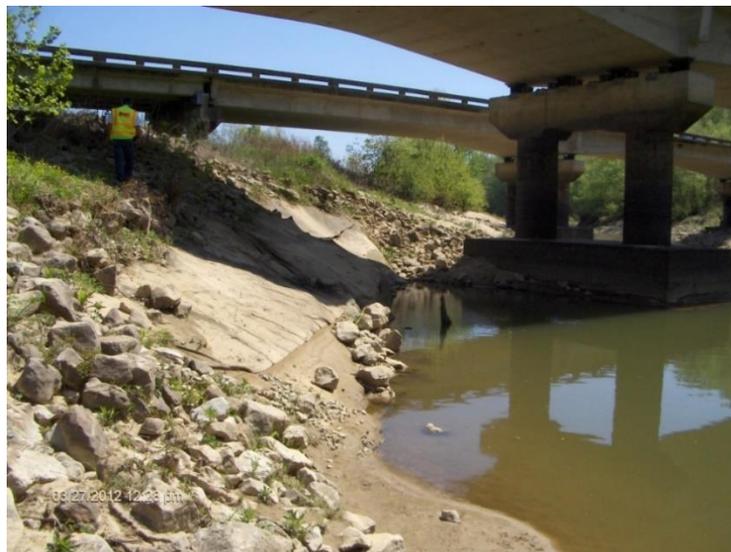
**Figure 87. Riprap Slope Failure (Courtesy of Mississippi DOT).**

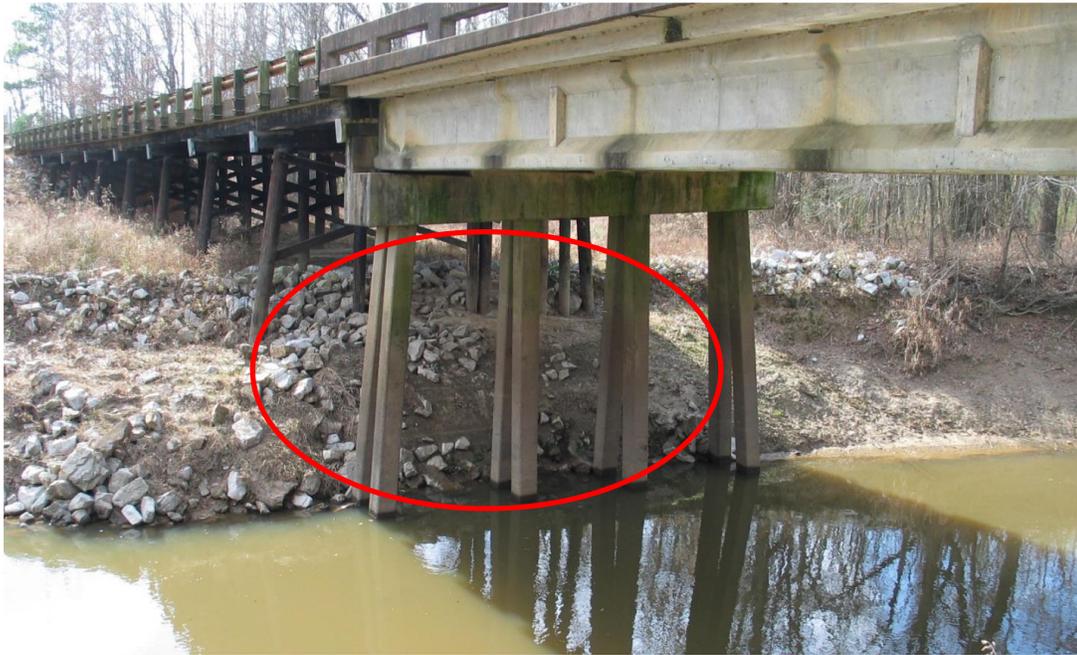
**Figure 88. Riprap Slope Failure (Courtesy of Mississippi DOT).**

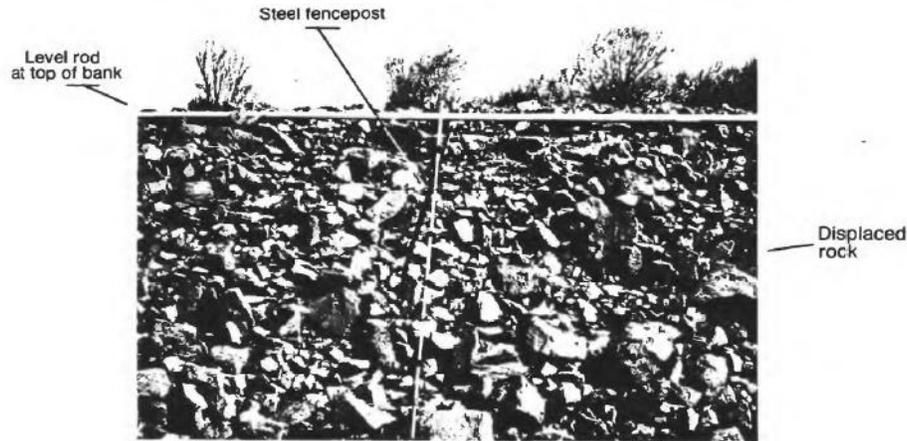
**Figure 90. Site E-10 over Sacramento River Riprap Failure (Blodget & McConaughy, 1986).**

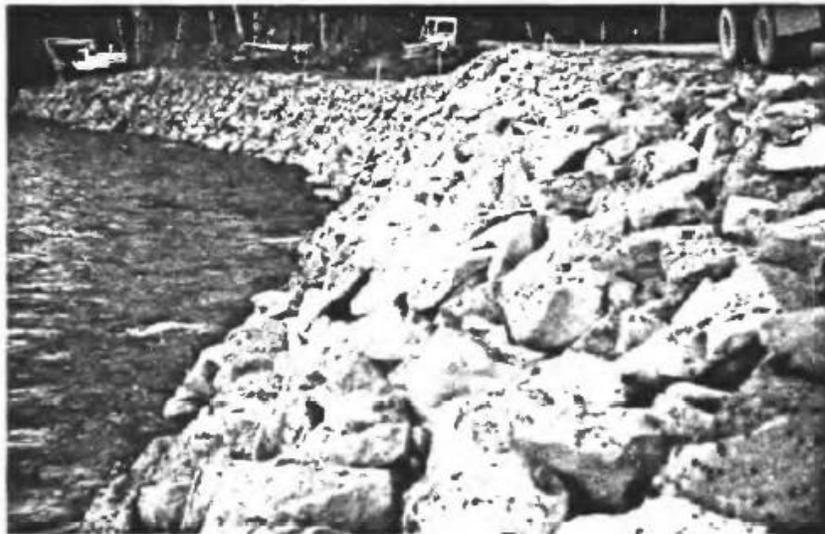
**Figure 91. Hoh River at Site 1 Forks Riprap Failure (Blodget & McConaughy, 1986).**

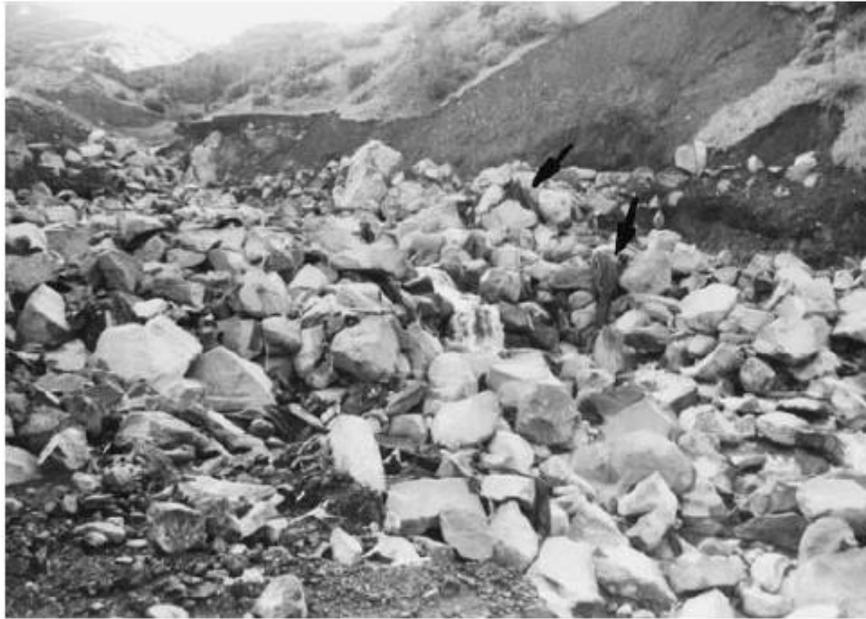
View is looking upstream. Woven-tape geotextile (slit-film) marked with arrows is inappropriate as RSP-fabric on banks (photographed May 1995)

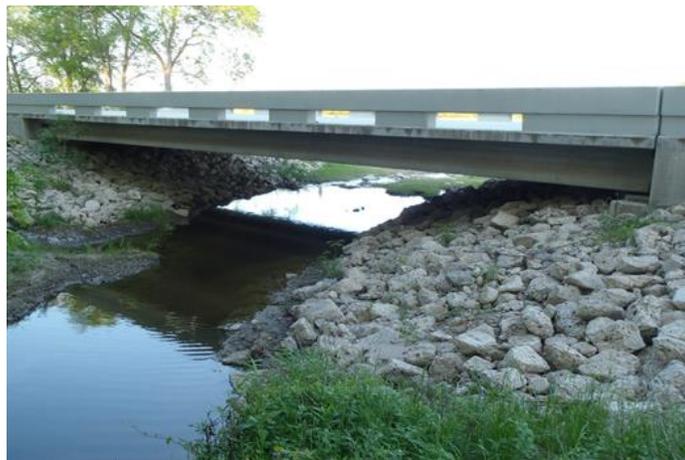
**Figure 97. FM 1155 Little Sandy Creek Riprap Failure (Courtesy of TxDOT).**

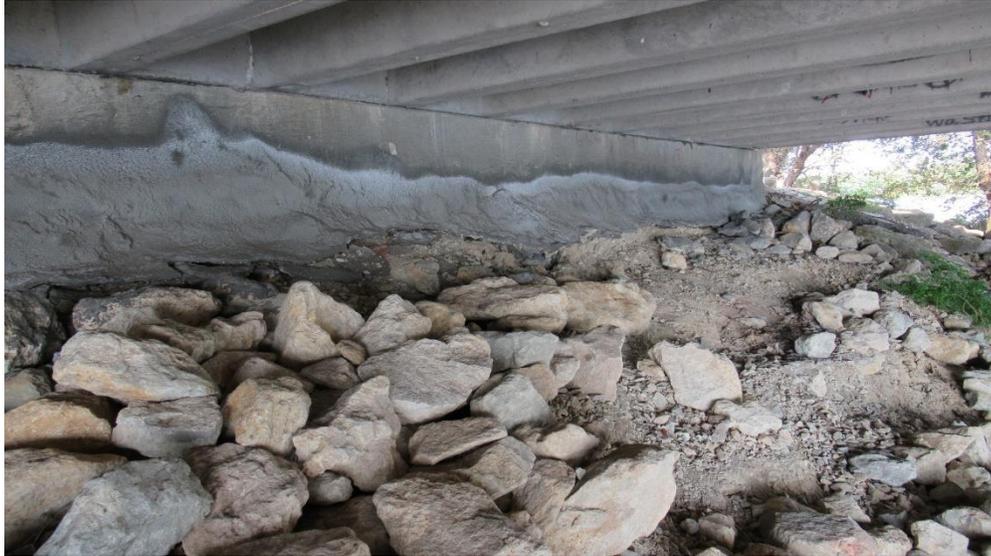
**Figure 100. SH 78 over Price Creek Riprap Slope Failure (Courtesy of TxDOT).**

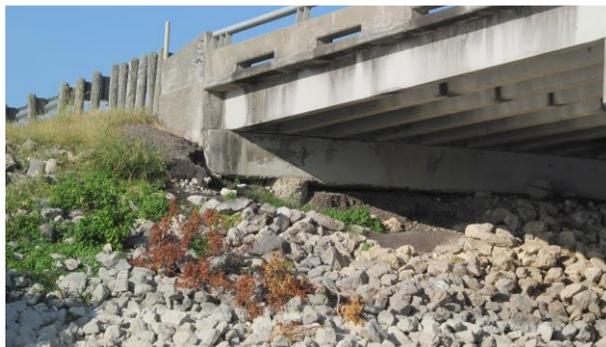
**Figure 101. FM 982 over Tickey Creek Riprap Slope Failure (Courtesy of TxDOT).**

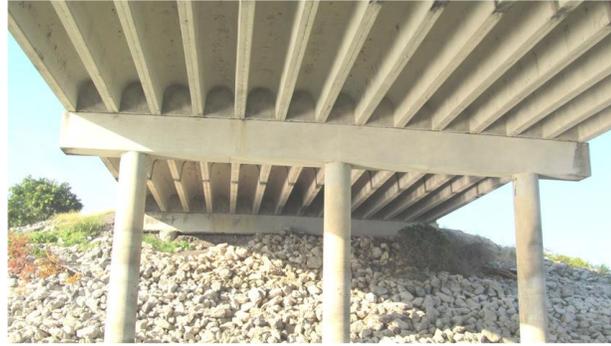
**Figure 102. FM 982 over Tickey Creek Riprap Slope Failure (Courtesy of TxDOT).**

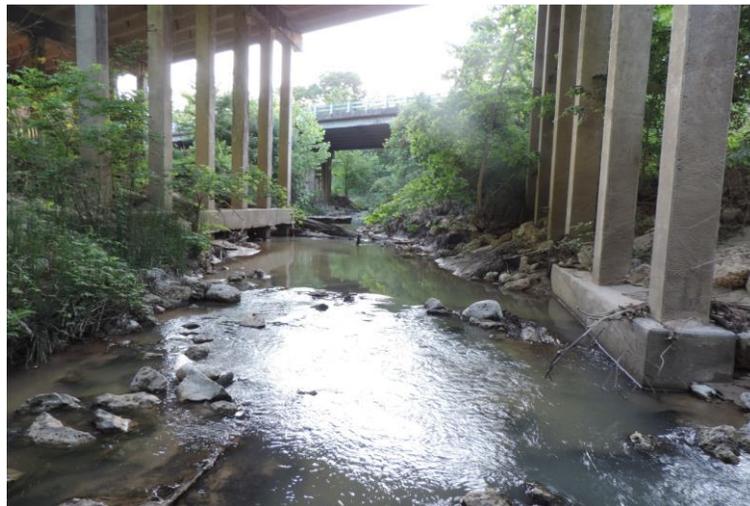
**Figure 103. US 59 over Morgan Creek Riprap-Covered Slope Failure (Courtesy of TxDOT).**

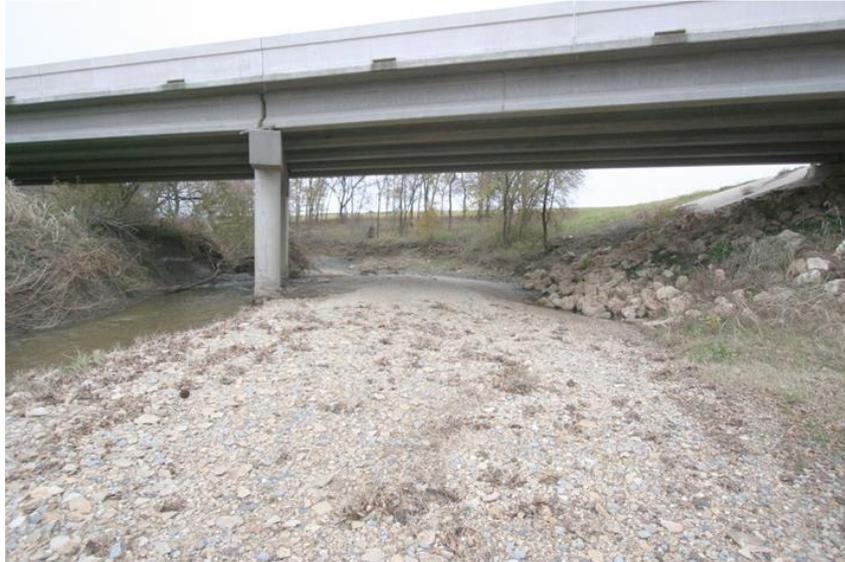
**Figure 104. IH 35 NBFR over Cobb Creek Riprap Slope Failure (Courtesy of TxDOT).**

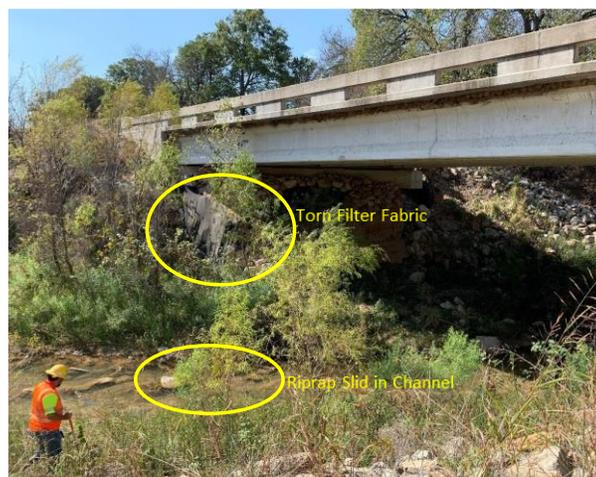
**Figure 106. FM 667 Cobb Hollow Riprap Slope Failure (Courtesy of TxDOT).**

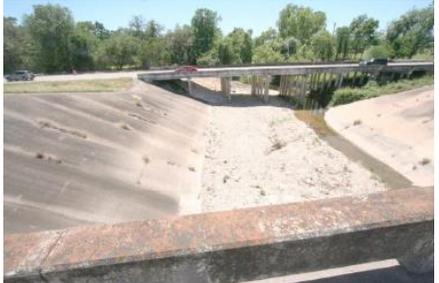
42	TxDOT	SH 71 EB over Rocky Creek - Yoakum	Concrete riprap being repaired by re-installing concrete riprap, but failed again. Rock riprap will be installed instead.

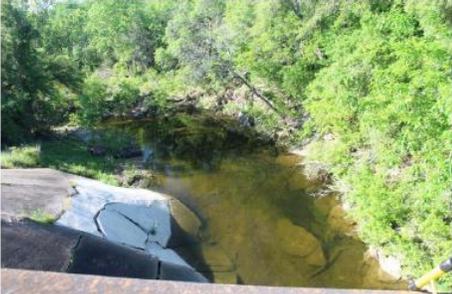
43	TxDOT	FM 667 Cobb Hollow - Wichita Falls	Riprap Washed away
