Performance and Improvement of Texas Poor Boy Continuous Bridge Deck Details: Final Report

Technical Report 0-7013-R1

TEXAS A&M TRANSPORTATION INSTITUTE COLLEGE STATION, TEXAS

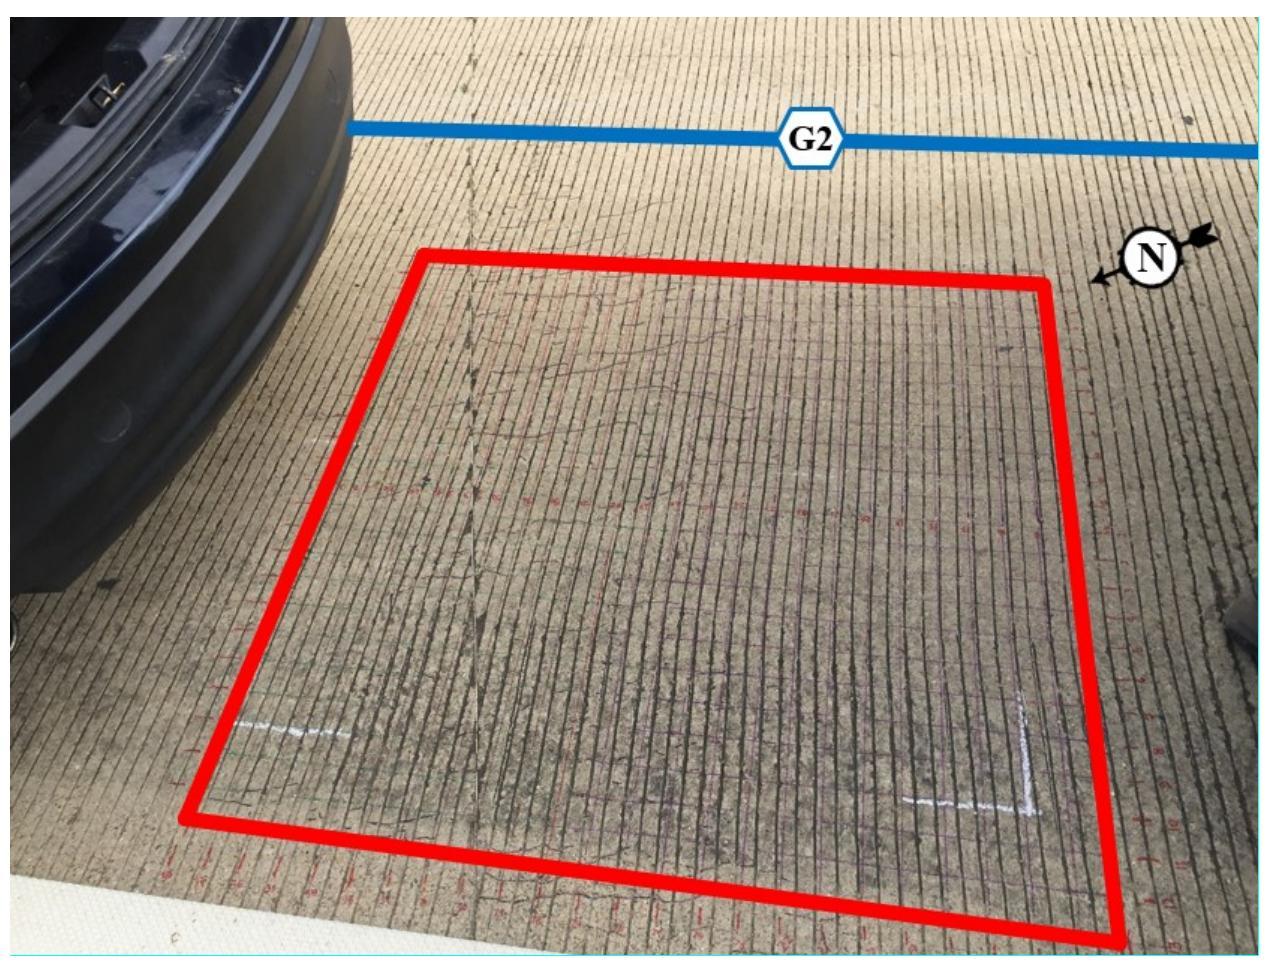
Figure 4.12. NDE region at Bent 3 for Bridge ATL2 (FM 250 over Black Cypress Creek).

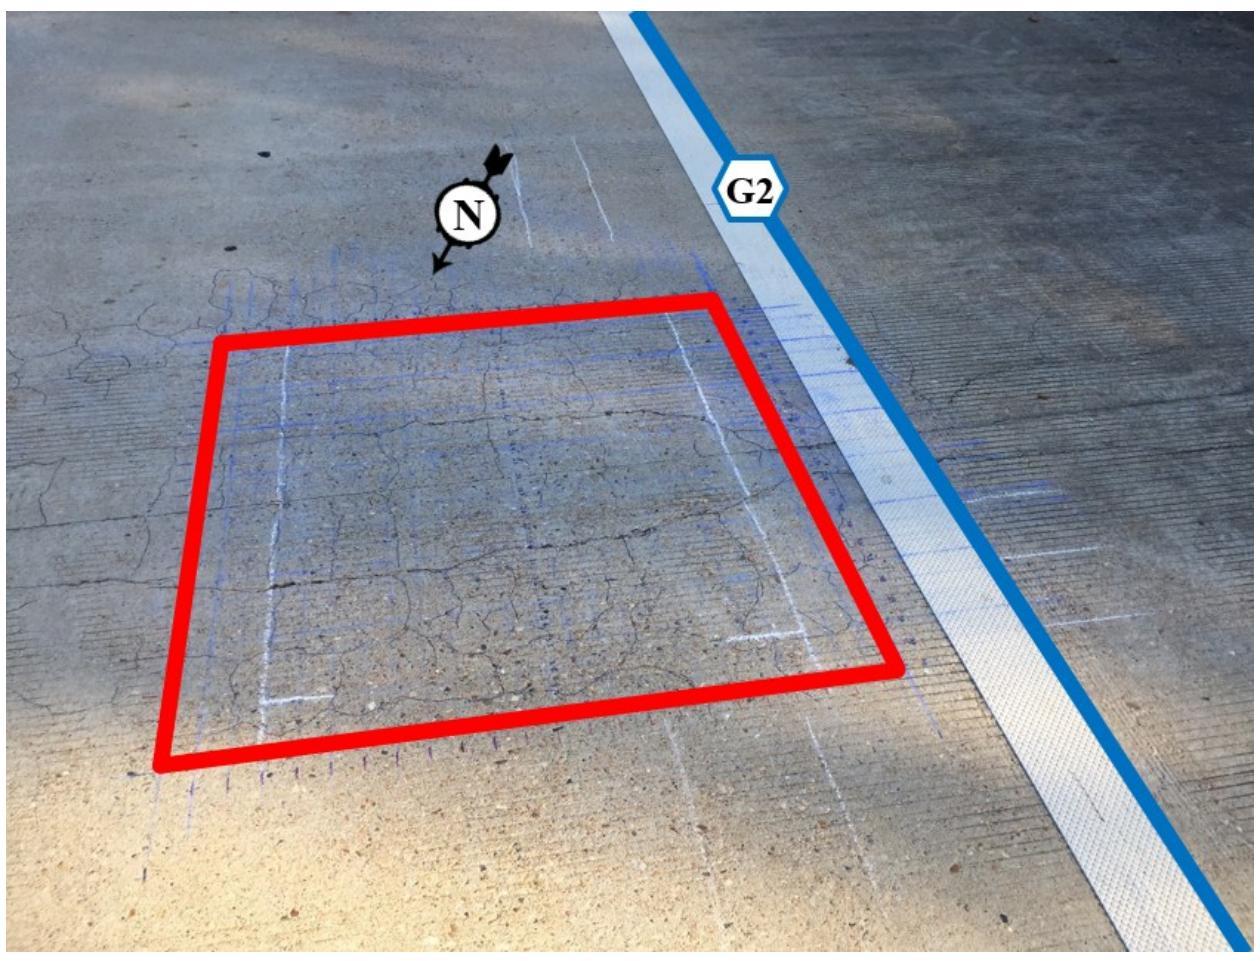
Figure 4.19. NDE region at Bent 3 for Bridge A3 (FM 154 over Little Cypress Bayou).

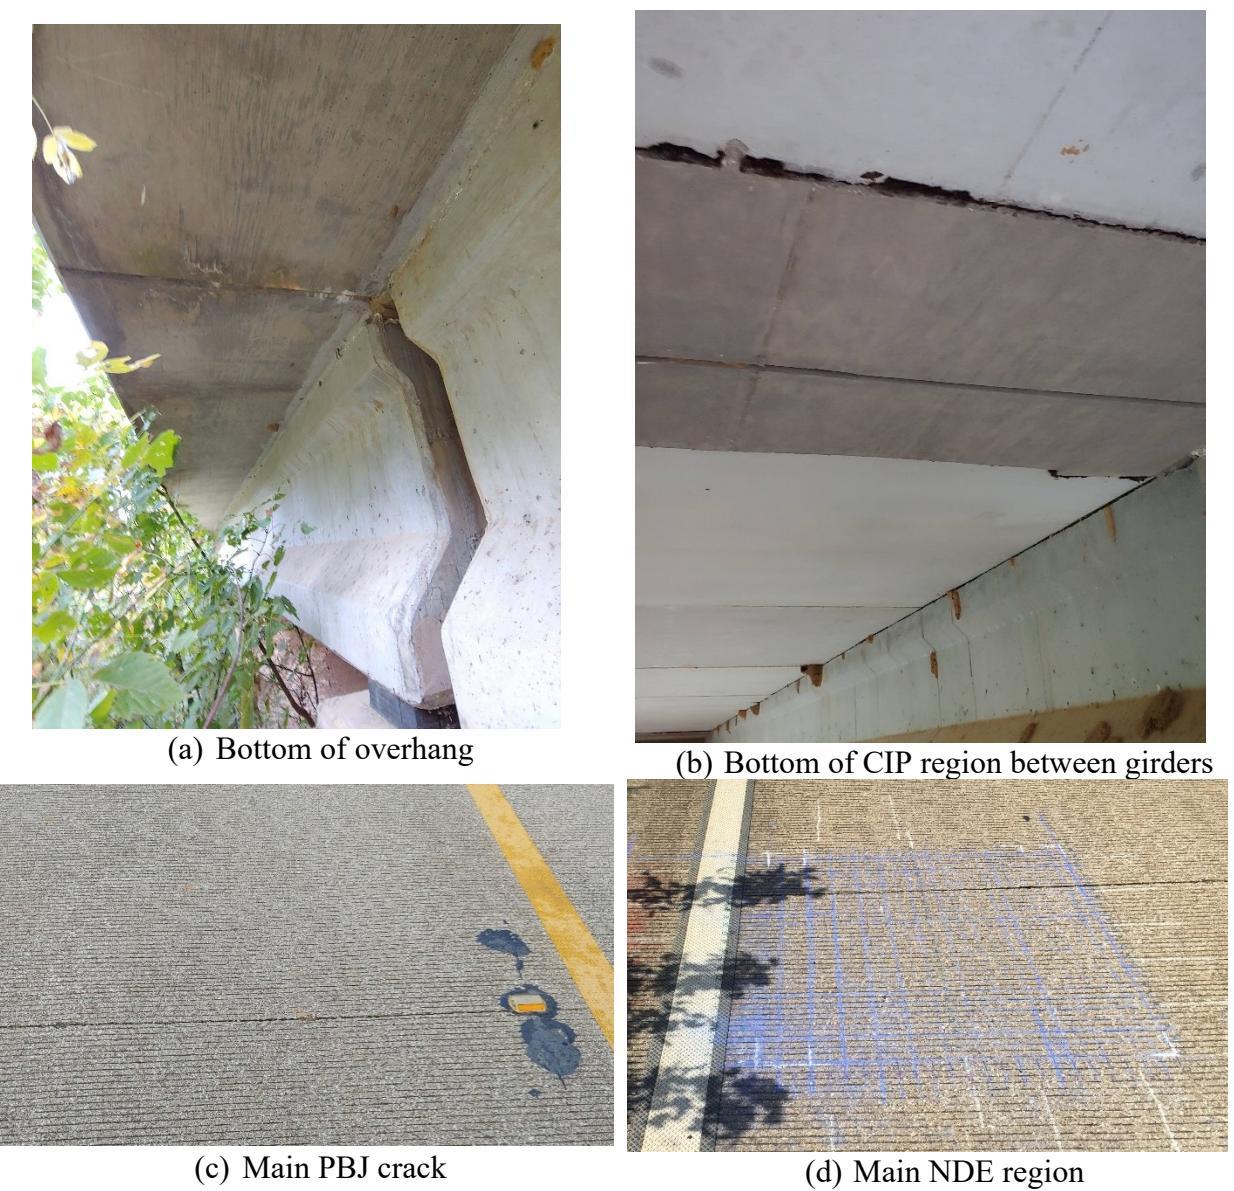
Figure 4.26. Typical link slab condition for Bridge ATL4 (FM 968 over Clarks Creek).

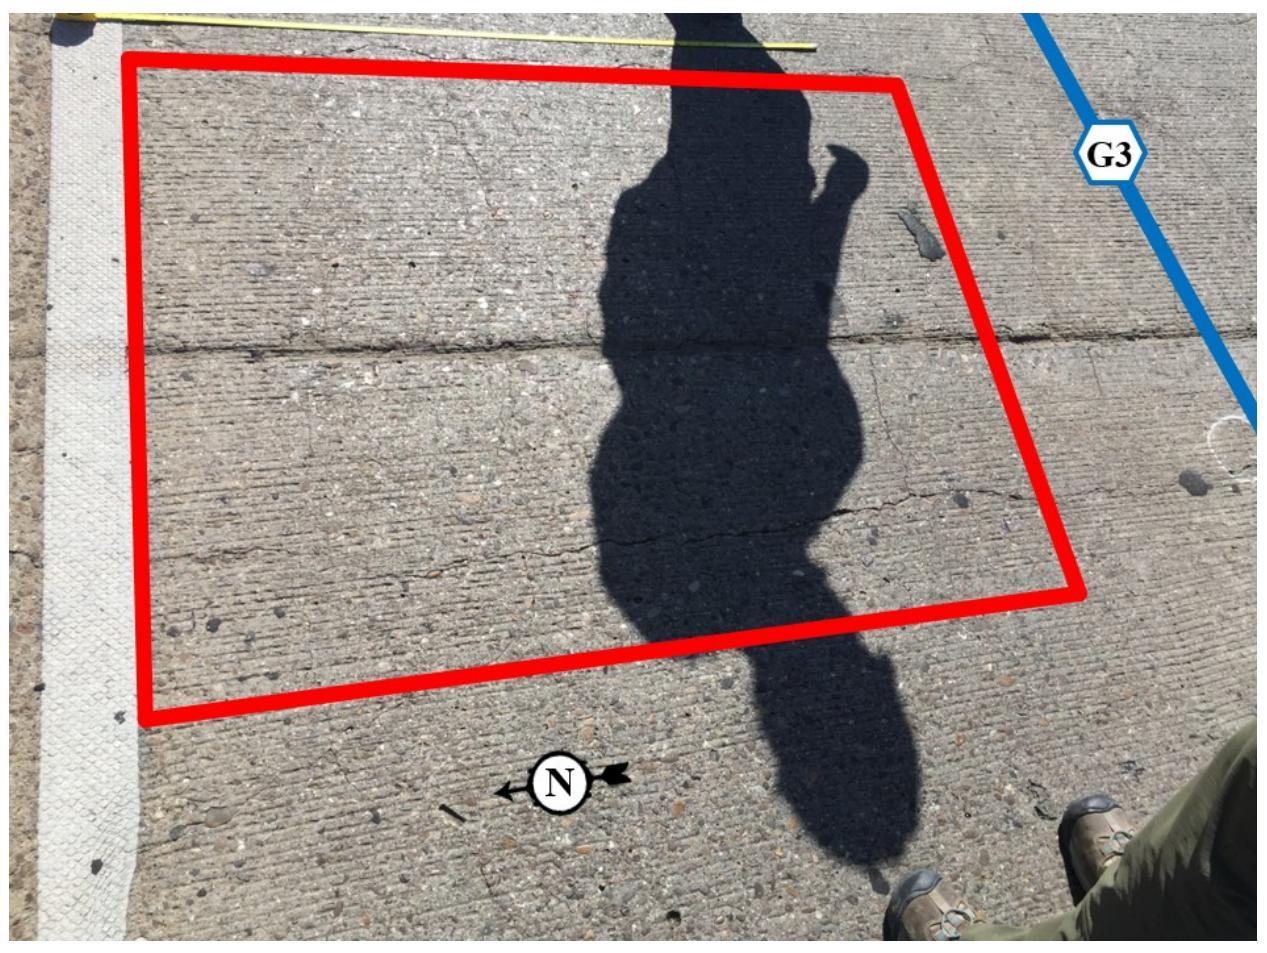
Figure 4.55. Primary NDE region at Bent 3 between G2 and G3 at Bridge LUB4 (WB Loop 289 over University Ave.).

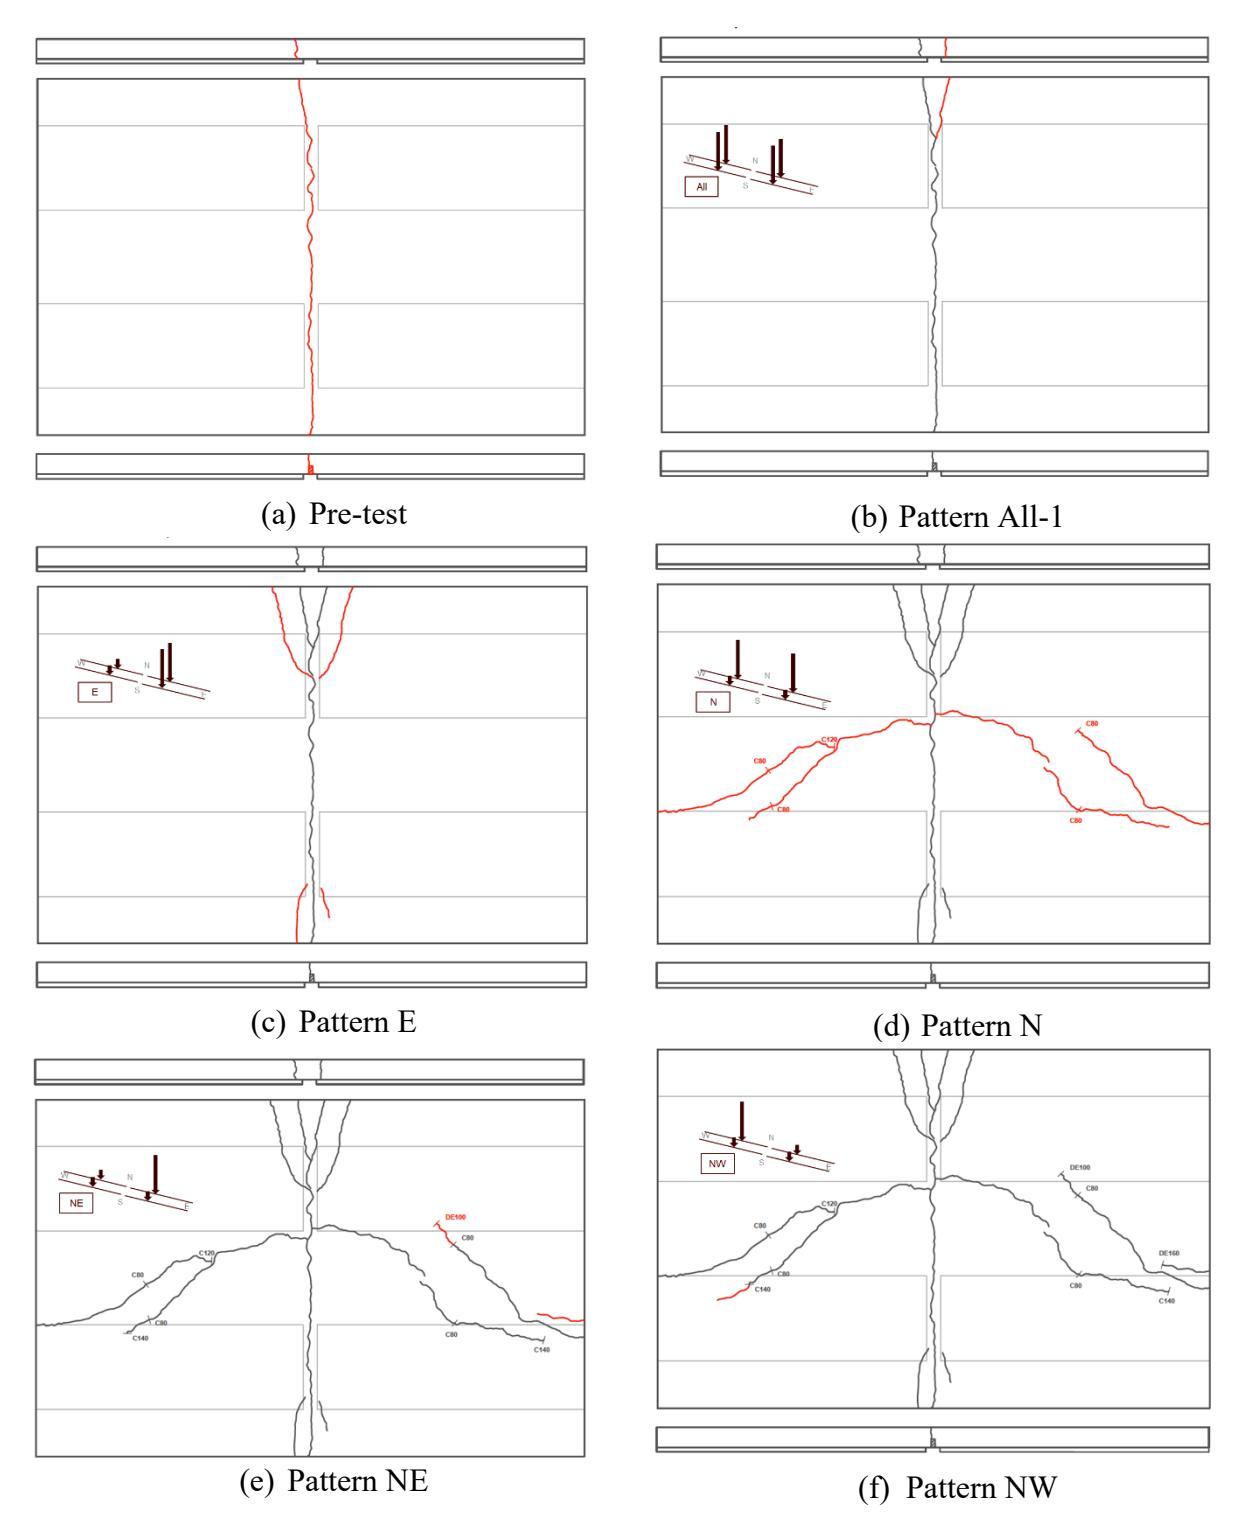
Figure 9.47. PBJ-FP1: Crack patterns at various stages of testing.

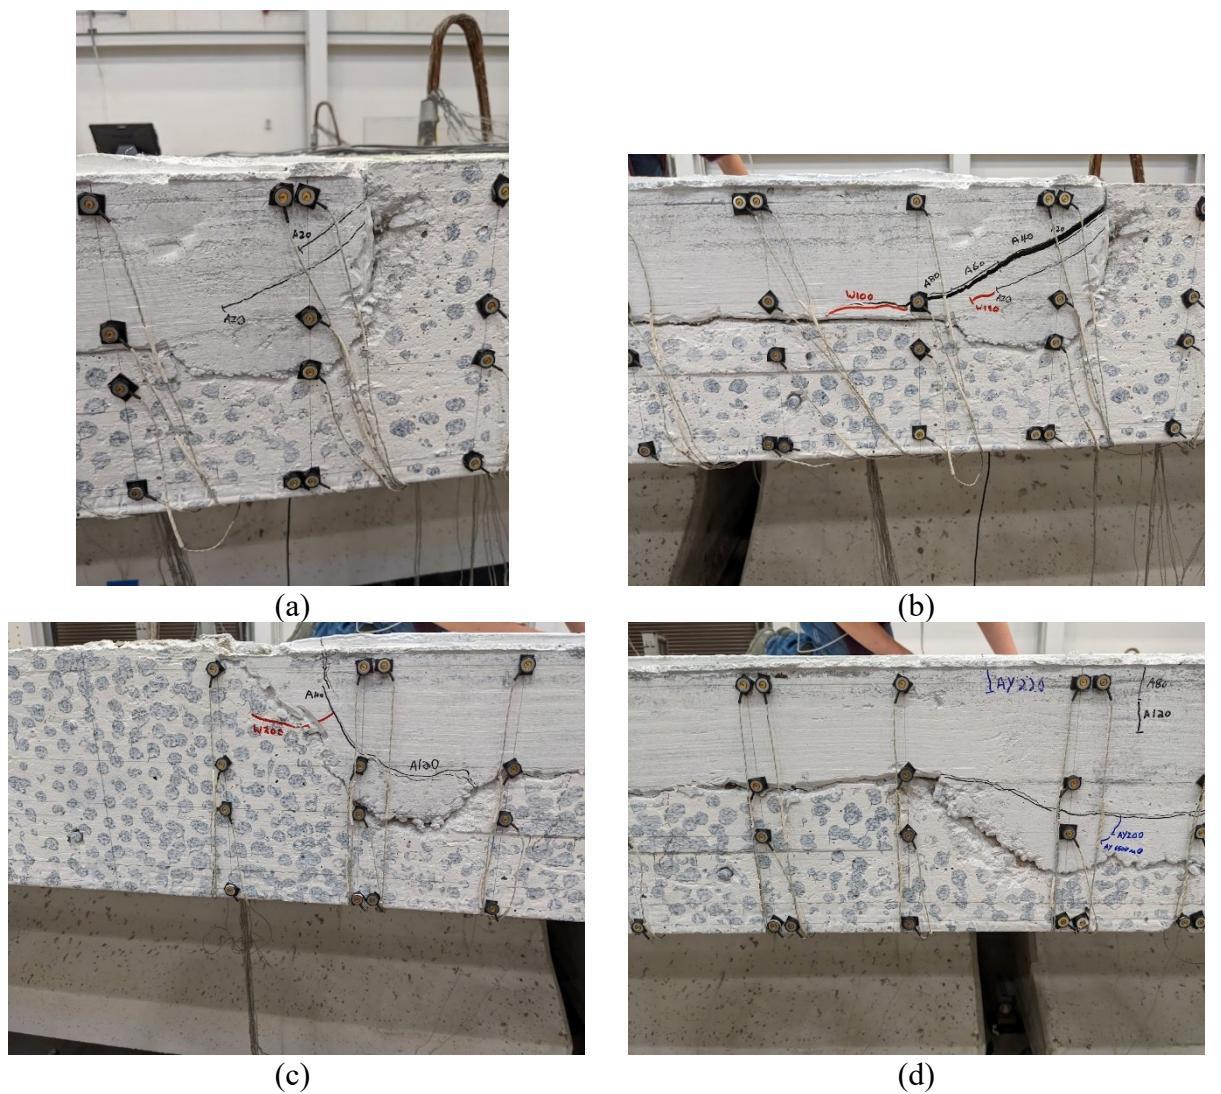
Figure 9.54. PBJ-OP1R—north overhang of HPC retrofit region: (a) diagonal cracks formed at west end during loading to 20 kips of Pattern All-1; (b) west end after all loading; (c) east end after all loading; and (d) shallow vertical cracks at center of slab after all loading.
