Evaluation of Corrosion Prevention and Mitigation Approaches Used on Texas Bridges—Volume 2: Reinforced Concrete Bridges

Technical Report 0-7040-R1-Vol2

TEXAS A&M TRANSPORTATION INSTITUTE COLLEGE STATION, TEXAS

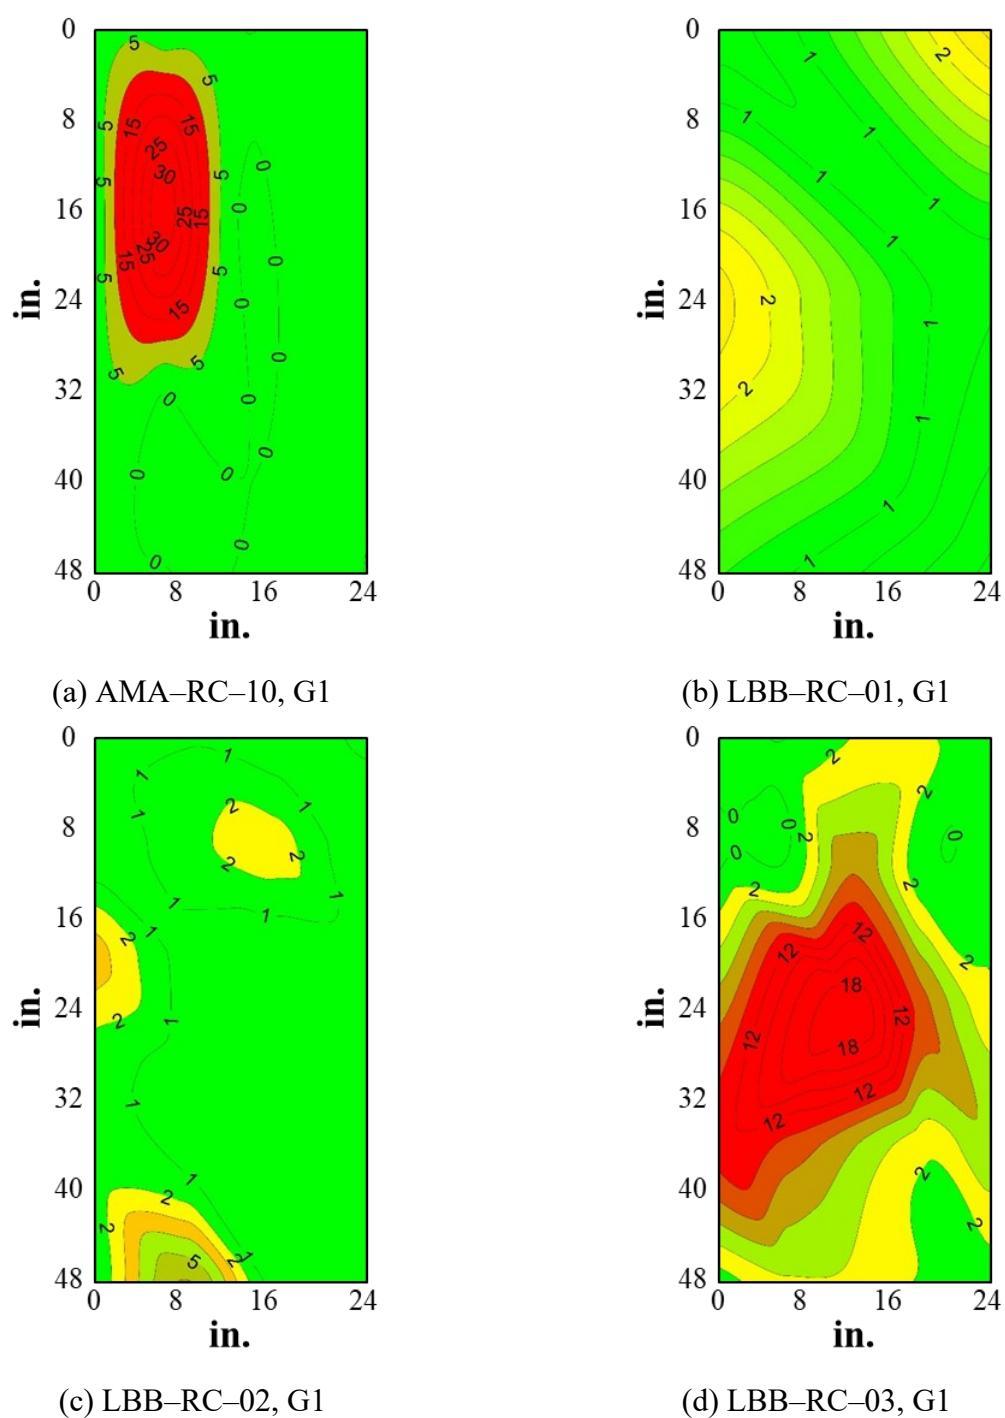
Figure 3.26 illustrates the corrosion rate mapping developed for concrete decks in Region 6, including AMA–RC–10, LBB–RC–01, LBB–RC–02, LBB–RC–03, LBB–RC–04, LBB–RC–06, and LBB–RC–07. Among these bridges, LBB–RC–01, LBB–RC–02, LBB–RC–04, LBB–RC–05, and LBB–RC–07 were determined to be in a moderate condition in terms of corrosion rate. These concrete structures exhibited corrosion damage within the range of 10 to 15 years. On the other hand, AMA–RC–10, LBB–RC–03, and LBB–RC–06 had high corrosion rates and were expected to have corrosion damage within the range of 2 to 10 years. Only limited areas of LBB–RC–03 and LBB–RC–06 showed corrosion rates of 18 and 15 μ A/cm², respectively. AMA–RC–10 G1 exhibited a corrosion rate of 30 μ A/cm² in a very limited area.

(d) LBB-RC-02, G1 Figure 3.26. Corrosion Rate Mapping Results of Bridges in Region 6, Corrosion Current Density (μA/cm²).

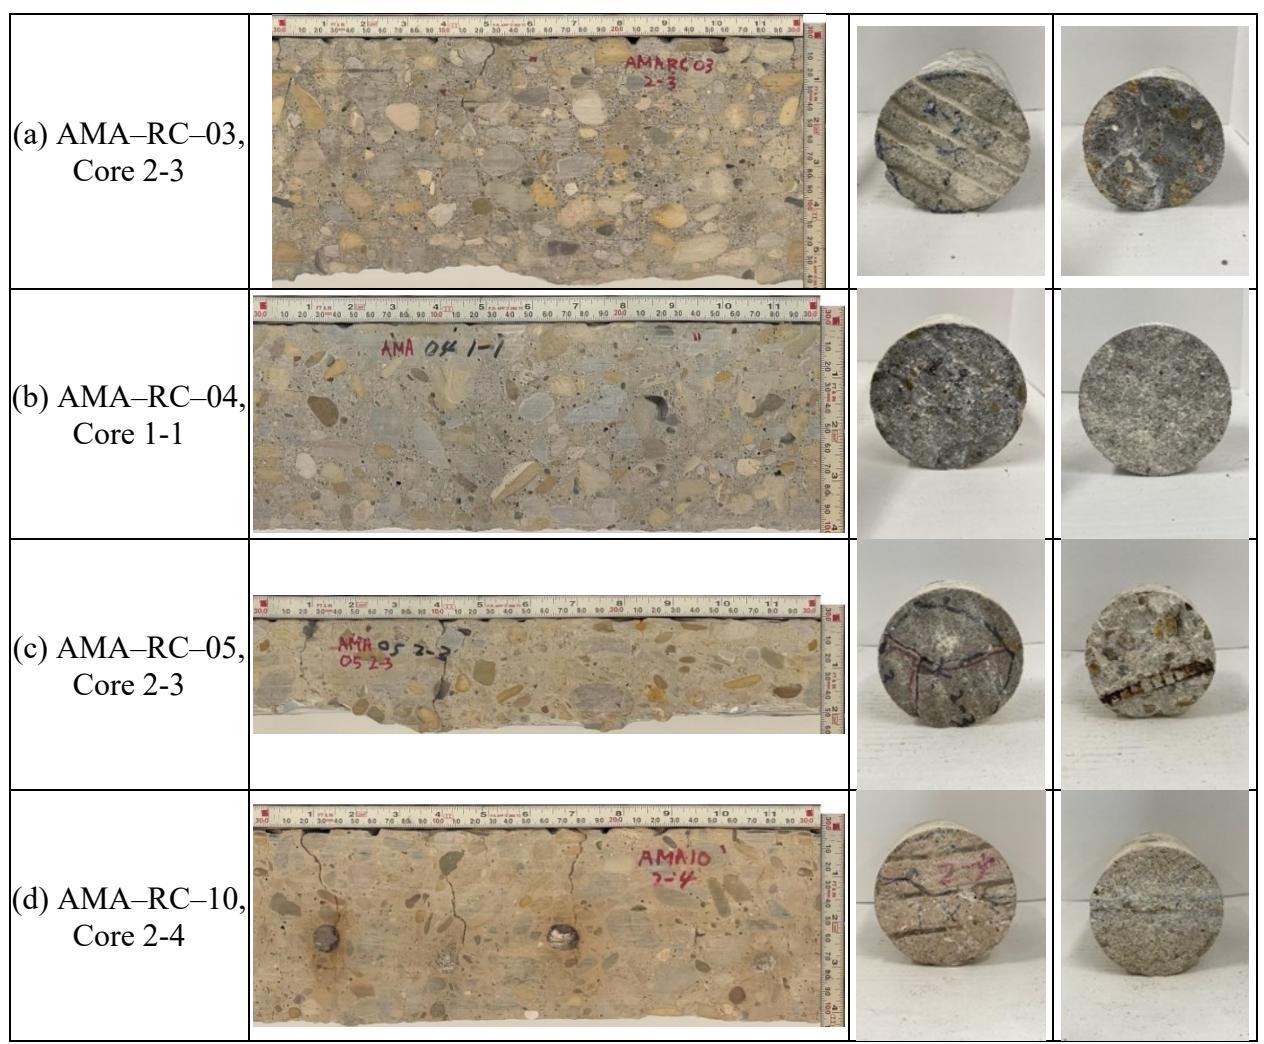
Figure 3.28. Pictures of Cores with Deterioration.

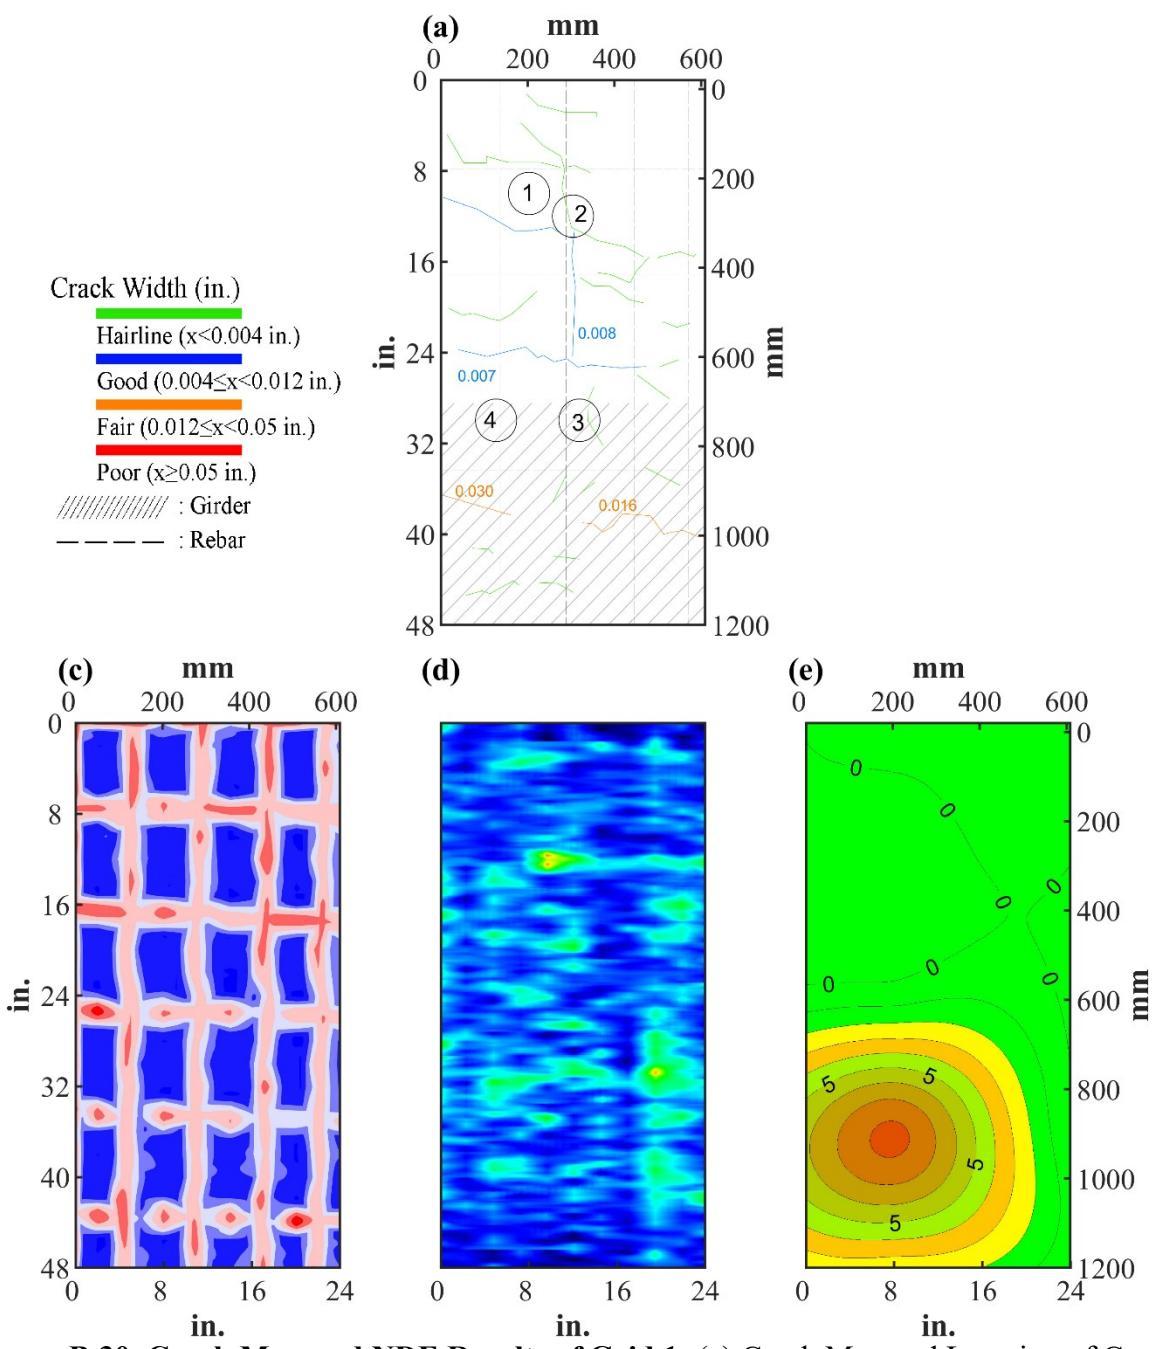
As shown in Figure B.30 (a) cracks with different width exist. On grid 1, the widest crack with 0.3 in. width was located on top. Figure B.30 (e) shows possibility of corrosion near lower left of the grid. Based on Figure A.4.5 (b), the widest crack on grid 2 was also 0.3 in. wide, but in overall, cracks were wider in grid 2. Based on Figure B.31 (e) grid 2 has very low possibility of corrosion.

Figure B.30. Crack Map and NDE Results of Grid 1: (a) Crack Map and Location of Cores; (c) GPR C-scan at 1.9 in. to 3.1 in. Depth; (d) UST C-scan at 4.32 in. Depth; (e) Corrosion Rate Map

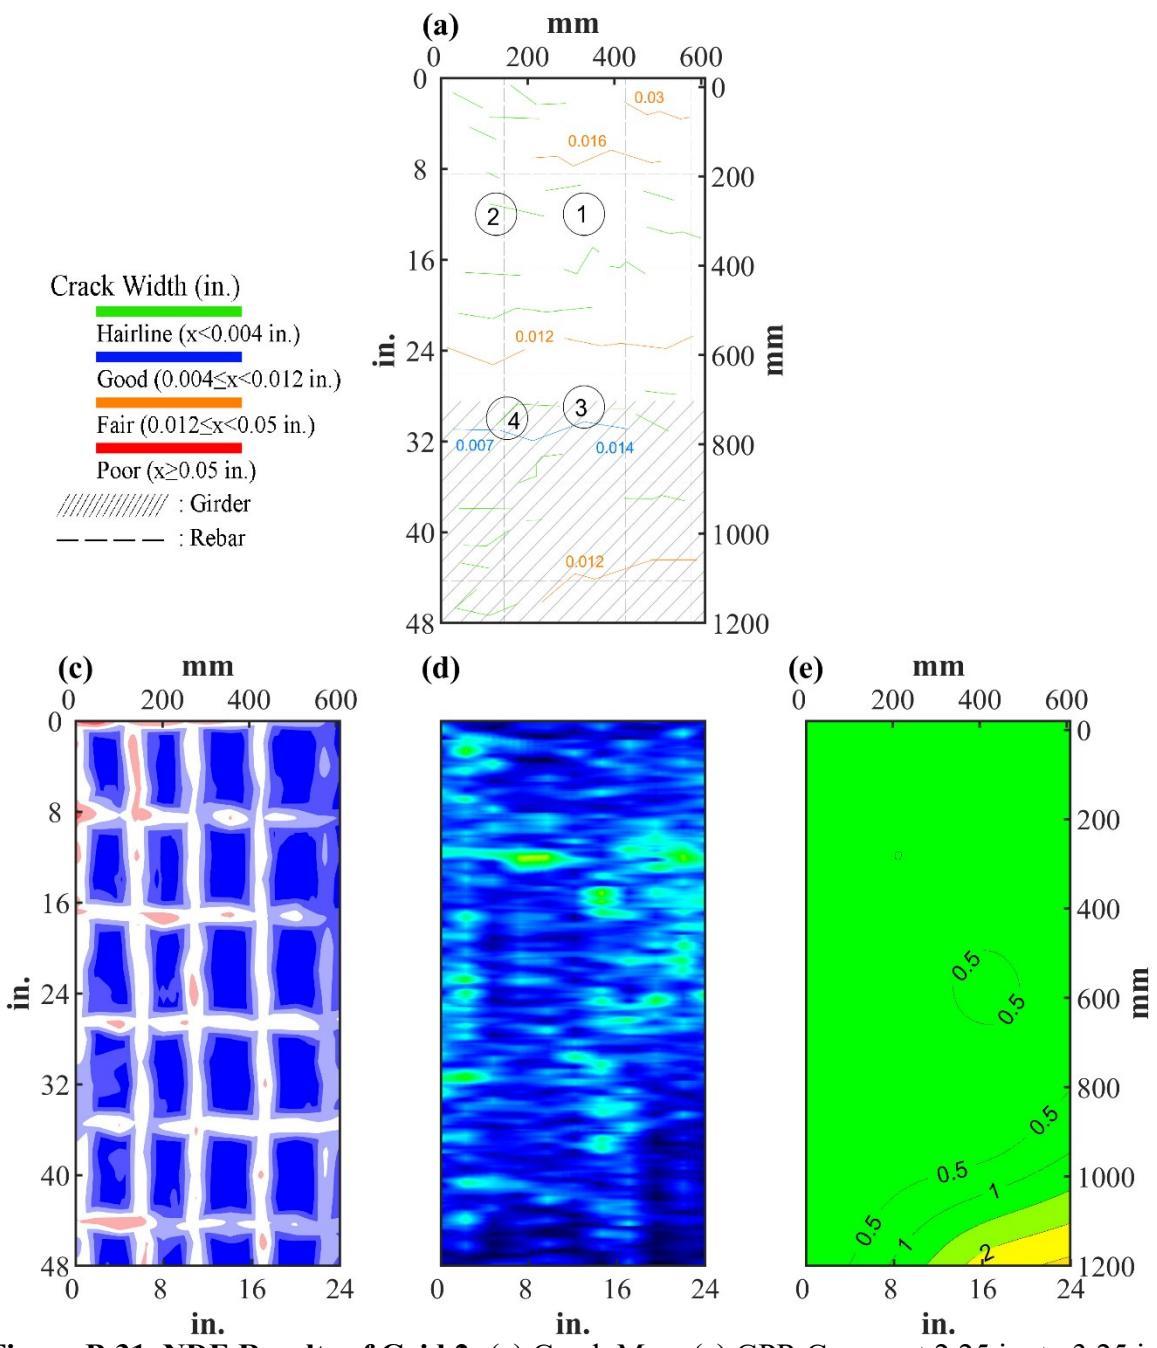
Figure B.31. NDE Results of Grid 2: (a) Crack Map; (c) GPR C-scan at 2.25 in. to 3.25 in. Depth; (d) UST C-scan at 2.01 in. Depth; (e) Corrosion Rate Map

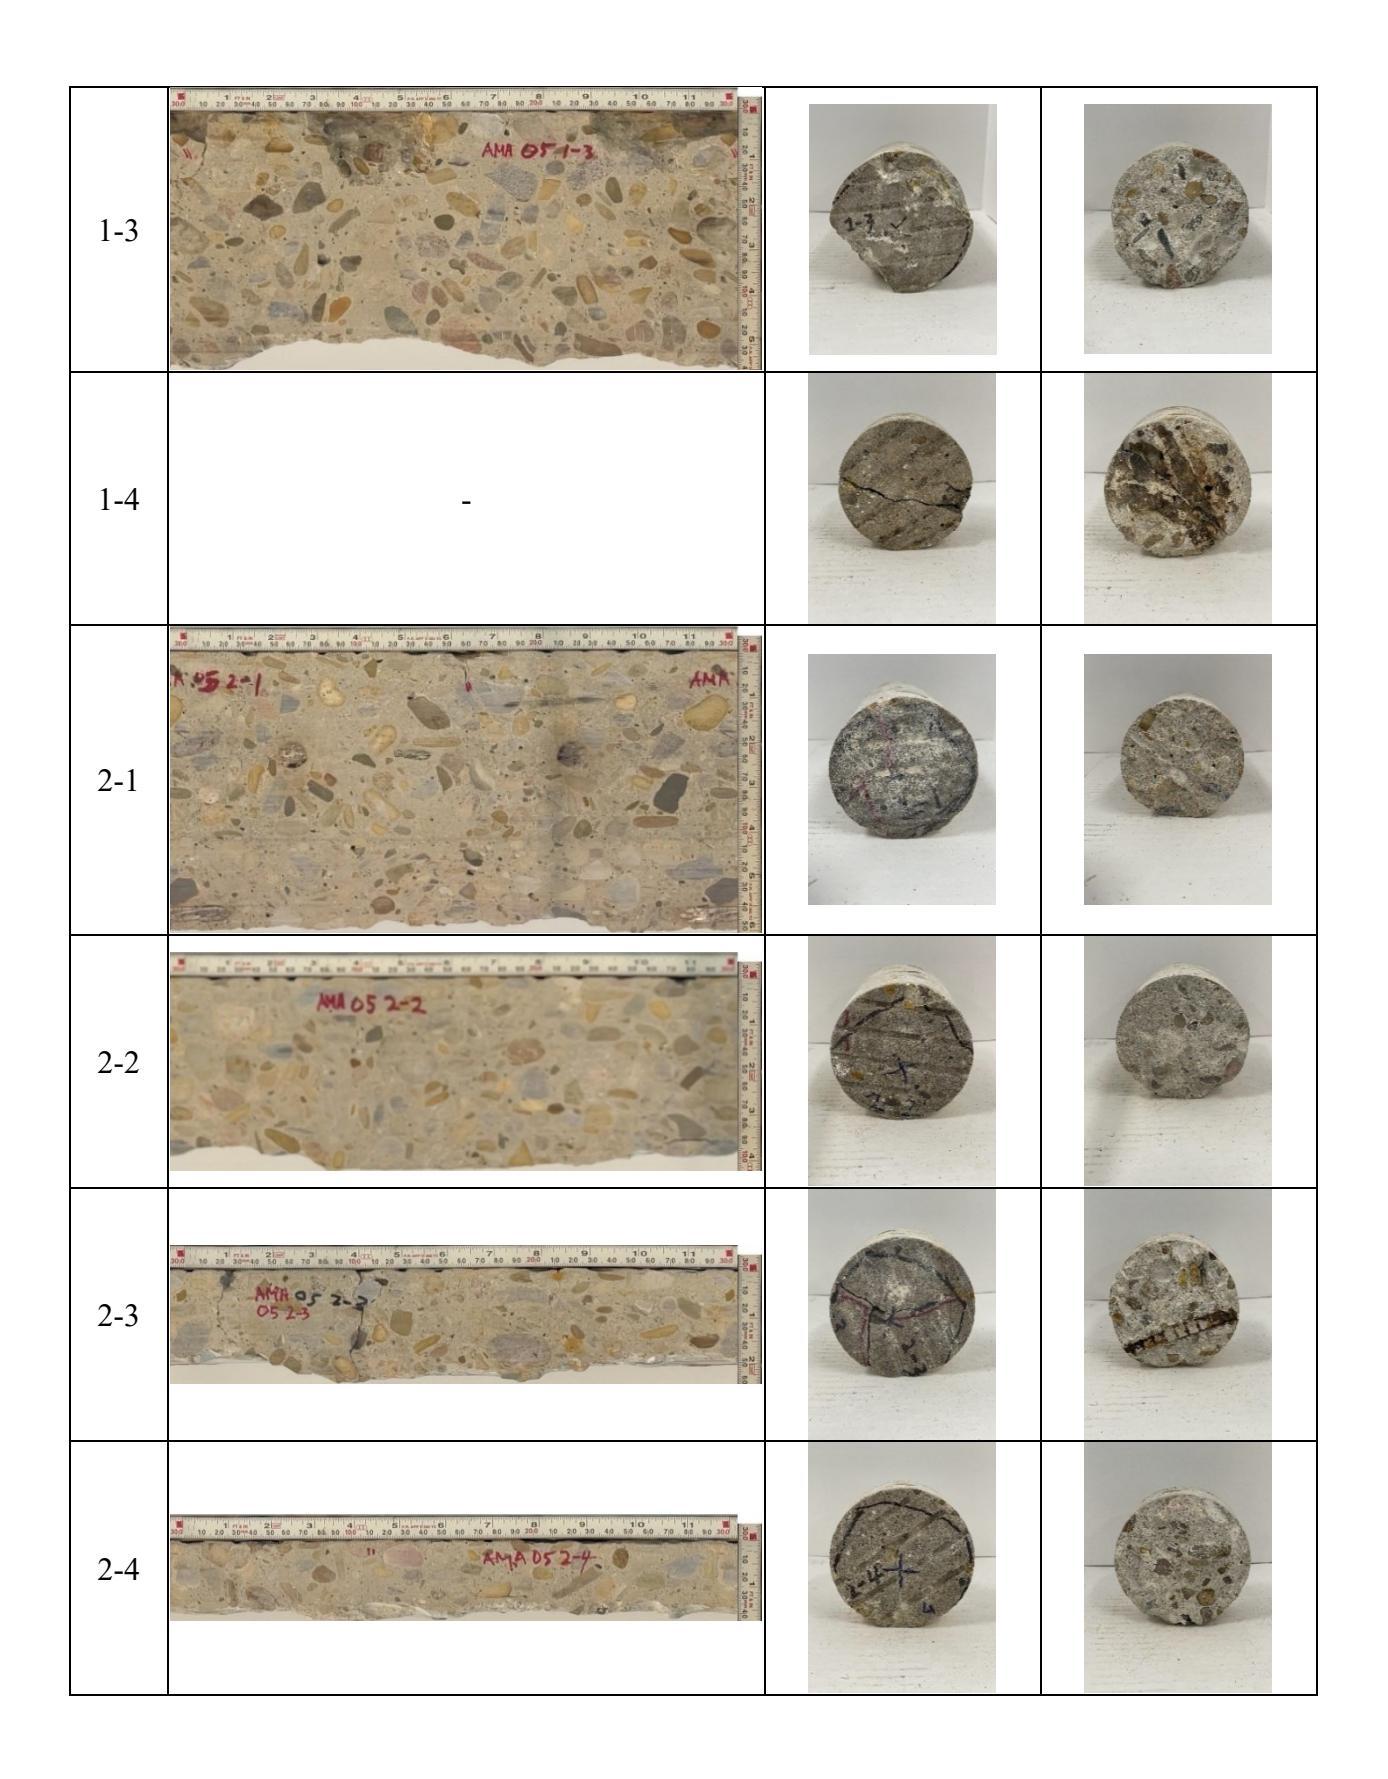
ECR extracted from the core 2-3 was corroded and the epoxy coating fell off from the rebar surface.

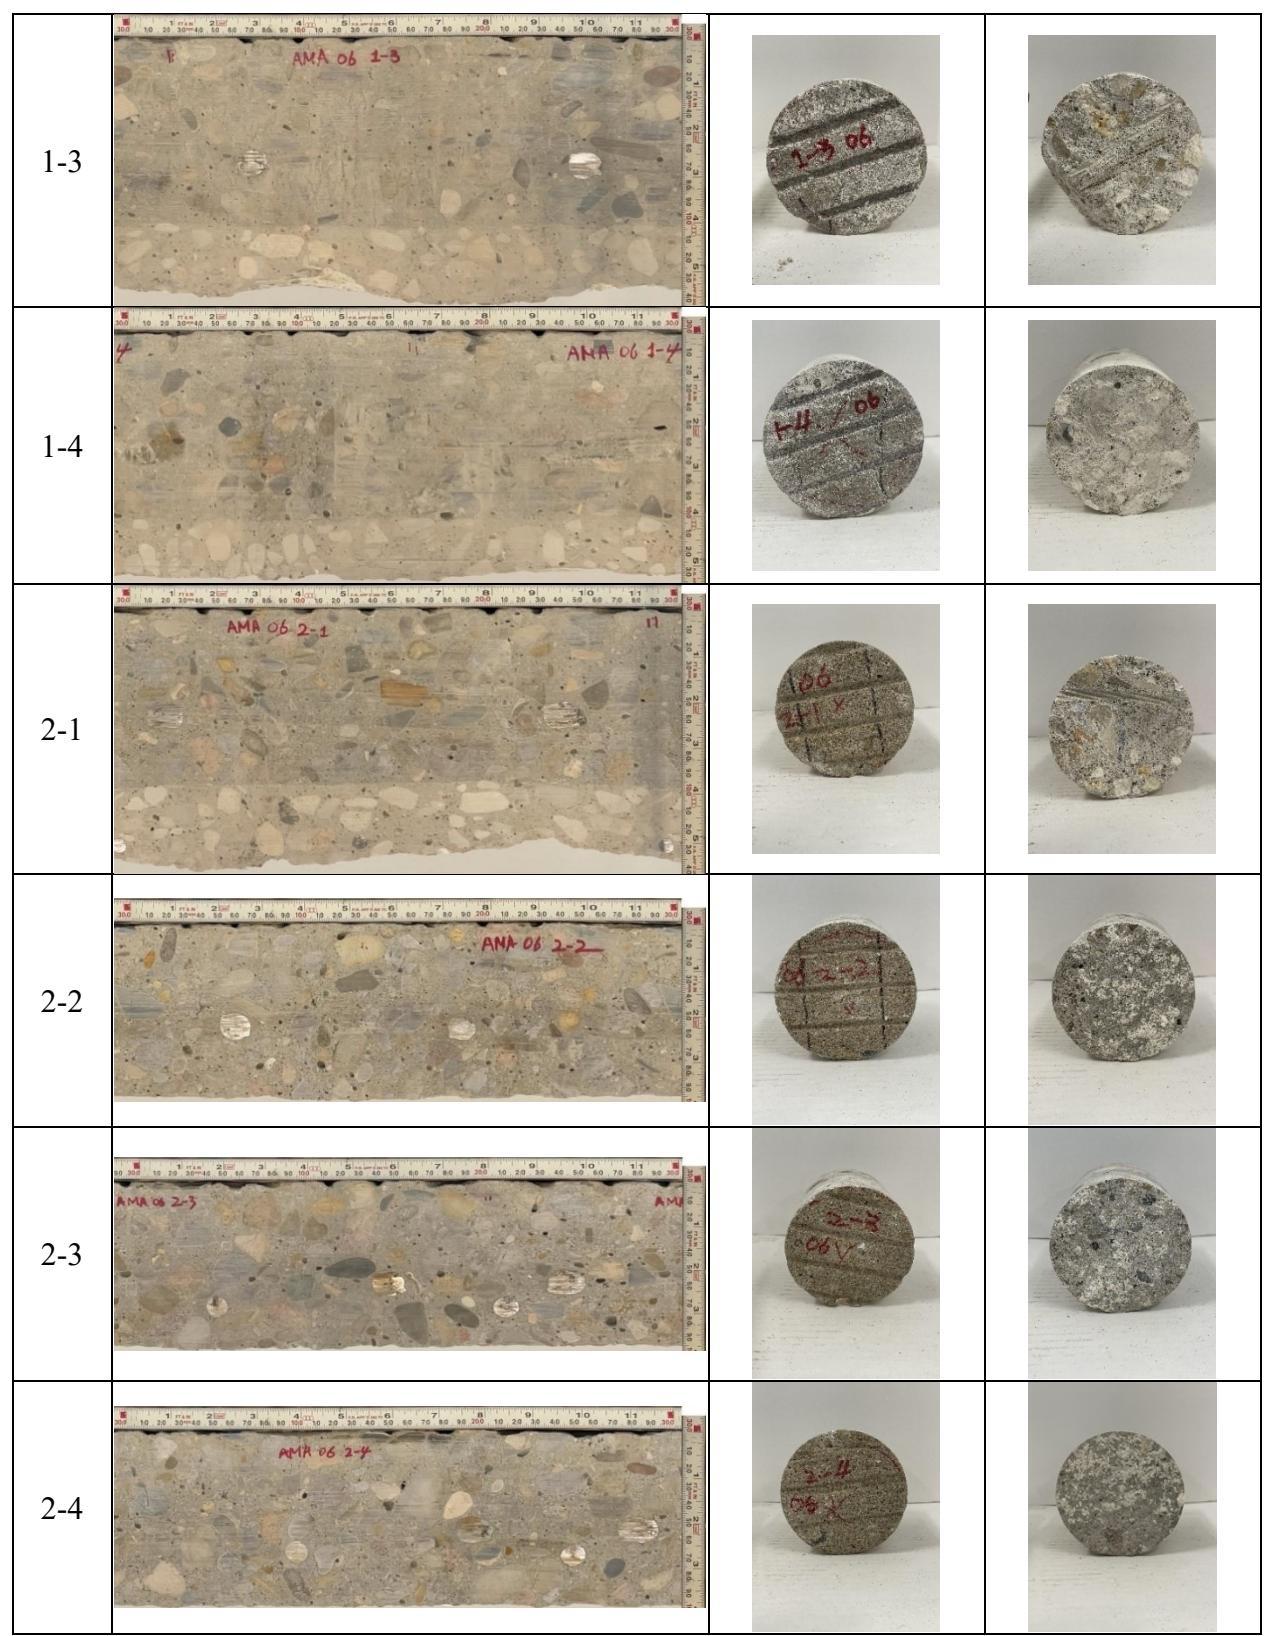
All rebar was epoxy coated and showed no sign of corrosion.

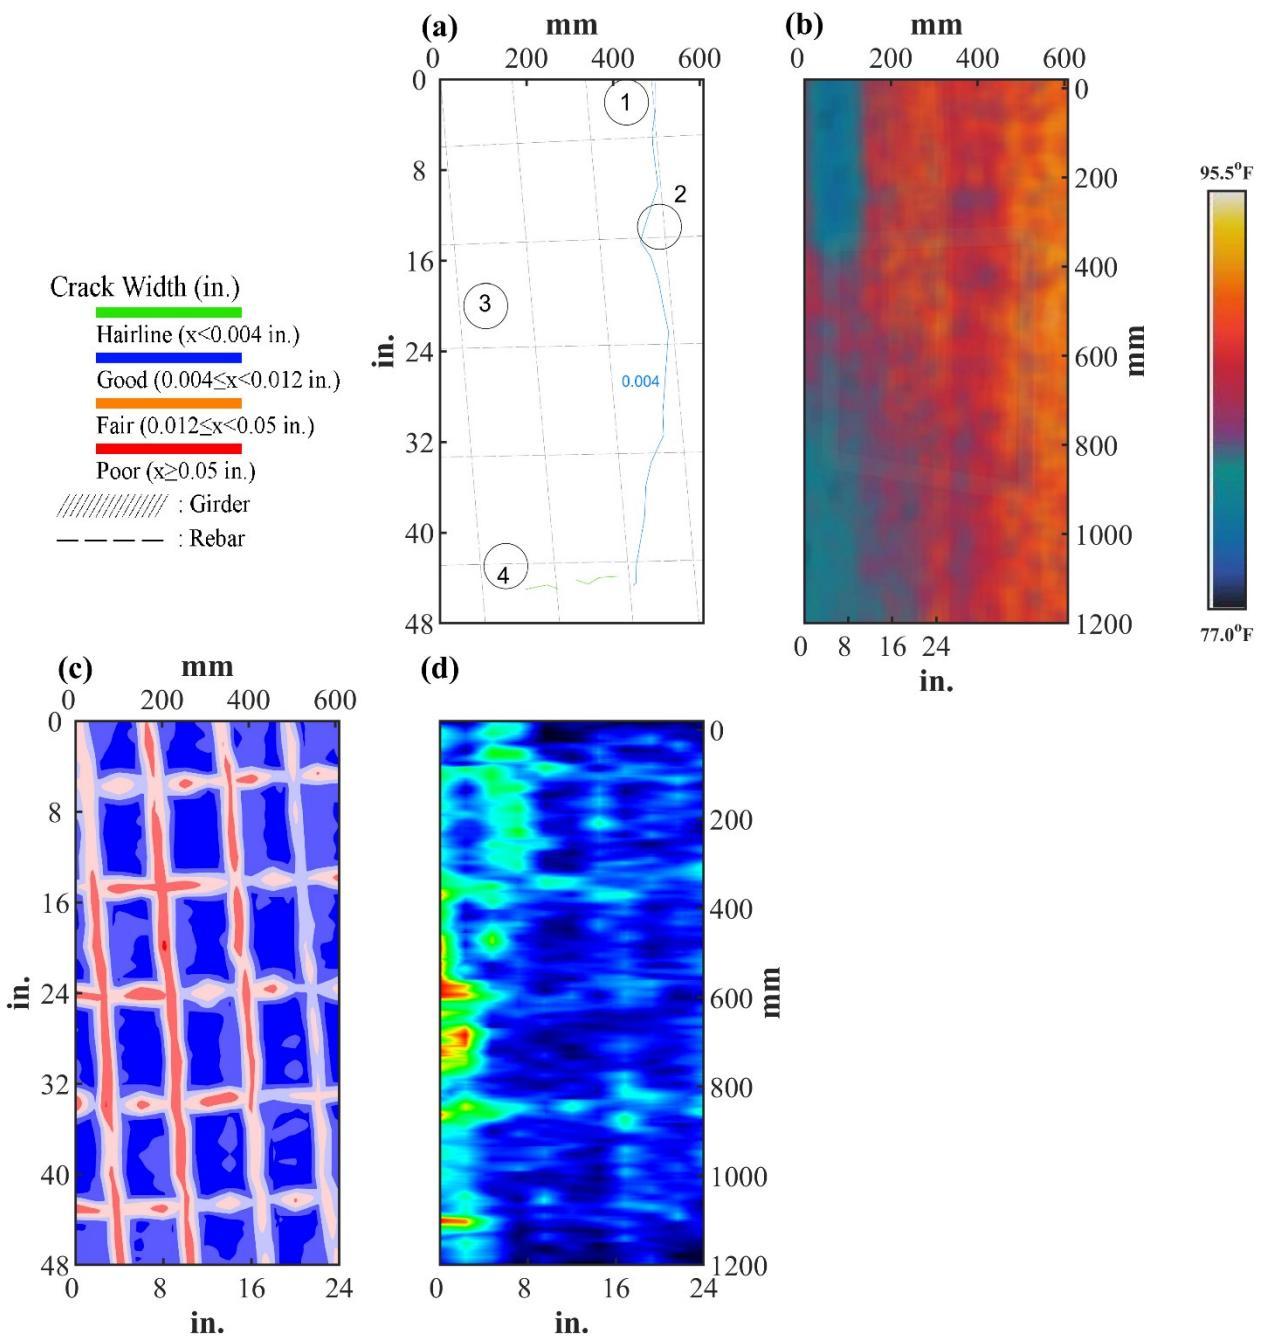
Figure 0.67 (a) shows that there was widespread of 0.004 in. wide cracks with one 0.012 wide transverse crack. The Grid 2 had one crack that was 0.004 in. wide as shown in Figure 0.68 (a).

Figure 0.68. Crack Map and NDE Results of Grid 2: (a) Crack Map and Location of Cores; (b) Infrared Picture; (c) GPR C-scan at 1.8 in. to 2.9 in. Depth; (d) UST C-scan at 3.93 in. Depth
B.9.3 Concrete Cores
