1. Report No. FHWA/TX-15/0-6663-3		2. Government Accession No.		3. Recipient's Catalog No.	
4. Title and Subtitle Automated Distress Surveys: Analysis of Network Level Data (Phase III)			5. Report Date February 2015; Published August 2015

6. Performing Organization Code		
7. Author(s) Pedro A. Serigos, Kuan-Yu Chen, Andre Smit, Mike R. Murphy, and Jorge A. Prozzi			8. Performing Organization Report No. 0-6663-3

## **Automated Distress Surveys: Analysis of Network Level Data (Phase III)**

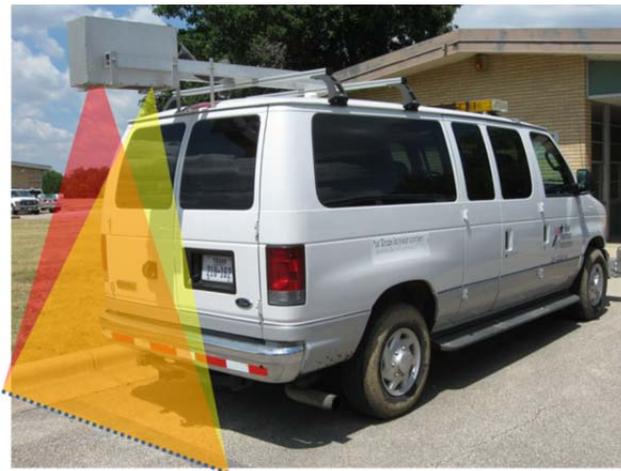
TxDOT developed a state-of-the-art 3D automated system (Figure 1.1) for the high-speed measurement of pavement surface rutting, cracking, and other types of distress. The goal was to obtain a more accurate and consistent assessment of road performance at both the network and project levels and potentially eliminate the need for manual or “windshield” visual assessments. To ensure the rational adoption of the new systems, TxDOT initiated this project to provide an independent assessment of the accuracy and repeatability of the new automated distress data measurements provided by the TxDOT systems as well as vendors’ systems used by other DOTs. This section presents a summary and lists the main conclusions from Phase I: Evaluation of Automated Rutting and Transverse Profile Measurements. Refer to Serigos et al. (2012) for the complete report.

*Figure 1.1: TxDOT’s 3D Automated Measurement System*

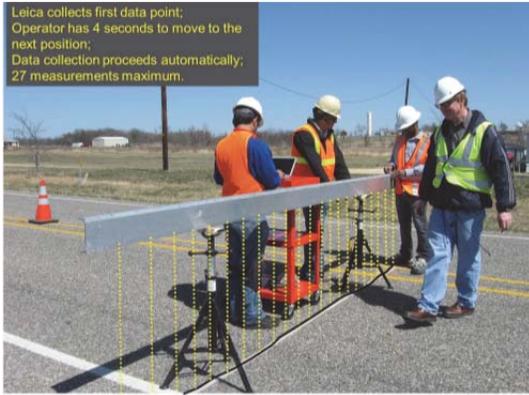
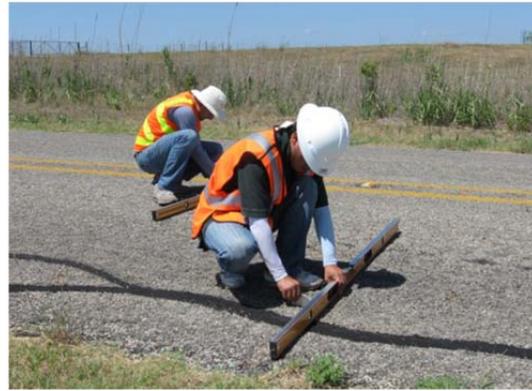
Phase I involved the development of a factorial experiment of over 26 550-ft-long pavement test sections to evaluate the rut and transverse profile measurement capabilities of automated systems at highway speeds. These test sections were located in the Austin District and included dense-graded and permeable friction course hot-mix asphalt concrete pavement, and surface treatments, thus representing the population of flexible pavement textures on the Texas road network. The reference data consisted of transverse profiles measurements collected every 25 ft on each test section using a laser distance measurement meter and a leveled beam (Figure 1.2a) and manual rut depth (RD) measurements collected every 5 ft in both wheel paths using a 6-ft straight edge and rut wedge (Figure 1.2b) based on the ASTM standard E1703.

(a) Leica laser system

(b) 6-ft straightedge and wedge

*Figure 1.2: Measurement of Reference Rutting Values*

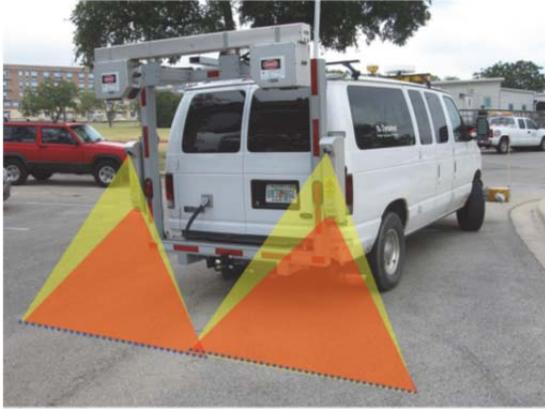
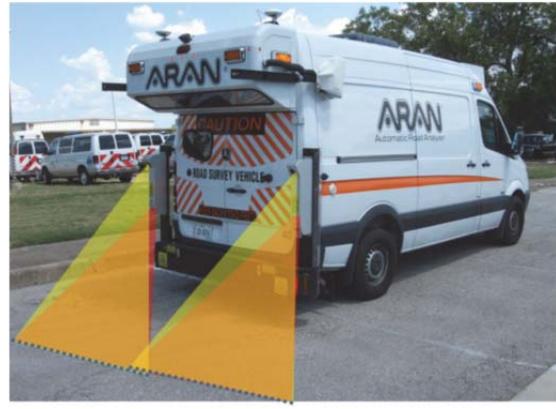
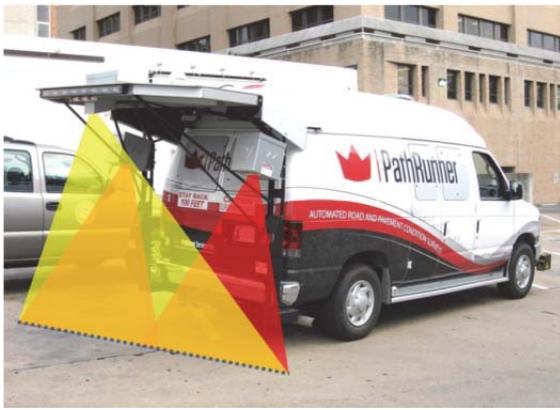
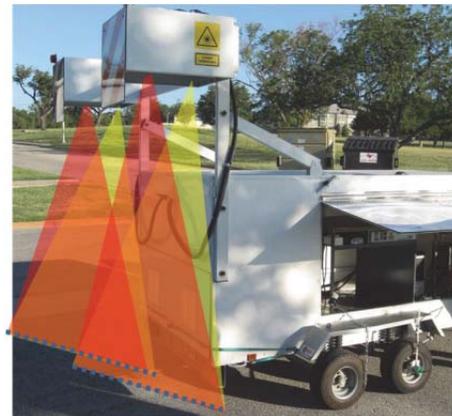
In addition to TxDOT's efforts, four service providers collected automated measurements on the same intervals as the reference data: Dynatest, with a National Optics Institute (INO) Laser Rut Measurement System (LRMS) (Figure 1.3a); Fugro-Roadware, with an INO LRMS (Figure 1.3b); Pathway Services, with a 3D system developed in-house (Figure 1.3c); and Applus, with a Laser Crack Measurement System (LCMS) from INO (Figure 1.3d). All of the automated systems used in the experiment were optical 3D systems capable of measuring more than 1,000 points per profile at highway speeds. Each participant used proprietary algorithms to calculate the RD values from their measured transverse profiles. While the sensors used by each participant consisted of a laser and a camera (laser and camera planes represented by the red and yellow triangles respectively in Figure 1.3), the configuration of the system (e.g., the angle at which the laser plane is projected) as well as the number of sensors varied, as Figure 1.3 indicates.

(a) Dynatest's System

(b) Fugro-Roadware's System

(c) Pathways's System

(d) Applus's System

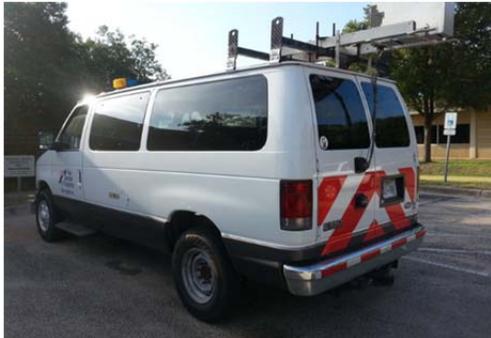
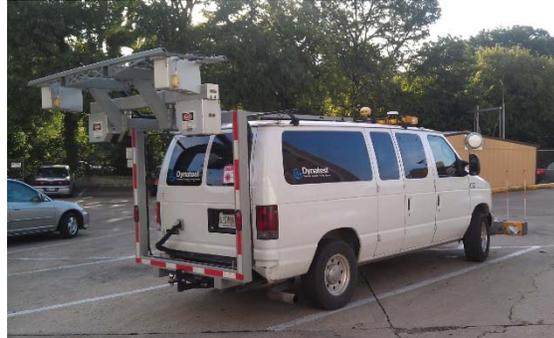
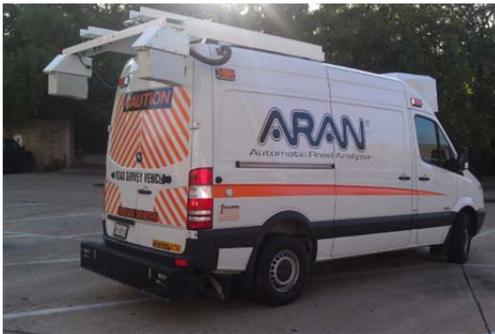
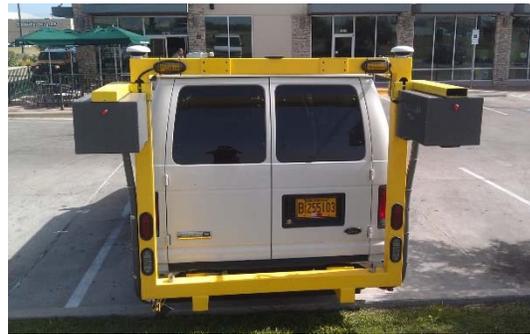
(a) TxDOT System

(b) Dynatest System

(c) Fugro-Roadware System

(d) WayLink-OSU System

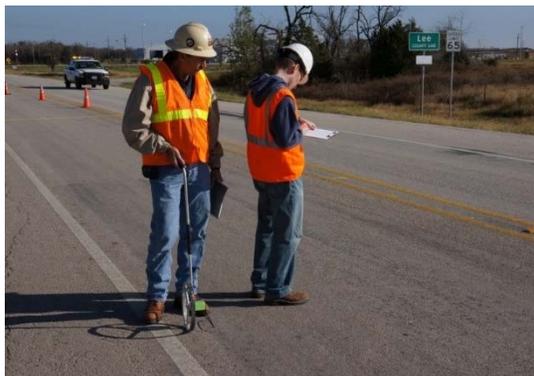
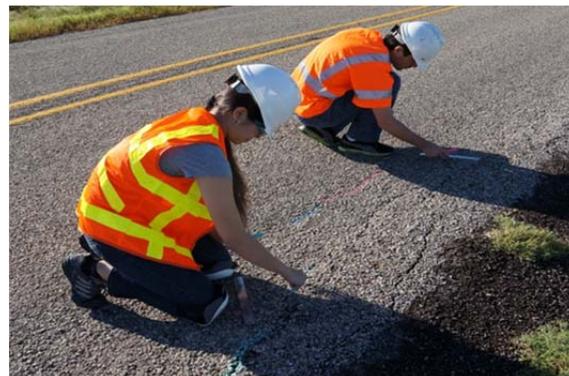
Each of the 550-ft-long test sections were sub-sectioned at 50-ft intervals and were evaluated manually by an experienced Long-Term Pavement Performance (LTPP) manual distress rating team (Figure 1.5a) and a TxDOT PMIS manual distress rating team. In each case the manual raters followed the LTPP or PMIS Rating Manual protocols (Miller and Bellinger, 2003; TxDOT, 2009) to identify and measure distress on each test section. Phase II analyses also included a qualitative comparison between the crack maps produced by the different automated systems at highway speeds and digital crack maps collected statically through manual measurement of the cracks. A comparative analysis of the digital crack maps allowed the researchers to obtain deeper insight into each system's quality of measurements and identify sources of error that cannot be detected by evaluation of summary statistics alone. Reference crack map images were obtained by manually marking each crack using different colors related

to three crack width (red < 3 mm, blue 3–6 mm, and green > 6 mm) categories and then photographing selected 50-ft subsections using a high-end digital camera.

(a) Visual Rating of Distresses

(b) Crack Map Production

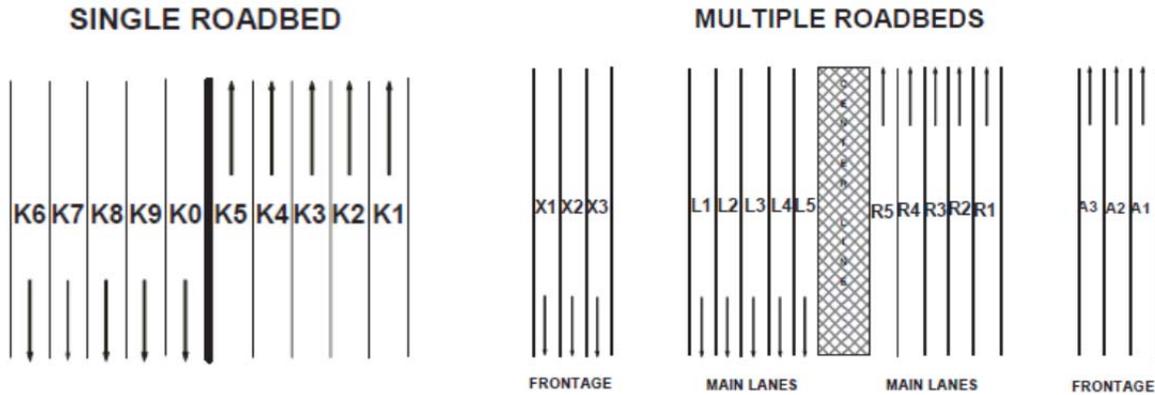
The accuracy for identifying pavement surface types by the automated systems was out of the scope of this study and each vendor was provided with information of each pavement section to be collected for the pilot study, which included detailed pavement type (1–10 pavement type code). In addition, each participating vendor was required to collect data on dry pavement surfaces during daylight hours, at or near the posted highway speeds and in the outermost lane of each roadbed (i.e., either K1, L1, R1, A1, or X1 from Figure 2.2). Thus, all automated systems were asked to collect data in the same lane.

Figure 2.2: Roadbed Types and Lane Codes Defined for PMIS Data Collection (TxDOT 2011)

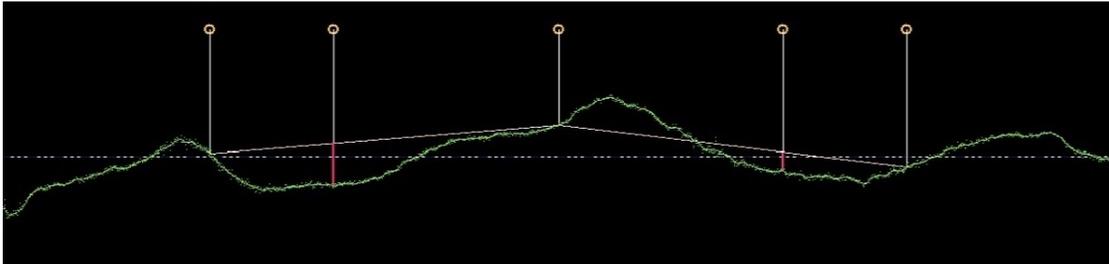
PMIS data, vendors were required to calculate rutting data simulating a five-point collection system from the continuous profile. For this, the sensor spacing was defined as “31.6 inches between the center sensor and the wheel path sensor, and 17.75 inches between the wheel path sensor and the outside sensor.” Figure 2.3 shows an example of a continuous transverse profile in green, and the sensors’ location on the simulated discrete system with yellow circles.

Figure 2.3: Location of Coordinates for Simulation of Five-Sensor System (Huang et al. 2009)

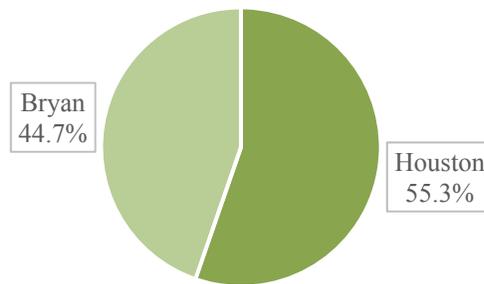
The total number of data collection sections in PMIS FY 2014 for Bryan and Houston’s highway networks is 16,463. As shown in Figure 2.5, the number of PMIS sections in each district is similar; Houston has a slightly larger proportion of the pilot study network. The large majority (almost 80%) of the PMIS sections in the two districts are 0.5 miles in length, 16% of the sections are less than 0.5 miles long (mainly 0.2-, 0.3- and 0.4 miles long), while the remaining sections are longer than 0.5 miles. These distributions of section length are similar within each individual district.

*Figure 2.5: Overall Distribution of PMIS Sections by District (16,463 PMIS Sections)*

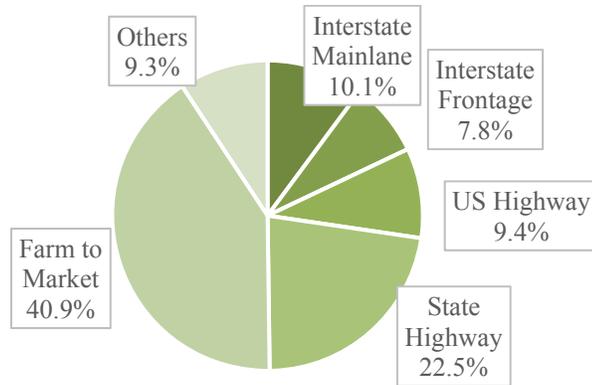
The IH group was divided into IH main lane and the IH frontage road. Both roadbed types play an important role in the TxDOT highway network and the surface type and condition on frontage roads may differ from those on main lanes. IH main lanes and frontage roads together account for about one-fifth of the PMIS section network in the study. As Figure 2.6 indicates, the number of main lanes is higher than the number of frontage roads.

Figure 2.6: Overall Distribution of Highway System (16,463 PMIS Sections)

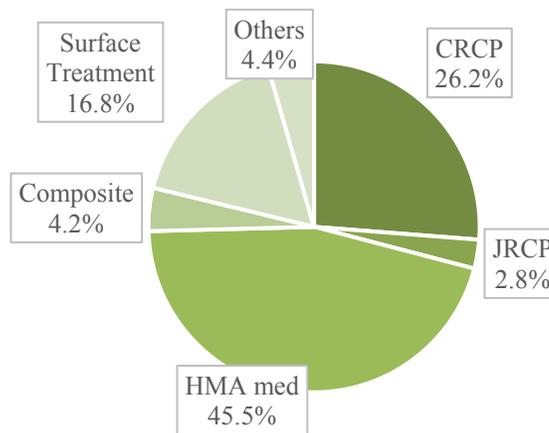
In addition to the highway system distribution, it is also relevant to analyze the surface type distribution for the network of the study (Figure 2.7). As observed from the distribution, about two-thirds of the network consisted of flexible pavements, composed mainly of medium thickness asphaltic concrete 2.5 in. to 5.5 in. thick (HMA med) and surface treatment pavements. Furthermore, almost half of the sections in the study were medium thickness HMA. Rigid pavements comprised a third of the network, including CRCP, jointed reinforced concrete pavements, and widen composite pavements (composite). A composite pavement consists of an asphalt overlay on top of a concrete pavement or an asphalt overlay on a stabilized (semi-rigid) base. This pavement type behaves essentially the same as rigid pavement under traffic loading; however, it would be rated as a flexible pavement due to having asphaltic material on its surface.

Figure 2.7: Overall Distribution of Pavement Type (16,463 PMIS Sections)

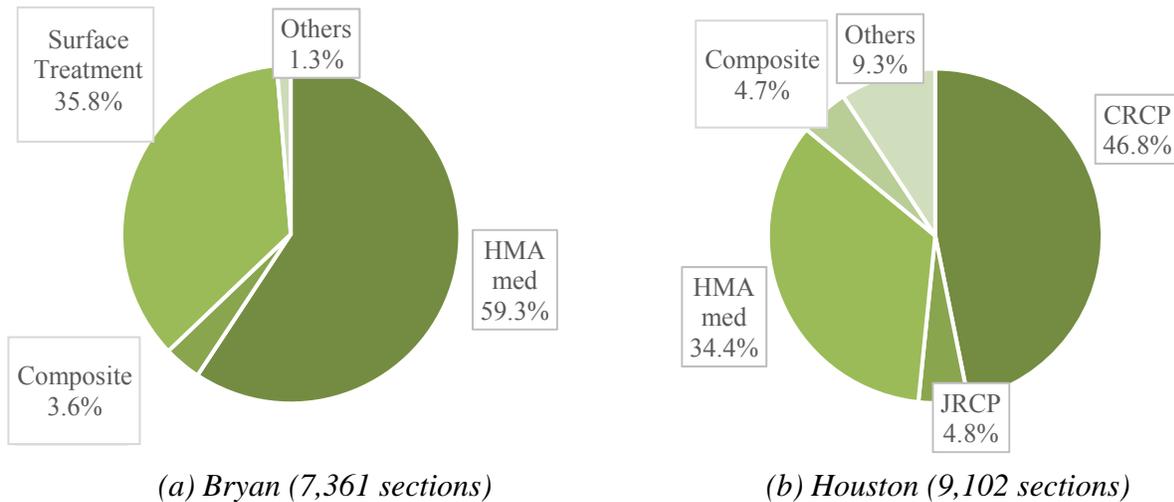
The Bryan District was chosen to represent typical rural highways in Texas while Houston was chosen to represent more urban and metropolitan highways, with a larger proportion of rigid pavements. Figure 2.8 (a) and (b) show the distribution of pavement surface types for the Bryan and Houston districts respectively. As its pavement type distribution profile indicates, Bryan’s highway network is predominantly composed of flexible pavements (more than 95% of the sections) as opposed to the Houston District, which is almost evenly distributed between rigid and flexible pavements. The predominant rigid pavement type in Houston is CRCP with a small percentage of JCPs. Flexible pavement in both districts is mainly composed of medium thickness HMA. Surface treatments have a significant presence only in Bryan.

Figure 2.8: Pavement Type Distribution in Bryan and Houston Districts

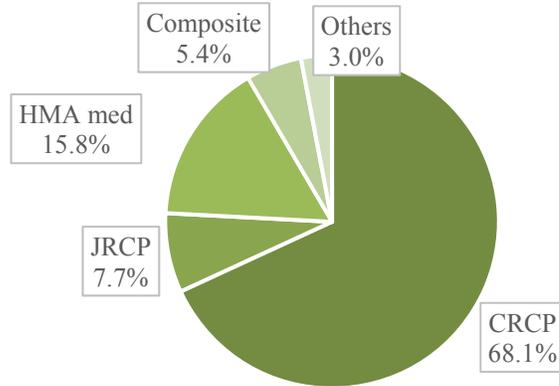
Figure 2.9 shows the distribution of pavement type in Harris County, which includes a total of 4,047 PMIS sections—about a quarter of the entire two districts’ network. Harris County includes the metropolitan area of the Houston District and, therefore, it contains most of the busiest highway sections in the analyzed network. As Figure 2.9 depicts, about three-fourths of this County’s network is composed of rigid pavements, mainly CRCPs. As opposed to the Bryan District’s network—mainly composed of rural, low-volume medium thickness HMA roads—the high percentage of rigid pavement in the Harris area shows that most of the high-volume corridors of this study heavily rely on the support of concrete pavements.

Figure 2.9: Distribution of Pavement Type in Harris County (4,047 Sections)

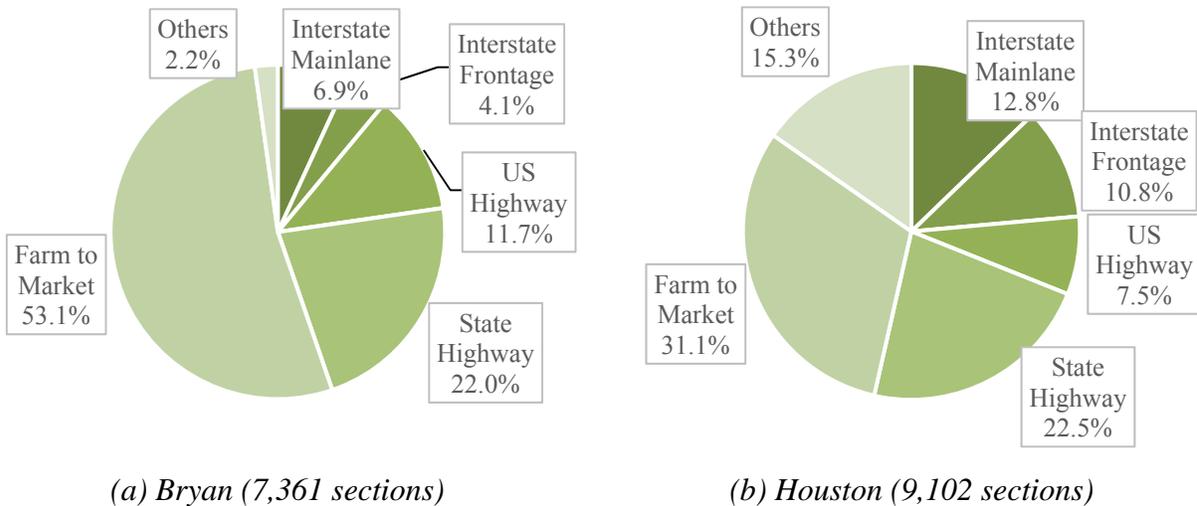
Figure 2.10 (a) and (b) show the highway system distribution for Bryan and Houston respectively. As Figure 2.10 (a) illustrates, more than half of the sections in Bryan are FM roads, followed by about one-fourth of sections on SHs. IHs and US highways comprise about a tenth of the network each. Figure 2.10 (b) indicates that the Houston District has a larger proportion of IHs than Bryan—from about a tenth in Bryan to about a quarter of the network in Houston, with a smaller proportion of FM and US sections. Still, FM roadways are the predominant route type for both Houston and Bryan. The proportion of SHs is similar for both districts.

Figure 2.10: Highway System Distribution in Bryan and Houston Districts

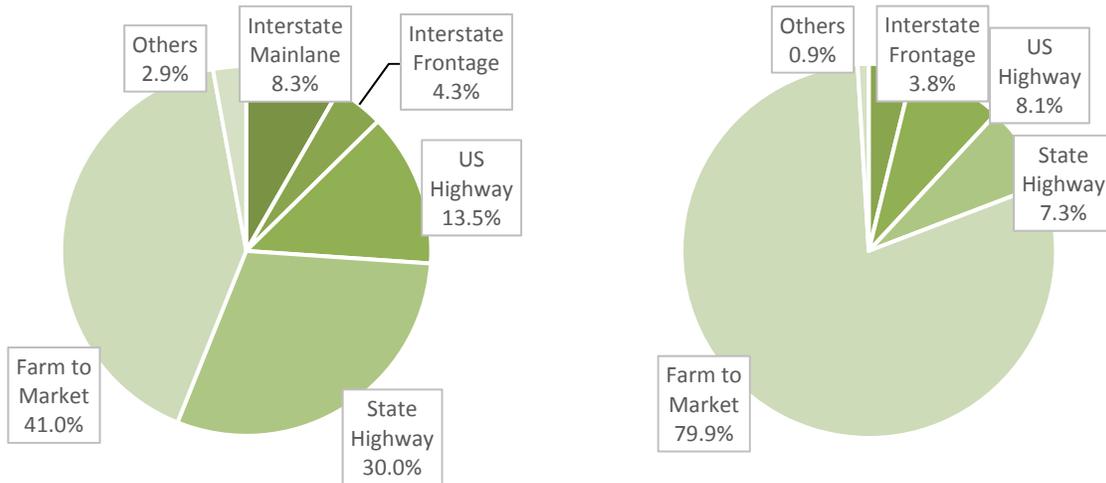
Further analysis of the distribution of highway systems for composite pavements in Bryan showed that more than half of composite surfaces are present on IH main lanes while none of them are present on frontage roads. It should be noted that the only IH in Bryan is IH 45.

(a) HMA med - Bryan (4,364 sections)      (b) Surface Treatment - Bryan (2,636 sections)

Figure 2.11: Highway System Distribution per Pavement Type in Bryan District

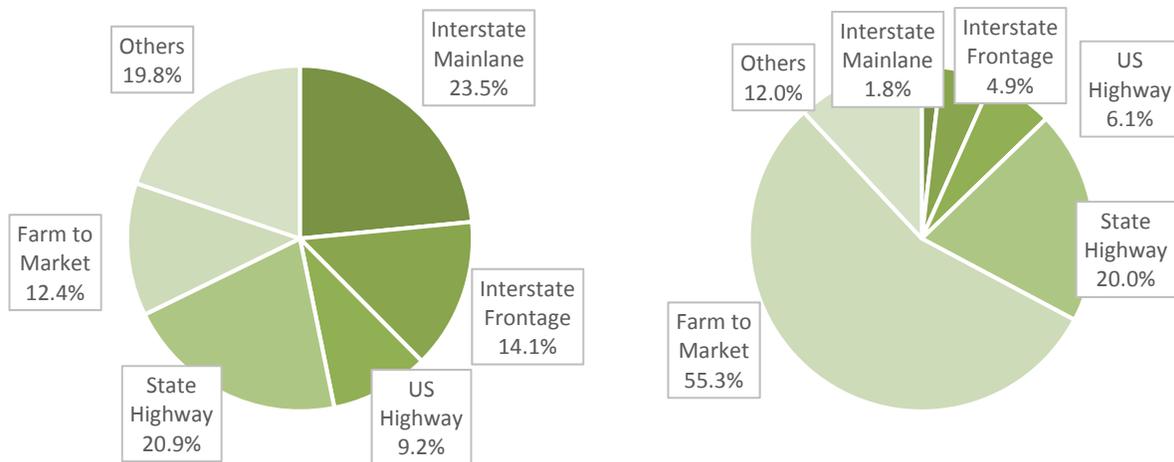
(a) CRCP - Houston (4,263 sections)      (b) HMA med - Houston (3,129 sections)

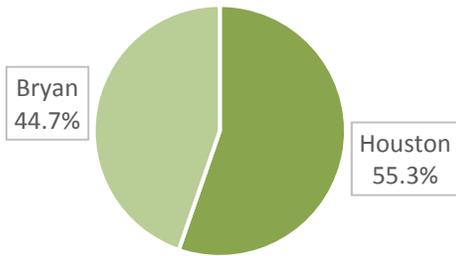
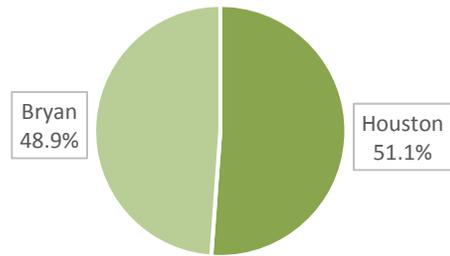
From comparing the characteristics of the overall two districts' highway networks against the subset of successfully processed and analyzed sections, we conclude that although the analyzed network was not complete (consisting of about 78% in the worst case), the networks' characteristics were preserved for all practical purposes.

(a) All Sections in PMIS (16,463 sections)

Figure 2.13: District Distribution for All Sections in PMIS and Sections in Comparative Analyses

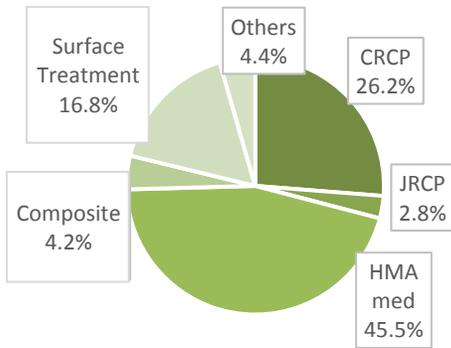
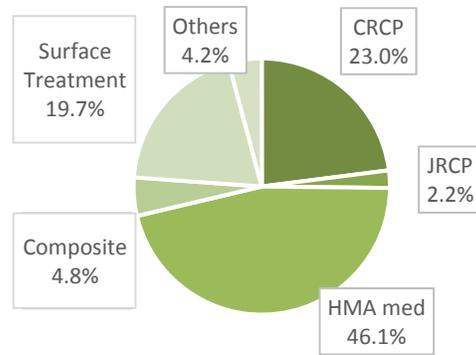
(a) All Sections in PMIS (16,463 sections)

Figure 2.14: Pavement Type Distribution for All Sections in PMIS and Sections in Comparative Analyses

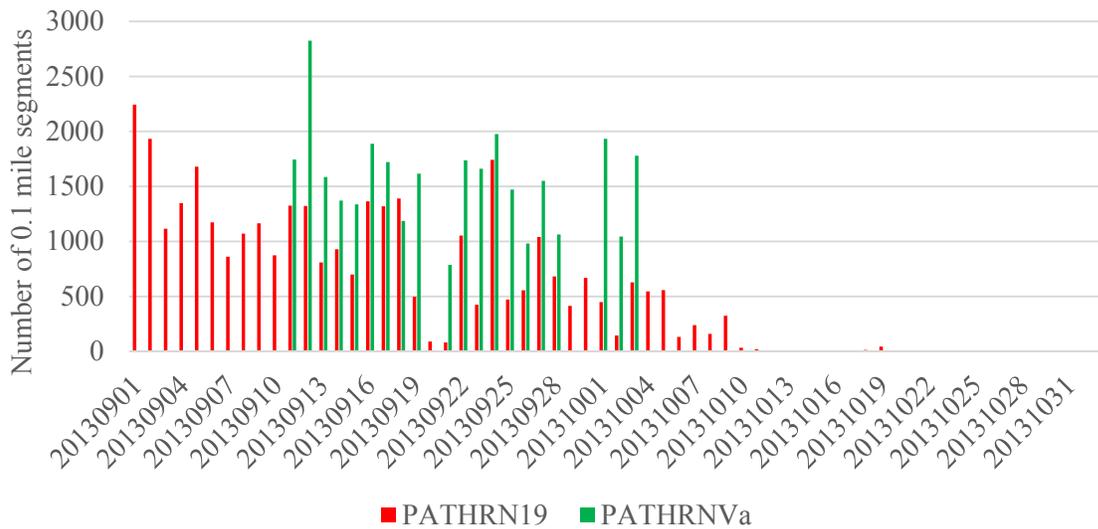
Figure 3.1: Data Collected per Day for the Two Pathway Services Automated Systems

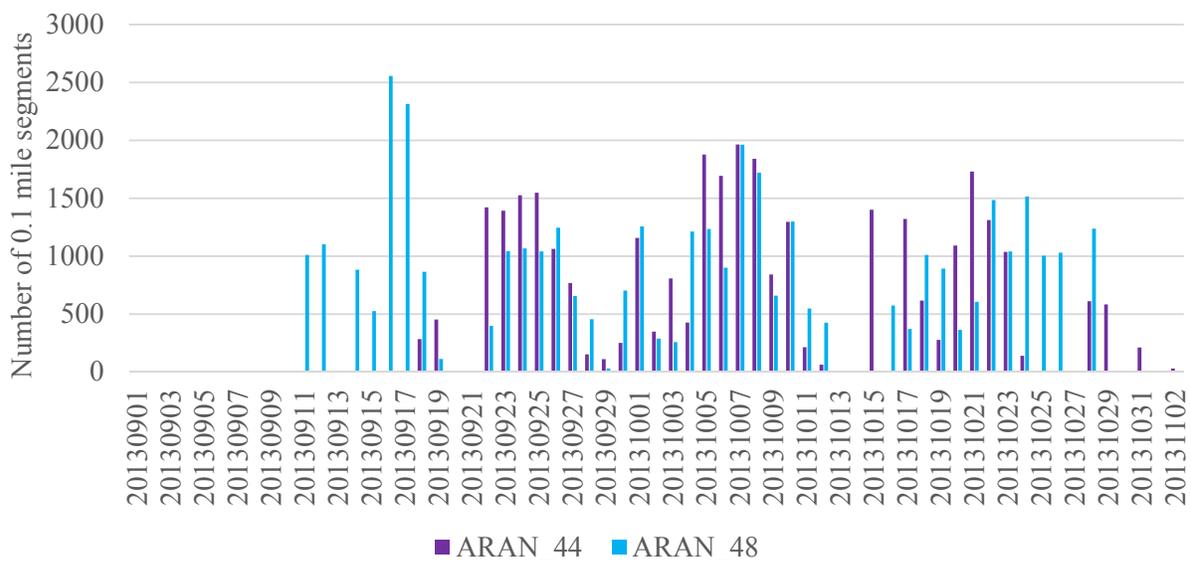
Figure 3.2: Data Collected per Day for the Two Fugro Automated Systems

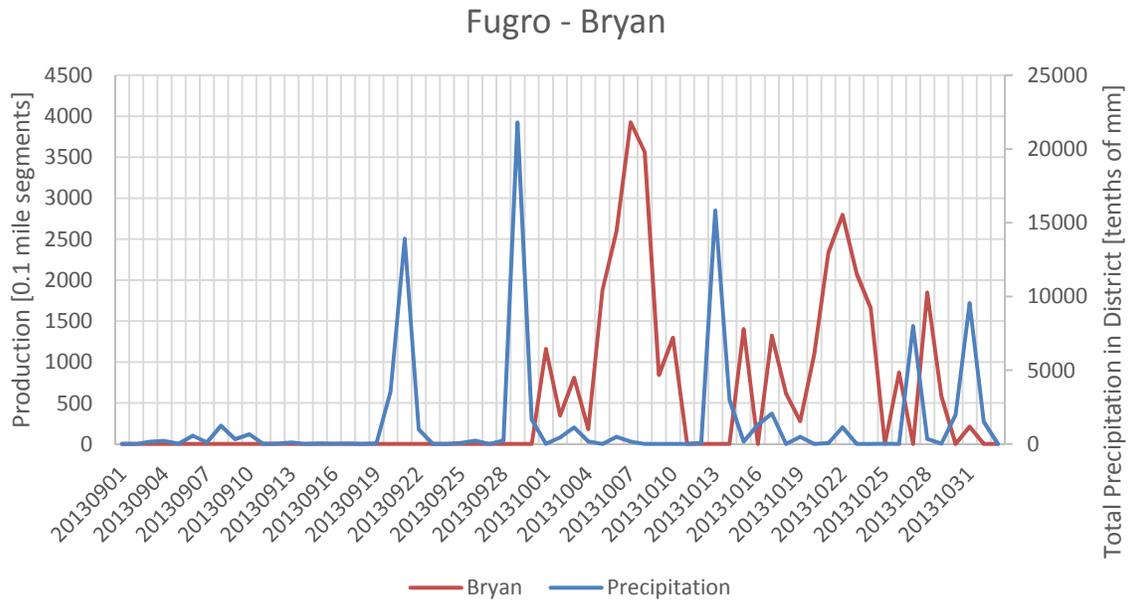
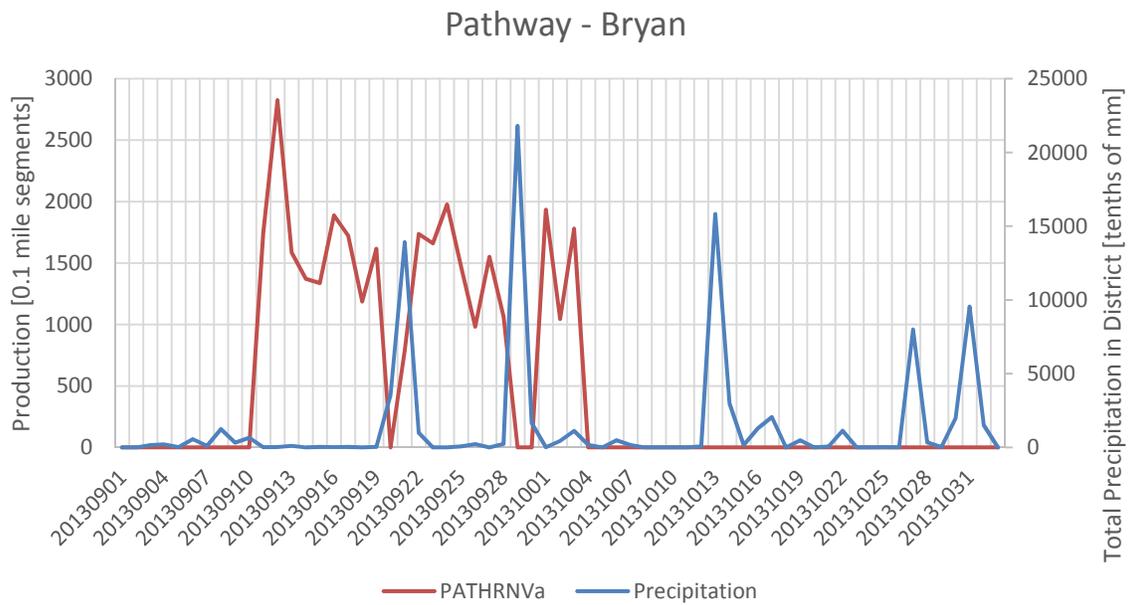
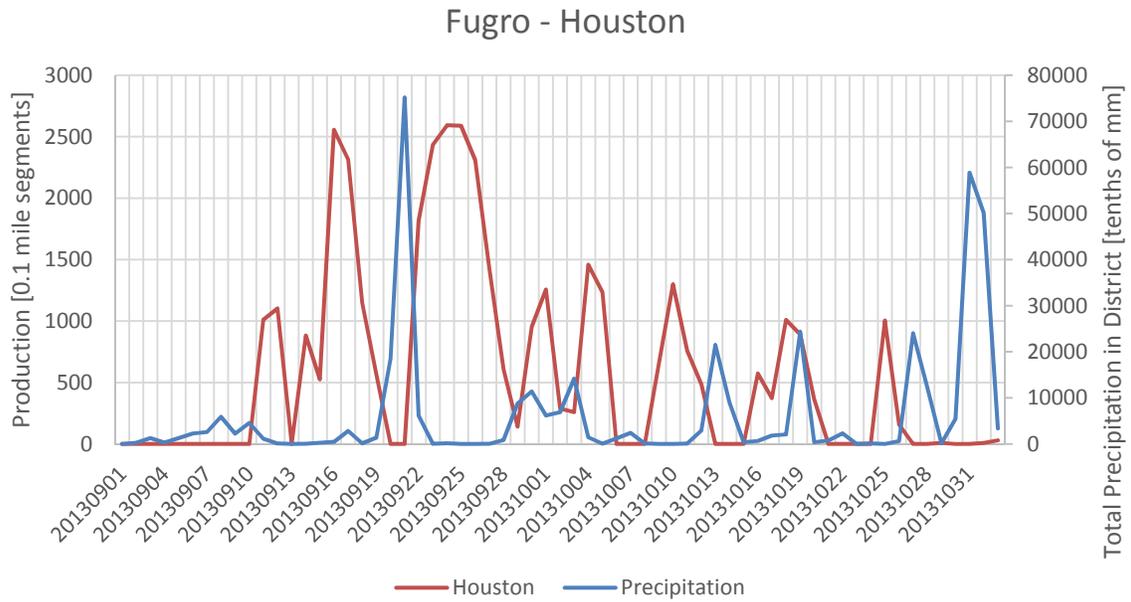
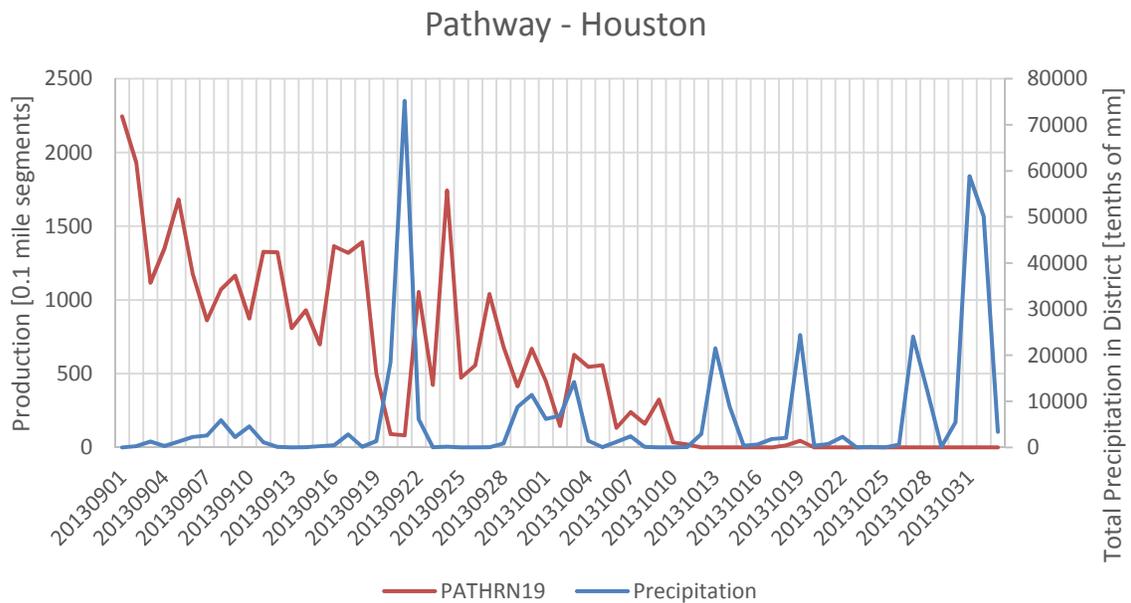
As Figures 3.3 to 3.6 depict, in general, for every peak on the precipitation curve there is a corresponding drastic drop in the production rate. This observation is more evident for the Bryan District, for which the peaks of total district precipitation curves on 09/20/2013, 09/29/2013, and 10/13/2013 clearly matched the dates for which the vendor’s daily production dropped to zero, or near zero values. This evident association implies that rain, or wet surface condition, was an important factor in explaining the percentage of non-active days reported in Table 3.1.

*Figure 3.3: Fugro's Daily Production and Total Precipitation in Bryan*

*Figure 3.4: Pathway Services' Daily Production and Total Precipitation in Bryan*

*Figure 3.5: Fugro's Daily Production and Total Precipitation in Houston*

*Figure 3.6: Pathway Services' Daily Production and Total Precipitation in Houston*

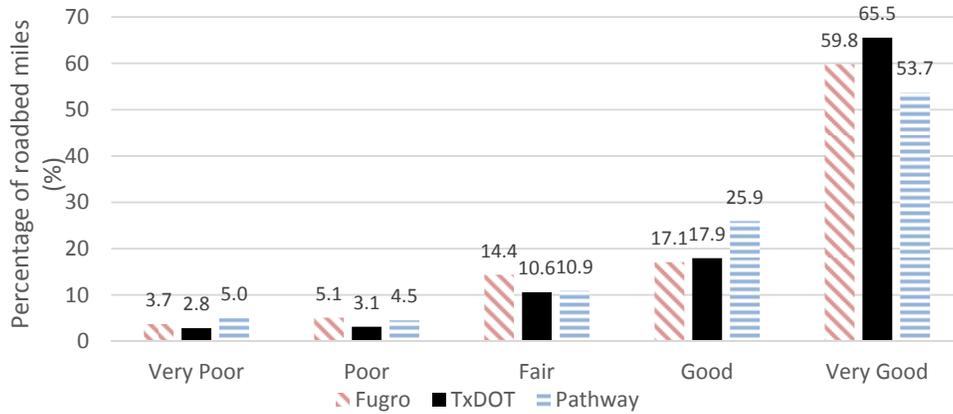
It is also interesting to note the significantly higher number of roadbed miles of DS in “Very Poor” condition measured by Fugro. The difference in PMIS scores distributions between data collection methods is analyzed in more detail on the following sections.

Figure 3.7: Histogram of Condition Score Categories (6,175.7 Roadbed Miles)

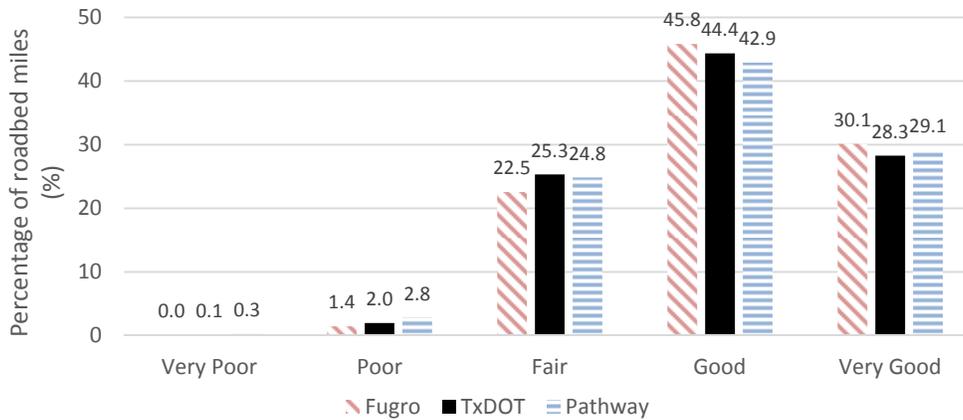
Figure 3.8: Histogram of Ride Score Categories (6,345.7 Roadbed Miles)

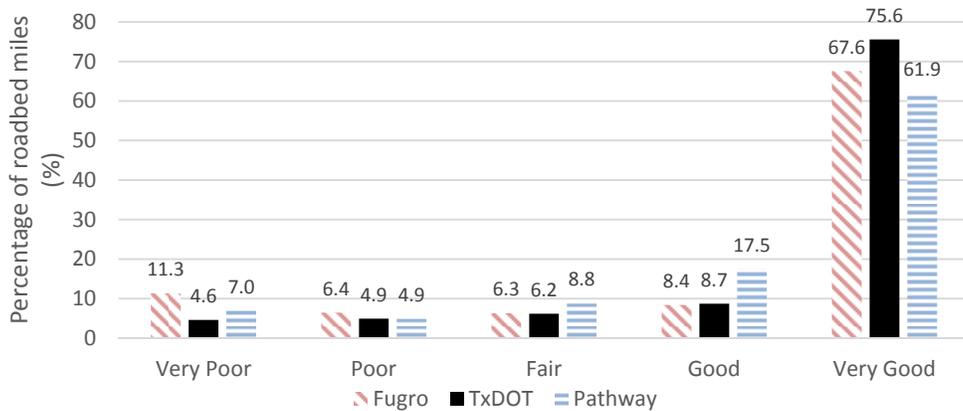
Figure 3.9: Histogram of Distress Score Categories (6,266.7 Roadbed Miles)

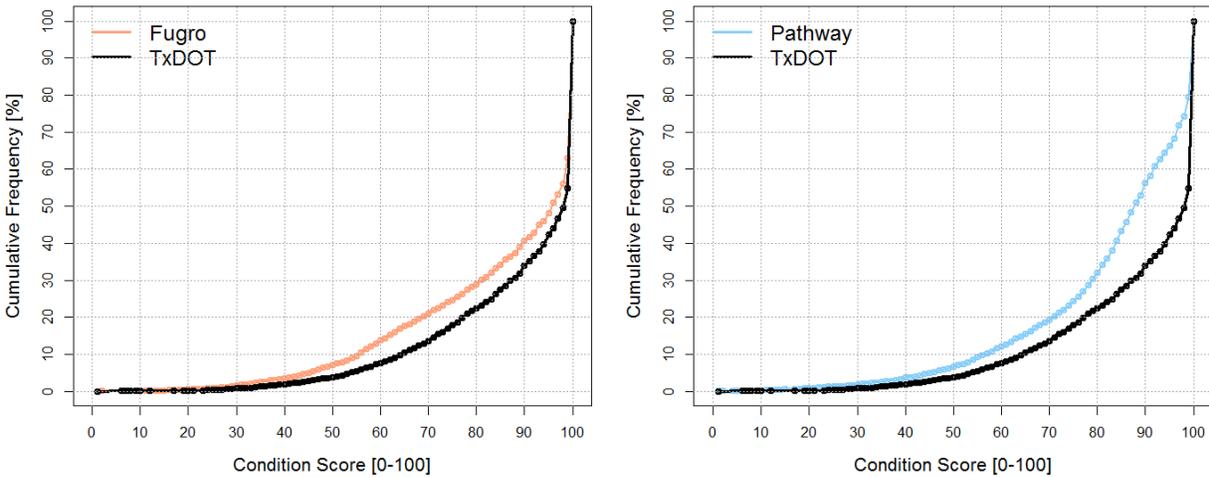
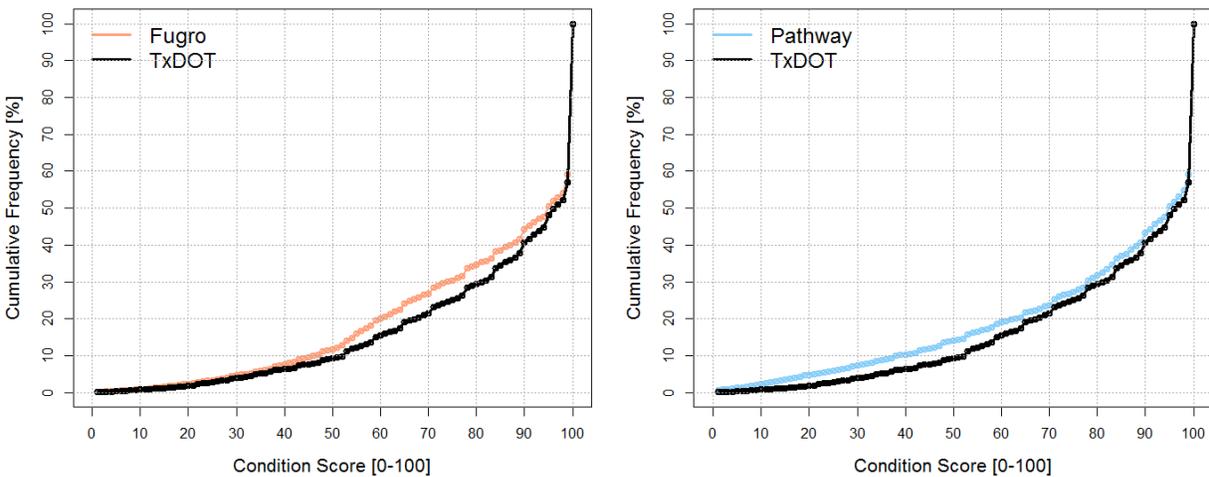
Figures 3.10 and 3.11 show the comparative cumulative CS distributions of each vendor and PMIS for the Bryan and Houston Districts. The distress and ride data collected by both vendors were used to compute CS for each data collection section for the entire two districts. As shown in the figures, the vendors measured a larger proportion of sections with lower CS (worse condition) than PMIS. For both vendors, there is a larger proportion of sections in worse condition for CS greater than or equal to 40. It is also interesting to note that the differences in CS distribution were larger in the Bryan District than in the Houston District for both vendors.

Figure 3.10: Distribution of Condition Score in the Bryan District

Figure 3.11: Distribution of Condition Score in the Houston District

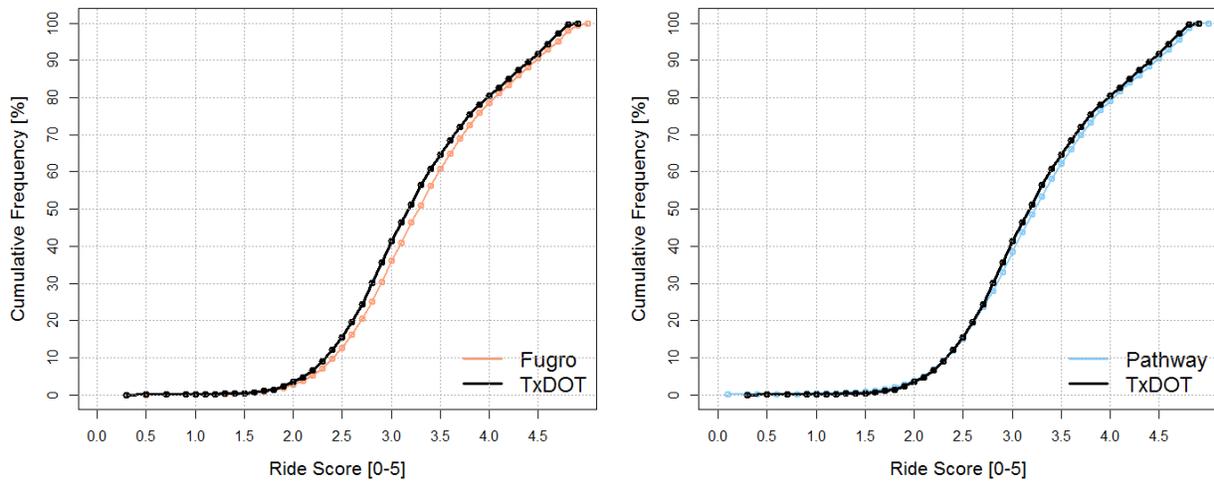
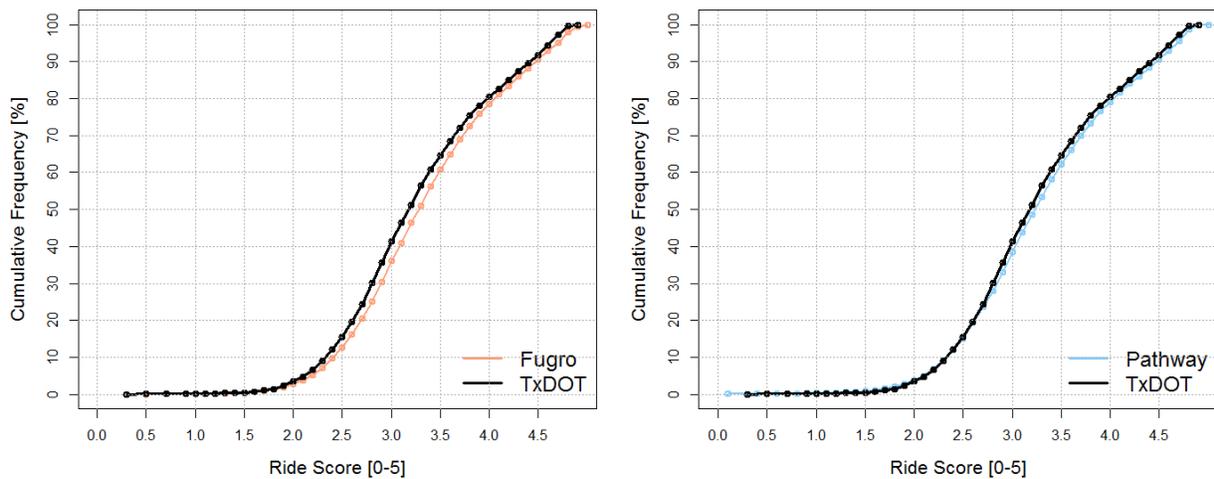
Figures 3.12 and 3.13 show the cumulative distribution of the RS in the Bryan and Houston districts, respectively. The figures illustrate a close agreement between PMIS and each vendor’s RS in both districts. Therefore, the differences observed in CS are not due to differences in RS but due to the differences in DS. It should be noted that all inertial profiler equipment used to collect IRI data for the pilot study, either TxDOT’s or vendors’ equipment, was certified by TTI under the same certification process.

*Figure 3.12: Distribution of Ride Scores in the Bryan District*

*Figure 3.13: Distribution of Ride Scores in the Houston District*

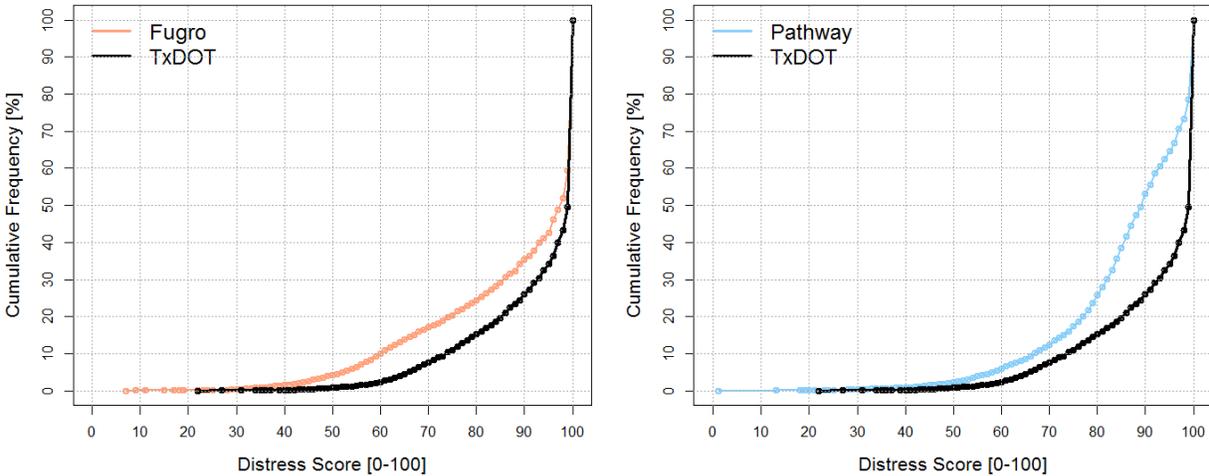
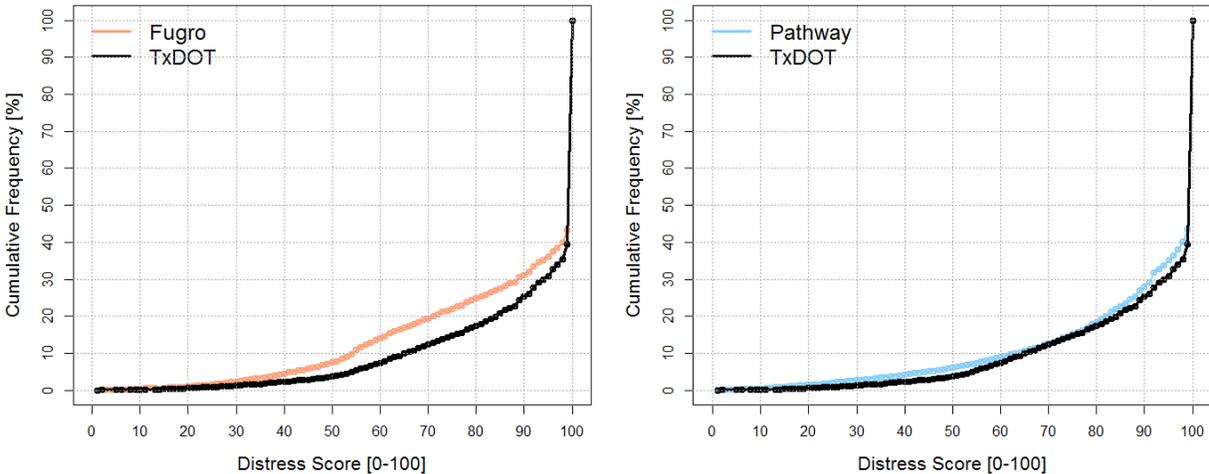
Figures 3.14 and 3.15 show the cumulative distribution of the DS in the Bryan and Houston districts, respectively. It is now evident that the differences in the CS are primarily due to differences in the DS. In general, both vendors captured more distresses than the distresses visually captured and reported in PMIS. However, it is interesting to note that, in the Houston District, a district with a high proportion of CRCP pavements, the agreement between Pathway Services and TxDOT PMIS is noticeable.

*Figure 3.14: Distribution of Distress Scores in Bryan*

*Figure 3.15: Distribution of Distress Scores in Houston*

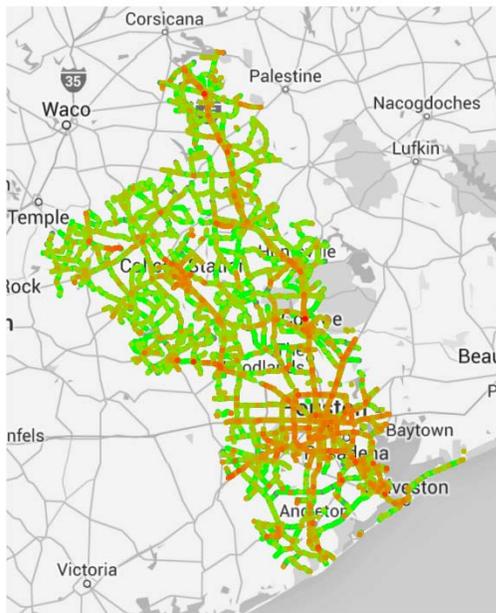
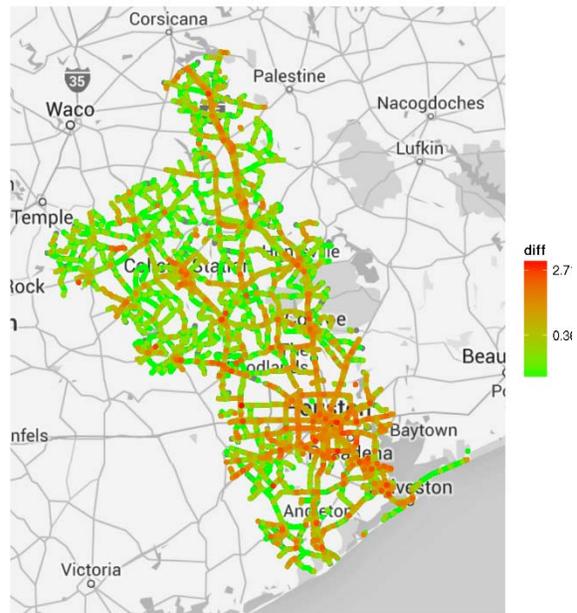
logarithmic scale for which red dots indicate higher differences and green dots indicate lower differences. Grey dots indicate zero difference.

(a) Fugro vs. PMIS

(b) Pathway vs. PMIS

Figure 3.16: Mapping the Differences in Ride Score

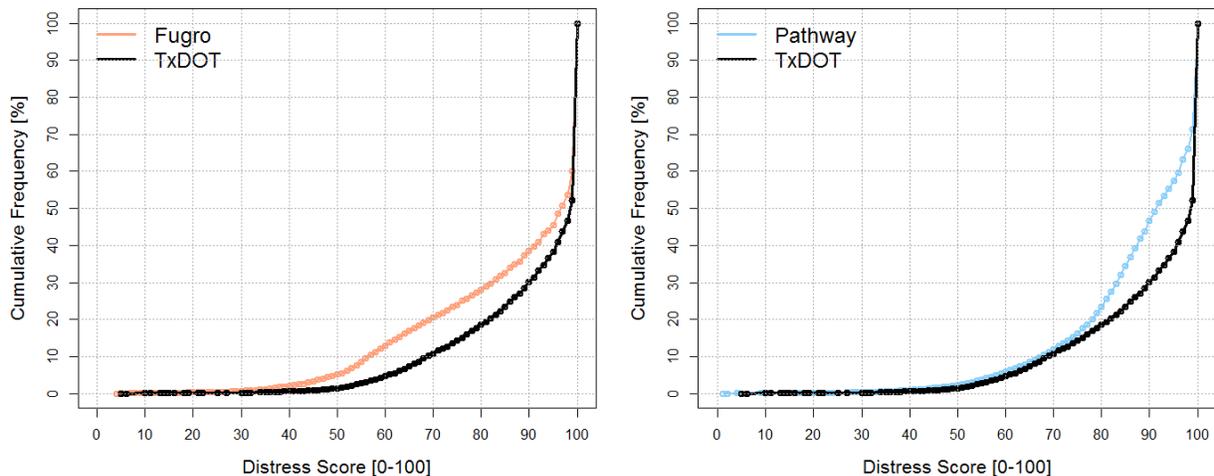
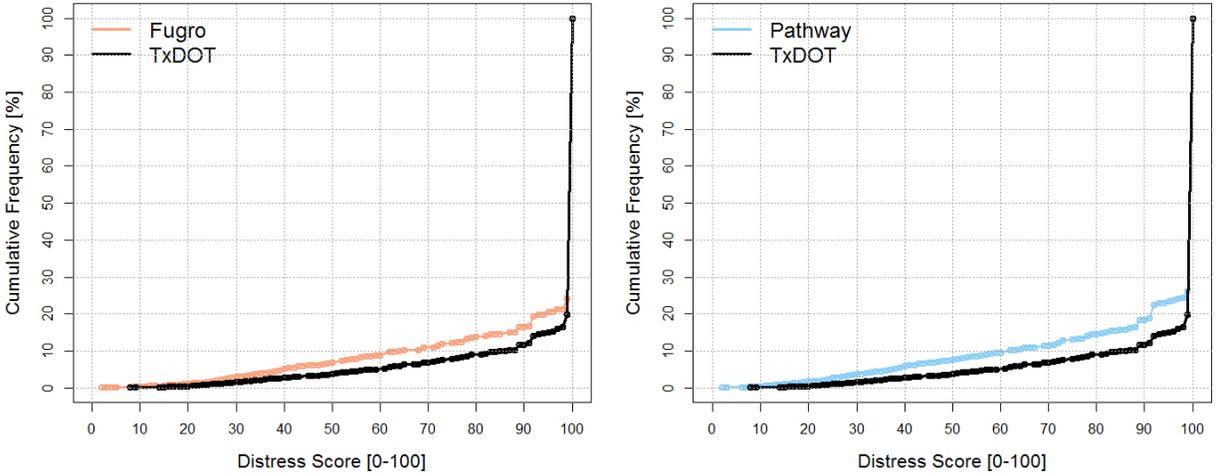
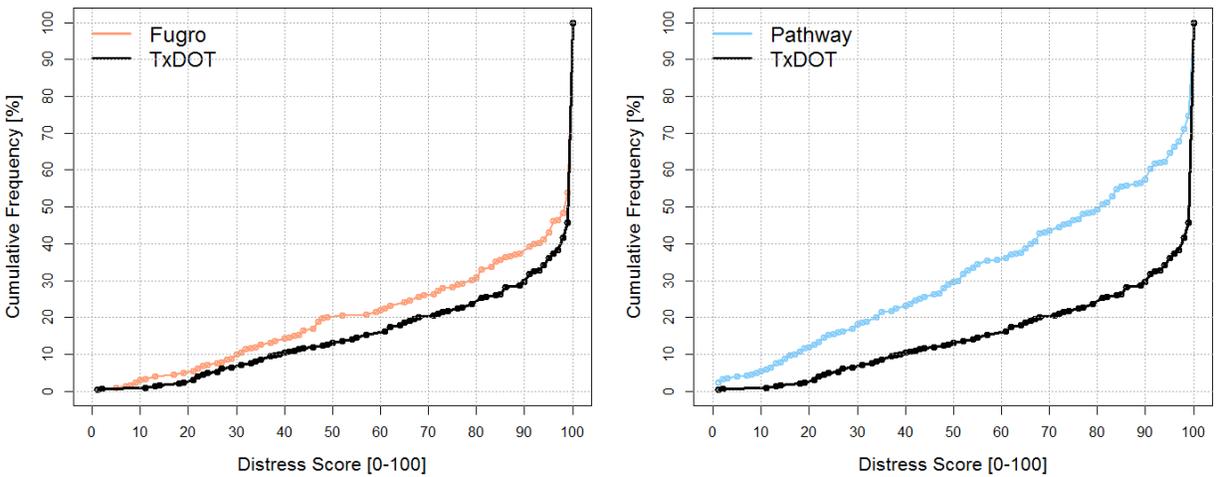
Figures 3.18, 3.19, and 3.20 show the differences in DS observed in both districts for the three broad surface types: ACP, CRCP, and JCP. For all types of pavements, the distributions of DSs calculated from the data collected by the vendors lie above the distributions using PMIS data. This means that, in general, the automated surveys capture more distress than the visual surveys. However, it is important to note that the differences vary depending on the pavement type. For example, in the case of ACP, the differences between Fugro and PMIS are most noticeable for DSs above 50; while the differences between Pathway Services and PMIS are only noticeable for DSs above 75 (Figure 3.18).

*Figure 3.18: Overall Distribution of Distress Scores for ACPs*

Figure 3.19: Overall Distribution of Distress Scores for CRCP Sections

Figure 3.20: Overall Distribution of Distress Scores for JCP Sections
