1. Report No. FHWA/TX-15/0-6663-3		2. Government Accession No.		3. Recipient's Catalog No.	
4. Title and Subtitle Automated Distress Surveys: Analysis of Network Level Data (Phase III)			5. Report Date February 2015; Published August 2015

6. Performing Organization Code		
7. Author(s) Pedro A. Serigos, Kuan-Yu Chen, Andre Smit, Mike R. Murphy, and Jorge A. Prozzi			8. Performing Organization Report No. 0-6663-3

## **Automated Distress Surveys: Analysis of Network Level Data (Phase III)**

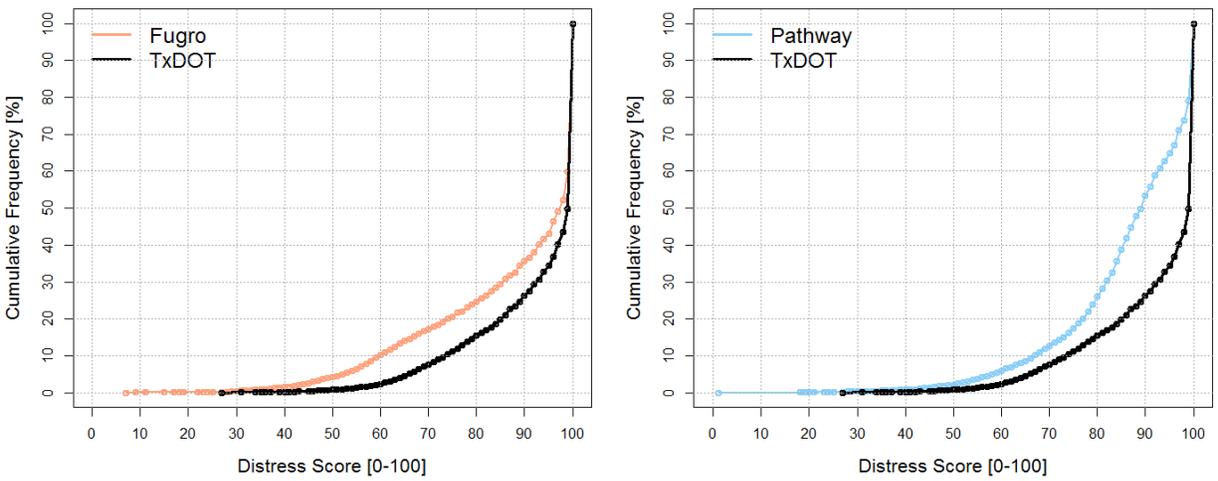
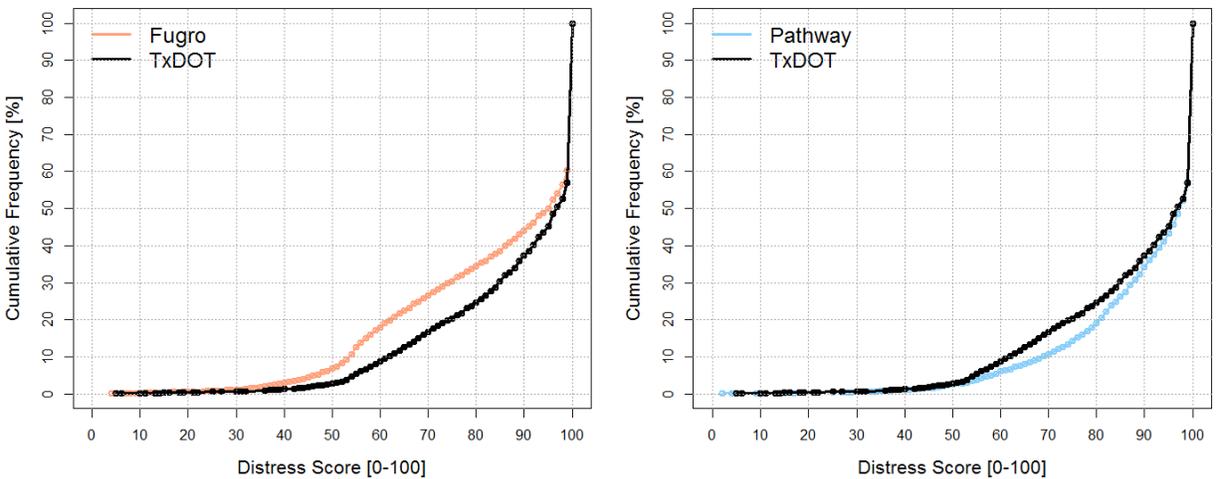
the two Pathway Services' survey vans, among other factors. It should be noted that each Pathway Services van collected data in one distinct district (see Table 3.1).

*Figure 3.21: Distribution of Distress Scores for ACP Sections in Bryan*

*Figure 3.22: Distribution of Distress Scores for ACP Sections in Houston*

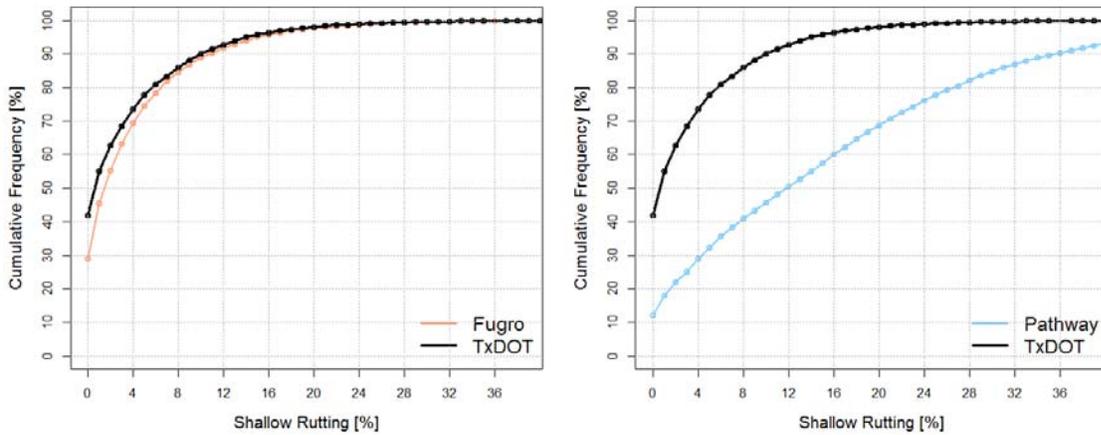
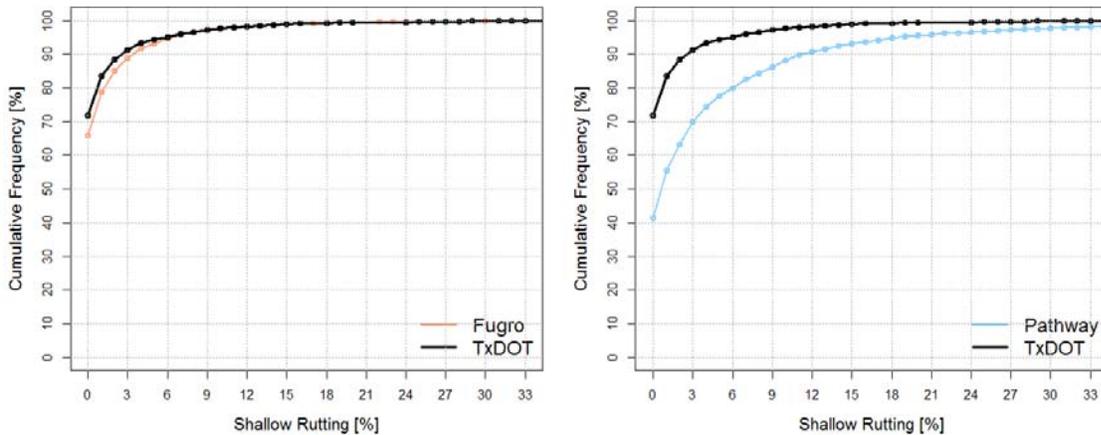
Figures 3.23 and 3.24 show the differences in shallow rutting for ACP in Bryan and Houston, respectively. It can be observed that Fugro's data match PMIS data relatively closely, while the differences in shallow rutting between Pathway Services and PMIS are significant. It is important to highlight that, as requested by TxDOT, rutting was to be calculated by simulating the use of a five-sensor measurement system -which consistently underestimates actual surface rutting- in order to match the technologies used for PMIS data collection. However, Pathway Services chose to report the rutting measurements obtained using the entire transverse profile, which explains, in part, the differences observed in Figures 3.23 and 3.24.

Figure 3.23: Distribution of Shallow Rutting for ACP in Bryan

Figure 3.24: Distribution of Shallow Rutting for ACP in Houston

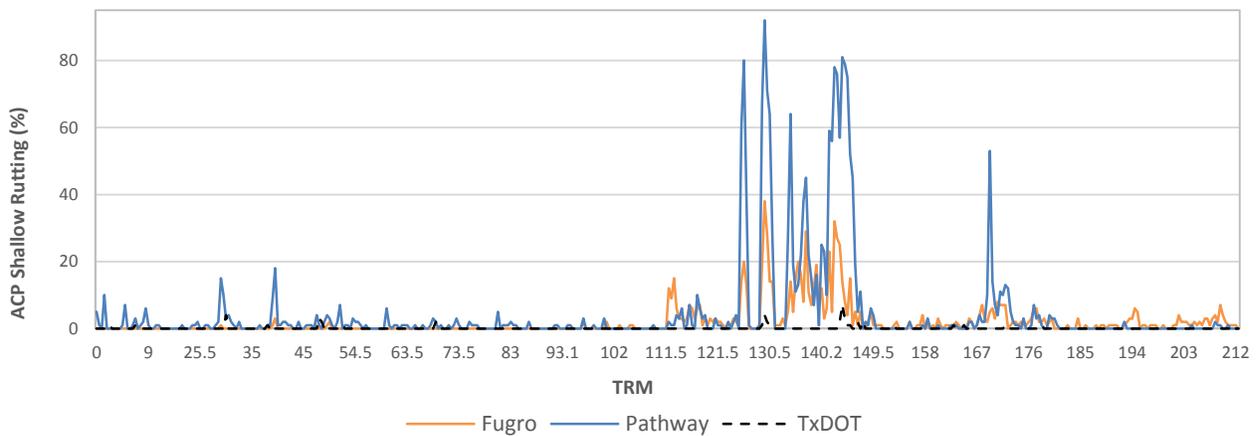
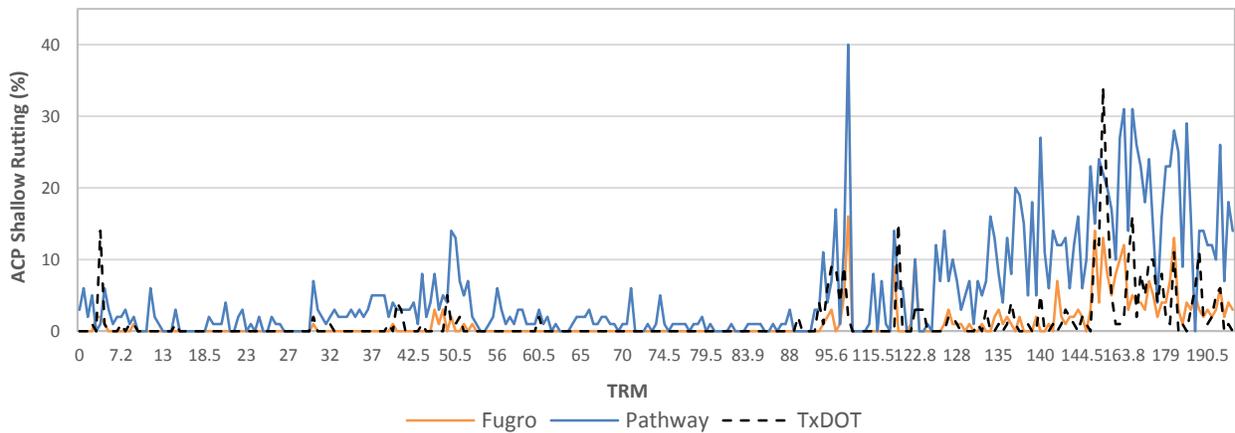
More detailed information on shallow rutting is shown in Figures 3.25 and 3.26. These figures show the percentage of shallow rutting in PMIS (green) and the corresponding values produced by Fugro (orange) and Pathway Services (blue) for a section of IH 45. Two lanes are shown: one on the main road (above) and one on the frontage road (below). It is clear that the differences grow as the percentage of shallow rutting increases. This is an indicator of the lack of accuracy and repeatability of the five-point algorithm for calculating rutting.

*Figure 3.25: Shallow Rutting along IH-45 for Main Lane L*

*Figure 3.26: Shallow Rutting along IH-45 for Frontage Road A*

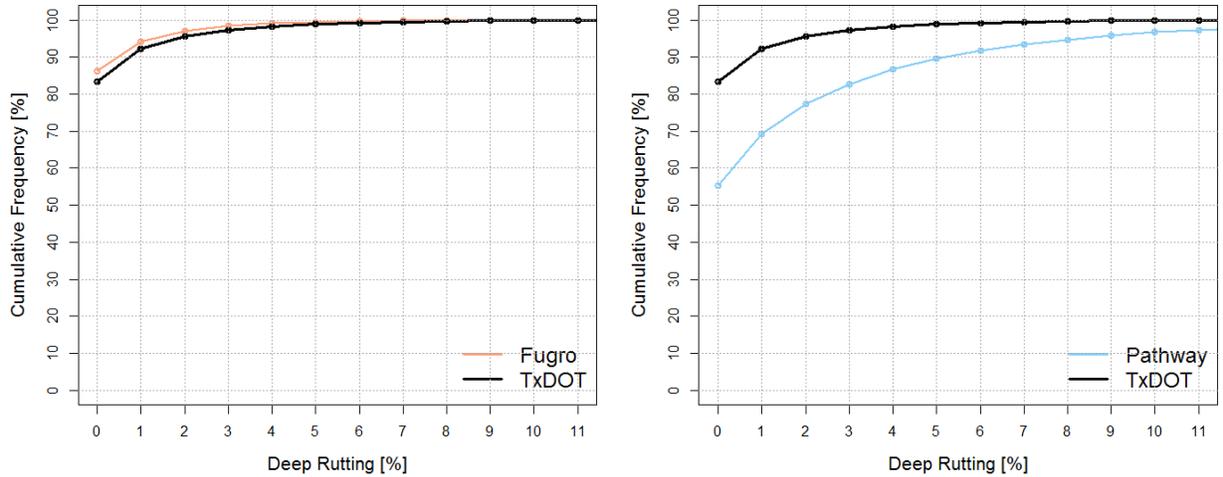
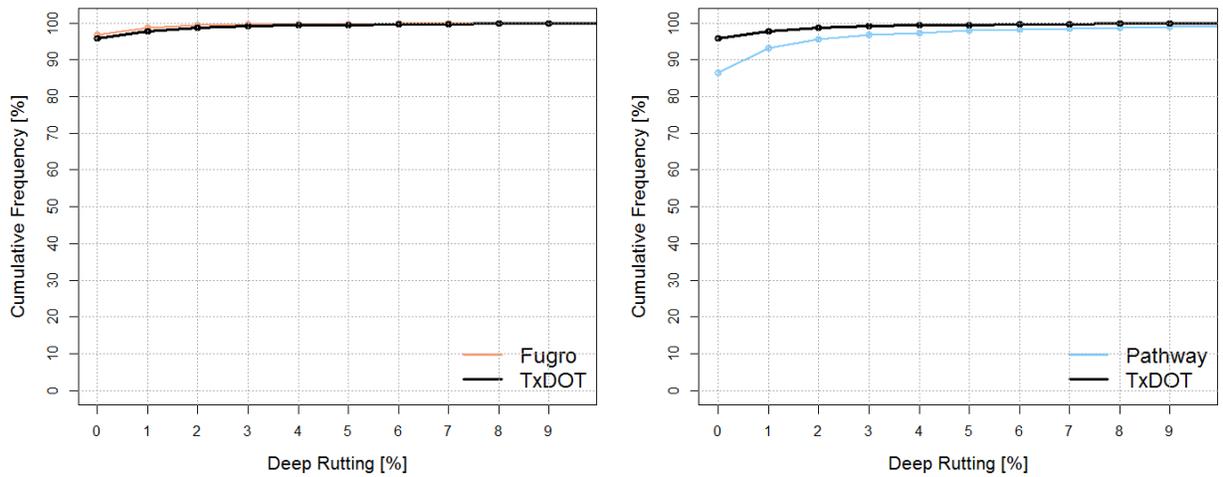
Figures 3.27 and 3.28 show the differences in deep rutting for flexible concrete pavements (ACP sections) in Bryan and Houston, respectively. As was the case for shallow rutting, Fugro’s data are in close agreement with PMIS data while Pathway Services’ data presented much larger discrepancies. However, in this case the differences are smaller and may be attributed to shortcomings in calculating rutting based on the five-point algorithm and not to inaccuracies in the raw data collected. In addition, as observed for shallow rutting, Pathway Services’ differences with PMIS were larger in Bryan than in Houston.

*Figure 3.27: Distribution of Deep Rutting for ACP in Bryan*

*Figure 3.28: Distribution of Deep Rutting for ACP in Houston*

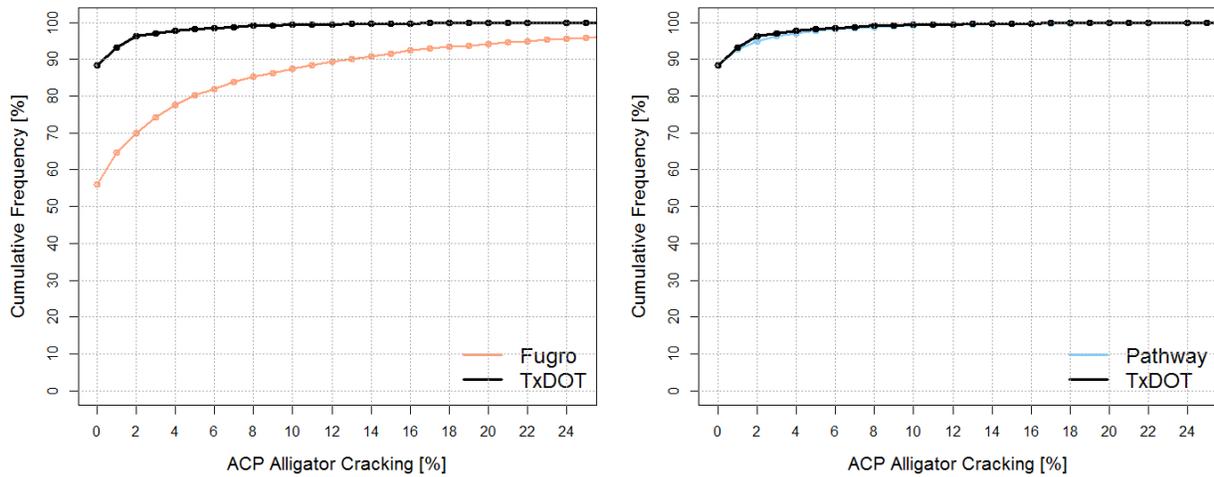
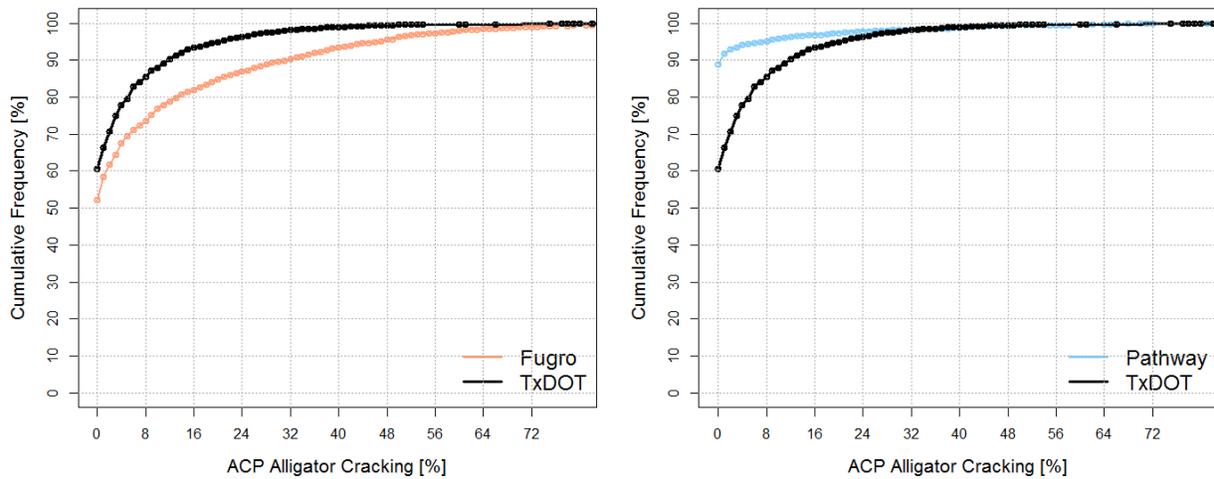
alligator cracking than visual windshield surveys, Pathway Services tended to detect less cracking. For the case of the sections at Bryan, Pathway Services observations match PMIS closely while Fugro captures significantly more alligator cracking.

Figure 3.29: Distribution of Alligator Cracking for ACP in Bryan

Figure 3.30: Distribution of Alligator Cracking for ACP in Houston

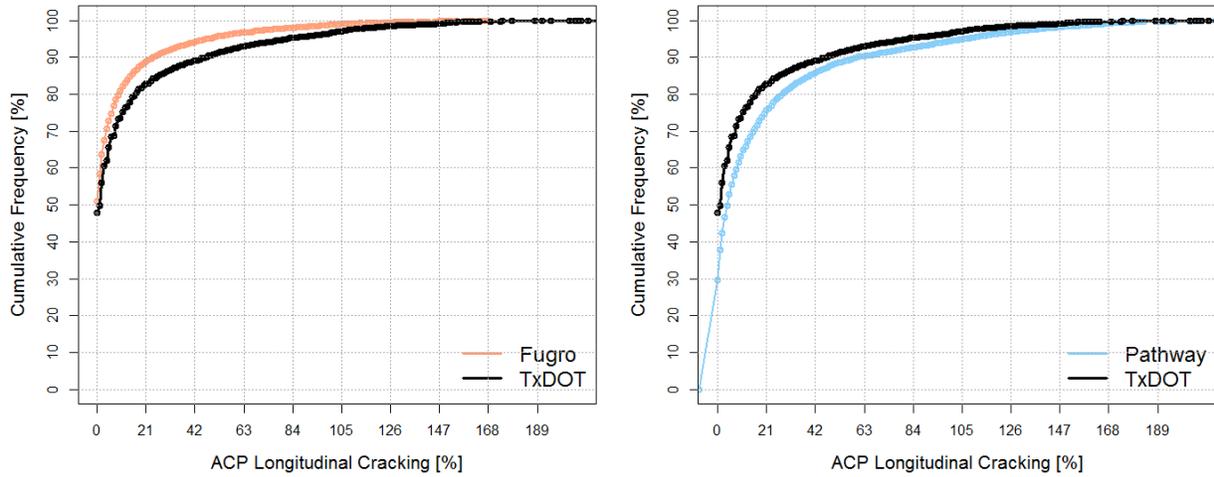
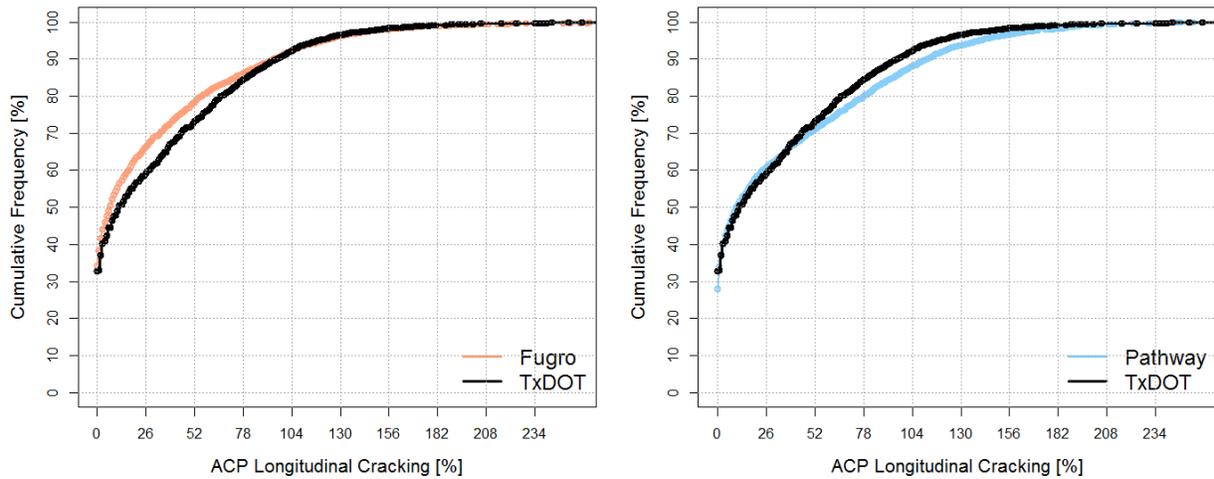
The observed greater amount of alligator cracking and the lower amount of longitudinal cracking reported by Fugro with respect to PMIS might be explained, in part, by differences in interpreting whether a crack developing in the wheel path is classified as alligator or longitudinal cracking.

*Figure 3.31: Distribution of Longitudinal Cracking for ACP in Bryan*

*Figure 3.32: Distribution of Longitudinal Cracking for ACP in Houston*

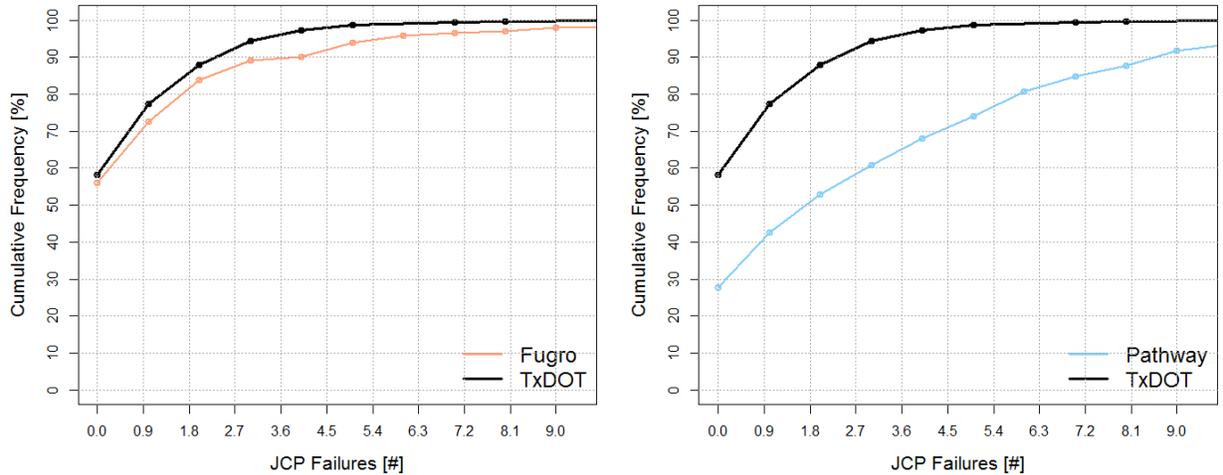
Figure 3.33: Distribution of Failures for JCP Sections in Houston

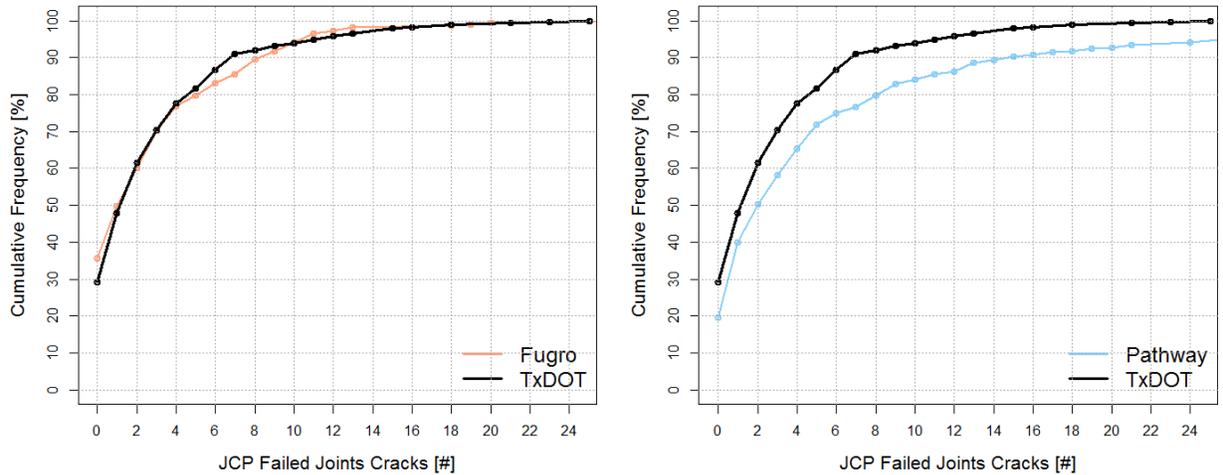
Figure 3.34: Distribution of Failed Joint Cracks for JCP Sections in Houston

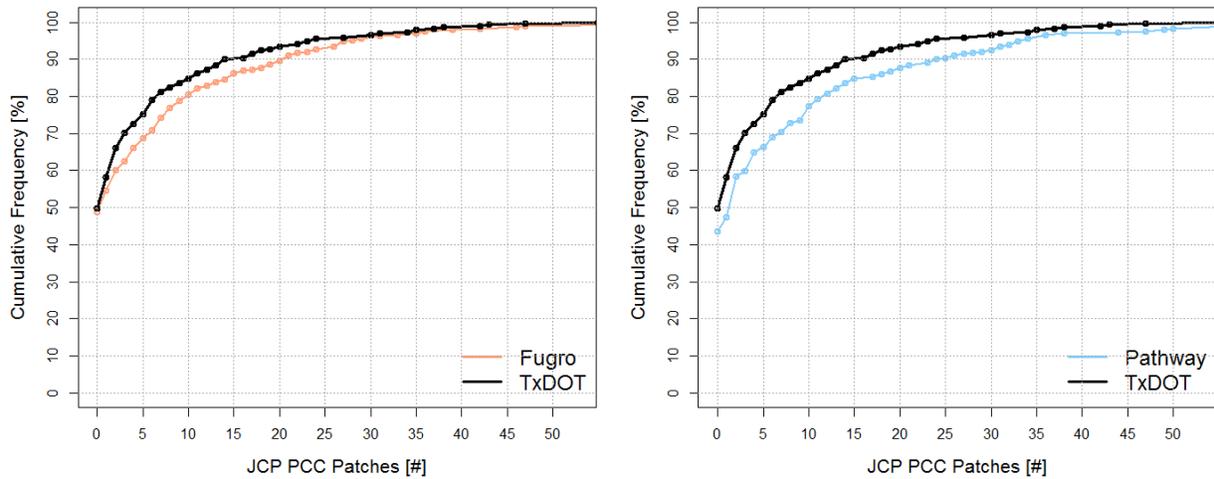
Figure 3.35: Distribution of PCC Patches for JCP Sections in Houston

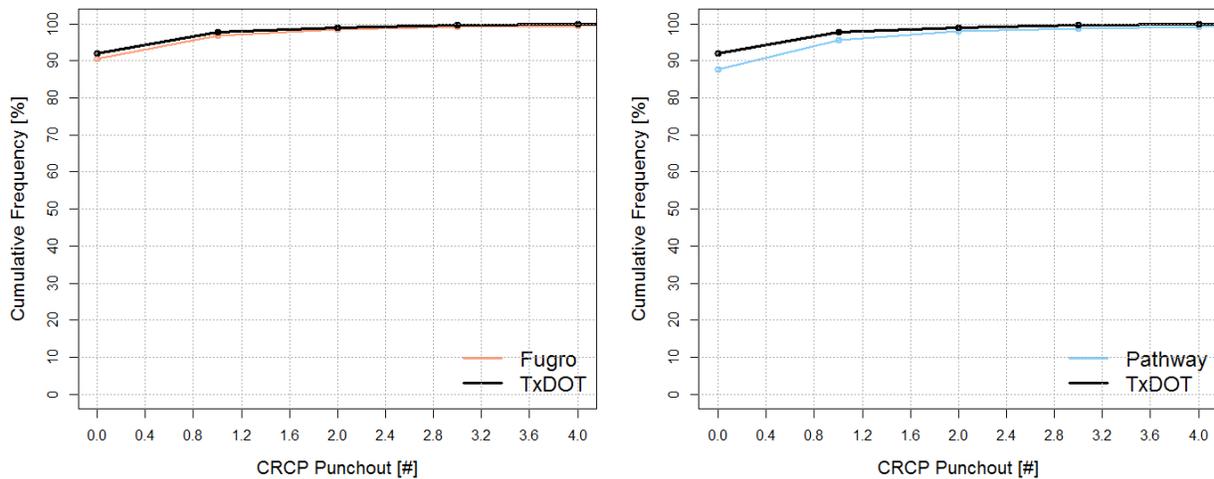
Figure 3.36: Distribution of CRCP Punchouts in Houston

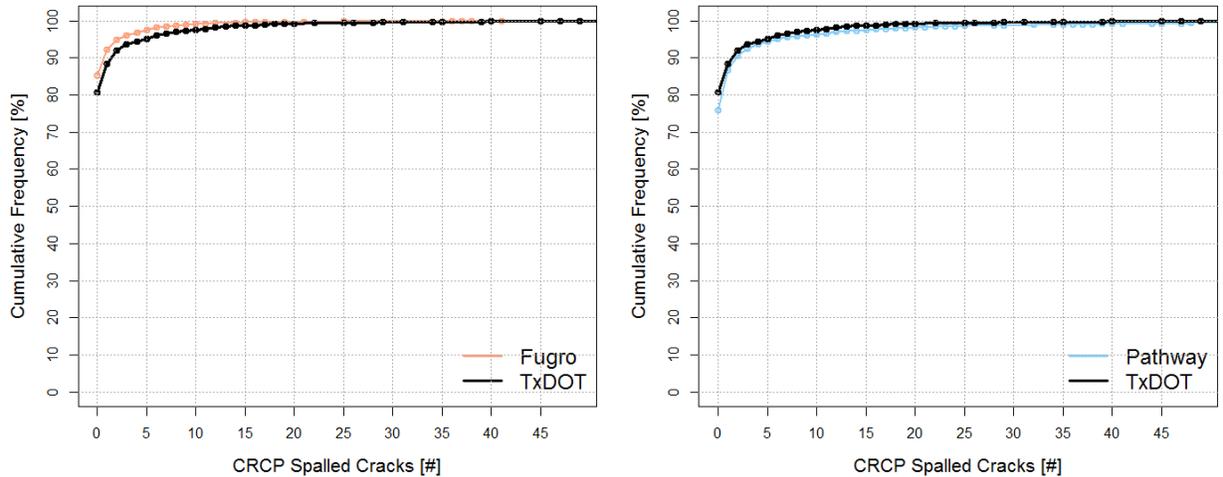
*Figure 3.37: Distribution of CRCP Spalled Cracks in Houston*
