TECHNICAL REPORT 0-6829-1
TxDOT PROJECT NUMBER 0-6829

Fatigue Resistance and Reliability of High Mast Illumination Poles (HMIPs) with Pre-Existing Cracks: Final Report

March 2018; Revised and Published November 2018

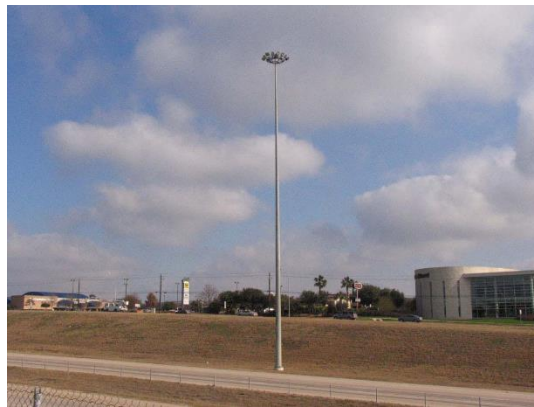
Figure 2.1: Typical High Mast Illumination Pole (Rios 2007)

High Mast Illumination Poles (HMIPs) are used throughout the U.S. to provide lighting along highways and at interchanges. HMIPs in Texas are typically tapered steel poles that are fabricated in segments and are galvanized for corrosion protection. There are currently about 5000 HMIPs in Texas that consist of 8 or 12 sided cross-sections, with heights varying from 100 to 175 ft. [Figure 2.1](#) shows an example of a typical high mast illumination pole. At its base, the HMIP shaft is welded to a steel base plate, which in turn is attached to a concrete foundation through a series of anchor bolts.

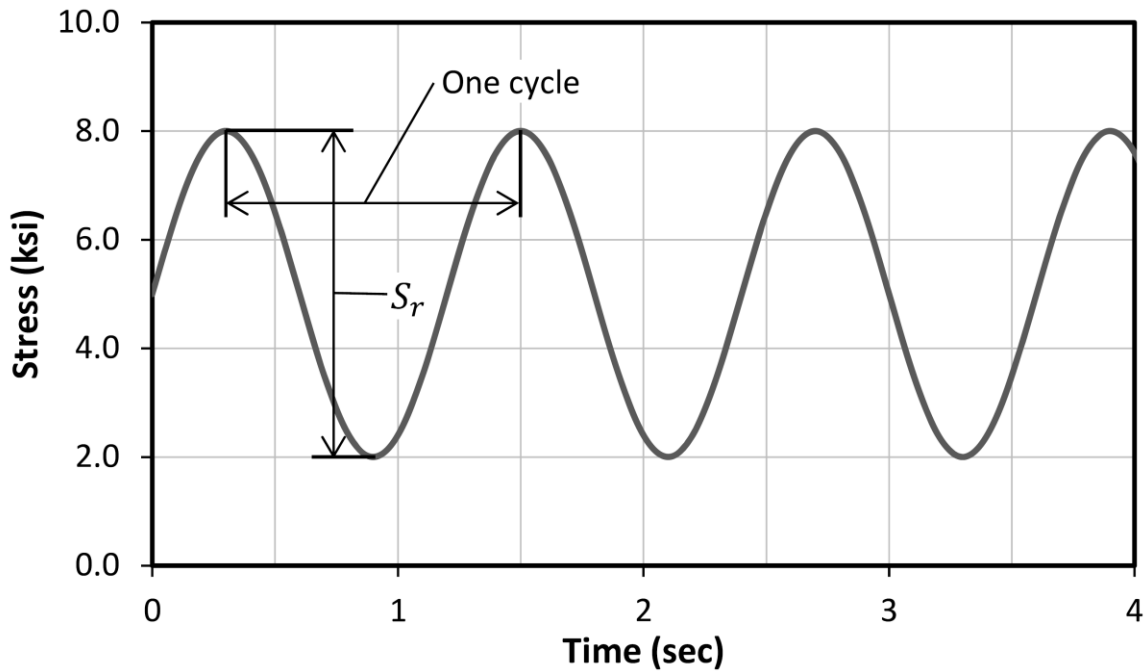
Figure 2.3: Definition of a Stress Cycle (Fasl 2013)

The classical experimental method to characterize fatigue resistance is to test a given detail in tension at a constant-amplitude stress range and count the number of cycles to failure. Nominally identical details are tested at different constant-amplitude stress ranges until failure. The stress range is defined as the difference between the highest and lowest values in a stress history (Figure 2.3).

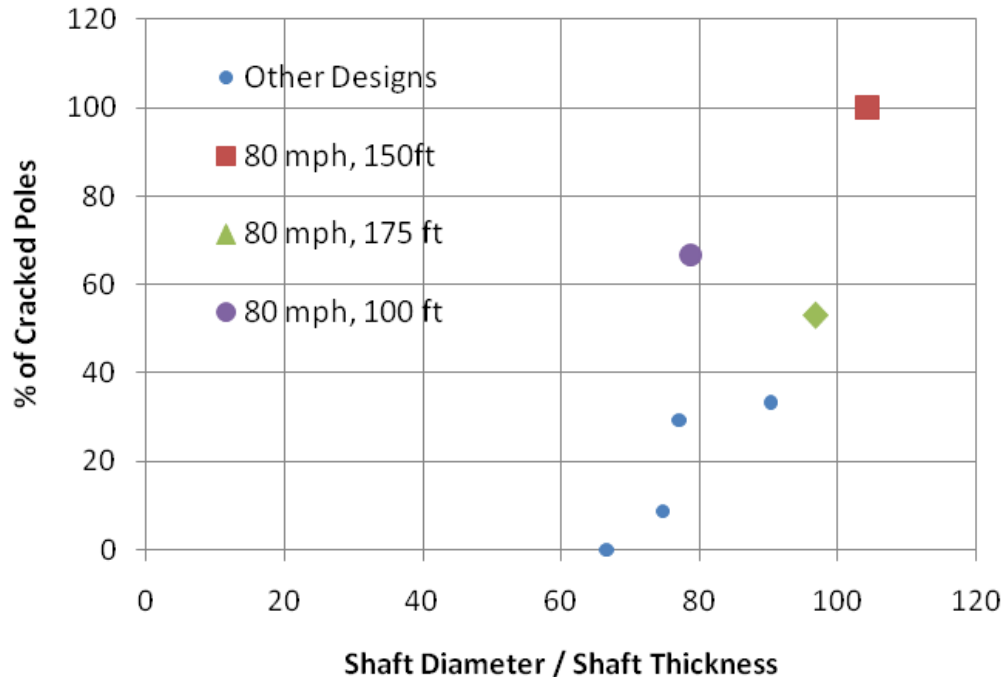
Figure 2.9: Percentage of Cracked In-Service HMIPs versus Shaft D/t Ratio (Magenes 2011)

Also listed in [Table 2.3](#) is the ratio of shaft diameter to thickness (D/t). A possible correlation between D/t and amount of cracking became evident in this data. [Figure 2.9](#) shows a plot of the percentage of cracked poles versus D/t of the shaft for the in-service poles evaluated by TxDOT. The D/t ratio of the shaft appears to be a useful indicator of the potential for cracks within in-service HMIPs. However, the impact of this cracking on the remaining fatigue life of the HMIP is still unclear.

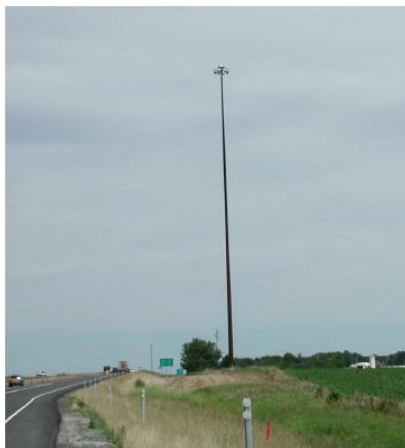
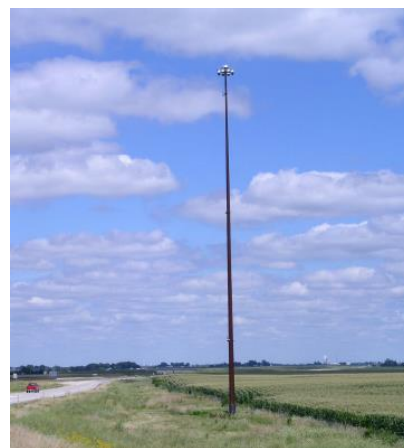
(a) Pole 1

(b) Pole 2

Figure 2.16: The Two High Mast Poles Monitored in Mason City, Iowa (Chang 2007)

In the field study reported by Chang (2007), two HMIPs were monitored near Mason City in Iowa from October 2004 to January 2006 (Figure 2.16). Two poles (12 sided, 148 ft. high, having three discrete sections and a taper ratio of 0.14 in./ft) were located two miles apart in an open terrain. Pole 1 and the auxiliary wooden pole near it were instrumented to monitor and record wind-induced vibrations of pole 1. Pole 2 was instrumented to capture the wind profile using anemometers distributed along its height. Strain gages were also installed on both poles to record the vibration-induced stresses.

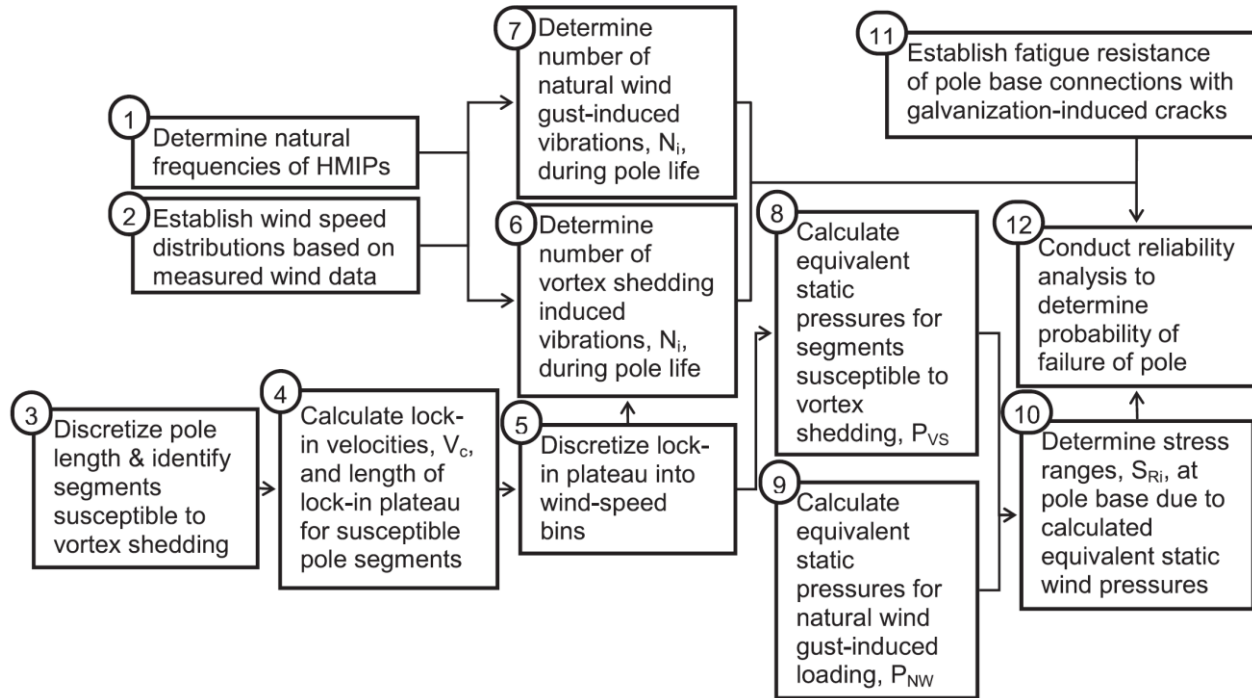
Figure 2.46: An Analysis Approach for Predicting Fatigue Behavior of In-Service HMIPs in Texas (Dawood et al. 2014)

Dawood et al. (2012, 2014) proposed a comprehensive analytical method that consisted of twelve individual steps shown as a flow chart in Figure 2.46. This method was used to analyze the wind-induced response of poles, and to provide an assessment of failure probability using AASHTO fatigue reliability approach (Chung et al. 2003, 2004).

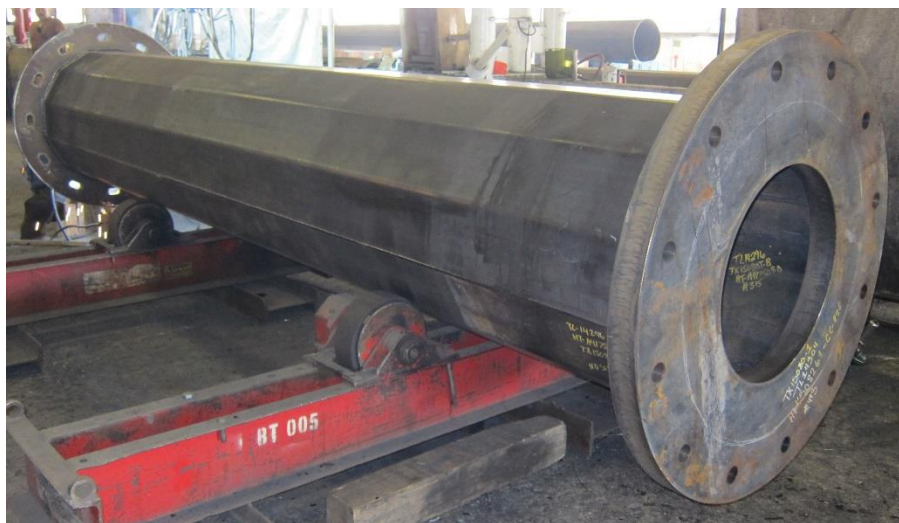
Figure 5.5: HMIP Fatigue Test Specimen of Primary Interest being Fabricated at the Shop

The specimens referred to as the specimens of primary interest are based on the TxDOT design for an HMIP with a pole that is 12-sided, 150 ft tall, with a design wind speed of 80 mph, and without ground sleeves. The layout of HMIP test specimens in the first series of fatigue tests is shown in Figure 5.1. The specimens are each approximately 14.5 ft. in length. One end of the specimen is provided with the actual shaft-to-base plate connection detail of interest described above (left end of specimen in Figure 5.1). The design of this base plate along with the weld details are shown in Figures 5.2 and 5.4, respectively. Note that this design (as shown in Figures 5.2 and 5.4) conforms to the TxDOT Standard HMIP (1)-98. The other end is provided with a welded reaction plate that allows attachment to the reaction support fixtures, as will be described and shown in Section 5.3. The design of this reaction plate (end plate) along with the weld details are depicted in Figures 5.3 and 5.4, respectively. A picture of HMIP test specimen used in the first fatigue test is further shown in Figure 5.5.

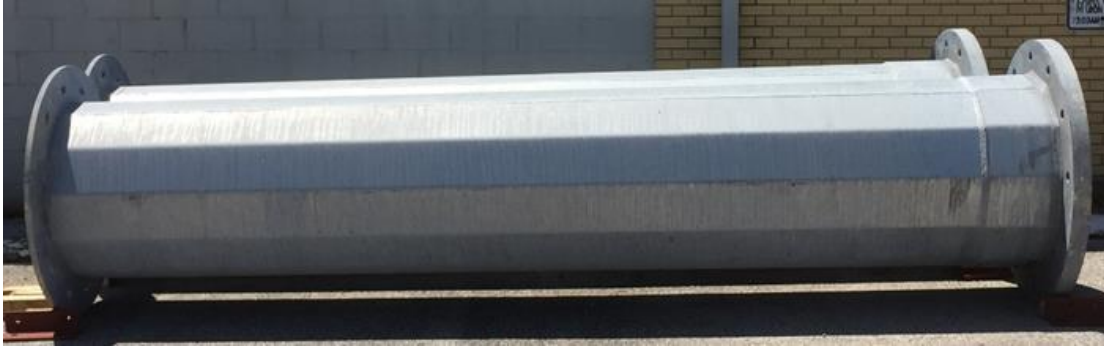
Figure 5.10: HMIP Fatigue Test Specimens of Secondary Interest following Fabrication

Pictures of HMIP test specimens of secondary interest are further shown in [Figures 5.10](#) and [5.11](#).

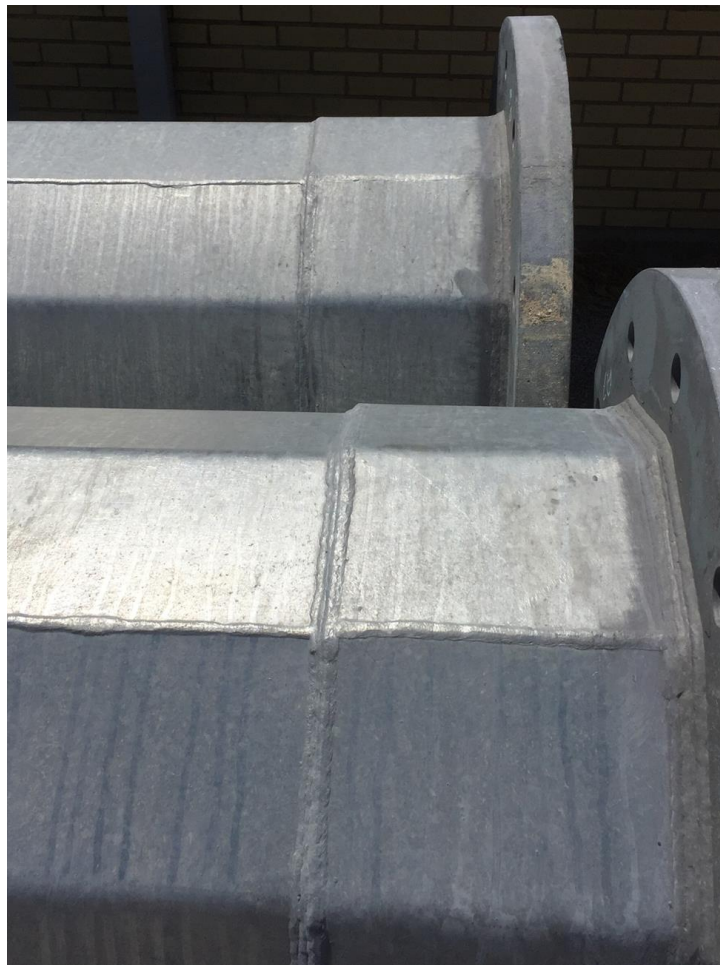
Figure 5.11: A close-up of the Ground Sleeves (External Collars) of the HMIP Specimens of Secondary Interest

As shown above in presenting the details of the shaft-to-baseplate connections for both primary and secondary designs, the connection details for specimens with primary design (Figures 5.1, 5.2, and 5.4) and those with secondary design (Figures 5.6, 5.7, and 5.9) are virtually identical. The only differences stem from the addition of the ground sleeve, which

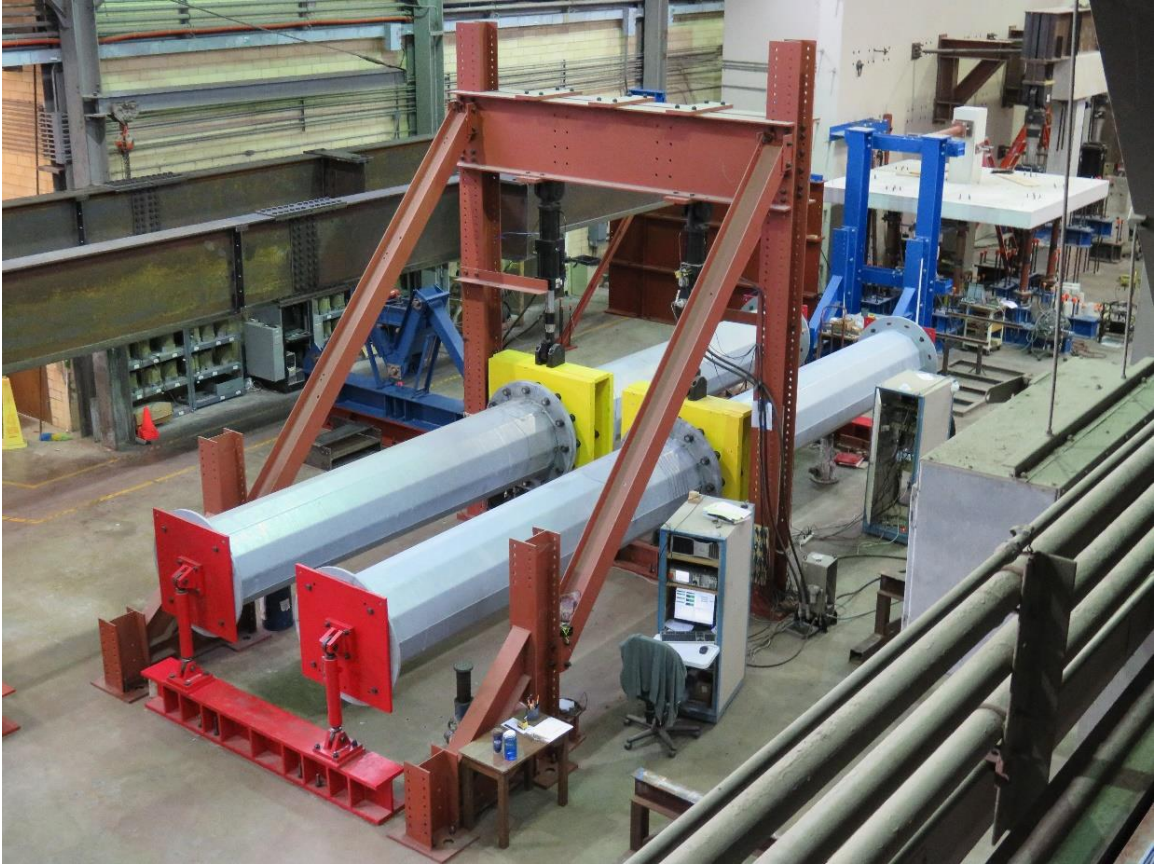
Figure 5.16: Portal Loading Frame Used in Fatigue Testing of HMIP Specimens at the Ferguson Structural Engineering Laboratory

Pictures in [Figures 5.16](#) to [5.19](#) provide more details of the fatigue test setup at the Ferguson Structural Engineering Laboratory, including the portal loading frame and lateral braces, the stiff reaction box, the hydraulic actuator, and the end support fixtures.

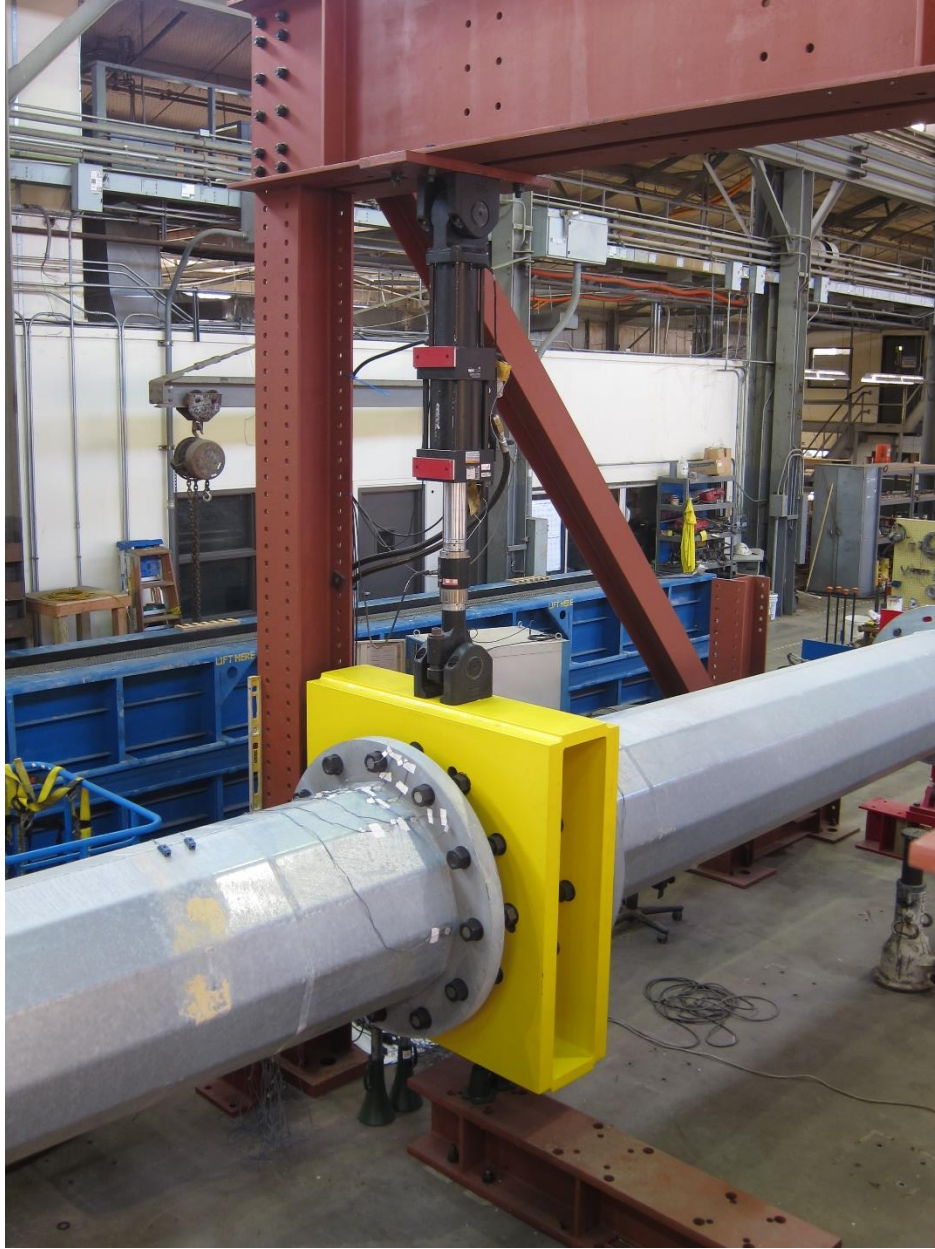
Figure 5.17: MTS 55-kip Hydraulic Actuator and the Stiff Reaction Box (the Load Box)

As also shown in [Figure 5.13](#), the Fatigue loading was applied by a single 55-kip MTS actuator working in displacement control. The 55 kip capacity MTS hydraulic actuator was controlled by an MTS FlexTest SE Controller. Hydraulic pressure was supplied by an MTS SilentFlo HPU operating at 3000 psi with a 30 gpm capacity. Hydraulic pressure was regulated by an MTS 293 Hydraulic Manifold.

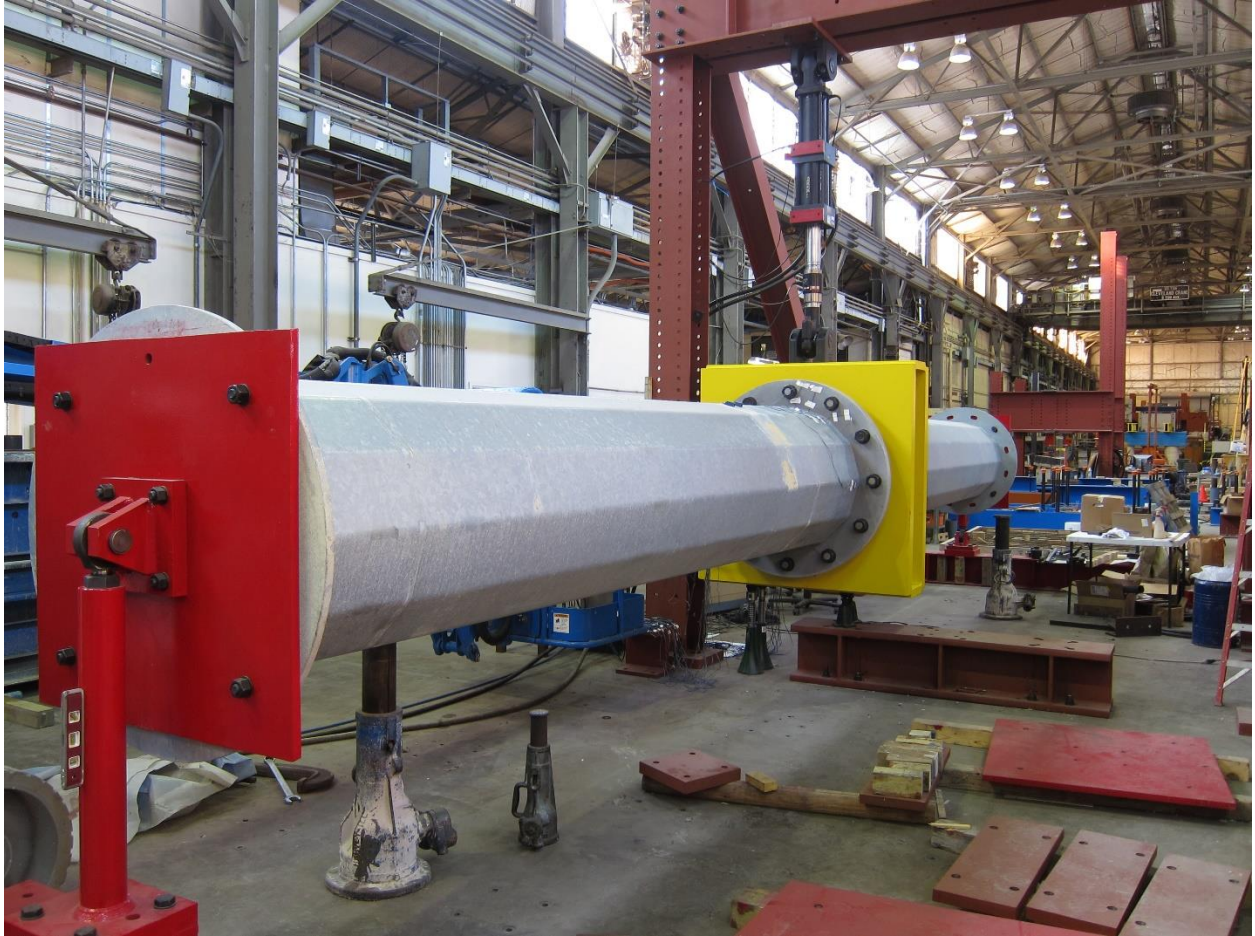
Figure 5.18: Pin Support (1 DOF End) in the Horizontal Fatigue Test Setup

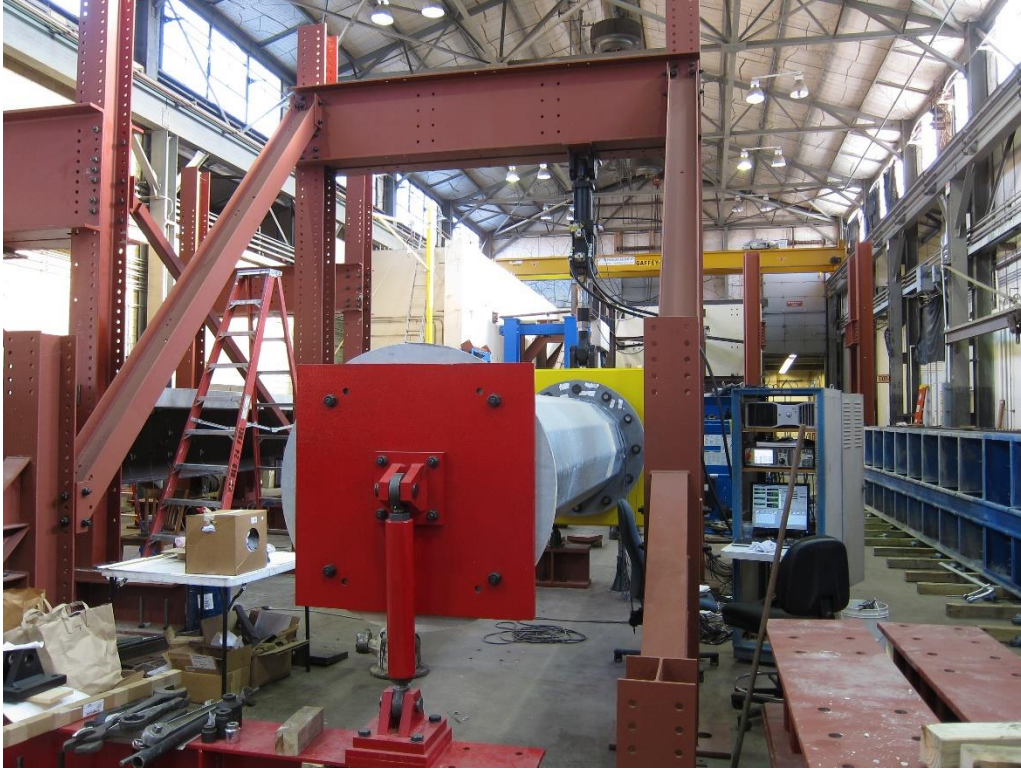
Figure 5.19: Roller Support (2 DOF End) in the Horizontal Fatigue Test Setup

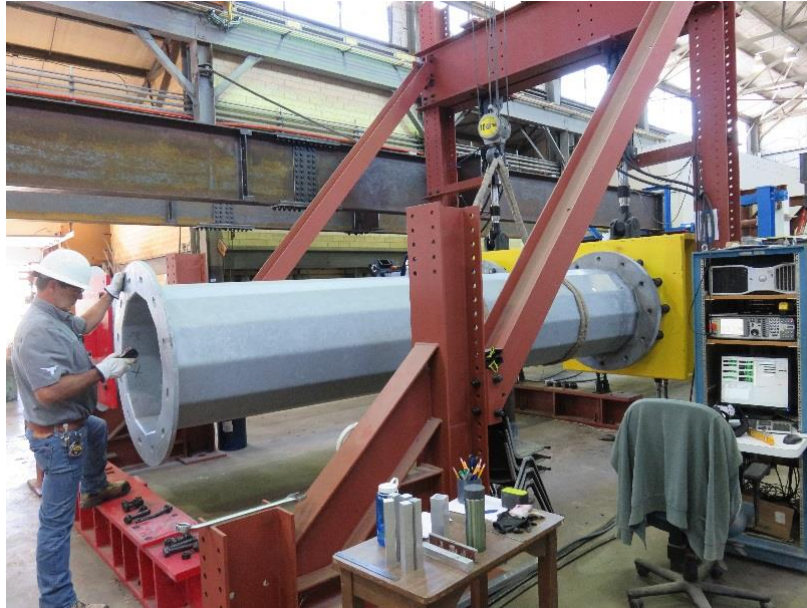
Figure 5.21: Installation of an HMIP Specimen into the Horizontal Fatigue Testing Setup.

As an example, representative pictures of the installation process are presented in [Figures 5.21 to 5.23](#). The pictured specimen was tested until failure, removed from the setup, rotated, and reinstalled. [Figures 5.21 and 5.22](#) were taken during the reinstallation of the specimen. [Figure 5.21](#) shows a lab technician directing the specimen toward the loading box. [Figure 5.22](#) shows this from another angle. Notice that the base-plate and the load box are in parallel planes. This was accomplished via a leveling process whereby the positions of the straps lifting the specimen were adjusted until the base-plate was level. This facilitated the process of installing the specimen, as it could be pushed straight on to the loading box's threaded rods. [Figure 5.23](#) shows the specimen after reinstallation. At this point, the nuts on the threaded rods were tightened, but the roller support was yet to be reattached. Taking its place was an adjustable jack that prevented the specimen from becoming a cantilever. This jack was removed after the roller connection was reattached to the specimen and the testing frame.

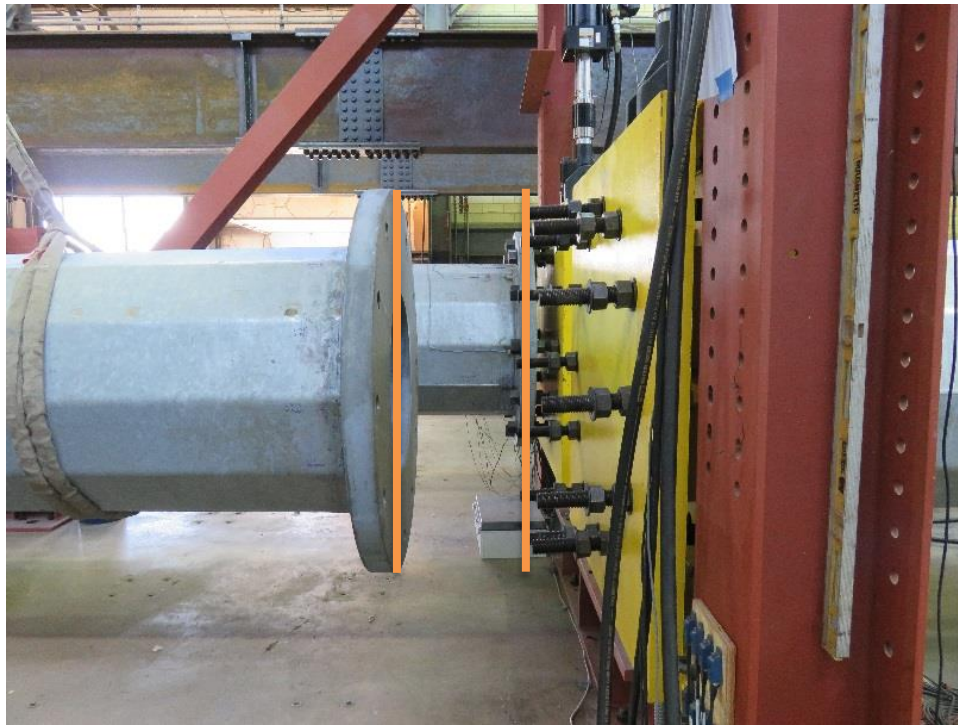
Figure 5.22: Attachment of a "leveled" HMIP specimen to the Load Box.

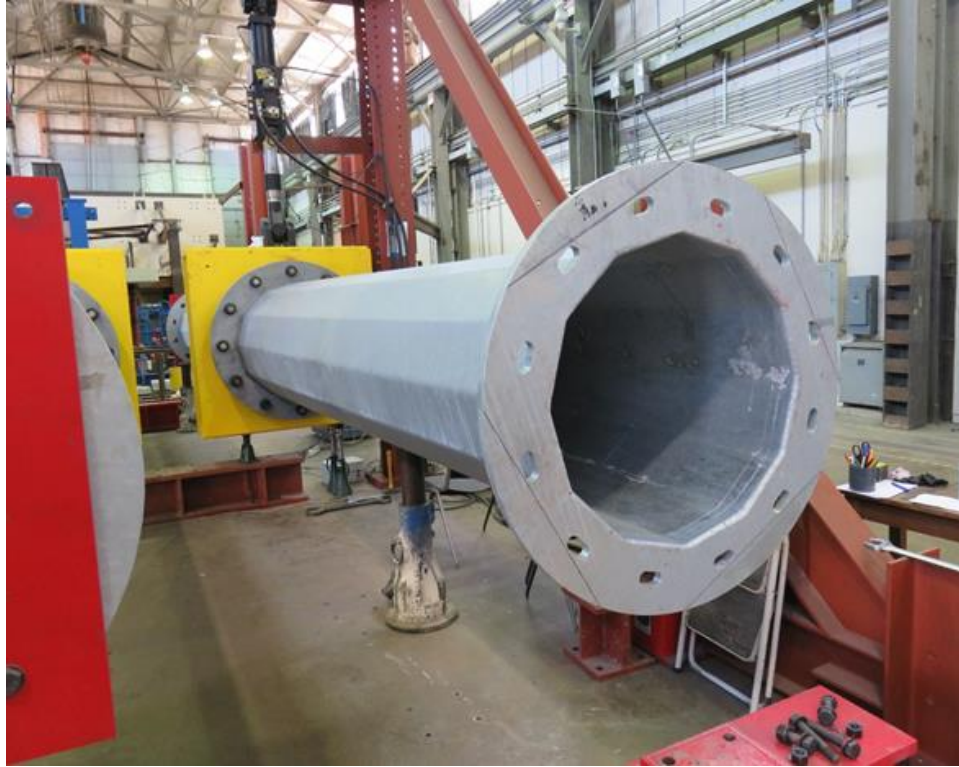
Figure 5.23: A specimen supported on a jack during Final Stages of installation.

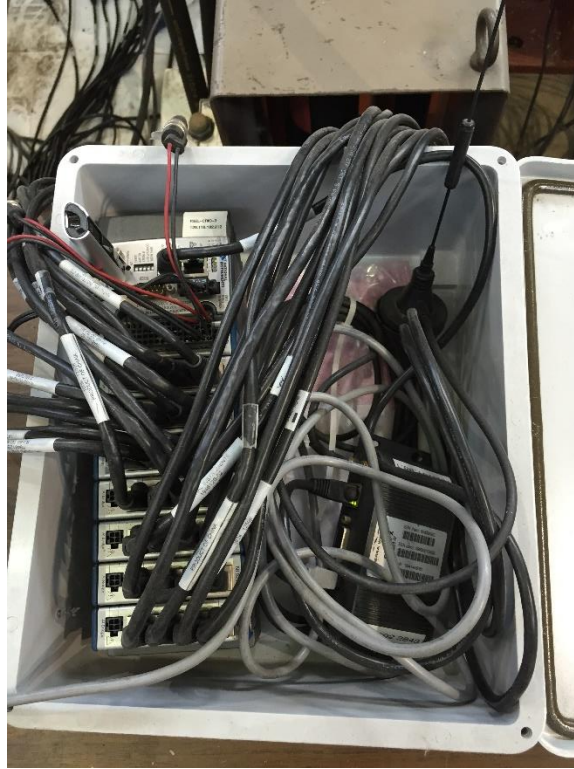
The data acquisition system, Compact RIO, from National Instruments (NI) was used to record and to analyze the fatigue test data. The Compact RIO consisted of the controller (Model cRIO-9024), an eight slot chassis (Model cRIO-9114), and a series of modules. Directly connected to MTS FlexTest SE Controller, One NI-9205 module was used to record forces and displacements from MTS actuator. Additionally, seven NI-9239 modules were used to record strain gauge data. A picture of the data acquisition system used in fatigue tests on HMIP specimens is presented in [Figure 5.26](#). As further seen in [Figure 5.26](#), an Airlink Raven X cellular modem from Sierra Wireless was also utilized to access the NI Compact RIO DAQ remotely through the GPRS/EDGE wireless network. The NI Compact RIO DAQ and the wireless modem were placed in a water-resistant enclosure box for better protection.

Figure 5.26: NI Compact RIO Data Acquisition System Used to Record Fatigue Test Data

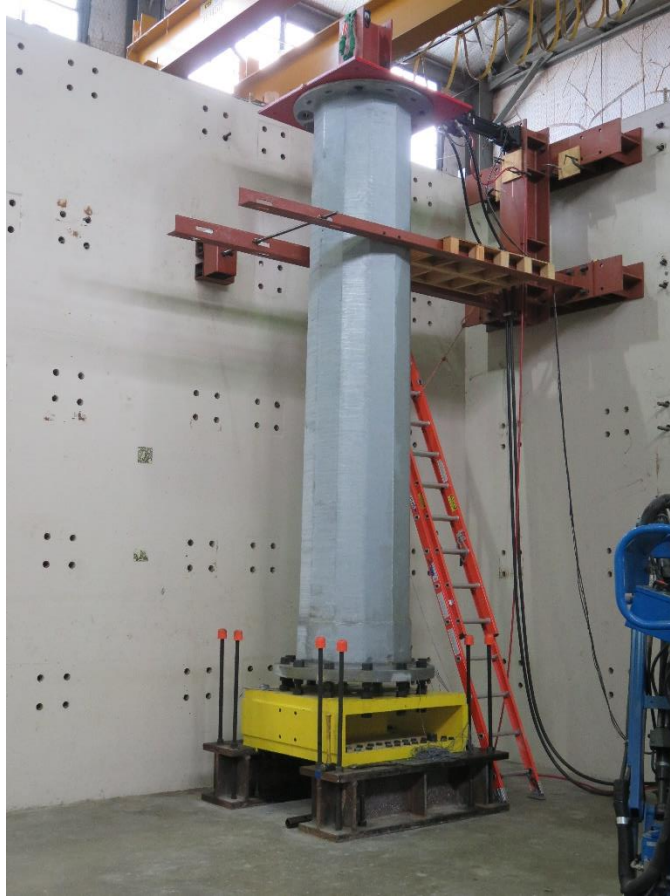
Figure 5.32: Vertical Setup Configured to Perform Fatigue Tests on HMIP Specimens at the Ferguson Structural Engineering Laboratory

A portrayal of the vertical test setup is displayed in [Figures 5.28](#) and [5.29](#), where different elements of the setup are indicated. More details on the vertical and lateral support conditions are further provided in [Figures 5.30](#) and [5.31](#). All materials needed for this setup, with the exception of nuts and bolts, was recycled from previous tests at the Ferguson Structural Engineering Laboratory. The setup consisted of two structural steel I-beams that were bolted to the strong floor. On top of these I-beams would rest the loading box that was previously used in fatigue tests on high-mast poles at the Ferguson Structural Engineering Laboratory. The testing specimen would then rest on top of the repurposed loading box. An actuator was bolted to the strong wall and connected to the specimen via a pinned connection. This actuator was utilized to apply forces to the specimen. Pictures of the vertical setup configured for both static and fatigue tests on cracked HMIP specimens along with more details on the actuators and on the force and displacement measurements are shown in [Figures 5.32](#) through [5.36](#).

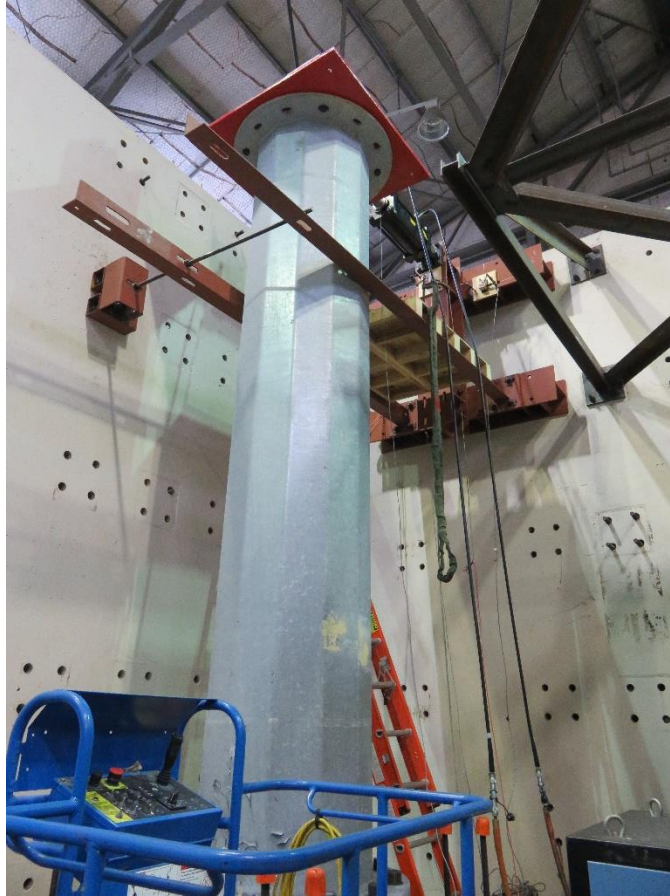
Figure 5.34: Vertical Setup Configured to Perform Ultimate Strength Test on an HMIP Specimen at the Ferguson Structural Engineering Laboratory

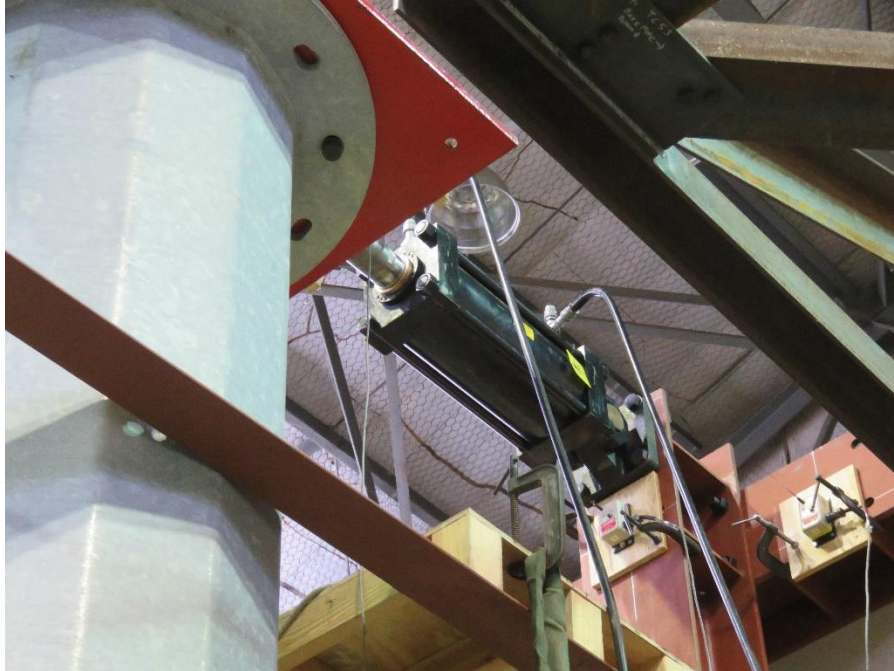
Figure 5.35: An Actuator in the Vertical Setup Used in Ultimate Strength Testing of an HMIP Specimen at the Ferguson Structural Engineering Laboratory

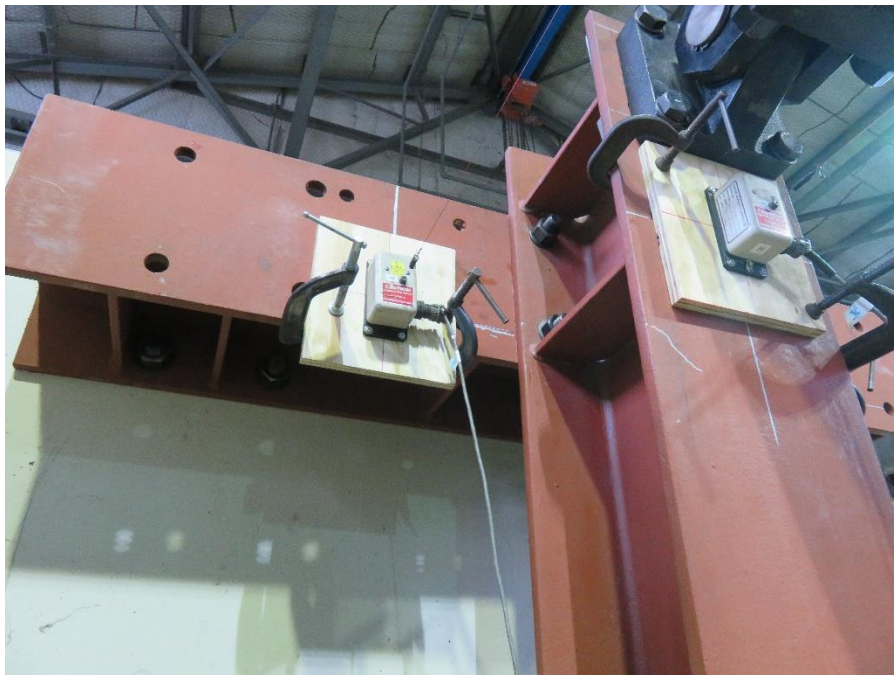
Figure 5.36: String Pods to Measure Lateral Displacements of an HMIP Specimen in the Ultimate Strength Testing at the Ferguson Structural Engineering Laboratory

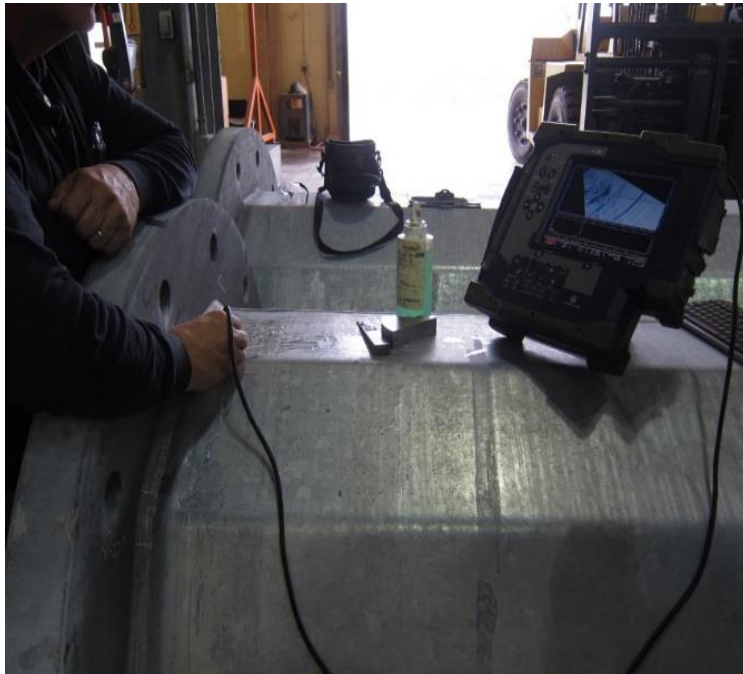
Figure 5.37: Hargang X-32 PAUT Instrument Used in Detecting Cracks in an HMIP Specimen

Phased Array Ultrasonic Tests (PAUTs) have been conducted on every specimen tested in the Ferguson Structural Engineering Laboratory. Conventional ultrasonic tests (UTs) were initially performed by TxDOT on Specimens 33-3-12-TX-A1 and 33-3-12-TX-A2 used in the fatigue test at a stress range of 6 ksi. Crack length, but no crack depth data were obtained using UTs. Starting in mid-November of 2015 until the end of the project, tests had been performed by Reinhart & Associates, a nondestructive evaluation testing and engineering firm based in Austin, Texas. Reinhart & Associates developed a specific procedure to measure the length and depth of the cracks existed in the shaft-to-baseplate welded connections of the HMIP specimens of primary interest (Figures 5.37 to 5.39).

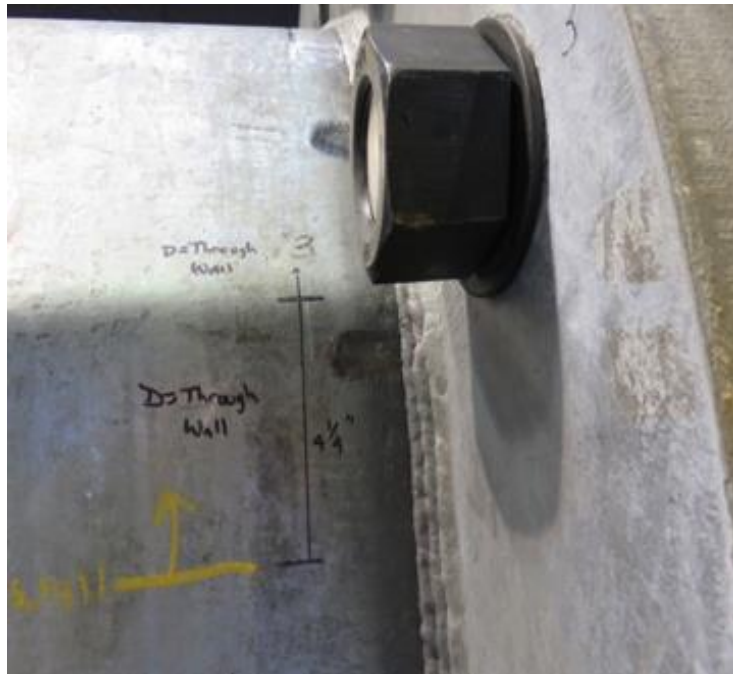
Figure 5.38: Sample of Crack Markings Indicating the Crack Locations, Lengths, and Depths Documented in a Fatigue Test

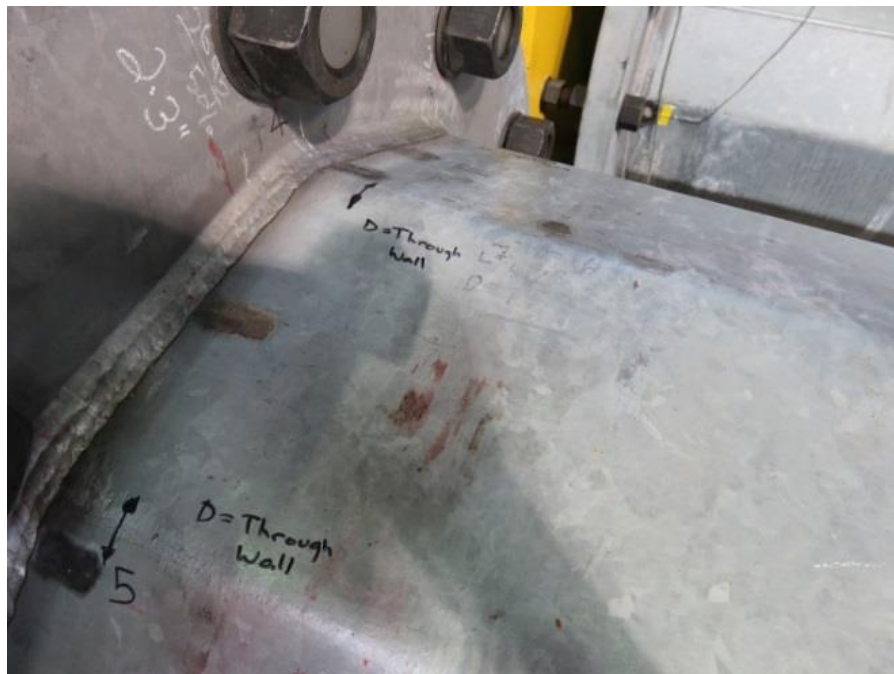
Figure 5.39: Sample of Crack Markings for a Specimen with Severe Cracking in a Fatigue Test

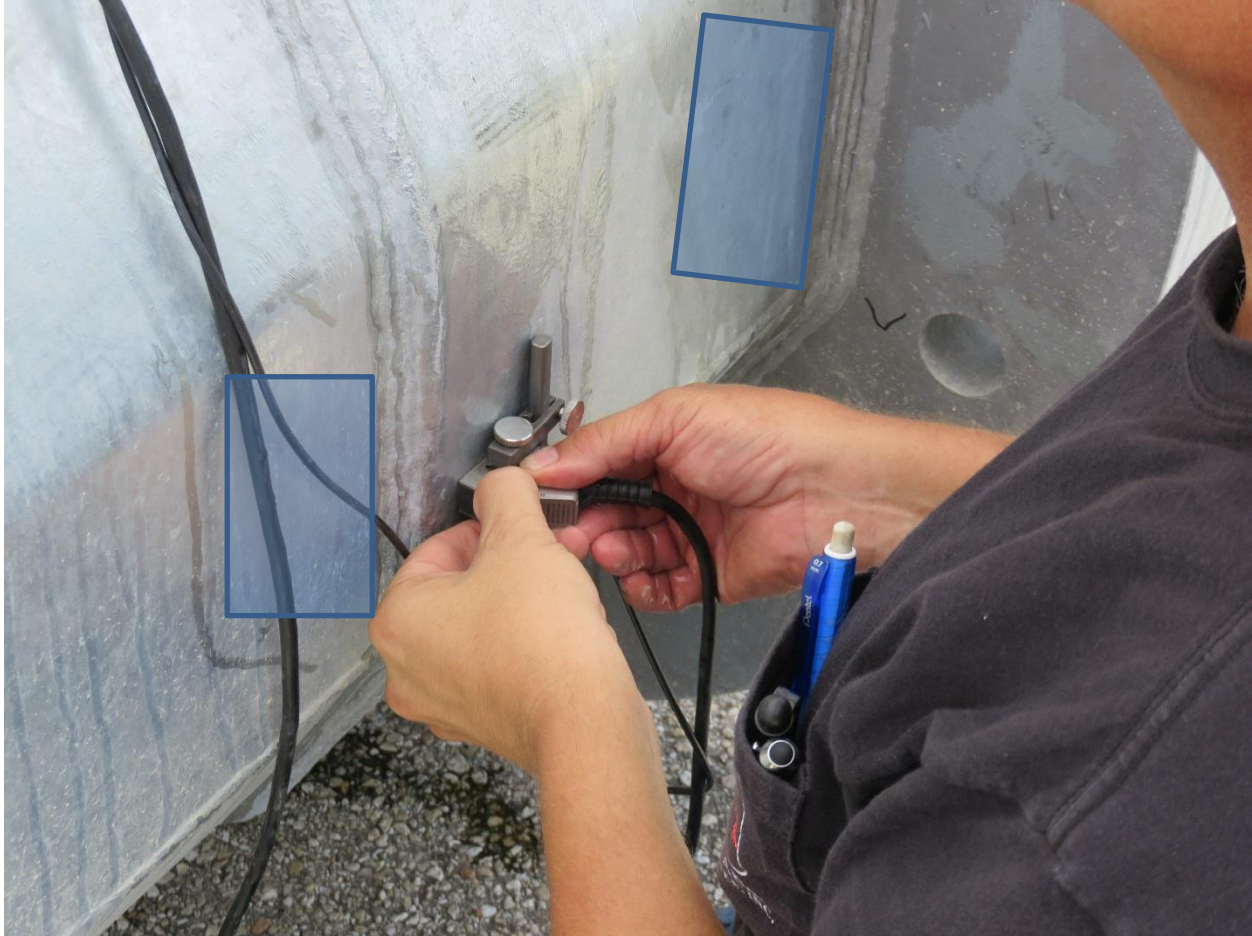
Figure 5.42: Probe Locations in PAUTs Conducted on the Specimens of Secondary Interest

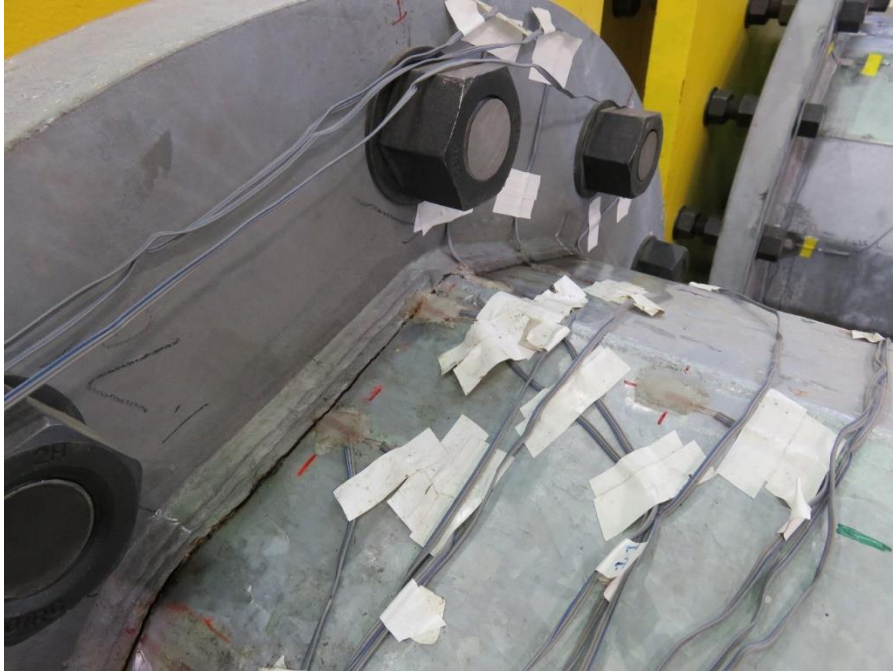
Figure 5.50: Specimen 33-3-12-TX-A1 following the Fatigue Test 1 at the Stress Range of 6 ksi (Fatigue Cracks after 19.4 Million Cycles)

Figures 5.50 and 5.51 represent the state of cracks on the three top bends of Specimen 33-3-12-TX-A1 tested in Test 1 under the stress range of 6 ksi. As seen in these figures, severe cracking occurred at the end of Test 1; resulting in through-thickness cracks over more than 40% of the connection length between the base plate and the shaft. As further indicated in Figure 5.52, despite being at a lower stress range of 5 ksi, the adjacent bends (Bends 2 and 12) to the top bend failed first. The cracks propagated from these two bends towards the top bend (Bend 1) at later stages of the fatigue test and ultimately resulted in the failure of Bend 1 (the tested bend). This mode of failure was probably due to the fact that Bend 1 was crack free at the beginning of the Test 1 (Figure 5.49).

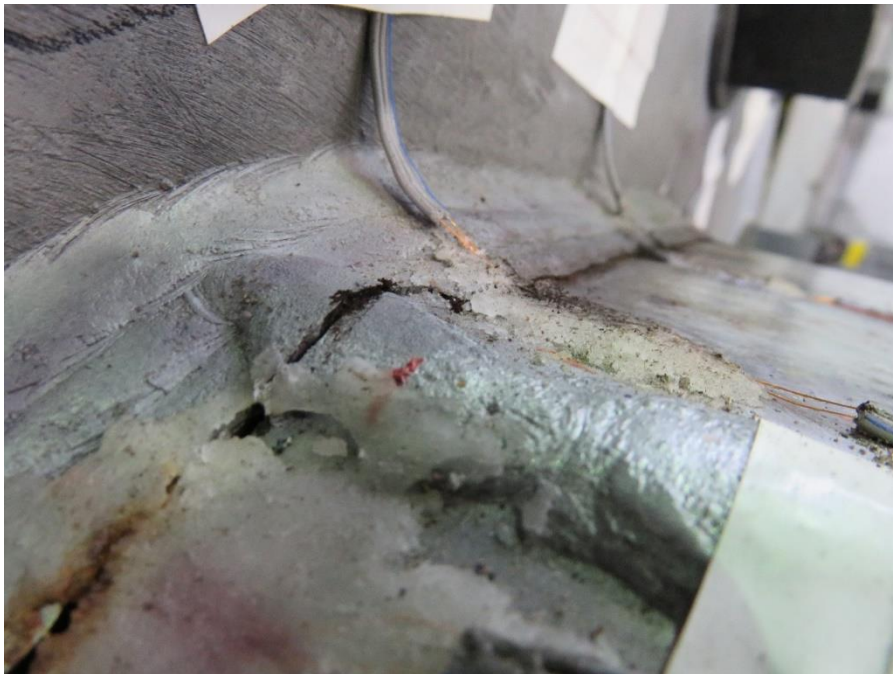
Figure 5.51: Specimen 33-3-12-TX-A1 following the Fatigue Test 1 at the Stress Range of 6 ksi (Fatigue Cracks at Bend 1 [Tested Bend] after 19.4 Million Cycles)

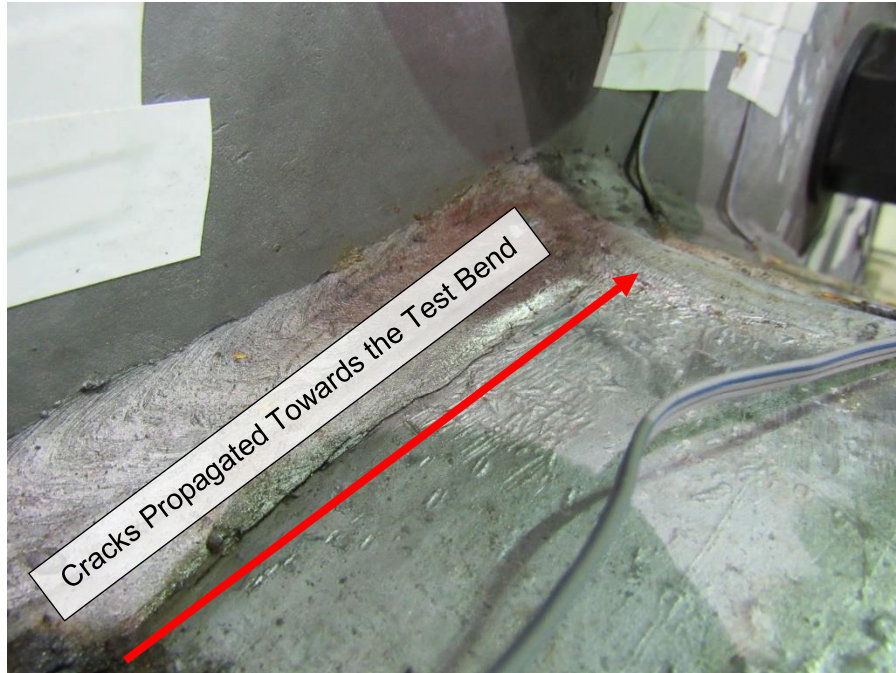
Figure 5.52: Specimen 33-3-12-TX-A2 following the Fatigue Test 1 at the Stress Range of 6 ksi (Fatigue-Crack Propagation after 19.4 Million Cycles)

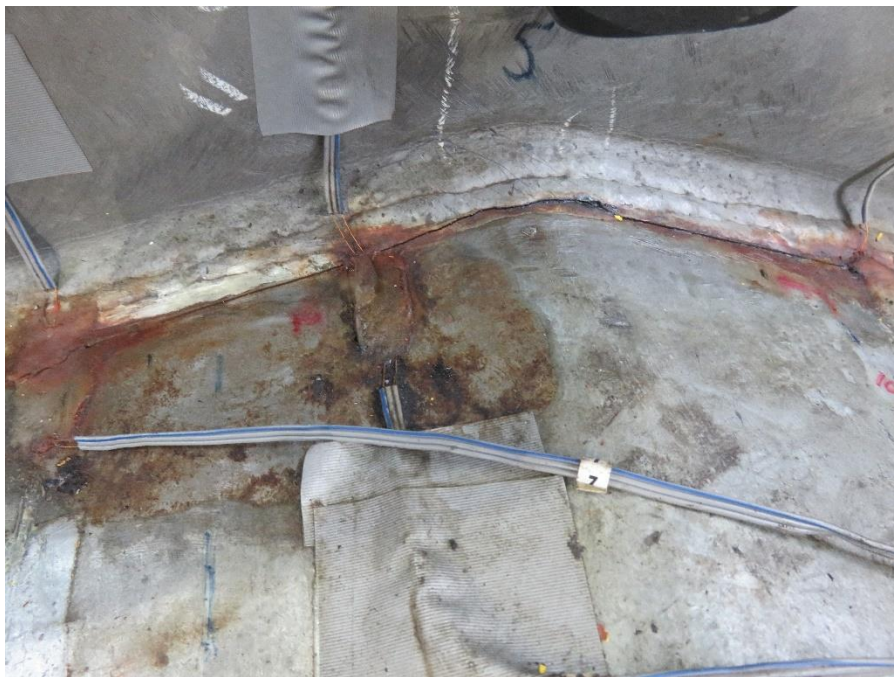
Figure 5.60: Specimen 33-3-12-TX-A6 following the Fatigue Test 2 at the Stress Range of 3 ksi (Fatigue Cracks after 169.0 Million Cycles)

Figures 5.60 through 5.62 represent the state of cracks on the three top bends of Specimen 33-3-12-TX-A6 tested in Test 2 under the stress range of 3 ksi. As seen in these figures, sever cracking occurred at the end of Test 2; resulting in through-thickness cracks over more that 20% of the connection length between the base plate and the shaft. The top bend (Bend 5) failed first in Test 2 and the cracks propagated from this bend towards the two adjacent bends (Bends 4 and 6) at later stages of the fatigue test. A very important observation to make from Figures 5.60 through 5.62 is that when cracks approached irregularities on the weld path (at the shaft-to-baseplate weld toe), they started to propagate in the shaft away from the weld path. When cracks started to propagate in the shaft, the rate of change in their length increased very rapidly causing a very fast fatigue failure.
