TECHNICAL REPORT 0-6829-1
TxDOT PROJECT NUMBER 0-6829

Fatigue Resistance and Reliability of High Mast Illumination Poles (HMIPs) with Pre-Existing Cracks: Final Report

March 2018; Revised and Published November 2018

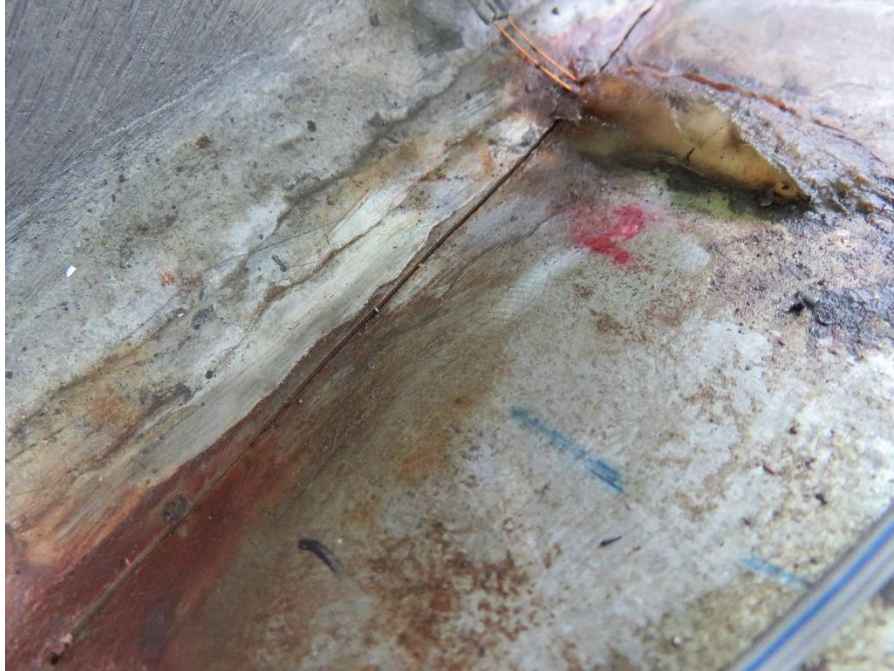
Figure 5.61: Specimen 33-3-12-TX-A6 following the Fatigue Test 2 at the Stress Range of 3 ksi (Fatigue Cracks Close to Bend 5 [Flat 5-6] after 169.0 Million Cycles)

Figures 5.60 through 5.62 represent the state of cracks on the three top bends of Specimen 33-3-12-TX-A6 tested in Test 2 under the stress range of 3 ksi. As seen in these figures, sever cracking occurred at the end of Test 2; resulting in through-thickness cracks over more that 20% of the connection length between the base plate and the shaft. The top bend (Bend 5) failed first in Test 2 and the cracks propagated from this bend towards the two adjacent bends (Bends 4 and 6) at later stages of the fatigue test. A very important observation to make from Figures 5.60 through 5.62 is that when cracks approached irregularities on the weld path (at the shaft-to-baseplate weld toe), they started to propagate in the shaft away from the weld path. When cracks started to propagate in the shaft, the rate of change in their length increased very rapidly causing a very fast fatigue failure.

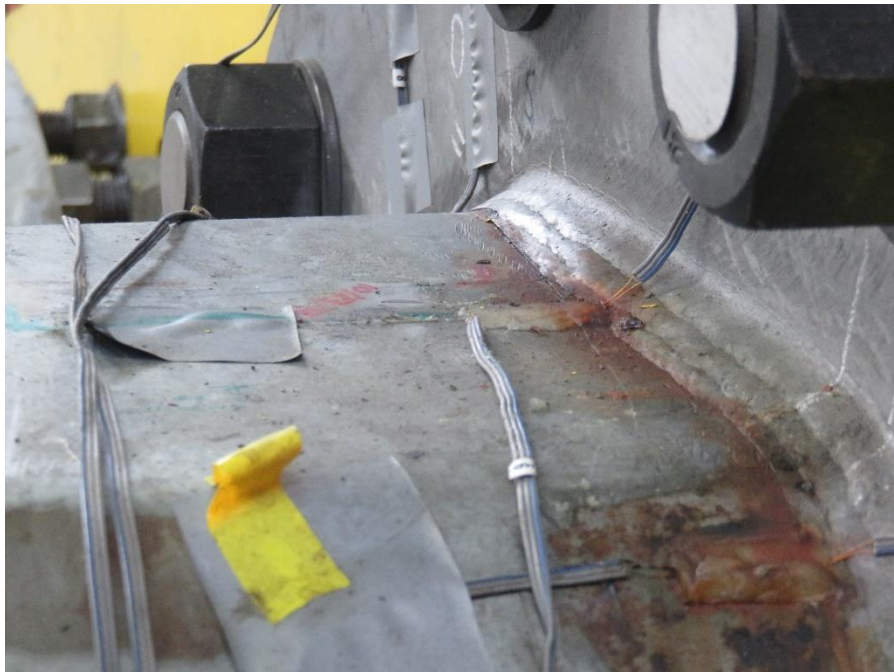
Figure 5.62: Specimen 33-3-12-TX-A6 following the Fatigue Test 2 at the Stress Range of 3 ksi (Fatigue Cracks Close to Bend 5 [Flat 4-5] after 169.0 Million Cycles)

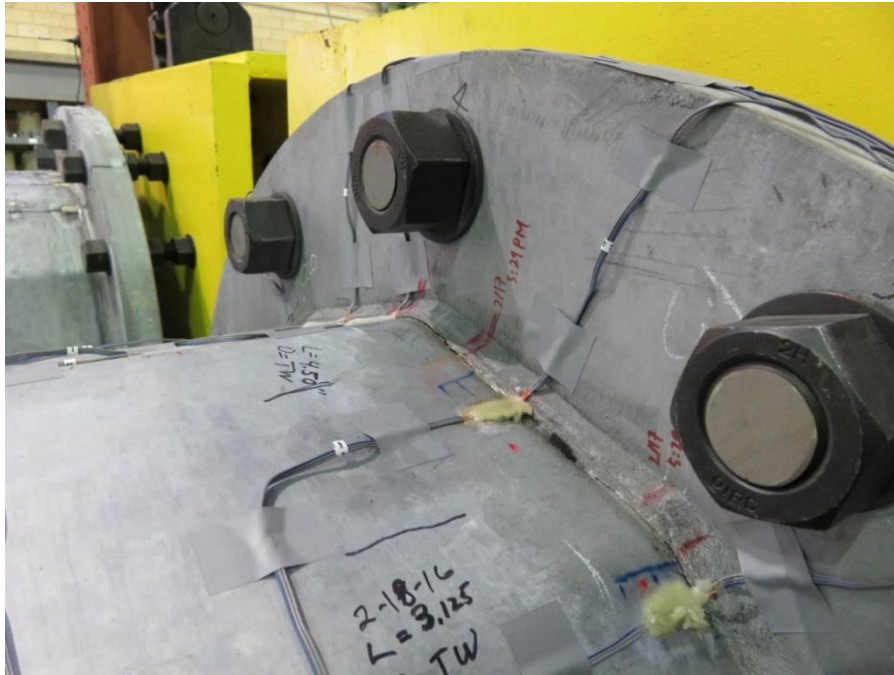
Figure 5.73: Specimen 33-3-12-TX-A4 following the Fatigue Test 3 at the Stress Range of 4 ksi (Fatigue Cracks after 3.8 Million Cycles)

Test 3 was completed after approximately one month of fatigue tests. Specimen 33-3-12-TX-A4 was deemed to have failed after it had developed sufficient cracking to reduce its stiffness by 10 percent. This reduction in stiffness occurred at 2.6 million cycles. The test was allowed to run to 3.8 million cycles before it was stopped. At that point, the stress range at the monitoring strain gauge dropped to 0 ksi. Pictures of Specimen 33-3-12-TX-A4 after failure can

be seen in Figures 5.73 and 5.74. At this point, cracks in the top bends had coalesced to form a nearly 31-inch long crack.

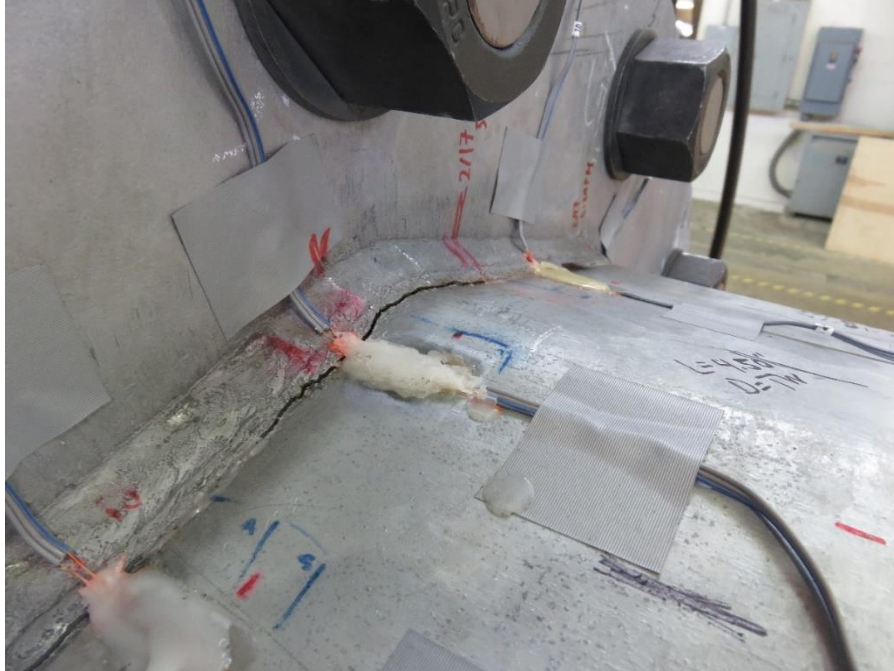
Figure 5.74: Severe Cracking on Bend 4 of the Specimen 33-3-12-TX-A4 following the Fatigue Test 3 at the Stress Range of 4 ksi (Fatigue Cracks after 3.8 Million Cycles)

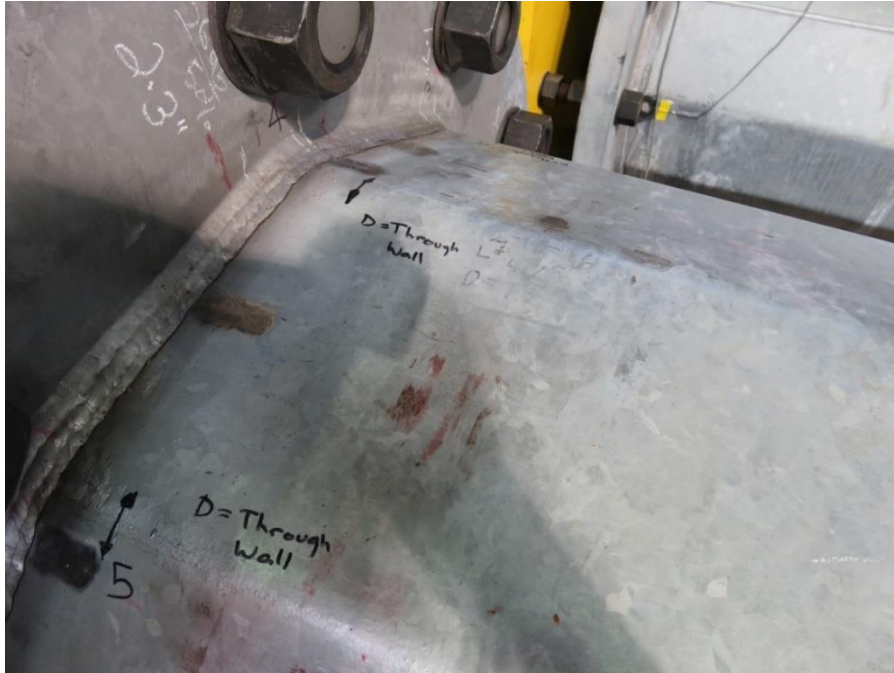
Figure 5.78: Specimen 33-3-12-TX-A3 following the Fatigue Test 4 at the Stress Range of 4 ksi (Fatigue Cracks after 5.5 Million Cycles)

A picture of Specimen 33-3-12-TX-A3 after failure in Test 4 is shown in Figure 5.78. Specimen 33-3-12-TX-A3 was deemed to have failed after it had developed sufficient cracking to reduce its stiffness by 10 percent. This reduction in stiffness occurred at 4.1 million cycles. The test was allowed to run to 5.5 million cycles before it was stopped. At that point, the stress range at the monitoring strain gauge dropped to 0 ksi.

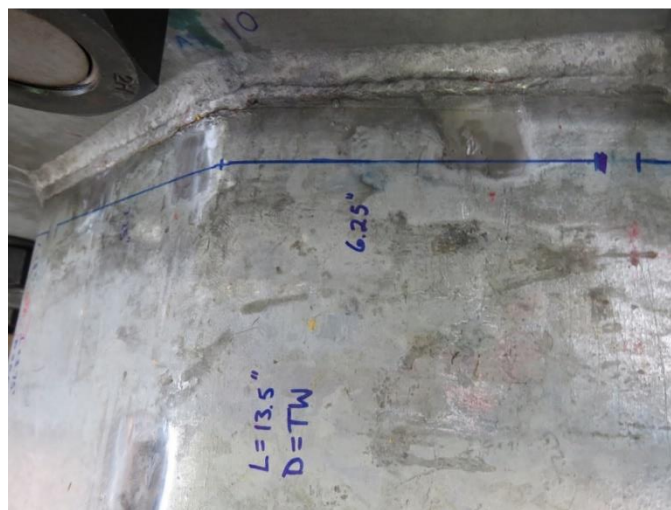
Figure 5.83: Specimen 33-3-12-TX-A4 following the Fatigue Test 5 at the Stress Range of 4 ksi (Fatigue Cracks after 6.5 Million Cycles)

Figure 5.83 shows the state of cracks on the three top bends of Specimen 33-3-12-TX-A4 tested in Test 5 under the stress range of 4 ksi. As seen in this figure, severe cracking occurred at the end of Test 5; resulting in through-thickness cracks over more that 17% of the connection length between the base plate and the shaft. The top bend (Bend 10) failed first in Test 5 and the cracks propagated from this bend towards the two adjacent bends (Bends 9 and 11) at later stages of the fatigue test. A very important observation to make from Figure 5.83 is that when cracks approached to irregularities on the weld path (at the shaft-to-baseplate weld toe), they started to propagate in the shaft away from the weld path. When cracks started to propagate in the shaft, the rate of change in their length increased very rapidly causing a very fast fatigue failure.

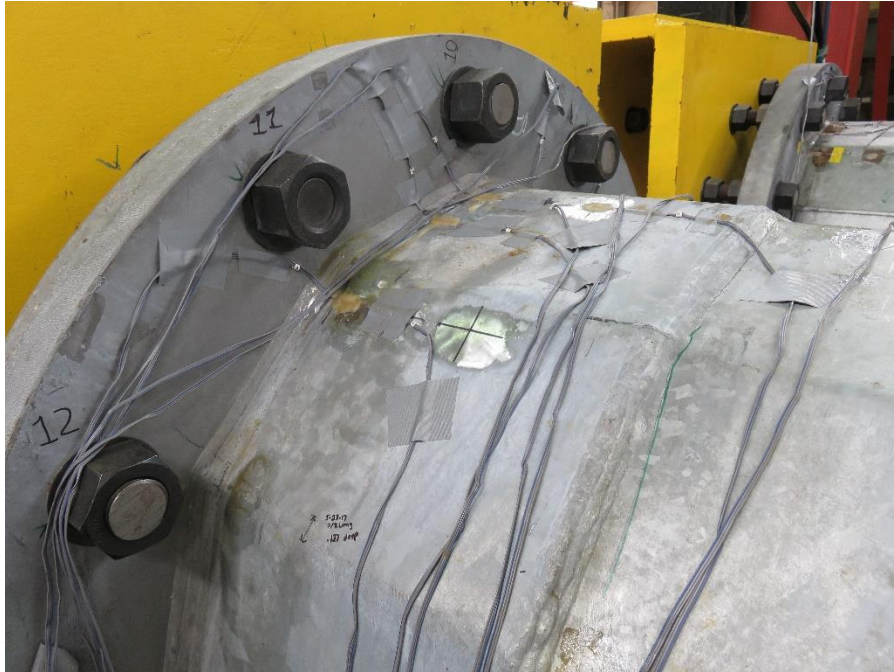
Figure 5.94: Specimen 33-3-12-TXEC-A7 (Bend 10) following the Fatigue Test 7 at the Combined Stress Ranges of 3 ksi and 5 ksi (Fatigue Cracks after 4.2 Million Cycles)

Figures 5.94 through 5.96 represent the state of cracks on the three top bends of Specimen 33-3-12-TXEC-A7 tested in Test 7 under the combined stress ranges of 6 ksi and 10

ksi. As seen in these figures, severe cracking occurred at the end of Test 7; resulting in through-thickness cracks over more than 20% of the connection length between the base plate and the shaft. It can also be observed that failure occurred at the location of fillet welds at the top of the ground sleeve. The top bend (Bend 10) failed first in Test 7 and the cracks propagated from this bend towards the two adjacent bends (Bends 9 and 11) at later stages of the fatigue test. A very important observation to make from Figures 5.94 through 5.96 is that when cracks approached to irregularities on the weld path (at the shaft-to-baseplate weld toe), they started to propagate in the shaft away from the weld path. When cracks started to propagate in the shaft, the rate of change in their length increased very rapidly causing a very fast fatigue failure.

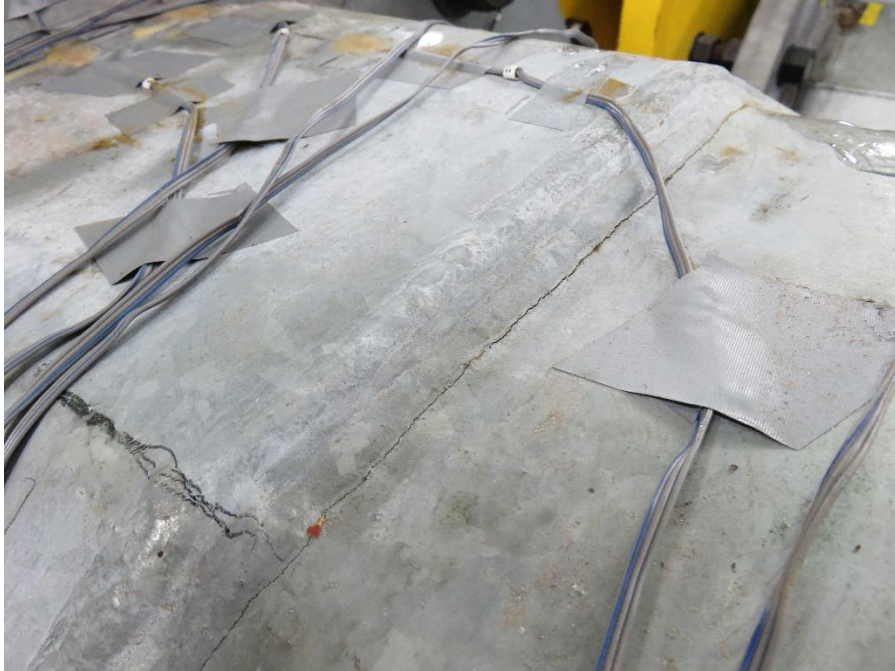
Figure 5.95: Specimen 33-3-12-TXEC-A7 (Bends 10 and 11) following the Fatigue Test 7 at the Combined Stress Ranges of 3 ksi and 5 ksi (Fatigue Cracks after 4.2 Million Cycles)

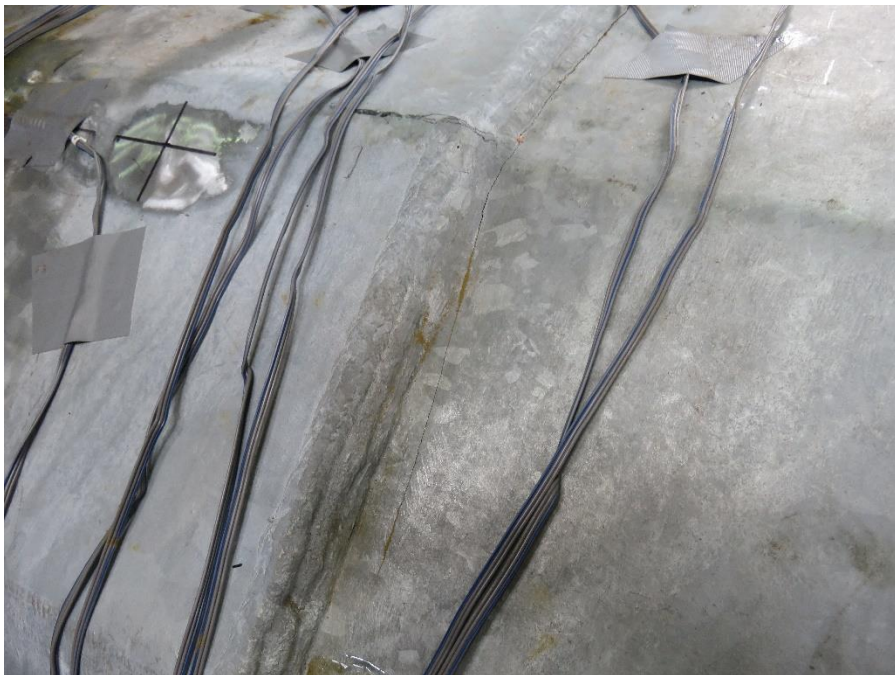
Figure 5.96: Specimen 33-3-12-TXEC-A7 (Bends 10 and 11) following the Fatigue Test 7 at the Combined Stress Ranges of 3 ksi and 5 ksi (Fatigue Cracks after 4.2 Million Cycles)

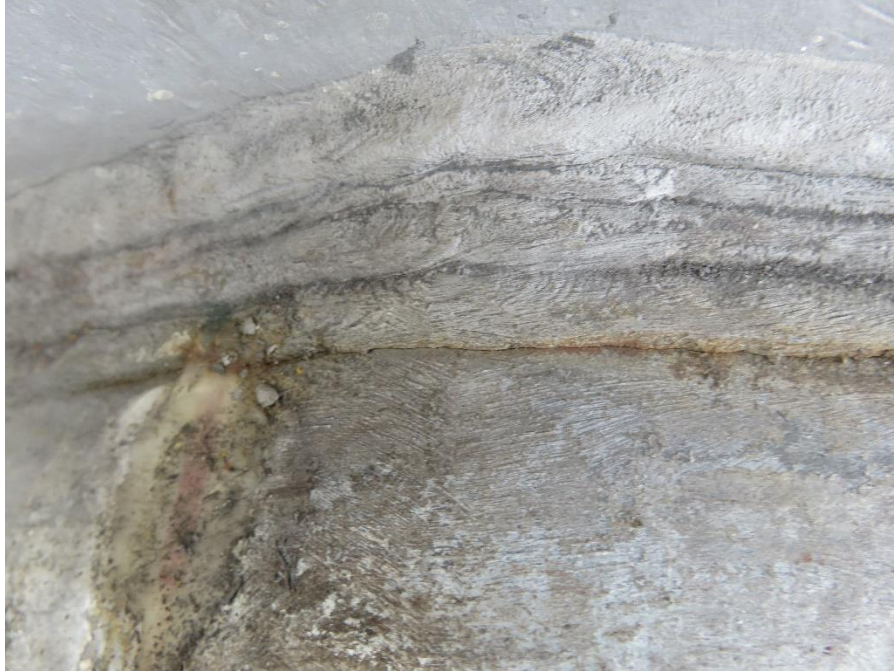
[Figure 5.99](#) represents the state of cracks on the Bend 4 of the Specimen 33-3-12-TXEC-A7 tested in Test 8 under the stress range of 5 ksi. As seen in this figure, the 10% drop in the stiffness of the specimen occurred without sever cracking. The top Bend 4 failed first in Test 8 and the cracks propagated from this bend towards the two adjacent bends (Bends 3 and 5) at later stages of the fatigue test. It should be noted that, at some points throughout the test, cracks were developing through the thickness of the shaft, but not through the thickness of the collar (10% drop in stiffness observed with apparent cracks from outside). This crack propagation phenomenon is unique to the specimens with ground sleeves. This behavior of cracks makes their in-service detections to be very challenging.

Figure 5.99: Specimen 33-3-12-TXEC-A7 (Bend 4) following the Fatigue Test 8 at the Stress Range of 5 ksi (Fatigue Cracks after 1.8 Million Cycles)

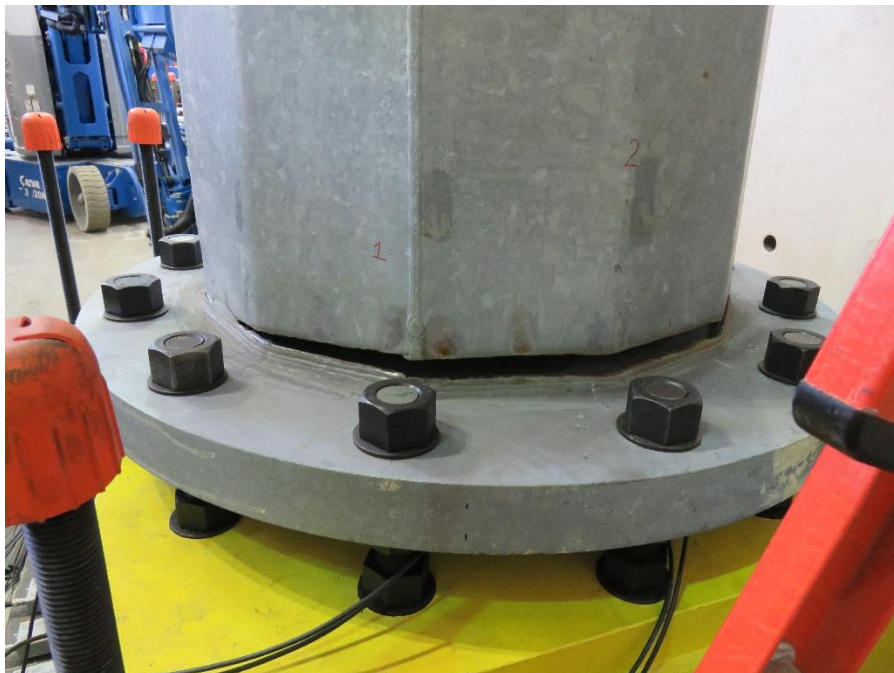
Figure 5.105: Tension Side of the Damaged Specimen 33-3-12-TX-A1 Following the Ultimate Strength Test

Results from an ultimate strength test on a cracked HMIP specimen are presented in [Figures 5.104](#) through [5.111](#). As can be observed from [Figures 5.104](#) through [5.111](#), during the ultimate strength test, cracks were propagating from the bends towards the flats nearly symmetrical on both sides of the specimen. This made the behavior of the severely damaged HMIP specimen very ductile in the test. As further shown in load-displacement plots in [Figures 5.104](#) and [5.111](#), the specimen achieved 80% of its calculated capacity based on the plastic moment of undamaged specimen (lateral force of 100 kips was calculated as the plastic strength of the specimen).

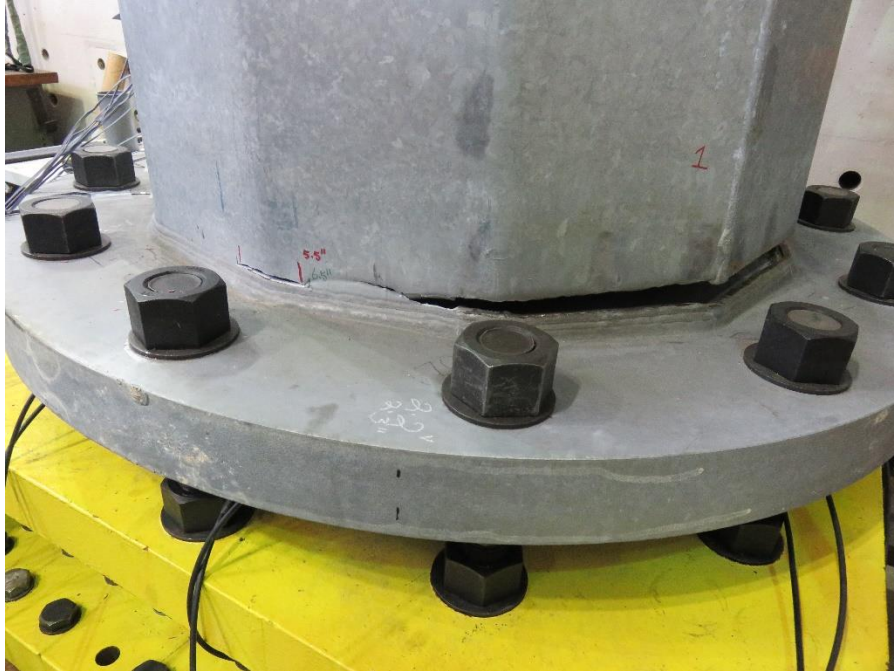
Figure 5.106: Propagation of Cracks in the Damaged Specimen 33-3-12-TX-A1 Following the Ultimate Strength Test

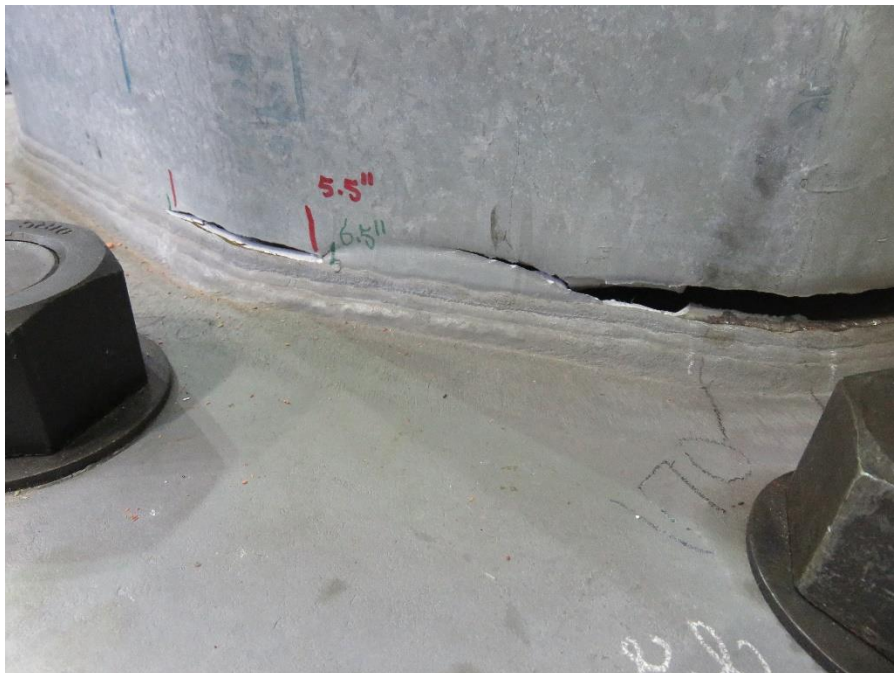
Figure 5.107: Propagation of Cracks from Bends 12 and 11 towards the flat Following the Ultimate Strength Test on the Damaged Specimen 33-3-12-TX-A1

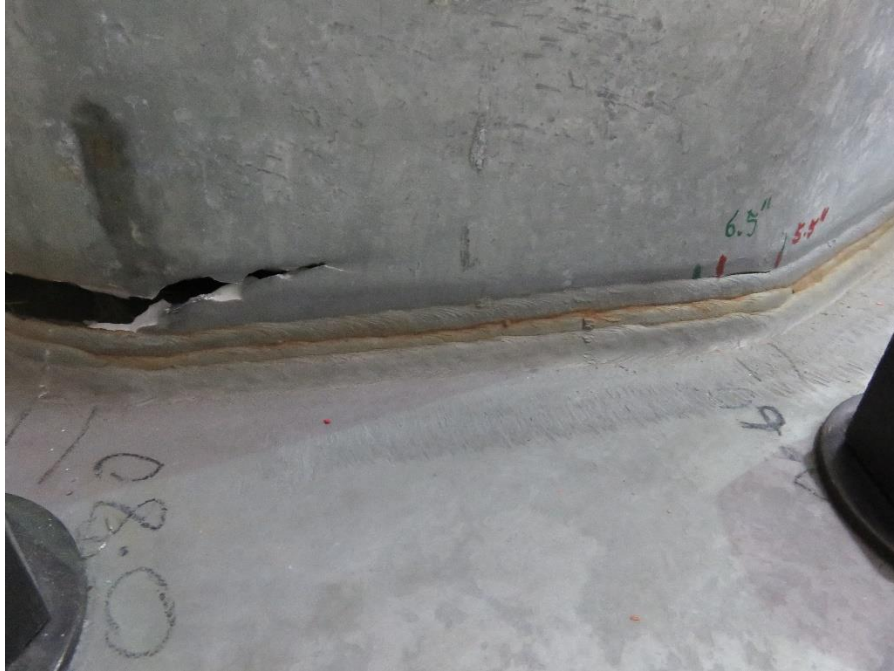
Figure 5.108: Propagation of Cracks from Bends 3 and 4 towards the flat Following the Ultimate Strength Test on the Damaged Specimen 33-3-12-TX-A1

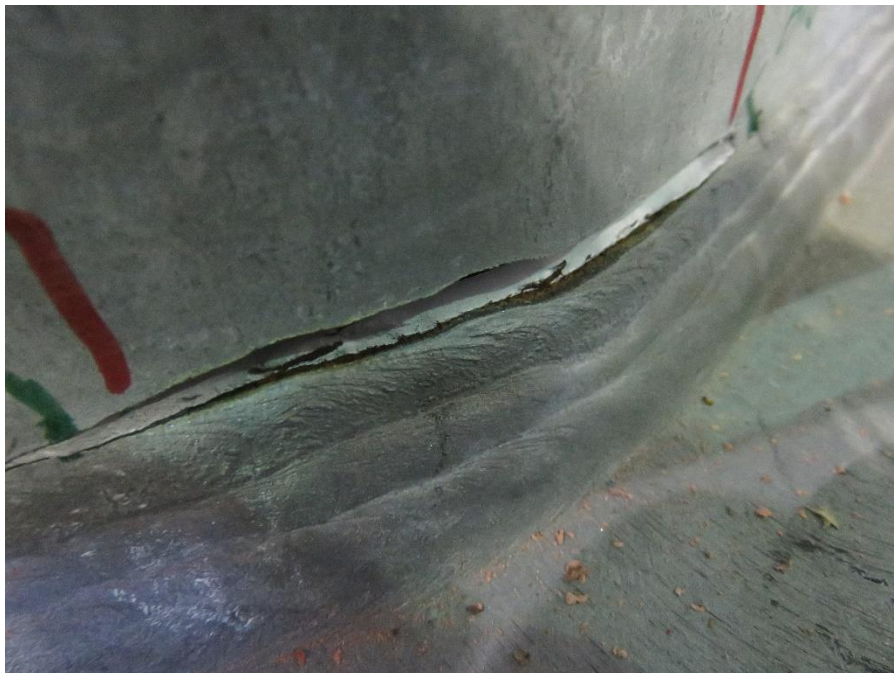
Figure 5.109: Close-up of Cracks on Bend 11 of the Damaged Specimen 33-3-12-TX-A1 – Cracks from a Fatigue test at a stress range of 6 ksi and from the Ultimate Strength Test

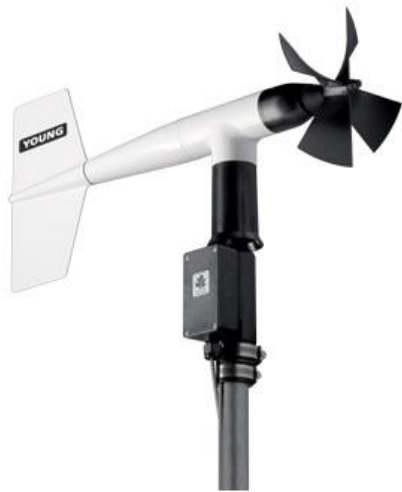
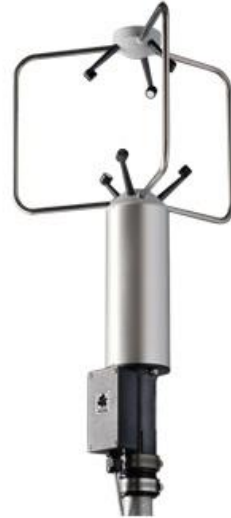
Two anemometers were installed on each pole to gather wind data. A propeller anemometer (Model Young 05103) (Figure 6.16a) was used to gather data on wind speed and direction. An ultra-sonic anemometer (Model Young 81000) (Figure 6.16b) was used to monitor wind speed and direction as well as wind turbulence. These anemometers have a frequency range that is broad enough to capture gust events. Further, having two anemometers installed over the height of each pole provides useful data on the variation of wind velocity with height.

(a) Propeller Anemometer

(b) Ultra-Sonic Anemometer

Figure 6.16: Anemometers to Monitor Wind Environment

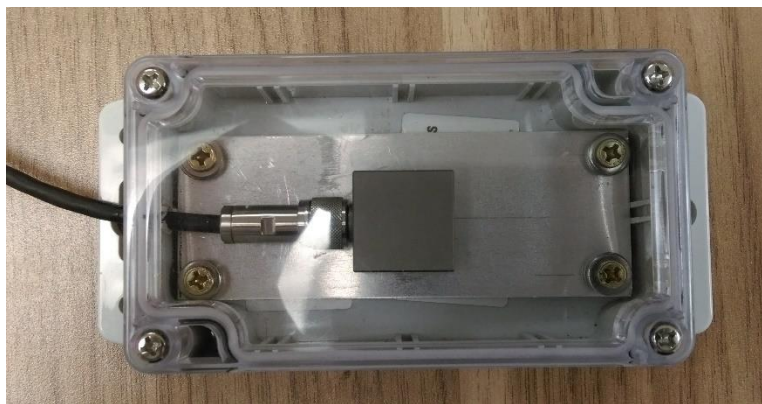
In addition to anemometers, three accelerometers (PCB Model 3713B1110G) were used to monitor the vibrations of the HMIP structure. The accelerometers manufactured by PCB were three-axis accelerometers with a measuring range of 10 G. Accelerometers were installed over the height of each HMIP to evaluate the dynamic characteristics of the poles in their first three modes of vibration. Moreover, as shown in [Figure 6.17](#), accelerometers were positioned inside small enclosures, and secured to the HMIPs using hose clamps.

Figure 6.17: Accelerometer shown in a small enclosure

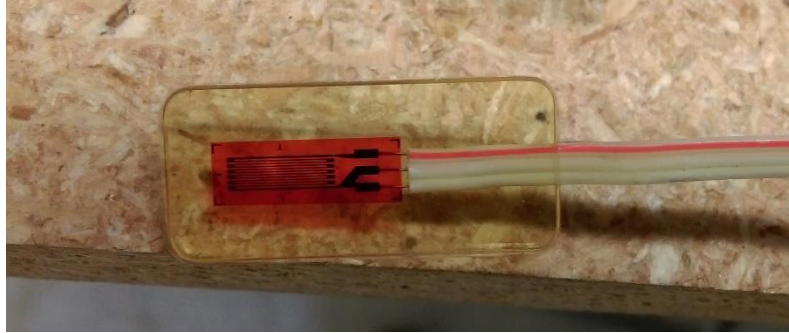
Four strain gages (Model WFLA-6-11-3LT as shown in [Figure 6.18](#)) were installed on each orthogonal face of the HMIPs near the base. The strain gages were used to monitor the stresses caused by the wind-induced vibrations of the HMIPs. Strain data were collected using a rainflow cycle-counting algorithm that allows counting the number of cycles of loading at various strain levels over the full monitoring period. Strain data were continuously recorded to make sure that the stresses caused by pole vibrations due to high winds, and vortex shedding winds were captured.

Figure 6.18: Strain Gage to Monitor Wind-Induced Stresses

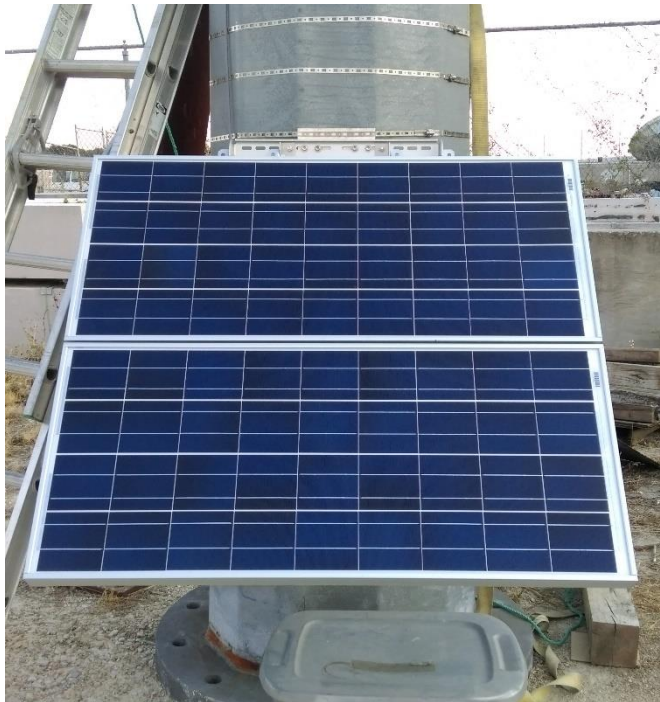
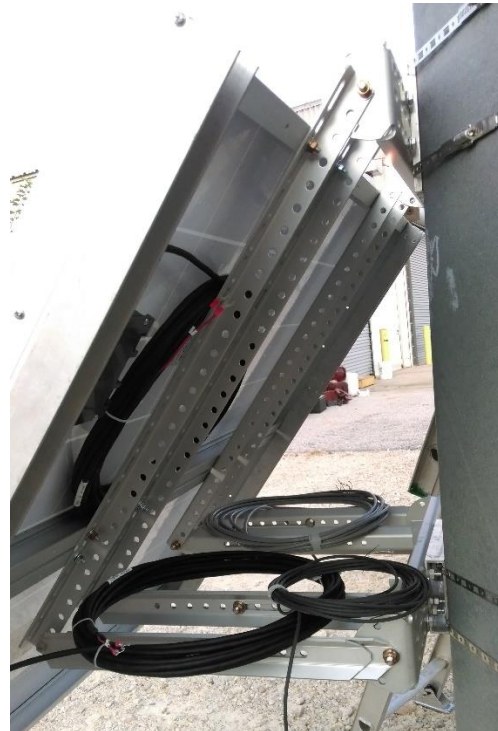
The power system for the field instrumentation consisted of solar panels, batteries and charge controllers. The solar panels were selected/designed to generate power required by the data acquisition system and by the sensors based on the shortest daylight in a year. The demand of the power load was approximately 42 W, which required 1088 W-hrs. The shortest daylight in a year was approximated to last 7 hours thereby requiring 156 W solar panels. As shown in [Figure 6.19](#), two 90 W solar panels (Model 90J) from Campbell Scientific were used to generate power for monitoring system. [Figure 6.19](#) further shows the mounting frame used to attach the solar panels to the poles.

(a) Two 90J Solar Panels

(b) Solar Panel Frames

Figure 6.19: Solar Panels and their Installation

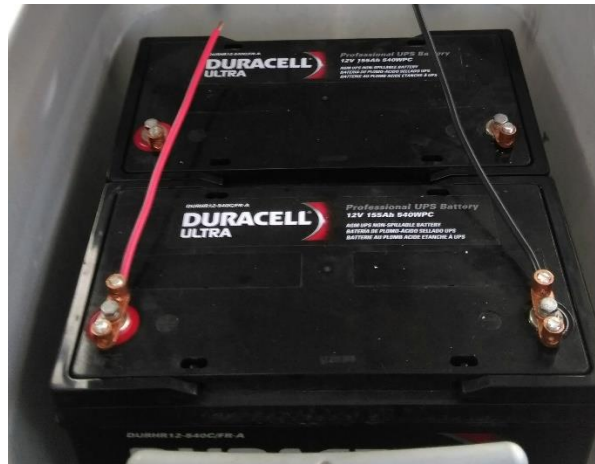
Two AGM batteries from Duracell (Model DURHR 12-540, shown in [Figure 6.20](#)) with the capacity of 155 AH (Amperage-Hours) were used to power the monitoring system. With no sunlight, a total of 310 AH provided power to the system for approximately 3.5 days.

Figure 6.20: AGM Batteries from Duracell

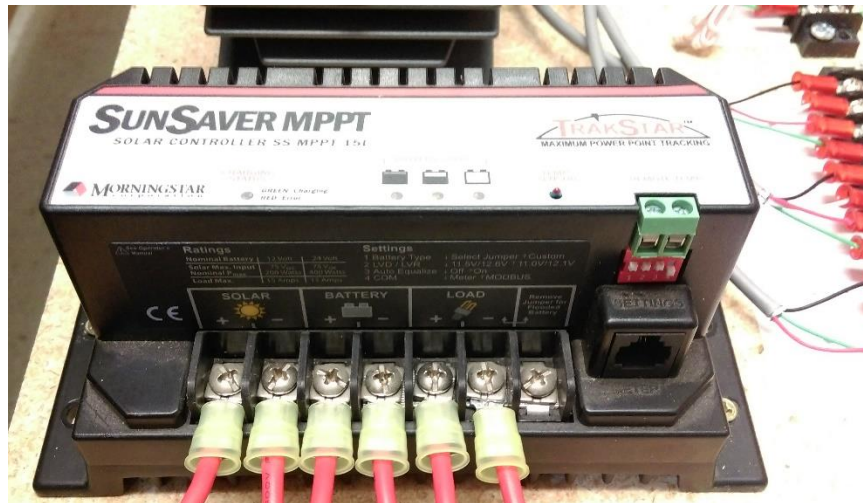
An MPPT charge controller from SunSaver (Model SS-MPPT-15L, shown in [Figure 6.21](#)) was used to maximize the usage of solar power. The charge controller saves the power collected from the solar panels to the batteries and provides a stable load current for the sensors and data acquisition system.

Figure 6.21: MPPT Charge Controller from SunSaver

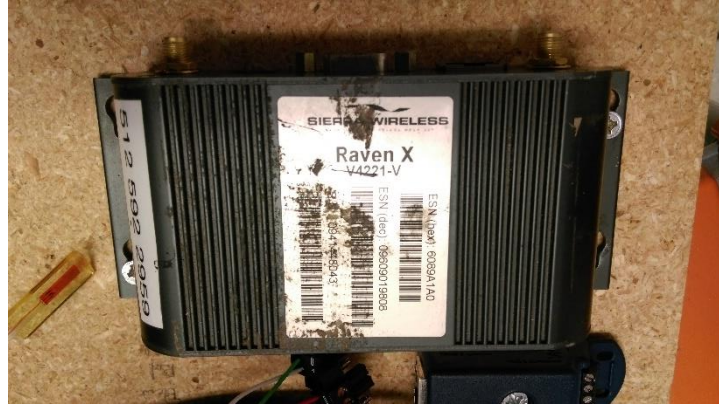
As shown in [Figure 6.22](#), a wireless modem (Model Raven X) from Sierra was used for remote control of the data acquisition system. The modem was also powered by the power system described above. The modem was connected to an antenna to transfer signals to the data acquisition system through an Ethernet cable.

Figure 6.22: A Raven X Wireless Modem

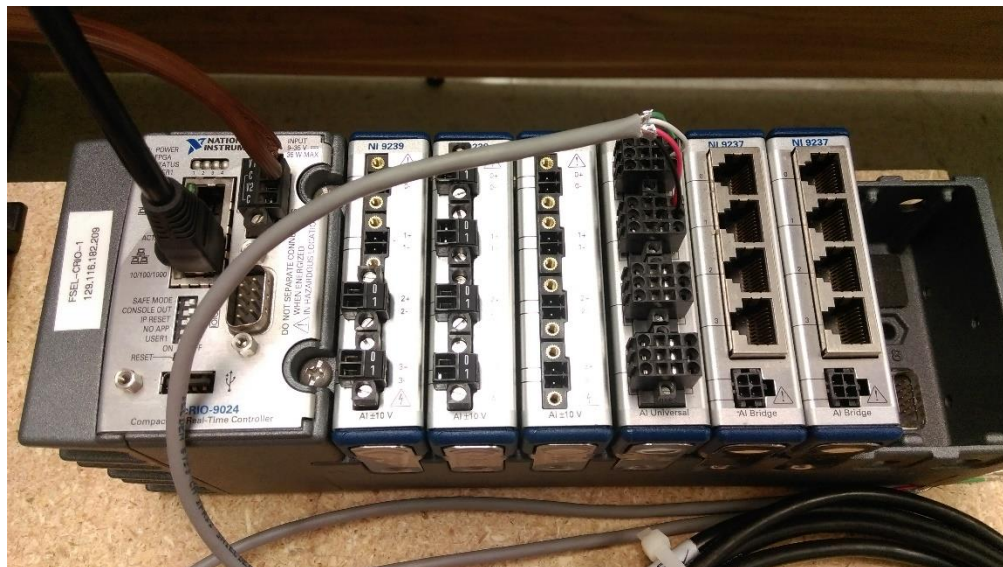
The data acquisition system, Compact RIO, from National Instruments (NI) was utilized to record and to analyze the field data. The Compact RIO (Figure 6.23) consisted of the controller (Model cRIO-9024), an eight slot chassis (Model cRIO-9114), and a series of modules. One NI-9237 module was used to record data from strain gages, three NI-9239 modules were used to record data from accelerometers and from the ultra-sonic anemometer, and one NI-9219 module was used to record data from the propeller anemometer.

Figure 6.23: NI Compact RIO Data Acquisition System

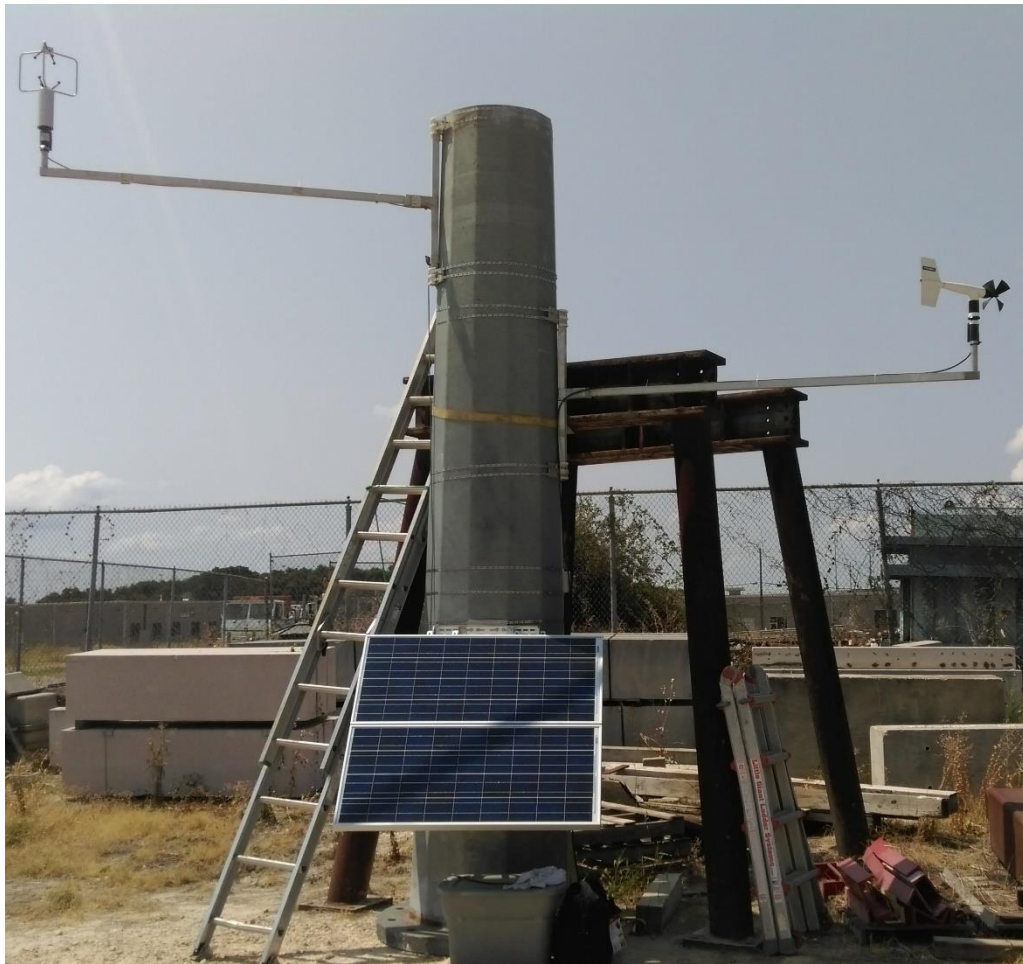
To evaluate the monitoring system and to practice different methods of installation of sensors, the research team setup a mock-up pole outside the Ferguson Laboratory at the University of Texas at Austin. As shown in [Figure 6.26](#), one ultra-sonic anemometer, one propeller anemometer, one accelerometer, and two 90 watt solar panels were mounted on the mock-up pole. All these sensors were attached to the pole shaft using hose clamps.

Figure 6.26: Anemometers and Solar Panel Installed on a Mock-up Pole

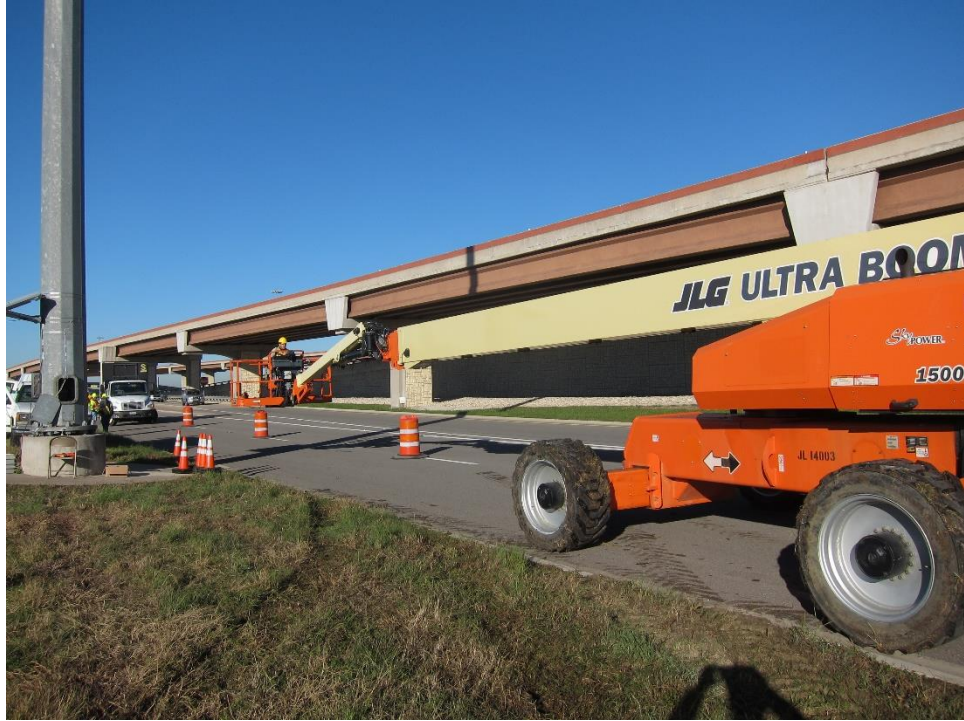
Figure 6.28 shows the boom lift used to install sensors at different locations along the height of the pole. The boom lift was a JLG Ultra Boom model 1500SJP. Traffic control was provided by TxDOT as shown in Figure 6.29.

Figure 6.28: JLG Ultra Boom Lift used to Instrument the Selected HMIP in Austin

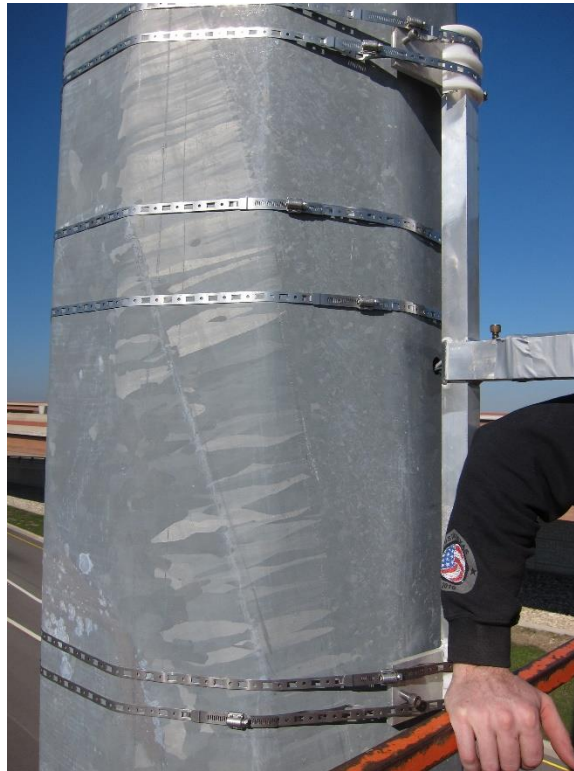
The aluminum arms for the anemometers were clamped with four adjustable hose clamps as shown in [Figure 6.30](#). The arms were clamped on the East side of the HMIP to avoid wind blockage by the HMIP. The selection of this direction was informed by the historical wind data indicating North and South as the most dominant wind directions. The anemometers were connected to the arms with hose clamps in the direction where the zero degree output direction aligned with the North direction ([Figure 6.31](#)). The socket screws on the clamped part of the arm frame were adjusted to ensure the arms were level. The accelerometers were clamped to the HMIP with two hose clamps on the North side of the HMIP as shown in [Figure 6.32](#).

Figure 6.30: Attachment Details for the Anemometer Arms

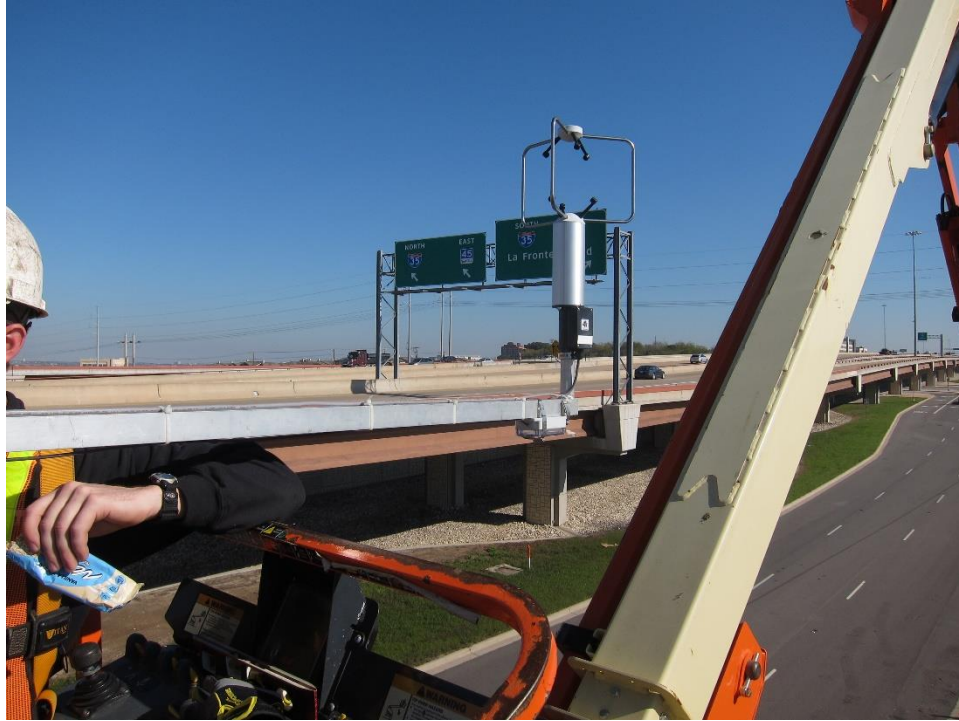
Figure 6.31: Ultra-Sonic Anemometer Installed on the Pole in Austin

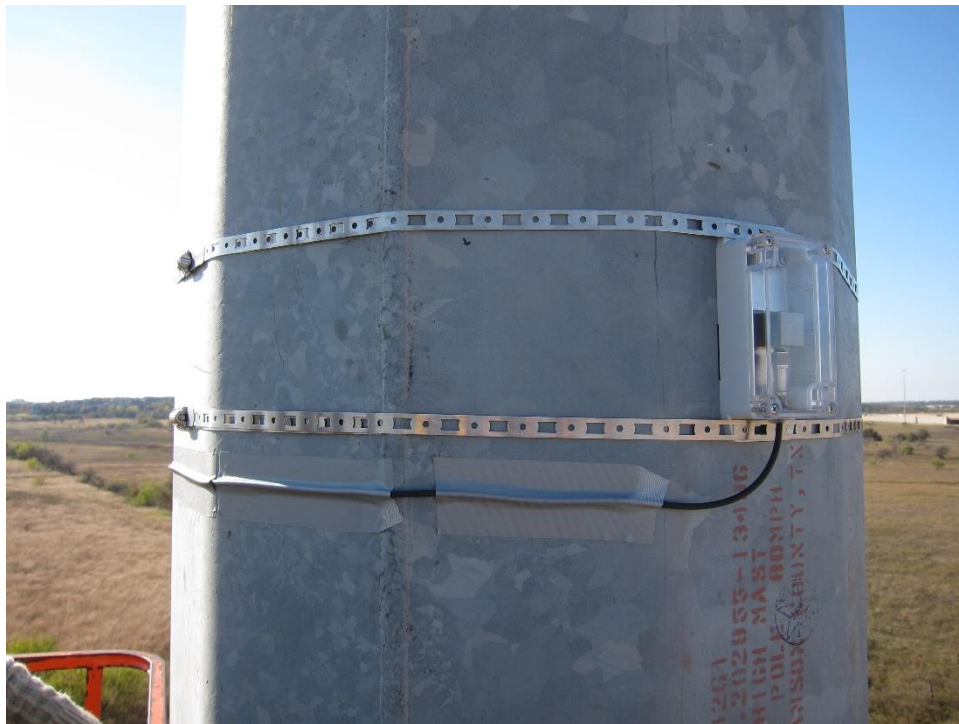
Figure 6.32: Accelerometer Clamped on to the HMIP in Austin

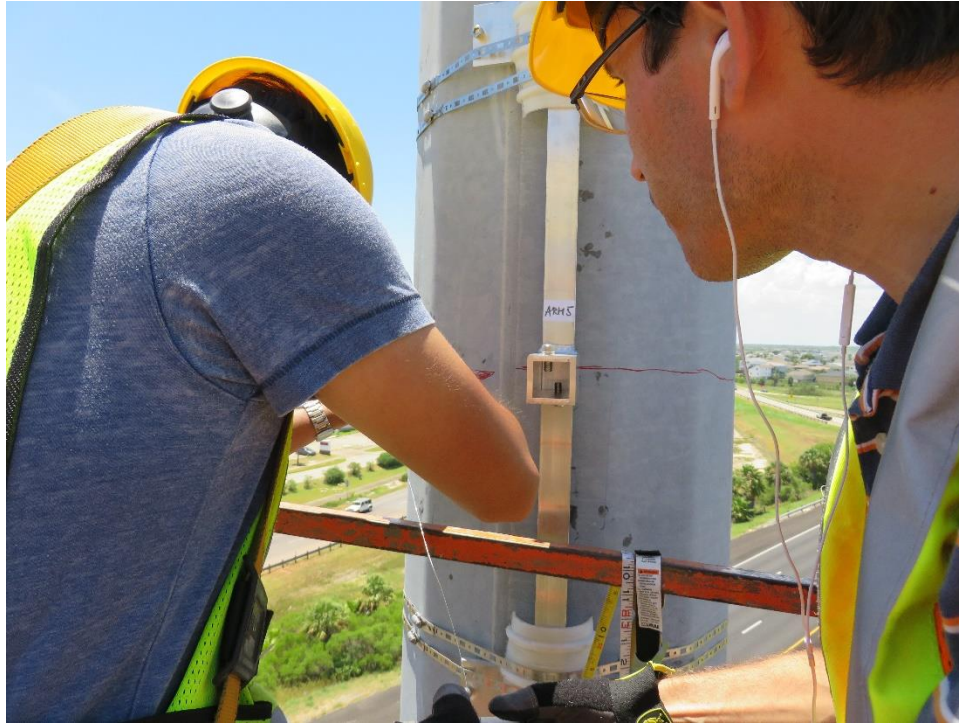
To run the accelerometer and anemometer cables inside the pole shaft, 0.75-inch diameter holes were drilled through the HMIP wall with a slugger drill at 30 and 80 feet (Figure 6.33). Cables at 50 and 105 feet were dropped through the existing holes in HMIP near 50 and 100 feet elevations. Fishing wires connected to a small screw were threaded in the holes first to ensure the wires could reach the bottom of the HMIP (Figure 6.34). After the fishing wires reached to the bottom of the pole, the sensor cables were connected to the other end of the fishing wires. The cables were then threaded through the holes while the personnel on the ground started pulling on the fishing wires until the cables also reached the bottom of the HMIP.

Figure 6.34: Threading the Fishing Wire inside the HMIP

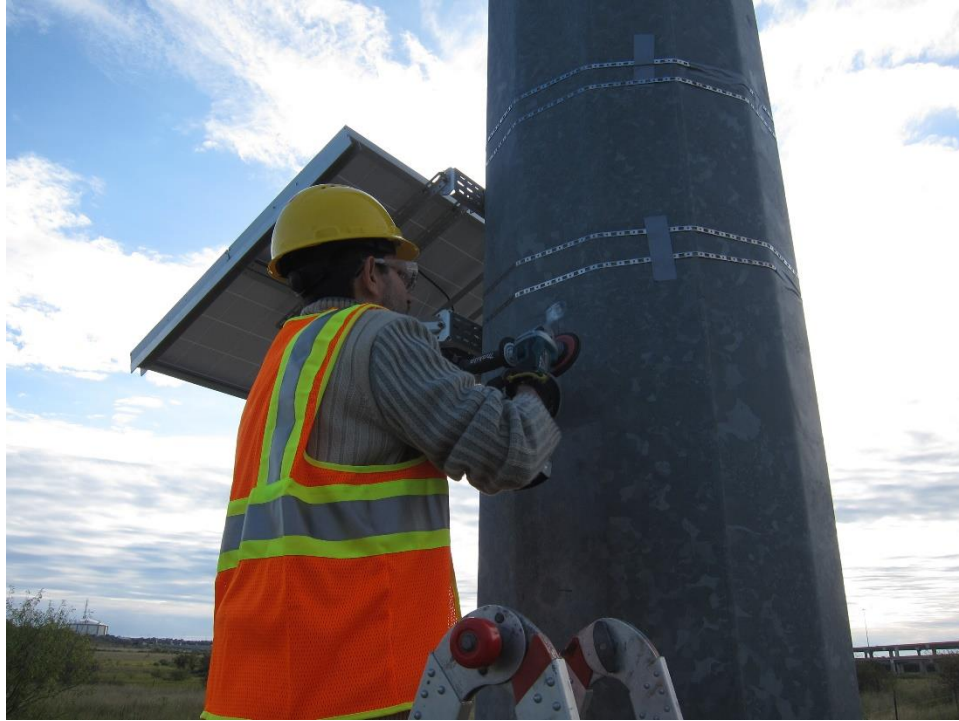
Figure 6.35: Preparation of the Surface to Install Strain Gages

- Grinding the steel surface at target locations ([Figure 6.35](#))
- Cleaning the grinded surface with acetone
- Applying the adhesive on the prepared surfaces and catalyst on the back surface of the strain gauges ([Figure 6.36](#))
- Pressing and holding the strain gauges on the targeted surfaces for several seconds for proper attachment
- Applying silicon coatings over the attached strain gauges ([Figure 6.37](#))
- Applying protective wax coatings over the strain gauges ([Figure 6.38](#))

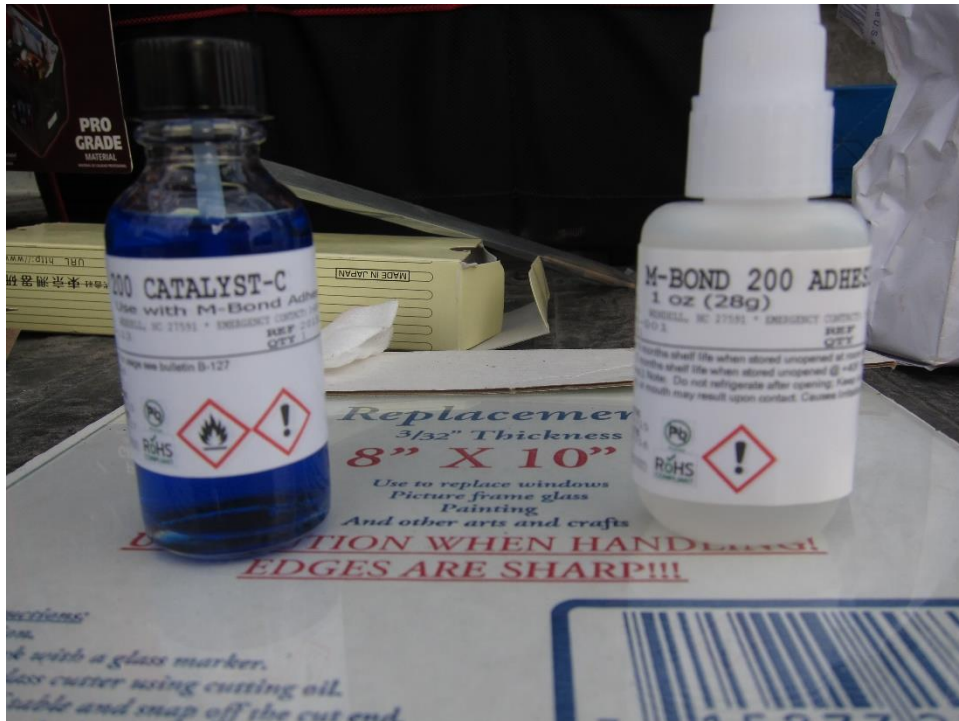
Figure 6.36: The Adhesive and Catalyst for Attaching Strain Gauges

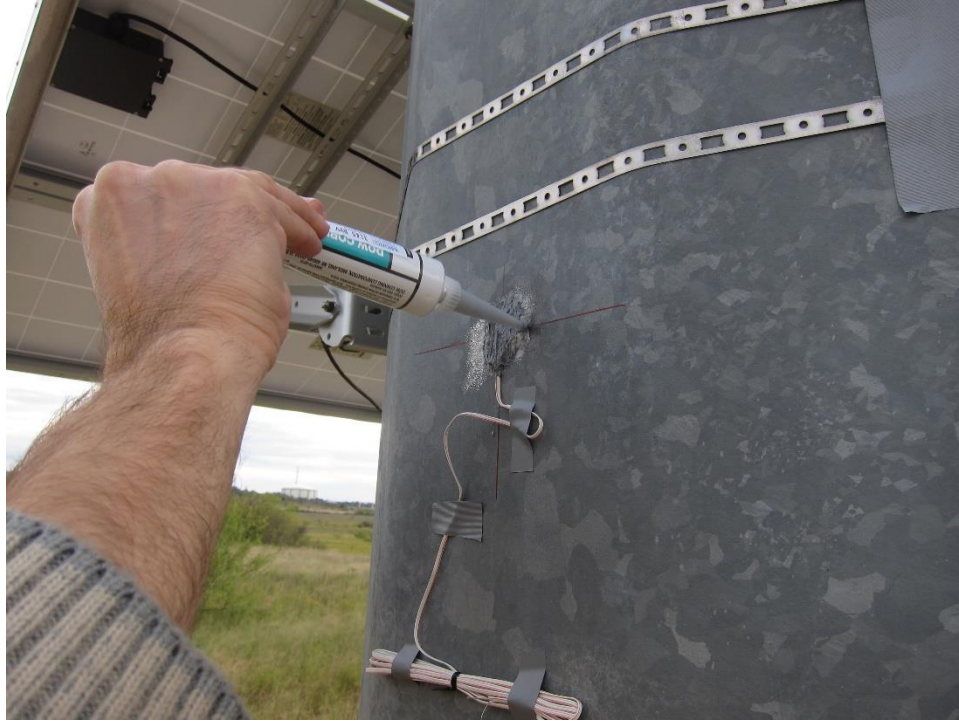
Figure 6.37: Silicon Epoxy to Protect the Strain Gages from Environment
