TECHNICAL REPORT 0-6829-1
TxDOT PROJECT NUMBER 0-6829

Fatigue Resistance and Reliability of High Mast Illumination Poles (HMIPs) with Pre-Existing Cracks: Final Report

March 2018; Revised and Published November 2018

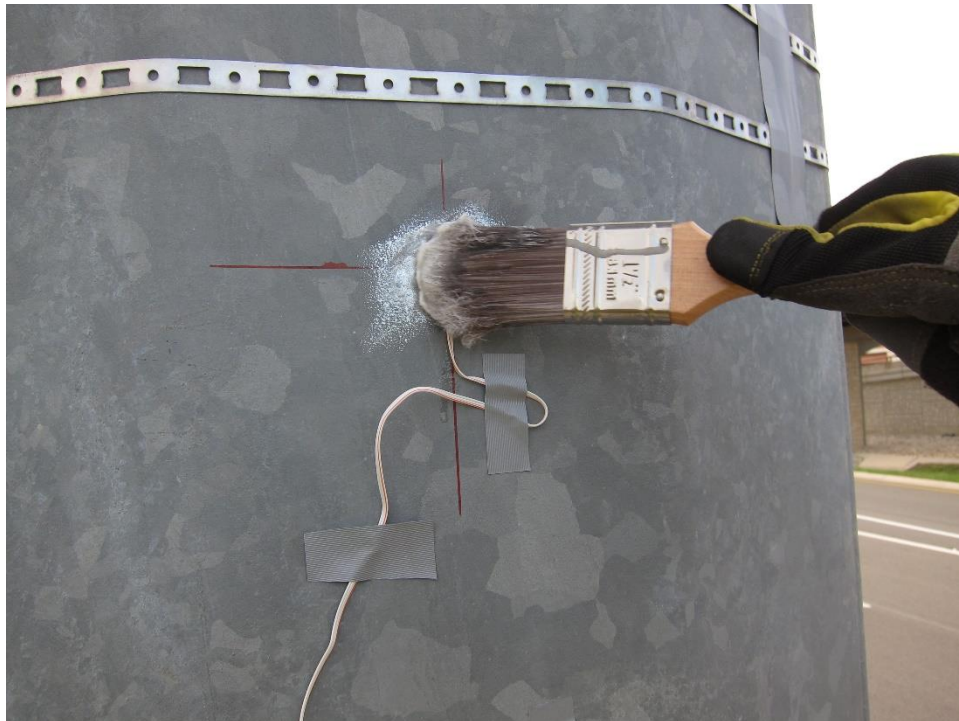
Figure 6.38: Wax to Protect the Strain Gages from Humidity

- Grinding the steel surface at target locations ([Figure 6.35](#))
- Cleaning the grinded surface with acetone
- Applying the adhesive on the prepared surfaces and catalyst on the back surface of the strain gauges ([Figure 6.36](#))
- Pressing and holding the strain gauges on the targeted surfaces for several seconds for proper attachment
- Applying silicon coatings over the attached strain gauges ([Figure 6.37](#))
- Applying protective wax coatings over the strain gauges ([Figure 6.38](#))

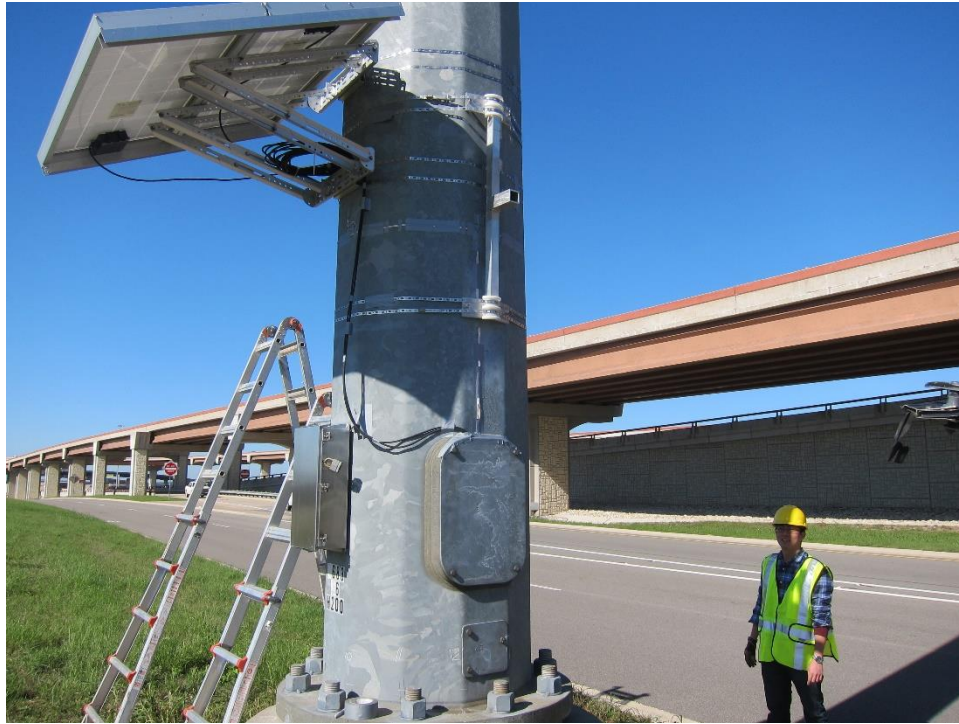
The solar panel was installed on the south face of the HMIP (Figure 6.39). Two rectangular box tubes were attached to the HMIP with four hose clamps. The frame of the solar panels were connected to the two rectangular tubes. The two 90-Watts solar panels connected by two aluminum angles were attached to the frames. The wires of the two solar panels were connected in series to achieve higher voltages. The battery was set on two steel plates resting on top of a wooden support inside the HMIP shaft (Figure 6.40).

Figure 6.39: Solar Panel Installed on the South Side of the HMIP in Austin

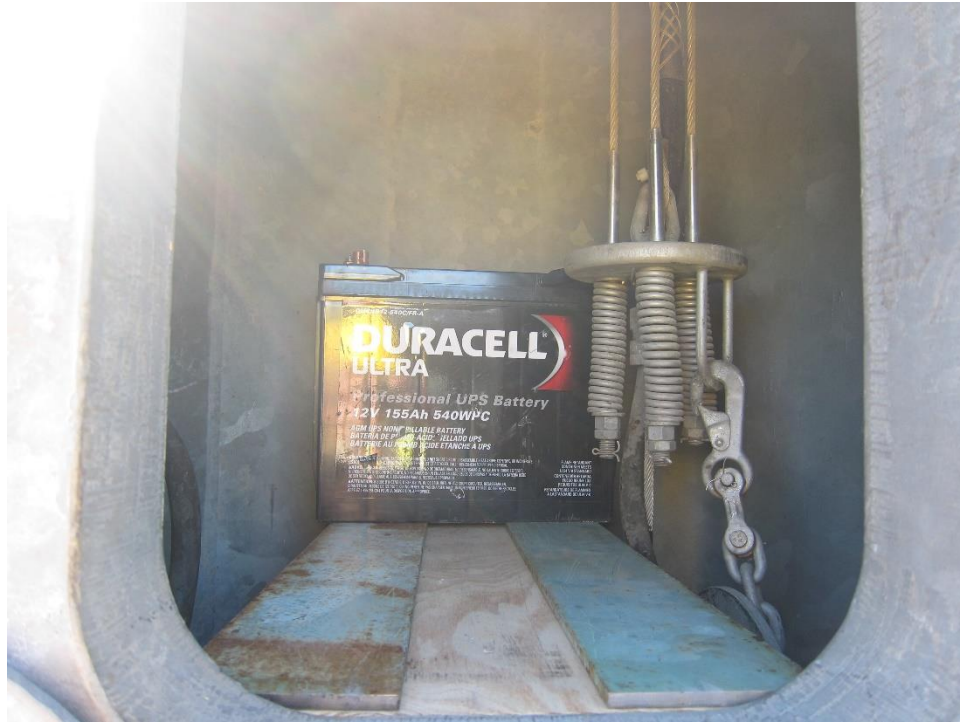
Figure 6.40: Battery Situated inside the HMIP

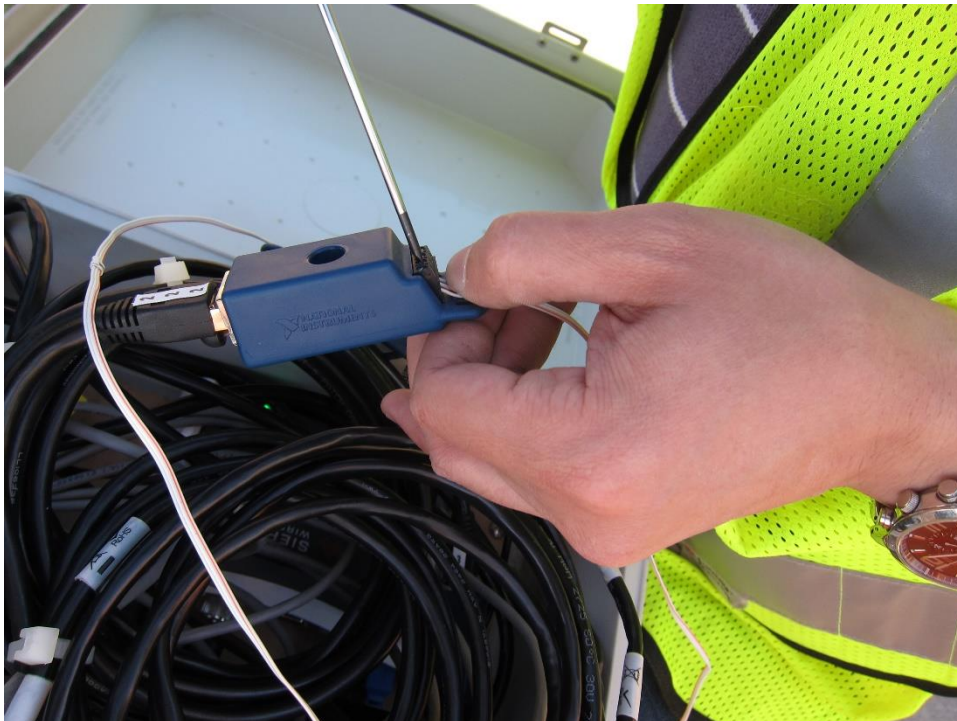
Figure 6.42: Connecting Strain Gauge Cables to the Data Acquisition System

The sensor cables were connected to the acquisition box first as shown in [Figure 6.41](#). The fuses for the charge controller were installed after the solar panel and battery were connected to the system. The system was switched on following the installation of fuses, and the preliminary check of the data acquisition system (NI Compact RIO) as well as the wireless modem. After the strain gauges were connected to the Compact RIO as shown in [Figure 6.42](#), the data acquisition program was tested ([Figure 6.43](#)). Once the data acquisition program was running, holes on the enclosure box for cables were sealed ([Figure 6.44](#)). After the two enclosure box were sealed and set on the wooden stool inside the HMIP, the hand hole was closed and the field instrumentation was finished ([Figure 6.45](#)). The instrumentation of the selected HMIP in Austin was completed on December 7, 2015.

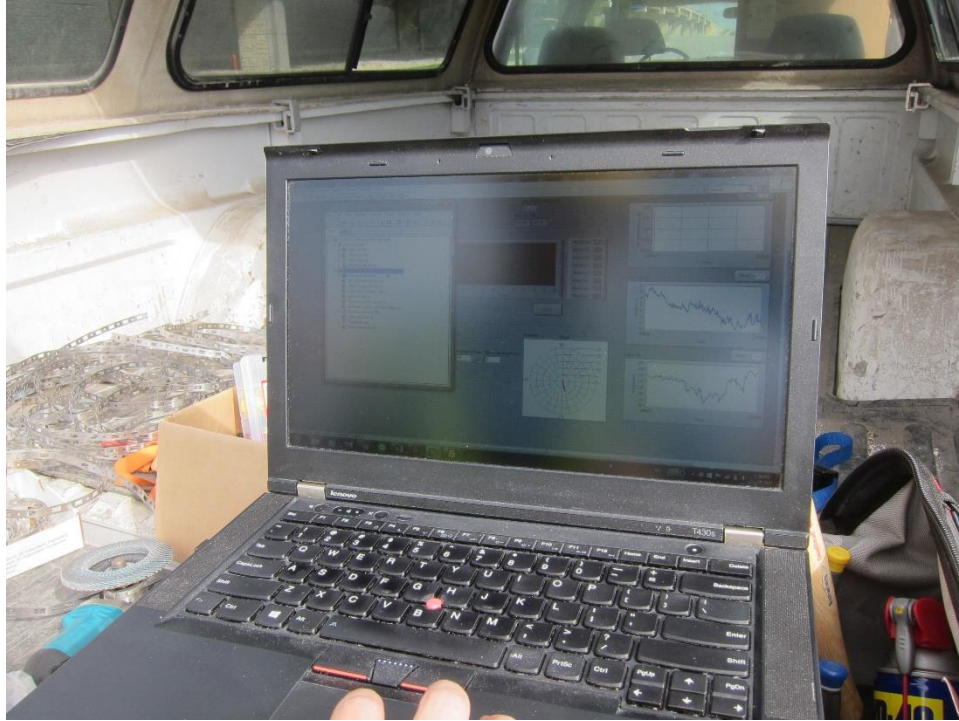
Figure 6.43: Testing of Data Acquisition Program

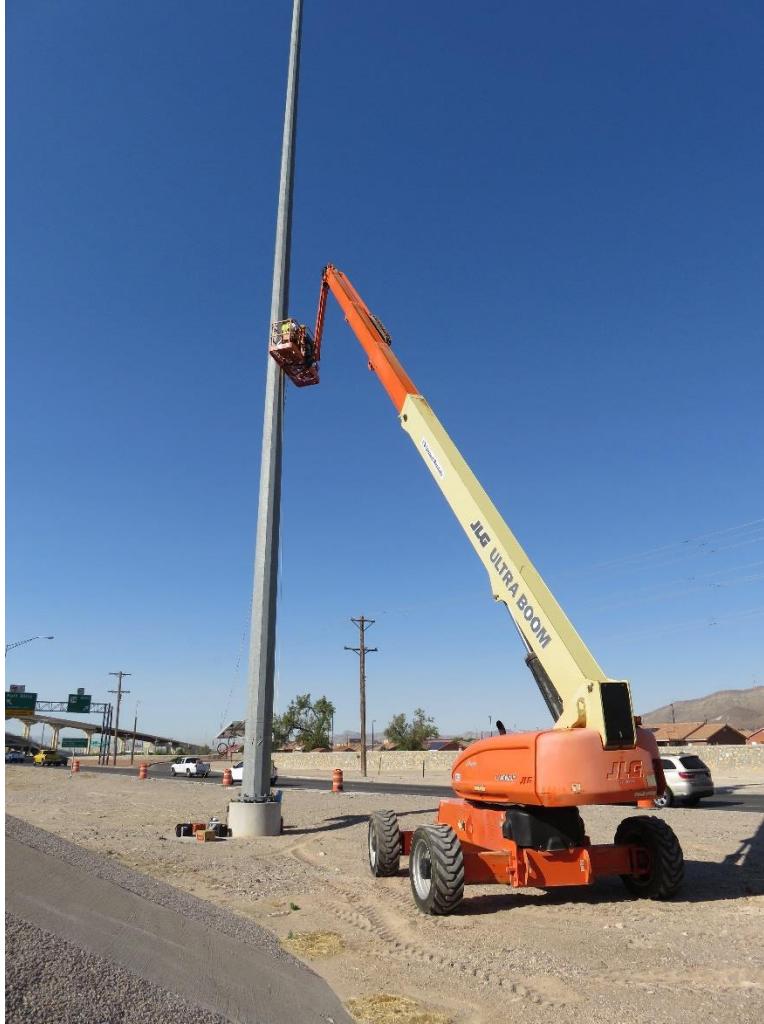
Figure 6.47 shows the boom lift used to install sensors at different locations along the height of the pole. The boom lift was a JLG Ultra Boom model 1200SJP. No traffic control was needed for this specific site. The general procedure for installing instruments and sensors on the selected HMIP in El Paso was the same as that for the pole in Austin. The major difference was in the direction of the arm that was changed to the West direction, a more frequent wind direction in El Paso. A picture of the instrumented HMIP in El Paso is shown in Figure 6.48. The instrumentation of the selected HMIP in El Paso was completed on June 18, 2016.

Figure 6.47: JLG Ultra Boom Lift used to Instrument the Selected HMIP in El Paso

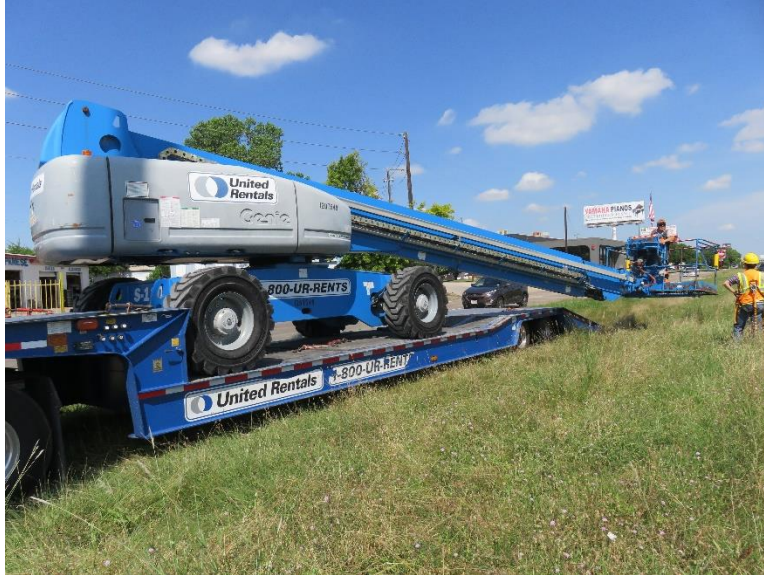
The instrumentation scheme for the Dallas pole was the same as that for the pole in El Paso. The boom lift used in Dallas was a Genie telescopic 120 feet capacity model (Figure 6.49). No traffic control was needed for this specific site. A picture of the instrumented HMIP in Dallas is shown in Figure 6.50. The instrumentation of the selected HMIP in Dallas was completed on June 28, 2016.

Figure 6.49: Genie Ultra Boom Lift used to Instrument the Selected HMIP in Dallas

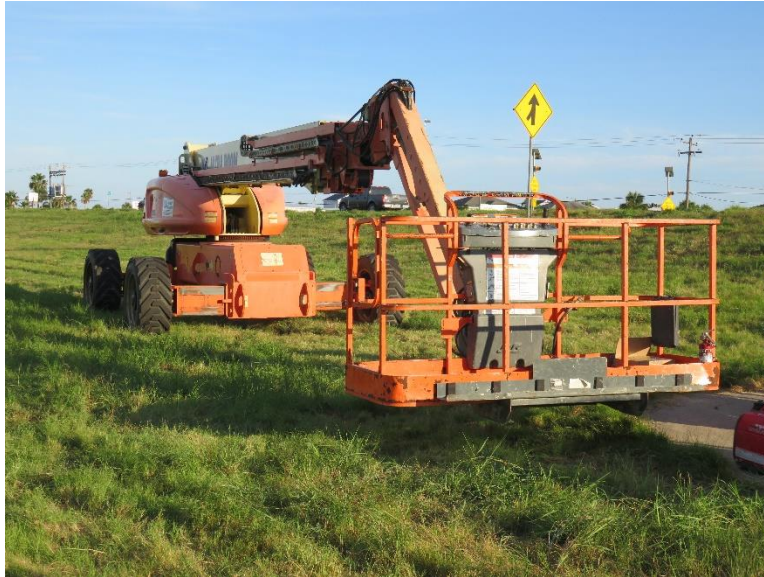
The instrumentation plan for the Galveston location was the same as that for the pole in El Paso. The boom lift used in Galveston was a JLG Ultra Boom model 1200SJP (Figure 6.51). No traffic control was needed for this specific site. A picture of the instrumented HMIP in Galveston is shown in Figure 6.52. The instrumentation of the selected HMIP in Galveston was completed on July 21, 2016.

Figure 6.51: JLG Ultra Boom Lift used to Instrument the Selected HMIP in Galveston

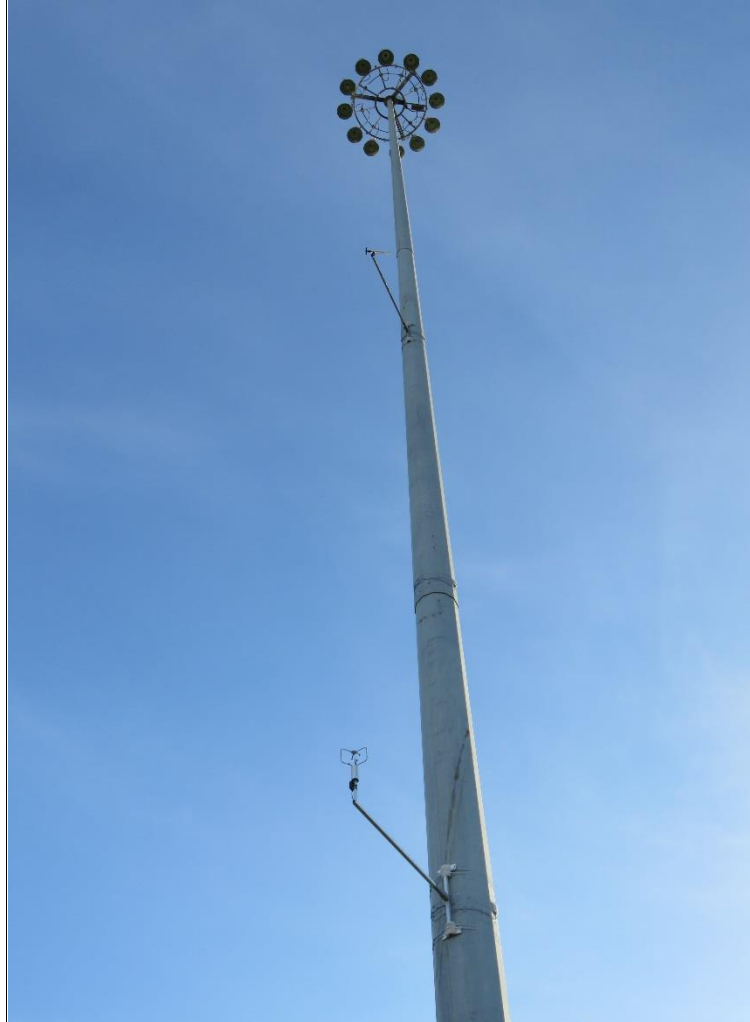
Figure 6.52: Instrumented HMIP in Galveston

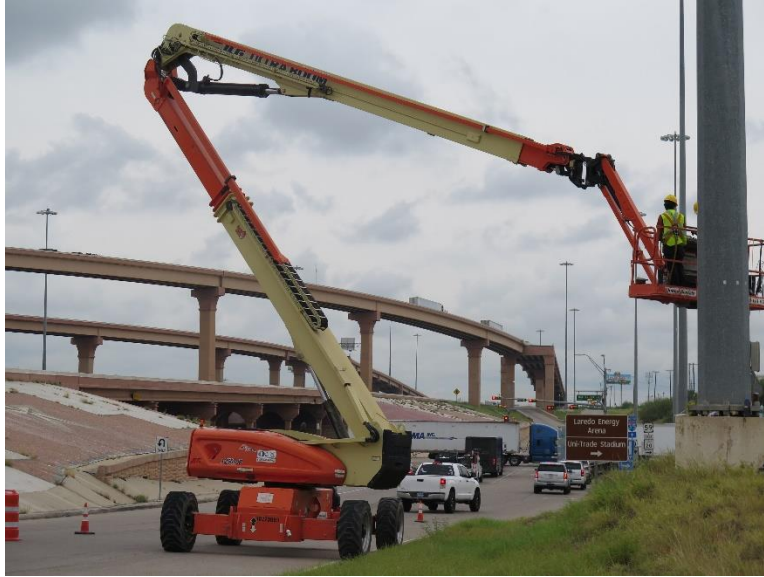
Figure 6.53: JLG Ultra Boom Lift used to Instrument the Selected HMIP in Laredo

The instrumentation plan for the Laredo location was the same as that for the pole in El Paso. The boom lift used in Galveston, shown in [Figure 6.53](#), was a JLG Ultra Boom model 1250AJP. Traffic control (lane closure) was provided by TxDOT. A picture of the instrumented HMIP in Laredo is shown in [Figure 6.54](#). The instrumentation of the selected HMIP in Laredo was completed on August 15, 2016.

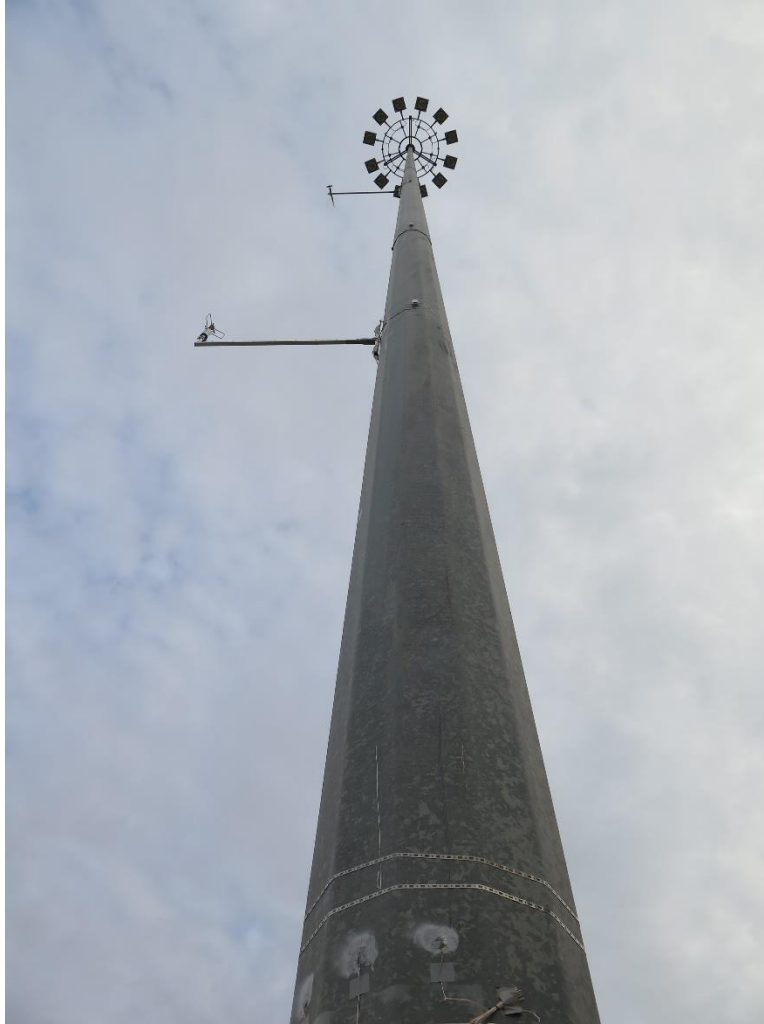
Figure 6.54: Instrumented HMIP in Laredo

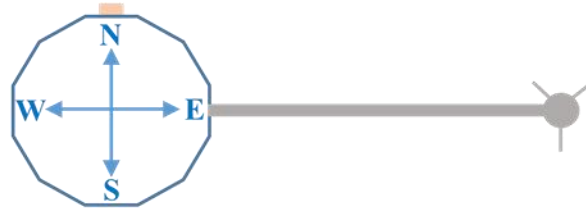
The turbulence intensity graph for the pole site in Laredo (Figure 6.69) indicates a more uniform distribution where most of the values are in the lower range as seen in the South-East side of the HMIP which is also the predominant wind direction. The lack of low turbulence intensity in

the North-East direction may be due to some low rise buildings in that direction as shown in the satellite map. Since the orientation of the supporting arm for the ultrasonic anemometer and a highway bridge is on the West side of the pole, a lack of low turbulence can also be observed. To avoid the local effect of the surrounding structures, the data from 0° to 90° and 180° to 360° directions were excluded in the analysis of wind data presented later in this chapter.

Figure 6.69: Topography, Orientation of the Ultrasonic Anemometer, and Turbulence Intensity at the Pole Site in Laredo

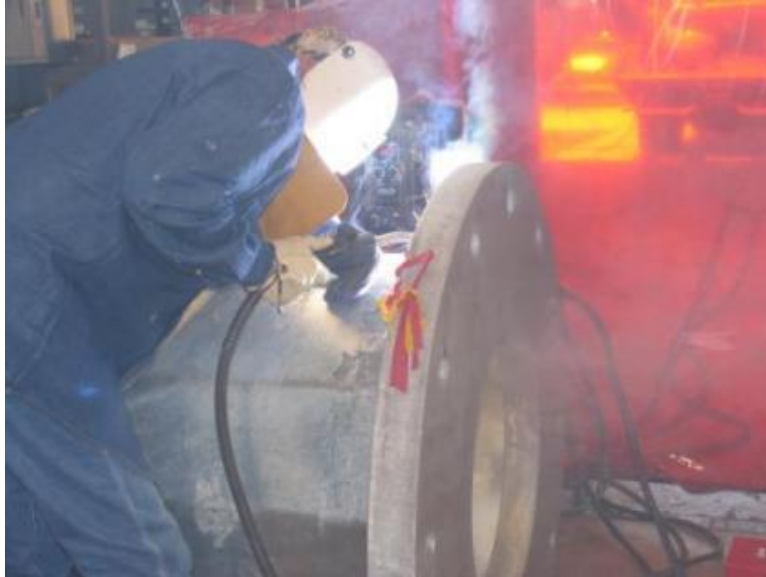
It was also helpful that this weld procedure only necessitated grinding down to one half of the wall thickness, comparatively less grinding than the field procedure. Having a larger root face enabled the welder to use more heat without fear of burning through to the other side, and to repair the weld in one pass. [Figure 8.5](#) below is a picture of the FCAW shop-repair procedure performed on the specimen at the Ferguson Structural Engineering Laboratory.

Figure 8.5: FCAW Being Performed at the Ferguson Lab (Pool 2010)

Because only one broad pass was needed to repair the weld, the weld profile on the shop repair specimen resulted in a smooth broad parabolic shape. Previous research was indicated that this interface is critical to maintaining smooth stress flow between the stiff base plate, and relatively flexible pole wall (Stam 2009). This shape is advantageous due to the reduction of the notch effect at the transition between the toe weld and pole wall, which, in turn, leads to a lower stress increase.

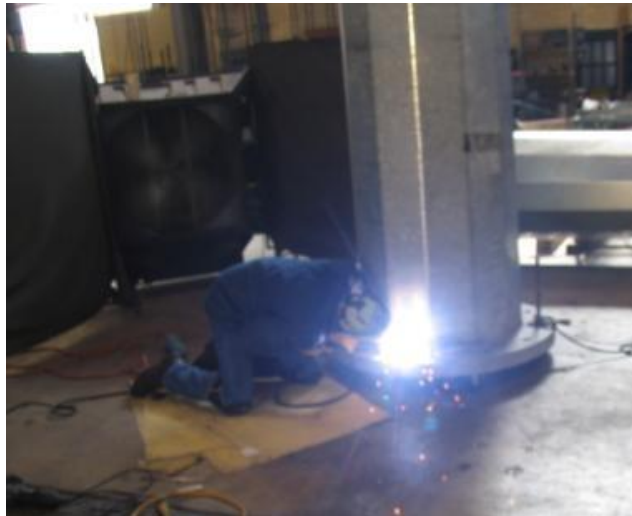
The tight controls on the depth of the grinding also added additional time into the weld repair process. Not only was it necessary for the welder to be careful to maintain the correct root face, one sixteenth of an inch, but if too much was ground off, the welder ran the risk of blowing through the root material during welding. In fact, the welder did burn through and had to fill the location of the hole, further contributing to a longer repair time, as well as risking disruption to the continuity of the surface on the inside of the pole. The welder performing the SMAW repair is shown in [Figure 8.6](#).

Figure 8.6: The Application of the Field-Repair Procedure at Ferguson Laboratory (Pool 2010)

To maintain the one sixteenth inch root face, the welder recommended using smaller electrodes, minimizing heat input into pole wall. This helped to maintain the root without burning through, but resulted in the larger number of passes to fill the ground opening. In doing so, the exterior of the weld had a noticeably rougher surface with many discontinuities.

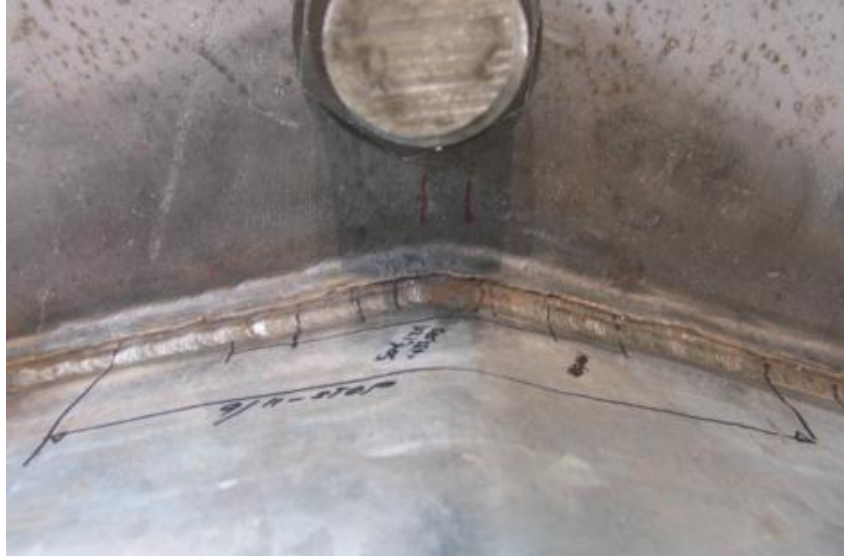
Following the repair, a fatigue test was performed at a 12 ksi stress range with a 10 ksi mean stress. The field-repaired specimen failed due to a loss of stiffness. Additionally, instead of failing in the typical manner, where the toe of the weld meets the shaft of the pole, this specimen failed in the middle between two weld passes. [Figure 8.7](#) shows this failure. Bends 10, 11, and 12 all had large fatigue cracks exhibiting this failure through the weld.

This failure occurred after 1,467,734 cycles, which places the Field Repair specimen in the D category, and showed a substantial improvement from the fatigue strength of the specimen prior to weld repair. This type of failure also progressed much slower than previous failures. The crack became visible after approximately 600,000 cycles, but no substantial loss in stiffness occurred until just before failure. The slow rate of propagation was attributed to the fatigue cracks progressing through the thicker weld profile instead of the thinner shaft. It was believed that this slow loss of stiffness highlighted another advantage to the use of the weld repairs: visible cracks can be found long before the system is likely to fail.

Figure 8.7: Bend 11 of the Field-Repaired Specimen with Failure through Weld

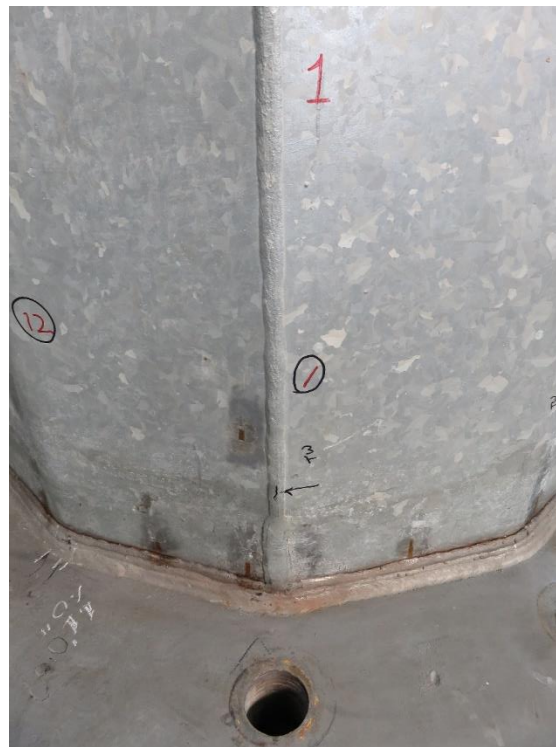
Figure 8.10: State of Cracks: Specimen 33-3-12-TX-A2 – Bend 1

Figures 8.10 through 8.22, and Figures 8.23 through 8.29 further depict the crack geometry at each specific bends of the Specimens 33-3-12-TX-A2 and 33-3-12-TX-A3, respectively. These figures specifically show the marks of 2-in. extension of cracks on both sides for grinding. More importantly, careful review of these figures reveals discrepancies in crack geometries between data shown in these figures and those shown in Figures 8.8 and 8.9. For most cases, larger values for both crack lengths and depths are reported in Figures 8.8 and 8.9. For example, for bend 10 on Specimen 33-3-12-TX-A3, the crack length is recorded as 3.750” in Figure 8.8, while it is indicated as 2.750” in Figure 8.27. The characterization of cracks by conducting PAUT testing on HMIP specimens in the horizontal versus vertical orientations is the main cause of the discrepancies in reported crack-geometry data. More specifically, detection of cracks when HMIP specimens are situated in the test setup (in horizontal orientation and displaced to the maximum stress in a fatigue test) results in higher values for both crack length and depth (values reported in Figures 8.8 and 8.9). This observation further justifies the extension of cracks beyond each ends for grinding to make sure the complete removal of cracks.

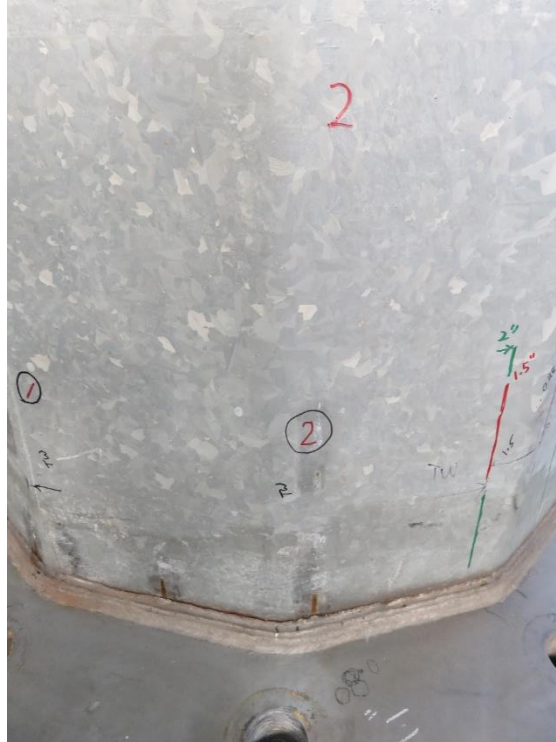
Figure 8.11: State of Cracks: Specimen 33-3-12-TX-A2 – Bend 2

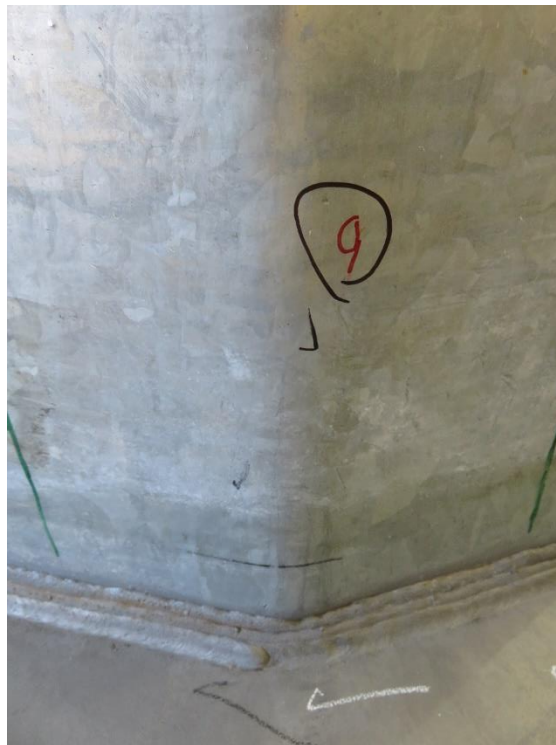
Figure 8.18: State of Cracks: Specimen 33-3-12-TX-A2 – Bend 9

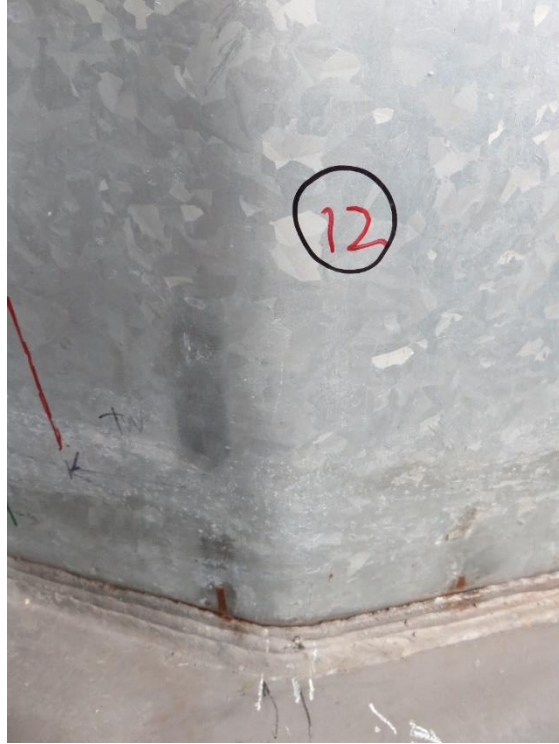
Figure 8.21: State of Cracks: Specimen 33-3-12-TX-A2 – Bend 12

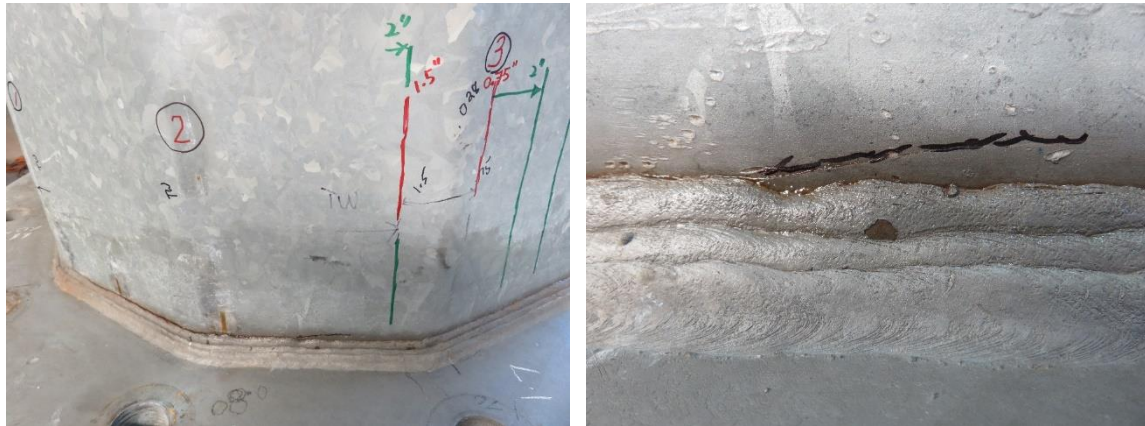
Figure 8.22 also shows a situation where a fatigue crack propagates away from the weld toe to the shaft wall during a fatigue test. When considered for weld-repair, cracks like the one shown in Figure 8.22 need more careful consideration in removing and rewelding of the shaft material.

Figure 8.22: Cracks Propagating Away from the Weld Toe: Specimen 33-3-12-TX-A2 – Bend 2

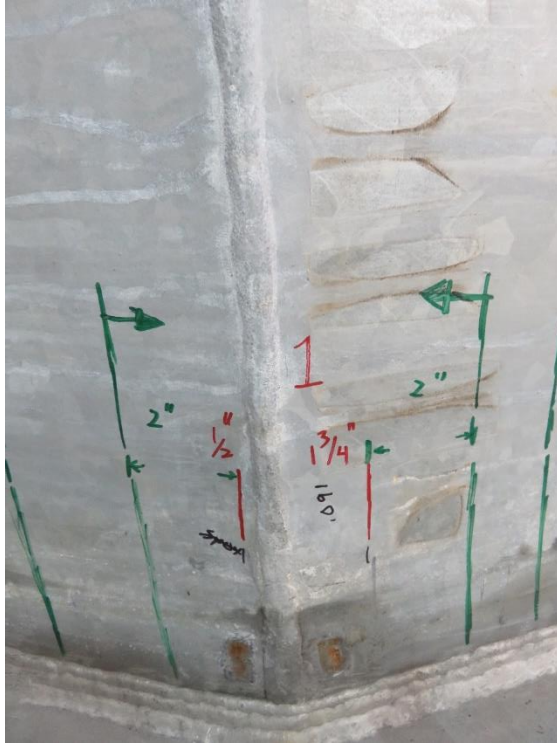
Figure 8.23: State of Cracks: Specimen 33-3-12-TX-A3 – Bend 1

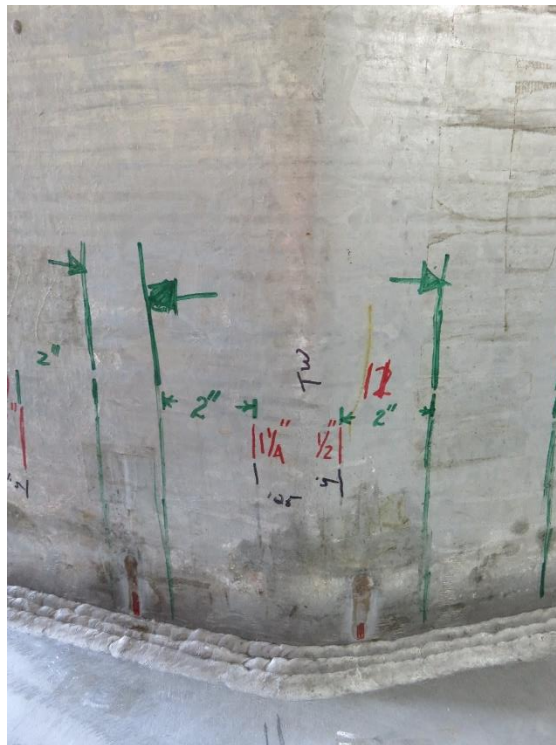
Figure 8.28: State of Cracks: Specimen 33-3-12-TX-A3 – Bend 11

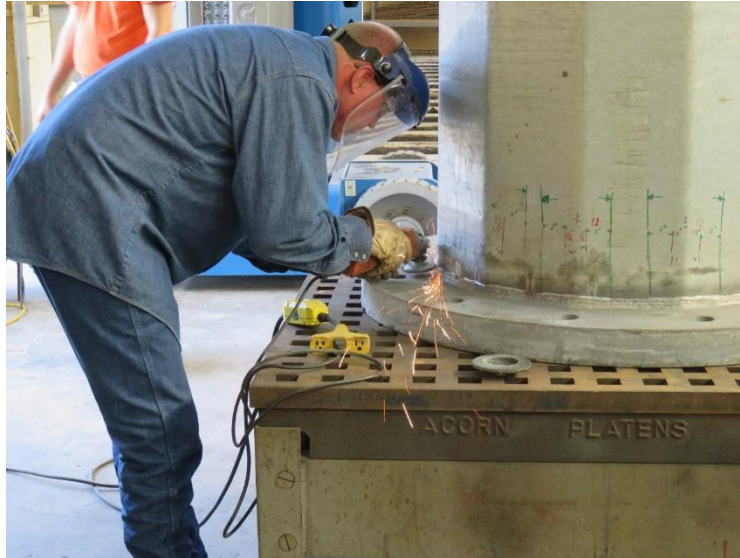
Figure 8.30: Grinding the Shaft Wall Adjacent to the Weld Toe to Remove Cracks – Orientation of the Specimen

Two methods of crack removal were studied in the development of the weld-repair procedure: Gradual Removal, and Rapid Removal. These procedures are explained in the following through series of pictures depicting the removal procedure. [Figures 8.30](#) through [8.32](#) presents some general aspects of the crack removal, including grinding orientation/technique, tools, etc.

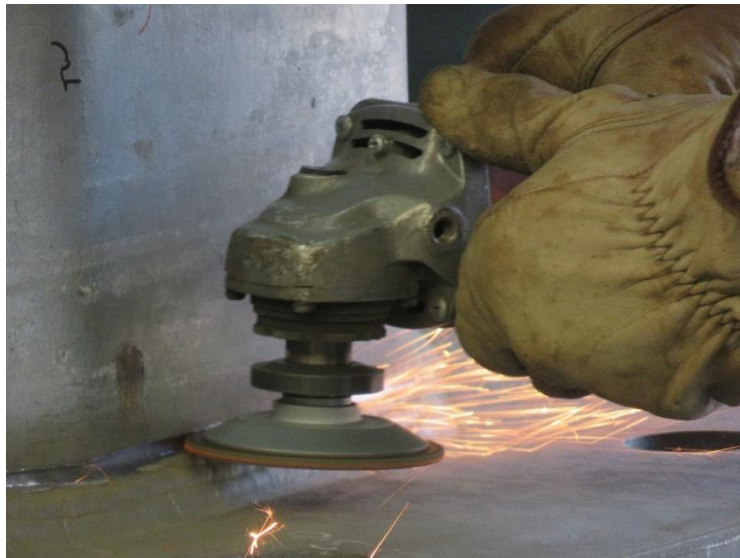
Figure 8.31: Grinding the Shaft Wall Adjacent to the Weld Toe to Remove Cracks – Grinding Technique

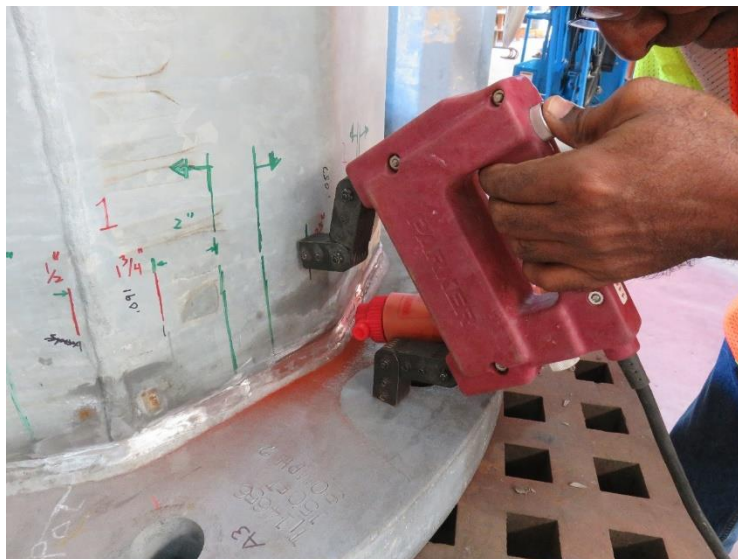
Figure 8.34: Magnetic Particle Testing to Trace the Cracks: Specimen 33-3-12-TX-A3 – Bend 10

In the gradual removal of cracks procedure, to expose the cracks, the cross-section of the HMIP specimen was slightly grinded over the identified crack length. Magnetic Particle Testing was then conducted to expose the cracks. The grinding was continued to remove magnetic evidence of the cracks. The gradual removal of cracks are shown in the following pictures for the Bend 10 of Specimen 33-3-12-TX-A3 (Figures 8.33 through 8.38). Since cracks are removed gradually, it is easier to observe, using Magnetic Particle Testing, if cracks are completely removed or not. The main disadvantage of the gradual removal procedure is that it is a long and tedious procedure.

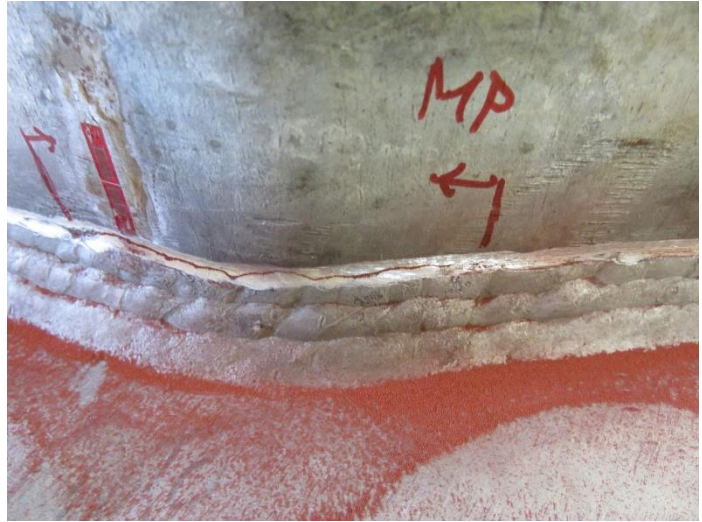
Figure 8.35: Grinding Continued to Remove Magnetic Particle Evidence of the Cracks: Specimen 33-3-12-TX-A3 – Bend 10

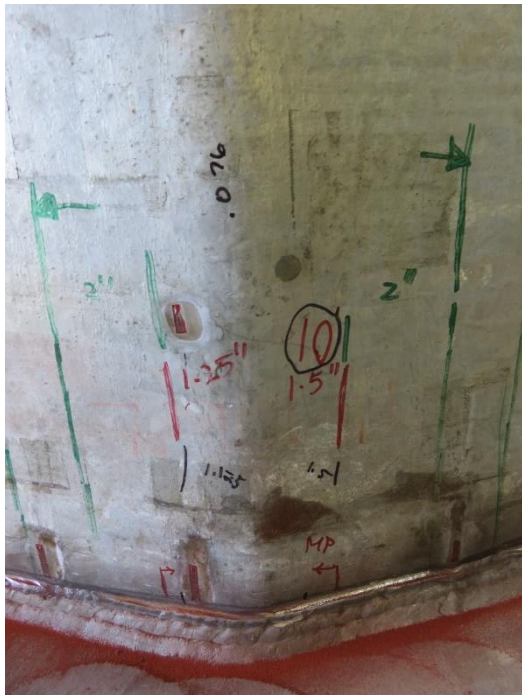
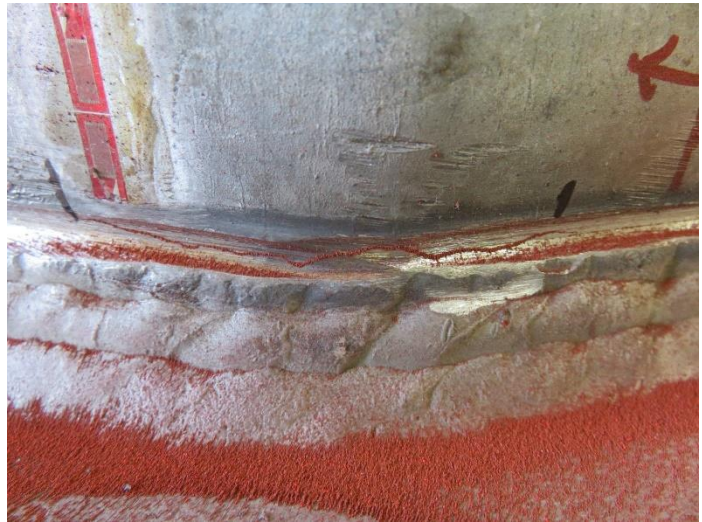
Figure 8.36: Grinding Continued to Remove Magnetic Particle Evidence of the Cracks: Specimen 33-3-12-TX-A3 – Bend 10

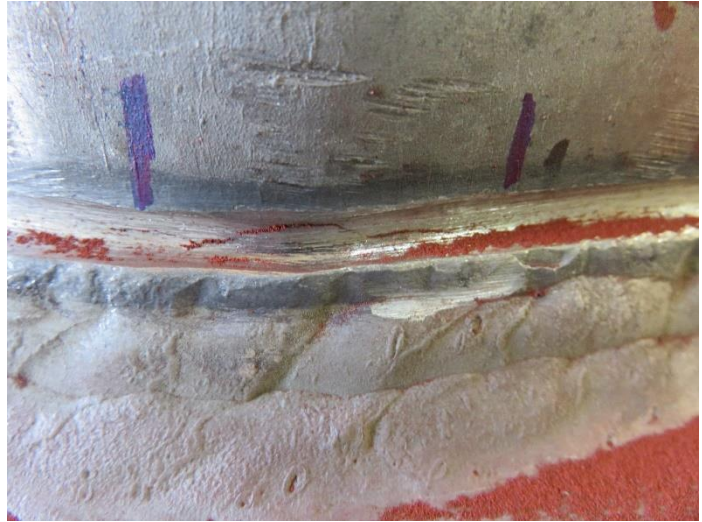
Figure 8.37: Grinding Continued to Remove Magnetic Particle Evidence of the Cracks: Specimen 33-3-12-TX-A3 – Bend 10

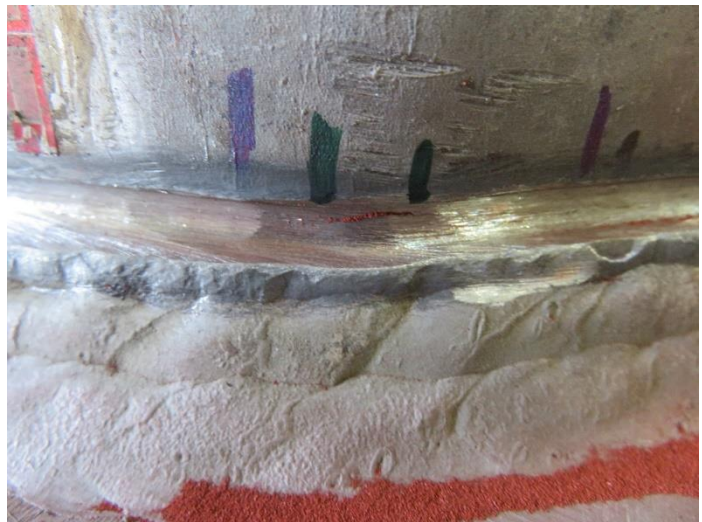
Figure 8.38: Grinding Continued to Remove Magnetic Particle Evidence of the Cracks: Specimen 33-3-12-TX-A3 – Bend 10

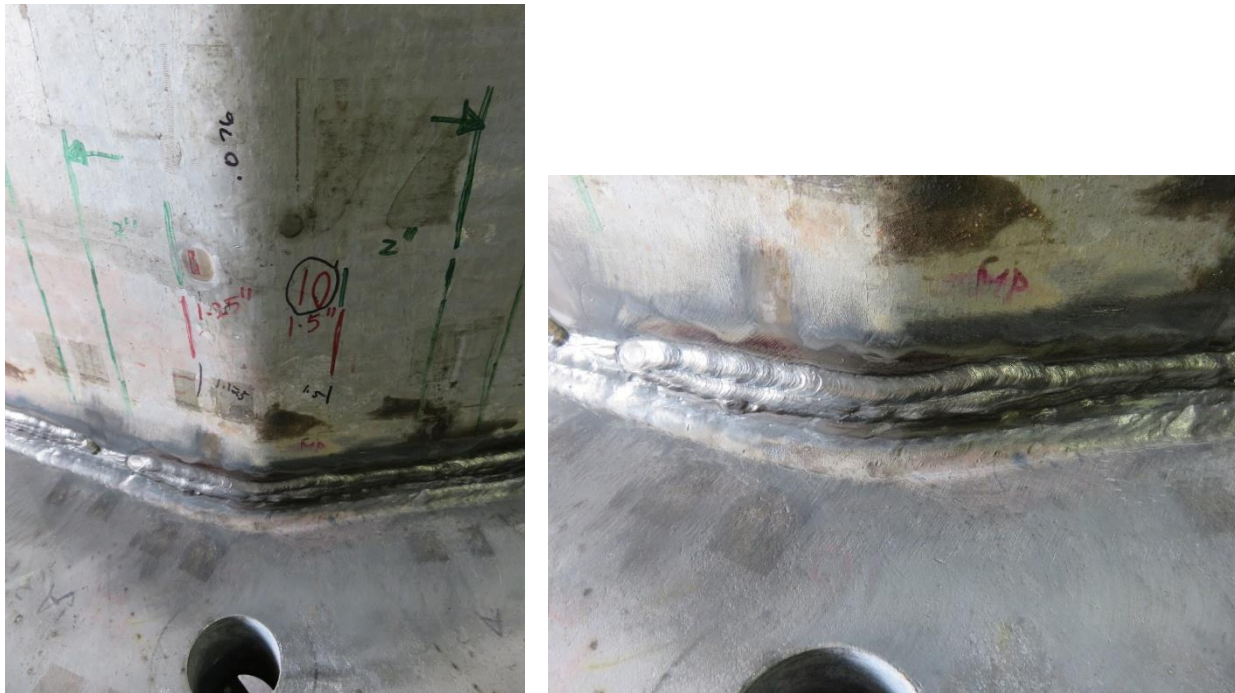
Figures 8.39 and 8.40 represent, respectively, the Bend 10 on Specimen 33-3-12-TX-A3, and Bend 5 on Specimen 33-3-12-TX-A2 following the application of the described weld-repair procedure. As can be seen from Figures 8.39 and 8.40, a slight modification in the grinding technique resulted in fewer weld passes as well as an improved weld profile for the Specimen 33-3-12-TX-A2. For the sake of this study, it was decided to leave the rough surfaces and welding profiles of the Specimen 33-3-12-TX-A3 as is and not to modify the welding profile by grinding.

Figure 8.39: Specimen 33-3-12-TX-A3 – Bend 10 Following the Weld-Repair

Shielded Metal Arc Welding procedure (SMAW) was used to reweld the cracks. The filler metal adhering to the AWS classification E7018 was used for the repair. Two different sizes of electrode were utilized: 3/32 inch electrode for the root pass, and 1/8 inch electrode for the other necessary passes. The weld was executed with a current of between 80 to 100 amps, DC+. The weld technique was composed of several stringer passes, using the appropriate electrodes specified above, and a wire brush was used for inter-pass cleaning.

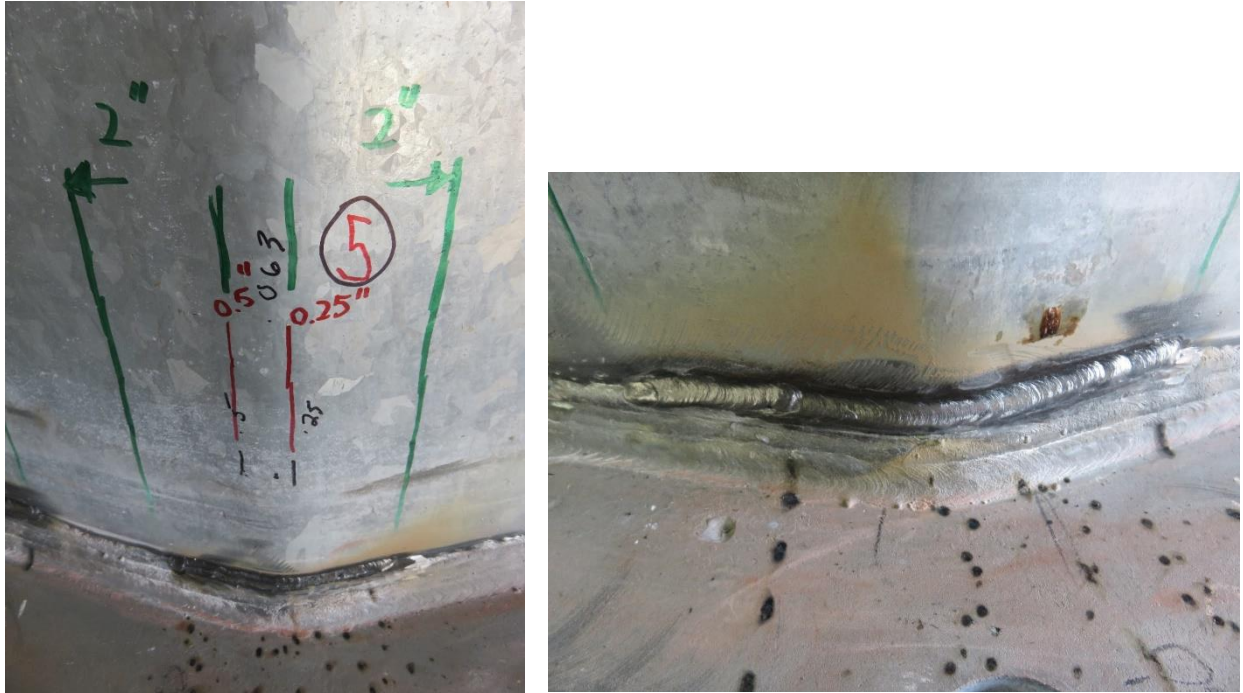
Figure 8.40: Specimen 33-3-12-TX-A2 – Bend 5 Following the Weld-Repair

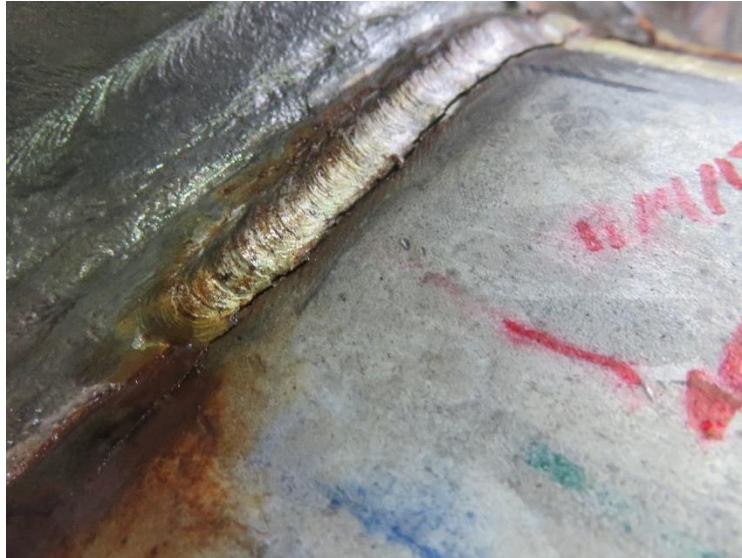
Figure 8.43: Weld-Repaired Specimen 33-3-12-TX-A2 – Bend 5 Following the Fatigue Test: Close-up View

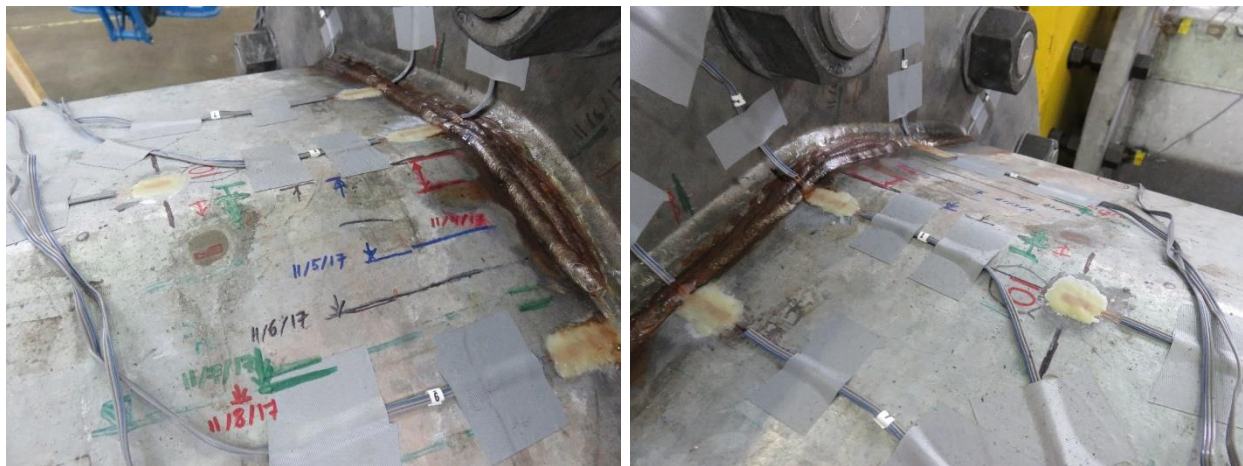
Figures 8.44 and 8.45 show the state of cracks on the top bend of Specimen 33-3-12-TX-A3 tested under the stress range of 10 ksi. As seen in these figures, sever cracking occurred at Bend 10. The top bend (Bend 10) failed first and the cracks propagated from this bend towards the two adjacent bends (Bends 9 and 12) at later stages of the fatigue test. A very interesting observation to make from Figures 8.44 and 8.45 is that following cracks appearance at the weld toe, cracks were also formed and propagated in between the passes of the original cracks.

Figure 8.44: Weld-Repaired Specimen 33-3-12-TX-A3 – Bend 10 Following the Fatigue Test: General View

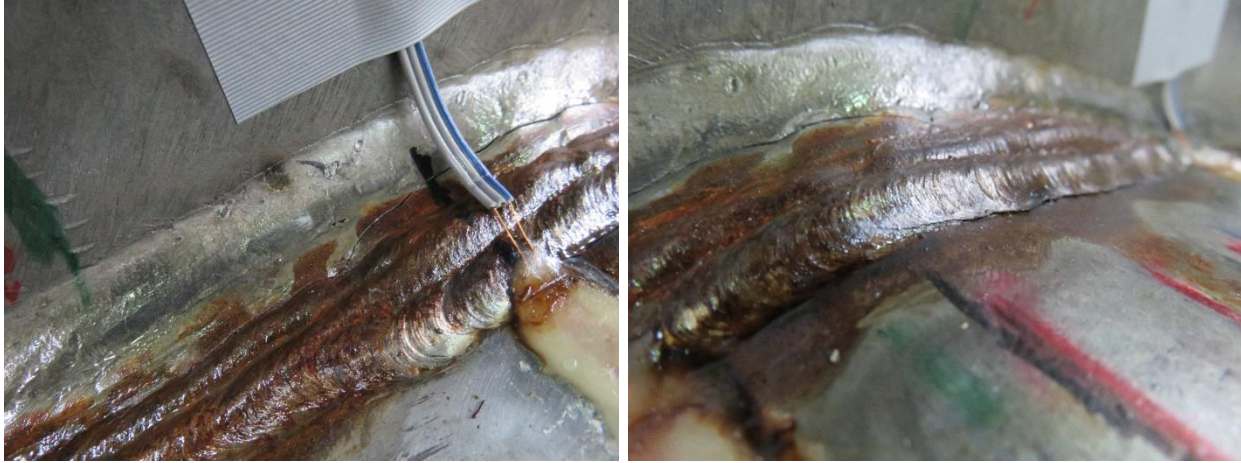
Figure 8.45: Weld-Repaired Specimen 33-3-12-TX-A3 – Bend 10 Following the Fatigue Test: Close-up View

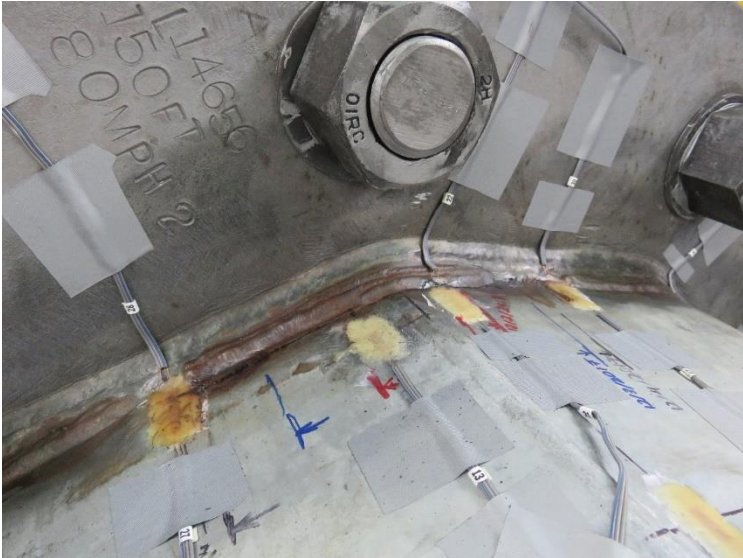
Figures 8.46 and 8.47 represent the state of cracks on the three top bends of Specimen 33-3-12-TX-A2 tested under the stress range of 10 ksi. As seen in these figures, sever cracking occurred at Bend 1. The top bend (Bend 1) failed first and the cracks propagated from this bend towards the two adjacent bends (Bends 2 and 12) at later stages of the fatigue test. A very important observation to make from Figures 8.46 and 8.47 is that when cracks approached to irregularities on the weld path (at the shaft-to-baseplate weld toe), they started to propagate in the shaft away from the weld path. When cracks started to propagate in the shaft, the rate of change in their length increased very rapidly causing a very fast fatigue failure.

Figure 8.46: Weld-Repaired Specimen 33-3-12-TX-A3 – Bend 1 Following the Fatigue Test: Close-up View
