TECHNICAL REPORT 0-6829-1
TxDOT PROJECT NUMBER 0-6829

Fatigue Resistance and Reliability of High Mast Illumination Poles (HMIPs) with Pre-Existing Cracks: Final Report

March 2018; Revised and Published November 2018

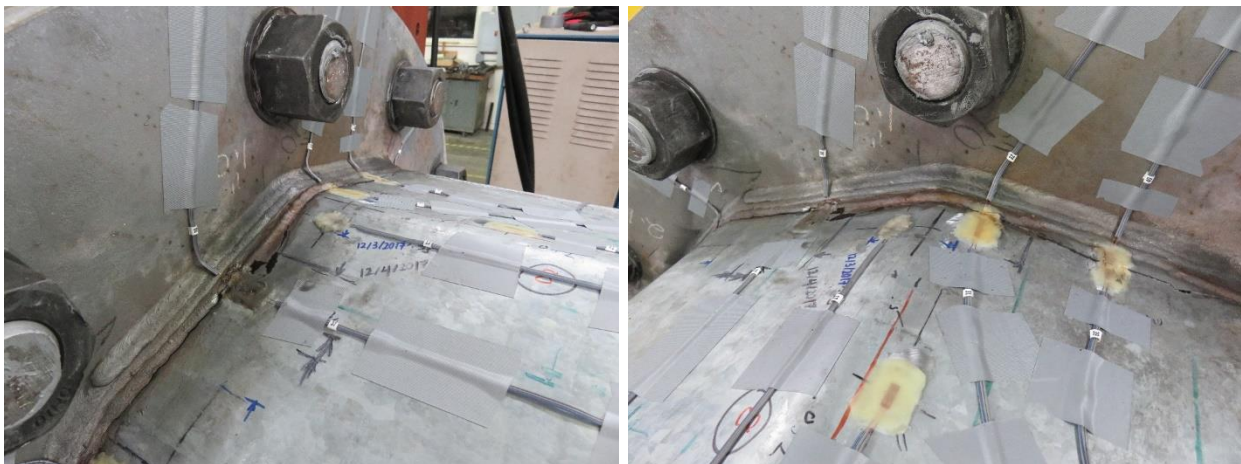
Figures 8.48 and 8.49 represent the state of cracks on the three top bends of Specimen 33-3-12-TX-A2 tested under the stress range of 10 ksi. As seen in these figures, sever cracking occurred at Bend 8. The top bend (Bend 8) failed first (at the same time that Bend 9 failed) and the cracks propagated from this bend towards the two adjacent bends (Bends 7 and 9) at later stages of the fatigue test. A very important observation to make from Figures 8.48 and 8.49 is that when cracks approached to irregularities on the weld path (at the shaft-to-baseplate weld toe), they started to propagate in the shaft away from the weld path. When cracks started to propagate in the shaft, the rate of change in their length increased very rapidly causing a very fast fatigue failure. As seen in Figures 8.48 and 8.49, the significant propagation of cracks resulted in rapid failure of the weld seam Bend 7 as well.

Figure 8.48: Weld-Repaired Specimen 33-3-12-TX-A2 – Bend 8 Following the Fatigue Test: General View

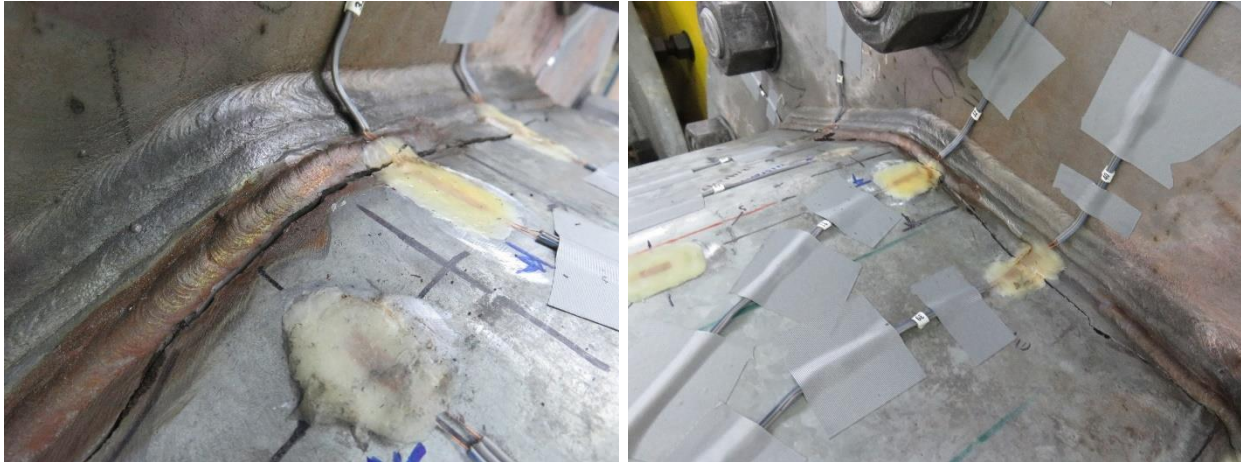
Figure 8.49: Weld-Repaired Specimen 33-3-12-TX-A2 – Bend 8 Following the Fatigue Test: Close-up View
