FATIGUE TESTS OF WELDED HYBRID
PLATE GIRDERS UNDER CONSTANT MOMENT

Research Report No. 77-2F

Fatigue Strength of Hybrid Plate Girders Under
Constant Moment

by the
CENTER FOR HIGHWAY RESEARCH
THE UNIVERSITY OF TEXAS
Austin, Texas

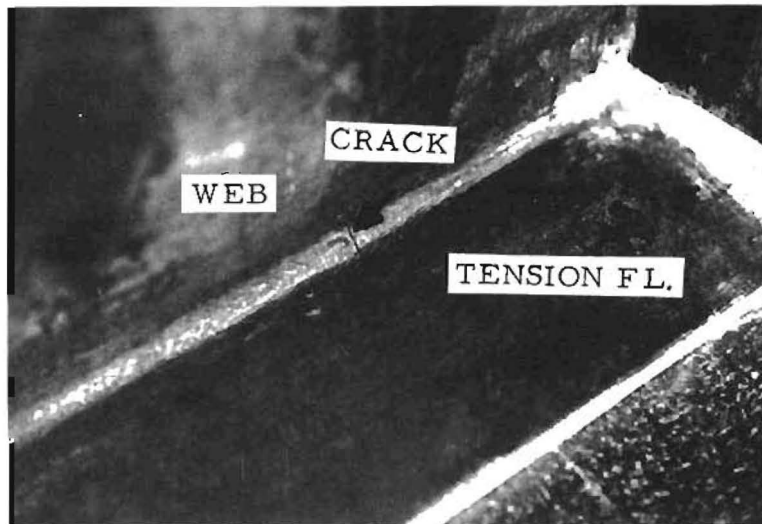
FIG. 23 DISCONTINUITY IN WEB TO TENSION FLANGE
FILLET WELD

Three cracks were found within the test section at 1,394,800 cycles. Two cracks occurred near the cut-off end of the transverse stiffener and one occurred at the tension flange to web juncture (Figure 22). A close examination of the latter crack revealed that the crack had initiated at the point where manual welding operation was interrupted in making the continuous longitudinal fillet weld (Figure 23). Since

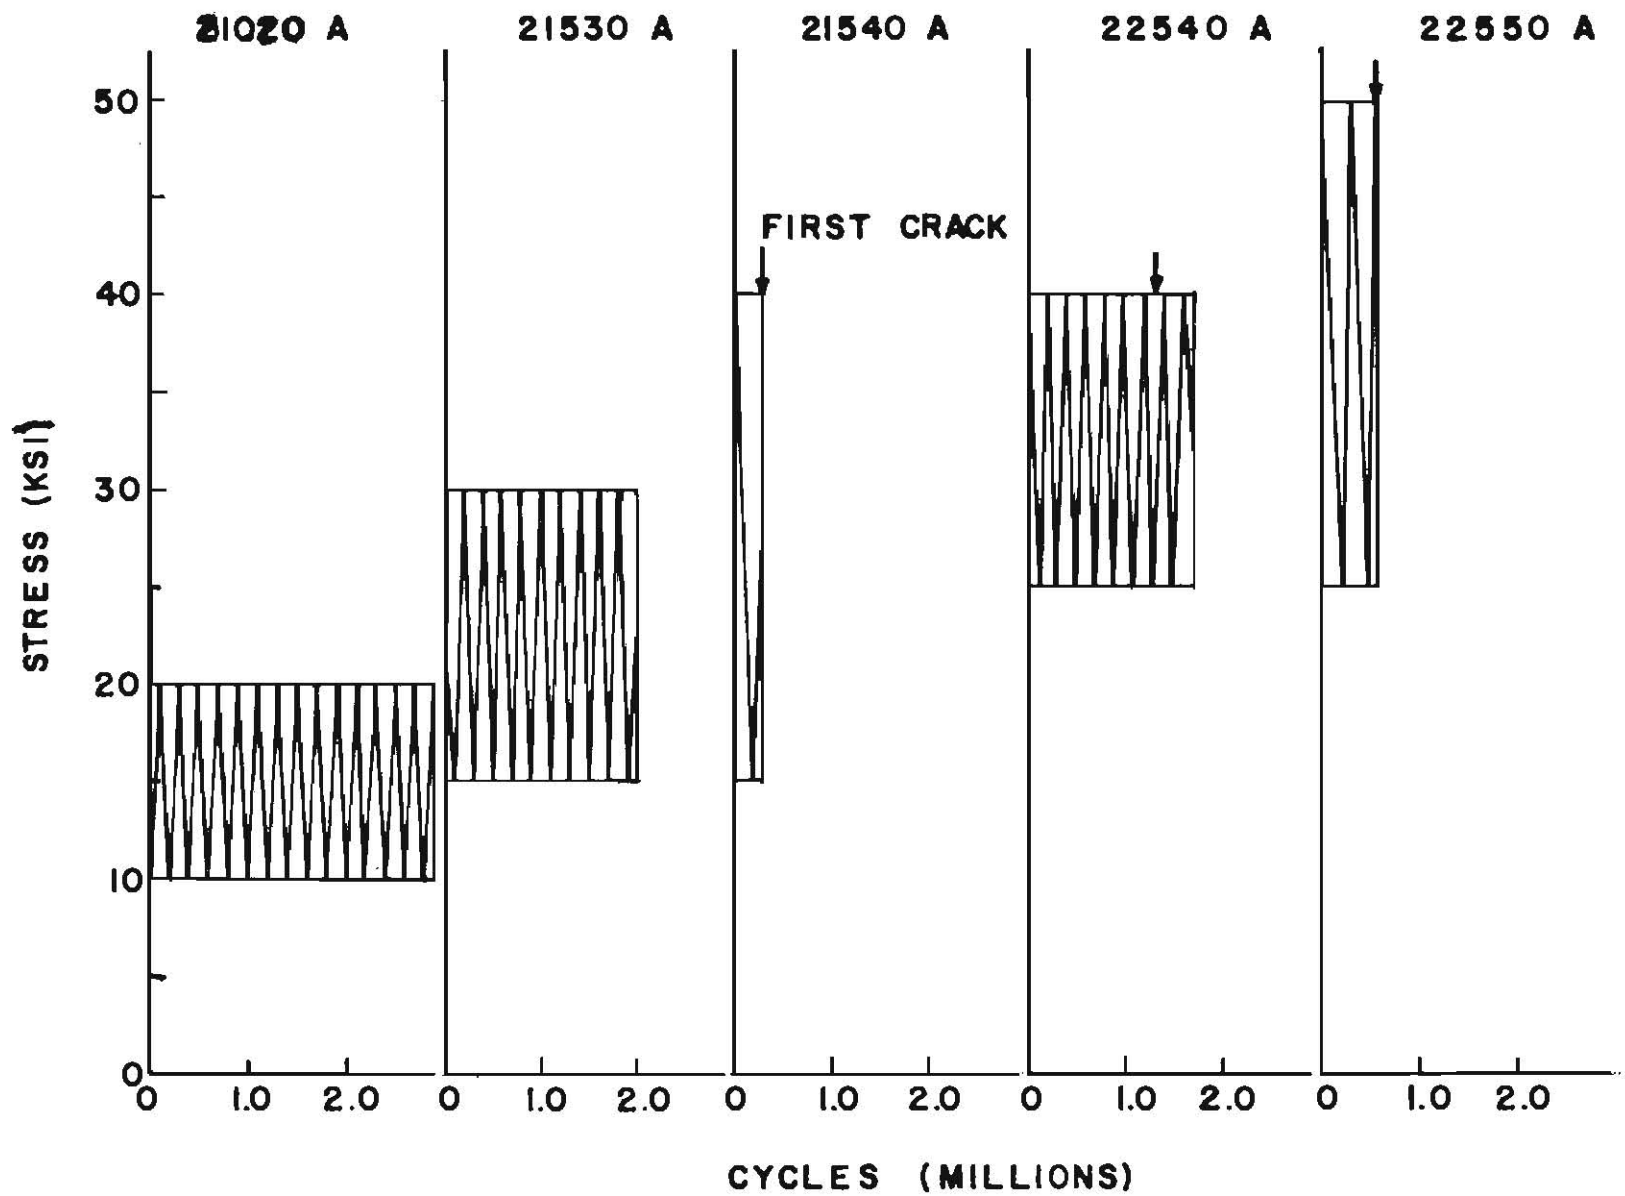
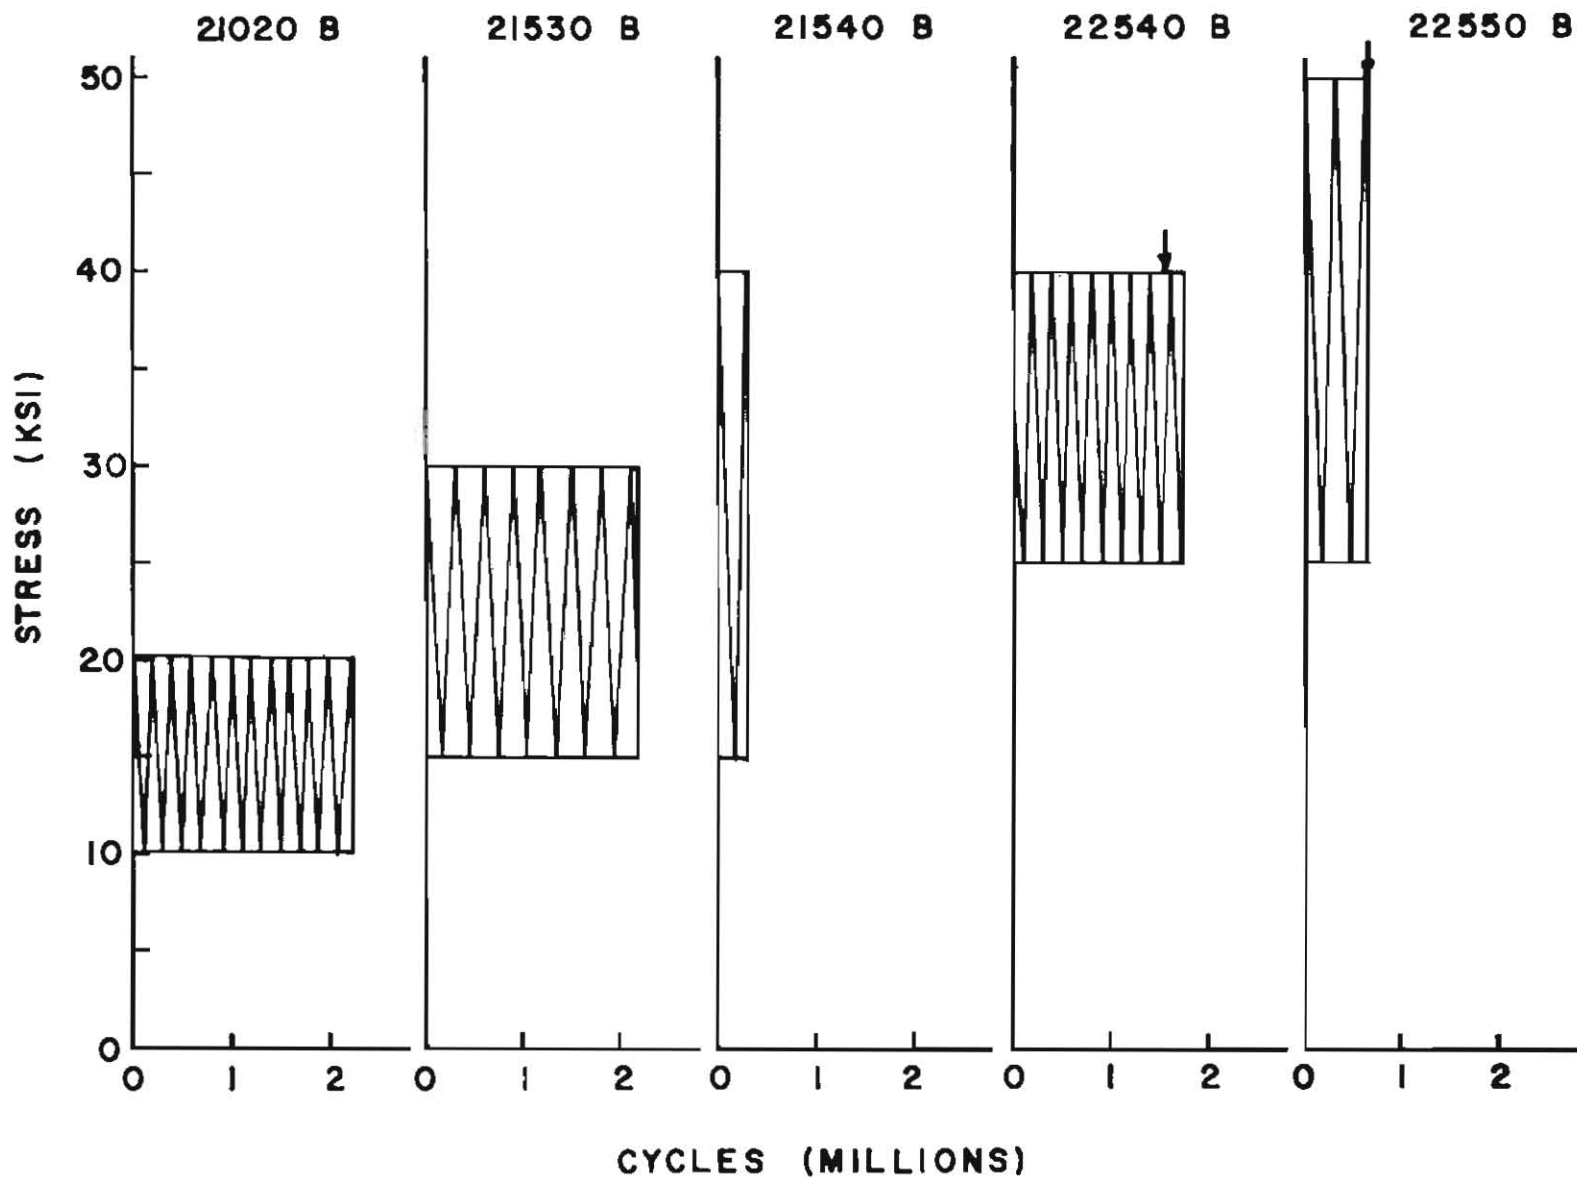
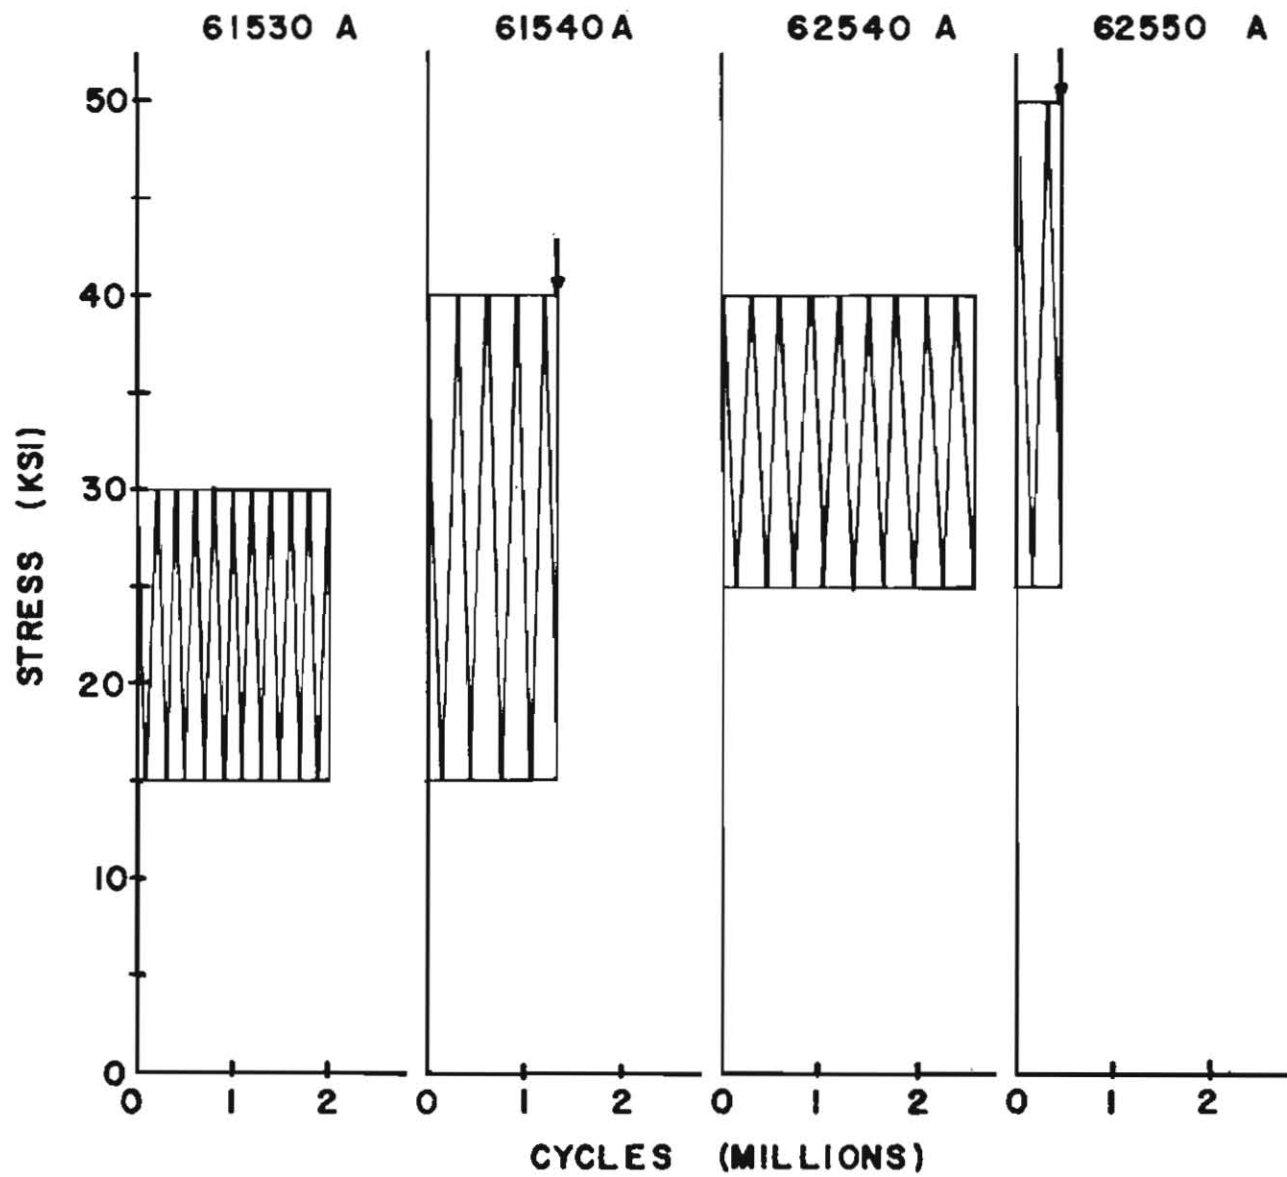
FIG. 25 SUMMARY OF FATIGUE TEST OF 1/8-in. WEB SPECIMENS - A SERIES

FIG. 26 SUMMARY OF FATIGUE TESTS OF 1/8 in. WEB SPECIMENS - B SERIES

FIG. 27 SUMMARY OF FATIGUE TESTS OF 1/4 IN. WEB SPECIMENS - SERIES A&B

FIG. 28 SUMMARY OF FATIGUE TESTS OF 3/8 in. WEB SPECIMENS - A SERIES

The total number of cycles to which each specimen was subjected are presented in Figures 25 through 28. In each figure, the fluctuating stresses for each specimen are depicted at pertinent minimum and maximum stress levels to indicate their relative positions with respect to the stress range spectrum. The arrow marks shown on each stress cycle curve denote the number of cycles at which the first crack was observed. The numerical values corresponding to the arrow marks are listed in the fourth column of Table IV. It can be seen from these values that all specimens subjected to a maximum stress below 30 ksi sustained two million cycles without any cracks in the test specimens. However, for those specimens which were strained beyond the yield strain of the web, fatigue cracks developed in both the compression and tension side of the girders. The actual magnitudes of the strains at the extremities of the web corresponding to the minimum and maximum test stresses are shown in the second and third column of Table IV as ratios of the extreme web fiber strain to the yield strain of the web. The values larger than 1.0 imply that the extreme web fibers were strained beyond the elastic limit.

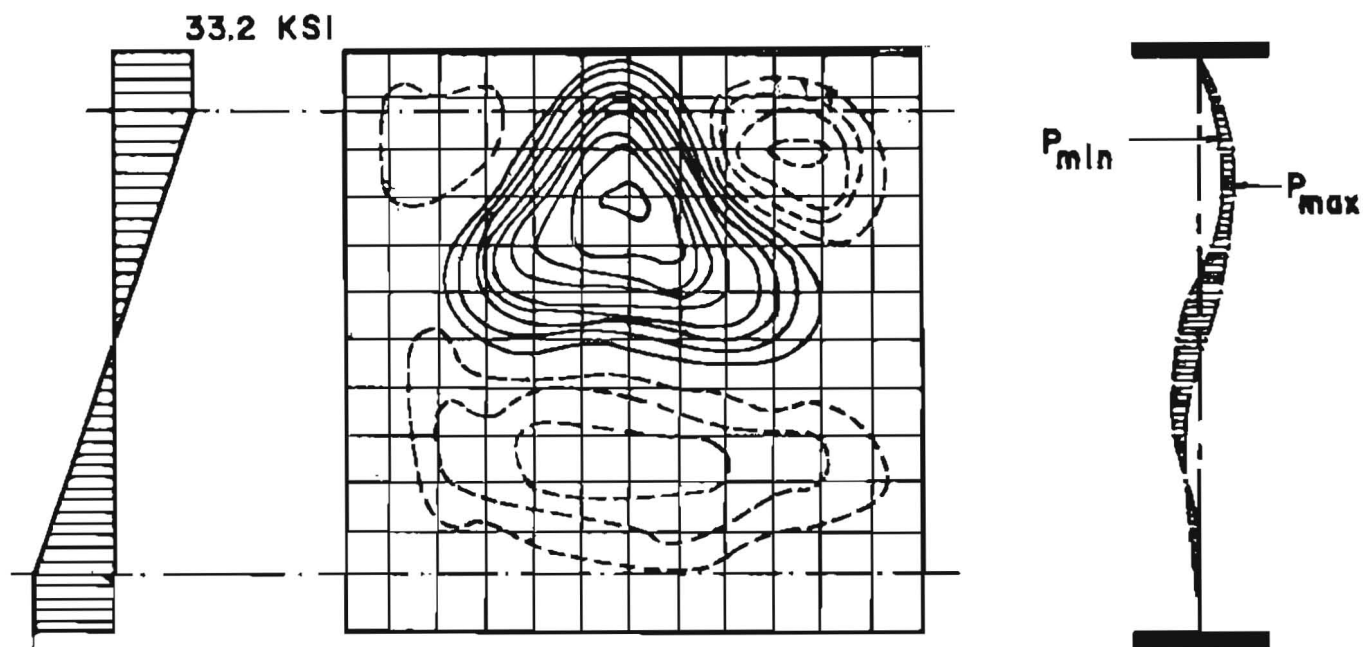
FIG. 31 WEB DEFLECTION OF SPECIMEN NO. 21540 A

A typical example of such lateral movements of the web at a cross section taken through the crack is given in Figure 31, together with a contour diagram showing the buckling pattern. The shaded portion of the diagram represents the range of lateral movements of the web between P_{\min} and P_{\max} .

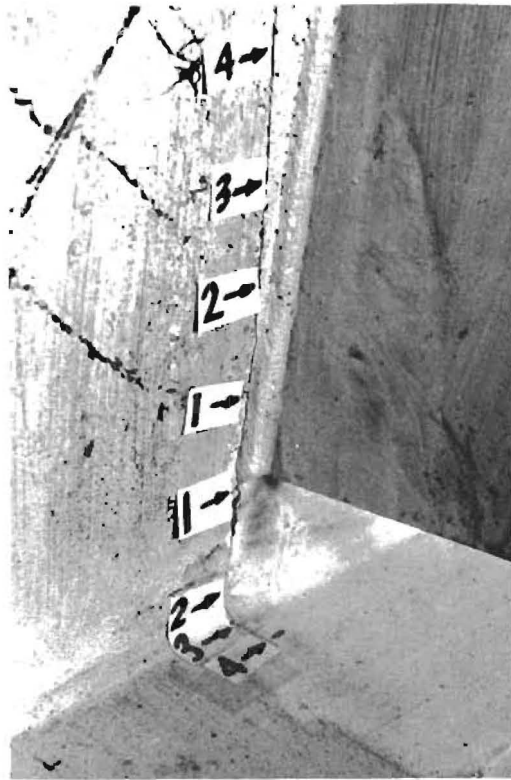
1. 878,000 cycles
2. 973,000 cycles
3. 1,024,600 cycles
4. 1,064,400 cycles
5. 1,075,000 cycles

a. Crack on web and bottom flange

b. Crack on bottom face of tension flange

FIG. 32 PROPAGATION OF TYPE 2 CRACK

Type 2 cracks were those found near the bottom of the transverse stiffener either in the heat affected area of the web along the toe of the fillet weld or in the weld itself. For all cases, the cracks were found when they were already 2 to 3 inches long and had propagated in both directions, upward along the toe of the fillet weld and downward into the tension flange. Figure 32 shows a typical crack of this type. In this figure, the numbers represent a sequence of crack propagation and the corresponding cycles are presented at

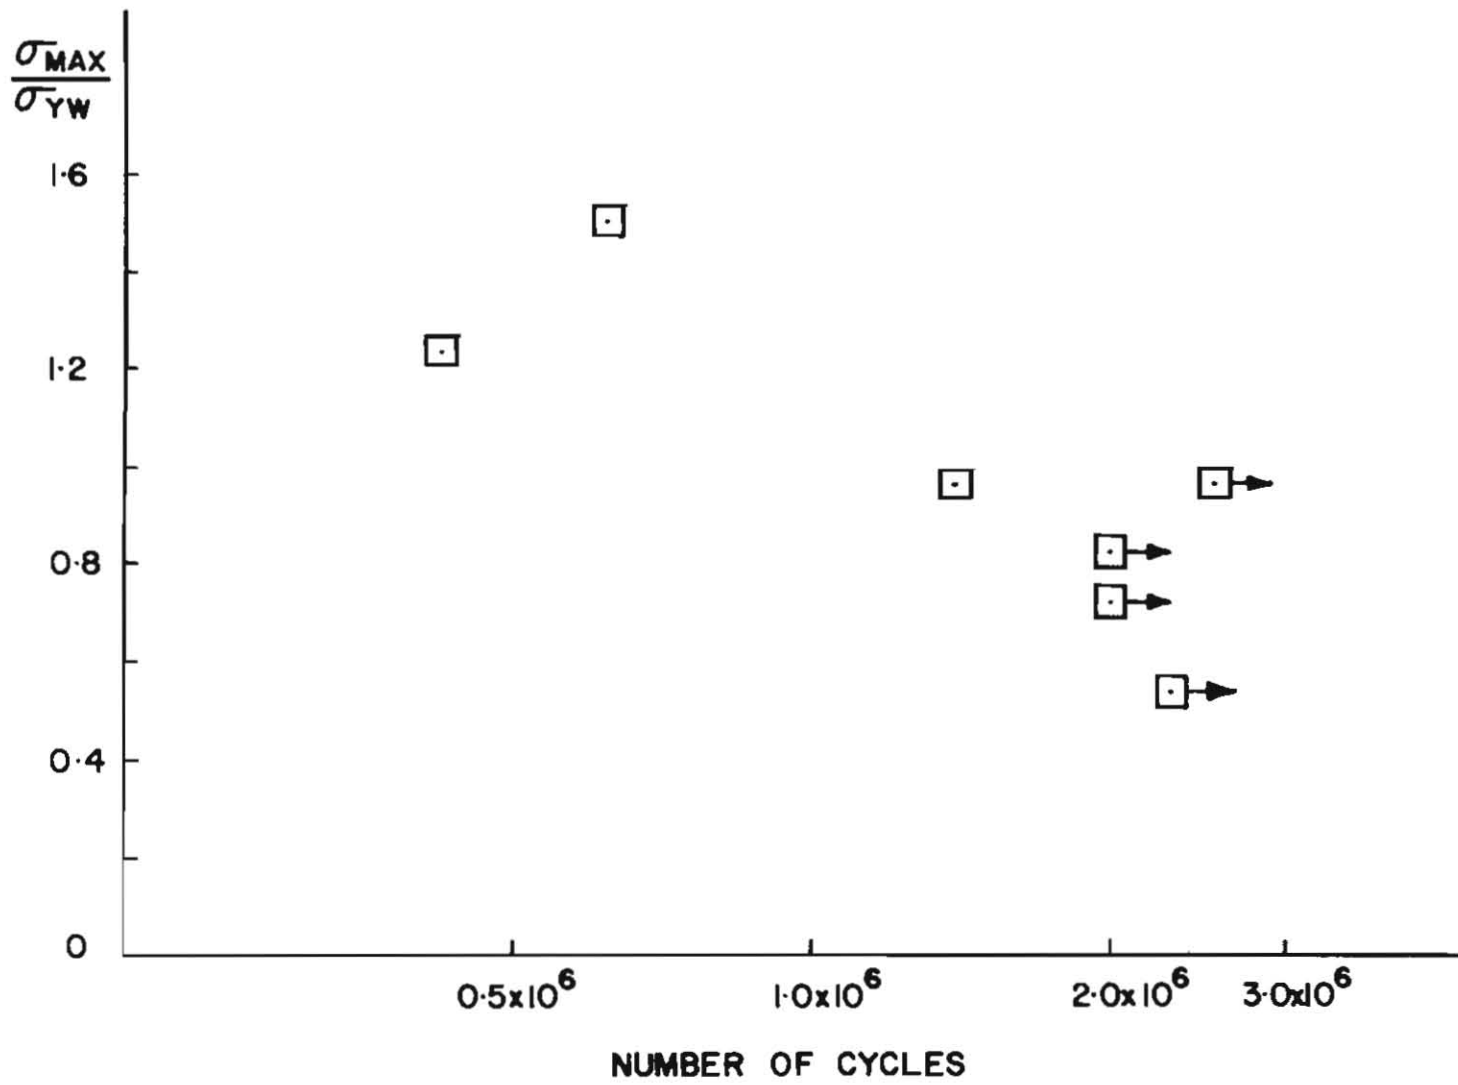
FIG. 38 TEST RESULTS OF TYPE 2 CRACK

The test results of Type 2 cracks are presented in Figure 38, as a function of the ratio of the maximum applied stress, σ_{max} to the

yield point of the web material, σ_{yw} . It is seen that only a small change in the ratio of σ_{max} to σ_{yw} results in a considerable increase in the fatigue life. When the ratio was reduced to 0.8, no Type 2 crack was observed in any of the test specimens.
