TEST OF UPPER ANCHORAGE OF #14S COLUMN BARS
IN PYLON DESIGN

Research Report No. 113-1

Research Project Number 3-5-68-113
Splices and Anchorage of Reinforcing Bars

CENTER FOR HIGHWAY RESEARCH
THE UNIVERSITY OF TEXAS AT AUSTIN

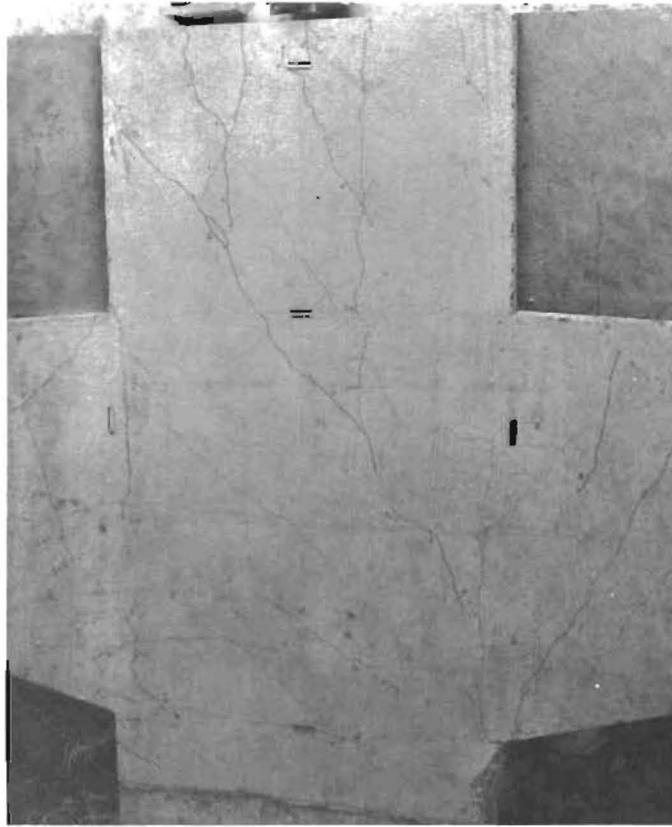
Fig. 8(a). Cracking pattern at the junction of the pylon and crossbeam.

Four days later, after some correction to the loading system, the testing was resumed in the same manner except with slightly larger load increments. This brought the heavily loaded beam to a level of dead load plus 6.75LL before failure occurred, equal to 2.54(DL + LL). The failure was the result of the yielding of the tensile steel in the column and the subsequent secondary compression failure at the opposite face of the column above the construction joint. The crack pattern in the joint at this stage is shown in Fig. 8, where the crushing of the concrete at the right foreground indicates the start of the compression failure. The loading, continued further at no higher level, finally resulted in breaking off the compression concrete outside the compression steel as shown in Fig. 8b.

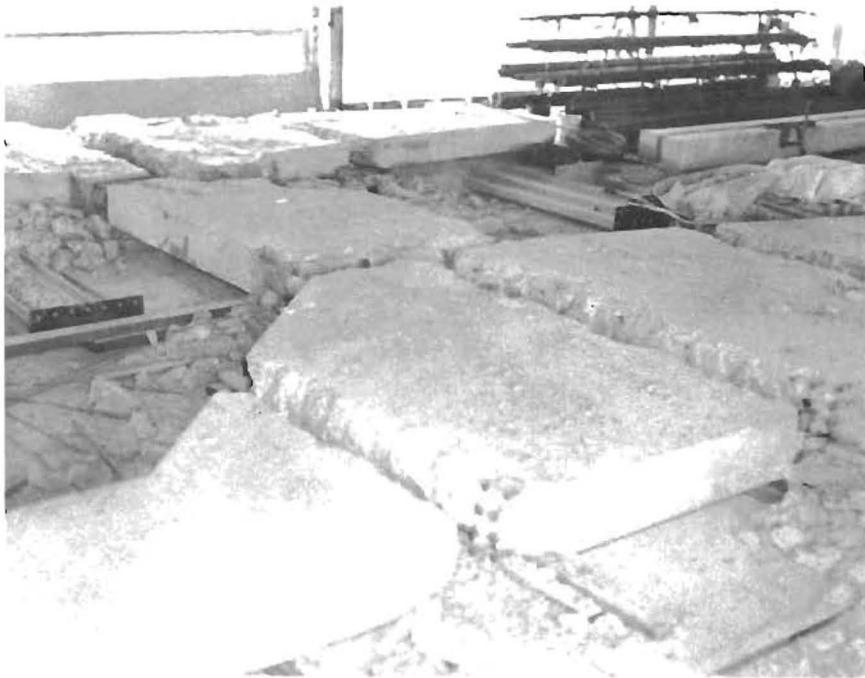
Fig. 10. Specimen broken up for removal.

One of the practical difficulties of this test was the removal of the specimen. It had to be broken up into truck-sized units as shown in Fig. 10.
