1. Report No.	2. Government Accession No.	3. Recipient's Catalog No.	
4. Title and Subtitle "Repair of Concrete with Polymers"		5. Report Date February 1975

REPAIR OF CONCRETE WITH POLYMERS

Research Report Number 114-3

Polymer-Impregnated Concrete for Highway Applications

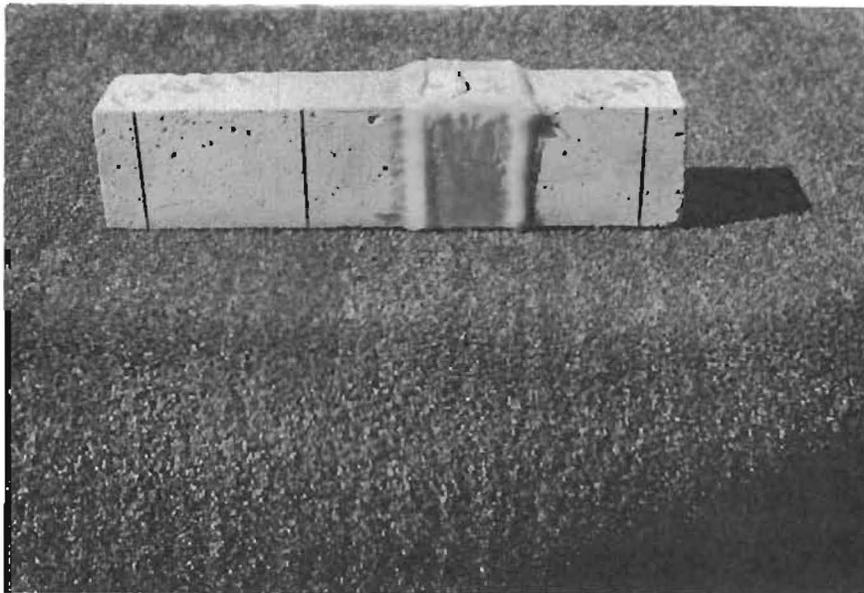
FIG. 2.1 A TYPICAL SPECIMEN WITH METAL FORM

The test utilized 3 in. x 3 in. x 14 in. modulus of rupture beams. Concrete properties and mix design are summarized in the Appendix. The beams were first oven-dried at $210^{\circ} \text{ F} \pm 10^{\circ} \text{ F}$ for a period of seven days. After removal from the oven the beams were loaded at third points to failure. The testing was done in general accordance with ASTM C78-64. After failure of each beam, the beam was completely broken into two halves. The two halves were brought together at a specified crack width measured from reference lines on each half marked prior to testing. A sheet metal form was bonded to the sides and bottom of the crack with a silicon adhesive. Using the same adhesive, a shallow dike was formed around the top of the crack to contain the monomer (Fig. 2.1). After the adhesive had hardened, the monomer solution was poured into the crack and replenished as necessary until polymerization occurred at room temperature. After 24 hours the forms were removed and the beams were tested in the original orientation.

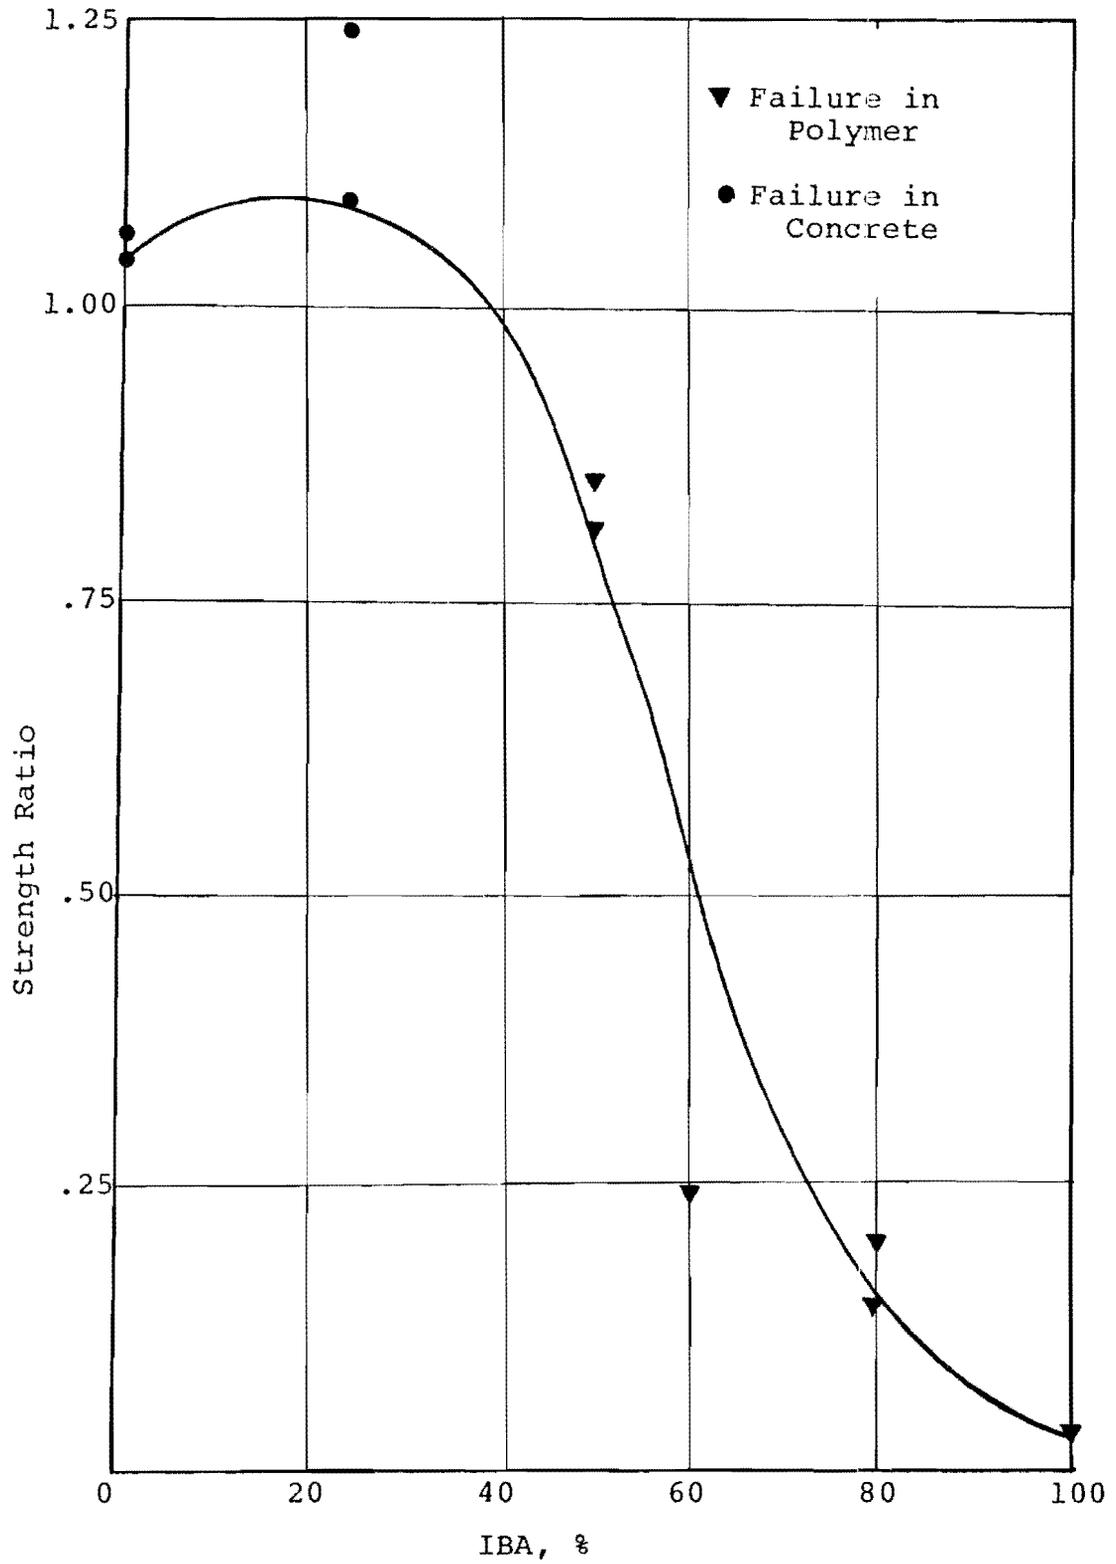
2.2.1 Methyl Methacrylate and Isobutyl Acrylate---Beams repaired with MMA and IBA had a crack of 0.05 in. Fig. 2.2 shows the effect of the percentage of MMA and IBA on the strength ratio of the repaired specimen. The strength ratio is the ratio of the ultimate load after repair to the original ultimate load.

FIG. 2.2 EFFECT ON FLEXURAL STRENGTH OF VARYING PERCENTAGE OF IBA IN MMA SOLUTION

The results indicate that when specimens were treated with percentages of IBA of up to 25 to 35%, the use of IBA did not decrease the strength but in some cases increased it. In this range, the failure was in the concrete, which indicated good adhesion of the polymer to the concrete.

At about 35%, the strength ratio starts to drop rapidly with increasing percentages of IBA until it reaches zero at 100% IBA, when the specimen did not even support its own weight. Although only visual observations were made, the ductility of the repaired zones utilizing IBA was generally more than the specimens with MMA alone. The specimens treated with 60% IBA had a centerline deflection of approximately 1/4 in. at the ultimate load and 1/2 in. when the test was terminated while the specimen still supported about 10% of its original ultimate load. Specimens with treatments using 75% or more of IBA were ductile but the polymer was very sticky and discontinuous and had a very strong smell. In one specimen a cross-linking agent, TMPTMA, was used but only a slight improvement in the strength was obtained.

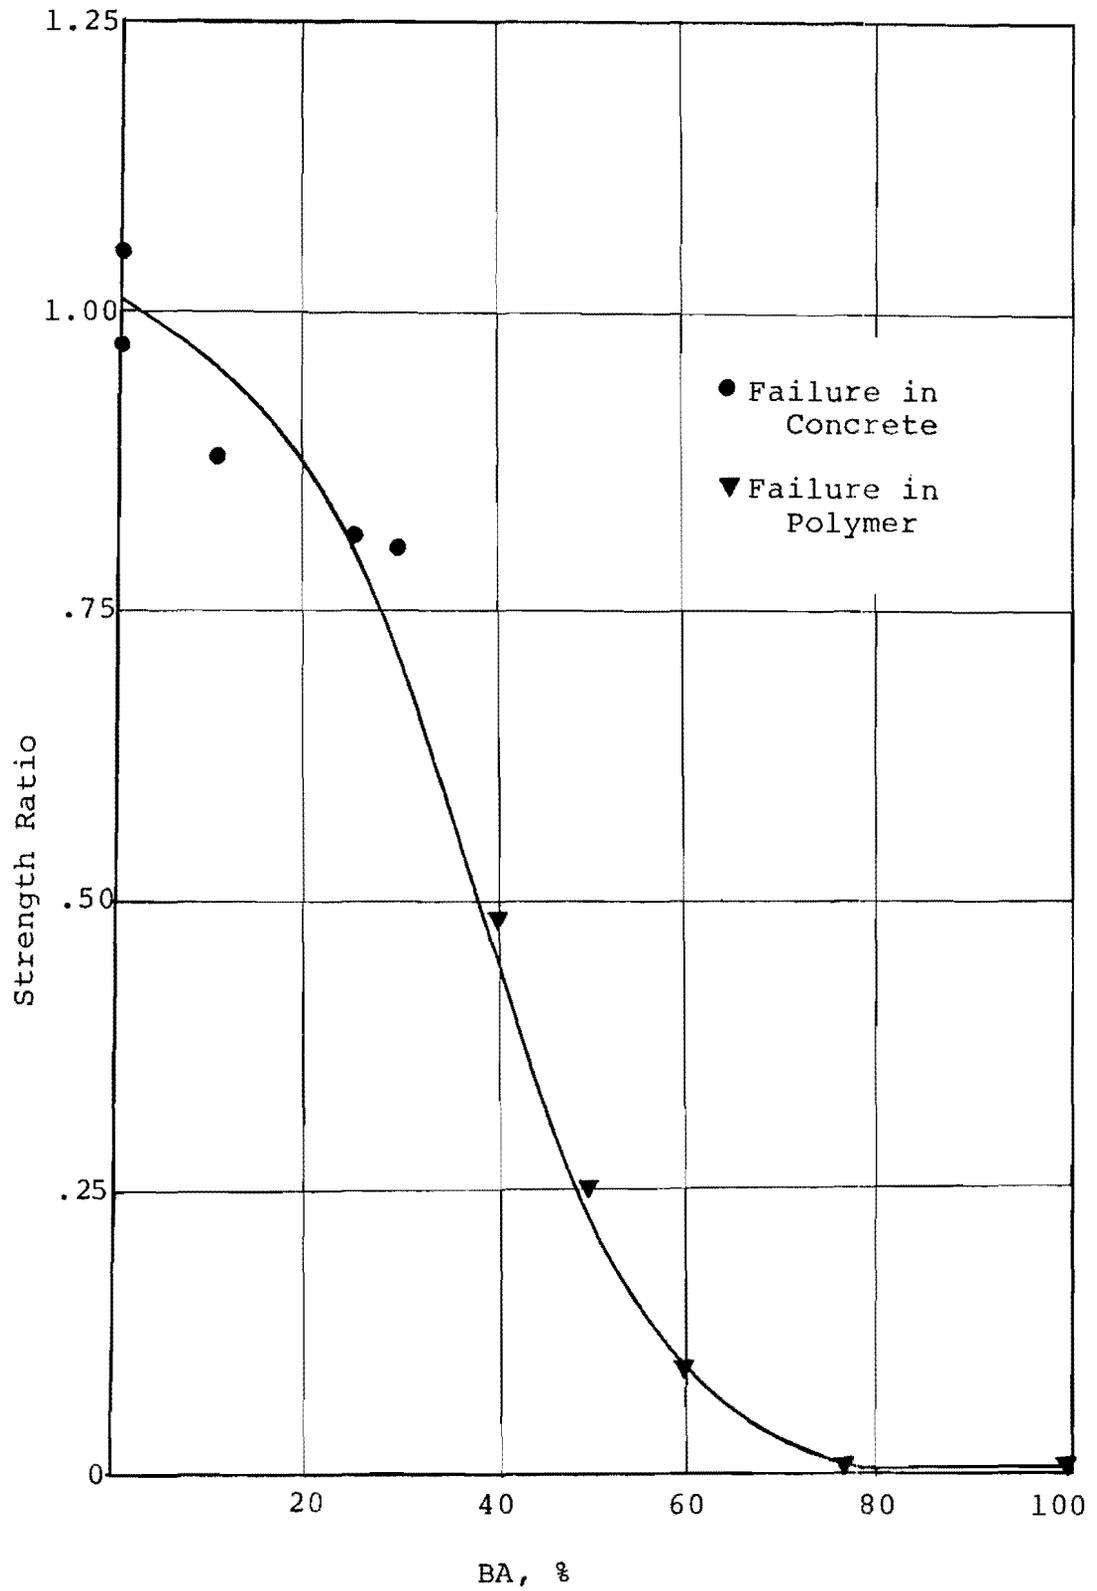
2.2.2 Methyl Methacrylate and Butyl Acrylate--This study employed a crack width of 1/2 in. and clean dry sand to fill the crack. The gradation of the sand is shown in the Appendix. The test results are shown in Fig. 2.3, in which the strength ratio is plotted against the varying percentages of BA. It is of interest to note that the curve had a similar shape as in the IBA study although the strength was less for corresponding percentages of BA. In all cases, the addition of BA resulted in a lower strength. Above 75% of BA the strength ratio was constant at zero since the specimens were unable to sustain their own weight. The specimens with percentages of BA less than 40% developed a failure in the concrete; specimens with 40% or more failed in the polymer.

FIG. 2.3 EFFECT ON FLEXURAL STRENGTH OF VARYING PERCENTAGE OF BA IN MMA SOLUTION

The specimens in the range of 40 to 60% BA were very flexible and would return to a horizontal position when unloaded even after the deflection increased without an increase in the load. The specimens with 60% or more BA were also flexible but the monomer was discontinuous and sticky.

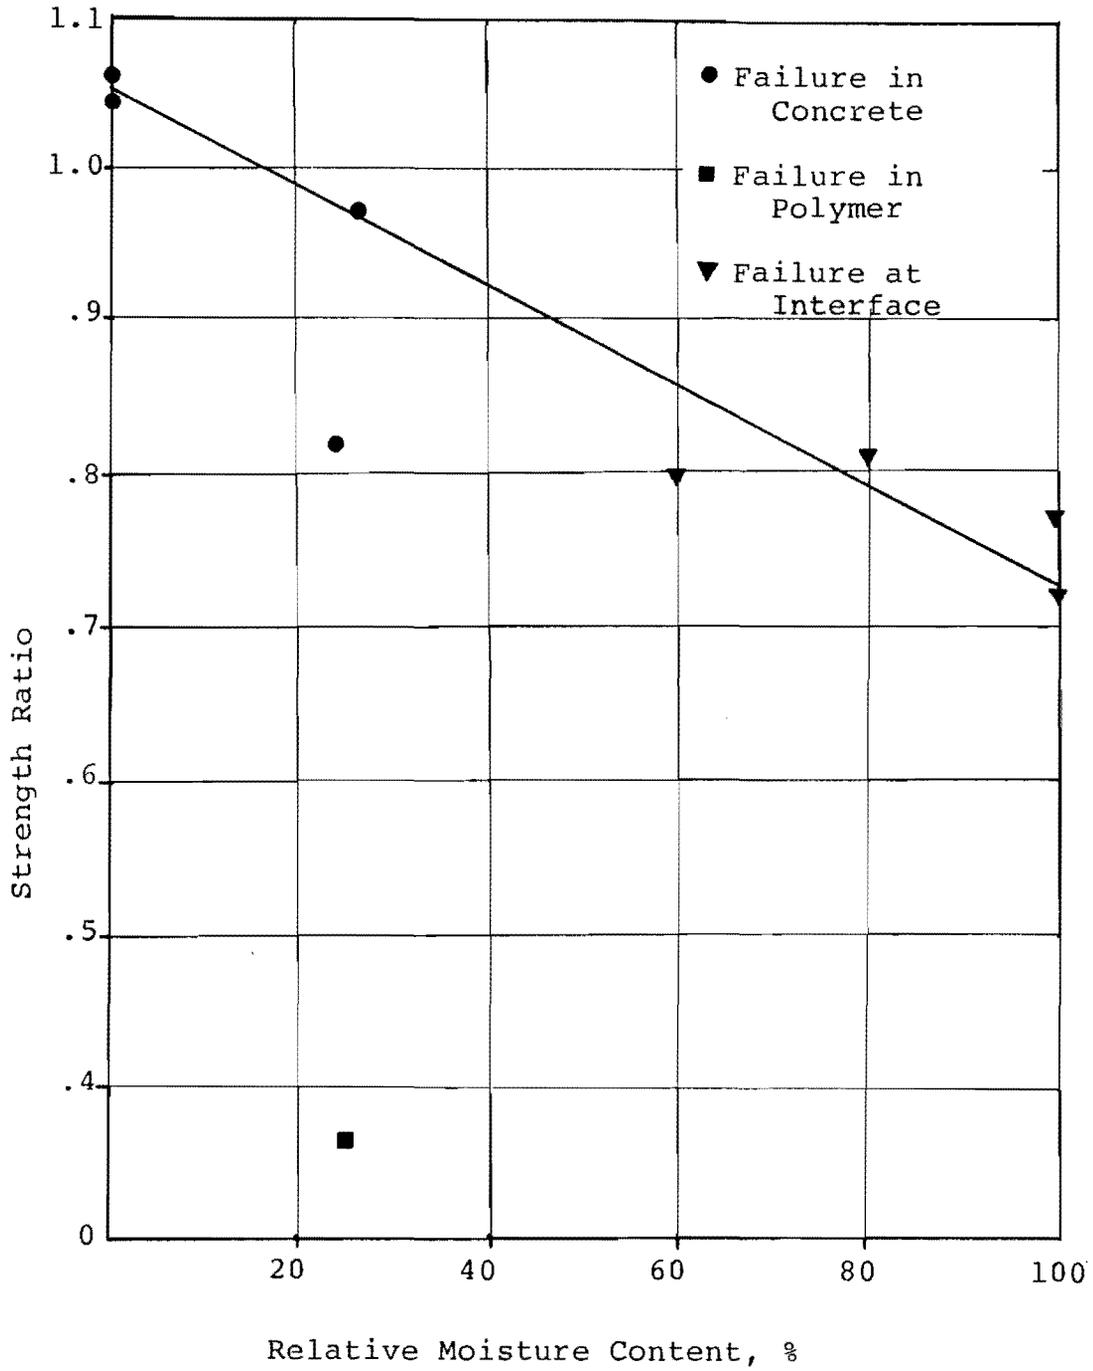
The specimens were tested as previously described in Chapter 2. After the specimens were broken, they were repaired using a monomer solution of 4% (wt.) LP and 2% (wt.) DMPT. A crack width of 0.25 in. was used for all specimens. The crack width was measured from reference lines marked on the specimens before the first testing. The monomer solution was replenished as needed until polymerization started. After approximately 24 hours the specimens were loaded again in the same orientation and using the same procedure until failure. The strength ratio was then calculated as a ratio of the ultimate load for the repaired specimen to the original ultimate load. The test results are illustrated in Fig. 3.1.

FIG. 3.1 EFFECT OF MOISTURE ON FLEXURAL STRENGTH

The scatter in the results was attributed to the nature of the problem and the difficulty of expressing the ratio of the strength after repair to the original strength since the failure did not always occur in the bond. Only specimens with more than 50% relative moisture content had a failure at the polymer concrete interface. Due to the high strength of the polymer, only one specimen failed in the polymer and this was attributed to incomplete polymerization since a strong smell was detected upon the failure of the specimen.

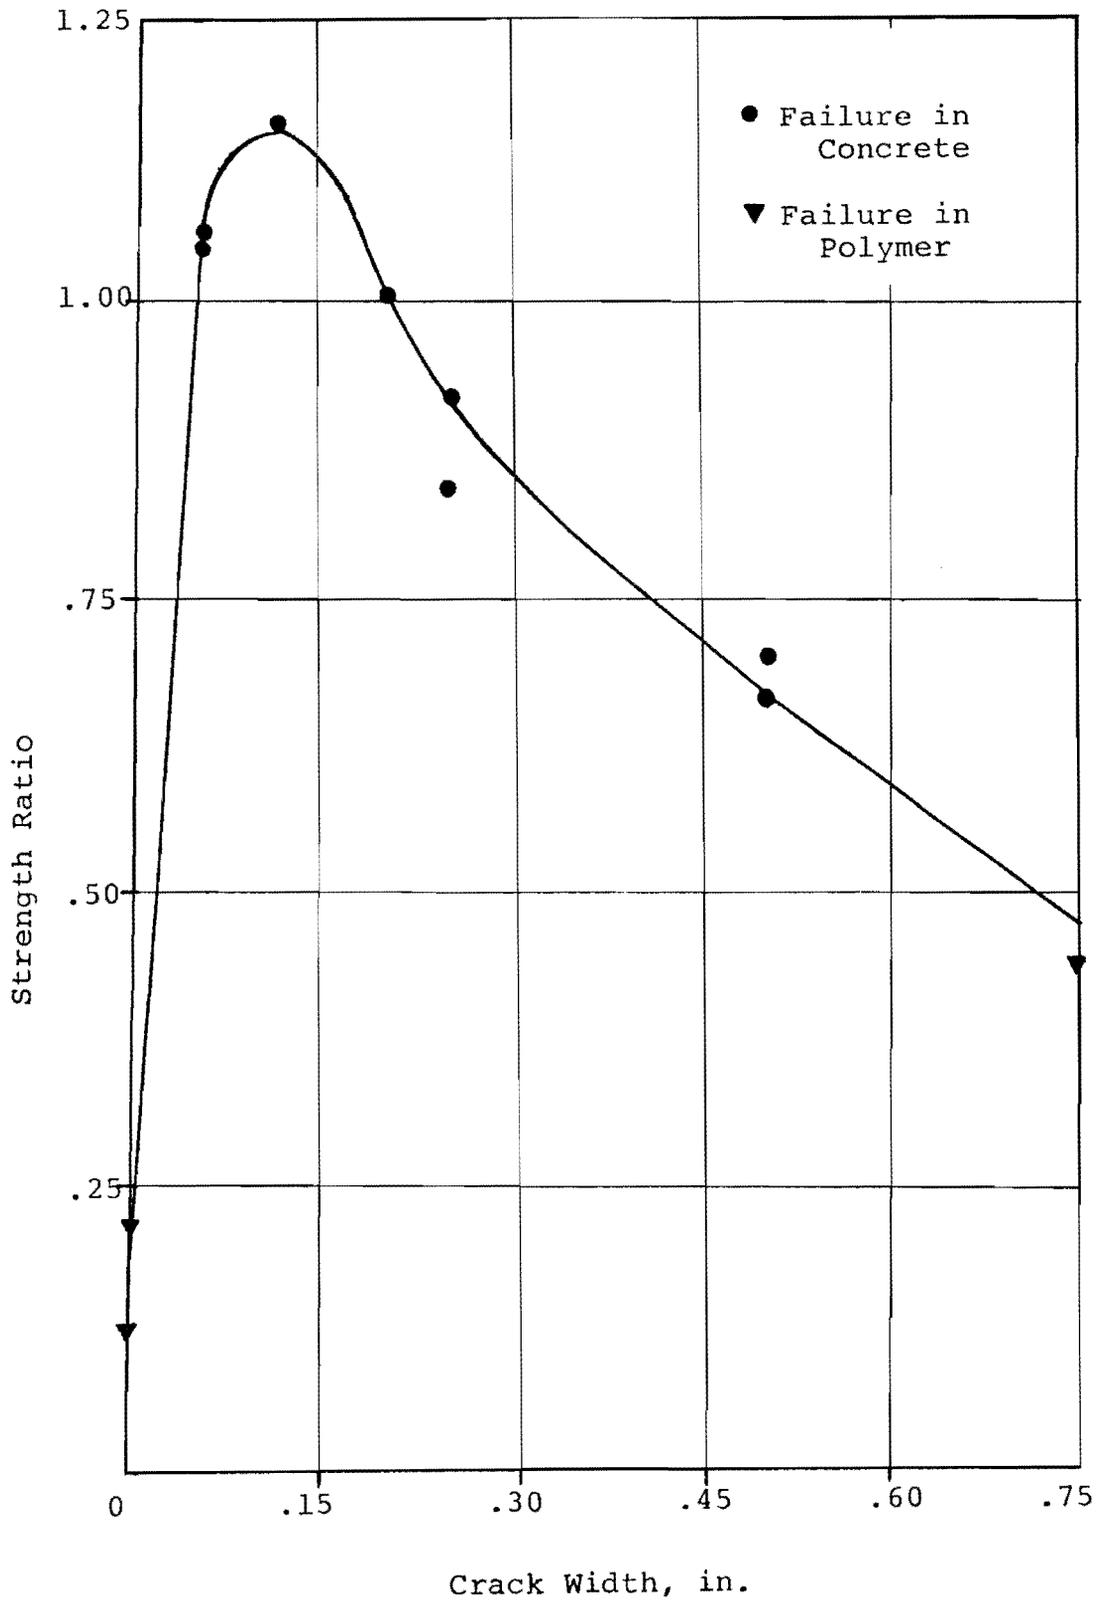
The results of this test are shown in Fig. 3.2. The figure shows that for crack widths between 0.05 in. and 0.20 in. the repaired specimens at least developed their original strength. It also shows that there was a

FIG. 3.2 EFFECT OF CRACK WIDTH ON FLEXURAL STRENGTH

significant decrease in strength as the crack widths decreased below 0.05 in. and increased above 0.20 in.

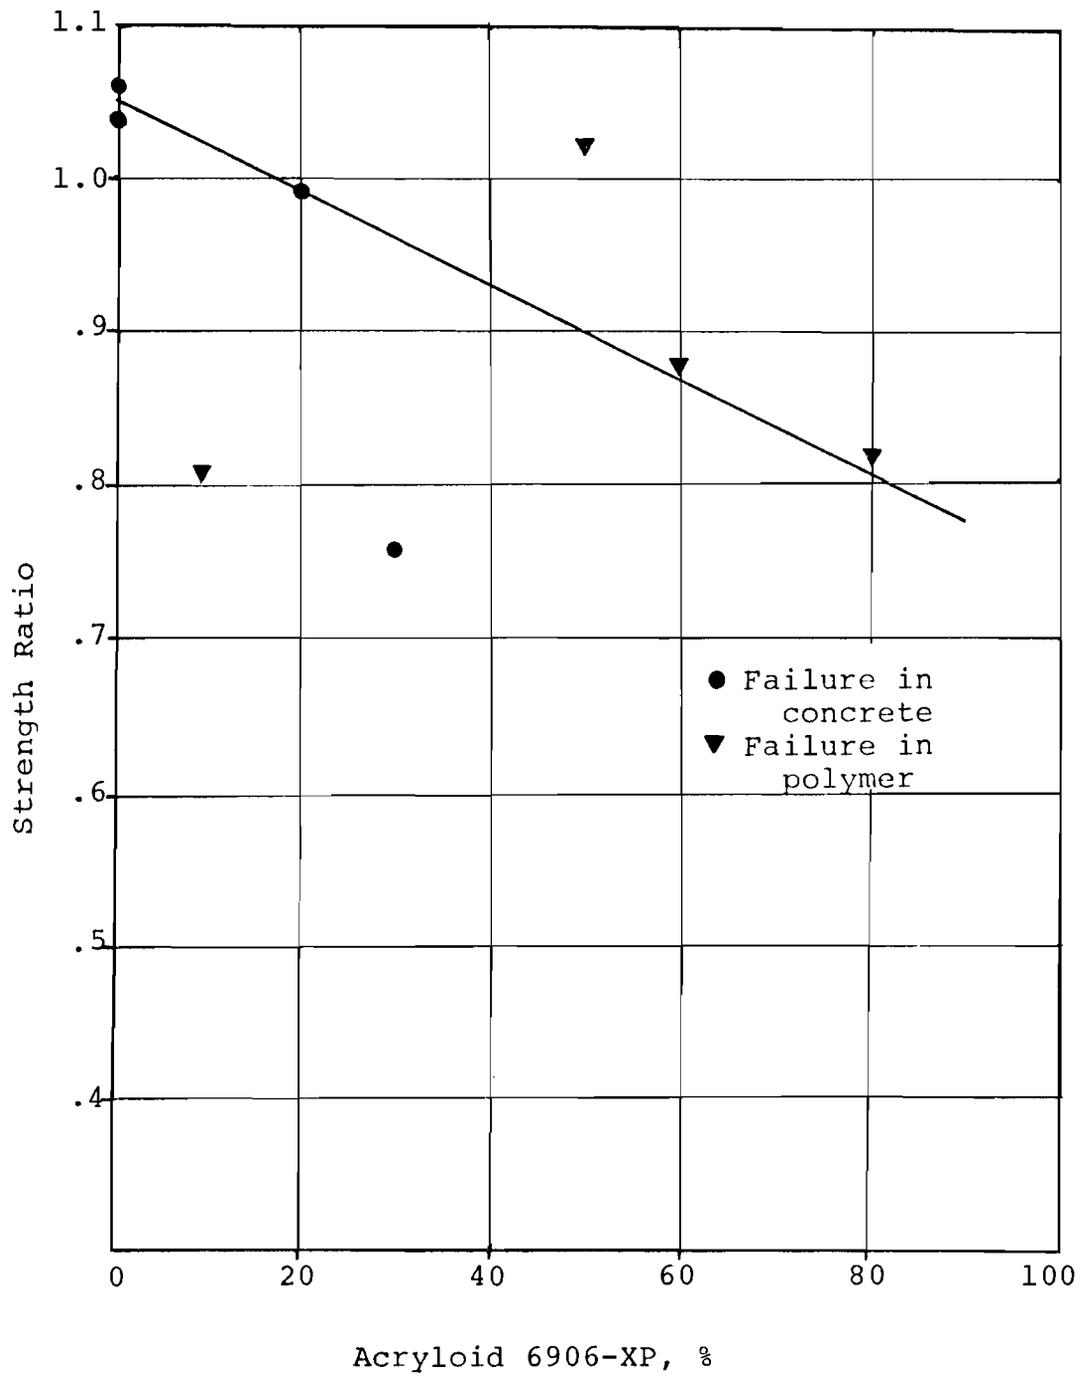
The test results are shown in Fig. 3.3. Although there was significant scatter in the results, it showed that the strength ratio decreased as the percent of polymer (and viscosity) increased. Failure usually occurred in concrete for percentages of polymer up to 25% and in polymer for percentages of 50% and above. Visual observations indicated that there was a decrease in ductility as the percentage of polymer increased.

FIG. 3.3 EFFECT ON FLEXURAL STRENGTH OF VARYING PERCENTAGE OF ACRYLOID 6906-XP IN MMA

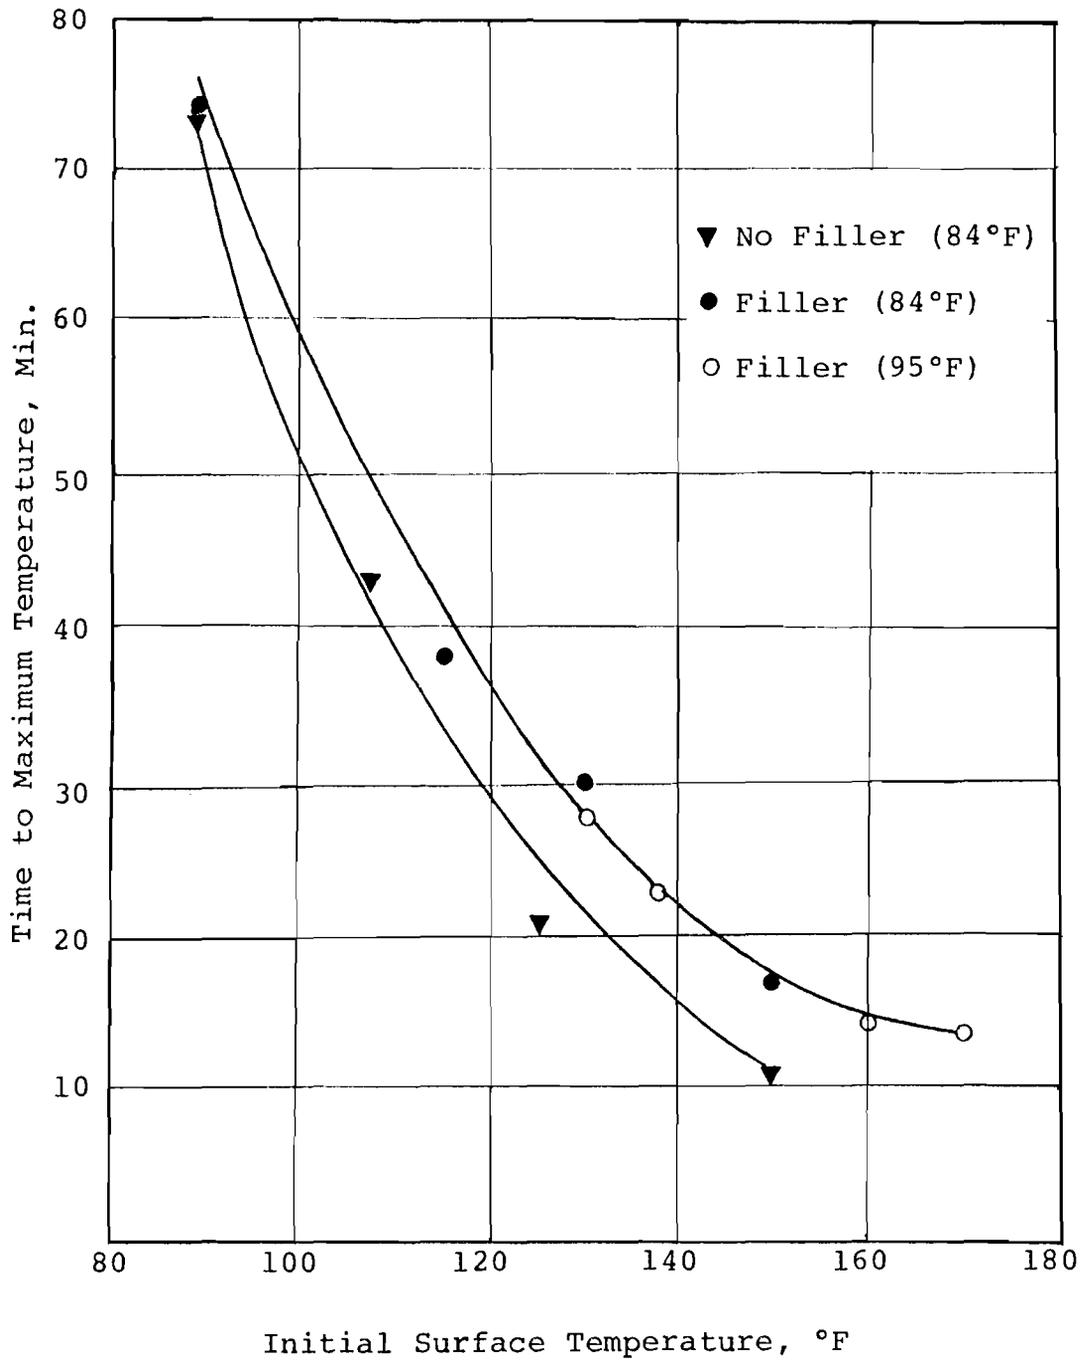
Fig. 3.4 shows that the time required to reach maximum temperature, which is a measure of the rate of polymerization, decreased as the initial surface temperature increased. Fig. 3.5 shows the relationship between the initial surface temperature and the maximum temperature. The results indicate that the maximum temperature increased as the initial surface temperature increased. When sand was used as a filler, the strength tests showed that there was no change in strength as the surface temperature was varied since generally all specimens were restored to their original strength. For specimens in which no sand filler was used, boiling of the monomer always occurred during polymerization. The amount of boiling increased with increased surface temperatures and the monomer was porous

FIG. 3.4 EFFECT OF INITIAL SURFACE TEMPERATURE ON TIME TO MAXIMUM TEMPERATURE

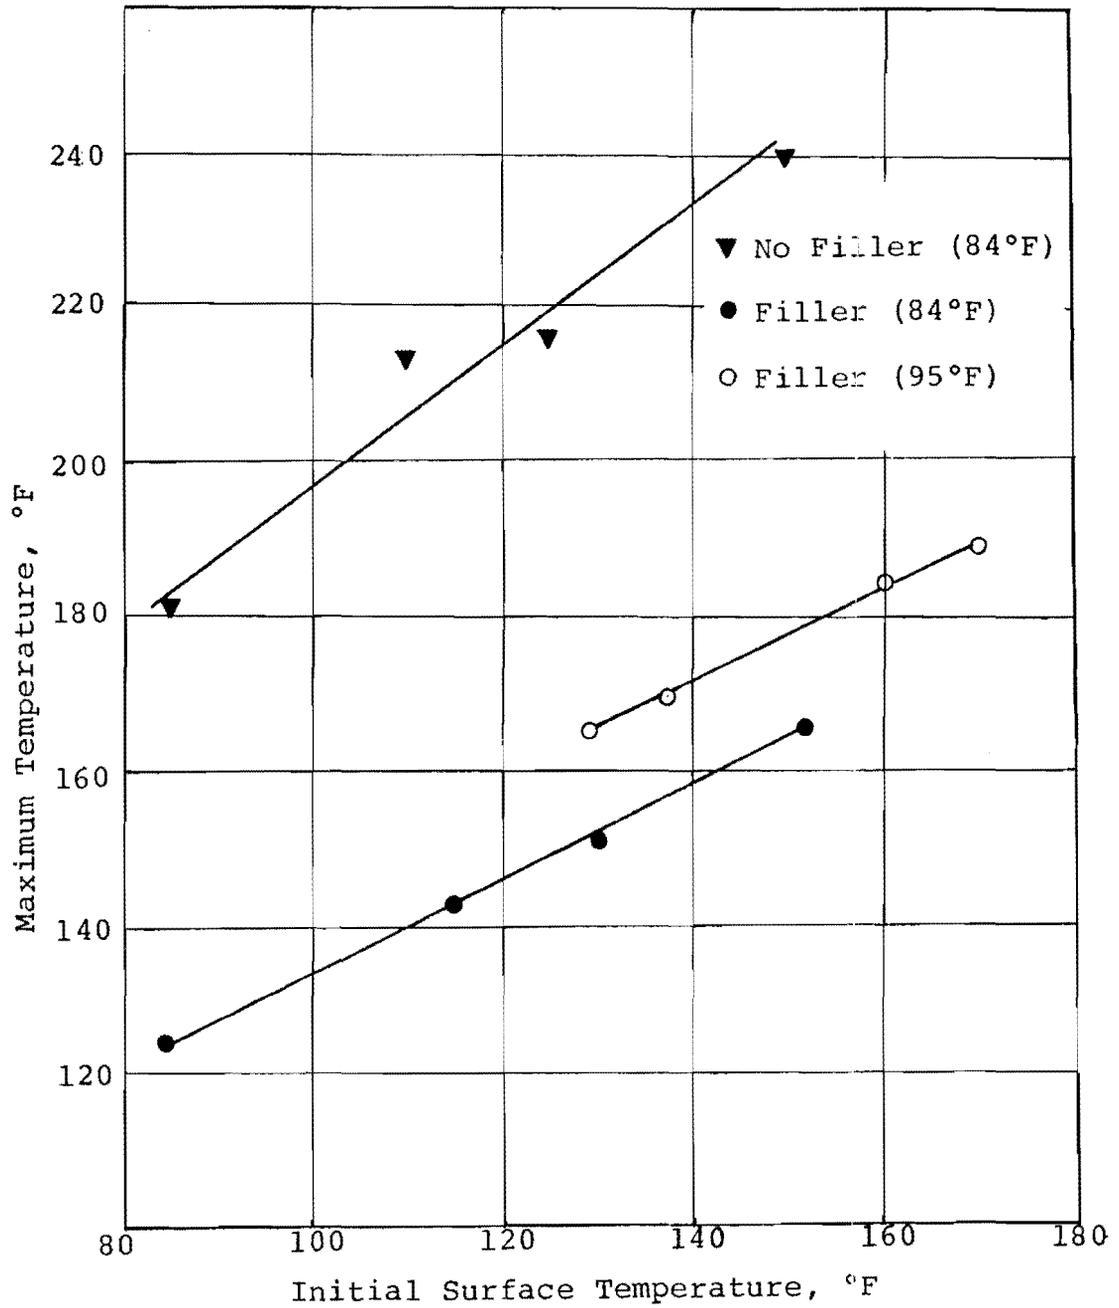
FIG. 3.5 EFFECT OF SURFACE TEMPERATURE ON MAXIMUM TEMPERATURE

and therefore had less strength. It was observed that the strength decreased as the surface temperature increased.

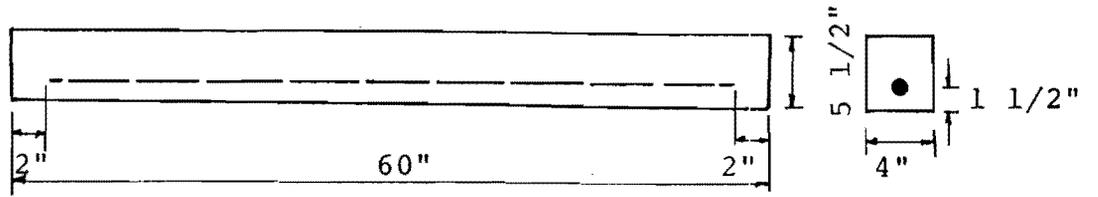
In this test 4 in. x 5-1/2 in. x 60 in. reinforced concrete beams were used. The beams were made of normal weight concrete and reinforced with one No. 5 grade 50 or 60 deformed steel bar at the bottom of the beam. The mix design and properties of concrete are shown in the Appendix. After casting, the beams were moist cured for one week and then air cured until tested. Beams were at least 28 days old before testing. The details of the beams are shown in Fig. 4.1, and the test setup is shown in Fig. 4.2. Beams were first tested to failure and load, and midspan deflection readings

FIG. 4.1 BEAM DETAILS

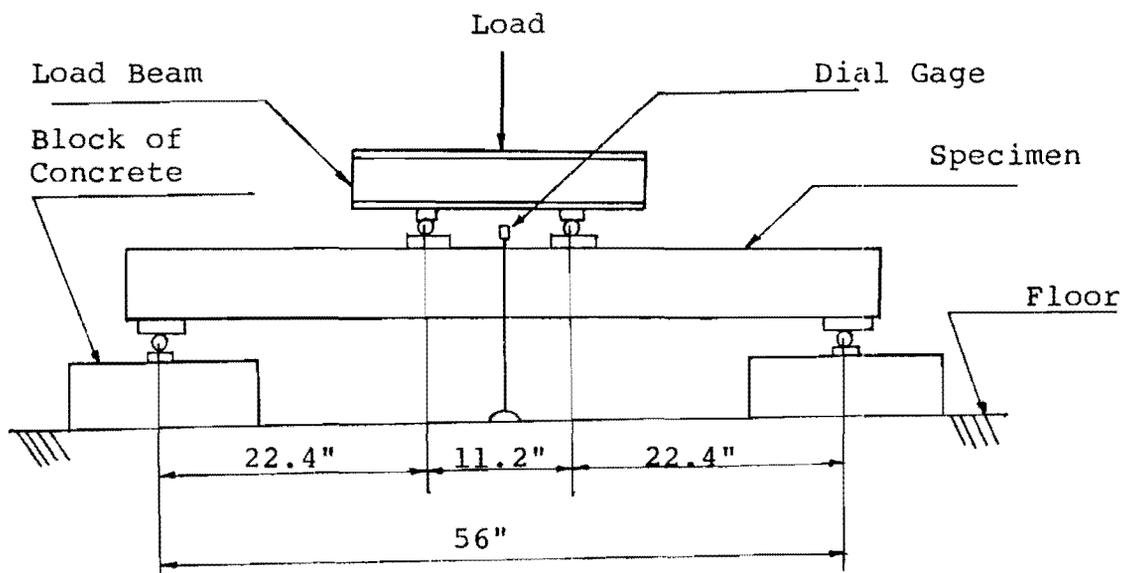
FIG. 4.2 TEST SETUP

were taken. The dial gages used to measure deflections were removed prior to failure so the load-deflection response all the way to failure was not obtained.

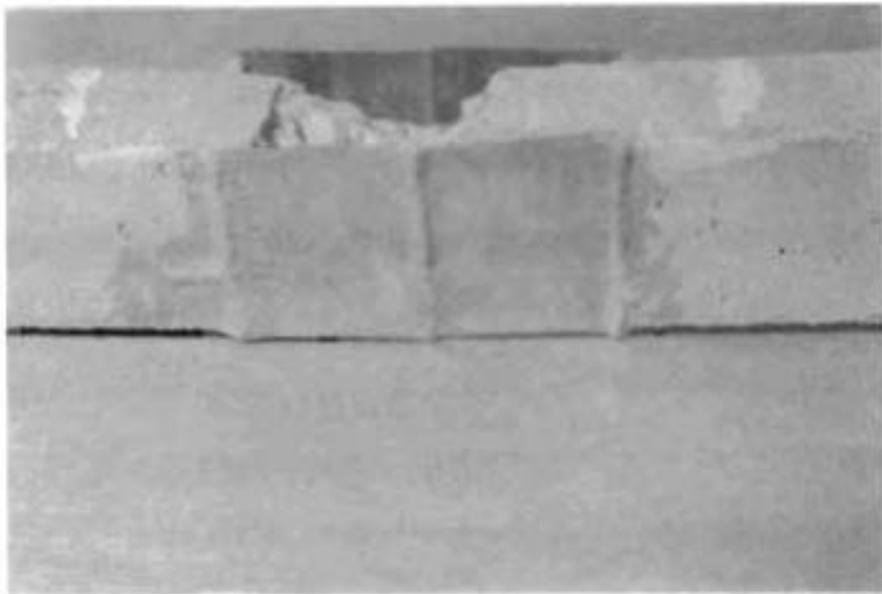
FIG. 4.3 TYPICAL BEAM WITH FORM

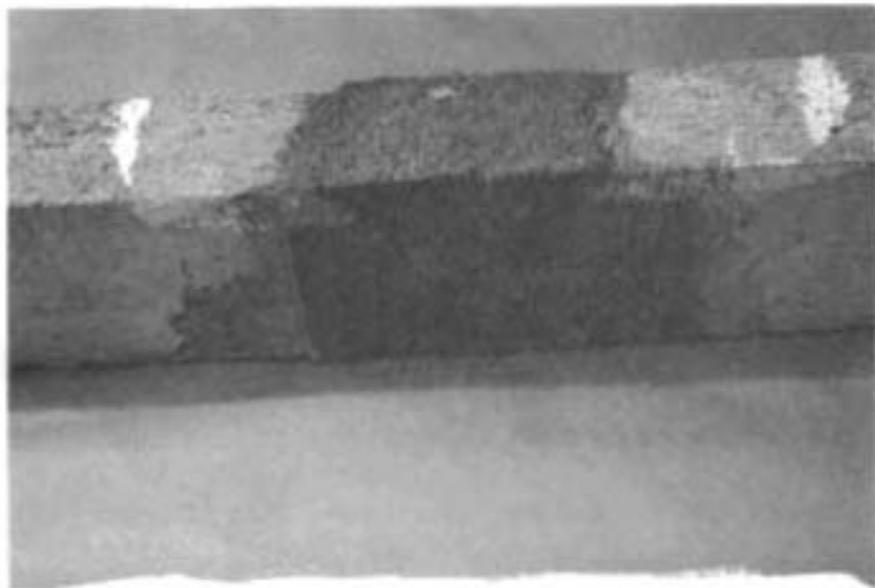
FIG. 4.4 TYPICAL BEAM AFTER REPAIR

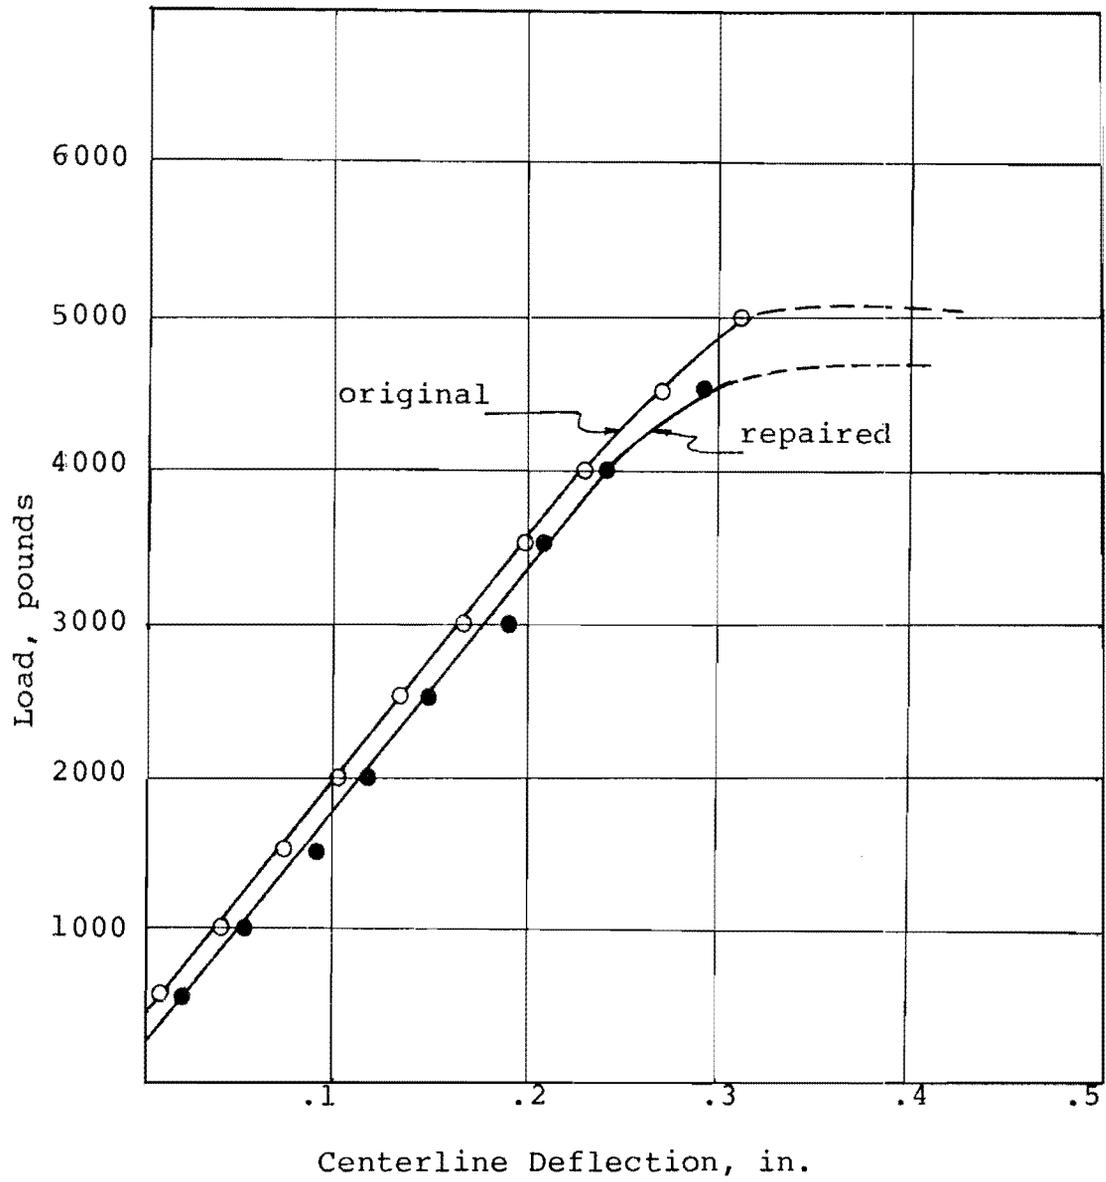
4.3.1 Beam 3RC-2--Beam 3RC-2 had an initial primary failure caused by yielding of the reinforcing steel and a secondary failure caused by the crushing of the concrete in compression. This type of failure will be subsequently referred to as a flexural failure. The failure mode of the repaired beam was diagonal tension and end anchorage. The strength ratio of the beam was 0.92, which was the lowest value obtained. The load deflection-curves before and after the repair are shown in Fig. 4.5, and the failure of the

FIG. 4.5 LOAD-DEFLECTION RESPONSE OF BEAM 3RC-2

repaired beam is shown in Fig. 4.6. The repaired beam had larger centerline deflections than the original beam at the same load level because of the slightly lower load at which the deflection readings were started. It is significant to note that (1) the slopes of the two curves are almost identical, which indicates that the initial or elastic stiffness was not significantly changed by the polymer-concrete repair, and (2) the failure occurred outside the repaired zone.

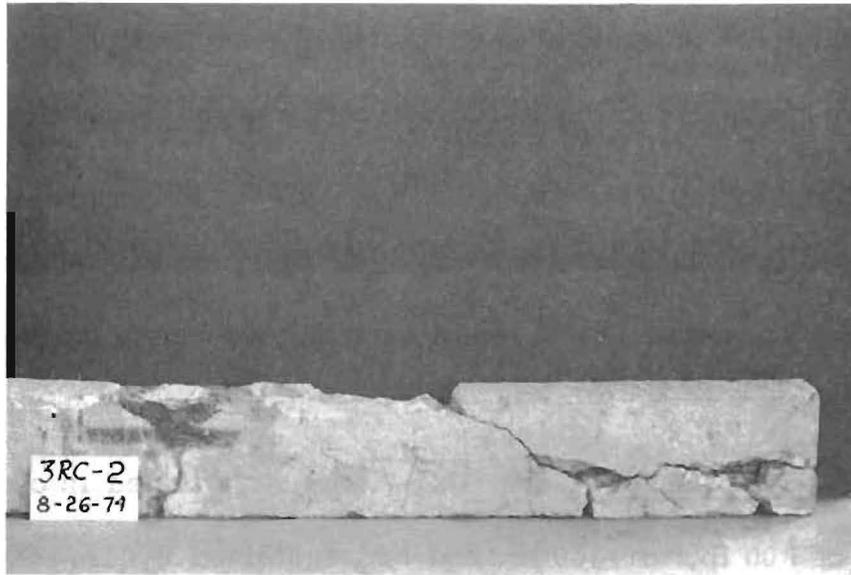
FIG. 4.6 FAILURE MODE OF BEAM 3RC-2

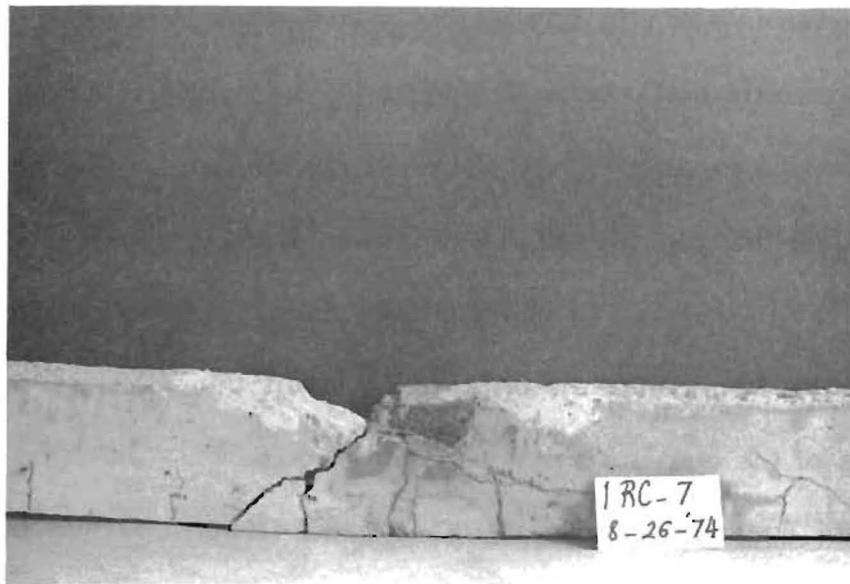
FIG. 4.7 FAILURE MODE OF REPAIRED BEAM 1RC-7

4.3.2 Beam 1RC-7--Beam 1RC-7 was first tested in cyclic loading in the range of 200 lb. to 1360 lb. and had sustained 2,029,477 cycles of loading before being subjected to static loading which resulted in a flexural failure. The failure after the repair was similar to the original failure but at a different location, as in Fig. 4.7. The strength ratio was 1.10. This significant increase in strength may be partly attributed to fatigue recovery since the first static test was made soon after the cyclic testing was completed whereas the repair was made several months later. The load-deflection response of both the original and the repaired beams is shown in Fig. 4.8. As concluded in the discussion of beam 3RC-2, the deflections for the repaired beam are usually larger than the original beam yet the stiffness, as indicated by the slopes of the curves, has not been altered.

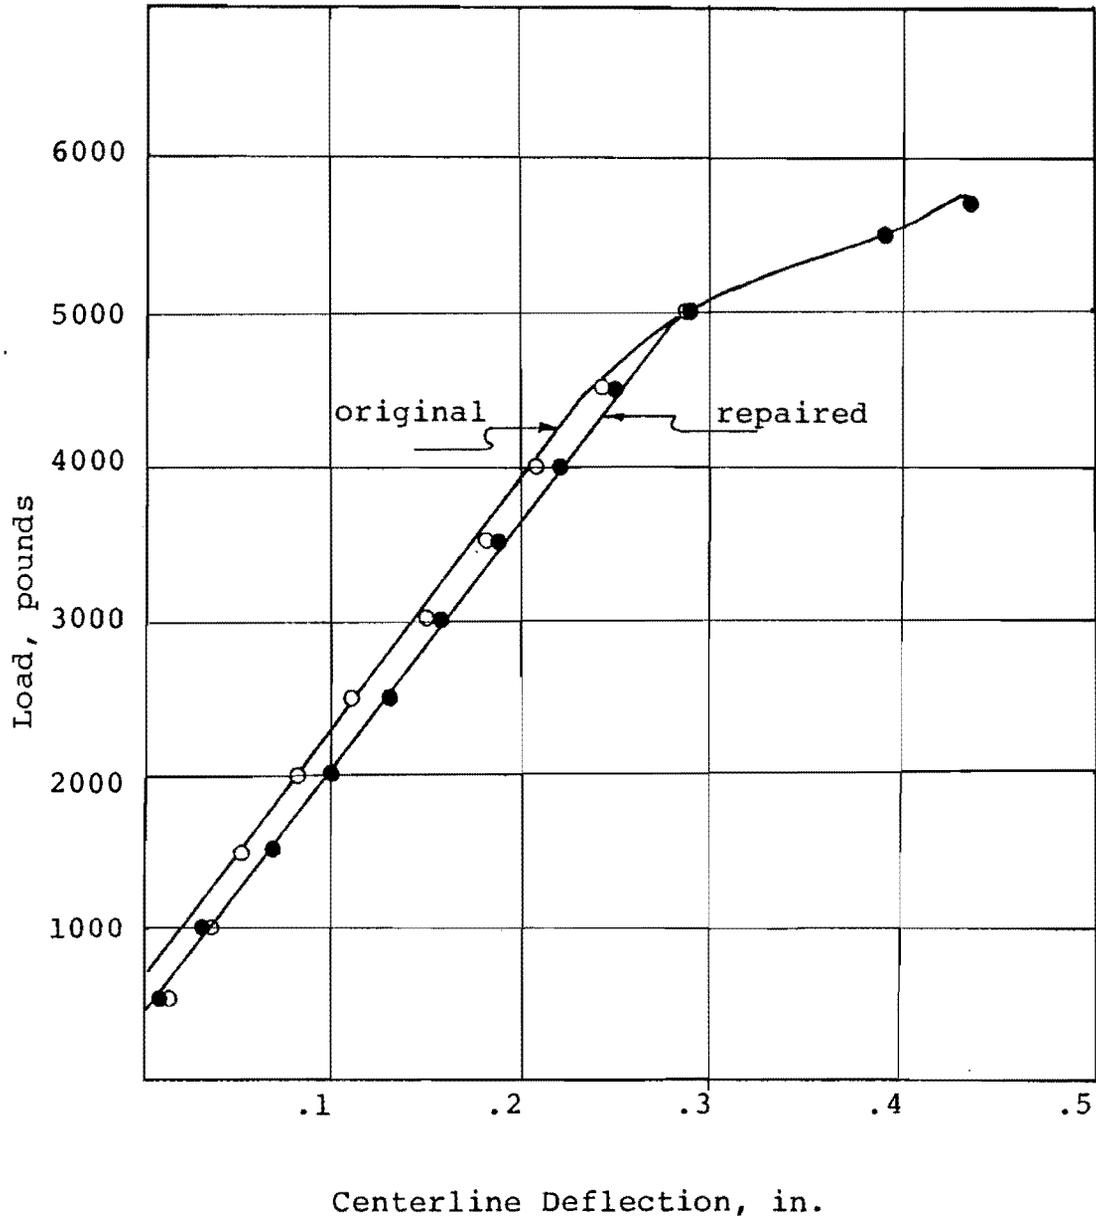
FIG. 4.8 LOAD-DEFLECTION RESPONSE OF BEAM 1RC-7

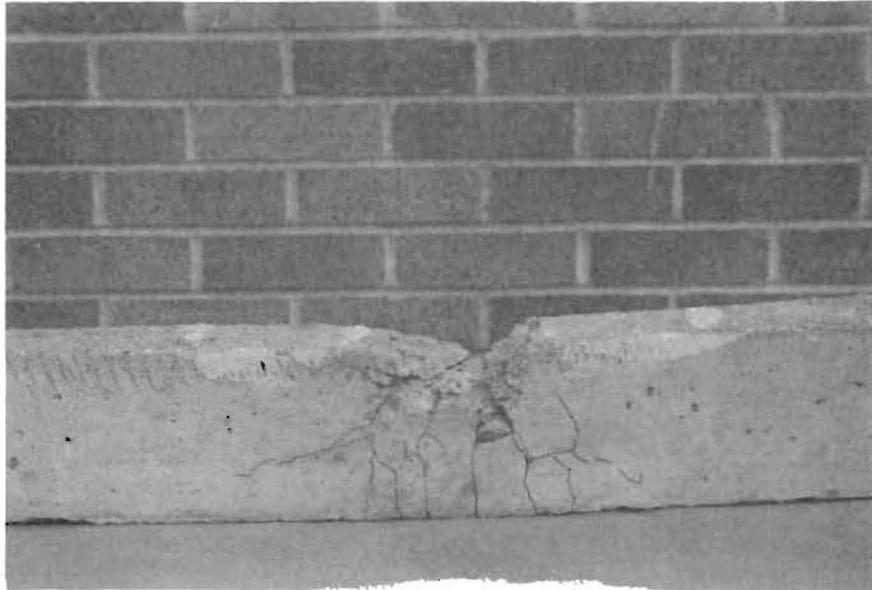
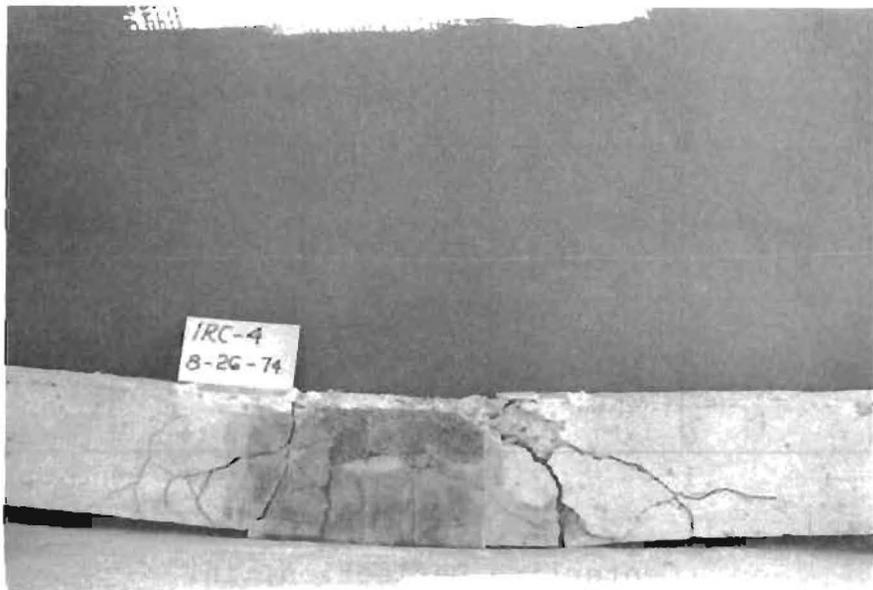
4.3.3 Beam 1RC-4--Beam 1RC-4 had a flexural failure in the original loading. In the loading after the repair, the beam developed a flexural failure at a different location than the original failure. Fig. 4.9 shows the original and the repaired beam failure modes. The strength ratio for this beam

a) Original Failure

b) Failure After Repair

FIG. 4.9 BEAM IRC-4

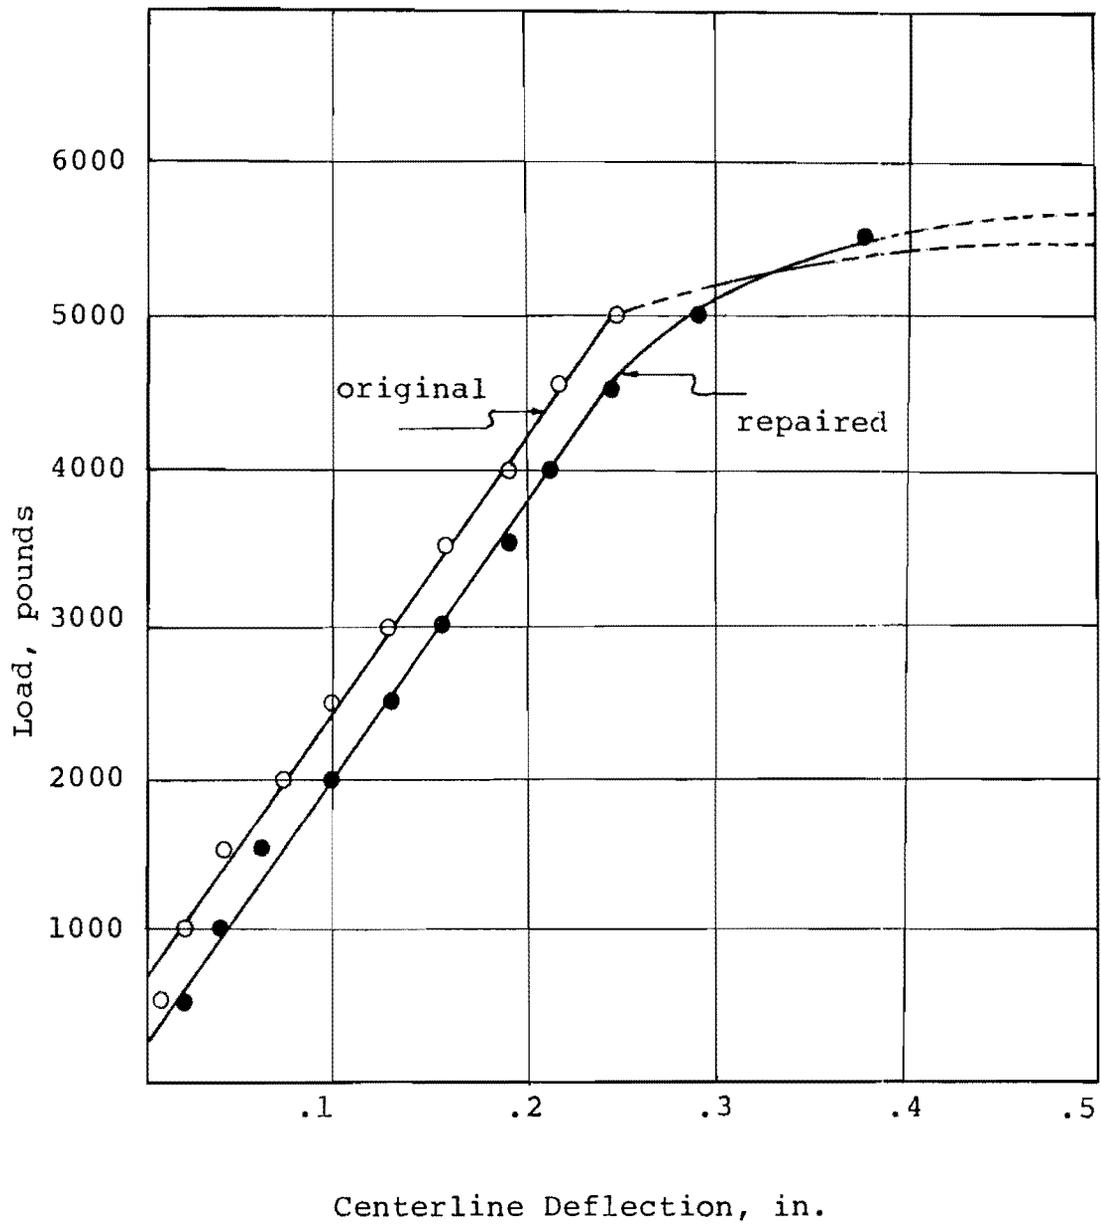
was 1.12. As evidenced by the similar load-deflection curves of the original and the repaired beam, there was no change in the flexural stiffness (Fig. 4.10).

FIG. 4.10 LOAD-DEFLECTION RESPONSE OF BEAM 1RC-4
