1. Report No.	2. Government Accession No.	3. Recipient's Catalog No.	
4. Title and Subtitle "Repair of Concrete with Polymers"		5. Report Date February 1975

REPAIR OF CONCRETE WITH POLYMERS

Research Report Number 114-3

Polymer-Impregnated Concrete for Highway Applications

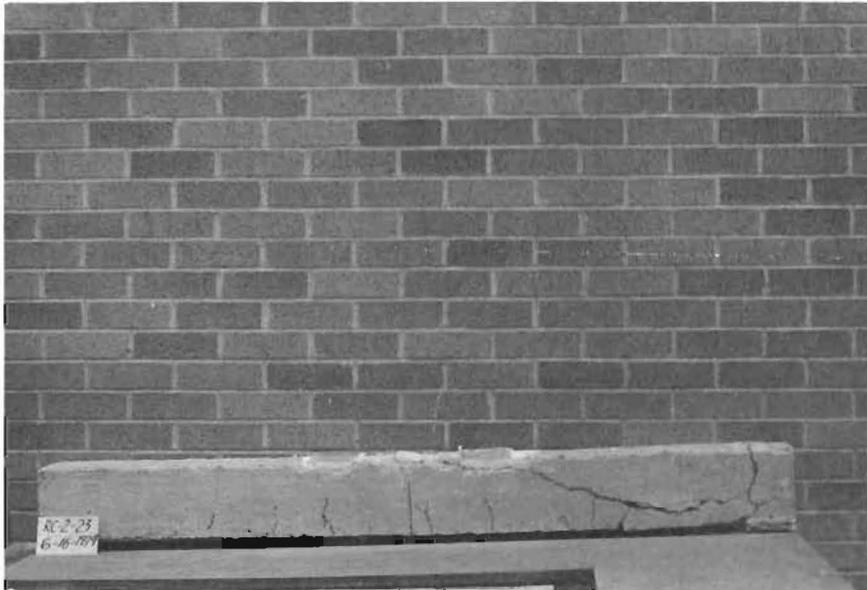
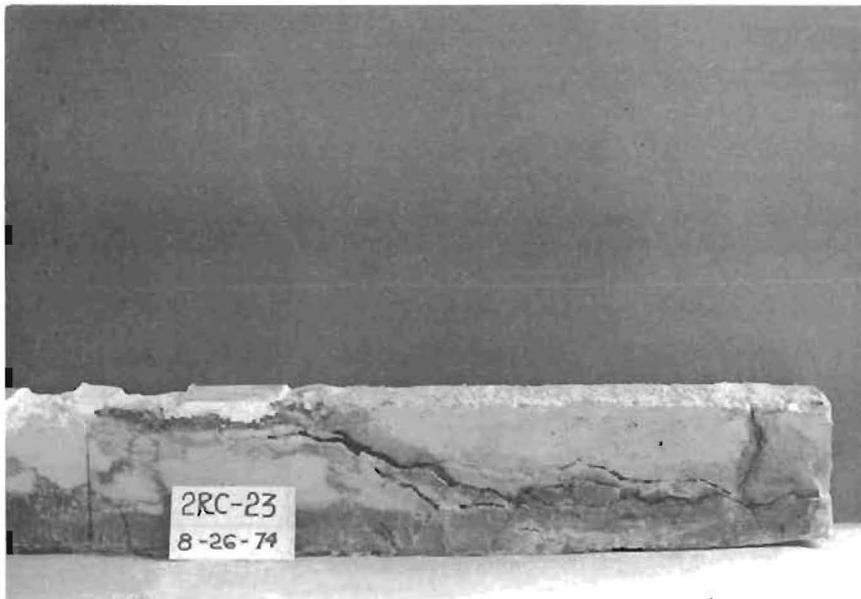
a) Original Failure Mode

b) Failure Mode After Repair

FIG. 4.11 BEAM 2RC-23

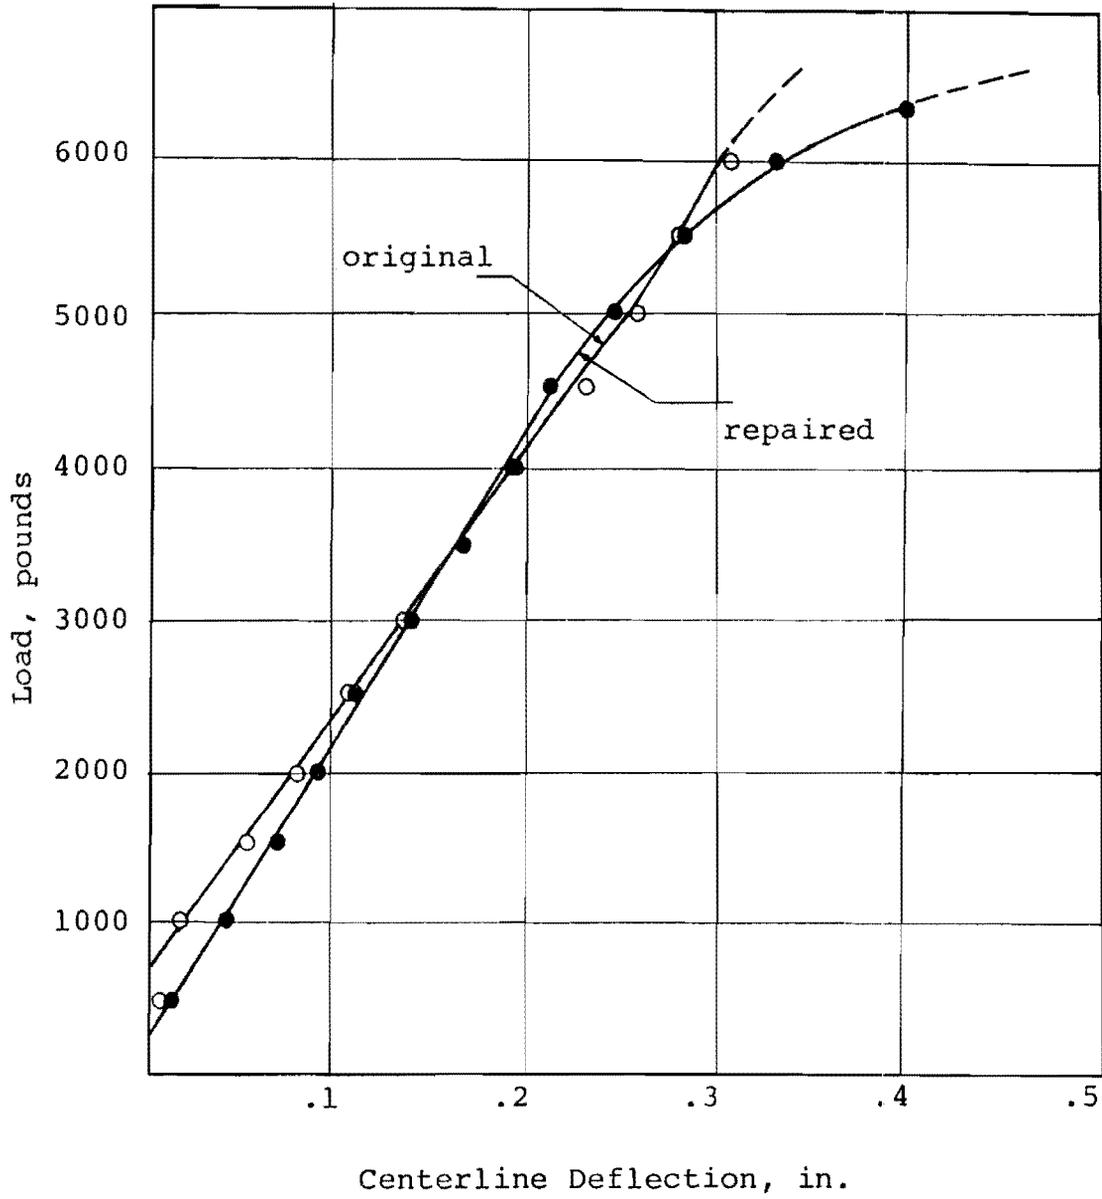
FIG. 4.12 LOAD-DEFLECTION RESPONSE OF BEAM 2RC-23

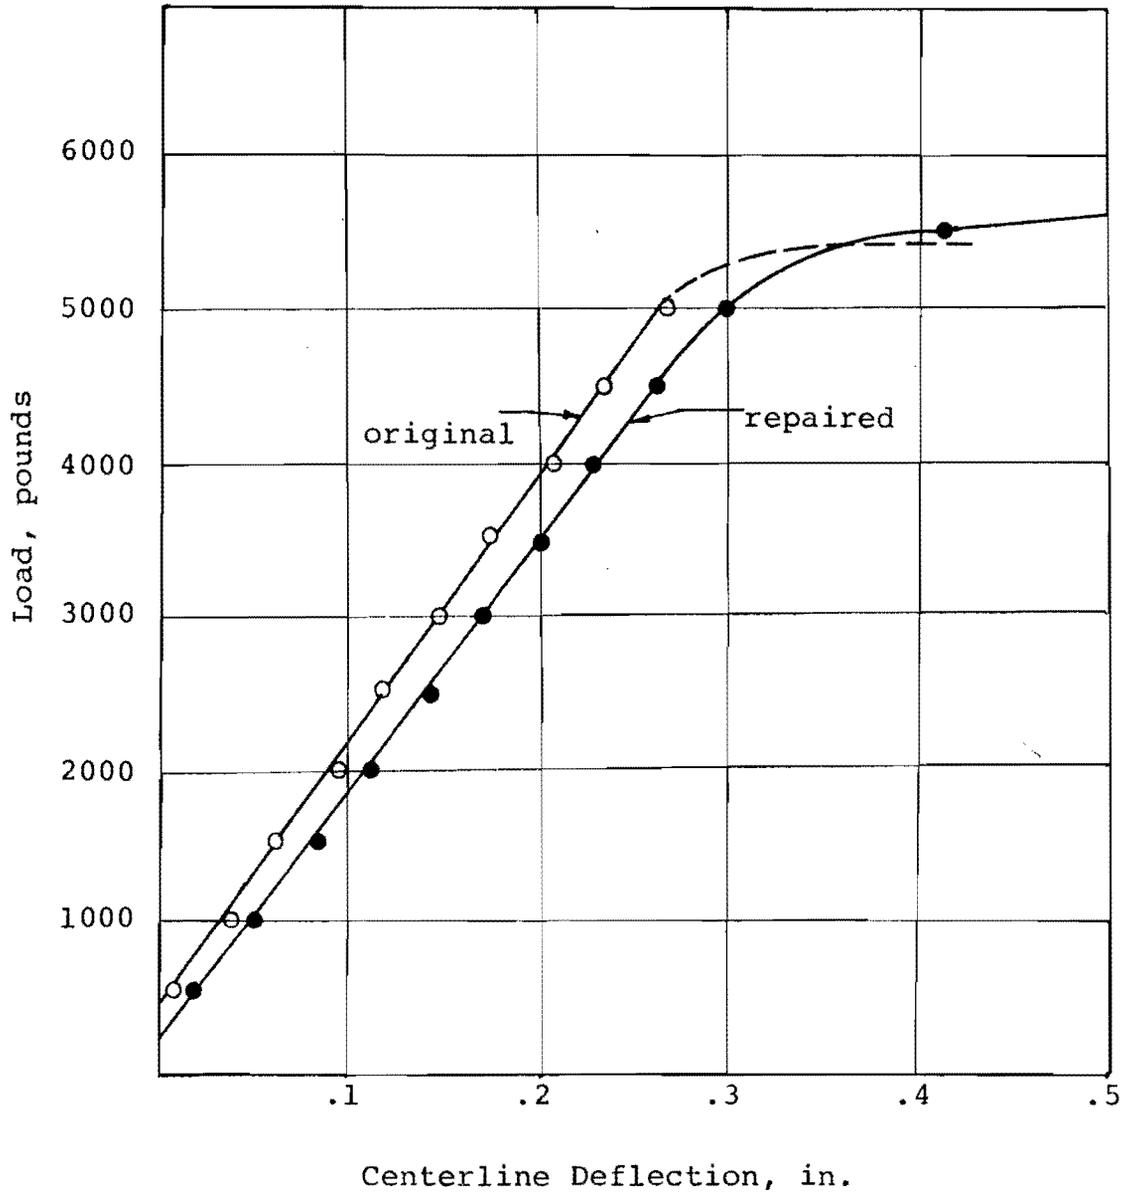
4.3.5 Beam 3RC-4--Beam 3RC-4 had a flexural failure in the original loading and a similar failure after repair but at different locations. Fig. 4.13 shows that the stiffnesses of the two beams were nearly the same. The strength ratio of the beam was 1.09. Fig. 4.14 indicates that the failure occurred adjacent to the repaired zone.

FIG. 4.13 LOAD-DEFLECTION RESPONSE OF BEAM 3RC-4

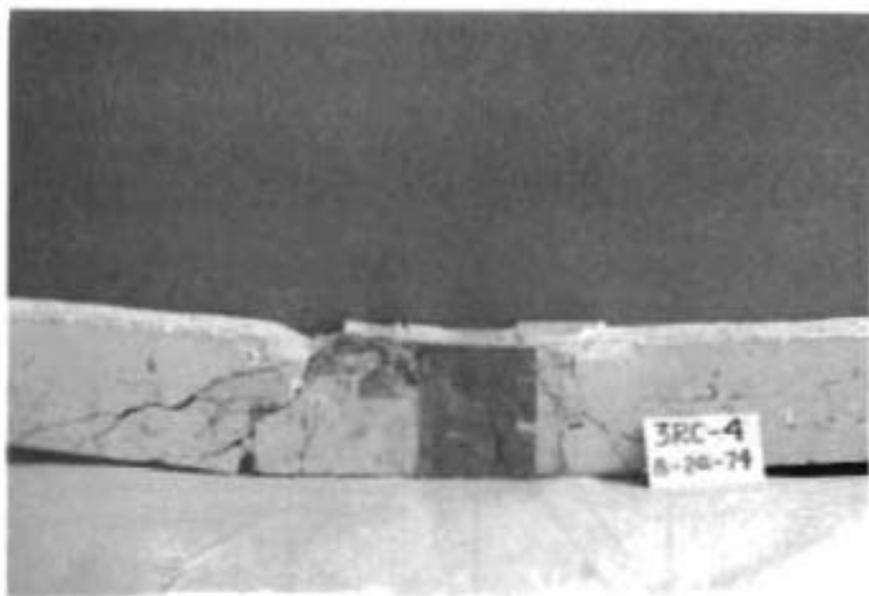
FIG. 4.14 FAILURE MODE OF REPAIRED
BEAM 3RC-4

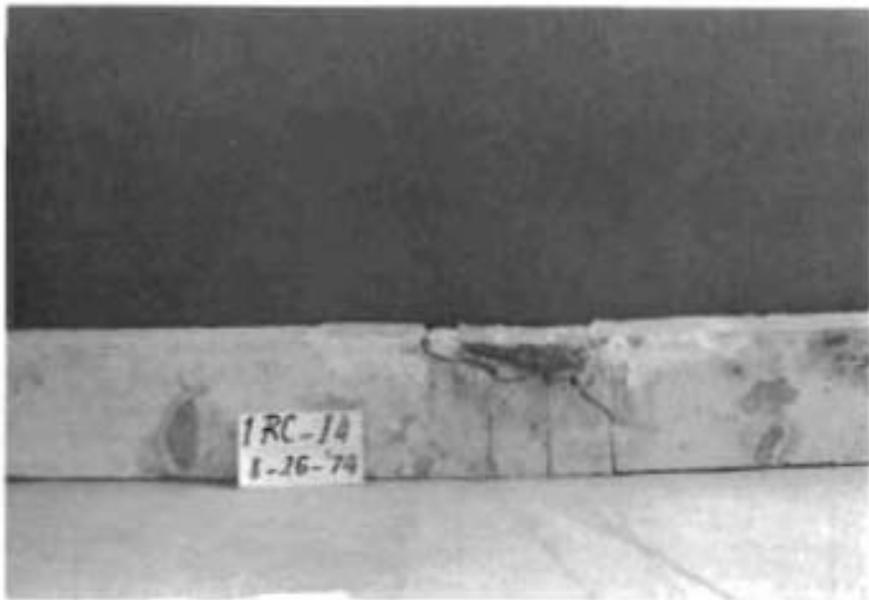
4.3.6 Beam 1RC-14--This beam had a flexural failure in the first loading. The failure mode after the repair was similar to the first but at a different location. Fig. 4.15 shows repaired beam 1RC-14 after failure. The strength ratio was 1.05. The load-deflection response is shown in Fig. 4.16 accompanied with the load-deflection response of beam 1RC-7 for purposes of comparison. There probably was a slight reduction in stiffness since the accompanying beam was made from the same concrete batch as 1RC-7, yet the difference in slopes is insignificant, as concluded from Fig. 4.16.

FIG. 4.15 FAILURE MODE OF REPAIRED
BEAM IRC-14

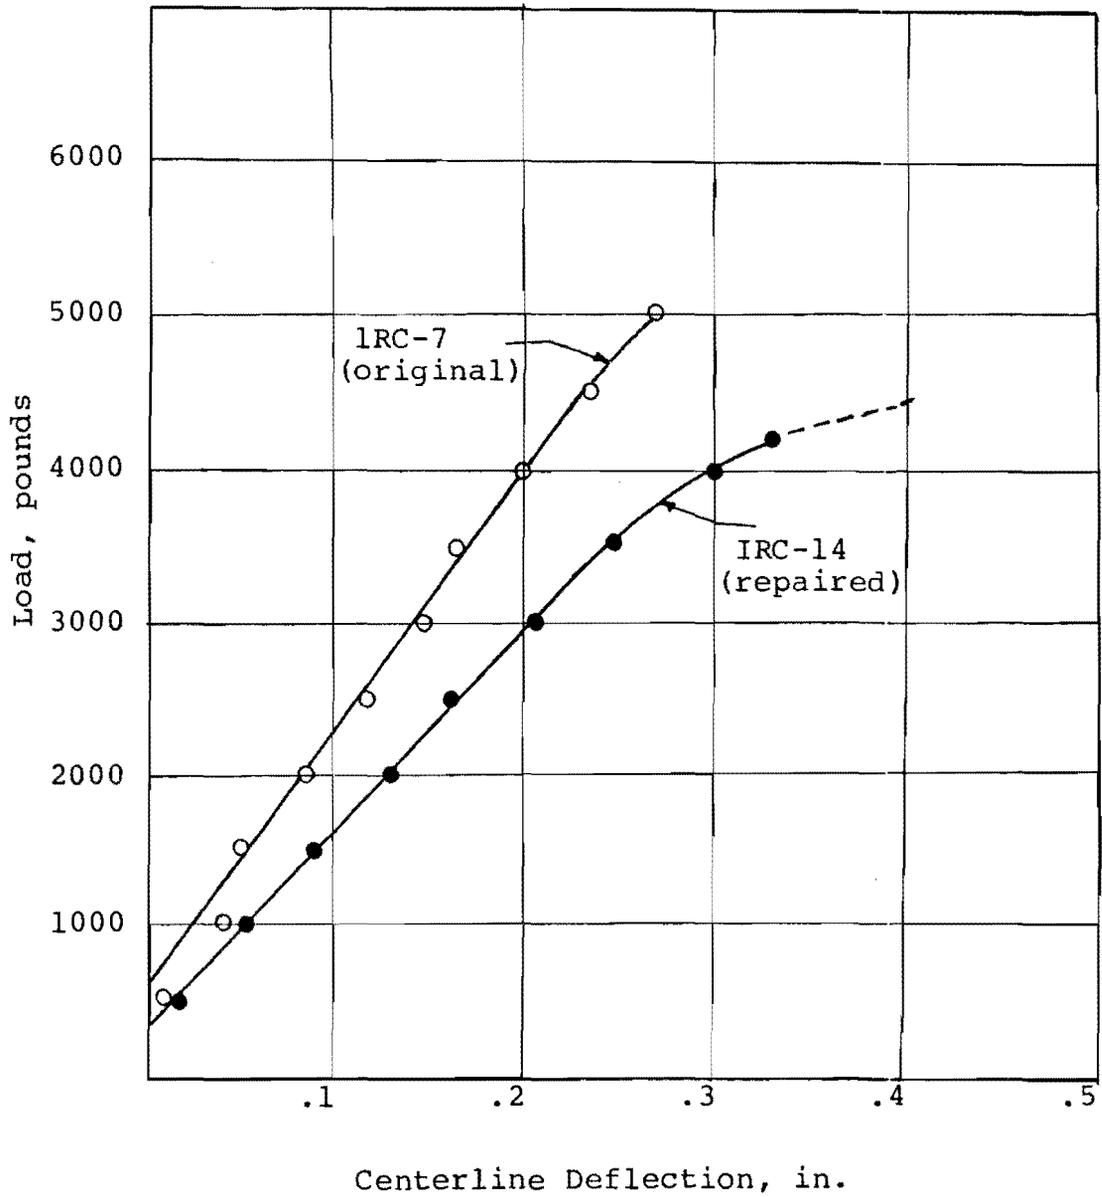
FIG. 4.16 LOAD-DEFLECTION RESPONSE OF BEAM IRC-14

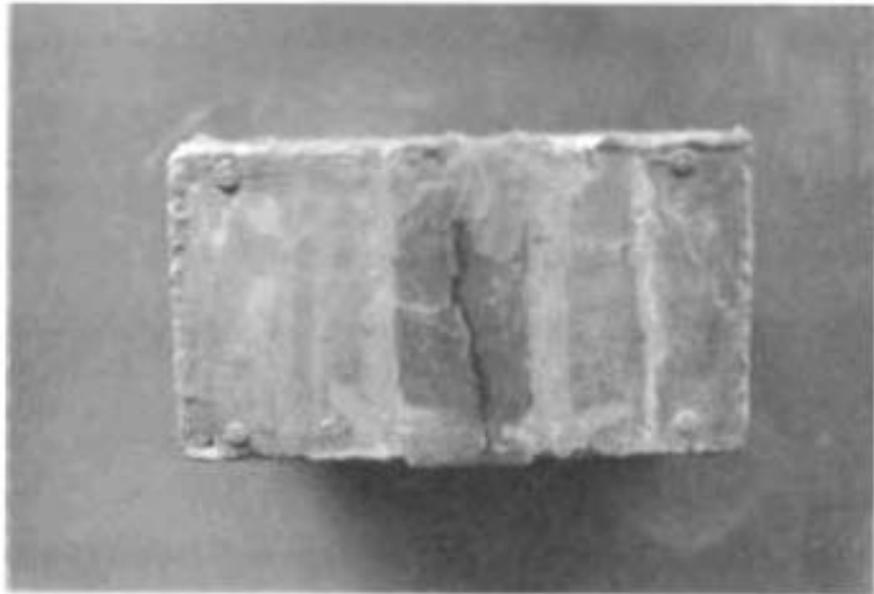
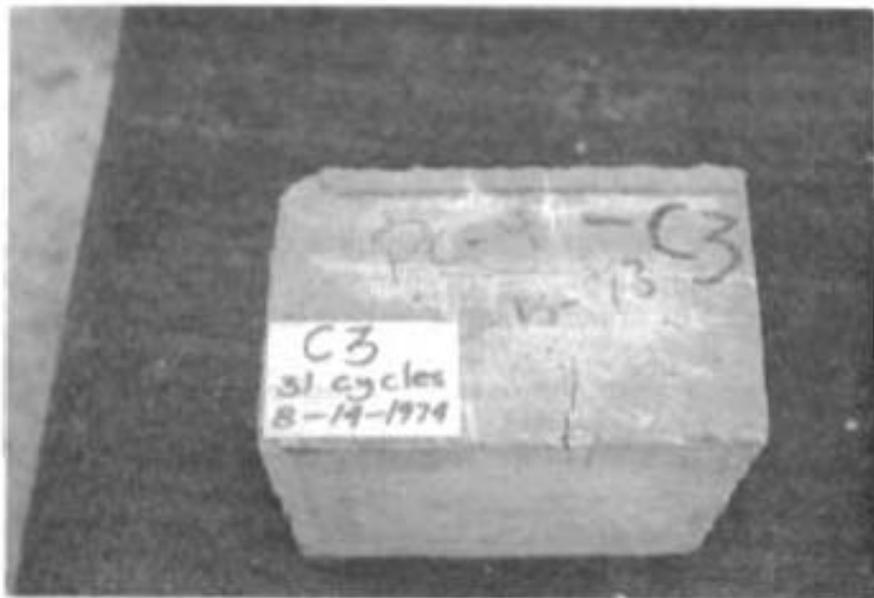
The specimens with the 0.25-in. cracks were able to hold water until failure of concrete occurred, at 31 cycles of freeze-thaw. Cracks in the concrete started to propagate after 22 cycles of freeze-thaw. The cracks occurred on all sides along which the crack was treated.

a) Cracking at Interface (Side View)

b) Severe Cracking of Freeze-thaw Specimens (Side View)

FIG. 5.1 FAILURE MECHANISMS IN FREEZE-THAW SPECIMENS

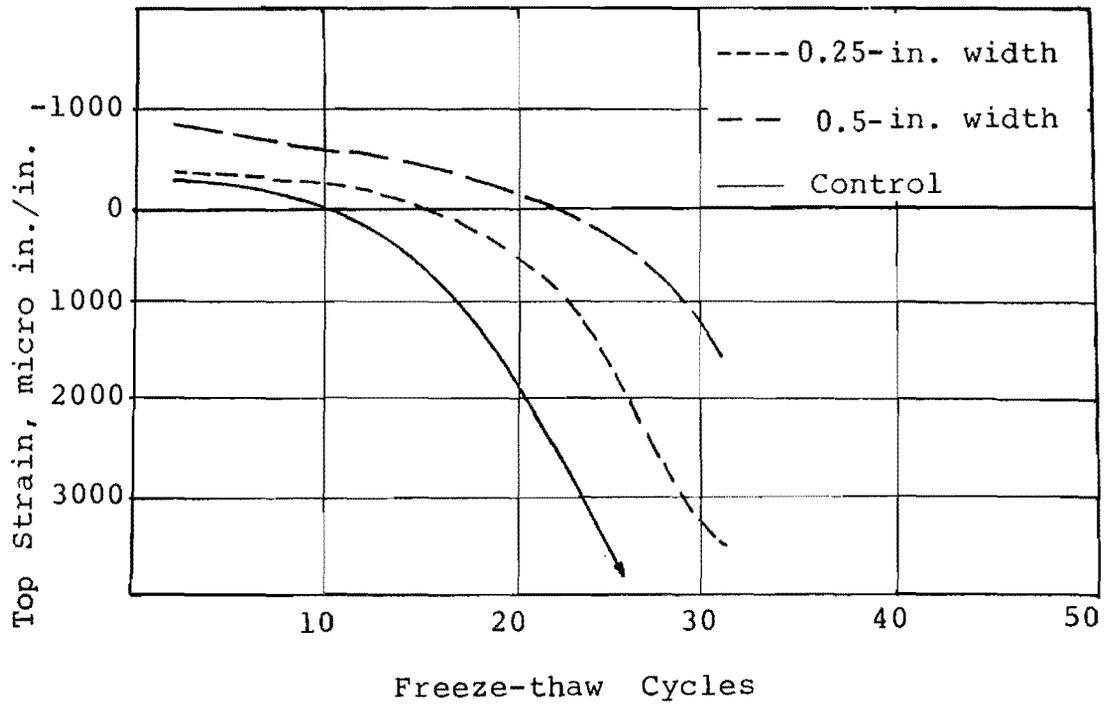
Fig. 5.2 compares the top strains of the specimens with the 0.25-in. and 0.5-in. cracks to those of the control specimens. It can be observed that the repaired slabs exhibited more volumetric stability than the

FIG. 5.2 EFFECT OF CRACK WIDTH ON FREEZE-THAW VOLUMETRIC STABILITY

control slabs, although it appears that the specimens with the 0.5-in. crack width exhibited more stability than slabs with the 0.25-in. crack as failure of concrete approached.

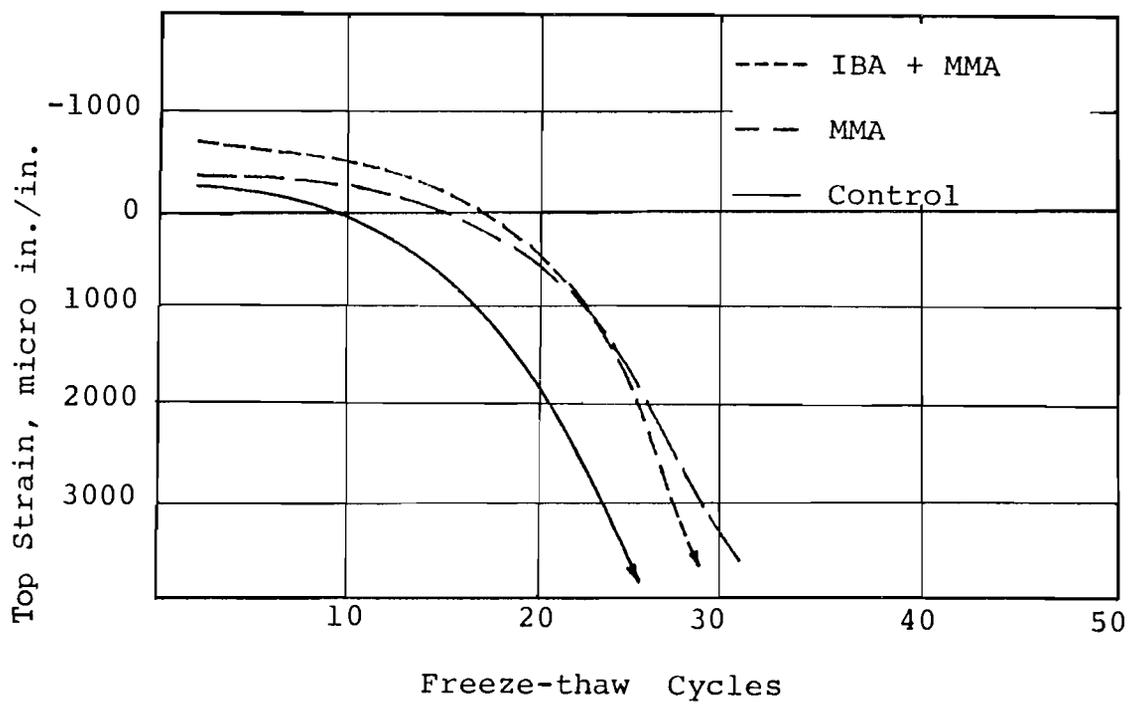
FIG. 5.3 EFFECT OF IBA ON FREEZE-THAW VOLUMETRIC STABILITY

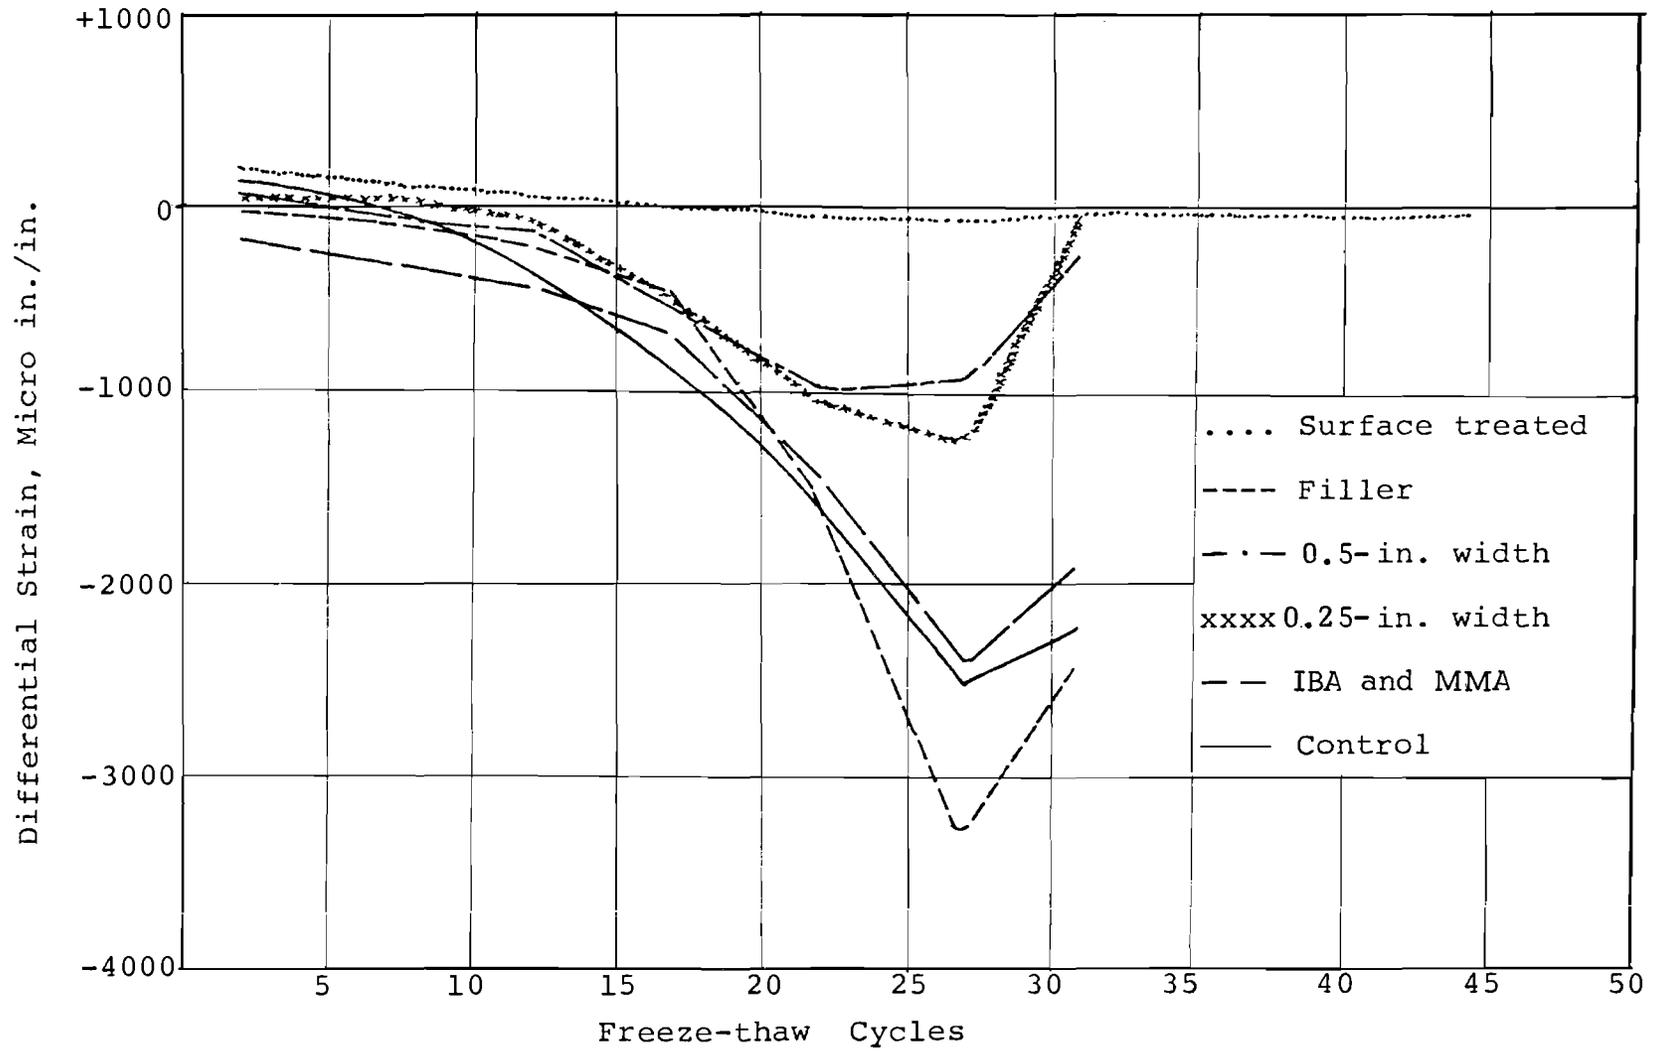
5.3.5 Summary of differential strains--Fig. 5.6 shows the difference between the top and bottom strains of each test versus the number of cycles of freeze-thaw. The strain difference is assumed positive if the top strain is larger than the bottom strain. From the figure it is apparent that the specimens with the highest positive strain differential were the slabs with the surface treatment. It also appears that the specimens with the highest negative strain differential were the slabs treated with IBA and MMA. The slabs with the surface treatment showed less change in strain differential than all the others. It might be of interest to note that the maximum strain differential usually occurred between 22 and 30 cycles of freeze-thaw, excluding the surface treated slabs. Other than the surface-treated slabs, slabs treated with MMA alone, with both 0.5-in. and 0.25-in. cracks, had the

FIG. 5.6 COMPARISON OF DIFFERENTIAL STRAIN

smallest maximum strain differential. Specimens with the MMA and sand filler had the largest maximum strain differential, which was more than three times as great as for the slabs with the same crack width but without filler.

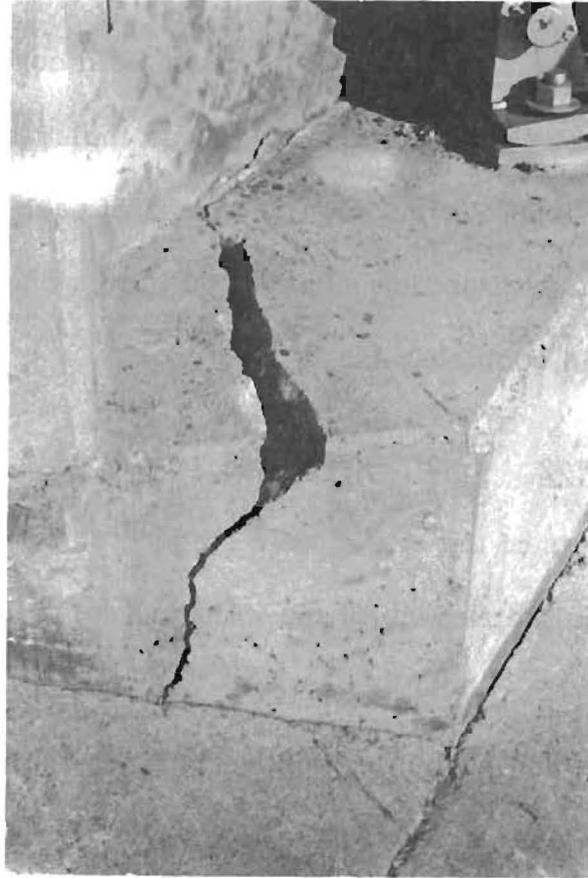
Both abutments of the bridge were cracked on both ends, apparently due to the differential settlement of the wing walls and abutments. The drilled shafts supporting the wing walls are not as deep as those supporting the abutments. The west side of the abutment had a single crack (Fig. 6.1), which varied in width between $1/2$ in. and $2-1/2$ in. and apparently continued all the way to the bottom of the abutment. One steel reinforcing bar could be seen about $2-1/2$ in. from the top of the abutment. The east side of the abutment had several cracks of lesser width (Fig. 6.2). Some of the cracks continued down but some stopped at about 5 in. from the top. The crack was repaired in December 1973.

FIG. 6.1 CRACKING ON THE WEST SIDE OF
ABUTMENT OF BRIDGE S36-T72

6.2.2 Observations--Three months later it was observed that the polymer concrete in the large crack in the west side of the abutment was starting to develop a hair-line surface crack. It was also observed that the area of concrete near the crack was starting to develop new cracks. The

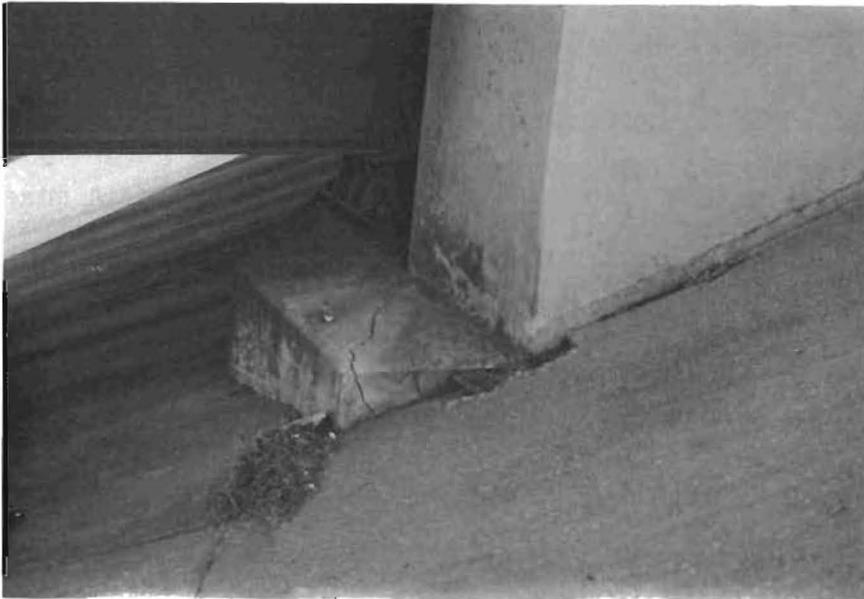
FIG. 6.2 CRACKING ON THE EAST SIDE OF
ABUTMENT OF BRIDGE S36-T72

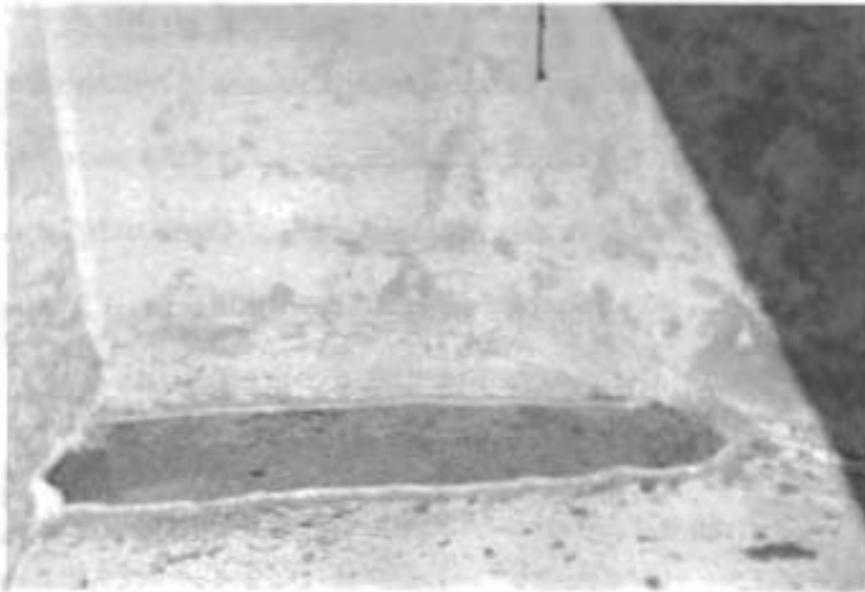
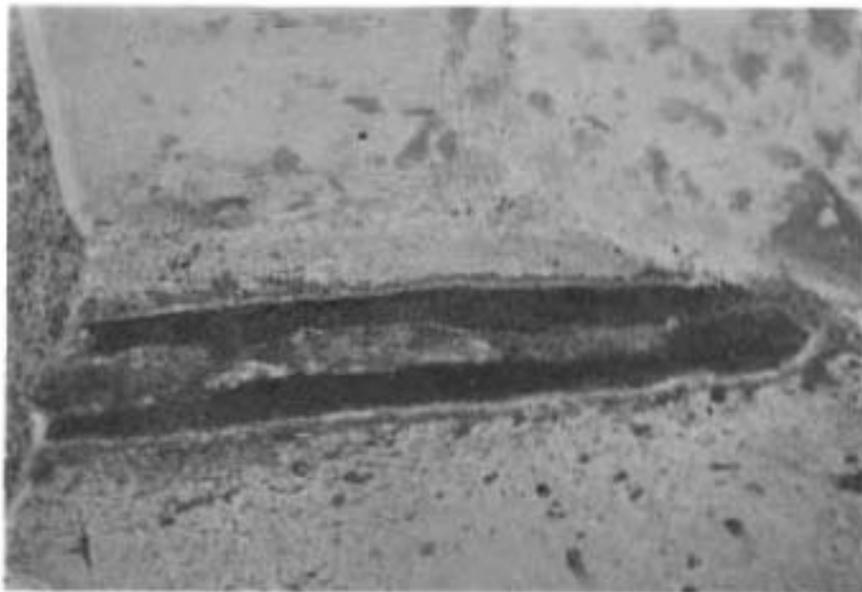
6.2.1 Repair procedure--First the surfaces of the cracks were brushed with a wire brush and then the cracks were washed several times with water. Next, the vertical surfaces where the cracks intersected were sealed with silicon adhesive to prevent the monomer from leaking. Using the same adhesive, a shallow dike was formed around the crack to contain the monomer (Fig. 6.3a). The crack was covered with polyethelene and left for two days, for the adhesive to harden. Two days later, the major crack was filled with clean oven-dried sand to minimize the amount of monomer to be used. The monomer solution was applied to the crack and replenished as necessary. The monomer solution consisted of MMA mixed with a polymer, Rohm and Haas Acryloid B-44, in the approximate proportion of one gram of polymer to 3 ml. of MMA. The polymer was used to increase the viscosity of the monomer, which reduced the amount of monomer wasted through leakage and evaporation. The monomer-polymer solution was mixed with 4% (wt.) LP and 2% (wt.) DMPT. Approximately 25 minutes later, the solution started to react, accompanied by boiling on the surface (Fig. 6.3b). The reaction was complete about 15 minutes later. The repair of the large crack used up about 1500 ml. of the solution. The air temperature during the treatment was about 65° F and it was windy and partly cloudy.

a) West Side With Sand and Adhesive Dike Around the Crack

b) West Side After Treatment

FIG. 6.3 REPAIR OF BRIDGE S36-T72

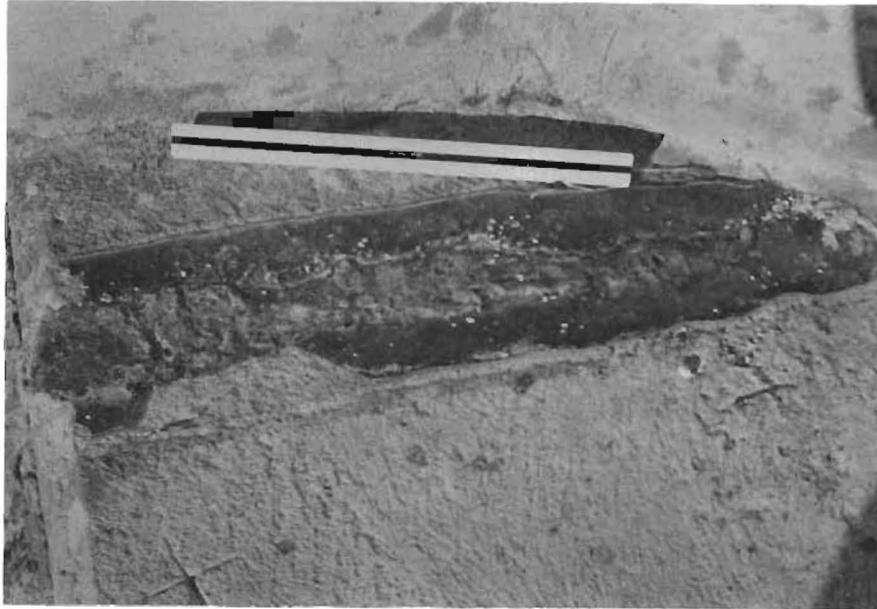
FIG. 6.4 BRIDGE S36-T72 ONE YEAR AFTER REPAIR

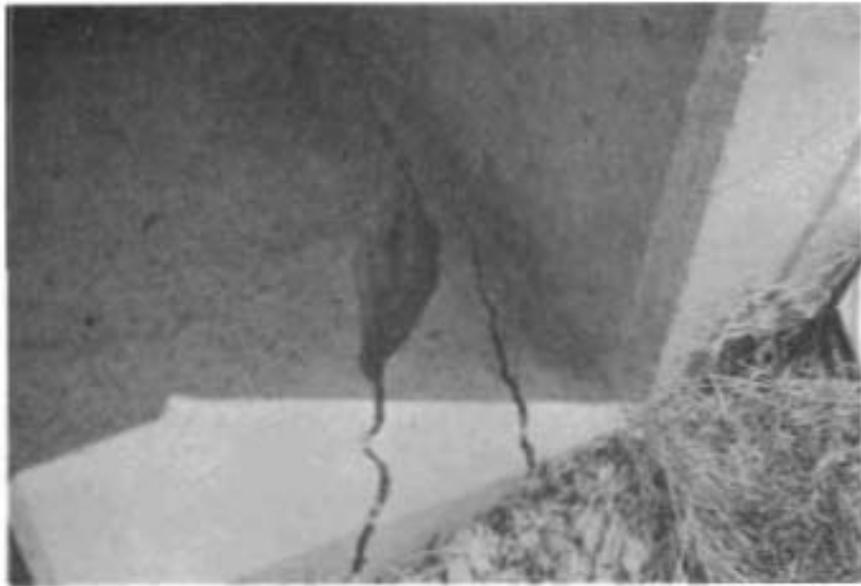
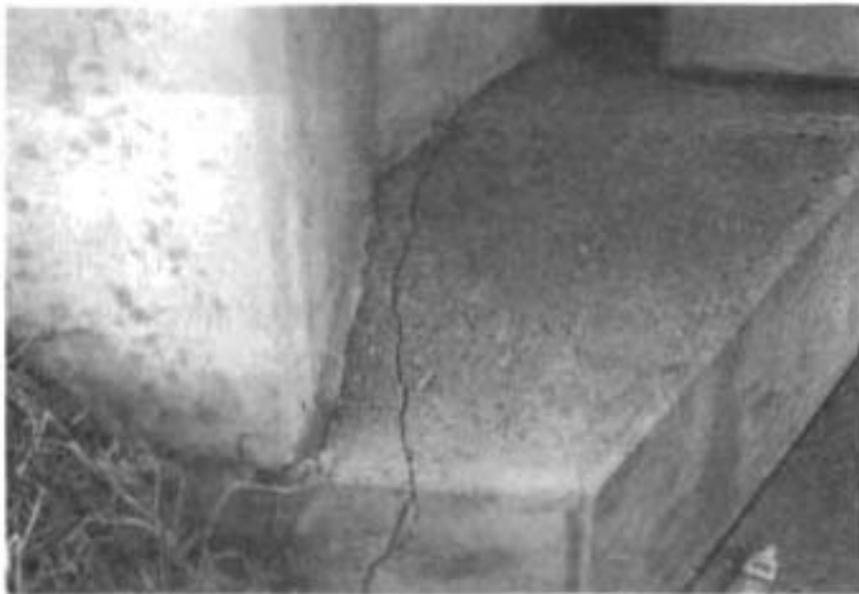
Both abutments of this bridge were cracked in a manner similar to bridge S36-T72 and apparently due to the same cause. One abutment of this bridge was treated on both sides. The west side of the abutment had one crack varying in width between 0.1 in. and 3 in. In the same side of the abutment, there was another crack with a 0.25-in. width that joined with the major crack (Fig. 6.5a). Apparently all the cracks continued all the way down to the bottom of the abutment. The cracks in the east side of the abutment are shown in Fig. 6.5b. The repairs were made in August 1974.

a) Cracking on the West Side

b) Cracking on the East Side

FIG. 6.5 ABUTMENT OF BRIDGE S44-750

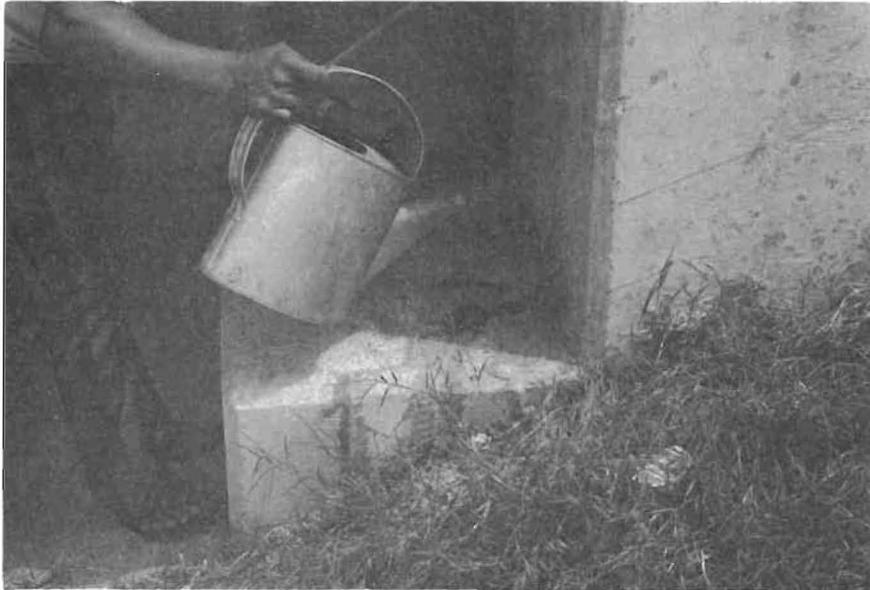
FIG. 6.6 APPLICATION OF THE MONOMER

6.3.1 Repair procedure--The cracks were first cleaned with an air compressor, and then clean dry sand was used to fill the cracks. Next, the

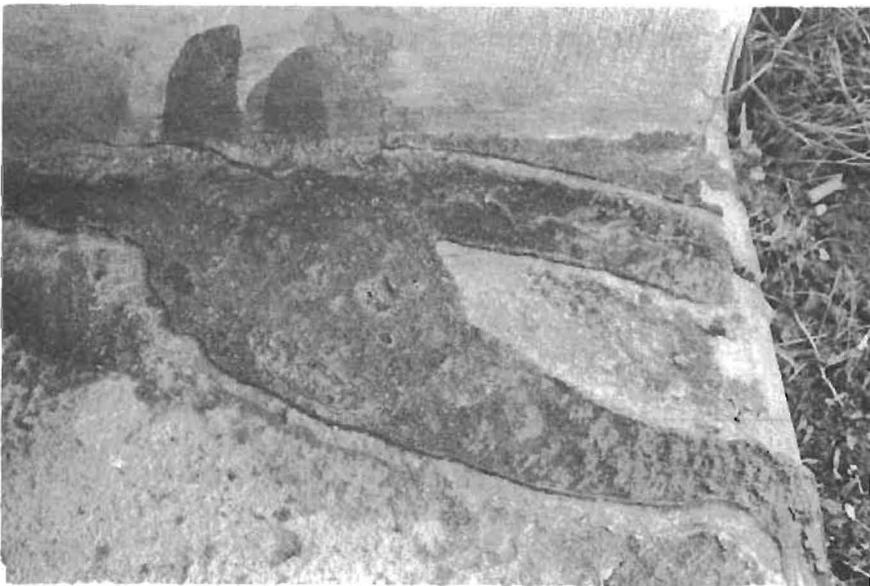
FIG. 6.7 THE WEST ABUTMENT OF BRIDGE S44-750
AFTER TREATMENT

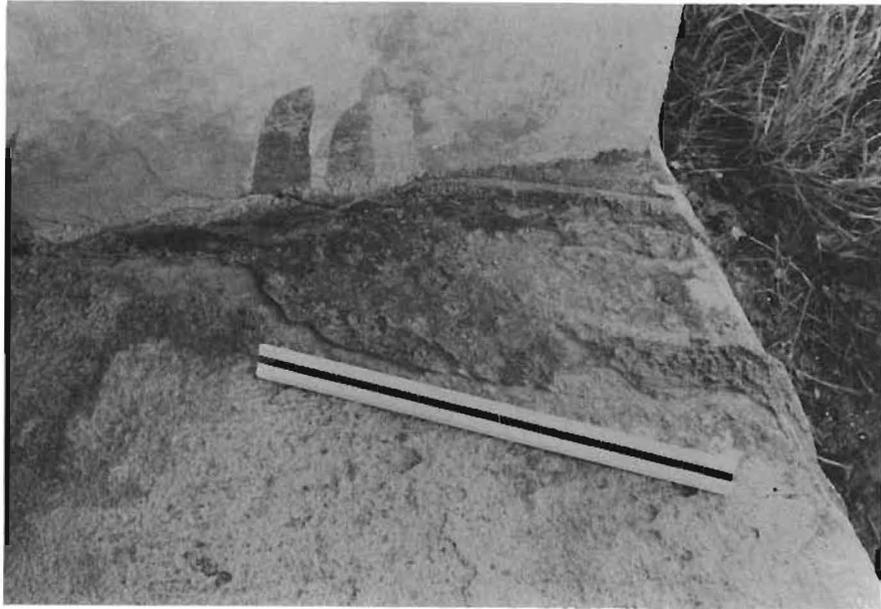
6.3.2 Observations--Observations in January 1975 indicated no visible cracks in the repair on the west side. On the east side, very fine cracks ($\ll 1$ mm) were observed (Fig. 6.8).

FIG. 6.8 WEST END REPAIR OF BRIDGE S44-T50 AFTER FIVE MONTHS
