THE INFLUENCE OF SHEAR ON LAPPED SPLICES IN REINFORCED CONCRETE

Research Report No. 242-2

Influence of Casting Position and of Shear on the  
Strength of Lapped Splices

July 1981

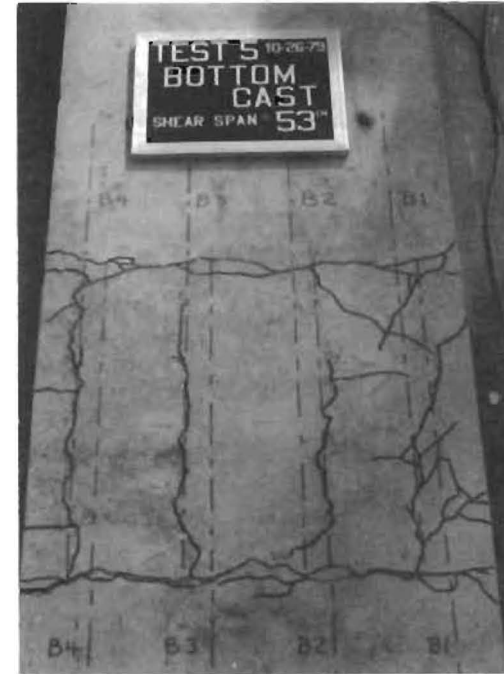
Fig. 4.1 Crack patterns, Test #5

The progression of cracking with increasing load was observed. Cracks were marked at each load stage and numbered. The crack pattern at failure shown in Fig. 4.1 is typical of many specimens. Tensile cracking produced by shear was manifested by diagonal cracks. Splitting cracks on the surface of the specimen produced by anchorage distress were characterized by closely spaced, short low angle diagonal cracks aligned with the axes of the splice. In every test, the first crack to appear on the specimen was a flexural crack at the end of the splice where the moment was greatest. The crack was followed immediately by a similar crack at the other end of the splice. Flexural cracking within the splice zone was fairly evenly spaced. As the load increased, evenly spaced flexural cracks also formed outside of the splice test zone, generally at the stirrup locations. Flexural cracks in the splice zone continued to extend and to bend diagonally toward the support indicating the influence of shear.

(a) Crack pattern B1 side

(b) Crack pattern B4 side

(c) Crack pattern on tension face,  $P_u = 56.9k$

Failure of the specimen was imminent when splitting cracks formed in the splice zone. Splitting initiated on the tension face of the specimen at an edge bar. First splitting was usually observed at the end of the splice subjected to the higher stresses. As the load increased, splitting cracks formed on the side of the specimen. When the splitting cracks began to extend rapidly, bond was lost along the splice and the load dropped off substantially. Failures were quite sudden with little warning except for the growth of the splitting cracks.

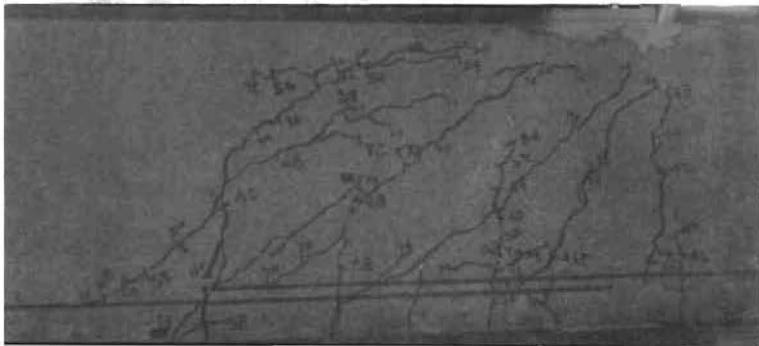
Fig. 4.4 Crack patterns, 40 in. shear span, #11 bars,  $f'_c \approx 4$  ksi

Diagonal shear cracks formed at approximately two-thirds of ultimate. Some of the inclined cracks propagated from the flexural cracks and others

(a) Test 1, top cast, two #3 @ 5 in.

(b) Test 11, top cast, four 6mm @ 5 in.

(c) Test 2, bottom cast, two #3 @ 5 in.

(d) Test 12, bottom cast, four 6mm @ 5 in.

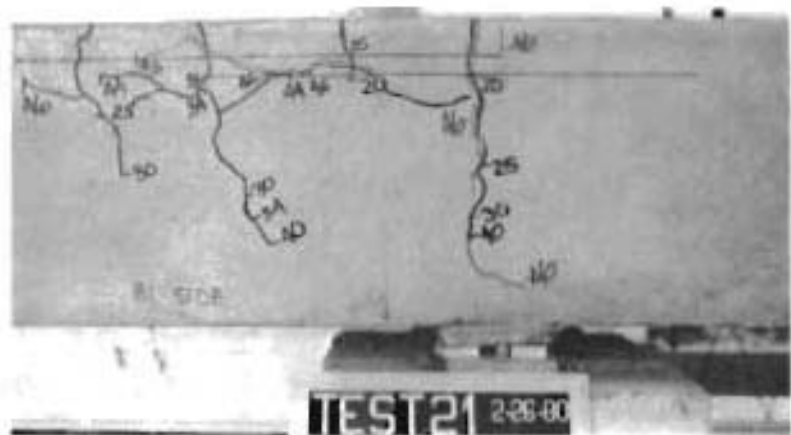
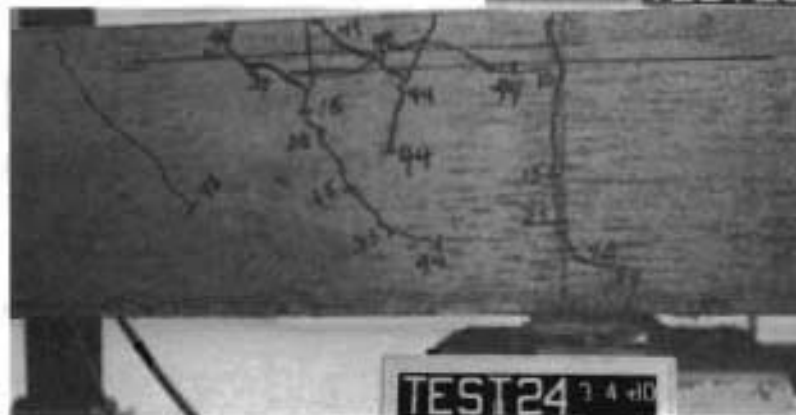
Fig. 4.7 Crack patterns, 53 in. shear span, #9 bars,  $f'_c \approx 6$  ksi

- (a) Test 21, top cast,  
no transverse  
reinforcement

- (b) Test 22, bottom cast,  
no transverse  
reinforcement

- (c) Test 23, bottom  
cast, two 6mm @  
4.5 in.

- (d) Test 24, bottom cast,  
two 6mm @ 4.5 in.

extended from the splitting cracks in the splice region. Splitting on the sides of the specimens was more pronounced than in the specimens tested on 40 in. shear spans.
