**DESIGN GUIDELINES FOR TRANSFER, DEVELOPMENT  
AND DEBONDING OF LARGE DIAMETER SEVEN WIRE  
STRANDS IN PRETENSIONED CONCRETE GIRDERS**

Bruce W. Russell and Ned H. Burns

**Research Report 1210-5F**

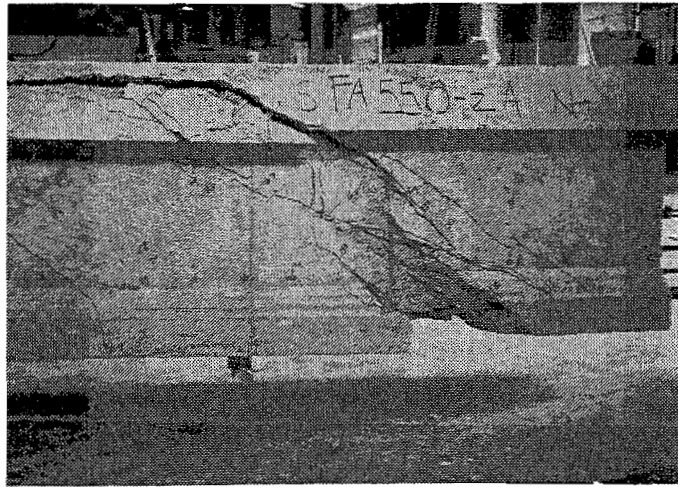
Figure 4.13 Photograph of FA550-2A Explosive Shear Failure

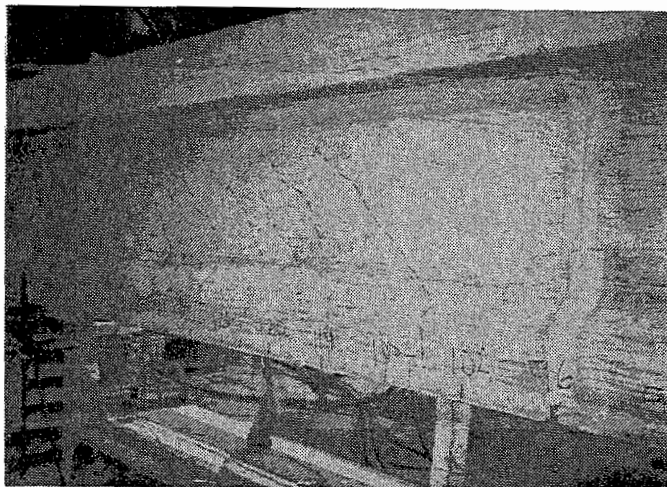
Figure 6.28 Test DB850-F2B at Load = 76 kips
