1. Report No. FHWA/TXDOT-96/1394-1		2. Government Accession No.		3. Recipient's Catalog No.	
4. Title and Subtitle BICYCLE HAZARD MITIGATION MANUAL				5. Report Date December 1995

BICYCLE Hazard Mitigation Manual

Detection and Mitigation of Roadway Hazards for Bicyclists

Research Study 0-1394

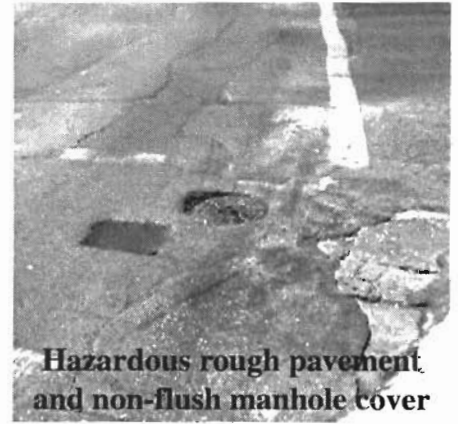
Hazardous rough pavement and non-flush manhole cover

- Steel plates on roadways
- Differential pavement settlement
- Non-flush manhole covers
- Unpaved driveways
- Unpaved/gravel roads
- Unsmooth patches (hardened cement, tar on surface)
- Stone-paved roads (cobblestones)

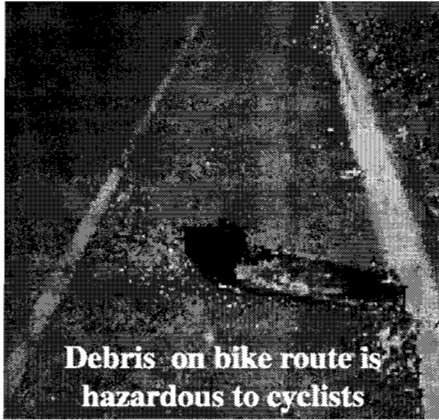
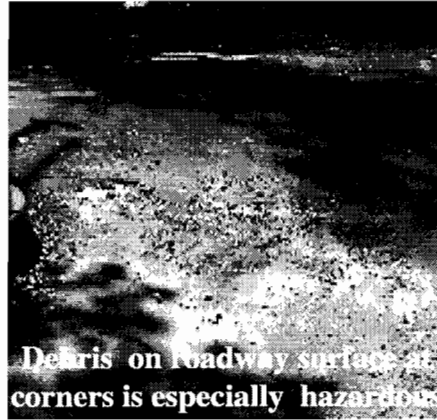
Debris on Roadway Surface

- Debris (e.g., sand, gravel) on roadway surface (especially at turns)
- Debris in bike lanes swept from auto lanes

These problems are also relatively inexpensive to address and are beneficial to motorists as well. Gravel, sand, or debris could substantially reduce surface skid resistance for all traffic. They could also increase frequency of incidents of broken windshields for motorists and flat tires for motorists and bicycles. Sources of roadway debris, sand, and gravel include sanding operations to de-ice bridges and overpasses, unpaved driveways, runoff water, dirt and debris from commercial trucks, and accidents. A primary means of mitigating this problem is to institute a regular roadway sweeping program, particularly for designated bike routes and roadways expected to be frequented by cyclists. To date, many Texas cities have no systematic street sweeping program. Unpaved driveways, particularly along bike routes, should also be paved. When driveway permits are issued for warehouses, loading docks, and other facilities used by commercial trucks, truck wash areas could be required. Washing commercial trucks before they leave these locations would prevent dirt and debris from tracking onto the roadway.

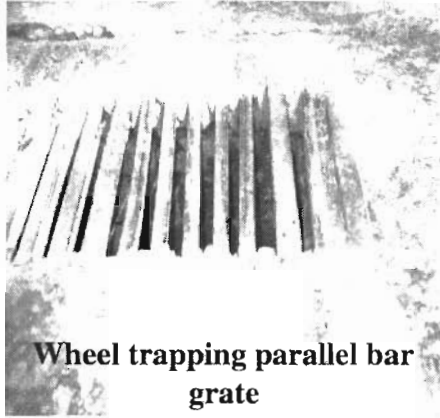
Hazard #3 Parallel Bar Grate Catch-Basins

- Parallel bar grate catch-basins

Drainage catch-basins with bars parallel to the roadway travel path are a serious hazard to cycling and must be remedied on a priority basis. The City of Dallas, for example, let a contract in March 1995 to replace such existing grates with a safer design. The replacement cost in the Dallas project averaged about \$280 per grate replacement (**Table 3**). Additionally, TxDOT calls for a bicycle-safe grate with perpendicular slots on new designs.

Among the potential solutions is the retrofitting of such existing grates with both longitudinal and horizontal bars to minimum design spacing specifications. In such retrofit, hydraulic efficiency should not be overlooked. A more costly alternative (**Table 3**) is to replace the unsafe grates with a criss-cross or angled slot design (U.S. DOT, 1993). In doing so, uniformity of slot orientation should be maintained to reinforce cyclists expectations of the hazards involved. These grates should be secured to the inlet structure/frame by tack welds or bolts to prevent “easy” removal but allow cleaning and maintenance of the drainage structure. One option is to design the grate with an attachment such as 13 mm (0.5") diameter stainless steel five-sided bolts to prevent unauthorized removal. Alternatively, design specifications could discourage the use of grates on pavement surface in favor of curb-opening type inlets.

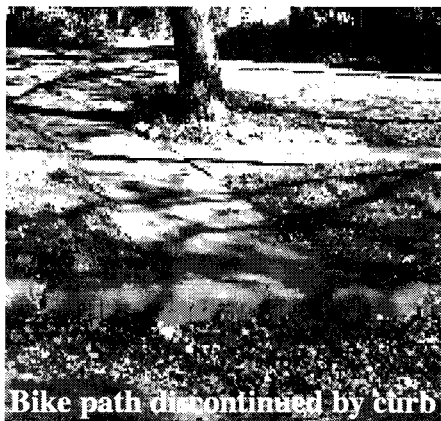
Hazard #7 Paths Discontinued by Curb

- Bike paths that are discontinued by a curb

Bicyclists should generally be discouraged from using sidewalks. Riding on sidewalks could result in serious conflict with pedestrians. Children, however, have a tendency to ride on sidewalks, particularly near school areas. At times, sidewalks in these and other locations have a curb ramp at one end while the other end is discontinued by a curb. In general such situations should be avoided as they are in direct conflict with Americans with Disabilities Act requirements. **Table 6** summarizes costs associated with constructing curb ramps.

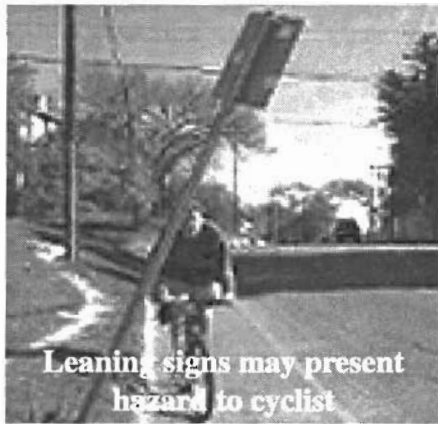
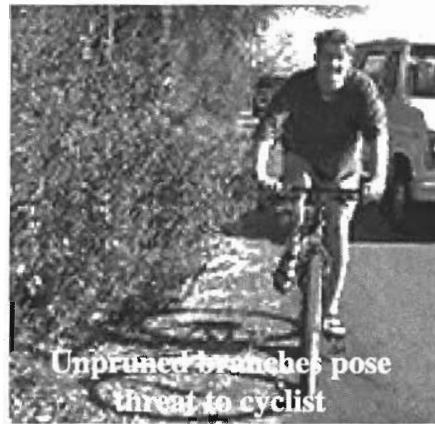
Hazard #9 Roadside Obstructions

- Obstructions restricting vertical clearance
- Unpruned trees more than 3' from pavement edge
- Signs close to roadway lower than 7'

To implement such measures, an inspection program should be initiated to identify all signs lower than 2.1 m (7') and to replace or relocate them so that they no longer pose a problem. Another project to be considered is an "Adopt-A-Bikepath" program. In this program bicycle groups and other interested entities help in maintenance of a bike path by regularly inspecting the paths and reporting such hazards as badly placed signs, overgrown vegetation, etc. Regular trimming of trees and other vegetation along streets and bike paths should also be implemented. **Table 8** (next page) summarizes the person-hours of effort required for trimming.

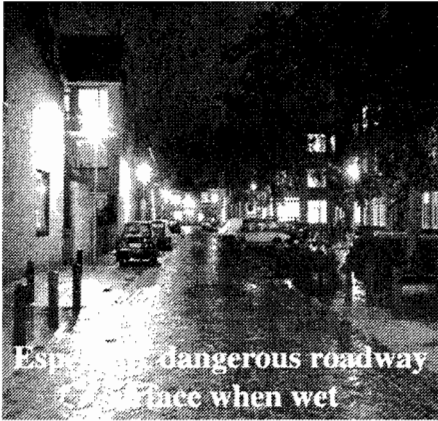
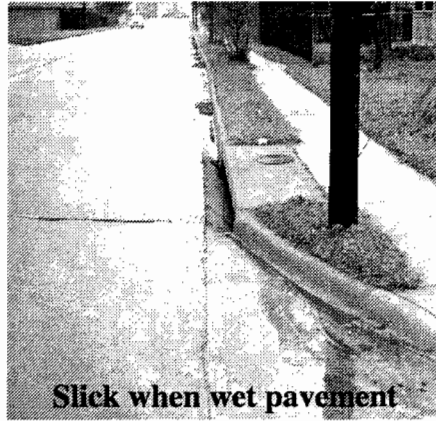
Hazard #10 Pavement Friction

- Slippery-when-wet-pavements (especially near intersections, horizontal curved downhill grades and immediately upstream of intersection stop lines)

Slippery-when-wet pavements could be due to a variety of sources. Main causes include motor oil spillage-especially near intersections, improper asphalt mix design resulting in asphalt bleeding, polished pavement surface texture, and friction reducing paint used in pavement marking.

Locations where reduced pavement friction is particularly problematic are at horizontal curves, downhill grades, and immediately upstream of intersection stop lines. Every effort should be made to identify the locations and the causes of pavement slipperiness at these critical areas. Mitigation measures vary depending on the cause of friction loss. They include use of thermoplastic material for pavement marking, slurry seal (sand-asphalt) or seal coat to provide texture, and grooving rigid pavements at the time of laying the pavement to enhance skid resistance. **Table 9** provides cost estimates for some of the above solutions.

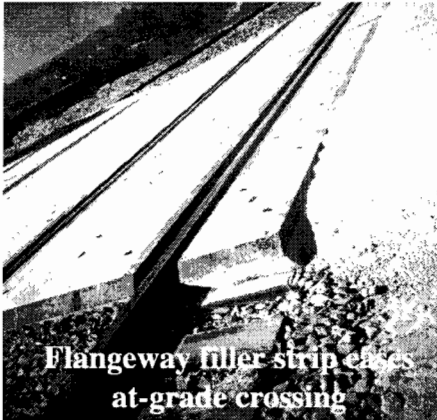
Hazard #11 Railroad Crossings

- Poorly designed crossings (e.g., not at right angle, at-grade)

The combination of high tire pressure, high suspension stiffness, short wheelbase, and high center of gravity make bicycles difficult to control when the rider hits even a small surface bump or depression. One such condition is an at-grade railroad crossing, which could easily cause loss of control of cycles. The problem is further aggravated if the railroad crossing is not at a right-angle to the roadway it crosses, as a bicycle tire could easily be trapped by the flangeway.

Typical remedies include use of rubberized railroad crossing with flangeway fillers. This allows the railroad crossing to be level with the pavement surface without significant gaps between the railbed and the rail. Use of this treatment should be coordinated with railroad companies and should be limited to low-speed, lightly traveled tracks. On high-speed trunk railway lines, trains risk derailment at locations where fillers are used as fillers do not compress fast enough (U.S. DOT, 1993). Finally, at crossings which are not at right angle, a designated bicycle crossing lane which intersects the track at a right-angle should be provided.

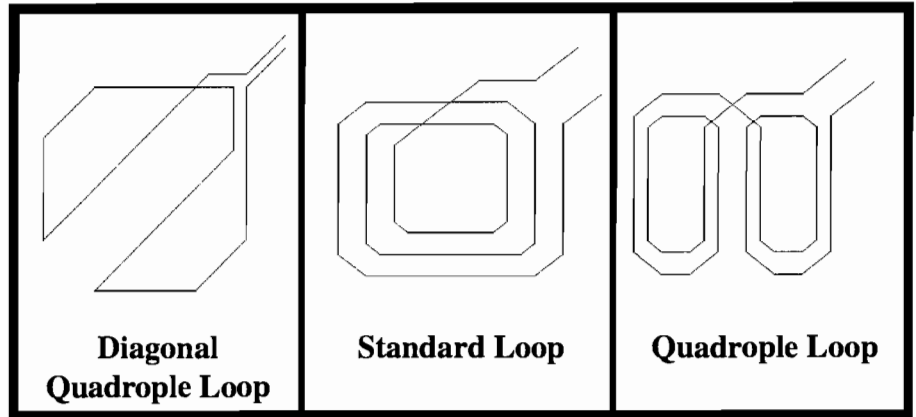
Hazard #12 Signal Detectors

- Insensitive bicycle signal detectors

- Place detectors (broken laser beam or motion) in areas that cyclists ride
- Mark pavement to delineate detector or most sensitive locations on detector
- Replace/install bicycle sensitive detectors
 - Type D, quadropole in bike lanes
 - Type Q, diagonal quadropole for shared road
 - Type A, standard loop detects over wires
- Add push-button for bike crossing close to roadway and at proper height

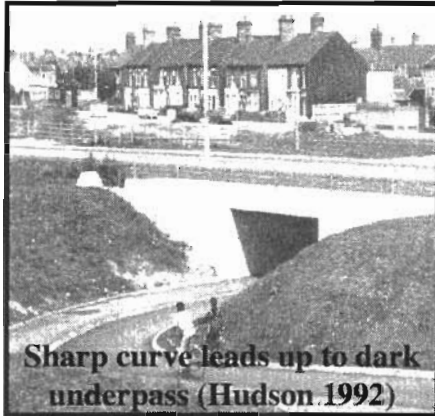
Hazard #13 Bicycle Underpasses

- Narrow underpasses (less than 10')
- Underpasses with long and/or curved entry approaches
- Insufficiently lighted underpasses (less than 150 kw)

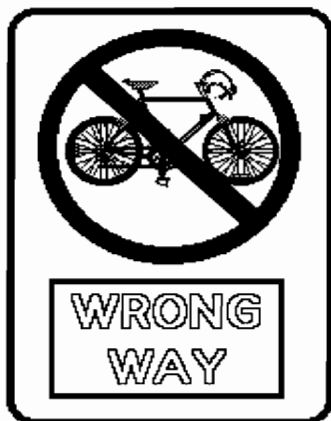
Hazard #14 Riding Against Traffic

- Observed/reported instances of repeated riding against traffic

This problem is particularly prevalent near schools, where children often tend to ride against traffic. This dangerous behavior partly results from the common misconception about the risk of being rear-ended by motor vehicles. Bicycle accident data show that cyclists being rear-ended is an uncommon occurrence, whereas riding against traffic is the cause of a relatively much higher percent of automobile-bicycle accidents (Mattingly, 1994).

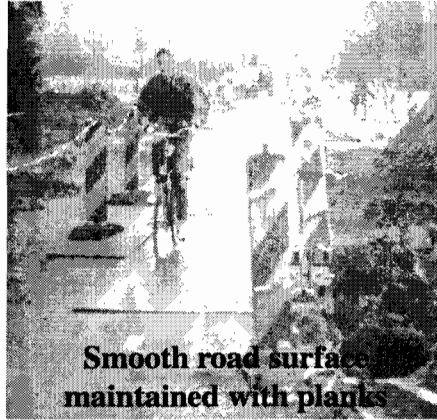
Hazard #15 Roadway Workzones

- Insufficient lighting
- Debris on roadway
- Surface irregularities
- Confusing traffic patterns
- Improper drainage
- Obstructions (vertical and otherwise)

Workzones are particularly inhospitable to cyclists. Not only are geometric widths generally more restricted but also a workzone is a major source of debris. Preferably, cyclists should be detoured away from workzones when feasible. If doing so would mean very long detours, a separate bike lane through the workzone should be erected. Such lanes should be properly signed and protected by means of barriers. Removable planks could also be used to maintain smooth debris-free surfaces through workzones. When neither detours nor dedicated lanes are feasible, consideration should be given to prohibiting bicycle traffic through workzones.

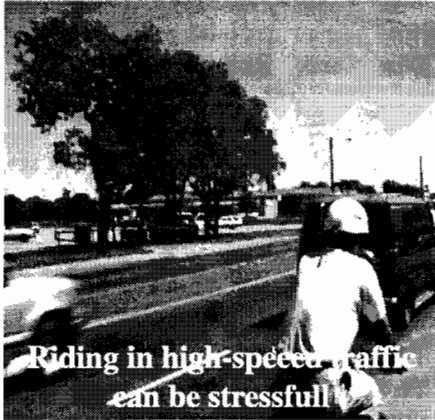
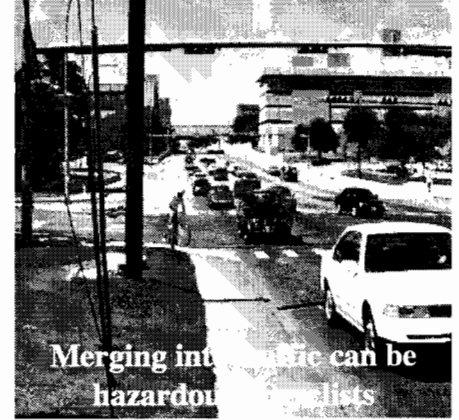
Hazard #16 High-Speed/Volume Roadways

- Cyclists on high-speed or high-volume roadways

Cycling through roadways carrying a high volume and/or high speed traffic is highly stressful to cyclists (Sorton, 1994). Roadways with a curb lane peak hourly volume greater than 325 vphpl and average speeds of 64 km/h (40 mph) or greater can be classified as high speed/high volume roadways, producing high stress levels of 4 to 5 on a 1-5 scale (NCTCOG, 1995). While presenting a stressful condition, these roadways generally constitute the most direct paths to cyclists' destinations.

Remedial solutions include widening the outside lanes to 4.6 m or 4.9 m (15' or 16') in urban areas and providing exclusive separated bike paths in rural conditions. Exclusive bike paths in rural areas are considerably less expensive per square foot than contiguous roadways designed for 40-ton vehicles (**Table 13**).

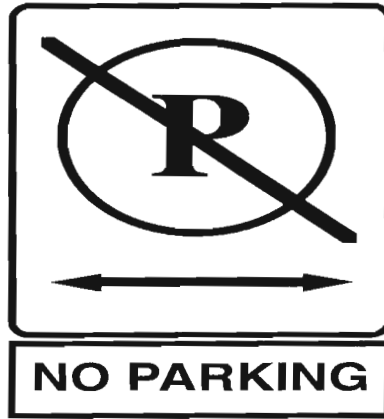
Hazard #17 Parked Cars

- Curbside parking along bike routes
