1. Report No. FHWA/TX-82/18+303-1F		2. Government Accession No.		3. Recipient's Catalog No.	
4. Title and Subtitle THE EFFECT OF TRANSVERSE STRAND EXTENSIONS ON THE BEHAVIOR OF PRECAST PRESTRESSED PANEL BRIDGES				5. Report Date June 1982

6. Performing Organization Code	
7. Author(s) L. A. Bieschke and R. E. Klingner				8. Performing Organization Report No. Research Report 303-1F	
9. Performing Organization Name and Address Center for Transportation Research The University of Texas at Austin Austin, Texas 78712-1075				10. Work Unit No.

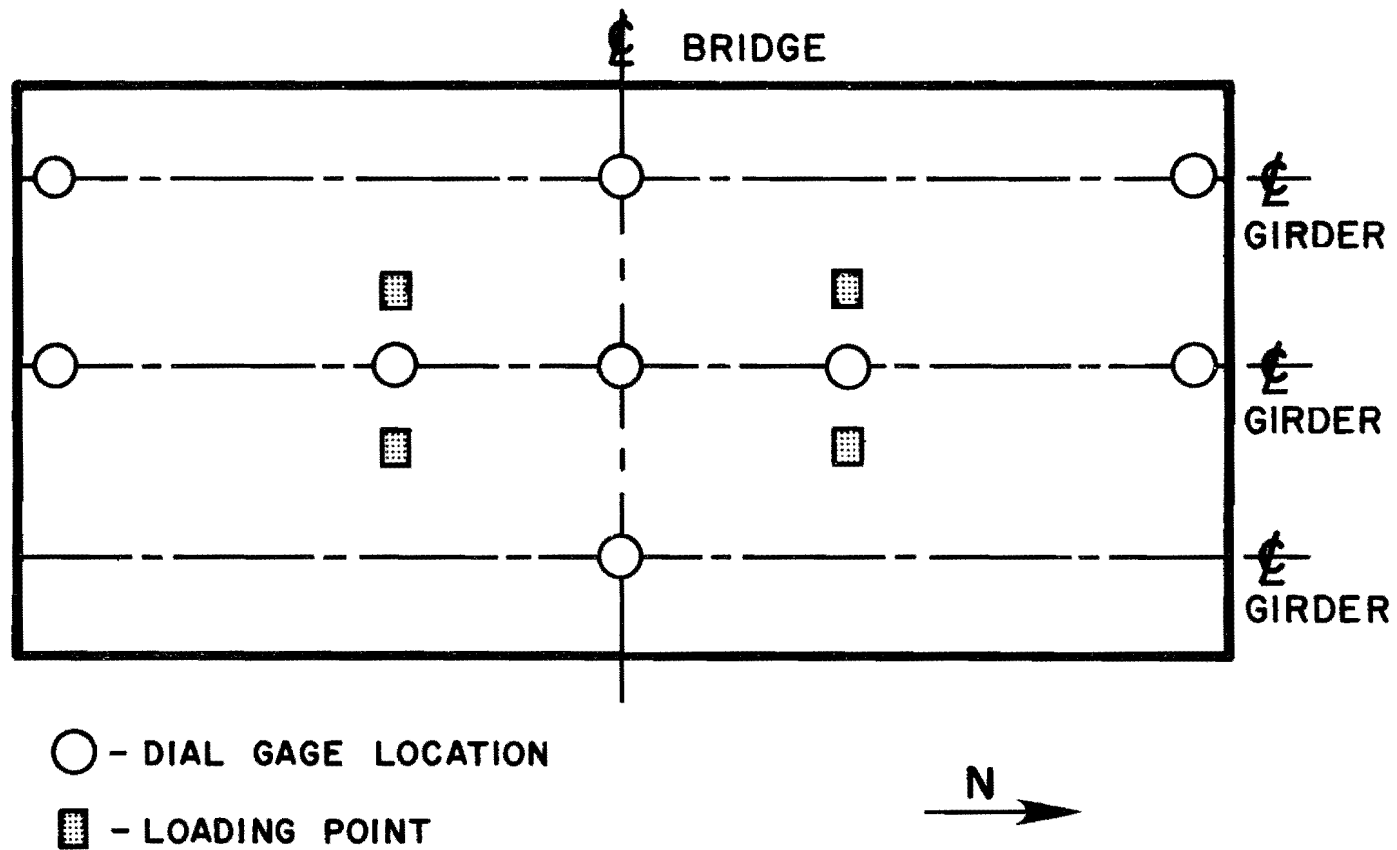
FIGURE 5.1 - LOCATION OF DEFLECTION DIAL GAGES

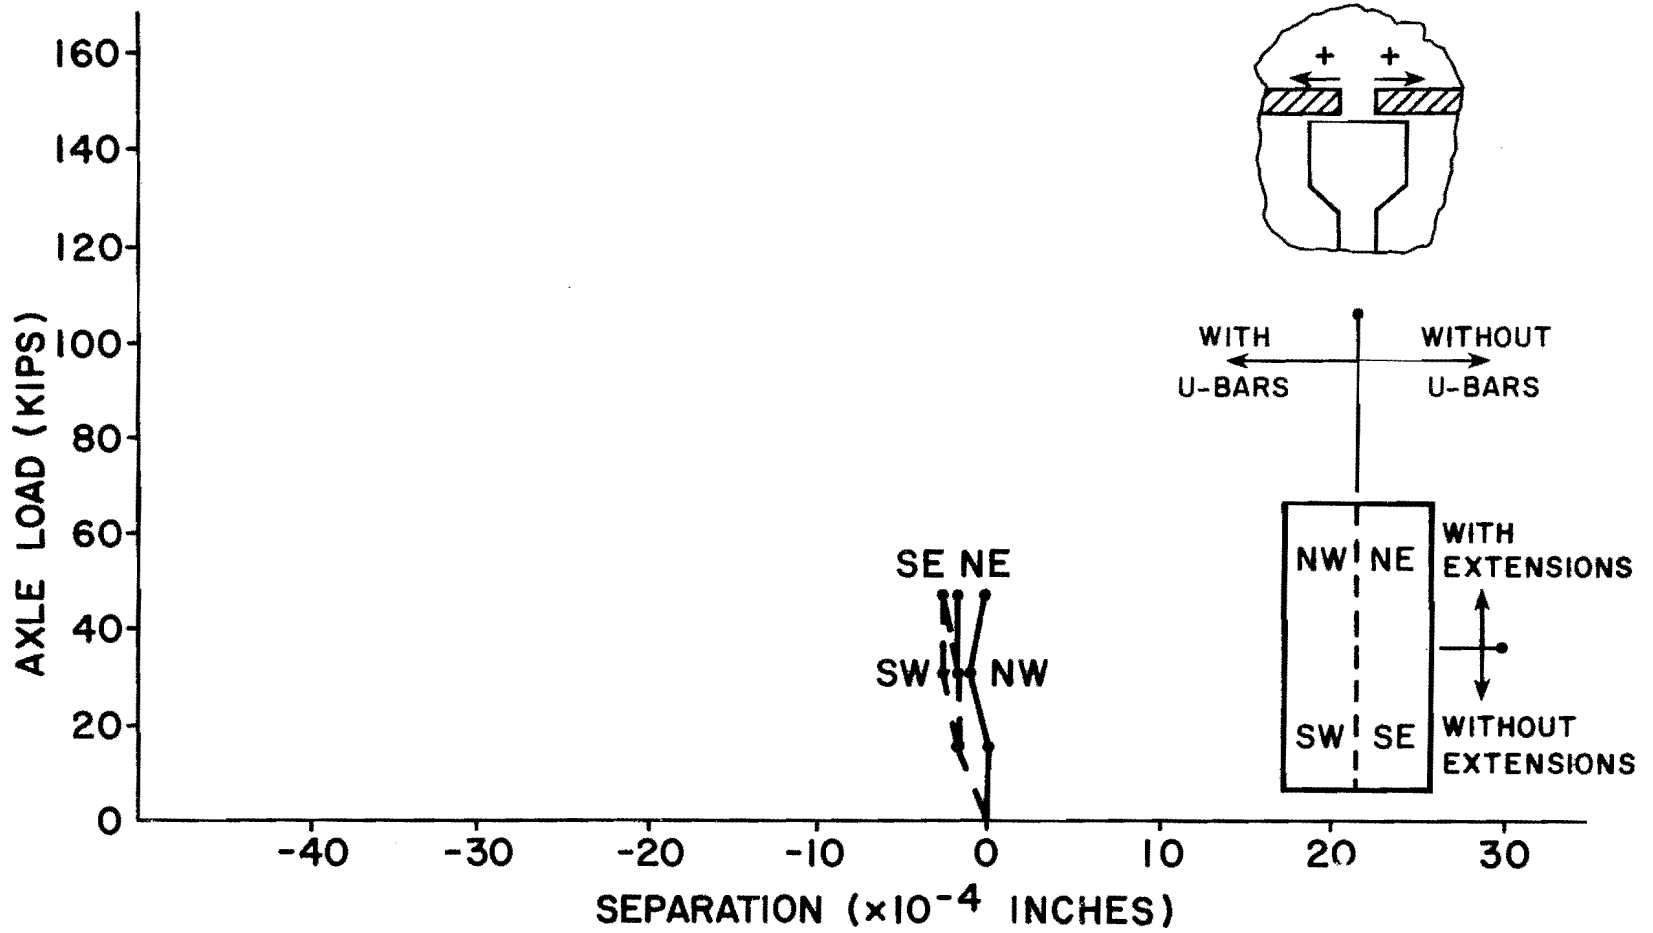
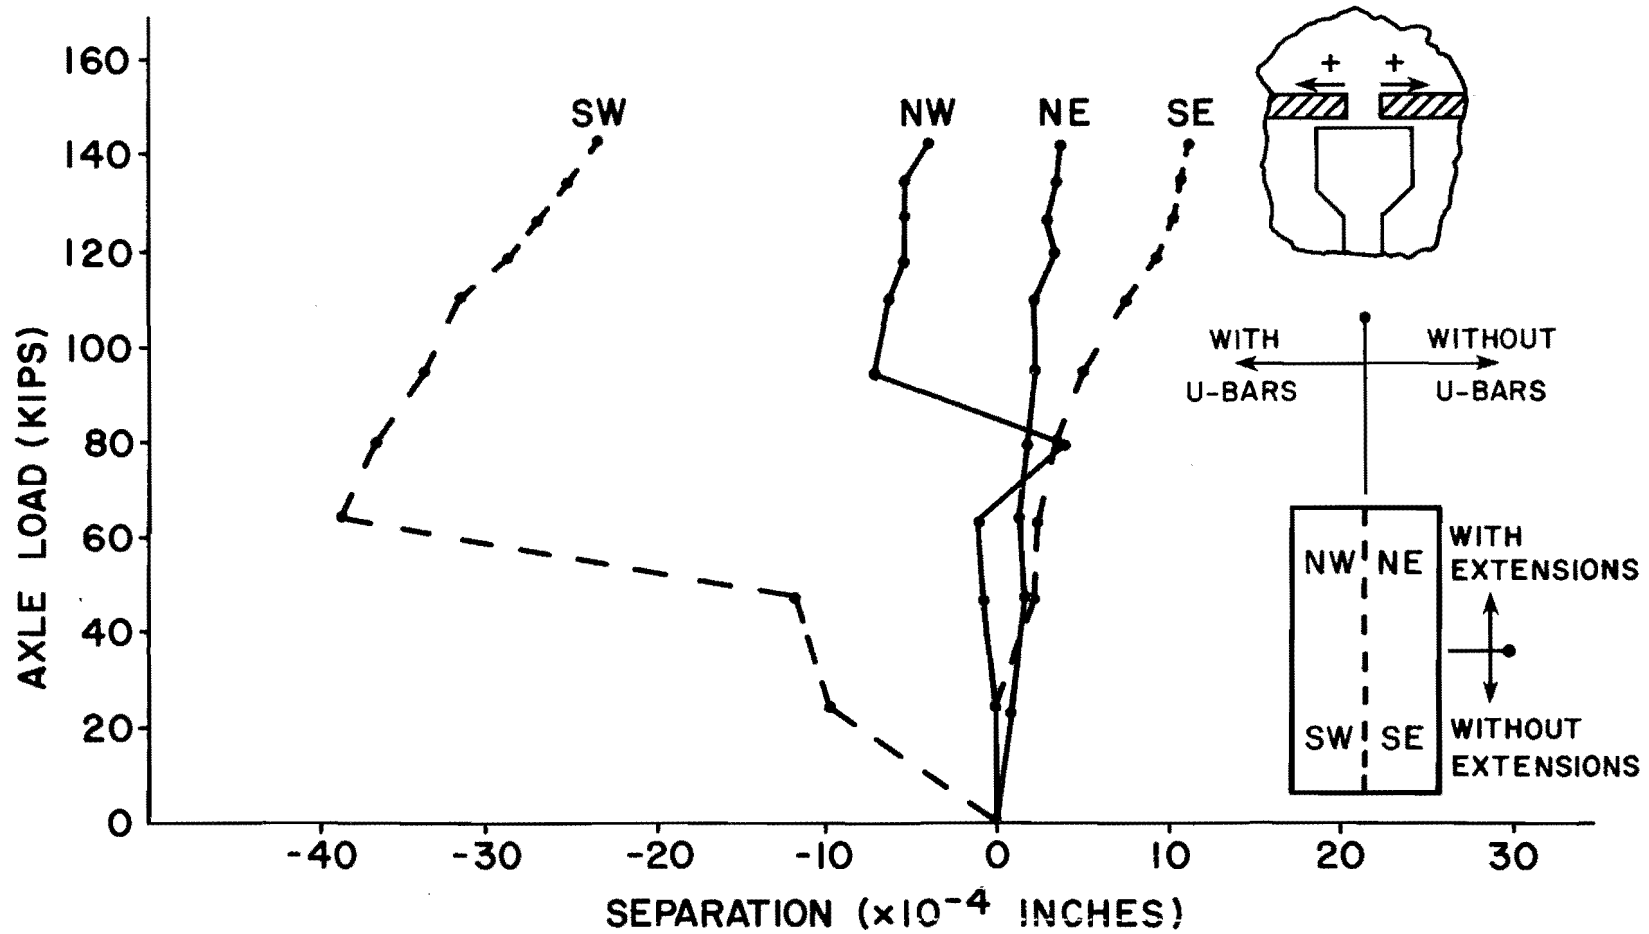
FIGURE 6.10 - SEPARATION - STATIC TEST NO. I

FIGURE 6.11 - SEPARATION - STATIC TEST NO.2

FIGURE 6.12 - SEPARATION - STATIC TEST NO. 3

FIGURE 6.13 - SEPARATION - STATIC TEST NO. 4

Separation results from Static Test No. 4 show that most of the movement occurs at the southwest quadrant, with some movement also occurring at the southeast and northwest quadrants. Most of the movement occurs in the form of large jumps between data points, similar to those observed in the angle change results for Static Test No. 4. As before, it is felt that this erratic movement was due to the extra fatigue cracking that occurred between Static Test Nos. 3 and 4. Again, note that most of the movement does not occur until the static axle load exceeds 50 kips.

In summary, more panel separation occurred on the south half of the bridge, where panels without strand extensions were placed, than on the north half of the bridge. However, as in the case of panel rotations, the maximum magnitude of panel separations was small, only  $40 \times 10^{-4}$  in. This separation, if considered to occur at one single location, would be conservatively consistent with a slab crack having a width of about 0.004 in., considerably less than the acceptable maximum width for flexural cracks. Again, most movement occurred at axle loads clearly in excess of design axle loads. While the second fatigue series tests led to more erratic results, they did not increase separation magnitudes. Examination of Figs. 6.10 through 6.13 also shows a slight tendency toward decreased local continuity on the west side of the deck as opposed to the east. This tendency is believed not conclusive enough to indicate a significant difference in behavior, and no explanation for it was readily apparent.

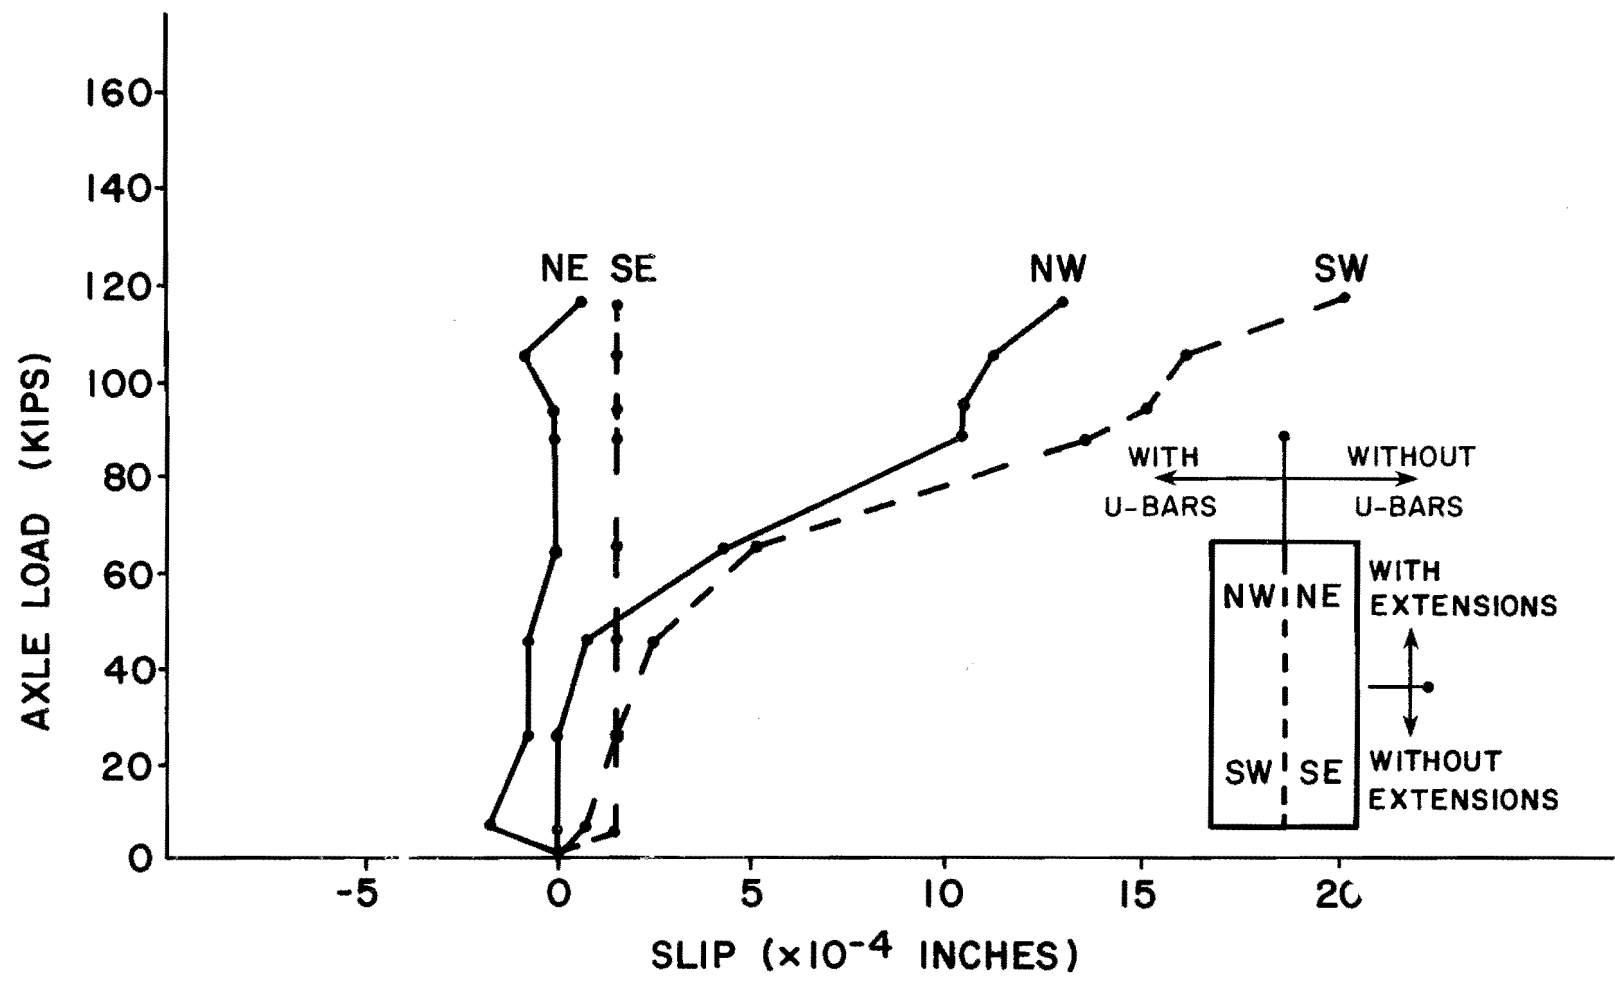
FIGURE 6.14 - LONGITUDINAL SLIP FOR STATIC TEST NO. 1

FIGURE 6.15 - LONGITUDINAL SLIP FOR STATIC TEST NO. 2

FIGURE 6.16 - LONGITUDINAL SLIP FOR STATIC TEST NO. 3

FIGURE 6.17 - LONGITUDINAL SLIP FOR STATIC TEST NO. 4

These results show that at any given load level the magnitude of the slip increases as the extent of composite action of the bridge decreases. As before, the results from Static Test No. 1 show movements too small to be useful for evaluation purposes. However, the slip results from Static Test Nos. 2, 3, and 4 all show

more slip occurring on the northwest and southwest quadrants of the bridge than on the northeast and southeast quadrants. The maximum recorded slip was  $20 \times 10^{-4}$  in., and most of this slip did not start until after an axle load of 60 kips had been reached.

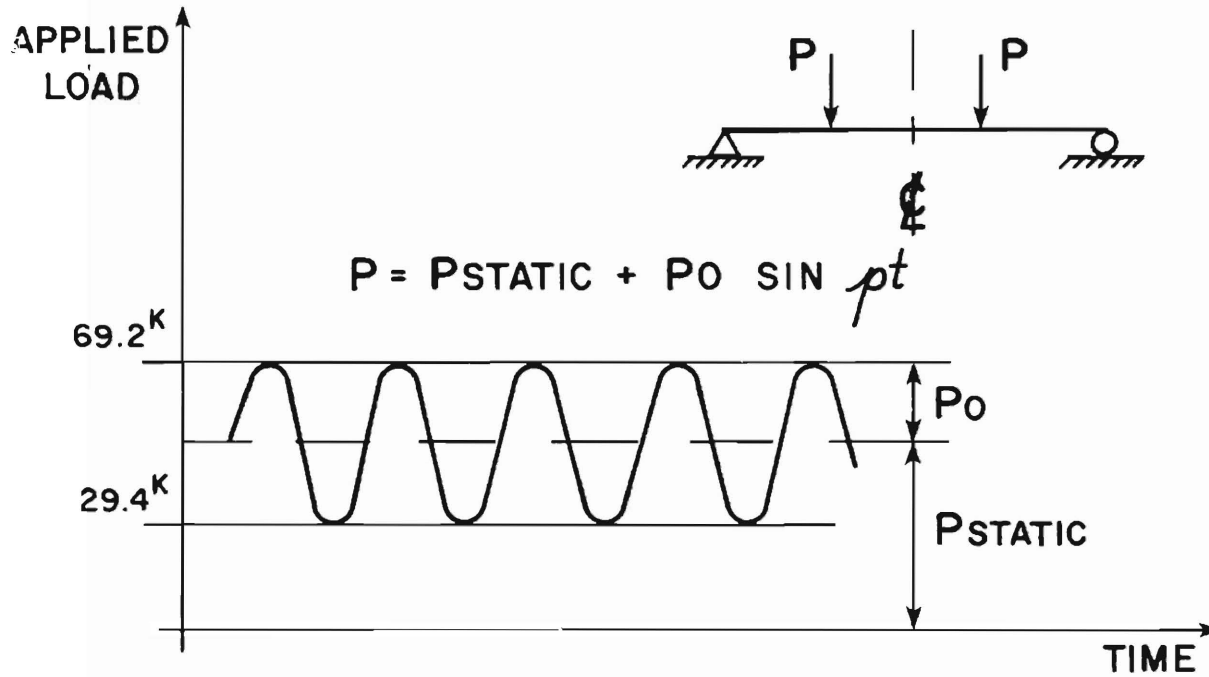
FIGURE A.3 - APPLIED LOAD AS THE SUPERPOSITION OF STATIC LOAD AND SINUSOIDAL LOAD

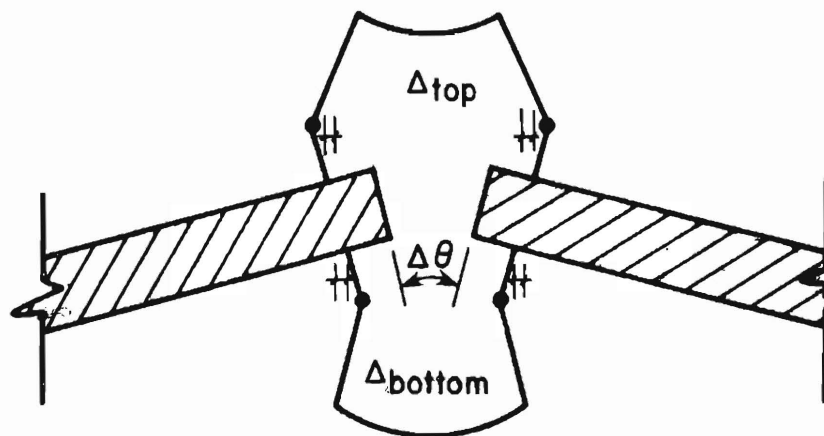
FIG. B.3

As shown in Fig. B.3, the relative movement can be considered as a separation of the panels  $\Delta_{\text{top}}$  at the top surface and  $\Delta_{\text{bottom}}$  at the bottom surface, corresponding to a concentrated angle change  $\Delta\theta$ .
