FRETTING FATIGUE IN POST-TENSIONED CONCRETE

**Research Report No. 465-2F
Research Project 3-5-86/8-465
"Fatigue Strength of Post-Tensioned Concrete"**

This report details the results of a comprehensive fatigue investigation of post-tensioned concrete specimens. The various tests included strand-in-air tests to characterize the prestressing strand utilized, a series of reduced beam specimens with single strands in a tendon, a series of reduced beam specimens with multiple strands in a tendon, and a series of complete beam specimens with multiple strands in a tendon. The report summarizes all results from the post-tensioned specimens along with the results of several other test programs and concludes with design recommendations.

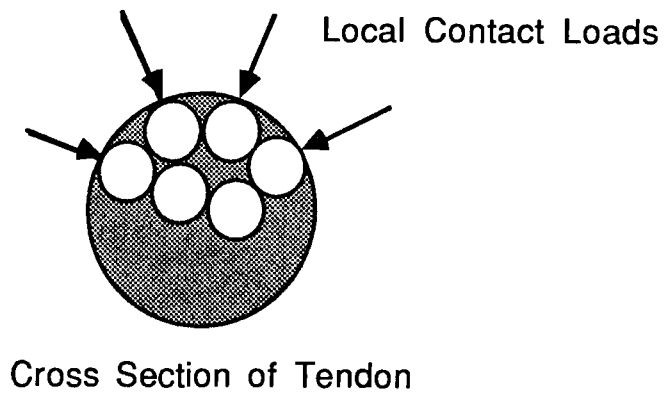
Figure 2.4 Post-Tensioned Beam

A closer look at the tendon conditions in a post-tensioned concrete beam reveals significant differences as compared to pretensioned concrete. Most notable is the presence of a sheath in post-tensioned concrete beams, to form a void in which prestressing steel is inserted after curing of the concrete. Very often the tendon is curved to generate lateral deviation forces for load balancing. Stressing of the prestressing steel brings it into contact with the duct along the inner side of the curvature, and individual strands or wires (which are usually isolated in pretensioning applications) touch each other as well (Fig. 2.4).

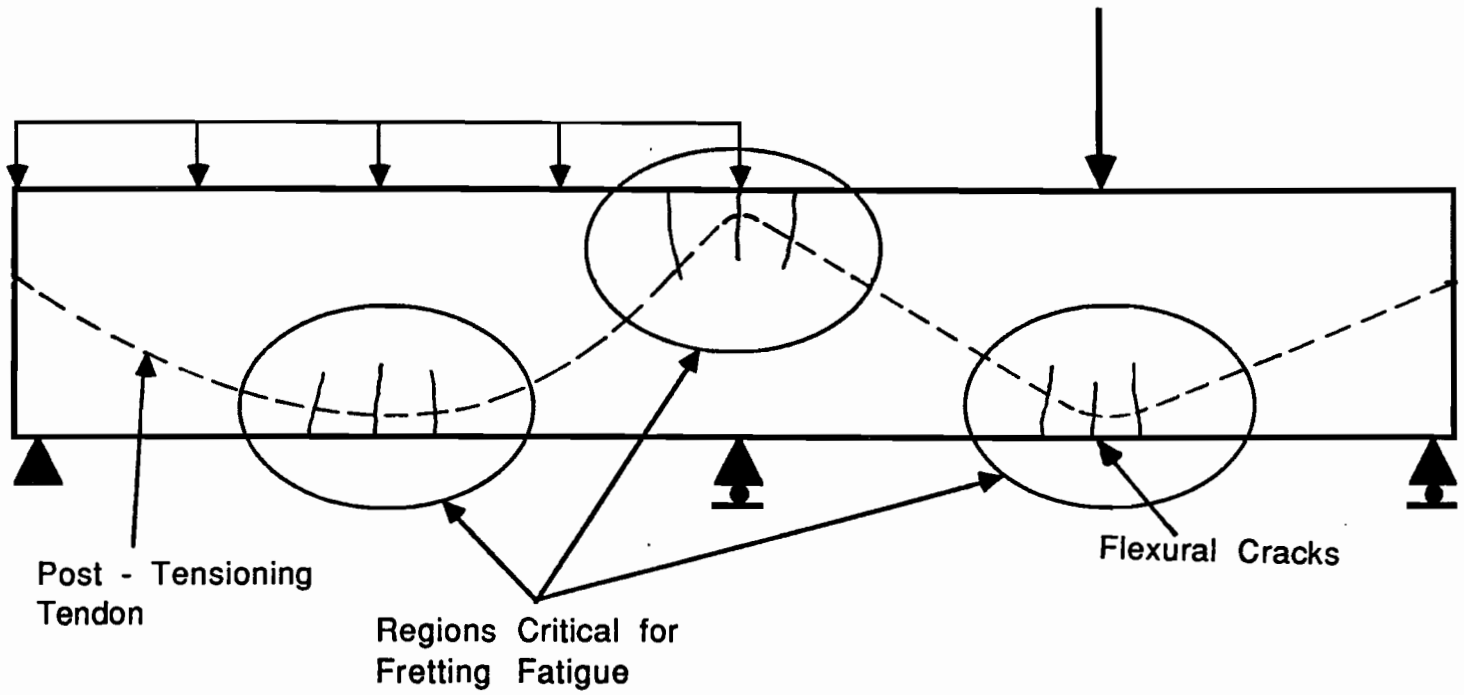
Figure 3.3 Critical Zones for Fretting Fatigue in Girders (after Yates [31])

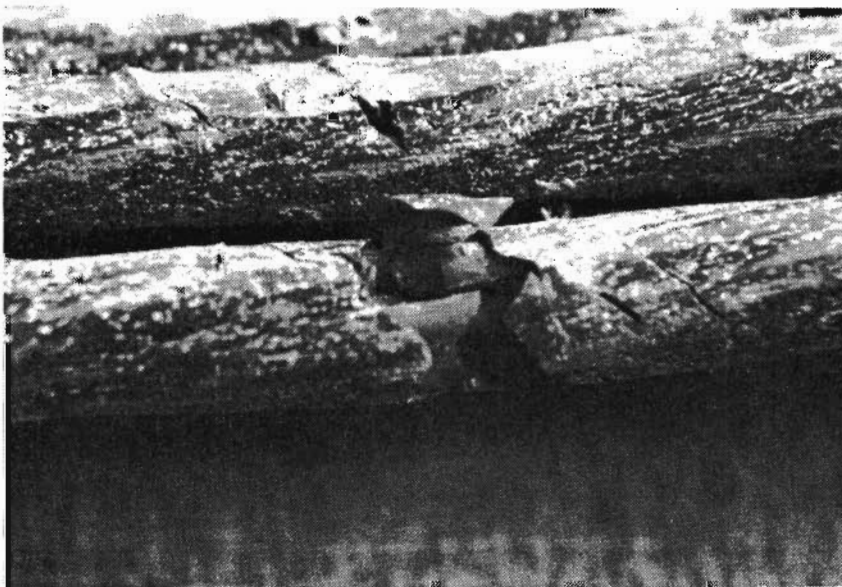
Figure 4.24 Fractures in epoxy coated strand

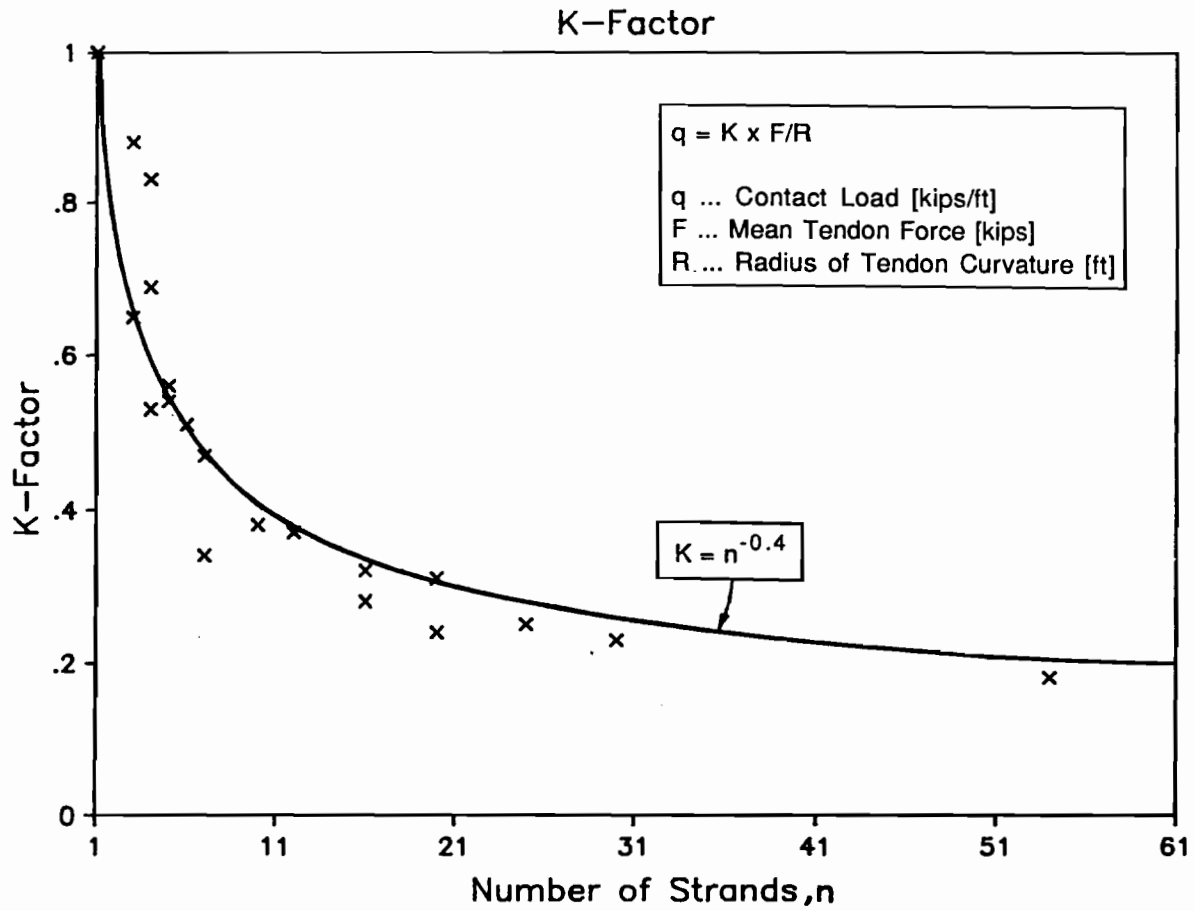
Figure 5.19 Determination of K-Factor
