**EVALUATION OF SEAL COAT PERFORMANCE USING MACRO-TEXTURE
MEASUREMENTS**

Research Report Number 0-5310-3

“Evaluation of a System for Measuring Seal Coat Quality”

THE UNIVERSITY OF TEXAS AT SAN ANTONIO

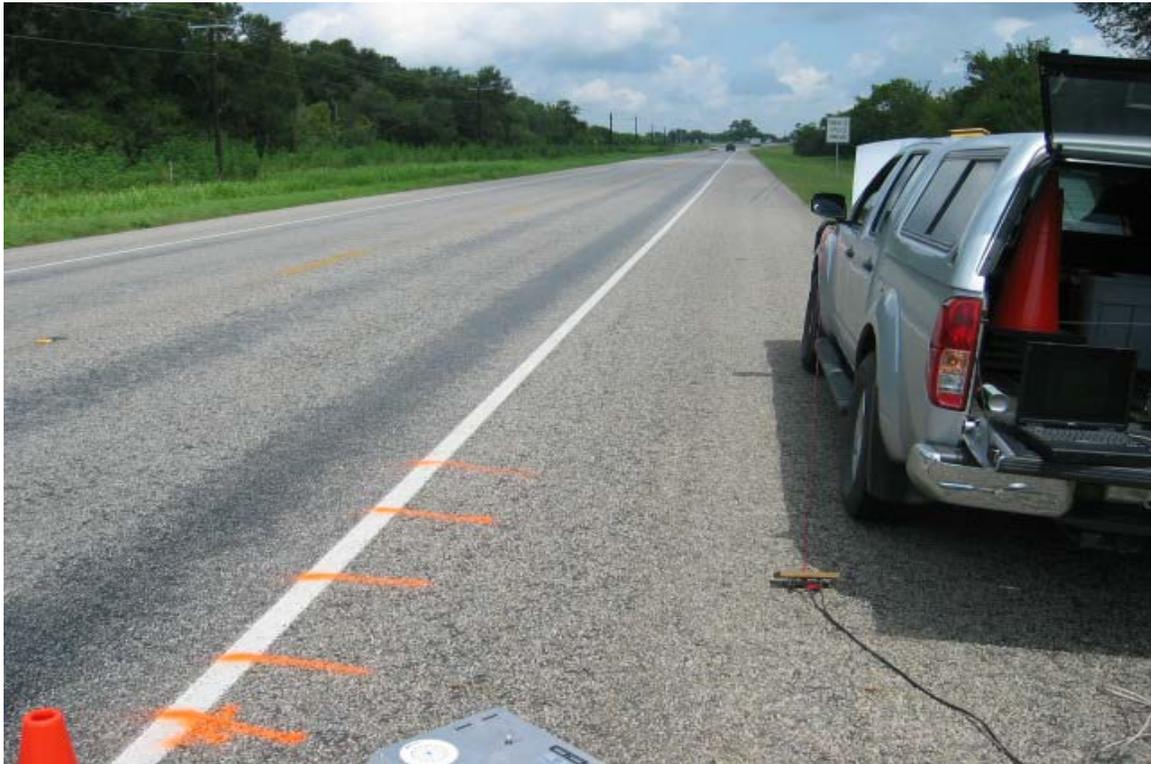
Figure 1.1. Seal coat pavement showing signs of flushing

Flushing occurs when too much binder is used during construction. It is one of the most common defects. The excess binder travels upward to the pavement surface. The pavement looks black and shiny. This defect tends to lead to loss of friction between the vehicle tires and the pavement resulting in loss of skid resistance (Texas Department of Transportation, 2004). Figure 1.1 is an example of a road showing extreme flushing.

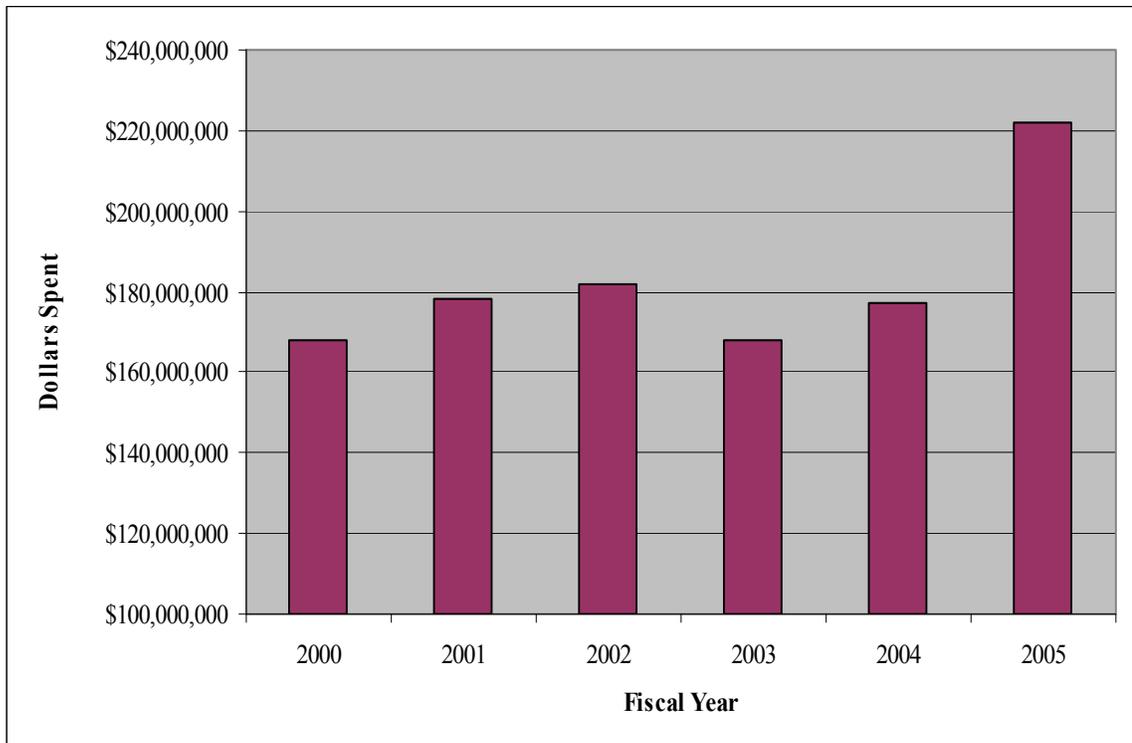
Figure 1.2. Seal Coat Dollars Spent
(Texas Department of transportation, 2006)

Figure 1.2 shows the amount of money spent on seal coats from 2000 to 2005.

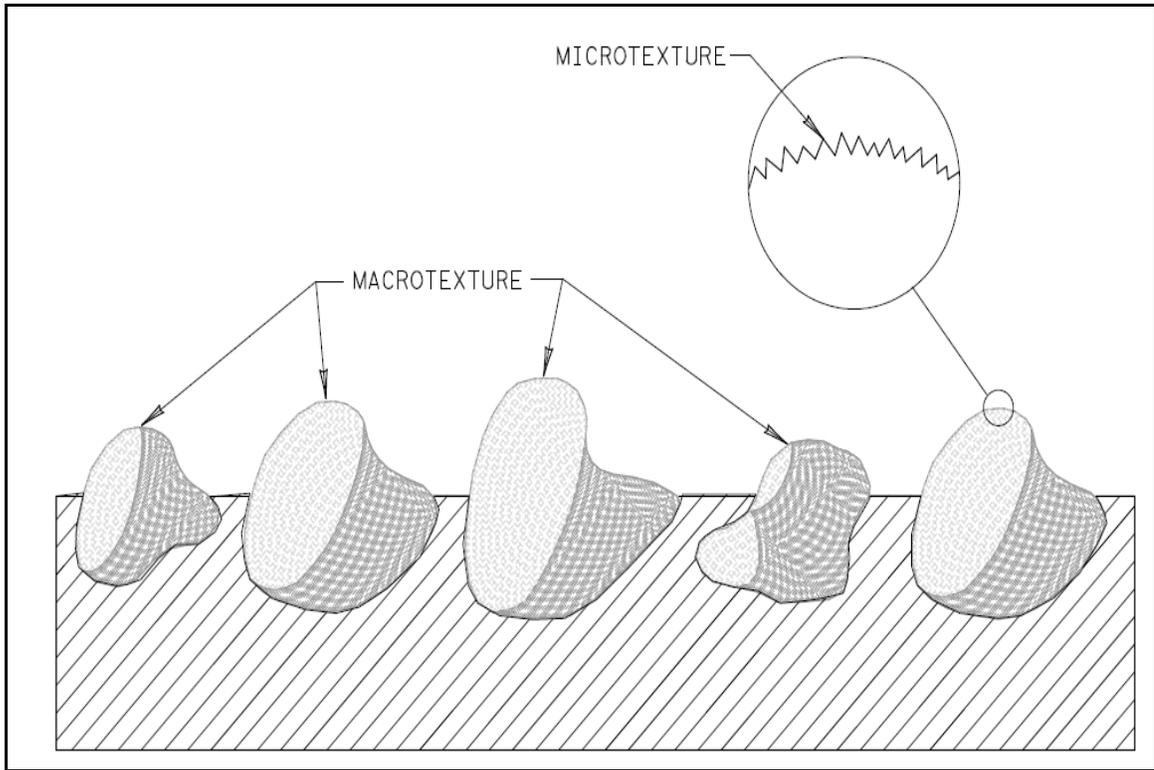
Figure 2.1. Macrotexture and microtexture representation

Figure 2.1 shows the difference between macrotexture and microtexture.

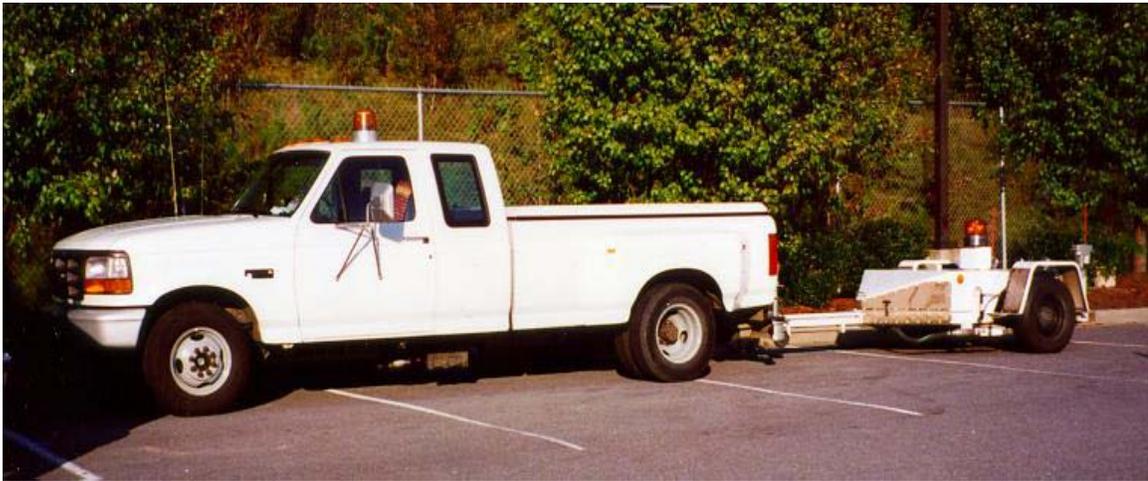
Figure 2.2 Skid Trailer (North Carolina Department of Transportation)

Figure 2.2 shows a skid trailer used by the North Carolina Department of Transportation.

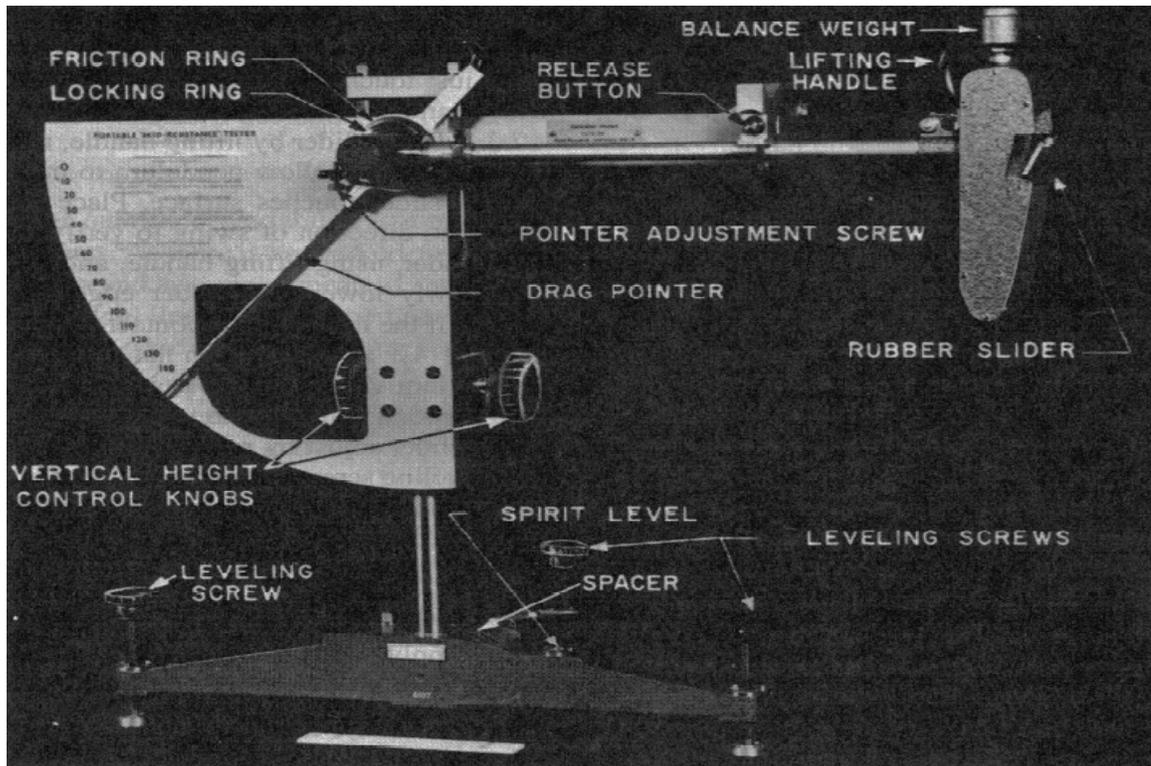
Figure 2.3. British Pendulum (ASTM International, 2007)

Another technique used for measuring skid resistance is the British Pendulum Tester (BPT) which is described in ASTM E 303 – 93 (ASTM International, 2007). It works by releasing a pendulum fitted with a rubber shoe which makes contact with the road surface. This device works by measuring the extent to which the pendulum is retarded when it comes in contact with the surface. The speed at which the pendulum contacts the surface is relatively low (approximately 10 km/hr). This device is mainly used for measuring microtexture and skid resistance at low speeds. This is important to determine the quality of aggregates used. In contrast to the skid trailer, this device is easy to carry and more affordable. The British Pendulum Tester is not capable of taking continuous measurements at highway speeds, making labor intensive if large amounts of data are required. It has been used to investigate the relationships between skid resistance and crashes (Cairney, 1997).

Figure 2.3 shows all of the different parts of the British Pendulum.

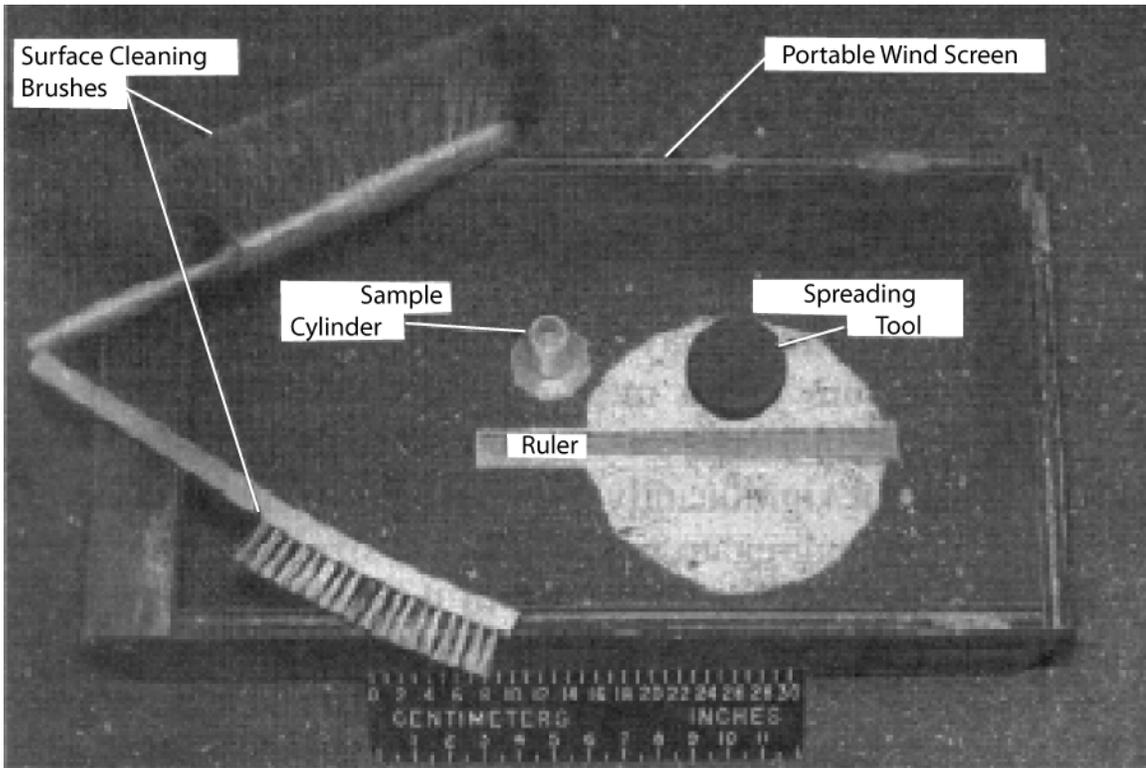
Figure 3.1 Tools used for performing the sand patch test

The materials needed to perform this test include a known quantity of sand, a container of known volume, a screen, a brush for cleaning the pavement surface of any loose debris, a flat tool for spreading the sand on the pavement, and a ruler for measuring the area covered by the sand. Figure 3.1 shows the various tools used for the Sand Patch Method.

The test involves spreading a known volume of sand on a dry and clean section of pavement. The section of pavement chosen to be measured should not have any localized characteristics such as crack and joints. The selected area is cleaned of any loose aggregate or debris using the brush. The screen is placed around the section being measured. The container of known volume is filled with sand and gently tapped at the bottom several times on a hard surface. This helps the sand to settle. More sand is added to the container until it is full to the top and leveled using a straightedge. The measured volume of sand is poured on the cleaned surface with the area protected by the screen. The sand is spread into a circular patch with the disk tool filling the pavement voids flush with the aggregate tops. The diameter of the circular area covered by the sand is then measured at a minimum of four equally spaced locations around the

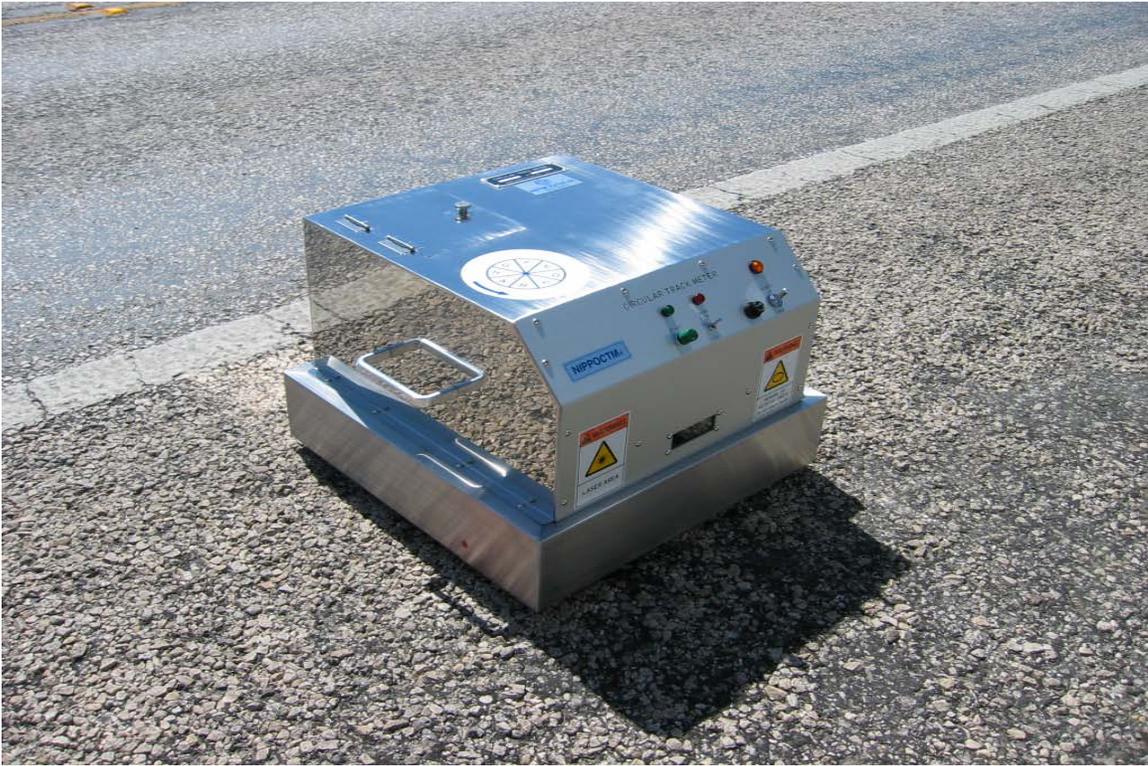
Figure 3.2 Circular Track Meter

The volumetric MTD was found to be linked to the speed constant of the International Friction Index. The MPD obtained by the CTM is also linked to the MTD and can replace the volumetric measurement obtained using the Sand Patch Method described in ASTM E 965 (ASTM International, 2007) for determination of the MTD.

Figure 3.2 shows the Circular Track Meter.

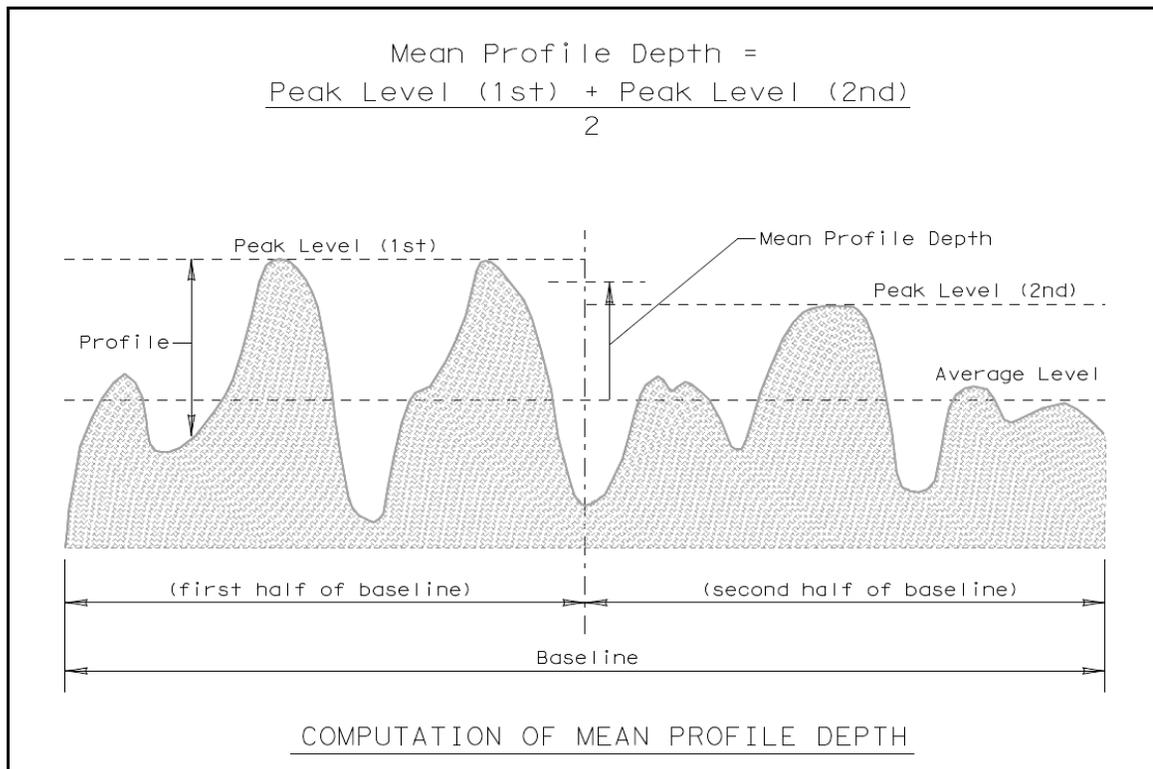
Figure 3.3 Procedure for Computing Mean Profile Depth (MPD)

highest peak in each half of the segments is determined. The difference between that height and the average level of the segment is calculated. The MPD is the average value of these differences for all segments of the measured profile.

Figure 3.3 illustrates the calculation procedure for the MPD.

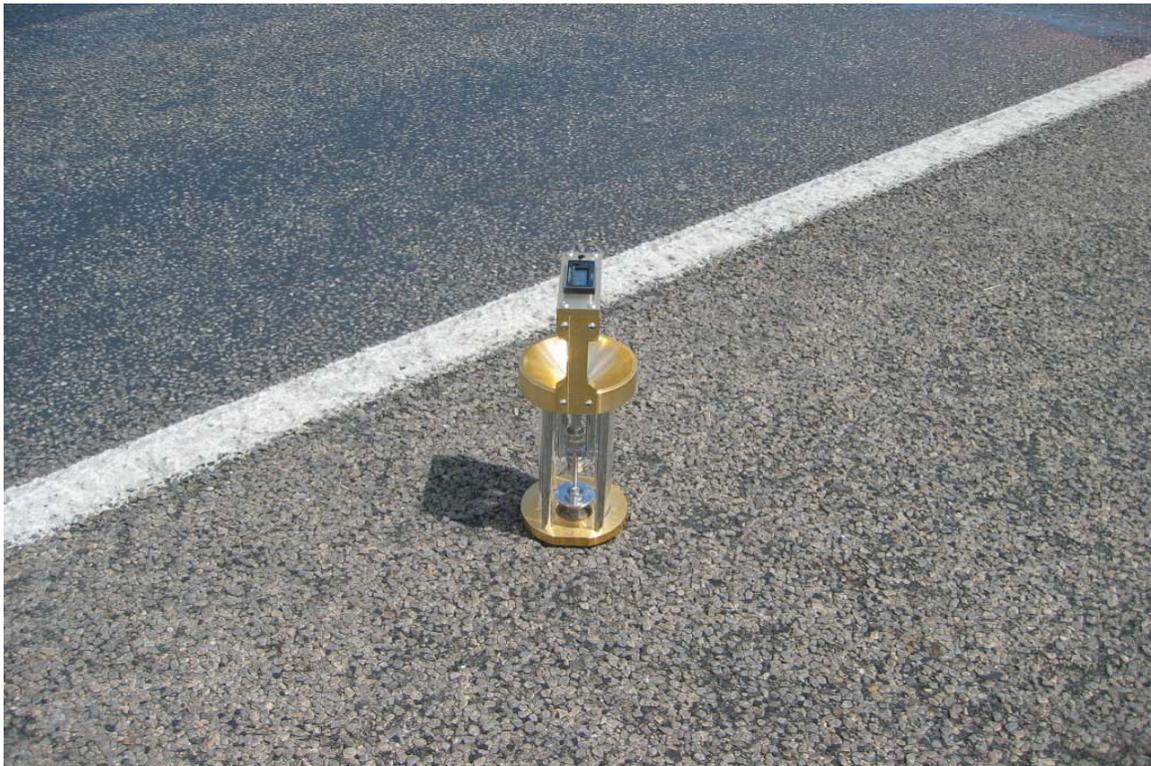
Figure 3.4 Outflow Meter

pavement. This test provides an indication of the ability of the pavement to relieve water pressure from the vehicle tires. This would provide the engineer a clear indication of hydroplaning potential under wet weather conditions. The faster the water escapes from the outflow meter, the least amount of water that may be present between the tire and the pavement therefore improving the amount of friction between the tire and the pavement. In other words, the faster the water escapes the outflow meter, the more texture the pavement has, which finally would improve friction. The higher coefficient of friction would reduce a vehicle's stopping distance. This would then translate to fewer crashes, especially in adverse weather conditions when friction is compromised. Figure 3.4 shows the OFM.

The outflow meter consists of a vertical cylinder for holding the water. It is opened on the top and bottom with a rubber gasket around the bottom opening in order to create a seal against the surface being measured. Water is discharged through the bottom opening and it is controlled by a spring plunger. Two float switches are located inside the cylinder and wired to an electronic timer located on top of the outflow meter. With the plunger closing the bottom or discharge opening, the outflow meter is placed on the desired surface to be measured. The outflow meter device is placed on the pavement making sure that it is stable and that the rubber seal uniformly makes contact with the pavement surface. The cylinder is then filled with enough water to activate the top float switch. The timer is reset and the plunger is released allowing the water to be discharged through the bottom opening. As water escapes the outflow meter, it triggers the first float switch, which causes the timer to start counting. As the water goes down, it triggers the bottom float switch causing the timer to stop. The time that it took for the water to drain from the top switch to the bottom switch is shown on the timer. This is known as the outflow time.

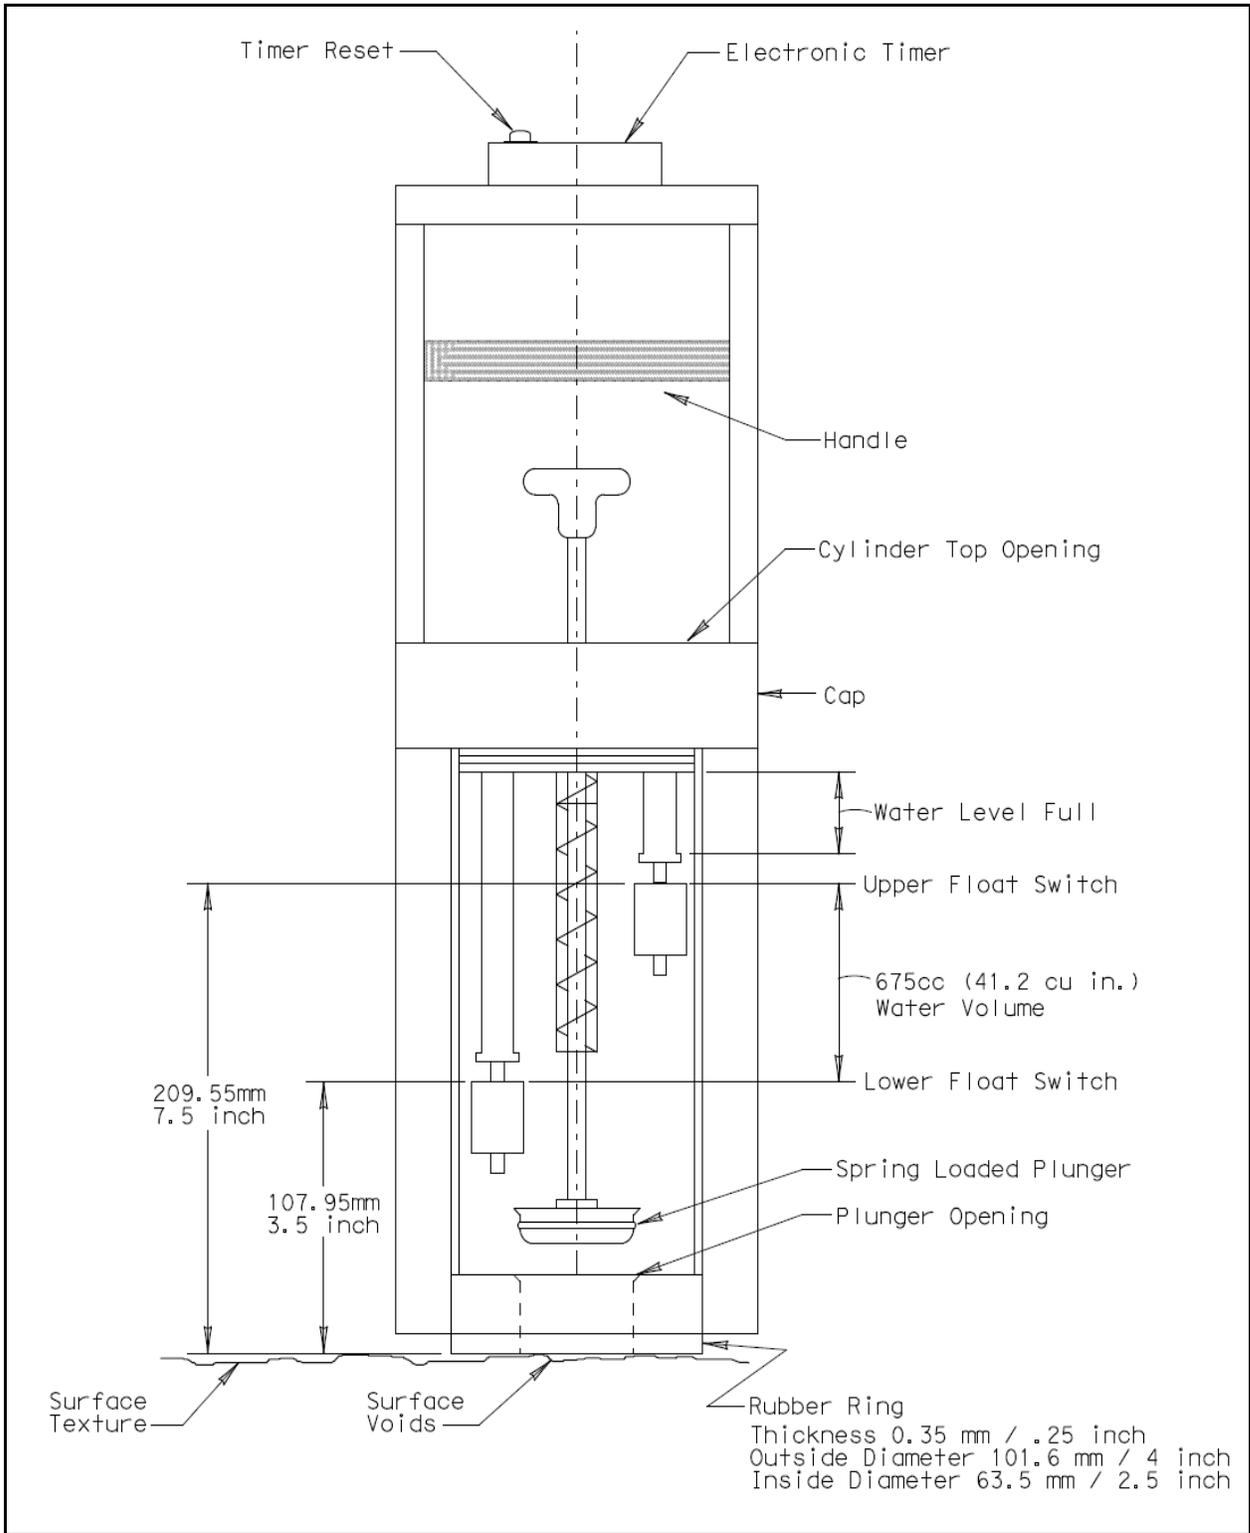
Figure 3.5 Outflow Meter Diagram (ASTM International, 2007)

Figure 3.5 shows a diagram of the Outflow Meter with its different parts.

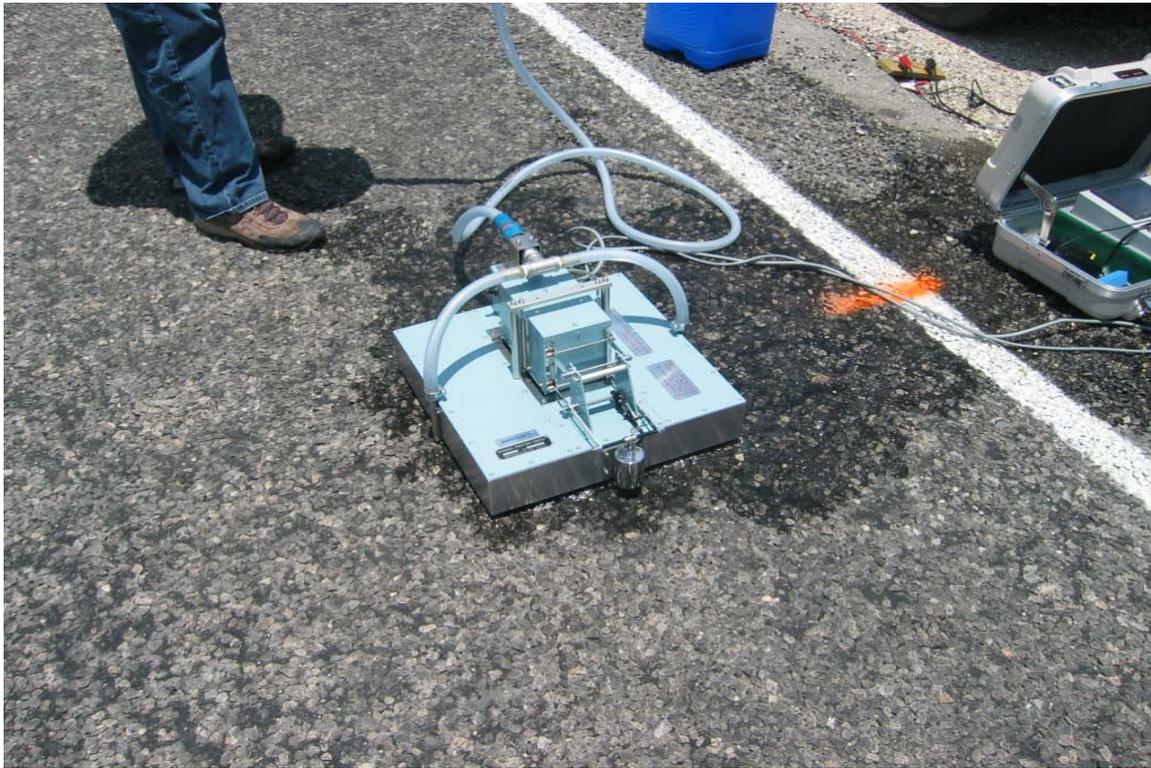
Figure 3.6 Dynamic Friction Tester

Figure 3.6 shows the Dynamic Friction being used on RM 1376 in Kendall County. This section is representative of a new seal coat.

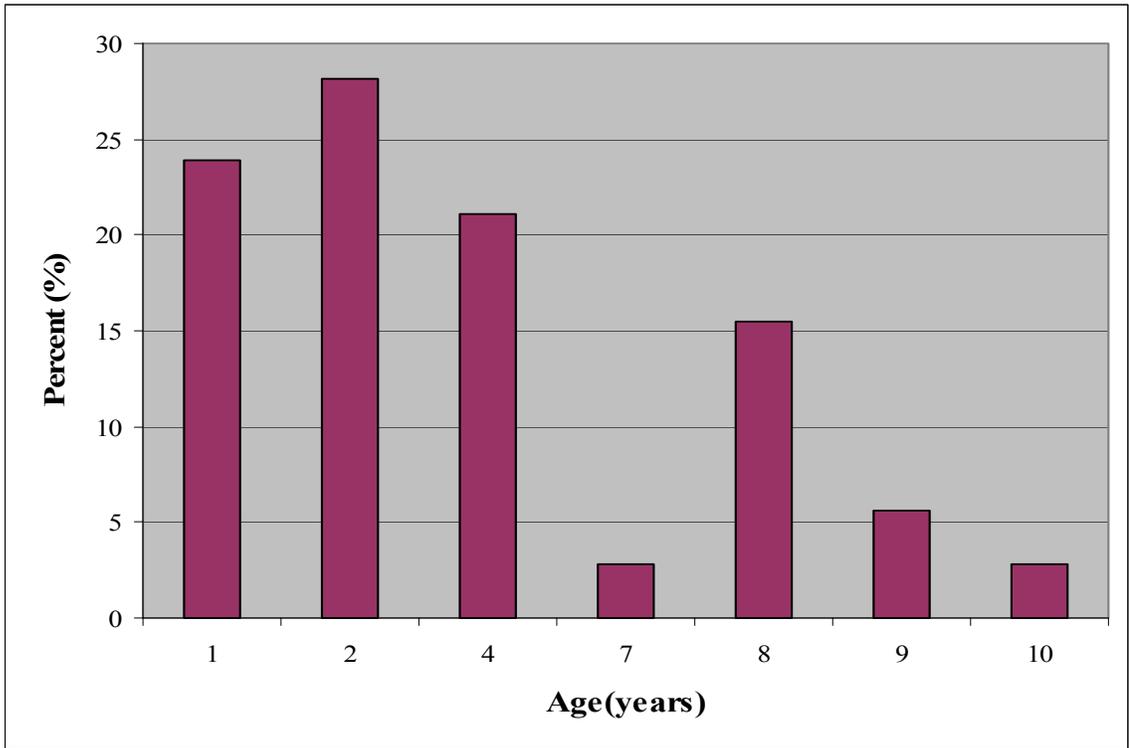
Figure 4.1 Seal coat sections distribution by age

Figure 4.1 shows a distribution according to age of all the seal coat sections for which data was collected using the Outflow Meter (OFM) and the Circular Track Meter (CTM).

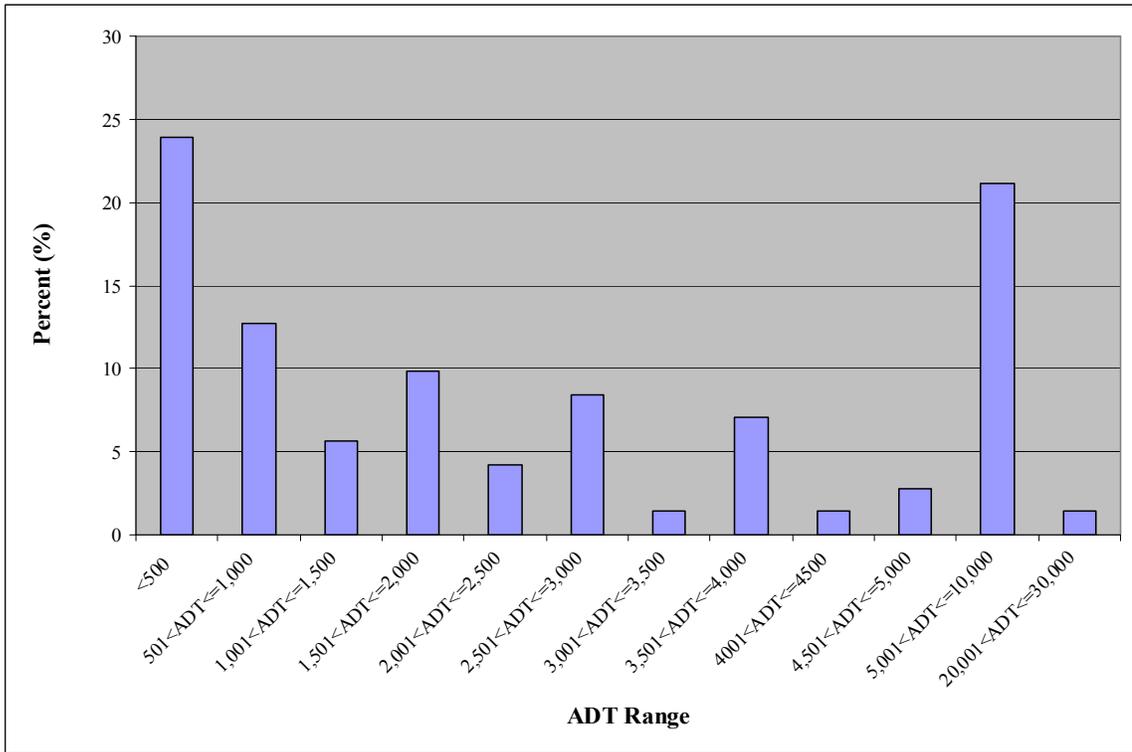
Figure 4.2 Seal coat sections distribution by age

Figure 4.2 shows the distribution according to ADT of all seventy one seal coat sections surveyed.

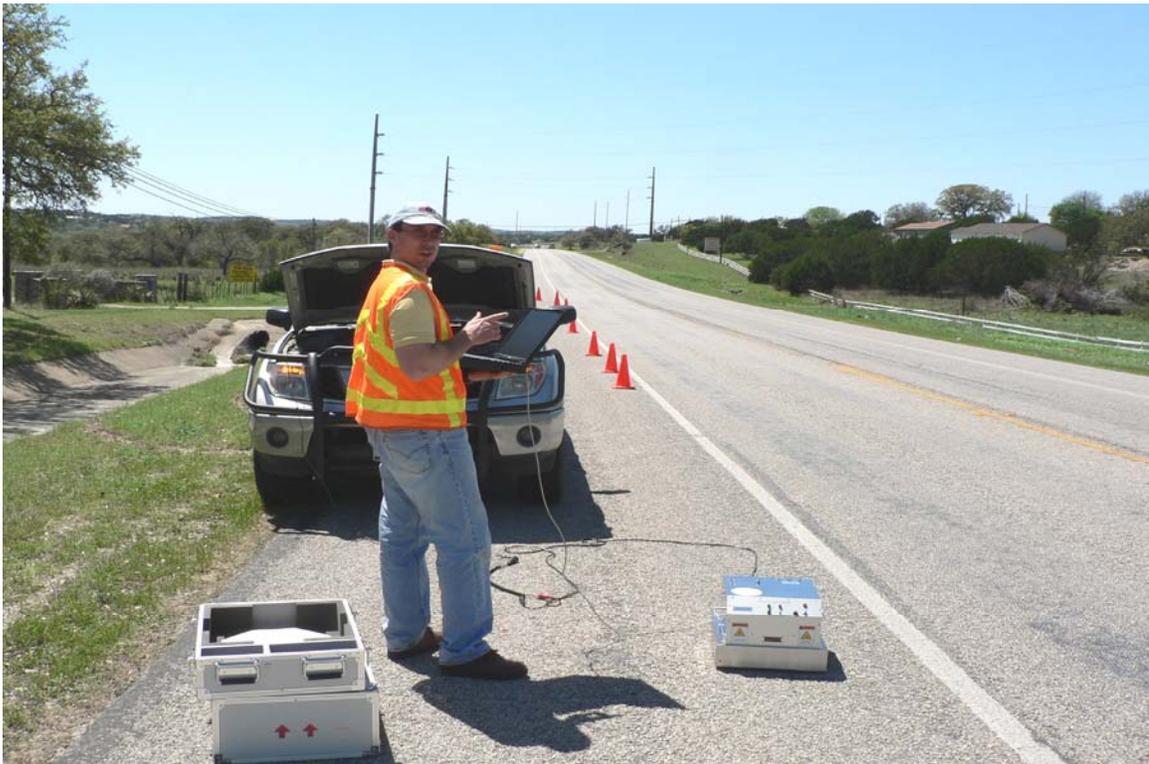
Figure 4.3 Data collection using the CTM

Figure 4.3 shows the data collection using the CTM.

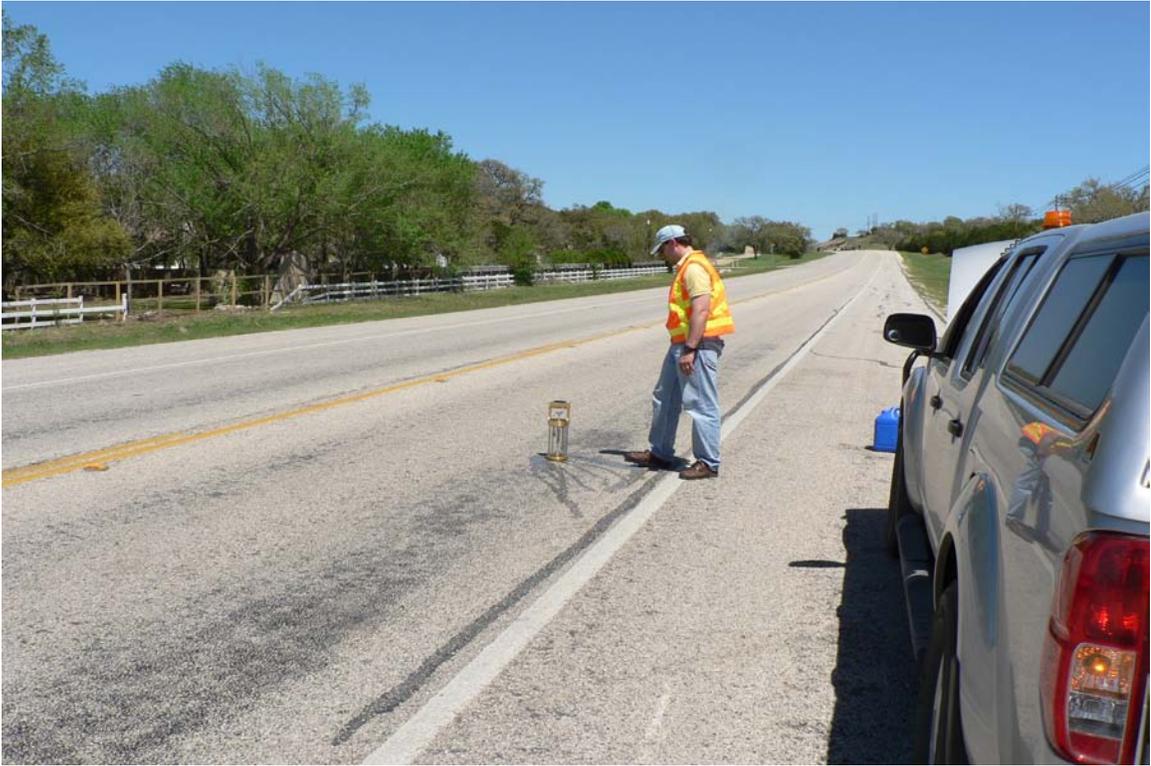
Figure 4.4 Data collection using the OFM

Figure 4.4 shows the data collection on the right wheel path using the outflow meter.

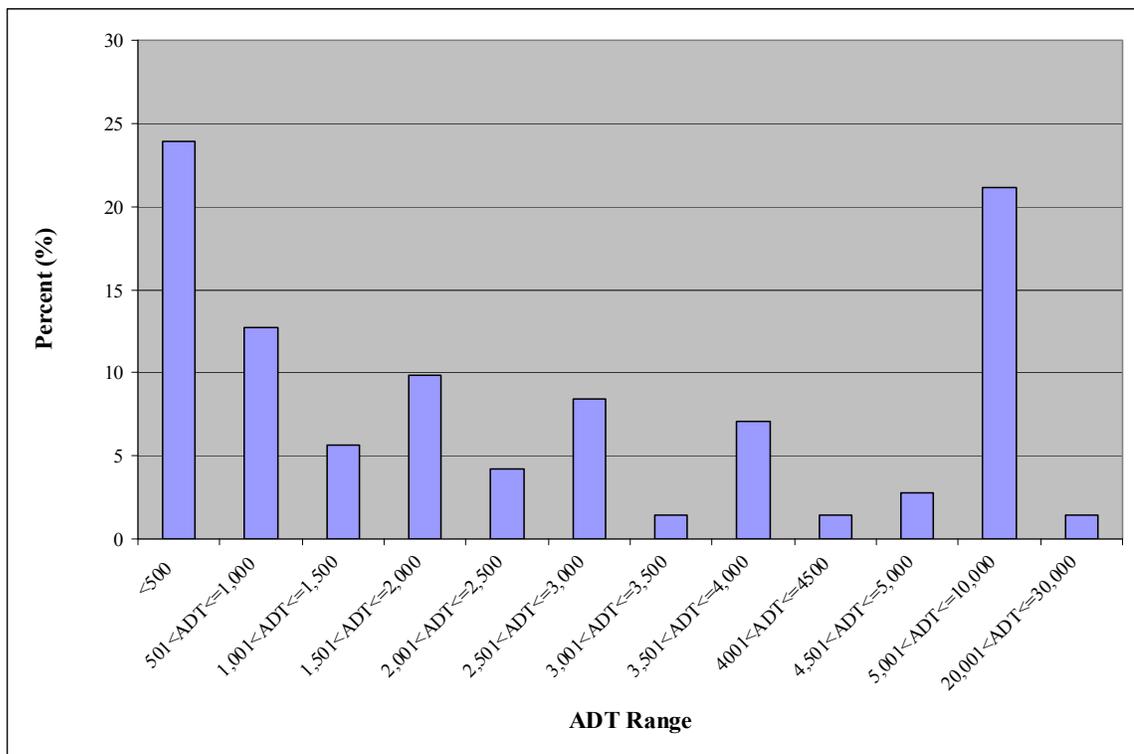
Figure 5.1 Seal coat sections distribution by ADT

Figure 5.1 shows the frequency distribution of seal coat sections per ADT class in percentage form. A total of seventy one sites were tested. All seventy one sections tested are part of TxDOT's San Antonio District. The San Antonio District carries out a seal coat program every year during the summer months. The seal coat plans are prepared in-house by TxDOT's engineers and technicians.

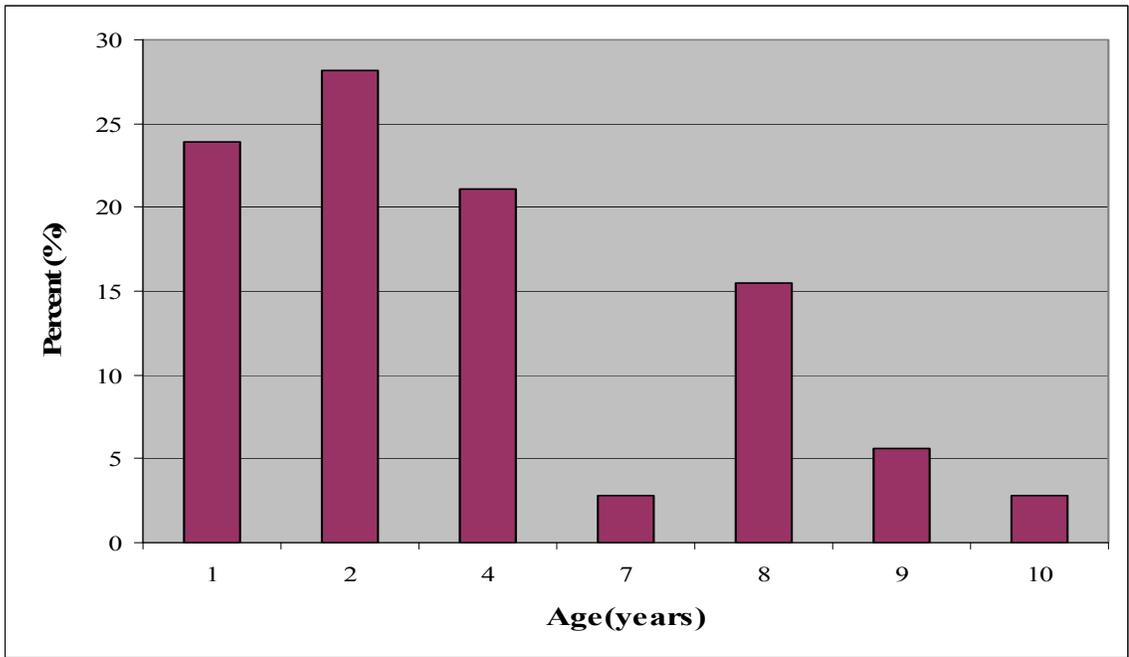
Figure 5.2 Seal coat sections distribution by age

Figure 5.2 shows the frequency distribution of all seventy one seal coat sections according to age. As mentioned before, seal coats lasts and average of eight years, therefore older seal coat sections are more difficult to find.

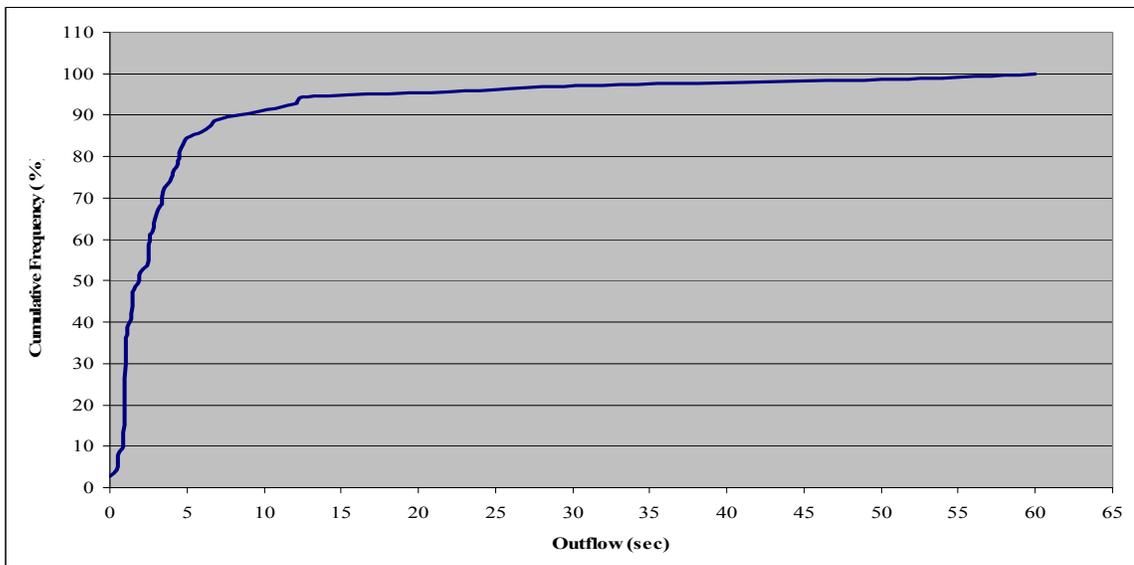
Figure 5.3 Outflow Time Cumulative Frequency

Figure 5.3 shows the cumulative frequency for Outflow Time for the seventy one test sections. The reading for the 50th percentile is about 3 seconds.

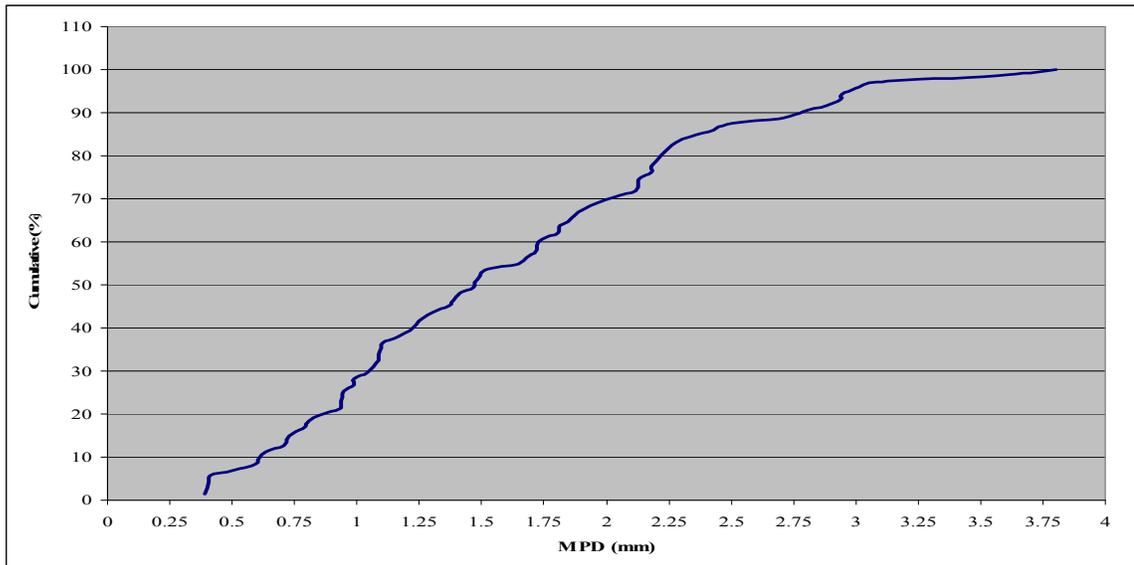
Figure 5.4 MPD Cumulative Frequency

Figure 5.4 shows the cumulative frequency for MPD for the seventy one test sections. The MPD for the 50th percentile is about 1.6 mm.

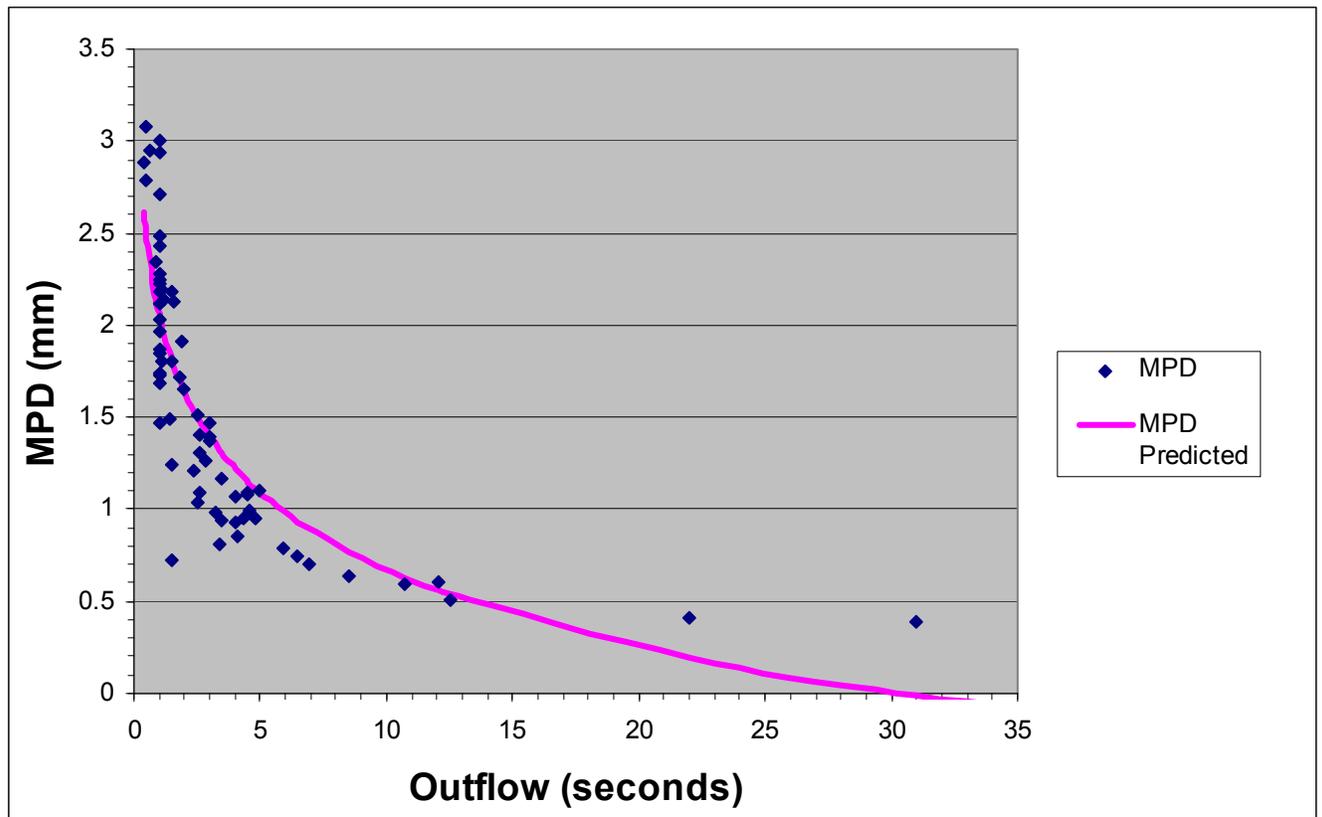
Figure 5.5 MPD vs. OFT

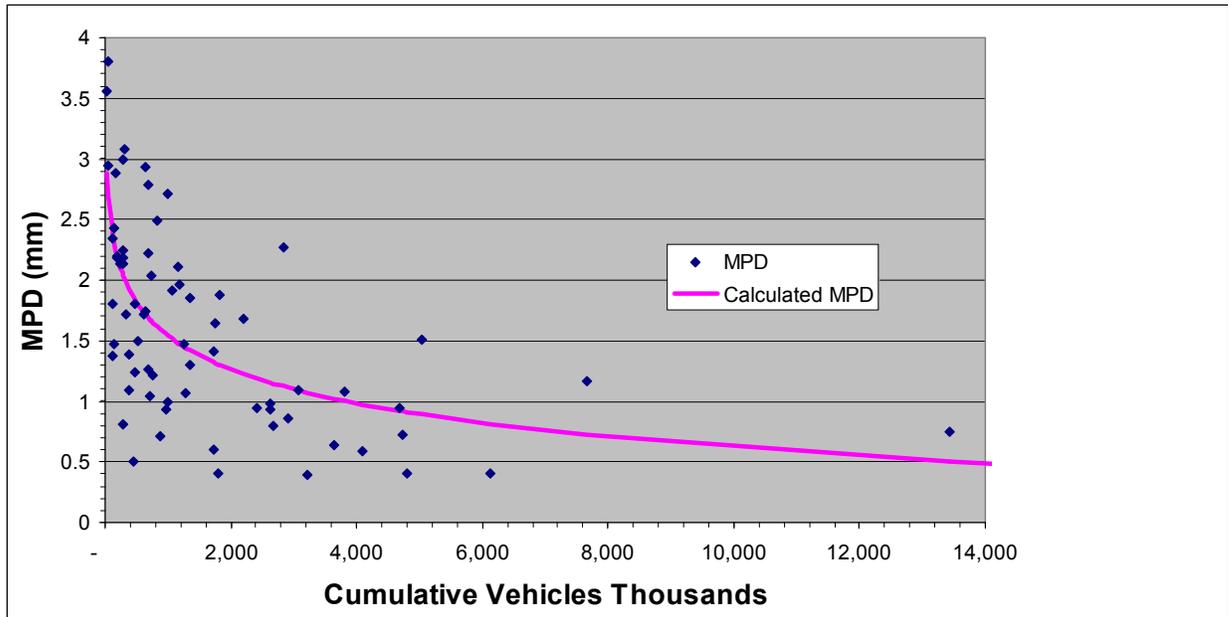
Figure 5.6 Seal Coat Performance Curve in Terms of MPD

Figure 5.6 shows how MPD decreases as the number of cumulative vehicles increases. A new seal coat will deteriorate quickly at first because the aggregate gets reoriented and pushed into the binder by the vehicles going over it. The deterioration will then slow down until it becomes asymptotic towards the right of the graph. Using this figure and the Cumulative Traffic Equation (5-2), the age at which a road will reach a certain MPD can be calculated. This method can be used to predict the service life of a seal coat. The failure and remaining life issue will be discussed in more detail in the next chapter. Equation 5-3 represents the correlation between MPD and Cumulative Vehicles.

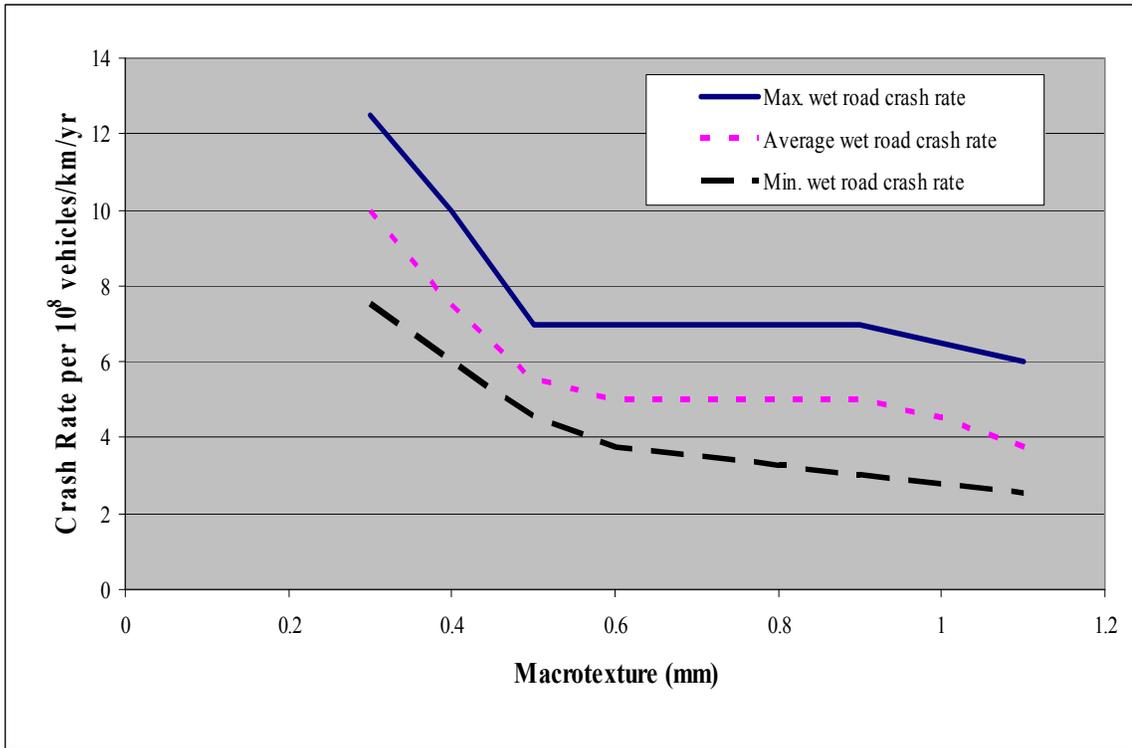
Figure 6.1 Relationship between macrotexture and wet road crash rate (Cairney, 2006)

In a similar research, Gothie (1993) reports a study involving wet-road crashes and macrotexture. The study covered 215 km of national roads in the Alpes region of France with an average daily traffic of approximately 10,000 vehicles. The study included 201 wet-road crashes over a period of almost five years. The relationship between crashes and macrotexture can be seen in figure 6.1. The top line represents the maximum wet road crash rates, the middle line the mean and the bottom line the lowest wet road crash rate. It can be seen that crash rate increases considerably when macrotexture drops below 0.5 mm. The x-axis represents macrotexture and the y-axis the wet road crash rate per 10^8 vehicles/km/year (Cairney, 2006).
