**EVALUATION OF SEAL COAT PERFORMANCE USING MACRO-TEXTURE
MEASUREMENTS**

Research Report Number 0-5310-3

“Evaluation of a System for Measuring Seal Coat Quality”

THE UNIVERSITY OF TEXAS AT SAN ANTONIO

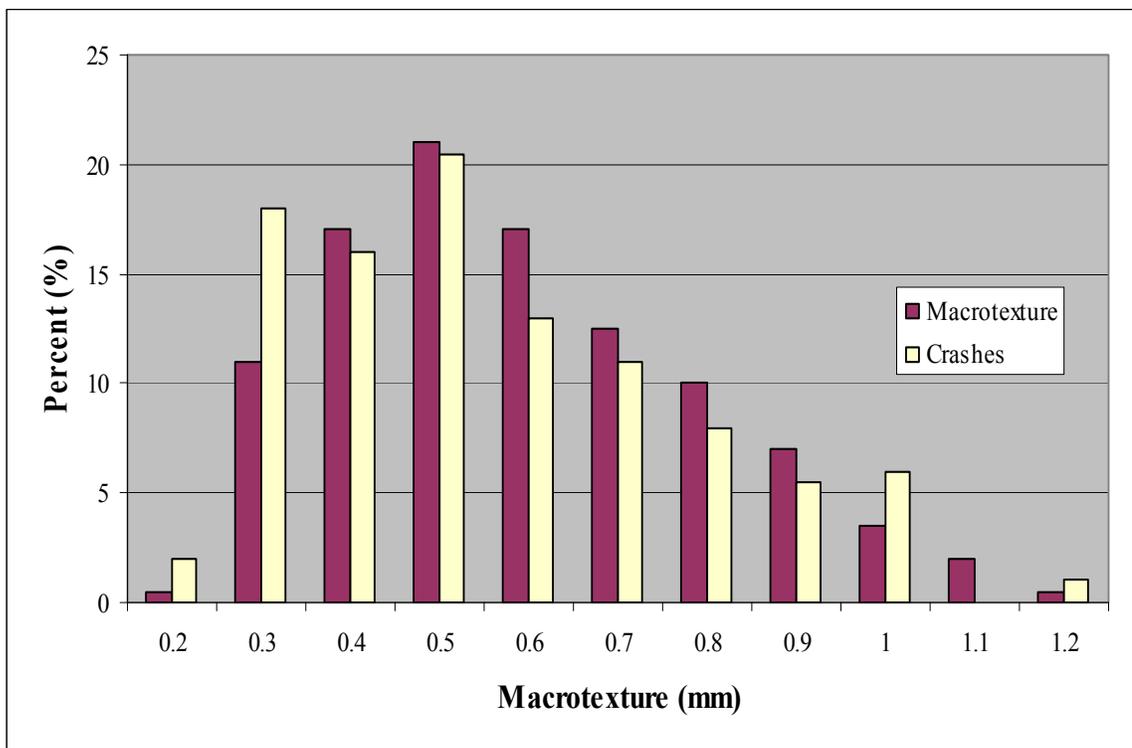
Figure 6.2 Relationship between macrotexture on all sites and at crash sites for Princes Highway West, rural (Cairney, 2006)

Two significant observations were made for this study. First, there was no increase in the percentage of low macrotexture sites for wet weather crashes. Second, there was a significant increase in the percentage of crashes for low macrotexture sites at intersections. This shows that there is no relationship between macrotexture and crashes occurring in wet weather. However, these data show that crashes are more likely to occur at intersections where unexpected braking is more likely (Cairney, 2006).

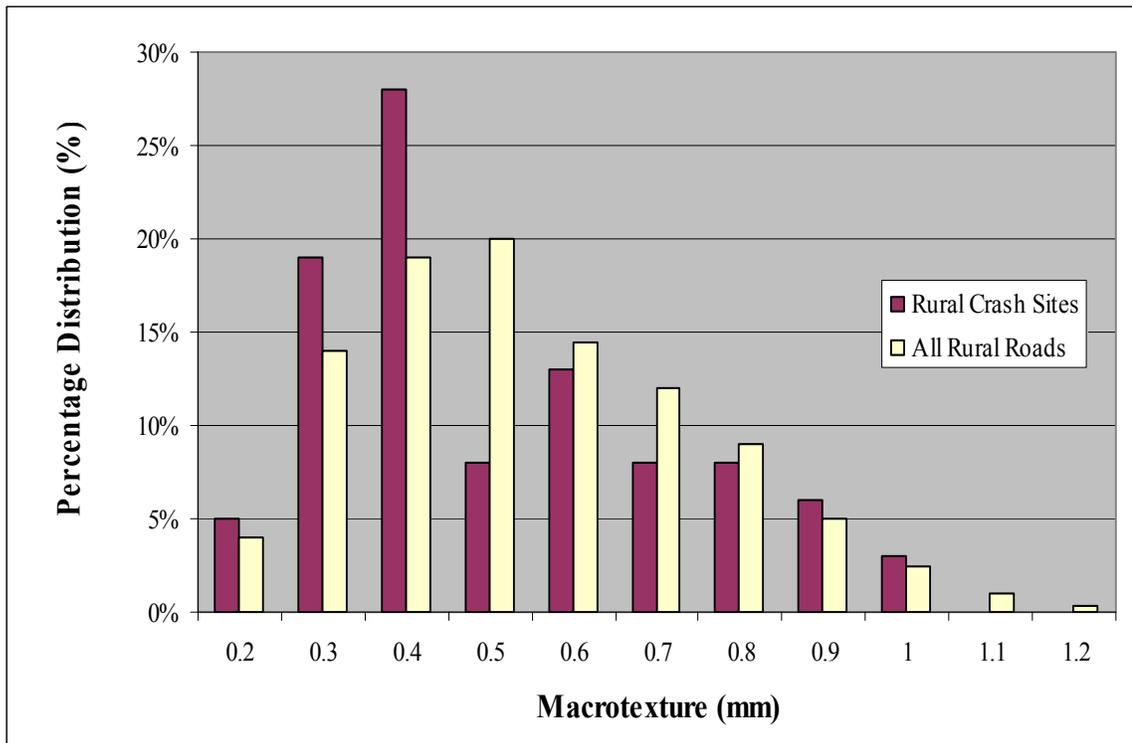
Figure 6.3 Relationship between macrotexture on all sites and at crash sites (Cairney, 2006)

The relationship between macrotexture and crash sites can be seen in figure 6.3. For sites with a SMTD of 0.4 mm or less, there is a greater percentage of crash sites than for all sites. The opposite is true for sites with an SMTD of 0.5 mm or greater, except for sites in the upper SMTD range of 0.90 and 1.00 mm, but the number is small. The results may have been affected by not having enough data available.

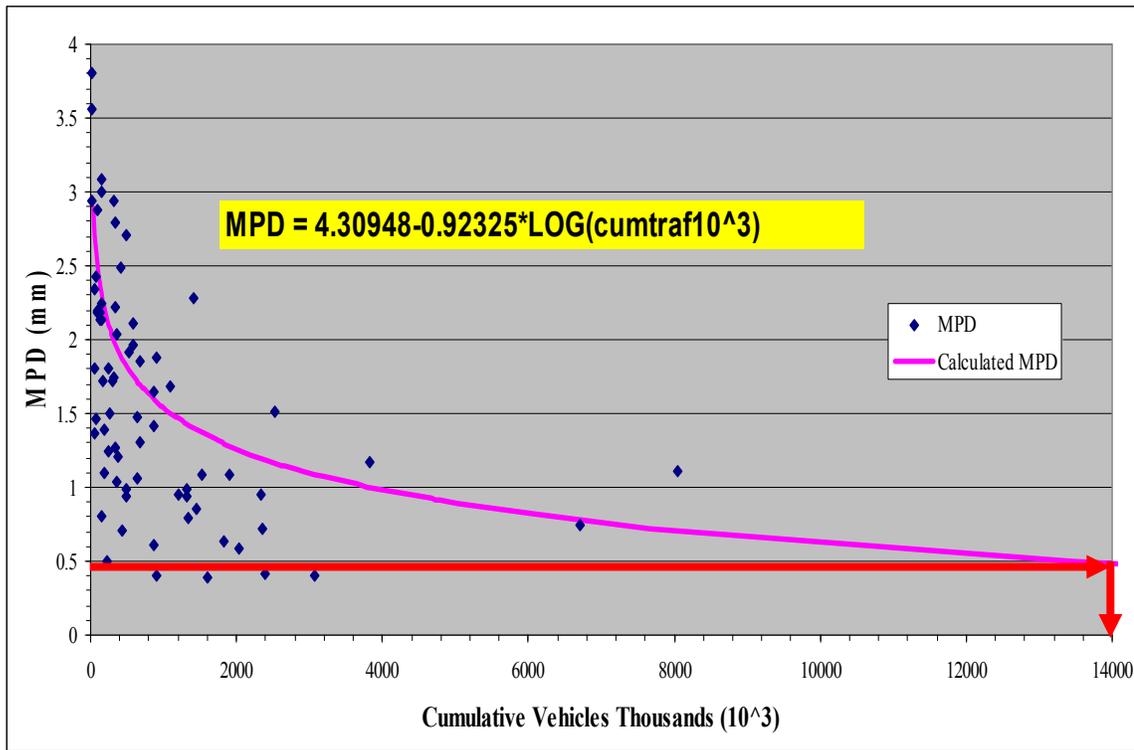
Figure 6.4 Seal Coat Failure Criteria in Terms of MPD and Cumulative Traffic

Figure 6.4 shows that failure occurs on average at a cumulative traffic of 14×10^6 vehicles, which corresponds to an age of 8 years for a bi-directional ADT of 9,500 vehicles per day. This may be shown by substituting the 9,500 bidirectional ADT in Equation 5-2 and calculation for age.

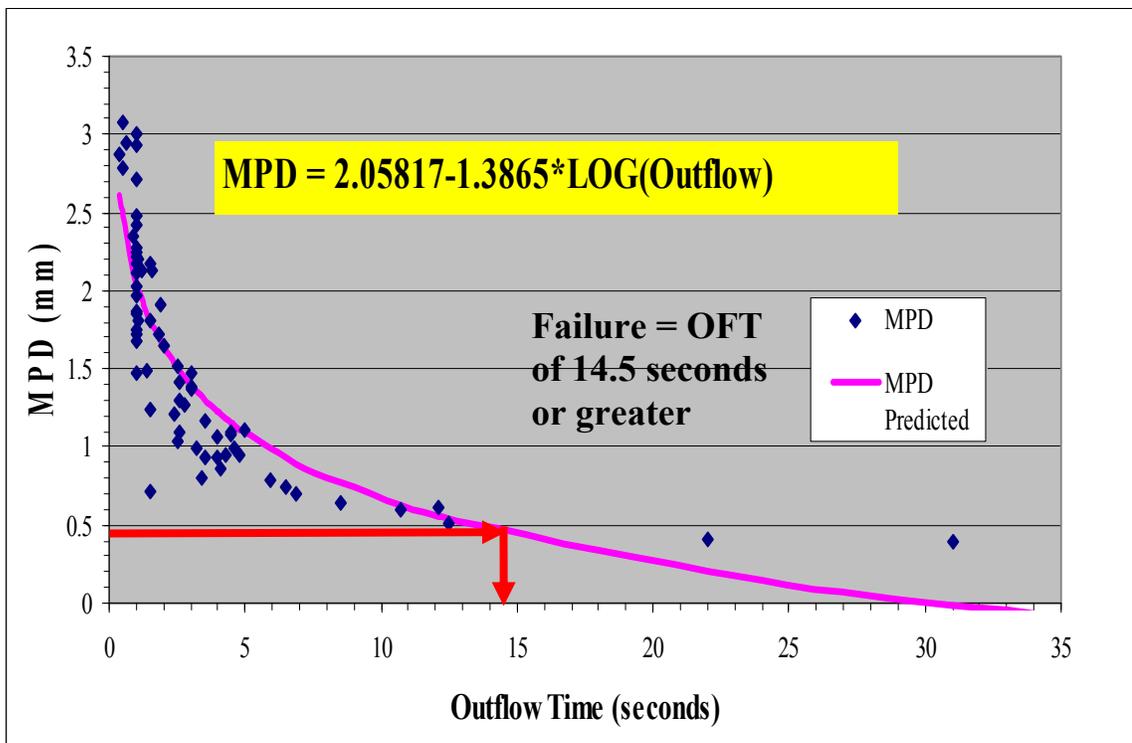
Figure 6.5 Outflow Time Failure Criteria

The threshold for failure can be defined as any seal coat road with a mean profile depth of 0.46 mm or less and an outflow time of 14.5 seconds or greater.

$$0.46 = 2.05817 - 1.3865 \times \text{LOG}(\text{Outflow}) \quad (6-4)$$

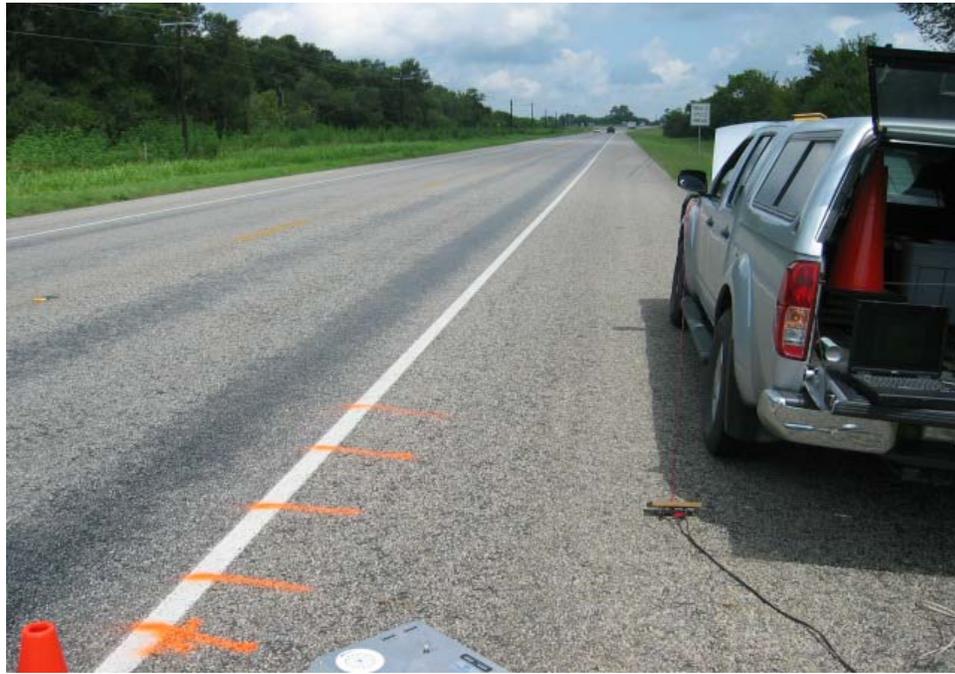
Figure A.3 Seal coat with excessive flushing

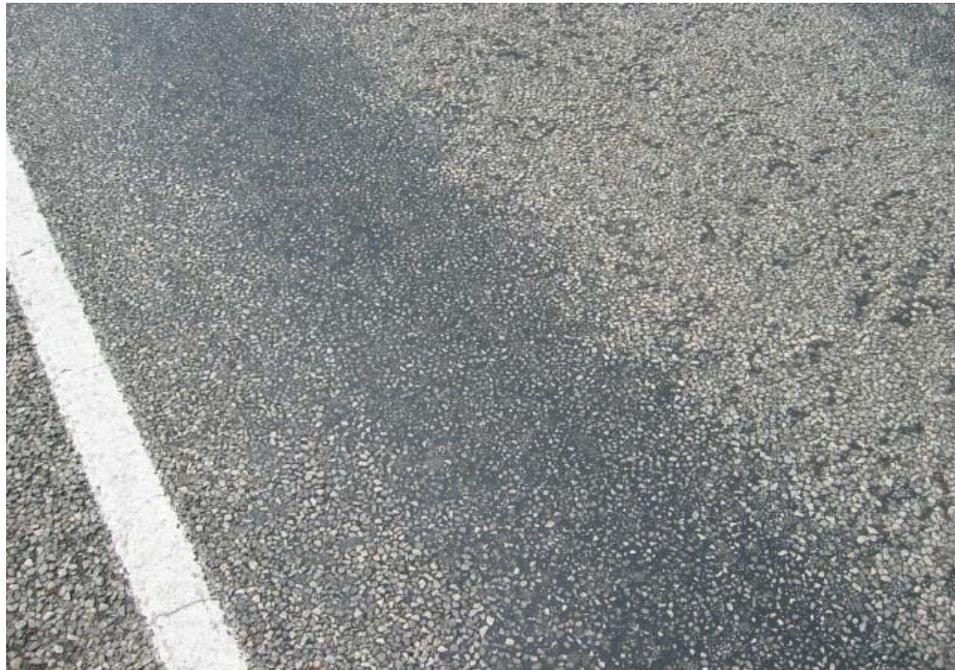
Figure A.4 Close up of seal coat with excessive flushing

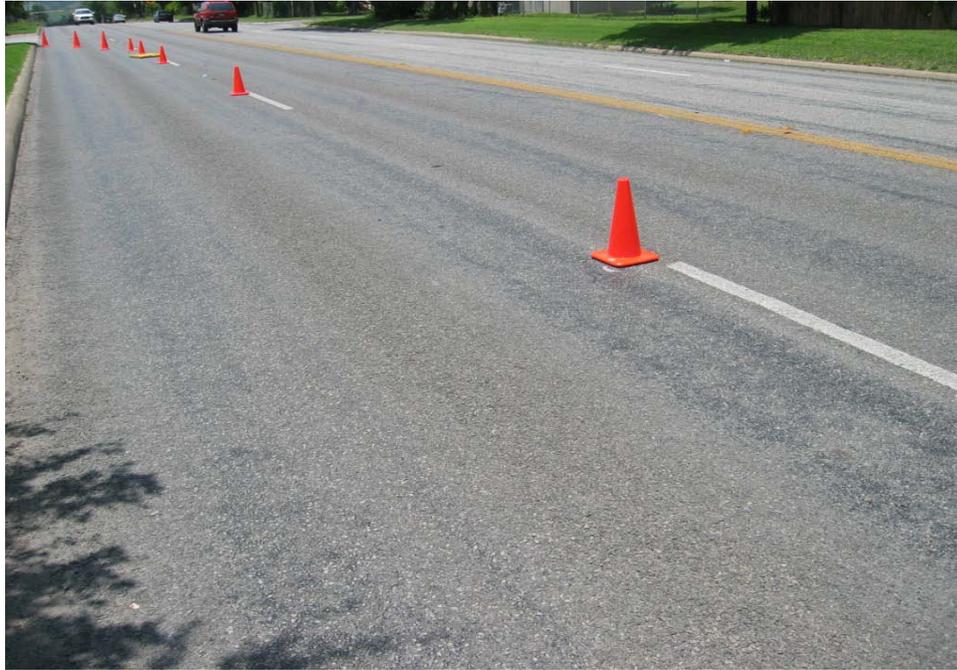
Figure A.5 Seal coat with moderate flushing

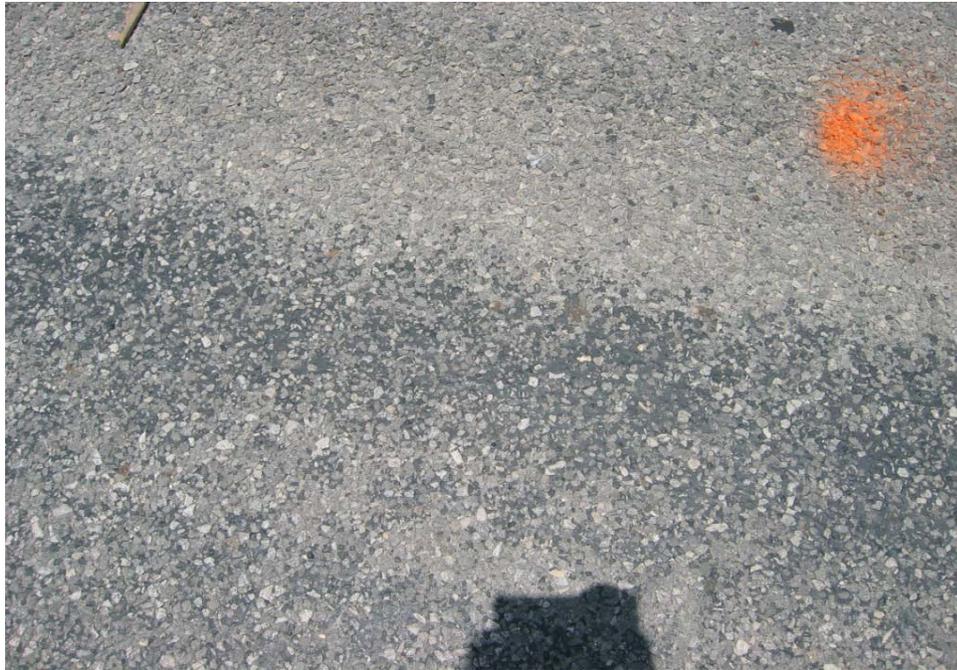
Figure A.6 Close up of seal coat with moderate flushing

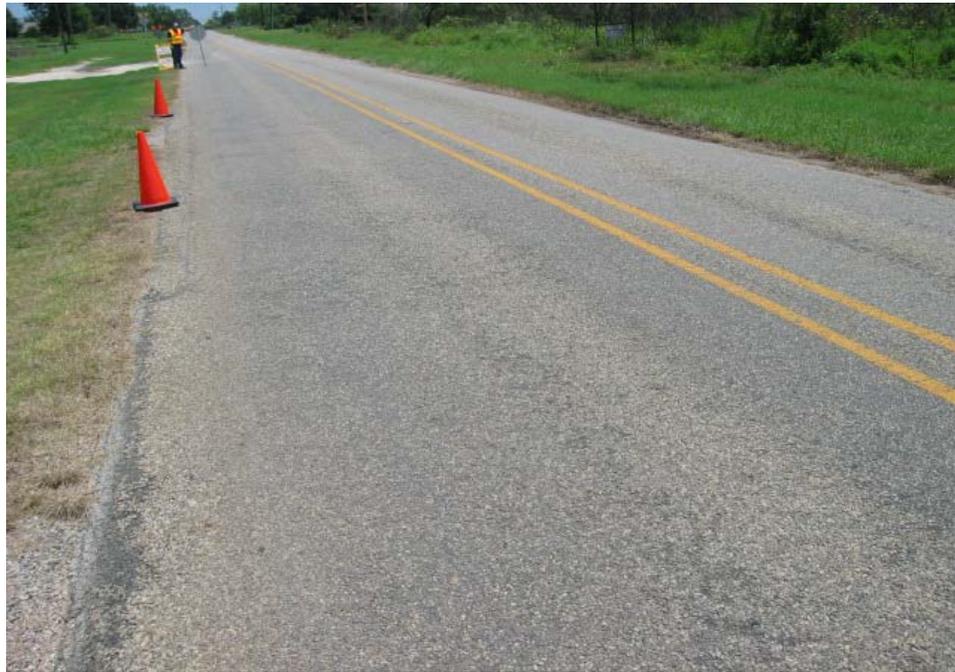
Figure A.7 Seal coat showing little distress

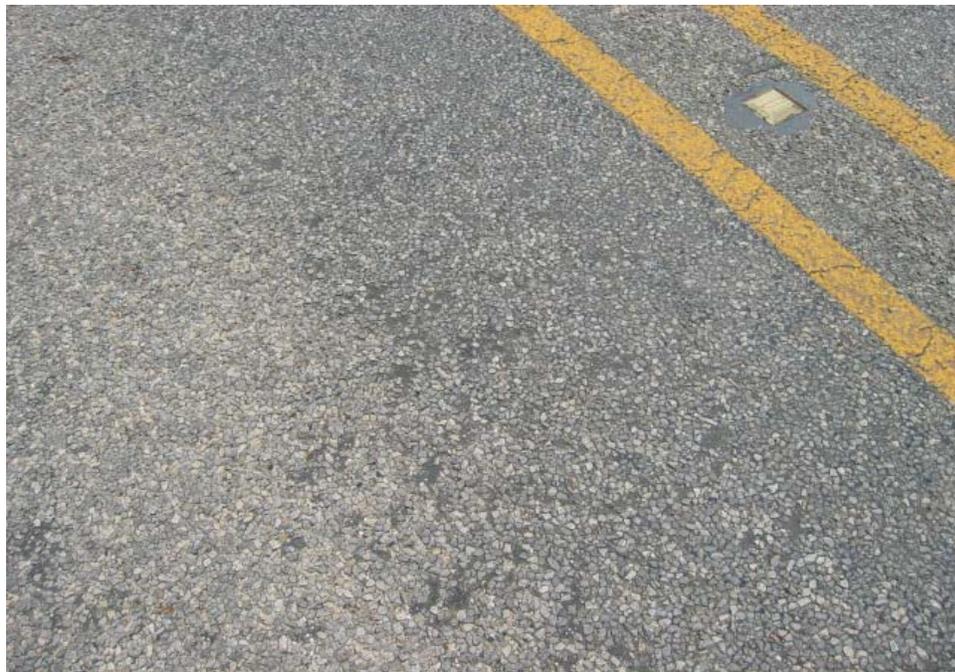
Figure A.8. Close up of seal coat showing little distress
