**MONITORING AND TESTING OF THE BONDED CONCRETE OVERLAY
ON INTERSTATE HIGHWAY 610 NORTH IN HOUSTON, TEXAS**

Research Report Number 920-3

Evaluation of Thin Bonded Concrete Overlay in Houston

February 1989

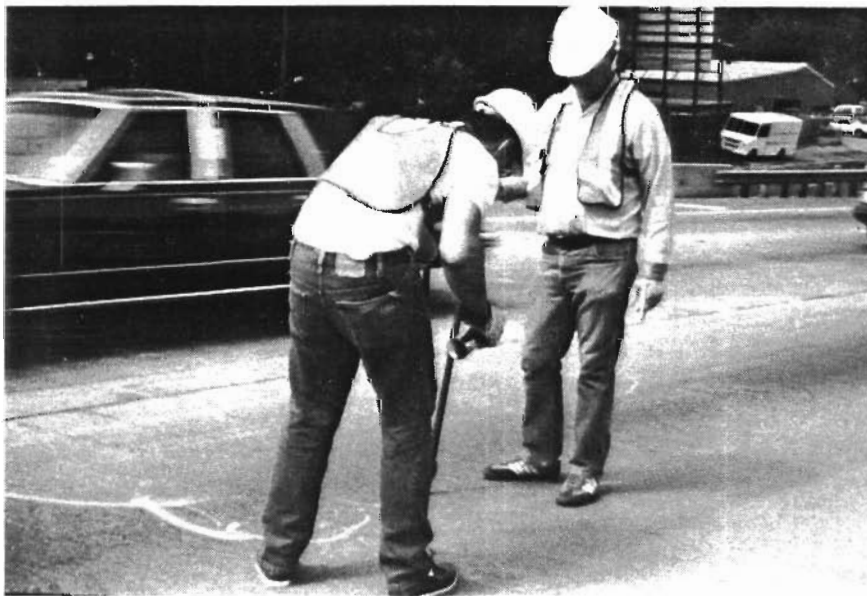
Delaminated areas were located by a technique called sounding (Fig 2.1). This technique required the use of a reinforcing steel bar, preferably No. 6 or 8 about 4 feet long, which was held in a vertical orientation and dropped onto the overlay. A solid sound indicated an absence of delaminations, while a hollow sound indicated the presence of delaminations. The limits of the delaminated areas were delineated by spray paint and were recorded by the recorder onto the scaled one-square-foot squares on the survey forms.

Fig 2.1. Sounding and marking off the delaminated area.

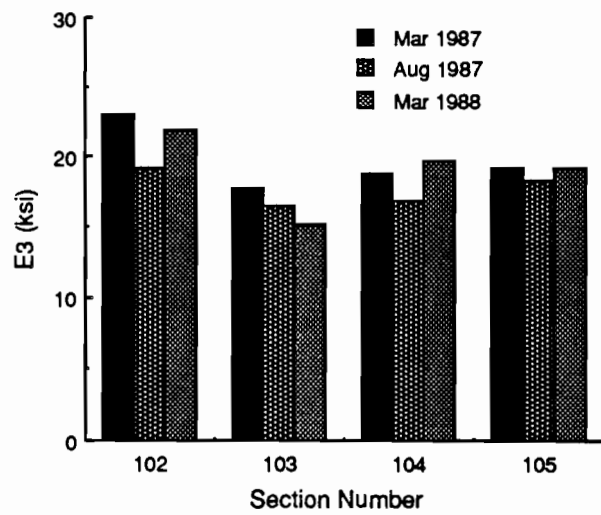
The moduli of elasticity as calculated by RPEDD1 are given in Table 3.3. It can be seen that there were statistically no changes in the moduli of the pavement in sections 102 to 104. However, in section 105 the modulus had decreased. A possible explanation for this could be the large amount of delamination found in this section. Figures 3.8 to 3.10 show the changes in the moduli of elasticity of the structure from March 1987 to March 1988.

Fig 3.8. Modulus of elasticity of PCC slab.

Fig 3.9. Modulus of elasticity of subbase.

Fig 3.10. Modulus of elasticity of roadbed.

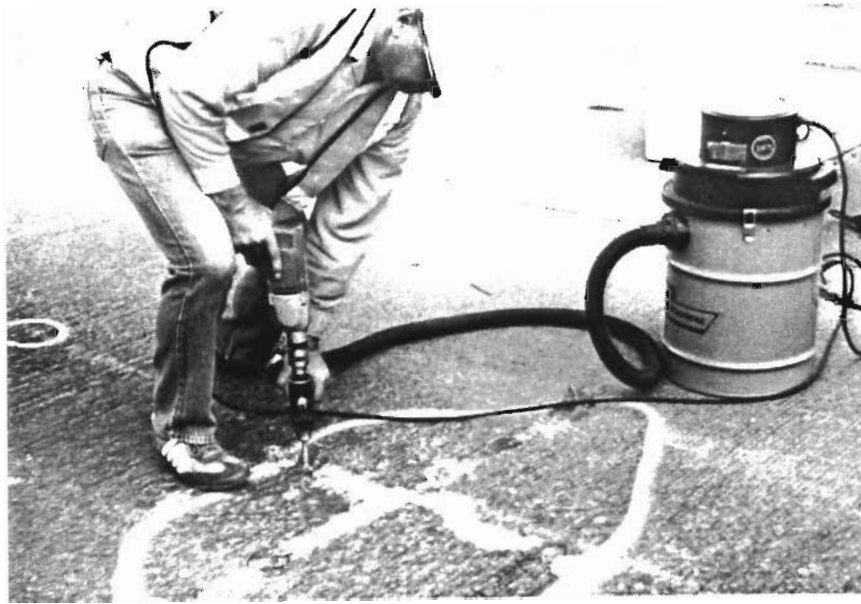
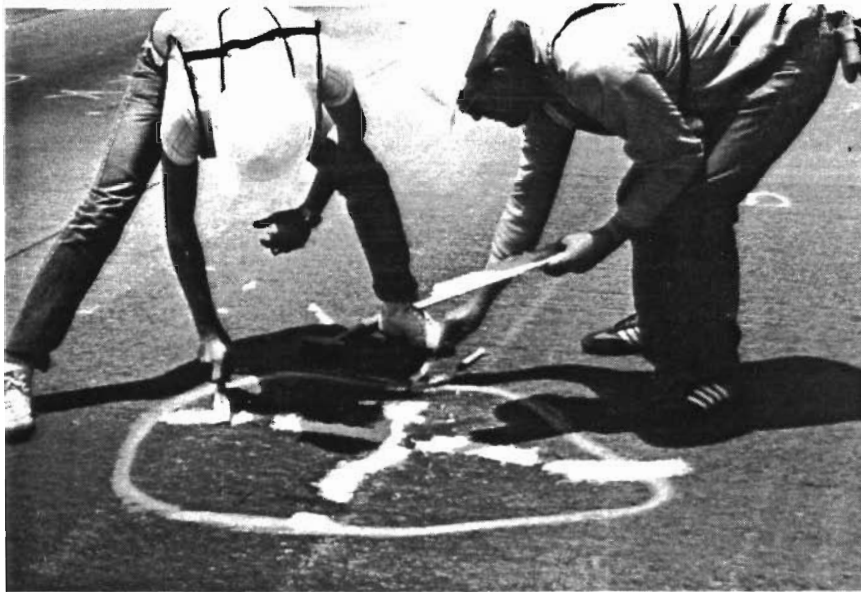
Fig 5.3. Repair of delaminated concrete by monomer injections.

(a) Drilling holes for injection ports.

(b) Installation of injection ports.

(c) Injecting monomer into the delaminated area through the ports.

- (2) Cracks with delaminations (Fig 5.2) and cracks running up significant slopes were injected with monomer. In these cases, injection ports were installed every foot along the crack length, and/or, where voids were present, at one-foot intervals along the void perimeter as marked on the previous condition survey. Monomer was pumped from the void perimeter ports to the cracks first, before any monomer was actually injected through a crack port (Fig 5.3).

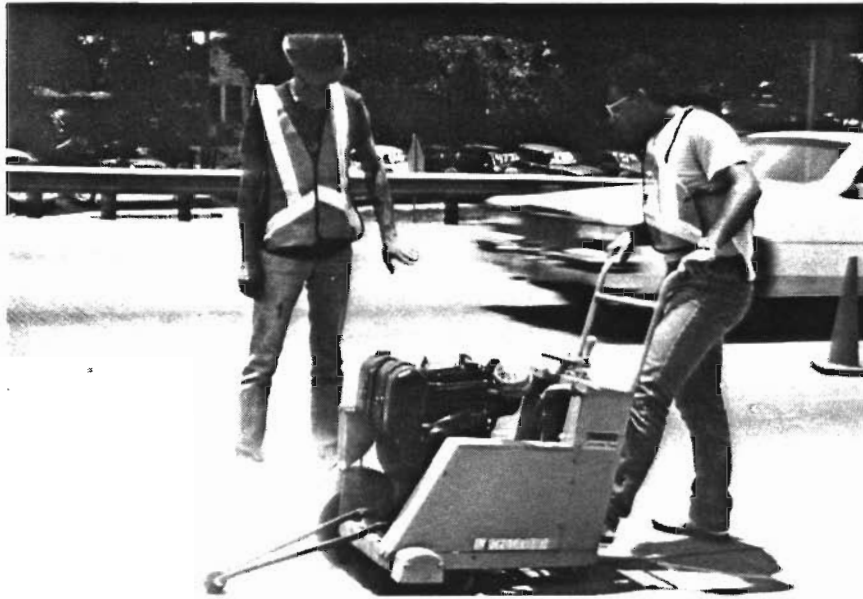
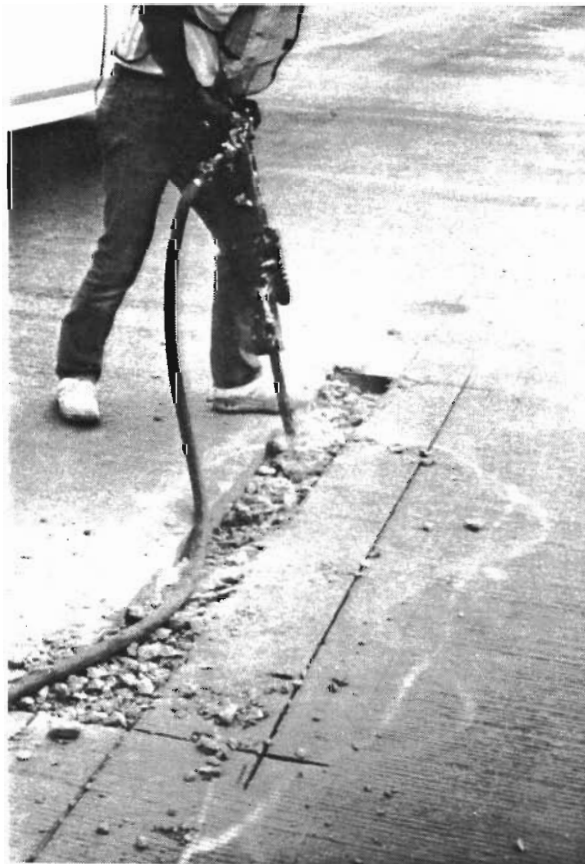
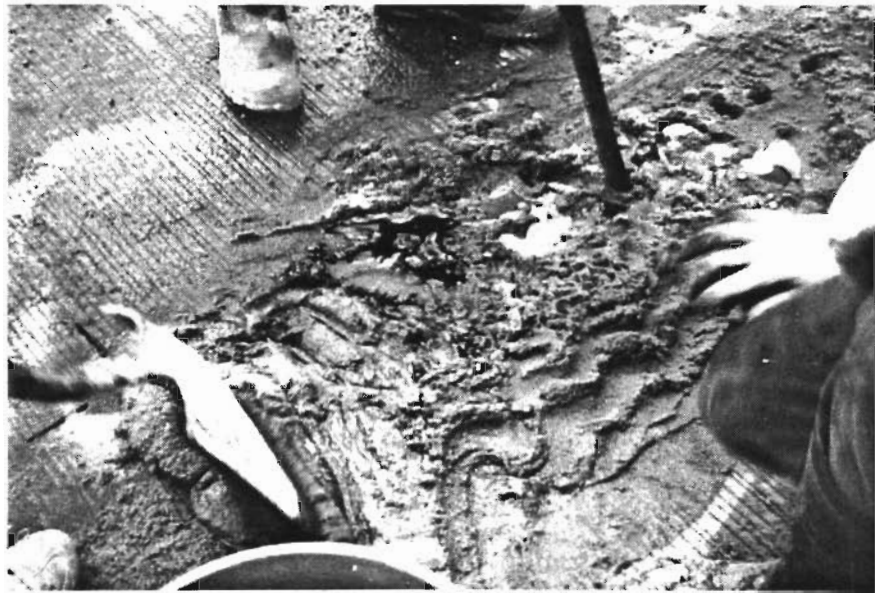
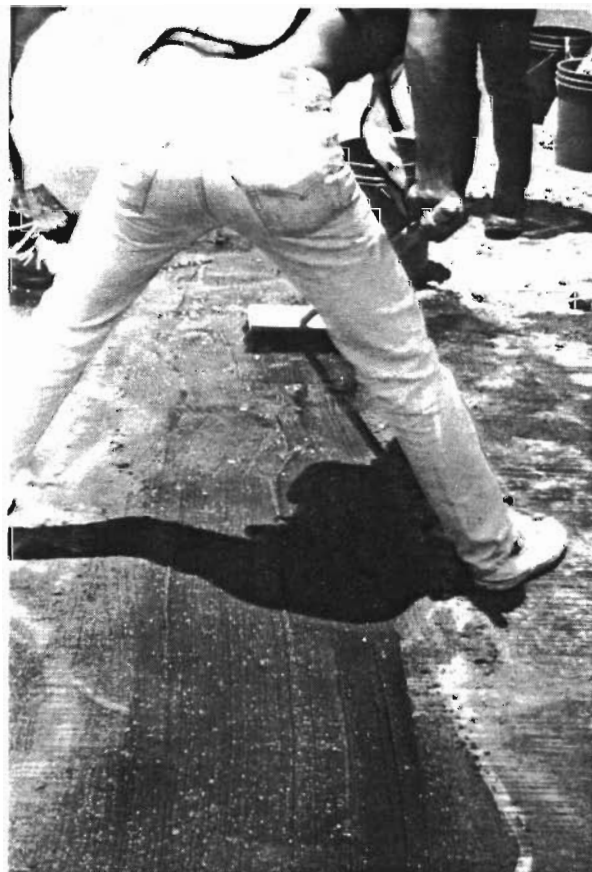
Fig 5.5. Repair with polymer concrete.

(a) Sawcutting the overlay.

(b) Removing the remaining concrete with a jackhammer.

(c) Repair area being filled with polymer concrete.

(d) Finishing the surface of the repaired area.

- (1) the overlay was sawcut to a depth of approximately 3 inches (just above the reinforcing steel) near the edge of the delaminated zone,
- (2) the overlay was then removed using a 30 lb jackhammer, however, the steel was left intact,

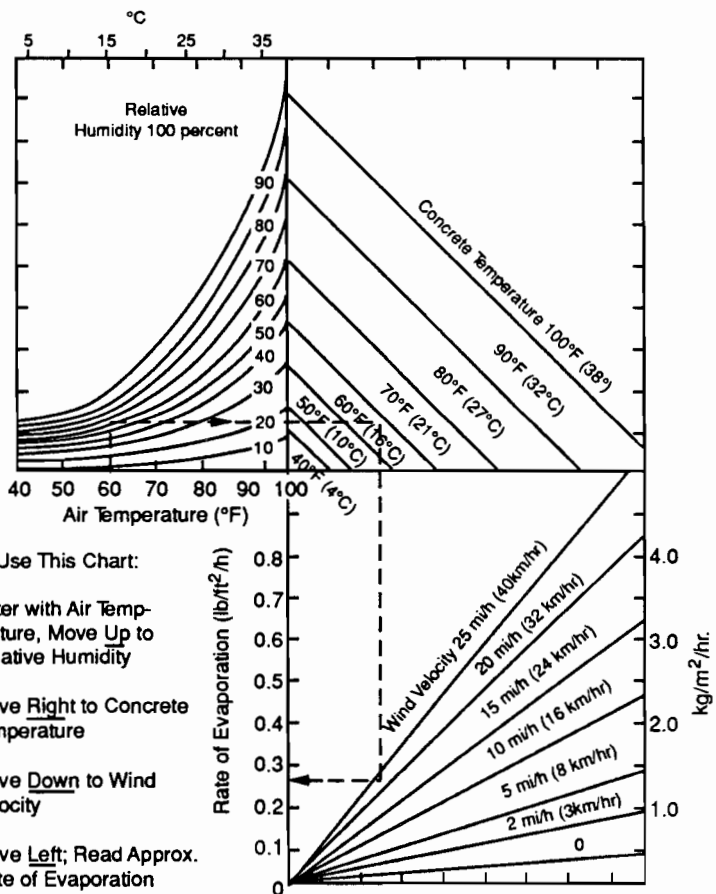
- ER = evaporation rate,
- WS = wind speed,
- CT = concrete temperature,
- RH = relative humidity, and
- AT = air temperature.

Fig 6.1. Chart to calculate the rate of evaporation of water from freshly placed concrete (from Engineering Bulletin, 11th Ed., Portland Cement Association, Skokie, Illinois, 1968).

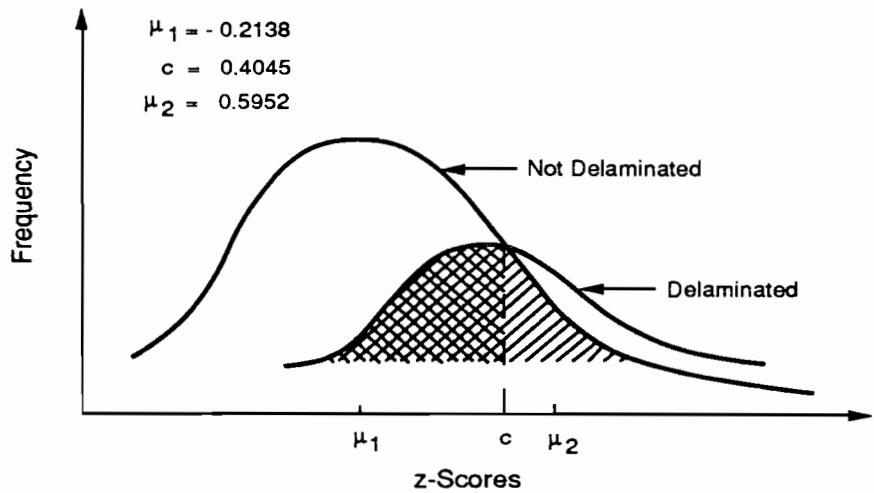
Fig 6.2. Curves showing the probability of misclassification in Run 6 (Appendix G).

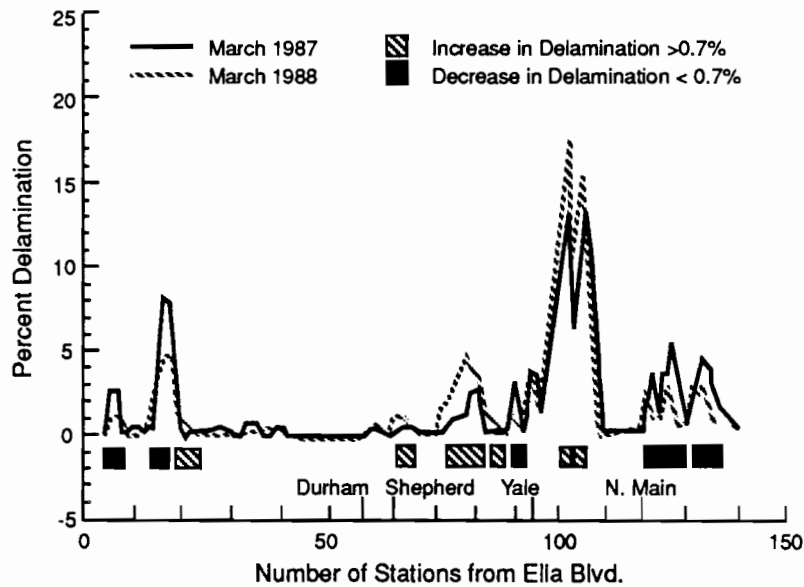
A three-point moving average of percent delamination was calculated by averaging the percent delamination for three consecutive 100-foot stations. Simply stated, the three point moving average of percent delamination for a particular 100-foot section is the delamination averaged over the previous 100-foot section, the section itself, and the next 100-foot section. Figures 6.3 and 6.4 show the number of stations from the start of the survey versus the percent delamination. Also shown are the shaded boxes which indicate the increase or decrease in delamination as determined with a 95 percent confidence level (greater than 0.7 percent change).

Examination of these plots shows that there are approximately as many decreases in delamination as increases between March 1987 and March 1988. Obviously the areas showing a statistically significant decrease in debonding have not rebonded. The "decrease" merely

Fig 6.3. Three-point moving average of delamination.

Fig 6.4. Three-point moving average of percent delamination (westbound both lanes).

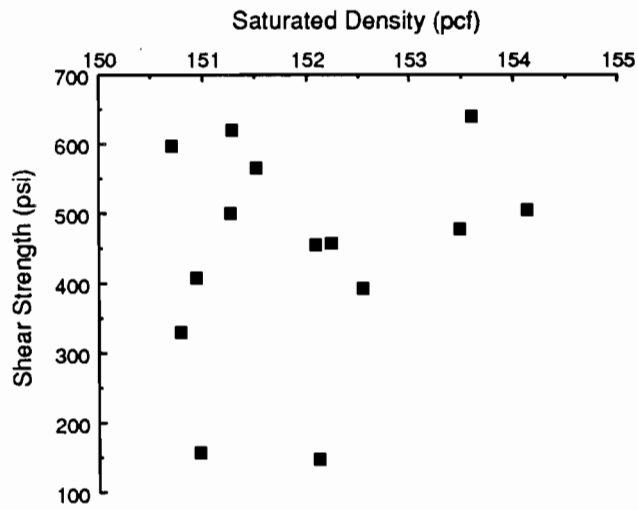
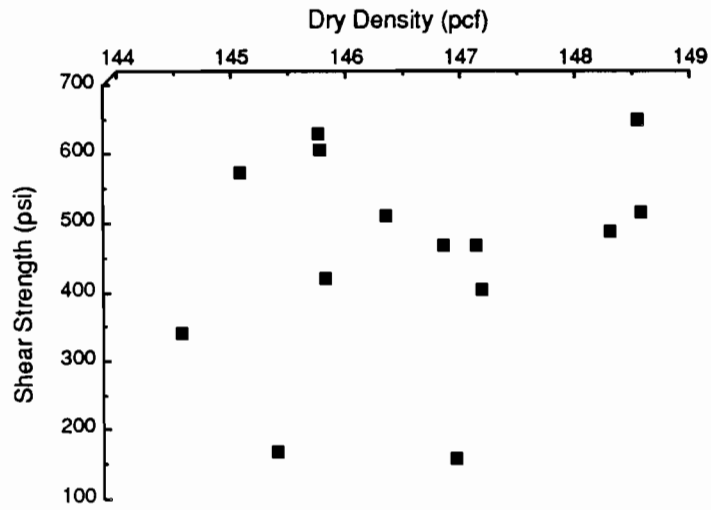
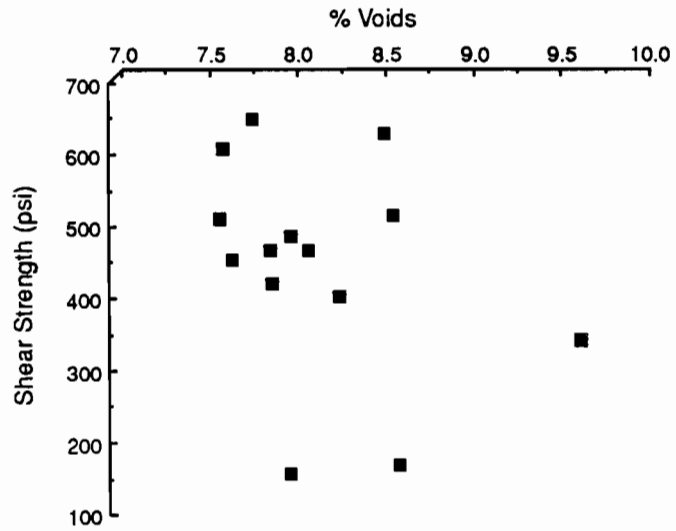
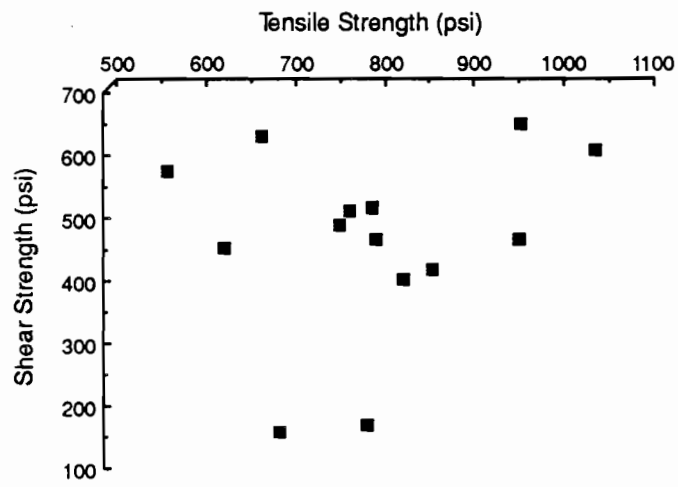
Cores were taken from intact and delaminated regions on the North Loop. Laboratory tests were conducted on intact cores to determine if a correlation existed between measurable physical properties and interface shear strength. As shown in Figs 6.3 - 6.9, no correlation could be found between shear strength and saturated or dry density, percent voids, percent absorption, or tensile strength.

Fig 6.5. Shear strength vs saturated density.

Fig 6.6. Shear strength vs dry density.

Fig 6.7. Shear strength vs percent voids.

Fig 6.8. Shear strength vs percent absorption.

Fig 6.9. Shear strength vs tensile strength.
