LOAD TESTS OF A PRETENSIONED GIRDER BRIDGE NEAR HAPPY, TEXAS

Report No. 921-1F

Texas State Department of Highways and Public Transportation

Center for Transportation Research  
Bureau of Engineering Research  
The University of Texas at Austin

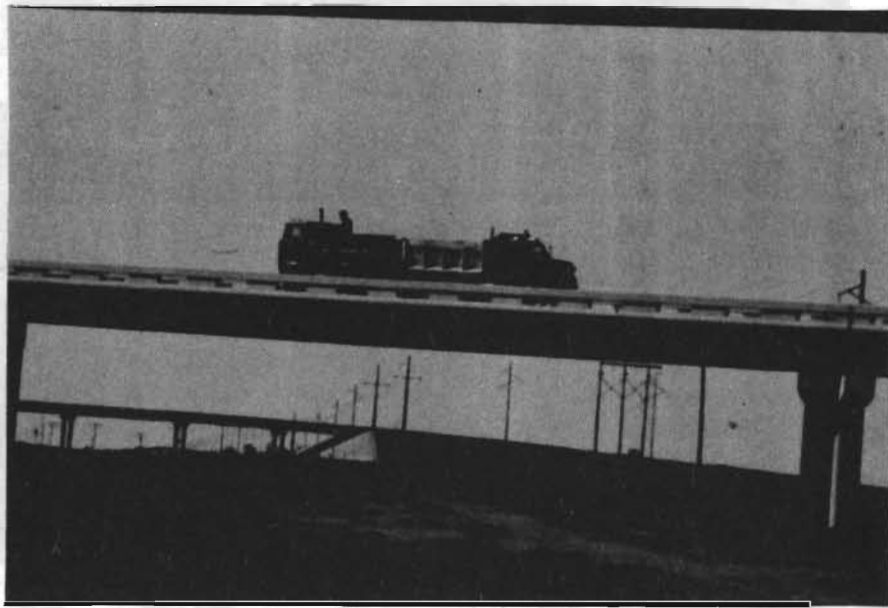
Fig. 2. Positioning of dump truck for simulation of H20-44 loading

Fig. 2 Dump trucks used for simulating service plus impact load magnitudes

Two dump trucks filled with earth were used, as shown in Figs. 2 and 3, to simulate the design level service load plus impact load magnitude on the 135-ft spans. Since the bridge is planned to be used only as a single-lane bridge for access to U.S. 87, although it has a width which could allow two-lane traffic, all loading and evaluation were done for single-lane traffic only. The gross weight of each truck was measured by the trucking company and the individual wheel loads were measured by TSDHPT at the bridge site. The recorded weights are shown in Fig. 4. There was a slight (less than 2%) discrepancy in the weights of Truck 1 as reported by the trucking company and the TSDHPT. Comparison of the total maximum moment produced by these trucks with the maximum live load plus impact moment produced by an AASHTO HS20-44 loading on the spans tested is given in Appendix A. As is shown in Appendix A, the load test performed on the bridge at Happy, Texas, subjected the loaded spans to the maximum moments that would be

Two dump trucks filled with earth were used, as shown in Figure 1 and 2, to simulate the design level service load plus impact load on the bridge. Since the bridge is designed to carry only a single-lane bridge for access to U.S. 87, it is not possible to load the bridge with two-lane traffic. All loading was done with one lane for single-lane traffic only. The gross weight of each truck was measured by the trucking company and the individual wheel weights were measured by TSD&P at the bridge site. The recorded weights are shown in Fig. 4. There was a slight (less than 2%) discrepancy between the weights of Truck 1 as reported by the trucking company and the weights of Truck 2 as reported by the trucking company and the weights of Truck 1 as reported by the trucking company. The maximum moment of the total maximum moment produced by these trucks was the maximum live load plus impact moment produced by an AASHTO HS-20 loading on the spans tested is given in Appendix A. The load test loading on the spans tested is given in Appendix A. The load test loading on the spans tested is given in Appendix A. The load test loading on the spans tested is given in Appendix A.

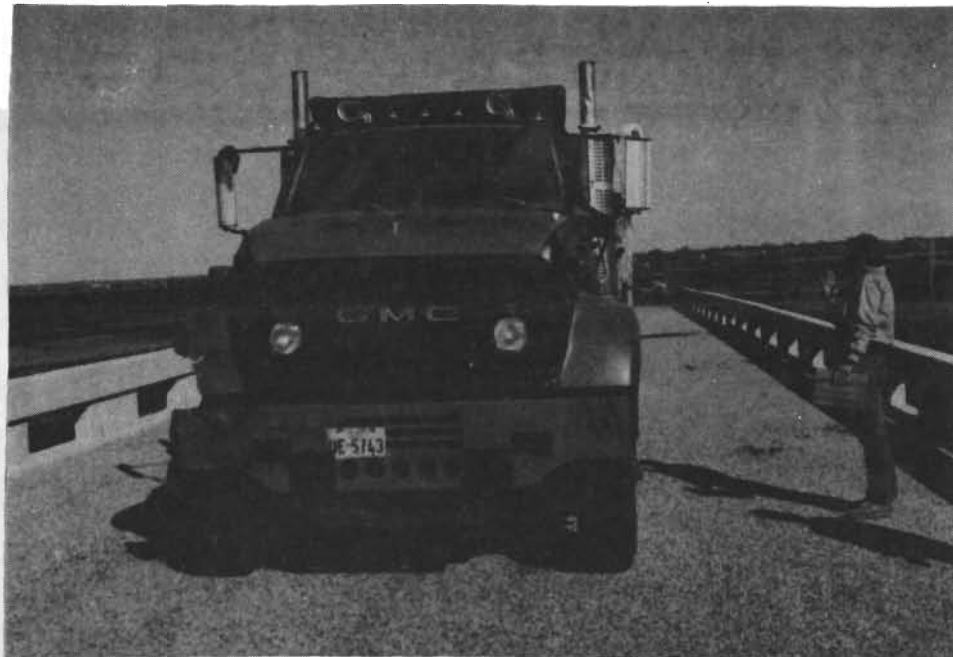
Fig. 3. Positioning of dump truck for simulation of HS20-44 loading

Fig. 3. Dump truck used for simulating  
HS20-44 load magnitude

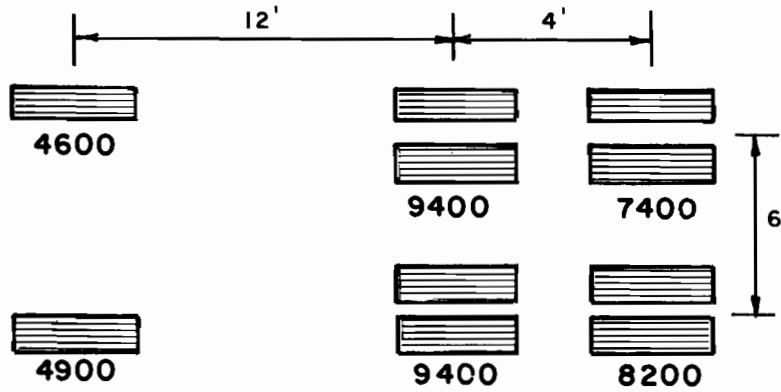
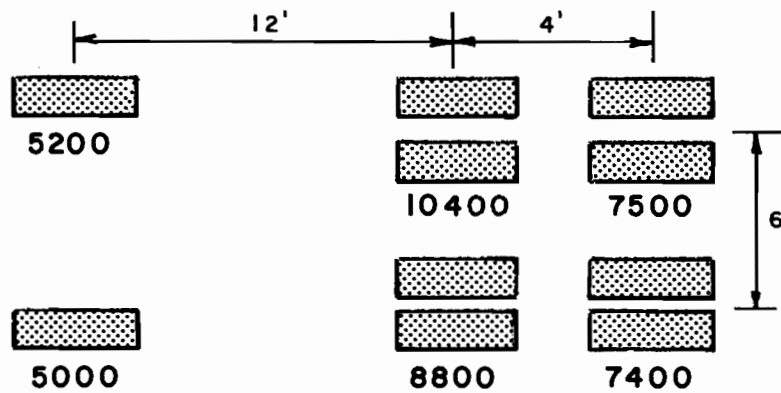
REPORTED TOTAL WEIGHTS		
TRUCK	SDHPT	TRUCKING CO.
1	44000	44720
2	44300	44320

a) SDHPT Measurement For Truck 1 (GMC Truck)

b) SDHPT Measurement For Truck 2 (Ford Truck)

Fig. 4 Test truck weights in pounds

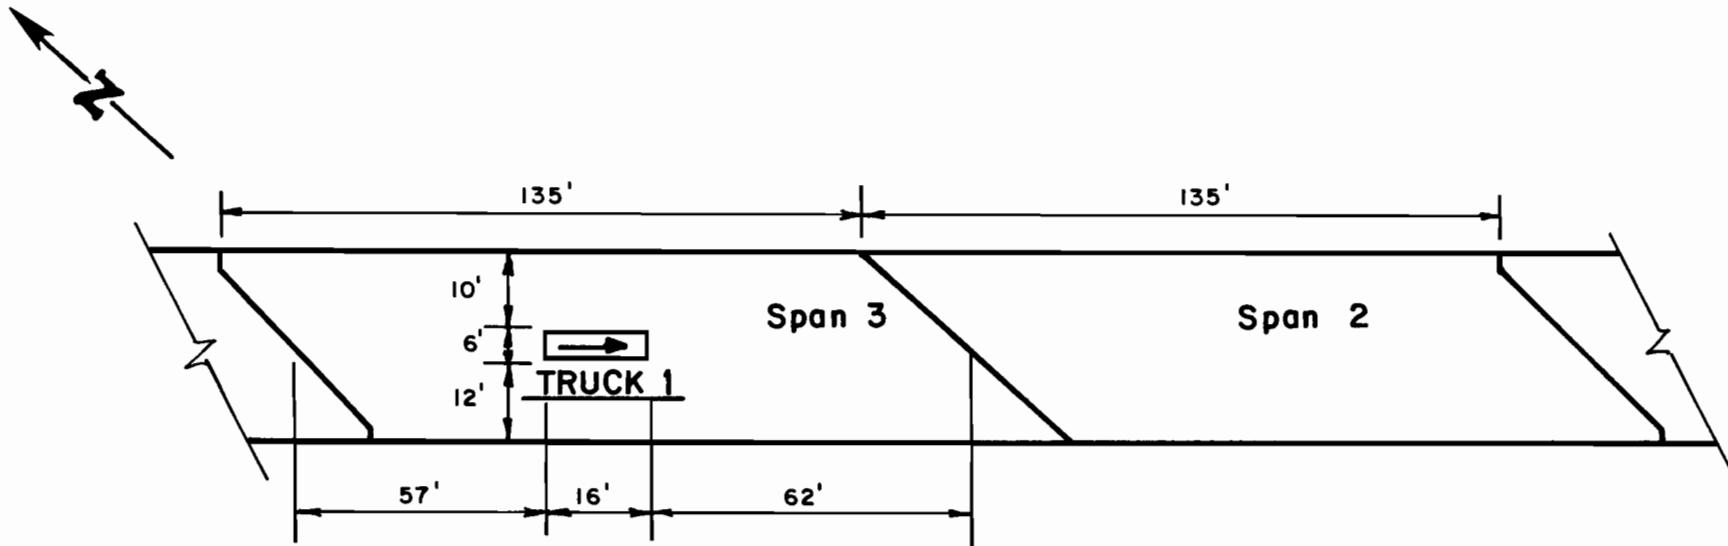
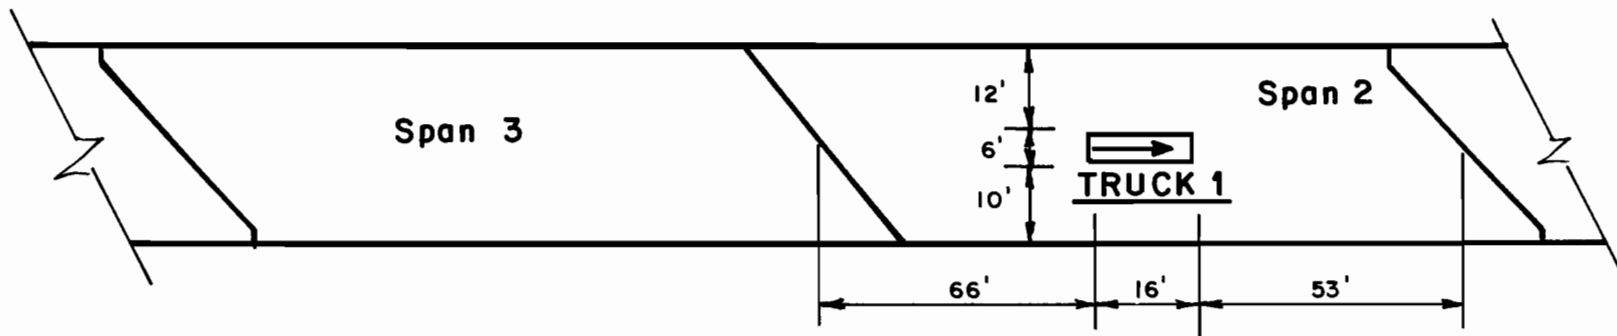
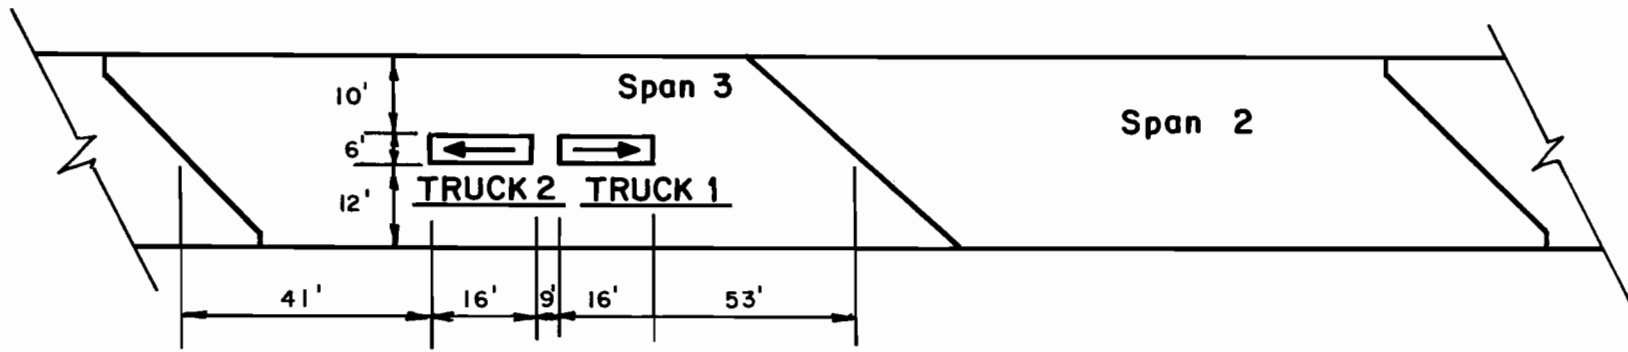
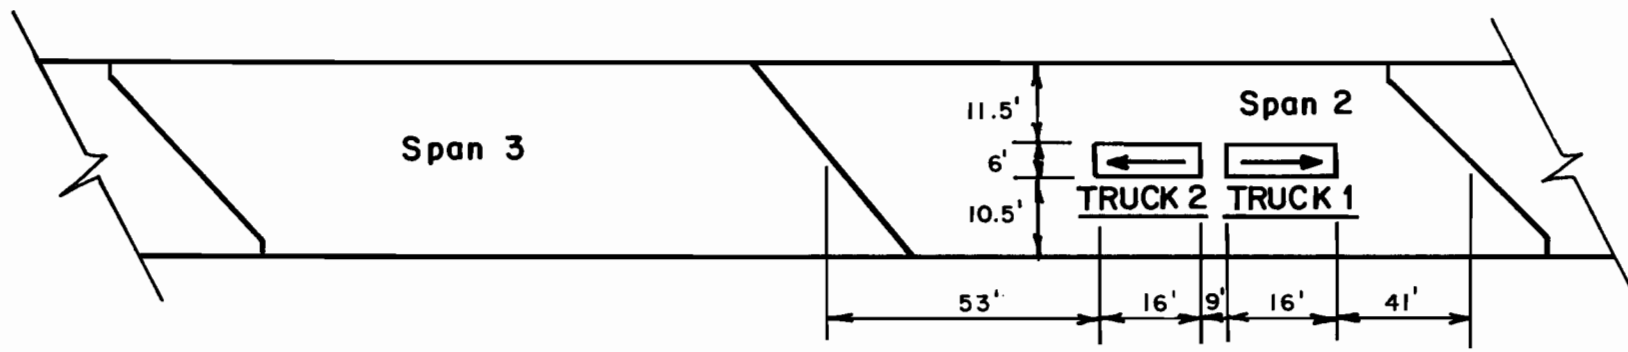
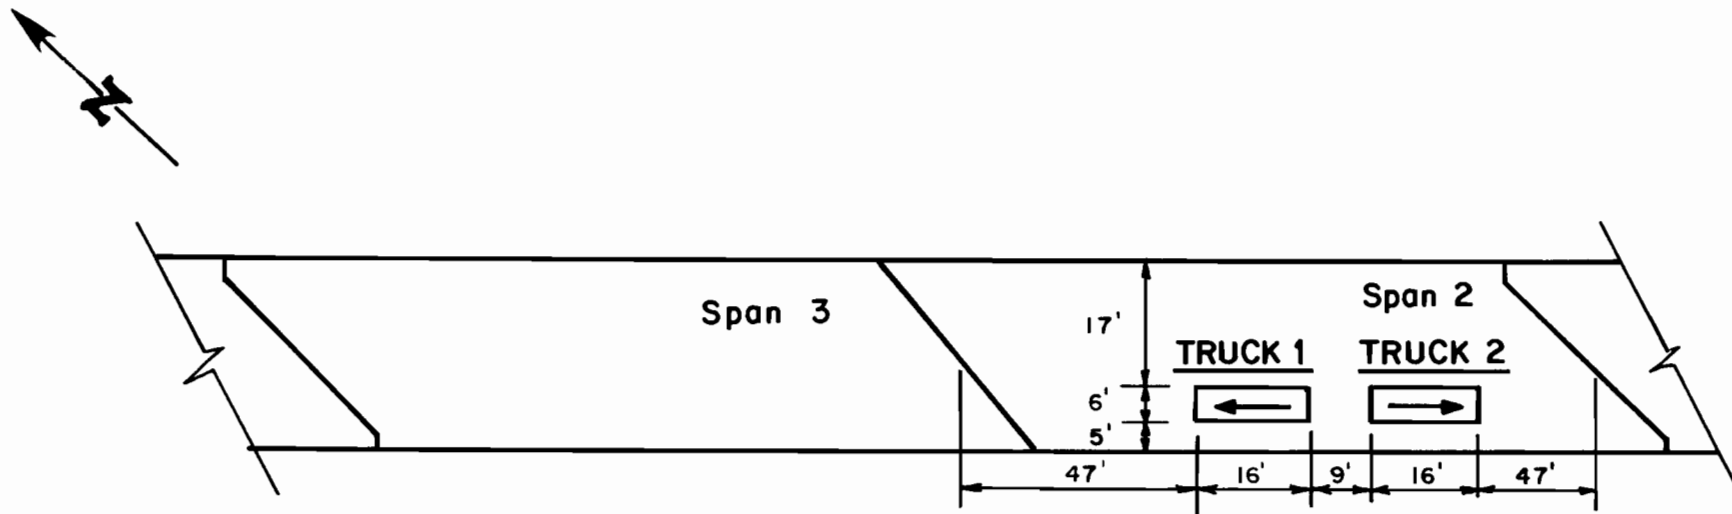
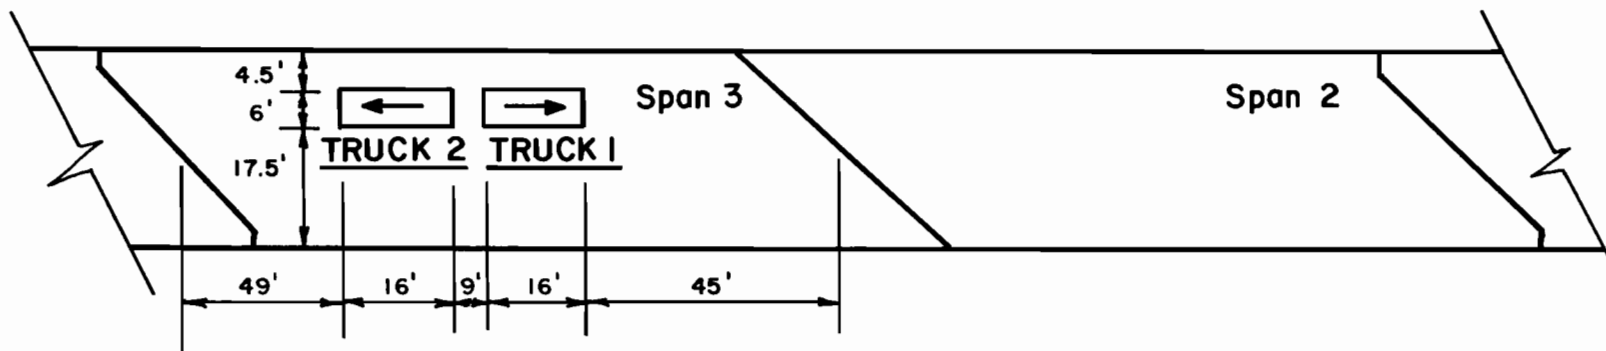
a) CASE 1

b) CASE 2

Fig. 5 Truck positions for various tests

c) CASE 3

d) CASE 4

e) CASE 5

f) CASE 6

produced by an HS20-44 truck loading. In all, six different tests were conducted utilizing the various truck positions shown in Fig. 5.

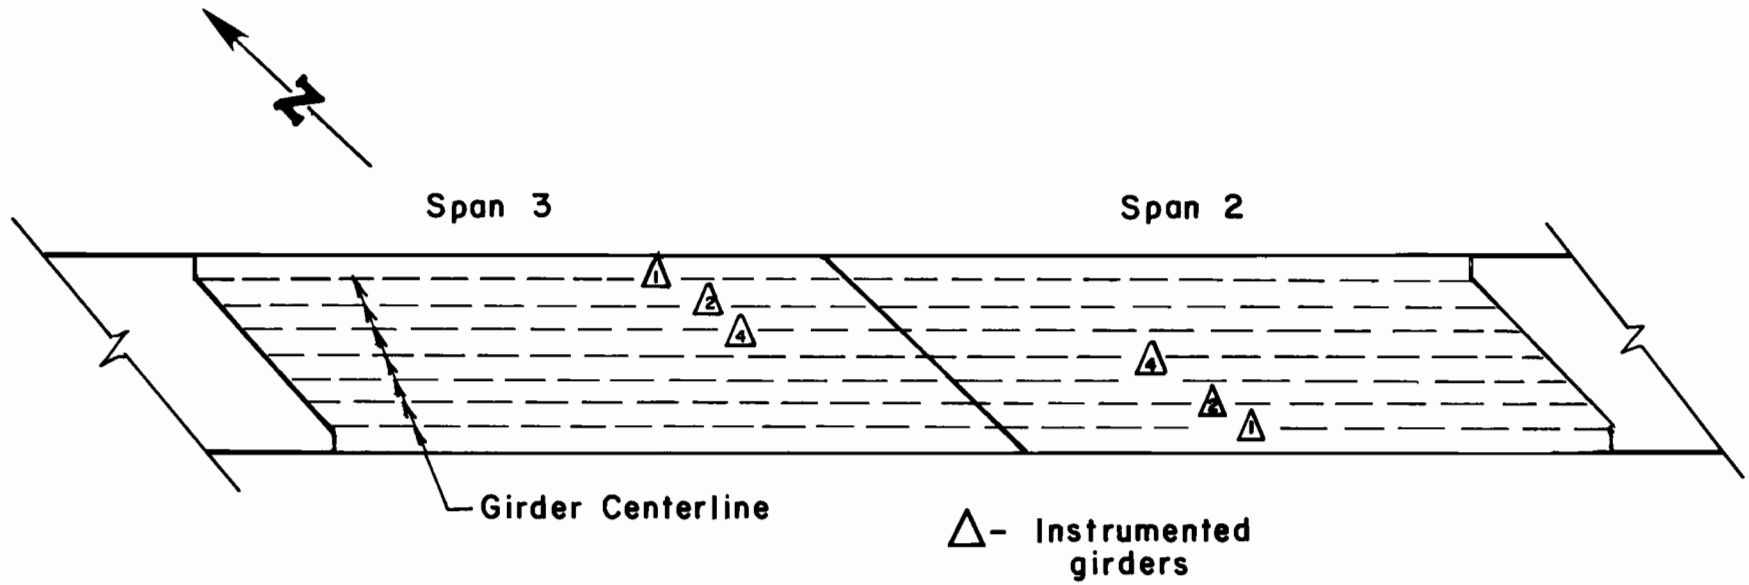
Fig. 6 Six girders instrumented for deflection measurements

The six girders shown in Figs. 6 and 7 were instrumented for deflection measurements. The girder deflections were monitored with respect to reference datum lines furnished by constant tension 0.016 in. dia. high-strength wires anchored to and spanning above the deck slab between bents as shown in Figs. 8 through 10. Using the initial deflected shapes of the wires and the bridge dead load condition as references, slab live load deflections over the instrumented girders were measured at the quarterpoints and centerlines. The supports were assumed not to deflect throughout the testing. Measurements of the gap between reference wire and reference points attached to the slab were made with a ruler accurate to 1/64 in. The reference points were stainless steel seats attached to tin caps epoxied to the base surface of the deck slab as shown in Figs. 11 and 12. When the tension in the piano wire is held constant or adjusted to a constant value prior to taking readings, the sagging shape of the piano wire is fixed. Therefore, the difference between an initial set of readings and readings taken with trucks on the bridge represented girder deflections under load.

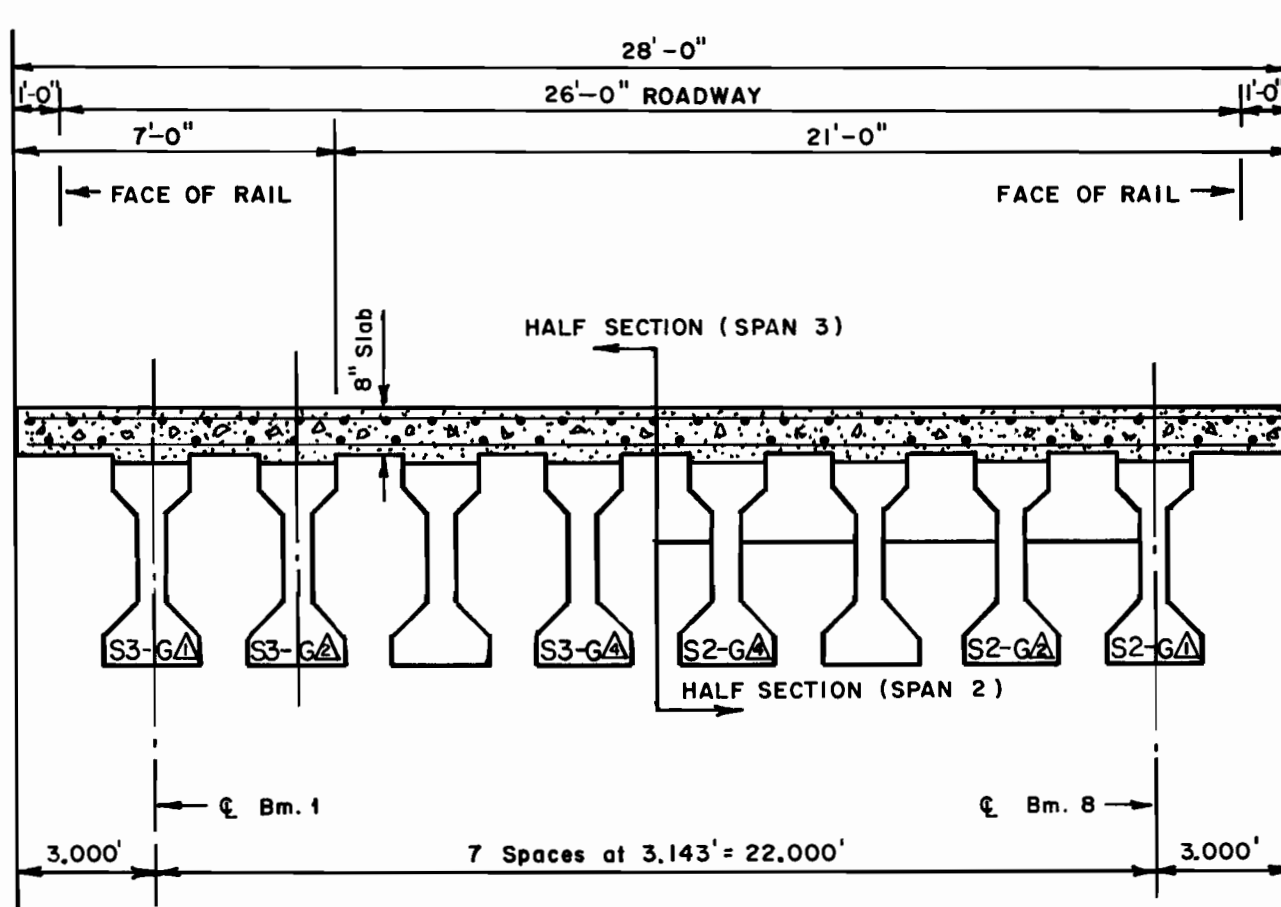
- NOTES: 1. DIAPHRAGM AND OVERLAY NOT SHOWN.  
 2. S ≠ = SPAN  
 G△ = INSTRUMENTED GIRDER

Fig. 7 Transverse section of bridge showing instrumented girders (looking SE)

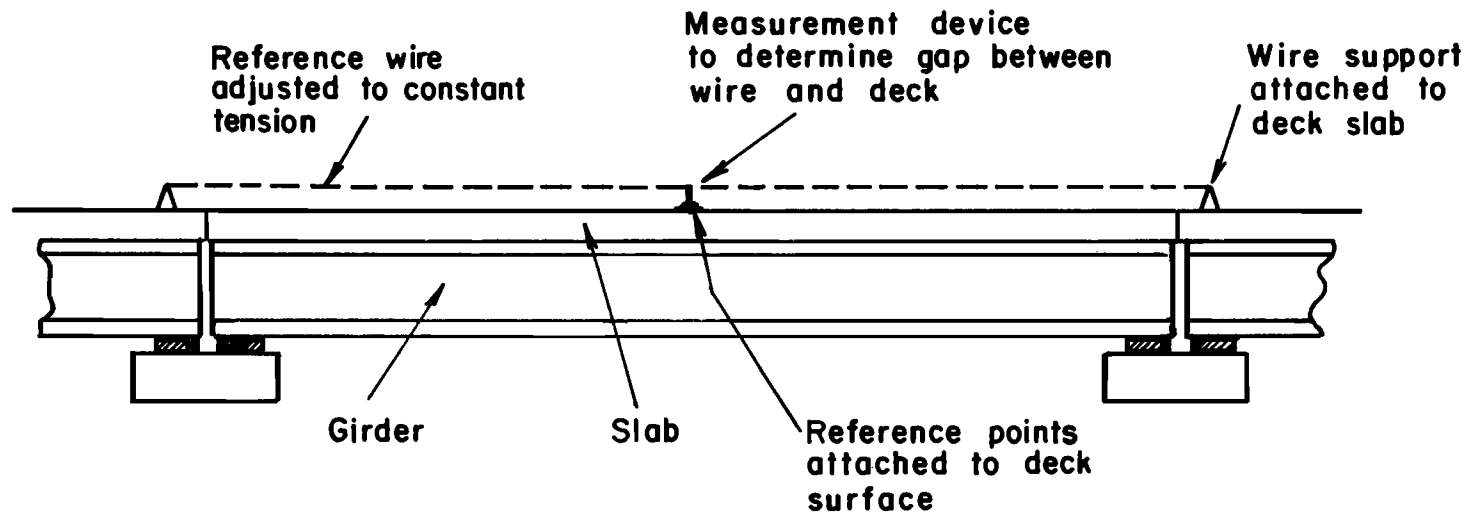
Fig. 8 Schematic of deflection measurement system

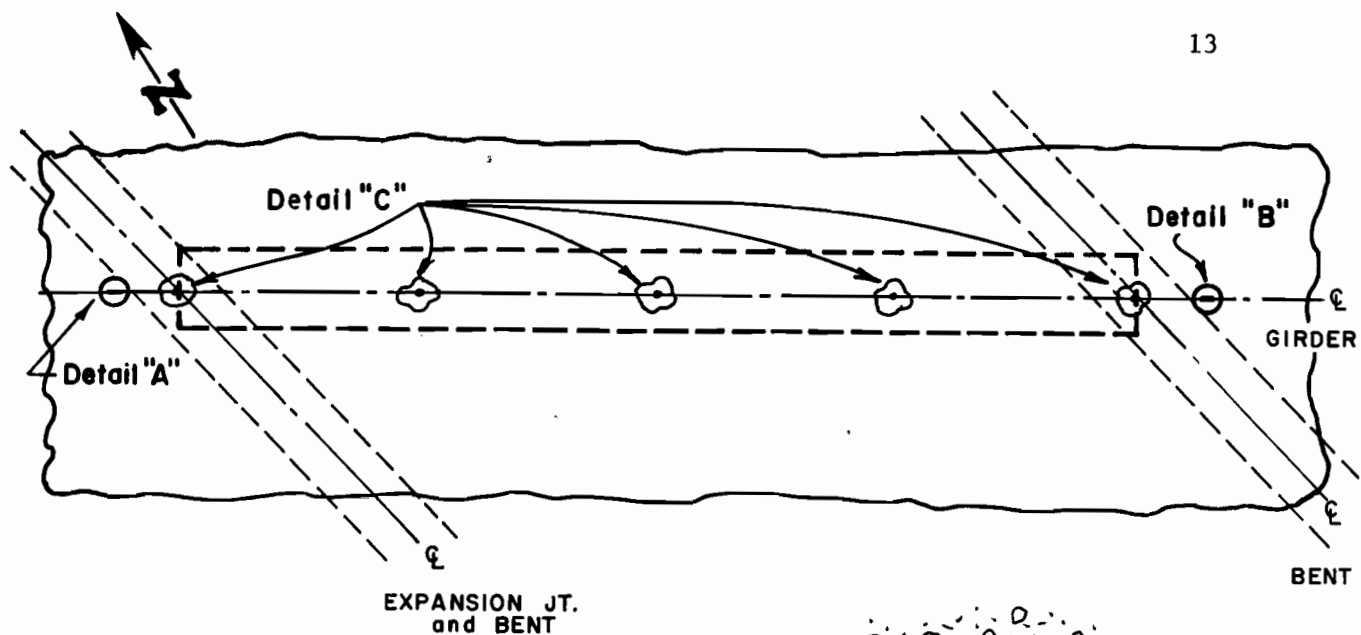
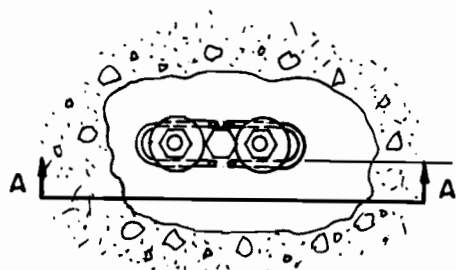
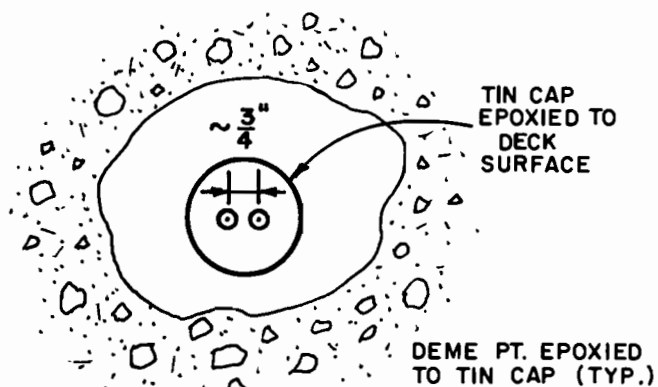
Detail A

Detail B (Reversed)

Detail C (Typ.)

Section A-A

Fig. 9 Layout of deflection measuring instrumentation for a typical girder (Span 3 as shown; Span 2 reversed) (no scale)

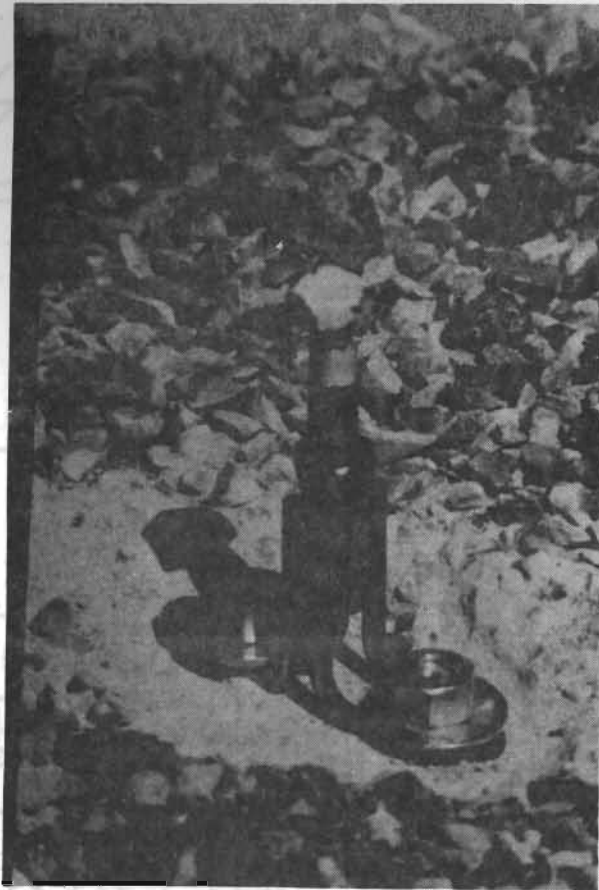
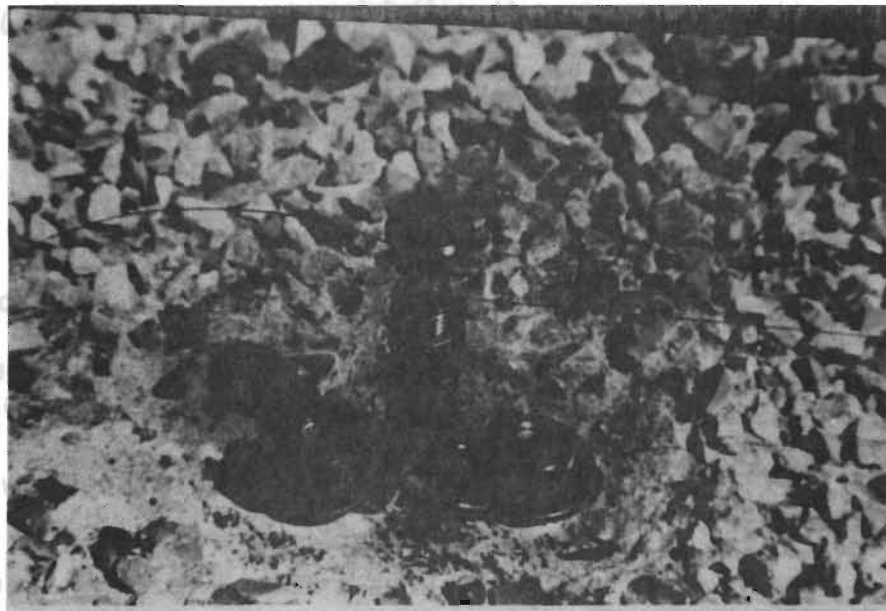
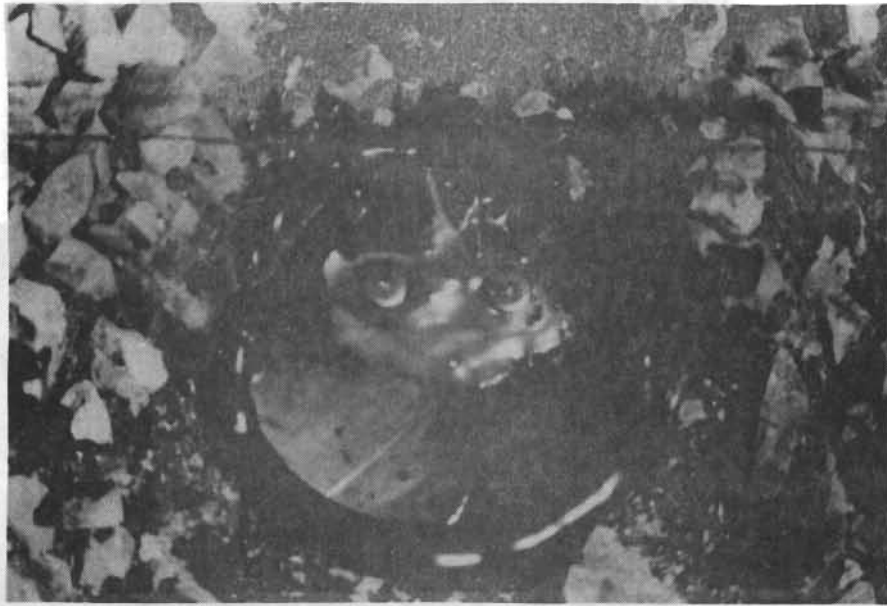
Fig. 10 Reference wires anchored in deck slab above girders of interest

Fig. 10 Reference wires anchored in deck

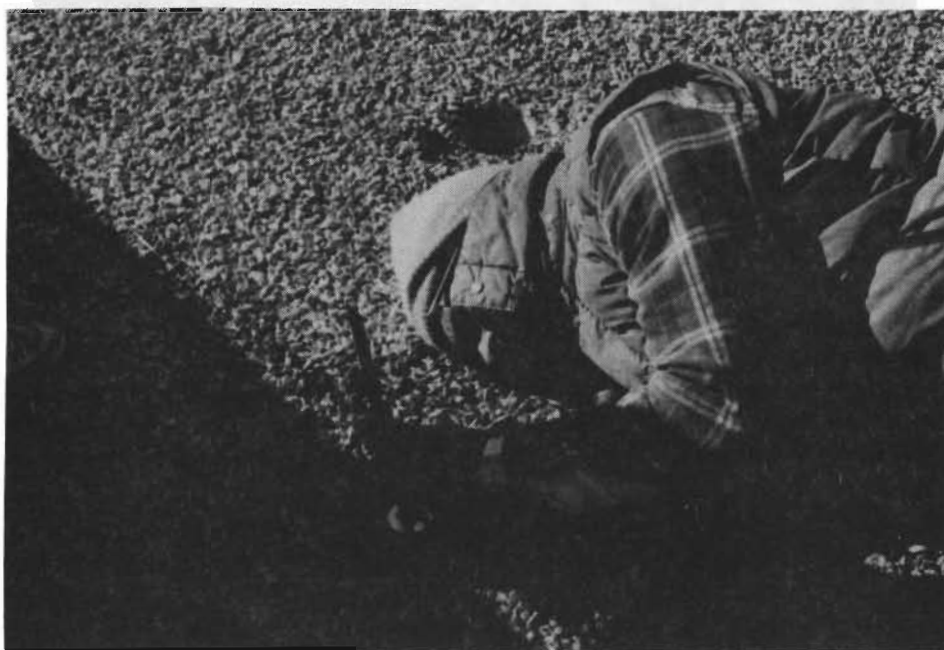
Fig. 11 Taking deflection readings with stainless steel ruler  
(Note: ruler seated on stainless steel reference)

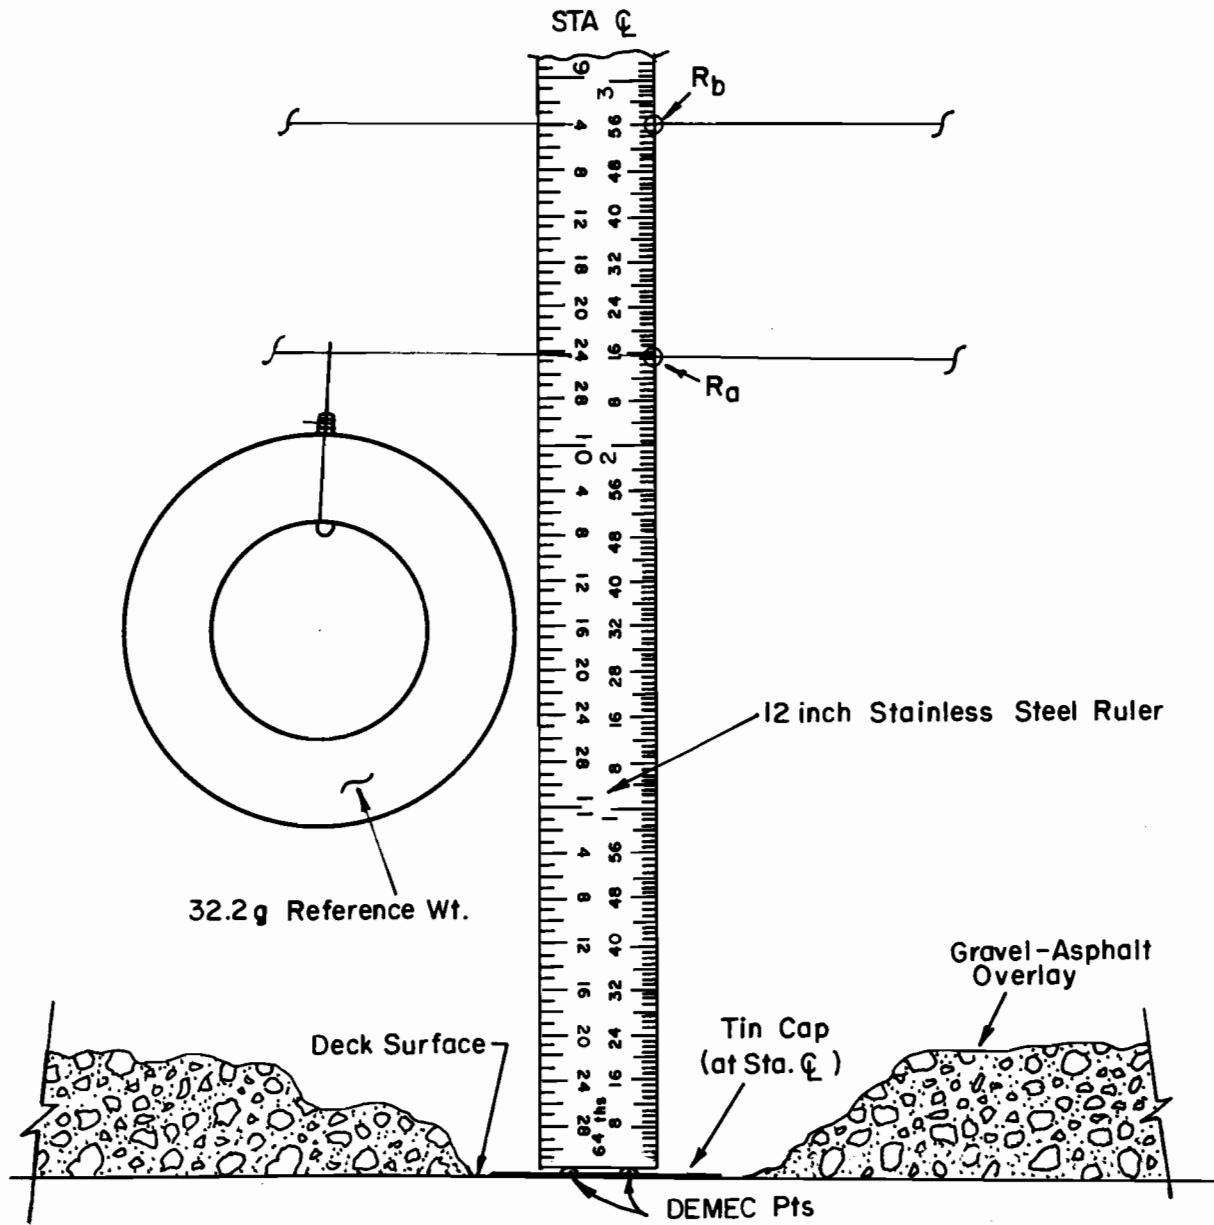
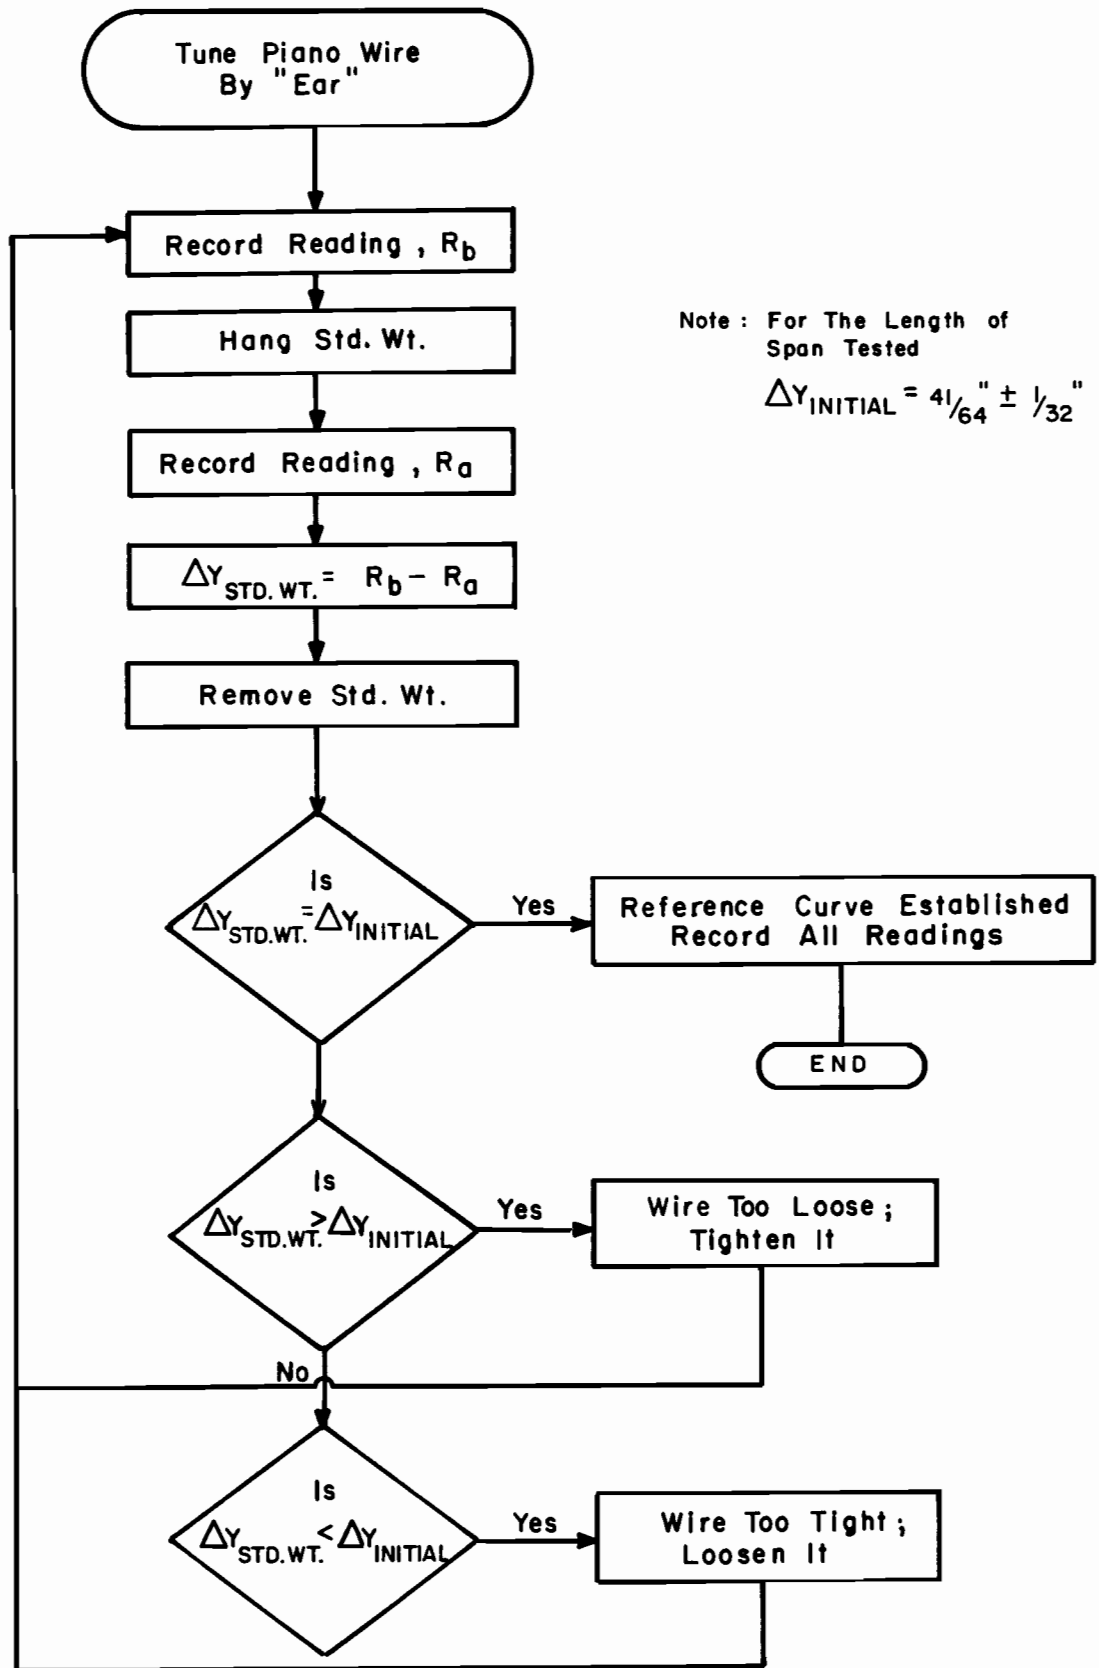
a) calibration procedure

Fig. 13 Standard weight deflection procedure for establishing and maintaining a fixed reference curve with high strength wire

b) calibration operations

Tension in the high-strength (piano) wire could not be measured directly. The indirect method being used in Research Project 3-5-84-381 was employed to maintain constant tension and thus establish the desired reference sagging shape of the piano wire. Figure 13 illustrates the essential steps of this "standard weight deflection" method of maintaining the initial shape of the reference and thus the initial wire tension throughout the testing. The wire sag due to a calibrating weight is checked and the tension adjusted to produce a constant sag. Each wire was "calibrated" with this procedure prior to taking deflection readings.

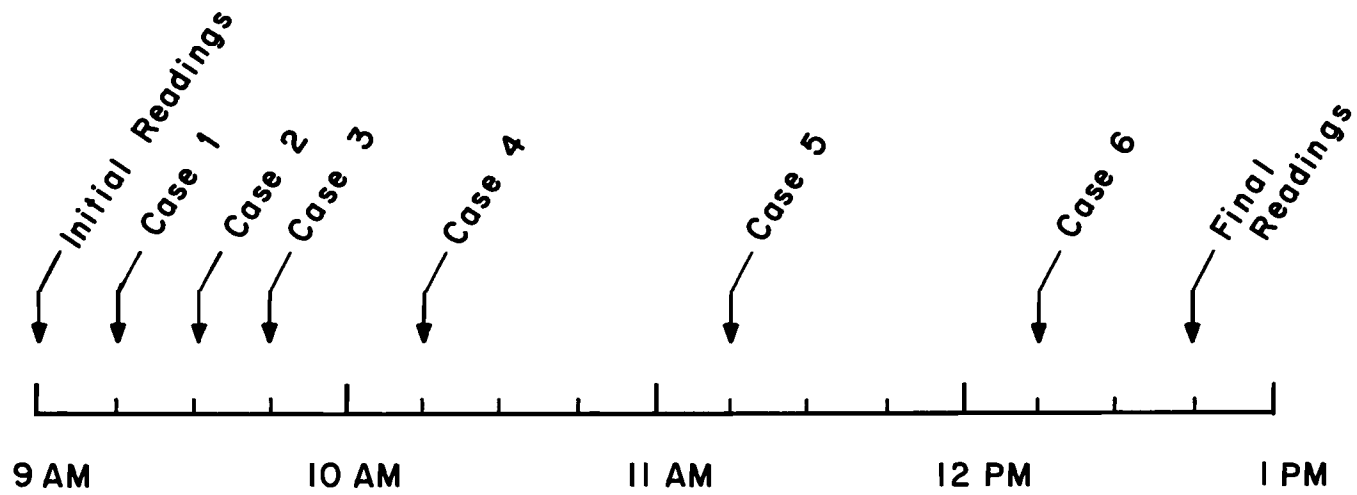
Fig. 14 Chronological sequence of testing

The temperature gradient produced by solar energy induced upward girder deflections over the four-hour testing period which were of the same order as the deflection due to truck loading. Thus, thermal effects could not be ignored. Figure 14 indicates the approximate time the deflection readings were taken for a given load case. Assuming a linear change with time of girder uplift due to rising temperature differential, thermal change corrections were determined to allow calculation of net girder deflections due to the truck live load. The net girder deflections were established by adding a percentage of the deflection due to temperature effects to the measured live load deflections taken at a given time.

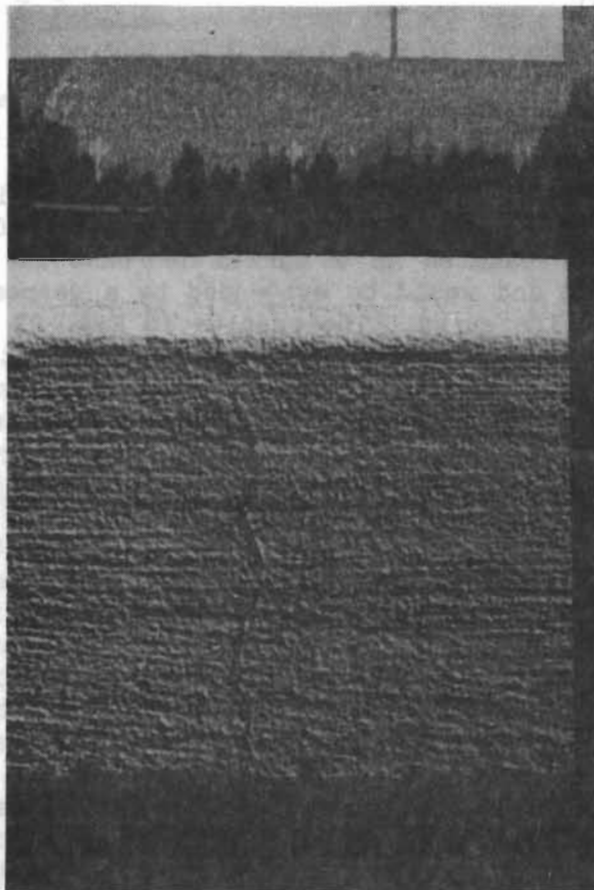
Fig. 21 Apparent shrinkage cracks in concrete guard rail

While extensive cracking was apparent in the barrier railings and top surface, as shown in Fig. 21, a detailed visual inspection of the instrumented girders (see Fig. 22) before and during the load test indicated no cracking of the girders. This result is substantiated by the observed load-deflection behavior shown in Fig. 23, for the centerpoint of the middle girders of each span. Cracking in the girders would have resulted in a marked decrease in girder stiffness with increased load and would be evidenced by a decrease in the slope of the load-deflection curve. The results in Fig. 23 clearly indicate no decrease in the stiffness up to service plus impact load levels for a single-lane bridge. In fact, the observed data indicate that, if anything, the bridge seemed stiffer under the second truck application. Such apparent stiffness may reflect changed load distribution or error in compensating for temperature effects.

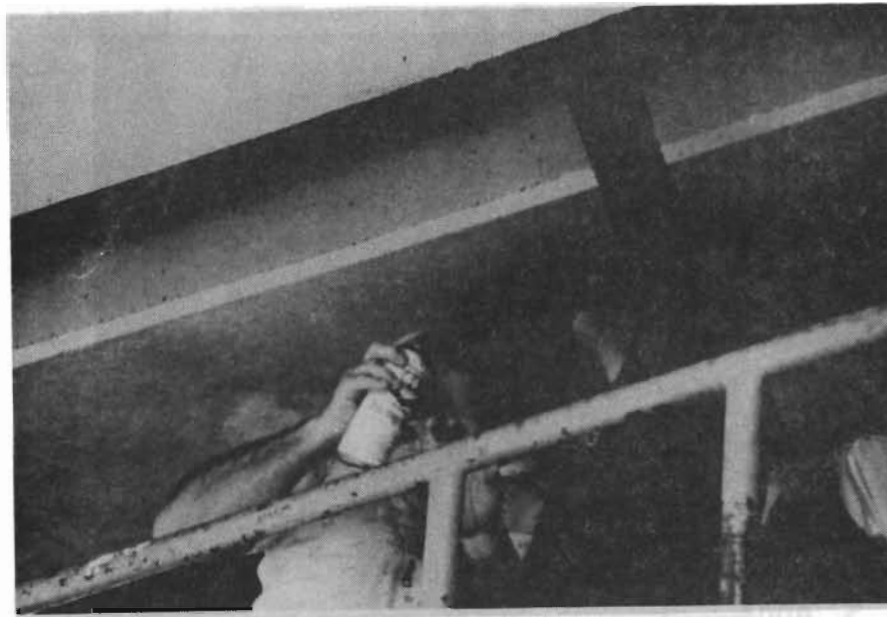
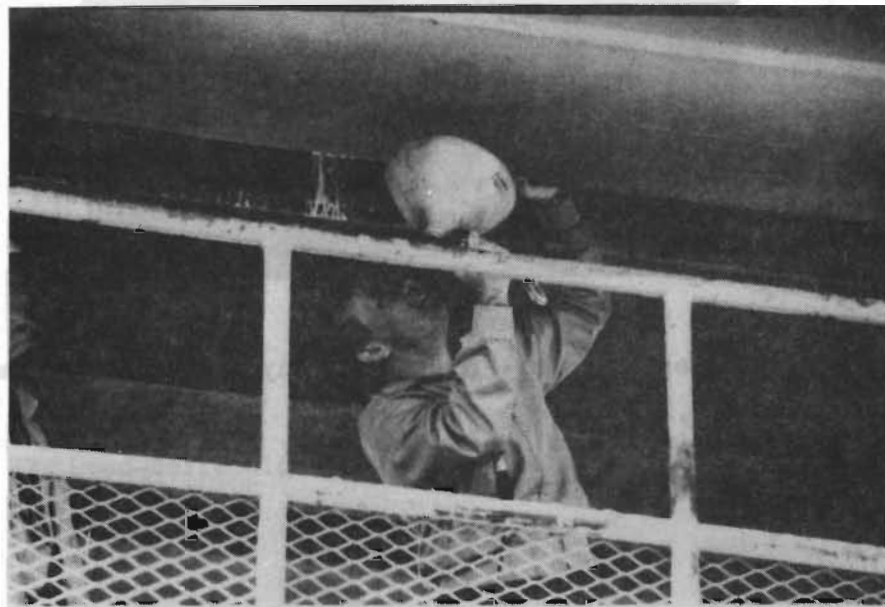
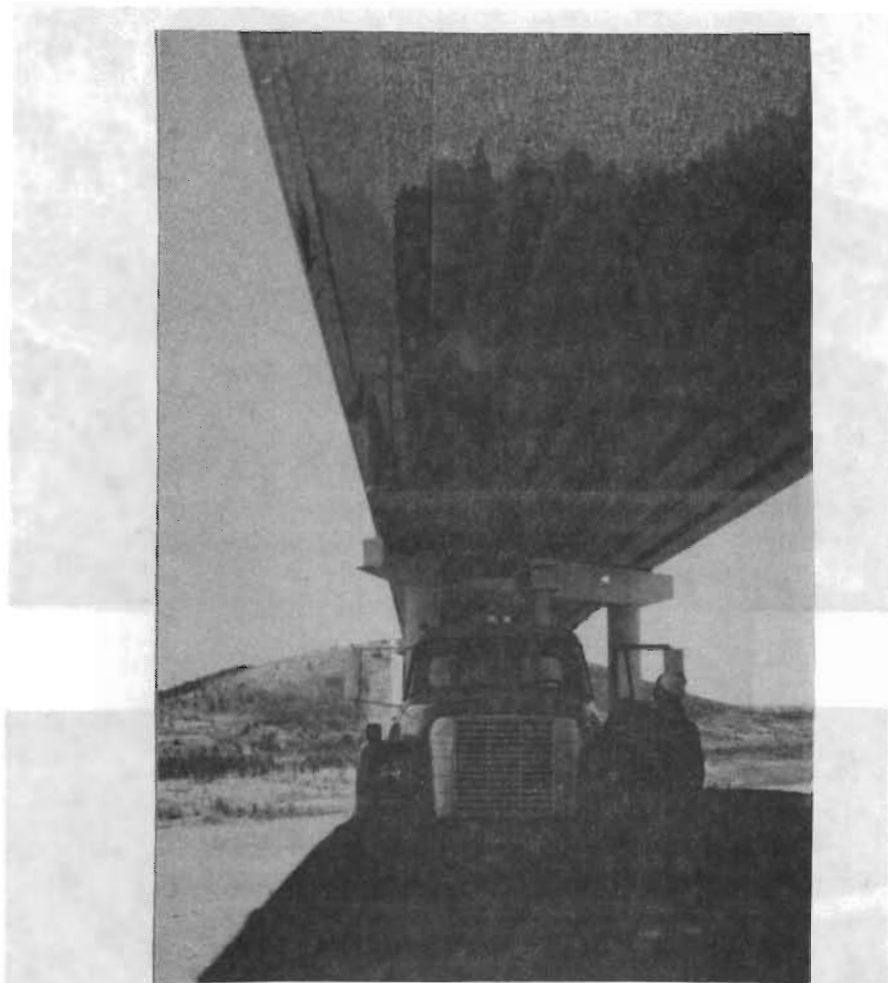
Fig. 22 Detailed inspection of girders for any indication of cracking

Fig. 22 Detailed inspection of girders for any indication of cracking (continued)

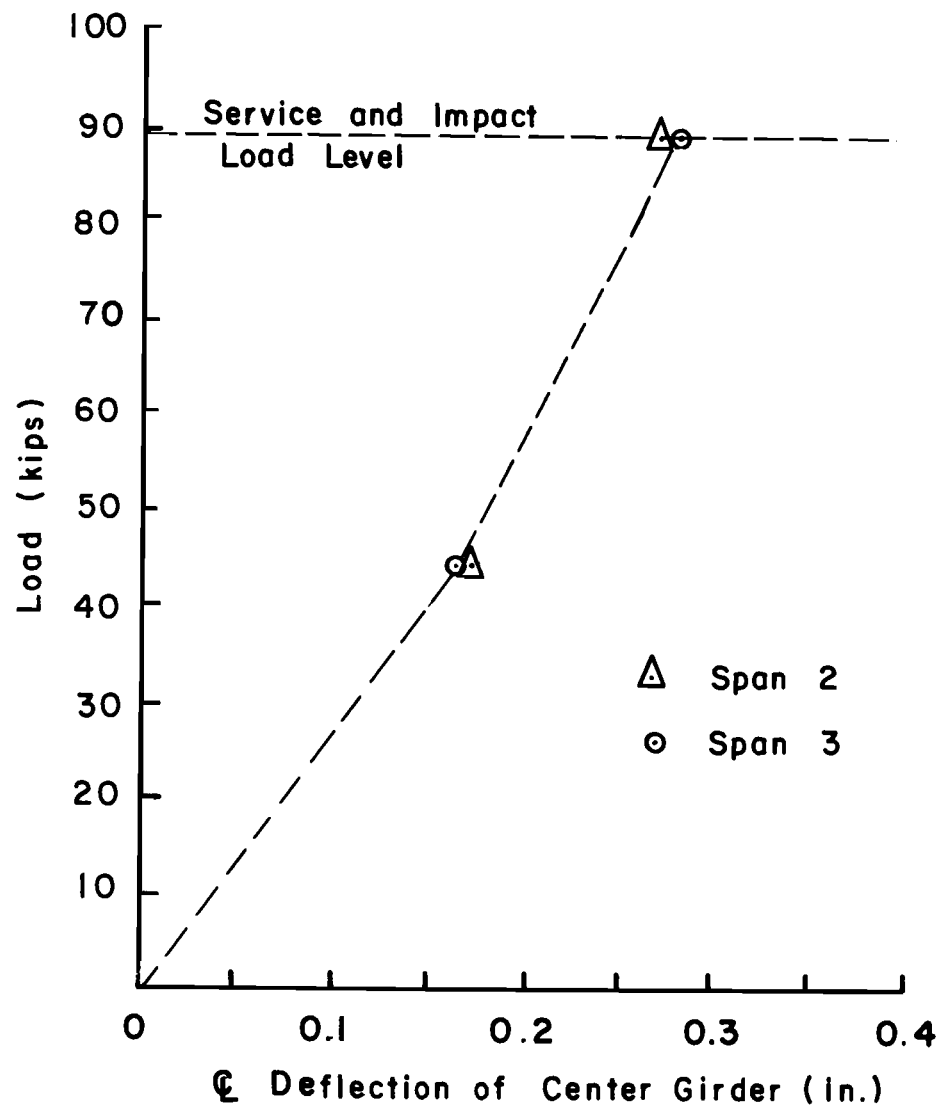
Fig. 23 Load-deflection behavior of center girders of each span

The results from the single-lane load test indicate that the load-deflection behavior of the sagging bridge near Happy, Texas, is stiffer than that predicted by a simplified elastic analysis which was based on an assumed concrete modulus of elasticity and an equal distribution of load to each girder. The service live load plus impact factor deflections measured substantially less than those predicted when employing AASHTO distribution factors and are only 20% of the allowable maximum live load deflection of  $L/800$ . The overall load-deflection behavior of the girders is essentially linear up to service plus impact load levels. This supports visual evidence that no cracking of girders occurred. If the stiffening effects of the barrier rail and increases in concrete modulus due to aging are taken into consideration, the computed deflections would be reduced by more than 18%. This would result in most measured deflections being closer to the computed  $(P/8)$  theoretical values and some greater than the  $P/8$  values. The dead load sag which exists in the long spans of the bridge apparently has no detrimental effect on the overall structural performance of the bridge at service load conditions for the contemplated single-lane use. In fact, since no cracking under full dead load plus impact load occurred in any of the girders, the bridge should have a substantial reserve in strength. Therefore, the only action which may be necessary to ensure the serviceability of the bridge is to regrade the underlying highway to meet any necessary clearance requirement. Should the bridge be used for two-lane traffic in the future, further study is recommended.
