LOAD TESTS OF A PRETENSIONED GIRDER BRIDGE NEAR HAPPY, TEXAS

Report No. 921-1F

Texas State Department of Highways and Public Transportation

Center for Transportation Research  
Bureau of Engineering Research  
The University of Texas at Austin

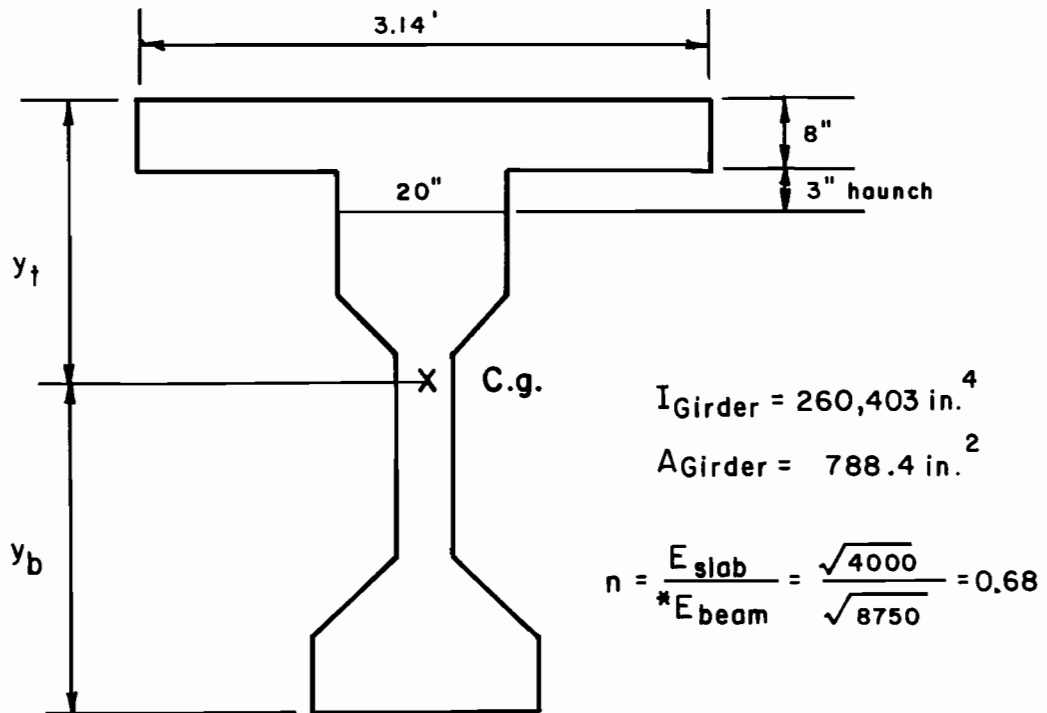
a) Composite Section Properties

$$I_{\text{cs}} = 496700 \text{ in.}^4$$

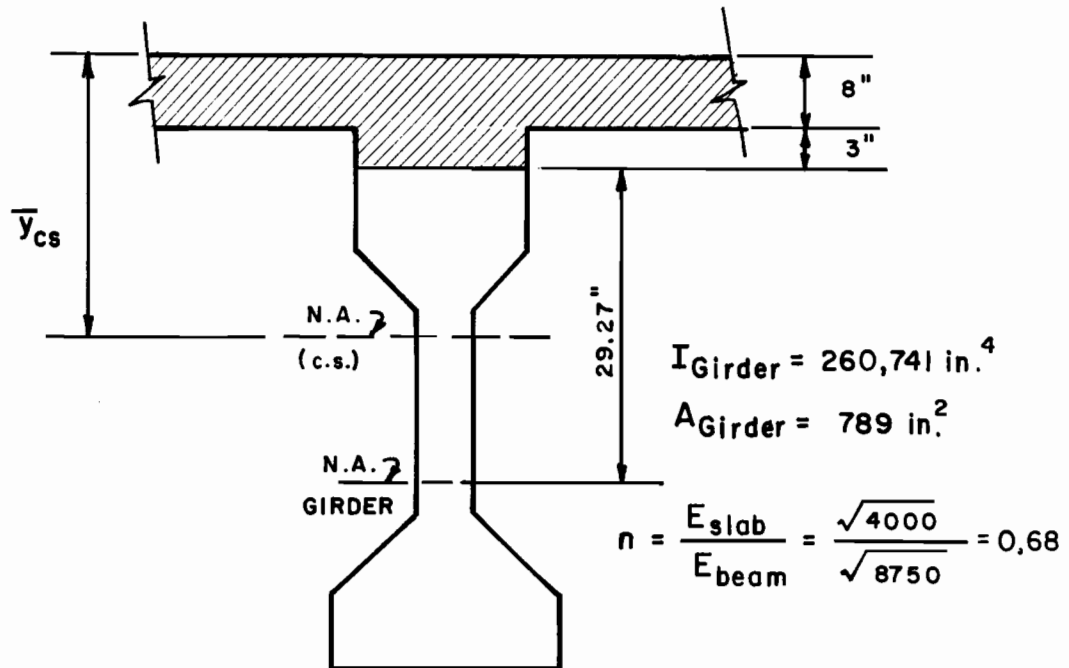
b) Independent Check of Composite Section Properties

$$I_{c.s.} = 260,741 + 789(40.27 - 31.87)^2 + (205.2)(31.87 - 4)^2 + 1094 + (40.8)(31.87 - 9.5)^2 + 30.6 = 497,340 \text{ in.}^4$$

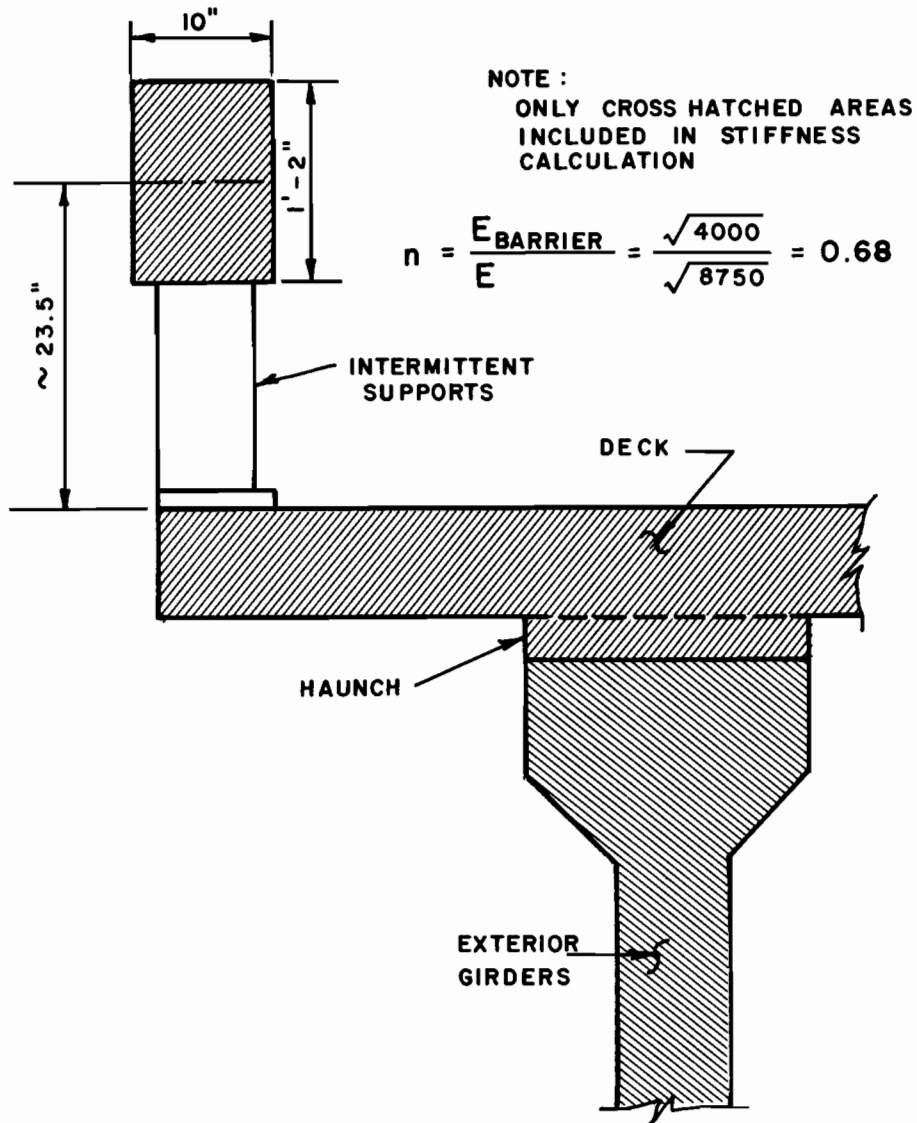
c) Effect of Inclusion of Barrier Rails in Stiffness Calculations (Simplified)

$$(1 - 1/1.1442) \times 100\% = 12.6\%$$

was neglected in the simplified analysis. As shown in Appendix D, including the stiffening effect of the barrier railings and concrete strengths greater than those assumed would reduce the theoretical deflections by more than 18% (12% for rails and 6% for increased concrete strength).
