TEST AND EVALUATION
OF
VEHICLE ARRESTING, ENERGY ABSORBING, AND IMPACT ATTENUATION SYSTEMS

F I N A L R E P O R T

CONTRACT NO. CPR-11-5851

U. S. Department of Transportation
Federal Highway Administration

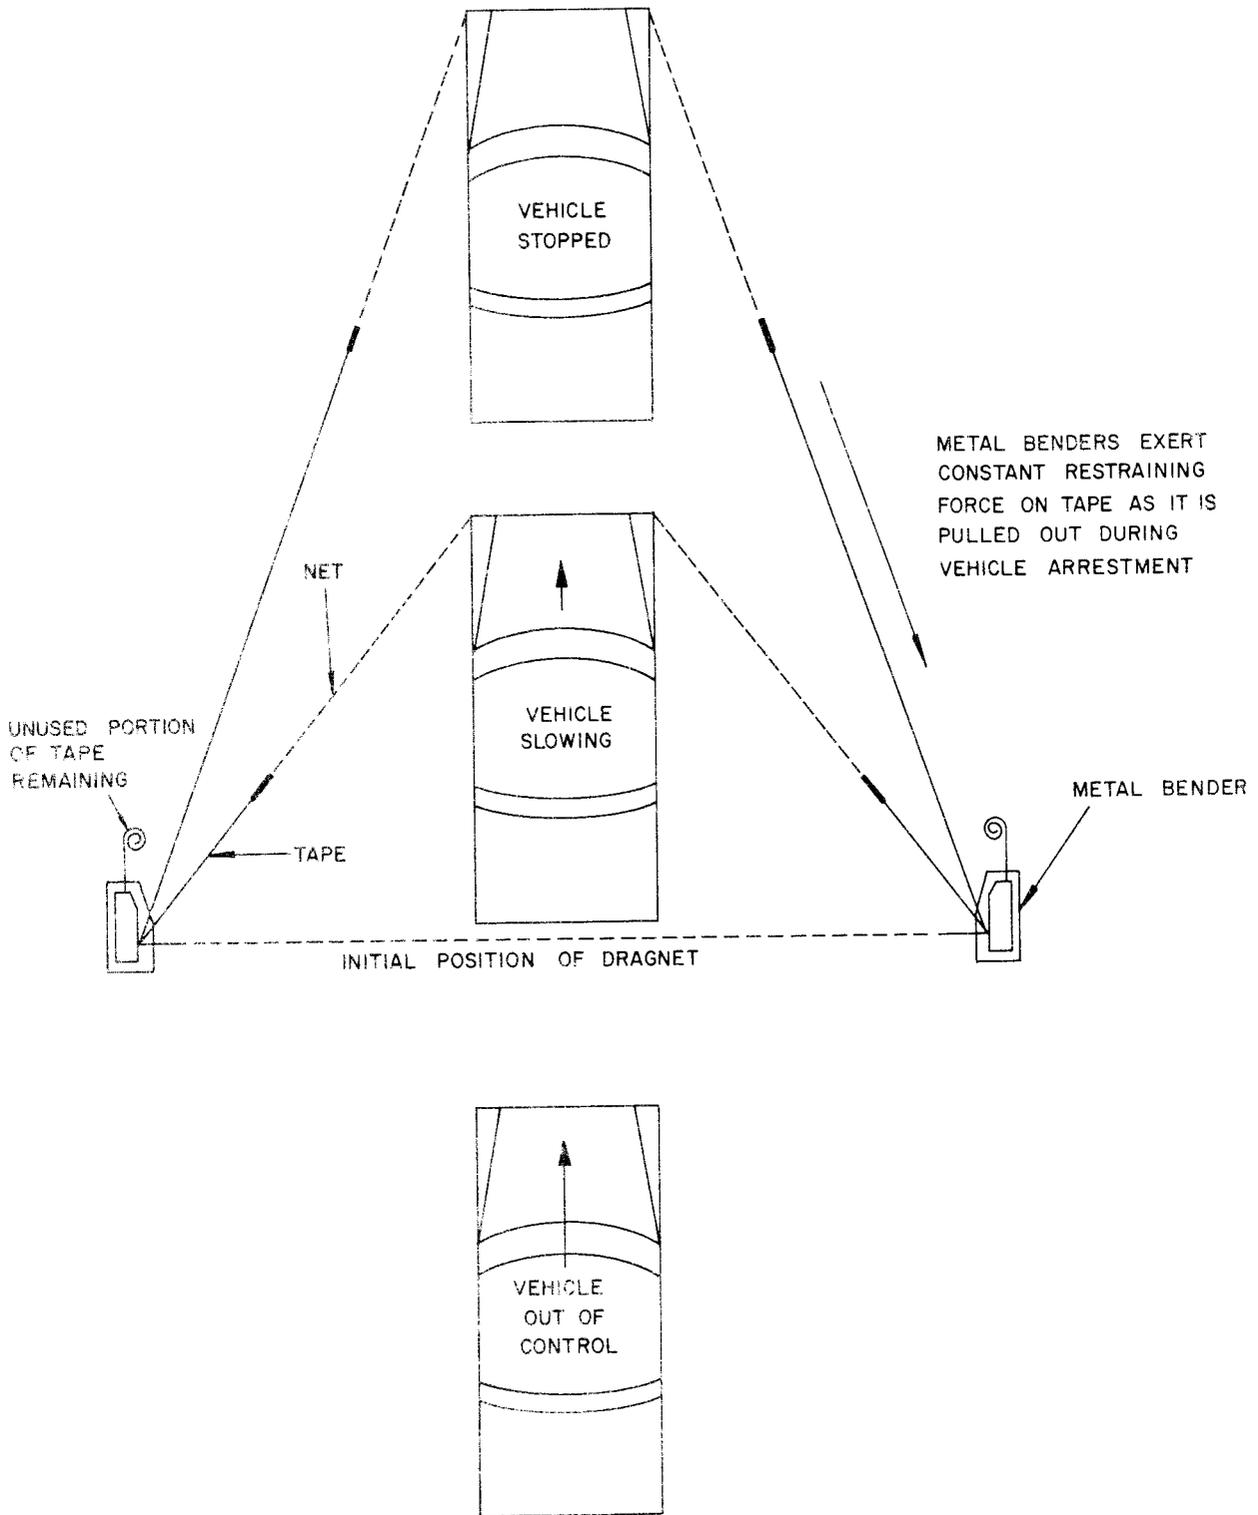
FIGURE IV.1.B.1. IDEALIZED FUNCTION OF DRAGNET ARRESTING SYSTEM

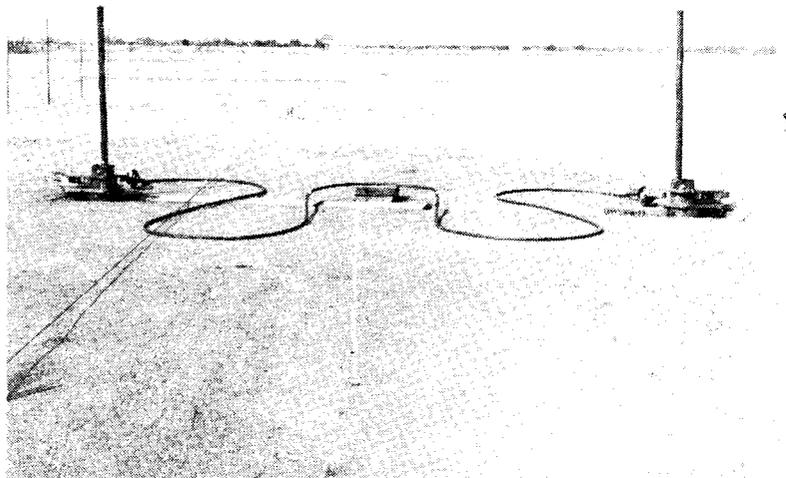
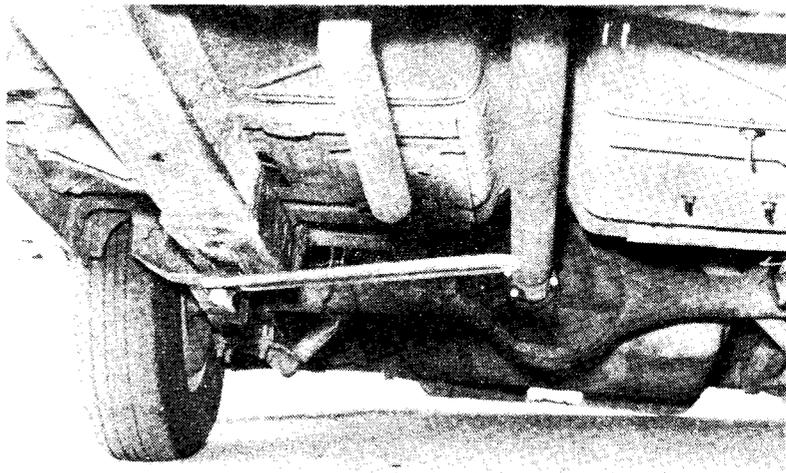
FIGURE IV.1.B.8. CABLE & METAL BENDER POSITION AND STEEL HOOK ATTACHED TO VEHICLE, BEFORE TEST 505-3B.

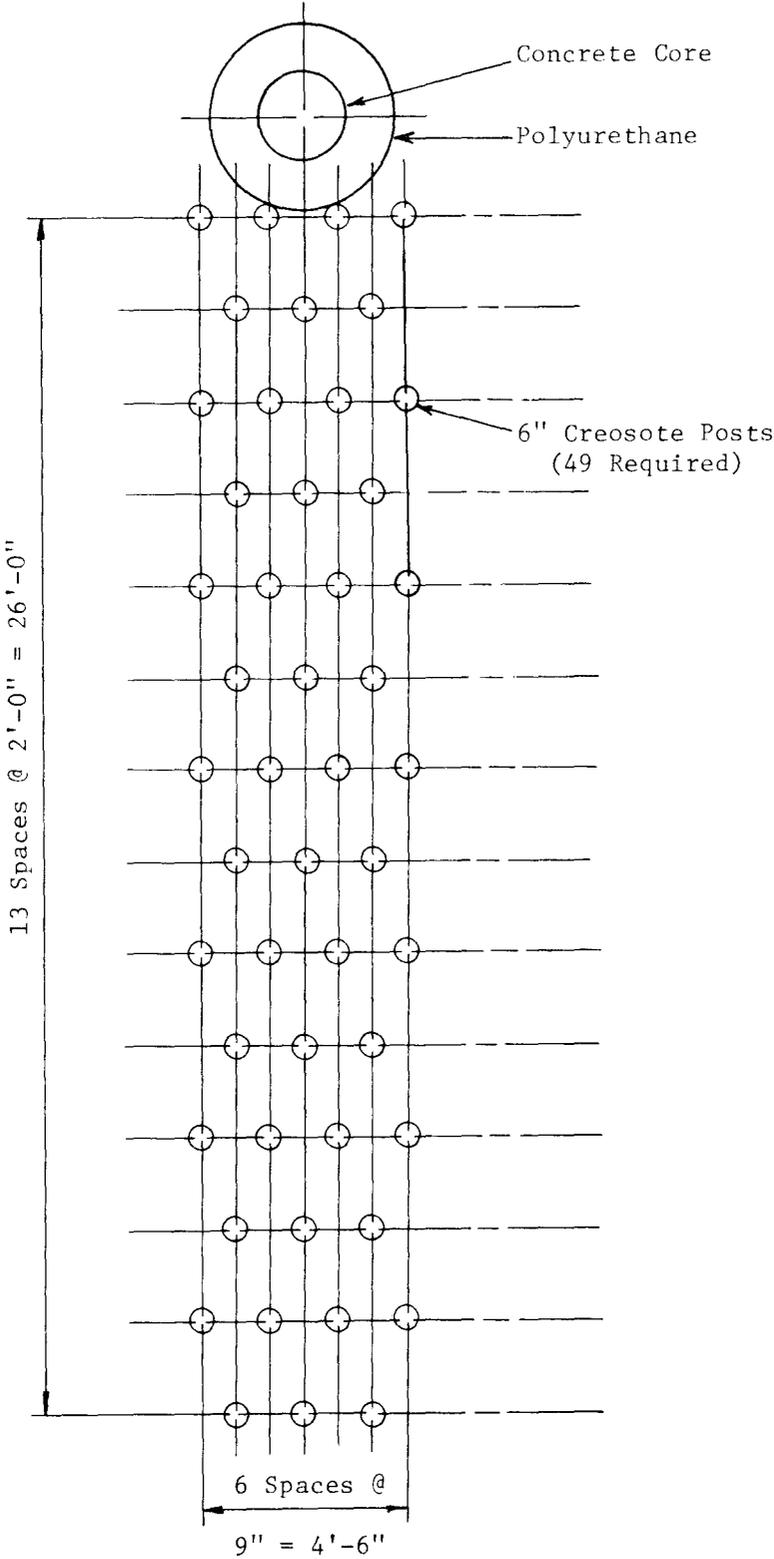
FIGURE IV.1.C.1. TIMBER POST ENERGY ABSORBING PROTECTIVE BARRIER

Analysis of the high-speed films revealed that the front rows of posts were pushed over as intended, but that these "pushed-over" posts formed a ramp which resulted in the vehicle becoming airborne. The soil surrounding

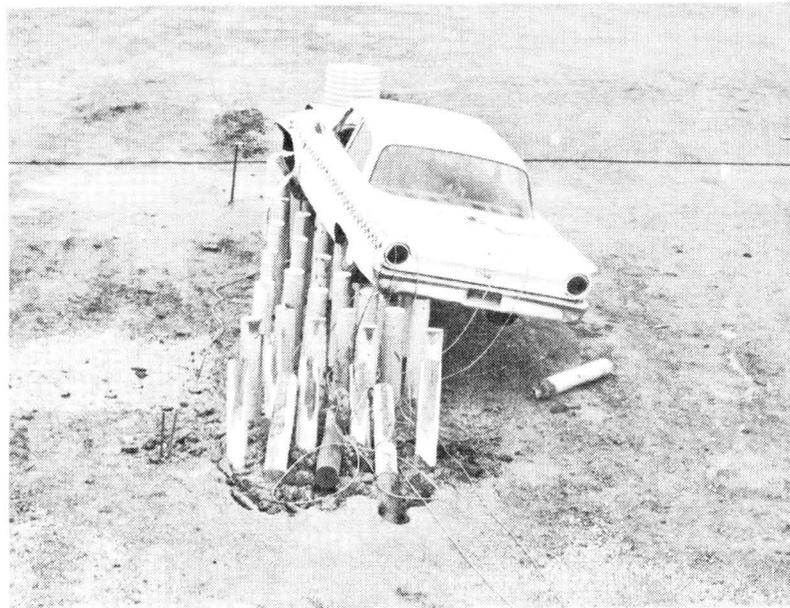
FIGURE IV.1.C.3. POSTS AND VEHICLE AFTER COLLISION
INITIAL VEHICLE SPEED 54.5 MPH
STOPPING DISTANCE 27.3 FT.,
AVERAGE VEHICLE DECELERATION 5.4 g's
(over first 0.352 sec following contact).

the timber posts and the depth of embedment has a great effect on the mode of energy transfer and also on the magnitude of the decelerations. The post spacing also appears to be a significant factor. Although the crash test did not yield the desirable behavior, modifications of this timber post barrier design and an awareness of the soil influence on the failure mode and magnitude of energy absorption may result in an effective timber post energy absorbing protective barrier.

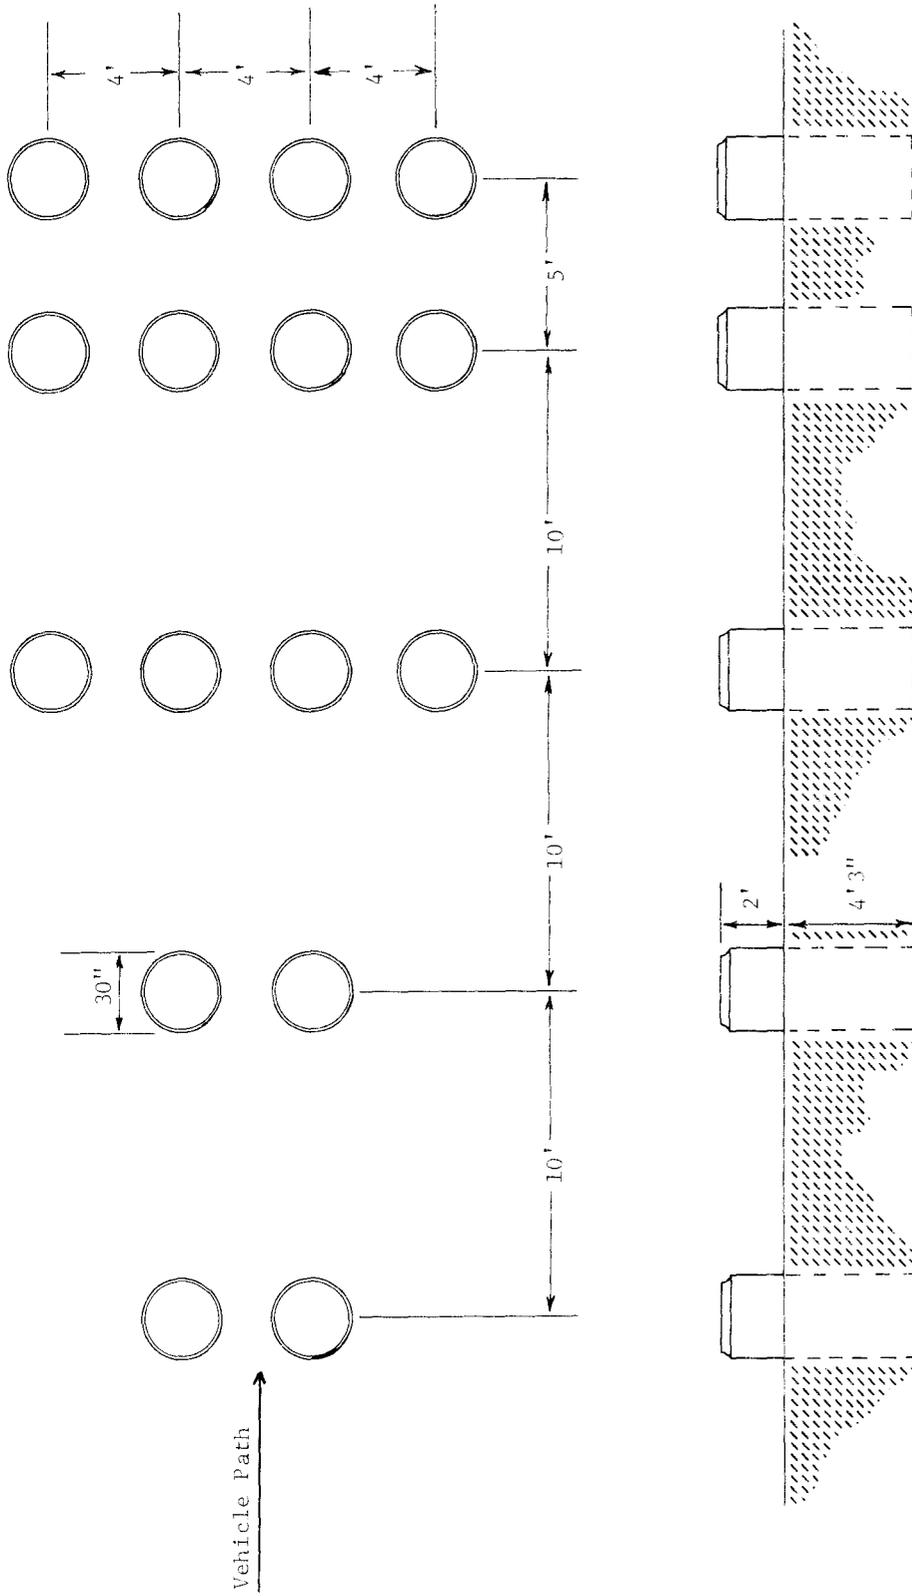
FIGURE IV. 1. D. 1. CONFIGURATION OF REINFORCED CONCRETE PIPE CRASH CUSHION

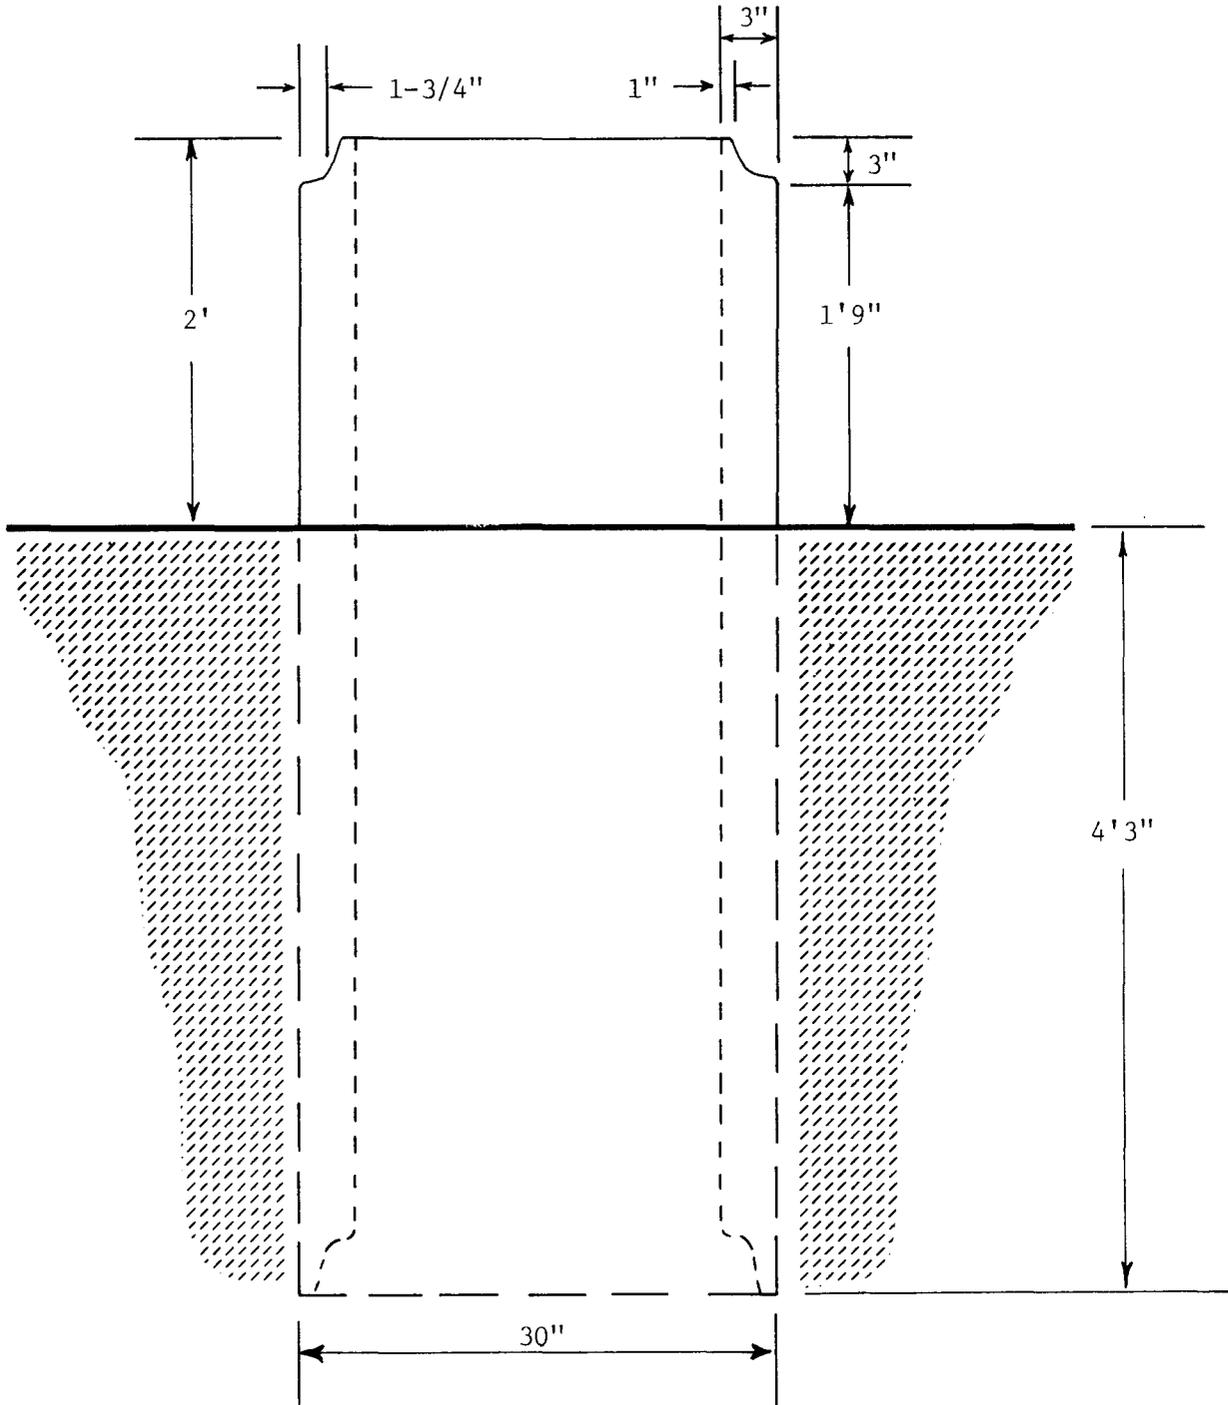
FIGURE IV.1.D.2. DETAILS OF ONE REINFORCED CONCRETE PIPE

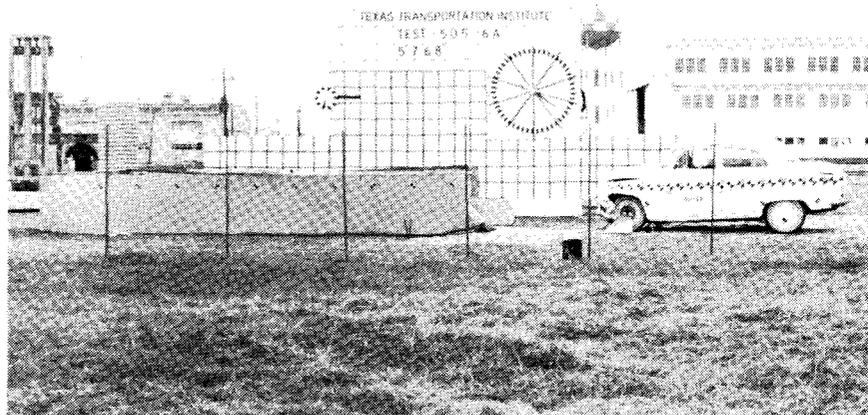
FIGURE IV.1.E.2. POLYURETHANE FOAM BARRIER AND VEHICLE AFTER COLLISION.

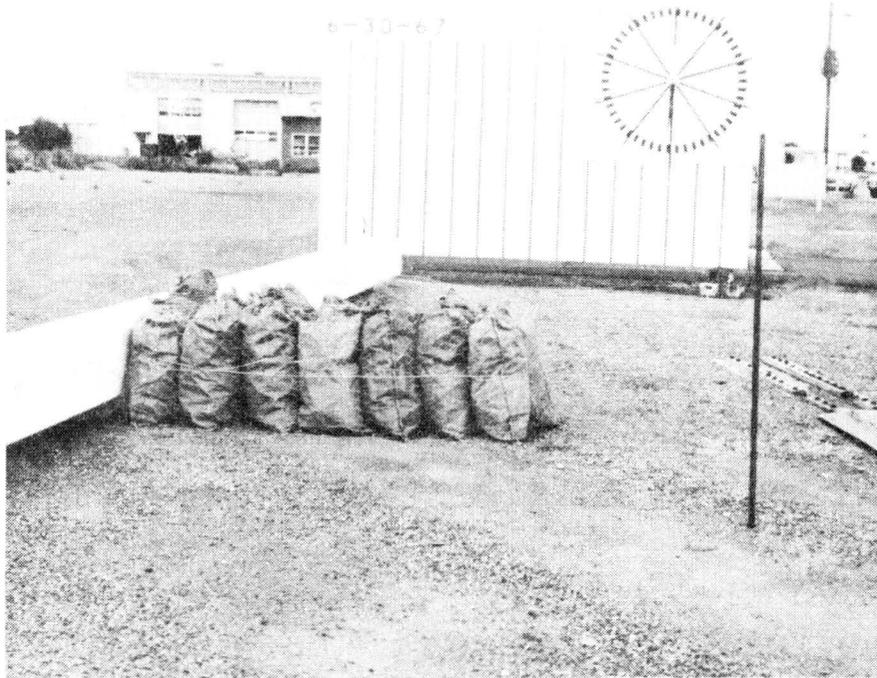
FIGURE IV.2.A.1. BURLAP BAGS FILLED WITH EMPTY BEVERAGE CANS BEFORE TEST 505-1A.

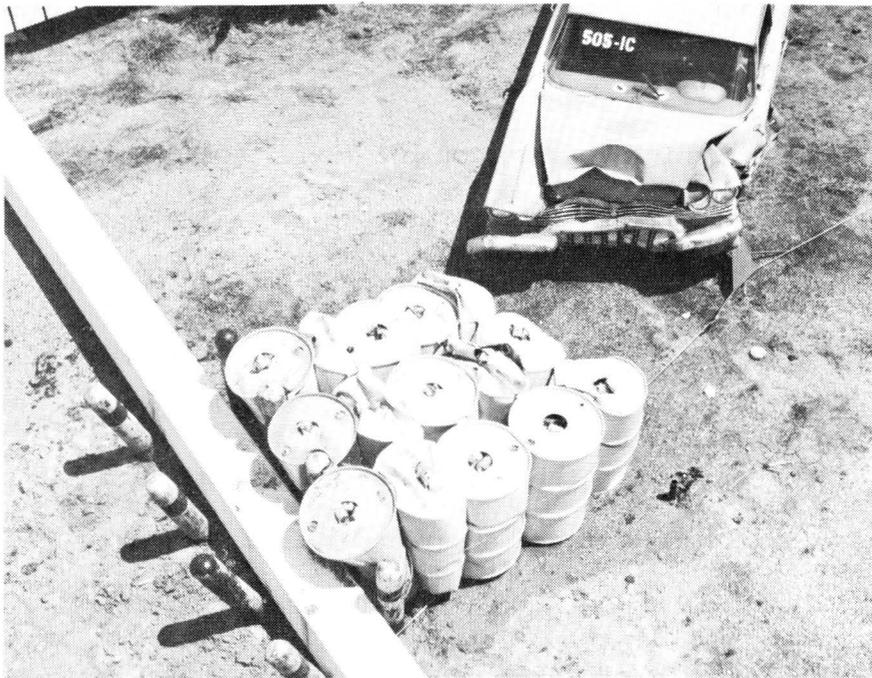
FIGURE IV.2.A.6. VEHICLE AND BARRIER AFTER TEST 505-1C.

In 505-1C, fifteen 55-gallon steel drums filled with empty beverage cans were arranged 3 drums wide and 5 drums deep. See Figure IV.2.A.5. A 3520 lb Plymouth impacted the barrier head-on at a speed of 59 mph. The vehicle received severe damage. The vehicle and barrier after the test are shown in Figure IV.2.A.6. The average deceleration was 14.2 g's over a distance of 7.1 ft.

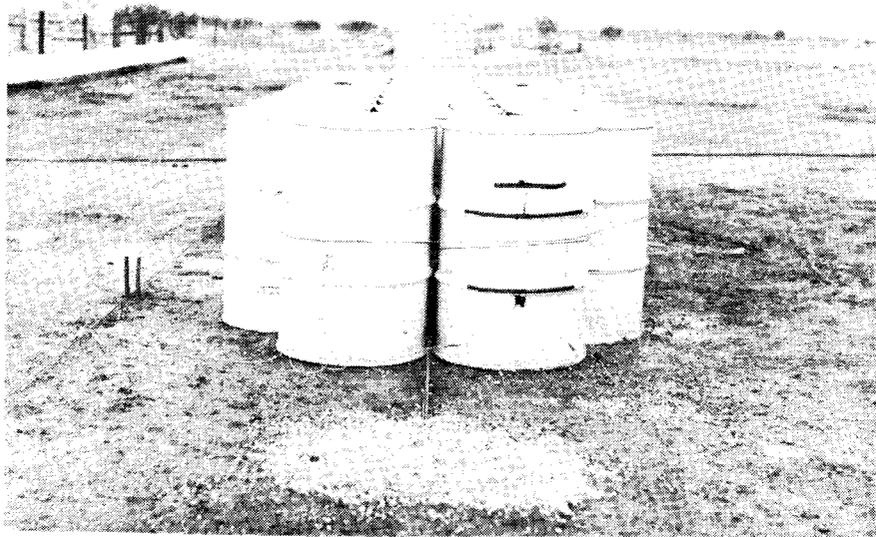
FIGURE IV.2.A.7. TWENTY-NINE 55-GALLON DRUMS FILLED WITH EMPTY BEVERAGE CANS BEFORE TEST 505-1D.

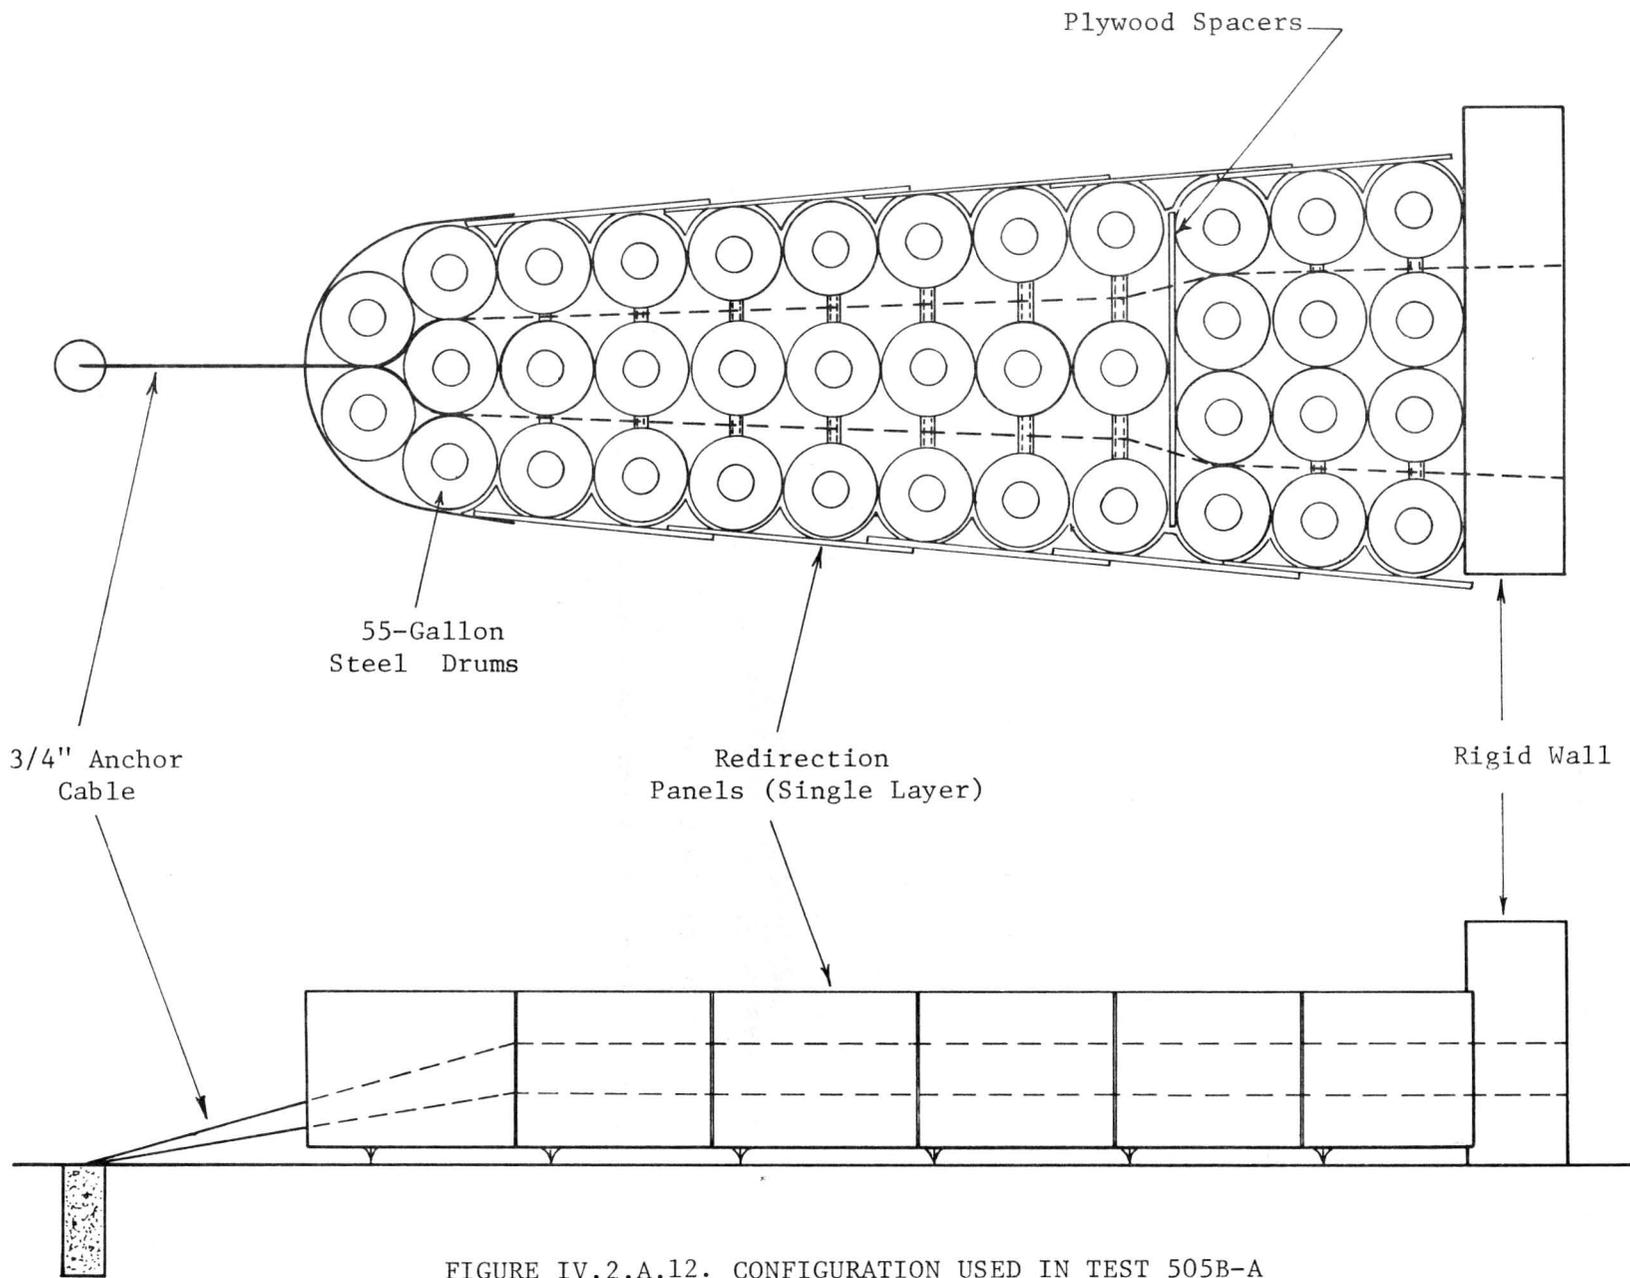
FIGURE IV.2.A.12. CONFIGURATION USED IN TEST 505B-A

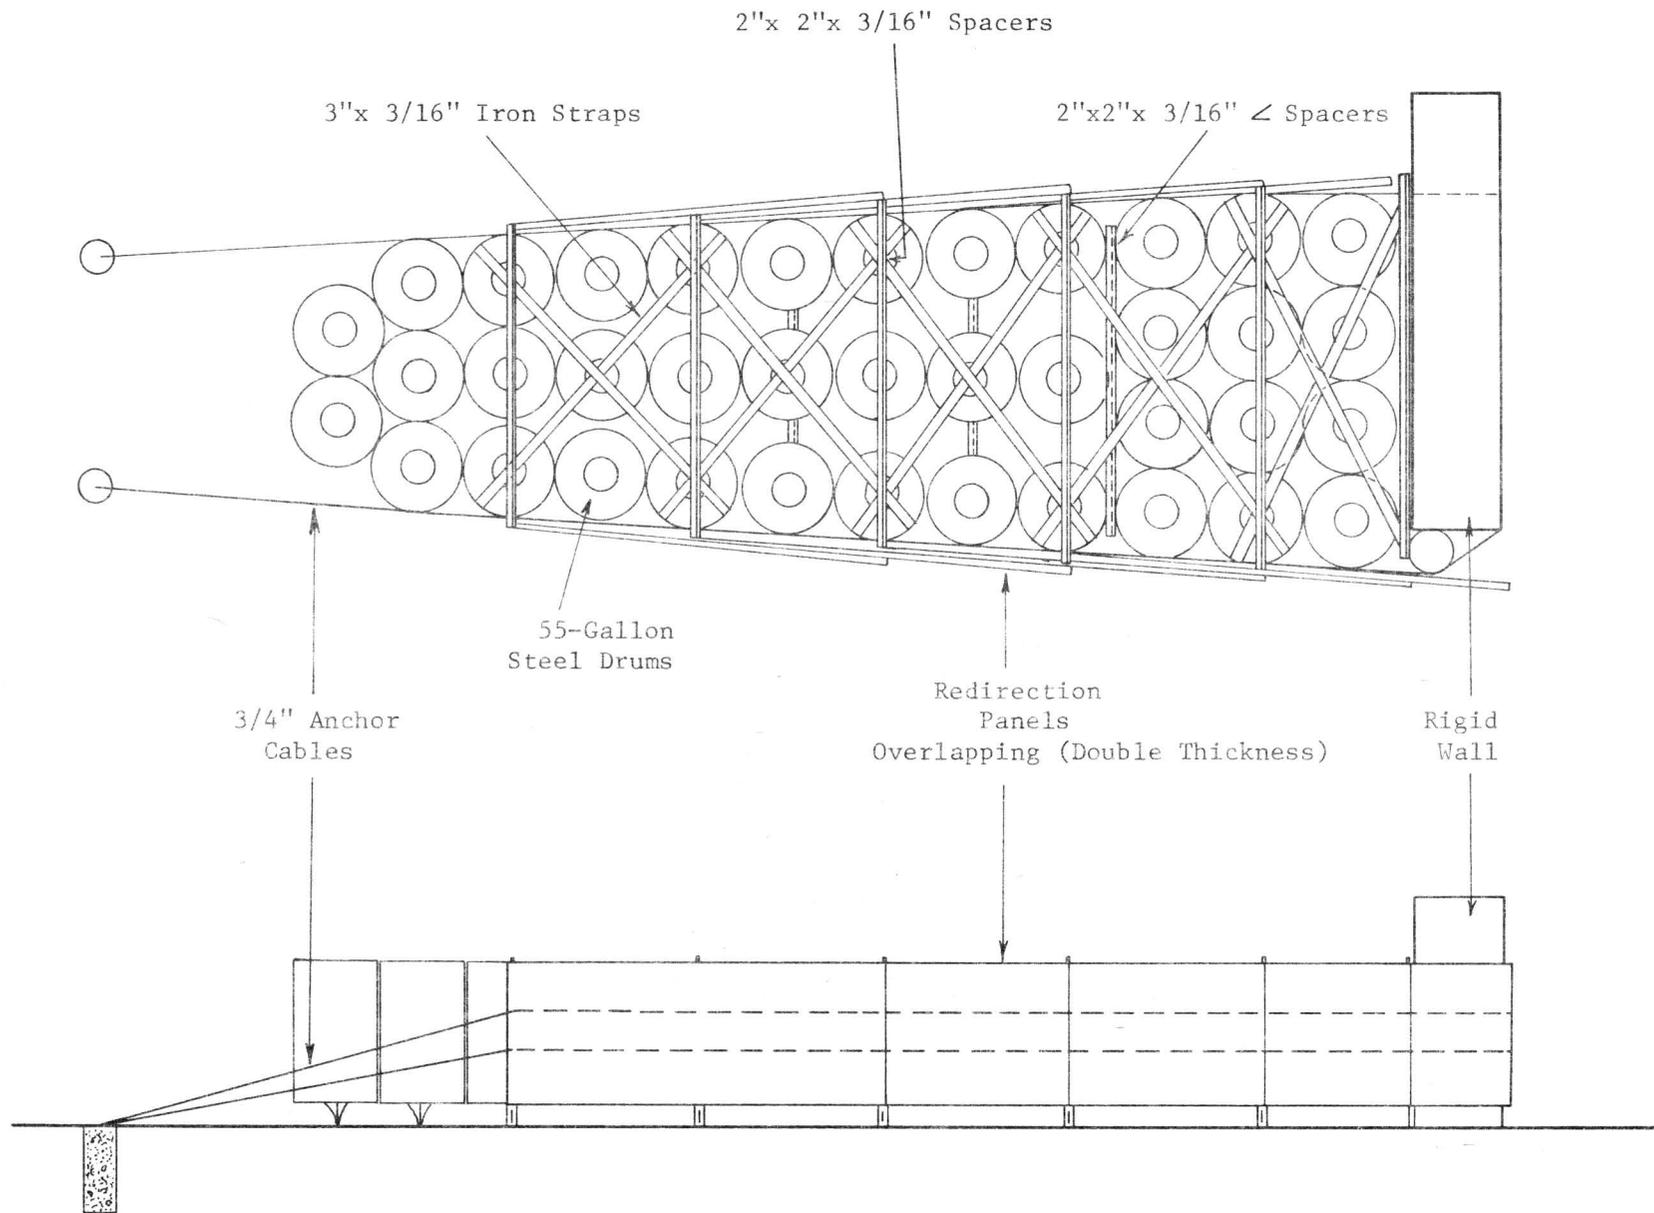
FIGURE IV.2.A.13. CONFIGURATION USED IN TESTS 505B-B AND 505B-C

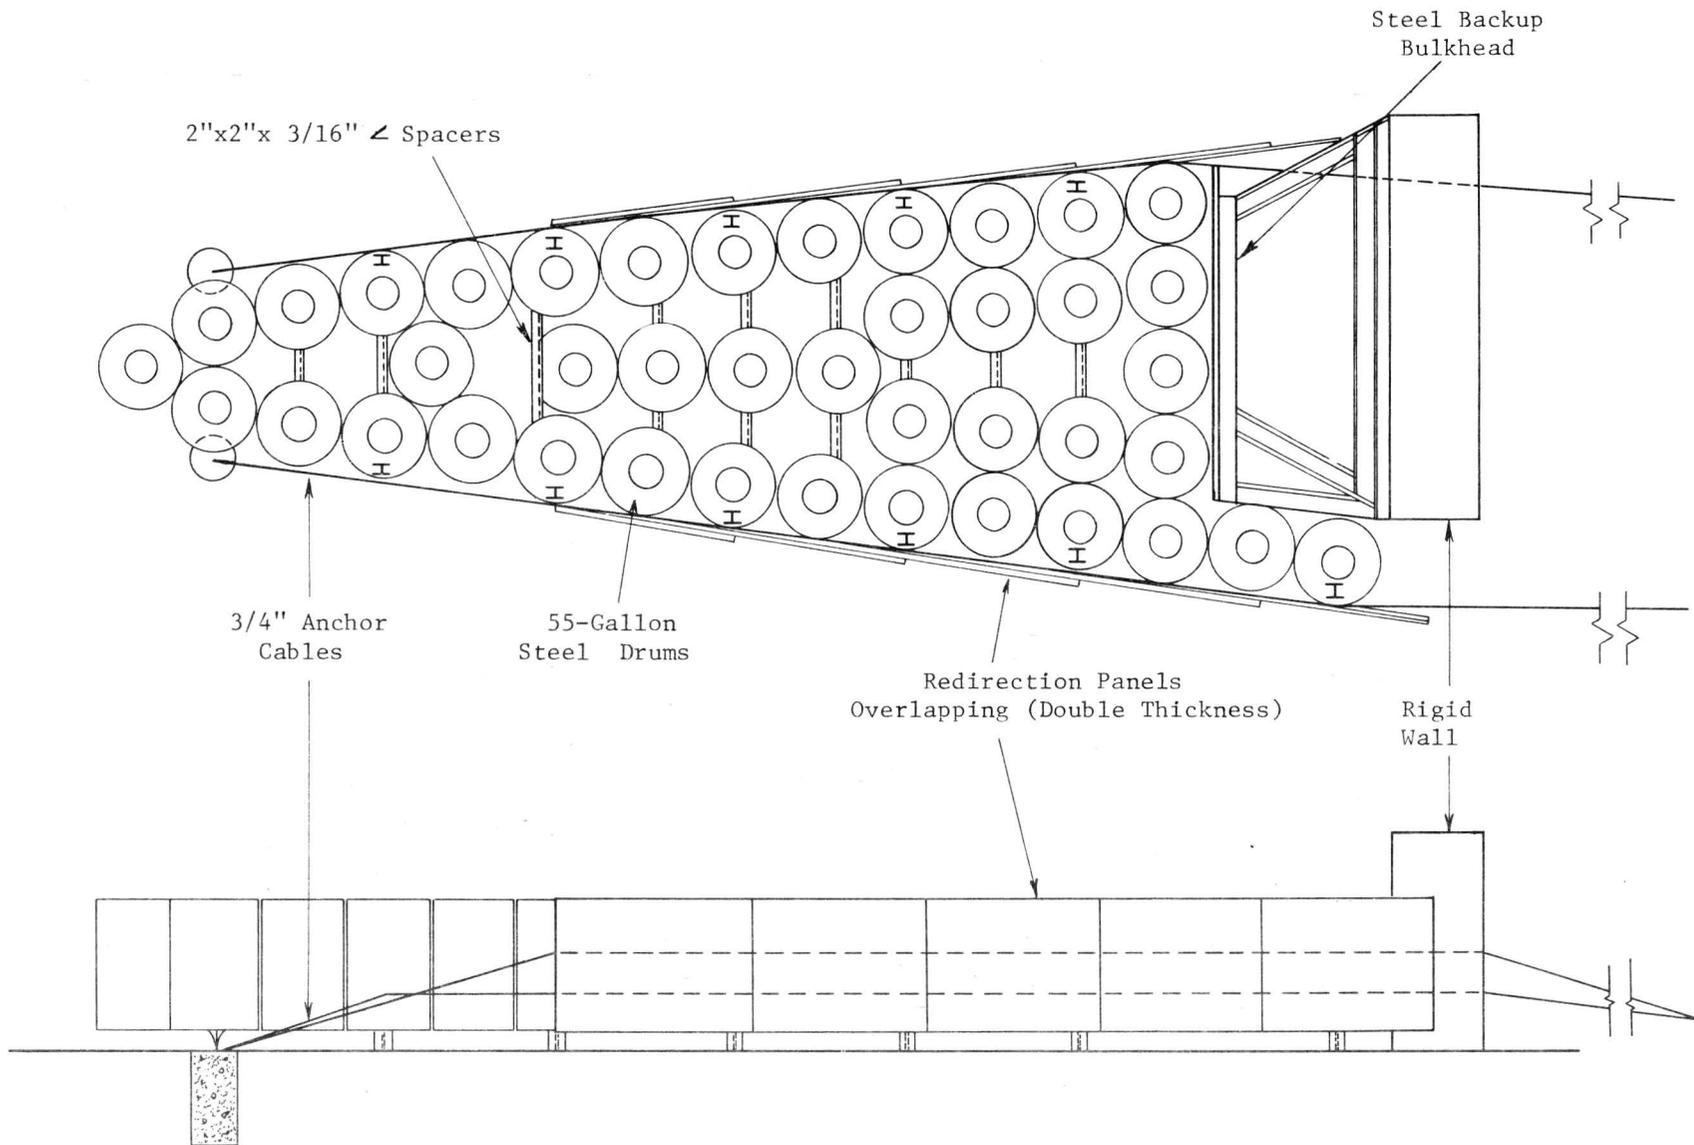
FIGURE IV.2.A.14. CONFIGURATION USED IN TESTS 505B-D AND 505B-E

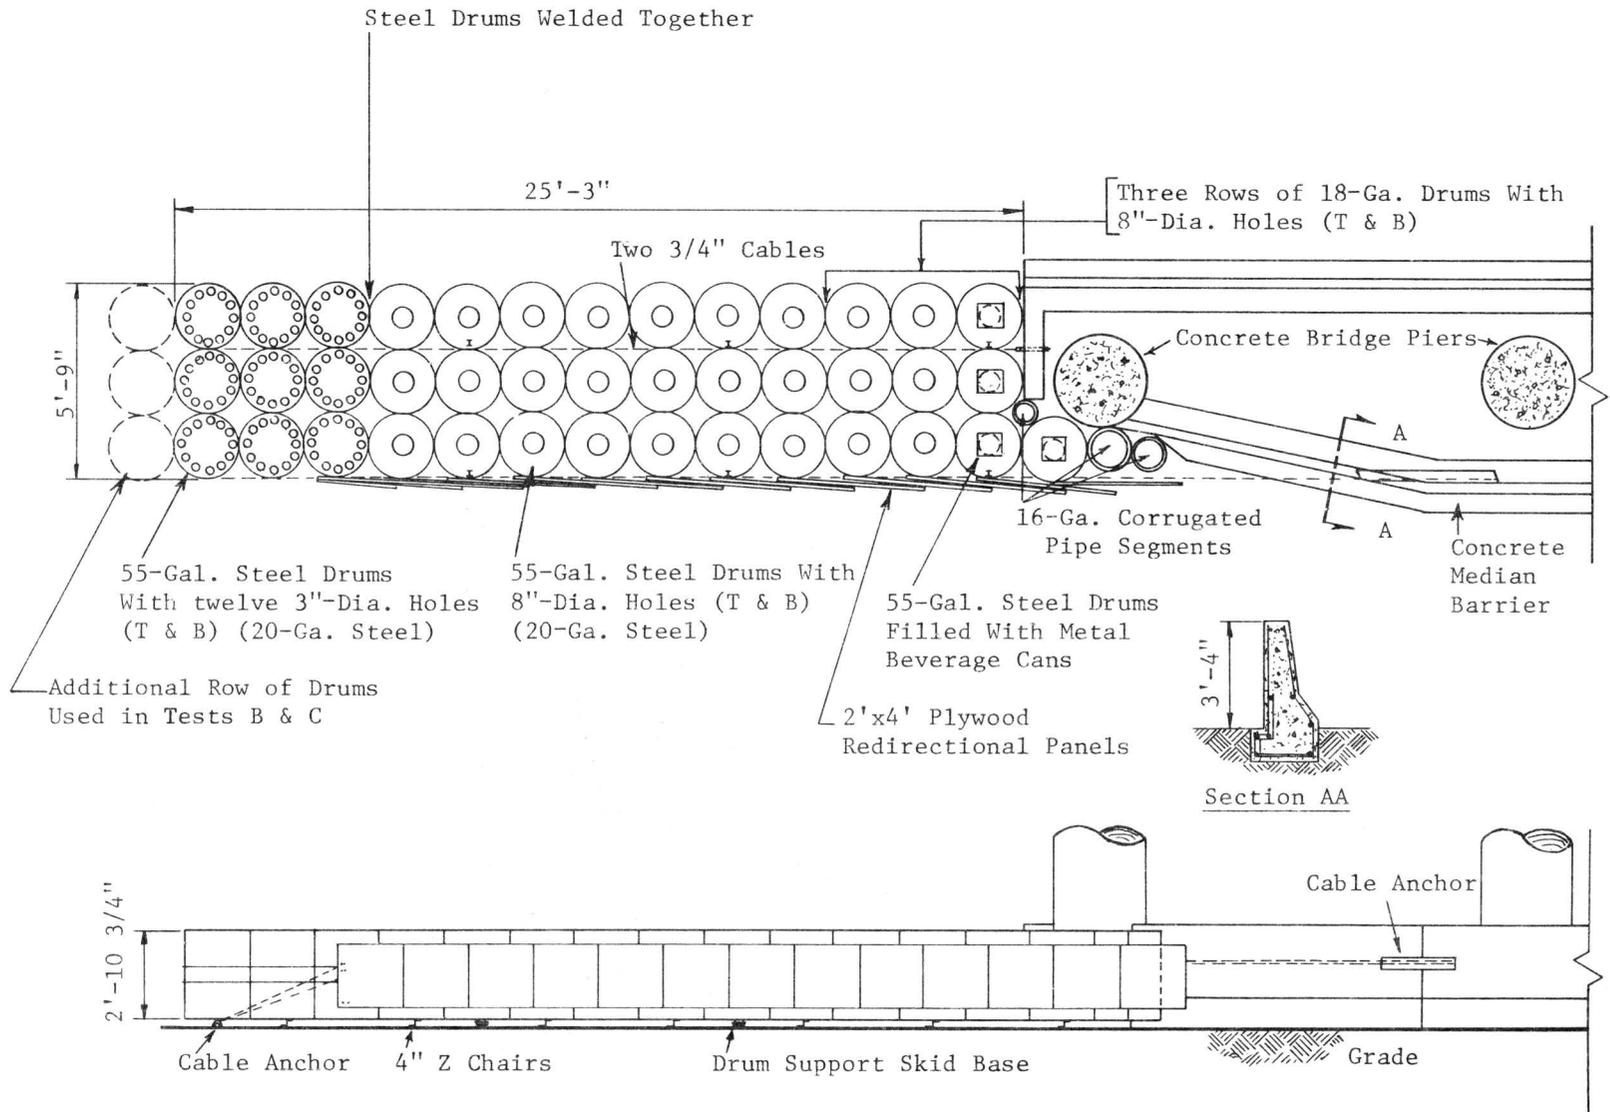
FIGURE IV.2.A.15. CRASH CUSHION-MEDIAN BARRIER SYSTEM (505 M-A, M-B, & M-C).

In another series, 505-M, two angle impacts and one head-on were conducted on a combination of a reinforced concrete median barrier and a variation of the Modular Crash Cushion. This system was installed around two simulated concrete bridge piers. The installation is shown in Figures IV.2.A.15-16 and consisted of 55-gallon steel drums with holes in the top and bottom. Redirectional panels were attached to the side of the crash cushion and steel cables gave the cushion lateral stability.

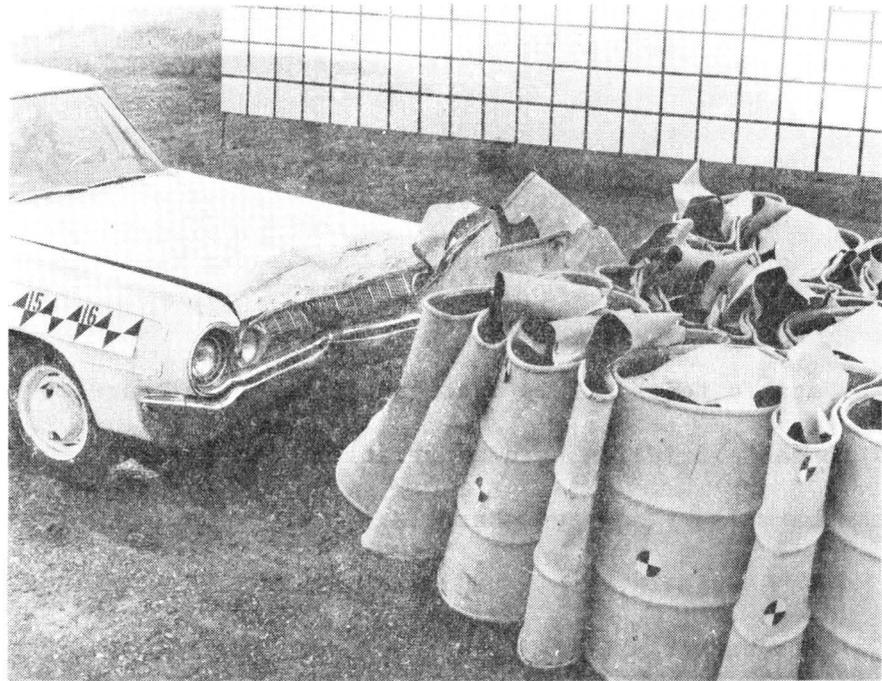
FIGURE IV.2.A.17. VIEW OF MINOR VEHICLE DAMAGE. ONLY ONE OF FOUR HEADLIGHTS WAS BROKEN; BUMPER AND GRILL DEFORMED APPROXIMATELY 4 IN. (TEST 505-1E).

One of the four headlights was broken and the front bumper and grillwork were deformed approximately 4 in. The vehicle was in running condition immediately after the impact. The vehicle stopping distance of 13.3 ft

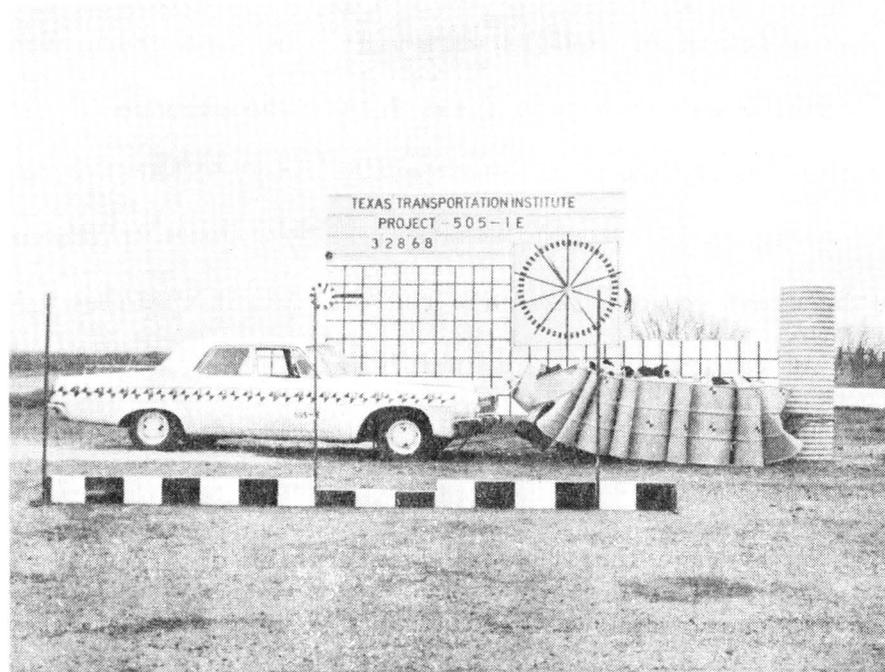
FIGURE IV.2.A.18. VIEW OF VEHICLE AND BARRIER AFTER IMPACT. (TEST 505-1E)

indicated that approximately 70% of the energy capacity of the barrier was used up. The vehicle had 387,000 ft-lbs of kinetic energy.

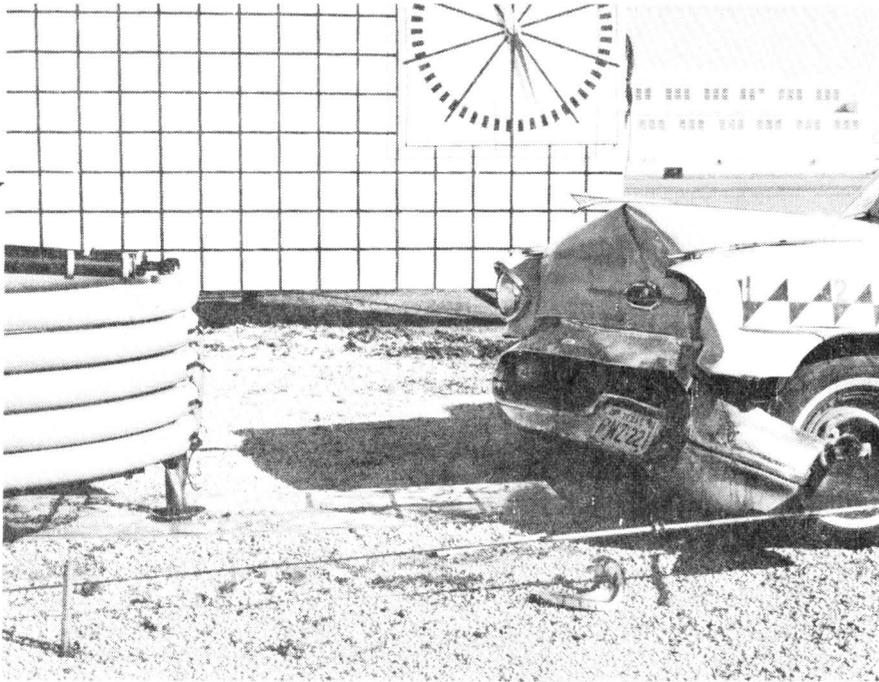
FIGURE IV.2.C.2. TOR-SHOK AND VEHICLE AFTER COLLISION, TEST 505-2A.

Other tests conducted on this system are described in Technical Memoranda 505-2 and 505-2S in Appendix F. For head-on collisions, the TOR-SHOK system provided reasonable impact attenuation when struck by heavy vehicles (4000 lb or more). When the kinetic energy of the vehicle exceeds about 425,000 ft-lb, considerable damage to the barrier and TOR-SHOKs can be anticipated. For the angled collisions conducted (Tests 2D and 2E), the performance of the system was unsatisfactory. Modifications of the system to insure proper activation of the TOR-SHOK arms under angle hits should minimize or correct this deficiency. Modifications are being made by the designers.

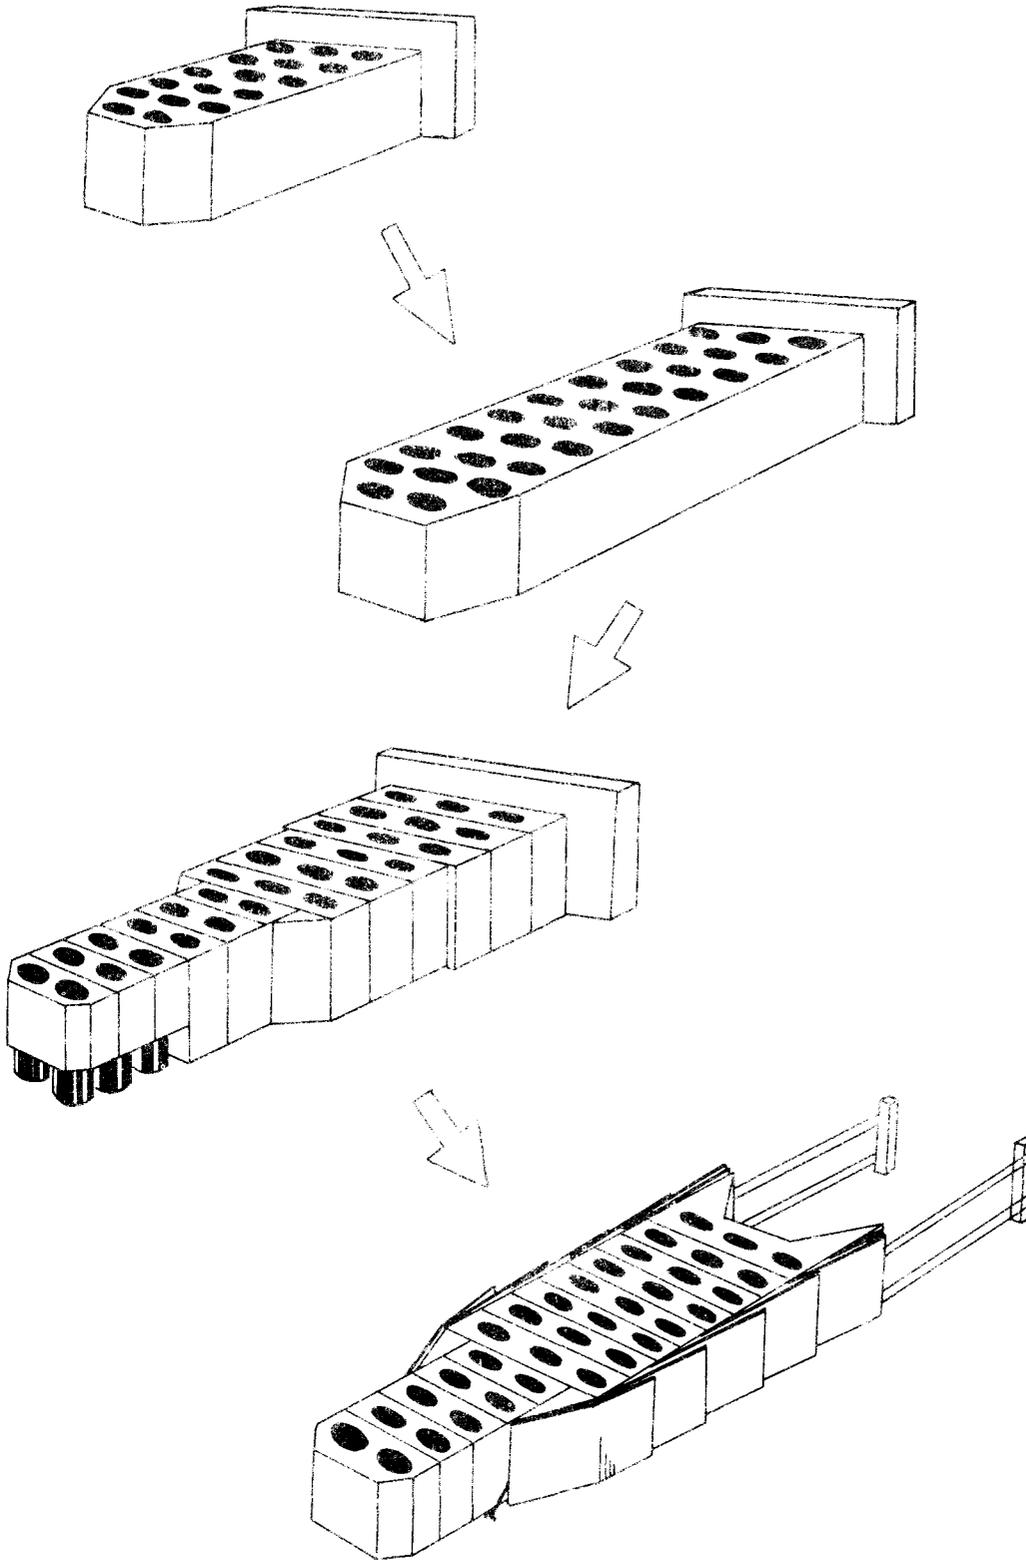
FIGURE IV.2.D.1. THE EVOLUTION OF THE CELLULAR CONCRETE CRASH CUSHION.

The evolution of the cellular concrete crash cushion is shown graphically in Figure IV.2.D.1. The first step in the evaluation of this newly designed system was the feasibility testing of a prototype cushion which was only one-half the length (12 ft) of the proposed full-size crash cushion (24 ft). With encouraging results from the first test, full-scale, head-on testing was conducted on two cushions incorporating design modifications and different construction techniques. Because of the excellent performance of the concrete crash cushion in the first three tests conducted, it was decided to take step three in the evaluation of the system-- side angle testing. Side fender panels which were previously tested as part of the Modular Crash Cushion were added to the concrete crash cushion,
