TEST AND EVALUATION
OF
VEHICLE ARRESTING, ENERGY ABSORBING, AND IMPACT ATTENUATION SYSTEMS

F I N A L R E P O R T

CONTRACT NO. CPR-11-5851

U. S. Department of Transportation
Federal Highway Administration

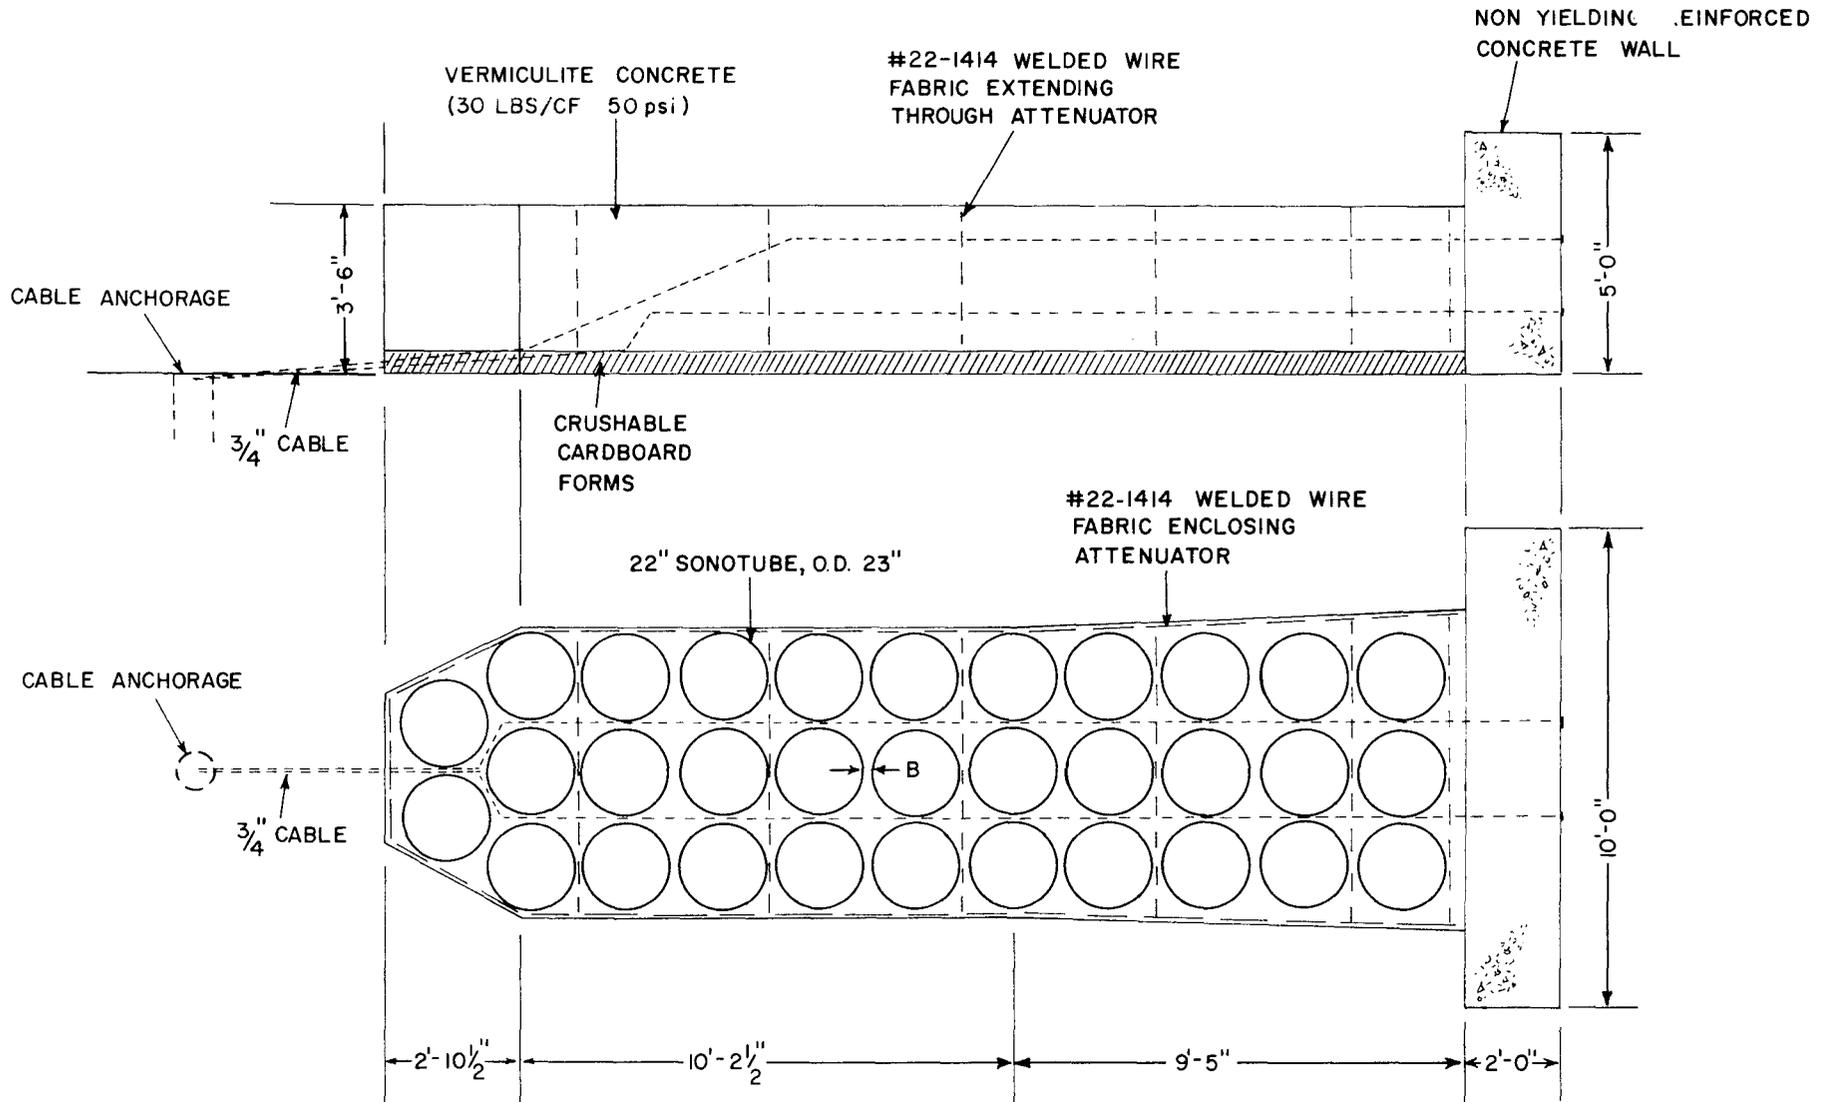
FIGURE IV.2.D.3 CONCRETE CRASH CUSHION, TEST 505 V-B

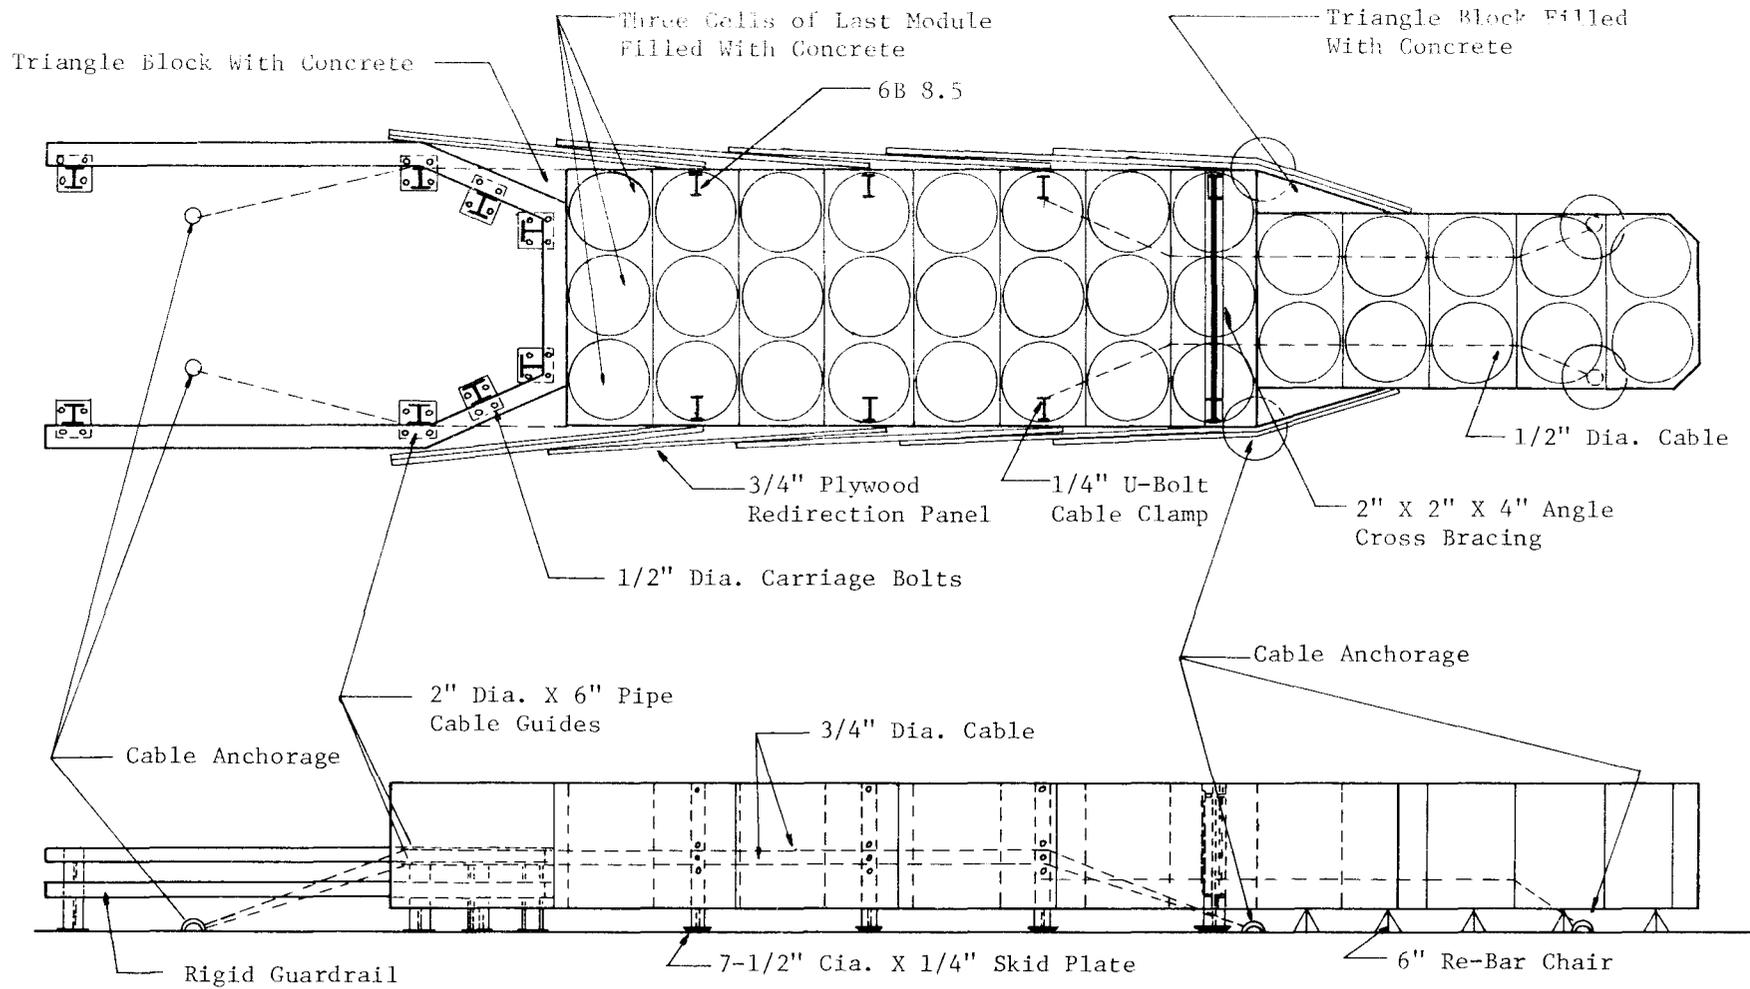
FIGURE IV.2.D.7. DETAILS OF CONCRETE CRASH CUSHION (TESTS 505 V-D, V-E, AND V-F).

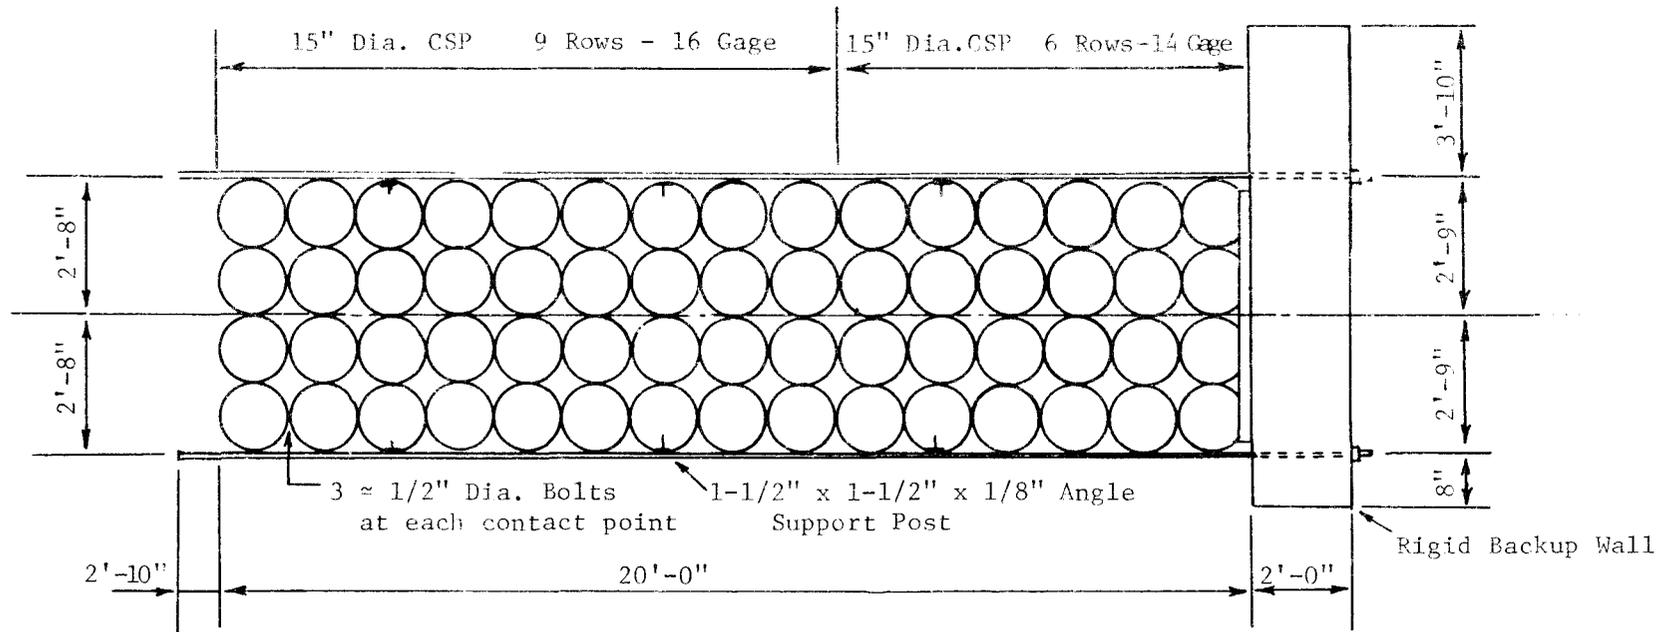
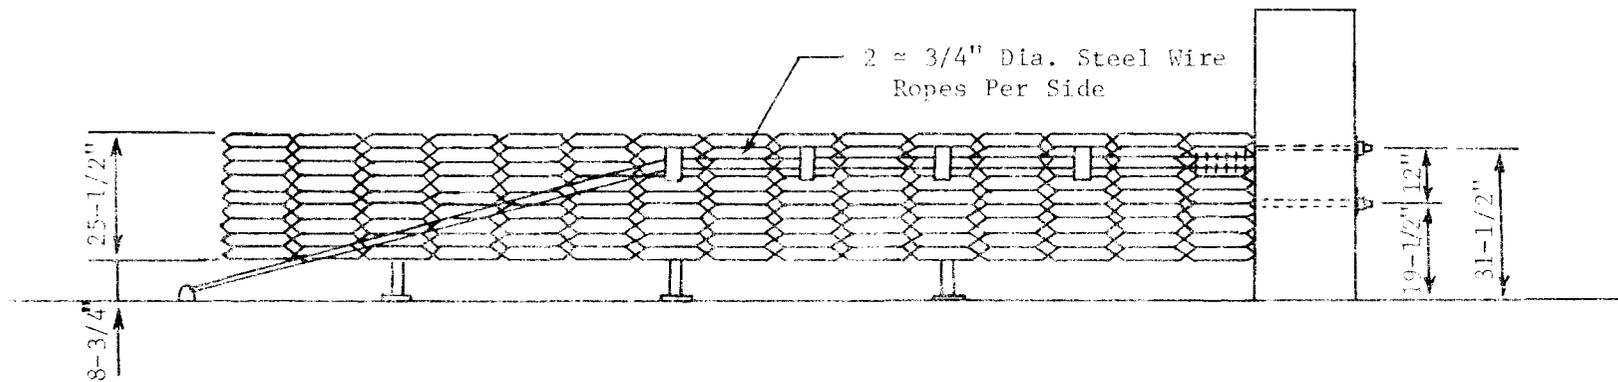
FIGURE IV.2.E.1. CORRUGATED STEEL PIPE CRASH CUSHION USED FOR FPST 505 CSP-1.

The head-on test of the first cushion (CSP-1) involved a 3750 lb vehicle traveling 58.4 mph. After the first seven rows of pipes had crushed, the vehicle ramped upward and became airborne. The front portion of the barrier pivoted upward and the first 5 rows of pipes became detached in a group and rotated through 360° in the air before coming to rest on top of the rear portion of the barrier near the backup wall (see Figures IV.2.E.3. & 4.). Little vehicle damage resulted (0.5 ft) despite an average longitudinal deceleration of 10.2 g's during the 89 msec before ramping.

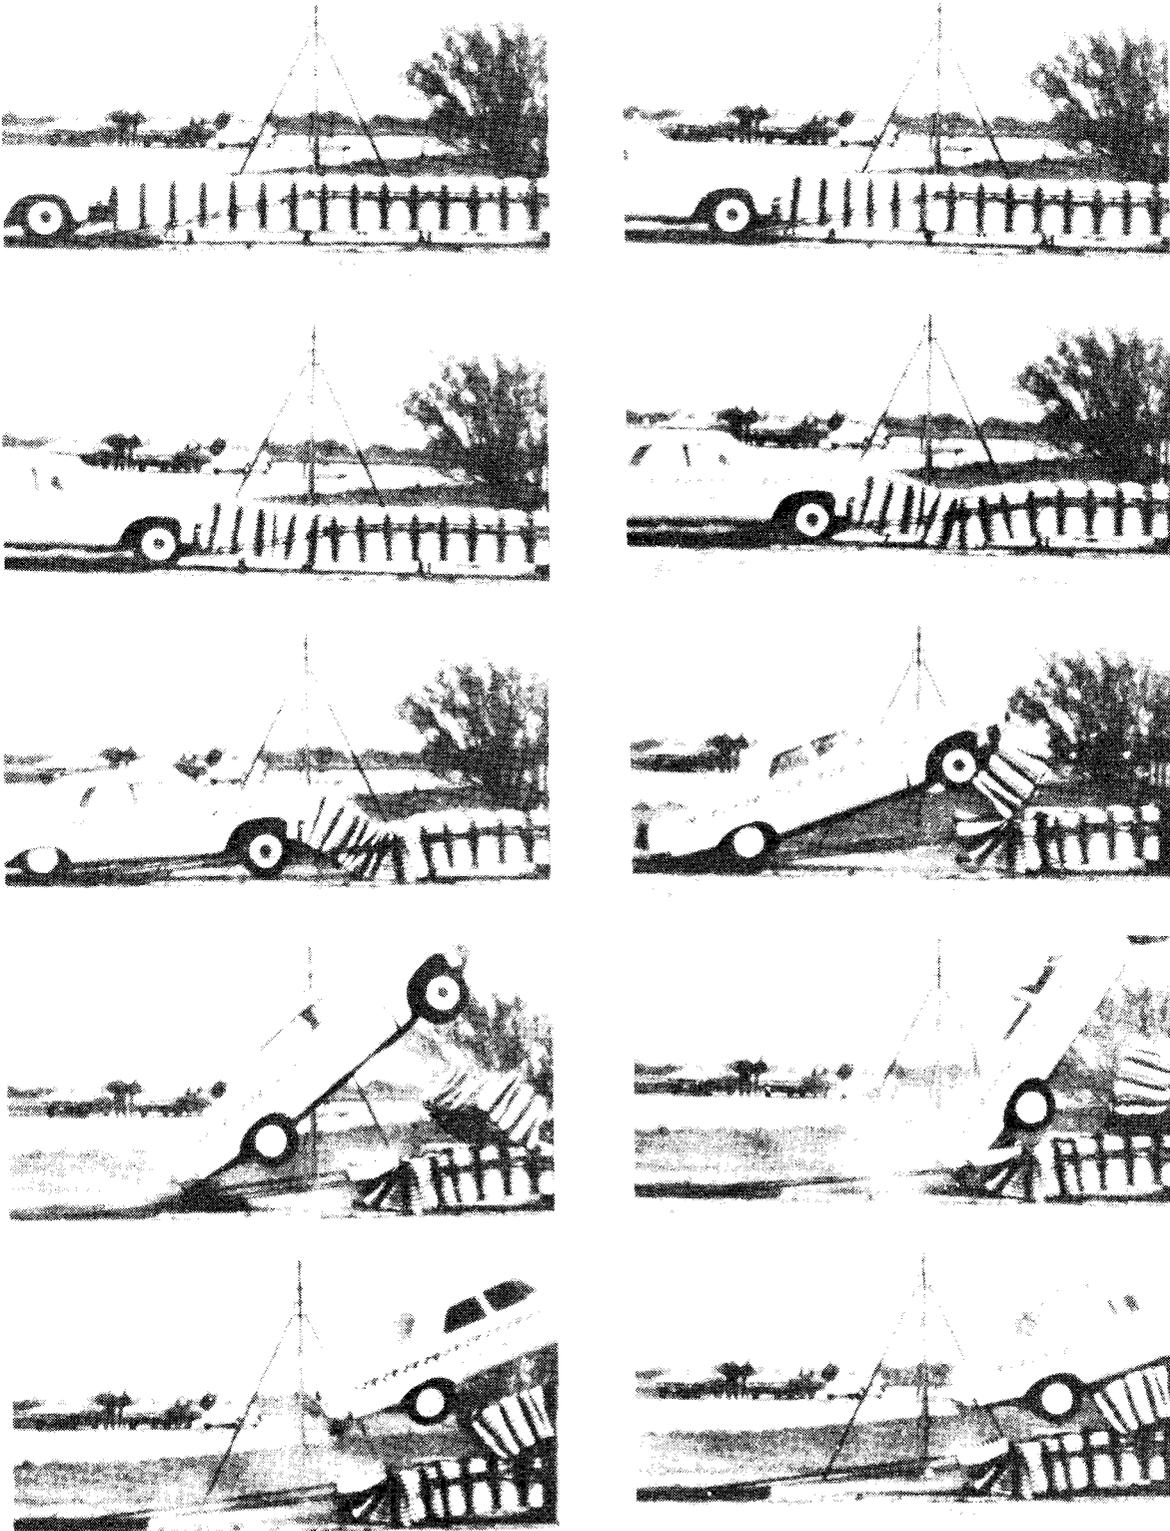
FIGURE IV.2.E.4. SEQUENTIAL PHOTOGRAPHS OF TEST 505 CSU-1.

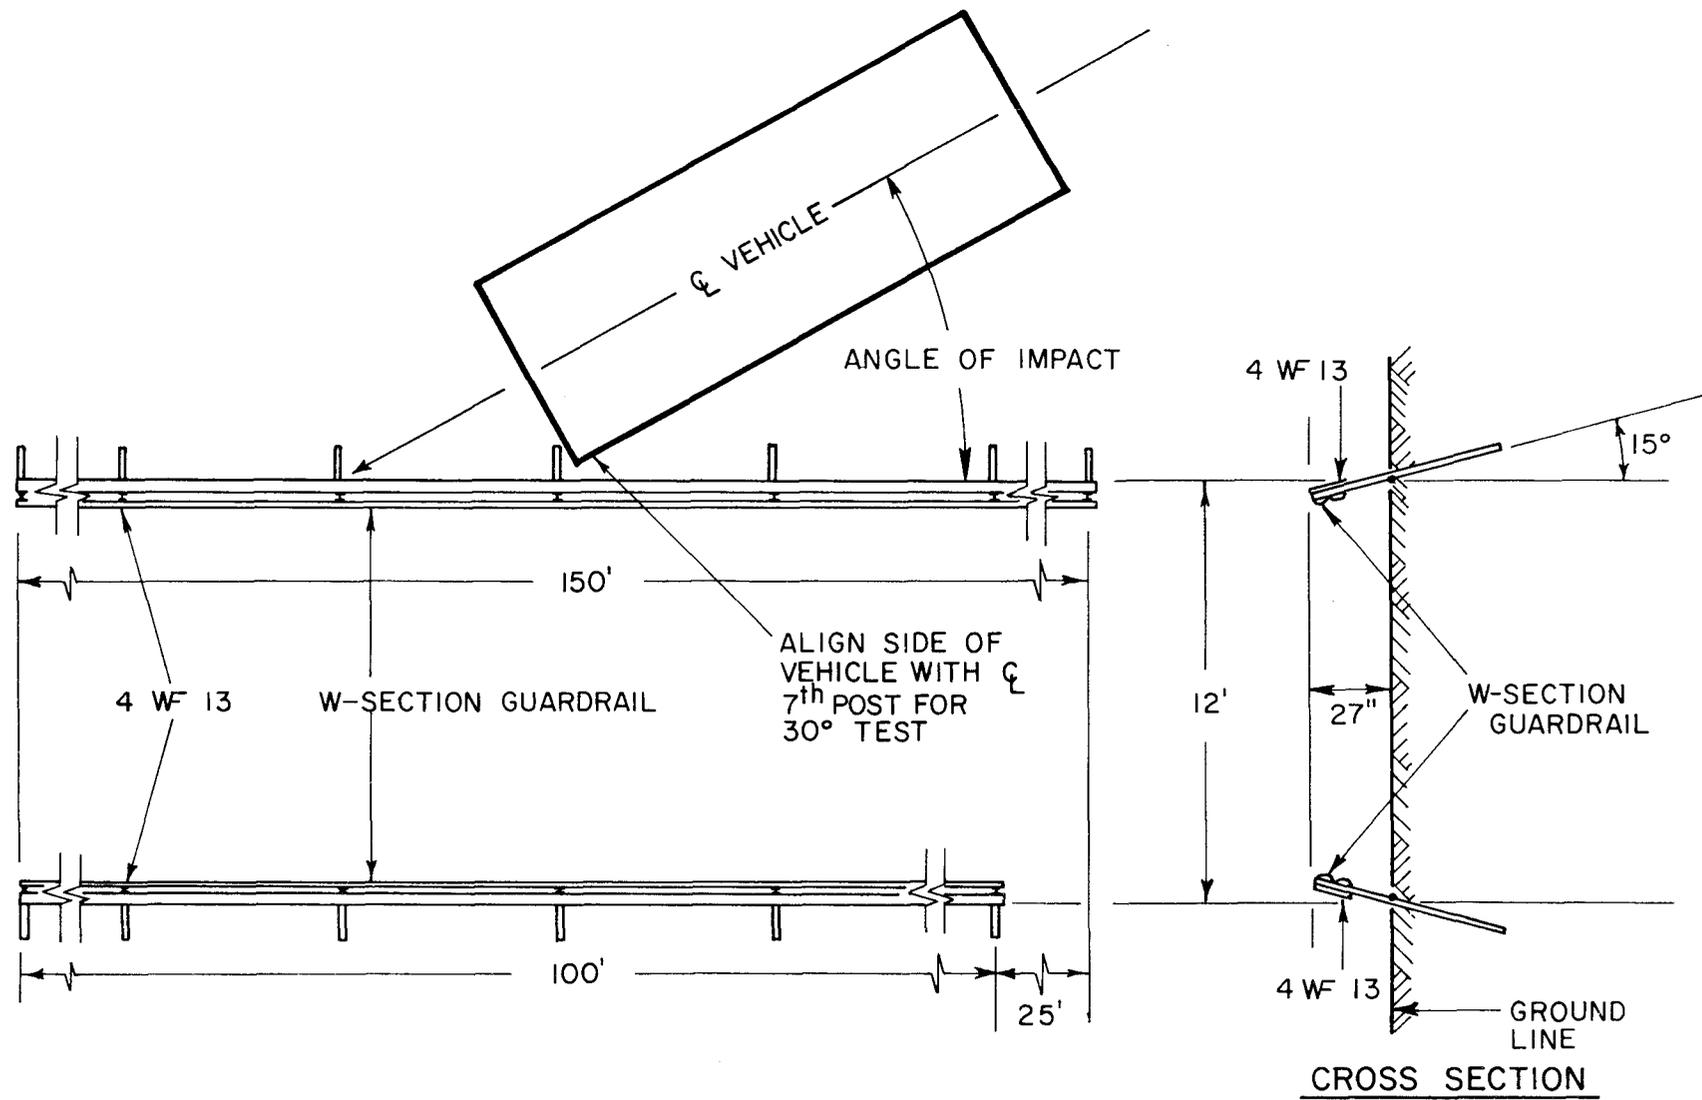
FIGURE IV.3.A.2. PLAN VIEW OF ONE-WAY GUARDRAIL ARRESTING SYSTEM

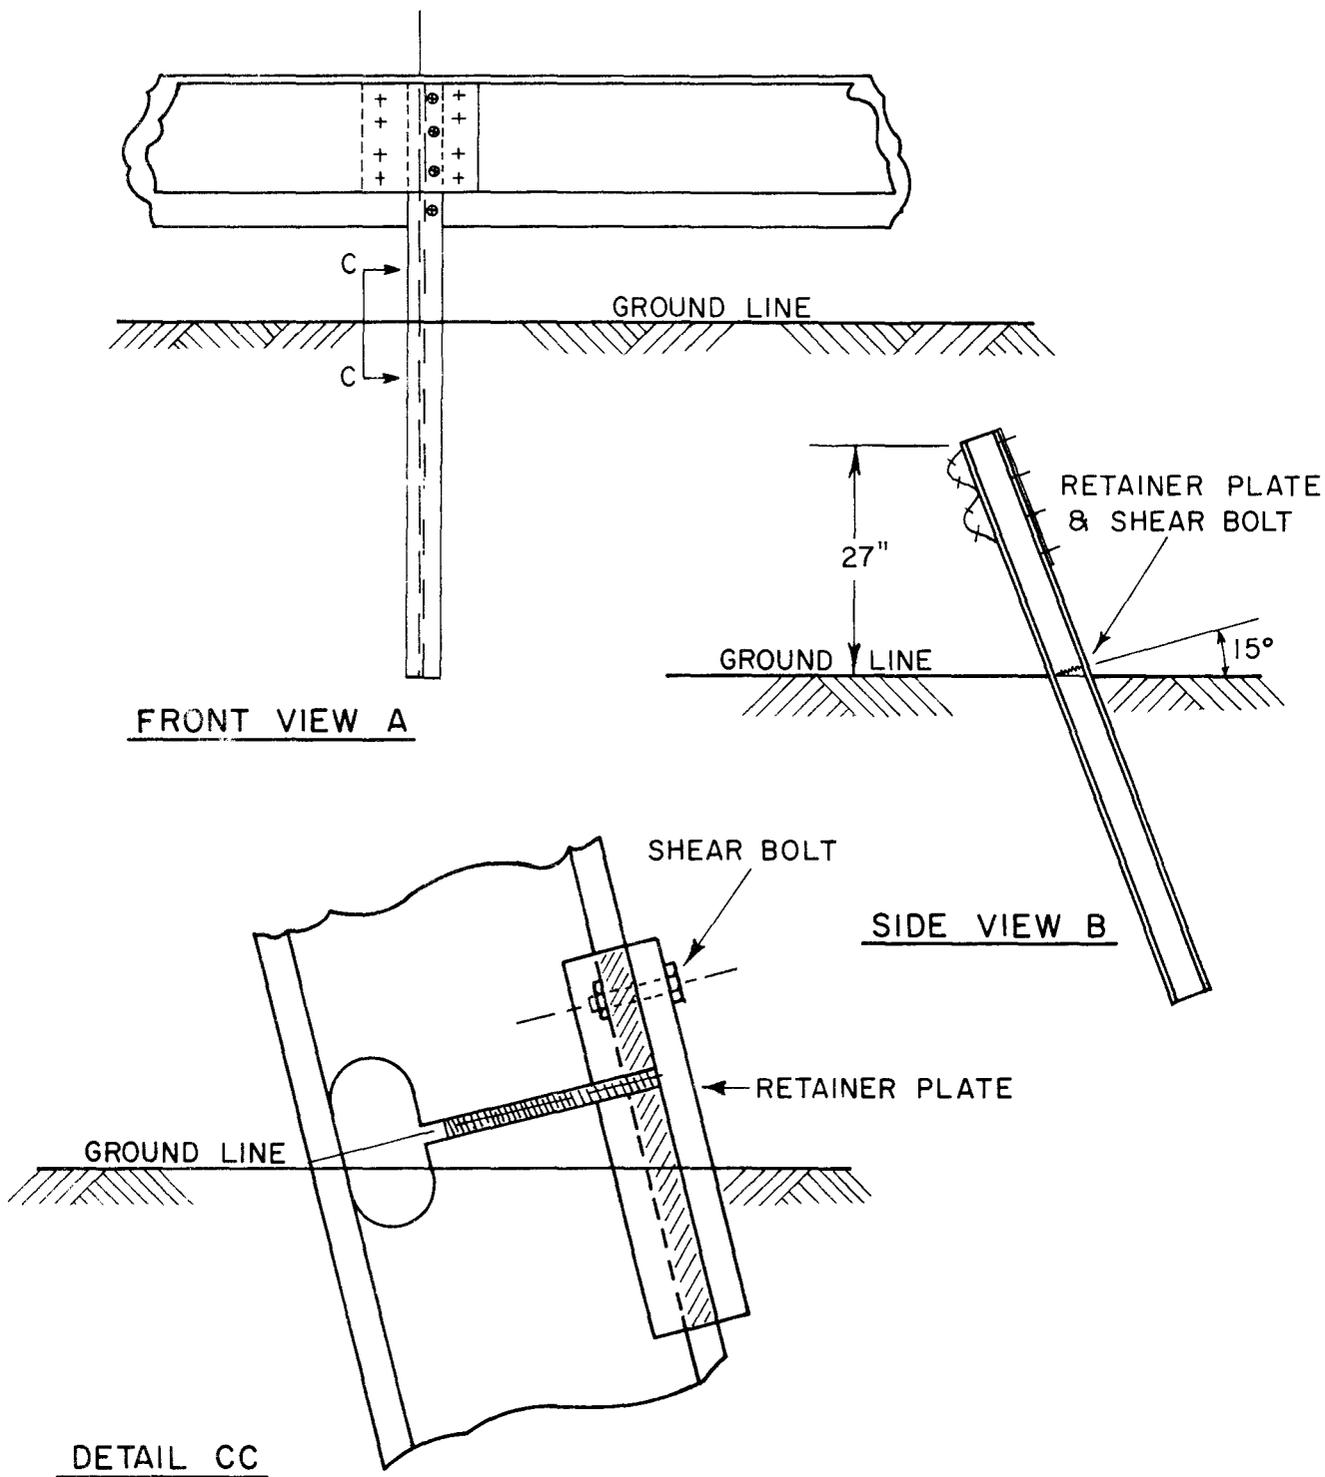
FIGURE IV.3.A.3. DETAIL OF ONE-WAY GUARDRAIL SYSTEM

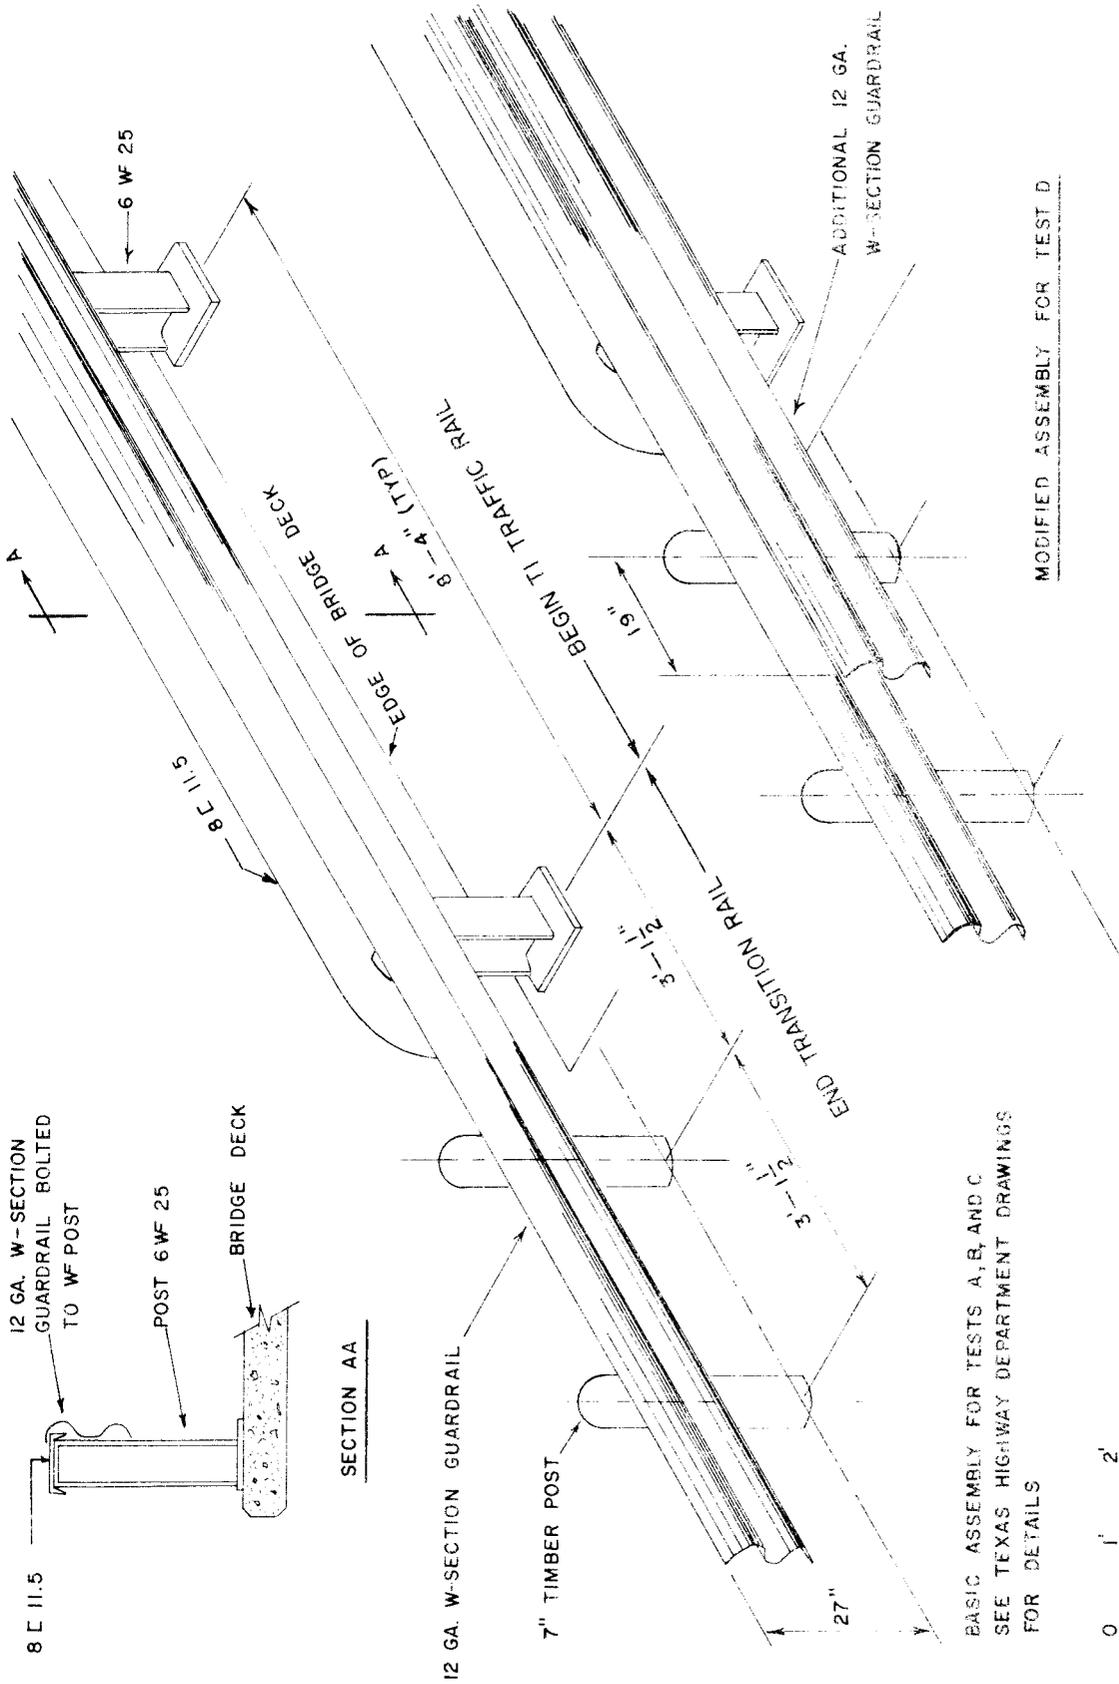
FIGURE IV.3.C.1. TEXAS TI PROTECTIVE BARRIER.

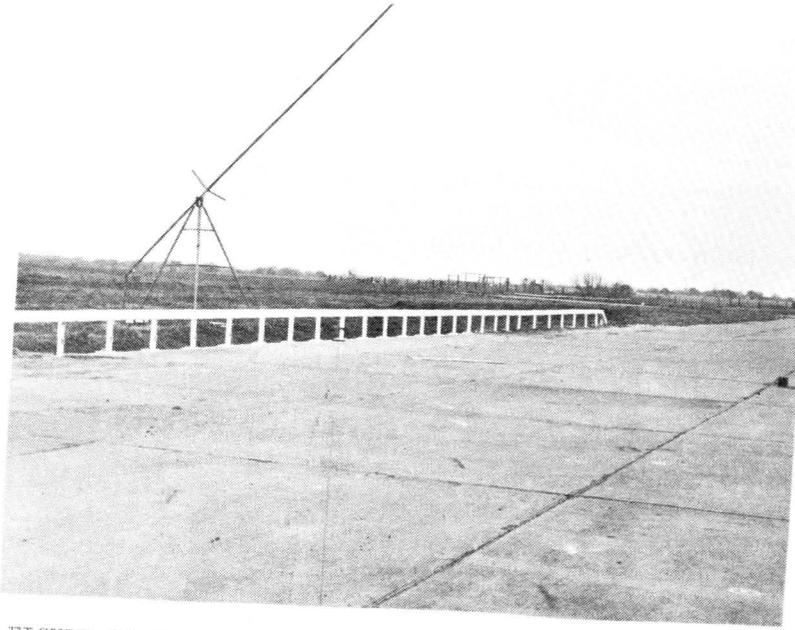
FIGURE IV.3.D.1. OVERALL VIEW OF BRIDGE RAIL-GUARDRAIL

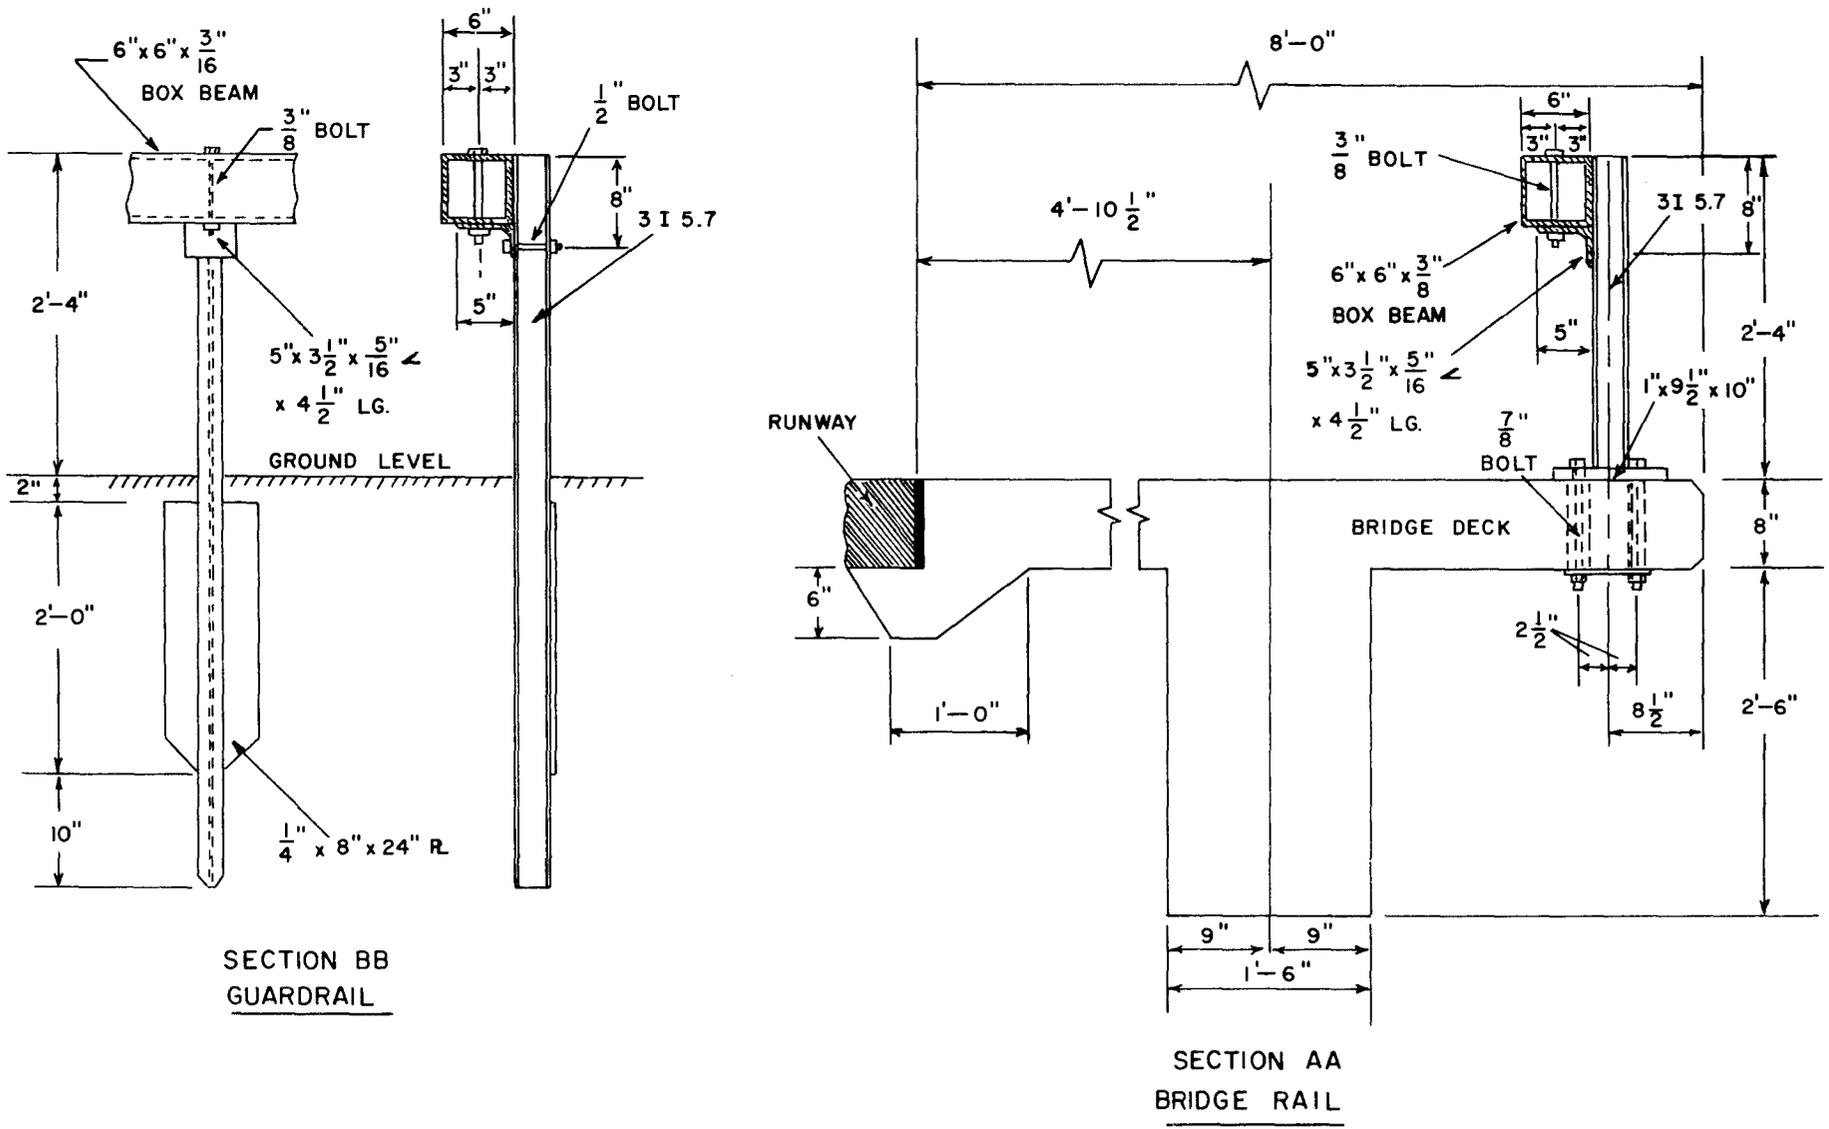
FIGURE IV.3.D.5. BRIDGE RAIL AND GUARDRAIL SECTIONS

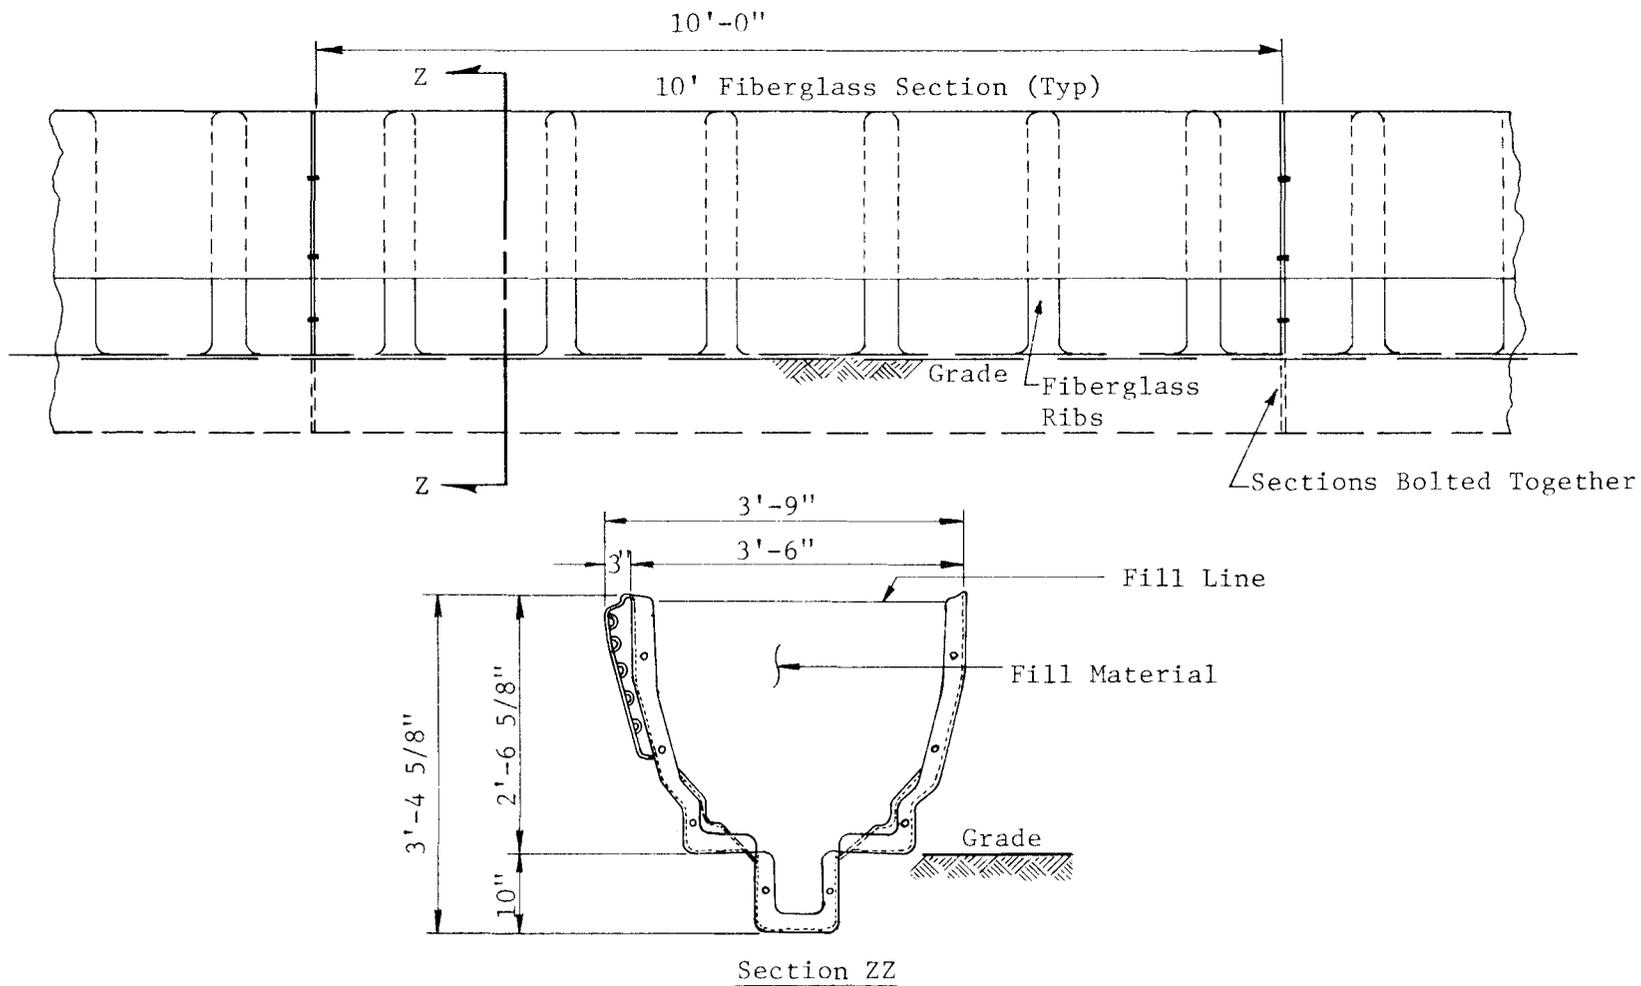
FIGURE IV.3.F.1. DETAIL OF FIBERGLASS SECTION

The only test conducted on this median barrier (Test 505 FG-A) involved a 1966 Chevrolet sedan weighing 4150 lb. The vehicle impacted the fiberglass barrier at a speed of 54.0 mph and an angle of 25°. The vehicle shattered a 12 ft segment of the fiberglass trough and rubrail, allowing it to penetrate the barrier. The vehicle then ramped on the barrier and came to rest astride the median barrier (see Figure IV.3.F.2.). The back wall of the trough collapsed when the front was shattered. The average longitudinal deceleration of the vehicle was 2.6 g's and the average transverse deceleration was 2.2 g's. The vehicle damage was severe, as evidenced by a right front fender deformation of 3.1 ft.

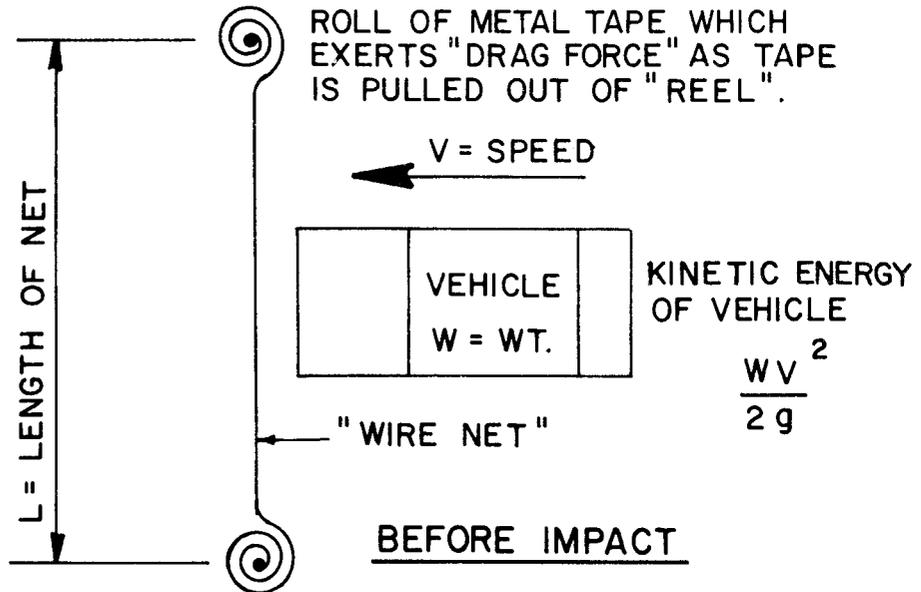
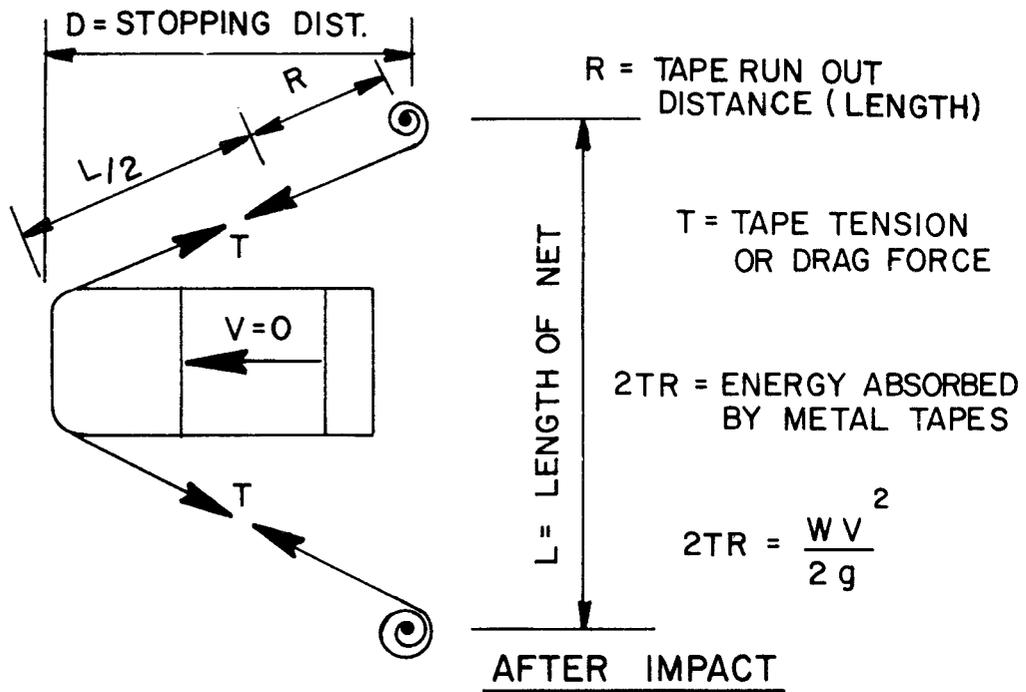
FIGURE V.2. PRINCIPLE OF ABSORBING VEHICLE KINETIC ENERGY - NETS OR SNAGGING DEVICES.

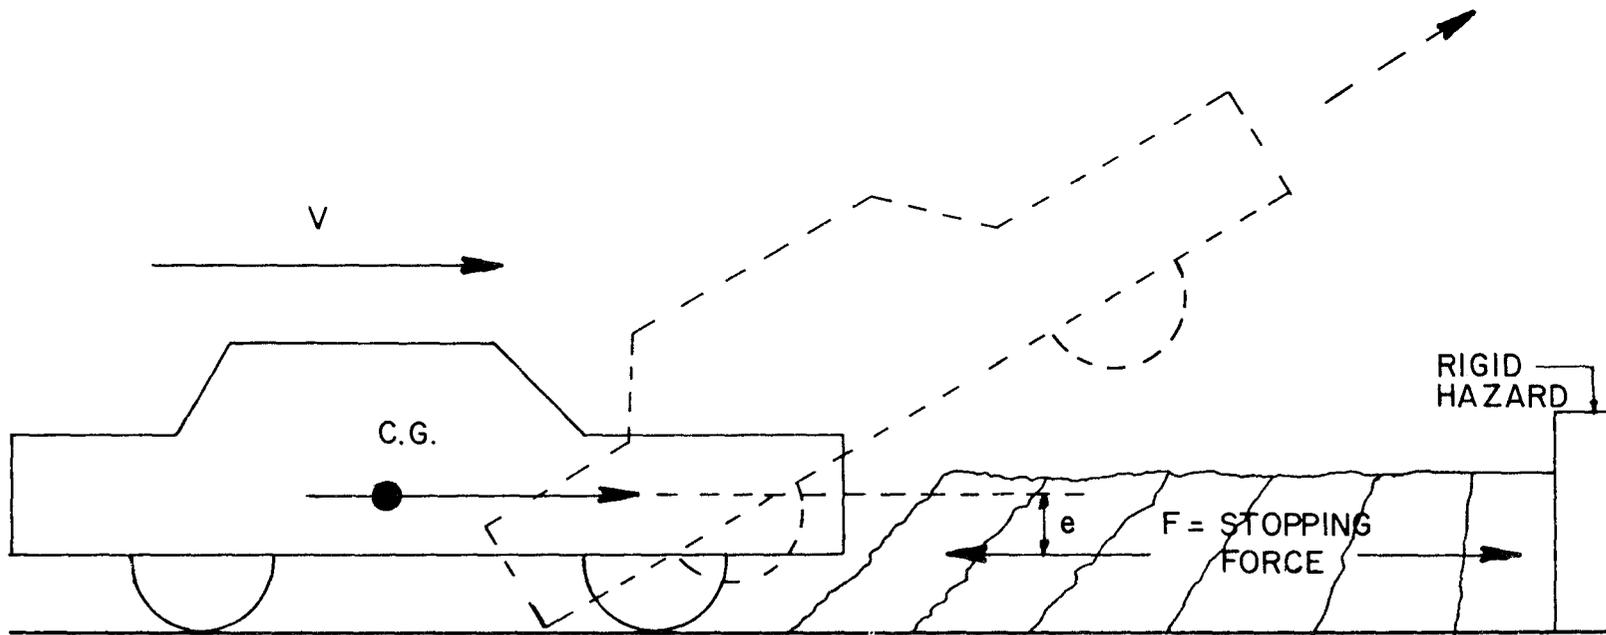
THE VEHICLE MAY RAMP AND JUMP OVER THE CRASH CUSHION.

On the other hand, Figure V.6 illustrates how a vehicle may submerge under the vehicle impact attenuation device if the resultant stopping force is considerably higher than the vehicle center of gravity. This tendency was observed in Tests 505 M-C and 505 B-E. To

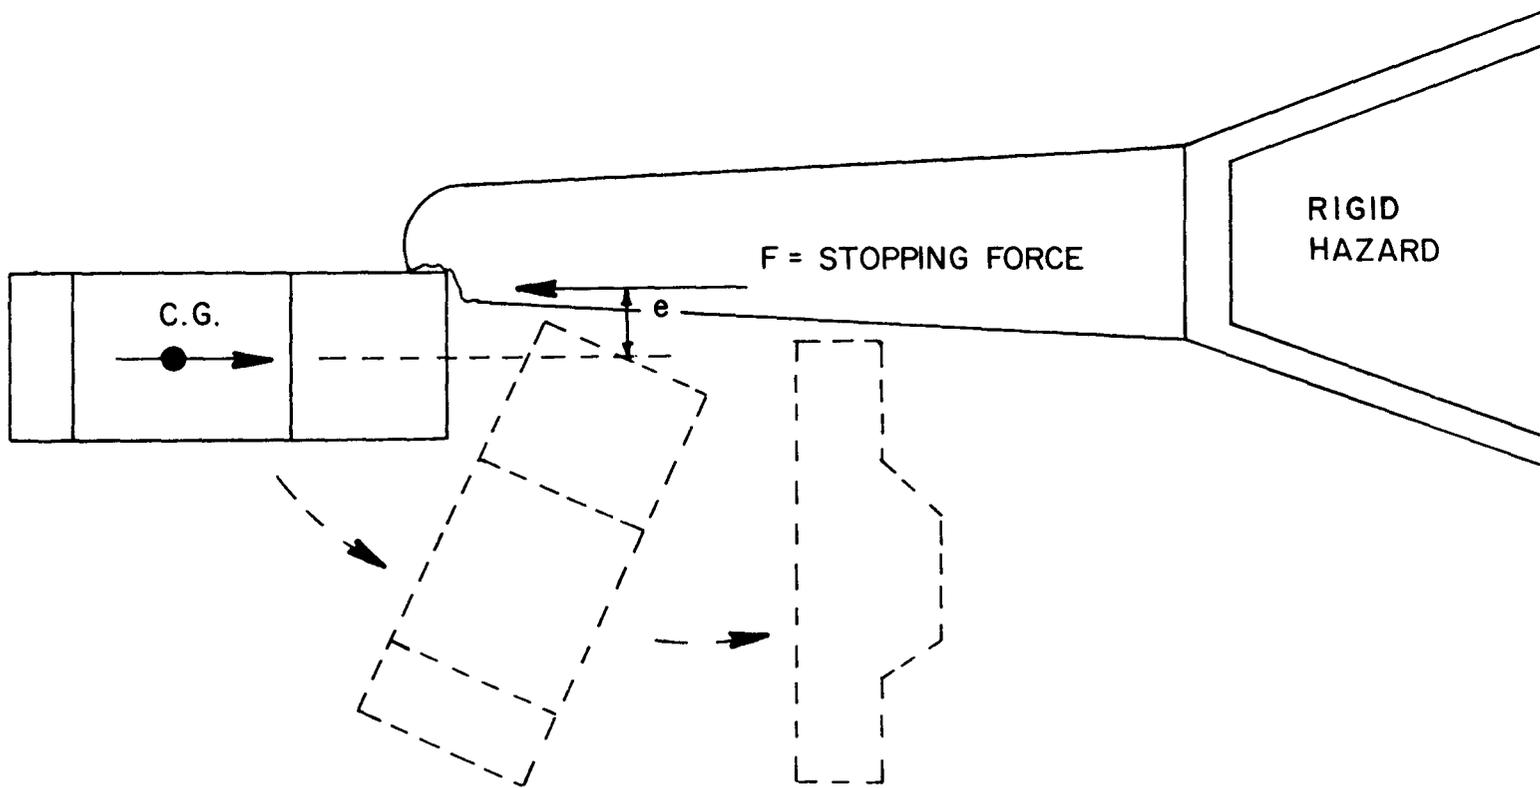
FIGURE V.7. VEHICLE IMPACT ATTENUATOR IS TOO MASSIVE AND STIFF (STOPPING FORCE TOO LARGE). AN OFF CENTER HIT MAY CAUSE THE VEHICLE TO "POCKET", "SPIN-OUT", AND "ROLL-OVER."

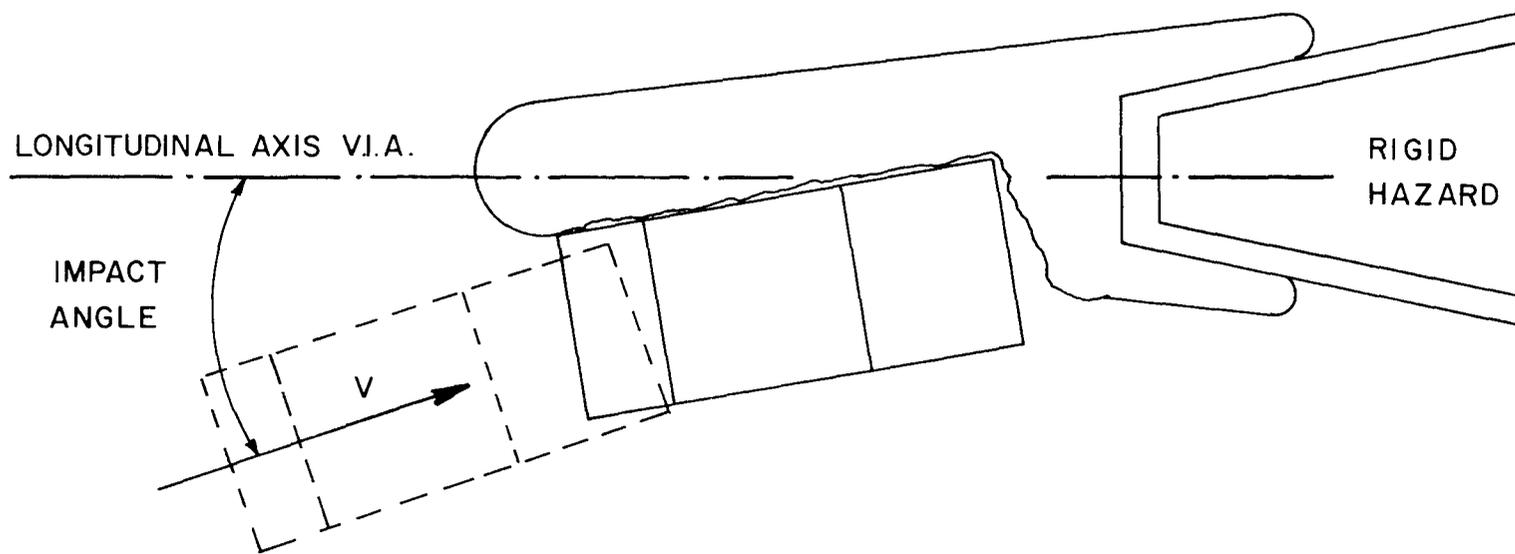
FIGURE V.8. VEHICLE ANGLE IMPACT NEAR THE NOSE OF THE IMPACT ATTENUATOR

Thus far this discussion of Vehicle Impact Attenuators (VIA) has been limited to head-on or near head-on impacts. Of importance also is the behavior of these devices when the vehicle impacts them at an angle with respect to the VIA's longitudinal axis. Figure V.8 illustrates how a typical Vehicle Impact Attenuator without redirection capabilities will behave under an angle impact near the nose. In this case, sufficient distance and energy-absorbing material may be available between the point of impact and the rigid hazard to stop the colliding vehicle safely. In such cases, it is satisfactory to allow the vehicle to "pocket" and come to a complete stop short of the rigid hazard.
