TEST AND EVALUATION
OF
VEHICLE ARRESTING, ENERGY ABSORBING, AND IMPACT ATTENUATION SYSTEMS

F I N A L R E P O R T

CONTRACT NO. CPR-11-5851

U. S. Department of Transportation
Federal Highway Administration

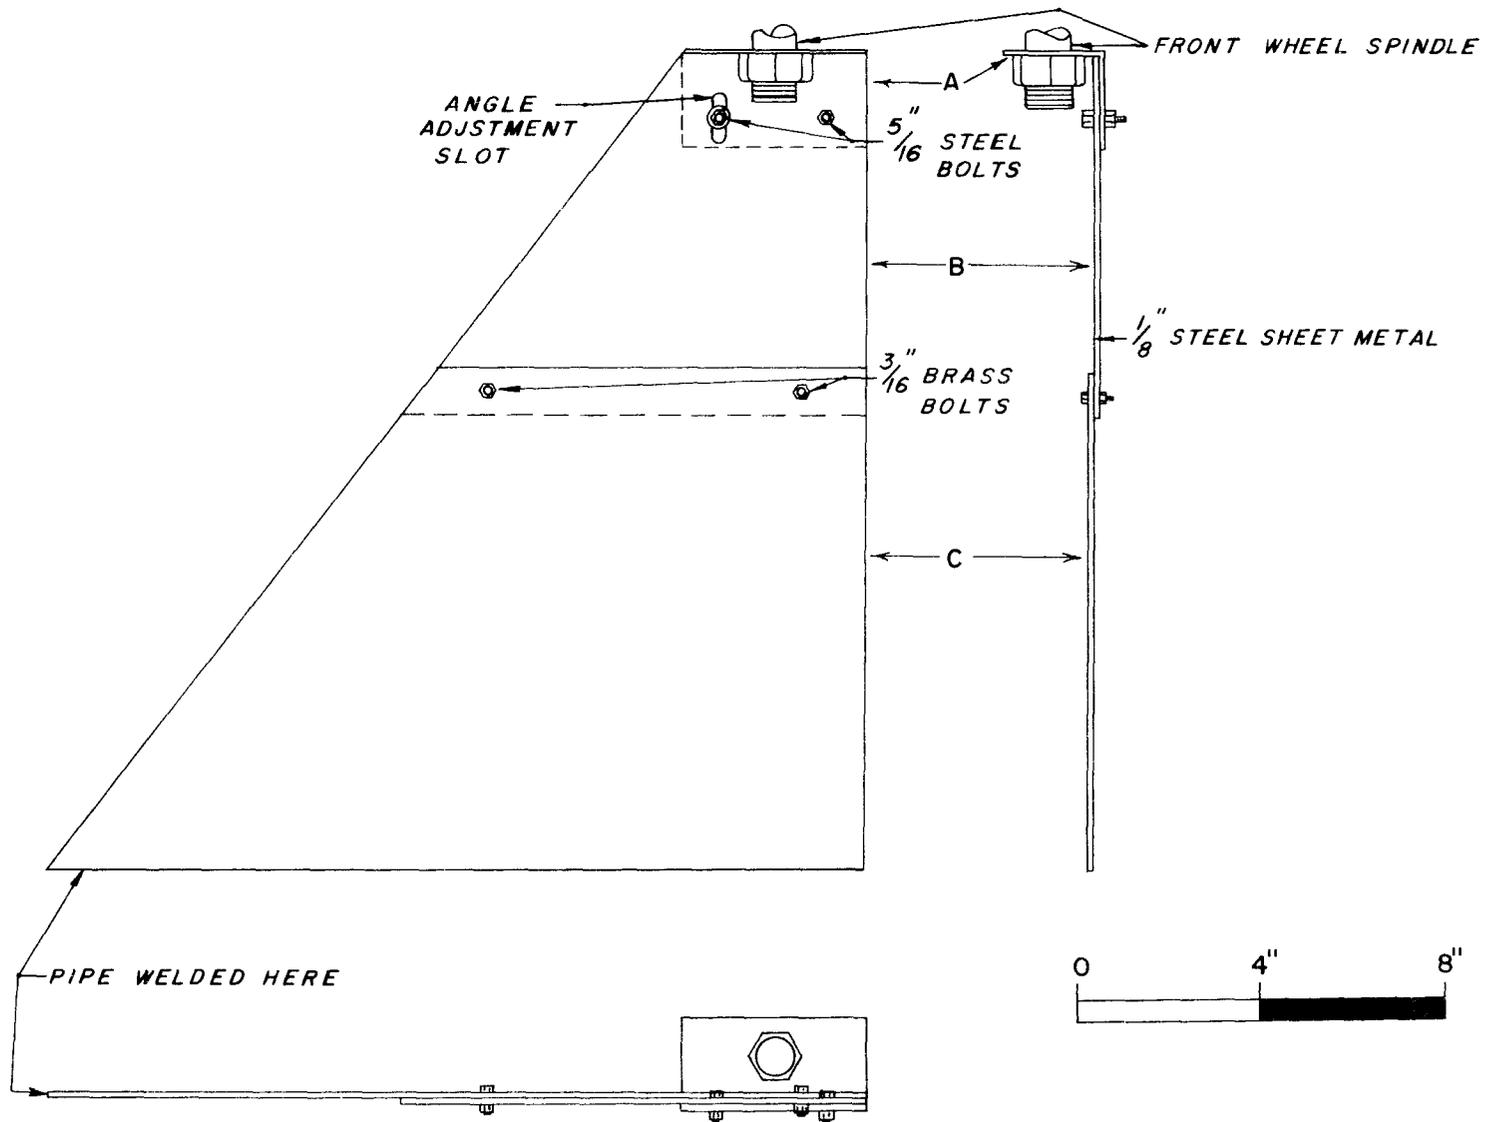
FIGURE A.5. COMPONENTS OF VEHICLE GUIDANCE SYSTEM.

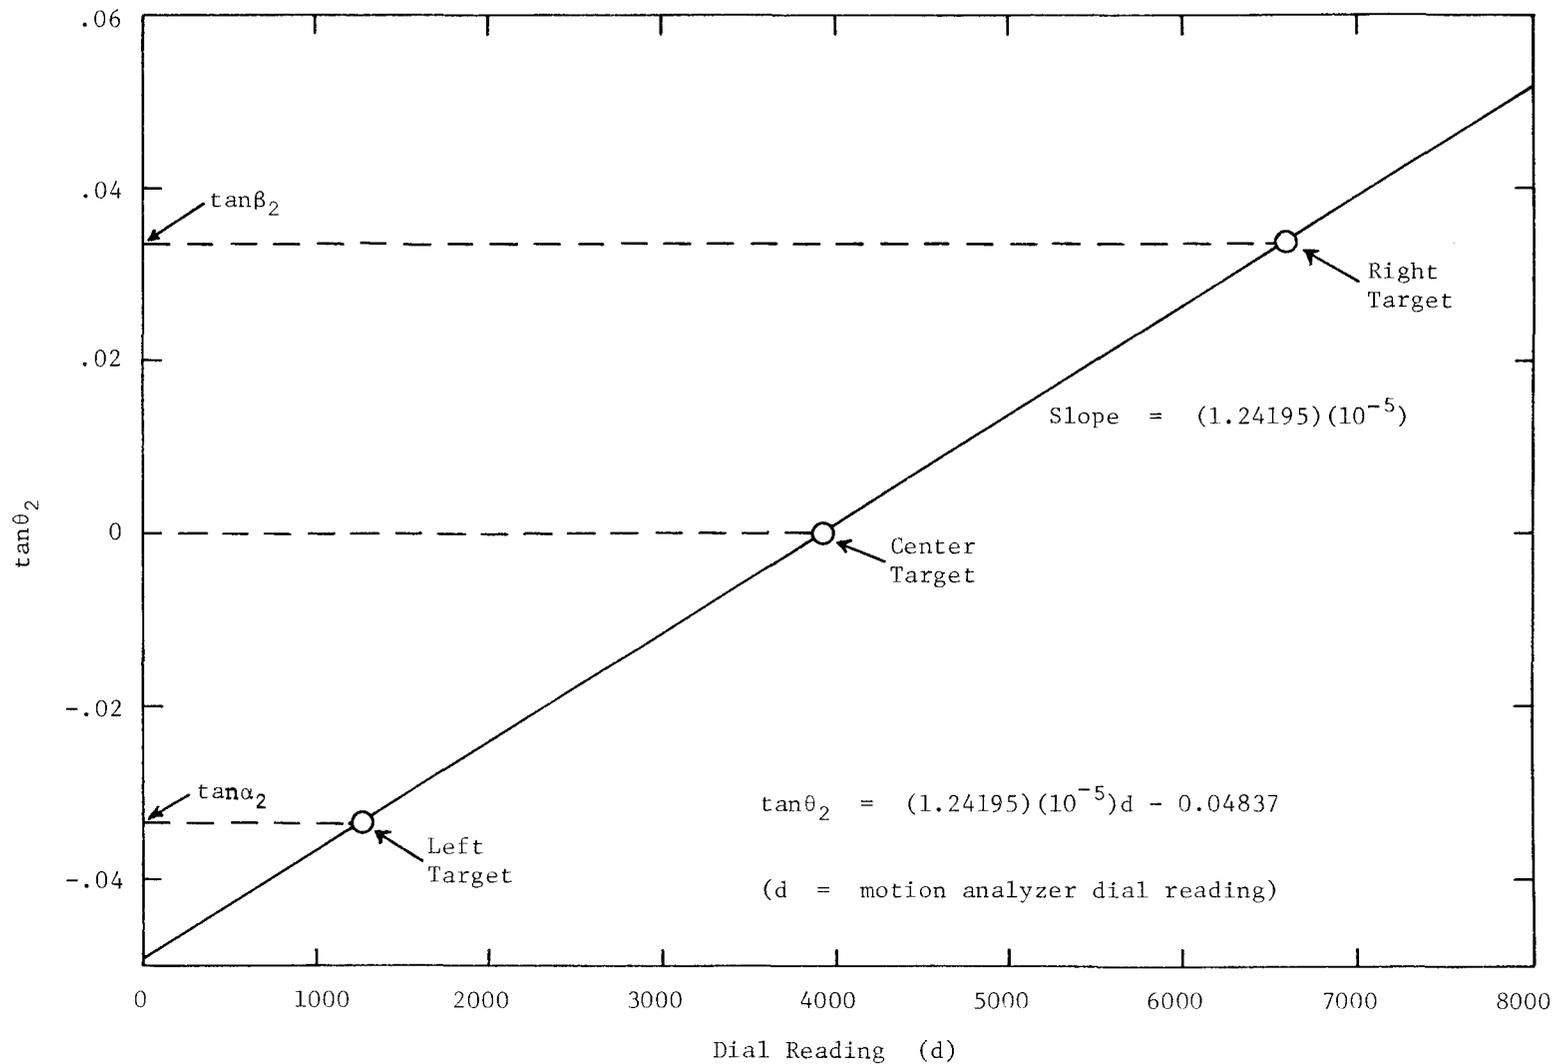
FIGURE C.4. TYPICAL ANGULAR CALIBRATION CURVE FOR CAMERA 2.

The tangent of the angular position of the vehicle target being tracked can now be read from these graphs by noting the dial reading when the crosshair is centered on the target. However, the angular displacement between readings is usually small, so that these tangents must have six decimal places (not necessarily that many significant figures). This is unwieldy to do graphically, so by noting the slope and intercept of the calibration curves (straight lines), formulas for $\tan\theta_1$ and $\tan\theta_2$ can be obtained requiring only dial readings of positions to be entered. As can be seen, it is better to determine $\tan\theta_1$ and then invert it to get $\cot\theta_1$, because $\cot\theta_1$ approaches ∞ as θ_1 approaches 0, and graphical methods are used to determine the corresponding functions at the same elapsed times.
