CRASH TEST EVALUATION OF GUARDRAIL SYSTEMS
UTILIZING THE NEW CHARLEY POST

FINAL REPORT

SwRI Project 03-3658

May 1974

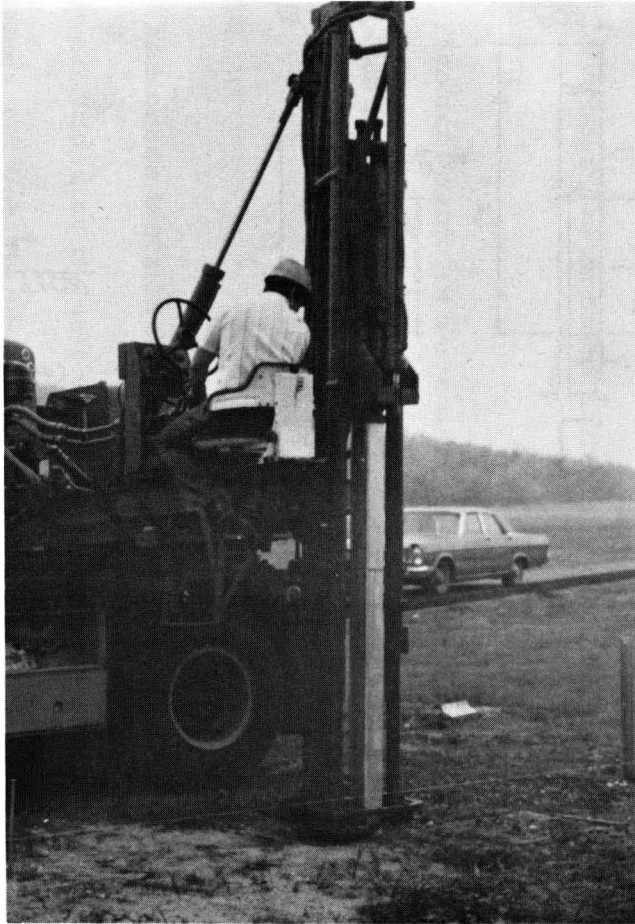
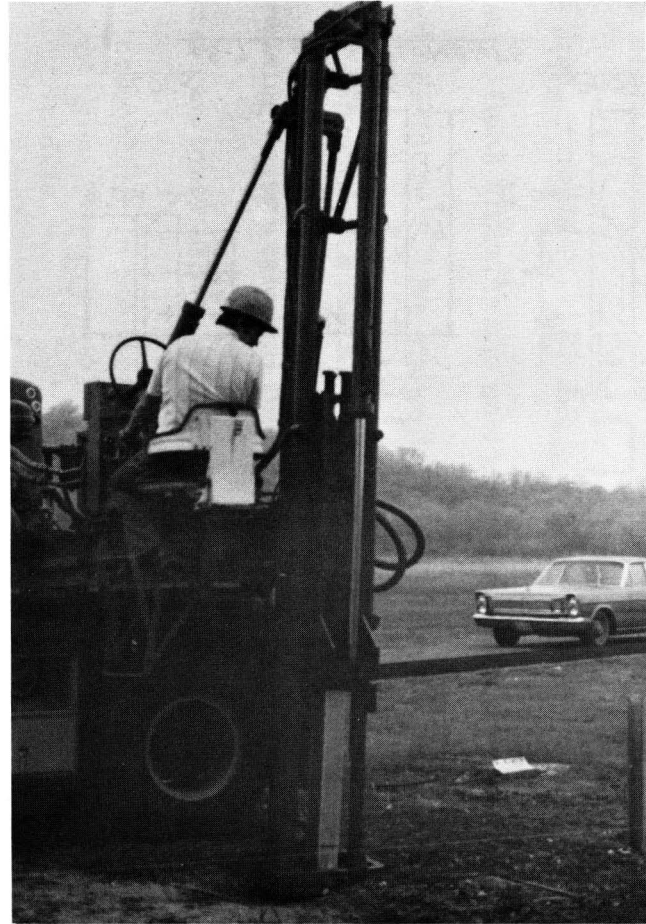
FIGURE 2. STERLING ENGINEERING COMPANY - POST DRIVER

The posts were driven to grade utilizing a new post driver as shown in Figure 2. The Sterling Self-Contained Impulse Post Driver* is a hydraulic-powered, nitrogen gas impulse unit which delivers 600 ft-lbs/blow at 890 blows/minute.

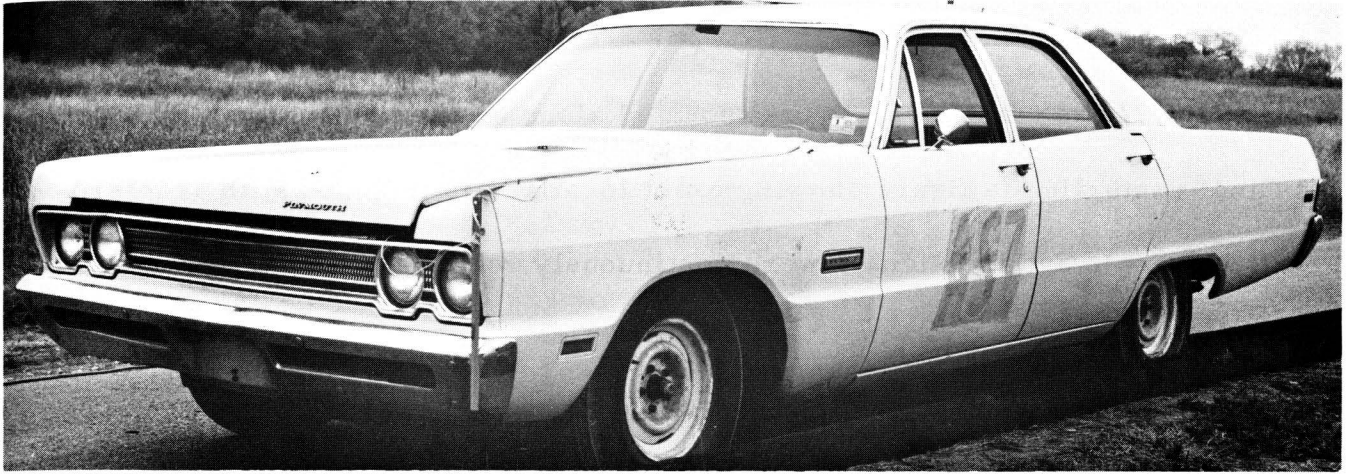
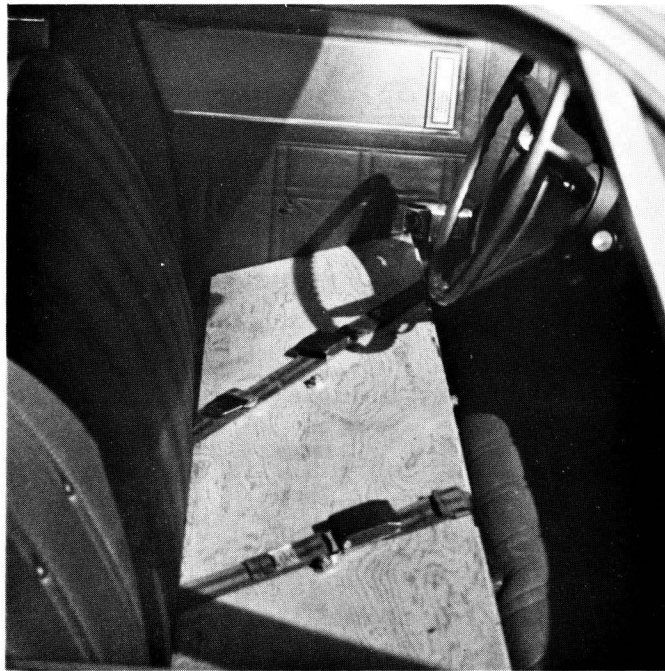
FIGURE 3. TEST VEHICLE

Identical vehicles were used in the three tests. The 1969 Plymouth sedans shown in Figure 3 were ballasted as shown to a test weight of 4323 lbs.

Ballast

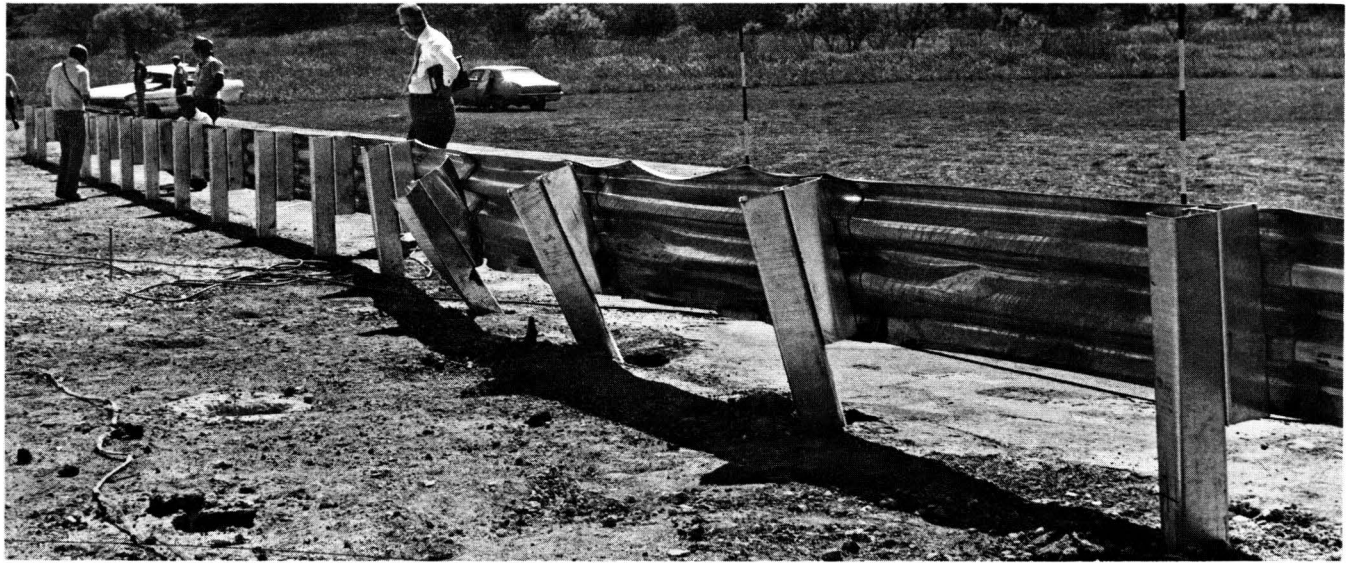
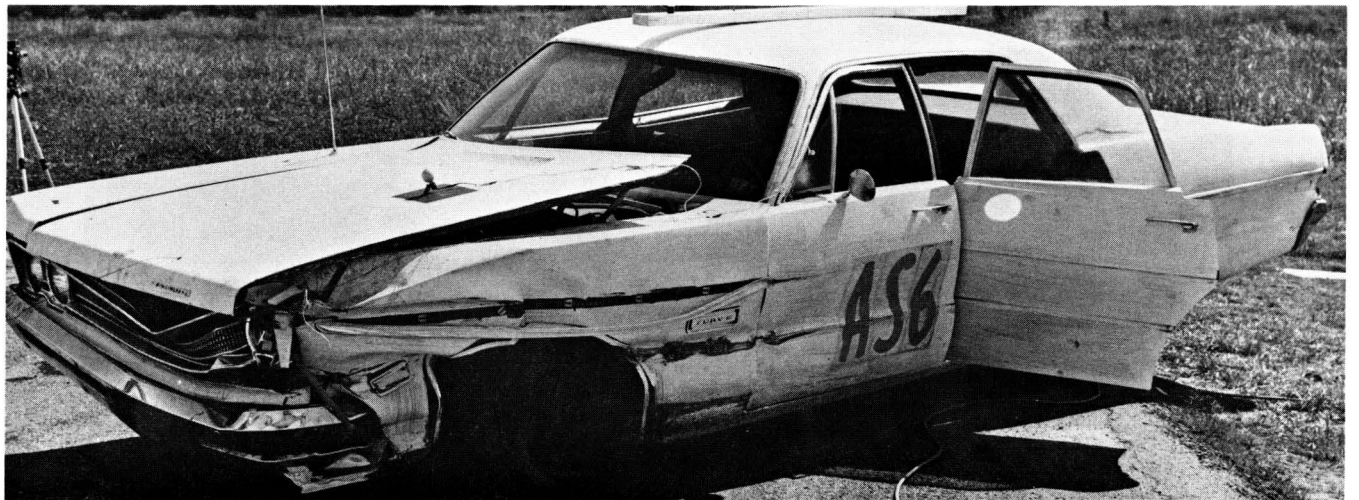
FIGURE 6. PHOTOGRAPHS AFTER TEST AS-6

Installation Damage: Damage to the installation included two rail sections between Posts 9 and 13, and posts and spacer blocks at Posts 10, 11, and 12 as shown in Figure 6. Table 3 contains permanent deflection and damage information.

Vehicle Damage: As shown in Figure 6, damage to the vehicle was confined to the left front quadrant. Rim damage at the left front wheel could be attributed to post contact.

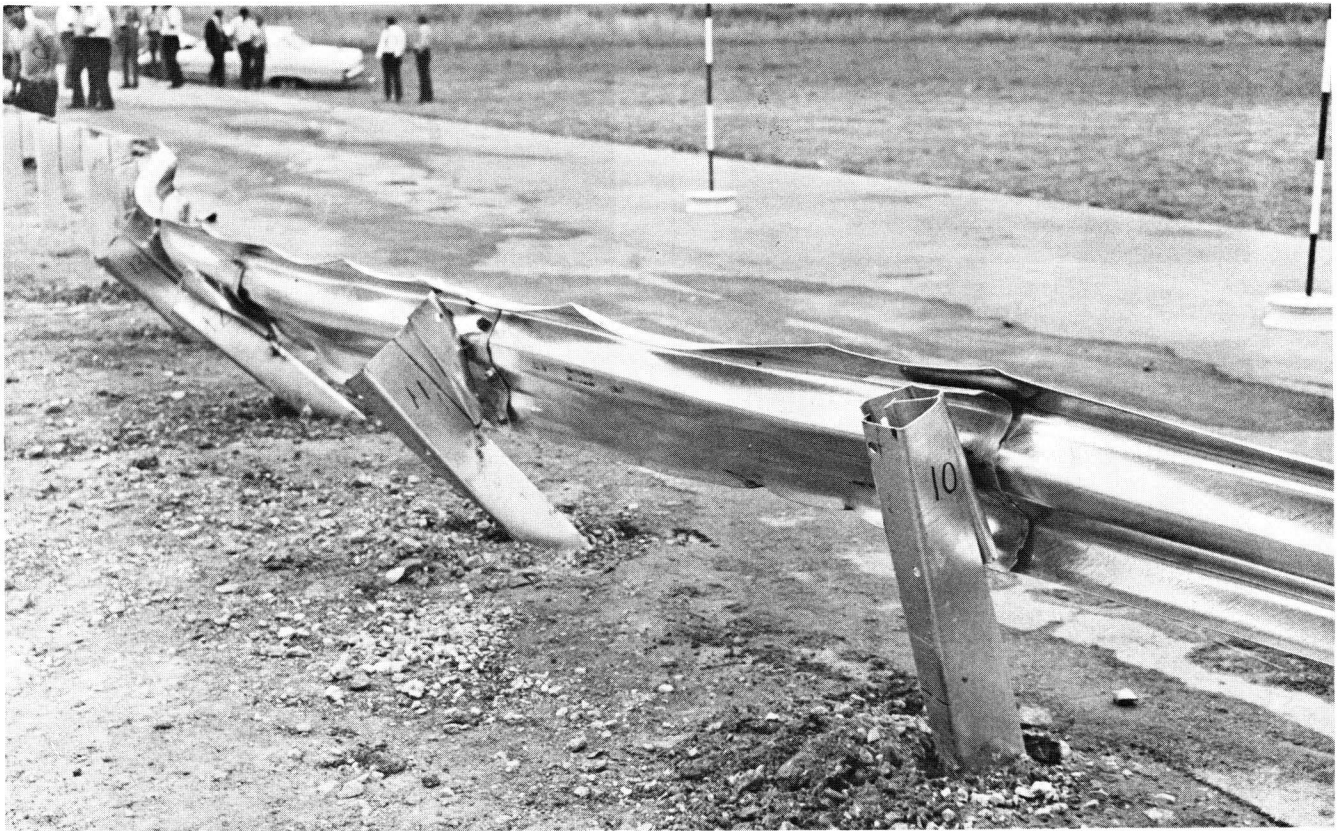
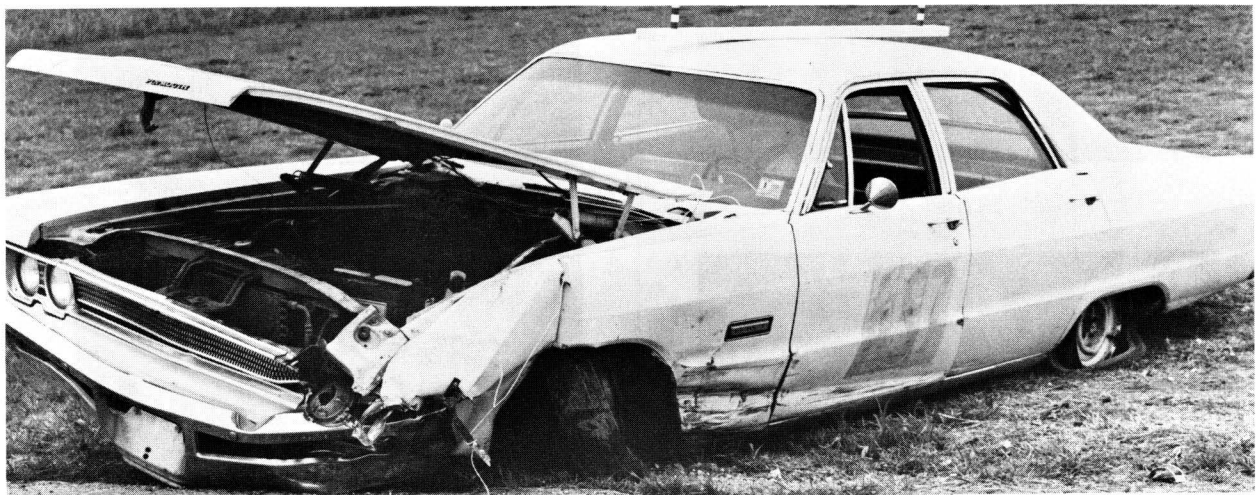
FIGURE 9. PHOTOGRAPHS AFTER TEST AS-7

Installation Damage: Damage to the installation included three rail sections between Posts 9 and 15 as shown in Figures 7 and 9. A summary of the permanent deflections and damage is given in Table 4. Figure 10 contains photographs of upstream anchor after test.

Vehicle Damage: Damage was confined to left front quadrant and the left rear wheel where a bent rim caused tire deflation (Fig. 9).

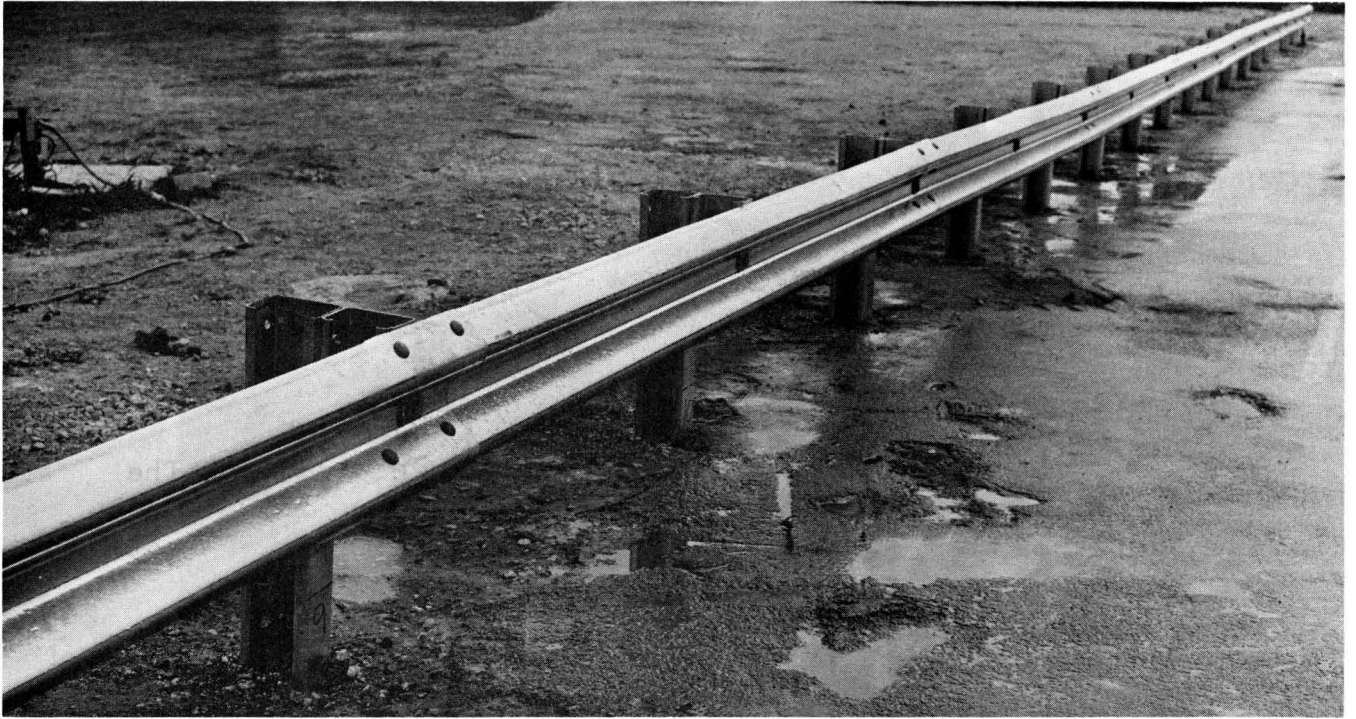
FIGURE 11. TEST AS-8 INSTALLATION PHOTOGRAPHS

Test Installation: The installation as described in Figure 1 and shown in Figure 11 was identical to that of AS-7 with two exceptions:

- . The C post and spacers were rotated 180°
- . The five anchor cable clips were torqued to 90 ft-lbs. The anchor cable preload corresponded to a torque of 90 ft-lbs on the 1 in. dia stud. This load was on the threshold of causing W-beam deformation

Installation Damage: Installation damage was confined to two beam sections between Posts 9 and 13. The damage is shown in Figures 11 and 13 and summarized in Table 5. No evidence of anchorage cable slip was noted. The two upstream beam splices at Posts 3 and 5 showed no evidence of slip.

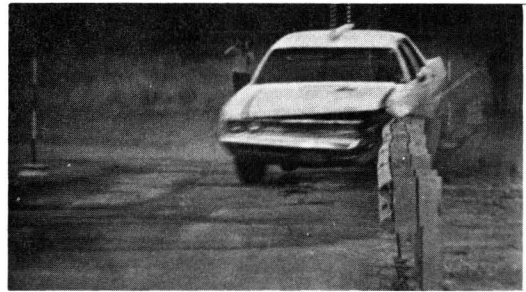
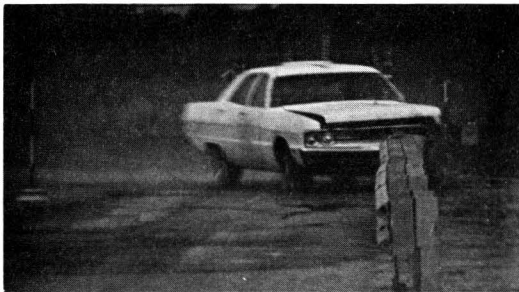
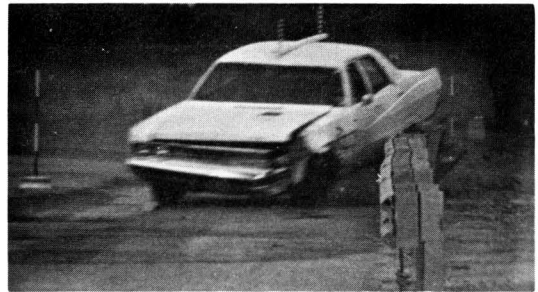
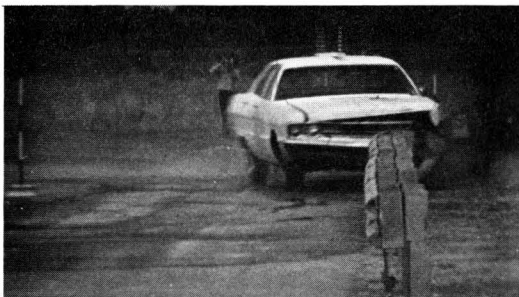
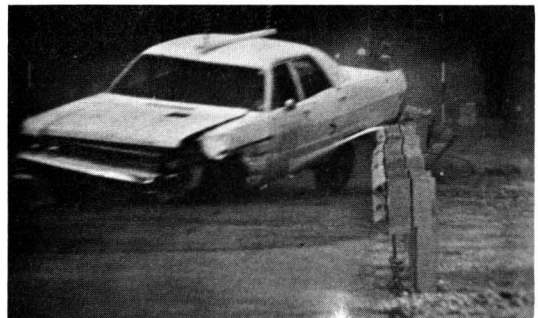
FIGURE 12. TEST AS-8 SEQUENTIAL PHOTOGRAPHS

Performance: The 4323-lb vehicle impacted the barrier upstream of Post 10 with a speed of 59 mph and at an angle of 25 deg. The vehicle was smoothly redirected as shown in Plate 3 and Figure 12. Maximum dynamic deflection of 2.9 ft occurred between Posts 11 and 12; maximum average (50 msec) vehicle decelerations were 3.7 g's (longitudinal) and 6.8 g's (lateral).

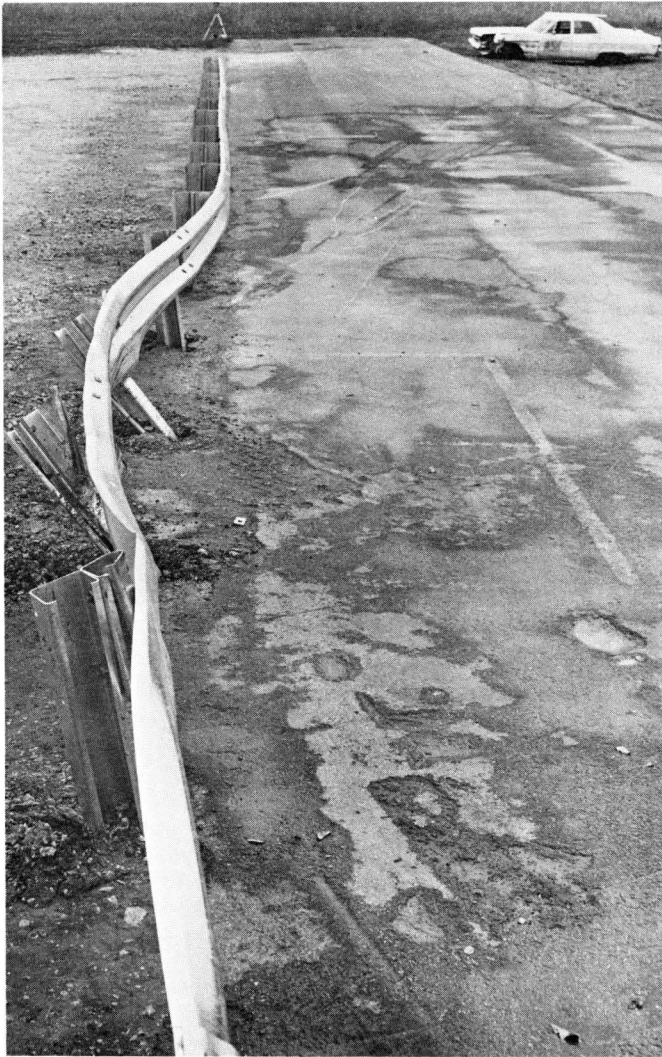
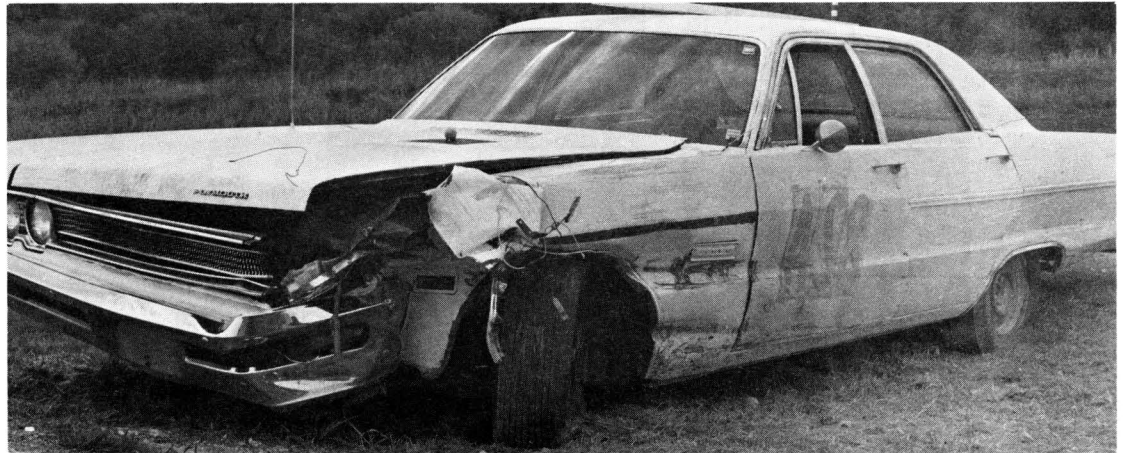
FIGURE 13. PHOTOGRAPHS AFTER TEST AS-8

Vehicle Damage: Damage was confined to left front quadrant of vehicle as shown in Figure 13.

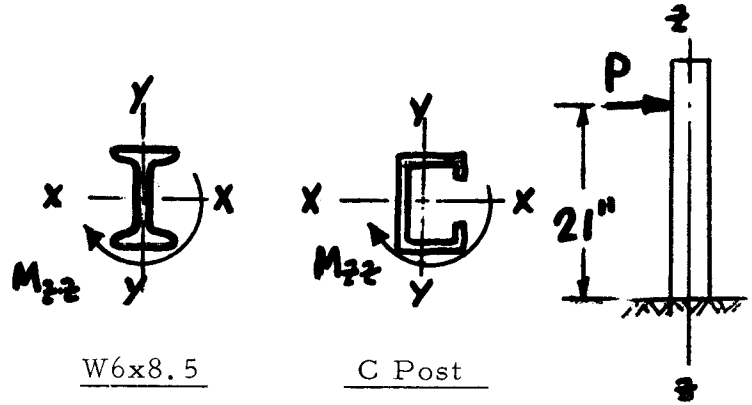
<u>W6x8.5</u>	<u>C Post</u>	Ratio $\frac{\text{C Post}}{\text{W6x8.5}}$
1. Plastic moment $M_{P_{x-x}}$	$5.566 \sigma_e$	$5.511 \sigma_e$	0.99
2. Plastic moment $M_{P_{y-y}}$	$0.773 \sigma_e$	$1.826 \sigma_e$	2.36
3. Plastic moment $M_{P_{z-z}}$	$0.265 \sigma_e$	$0.203 \sigma_e$	0.90
4. Buckling P_x	$0.265 \sigma_e$	$0.263 \sigma_e$	0.99
5. Buckling P_y	$0.037 \sigma_e$	$0.087 \sigma_e$	2.36
