**THE PERFORMANCE OF CEMENT-STABILIZED
PHOSPHOGYPSUM AS BASE
STATE HIGHWAY 146, LA PORTE, TEXAS**

DHT-11

By Constance Wong and Michael K. Ho, P.E.

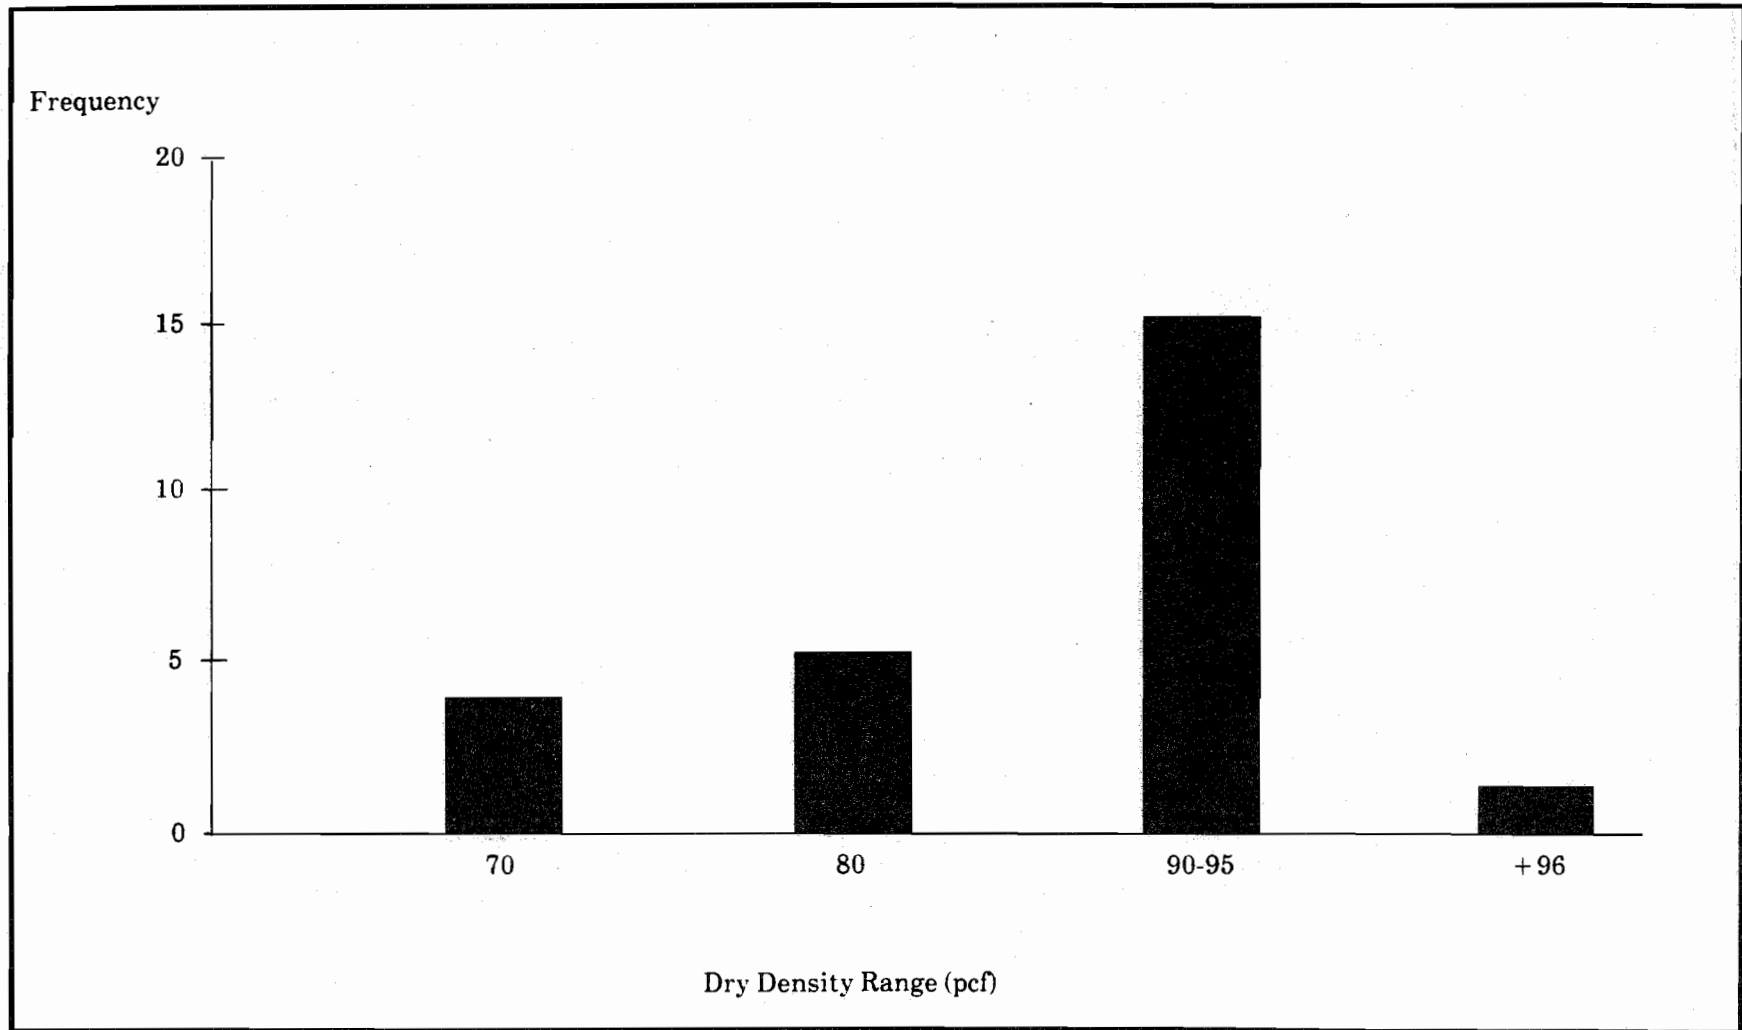
Figure 22

Figure 21 shows that 64 percent of the 9 percent cement-stabilized phosphogypsum densities made the specified minimum compaction of 95%. Most of the densities were just below the maximum dry density of 96.4 pcf, as shown in Figure 22. In Figure 23, the distribution of moisture contents peaked around 13.8 percent, using data from Figure 18.

9% CEMENT STABILIZED PHOSPHOGYPSUM BASE

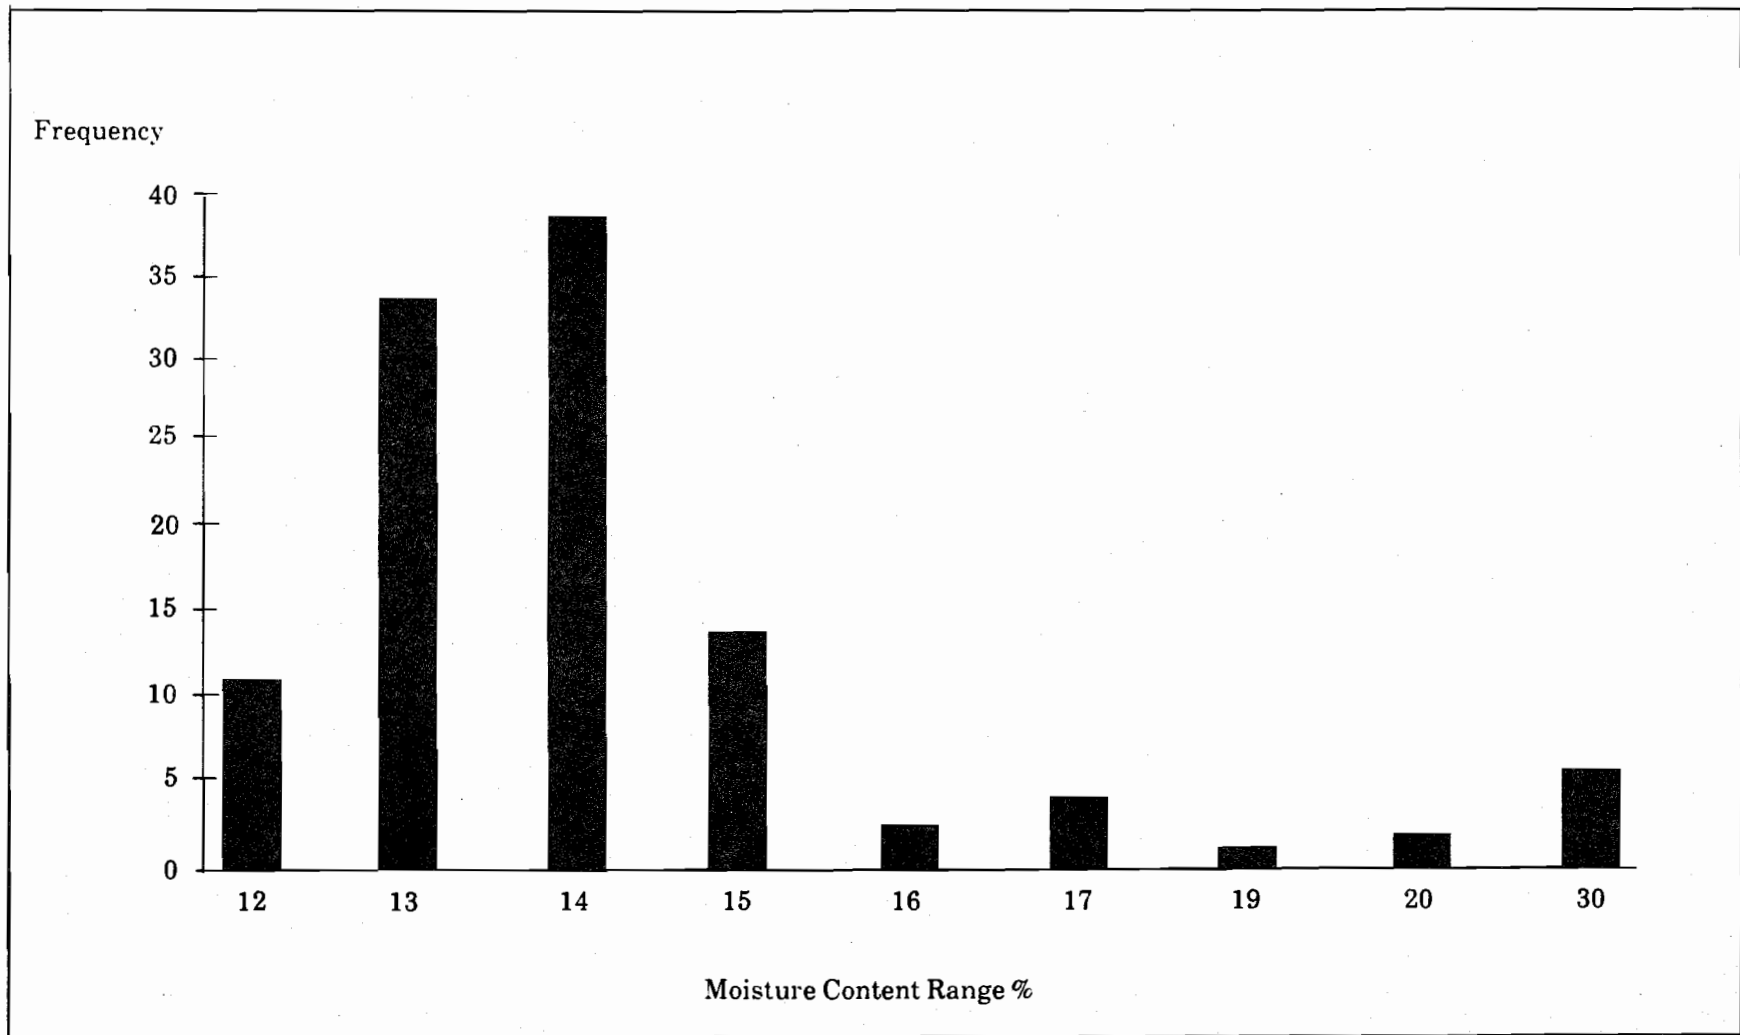
Figure 23

9% CEMENT STABILIZED PHOSPHOGYPSUM

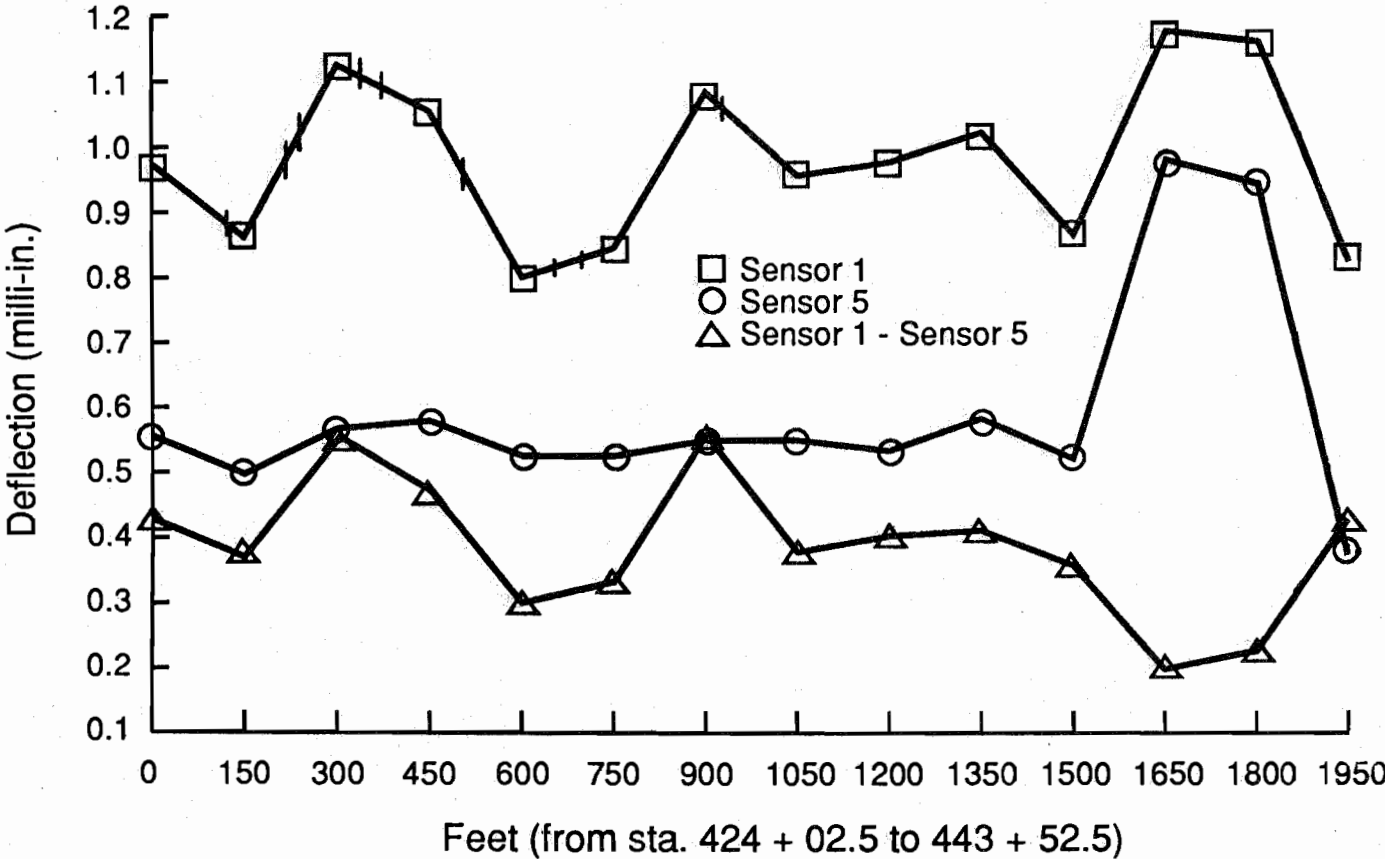
FIGURE 27

Phosphogypsum + 9% Type II Cement

About half of the locations of the cracks in these pictures coincide with increases in deflection. The lines in Figure 27 that intersect Sensor 1 Line are locations of cracks. Not all surficial cracks may extend into the base, but they probably could. From the coincidences of cracks with deflections, it may be assumed that deflections were caused by the cracks in pavement or base. For those cracks not incidental to increases in deflections, they may not have been directly in the path that the dynaflect rig took. Deflection increases can manifest in some physical way, such as voids, weak spots, excessive moisture or anisotropies. An example of deflection data matching actual weaknesses in pavement is given in Reference 31. Peaks correlate to stations which actually have water underneath the stabilized subgrade or voids under the pavement.

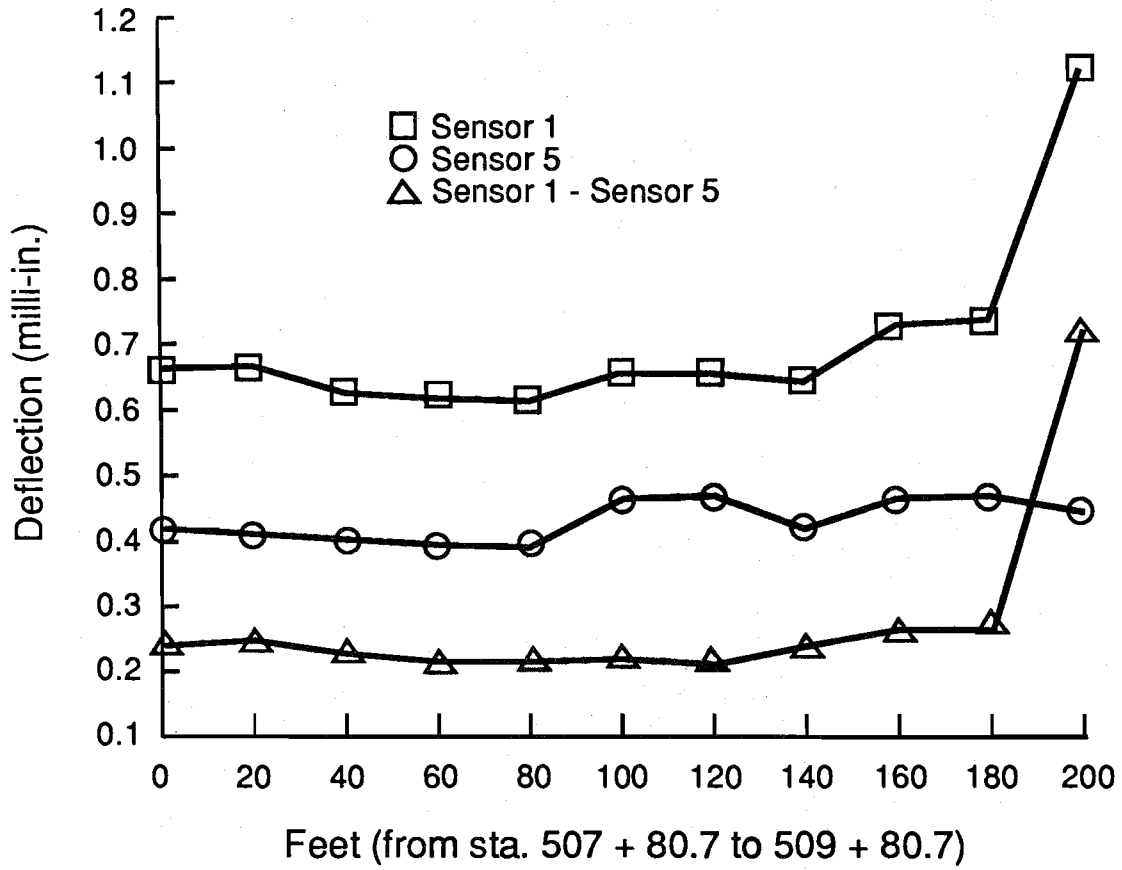
FIGURE 28

80% Phosphogypsum + 20% Sand + 6% Cement

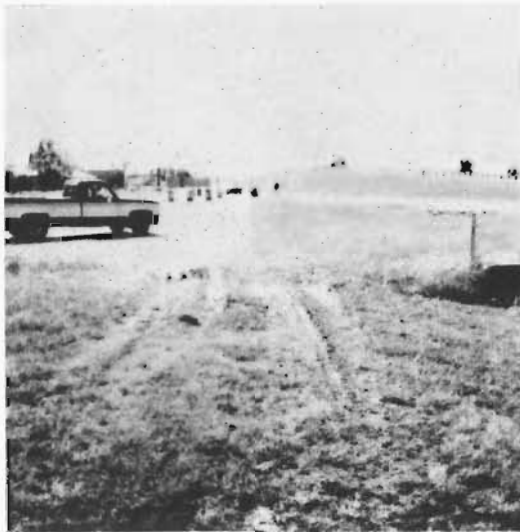
SH 146 feeder location
looking south, between
Spencer Hwy and Tyler
Street (11-16-83).

At least 122 days after placement of the cement-stabilized base, cracking of the base and flexible pavement were found on the section from Adams St. to Barbours Cut. To start with, Pictures C and D show the location of the frontage road before it was built. After construction of the 15-inch phosphogypsum base and 1 1/2-inch asphaltic concrete pavement, pictures looking north were taken at 122 and 183 days. The beginnings of alligator cracking were observed in Pictures E to I. Also, Pictures J to M show transverse cracks. Longitudinal cracks are seen in Pictures N and O.

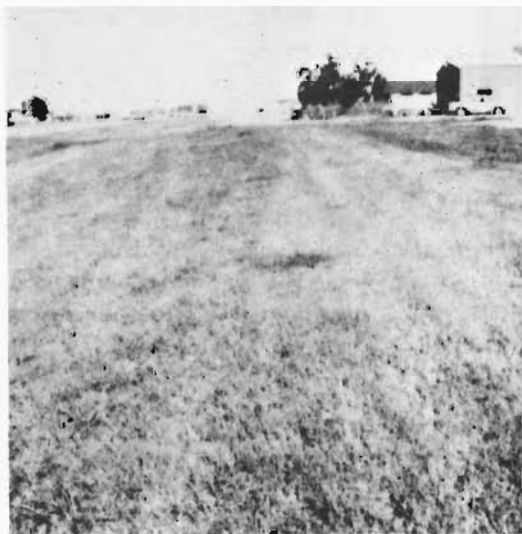
D

SH 146 feeder location
looking north (11-16-83).

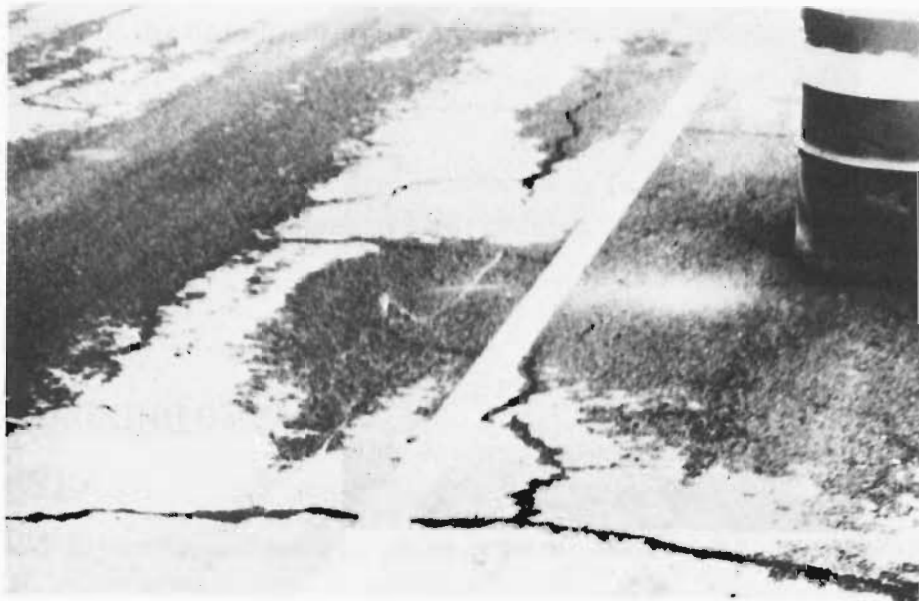
E

The cause of cracking may be due to a variety of reasons including improper design, weak base or subgrade, joint cracks, reflection cracks; and volume changes in base, pavement, or subgrade.²⁹ One factor that may be significant in this case is the cement content. Pictures P, Q, and R show that these intersection cracks originated in the top of the base and migrated through the asphaltic concrete pavement. Three sets of intersecting cracks were cored. Figure 31 shows their compressive strengths at 183 days, which ranged from 424 psi to 602 psi. The high cement content, along with excess moisture, may have caused the cracking: "The hydration reaction of cement is accompanied by the evolution

Picture taken at 122 days of alligator cracks. Taken on Oct. 23, 1987 on west lane of SH 146 feeder looking north.

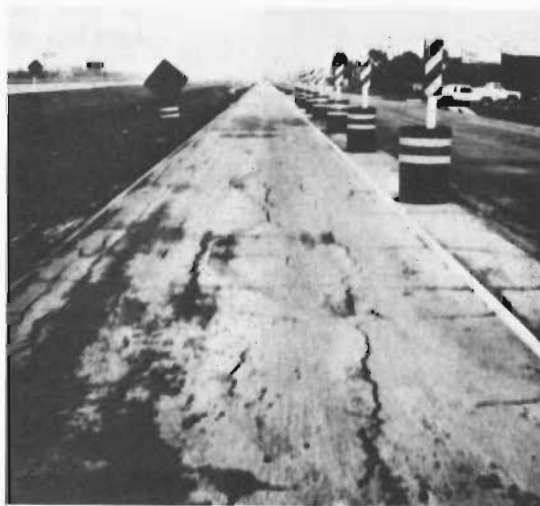
F

Alligator cracks on lane under traffic at 122 days (10-23-87). Station 431+50 to 433+50 Lf. CT.

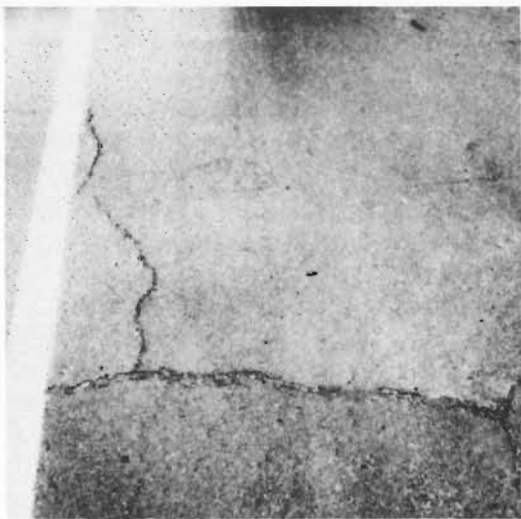
H

Close-up of alligator crack in area not under traffic. Taken at 122 days (10/23/87). Station 426+53, offset 3' Lf. CT.

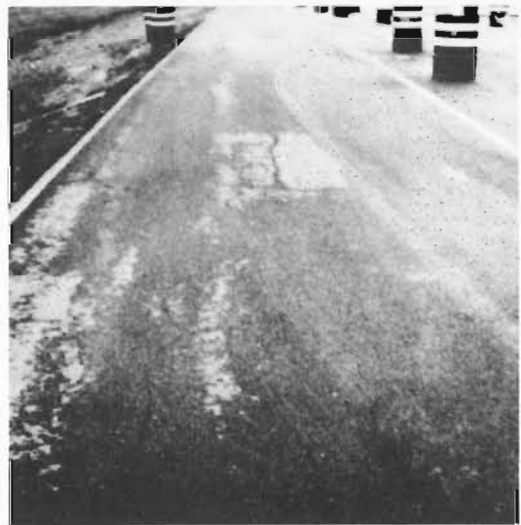
I

Cracks are developing randomly on this lane under traffic (10/23/87). Station 428+10, offset 13' Lf. CT.

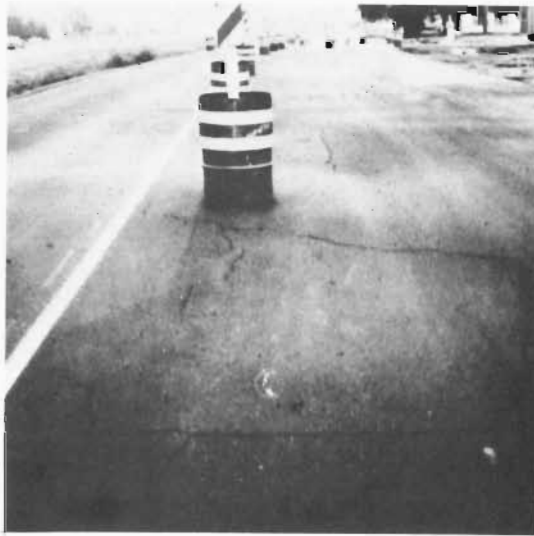
J

Area not under traffic
pictured at 122 days on
10-23-87 showing inter-
secting cracks.
Station 426+73,
offset 3' Lf.CT.

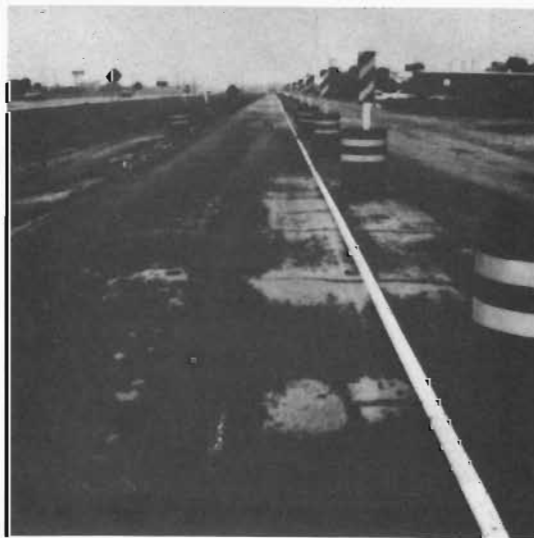
K

Transverse cracks are
shown in this area under
traffic on 10-23-87.
Station 429+50,
offset 2-3' Lf.CT.

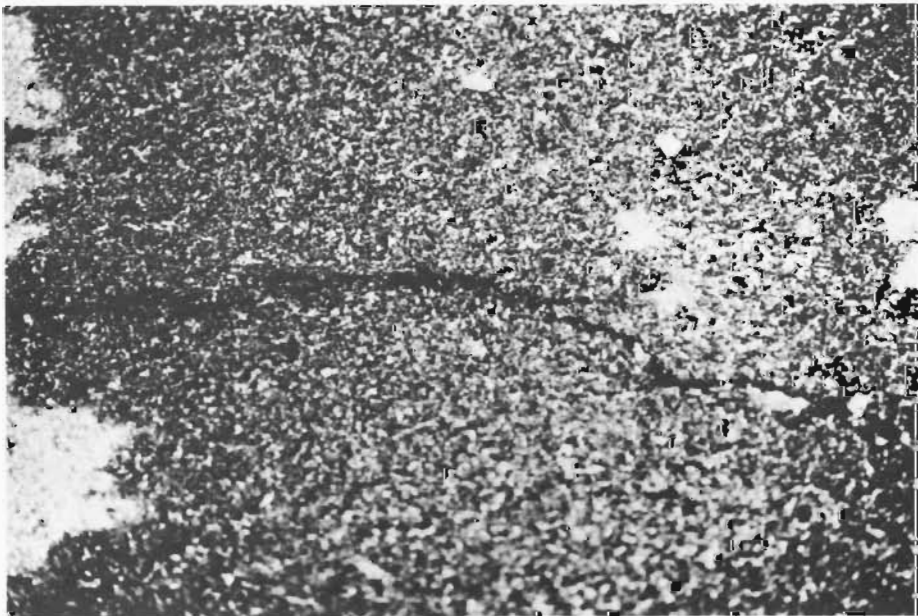
M

Close-up of transverse crack taken at 183 days
on Dec. 23, 1987.

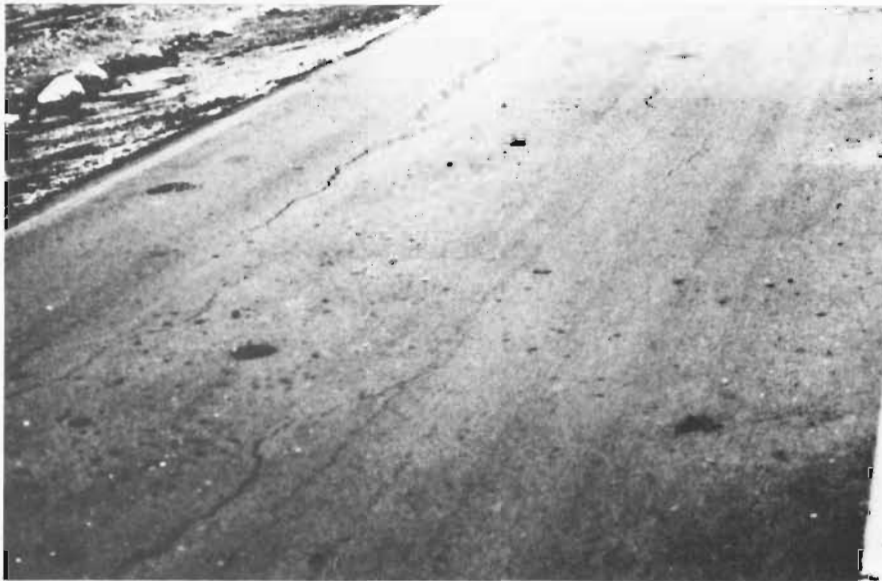
N

Note longitudinal cracks in wheelpath and center of lane; picture taken at 183 days on Dec. 23, 1987.

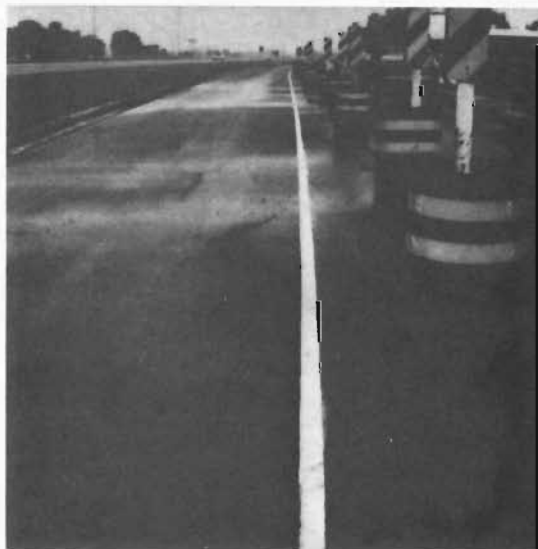
0

Longitudinal crack semi-parallel to centerline developed in area under local traffic with light to medium loads. Picture taken at 122 days on 10-23-87. Station 425+58, offset 6' Lf.CT.

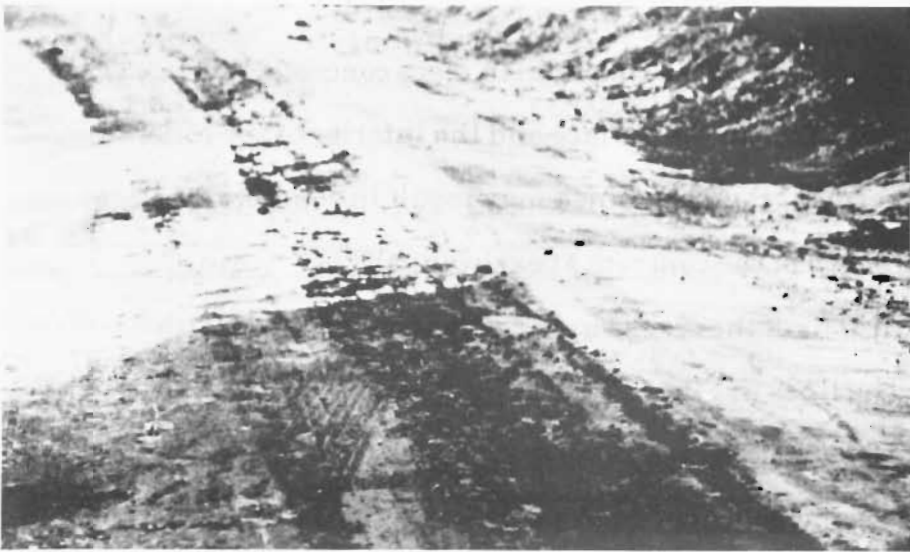
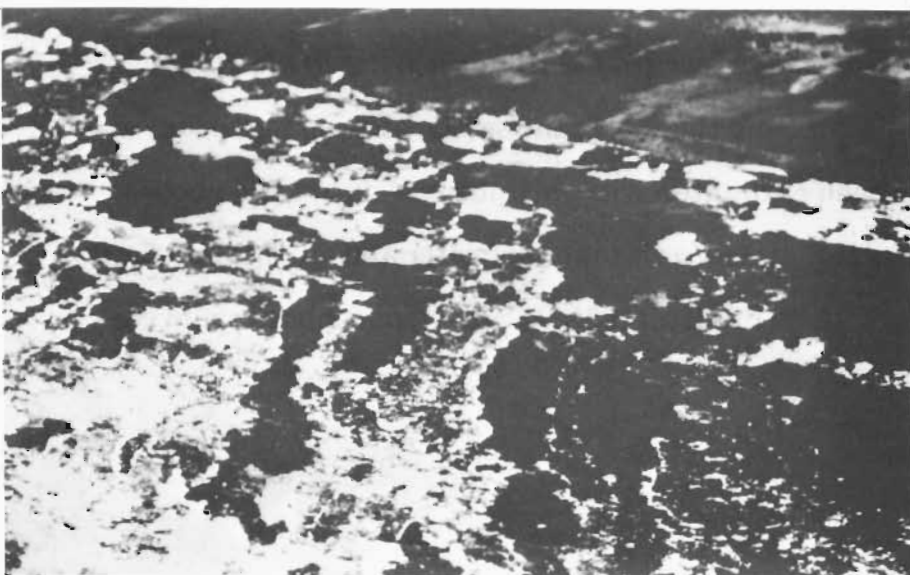
S
T
U

Cement-stabilized phosphogypsum may wash out during a rain if exposed through cracks in the asphaltic concrete pavement. As Pictures S, T, and U suggest, phosphogypsum may have leached out from the holes drilled that were not immediately filled or from the side of the section. Phosphogypsum's tendency to dissolve has been encountered in previous research: "The phosphogypsum produces a crystal matrix as it takes on water and . . . this matrix is somewhat water soluble."³² Also in Pictures V, W, and X, phosphogypsum con-

These three pictures show 9% cement stabilized phosphogypsum washed out from somewhere, either the sides of the section (from Station 509+80 to 516+40) or drilled holes. The residue lies on top of the asphalt; no hot mix has been placed yet. This was taken at 9 days after compaction on 10-14-87. Tire tracks are evidence some traffic came through by this time.

temporarily dissolved in lubricating water as the drilling barrel rotated. Stricter timing for sealing and covering the phosphogypsum with asphaltic concrete pavement must be met so that additional moisture will not seep in or so that moisture will not evaporate out. Excess water may cause the base to swell or shrink and cause the material's strength to decrease.

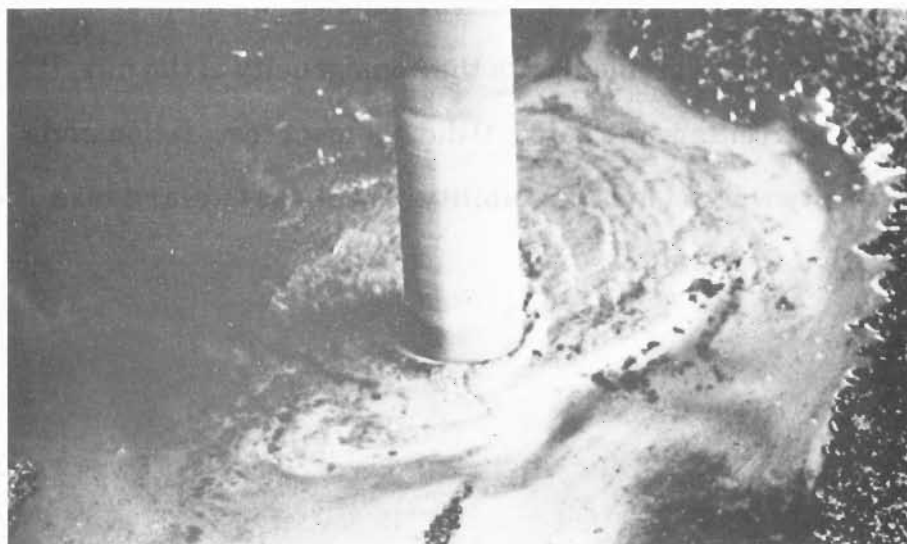
Picture X shows a brown solution, dissolved subgrade, and a white solution of phosphogypsum. Auger is being lifted from hole.
