B F RIDGE REEWAY

- VEHICLE
 - SPEED
 - AND
 - PLACEMENT
 - SURVEY
 - JULY, 1957
- RP 17(3)

PREPARED BY ROAD DESIGN DIVISION
TEXAS HIGHWAY DEPARTMENT

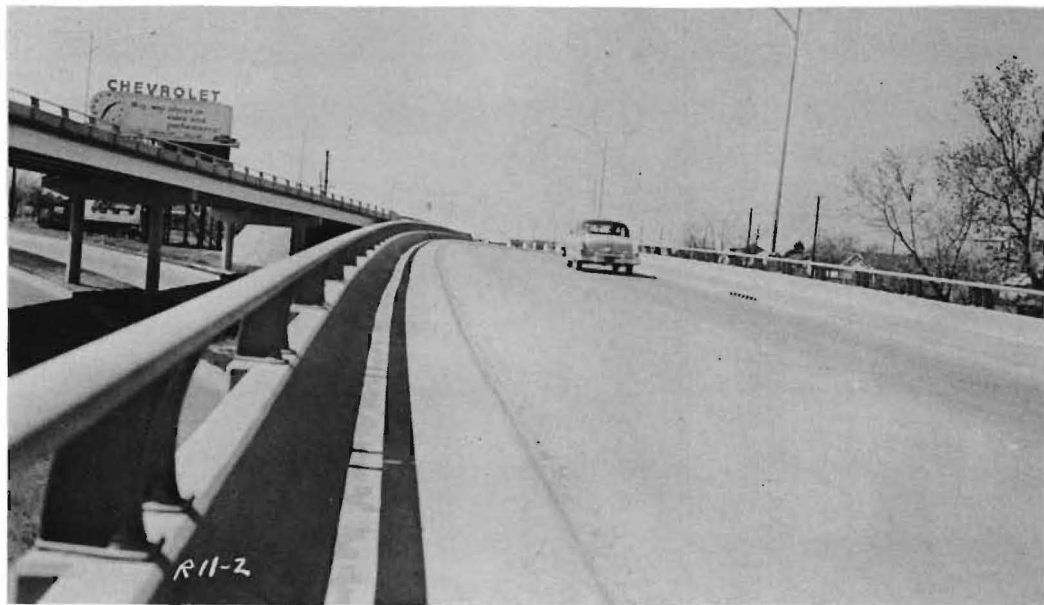
Figure 1

SHOULDER CLEAR

The conditions without and with vehicle on six foot emergency shoulder are shown by Figures 1 and 2.

The study was conducted from 7:00 AM to 12:00 midnight on March 19, 1956 and March 20, 1956. On the first day the six foot shoulder was clear as shown in Figure 1. On the second day a car, supposedly a disabled vehicle, was stopped on the shoulder with the hood raised as shown in Figure 2. There was no one visible around the parked car. Speed and lateral placement were studied under both of these conditions.

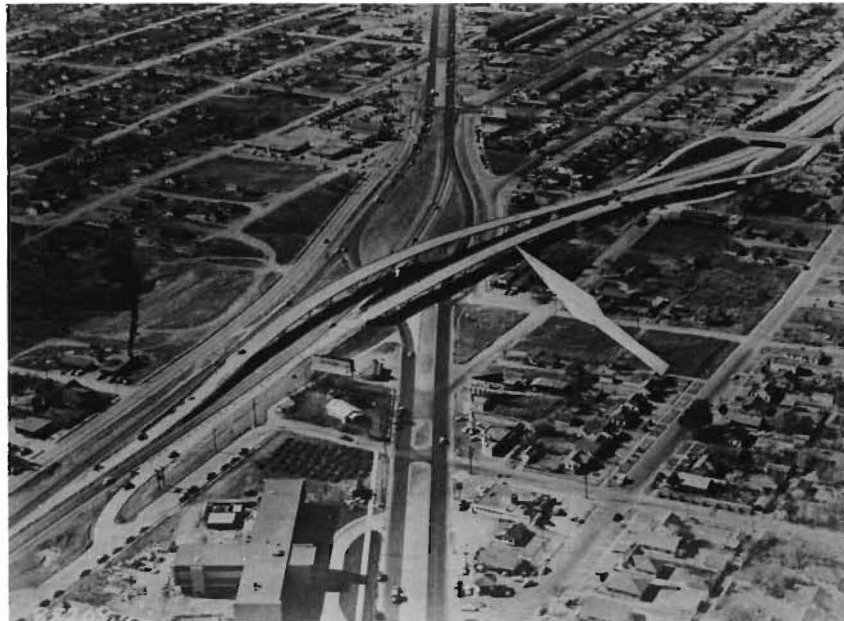
Figure 3

The study was conducted on the westbound lanes of State Highway 550 Freeway bridge crossing over Camp Bowie Boulevard in Fort Worth, Texas. A photograph of the overall site is shown in Figure 3.

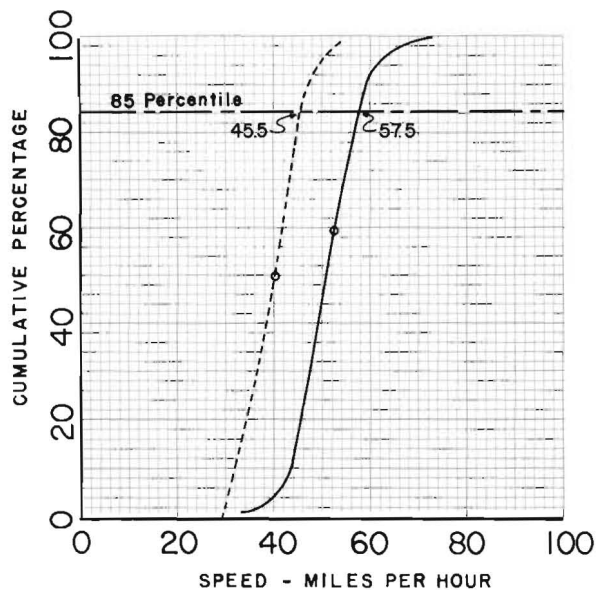
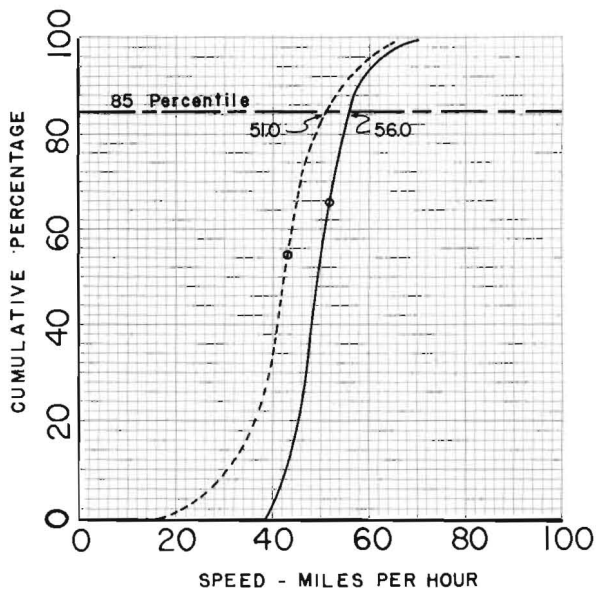
Figure 7

SPEED CURVES

SITE 25 (WITHOUT VEHICLE)

— PASSING --- BEING PASSED

Cumulative speed curves and the 85 percentile speeds for the various volume conditions and vehicle maneuvers are shown in Figures 7,

7A, 8 and 8A. These curves have been arranged so that comparisons may be made between the two shoulder conditions. The general effect of the parked car seems to have been to reduce speeds. It is also evident that speeds are lower in the right lane than they are in the left lane.

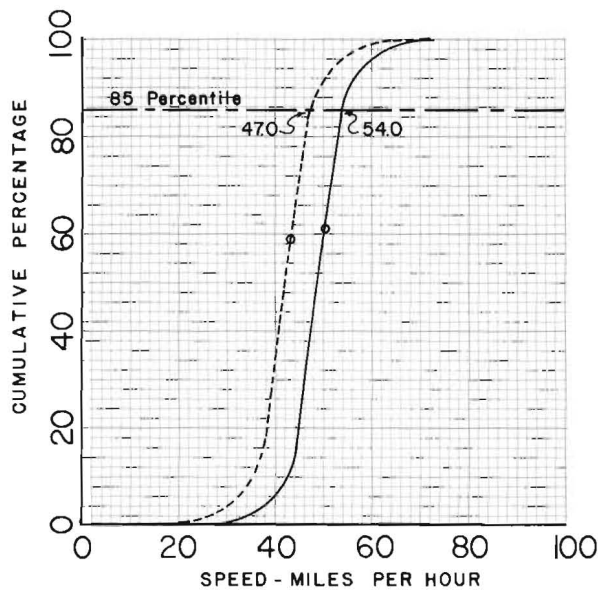
Figure 8

SPEED CURVES

NON-PASSING
SITE 25 (WITHOUT VEHICLE)

--- LANE 1 — LANE 2
AVERAGE SPEED

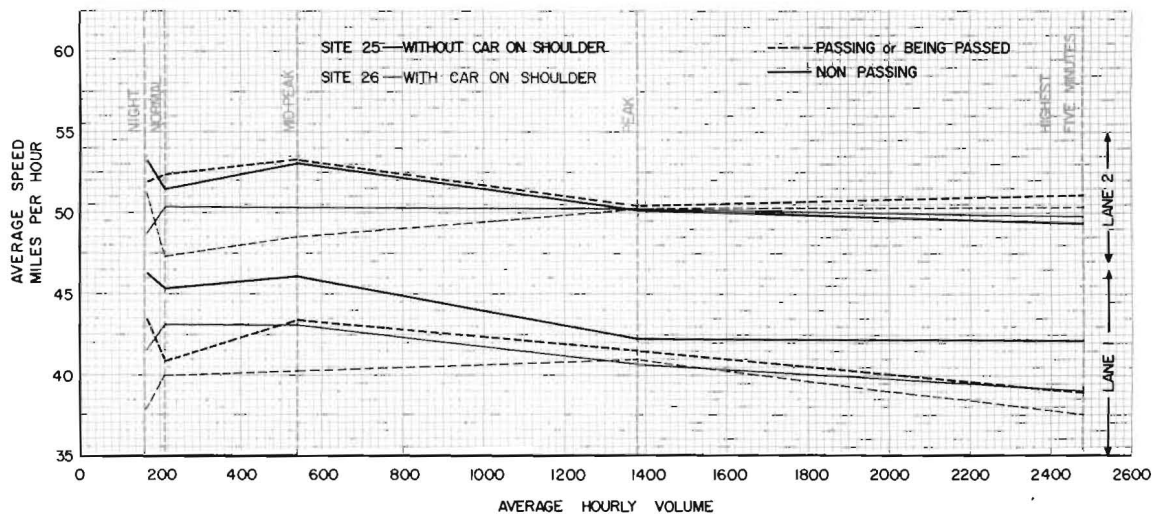
Figure 9 shows the average speed plotted in relation to the hourly traffic volumes for the two shoulder conditions. Several things are illustrated here. Speeds in Lane 1, the right lane, are less than they

are in Lane 2. This difference seems to be increased by the presence of the vehicle on the shoulder, as volumes increase. This increased influence is more pronounced for passing and being passed vehicles than for non-passing vehicles, which indicates that a car in the right lane decreases its speed when it is "sandwiched," so to speak, between

a car on the shoulder and a car in the left lane. The effect on speeds by the vehicle on the shoulder is somewhat similar for both lanes for lower volumes, but as volumes increase, the effect on the left lane decreases.

There is a general converging of the speeds at the peak hour, with vehicles in the left lane traveling at a speed of about 50 MPH and those in the right lane at about 41 MPH. Speeds in the left lane continue to be fairly constant through the peak 5-minute volume while speeds in the right lane tend to decrease and show a wider variation between passing and non-passing vehicles.

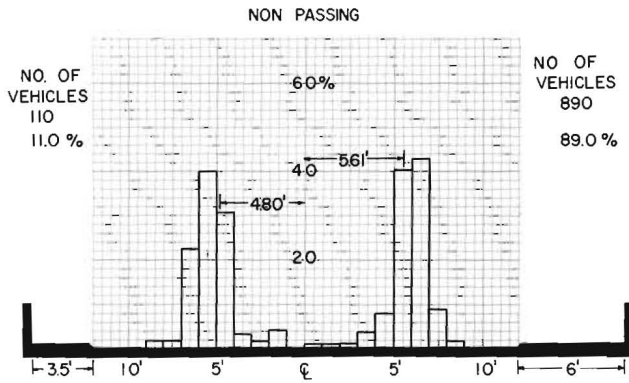
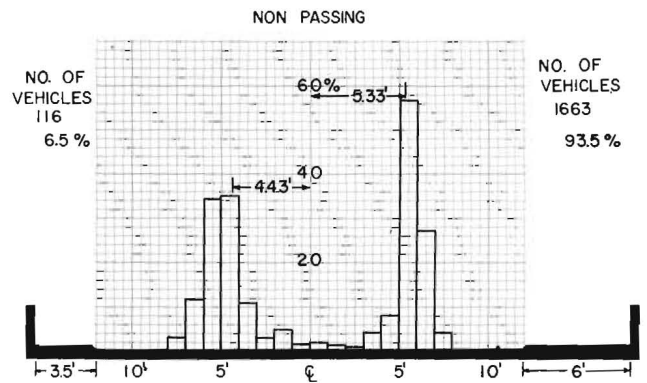
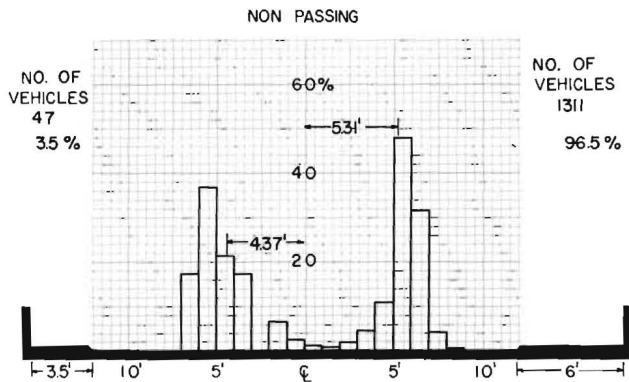
The lateral placement of the vehicles is shown in the form of bar charts in Figures 10 and 10A. These bar charts show the distribution of vehicles within the lanes and the percentage is shown by the height of the bars. Each lane is plotted separately so that the percentages in each lane will add up to 100 percent. Volumes are not the same in each lane. Figure 11 shows the lane volume distribution for the various volumes studied. The percentage of the traffic in the right lane decreases steadily as the total volume increases. The effect of the car on the shoulder was to increase the percentage of vehicles in the left lane at all volume conditions, indicating that regardless of the volume some vehicles moved from the right lane to the left lane because of the vehicle on the shoulder.

SITE 25 (WITHOUT VEHICLE)

LATERAL PLACEMENT OF VEHICLES BY LANE

This movement became less pronounced as volumes increased, partly because it became more difficult to find a gap in the left lane to move into, and partly because vehicles traveling in a more dense stream of traffic did not become aware of the vehicle on the shoulder until after it was too late to take any action.

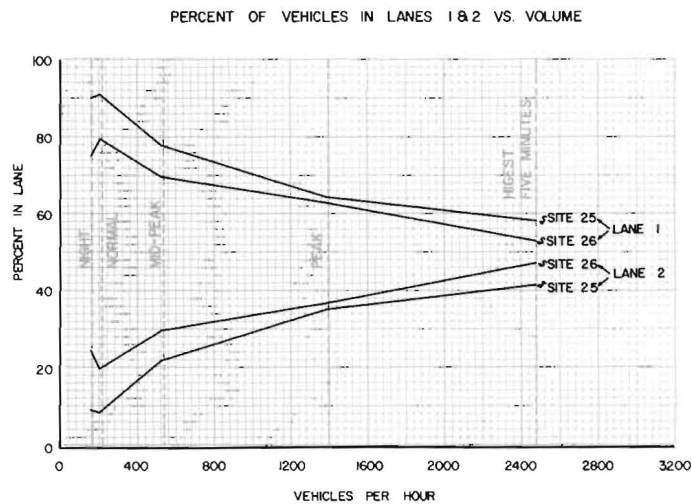
Figure 11

The shape of the curve for the non-passing vehicles in the left lane with the car on the shoulder indicates that, at lower volumes, vehicles were moving from the right lane to the left lane to allow a greater lateral distance to the stopped vehicle. This substantiates Figure 11, which shows a greater percentage of vehicles in the left lane when the car was stopped on the shoulder.
