## 0-6643: Guidelines for the Effective Use of Flexible Pylons for Congestion Mitigation, Access Management, and Safety Improvement

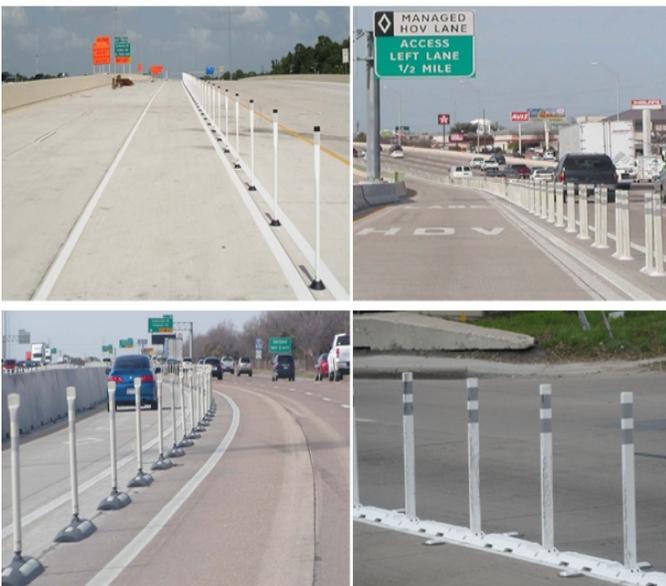
**Figure 1. Examples of Pylon Devices.**

Over the past decade, flexible pylons have been increasingly used on Texas roadways for the purposes of lane delineation and separation. Pylons (see Figure 1) are used for lane separation, delineation of median curbs, and access management on arterials, among other applications. If pylons are hit by a vehicle, an unsafe condition for motorists could result as debris from broken pylons and/or curbs leave exposed nails or broken curbs. The use of pylons can result in increased long-term maintenance costs for the Texas Department of Transportation (TxDOT) and other agencies, even though the initial deployment costs are typically much less than traditional concrete median barriers. While some standards exist to test durability of pylons, this project aimed to provide guidelines for implementation of pylons.
