Rapid Bridge Replacement Techniques

Report No. 0-4568-1

October 2004

RAPID BRIDGE REPLACEMENT TECHNIQUES
RESEARCH REPORT

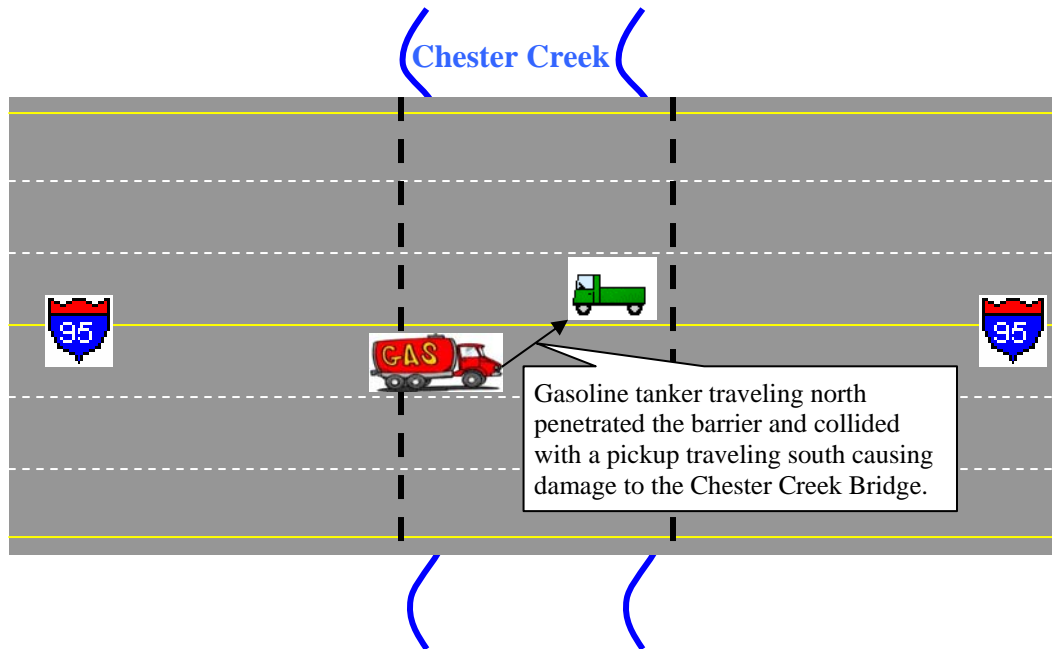
Figure 1 Sketch of Incident Site

A gasoline tanker-truck owned by the Samuel Coraluzzo Company of Vineland, New Jersey, hauling 8,700 gallons of fuel and traveling northbound on Interstate 95 (I-95), crashed through the concrete median barrier and exploded after striking a pickup truck traveling southbound on I-95 on the bridge over Chester Creek in Delaware County, Pennsylvania, at about 7:00 a.m. on Saturday, May 23, 1998. Figure 1 shows a sketch of the incident site. The explosion caused a fireball and the charred bridge buckled under intense heat exceeding 2,000°F. The Pennsylvania Department of Transportation (PennDOT) immediately closed I-95's three northbound and three southbound lanes between I-476 and State Route 452 because of the fear that the bridge might be unsafe for the traveling public. The timing of the accident was worse since it was the start of the Memorial holiday weekend. Traffic backups stretched for miles as motorists clogged alternate routes. The fire-damaged bridge on I-95 normally carries 80,000 vehicles per day and is among the most heavily traveled corridors in the United States. The tanker-truck driver, Keith Thomas, and Michael Mazzola who drove the pickup passing the accident site, were killed. Bobby Hill, a New Jersey resident who drove a Starr Tours bus from Trenton, had minor injuries.

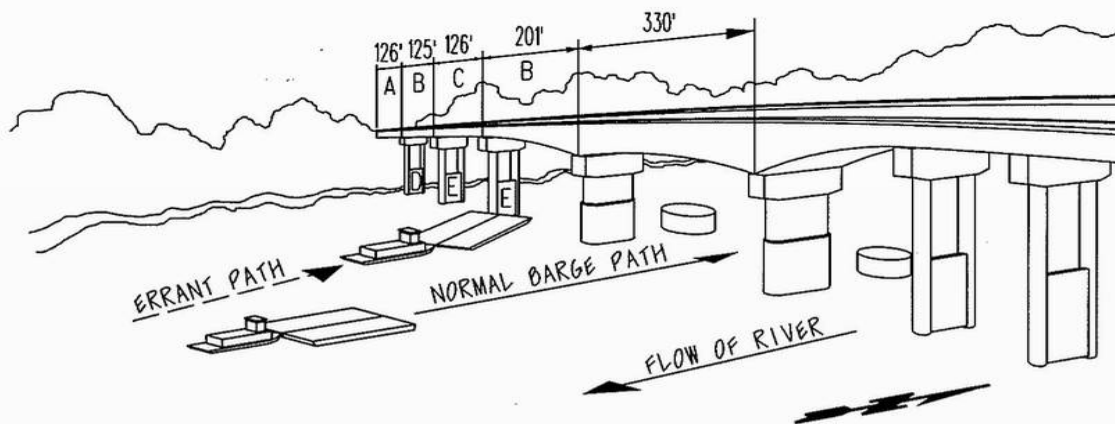
Figure 1 I-40 Bridge Incident Sketch (Provided by ODOT)

Total Bridge Length = 1988.5'
Total Piers = 12

The old piers had two columns supporting them. The new piers were three column structures supported by drilled shafts. Pier 3 (shown as E in Figure 1 towards undamaged bridge) was rebuilt at the original station. Its three columns were spaced to straddle the existing spread footings that were left in place. Figure 4 shows the substructure layout. The solid lines indicate the new pier structure and the dash lines represent the old pier structure. Figure 5 presents the details of pier 1 (shown as D in Figure 1) and 2 (shown as E in Figure 1 that is in the middle of three piers). The new piers were 9 feet in diameter (under web wall portions) which was 2 feet larger than the old one. Figure 6 shows the new pier structure under construction. The new piers were constructed with a construction joint at the top of web walls which were full column width with some chamfering at the ends for ease of forming. Substructure concrete was permitted to be loaded after it reached 75% of design strength.

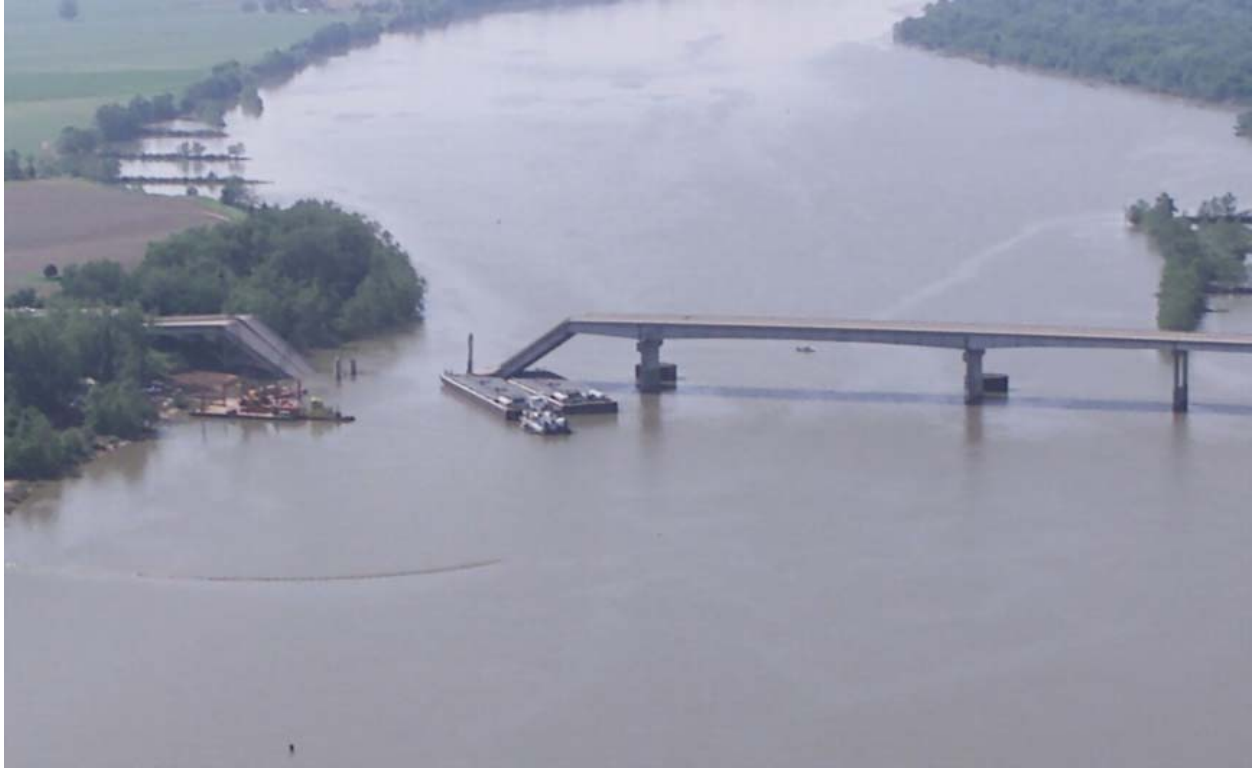
Figure 2 Overview of the Damaged Bridge (Provided by ODOT)

The 64-foot wide, 1988-foot long, four-lane bridge was built in 1967 over the Arkansas River near Webbers Falls, Oklahoma. The original structure was a continuous haunched steel girder bridge with a 200 feet/330 feet/200 feet approach span/main span/approach span configuration and a reinforced concrete deck. The steel girders were supported by 12 concrete piers. Figure 1 shows what happened on the morning of May 26, 2002. The barge was about 300 feet outside the regular navigation channel (main channel) when it rammed into the unprotected piers of the bridge, knocking down two piers (indicated as E piers) and damaging one pier (shown as D pier). Four spans of approximately 500 feet were also damaged. Span 1 (shown as A) was damaged, but did not fall. Span 2 (shown as B, 125 feet long) and span 4 (shown as B, 201 feet long) partially fell into the river. Span 3 (shown as C) completely collapsed into the river. Many drivers were unaware of the collapse of the bridge and eleven vehicles plunged 62 feet into the river. A total of 14 people died in the incident. Figure 2 shows the damaged bridge.

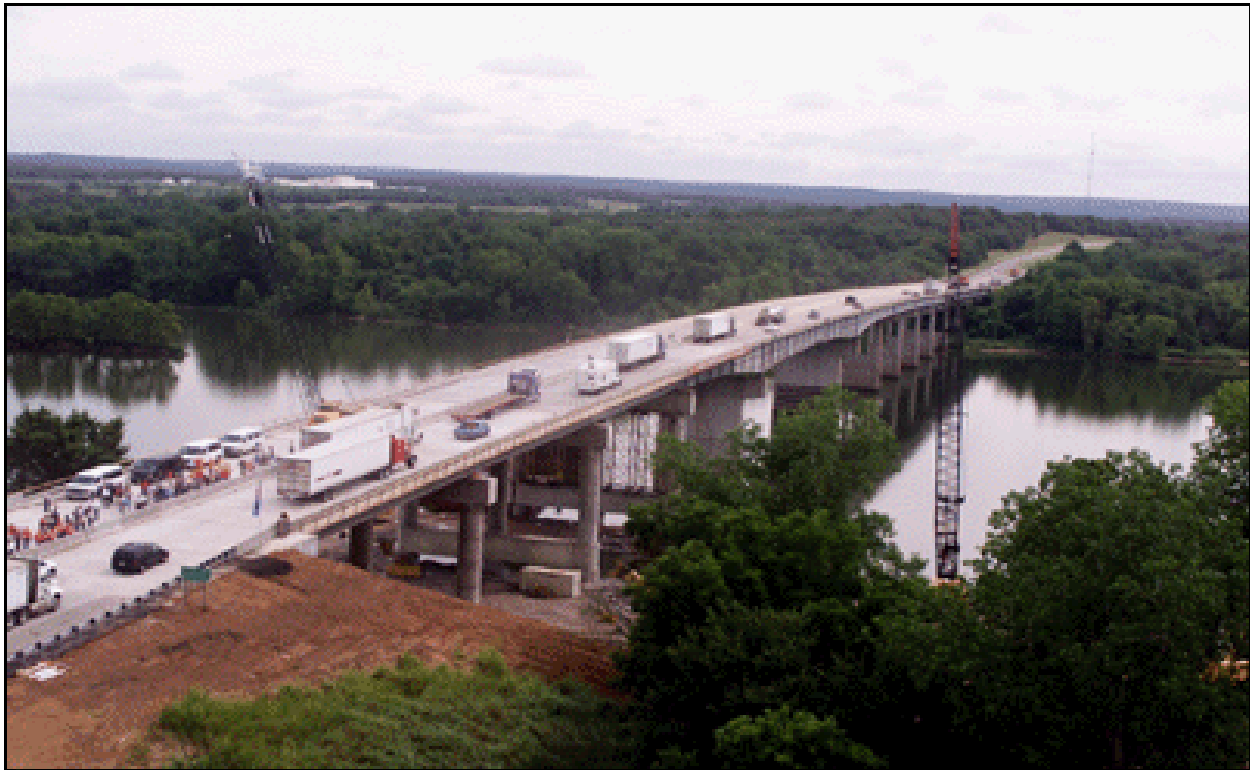
Figure 7 I-40 Bridge Re-Opened to the Traveling Public (Provided by ODOT)

Besides efforts from the industry, coordination among federal, state, and tribal governments was crucial to putting the bridge back into commission on the fast track. As the sole owner of the Arkansas Riverbed and banks at Webbers Falls, the Cherokee Nation controls the land around the reconstruction site. From day one, the Cherokee Nation contributed land and manpower and facilitated the project by making work areas easily accessible to contractors. The Federal Highway Administration (FHWA) approved \$3 million in federal emergency relief funds to get the repair work started immediately. Through the repair process, FHWA provided technical expertise and assistance to ODOT, particularly in the areas of bidding and contract administration. Both agencies worked together to streamline the bid review and approval procedures and get the reconstruction contract ready to put out for bid. ODOT also received technical help and cooperation from the US Army Corps of Engineers, US Coast Guard, and other State DOTs. Figure 7 shows the bridge re-opened to the traveling public on July 29, 2002.

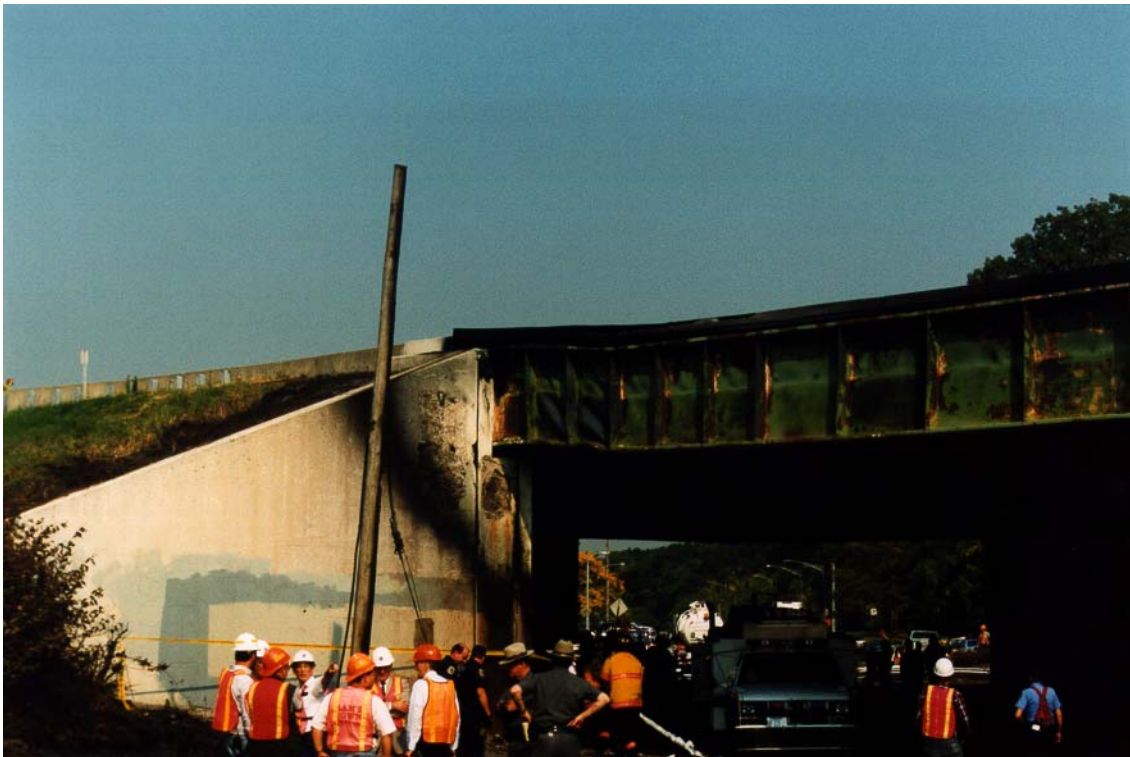
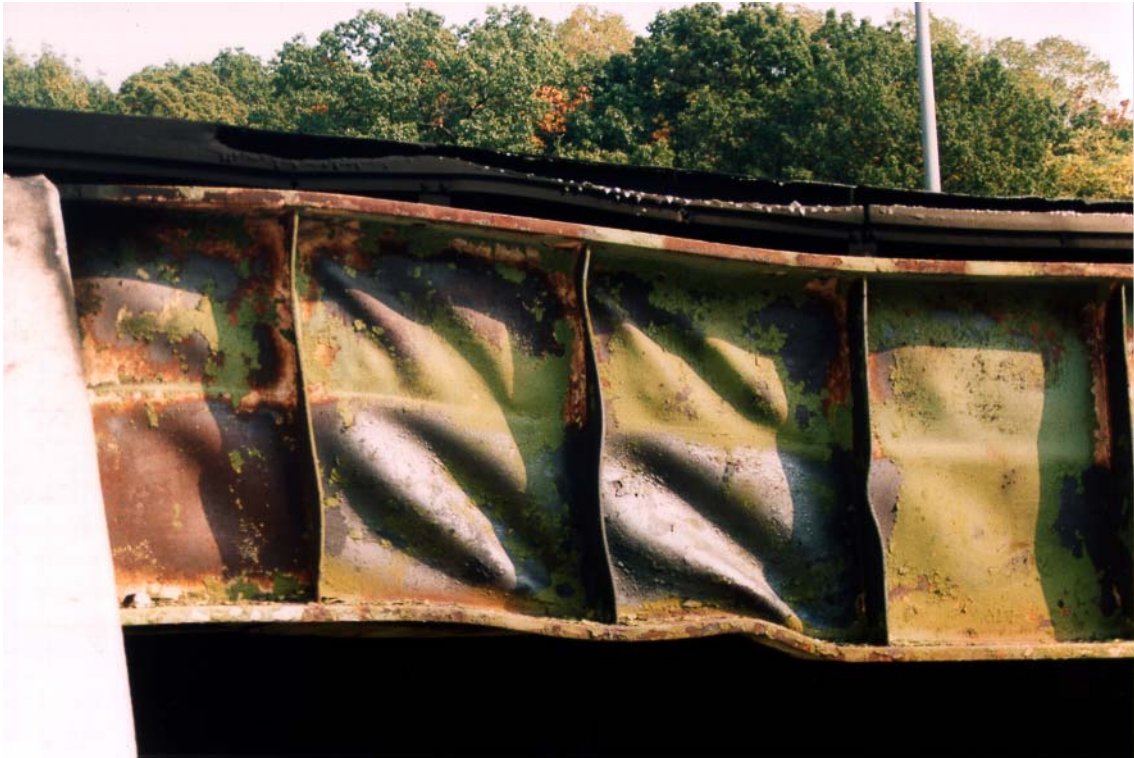
Structural engineers assessed the damages and concluded that the bridge was unsafe for the traveling public. This left the New York State Thruway Authority no choice but to close the bridge immediately. The Thruway is one of the busiest commuting routes to New York City, which is used by 2,500 to 3,000 vehicles per hour in each direction in peak hours and 65,000 vehicles per day. Figures 1 and 2 show the damaged bridge in Yonkers.

Figure 1 Damaged Bridge in Yonkers (provided by NY State Thruway Authority)

Figure 2 Damaged Bridge in Yonkers (provided by NY State Thruway Authority)

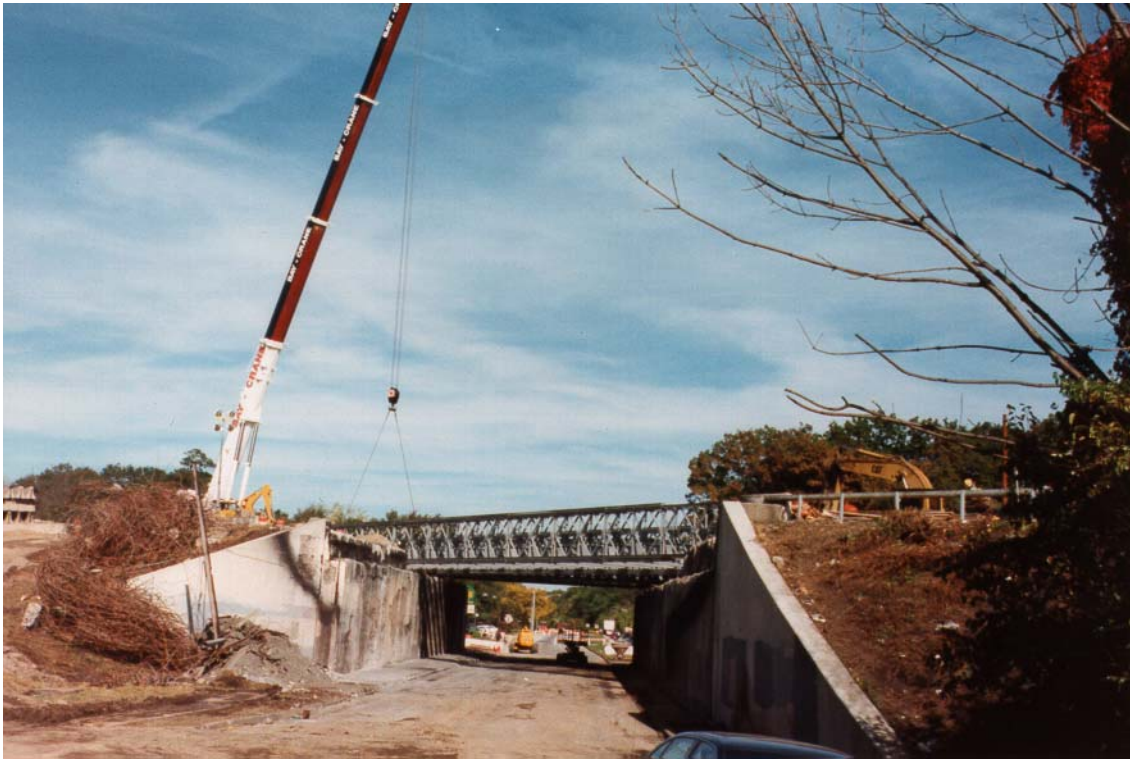
Figure 4 Two temporary bridges in Yonkers (provided by NY State Thruway Authority)

It was determined that the use of temporary bridges would be the fastest and best way to accommodate traffic while the permanent bridge was under construction. Demolition of the damaged bridge started immediately to provide space for erection of two two-lane temporary bridges, one for southbound traffic and another for northbound traffic. The bridges were selected as a temporary measure to handle traffic while a new permanent bridge was being designed and constructed. Mabey Bridge & Shore, Inc. of Maryland manufactured the temporary bridges, and they were erected by Yonkers Contracting, see Figure 4. These panel bridges were prefabricated steel truss structures similar to British Bailey bridges that were developed during World War II for use in remote combat areas. The southbound temporary bridge was about 147 feet long and the northbound bridge was about 155 feet long in order to span over the existing abutments, so that repair work on the permanent abutments could be done without interfering with the traffic above. Temporary bridges were shifted about 3 to 5 feet to the east and the supports of the bridges were built on cantilever over the sidewalk of the Central Parkway Avenue. Each bridge weighed more than 100 tons. A ten-man crew assembled the temporary bridges and installed them using stationary launch rollers and a crane. Stationary launch rollers were used to move the temporary bridges horizontally and the crane was utilized mainly for vertical lifting of the bridges. The temporary bridges were ready for use by the traveling public in only 11 days. On October 20, 1997, the northbound temporary bridge was opened to traffic at 10:30 a.m., and the southbound bridge was opened to traffic at 12:00 noon. With the completion of the temporary bridges, the temporary detour routes were no longer necessary.
