TEXAS TECH UNIVERSITY

Construction and Evaluation of Post-Tensioned Pre-Stressed Concrete Pavement

Report No. 5-4035-01-2
www.techmrt.ttu.edu/reports.php

September 2010

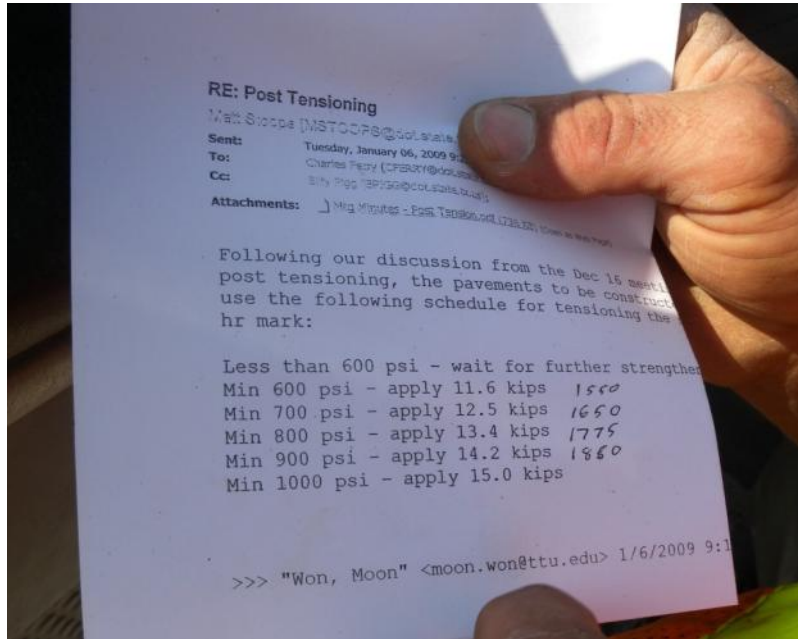
Figure 2.1 shows the initial post-tensioning force table that field crew carries in his truck. It shows that, if the compressive strength is 600 psi or less, they have to wait for further strength gain. It shows that the initial post-tensioning force is reduced as concrete strength decreases. The decrease is proportional to the square root of concrete compressive strength.

Figure 2.1 Reduction of initial post-tensioning force for low concrete strength

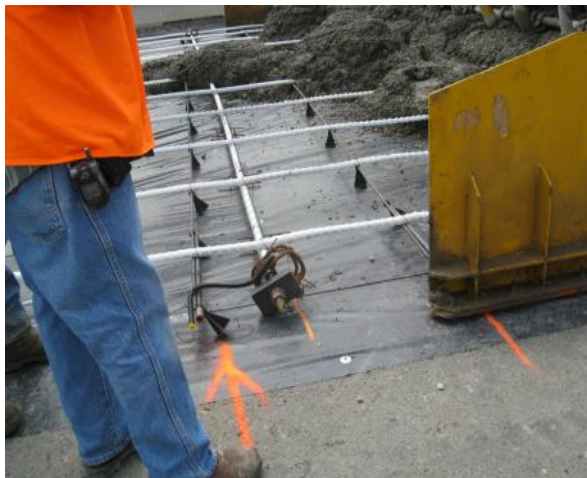
During the paving on the first day of PCP construction on May 27, 2008, it was noticed that longitudinal tendons were pushed by the concrete, which again pushed transverse post-tension bar and transverse steel, as shown in Figure 2.2. To prevent this, the contractor personnel had to push transverse post-tension bars and steel with his foot, as shown in Figure 2.3.

Figure 2.2 Tendons and transverse bars pushed by concrete

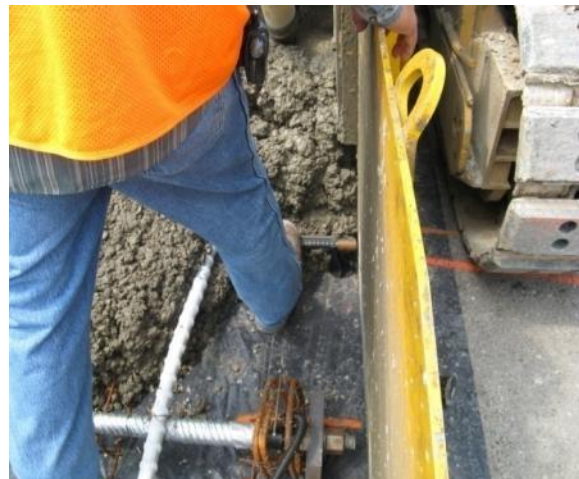
Figure 2.3 Contractor trying to hold transverse bars in place

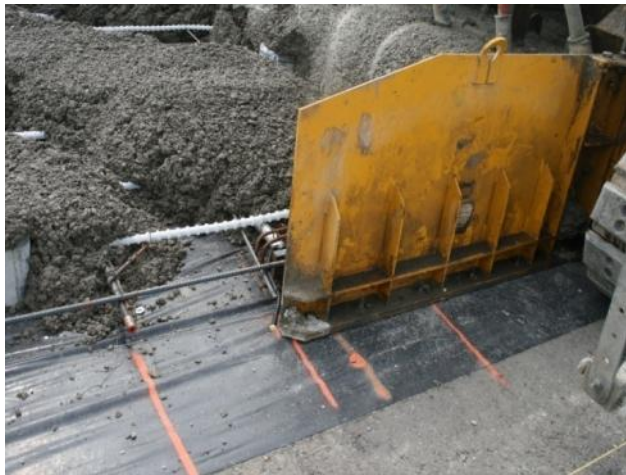
The contractor shortly came up with the idea of placing #6 rebar longitudinally and tying transverse post-tension bars and transverse rebar to the longitudinal #6 bars. Figure 2.4 shows the longitudinal rebar placed. This system of placing longitudinal bars, with one bar at each side of the slabs and one bar in the middle for more than 30-ft wide placement, was incorporated for the rest of the project, as shown in Figure 2.5. This system of placing longitudinal bars helped keep the transverse post-tensioning bars and transverse steel in place a little. However, it did not prevent the transverse post-tensioning bars and transverse steel from being pushed. As discussed below, the contractor started staking bars to the asphalt to keep the transverse post-tensioning bars in place during concrete placement.

Figure 2.4 Longitudinal rebar placed to correct the problems of bars being pushed by concrete

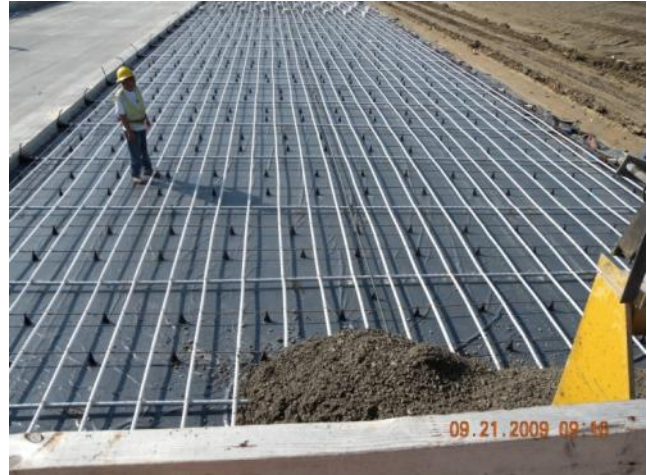
Figure 2.5 Longitudinal rebar placed at both sides and in the middle of the slab

The placements of the longitudinal rebar will reduce the pre-stress level in the concrete; however, the cross-sectional area of the rebar is quite small compared with the pavement section, and the reduction was considered to be insignificant, especially when there were no better alternatives for this constructability problem. In addition, without these longitudinal bars, tendons won't be placed straight and the resulting pre-stress loss will be more substantial.

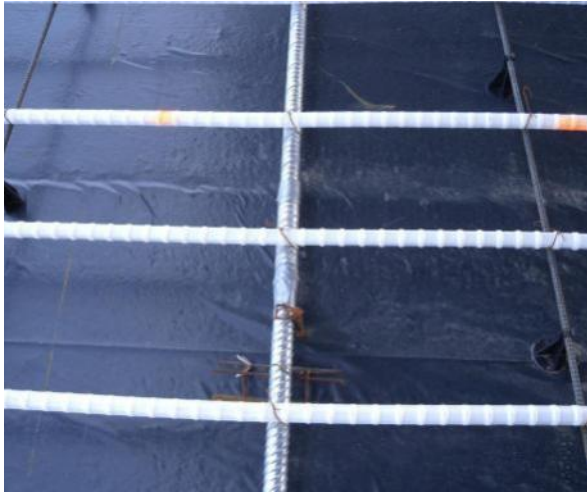
installed every third transverse post-tensioning steel. When the two transverse post-tensioning steel where vertical bars were not installed were not tightly fixed with longitudinal tendons, the transverse post-tensioning bars were bent as shown in Figure 2.7 due to the concrete pushing the bars.

Figure 2.6 Bar installed to keep transverse post-tensioning bar in place

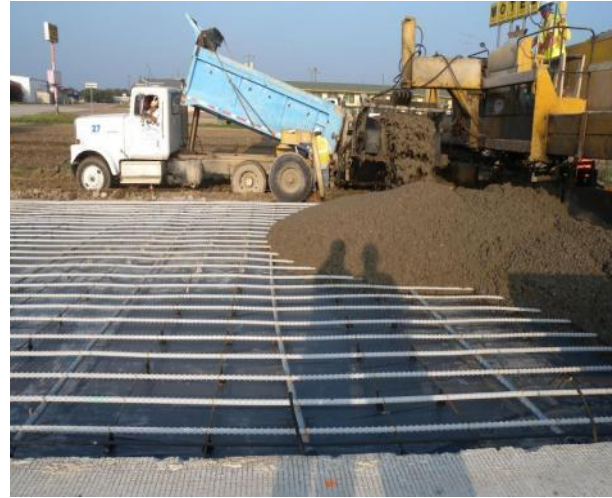
Figure 2.7 Transverse post-tensioning bar being bent due to concrete pressure

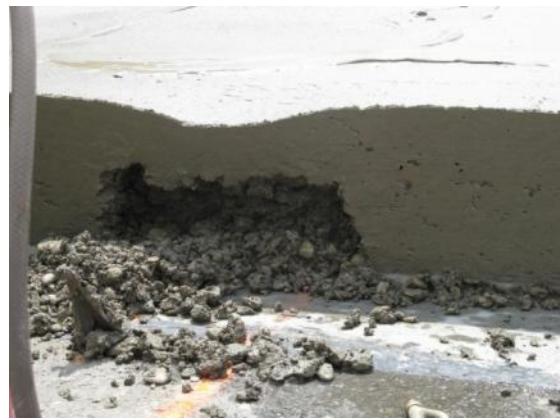
Figure 2.9 Edge slump due to the removal of concrete for the space for the connection of transverse bars

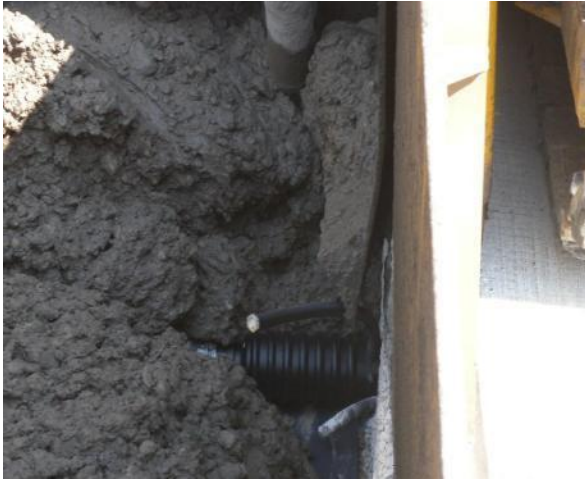
Figure 2.10 Grouting hose at longitudinal construction joint not interfering with placement

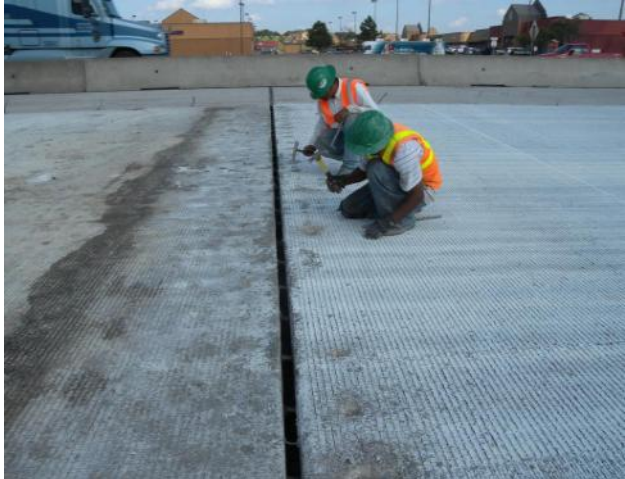
manually. Identifying the exact location of the grouting hoses and exposing them by chipping concrete was time consuming and labor intensive, as can be seen in Figure 2.11. Improved method could enhance the productivity of the PCP construction.

Figure 2.11 Chipping concrete to expose grouting hoses at armor joints

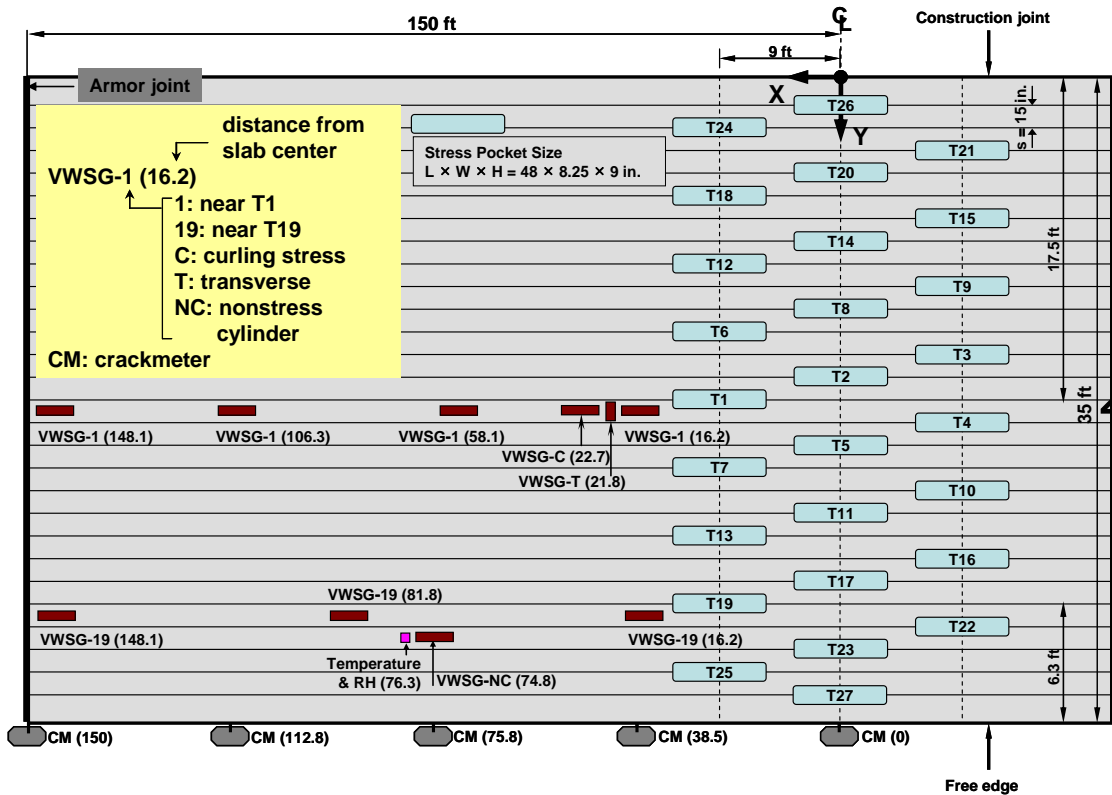
The longitudinal post-tensioning (PT) was introduced with a tendon coupler at stressing pockets located in the middle portion of the 300-ft long slab between two transverse armor joints (see Figure 3.1). Steel plates with 0.4-in. thickness, which were placed near the armor joints, were used to apply compressive force to the concrete slab when PT was applied to tendons. The number in the stressing pockets in Figure 3.1 represents the sequence of PT application. Table 3.1 summarizes the procedure of PT application in the PCP test section. Longitudinal PT was applied twice with different levels of forces in the tendon. In order to accurately estimate concrete compressive stress as induced by PT, the compressive strength and elastic modulus of the cylinders under standard curing conditions were measured in accordance with ASTM C 469-02 (1). The elastic modulus of the slab was correlated with that of the concrete cylinder through the maturity based on measured temperature (2). The sectional average temperature was used to calculate the equivalent age of the concrete slab.

Figure 3.1 Test section geometry and field instrumentation of various sensors

movement were placed at different distances from the slab center before the first longitudinal PT application (see Figure 3.1). As shown in Figure 3.2-(d), each crackmeter set can measure slab movement in longitudinal, transverse, and vertical directions.

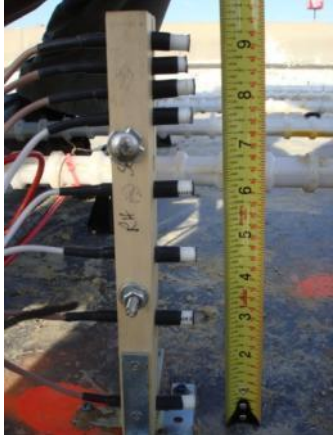
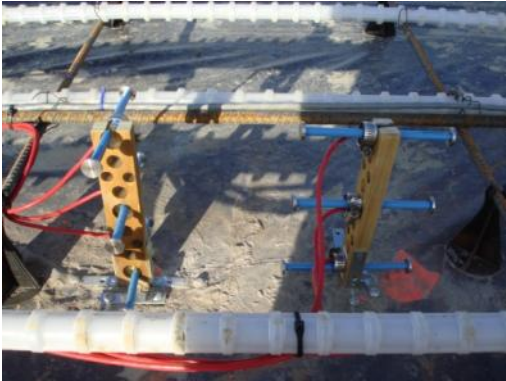
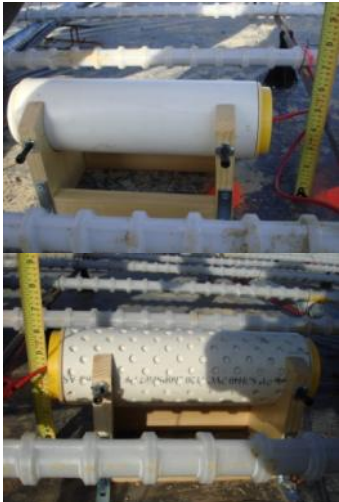
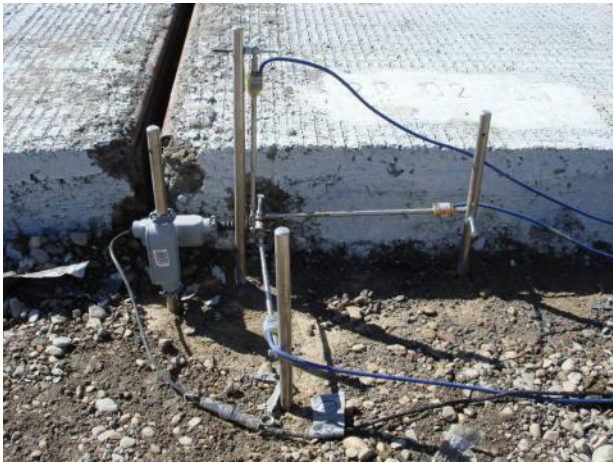
(a) Sensor for temperature and RH

(b) VWSG at different depths

(c) Non-stress cylinders

(d) Crackmeter at armor joint

Figure 3.2 Various gages installed

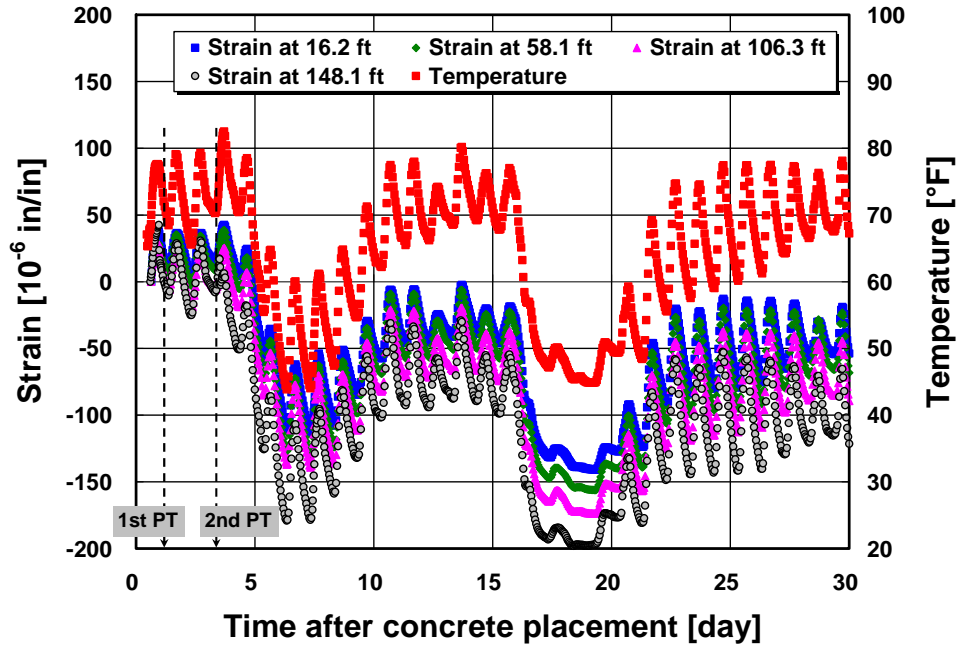
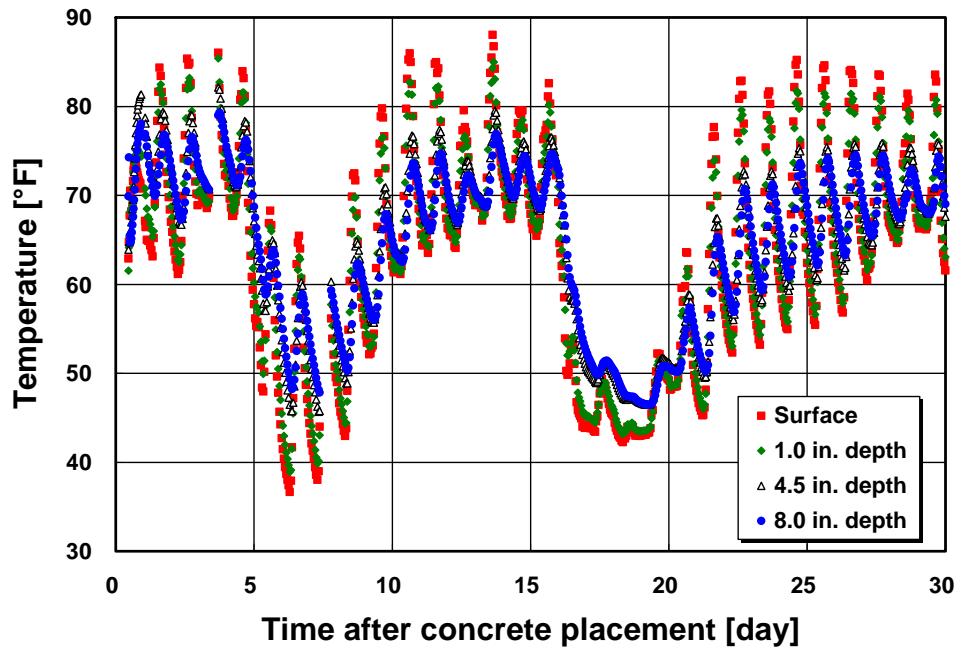
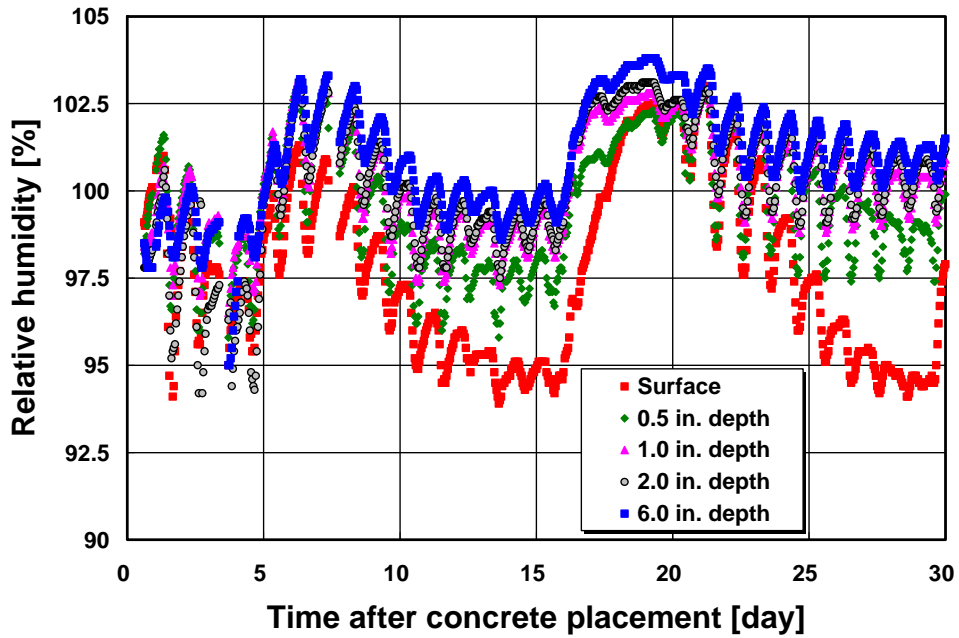
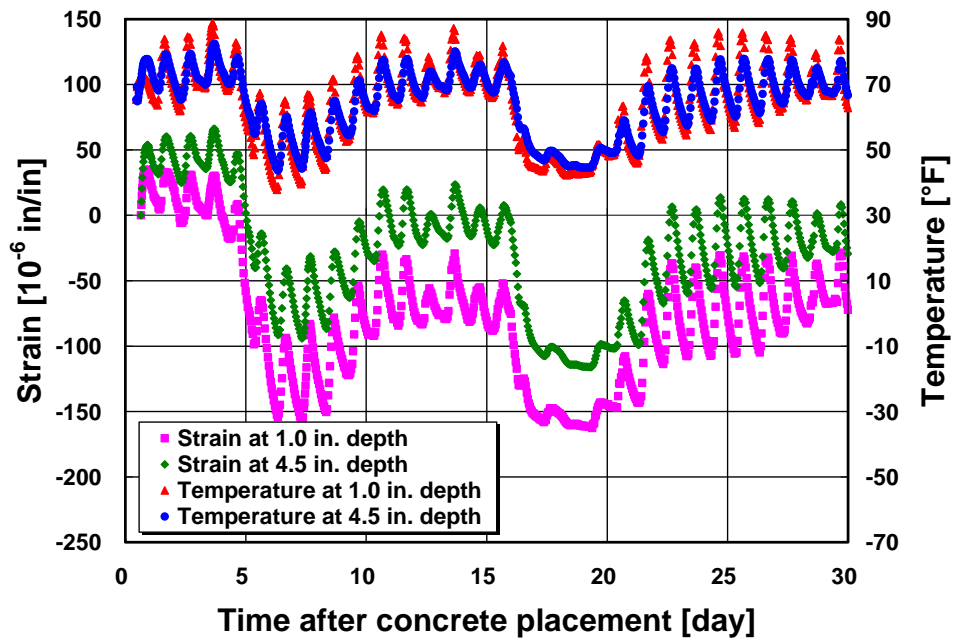
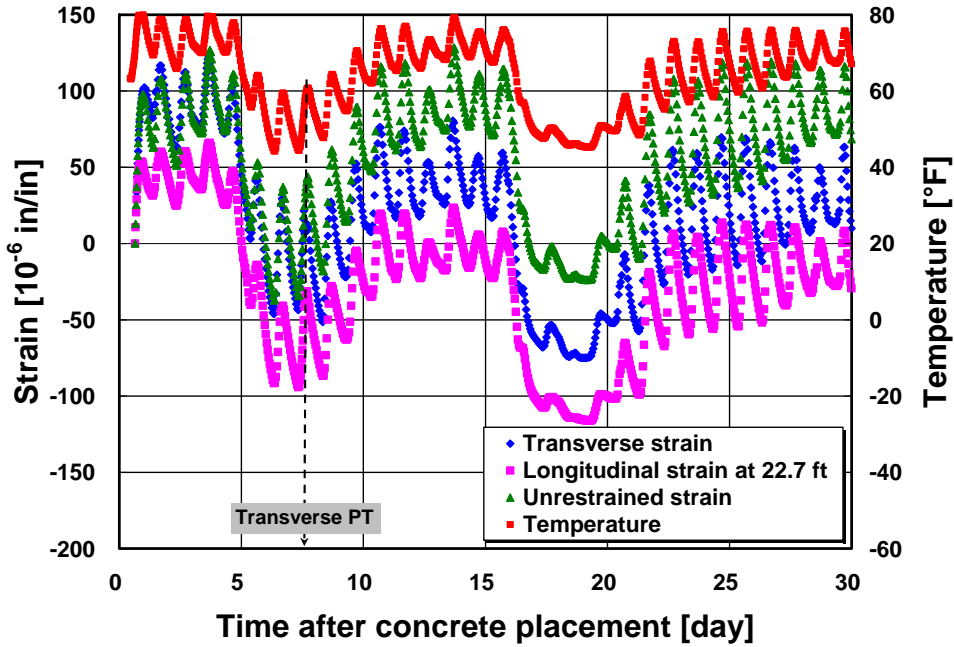
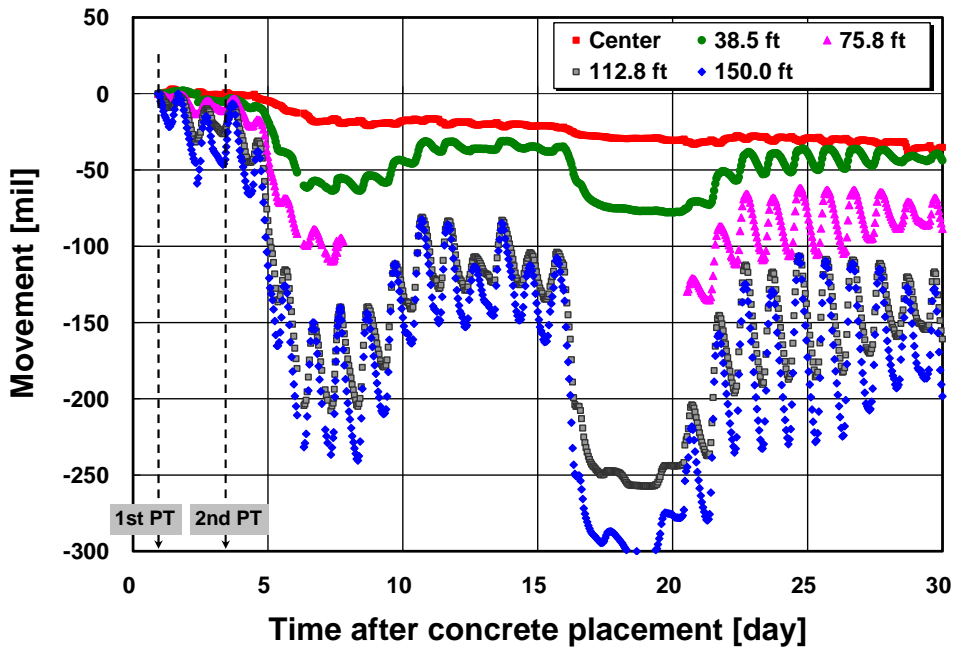
Figure 3.3-(a) illustrates the variations of longitudinal strain and temperature measured with VWSG-1 gages from the time of concrete placement (see Figure 3.1). The whole number in the x-axis denotes midnight of the day after concrete placement. For example, “5” means midnight of the fifth day after concrete placement. It shows that temperature played an important role in the development of longitudinal concrete strain in PCP. The measured strains responded positively with temperature variations. The figure also illustrates that compressive strains increased moving away from the center of the slab towards the armor joint. It is postulated that the friction between the concrete slab and the subbase caused these variations, which will be discussed in next section. Also, the practice of leaving bars driven into the subbase to keep the transverse post-tensioning steel appears to have contributed to this. Figures 3.3-(b) and (c) show measured temperature and RH along the depth of slab, respectively. As expected, the maximum temperature variations occurred near the top of the slab, with the smallest variations near the bottom of the slab. For the monitoring period, the average temperature in the section was very similar to that at mid-depth (4.5-in.) which will be further discussed later. The variation of RH was limited to only the surface region, with negligible variation at inner regions as shown in Figure 3.3-(c). It appears that the curing operations were done properly in accordance with TxDOT specification requirements of two applications with each application of not to exceed 180 ft²/gal of curing compound. Figure 3.3-(d) shows the longitudinal strain and temperature of PCP slab at different depths measured with VWSG-C in Figure 3.1. At early ages, the strain at 4.5-in. depth was higher than that at 1.0-in. depth. At older ages, however, the variation of strains was almost similar to each other even though significant differences of temperature still existed. It suggests that the curling stress was present in the measured concrete element. Figure 3.3-(e) shows the transverse, longitudinal, and unrestrained strains in the slab depending on temperature variation. Because RH variations were limited to the surface region for the monitoring period, measured strain with VWSG in non-stress cylinder with holes was very similar to that in non-stress cylinder without holes. Compared with the unrestrained concrete strains obtained in the non-stress cylinder with holes (see Figure 3.2-(c)), the transverse and longitudinal strains were smaller. This indicates that the concrete in the slab was in a compression stress state in the longitudinal as well as the transverse direction. In the non-stress cylinder, the concrete is in a stress-free condition. Figure 3.3-(f) illustrates that the slab movement in the longitudinal direction was mainly caused by temperature variations. The movement was correlated quite well with the temperature variations in Figure 3.3-(a). The longitudinal slab displacements became larger moving away longitudinally from the center of the slab. The details on each measured data will be thoroughly discussed in the next section.

Figure 3.3 (a) and (b) Measured data for one month in field instrumentation

Figure 3.3 (c) and (d) Measured data for one month in field instrumentation

Figure 3.3 (e) and (f) Measured data for one month in field instrumentation

The measured concrete strain by VWSG is total strain, which includes strains due to temperature and moisture variations as well as strains due to stress and creep (7). Because the longitudinal and transverse strains existed in the range of smaller values than unrestrained strain as shown in Figure 3.3-

(e), the concrete element at mid-depth of PCP may be in a compression stress state. This compressive stress will induce such additional strain as creep, which was shown in Figures 3.4-(a), (b), (c), and (e). The variations of strain and movement along with temperature changes were different before/after the longitudinal PT application. Moisture differential would also affect long-term behavior of PCP. Figure 3.9 shows the variation of longitudinal slab movement at different locations when the temperature of concrete at mid-depth was 70 °F. It indicates that the slab contracted with time after placement. It is postulated that creep and shrinkage induced this gradual slab contraction. Therefore, creep and shrinkage effects should be included in the design of initial joint width.

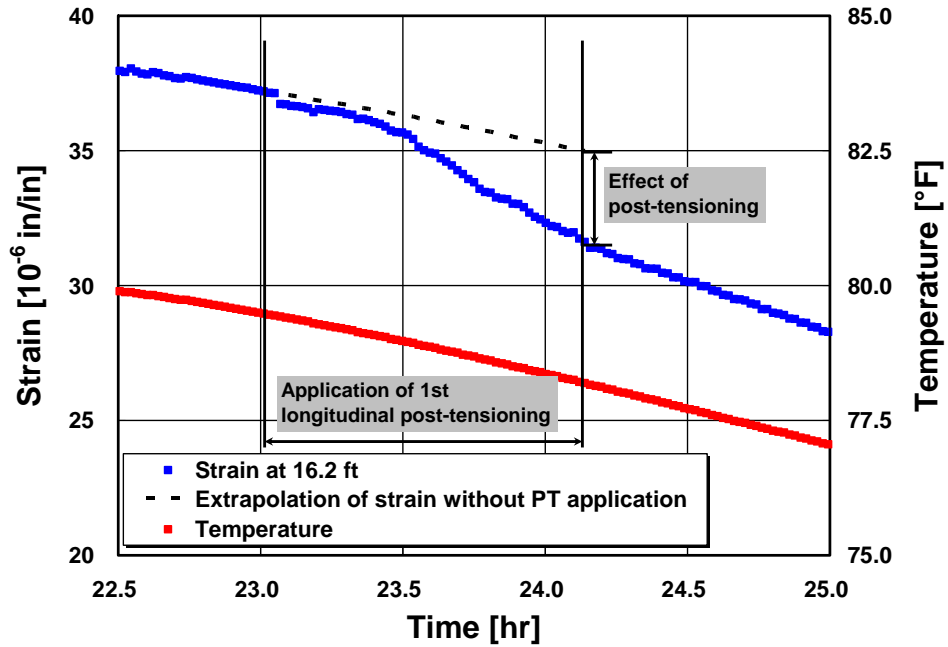
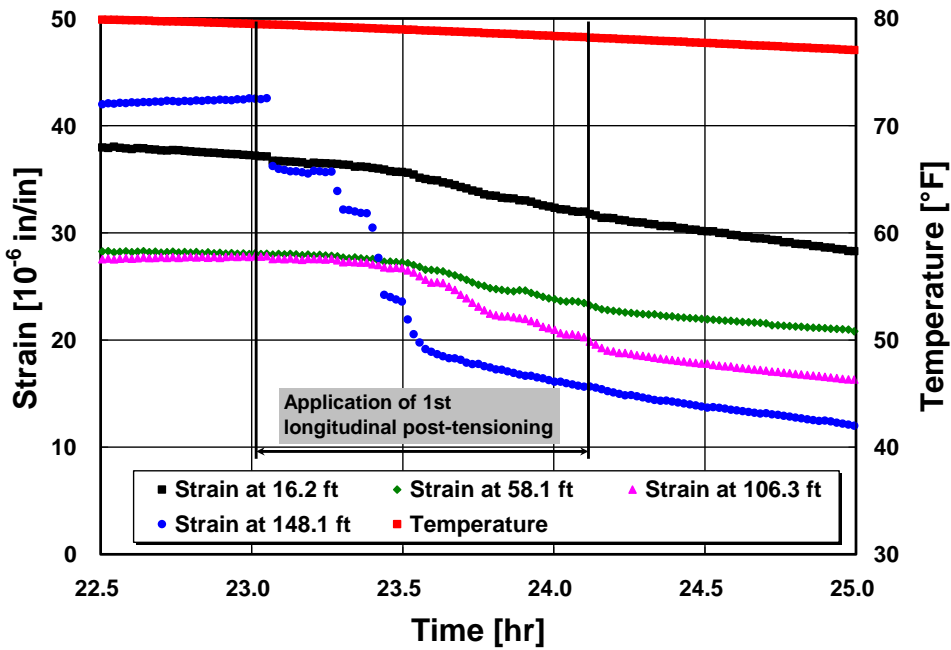
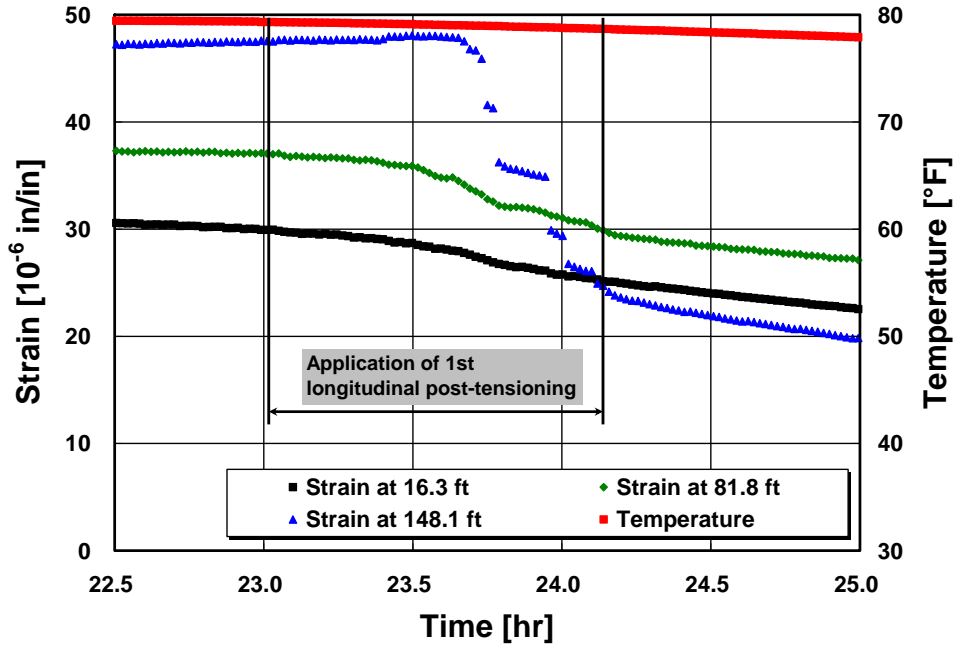
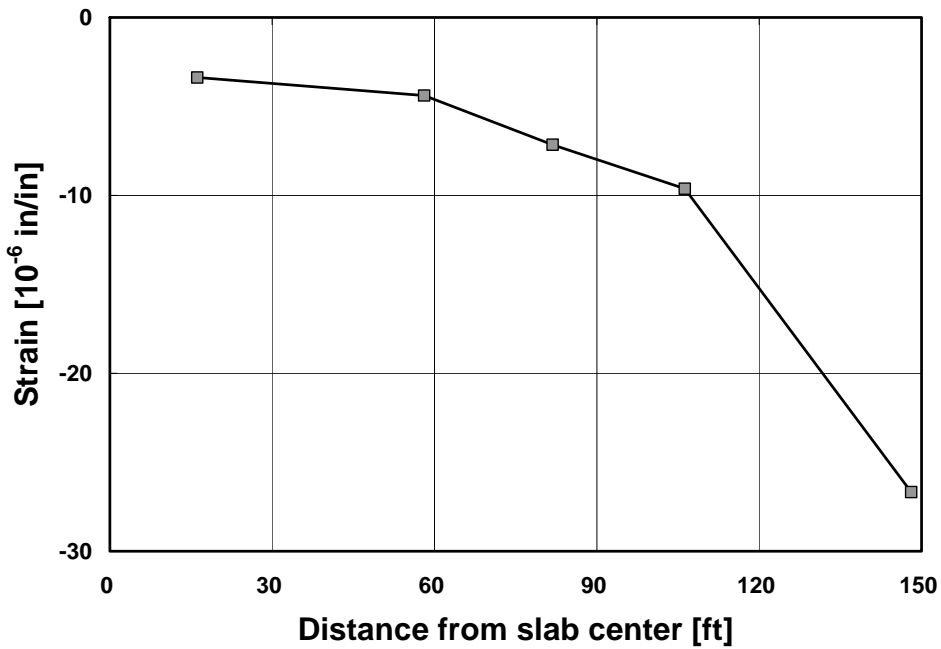
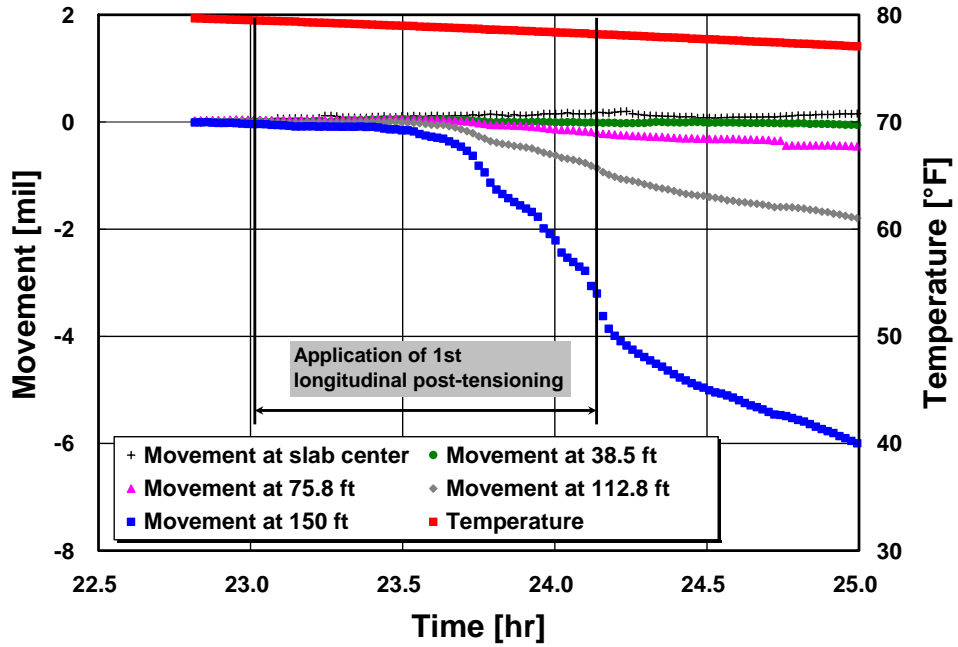
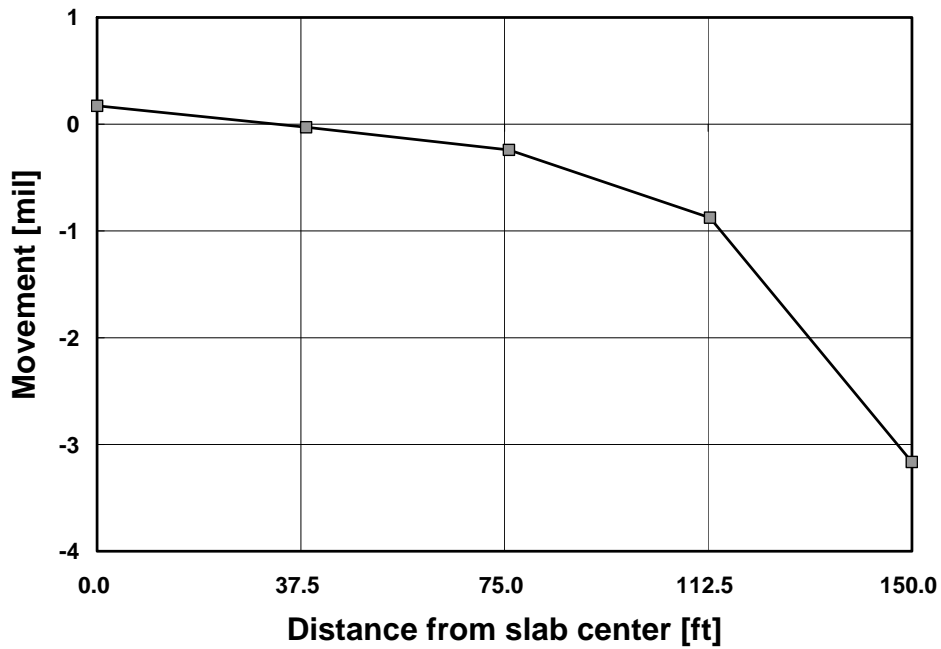
application. The similar distribution of concrete strain changes and slab movement were recorded when the second longitudinal PT was applied to slab as well.

Figure 3.4 (a) and (b) Concrete strain and slab movement due to first longitudinal PT application

Figure 3.4 (c) and (d) Concrete strain and slab movement due to first longitudinal PT application

Figure 3.4 (e) and (f) Concrete strain and slab movement due to first longitudinal PT application

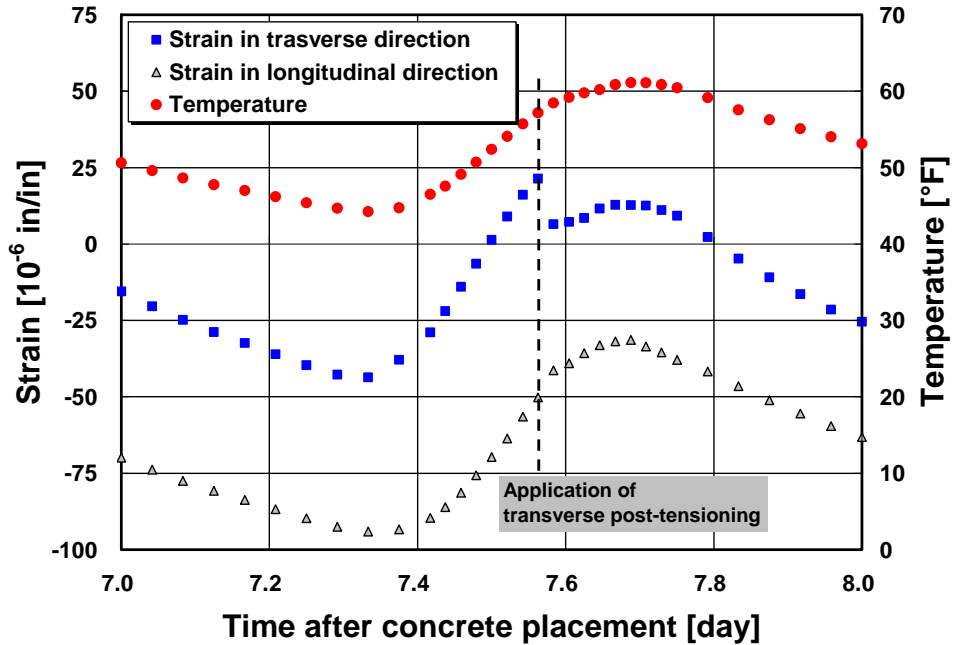
Figure 3.5 illustrates the variations of concrete strain in transverse and longitudinal directions when the transverse PT was introduced. It indicates that the transverse PT efficiently induced the compressive concrete stress in the transverse direction. As expected, the transverse strain decreased rather quickly due to transverse PT. The longitudinal strain, however, was slightly increased due to the Poisson effect. The amounts of transverse and longitudinal strains were -21.5×10^{-6} in./in. and 3.1×10^{-6} in./in., respectively. The corresponding compressive stress—114.2 *psi*—was introduced in the concrete slab in the transverse direction. Since the transverse post-tensioning of 46.6 kips per bar is specified with 6-ft spacing between transverse post-tensioning steel, the equivalent average concrete compressive pre-stress is 72 psi in the transverse direction. The applied pre-stress in concrete is much larger than the specified value.

Figure 3.5 Variation of transverse and longitudinal strains in concrete slab due to transverse PT application

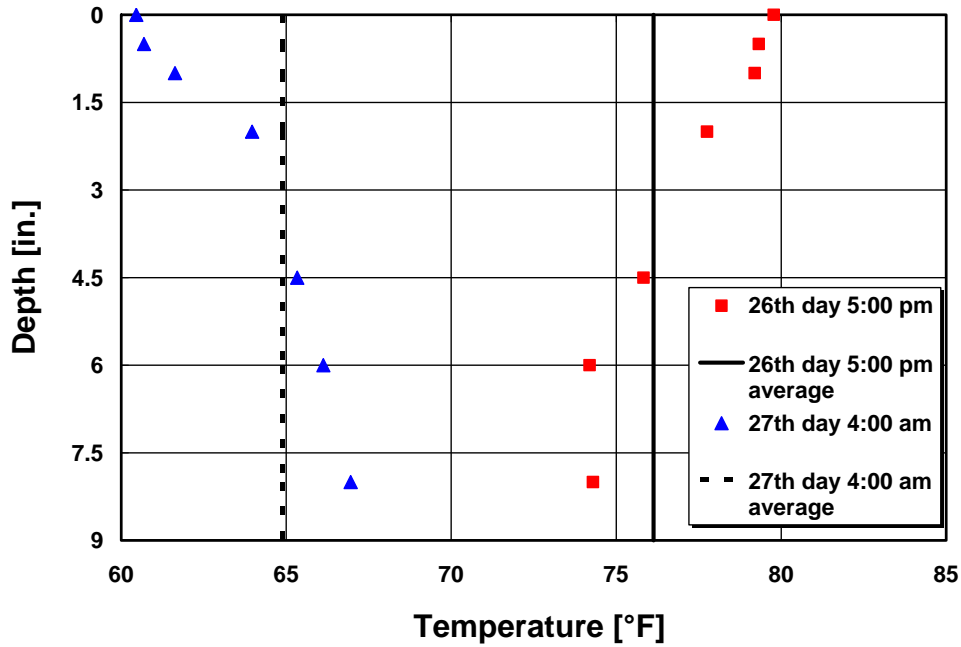
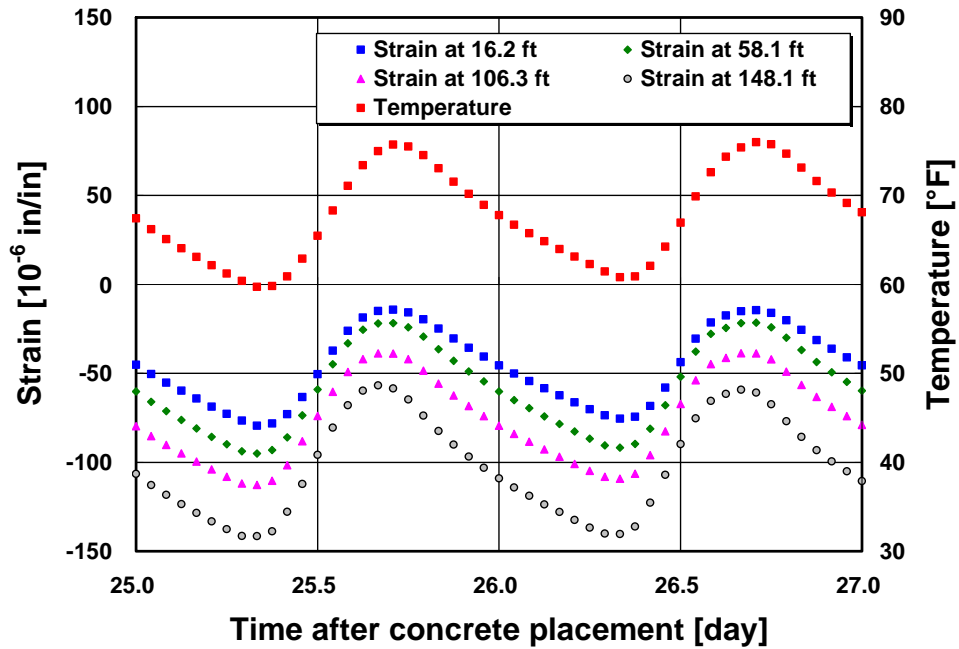
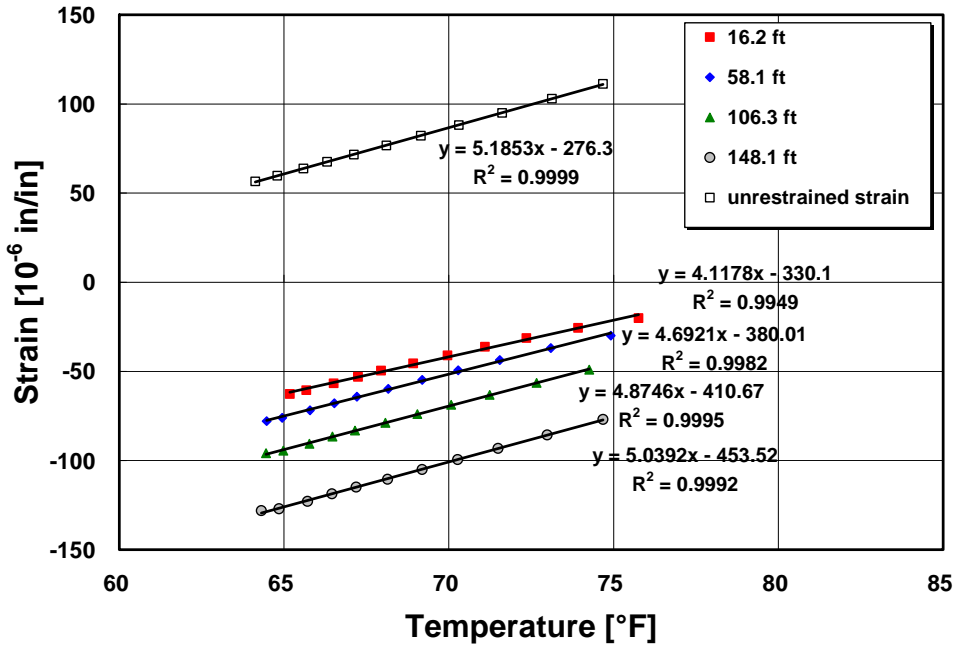
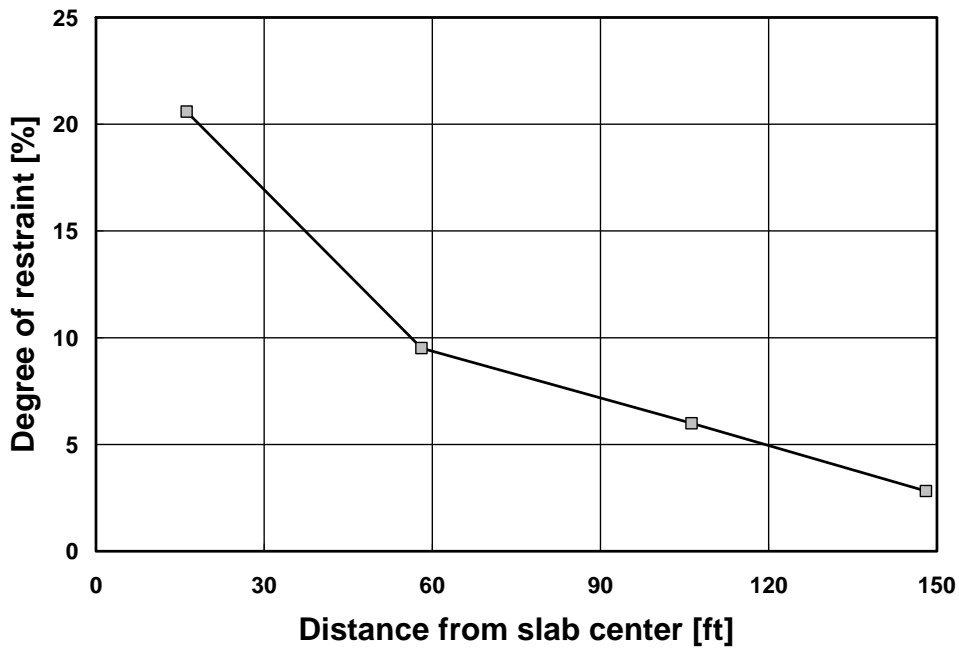
The degree of restraint of the concrete element at different locations from PCP slab center is shown in Figure 3.6-(d). Figures 3.6-(c) and (d) illustrate that more restraint existed as the concrete element became closer to slab center. It suggests that the slab's center region was subjected to more restraint due to friction and the vertical bars, which would result in the development of higher stresses in concrete due to environmental and wheel loading. In this project, one layer of polyethylene sheet was placed to reduce the subbase friction and pre-stress loss. An option of two layers of polyethylene sheet was considered but abandoned due to construction difficulty. Because two layers of polyethylene sheet provide less subbase friction, their use would be more desirable in addressing pre-stress loss.

Figure 3.6 (a) and (b) Distribution of longitudinal strain and degree of restraint of concrete element at different locations in PCP slab for specified period

Figure 3.6 (c) and (d) Distribution of longitudinal strain and degree of restraint of concrete element at different locations in PCP slab for specified period

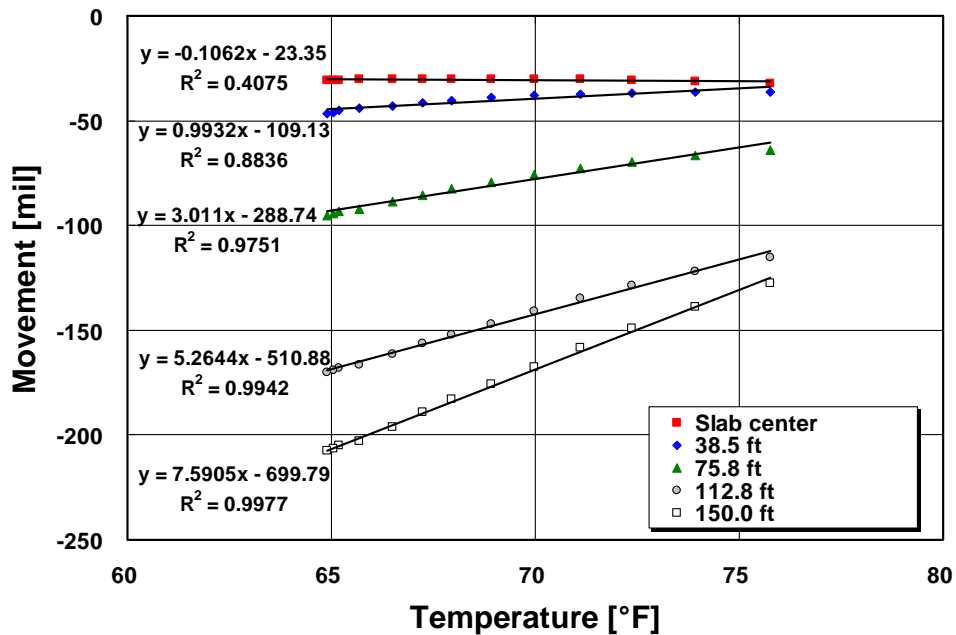
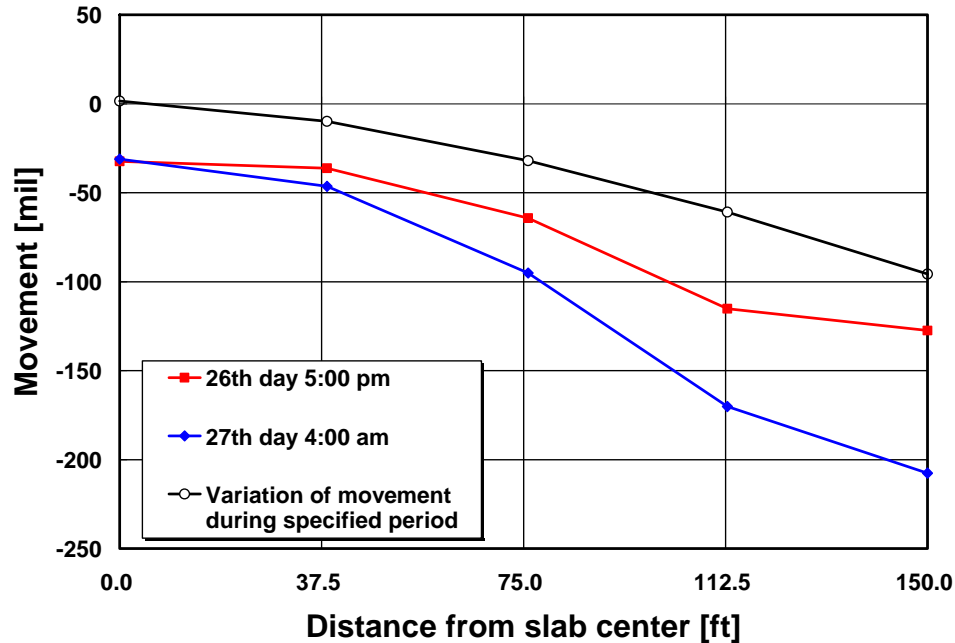
Figure 3.7-(a) illustrates the relationship between longitudinal slab movement at different locations along the slab edge and temperature changes for the specified period (26th day 5:00 p.m. to 27th day 4:00 a.m.). As expected, the slope was highest at the armor joint and smallest at slab center. The degree of restraint for slab movement can be also evaluated based on the equation (3.1). Because the slope of unrestrained strain in Figure 3.6-(c) is equal to the coefficient of thermal expansion (8, 9), free thermal movement of PCP without restraint can be numerically estimated and the degree of restraint for slab movement can be also calculated with equation (3.1). From the slope of the armor joint movement in Figure 3.7-(a), the calculated degree of restraint at the slab's armor joint was 19%, which means that 19% of free slab movement was restrained at the armor joint. Figure 3.7-(b) shows the distribution of slab movement in the longitudinal direction for the specified period. The variation of movement during the specified period displayed nonlinear distribution along the distance from slab center. This result is consistent with the slopes of measured strains as shown in Figure 3.6-(c) because the concrete strain, which is a spatial derivative of movement, increased nonlinearly as the measured element approached the armor joint.

Figure 3.7 (a) Distribution of longitudinal slab movement under environmental loading for the specified

Figure 3.7 (b) Distribution of longitudinal slab movement under environmental loading for the specified period

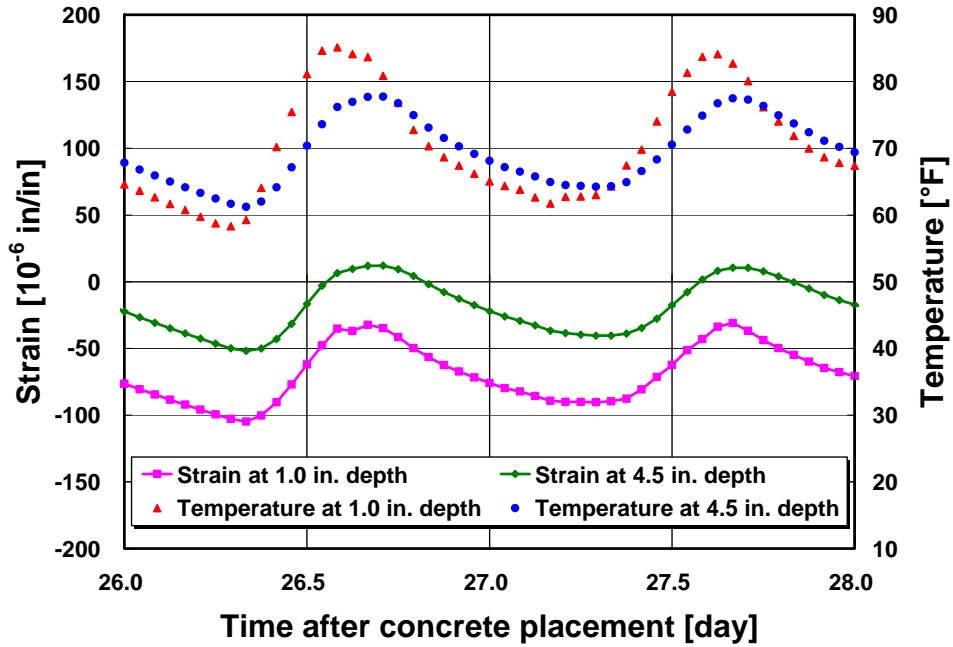
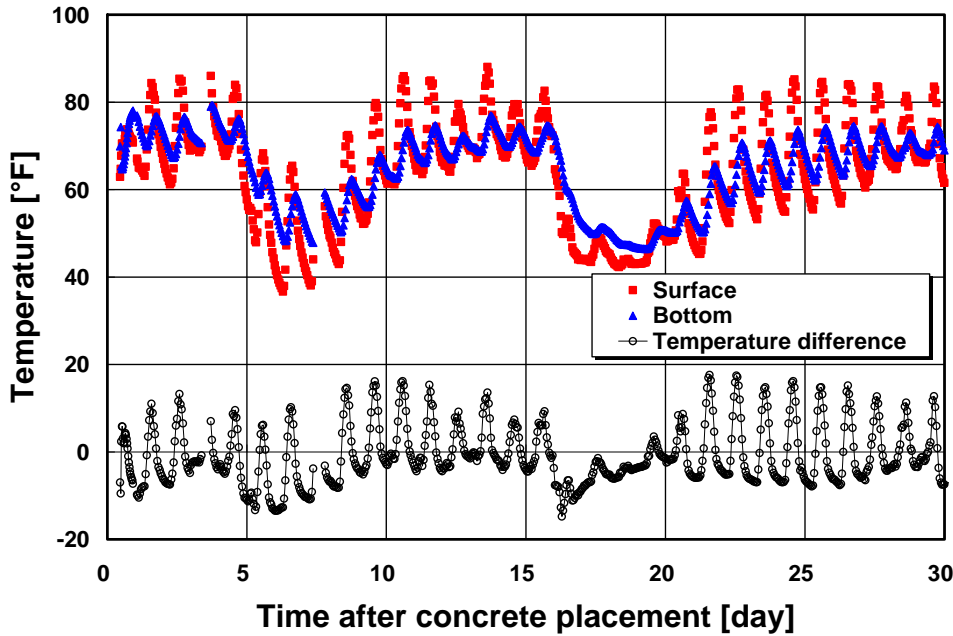
Figure 3.8-(a) shows concrete temperature and strains at different depths measured by VWSG-C in Figure 3.1. The variation of concrete strain at 1.0-in depth was comparable to that at 4.5-in. depth even though the variation of temperature was higher at 1.0-in. depth than at 4.5-in. This implies that the curling stress exists in the measured concrete element. The measured element was located near the slab center (see Figure 3.1) and thus the bending component of slab movement was restrained by the slab's self-weight. Therefore, the variation of strain at 1.0-in. depth in Figure 3.8-(a) mainly included the concrete slab's axial movement. Figure 3.8-(b) illustrates temperatures at the surface and bottom of the slab and corresponding temperature difference. The maximum difference—18 °F—occurred at the 21st day. If the temperature gradient can be assumed to be linear, the curling stress—±320 psi—can occur in a PCP slab. In the curling stress calculation, the slope of unrestrained strain in Figure 3.6-(c) was used as the coefficient of thermal expansion and 28-day elastic modulus was assumed. As shown in Figure 3.6-(a), however, the PCP had a nonlinear temperature gradient and thus the curling stress will be affected by not only temperature difference between the top and bottom of slab, but also the degree of nonlinearity of temperature gradient (3).

Figure 3.8 Curling strain and stress in PCP slab

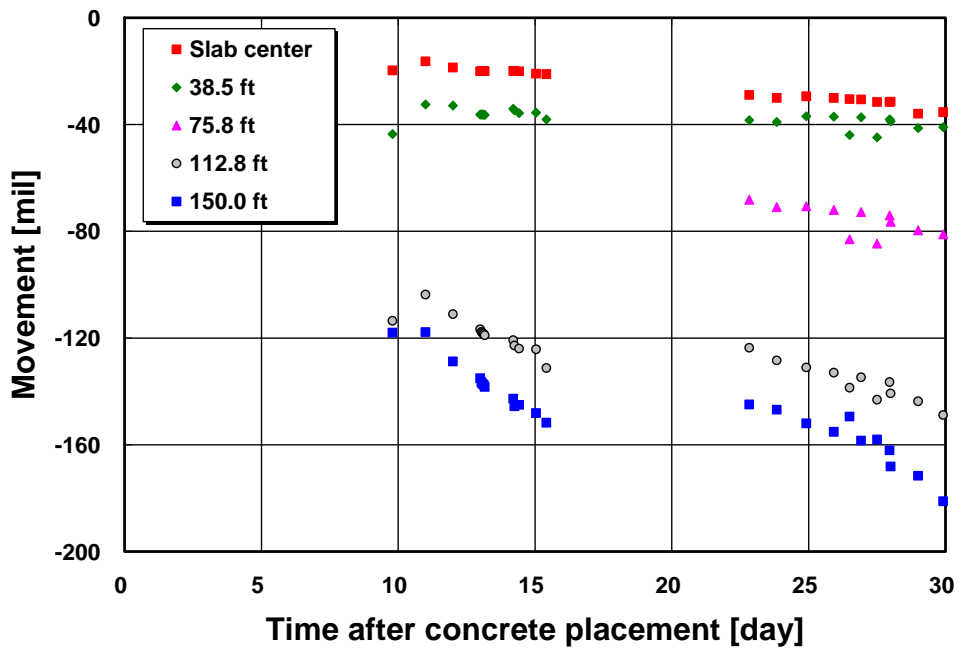
Figure 3.9 Variations of slab movement at different locations due to creep and shrinkage

- d. The effect of concrete creep and shrinkage was observed. Continued contraction of the concrete slab due to creep and shrinkage will result in the opening of joint width. Creep and shrinkage effects should be included in the design of initial joint width.
