TEXAS TECH UNIVERSITY

Construction and Evaluation of Post-Tensioned Pre-Stressed Concrete Pavement

Report No. 5-4035-01-2
www.techmrt.ttu.edu/reports.php

September 2010

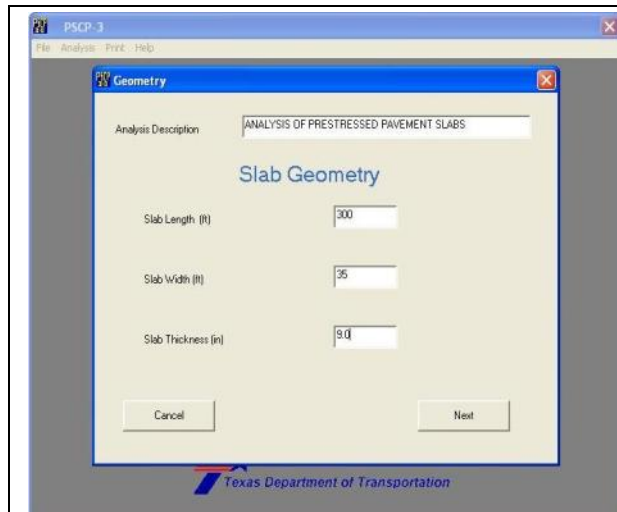
Figure 4.1 Input screen for slab geometry

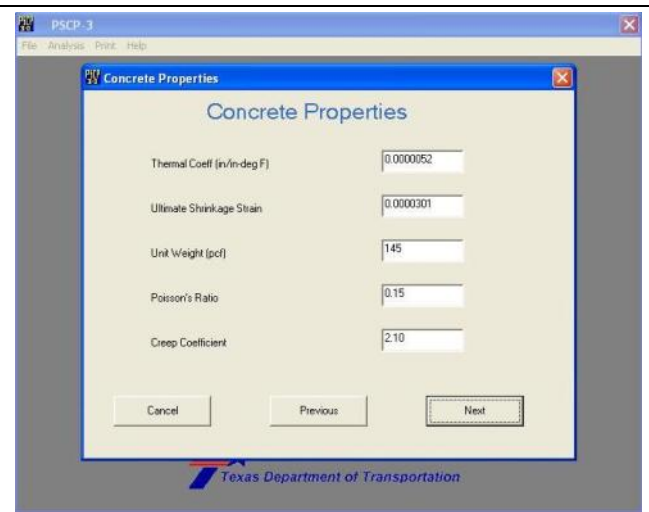
The next input screen, shown in Figure 4.2, asks for various properties of the concrete mix that will be used for the construction of PCP. The default values are provided by the program in case the user does not have information. In this screen, five concrete properties are required; coefficient of thermal expansion (CTE), ultimate drying shrinkage strain, unit weight of concrete, Poisson's ratio, and creep coefficient. Unit weight of concrete and Poisson's ratio do not have substantial effects on PCP behavior, so the value between 140 and 150 pounds per cubic ft for unit weight and 0.15 for Poisson's ratio will be adequate. However, the other three variables, especially CTE, have significant effects on PCP behavior and performance. TxDOT has the capability to evaluate CTE of concrete fairly accurately, and the user is encouraged to have the CTE of the concrete evaluated by CSTMP in Austin. Ultimate drying shrinkage strain is somewhat difficult to evaluate. Also, it is dependent on not only concrete material properties, but curing condition as well, which cannot be predicted with a reasonable accuracy during the design phase of PCP. The research team of this implementation project evaluated drying shrinkage of concrete in several CRCP projects and this PCP project, and found that the use of default value provided in the program (0.0003 in/in) is conservative. Accordingly, with good estimates of the ultimate drying shrinkage, it may be acceptable to use the default value provided in the program. The last input of concrete property on this screen is the concrete creep coefficient. The creep coefficient is defined as the final asymptotic amount of additional creep strain that occurs over time divided by the initial elastic strain that occurs when load is first applied. Creep of the concrete is quite difficult to evaluate. Fortunately, its effects are not as significant as CTE or ultimate drying shrinkage, and it is recommended that the default value provided in the program (2.10 in/in) be used.

Figure 4.2 Input screen for concrete properties

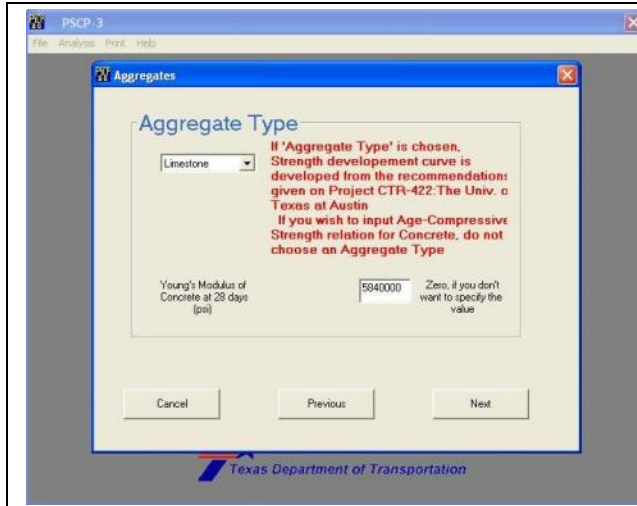
In that case, the input for coarse aggregate type can be skipped and the 28-day concrete modulus of elasticity can be entered in the screen. If the modulus value is not known during the design phase of PCP, it could be estimated from the ACI equation (2.1) using 28-day compressive strength of concrete.

Figure 4.3 Input screen for coarse aggregate type

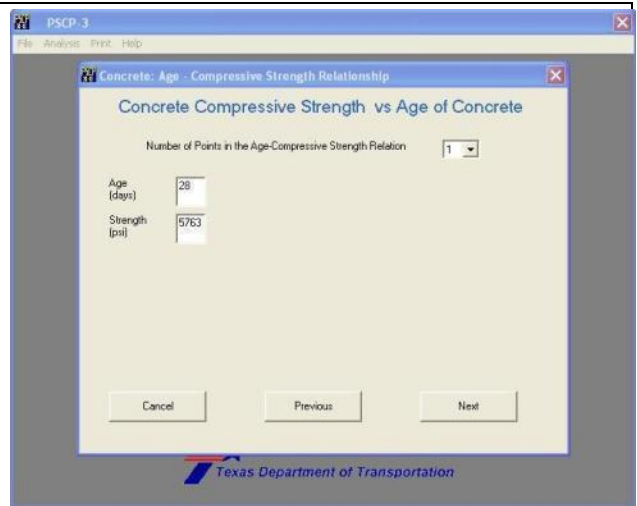
Figure 4.4 Input screen for age-strength of concrete

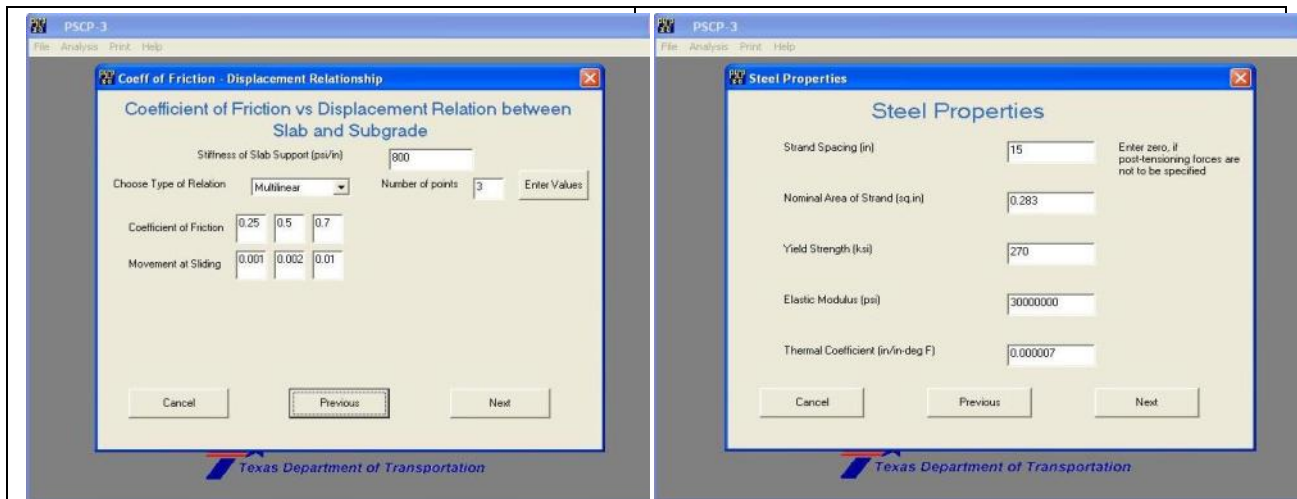
For the calibration of the program, multi-linear model was chosen as shown in Figure 4.5. The values in this screen were selected from a study by Wesevich et al.

Figure 4.5 Input screen for subbase friction vs displacement

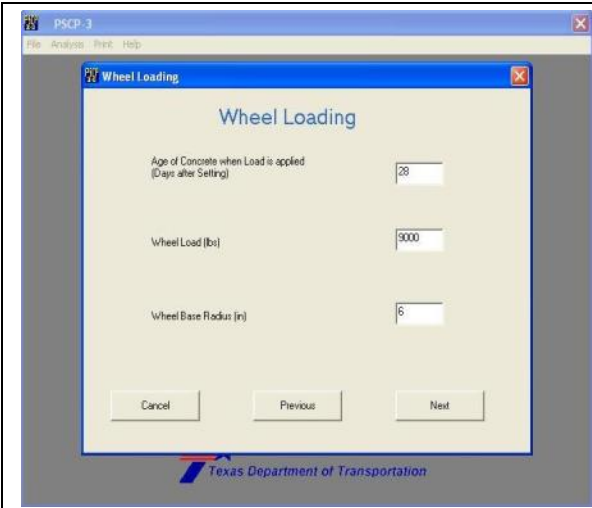
Wheel load stress is computed using Westergaard’s interior loading condition.

Figure 4.7 Input screen for wheel loading

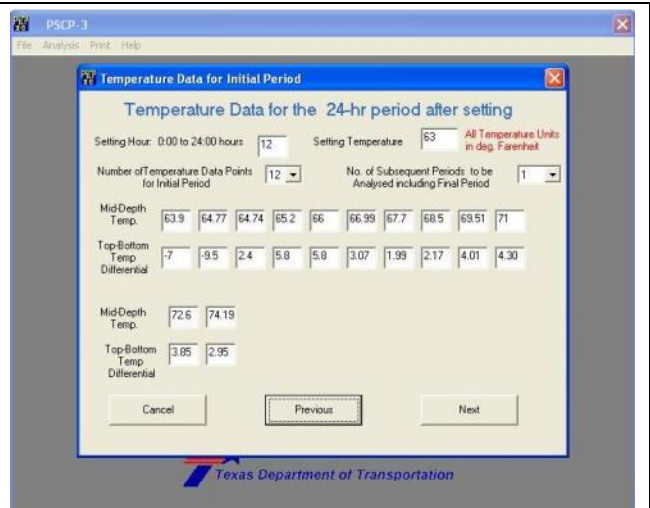
Temperature history at early ages of PCP, called initial period in the program, is quite important in evaluating subsequent behavior of PCP slabs in terms of concrete stresses and displacements. The required inputs for concrete temperatures in the initial period are (1) time of setting, (2) setting temperature, (3) number of temperature data points for initial period, (4) number of subsequent periods for the analysis, (5) mid-depth temperature and top-down temperature differentials for the number of data points specified in (4). The input screen is shown in Figure 4.8. As stated earlier, the input data shown in this screen was actual data obtained in the slab that was heavily instrumented for the evaluation of PCP behavior for the calibration of this program.

Figure 4.8 Input screen for initial period concrete temperature

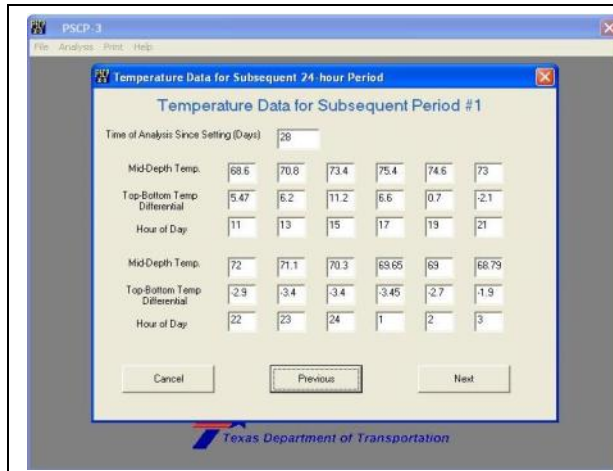
slab's mid-depth temperature, top to bottom temperature differentials, and hour of day for 12 time periods, as shown in Figure 4.9.

Figure 4.9 Input screen for concrete temperature for subsequent period

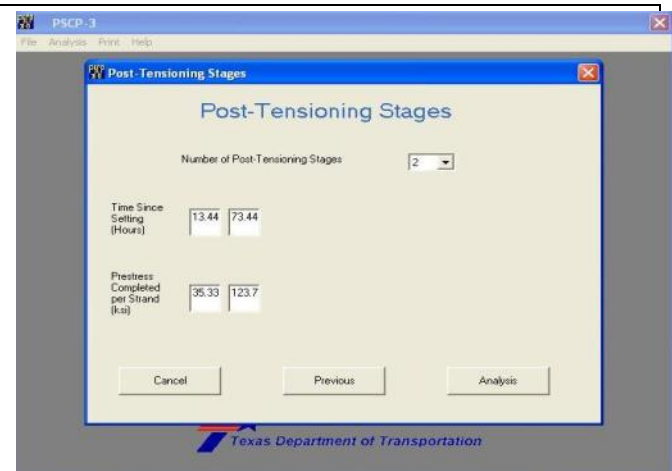
Figure 4.10 Input screen for information on post-tensioning

The final input group is related to post-tensioning. Figure 4.10 shows the input screen. The number of post-tensioning stages needs to be specified. Normally, two stages are needed – first for initial post-tensioning to prevent early-age transverse cracking, and the final one to apply design tensioning force. For each stage, time of post-tensioning application after the concrete setting and applied force per strand are to be provided.

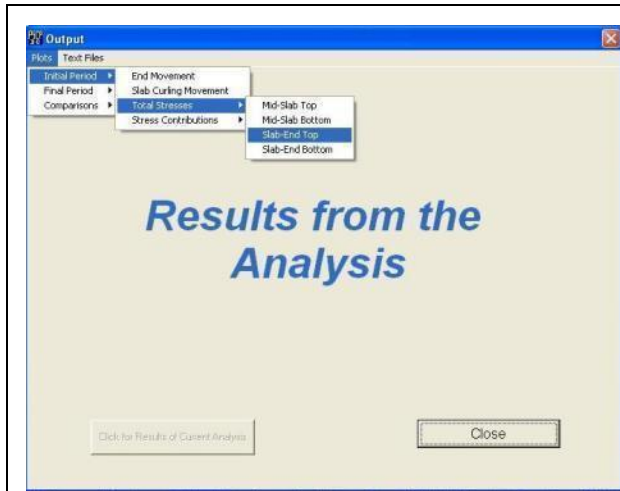
This section briefly presents the outputs from the program for the input values shown in the Figures 4.1 through 4.10 above. In PCP 3.0, output information can be presented in two formats – plots and texts. Figure 4.12 presents the slab displacements at the armor joint. It shows that, for the first 24 hours, there was very little slab movement. It might be due to the small temperature variations within the time frame. Initial curling movement at the armor joint is shown in Figure 4.13. It shows that, at the beginning, there was upward curling, and with time, it became downward curling. Figure 4.14 illustrates the concrete stress at the top of the mid-slab for the first 24 hours. It shows that, initially there was tensile stress, and after initial post-tensioning, the concrete was in compression state.

Figure 4.11 Output screen from PCP 3.0

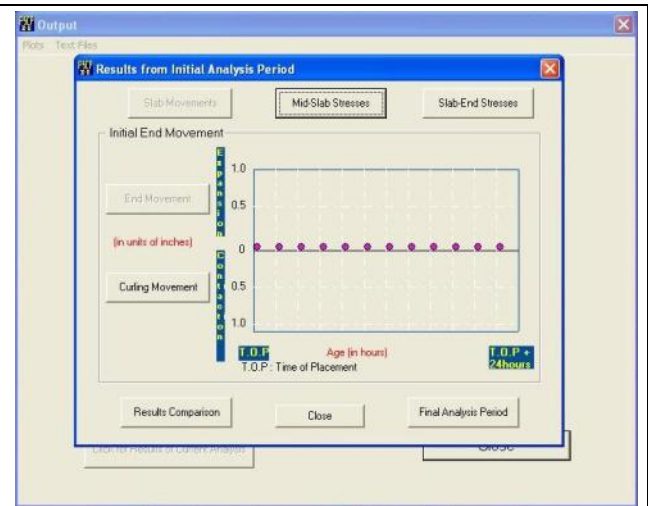
Figure 4.12 Initial slab end movement

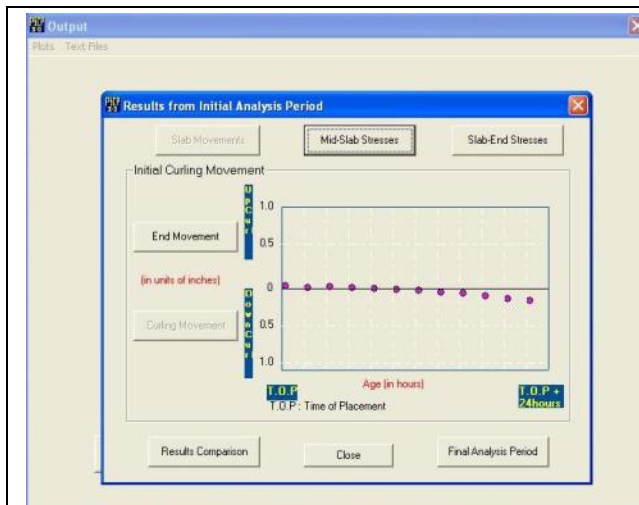
Figure 4.13 Initial curling movements

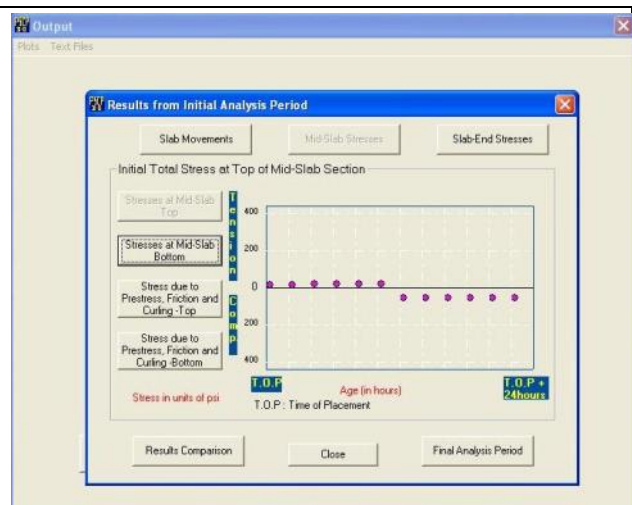
Figure 4.14 Initial stress at mid-slab top

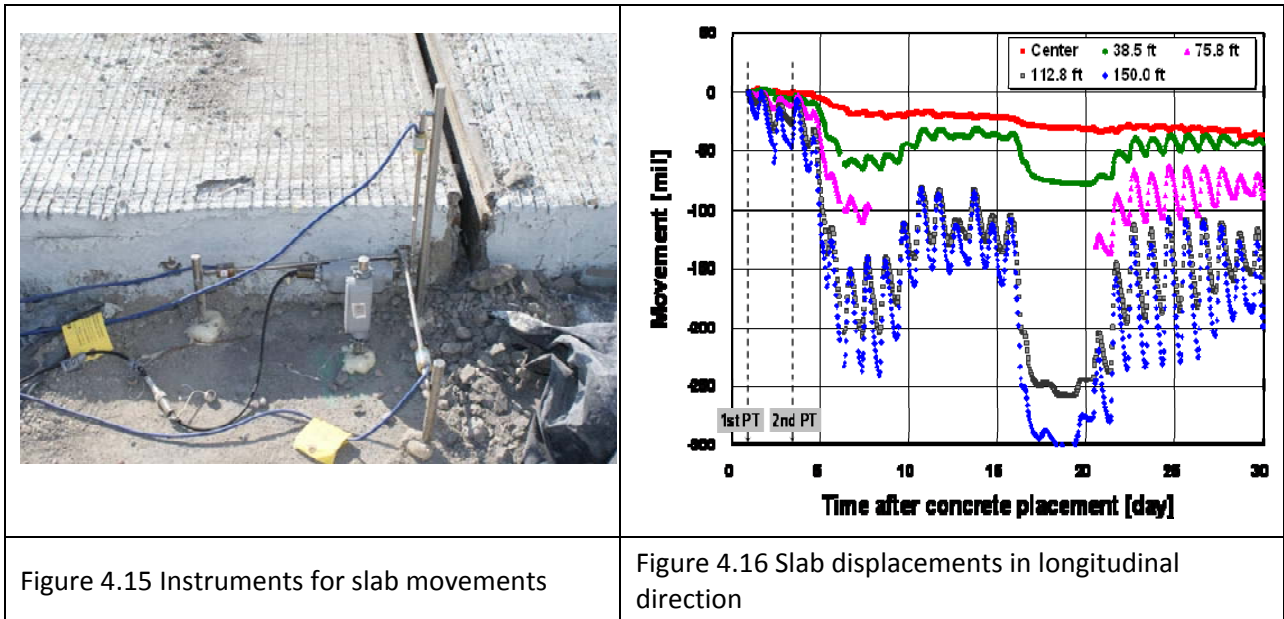
For the first effort to calibrate PCP 3.0, slab displacements were compared. The actual slab displacements were measured in three different directions (x-, y-, and z-direction) at five locations along the slab edge, as described in the previous chapter. Figure 4.15 shows the instrument installed to measure slab displacements. Figure 4.16 illustrates the slab displacements in the longitudinal direction at 5 different locations along the slab edge. The distance shown in Figure 4.16 is from the center of the slab, which is 150-ft from a transverse armor joint. It shows that the displacements are the minimum at the center of the slab, and the maximum at the arm or joint. It also illustrates that the displacements are approximately proportional to the distance from the center of the slab.

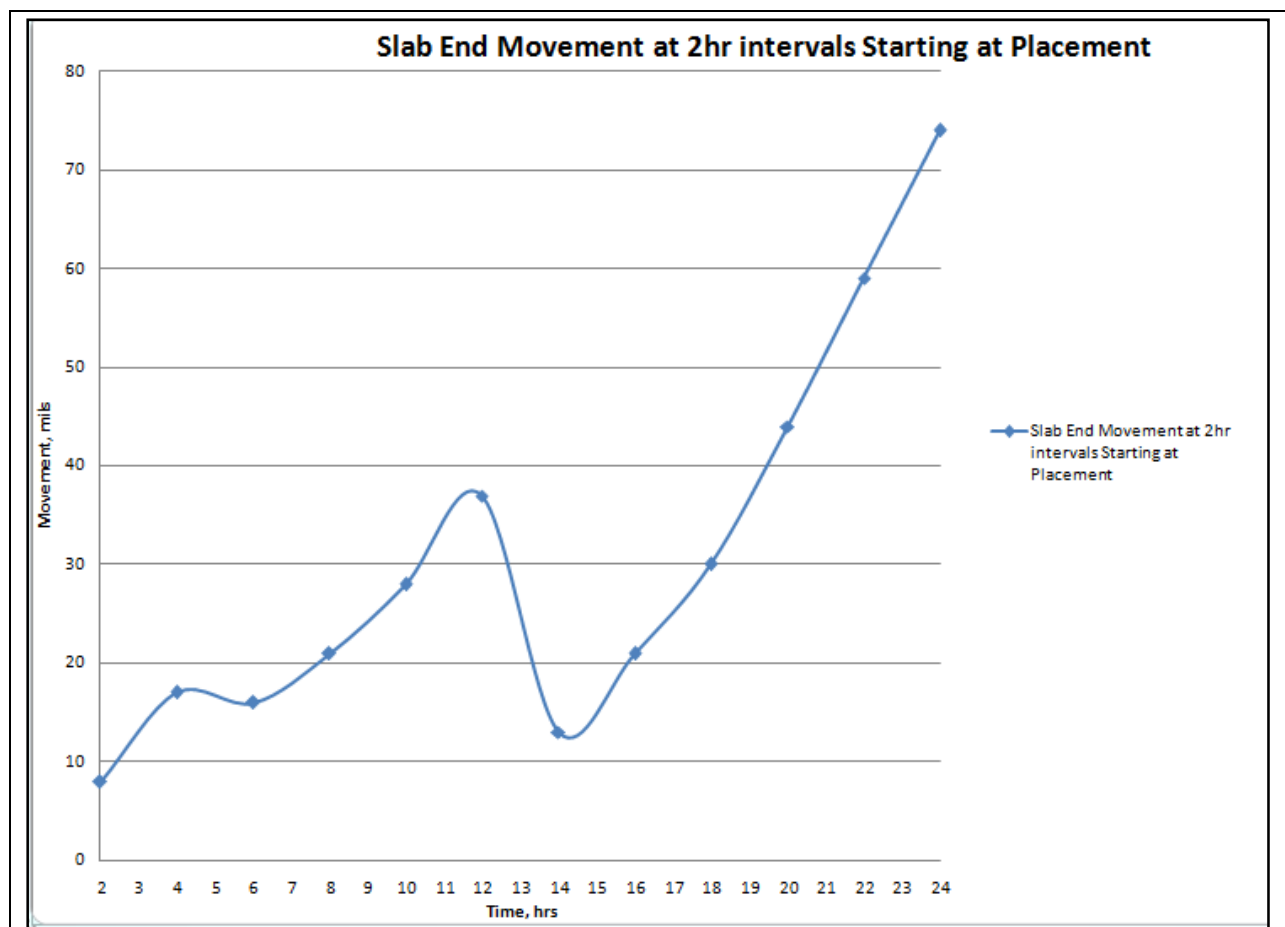
The predicted slab movements in the longitudinal direction from the PCP 3.0 for the first 24 hours are presented in Figure 4.17. It is observed that the slab displacements at 2 hours after concrete setting are much larger than the measured ones. Also, it indicates that the slab actually expanding over 24-hr period except when the initial post-tensioning was applied. This expansion of the slab is supposedly due to the increase in concrete temperature for the 24-hr period, which was less than 10 F from the setting temperature. What is noted is the rather large expansion due to the temperature increase of less than 10 F. Also, the contraction of the slab during the initial post-tensioning is about 25 mils from the program. Figure 4.18 illustrates the measured slab displacements at various locations during the initial post-tensioning. At the slab end, or at the armor joint, the contraction was less than 4 mils. There are more than 6 times difference in slab displacements between PCP 3.0 predictions and actual

Figure 4.17 Longitudinal slab movements predicted from PCP 3.0

Efforts were made to calibrate the theoretical model PCP 3.0 using actual slab behavior measured in the field. As a first step, the predicted slab movements from PCP 3.0 were compared with actual measurements. A large discrepancy was observed. When there is such a large difference in slab displacements between predicted and actual values, efforts should be made to identify the cause(s). However, those efforts were out of the scope of this implementation project. Further calibration efforts were not made. It appears that there was a conflict between the need for constructability and what's desirable from a theoretical standpoint. The practice of installing and leaving bars driven into the subbase to support the transverse post-tensioning steel is a good example. Similar practice is currently exercised in the construction of CRCP, and no efforts were made to evaluate the consequences of that practice on CRCP performance. Further research effort could provide answers to the technical validity of the practice.

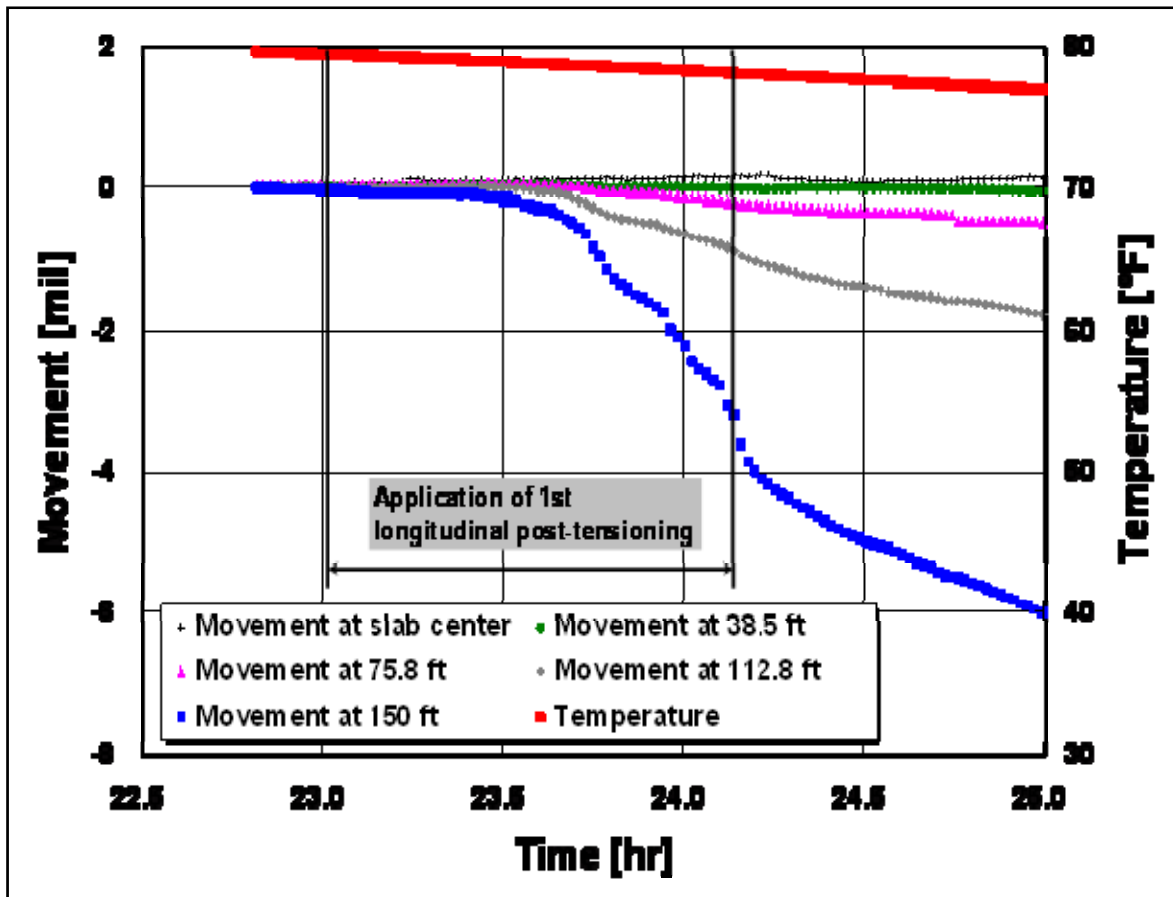
Figure 4.18 Measured slab displacements during post-tensioning

measurements. When there is a substantial difference between values predicted from a theoretical model and actually measured, other efforts should be preceded to investigate the reason for the large difference before any effort to calibrate the model is made. The evaluation of the model for its reasonableness and validity was out of the scope of this implementation project, and no substantial efforts were made in this regard. However, the practice of leaving the bars hammered into the subbase to support transverse post-tensioning bars, as discussed in Chapter 2, could have resulted in this large difference. Also, the use of single polyethylene sheet might have not provided as frictionless a system as considered. The real reason for this discrepancy has not been identified in this study. Further evaluations are recommended to resolve this issue.
