Maintenance Solutions for Bleeding and Flushed Pavements Surfaced with a Seal Coat or Surface Treatment

William D. Lawson, Michael Leaverton, Sanjaya Senadheera

Technical Report 0-5230-1
www.techmrt.ttu.edu/reports.php

February 2007

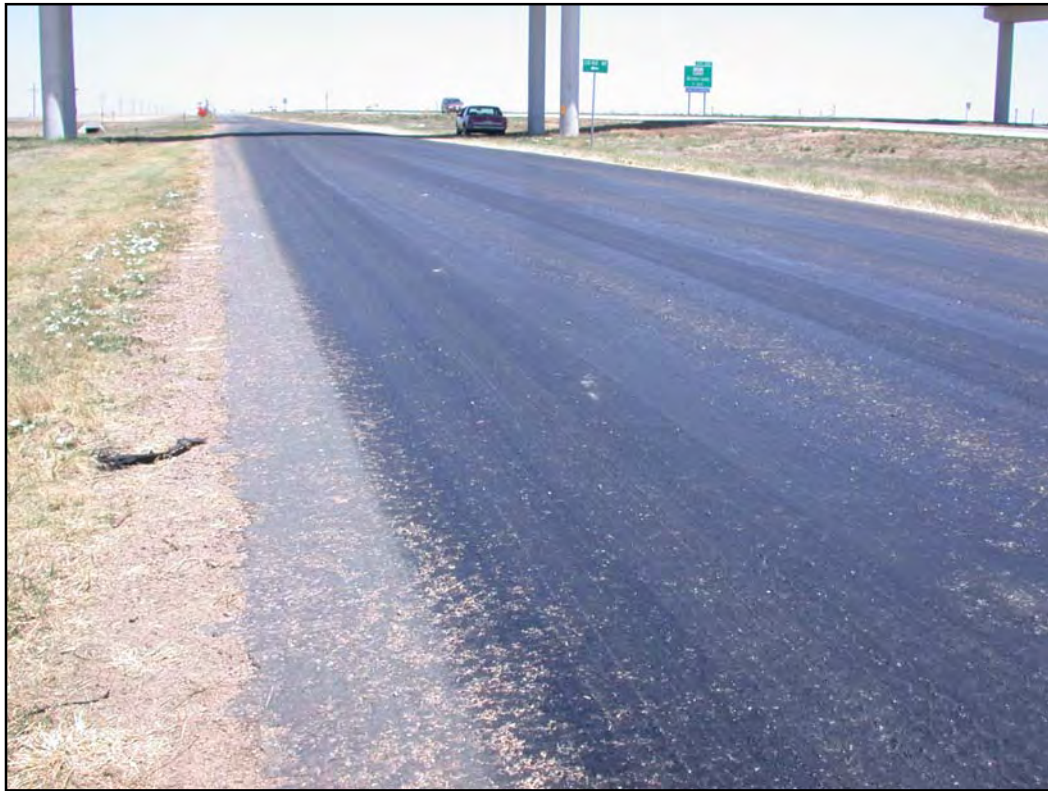
As used in this document, bleeding is the upward movement of asphalt in a seal coat or surface treatment resulting in the formation of a film of asphalt on the roadway surface (Figure 3.2). Bleeding occurs when excess asphalt binder fills the voids in the aggregate mat and then moves upward to the pavement surface under traffic and with heat expansion in a non-reversible, cumulative process.

Figure 3.2 Bleeding Asphalt Caused by Excessive, Heavy Truck Traffic and Hot Weather

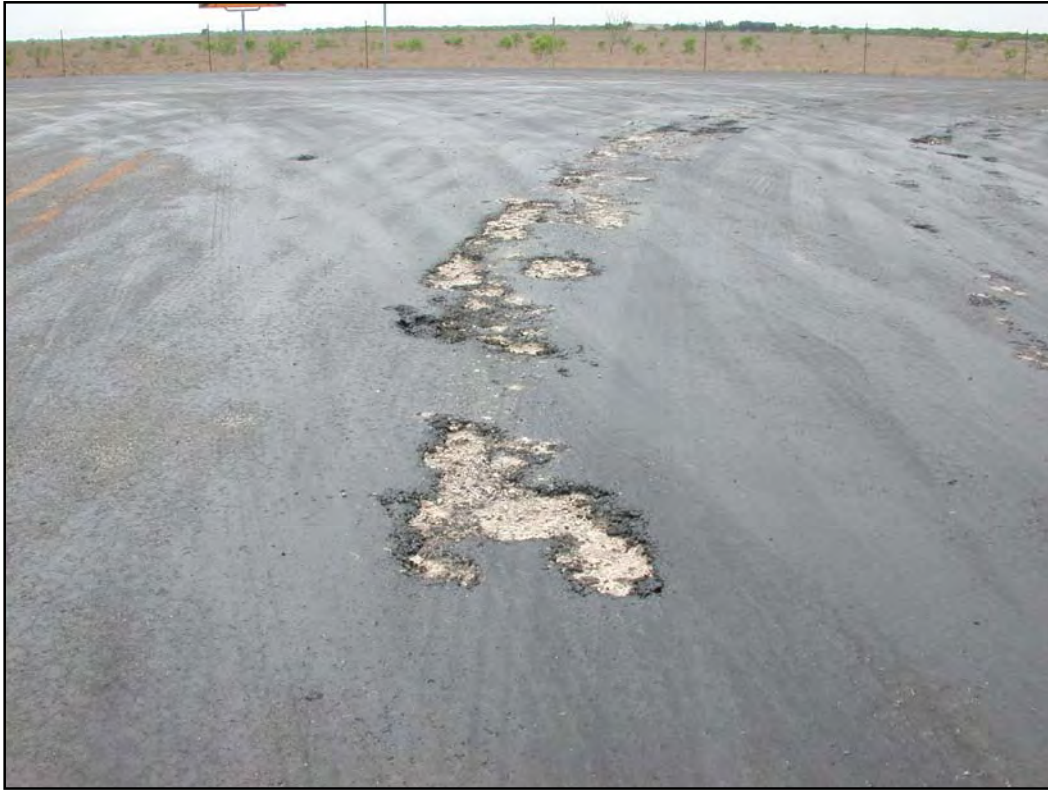
Bleeding asphalt sticks to aggregate and tires and causes tracking. Left unattended, bleeding can result in the seal coat or surface treatment aggregate rolling over and being picked up. This can lead to “pitting out” or pulling up chunks of pavement — “slinging” as opposed to “singing.” With reference to Figure 3.3, both the asphalt *and* the aggregate are picked up, effectively ruining the seal.

Figure 3.3 Pavement Damage – Picking Up of Seal Coat – Caused by Bleeding

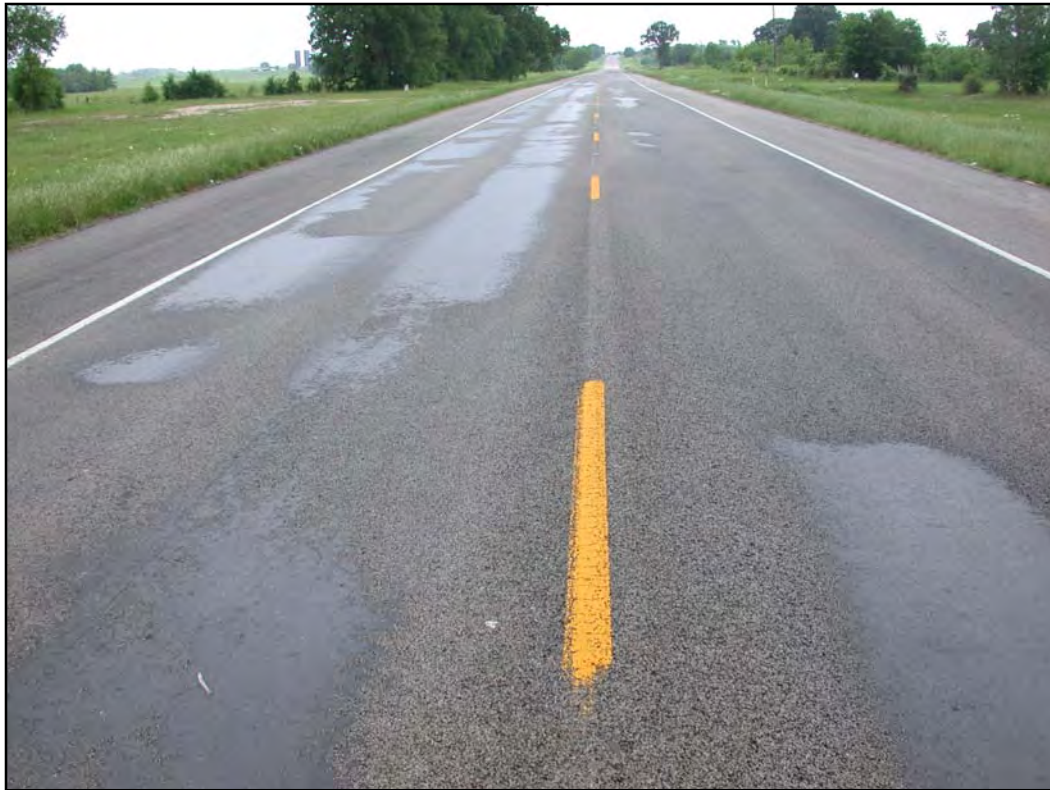
First and foremost, flushing is typically not an immediate maintenance problem and may not be a maintenance problem at all. In a flushed pavement, asphalt fills the voids in the aggregate mat and comes up flush with top of rock, but the binder is not liquid — it is solid or semi-solid. A flushed pavement is still holding its seal, so in a very real sense, the seal coat is still performing at least one critical aspect of its function (Figure 3.4).

Figure 3.4 Flushed Pavement

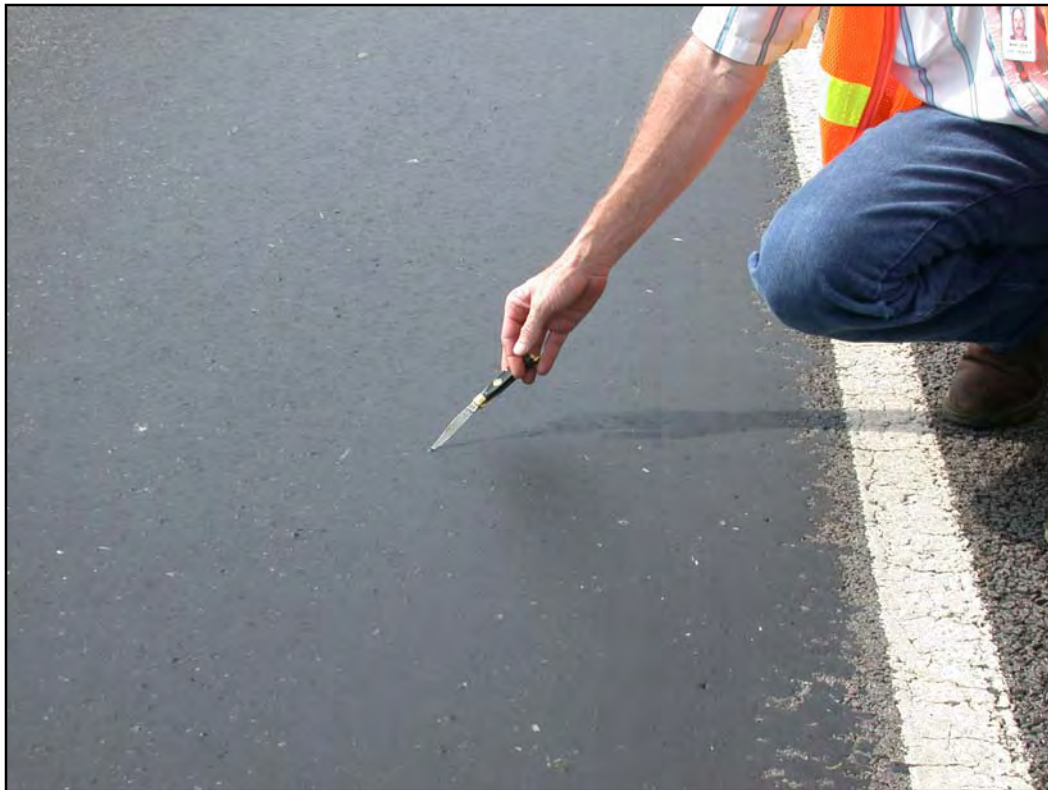
Depending on the degree of severity, flushed areas of the pavement surface may be discolored/darker (low severity), experience a loss of surface texture (moderate severity), or have a shiny, glossy appearance showing tire marks in warm weather (high severity – see Figure 3.5). Flushed pavements can track and bubble, eventually going to bleeding. The excess asphalt associated with flushing frequently appears in the wheel paths.

Figure 3.5 Heavily Flushed Pavement

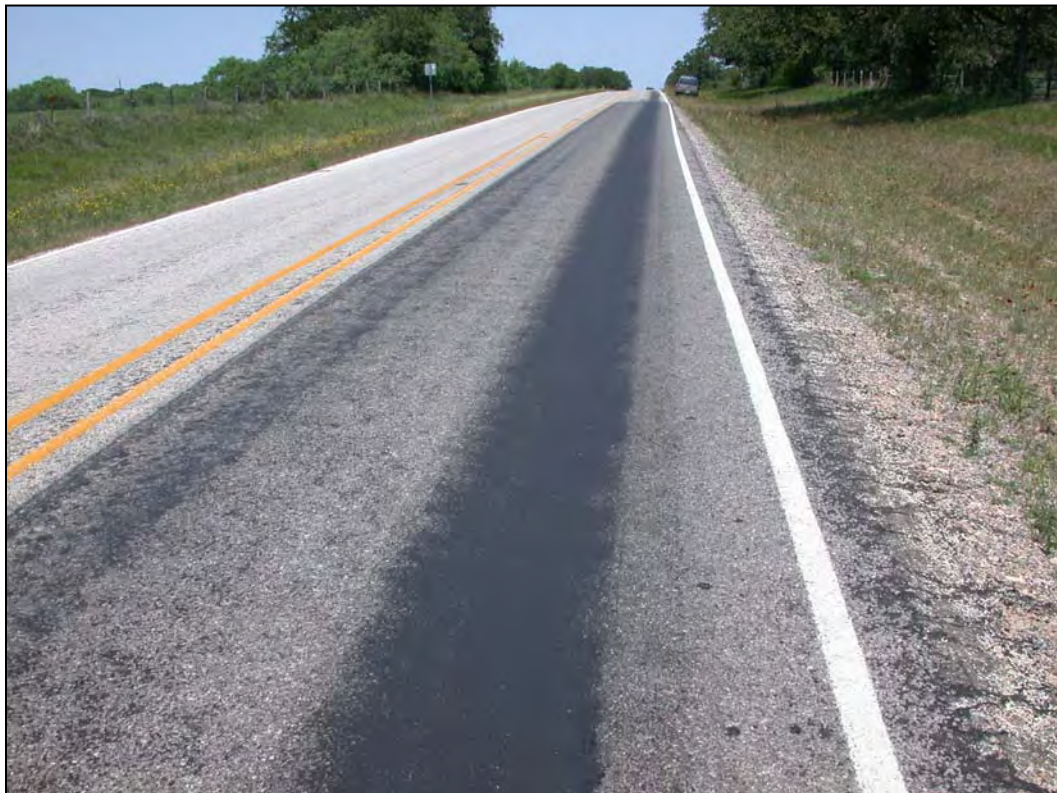
When a seal coat or surface treatment loses its rock, flushing and/or bleeding will be the result (Figure 4.1). Aggregate issues include rock loss, application of too much rock, use of dirty rock, use of soft rock, and judicious use of modified aggregate grades.

Figure 4.1 Flushing in Wheel Paths

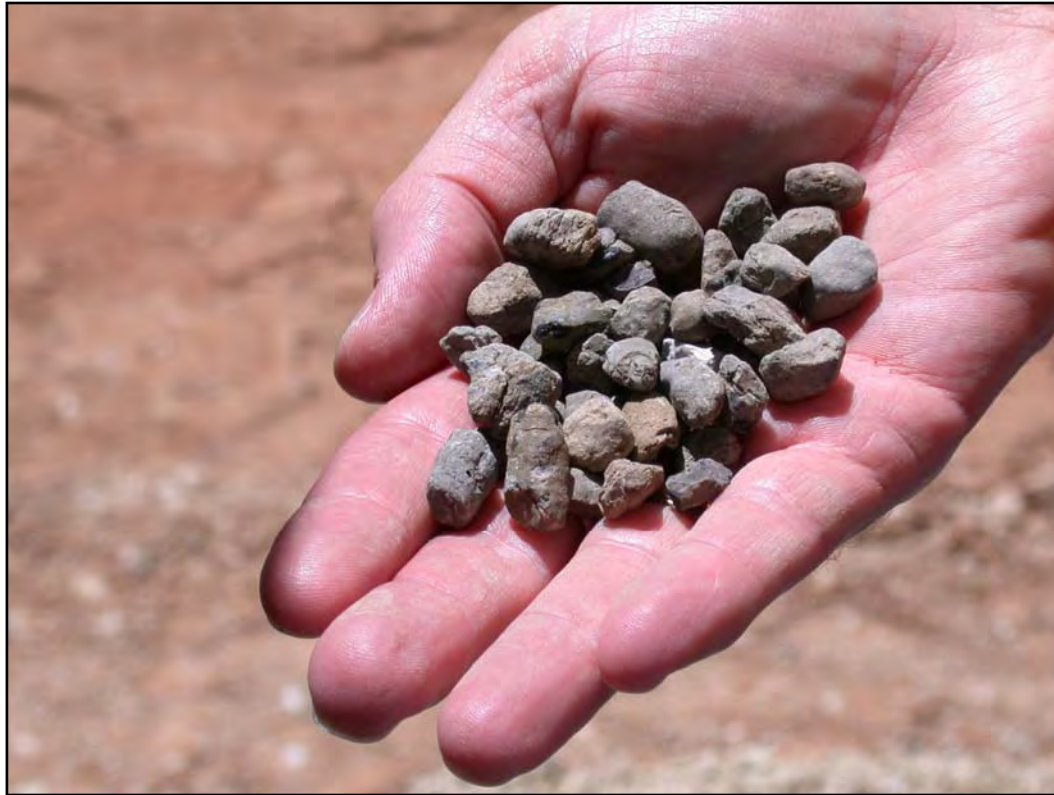
Figure 4.2 Dirty Seal Coat Aggregate

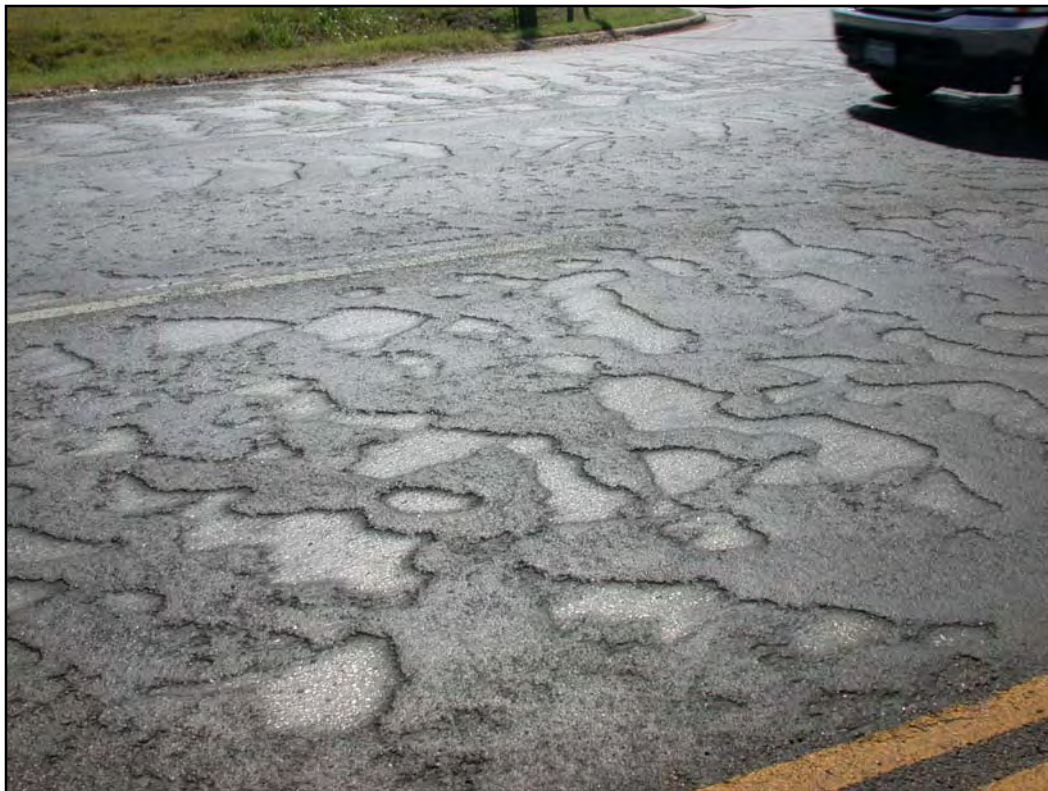
Turning causes the aggregate to mound up and shove. The reason is that, unlike cars and most other vehicles, the rear tandem axles of trucks do not have differentials that allow the rear wheels to turn at different rates as the vehicle makes a turn. This twisting action of tandem axle tires as they essentially slide across the pavement surface is one of the main causes of scrubbing at intersections and curves. The result is a “washboard” effect on the pavement surface (Figure 4.3).

Figure 4.3 Pavement Distress Caused by Starting/Stopping and Turning Maneuvers

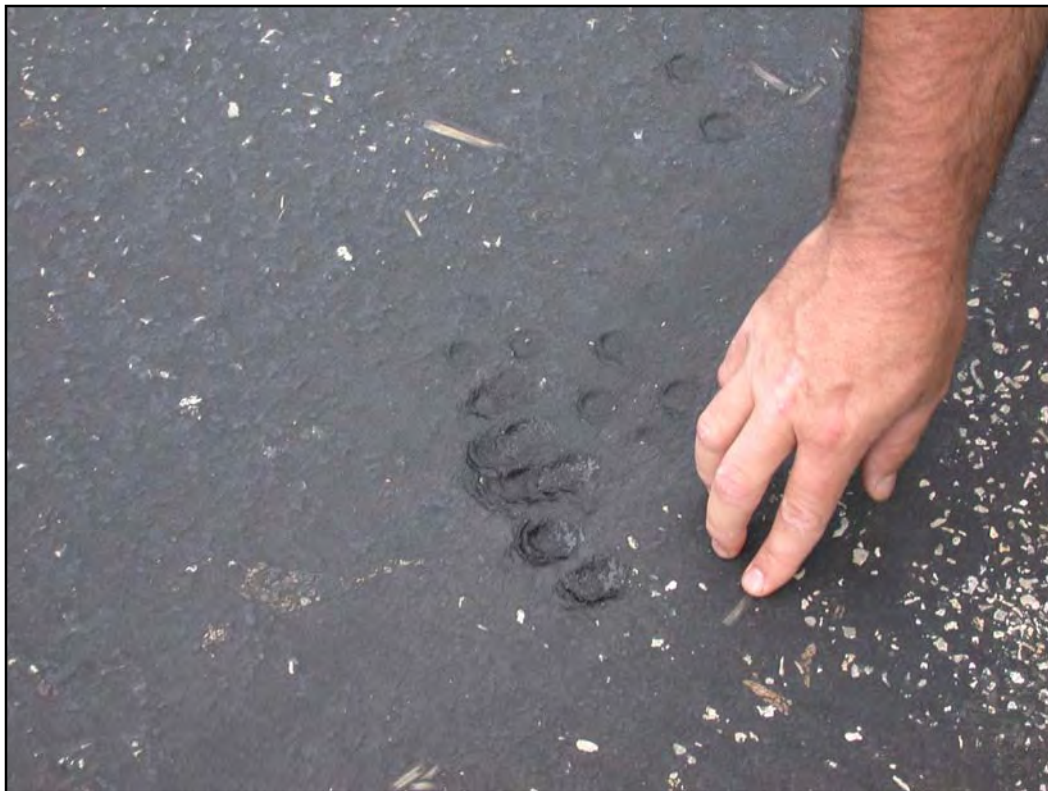
Figure 4.4 Soft Pavement (Flushing) Resulting From High Temperature/Humidity

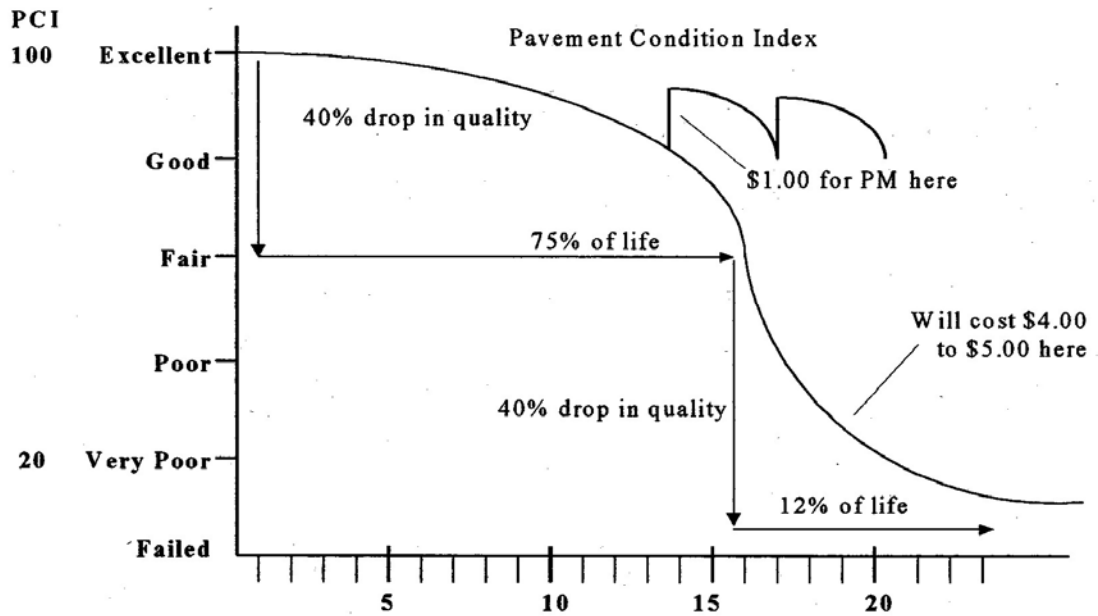
Figure 5.1 illustrates the typical pavement life cycle. It shows that speed of deterioration increases rapidly in the latter part of the performance curve. Moreover, the cost of a possible rehabilitation at the late stages in the performance cycle is three to four times more expensive than when applied early in the life of pavement. Therefore, preventive maintenance makes sense provided it is used at the appropriate time.

Figure 5.1 Typical Pavement Life Cycle (*Source: Hicks, et al. [35]*)

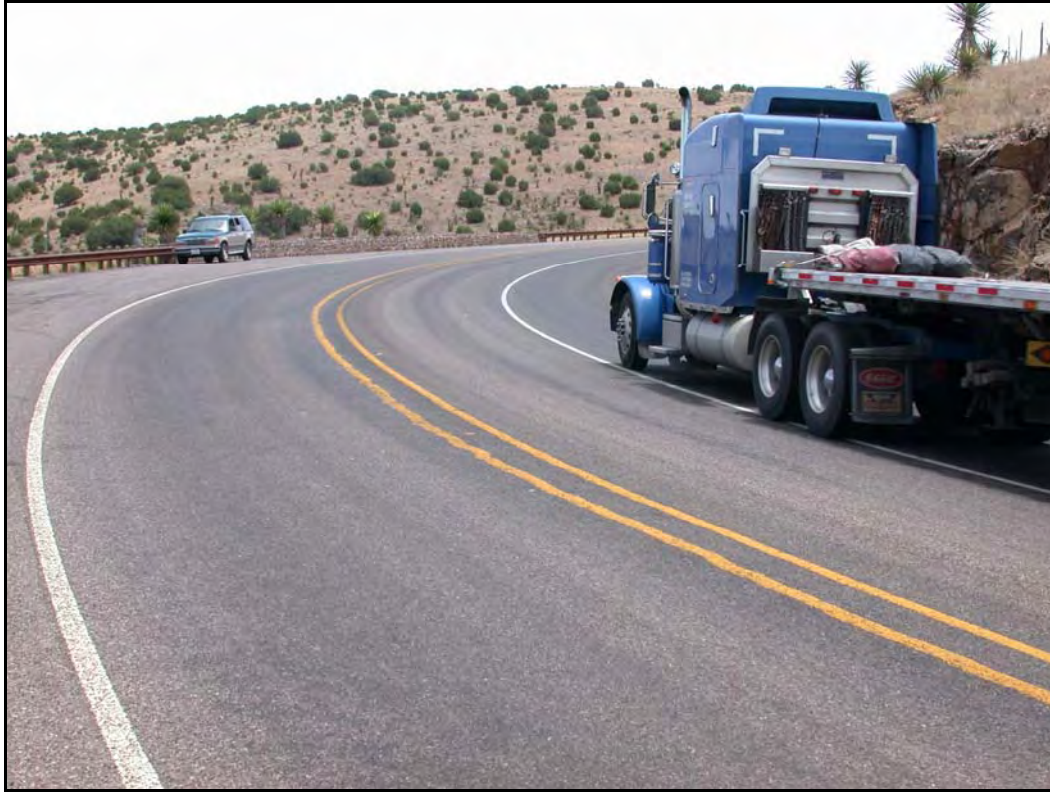
Another important part of the process is design (Figure 5.2). The Seal Coat Program Manager is typically responsible for seal coat design, which includes material selection (asphalt and rock), development of asphalt and rock base rates, use of variable rate nozzles, and preparation of plans.

Figure 5.2 Proper Design Based on Experience is Key to Quality Seal Coat Performance

Material selection is mostly based on experience and on what has worked well in the past. Design procedures such as the modified Kearby method can be used, and these methods are typically adjusted to account for local experience. Once the materials are selected and the base rates established, seal coat plans are developed, finalized and put out to bid.

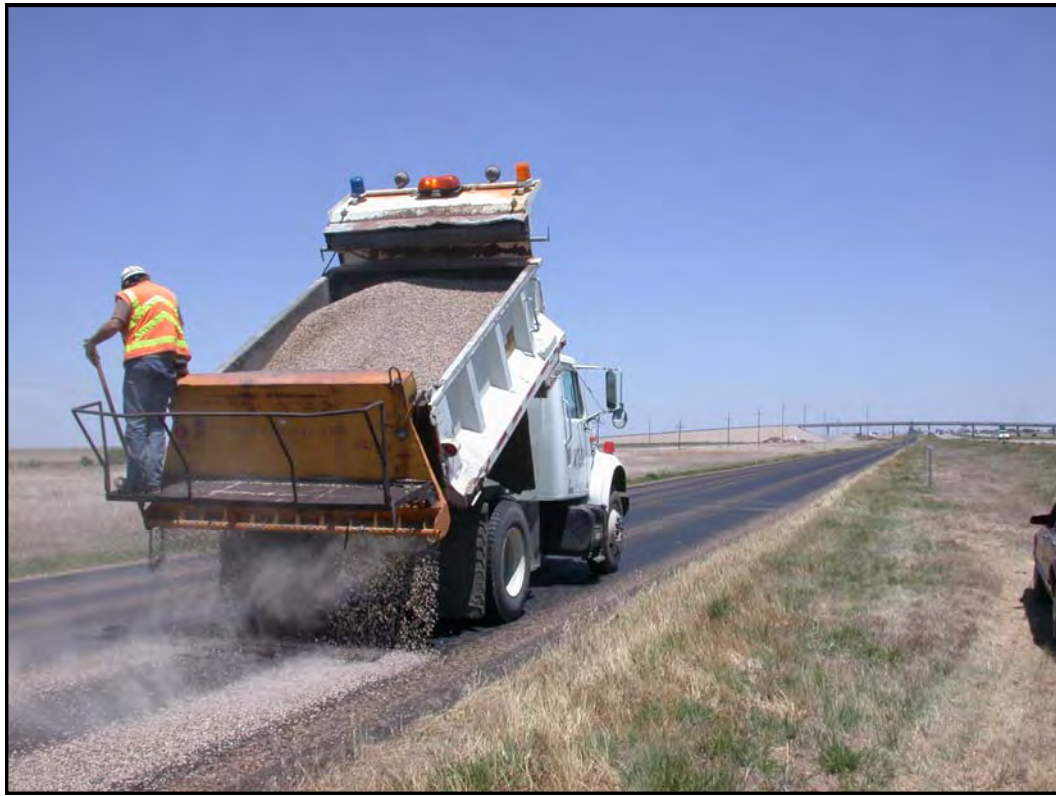
This method is typically used to treat light to moderate bleeding. The key with any aggregate remedy is to get the rock to stick to the pavement surface, and the primary objective is to get the tires out of the asphalt. Some maintenance forces use this treatment in conjunction with lime water.

Figure 6.1 Applying Small-Size Aggregate to Treat Bleeding Pavement

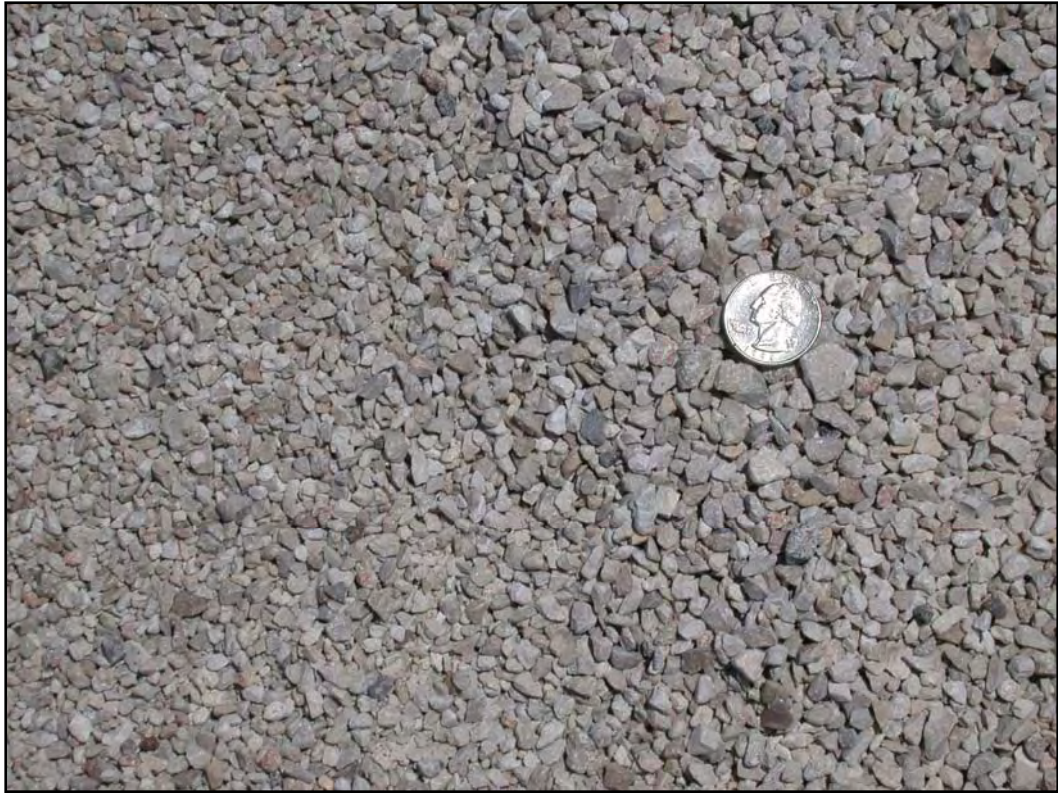
Figure 6.2 Small-Size (Item 302, Grade 5) Aggregate

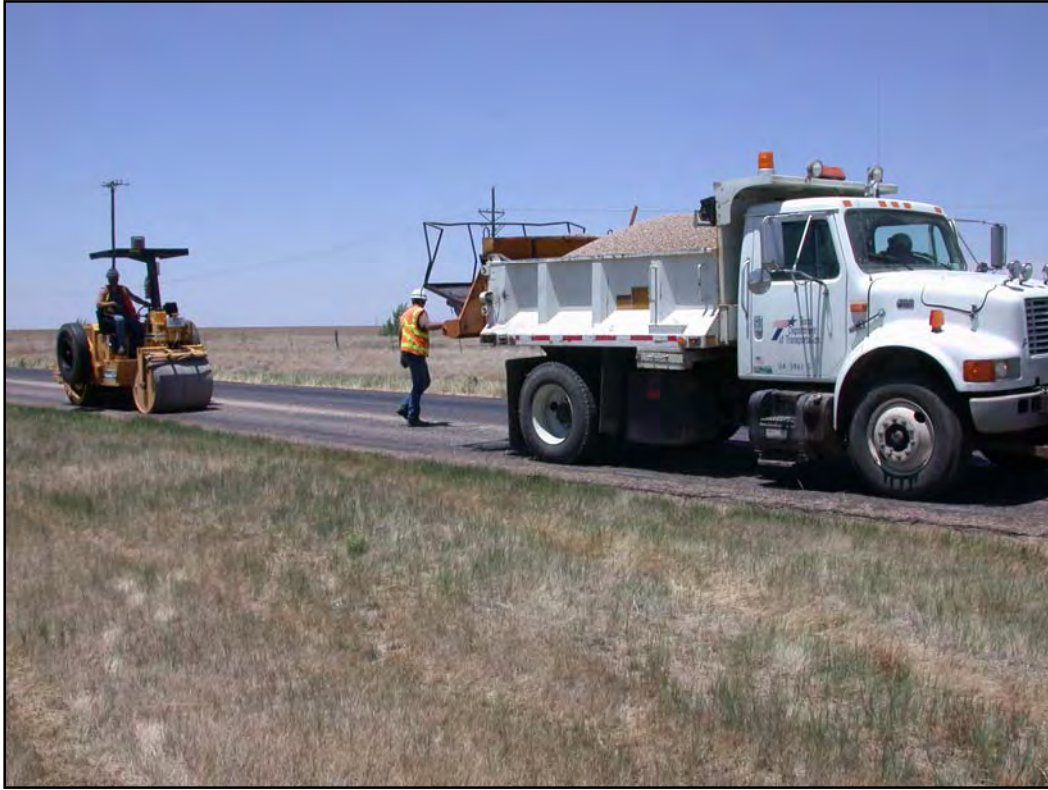
An aggregate spreading operation typically uses one dump truck with a tailgate spreader (one driver and one spreader operator), one steel wheeled roller with operator, and a crash attenuation vehicle with driver (see Figure 6.3). Sometimes an additional dump truck is used. Traffic should be slowed or stopped (controlled) during the treatment process.

Figure 6.3 Application of Grade 5 Aggregate to Treat Bleeding

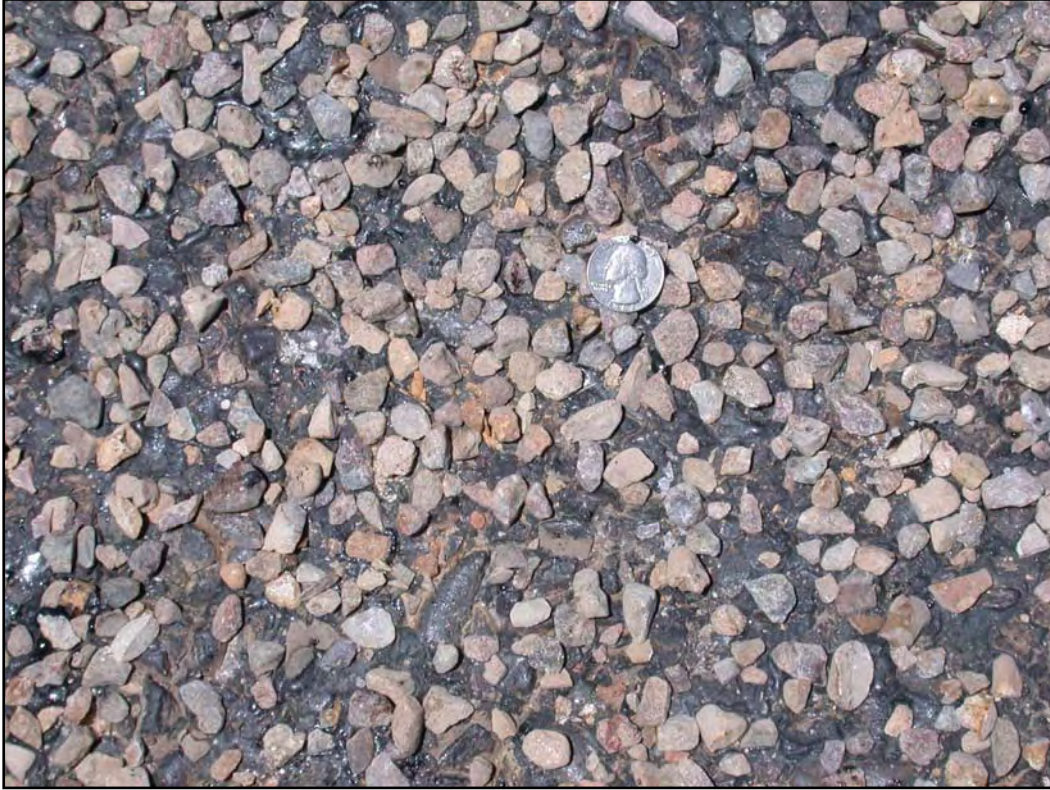
Larger aggregates (Grade 3 and Grade 4) are used when bleeding is severe. This solution is typically employed by construction contractors for treatment of bleeding that occurs *during* or *shortly after* seal coat construction. Here, the contractor applies the same rock that was used for the original seal coat, these original aggregate materials being still available (stockpiled) on site.

Figure 6.4 Grade 3 Aggregate to Treat Bleeding

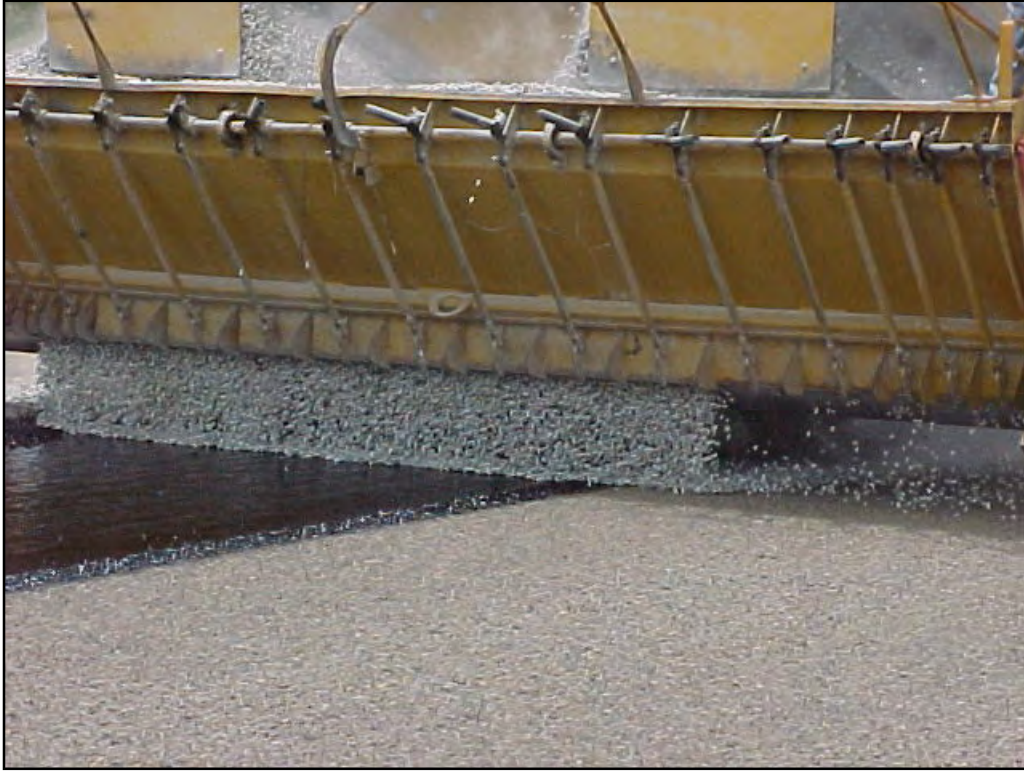
Figure 6.5 Application of Grade 3 Seal Coat Aggregate

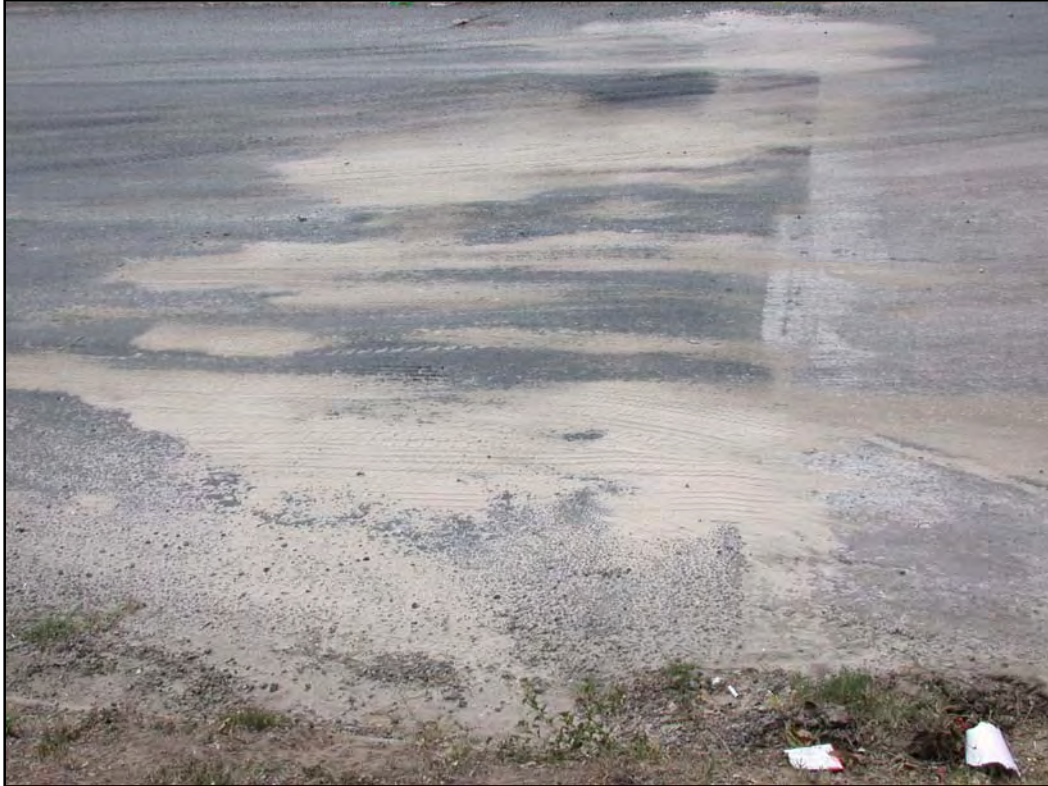
Figure 6.6 Application of Sand Blotter Material to Treat Bleeding Pavement at an Intersection

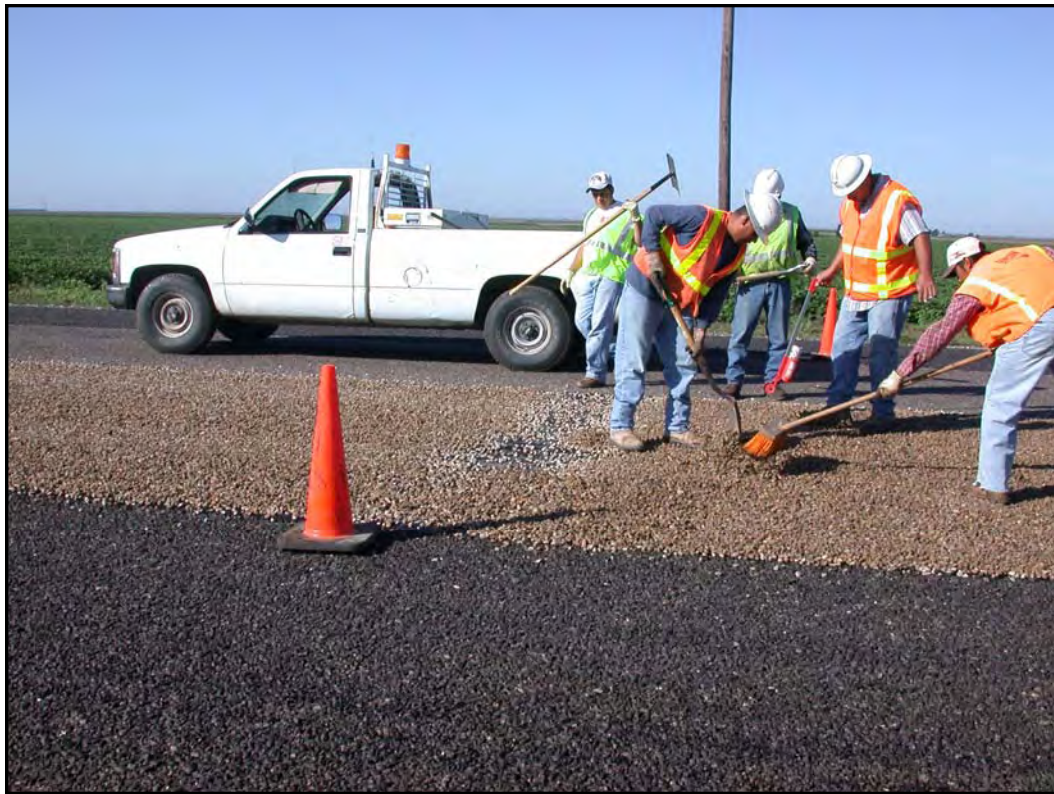
Timing of this treatment is essential. These materials should be spread in the heat of the day when bleeding is active and there is liquid asphalt on the pavement surface.

Figure 6.7 Hand Application of Aggregate to Treat Bleeding Pavement

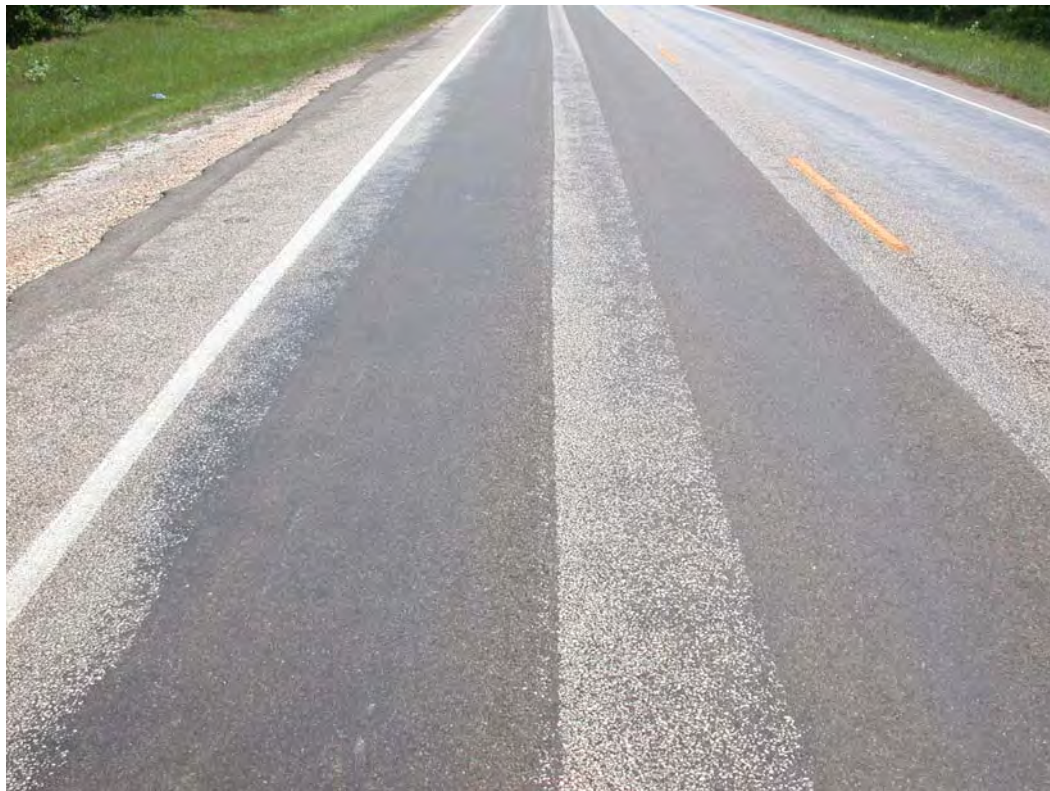
To construct a sandwich seal, first, a clean coarse aggregate (seal coat rock) is spread on top of the bleeding asphalt. A layer of asphalt binder is then sprayed on top of the untrafficked coarse aggregate, and then a second layer of finer seal coat rock is placed over

Figure 6.8 Sandwich Seal Used to Treat Bleeding Pavement in the Wheel Paths

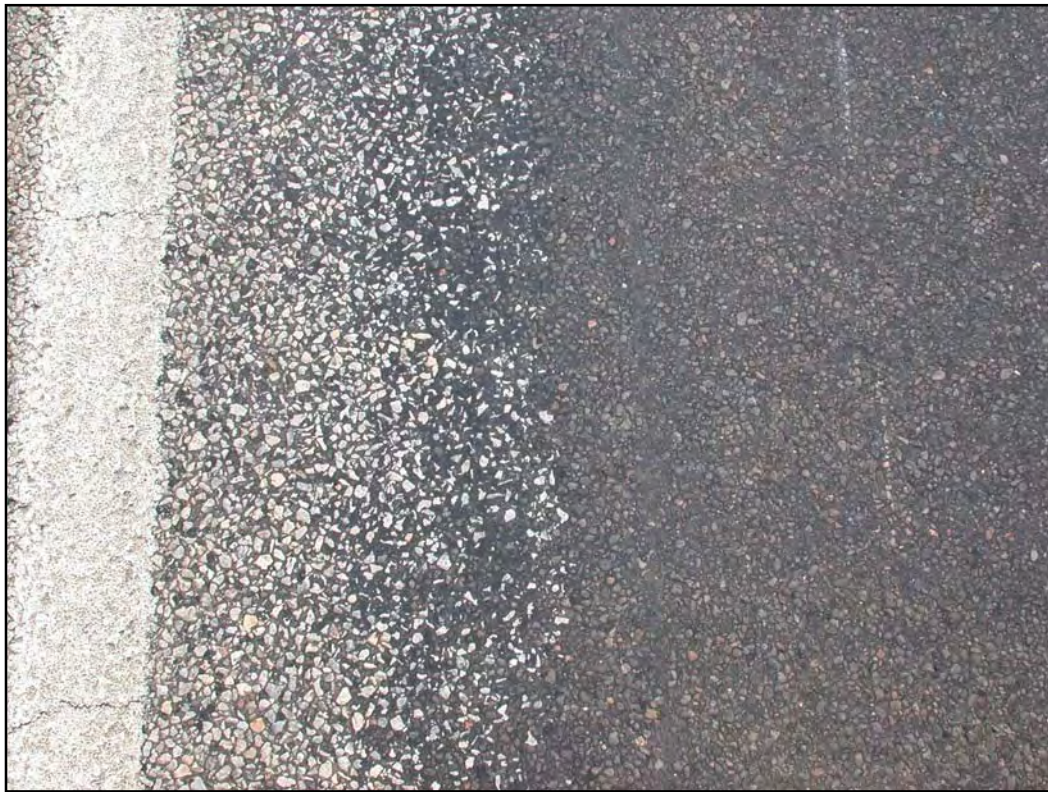
The sandwich seal is typically applied as a strip seal to correct moderate to severe bleeding and minor rutting in the wheel paths. This method yields exceptional friction or skid resistance properties with good macrotexture in the surface (Figure 6.8). Another benefit is that no coarse aggregate is loose and flying, considerably decreasing the chances of headlight and windshield breakage.

Figure 6.9 Improved Macrotexture in the Wheel Paths Using a Sandwich Seal

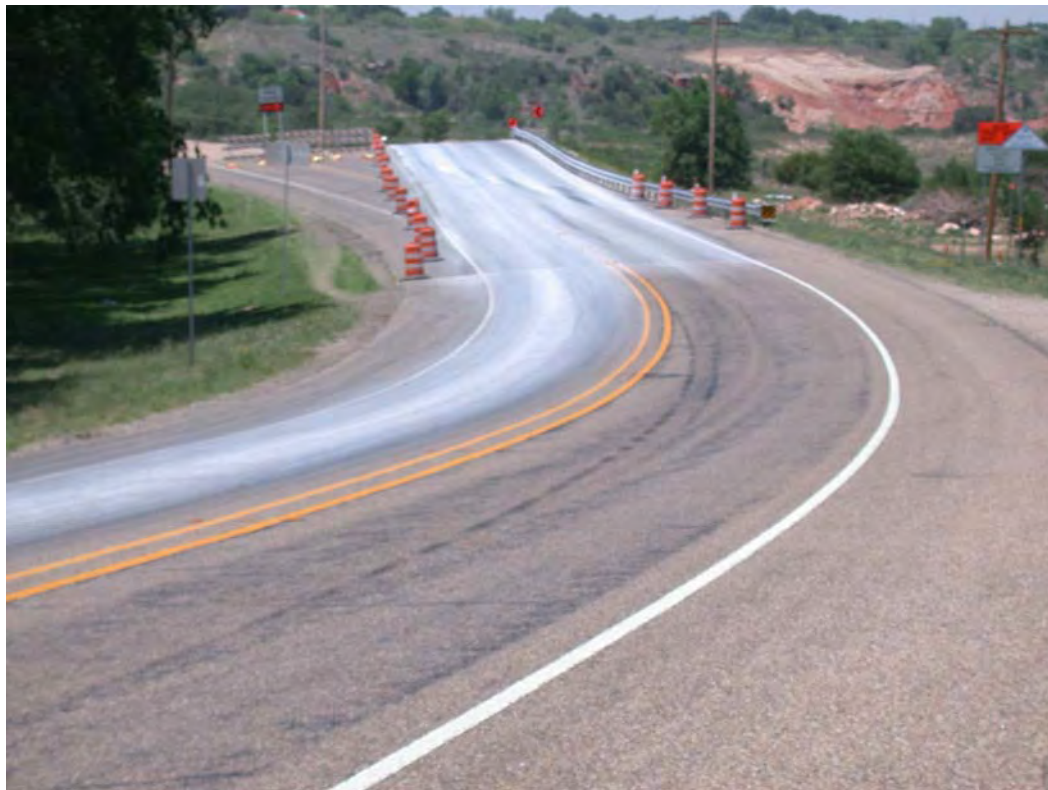
The application of hydrated lime mixed with water is one of the most commonly-used maintenance solutions for the treatment of bleeding asphalt pavements in Texas (Figure 6.9). Customary practice is to mix lime water using a portable 1000 gallon water tank unit that slides into the back of a dump truck. The tank unit comes with an agitator pump to keep the lime in suspension, and the lime water is applied to the bleeding pavement surface using a spray bar.

Figure 6.10 Application of Hydrated Lime to Cool Bleeding Pavement

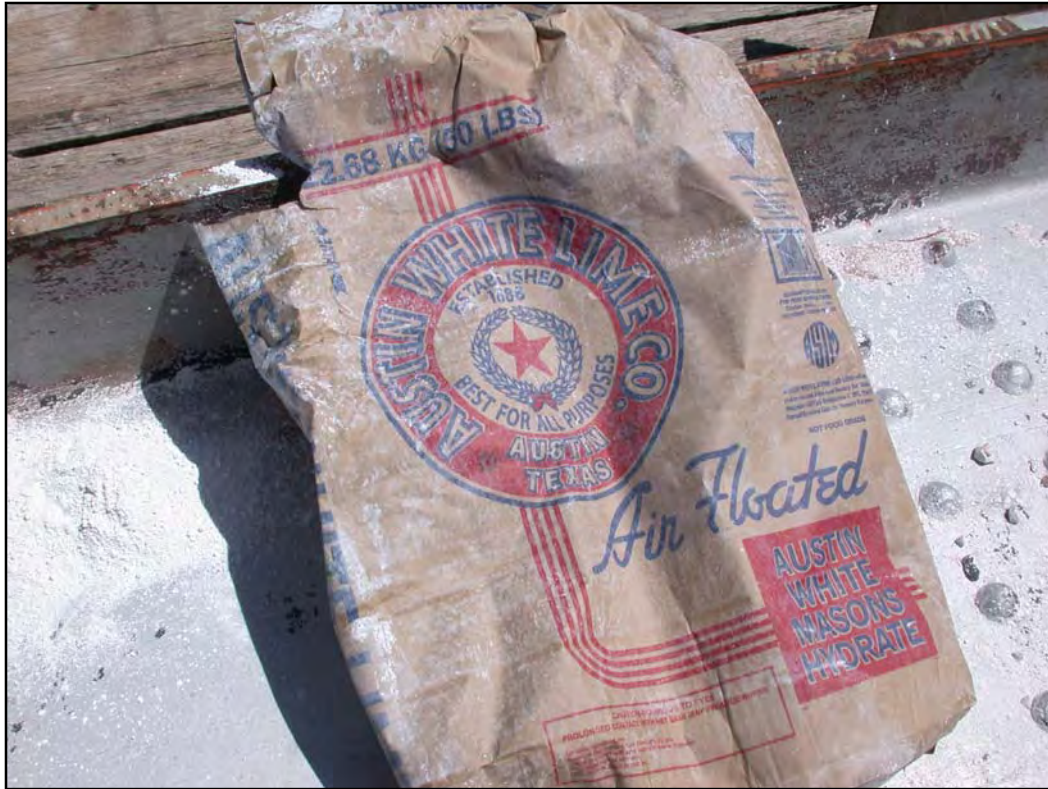
Figure 6.11 50-lb Bag, Type A Hydrated Lime

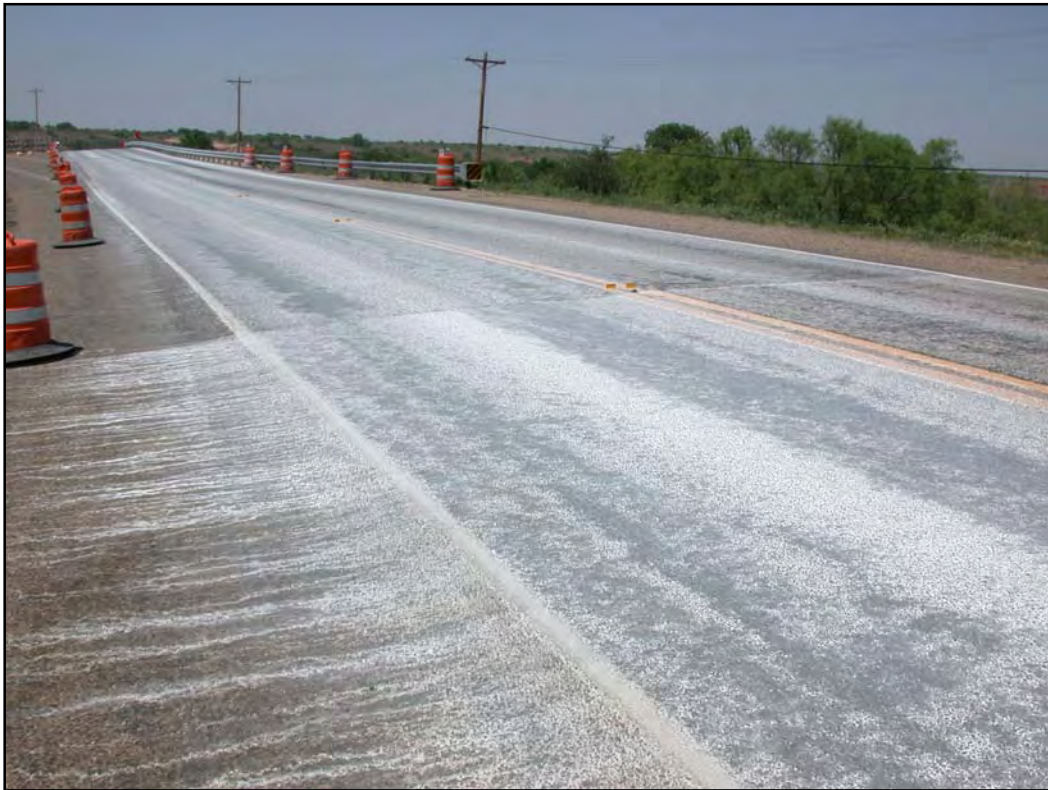
Recipes for lime water concentrations vary with individuals and is more art than science. An incremental approach to lime water treatment is the recommended practice. This approach starts with a higher lime concentration for the first treatment and then reduces the lime water concentration with each successive treatment until the bleeding is under control.

Figure 6.12 The Lime Application Rate Should Achieve Good Splatter (Dosage) of Lime Water Solution on the Affected Pavement Surface

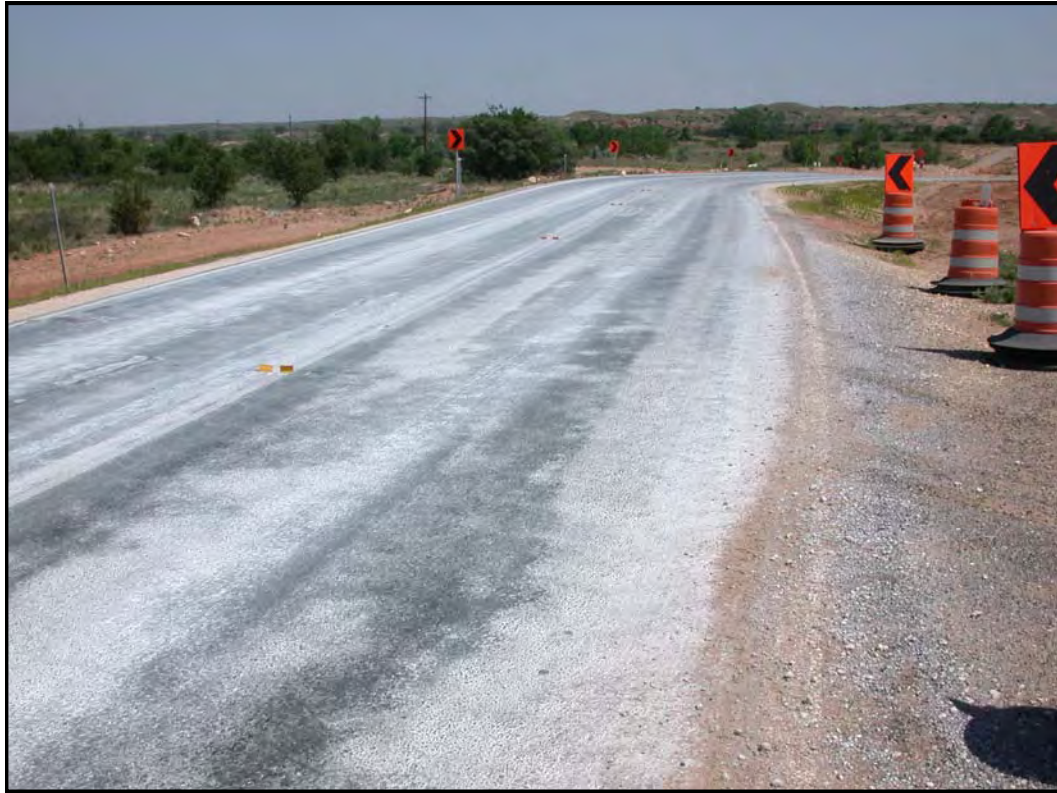
One of the disadvantages of this treatment is that lime water puts a white film on everything and kills the reflectability of pavement markings and striping (Figure 6.12).

Figure 6.13 Lime Can Obscure the Reflectability of Pavement Markings and Striping

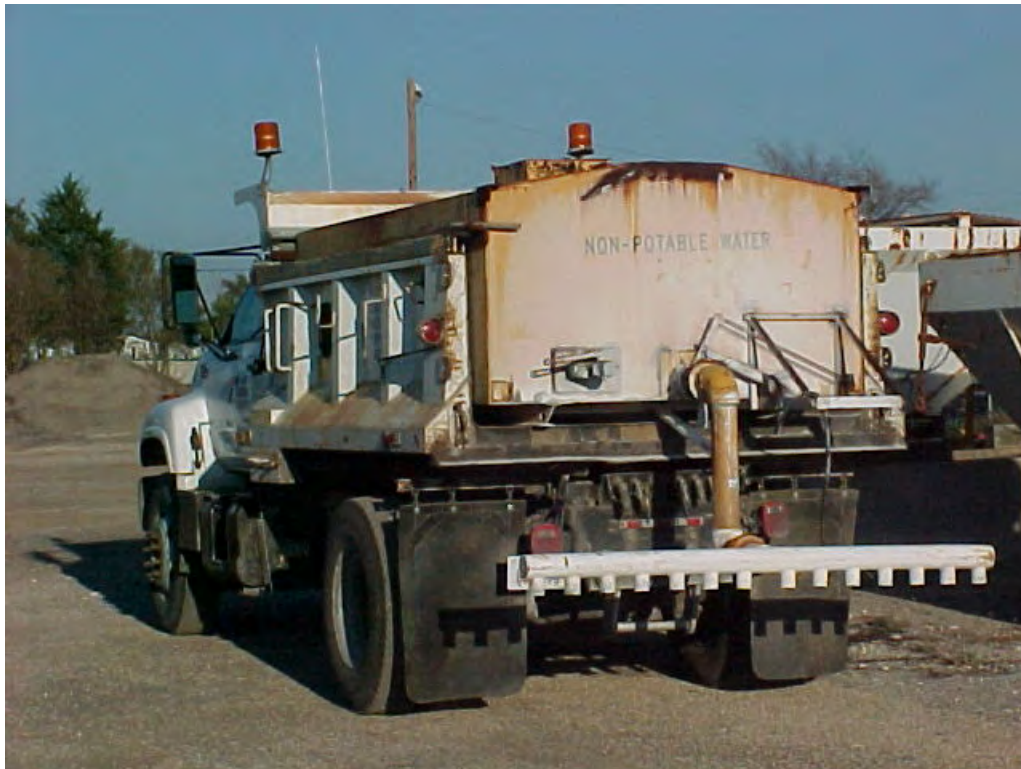
Customary practice is to apply water using a standard construction water truck equipped with a spray bar (Figure 6.13).

Figure 6.14 Application of Water Using a Standard Construction Water Truck

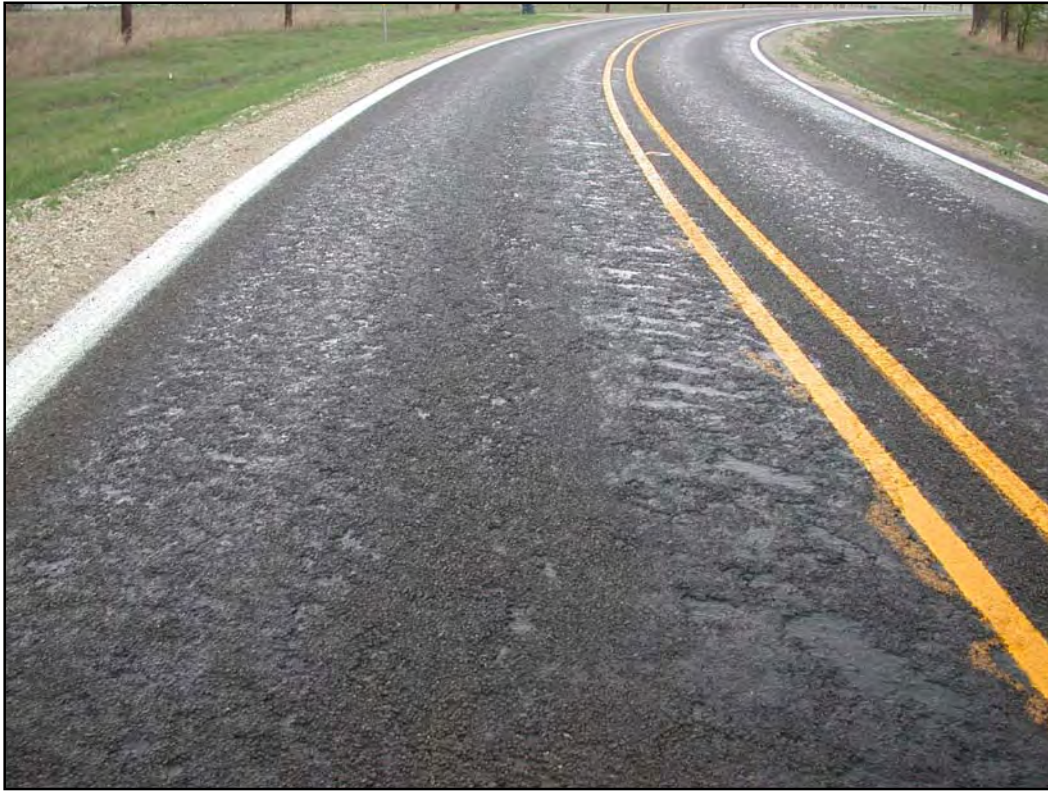
Figure 6.15 Removal and Replacement May Be Necessary When a Fresh Seal Coat Totally Fails
