Maintenance Solutions for Bleeding and Flushed Pavements Surfaced with a Seal Coat or Surface Treatment

William D. Lawson, Michael Leaverton, Sanjaya Senadheera

Technical Report 0-5230-1
www.techmrt.ttu.edu/reports.php

February 2007

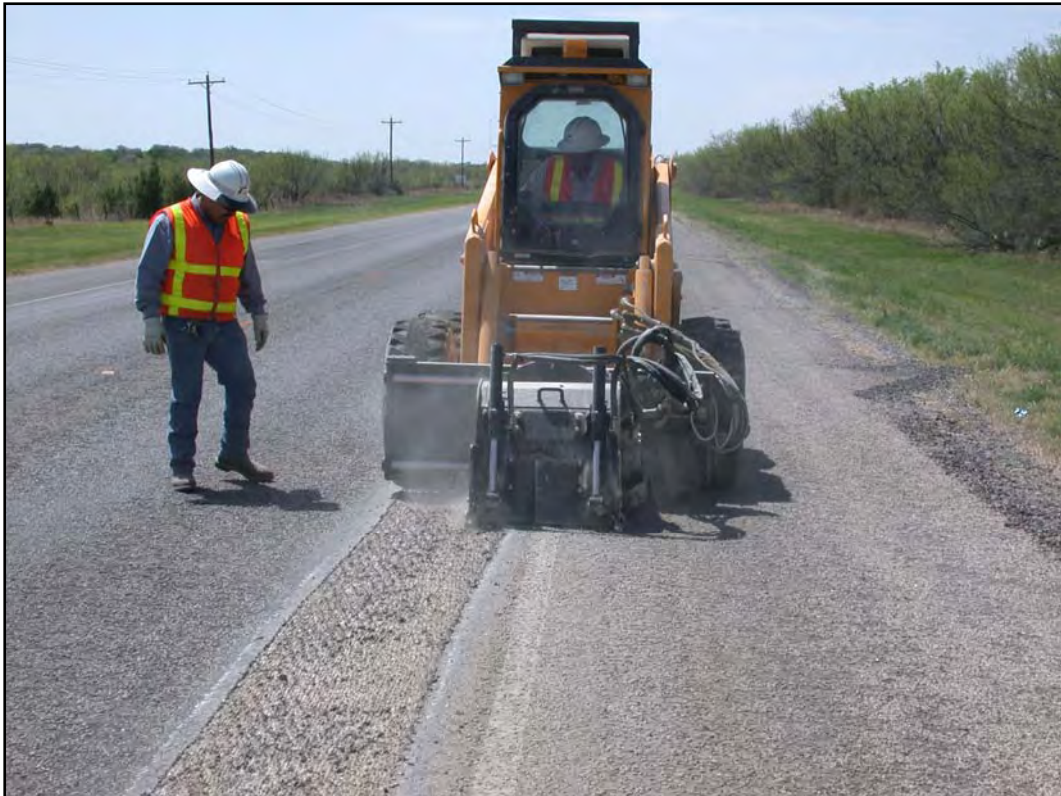
Cold milling is the controlled removal of the surface of the existing pavement to the desired depth, with specially designed milling equipment (Figure 7.1). Milling is done either to prepare the surface to receive overlays (by removing rutting, flushing, and surface irregularities), to restore the pavement cross slopes and profile, or to re-establish the pavement's surface friction characteristics. Surface removal is typically done with a milling machine which uses a drum equipped with carbide-tipped teeth that impact and chip the pavement surface. The resulting textured pavement can be used immediately as a driving surface.

Figure 7.1 Cold Milling to Retexture Flushed Pavement in the Wheel Paths

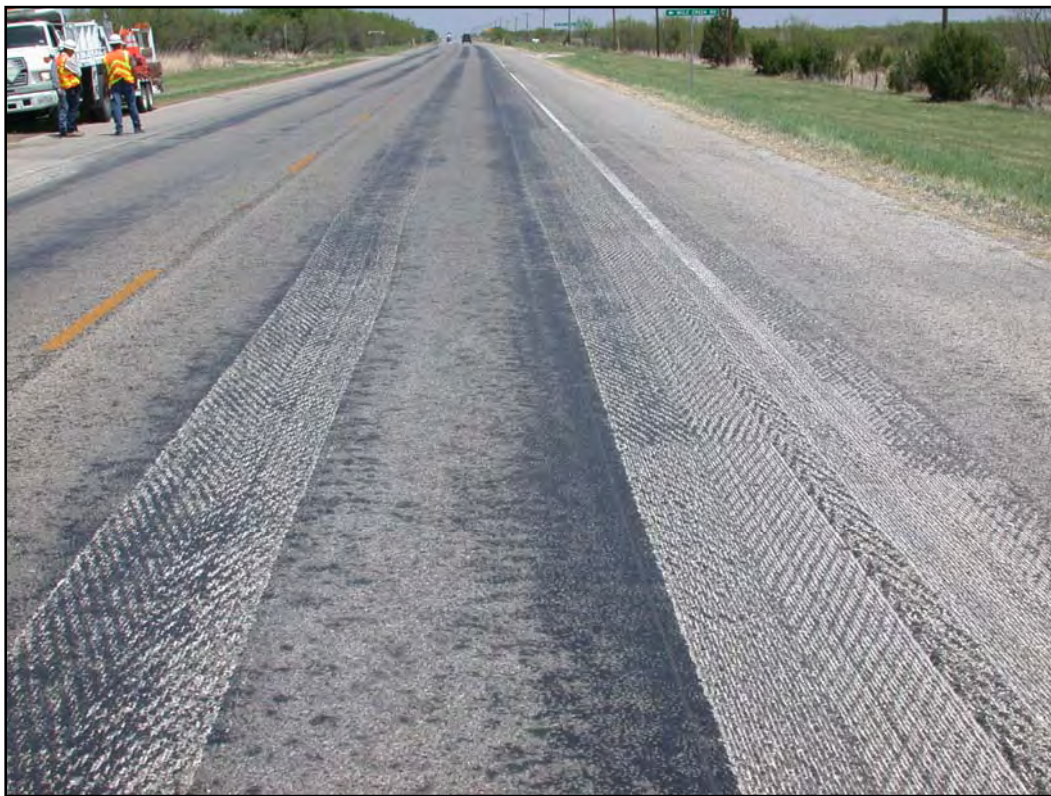
The pavement surface is often left in a milled condition for extended periods of time until subsequent treatments such as a new seal coat or hot mix overlay are applied. In some cases, maintenance crews will go back over the milled areas with premix patch materials using blade level-up methods in advance of subsequent seal coat or overlay operations.

Figure 7.2 Cold Milling Yields a Grooved Surface Texture Along the Longitudinal Axis of the Roadway

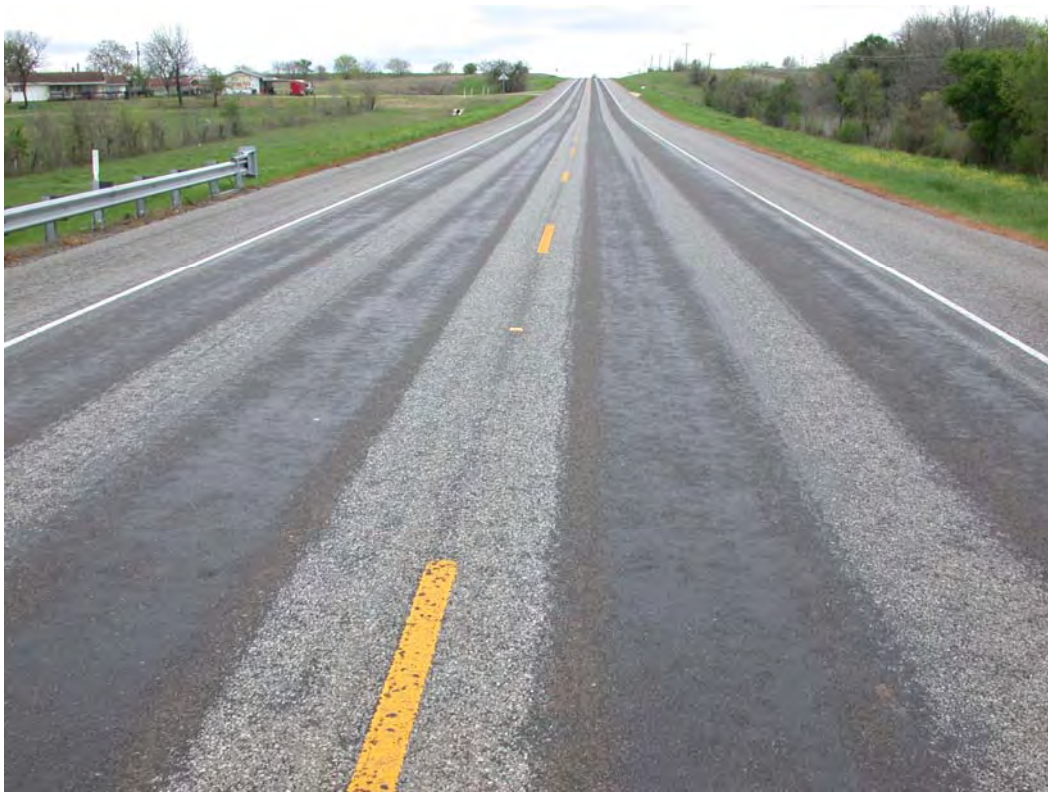
Figure 7.3 Strip Seals (a New Seal Coat in Wheel Paths) to Control Flushed Pavement Must Be Carefully Designed to Avoid Additional Flushing

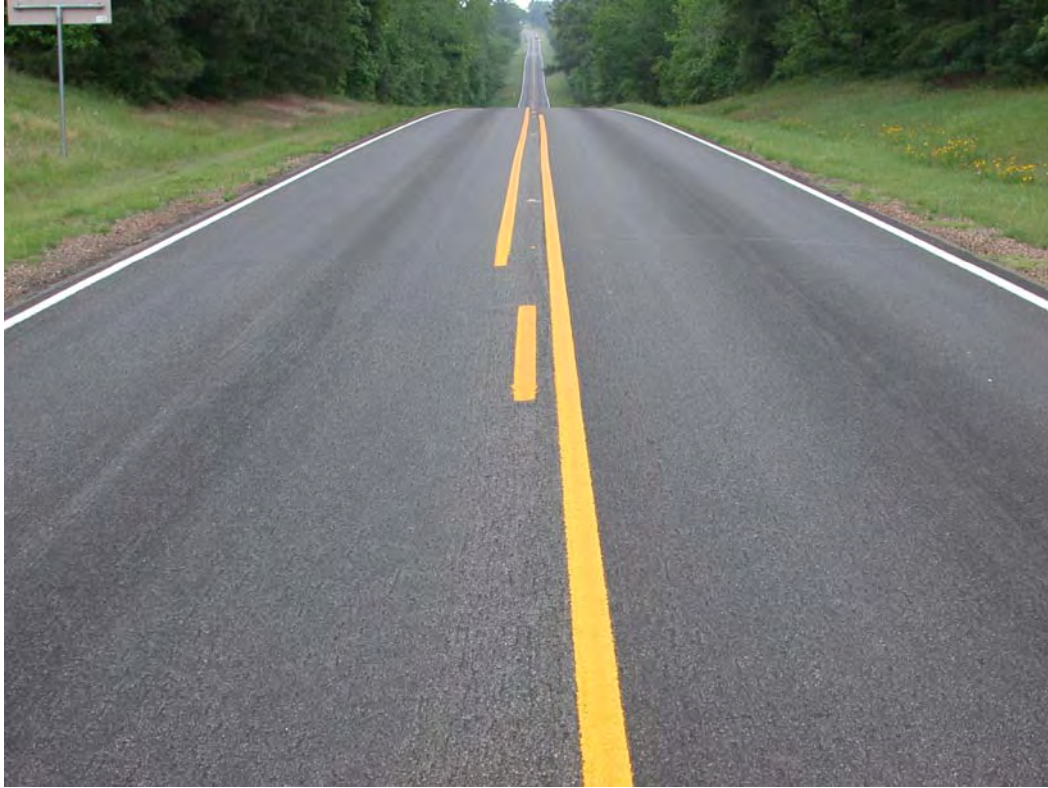
Microsurfacing is considered to be a long term treatment for flushed pavements and has to be done by specialty contractors under an engineer's contract. Maintenance personnel indicate that they have used this solution successfully and can get about 5 to 7 years of

Figure 7.4 Microsurfacing Can Be Used to Remediate Minor Rutting, Flushed Pavement, Poor Ride Quality and Low Skid Resistance

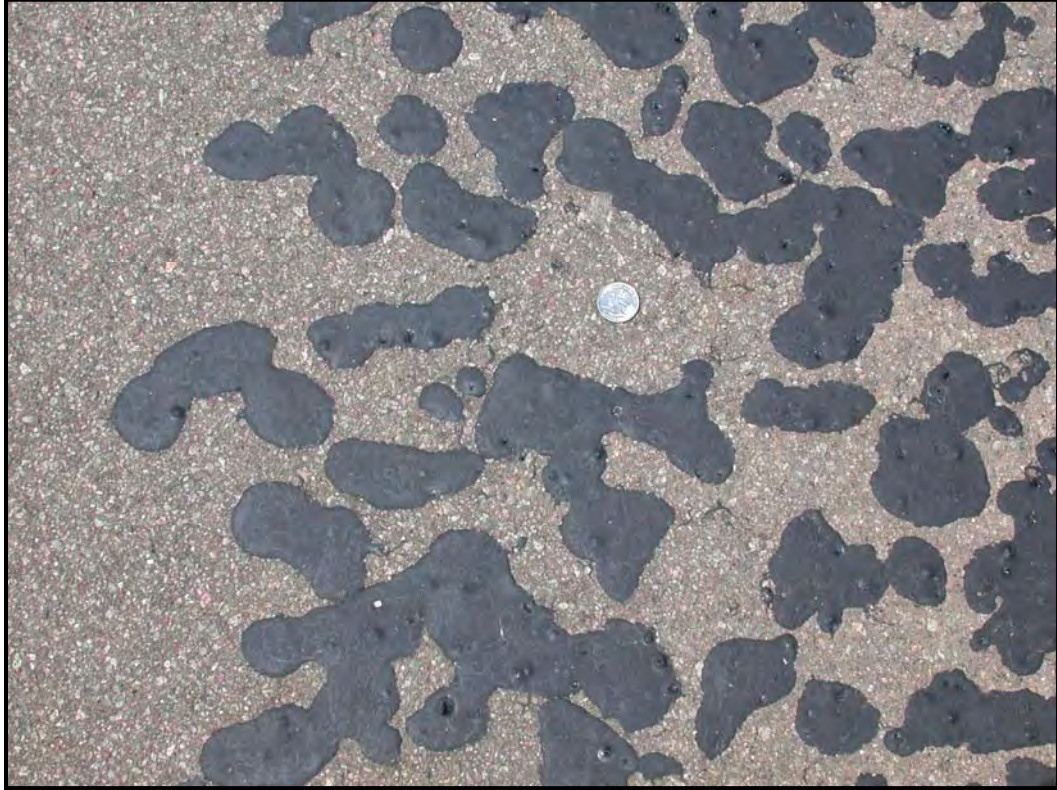
Figure 7.5 Excess Asphalt from Flushed Pavement Can Work Its Way Through Microsurfacing

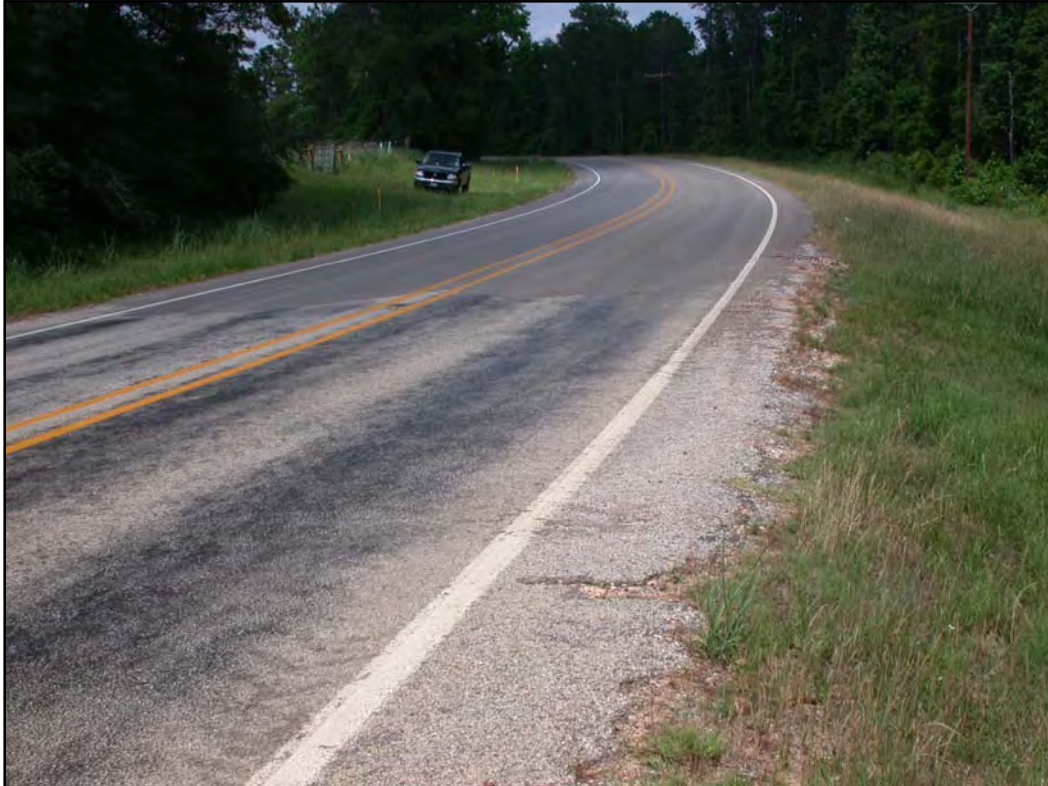
Mill and fill operations, where the overlay is constructed with a laydown machine, may be used at intersections where start-stop and other abusive traffic movements occur. This type of overlay is considered as the final, last-resort type of treatment where no other solution seems to work.

Figure 7.6 Blade Level-ups and Other Thin Asphaltic Concrete Overlays Restore Friction and Skid Resistance

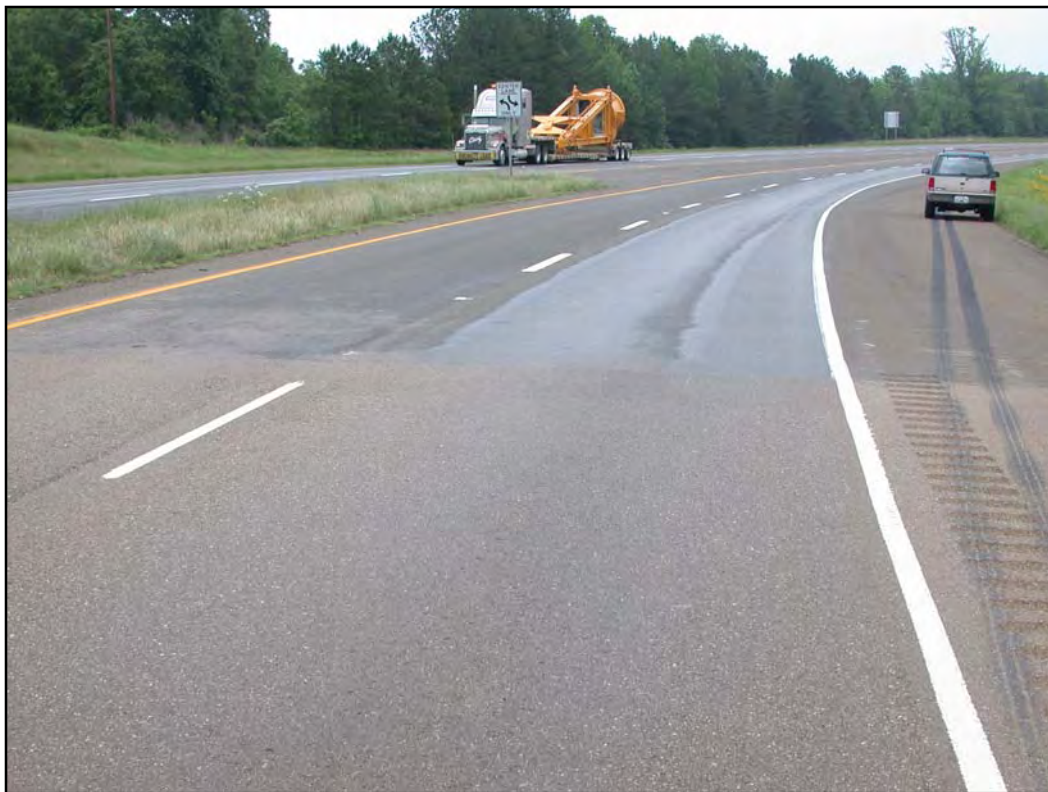
Figure 7.7 Thin Overlays to Treat Flushed Pavement Can Be Applied Using Asphalt Laydown Machines

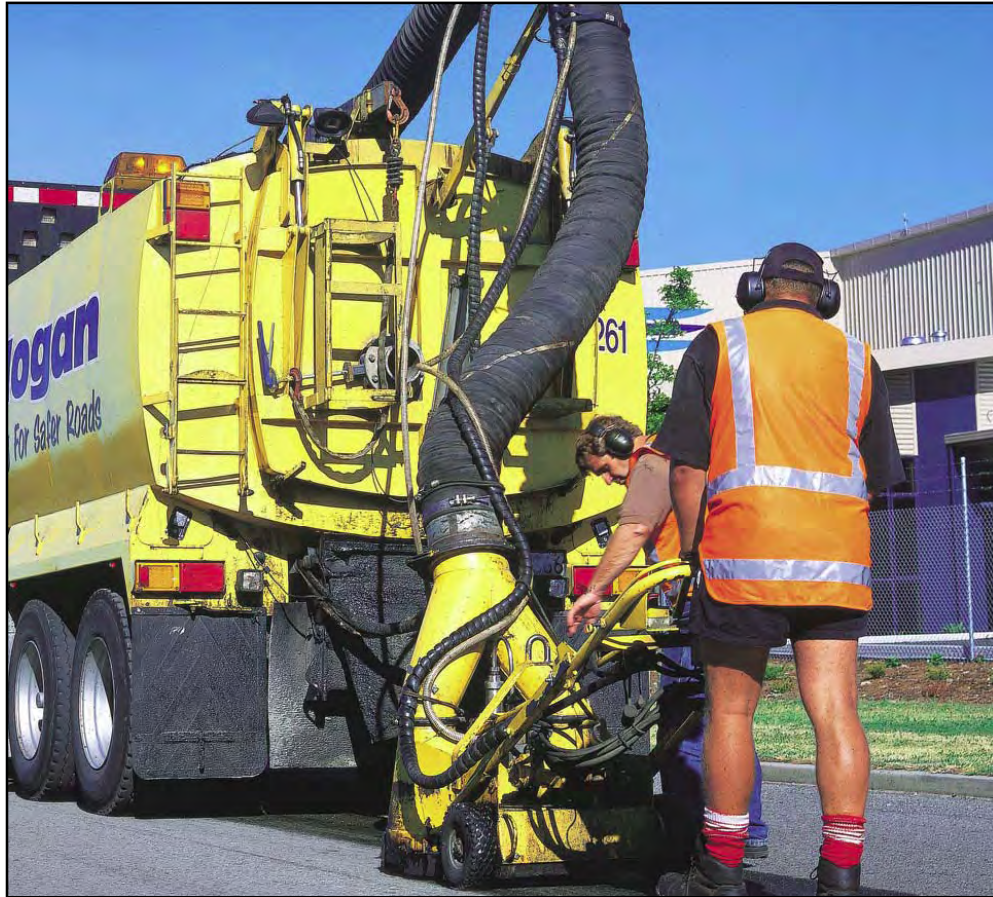
Figure 7.8 The UHP Watercutter Combines a Truck-Mounted UHP Pump, Water Supply, and Vacuum Recovery System with an Independently Operated Umbilical Deckblaster.
Source: Fulton Hogan, Ltd. [www.fh.co.nz]

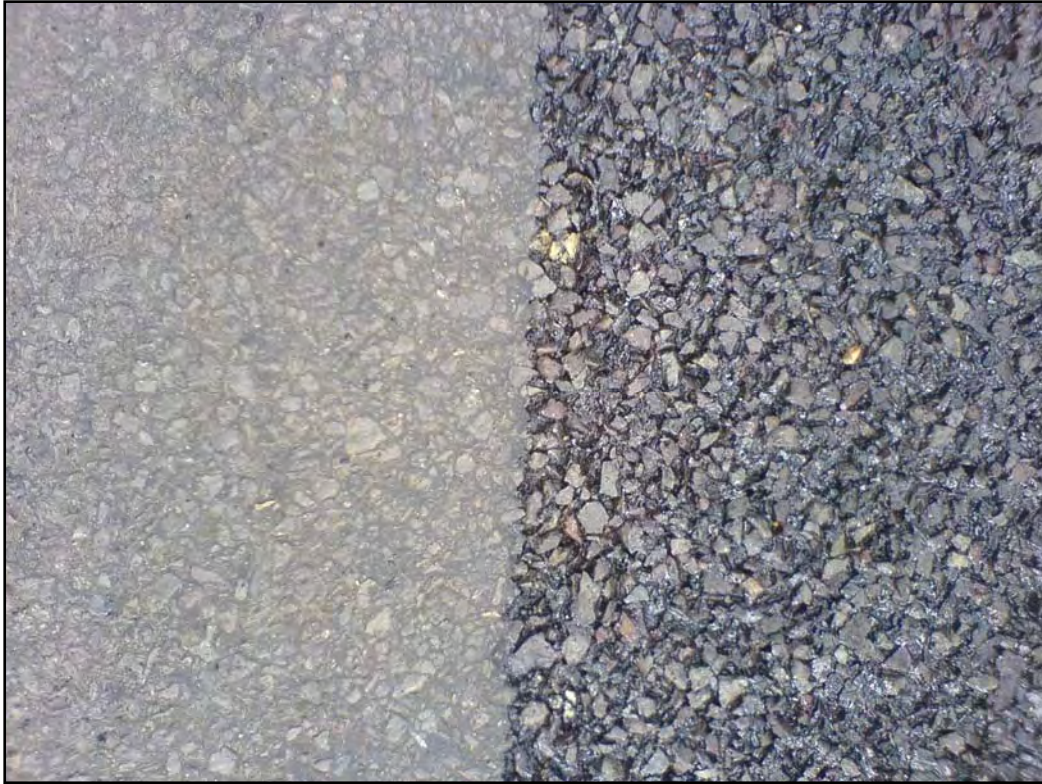
Precise control of pressure, water volume and speed allows effective removal of excess asphalt binder and surface contamination with minimal damage to the surface or dislodgement of coarse aggregate particles (Figure 7.9). Powerful suction heads are used to collect water and debris from the surface for later disposal.

Figure 7.9 Ultra High Pressure Watercutting Allows Effective Removal of Excess Asphalt Binder *Source:* Fulton Hogan, Ltd. [www.fh.co.nz]

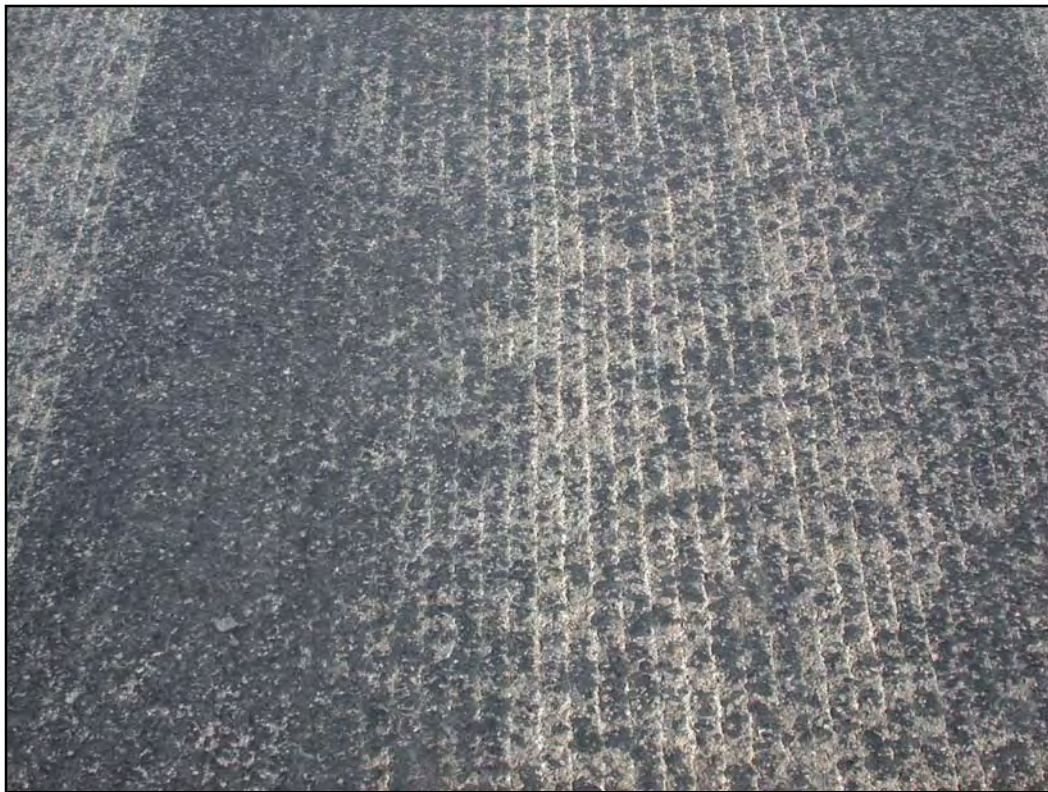
A similar approach consists of welding carbide bullet tips on the mold board. Either approach creates a tool which can be used to score/texture the pavement surface.

Figure 7.10 Grooves in a Motor Grader Mold Board Can Score the Flushed Pavement to Improve Surface Texture

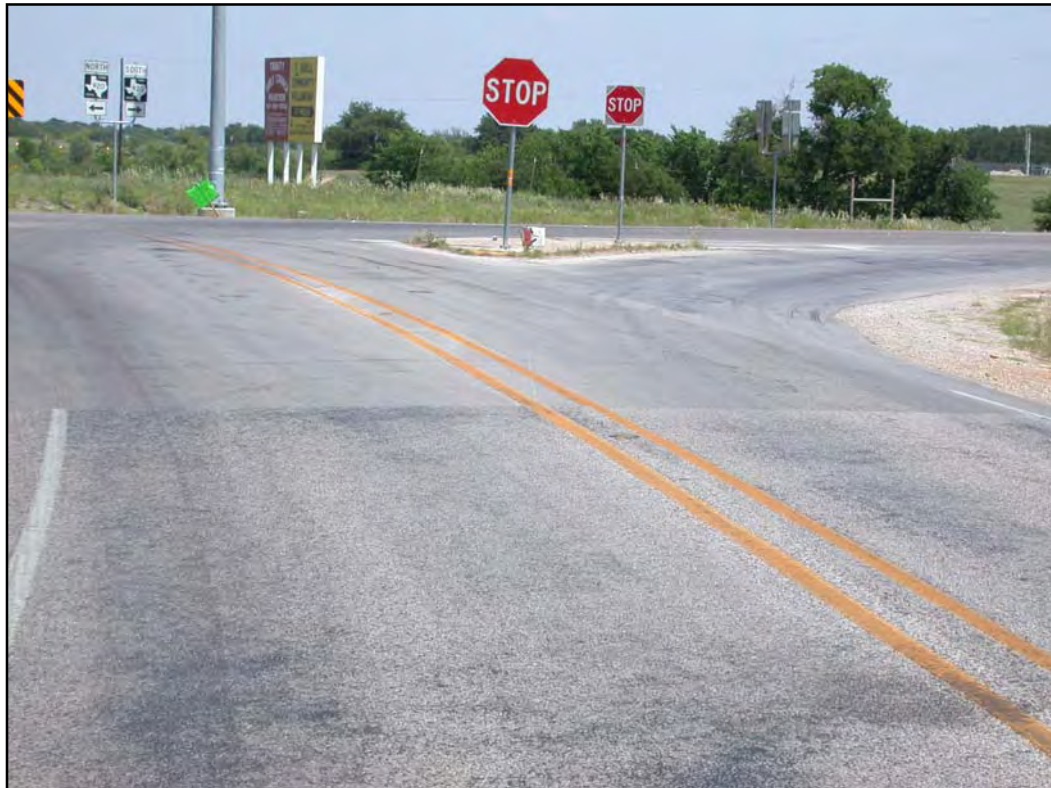
Figure 8.1 Use of Hot Mix Asphalt at an Intersection Largely Depends on Economic Considerations Including Life Cycle Costs

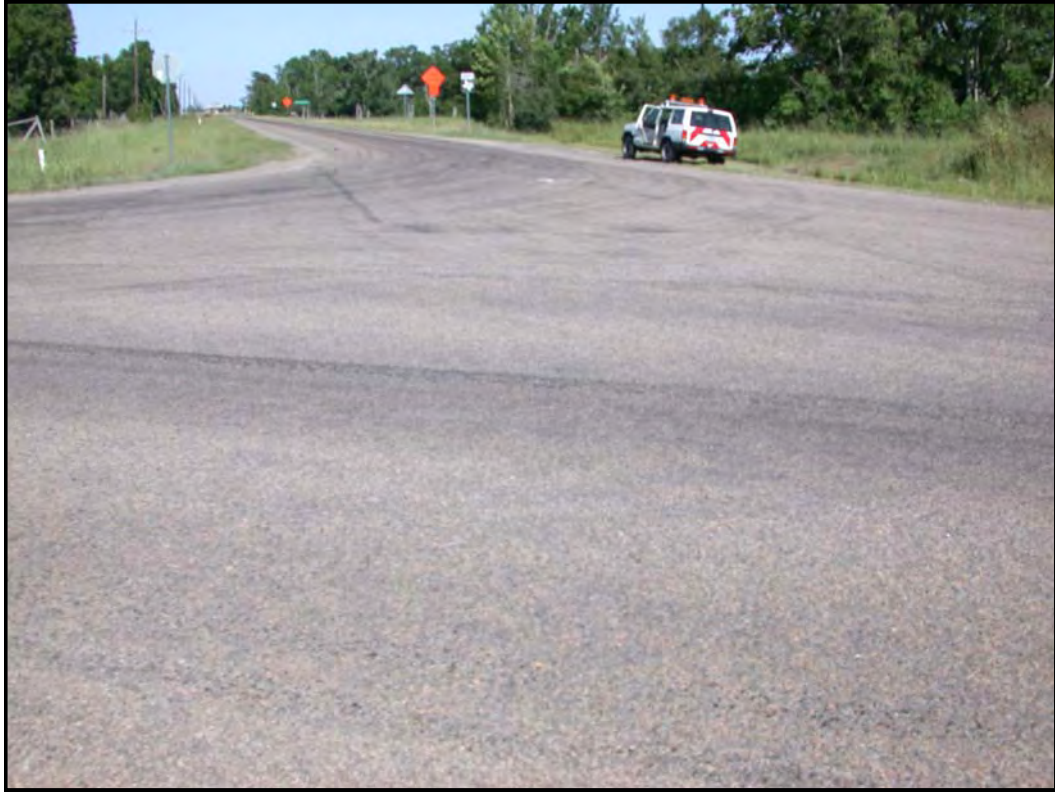
The racked-in seal is a variation to the single course seal coat (Figure 8.2). The racked-in seal consists of one heavy layer of binder followed by two layers of cover aggregate. The second layer of aggregate, or scatter coat, is smaller than (one-third to one-half size) the first layer. The smaller aggregate fills the voids and displaces the binder further upward on the larger stone, thereby mechanically locking the larger aggregate in position and producing a stable matrix.

Figure 8.2 The Racked-In Seal Can be Used at Intersections to Improve Seal Coat Performance Under Heavy Traffic or Abusive Traffic

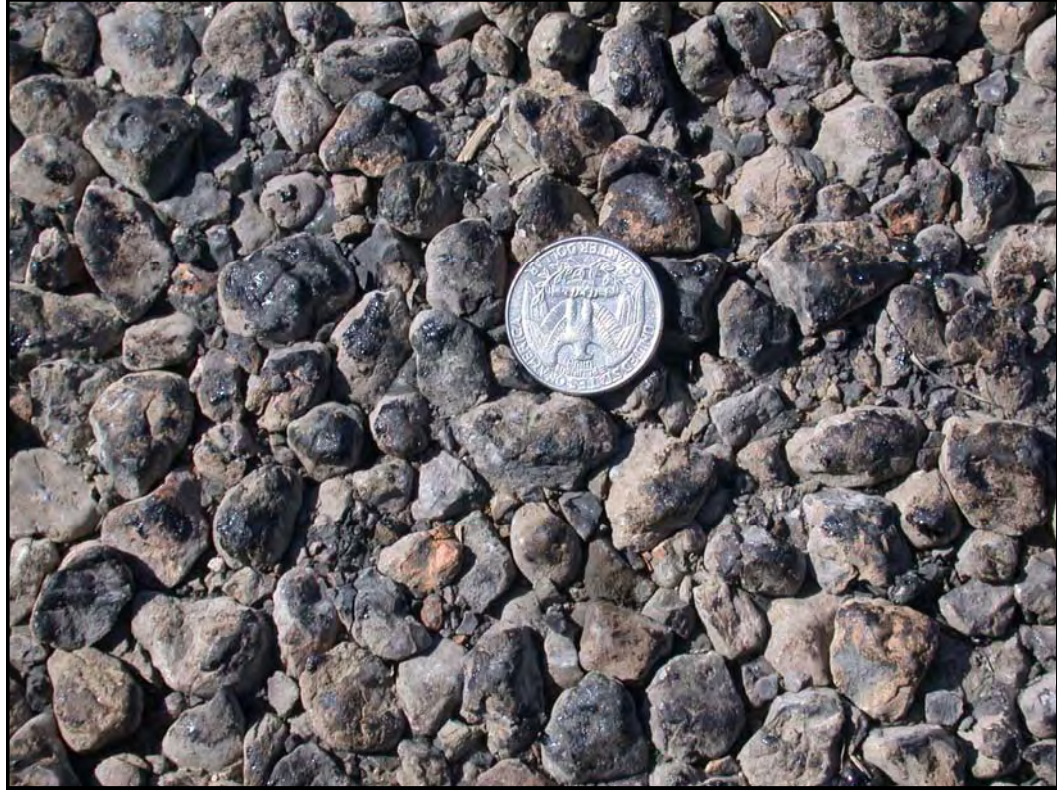
Figure 8.3 The Racked-In Seal Involves a Light Application of Small Size Aggregate (Scatter Coat) Over a Traditional Coarser Aggregate Seal Coat
