1. Report No. FHWA/TX-10/0-1777-3		2. Government Accession No.		3. Recipient's Catalog No.	
4. Title and Subtitle TESTS OF HMA OVERLAYS USING GEOSYNTHETICS TO REDUCE REFLECTION CRACKING				5. Report Date February 2009 Published: December 2009

# **TESTS OF HMA OVERLAYS USING GEOSYNTHETICS TO REDUCE REFLECTION CRACKING**

Report 0-1777-3  
Project 0-1777

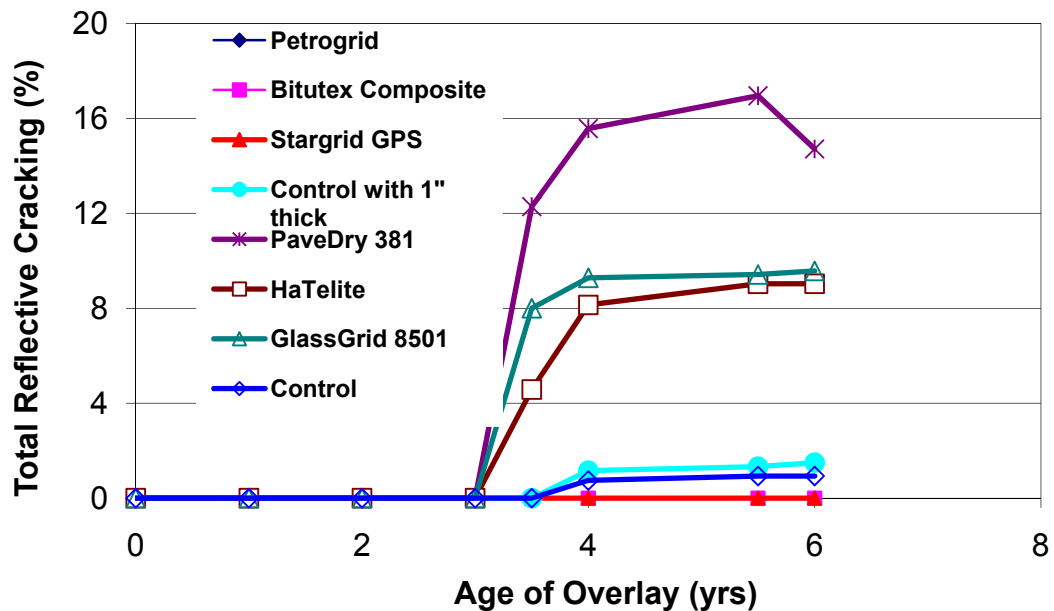
Figure 3-3. Reflective (Total) Cracking vs. Time – Pharr District.

Subsequent monitoring in October 2006 and May 2007 did not reveal any significant crack growth in these test sections. Table A5 documents the crack lengths observed in all test sections of this test pavement. Only one 5-ft long longitudinal crack was observed in the control section in October 2006, and this crack did not grow after one year. These test sections were constructed on a lane with a very thin asphalt layer due to the milling operation to match the curb and gutter, which may have contributed to a very small number of reflected cracks. Figure 3-3 depicts the total reflective cracking percentage. The maximum cracking observed on Pavé-Dry section is only 16 percent after six years in service. All of the cracks shown here are with low severity. Besides Pavé-Dry, only HaTelit and GlasGrid exhibited notable cracks. Otherwise, the remainder of the test sections exhibited very little or no cracking.

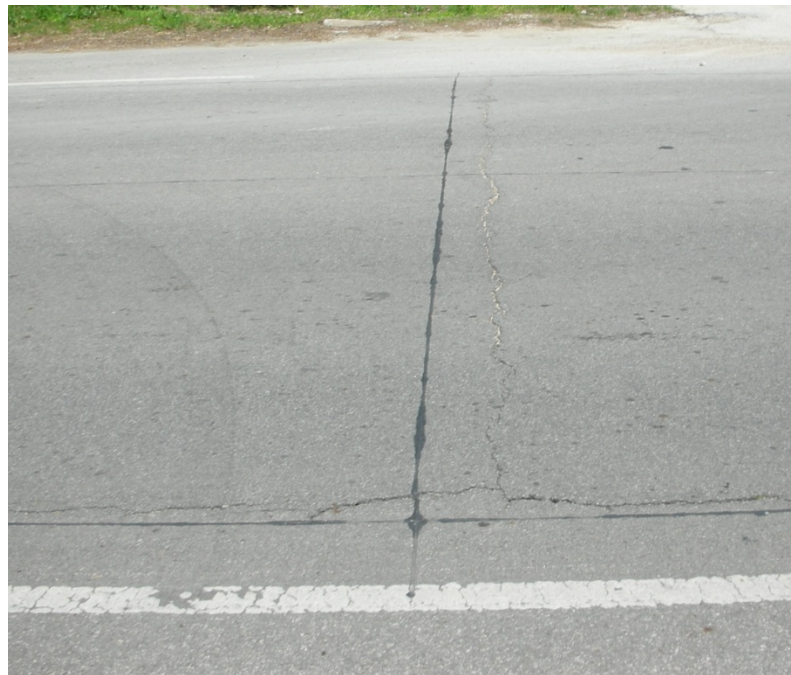
**Figure 3-5. Cracking Parallel to Saw & Seal in May 2007.**

In May 2005, several more joints/cracks had reflected through the overlay. The most notable ones were located at the transverse joints. [Figure 3-5](#) exhibit the cracks observed in 2007 parallel to saw cutting.

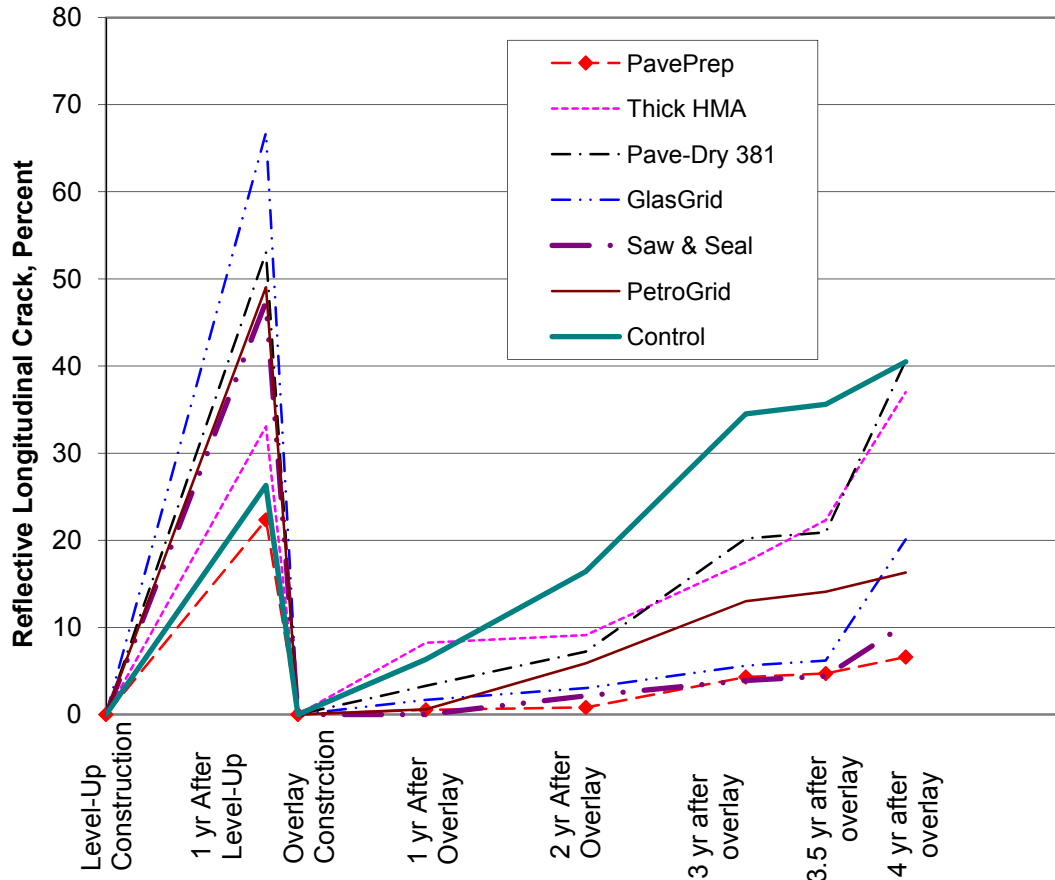
**Figure 3-7. Reflective (Longitudinal) Cracking vs. Time – Waco District.**

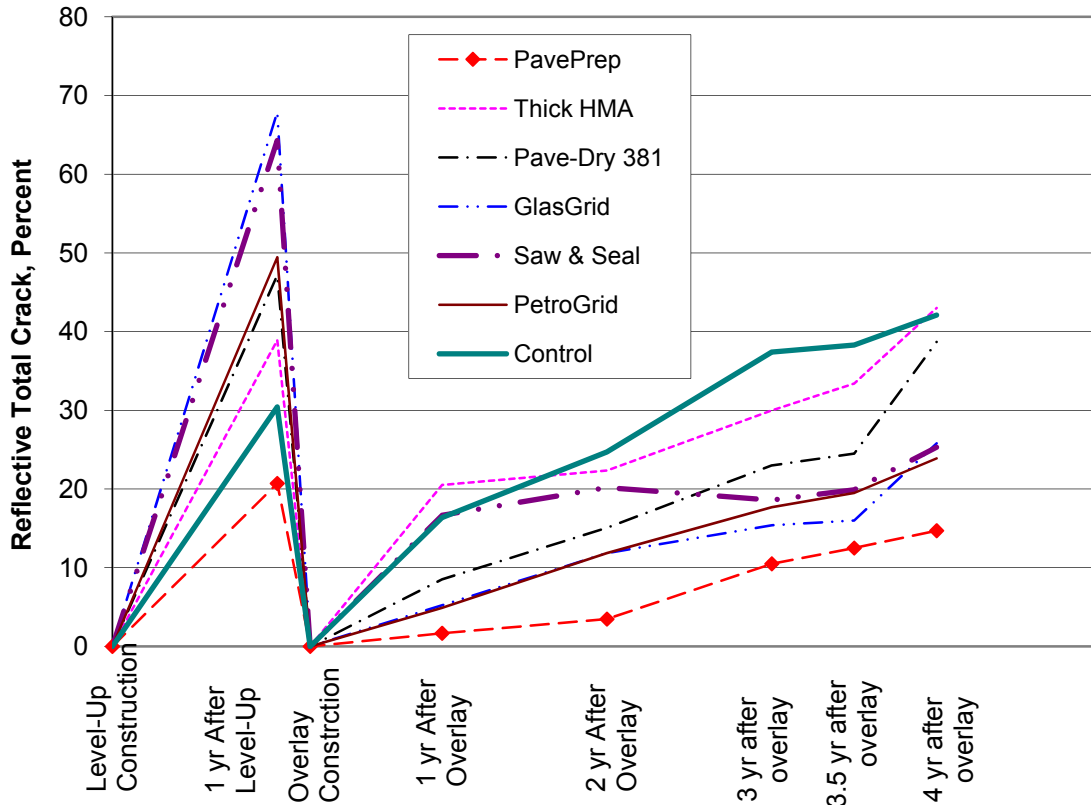
**Figure 3-8. Reflective (Total) Cracking vs. Time – Waco District.**

Alternatively, percent cracking after overlaying was recalculated based on the cracks measured on the leveling course instead of the original cracks/joints in the concrete measured before construction. Graphs similar to [Figure 3-6](#), [3-7](#), and [3-8](#) were redrawn based on the new calculation and documented in the [Appendix](#). These new graphs show that some sections have more than 100 percent reflective cracking, which indicates that the leveling course did not exhibit 100 percent reflective cracking during the cracking measurement of the leveling course (just prior to placement of overlay).

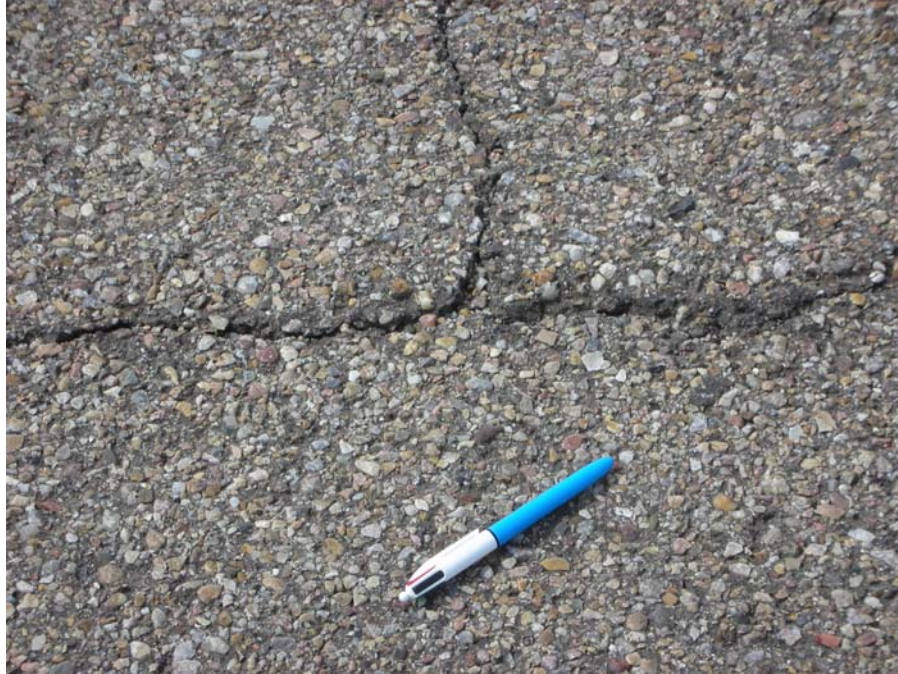
**Figure 3-10. Reflective Crack on Amarillo Test Pavement in 2007.**

[Figures 3-10](#) and [3-11](#) show some pictures from more recent visits at Amarillo test pavements in 2007.

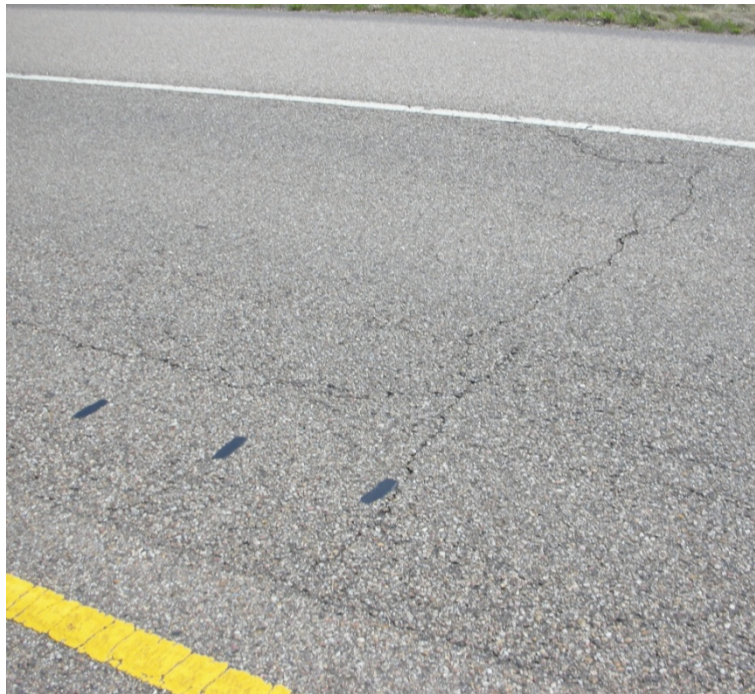
**Figure 3-11. Typical Reflective Crack on Amarillo Test Pavement in 2007.**

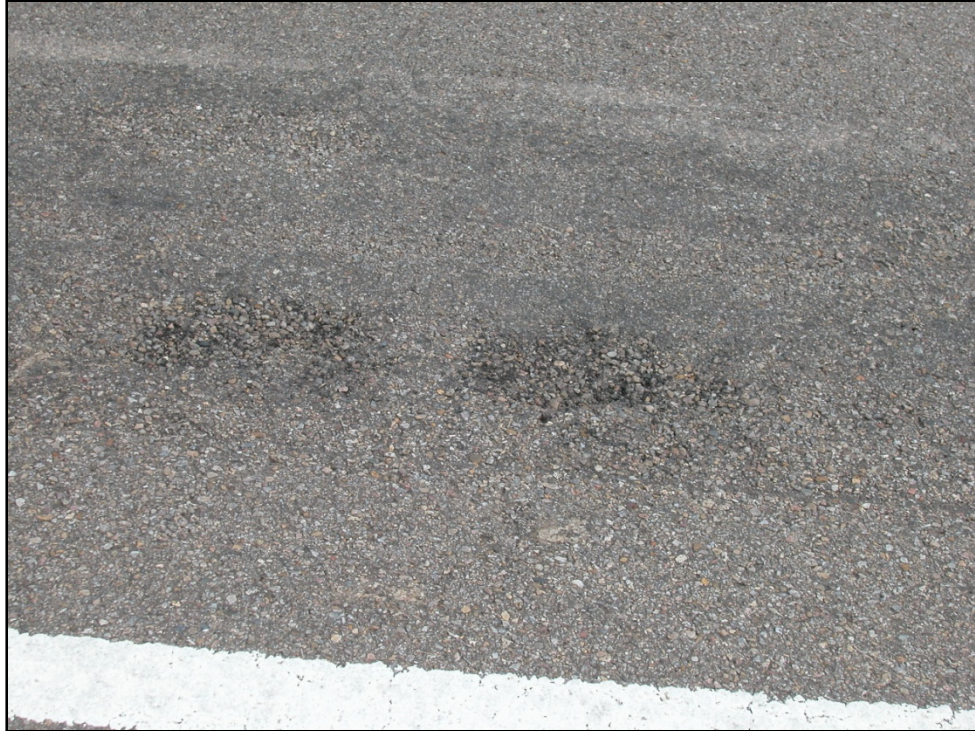
**Figure 3-12. Raveling Observed in the PaveTrac Section in 2004.**

In April 2004, the surfaces of the test pavements generally appeared to be in excellent condition. Minor transverse and longitudinal cracks were observed in some of the test sections. The PFC with seal coat did not exhibit any cracking, but the PFC with a leveling course exhibited a few short, narrow longitudinal and transverse cracks. The PFC with seal coat developed a few small potholes.

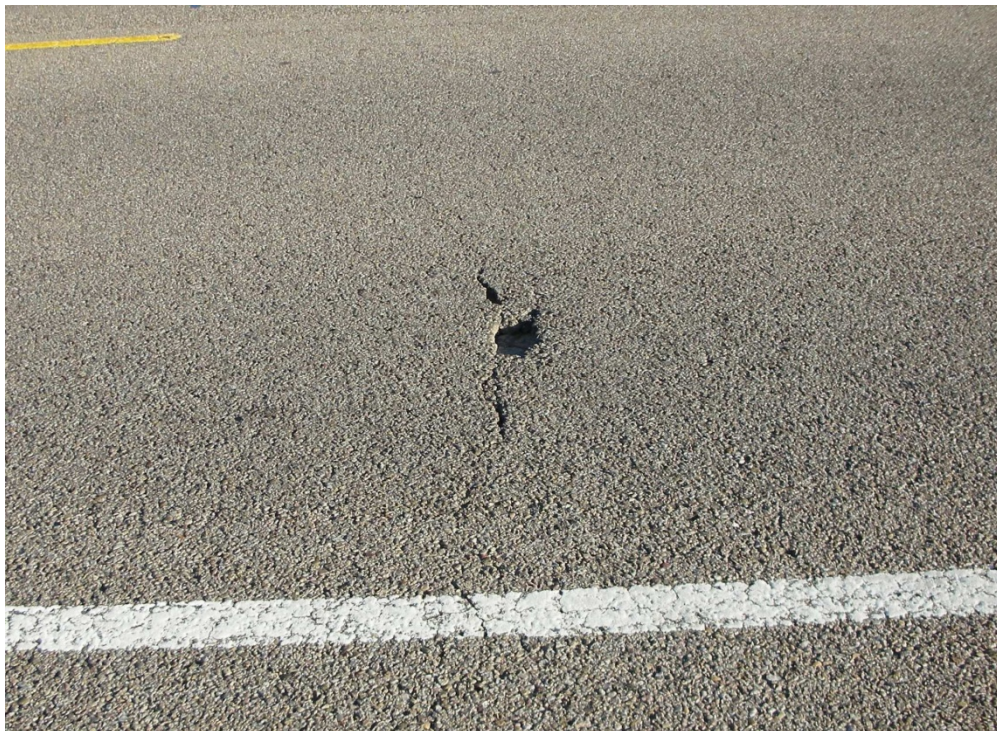
**Figure 3-13. Pothole Observed in PaveTrac Section in 2006.**

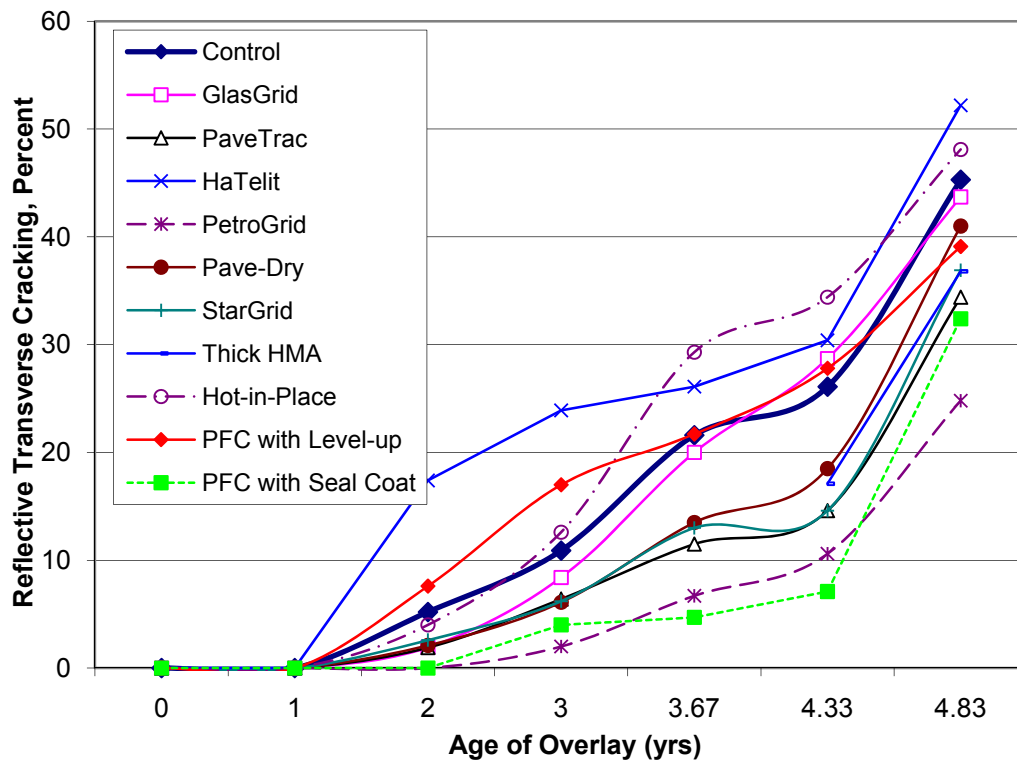
Figure 3-14. Reflective (Transverse) Cracking vs. Time after Placement.

significantly slowed down. On the contrary, transverse cracks on the same section grew rapidly. GlasGrid and hot-in place recycling sections exhibited rapid growth of both transverse and longitudinal cracks. Figures 3-14 through 3-16 present the growth of transverse, longitudinal, and total reflective cracks, respectively.

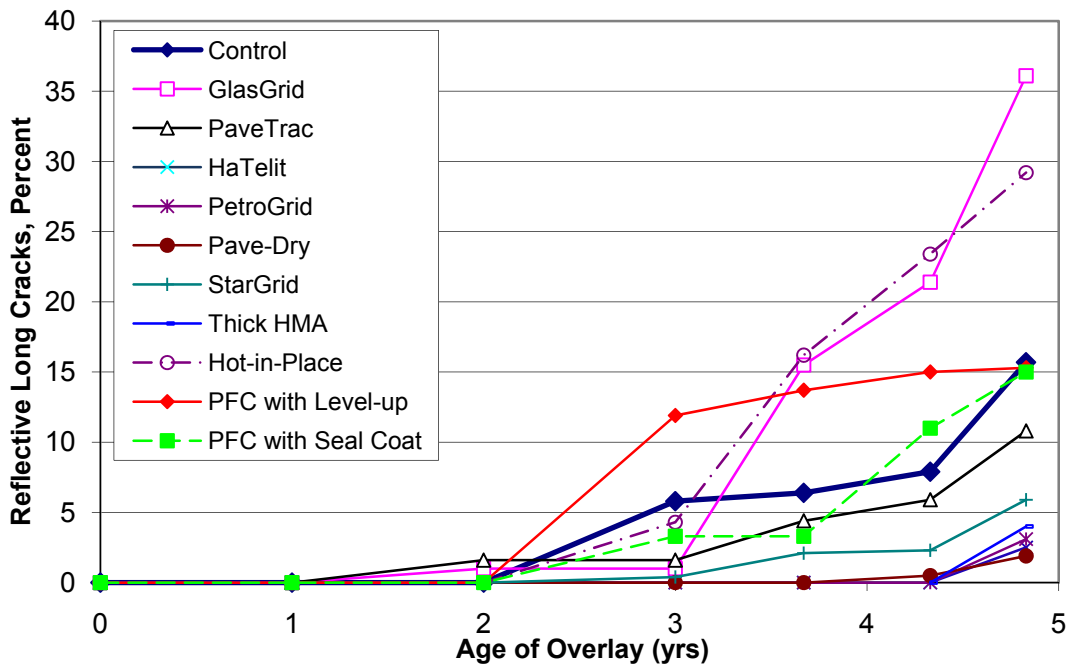
Figure 3-15. Reflective (Longitudinal) Cracking vs. Time after Placement.

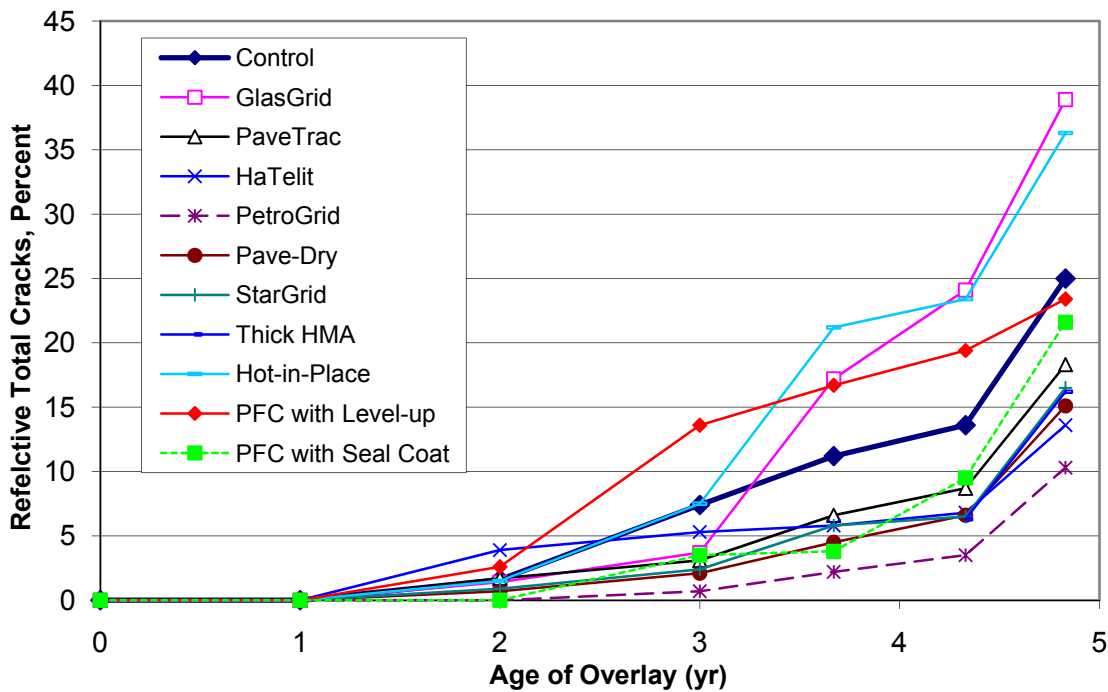
Figure 3-16. Reflective (Total) Cracking vs. Time after Placement.

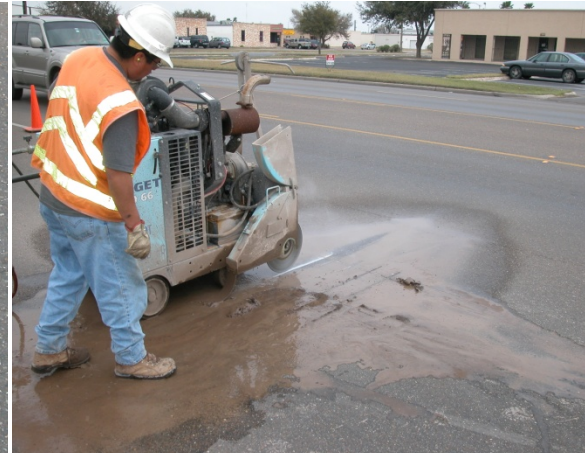
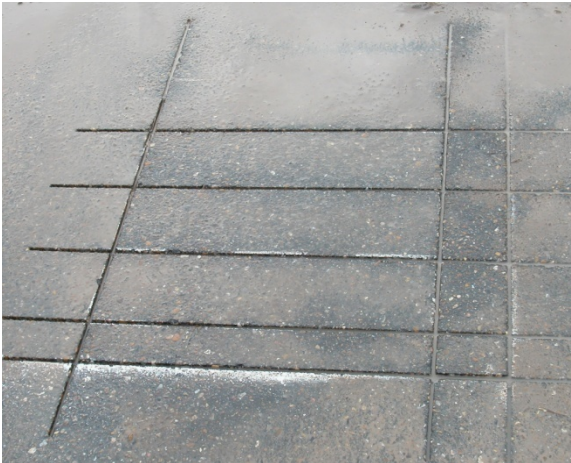
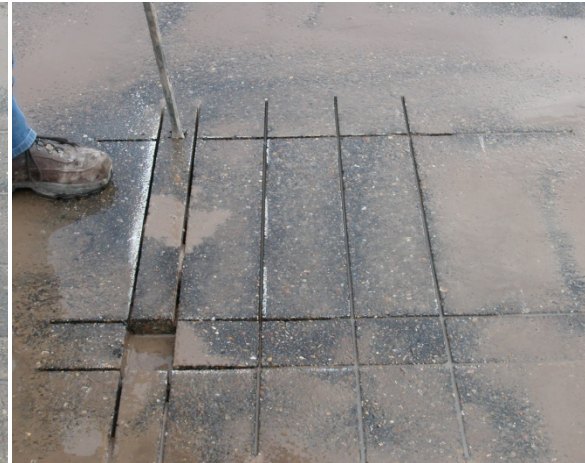
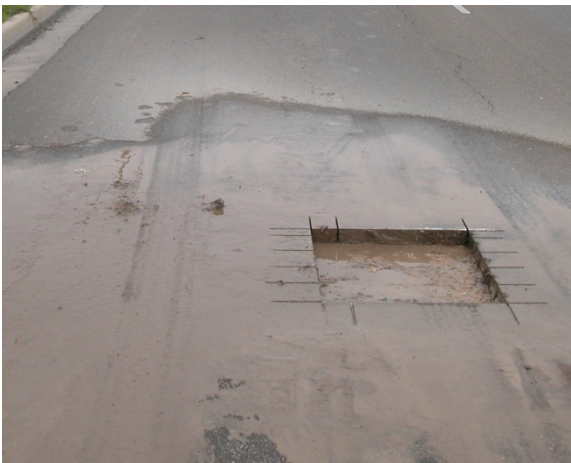
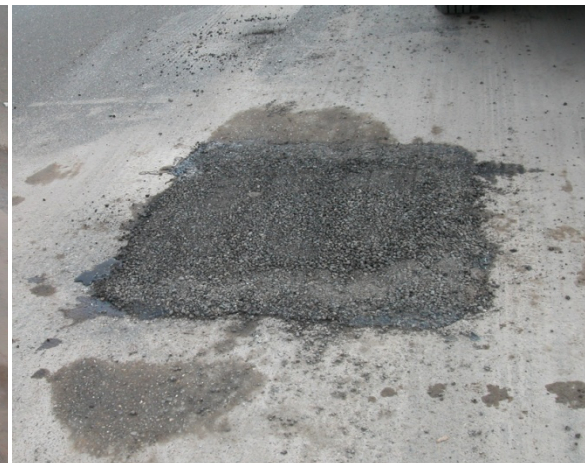
(a) Setting Template Marking

(b) Sawing Along the Template Marking

(c) Pavement after Saw Cut

(d) Removal of Specimens

(e) Empty Trench

(f) Trench Filled up with Coldmix

**Figure 4-1. Specimen Collection Sequence at Pharr Test Section.**

All four large and small specimens from a given test section were obtained from one single location. This was done to minimize variability between the specimens. Sectional specimens were obtained in a location where there were no cracks. [Figure 4-1](#) shows the typical specimen collection sequence.

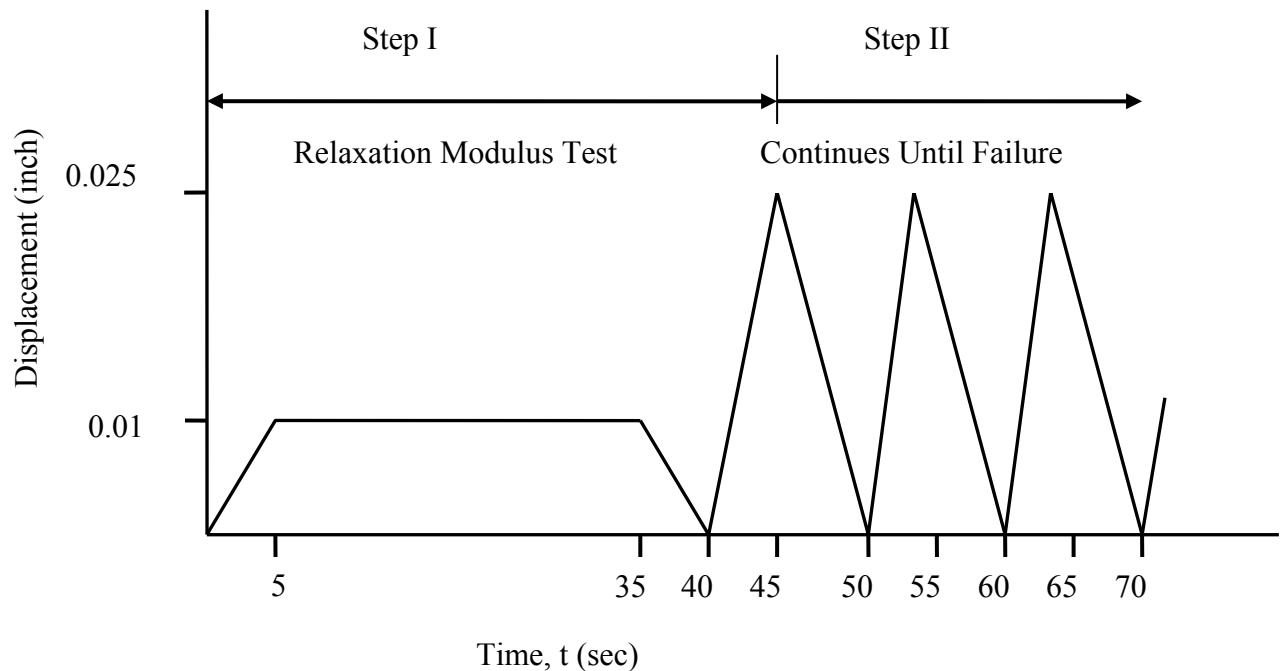
**Figure 4-3. Schematic Diagram of Loading Used in Overlay Tester.**

All the beam specimens were tested to failure in a controlled displacement mode in two phases, as shown in Figure 4-3. Phase I consists of a constant displacement waveform having a ram displacement of 0.01 inch. Measurement of displacement and load from 5 to 35 seconds was used to determine the relaxation modulus curve. Phase II testing was continued until failure occurred at a loading rate of one cycle per 10 seconds using a cyclic triangular displacement waveform having a ram displacement of 0.025 inches.

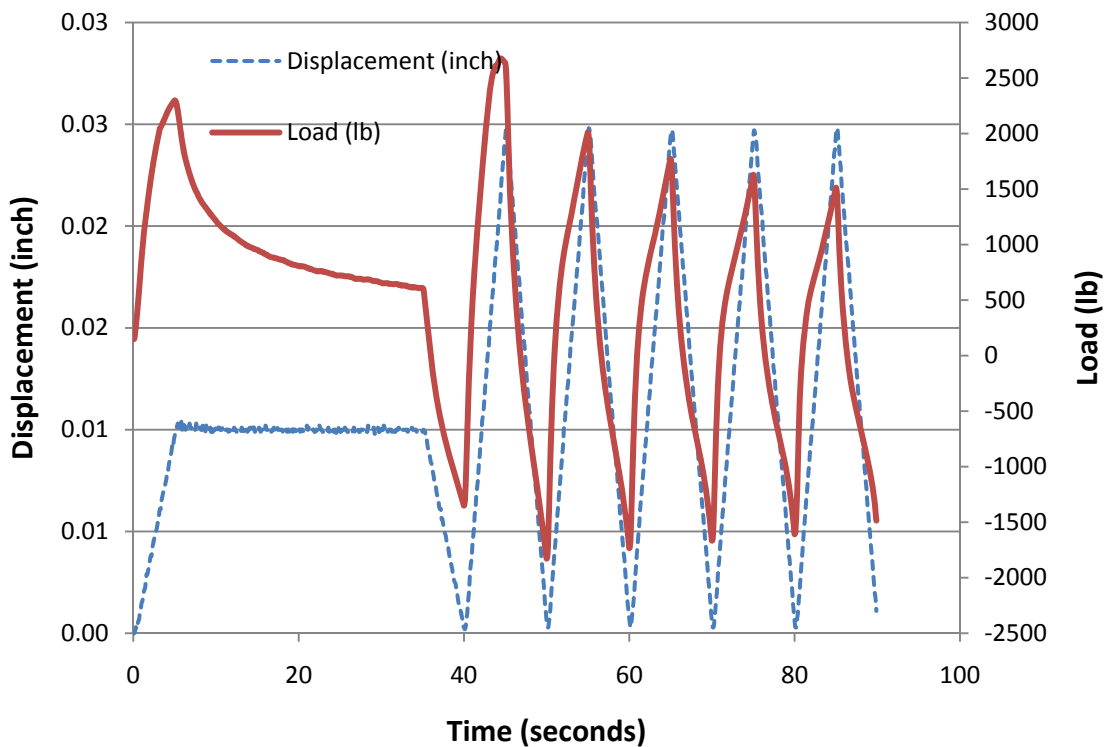
**Figure 4-4. Data Acquired during the Overlay Test of a Large Specimen.**

During the test period, an automated data acquisition system recorded the displacement and load at every 0.01 second. Figure 4-4 exhibits a typical data set acquired during the first 100 seconds for a specimen tested using the large overlay tester. The small overlay tester produced a similar graph, except that the magnitude of load is much smaller. Since the cyclic

displacement was kept constant at 0.025 inches, the load required to cause such displacement started decreasing. Propagation of the crack reduced the load required to induce constant displacement. Throughout the test procedure, propagation of crack was closely monitored by drawing a parallel line along the crack(s) observed on the three sides of the beam specimens. Cyclic displacement was continued until failure of the specimen. Failure is defined as the condition when continuous crack(s) are visible along both sides and the top of the specimen. But, on occasion, this condition was not observed; instead, intermittent cracks were observed and remained like that for several cycles. In those situations, the test was discontinued when the observed load remained constant for a long time (several hundred cycles). At the end of the test, the crack propagation map was photographed from all three sides of the specimens and filed for future analyses (Figure 4-5, Figure 4-6).

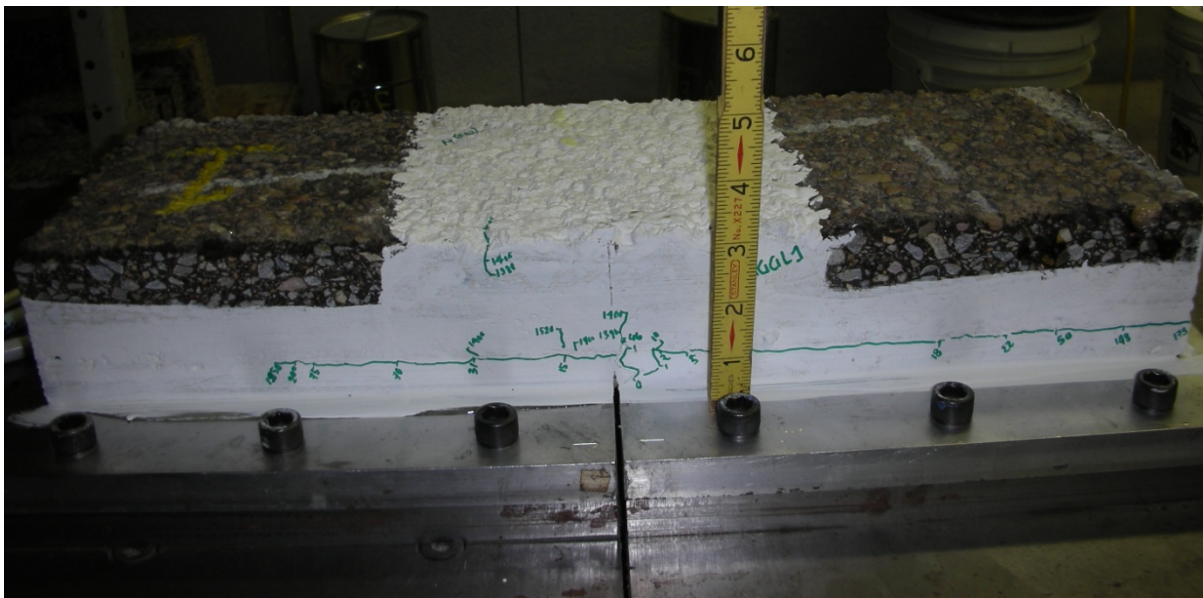
**Figure 4-5. Test Setup with Large Overlay Tester.**

between the specimen and the testing plate. These specimens could not be retested. Crack propagation was manually recorded along with the automated data acquisition. Tables 4-1 through 4-3 show the number of load cycles required to fail the specimens from Amarillo, Pharr, and Waco test pavements, respectively. Figures 4-9 through 4-11 depict the same results in a graphical form. In a few cases, cracks initiated at the bottom near the joint during the first part of the relaxation modulus test, even though the displacement was only 0.01 inch. Usually, vertical cracks reached the geosynthetic interlayer rather quickly. In general, it took much longer for the cracks to propagate vertically upward into the top layer (overlay). A few specimens with geosynthetics showed propagation of horizontal cracking along the interlayer (as shown in Figure 4-5) rather than moving upward.

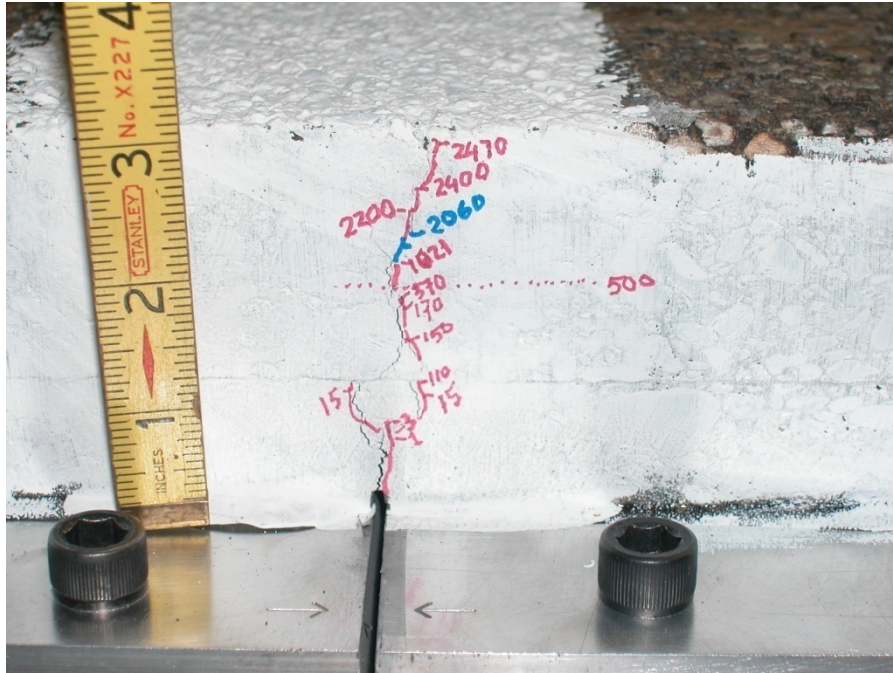
**Figure 4-6. Monitoring of Crack Propagation with Large Specimens.**

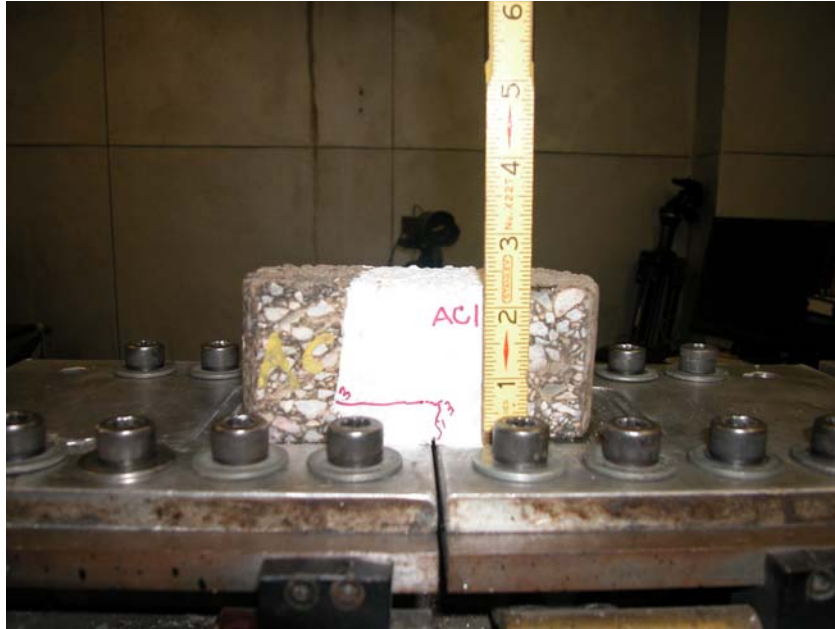
**Figure 4-7. Testing of Small Specimen with Small Overlay Tester.**

Most of the small specimens failed due to separation along the interlayer instead of crack propagation vertically upward to the top surface. Therefore, in most cases, tests were terminated very quickly. The reason for this is that the shearing strength at the interlayer was relatively low due to its smaller surface area relative to the larger overlay specimens. Consequently, specimens from other test pavements were not tested using the small overlay tester.

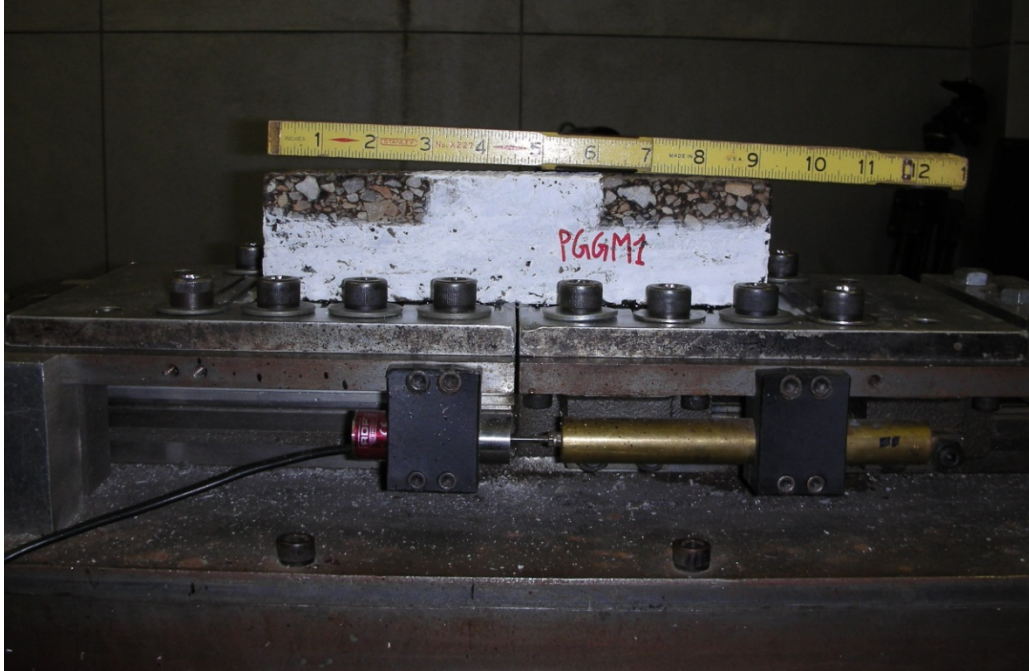
**Figure 4-8. Test Setup of Medium-Sized Specimen with Small Overlay Tester.**

Since TxDOT already invested significant resources in the small overlay tester, TxDOT engineers were interested in further evaluating whether the small overlay tester was capable of testing composite specimens. Once the research team was confident that composite specimens with 6-inch length and 3-inch width could not be tested using the small overlay tester, they made an attempt to test slightly larger specimens. Specimens were trimmed to 9-inches long and 3-inches wide. [Figure 4-8](#) shows this medium-sized specimen setup for testing using the small overlay tester. Four specimens from Pharr (GlasGrid and HaTelit) were prepared and tested accordingly. Unfortunately, all four specimens separated at the interlayer during the testing. Testing of medium-sized composite beams using the large overlay tester yielded similar results. This led the research team to believe that composite beams can be tested only by using large specimens with the large overlay tester.

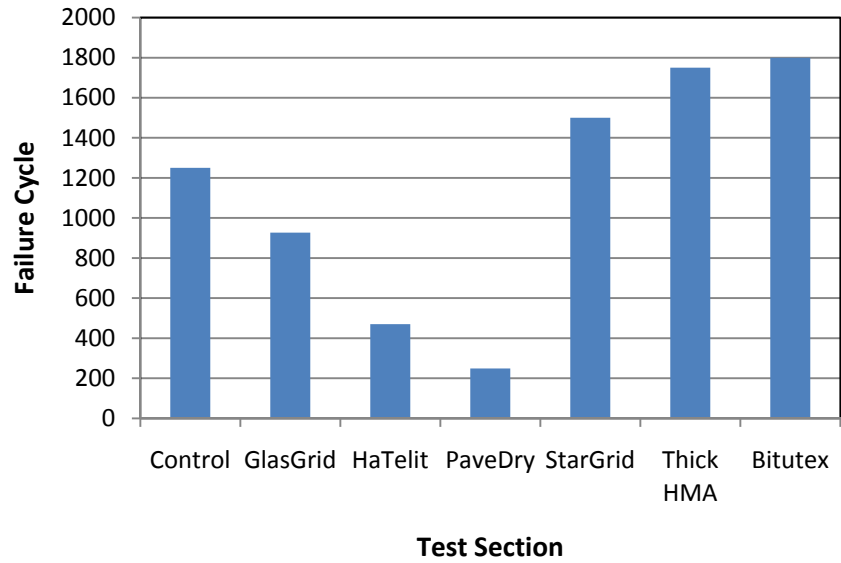
**Figure 4-10. Large Overlay Tester Results with Pharr Specimens.**

Specimens from the control section in the Pharr District survived a large number of load cycles compared to the other test pavements. This indicates that the overlay mixture itself was comparatively very crack resistant. The idea that the HMA used in this overlay is very crack resistant is supported by the field observations. Even after six years in service, only a very small amount of cracks were reflected in this test pavement. HaTelit and Pave-Dry specimens from the Pharr pavement exhibited relatively early failure. Most likely, this early failure is attributed to the specimens' configuration rather than their geosynthetic properties. Some specimens had a very thin bottom layer (due to milling of existing HMA surface). Milling away of most of the cracks in the existing HMA layer may have contributed to lower cracking reflection potential in the overlay.

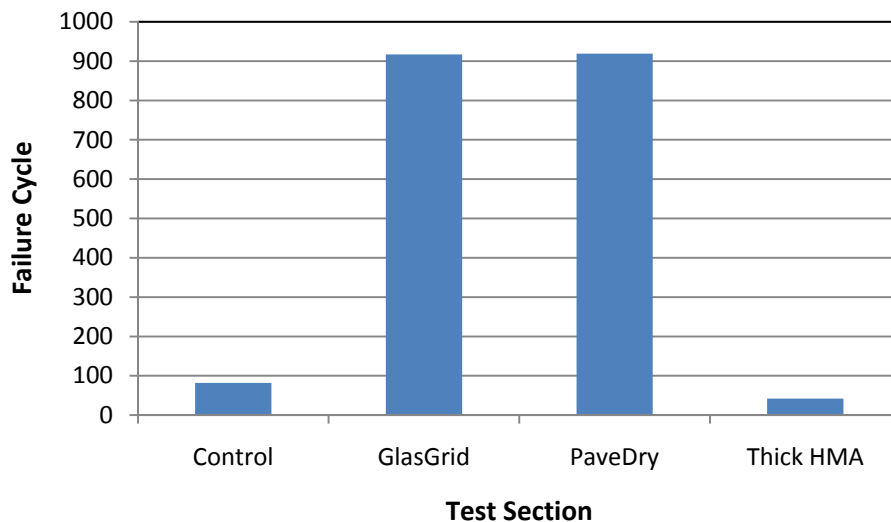
**Figure 4-11. Large Overlay Tester Results with Waco Specimens.**

Table 4-3 and Figure 4-11 present results from the large overlay tester for the Waco test pavement. Specimens containing a geosynthetic survived a significantly large number of load cycles compared to the specimens without a geosynthetic (control and thick control). During the field observations, it was noted that these same test sections performed better than the control section but not as much as their superior performance observed in laboratory testing.

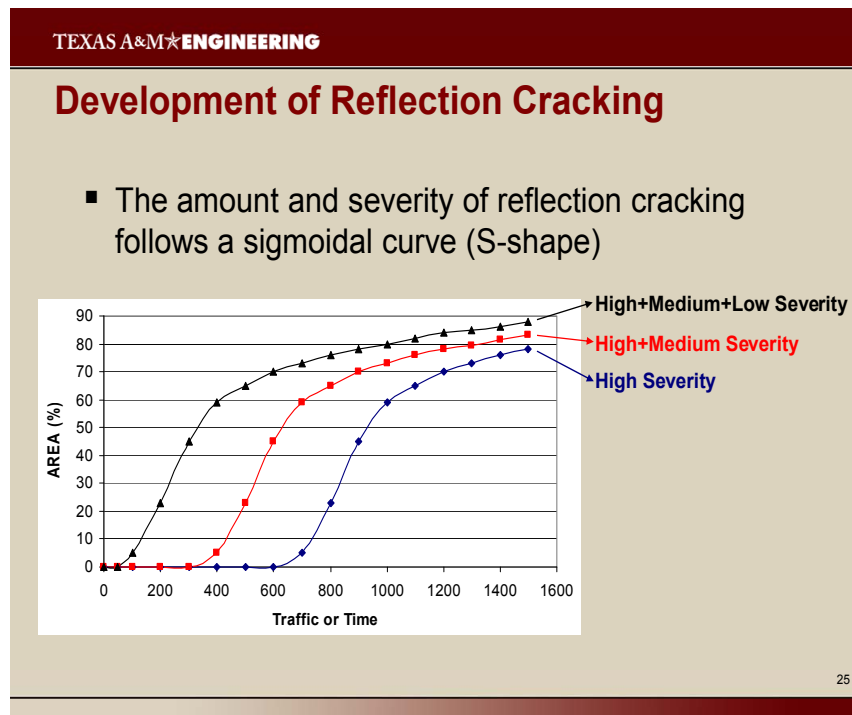
**Figure 5-1. S-Curve Showing Crack Development and Severity Level.**

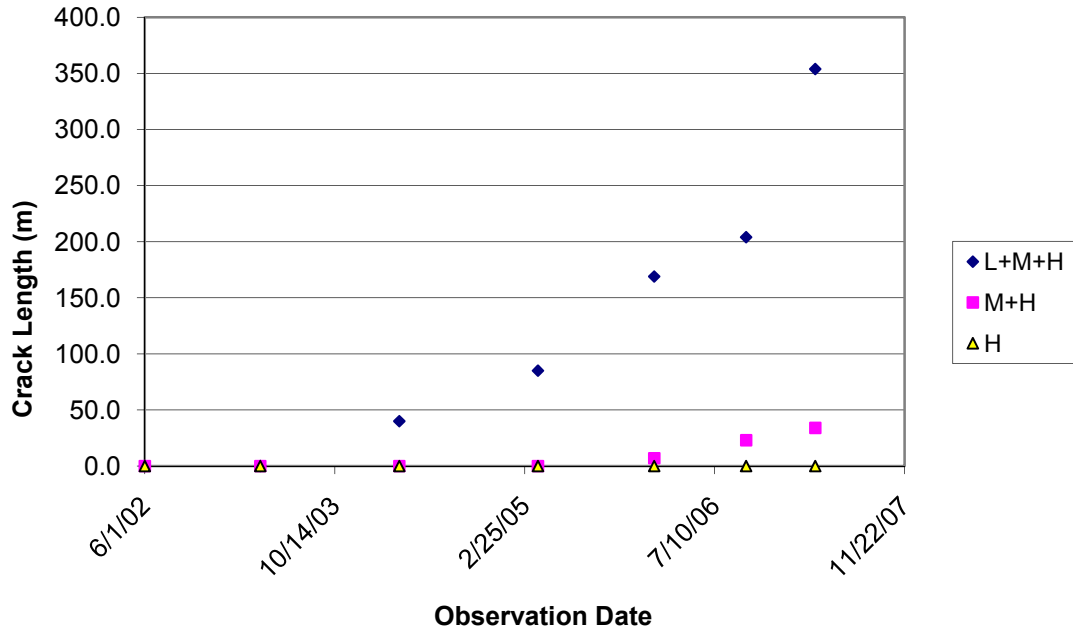
**Figure 5-2. Amarillo Control Section Transverse Reflective Cracks.**

Figures 5-2 and 5-3 exhibit the transverse reflective cracking of different severity levels on the control section in the Amarillo test pavement. Figure 5-4 demonstrates the trend curve prepared from observed data. Since the amount of medium-severity cracks was very small (if any), all the cracks were considered as low severity. Similarly, graphs were produced for each test section of Amarillo and Waco test pavements for further analyses.

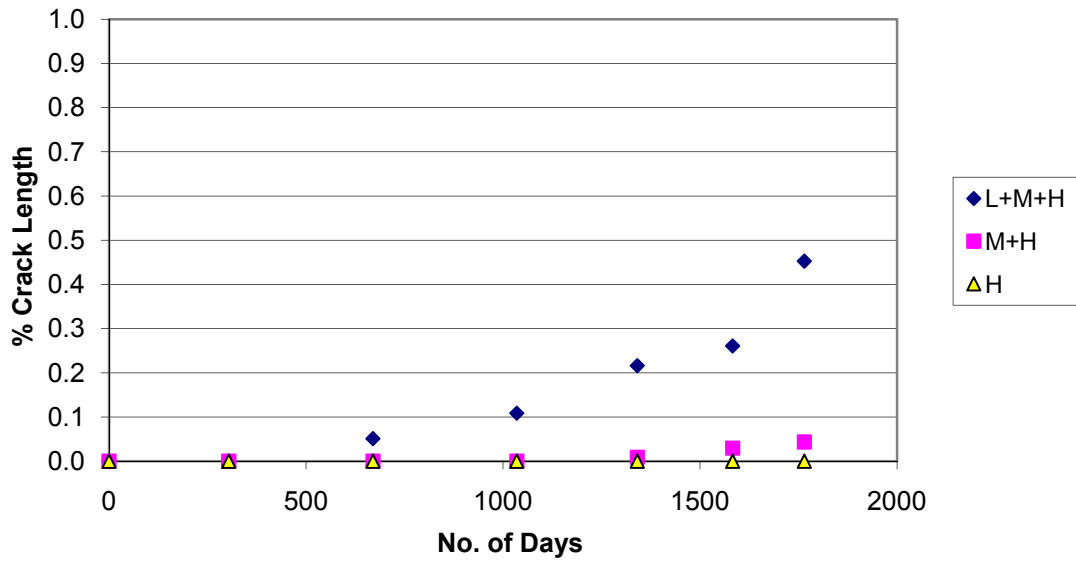
**Figure 5-3. Amarillo Control Section Transverse Reflective Cracks Percentage.**

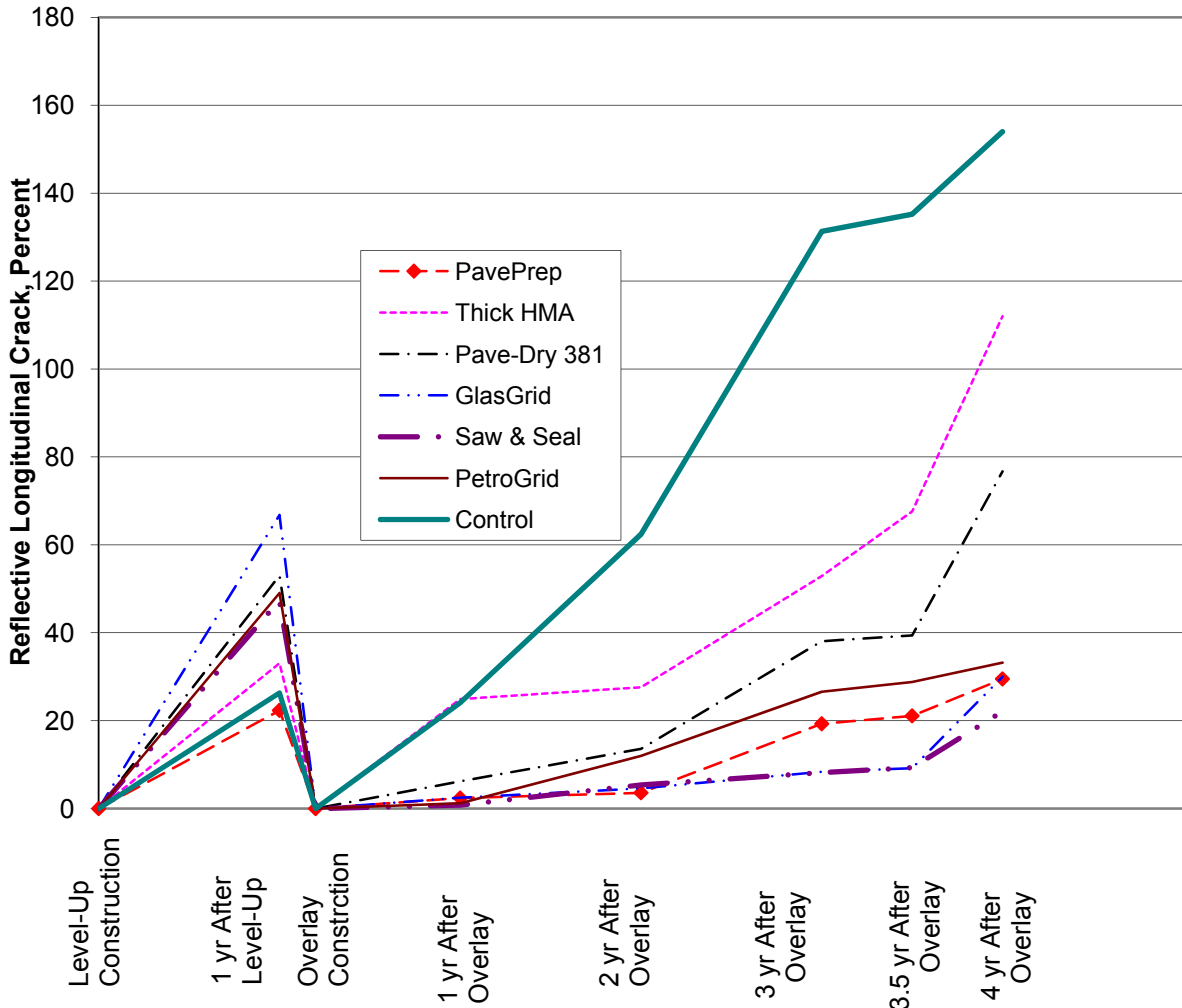
**Figure A2. Waco District Reflective (Longitudinal) Cracking vs. Time — Based on Cracking Measured on Leveling Course before Overlay.**

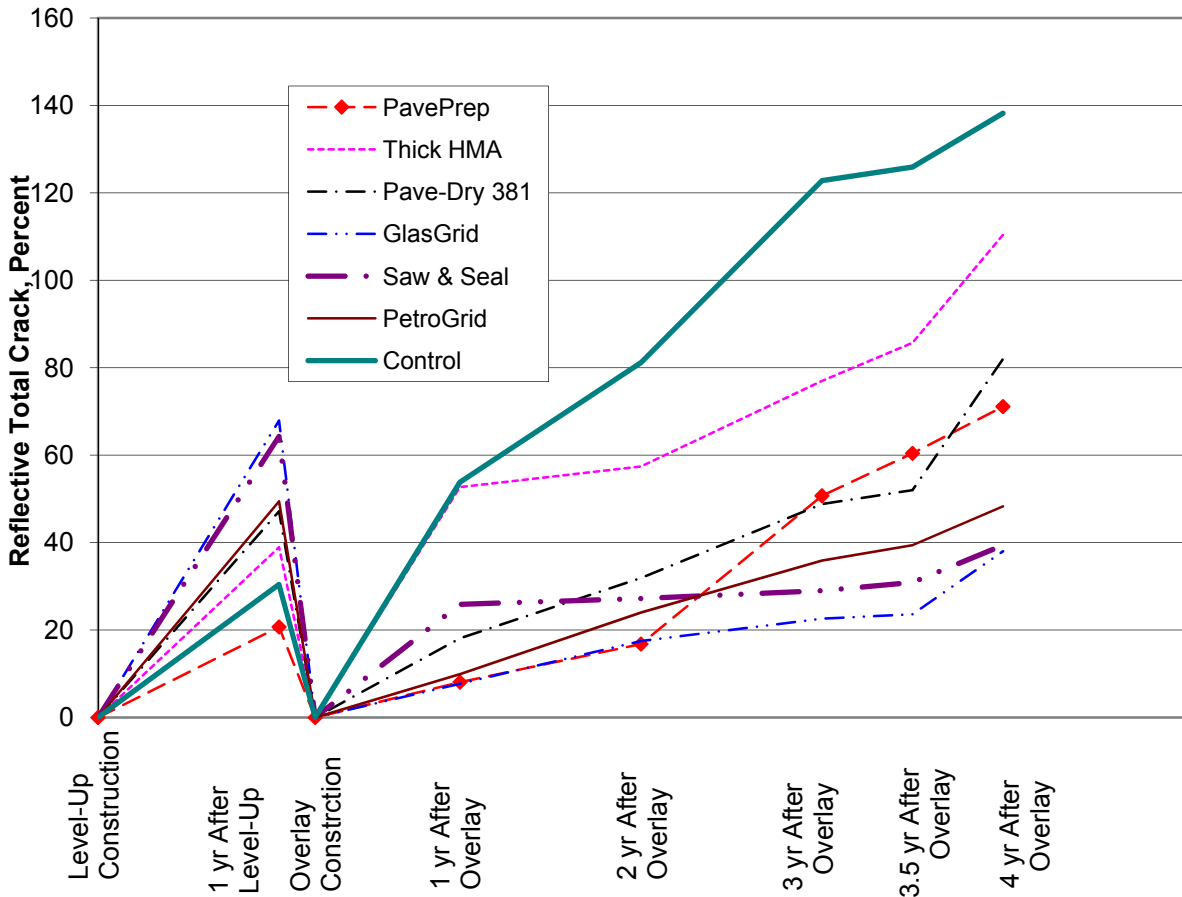
**Figure A3. Waco District Reflective (Total) Cracking vs. Time — Based on Cracking Measured on Leveling Course before Overlay.**

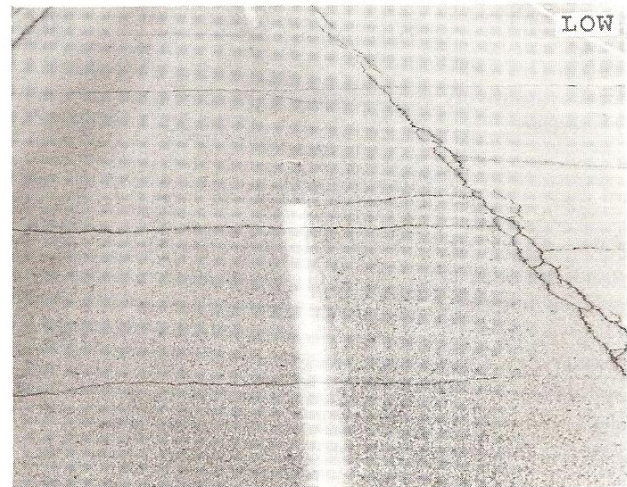
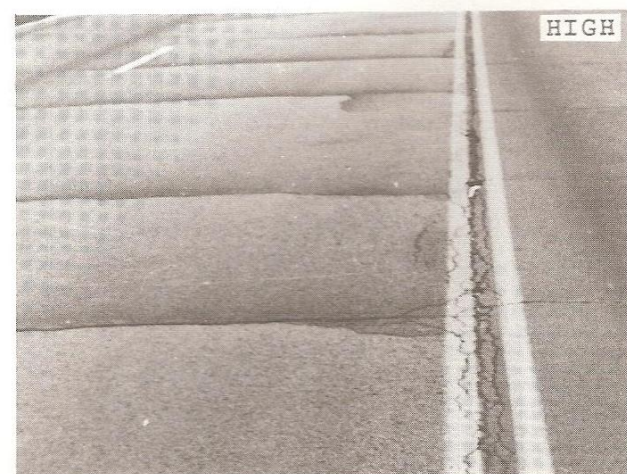
**Figure A4. Classification of Reflection Cracking (after SHRP-LTTP/FR-90-001).**

- Number and linear feet of longitudinal and transverse cracks at each severity level.
- Measurements for longitudinal and transverse cracks shall be recorded separately.

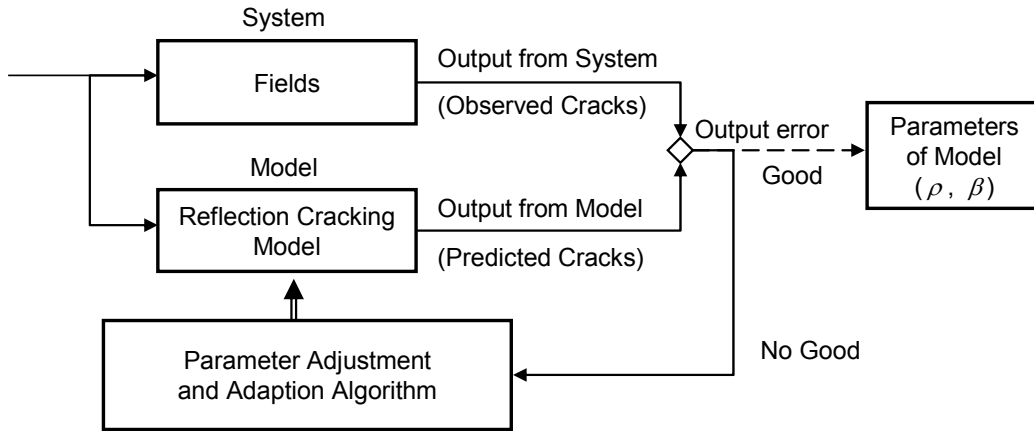
**Figure A6. Scheme of System Identification Process.**

When the output error between system and model is small enough to meet an error criterion, it is assumed that an optimal model for the system is obtained. However, if the error does not meet the criterion, the parameters in the mathematical model should be corrected by a parameter adjustment and adaptation algorithm. The correction process is performed iteratively until the error becomes small enough using the algorithm. Figure A6 depicts the scheme of a system identification process based on the forward model and parameter adjustment and adaptation algorithm for the reflection cracking model calibration.
