1. Report No. FHWA/TX-10/0-1777-3		2. Government Accession No.		3. Recipient's Catalog No.	
4. Title and Subtitle TESTS OF HMA OVERLAYS USING GEOSYNTHETICS TO REDUCE REFLECTION CRACKING				5. Report Date February 2009 Published: December 2009

# **TESTS OF HMA OVERLAYS USING GEOSYNTHETICS TO REDUCE REFLECTION CRACKING**

Report 0-1777-3  
Project 0-1777

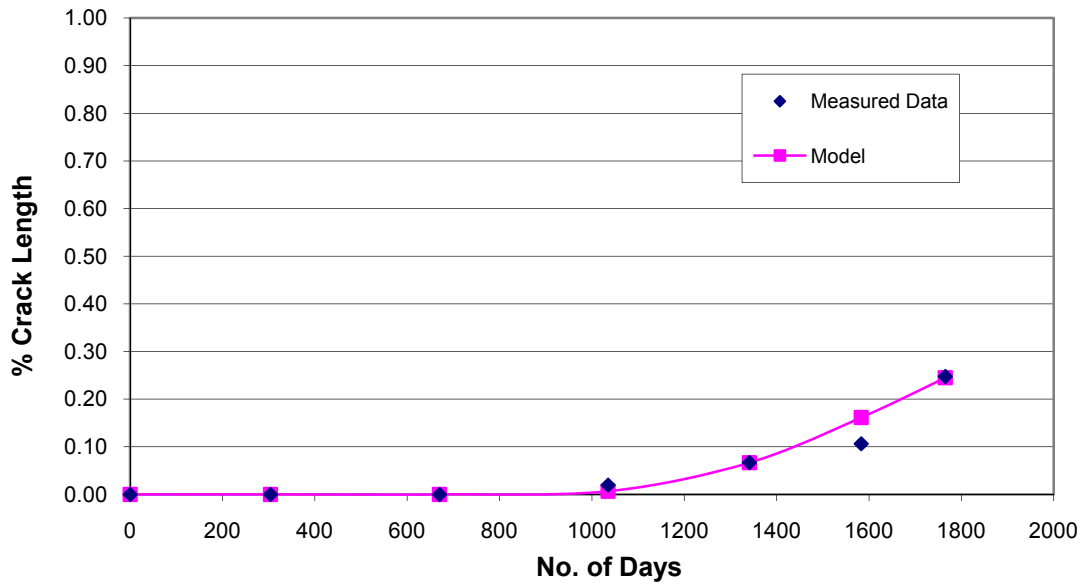
**Figure A7. Calibrated Model on Measured Reflective Crack for PetroGrid Section in Amarillo.**

Section ID	Overlay Type	Model Parameters (L+M+H)	
		$\beta$	$\rho$
PetroGrid - Amarillo	AC/AC	2.383	2036.85
PetroGrid - Waco	AC/Jointed Concrete	0.800	1881.81
