1. Report No. FHWA/TX-03/0-4150-4		2. Government Accession No.		3. Recipient's Catalog No.	
4. Title and Subtitle EFFECTIVE PAVEMENT MARKING PRACTICES FOR SEALCOAT AND HOT-MIX ASPHALT PAVEMENTS				5. Report Date August 2003

6. Performing Organization Code	
7. Author(s) Timothy J. Gates, H. Gene Hawkins, Jr., and Elisabeth R. Rose				8. Performing Organization Report No. Report 0-4150-4

9. Performing Organization Name and Address Texas Transportation Institute The Texas A&M University System College Station, Texas 77843-3135				10. Work Unit No. (TRAIS)

**EFFECTIVE PAVEMENT MARKING PRACTICES FOR SEALCOAT  
AND HOT-MIX ASPHALT PAVEMENTS**

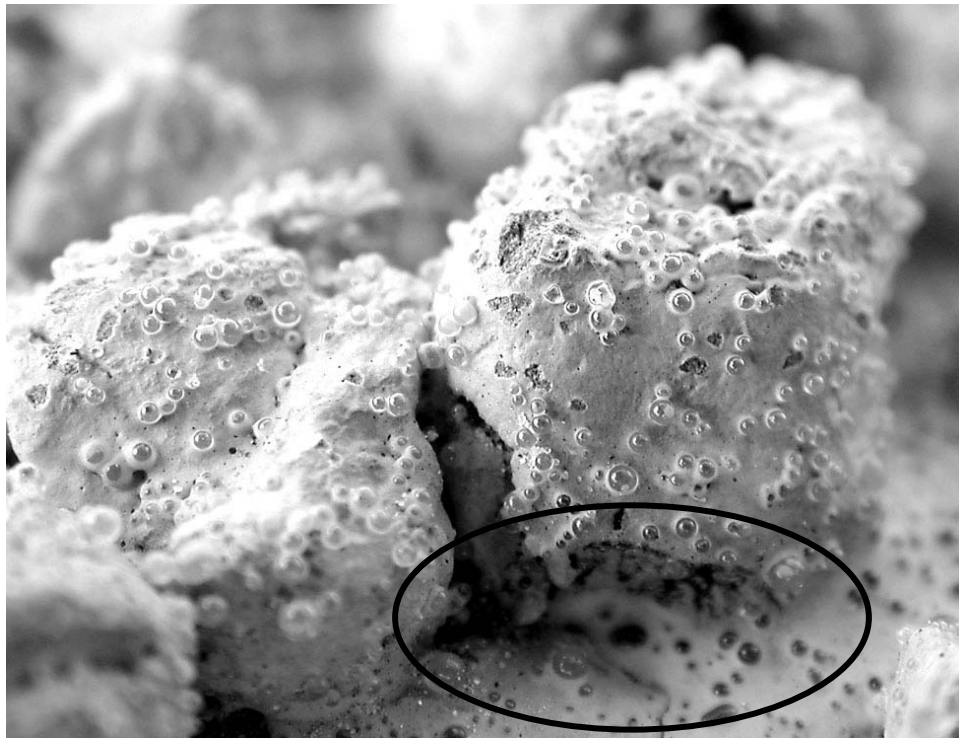
**Figure 9. Beads Falling between Aggregates.**

<b>Problem</b>	<b>Cause</b>
Lower overall retroreflectivity	A high percentage of the binder and beads falls into the surface voids and crevices where shadowed by aggregates ( <a href="#">Figure 9</a> ).
Material has worn off from tops of aggregates	Exposed binder material on top of aggregate results in material wearing off quickly ( <a href="#">Figure 10</a> ).
Poor retroreflectivity on backside of aggregate	The momentum of the striping truck causes the frontsides of the aggregates to receive ample binder and bead coverage, while the backsides remain uncoated ( <a href="#">Figure 11</a> ).
Bead loss on top of aggregates	Thin binder material on top of the aggregates results in poor bead embedment and adhesion ( <a href="#">Figure 12</a> ).

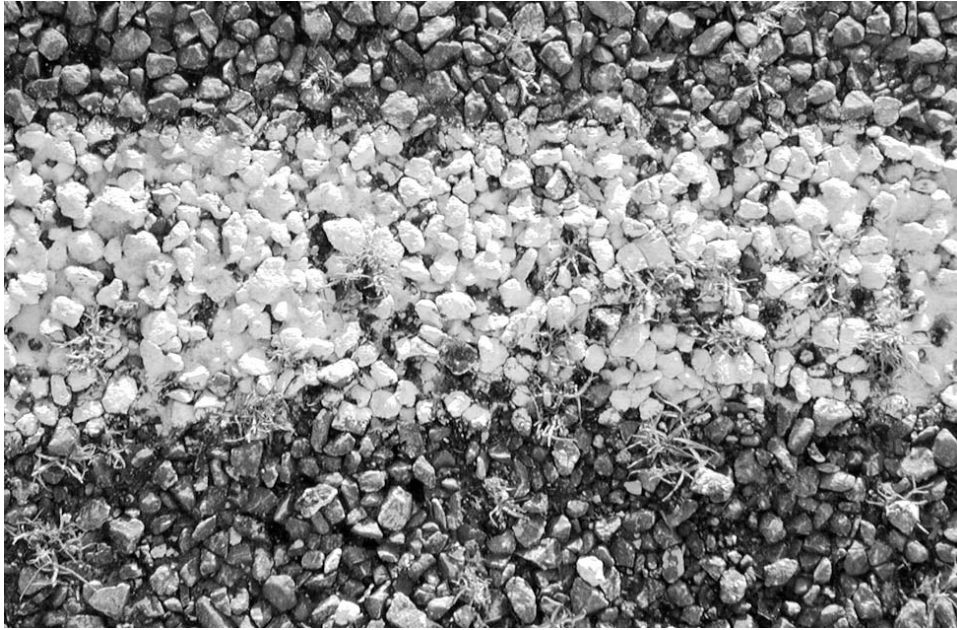
**Figure 13. Pavement Marking on Sealcoat with Aggregate Roll and Pop-Out.**

<b>Problem</b>	<b>Cause</b>
Aggregate-sized holes in marking material	Uncured asphalt allows loose aggregates to pop out from the surface, removing portions of the markings (Figure 13).
Spots of asphalt on markings	Sprayed hot thermoplastic often boils the asphalt to the surface of the marking (Figure 14).
Markings covered with asphalt	Uncured asphalt bleeds to the pavement surface and is tracked onto markings (Figure 15).

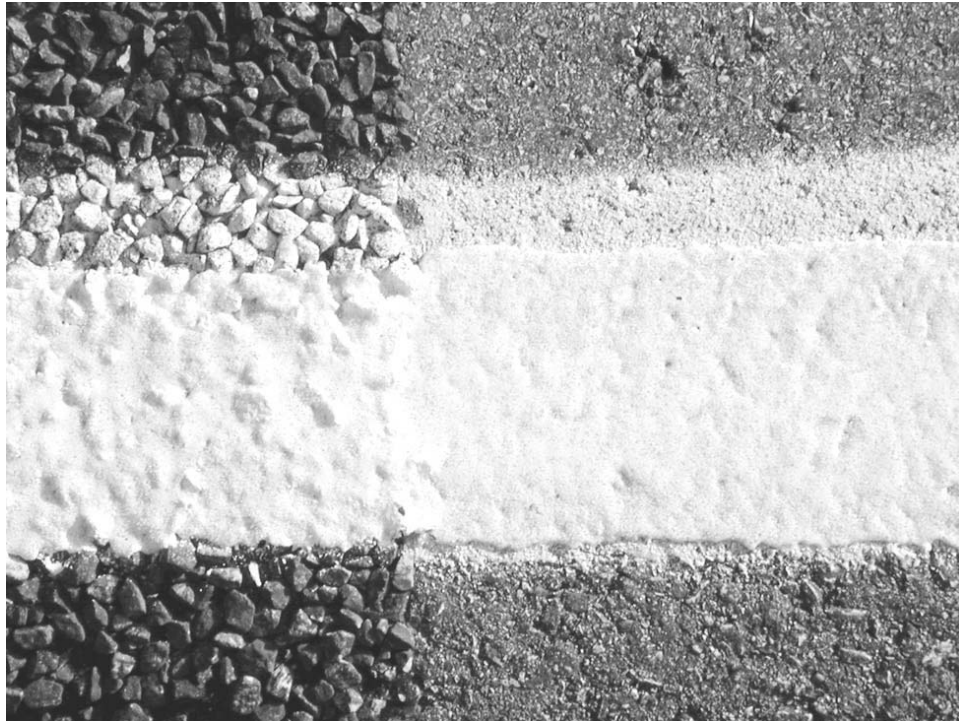
**Figure 16. Thermoplastic Marking on HMA vs. Sealcoat.**

Location	SH 64, west of Tyler, Texas
Roadway Type	Two-way, two-lane rural highway with shoulders
Evaluation Date	March 30, 2001
Length of Section	100 ft (50 ft HMA, 50 ft sealcoat)
Age of Pavement Markings	14 days
Striping Condition	Restripe
Beads	TxDOT Type II
Specified Marking Thickness	100 mil
Experimental Variable	<ul style="list-style-type: none"><li>• Pavement Surface Type<ol style="list-style-type: none"><li>1. HMA</li><li>2. Sealcoat (Grade 4)</li></ol></li></ul>
Measure of Effectiveness	<ul style="list-style-type: none"><li>• Initial Retroreflectivity</li></ul>

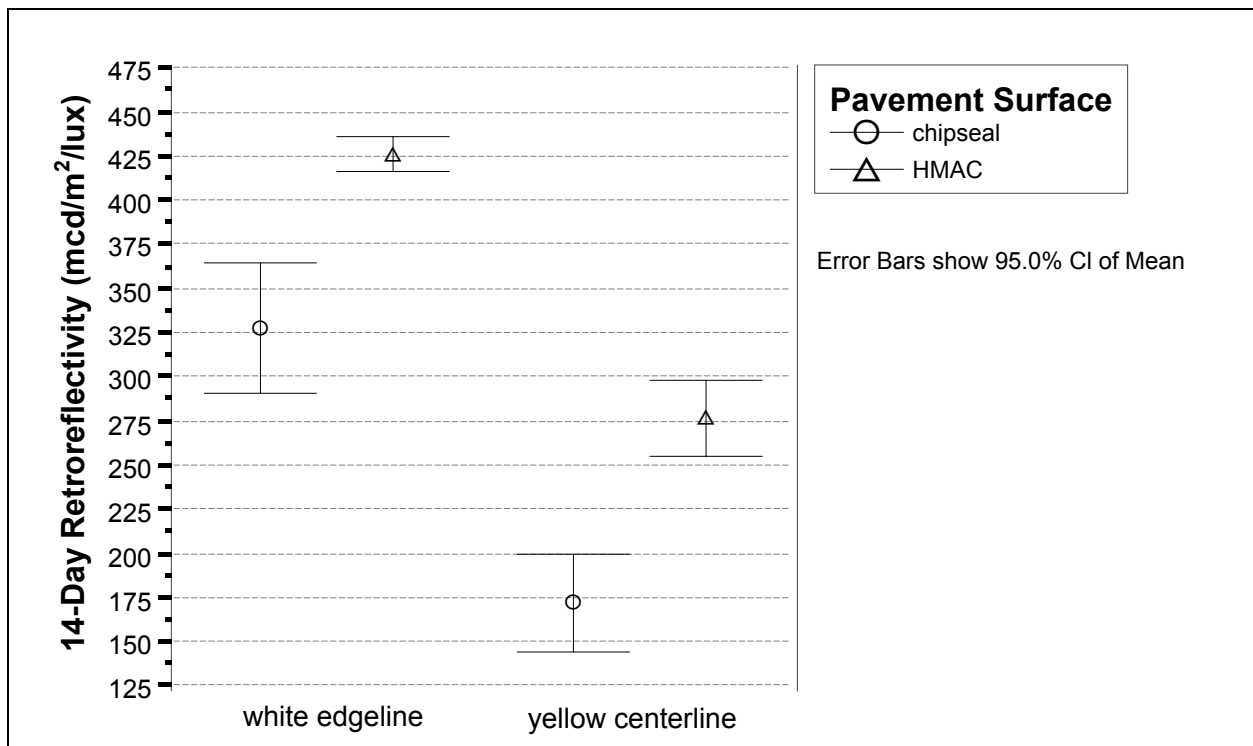
**Figure 17. 14-Day Retroreflectivity vs. Pavement Surface Type and Marking Color.**  
**Figure Note: Overlapping confidence intervals (CI) indicate no statistical difference between the populations.**

[Figure 17](#) shows a graphical representation of the retroreflectivity averages and 95 percent confidence intervals for the averages.

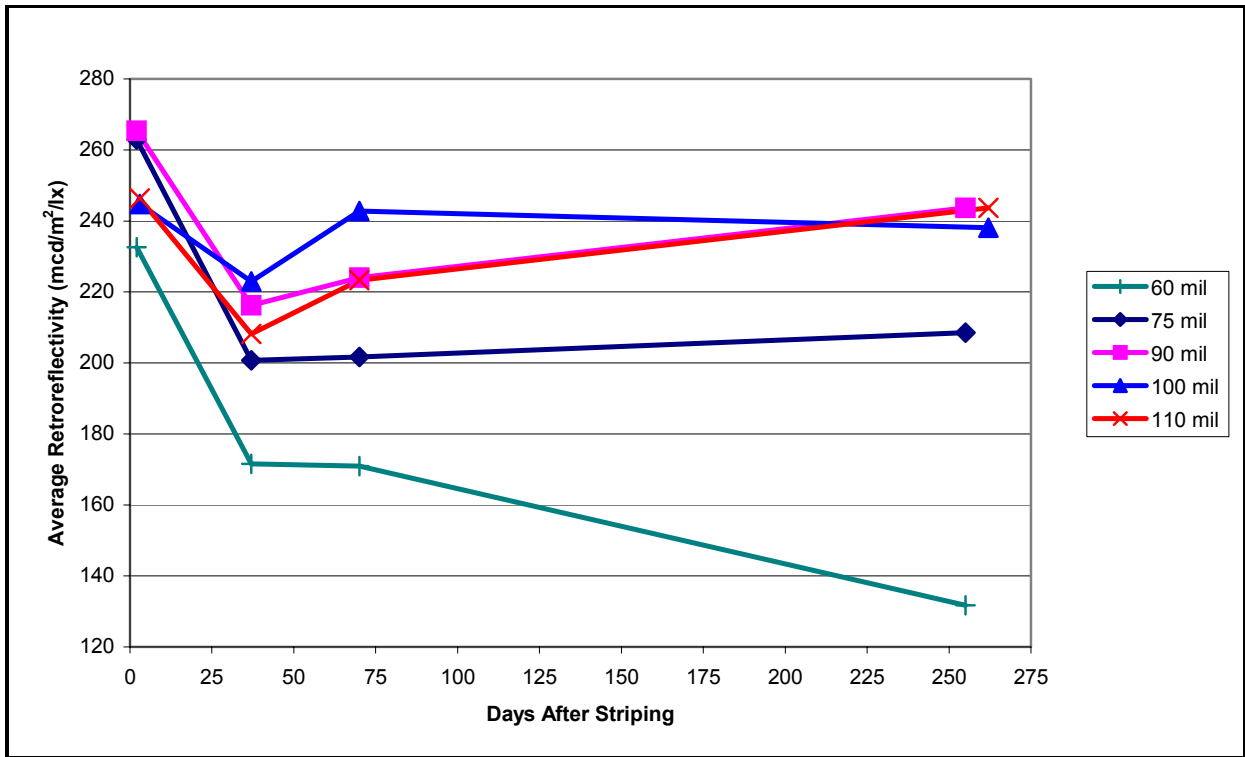
Figure 21. Average Retroreflectivity for White Edge Line.

It can be observed in the preceding tables and figures that for nearly every marking thickness, retroreflectivity declined significantly over the first month, but leveled off after one month, and in many cases began to increase after the first or second month. The retroreflectivity degradation was generally less pronounced for thicker markings.

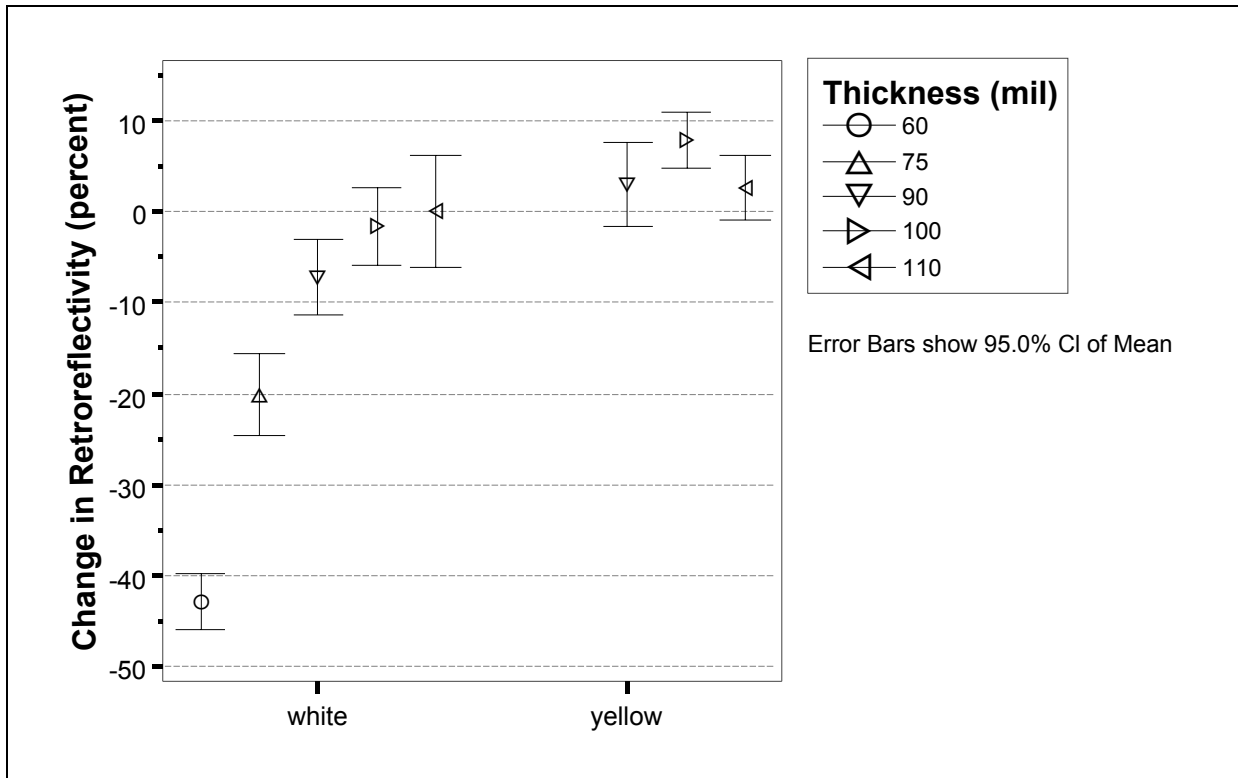
**Figure 24. Confidence Intervals for Average Percent Change in Retroreflectivity during First Nine Months.**

It can be observed from the preceding tables that thermoplastic thickness had a significant effect on the change in retroreflectivity over time, but only for markings equal to or greater than 90 mil. Figure 24 shows that markings with thicknesses equal to or greater than 90 mil retained initial levels of retroreflectivity during the first nine months significantly better than marking sections that were thinner than 90 mil.

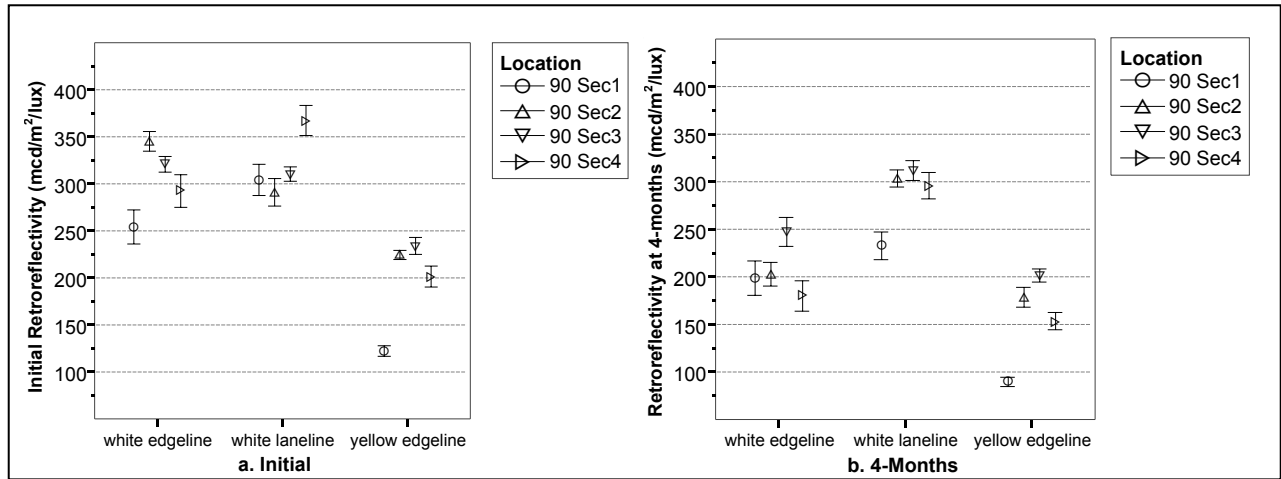
**Figure 25. Confidence Intervals for Average Retroreflectivity, US 90.**

Statistical analysis showed that the type of material, color, and position on the roadway had a highly significant effect on retroreflectivity both initially and after four months for both white and yellow markings. Figures 25 and 26 display the 95 percent confidence intervals for average retroreflectivity initially and at 4 months as a function of marking type (denoted by section number), color, and position on the roadway.

It can be observed in Figures 25 and 26 that for every line type except the white edge line on US 90, waterbased paint used by itself (Treatment 1) clearly provided significantly lower levels of retroreflectivity than each of the thermoplastic applications (Treatments 2-4), both initially and even more so at 4 months. Initial retroreflectivity levels for paint were up to 150 mcd/m<sup>2</sup>/lx less than those of thermoplastic sections and were up to 225 mcd/m<sup>2</sup>/lx less after 4 months. Each of the thermoplastic applications provided similar levels of retroreflectivity both initially and at 4 months. Figure 28 shows typical paint stripes after four months on FM 365. Note the worn appearance of the markings, which helps explain the poor retroreflectivity levels.

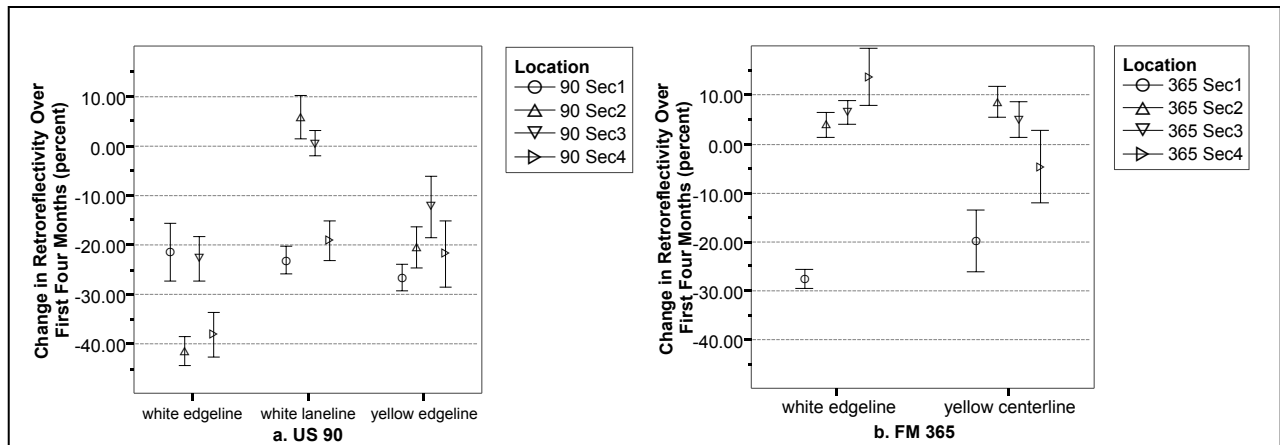
**Figure 27. Confidence Intervals for Average Percent Change in Retroreflectivity.**

Statistical analysis showed that the type of material, color, and position on the roadway had a highly significant effect on the change in retroreflectivity over the first 4 months. Figure 27 displays the 95 percent confidence intervals for average percent change in retroreflectivity as a function of marking type (denoted by section number), color, and position on the roadway for US 90 and FM 365.

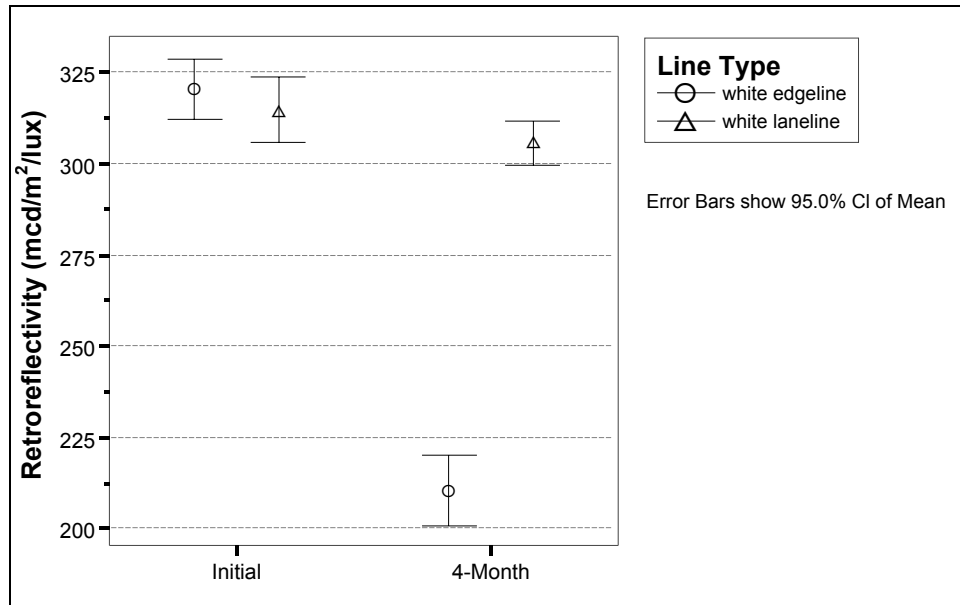
**Figure 33. Confidence Intervals for Average Initial and 4-Month Retroreflectivity for Edge Line vs. Lane Line.**

Figure 33 provides a comparison of the retroreflectivity data from the white thermoplastic edge line (sparse aggregate spacing) vs. lane line (dense aggregate spacing).

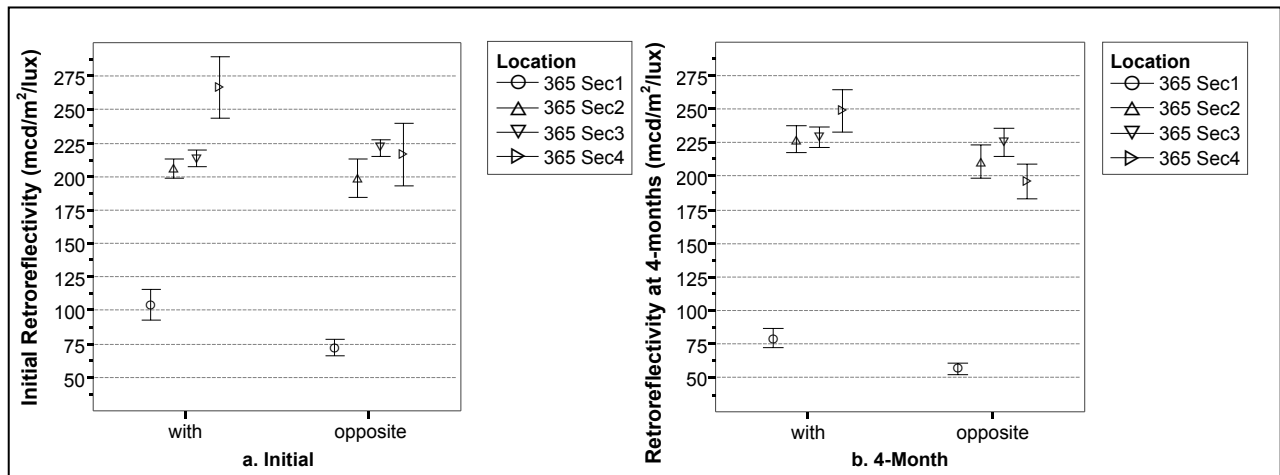
**Figure 34. Confidence Intervals for Average Initial and 4-Month Retroreflectivity for Yellow Centerline.**

Retroreflectivity data for the yellow centerline on FM 365 mostly showed slight differences as a function of measurement direction. Figure 34 displays the 95 percent confidence intervals for average yellow centerline retroreflectivity on FM 365 both initially and after four months as a function of measurement direction and material type.

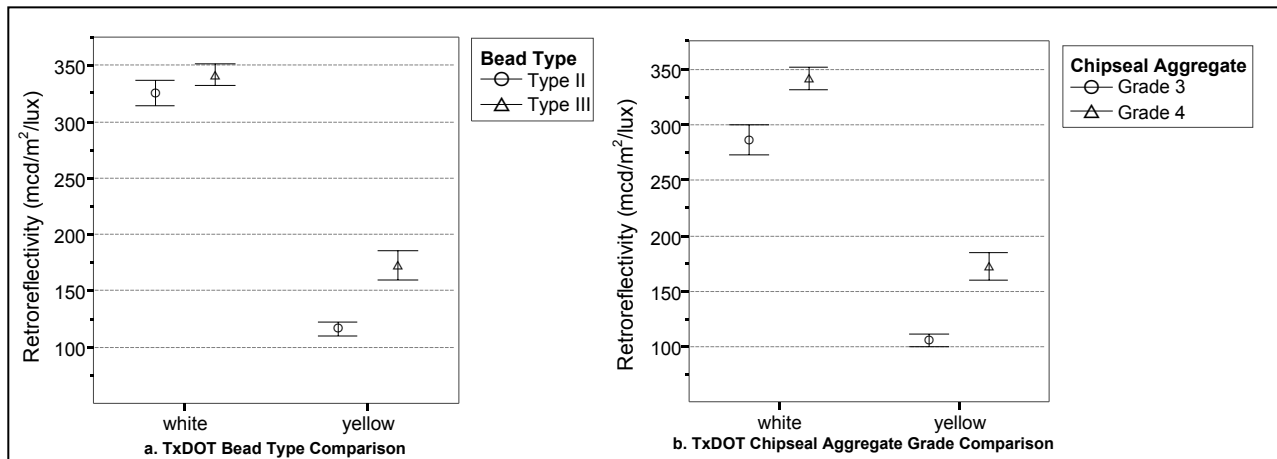
**Figure 35. Confidence Intervals for Average 1-Month Retroreflectivity.**

Statistical analysis showed that the glass bead type, sealcoat aggregate grade, and marking color all had a statistically significant effect on retroreflectivity after one month. Figure 35 displays the 95 percent confidence intervals for average 1-month retroreflectivity as a function of the glass bead type, sealcoat aggregate grade, and color. Please note that the bead type comparison included only markings on Grade 4 sealcoat, and the sealcoat aggregate comparison included only markings with Type III beads.

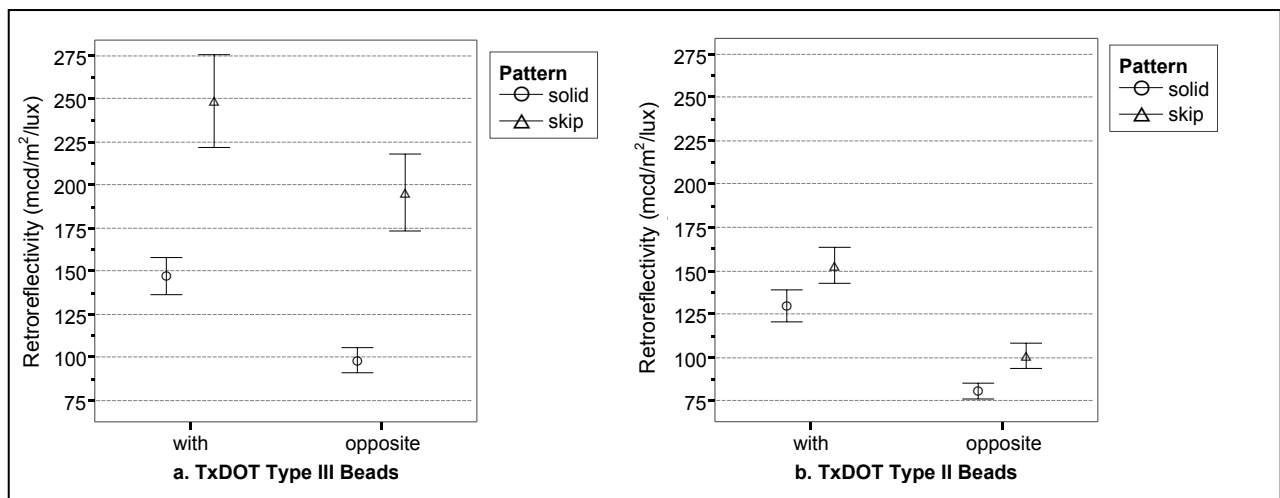
**Figure 36. Confidence Intervals for Average 1-Month Yellow Centerline Retroreflectivity.**  
**Figure Note: Overlapping confidence intervals indicate no statistical difference between the populations.**

Further analysis on the yellow centerline markings on the Grade 4 sealcoats showed that the measurement direction, marking pattern, and glass bead type, all had a statistically significant effect on retroreflectivity after one month. Figure 36 displays the 95 percent confidence intervals for average 1-month retroreflectivity of yellow centerlines as a function of measurement direction, marking pattern, and glass bead type.

Figure 36 shows that in every case, skip centerlines provided significantly higher levels of retroreflectivity when compared to solid centerlines. These differences were much more pronounced when Type III beads were used. During the site visit, TTI researchers noted that the skip centerline always appeared to be slightly thicker and with better bead dispersion than its solid counterpart. A typical skip/solid centerline combination is shown in Figures 37 and 38. Note the thicker appearance of the skip centerline (left) vs. the solid centerline (right).
