1. Report No. FHWA/TX-05/0-4366-1		2. Government Accession No.		3. Recipient's Catalog No.	
4. Title and Subtitle DEVELOPING AN IN-SERVICE PERFORMANCE EVALUATION (ISPE) FOR ROADSIDE SAFETY FEATURES IN TEXAS				5. Report Date December 2004

14. Sponsoring Agency Code	
15. Supplementary Notes Project performed in cooperation with the Texas Department of Transportation and the Federal Highway Administration. Project Title: In-service Performance Evaluation of Roadside Safety Features url: http://tti.tamu.edu/documents/0-4366-1.pdf

**DEVELOPING AN IN-SERVICE PERFORMANCE EVALUATION (ISPE)
FOR ROADSIDE SAFETY FEATURES IN TEXAS**

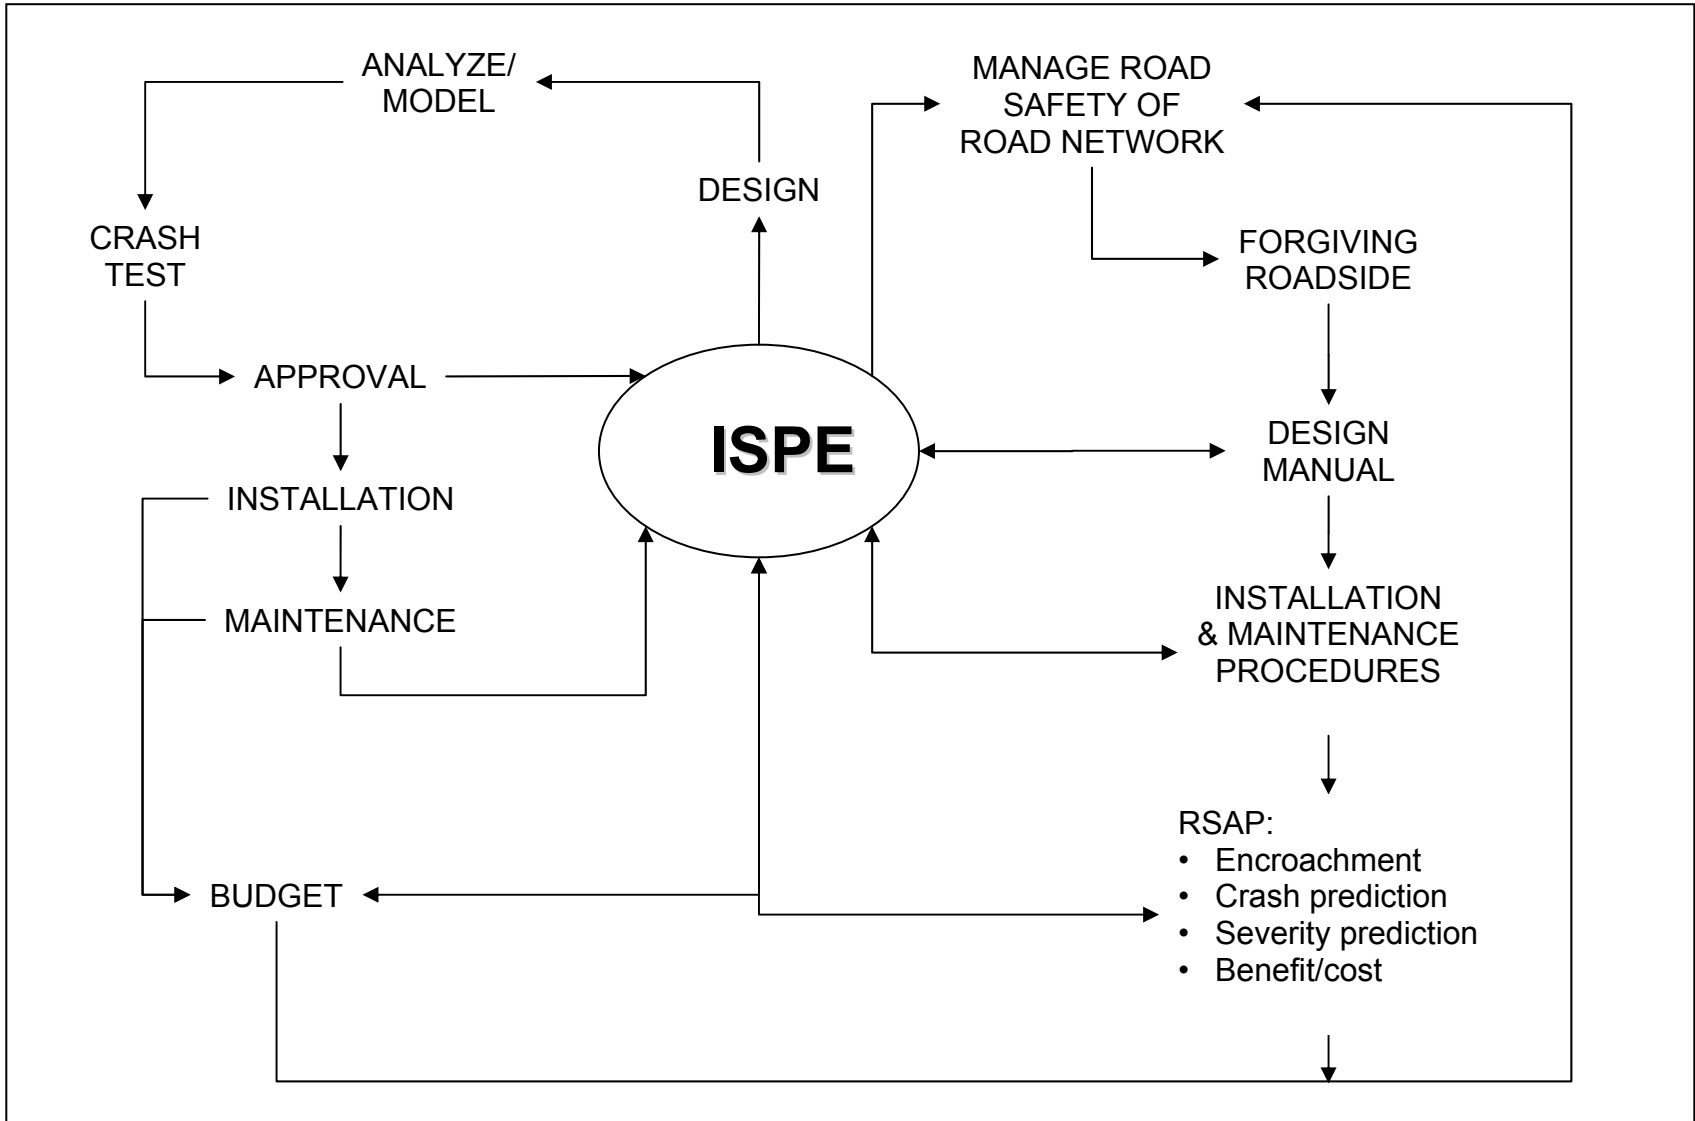
Figure 2: The ISPE Process as Part of the Maintenance Process, the Safety Management Process of the Road Network and the Development of Safety Features Process

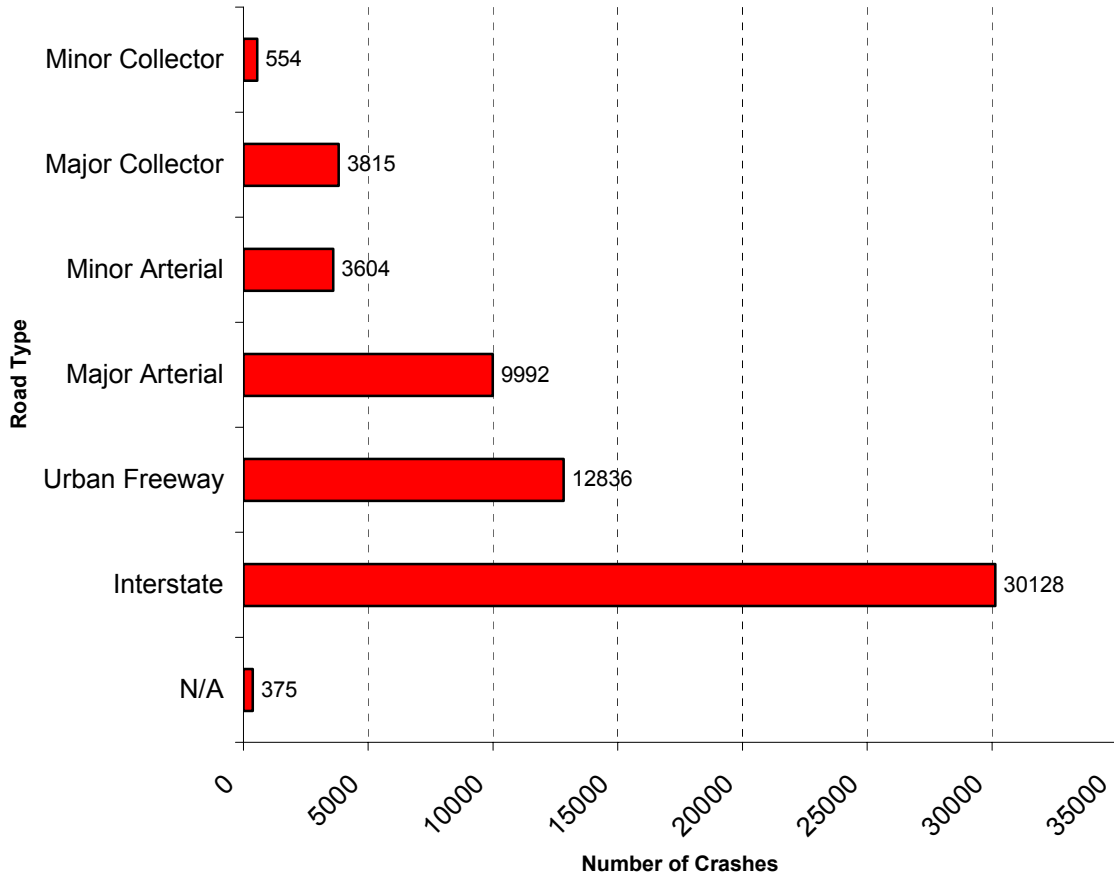
Figure A4. Number of Crashes by Road Type (1997-1999).

Figure A4 illustrates the number of crashes by road type. This figure shows that more than 60 percent of all crashes occur on interstate and urban freeways. Nonetheless, a relatively high percentage of collisions (40 percent) takes place on state maintained arterial and collector roads.

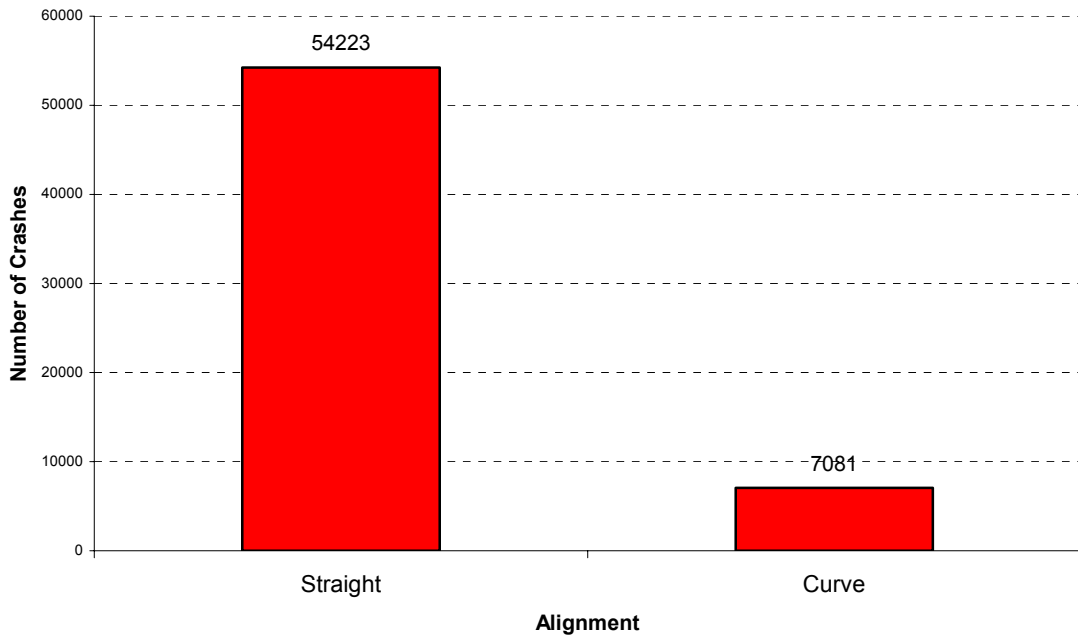
Figure A5. Number of Crashes by Alignment Type.

Figure A5 illustrates the number of crashes by alignment type. About 88 percent of all crashes involving a roadside safety feature occur on a straight alignment. Previous work on this topic has shown that crashes occur 70 percent of the time on straight alignment (Miaou and Bullard, 2001). It should be noted, however, that the study has been performed with a weighted sample. It is estimated that less than 0.5 percent of crashes happened on either a grade or on a hill.

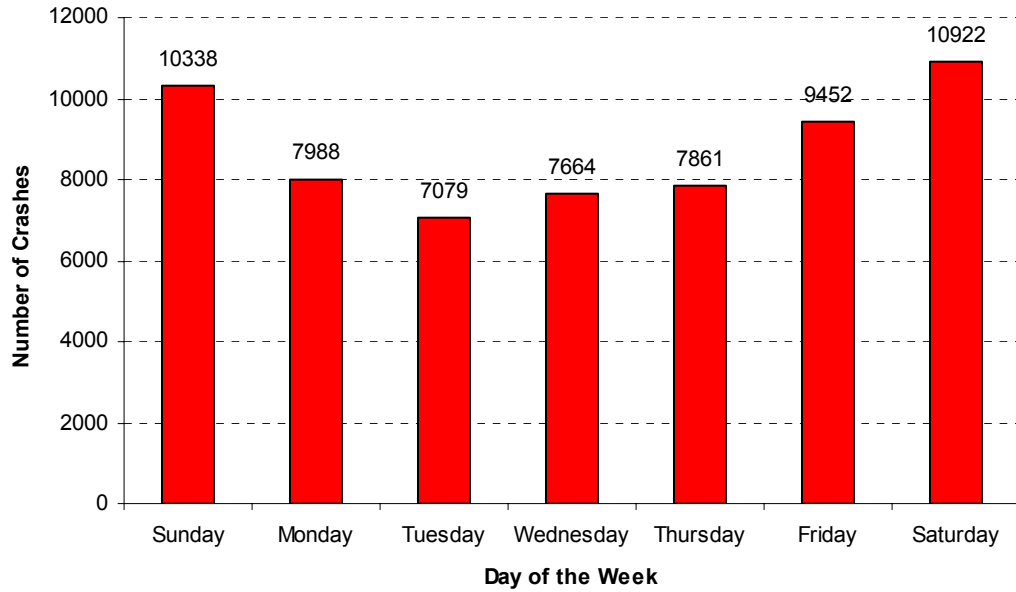
Figure A7. Number of Crashes by Day of the Week (1997-1999).

Figure A7 illustrates the number of crashes by the day of the week. This figure demonstrates that crashes occur more frequently on weekends. There are about 33 percent more crashes on a Saturday or Sunday than on a typical weekday.

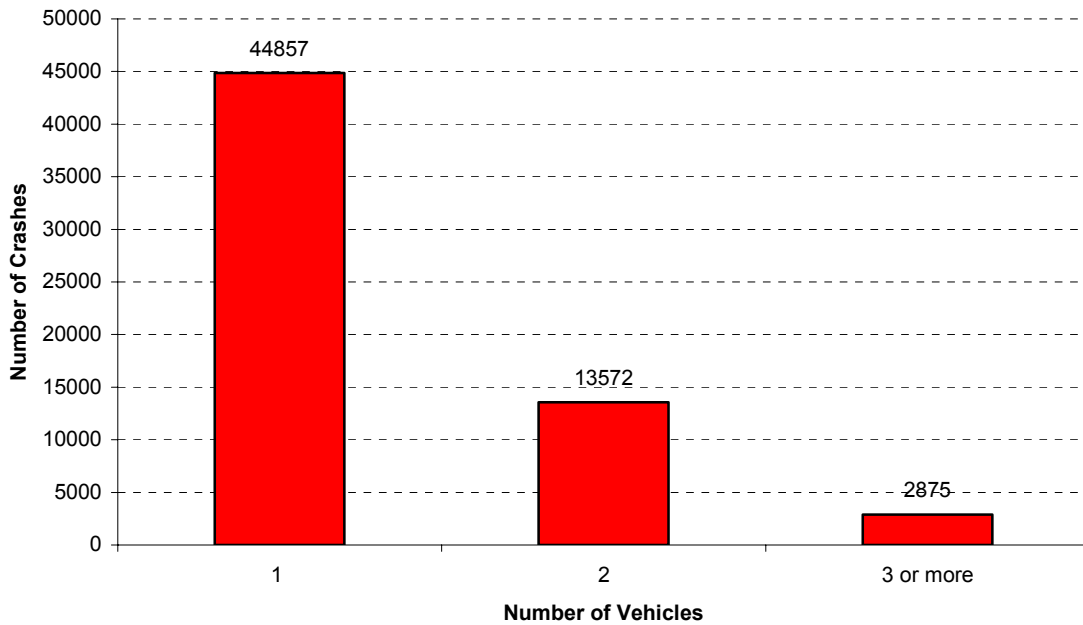
Figure A8. Number of Vehicles in the Crash (1997-1999).

Figure A8 illustrates the number of vehicles involved in a crash. This figure reveals that about 73 percent of crashes are classified as a single-vehicle collision. It should be pointed out that in about 5 percent of single-vehicle crashes, another object was hit first before hitting one of the nine roadside safety features (the other objects were reported as the first harmful event for the crash rather than any one of the roadside safety features). Single-vehicle crashes are described in greater detail in Section A3.3.

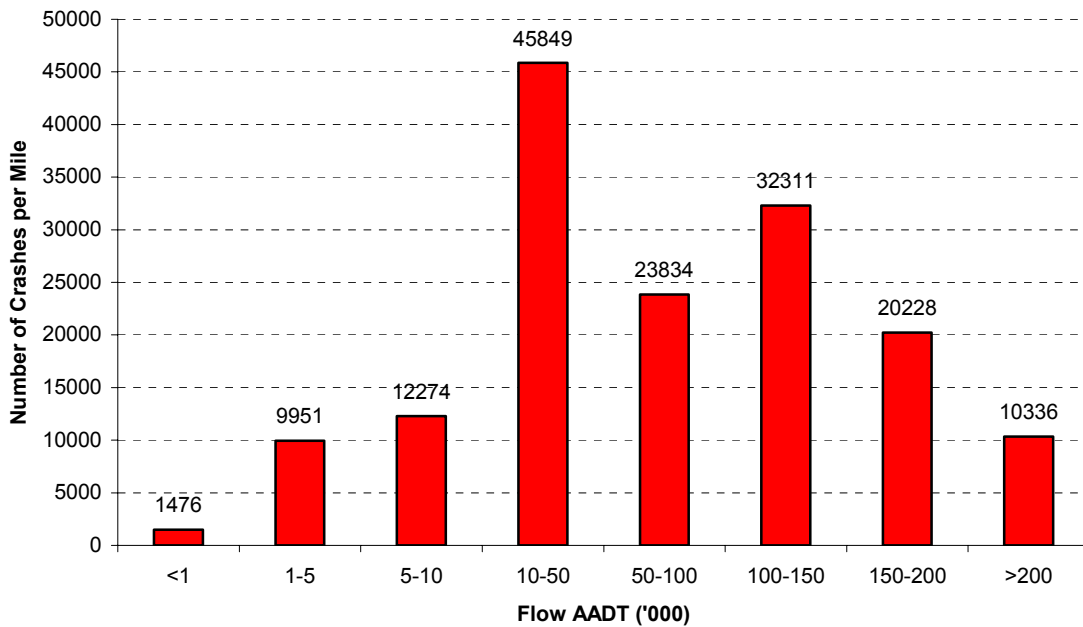
Figure A9. Relationship Between the Number of Crashes per Mile and Traffic Flow (1997-1999).

Figure A9 shows that the number of crashes increases, peaks and then decreases as traffic flow increases. This relationship is known to follow a Gamma function.

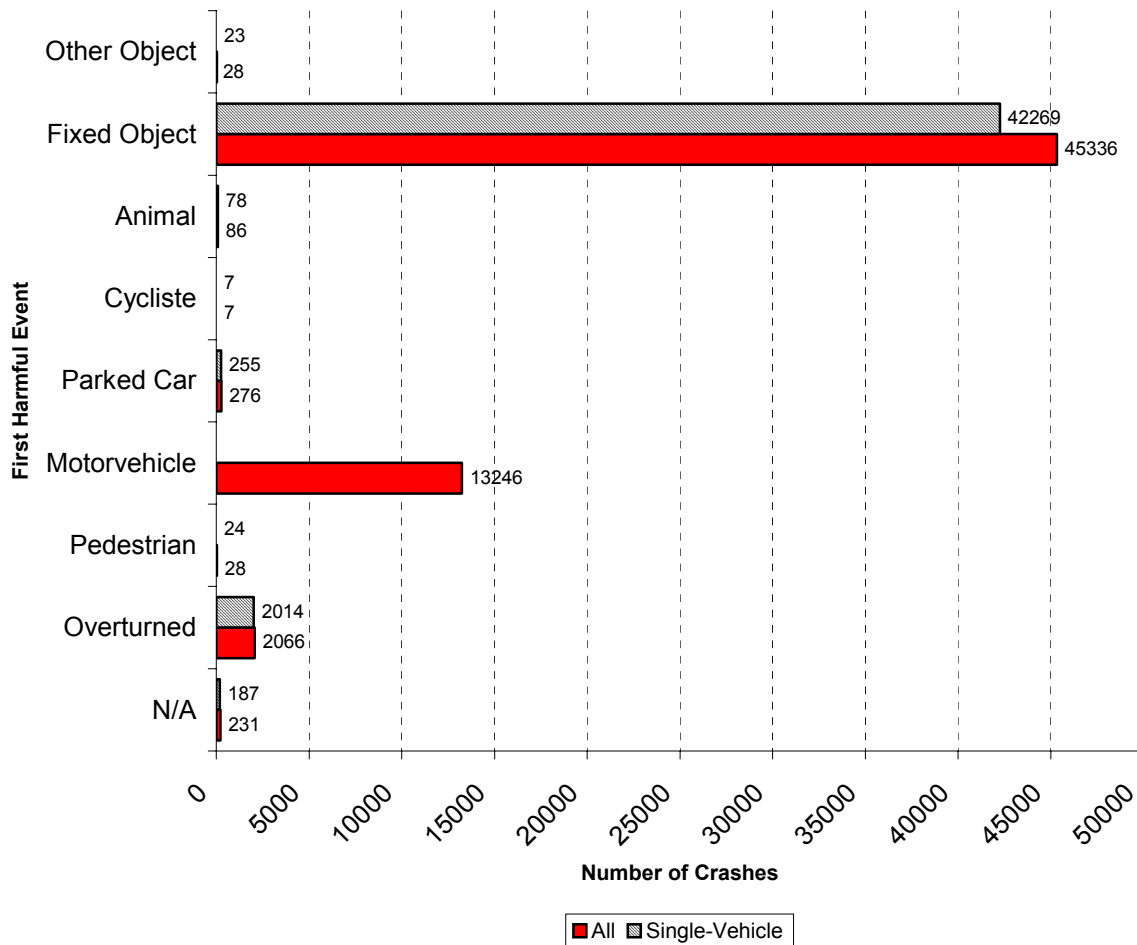
Figure A10. Number of Crashes defined by the First Harmful Event for All and Single-Vehicle Crashes (1997-1999).

Figure A10 shows the number of crashes defined by the first harmful event for all and single-vehicle crashes respectively. According to the DPS, the first harmful event is defined as the first event that caused either an occupant to become injured or substantial damages to the vehicle. This field should not be mistaken with the most harmful event. The accident form and the DPS database do not contain such a field.

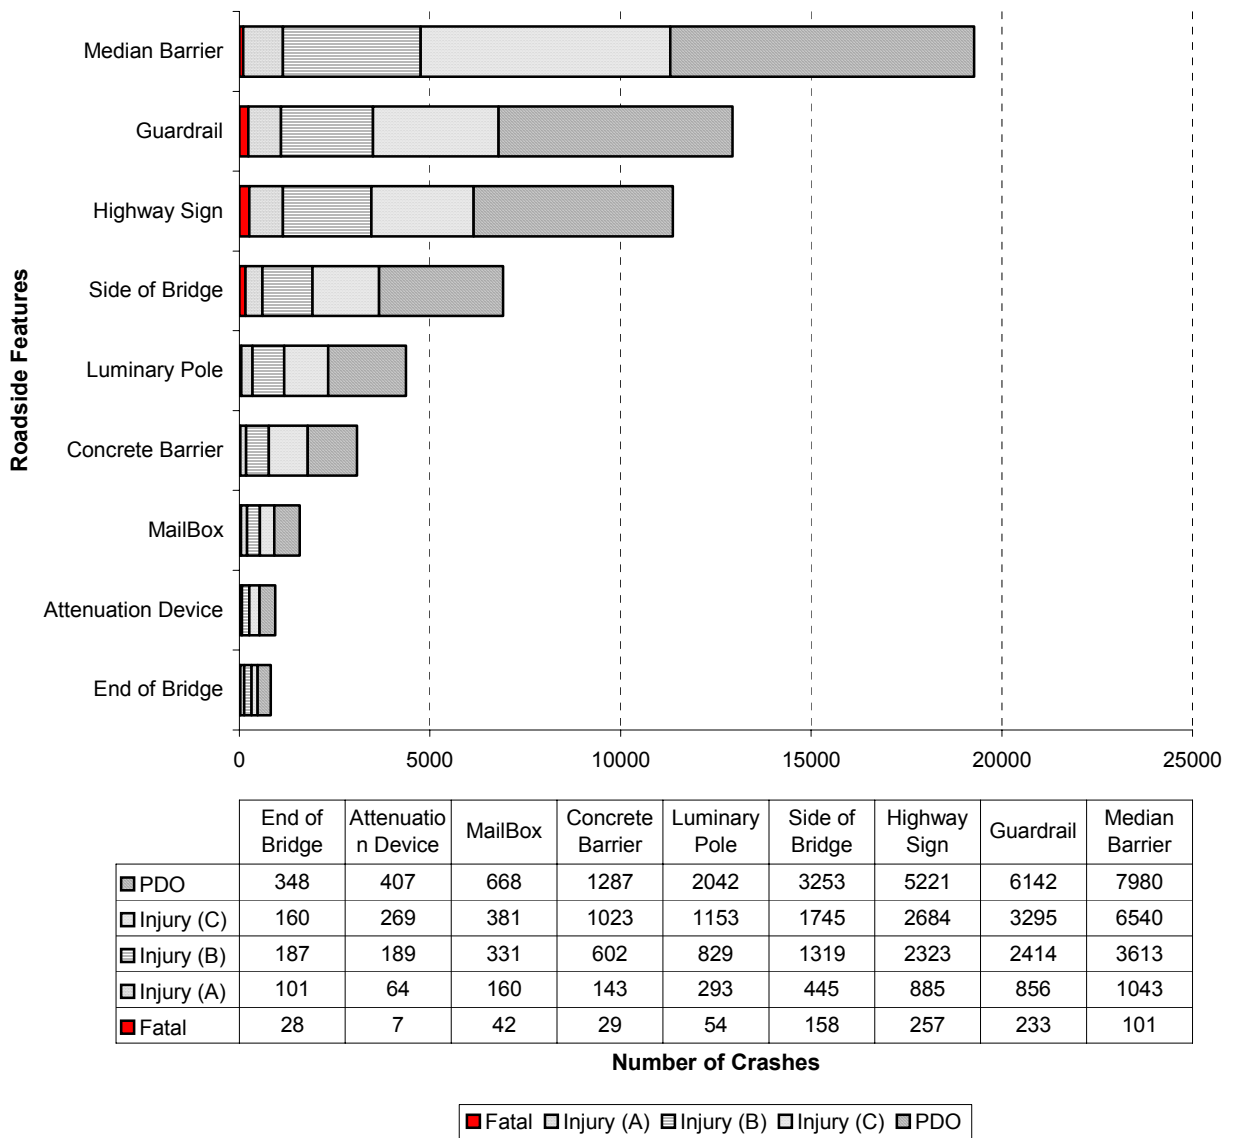
Figure A11. Number of Crashes by Roadside Feature (1997-1999).

Figure A11 exhibits the summary of the crash data for each feature. This figure reveals that median barriers, guardrails, and highway signs account for more than 70 percent of all roadside objects hit by a vehicle. However, these features are also the ones most often used on the TxDOT maintained highway system.

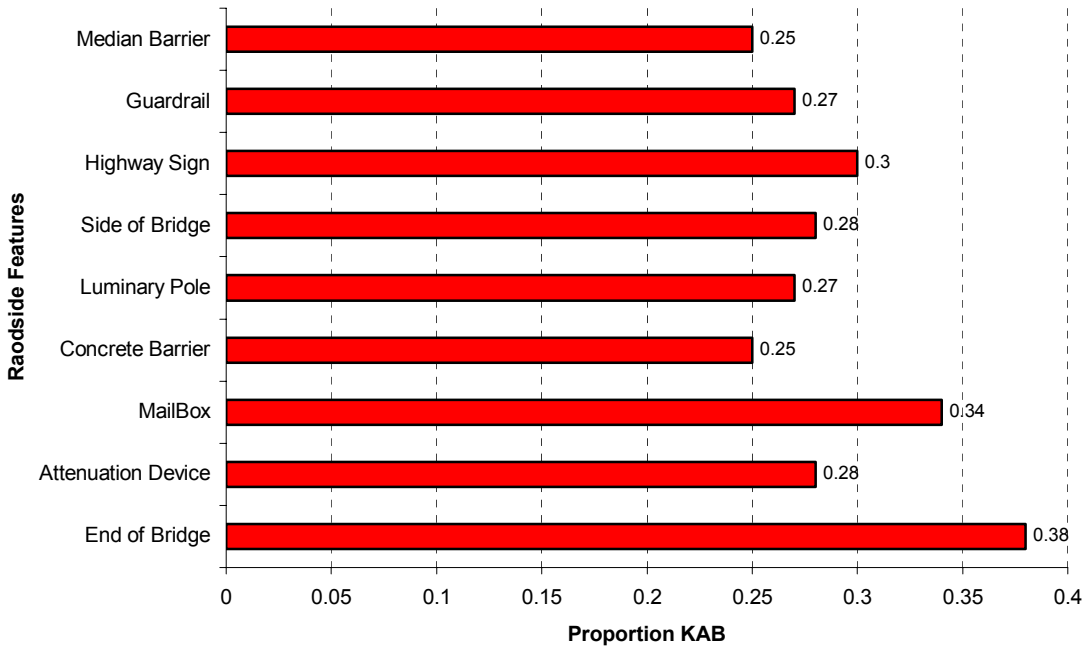
Figure A12. Proportion of KAB Crashes by Roadside Feature.

Figure A12 displays the proportion of reported fatal and injury of types A and B (KAB) crashes for each roadside feature. This figure shows that end of bridges and mailboxes appear to cause more serious injuries than the other features. In fact, the proportion of KAB crashes is about 38 percent and 34 percent respectively. It should be noted that other factors such as side slopes or type of surface might contribute to the harmful event, in addition to hitting the object per se. As indicated above, the data shown in this figure do not include missing crash counts. Hence, the researchers point out that the numbers shown in Figure A12 should be interpreted with caution. It is likely the “true” percentages would be less than the ones reported in Figure A12.

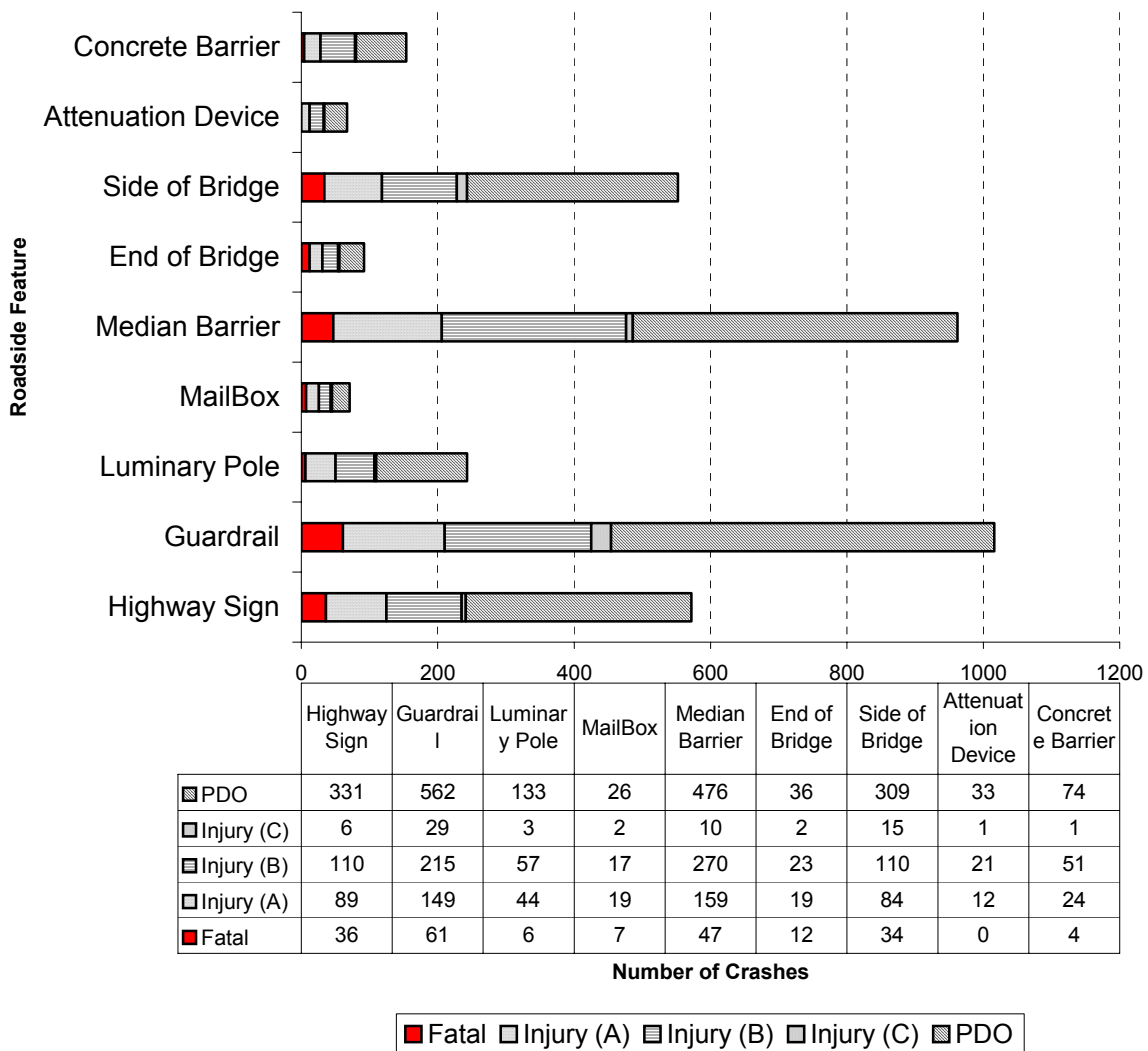
Figure A26. Number of Single-Vehicle Crashes Involving a Large Truck by Severity (1997-1999).

Figure A26 shows the number of single-vehicle crashes involving a large truck for each roadside feature. This figure demonstrates that more than 45 percent of large truck-related crashes are either fatal or very severe. A truck driver has more than 60 percent chance of being involved in an KAB crash when either a mailbox or an end of bridge is hit. In addition, the data shows that very few crashes lead to minor injuries (type C). The crash data tend to indicate that roadside features fail more frequently when a large truck is involved in a collision.

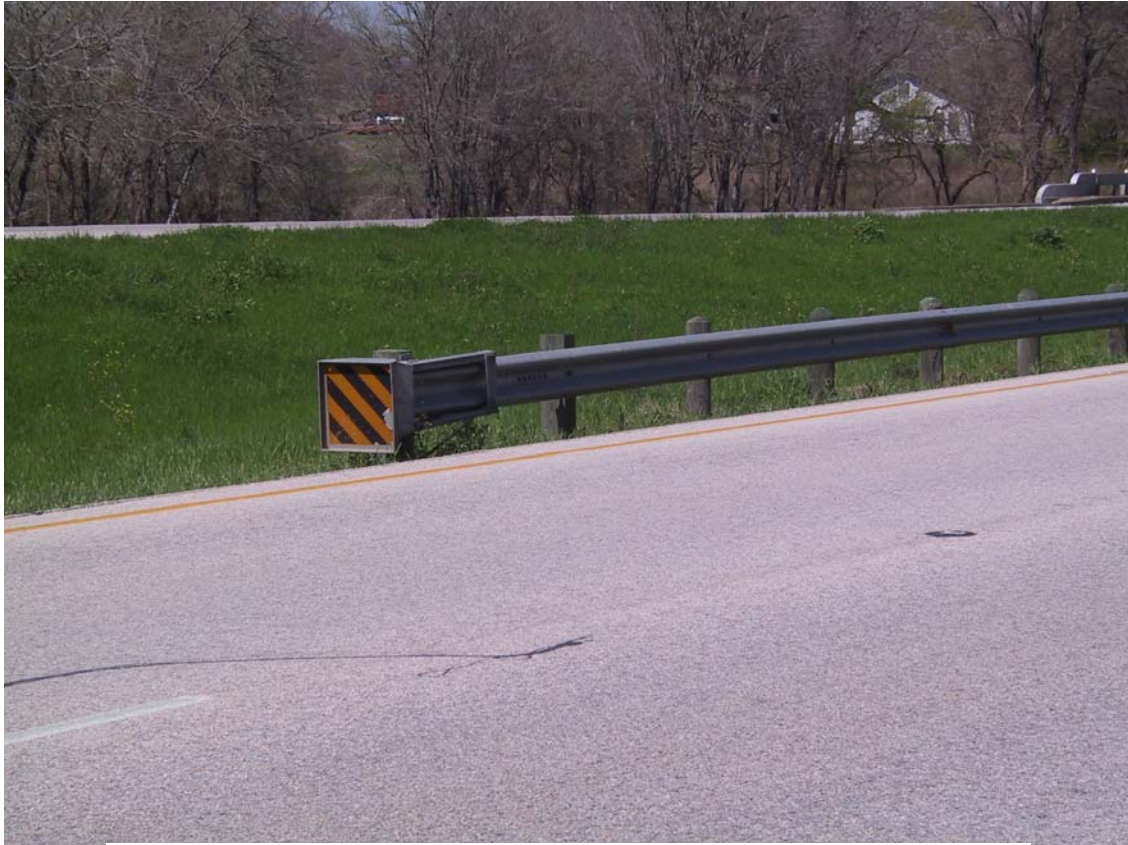
Figure D3: An Example of An ET-2000 Installed On a Slope.

If the guard fence is installed on a roadside slope, as shown in [Figure D3](#), and the height is maintained relative to the ground rather than the travelway, the rail will be underheight with respect to the travelway. Impacting a terminal in such a situation can lead to the impacting vehicle becoming unstable and/or overriding the system. Some impact conditions may be more conducive to this problem than others. It is therefore important to understand the fundamental behavior of the terminal system and its components and how installation and site variations might affect impact performance. Members of the proposed team have developed such insight through their experience in designing, testing, and evaluating various guard fence terminals and participating in previous in-service evaluation efforts.

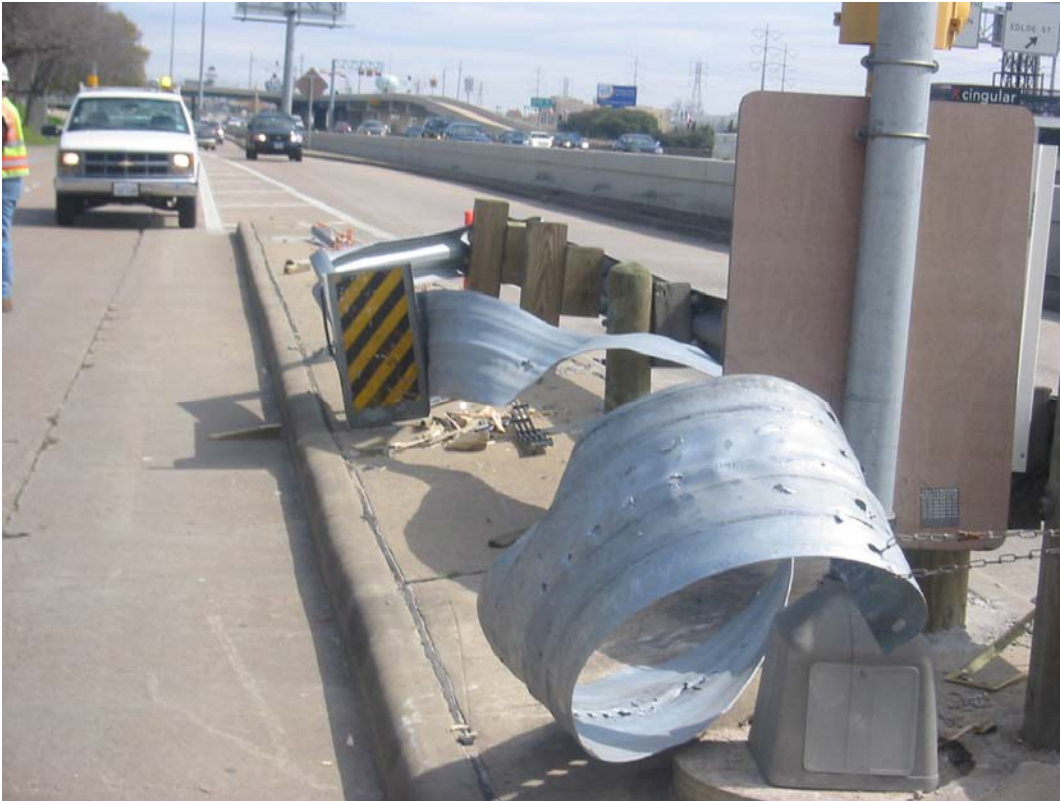
Figure D5: An Example of An Extruder Head Buckling: Note that, In This Case, The SGT Performed As Intended. The Buckling of the Extruder Head Do Not In Itself Imply That the Device Did Not Perform As Intended.

the “elbow” formed in the rail at the hinge point has penetrated the occupant compartment of the vehicle. This behavior should be investigated further in a SGT specific ISPE project, i.e., where significant samples of ISPE information can be collected.

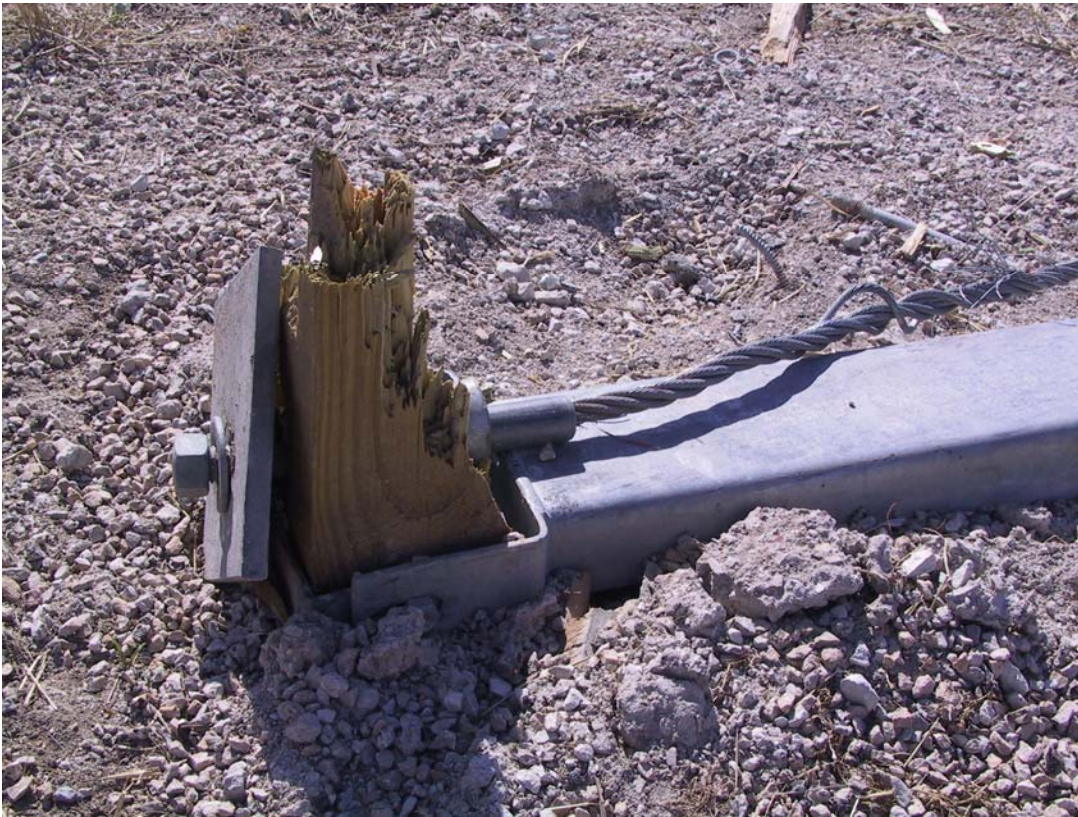
Figure D6: An Example of an ET-2000 Impact Observed During the Pilot Test.

During the Phase I in-service pilot test, selected participating maintenance sections observed selected crashes in which an SGT failed to perform as designed due to component failures. In one such crash, as shown in [Figure D6](#), the first post of the terminal failed to release the cable anchor as designed. Although the first post fractured, the failure plane was above the weakening hole through which the cable passes. Since the cable did not release from the first post, tension developed in the cable when the impact head contacted the anchor box attached to the back side of the rail. As a result, the extrusion of the rail and the forward motion of the impacting vehicle were abruptly stopped.

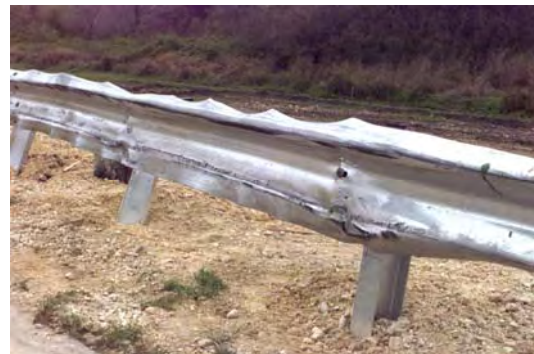
Figure 1-1: Flattened rail

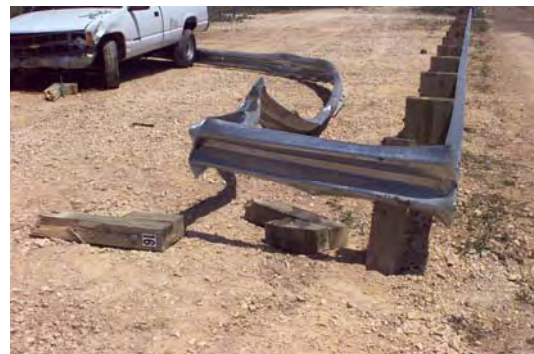
Figure 1-2: Ruptured rail

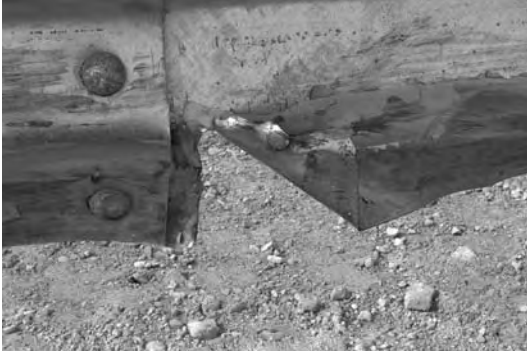
Figure 1-3: Torn rail

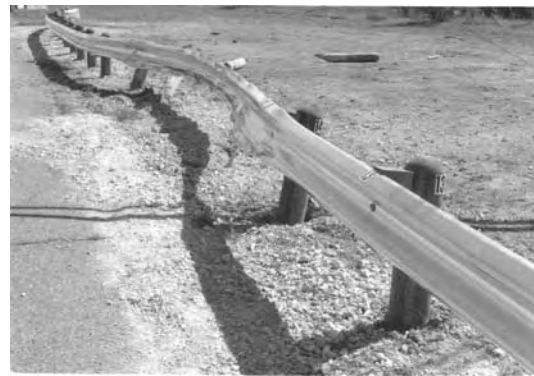
Figure 1-5: Guardrail with round wooden post that failed.

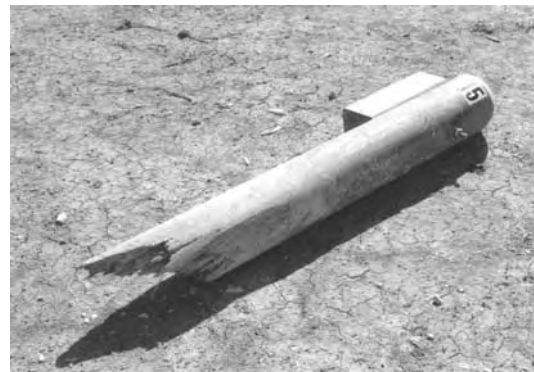
Figure 1-6: Fractured wooden post

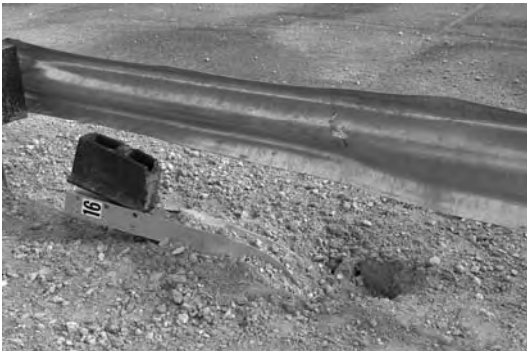
Figure 1-9: Damage to a steel post system – bend post

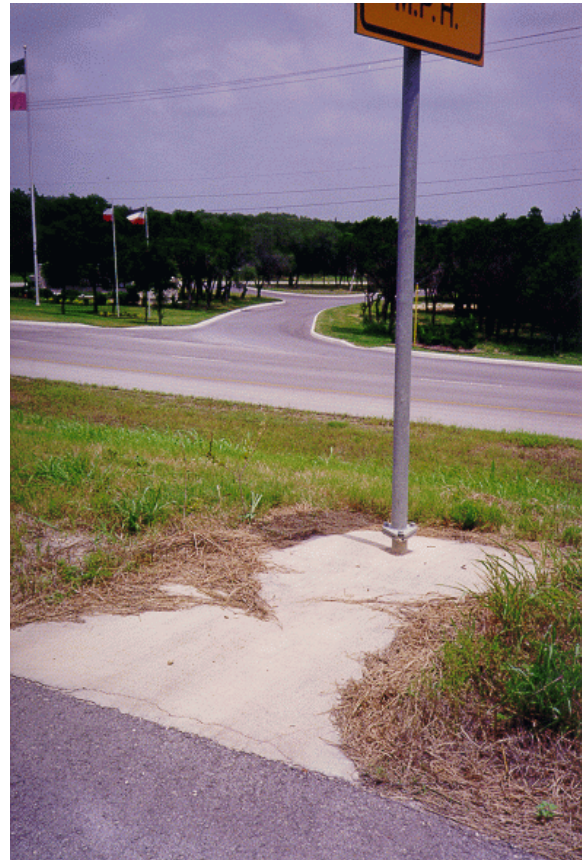
Figure 2-1: Concrete riprap around sign support

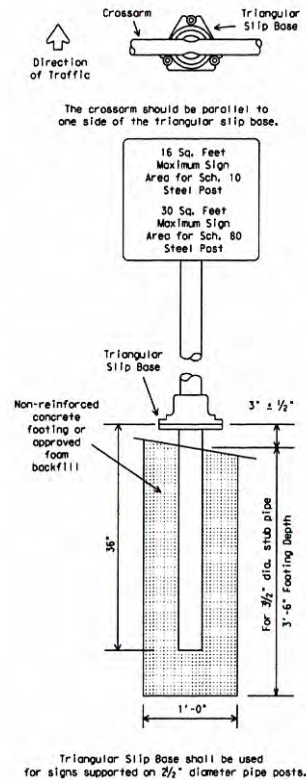
Three bolts clamp the individual slip base components together. When impacted these bolts are forced out of slots in the base. The support(s) yield to the vehicle by allowing the top support to release from the stub post by pushing out the three bolts clamping the upper and lower section together and thus releasing the slip base. It has been observed in the field that the schedule 10 support type may bend over rather than release from the slip base. This type of performance has not proven to be a hazard to the motorist but should be noted during inspection of the installation.

Figure 2-2: Triangular slip base

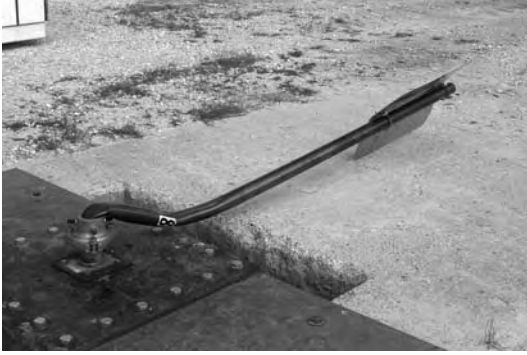
Improper impact performance would be demonstrated by the sign support failing to yield or do so in such a manner as to cause the support or sign panel to penetrate into the occupant compartment from any surface of the vehicle. A slip base support that does not separate from the slip base stub post and may be considered “locked up” is considered a performance failure. The unit should be disassembled and examined to determine if the proper hardware was provided during initial installation. If available, a torque wrench should be used to attempt to estimate the assembly torque used during installation. In addition, the ground stub and/or its foundation should not be pulled or displaced from the soil.

Figure 2-3: Schedule 10 Triangular slip base that did not perform as intended.

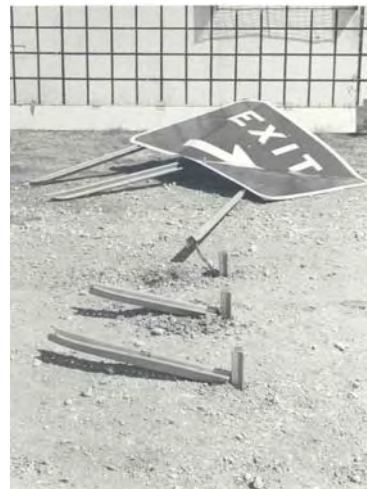
Figure 2-6: U-channel system that performed as intended

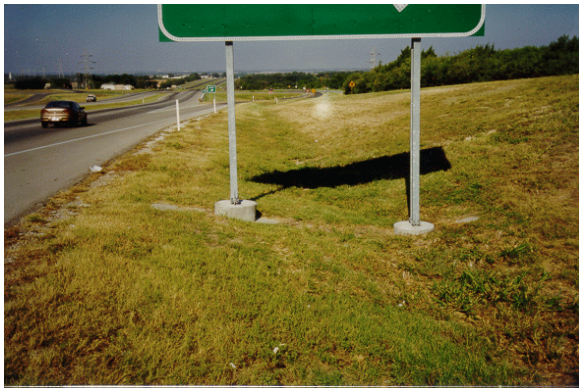
Figure 3-2: The grading of surrounding terrain should enable an errant vehicle to pass over any non-breakaway portion of the post installation. To ensure this, the AASHTO Roadside Design guide provides a recommendation as shown in Figure 3-3.

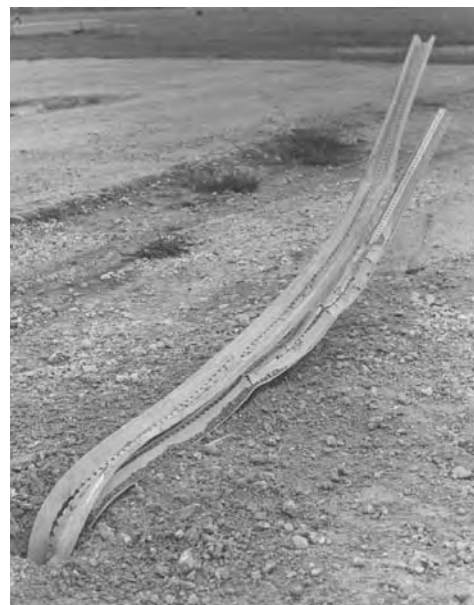
Figure 3-10: U-channel system that did not perform as intended

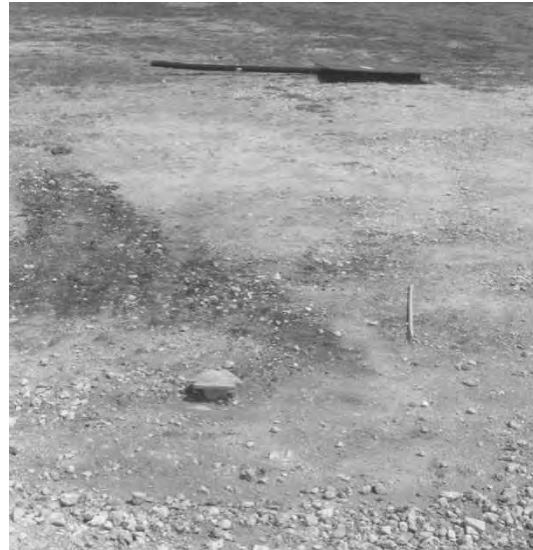
Figure 3-11: Slip Base activated

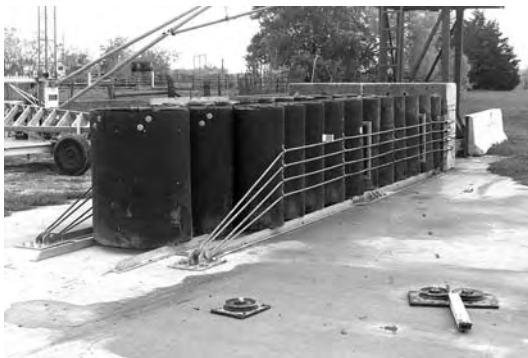
The REACT is a non-gating impact attenuator using High Density Polyethylene (HDPE) vertically oriented cylinders to absorb energy from errant vehicle impacts. Steel cables are attached to each side of the device for re-directive type impacts. A steel undercarriage provides anchorage of the cylinders and cables, it also provides a means of anchoring the system to the road surface.

Figure 4-3: System performed as intended

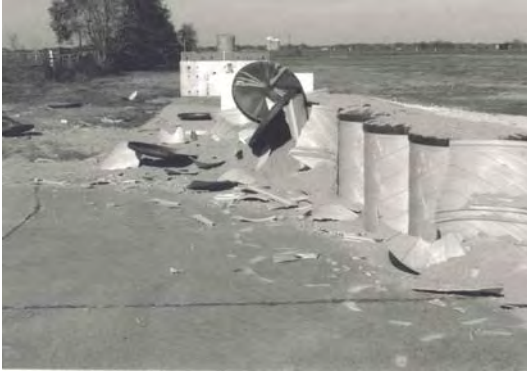
Figure 4-9: system performed as intended

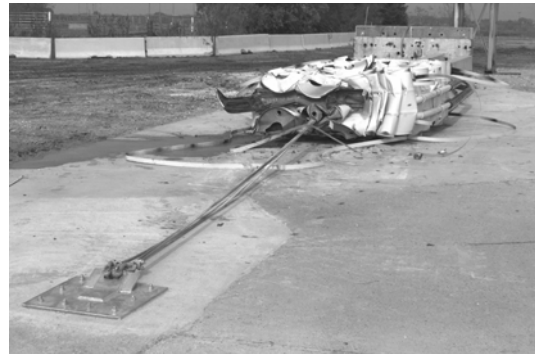
Excessive deflections near the rear of the system may allow errant vehicles to contact the object being shielded. The system has not been tested to current standards, NCHRP Report 350, and its response to pickups and sport utility trucks is limited to field experience.

Figure 4-10: System performed as intended.

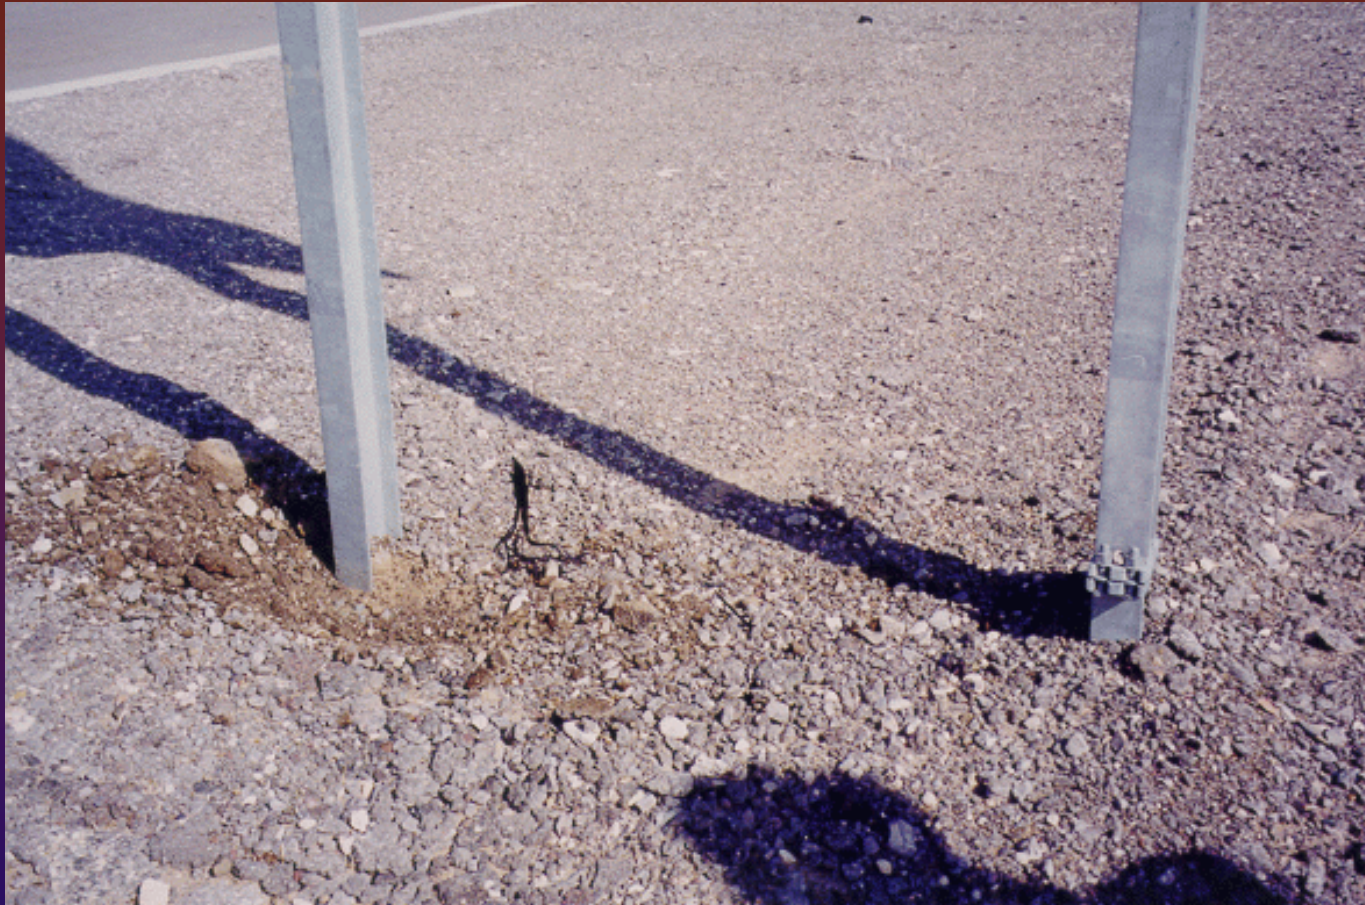
Post on left buried – Will not perform as intended!
