1. Report No. FHWA/TX-06/0-4391-1		2. Government Accession No.		3. Recipient's Catalog No.	
4. Title and Subtitle GUIDELINES FOR THE USE OF UNDERSEALS AS A PAVEMENT MOISTURE BARRIER				5. Report Date August 2006 Published: November 2006

**GUIDELINES ON THE USE OF UNDERSEALS AS A  
PAVEMENT MOISTURE BARRIER**

Report 0-4391-1

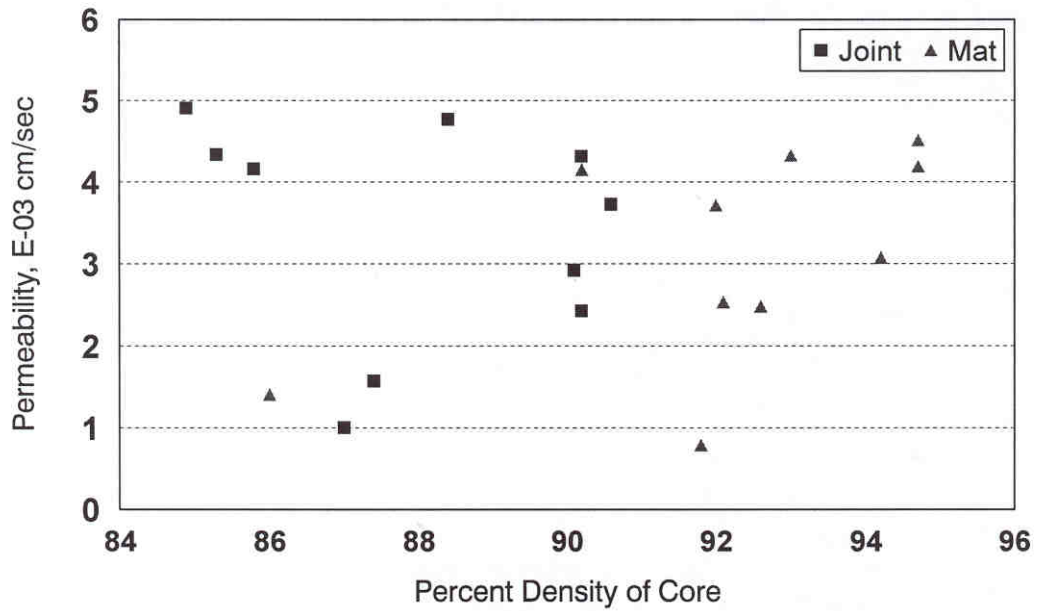
**Figure 4. Permeability Data for TxDOT Hot Mix Asphalt Coarse Matrix High Binder Pavement Cores. (Estakhri et al. 2001)**

Based on the data shown in [Figures 3 and 4](#), the permeability of newly constructed dense-graded asphalt pavements in Texas can range from about 0.00002 cm/sec (or 0.03 in./hr and 0.1 ft/day) to about 0.0005 cm/sec (or 0.7 in./hr and 1.4 ft/day). The permeability of new CMHB pavements can range from about 0.0001 cm/sec (or 0.06 in./hr and 0.3 ft/day) to about 0.0005 cm/sec (or 0.7 in./hr and 1.4 ft/day). The permeability of these mixes will likely decrease with further densification by traffic, but probably not in the areas between the wheel paths. When cracks begin to appear in the surface, the global permeability of the pavement will increase significantly.

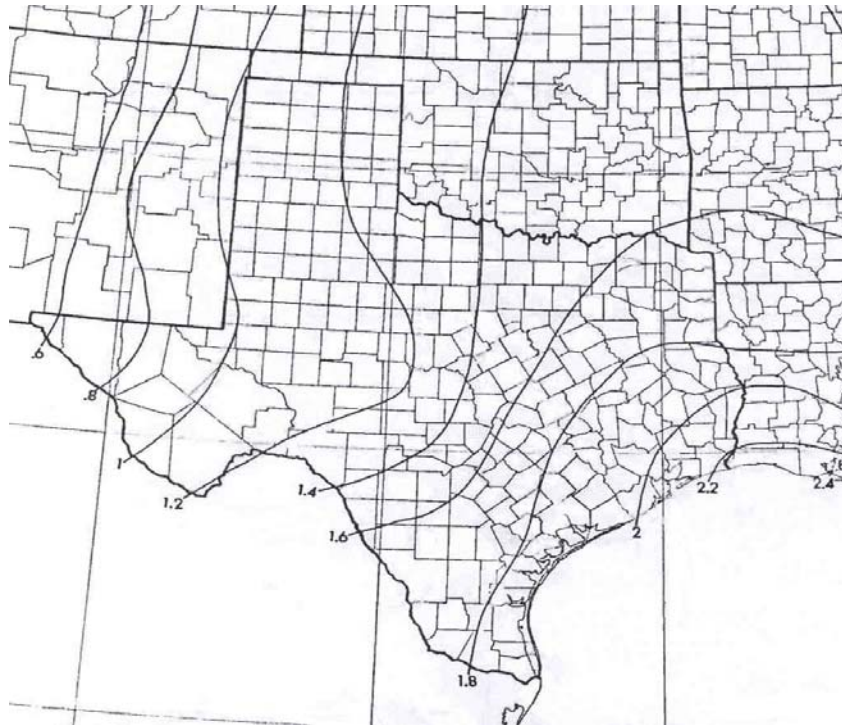
**Figure 5. The 1 Hour 1 Year Frequency Precipitation Rates.** (National Oceanic and Atmospheric Administration)

The Federal Highway Administration *Guidelines* (FHWA 1973) recommend using the 1 hour 1 year frequency precipitation rate as a design precipitation rate. This rate is the maximum rainfall in 1 hour that can be expected to occur on the average of one time each year. Figure 5 shows contours of the 1 hour 1 year frequency precipitation rates for Texas. These precipitation rates are recommended for use in the design of drainable bases. When considering the potential rainfall that can enter a base material which is *not* designed to drain, a more critical precipitation rate is one that occurs over a longer period of time, which is shown in Figure 6. If the permeability of a mix is 0.7 in./hr and a 6 hour rainfall of 3 inches (or 0.5 in./hr) occurs, the potential exists for all of this rainfall to enter the pavement structure. FHWA *Guidelines* suggest that for design purposes, assume that the infiltration rate for PCC pavements is between 50 and 67 percent (of the 1 hour 1 year frequency rate) and from 33 to 50 percent for AC pavements.

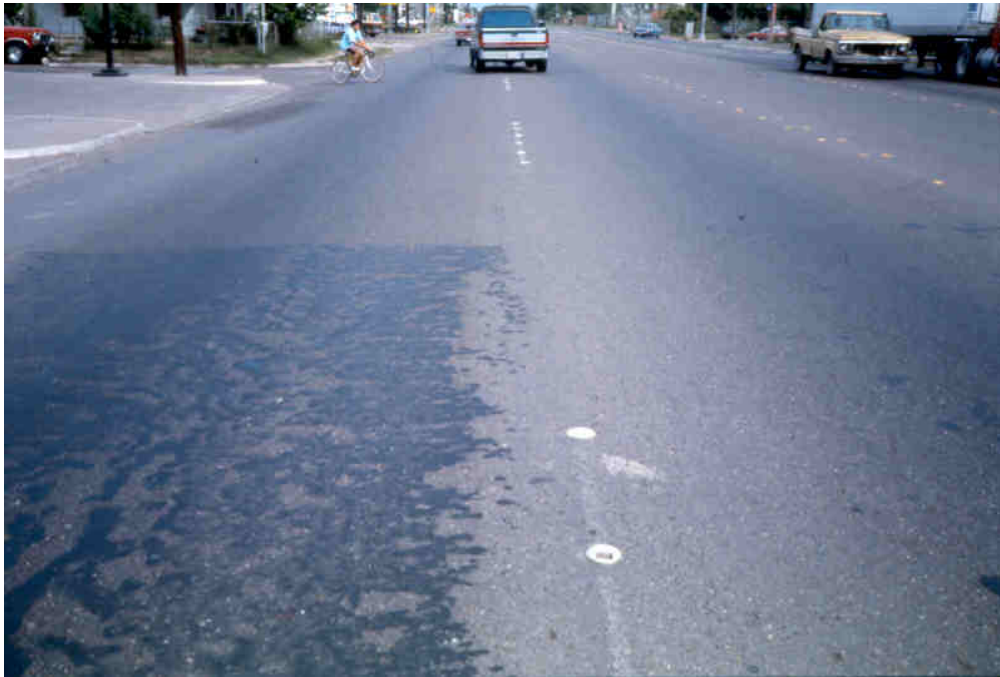
**Figure 20. Underseal Test Section Bleeding Through to Surface.**

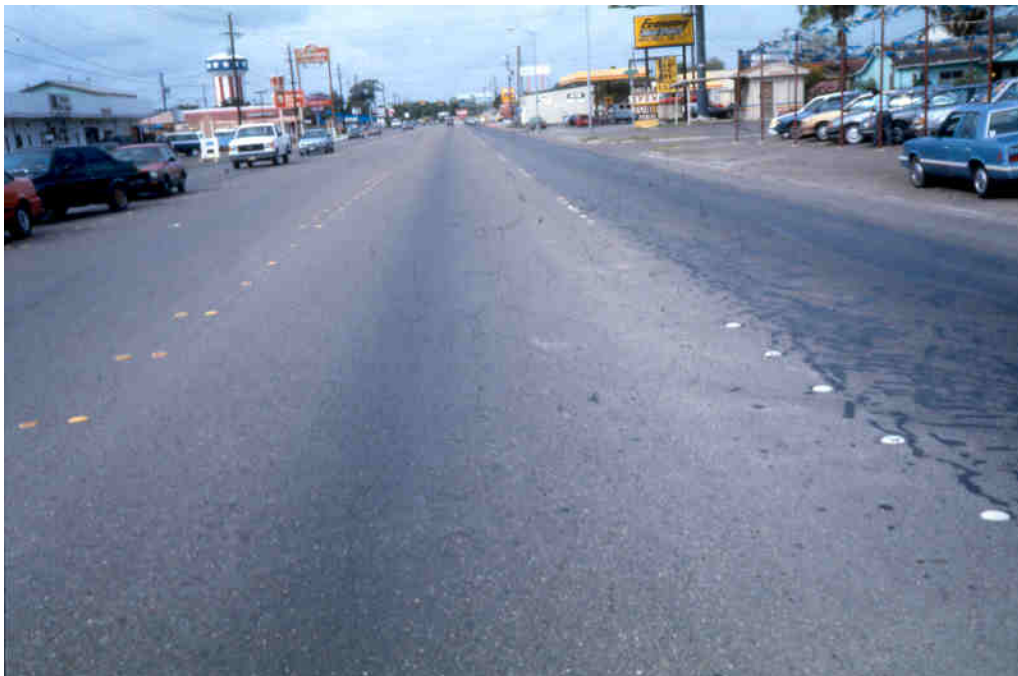
**Figure 21. Inside Lane Test Sections Flushing Less Than Outside Lanes.**

Examples of the flushing distress seen on the test sections are shown [Figures 20 and 21](#).

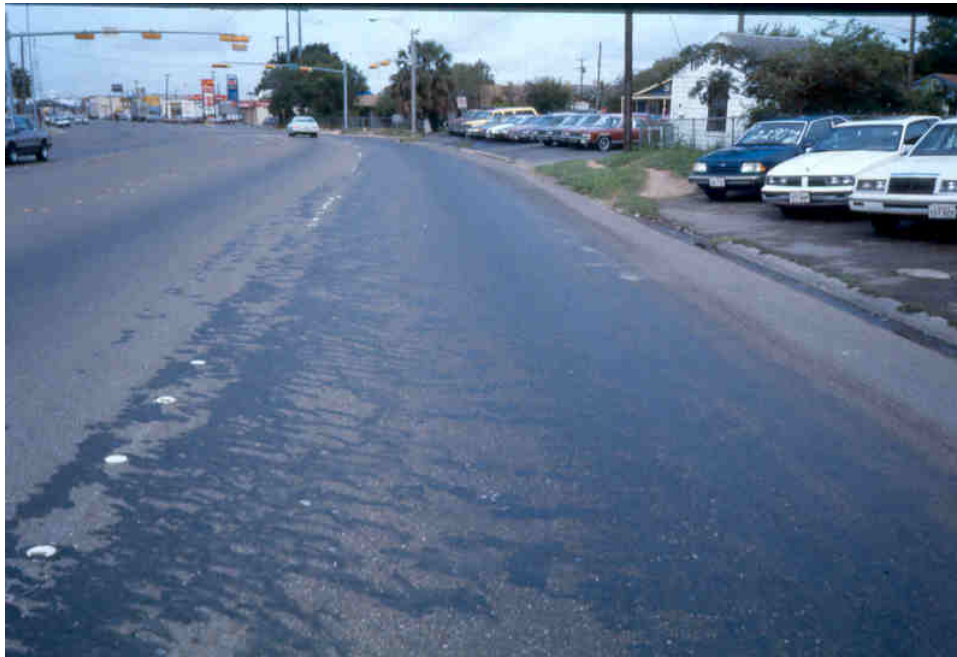
**Figure 22. Severe Flushing From Underseal.**

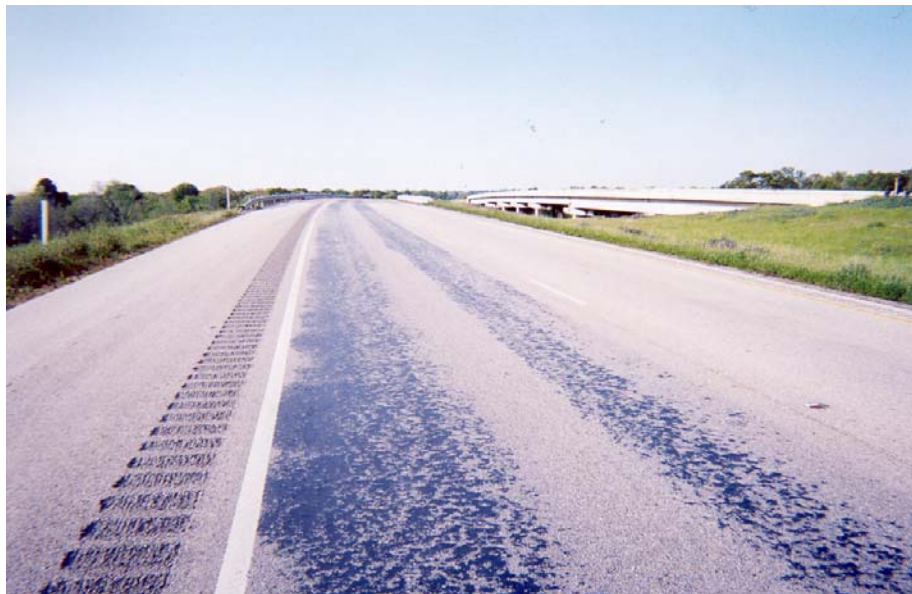
**Figure 23. Underseal Flushing on SH 6.**

Figures 23 and 24 show other examples of an underseal flushing through to the pavement surface. The case in Figure 23 represents one in which the underseal binder was field changed prior to placement to use a softer asphalt since construction was during colder months. Therefore, it was believed that the softer binder contributed to flushing.

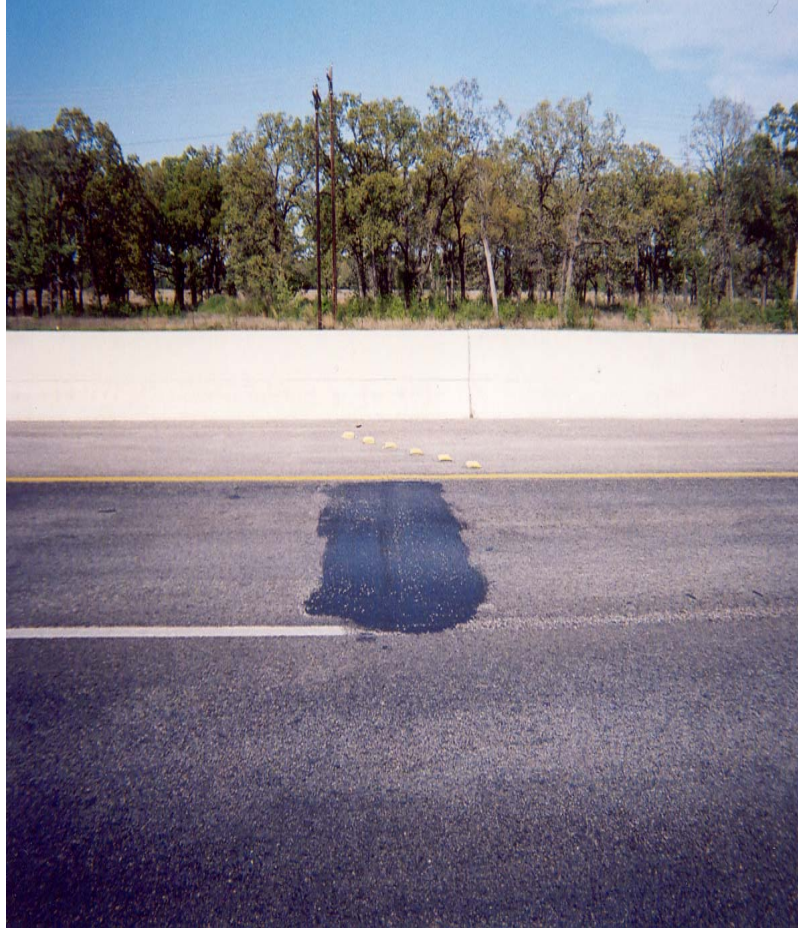
**Figure 24. No Paper Joint Used In Underseal Construction.**

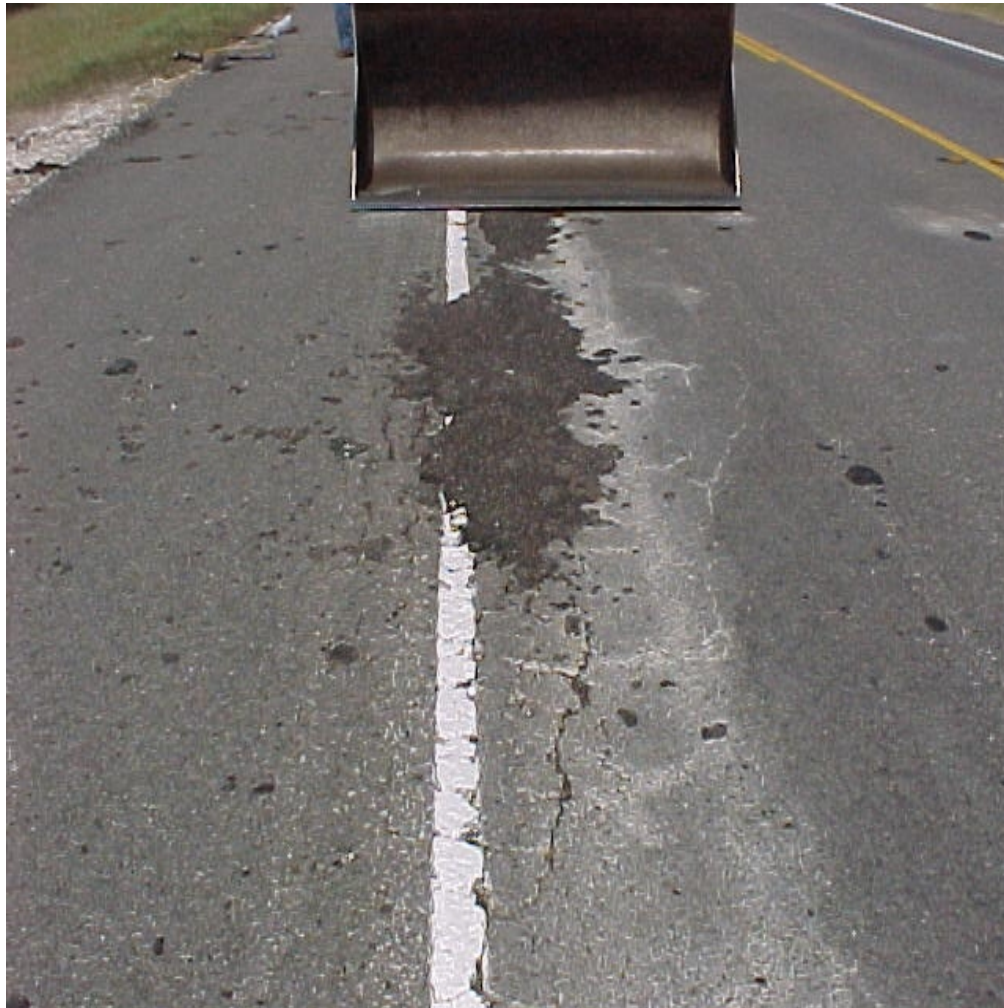
**Figure 25. Distressed Area on SH 7.**

[Figure 25](#) displays the distresses along the edgeline in the hot mix pavement (this is one of the worst locations). Testing was performed just north of this location and the stabilized base was found to be solid.

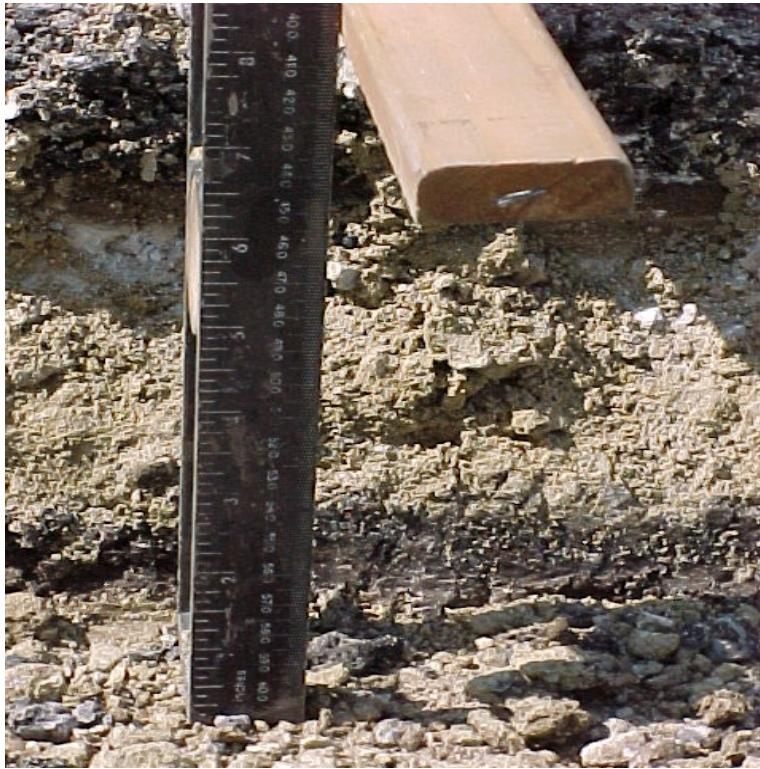
**Figure 26. Cross Section of Shoulder Materials.**

Figure 26 displays the material in the shoulder. The shoulder consists of approximately 2 in. of hot mix, seal coat, 4 in. of unstabilized flexible base, seal coat, etc.(did not test below the 2<sup>nd</sup> seal coat). The shoulder material extends out towards the lane under the edgeline.

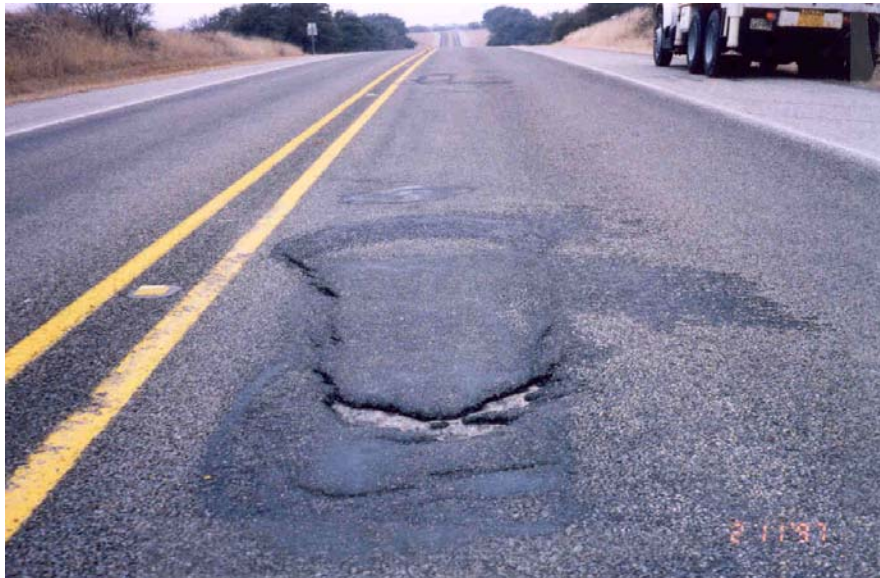
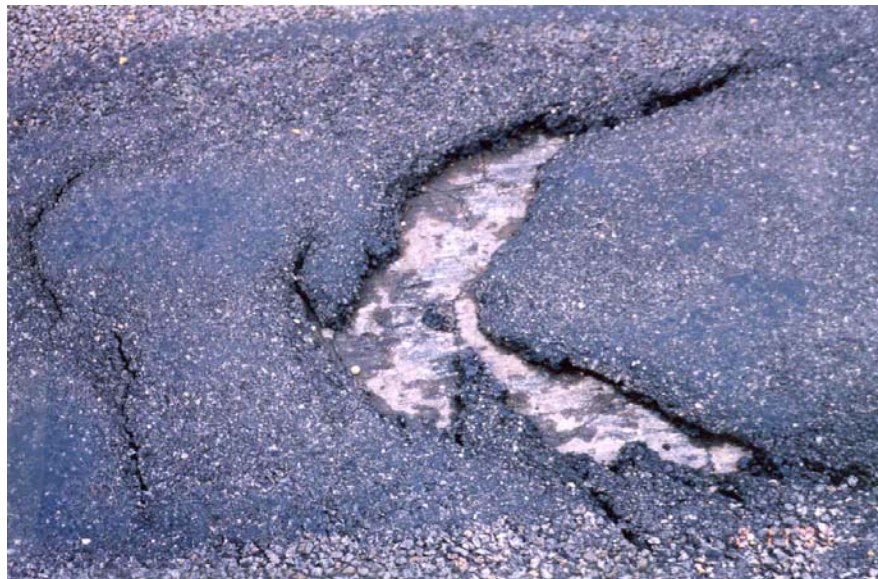
**Figure 28. US 190 Pavement Failure.**

**Figure 29. Close-Up of US 190 Pavement Failure.**

In 1997, the Brownwood District experienced some pavement failures on US 190 in San Saba County. This pavement exhibited half-moon shaped tears in the top 1 inch of the pavement surface, primarily in the inside wheel paths. See Figures 28 and 29.

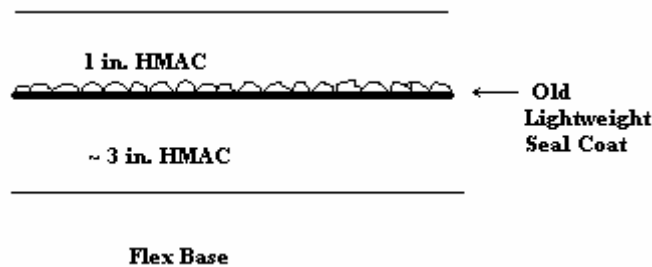
**Figure 30. US 190 Pavement Cross Section.**

This pavement consisted of about 1 inch of HMAC over a lightweight seal coat, about 3 inches of HMAC, and flex base (Figure 30). The seal coat binder was probably a CRS-2. The seal coat was not placed as an underseal but had been in service for many years prior to the HMAC overlay and had performed well. After the seal was overlayed, these types of failure started to occur. The failure was occurring at the bottom of the seal coat (i.e. the seal coat debonded). As can be seen in Figure 29, no binder from the seal coat is visible on the underlying HMAC surface.

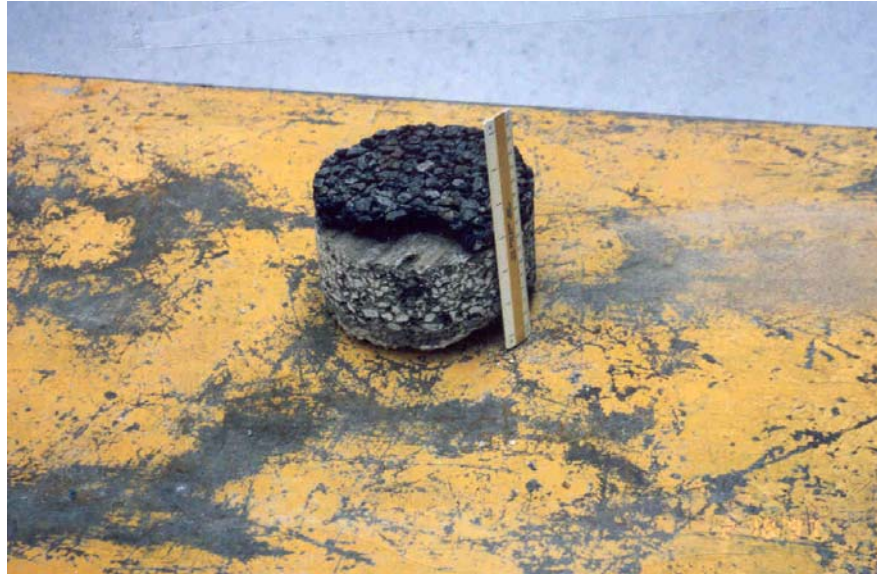
**Figure 31. Pavement Cores Showing Debonded Overlay.**

The District removed and replaced the debonded surface mix. There was no definitive conclusion as to the cause of the pavement failure. District staff speculated that possibly water was coming through cracks of the underlying pavement causing the asphalt from the seal coat to strip from the surface. Another speculation was that there may have been contaminants on the roadway prior to the seal being placed.

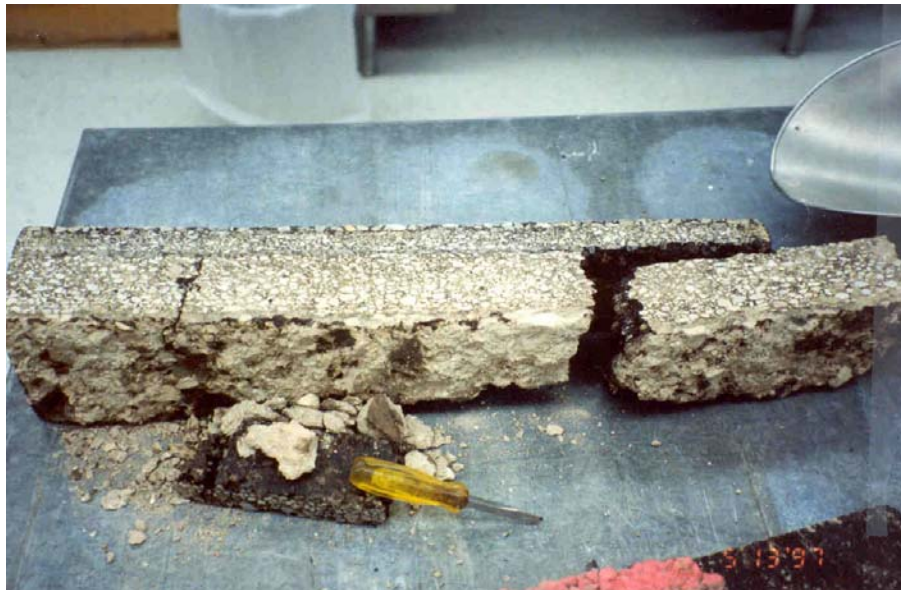
**Figure 32. Pavement Slabs Cut From US 190.**

The district performed an investigation consisting of coring the asphalt layers (Figure 31), sampling the base and subgrade and also removing slabs of the pavement (Figure 32). Field personnel noticed that the “slid areas” appeared to be asphalt rich.

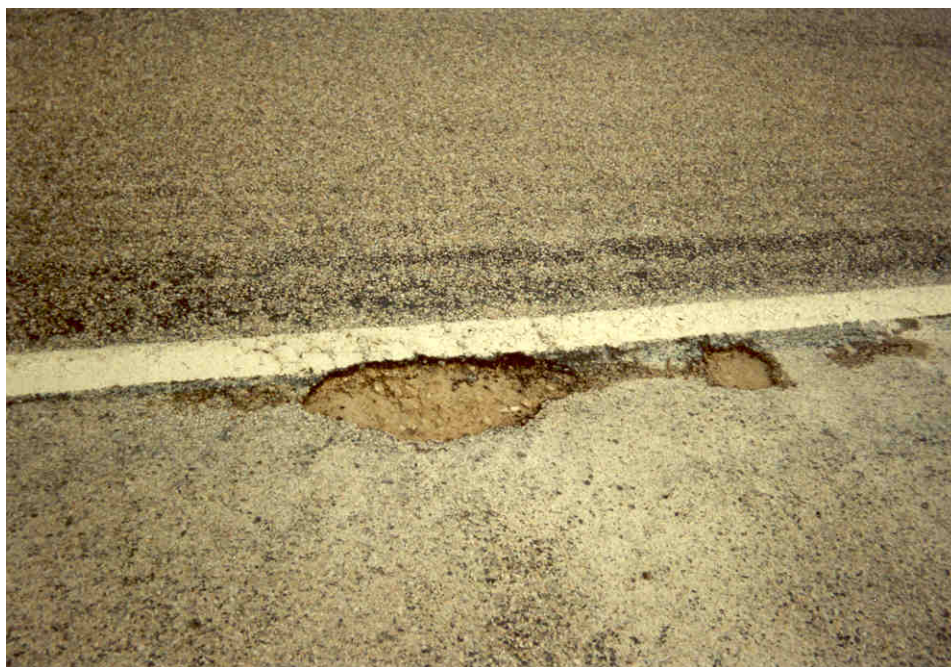
**Figure 33. Delamination of One-Course Surface Treatment (Loop 390).**

The Atlanta District constructed six test roads using fly ash bases. Some of these pavements experienced problems with the surface treatment. Five of the pavements were scheduled to receive a one-course surface treatment as the final riding surface. However, soon after placement, the surface treatment began to delaminate from the underlying fly-ash base (Figure 33). This required the placement of HMAC over the surface treatment on some of the more heavily trafficked roadways.

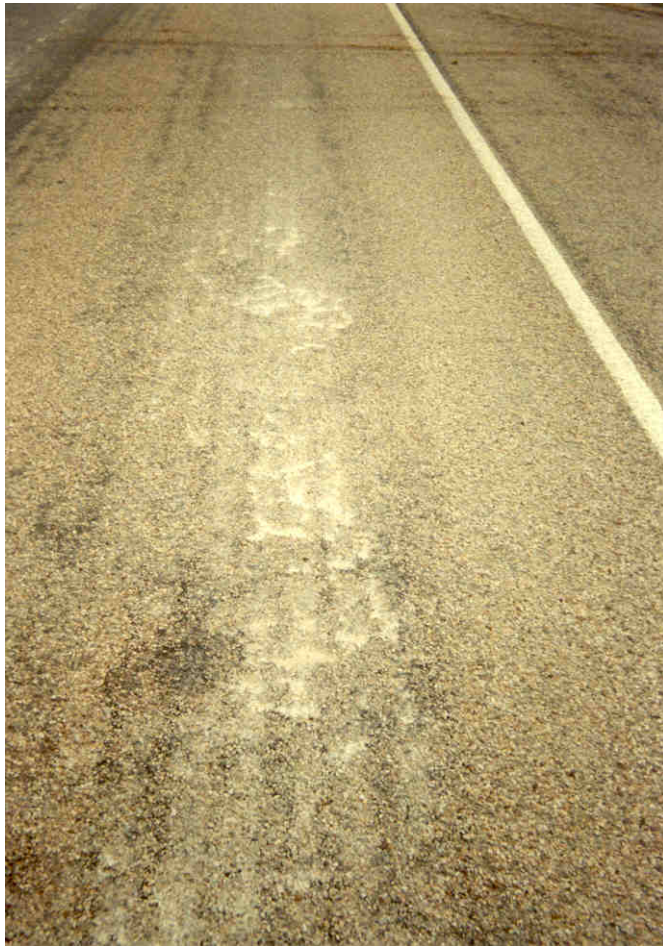
**Figure 34. Alligator Cracking Distress on Loop 390 in Atlanta.**

Perhaps sealing the surface helped arrest the problem with the alligator cracking because it subsided and the pavement performed well for several years afterward.

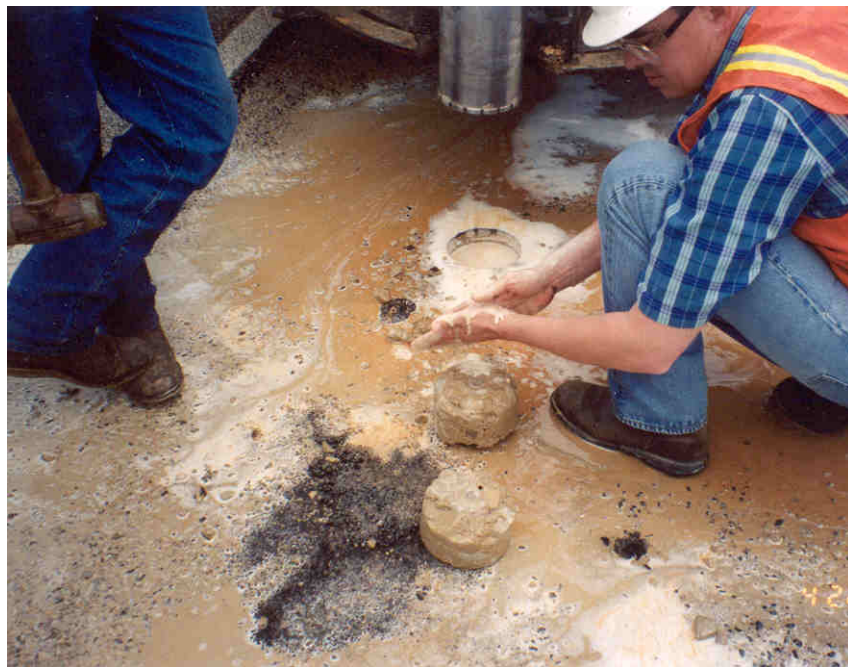
**Figure 36. Core of Stabilized Base on Loop 390.**

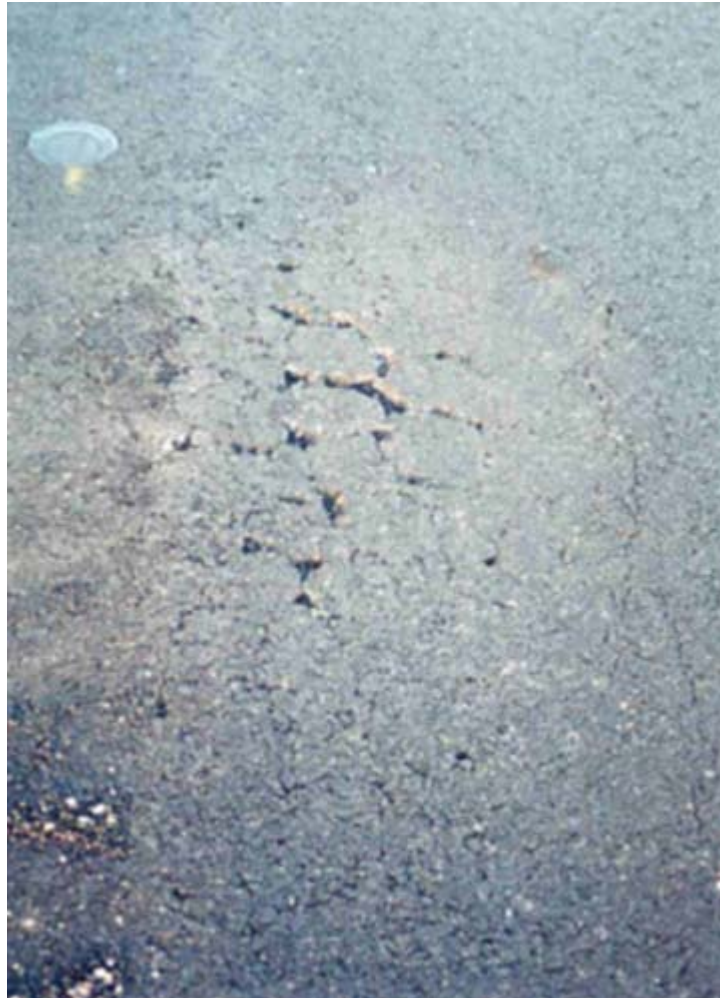
**Figure 37. Cracking Distress on IH 20 Near Pecos.**

A section of IH 20 near Pecos exhibited premature distress consisting primarily of alligator cracking as shown in [Figure 37](#). This pavement was newly constructed with a flexible base, surface treatment and HMAC surface course.

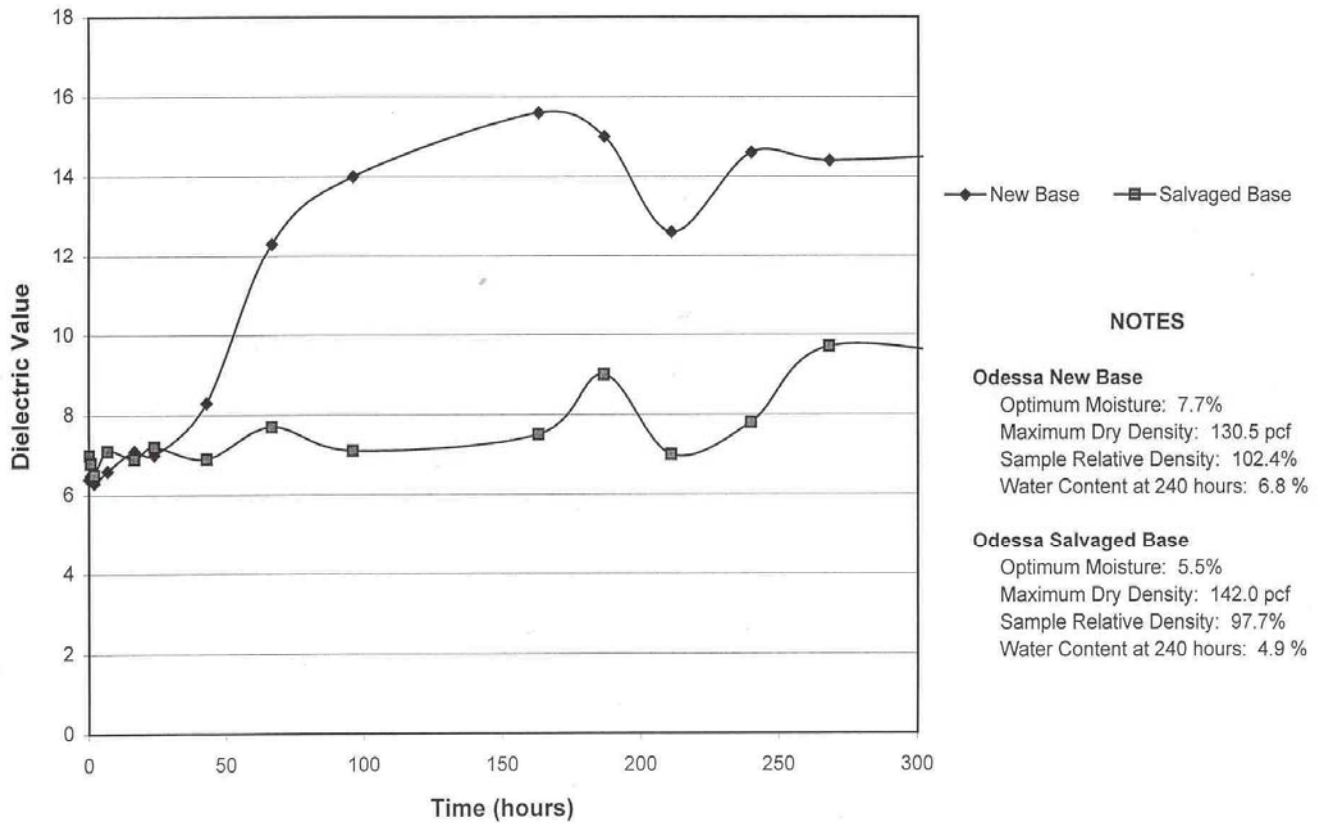
**Figure 38. Laboratory Tube Suction Test Results on Odessa Bases.** (Personal communication from Tom Scullion, TTI Research Engineer to Steve Smith, Odessa District Construction Engineer, 1999)

measured with a special dielectric probe. The dielectric is an indication of both the amount of water and also the state of bonding of the moisture within the sample.

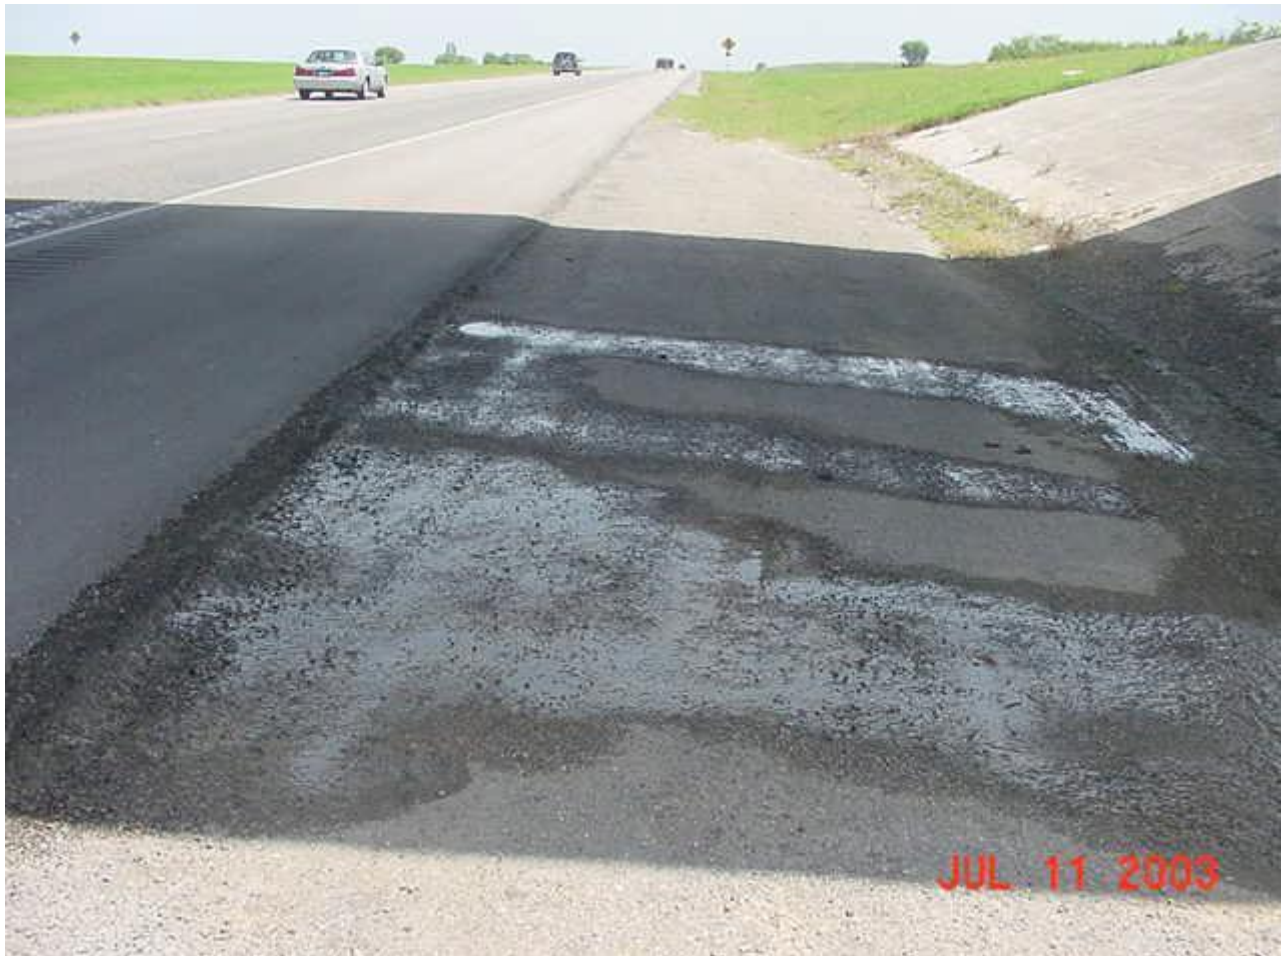
**Figure 39. Moisture Seepage from IH 37 in Atascosa County.**

TxDOT’s Construction Division (Personal communication from Jeff Seiders, TxDOT Construction Division, to David Kopp, San Antonio District Construction Engineer, 2004) performed GPR in the summer of 2003 which showed that there was a significant increase in the dielectric properties at the interface of the Type C and Type B layers. There was no indication of increased moisture levels within the base materials or at the subgrade that might be indicative of underground springs.

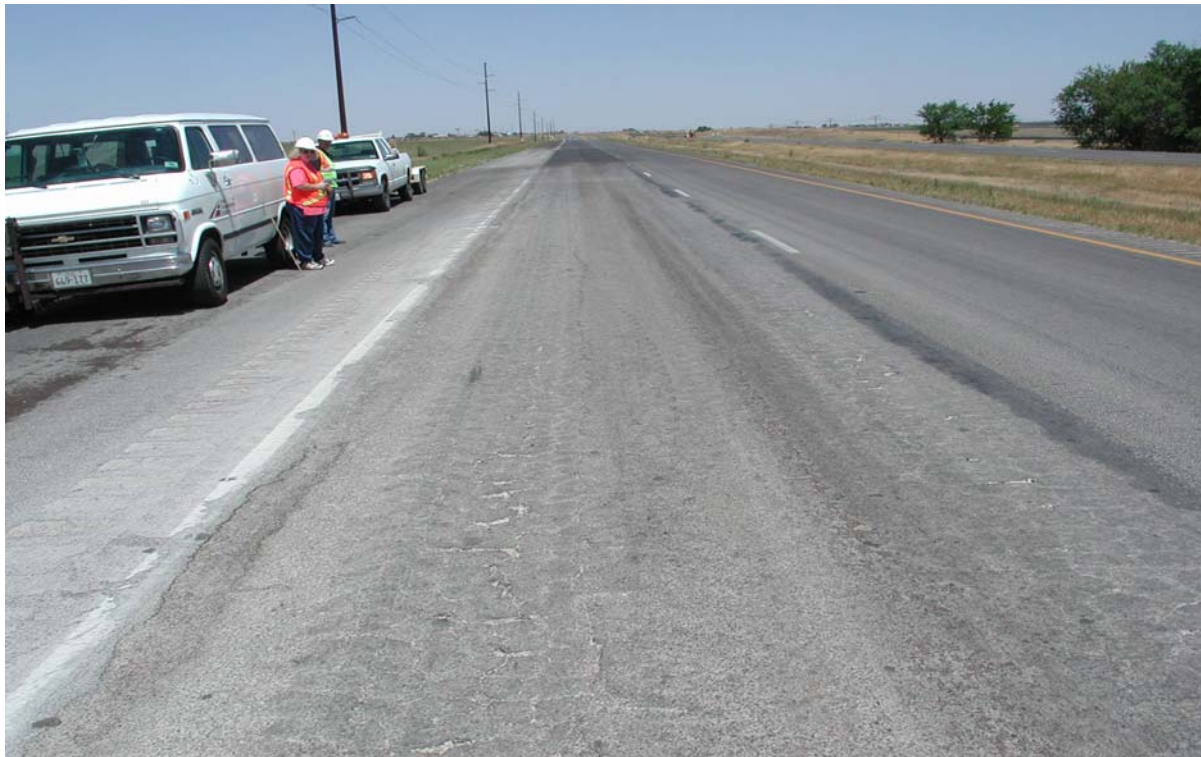
**Figure 40. Damage on US 84 in West Texas.**

District personnel indicated that the base material may not have cured sufficiently and that the underseal was damaged by traffic prior to overlay.

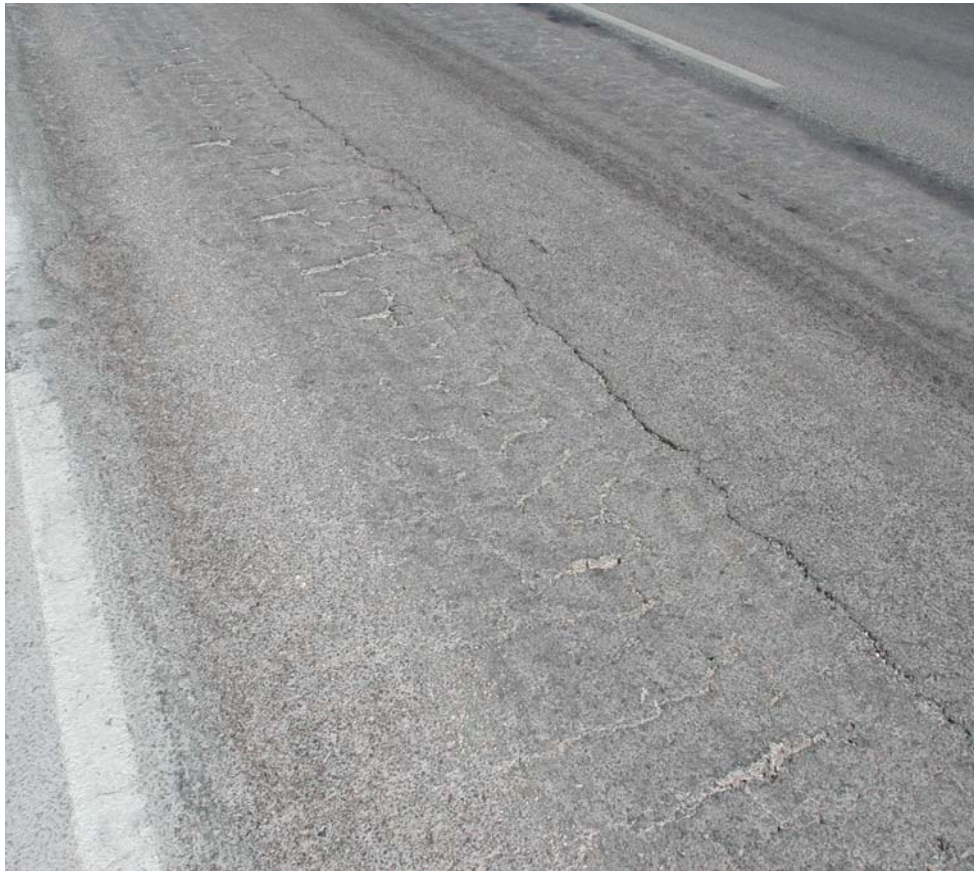
**Figure 41. Close-Up of Damage on US 84.**

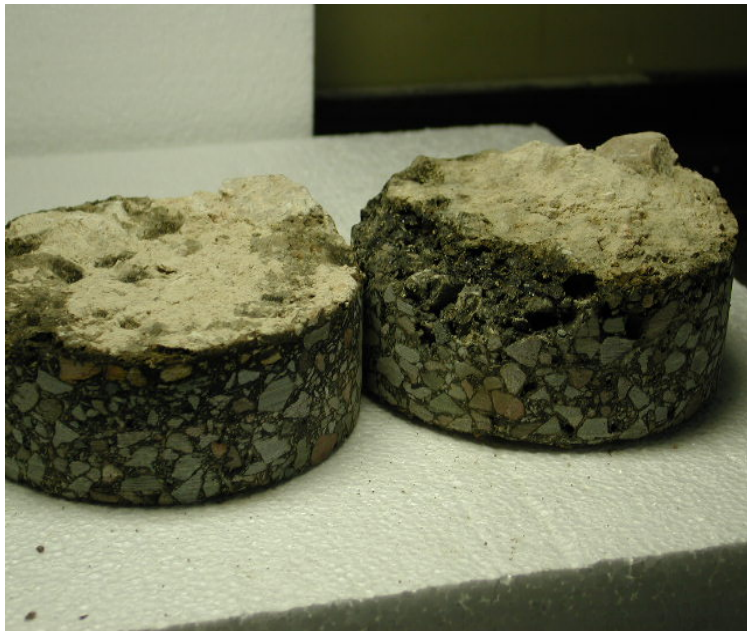
**Figure 42. Cores of US 84.**

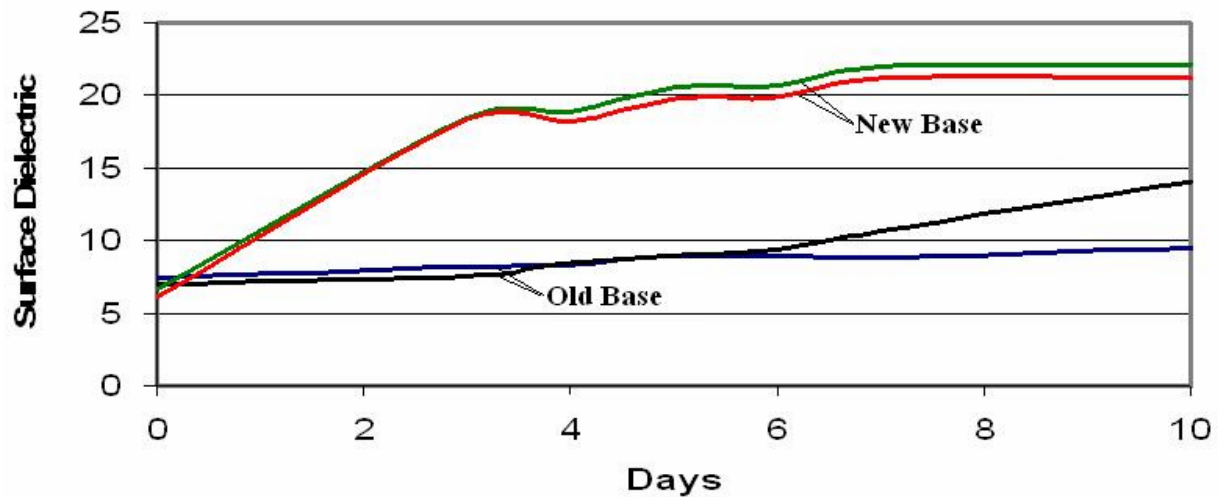
**Figure 43. Tube Suction Test Results for Base Materials (US 84).**

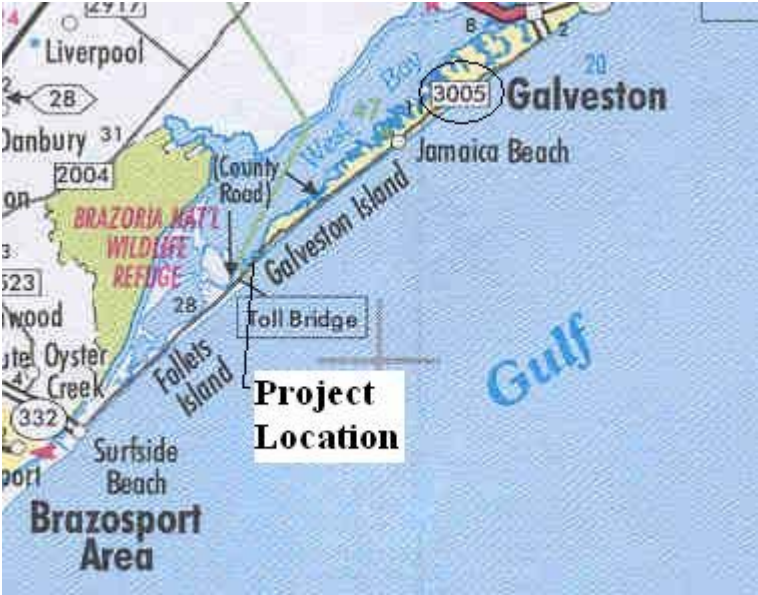
The Galveston Area Office agreed to omit the underseal from a portion of the project to evaluate the effects of the underseal at a future time. The test section location (with no underseal) is located in the west bound lane from Station 73+00 (4<sup>th</sup> crossover past Catalina Drive) to 1000 ft west as shown in [Figure 47](#).

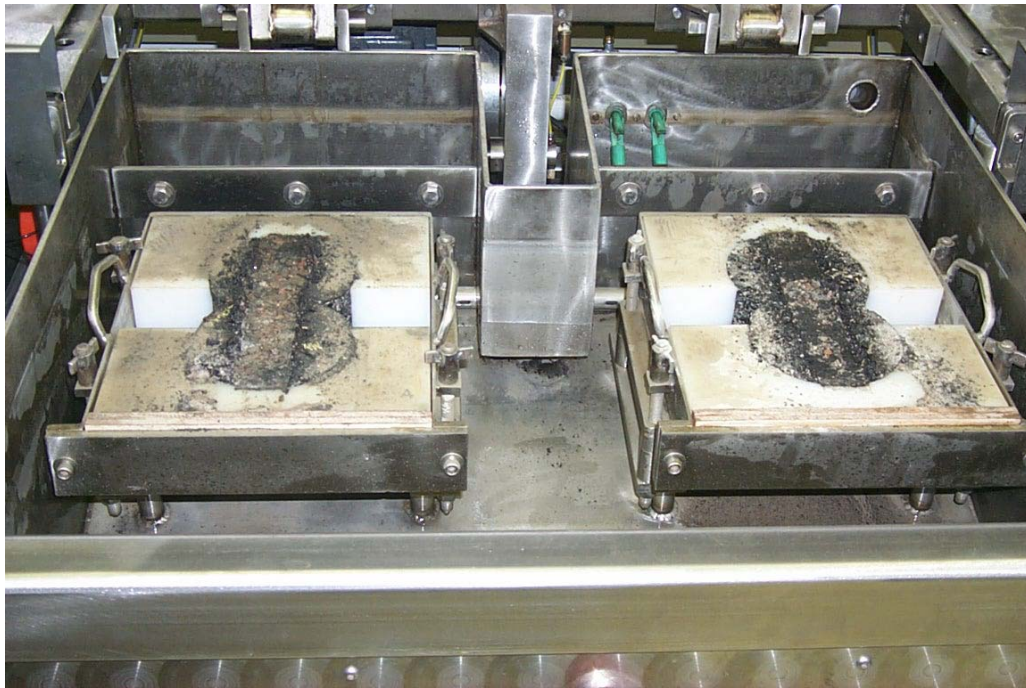
**Figure 2-1. Hamburg Wheel Tracking Test.**

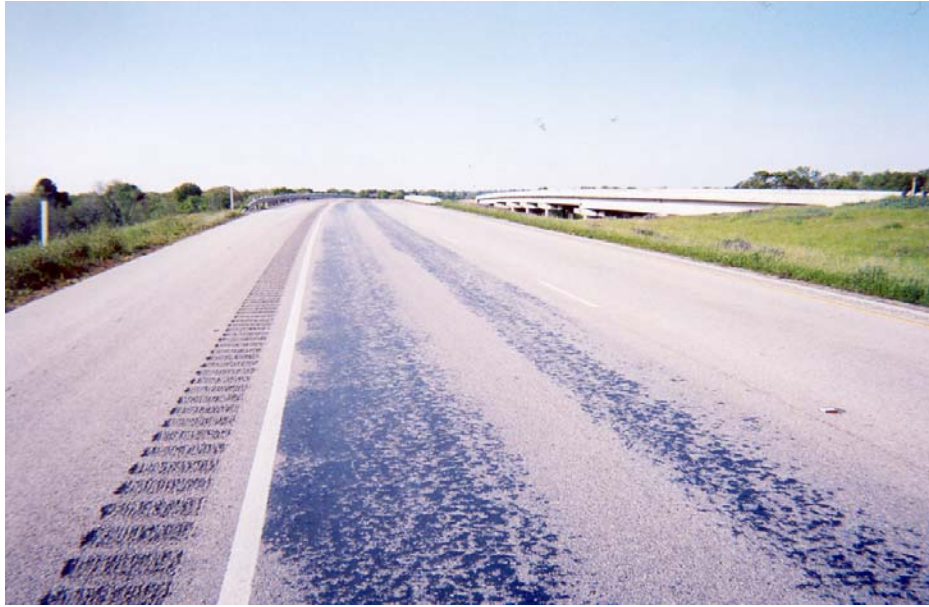
**Figure 2-2. Excess Asphalt from Underseal Migrating Through to HMAC Surface.**

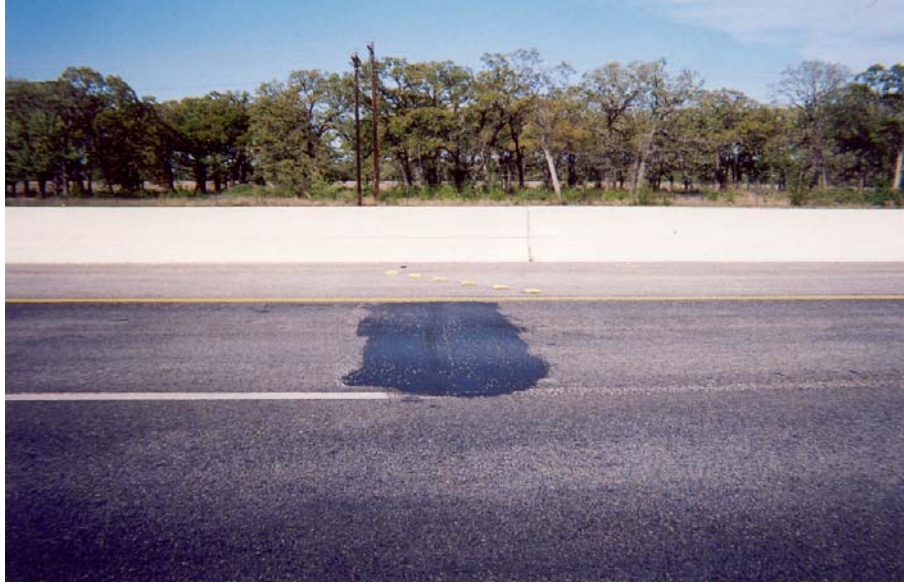
**Figure 2-3. Improper Underseal Joint Construction Revealed in the HMA Overlay Surface.**

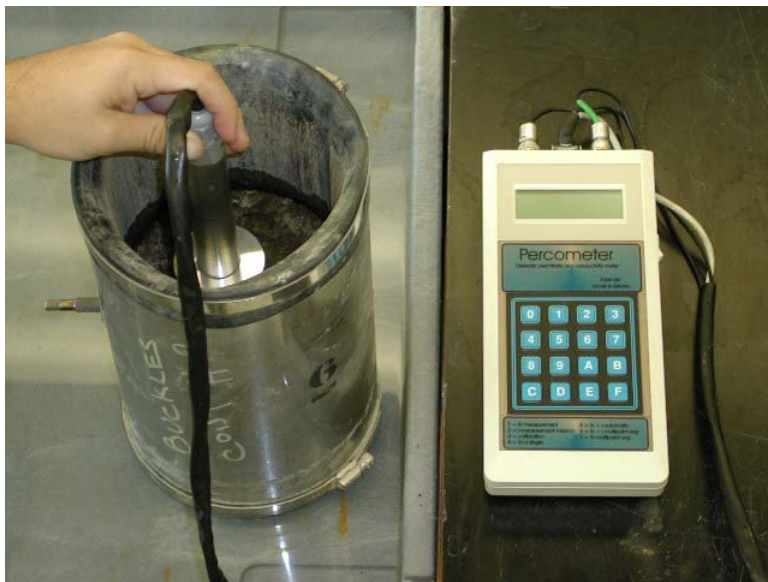
**Figure 3-2. Using the Adek Percometer™.**
