1. Report No. FHWA/TX-05/0-4413-2		2. Government Accession No.		3. Recipient's Catalog No.	
4. Title and Subtitle ADVANCE WARNING OF STOPPED TRAFFIC ON FREEWAYS: FIELD STUDIES OF CONGESTION WARNING SIGNS				5. Report Date March 2005

**ADVANCE WARNING OF STOPPED TRAFFIC ON FREEWAYS:
FIELD STUDIES OF CONGESTION WARNING SIGNS**

Report 0-4413-2
Project Number 0-4413
Project Title: Advance Warning of Stopped Traffic

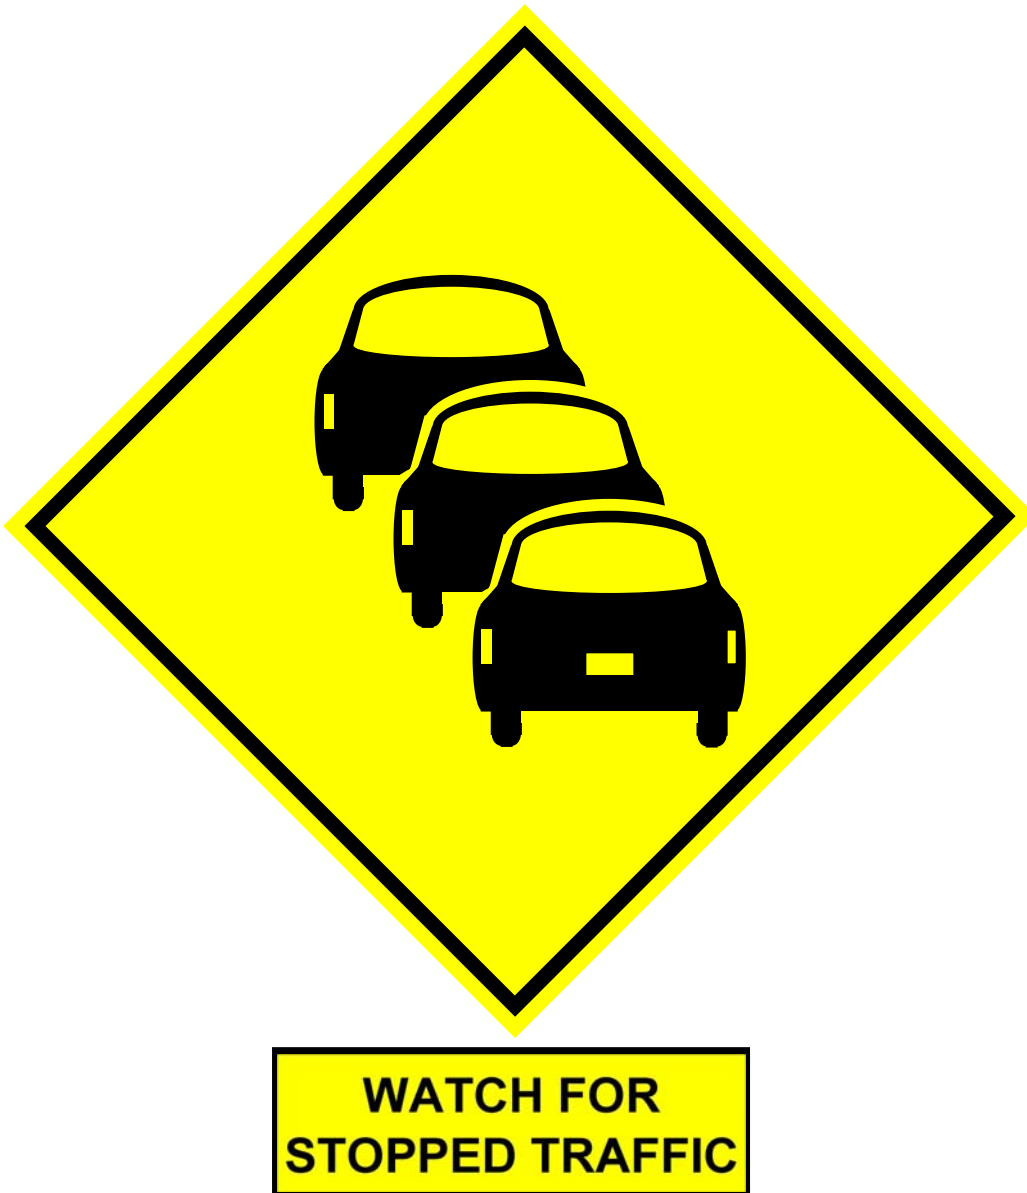
Figure 2-1. Conceptual Design of Pictogram Congestion Warning Sign.

Researchers, in conjunction with the PMC, decided to test the pictogram sign without the supplemental plaque “Watch for Stopped Traffic.” Subsequent field tests could include this plaque. An alternative text could be “Watch for Congestion.” The “Watch for” part of the text message was desirable because it did not specifically require that the congestion be present. If congestion is detected in a real-time basis, then a flashing beacon and a “When Flashing” supplemental plaque could be used. Additionally, researchers made the pictogram symbol as large as possible on the sign face, while maintaining some yellow border around the symbol. Researchers recommend that future research use surveys to help determine preferred messages that correlate to specific needs.

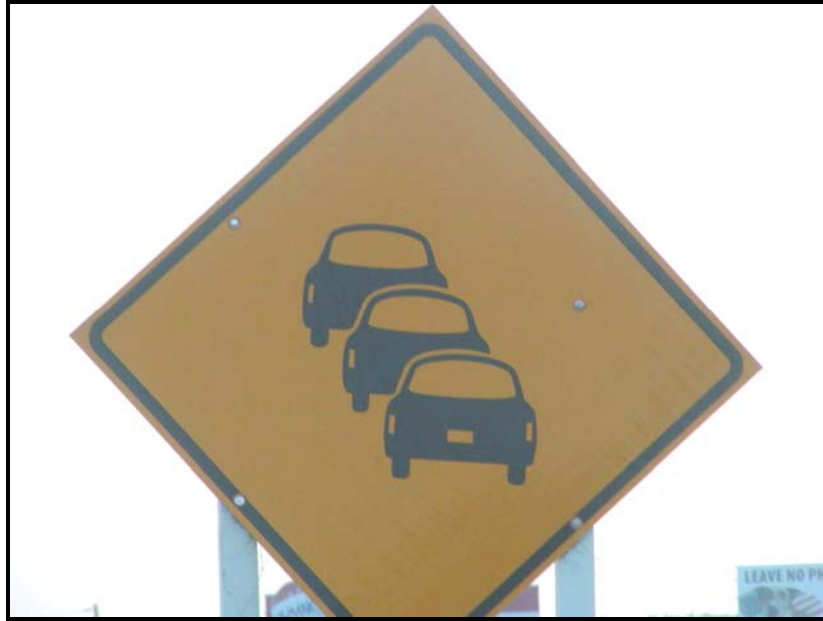
Figure 2-2. Photograph of Pictogram Congestion Warning Sign Used in Field Study.

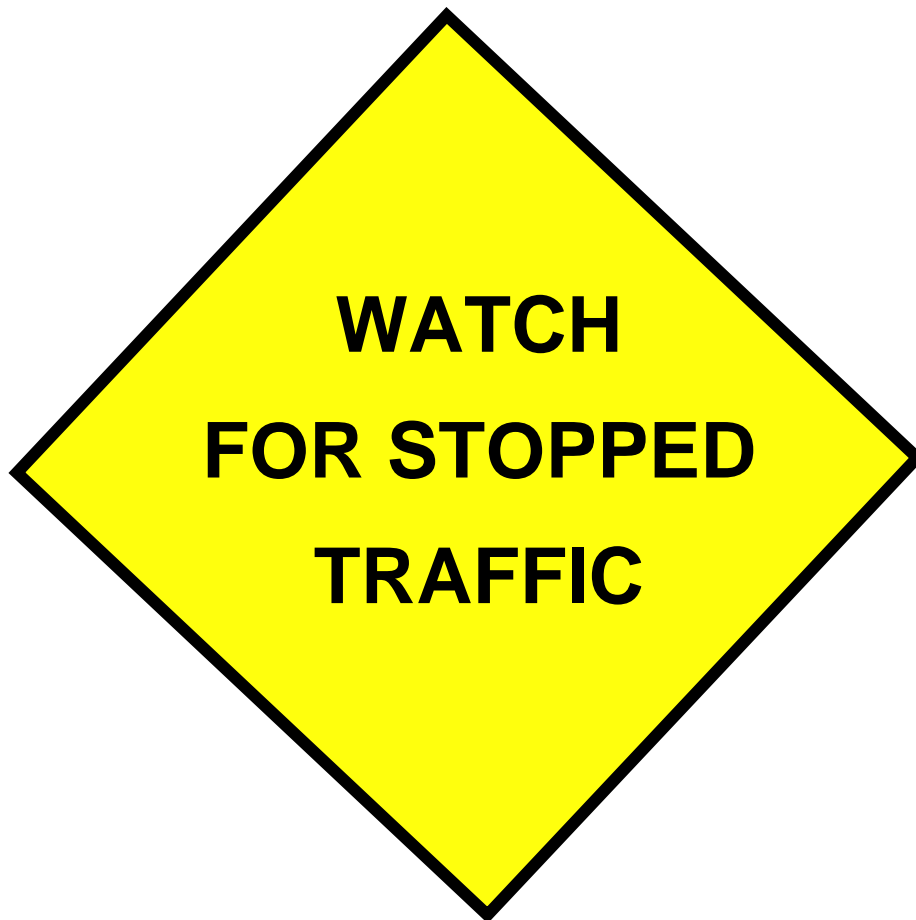
Figure 2-3. Conceptual Design of Text Congestion Warning Sign.

Considerations for the text sign message included the determination of an appropriate test message. Various words were considered for warning drivers of stopped traffic, including the words “queue,” “congestion” and “slow or stopped traffic.” Researchers selected the words “stopped traffic” because of the specific nature of the words and the familiarity drivers might have with the words. The decision not to include slow traffic in the warning was because of the transient nature of slow or stopped conditions (see research report 4413-1) and because of a similar desired driver response to either condition.

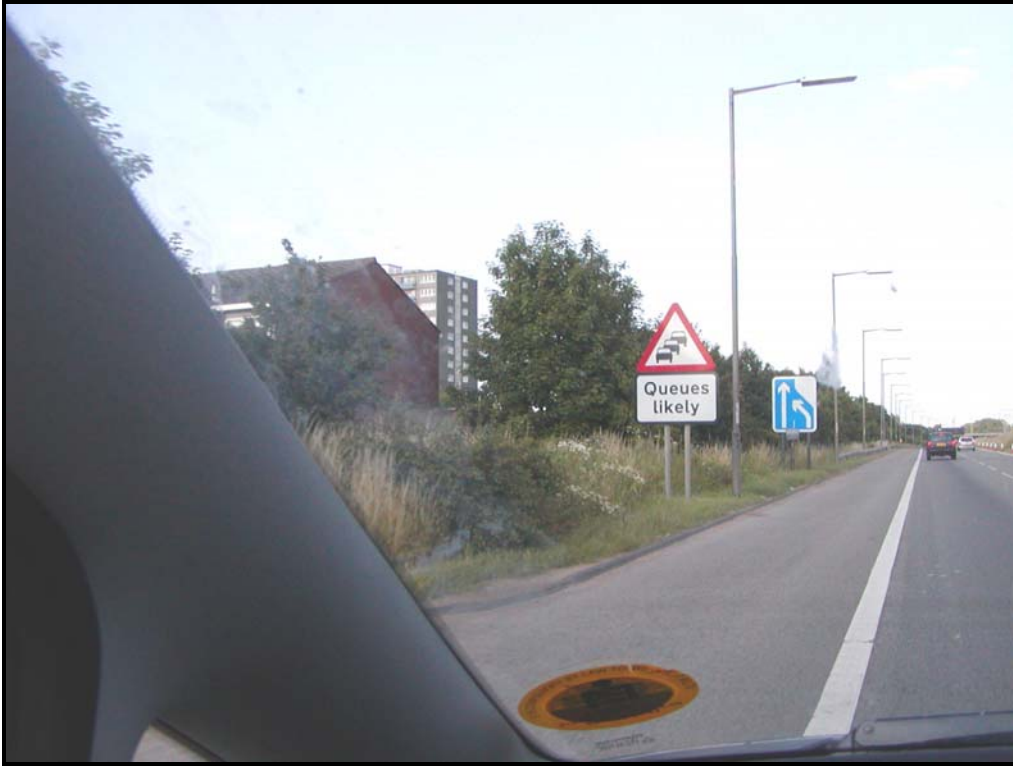
Figure 2-4. Congestion Warning Pictogram Sign in England (Photo by Poonam Wiles).

The supplemental plaques used on the United Kingdom signs were not always present (see [Figure 2-4](#)), and as shown, the messages sometimes varied. In lieu of frequent repetition of the sign, the “for 16 miles” text was added to the supplemental sign message “queues likely” (see [Figure 2-5](#)).

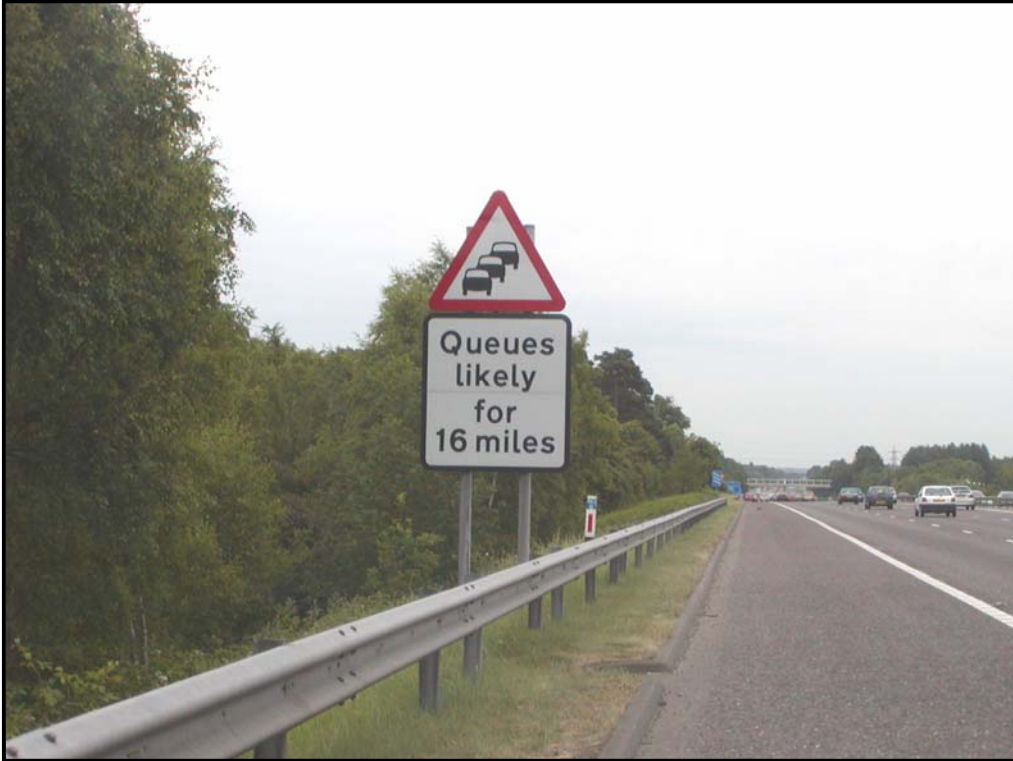
Figure 2-5. Congestion Warning Pictogram Sign in England with Distance (Photo by Poonam Wiles).

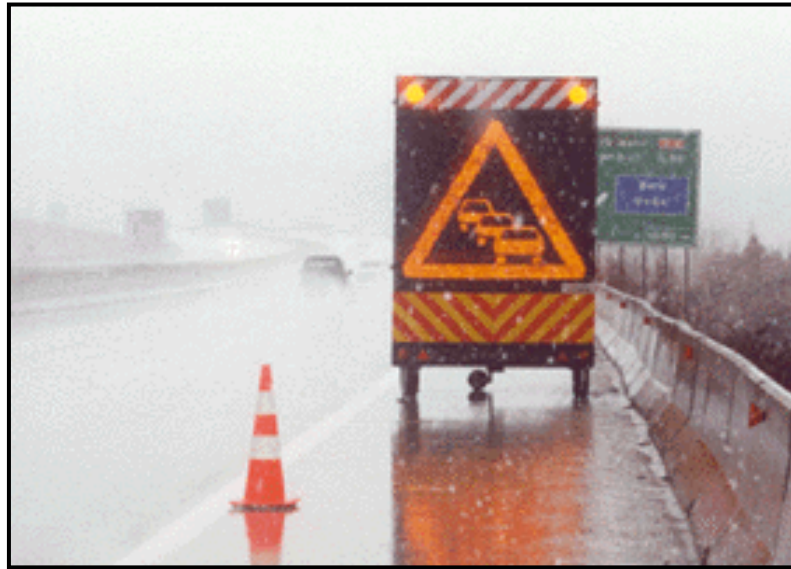
Figure 2-6. Portable Sign Deployment in Turkey.¹

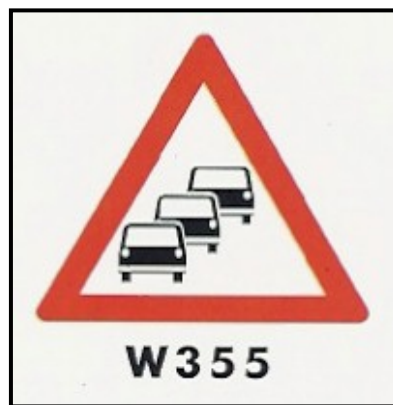
Figure 2-7. New Zealand Congestion Warning Sign.²

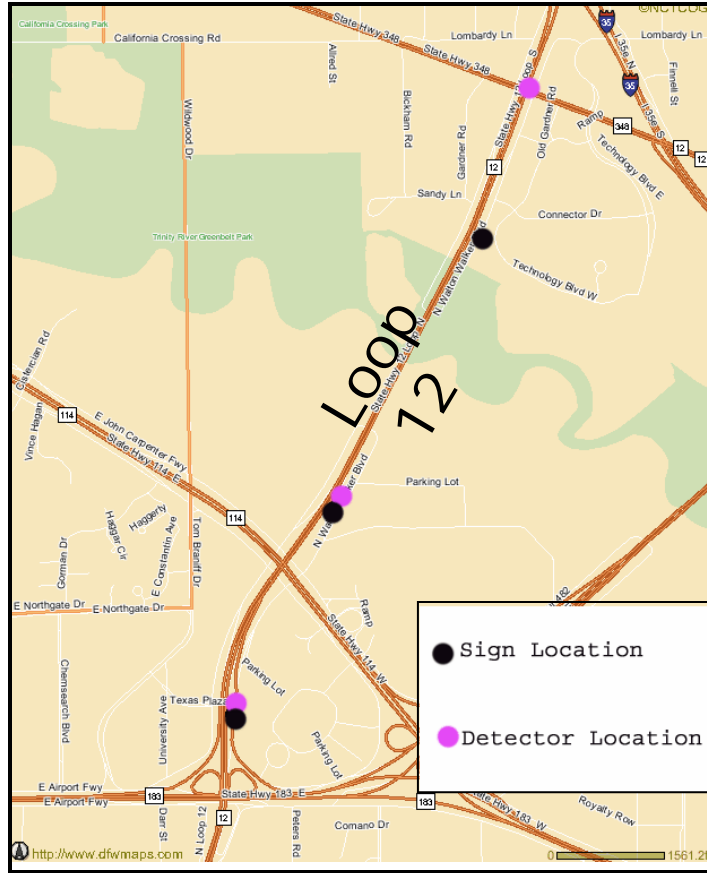
Figure 2-13. Loop 12 Field Test Sign and Detector Locations.

For each field test, signs were deployed at three locations on the right-hand side of the freeway only, well in advance of any anticipated queuing, and prior to locations where queuing would be (typically) visible from the signs. Figures 2-12 and 2-13 show sign placement and detector availability for each study. Figures 2-14, 2-15, 2-16 and 2-17 show the deployment of the signs in the field during the test period.

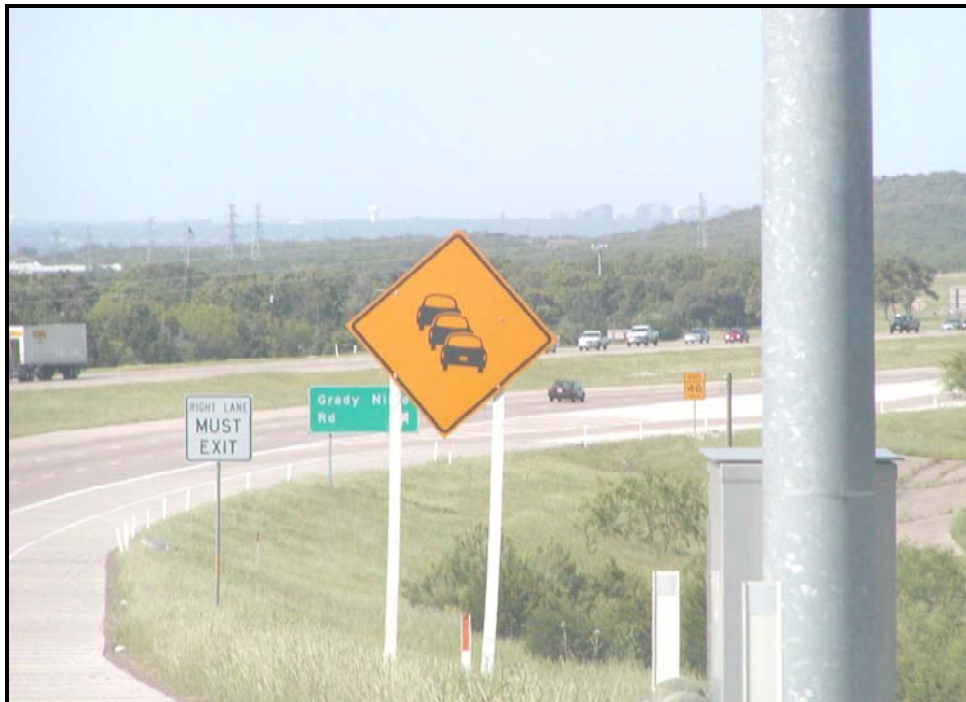
Figure 2-14. Pictogram Sign at Spur 408 Field Study Site.

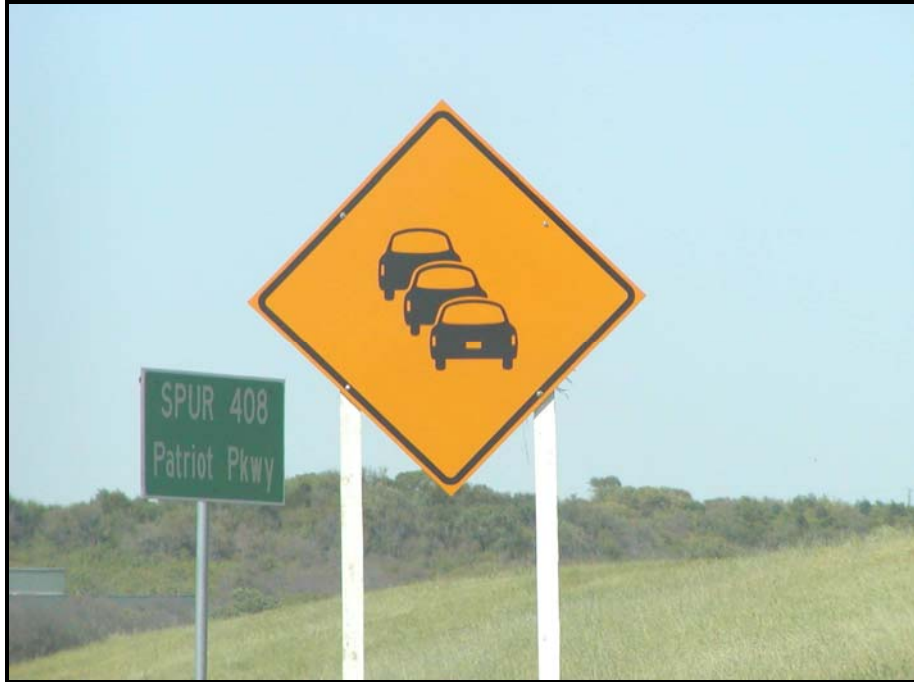
Figure 2-15. Close-up View of Pictogram Sign at Spur 408 Field Study Site.

Anecdotal comments about the pictogram signs as deployed at Spur 408 included several comments that the picture on the signs seemed very small. This comment was from drivers familiar with the pictogram. One reason for this could be that the adjacent auxiliary lane necessitated the placement of the sign farther to the right from through traffic than would generally be the case. Suggestions for improving the pictogram sign included making the picture as large as reasonable. Members of the Project Monitoring Committee also recommended the use of high intensity sheeting to make the sign more visible. This became a reasonable alternative after the production of the field test signs, and will be suggested for use in subsequent research. Additionally, the placement of the signs on temporary supports such as those used for construction zone signing was perceived as a possible influence on driver reaction to the signs.

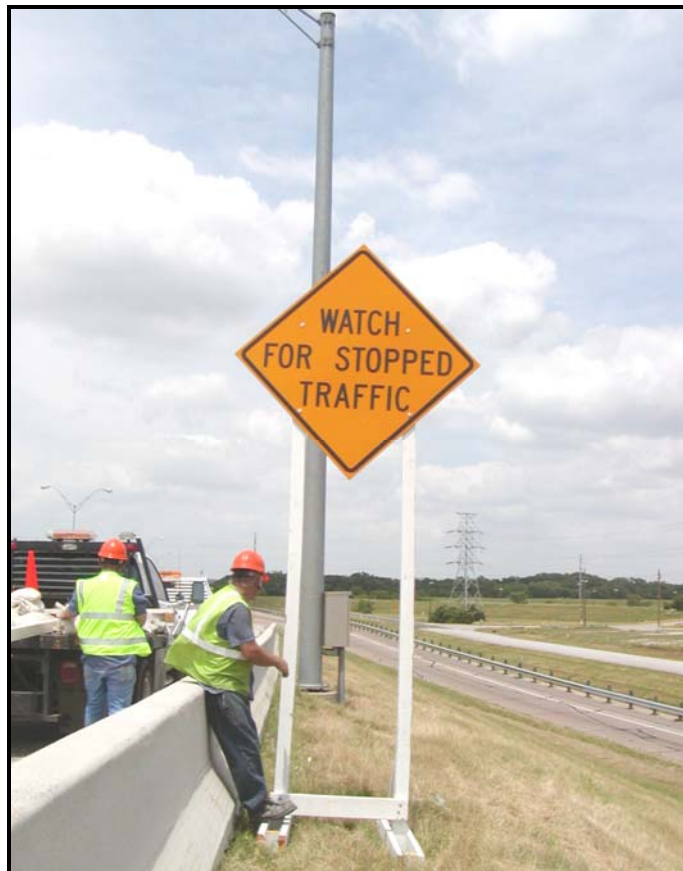
Figure 2-16. Text Sign at Loop 12 Field Study Site.

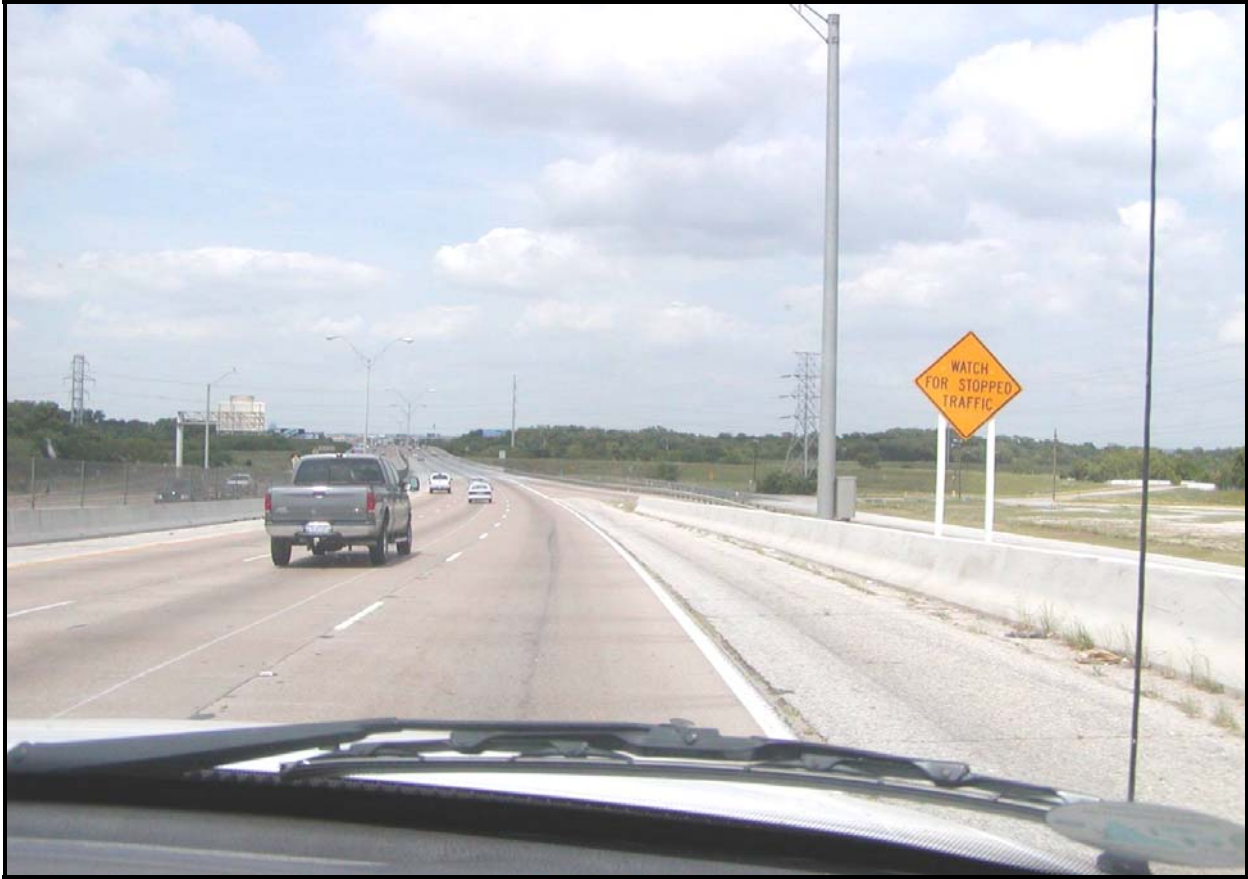
Figure 2-17. Text Sign at Loop 12 as Seen from Vehicle during Site Drive-Thru.

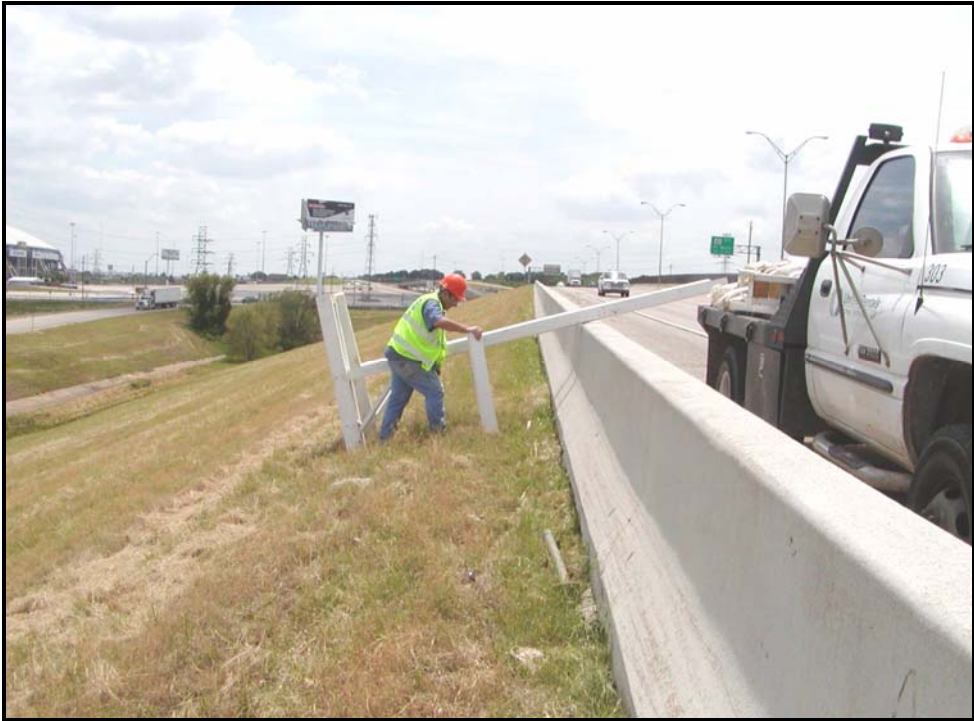
Figure 2-18. United Rental Crews Deploying Signs.

Sign deployment and removal for each of the studies was provided courtesy of United Rental (Figure 2-18). During the study period they also provided sign supports and sandbags for each sign. United Rental met researchers out in the field on numerous occasions to go over sign placement details, and they came out with a several-member crew to place each sign according to safety requirements and mounting requirements. Their assistance was invaluable in this project.

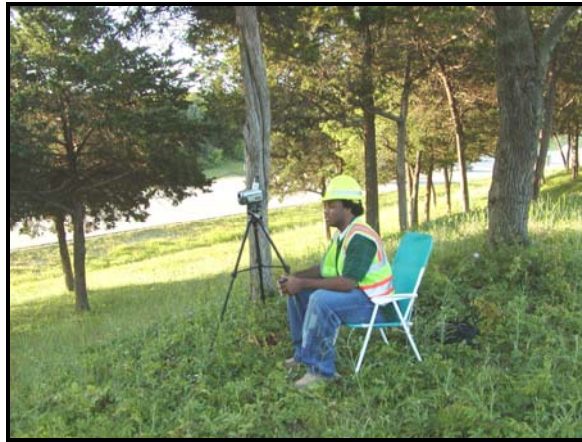
Figure 3-1. Video Tape Data Collection on Spur 408.

Field personnel located out of view of drivers in the area under study (see Figures 3-1 and 3-2) collected data via traditional video cameras. This video data was collected for the potential to view possible driver reactions to the signs such as increased braking. However, the primary data collection was conducted via the ITS systems in place on Spur 408 and Loop 12. The internet was used extensively in the data collection process. Personnel monitored the CCTV cameras located at each facility via the internet. Snapshots of traffic conditions were observed, such as those seen in Figures 3-3 and 3-4. These figures show free flow and congested conditions as seen via the internet web site at <http://www.daltrans.org/>. Monitoring of traffic conditions which could impact traffic flow in the study section was also conducted in this manner.

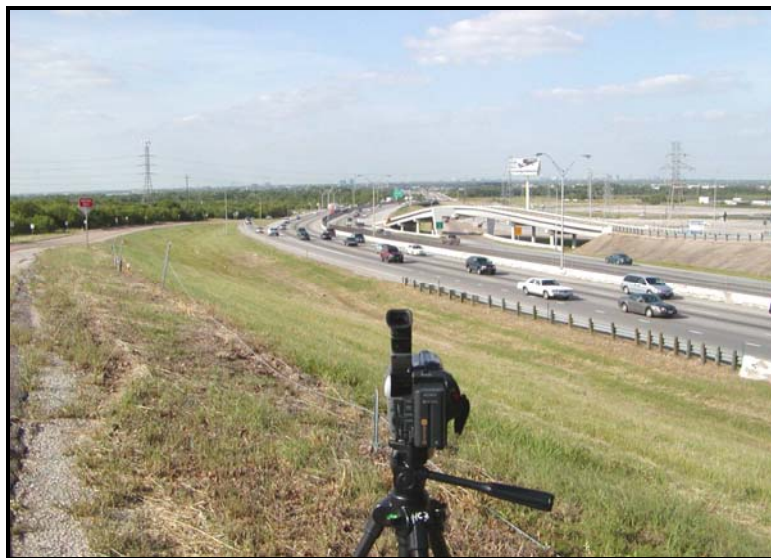
Figure 3-2. Video Tape Data Collection on Loop 12 (Observing Vehicles Moving Away from Camera).

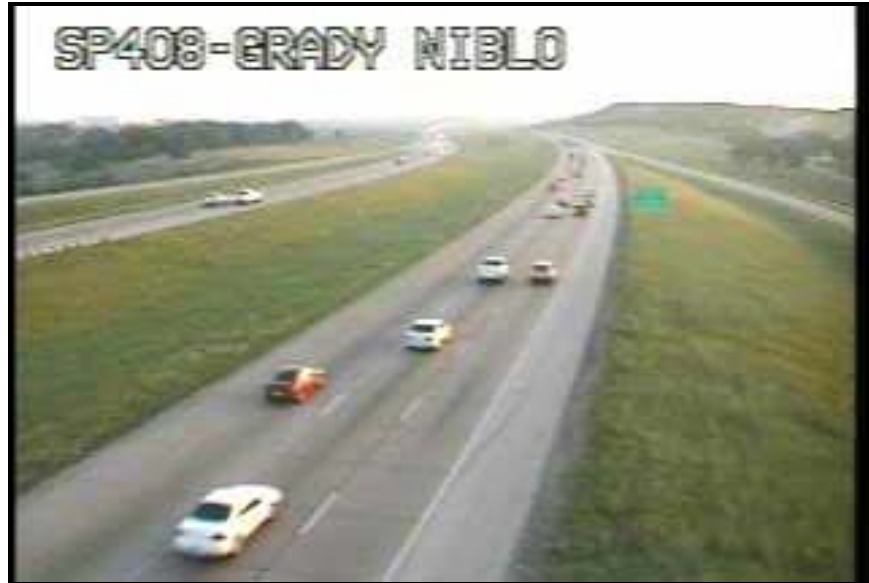
Figure 3-3. View to North, No Congestion.

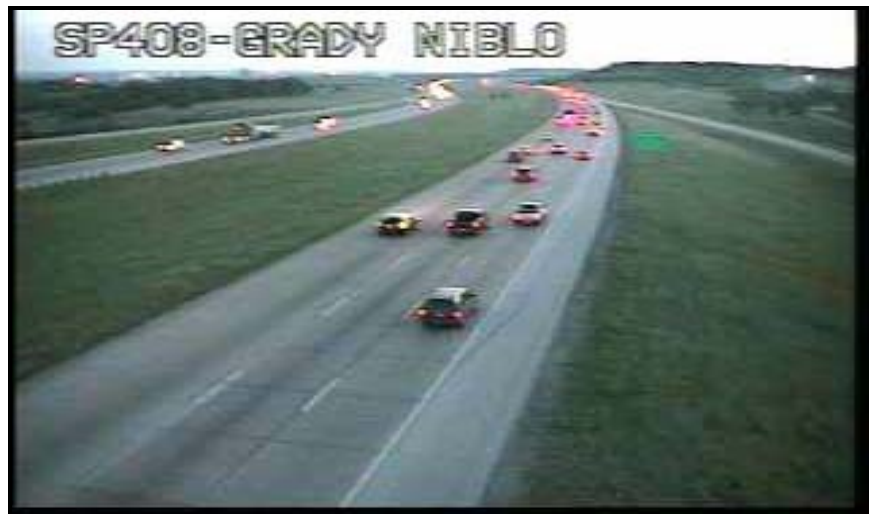
Figure 3-4. View to North, Congested.

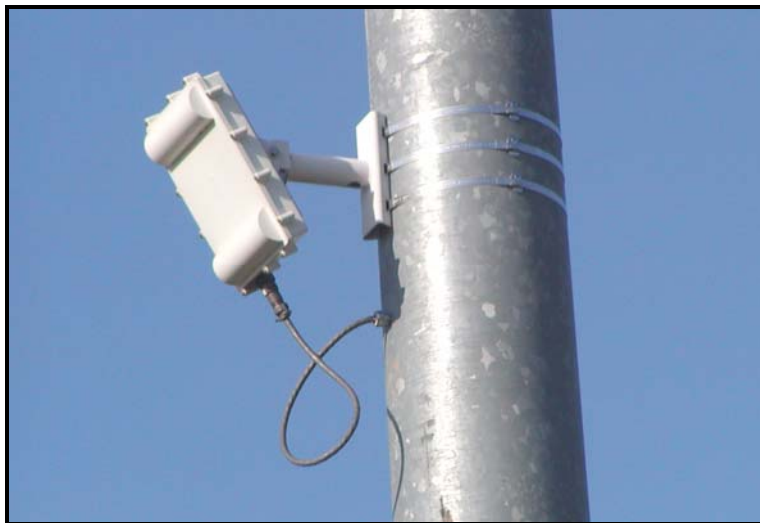
Figure 3-5. SmartSensor by Wavetronix Detection Used on Spur 408.

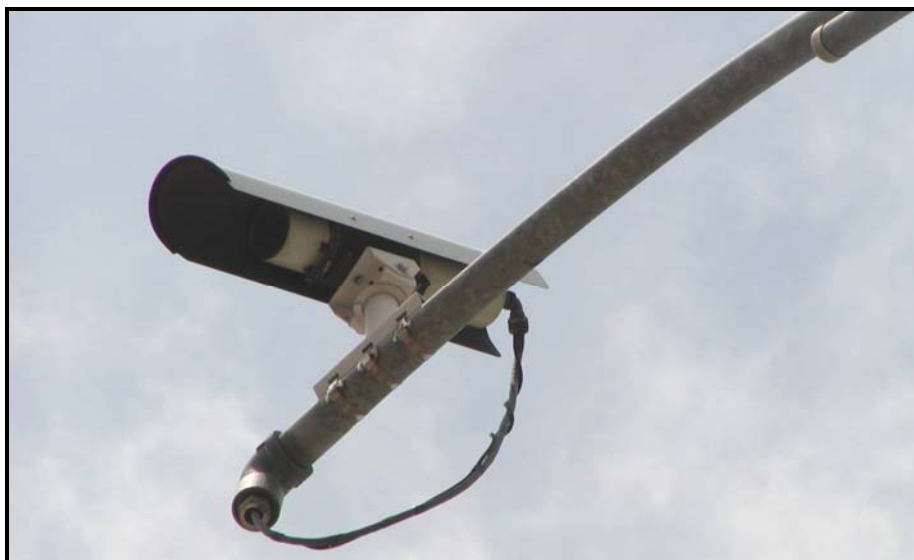
Figure 3-6. Autoscope Video Detection Used on Loop 12.

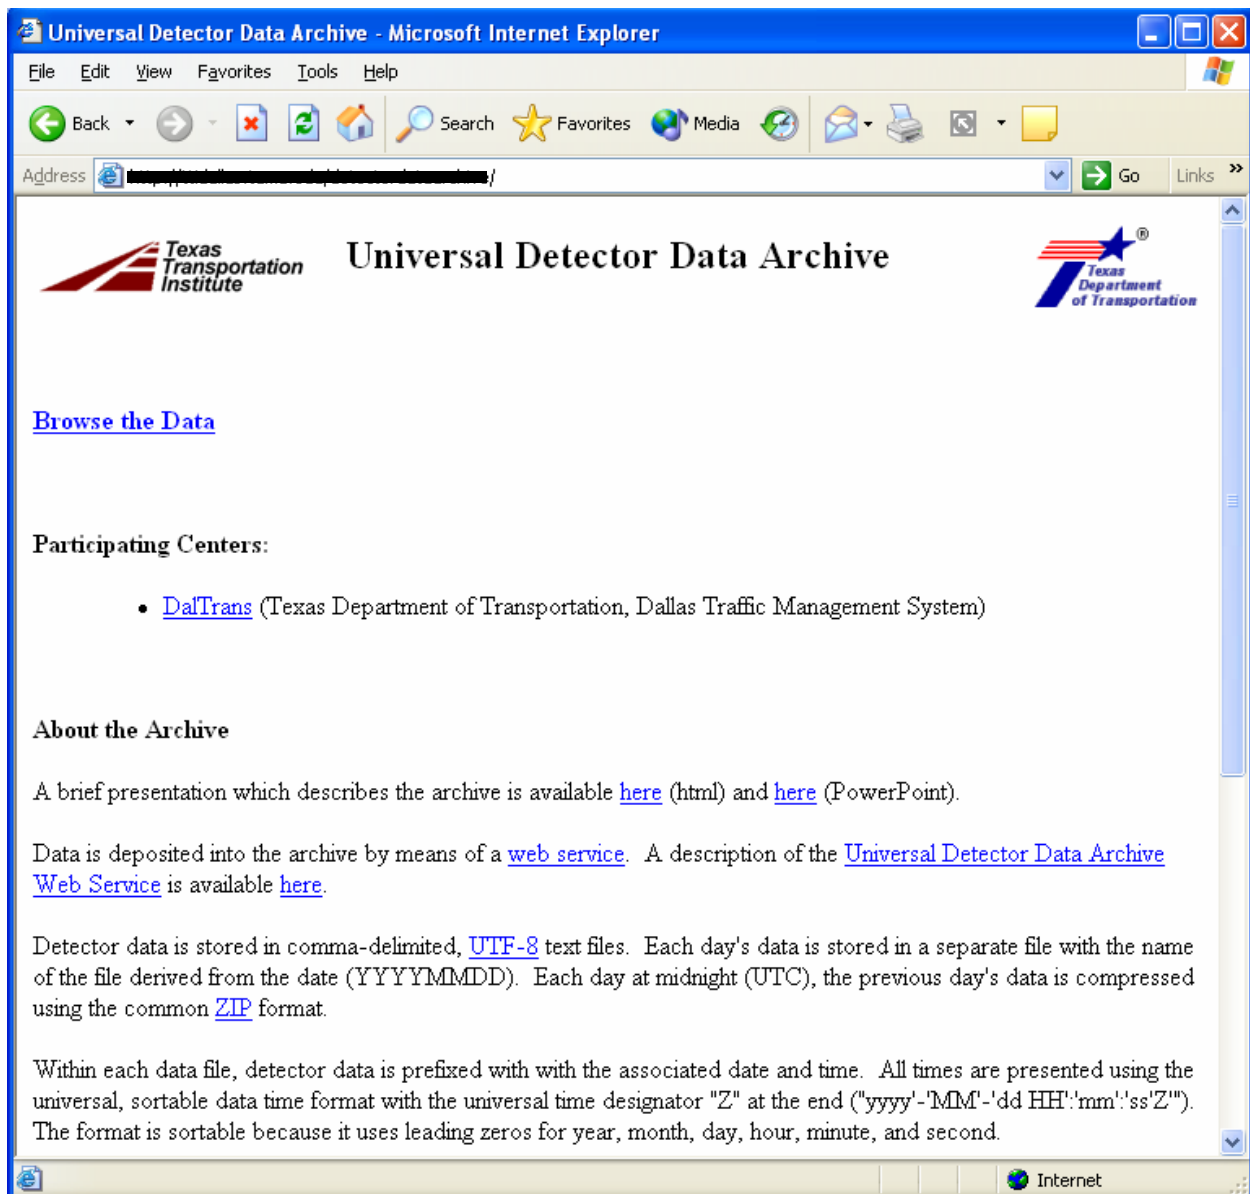
Figure 3-7. Internet-Based Universal Detector Data Archive.

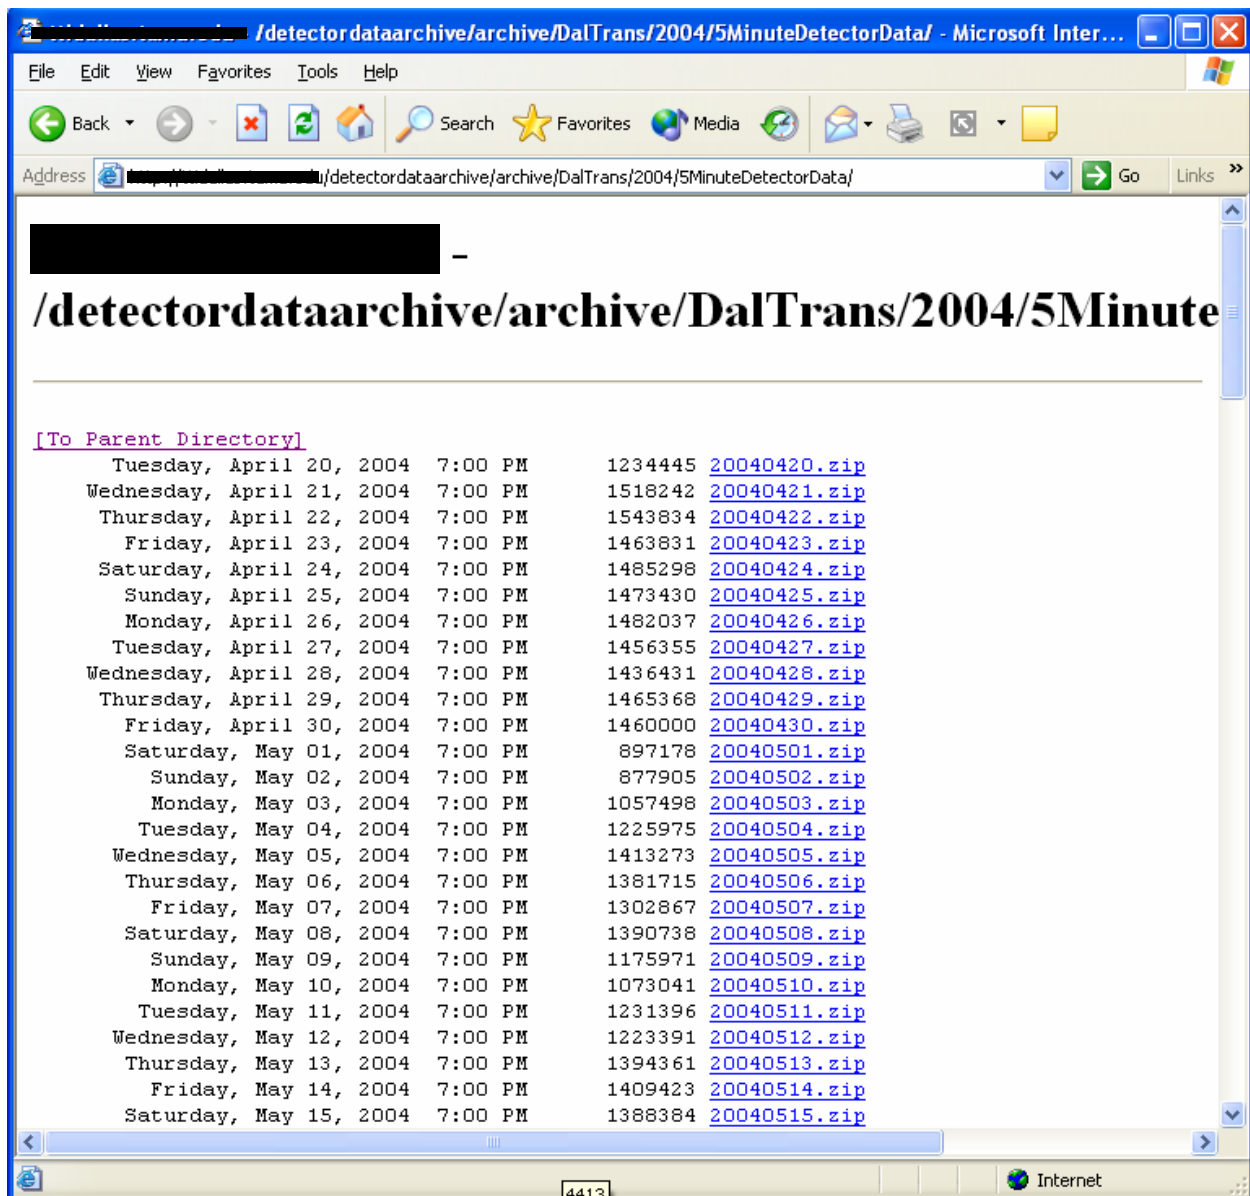
Figure 3-8. Internet-Based Detector Data Archive, by Day.

Figure 3-8 shows traffic volume and speed data from the field test sites that were summarized in five minute intervals and archived (by day) on the internet. Figure 3-9 depicts when one day is reviewed in detail. The data were sorted using Microsoft Access, and then tabulated and graphed using Microsoft Excel. Chapter 4 reports the findings.

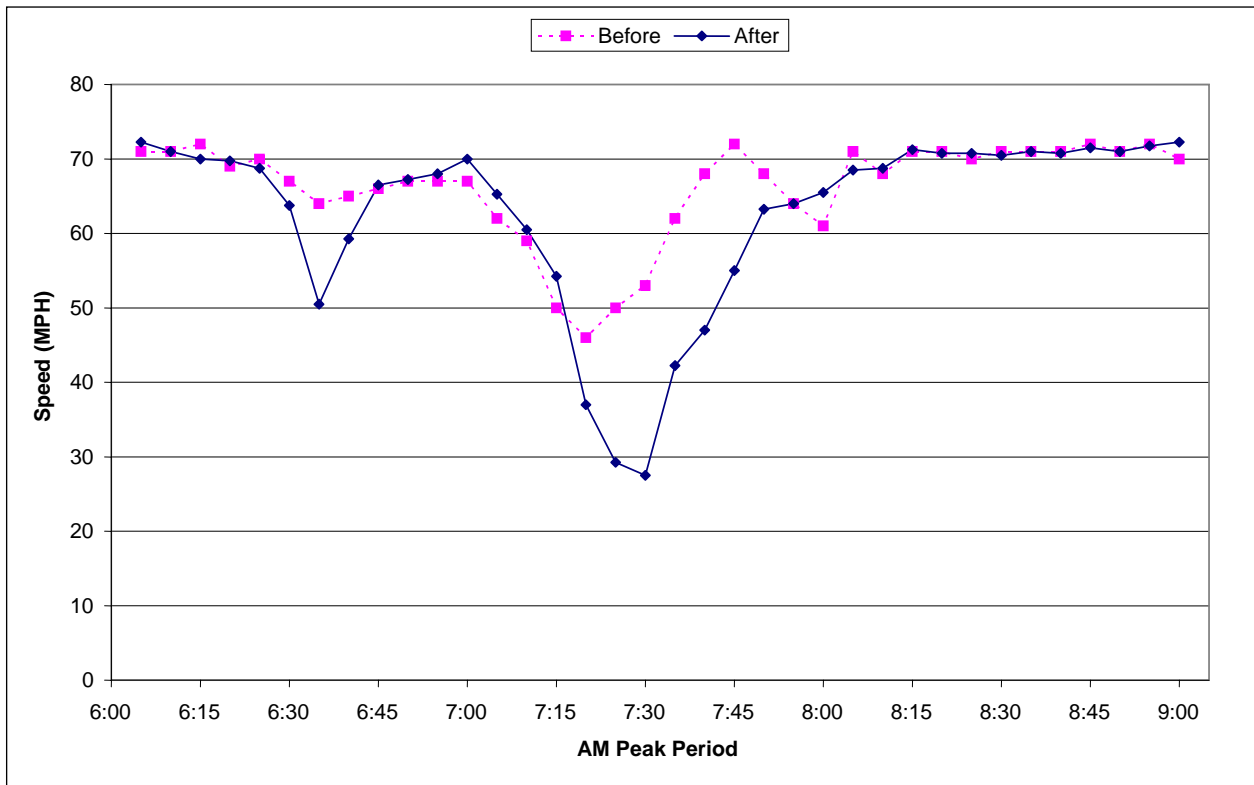
Figure 4-1. Comparison of Speeds at Spur 408 Field Site: Lane 1 AM.

Figure 4-2. Comparison of Speeds at Spur 408 Field Site: Lane 2 AM.

Figure 4-3. Comparison of Speeds at Spur 408 Field Site: Lane 3 AM.

The Spur 408 field test had one detection station available, located immediately following the last of the three signs viewed by drivers (Figure 2-12). Traffic volumes were similar for both the “before” and “after” study. Researchers collected “before” data the week before sign deployment and “after” data reflects conditions while the signs were in place. The speed data obtained was an average (over several days) spot speed, reported by lane. A review of the speeds during the AM peak period shows a marked drop in average speeds for each of the three lanes at the detection point when the pictogram signs were present, but only during the 7:15 AM to 7:45 AM timeframe (Figures 4-1, 4-2 and 4-3).

No other variable, other than the presence of the signs, was evident to researchers. The magnitude of the speed drop varies from about 15 mph to about 25 mph. Perhaps because drivers anticipate possible congestion during that timeframe, the speed in the “before” condition dropped from general approach speeds of around 65 mph to about 45 mph. With the presence of the pictogram signs in the “after” conditions, the drop in average speeds of an *additional* 15 mph to 25 mph resulted in approach speeds dropping to a low of about 28 mph.

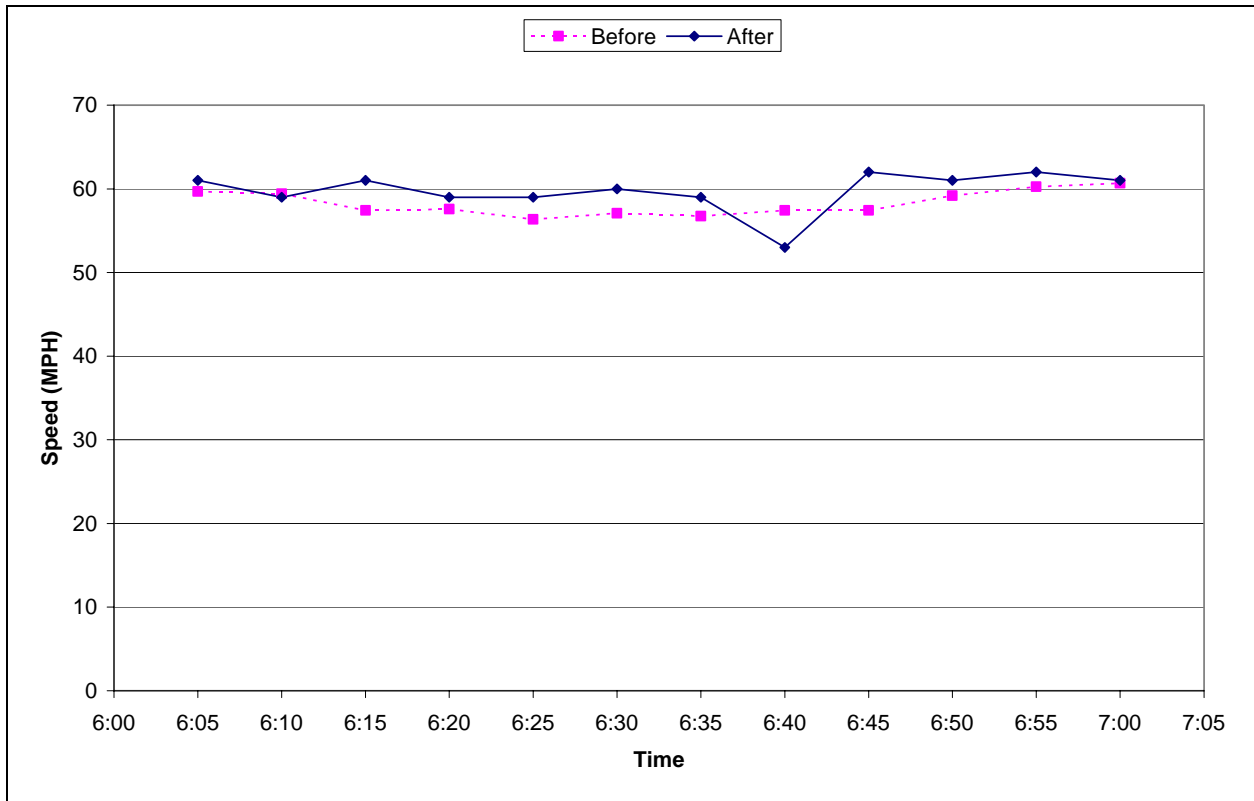
Figure 4-10. Comparison of Speeds at State Highway 183 Field Site: Lane 1 AM.

Figure 4-11. Comparison of Speeds at State Highway 183 Field Site: Lane 2 AM.

Figure 4-12 Comparison of Speeds at State Highway 183 Field Site: Lane 3 AM.

Figures 4-4, 4-5 and 4-6 show speeds before and during sign deployment at Northwest (NW) Highway, a location where drivers have had the opportunity to view all three signs. Recurrent congestion routinely exists downstream of this location due to a lane drop at the merge of Loop 12 with I-35E. Figures 4-7, 4-8 and 4-9 show speeds after drivers have passed two signs (at SH 114), and Figures 4-10, 4-11 and 4-12 show speed conditions after drivers have viewed only one sign (at SH 183).

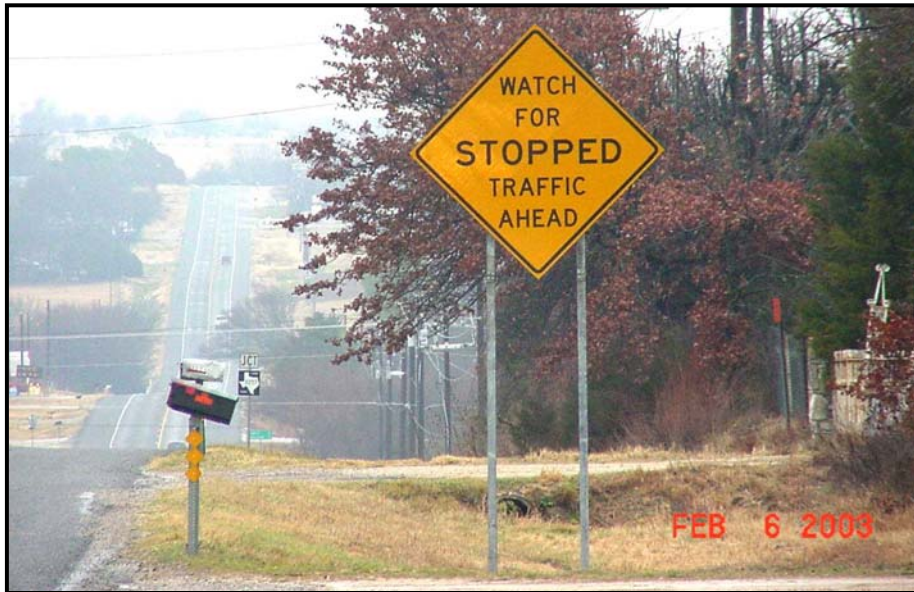
Figure 4-13. Example of Diamond-Shaped Warning Sign – Fort Worth, Texas.

The color of these types of signs is recommended to be yellow background with black text. Appropriate messages include those listed in the chart: WATCH FOR STOPPED TRAFFIC and WATCH FOR CONGESTION. The word AHEAD may be added to the message. If a rectangular sign is used, the word CAUTION can be added to the message, since a warning is not inherently implied by the sign shape. The congestion pictogram, although promising, is not currently approved for use. It is worthy of additional research and development. Other sign messages observed in the current practices review include the following:

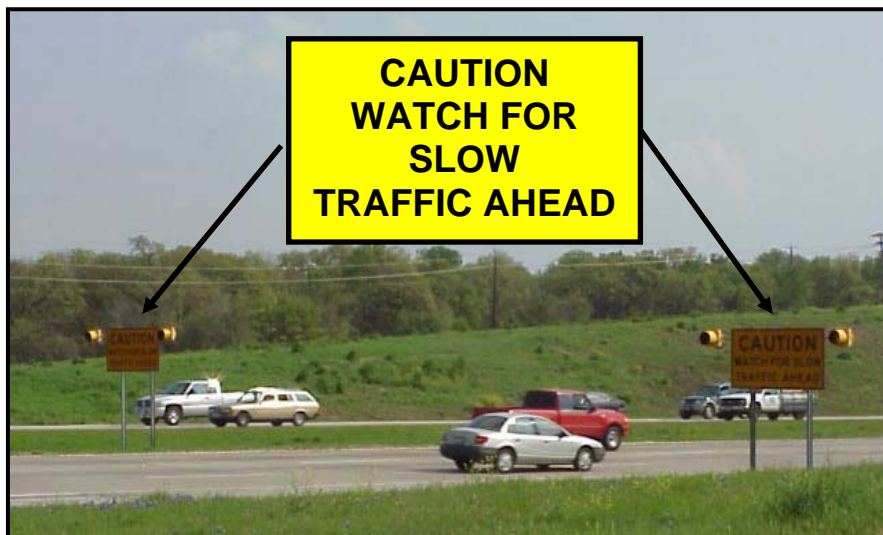
Figure 4-14. Example of Rectangular-Shaped Warning Sign – Fort Worth, Texas.

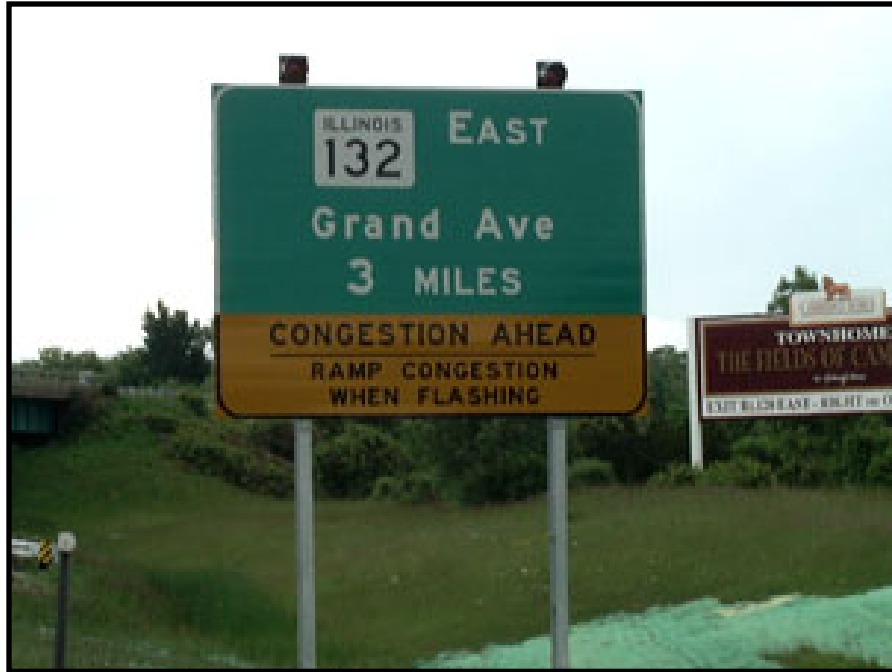
Figure 4-15. Example of Sign Panel on Guide Sign.¹

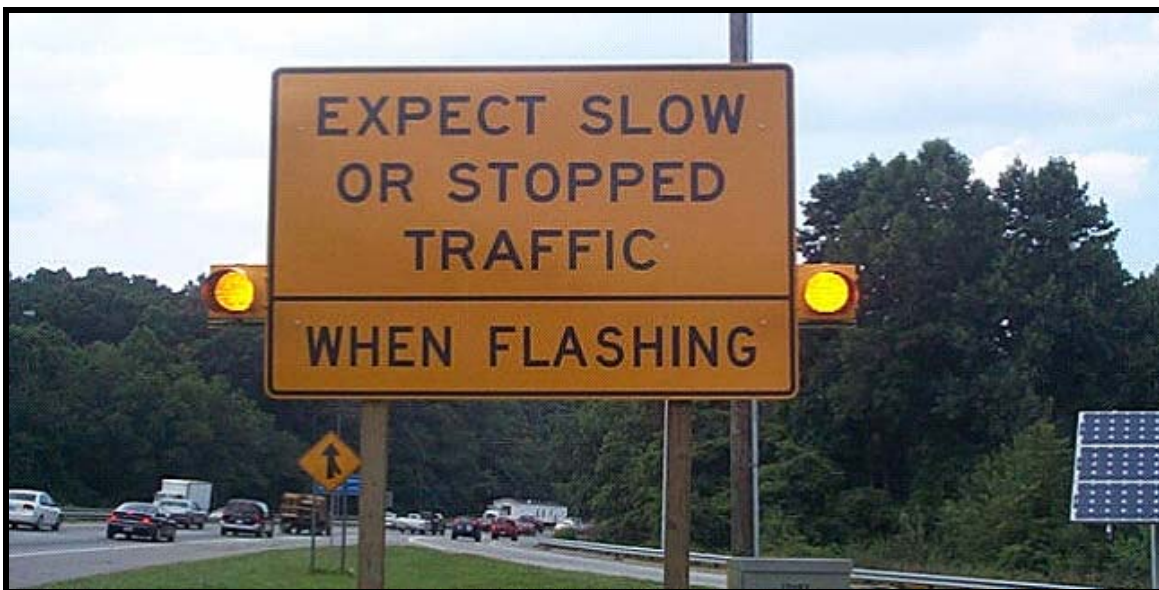
Figure A-1. Picture of Queue Warning Sign on Interstate 26 in Asheville, North Carolina.

Project Benefits: North Carolina DOT performed a before and after crash analysis and found some positive benefits for the queue warning system:

Variable	Before	After
Number of Crashes	36	27
Crash Rate	119.98	91.89
Severity Index	5.96	2.37

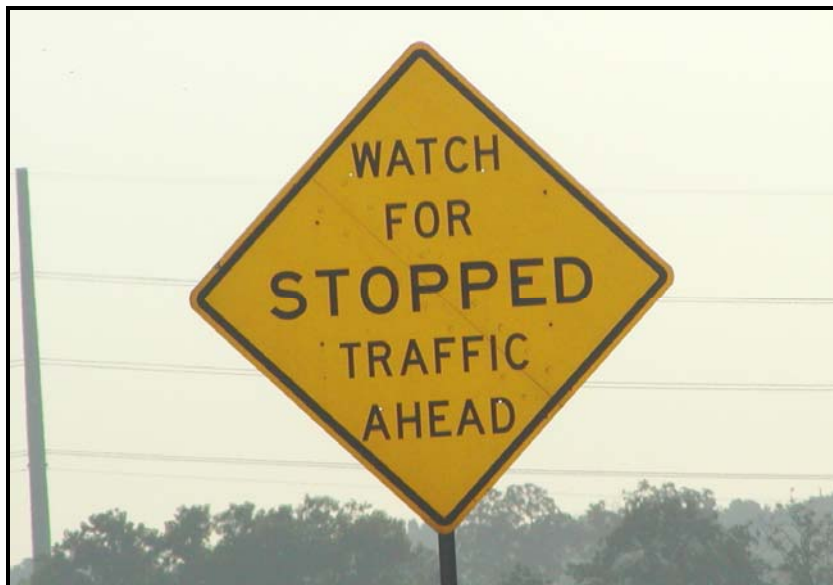
Figure A-2. First Queue Warning Sign on Interstate 20 in Dallas, Texas.

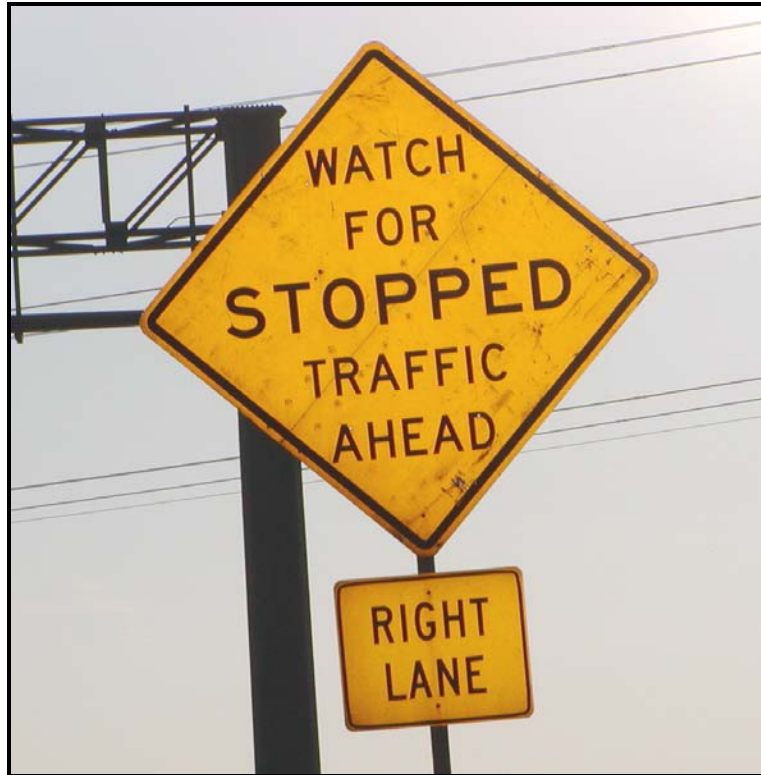
Figure A-3. Second and Third Queue Warning Sign on Interstate 20 in Dallas, Texas.
