1. Report No. FHWA/TX-05/0-4413-2		2. Government Accession No.		3. Recipient's Catalog No.	
4. Title and Subtitle ADVANCE WARNING OF STOPPED TRAFFIC ON FREEWAYS: FIELD STUDIES OF CONGESTION WARNING SIGNS				5. Report Date March 2005

**ADVANCE WARNING OF STOPPED TRAFFIC ON FREEWAYS:
FIELD STUDIES OF CONGESTION WARNING SIGNS**

Report 0-4413-2
Project Number 0-4413
Project Title: Advance Warning of Stopped Traffic

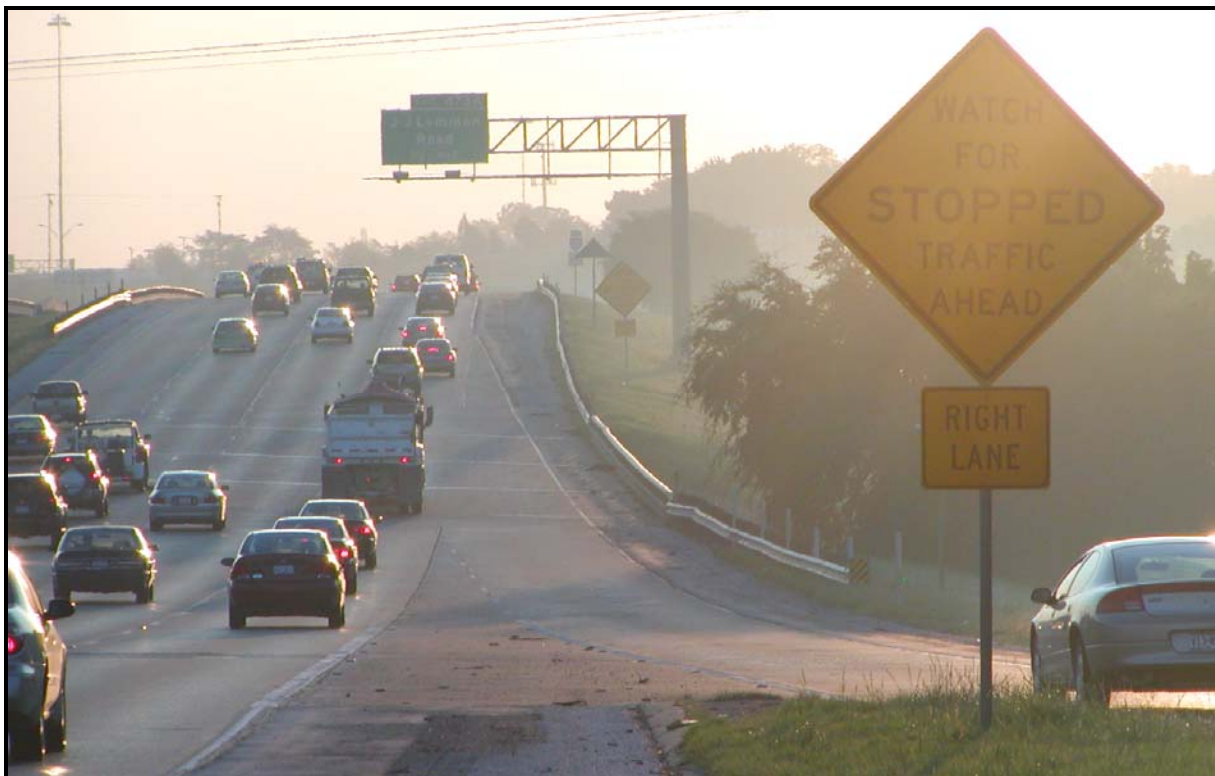
Figure A-4. Queuing in the Right Lane of Interstate 20 in Dallas, Texas.
