Project Summary Report O-4471-S

Project O-4471: Evaluation of Horizontal Signing Applications

## Research Recommendations for Pavement Marking Words and Symbols

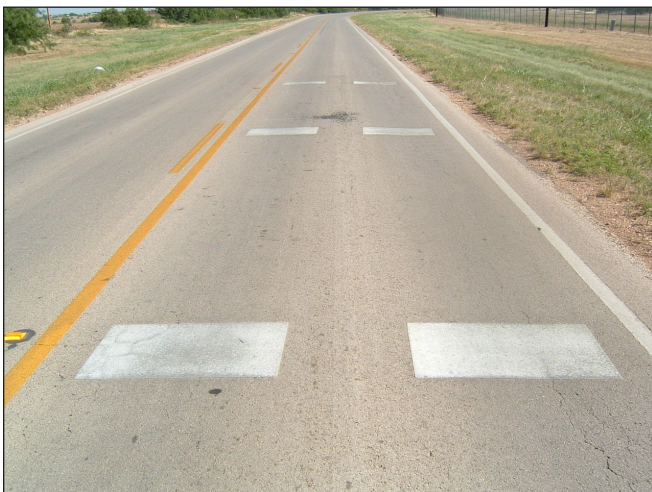
Figure 1. Transverse Line Treatment.

*Transverse Lines:* The northbound direction of FM 707

in the Abilene District received a treatment of simple transverse lines (see Figure 1). This treatment was selected to represent the lowest-cost minimal treatment. The treatments applied here attempted to provide a visual warning, a “visual rumble strip” of sorts, to alert drivers to some upcoming change or hazard.

**Transverse Lines:** The transverse line treatment at the study location did not appear to have a measurable effect on speed. The results indicate that the materials did not provide a sufficient cue to drivers that they should slow for the approaching curve.

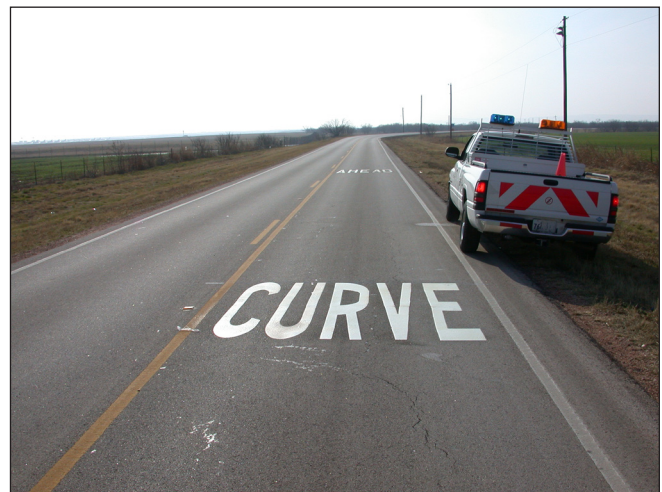
Figure 2. CURVE AHEAD Treatment.

**CURVE AHEAD Text:** The southbound direction of FM 707 received a treatment of the text message CURVE AHEAD. The text consisted of 8-ft letters as shown in Figure 2.

**CURVE AHEAD Text:** The CURVE AHEAD treatment at this location did not have the expected effect on speed selection. The number of observations for this site was smaller than the number for other sites, but still of

sufficient size to draw the conclusion that the CURVE AHEAD text treatment did not succeed in changing driver behavior.

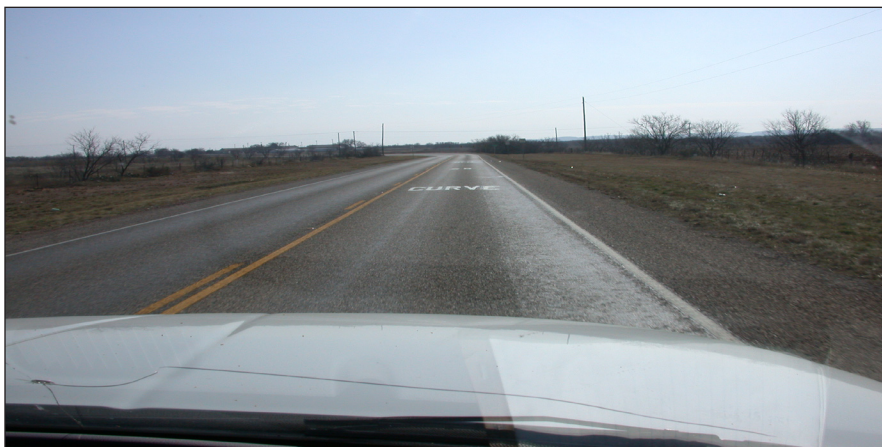
Figure 3. CURVE 55 MPH Treatment.

**CURVE 55 MPH Text on Rural Curve:** The treatment consisted of the words CURVE 55 MPH. The treatment began approximately 400 ft after the standard curve warning sign (see Figure 3).

**CURVE 55 MPH Text on Rural Curve:** With only a standard warning sign drivers slowed down approximately 8 mph, while after the installation of the text on the pavement they slowed down 12 mph. This difference was not statistically significant, but it does suggest a benefit of the horizontal signing treatment that is worthy of further exploration.

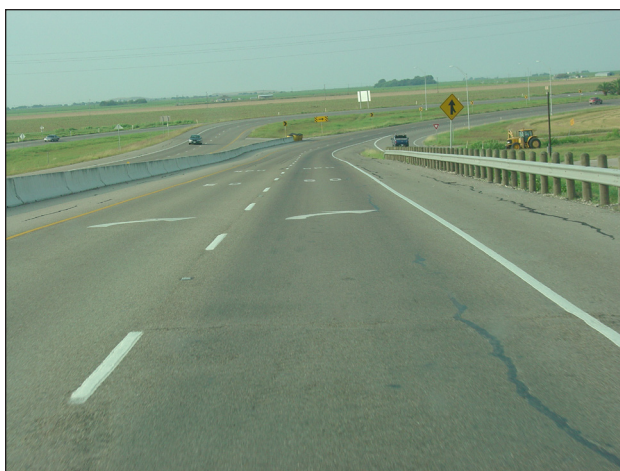
Figure 4. Curve Arrow and Advisory Speed Treatment.

**CURVE 50 MPH Text on Urban Curve:** An urban curve location was selected on US 77 near Robstown in the Corpus Christi District. This location, on a divided four-lane highway, was selected based on a high number of truck rollover accidents in the area as reported by the TxDOT district engineer. Directional curve arrows and a 50 mph advisory speed were placed on the pavement as shown in Figure 4.

**CURVE 50 MPH Text on Urban Curve:** The average speed data showed that because of the vertical crest between the control point and the warning sign, vehicles slowed down between the first and second counter locations. After passing the warning sign, vehicles in the before period accelerated as they went down the overpass. In the after condition, vehicles did not accelerate. The percentage of vehicles exceeding the speed limit revealed the effectiveness of this treatment.

The project showed substantial reductions in speed for the multi-lane freeway location marked with a curve arrow and an advisory speed, while the rural curve marked with the word CURVE and the advisory speed showed modest reductions in speed. Both treatments that included a specific advisory speed produced clearer results than the treatments that simply warned

of an upcoming curve through words and transverse lines. In addition, the use of the curve arrow provides drivers with information about the direction of the curve that can be particularly useful on a blind approach like the one created by the vertical crest of the overpass at our test location. Overall, the results of the rural location field studies of speed on horizontal curves were fairly inconclusive.

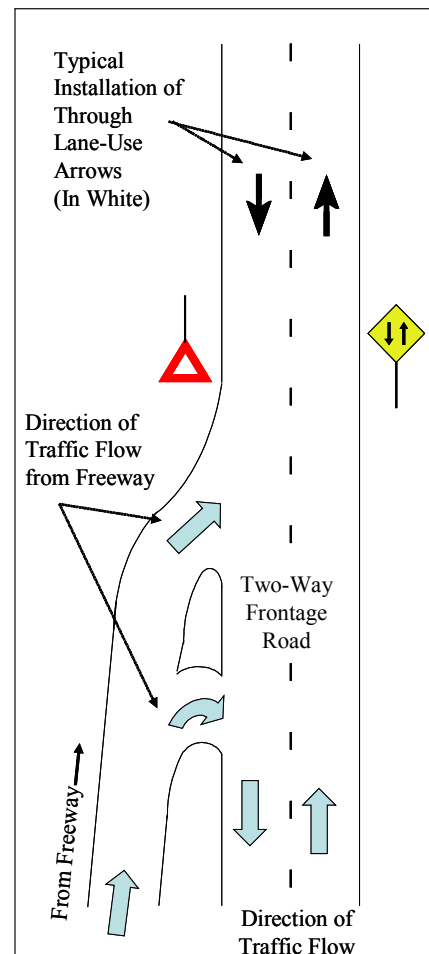
Figure 5. Typical Installation for Directional Arrows on Two-Way Frontage Road to Reduce Wrong-Way Movements.

one-way roadways, while rural areas tend to have two-way frontage roads. The presence of both one-way and two-way frontage roads in a given area may create increased potential for wrong-way movements. The location selected for the field evaluation was a short section of two-way frontage road on the fringe of the College Station, Texas, urban area. The diagram in Figure 5 shows the ramp configuration and adjoining frontage road.

The pavement marking treatment was a pair of standard 9-ft white retroreflective thermoplastic pavement marking arrows defined in the *Manual on Uniform Traffic Control Devices (MUTCD)* as a “Through Lane-Use Arrow.” Typical cost for such an installation is in the range of \$300.

Overall, incorrect maneuvers were reduced from 7.4 percent to 0.7 percent, a 90 percent reduction of the number of vehicles driving the wrong way. Stated another way, prior to the installation of the lane direction arrows about 1 out of every 13 vehicles that exited the freeway at this location ended up

driving in the wrong frontage road lane. After the installation of the arrows, this number dropped to about 1 out of every 150 vehicles.
