Project Summary Report O-4502-S

Project O-4502: Microcracking Stabilizes Bases  
during Construction to Minimize Shrinkage Cracks

## Microcracking for Reduced Shrinkage in Cement-Treated Base

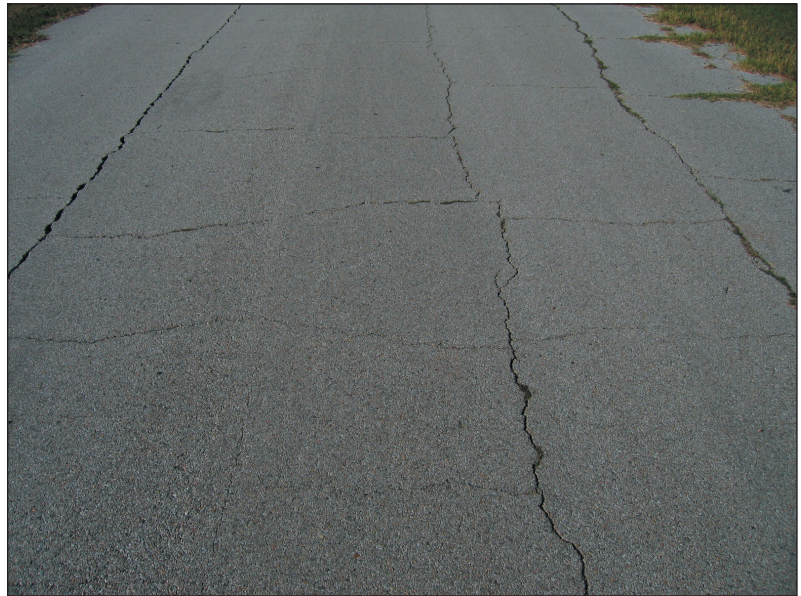
Figure 1. Shrinkage Cracking Resulting from Problems with Cement-Treated Base.

Shrinkage cracking such as that illustrated in [Figure 1](#) occurs in cement-treated bases (CTB) due to desiccation and cement hydration. Eventually these cracks start to reflect through the pavement surfacing. While initially cosmetic in nature, these cracks open the pavement to water infiltration and increase the likelihood of accelerated pavement distress.

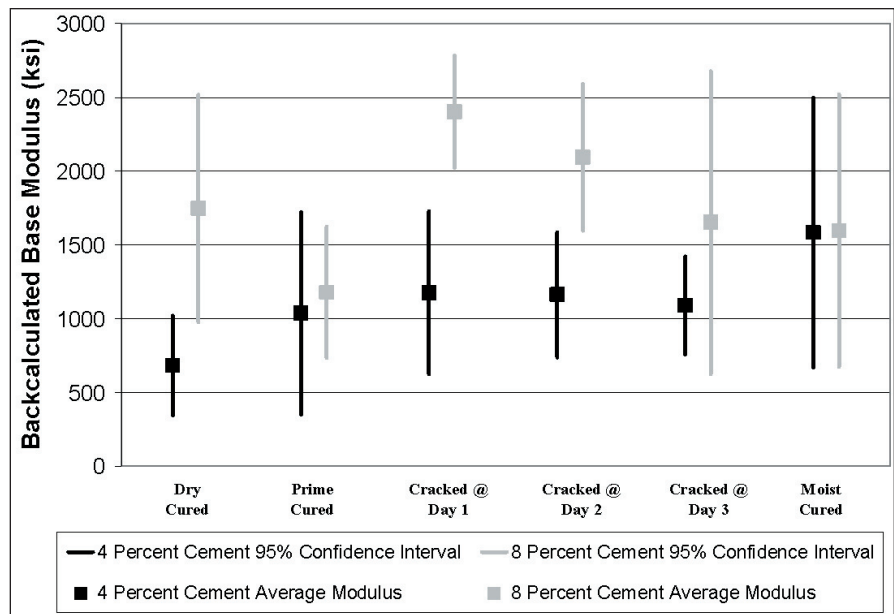
The best opportunity to study microcracking occurred through the construction of test sites at Riverside Campus. For each of the sections, [Figure 2](#) shows both the average backcalculated modulus and the 95 percent confidence interval. For a given cement content, no difference exists in the average modulus values among the different treatments. Microcracking did not harm the long-term in-service modulus.

Figure 2. Backcalculated Moduli for Test Construction Sites.

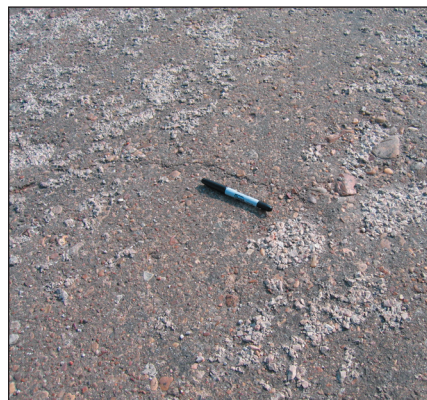
3a. Sample Cracking in Microcracked Pavement (top)

At the Riverside Campus test sites, microcracking reduced crack severity (width) and crack length. [Figure 3](#) illustrates the difference in crack severity between the moist-cured and the microcracked site with 4 percent cement. The cracks in the moist-cured sections are such that spalling is starting to occur. The best performance was at the 4 percent cement site

Figure 3. Differences in Crack Severity.

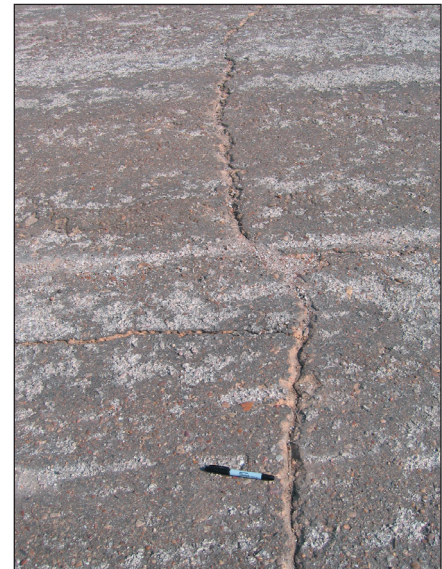
3b. Sample Cracking in Moist-Cured Pavement (right)

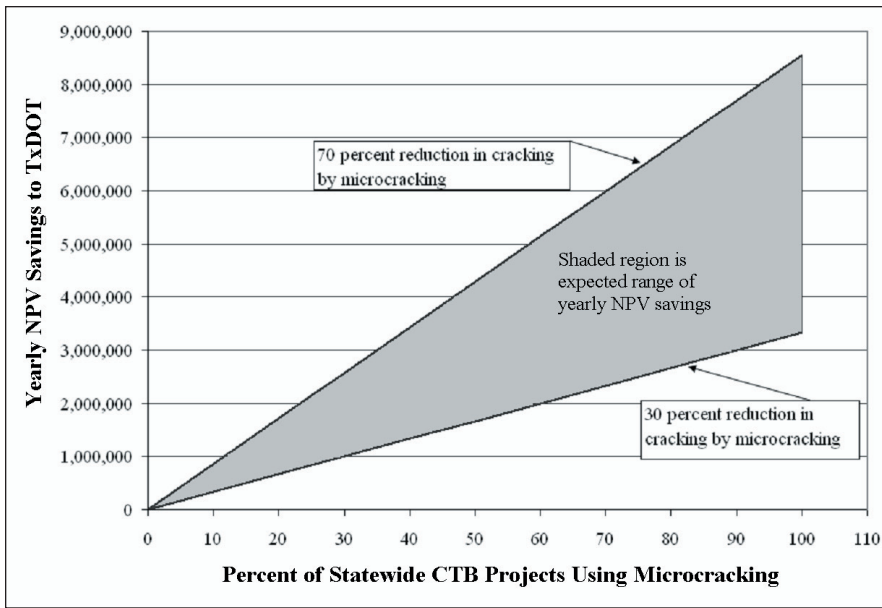
On average, with a properly designed base, microcracking reduced the amount of cracking by 50 percent, with reductions ranging from 30 to 70 percent. [Figure 4](#) illustrates the range of potential yearly net present value (NPV) savings to the Texas Department of Transportation

(TxDOT) with varying levels of implementation of microcracking. The cost savings result from reduced amounts of crack sealing required on the section over the pavement life.

Figure 4. Yearly Net Present Value Savings.

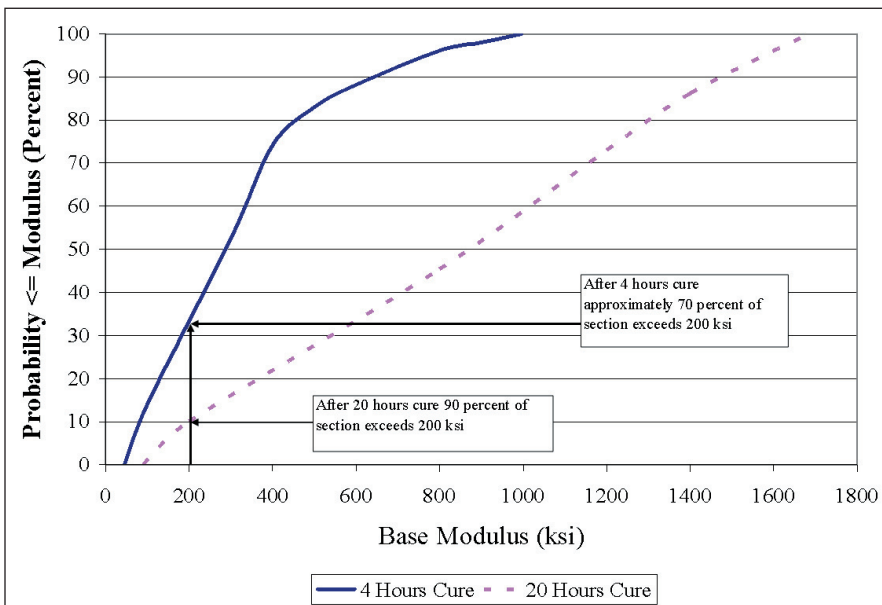
Figure 5. Comparison of Field Modulus at Early Curing Times.

moist cure as one option for curing; however, in some cases the road may need to be opened sooner. Figure 5 shows the cumulative distribution of the Riverside site with 4 percent cement at curing times of approximately 4 and 20 hours. If a minimum CTB modulus of 200 ksi was desired before allowing traffic on the section,

then after 4 hours curing only 70 percent of the section would meet the desired modulus value. However, after 20 hours curing 90 percent of the section would exceed the minimum desired modulus. The data indicate that earlier trafficking of the cement-treated base than what is typically allowed should not pose a problem.
