Project Summary Report O-4517-5  
URL: <http://tti.tamu.edu/documents/O-4517-S.pdf>

Project O-4517: Develop Statewide Recommendations for Application of PCC Joint Reflective Cracking Rehabilitation Strategies Considering Lufkin District Experience

## Developing Statewide Recommendations for Rehabilitating Jointed Concrete Pavements

PROJECT SUMMARY REPORT

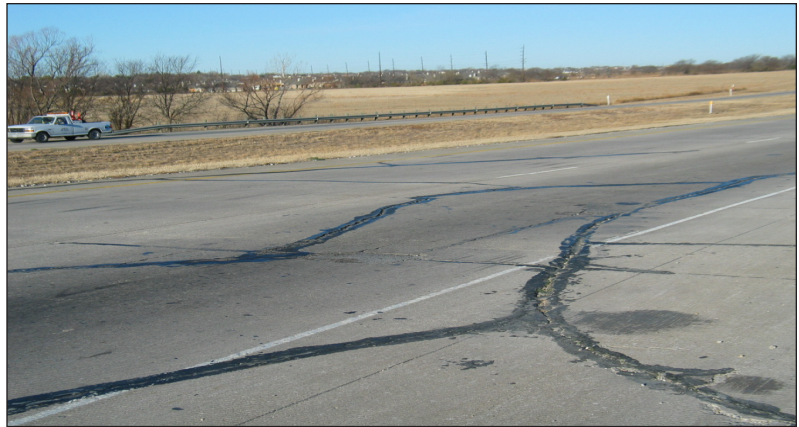
Figure 1. Distressed Jointed Concrete Pavement.

Selecting the optimal rehabilitation strategy for distressed jointed concrete pavement (JCP), such as the one shown in [Figure 1](#), continues to be a daunting challenge for Texas Department of Transportation (TxDOT) engineers.

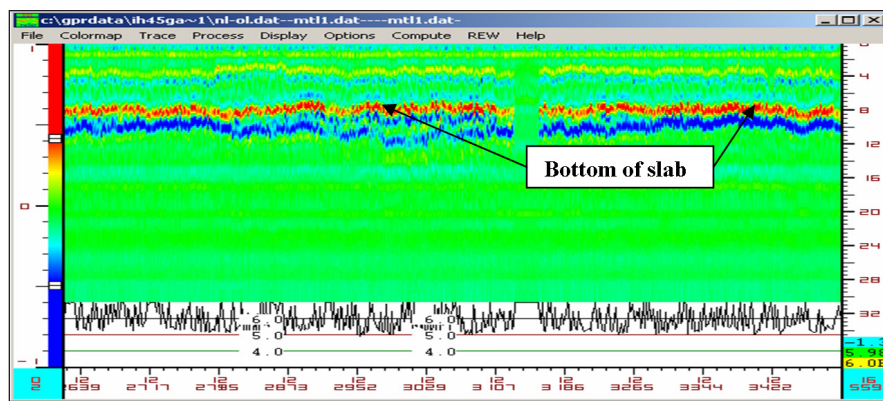
Figure 2. GPR Data from JCP with Trapped Moisture.

2. *Conduct a GPR survey and visual inspection.* The GPR data is used to identify areas of trapped moisture. A problem pavement is shown in [Figure 2](#).

The strong reflection pattern shown in [Figure 2](#) is typical of sections with substantial free water trapped beneath the slab. Not addressing this trapped moisture in the rehabilitation design process is guaranteed to cause rapid failure.

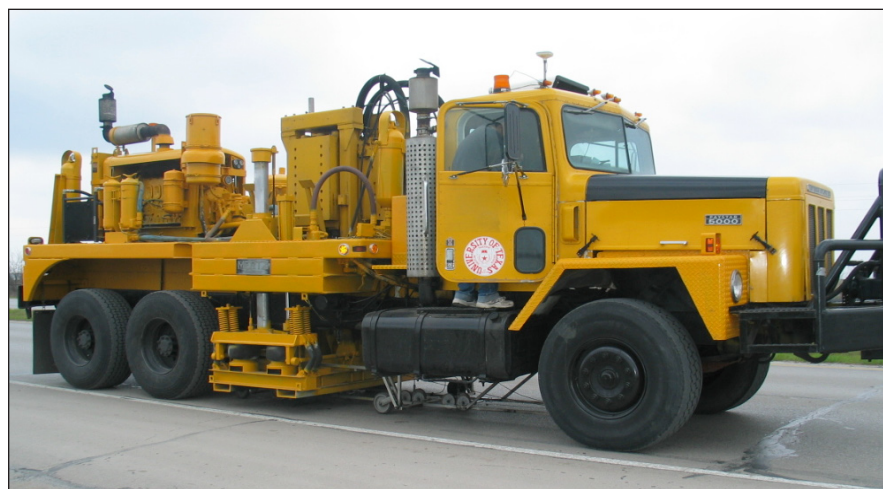
Figure 3. The Rolling Dynamic Deflectometer.

3. *Conduct a deflection survey.* The Rolling Dynamic Deflectometer (RDD) (shown in Figure 3) is the preferred tool for testing jointed concrete pavements.

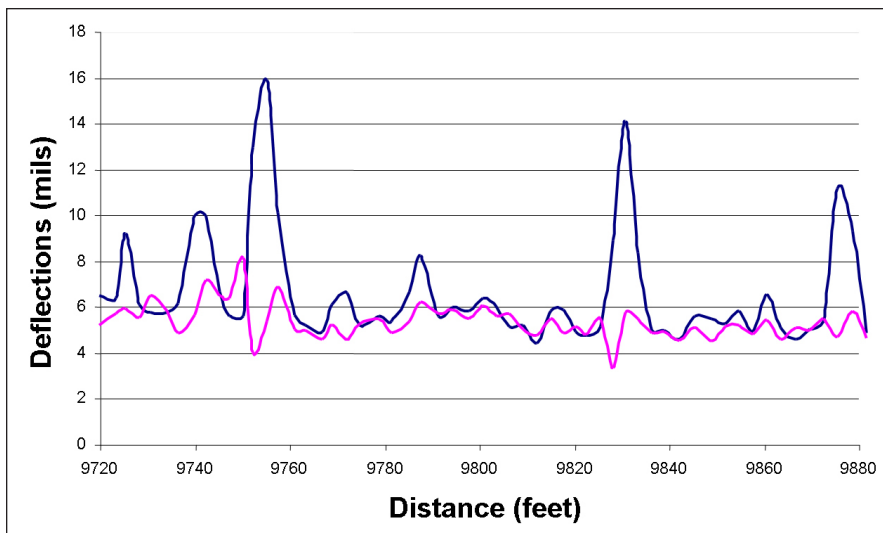
Figure 4. A Typical Two-Channel Continuous Deflection Plot from the Rolling Dynamic Deflectometer for Jointed Concrete Pavement.

A typical data set for the RDD is shown in Figure 4. This graph shows continuous deflection profiles from two sensors collected at 2-foot spacing. The blue line is from a rolling geophone placed directly between loading wheels. The red line is from a sensor 38 inches from the load wheels. The large spikes in deflection occur when the RDD sensors pass over joints with poor load transfer.

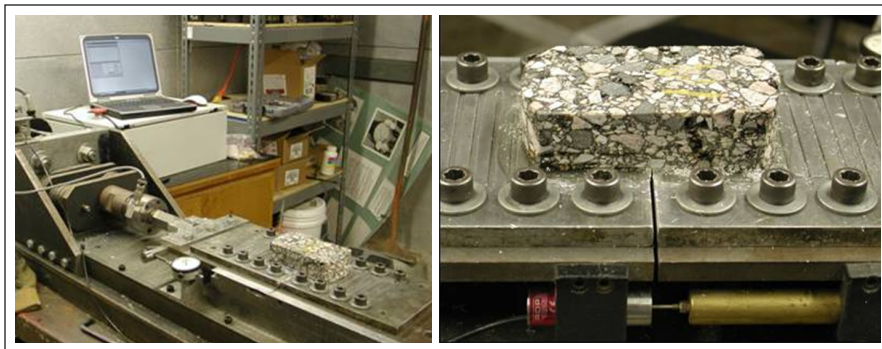
Figure 5. TTI Overlay Tester (a New Version Is in Operation in TxDOT's Flexible Pavement Branch of the Construction Division).

For those JCPs measured to be in good structural condition with few joint failures and reasonable load transfer efficiency, a hot-mix asphalt (HMA) overlay should be applied. Project 0-4517 determined that field performance is well matched to the performance of the mixes found in the laboratory with Texas Transportation Institute's (TTI's) overlay tester, shown in Figure 5.
