1. Report No. FHWA/TX-04/0-4523-1		2. Government Accession No.		3. Recipient's Catalog No.	
4. Title and Subtitle RECOMMENDATIONS FOR MINIMIZING POOR QUALITY COARSE AGGREGATE IN ASPHALT PAVEMENTS				5. Report Date March 2004

**RECOMMENDATIONS FOR MINIMIZING POOR QUALITY COARSE
AGGREGATE IN ASPHALT PAVEMENTS**

Report 0-4523-1
Project Number 0-4523
Research Project Title: Controlling Mineralogical Segregation in Bituminous Mixes

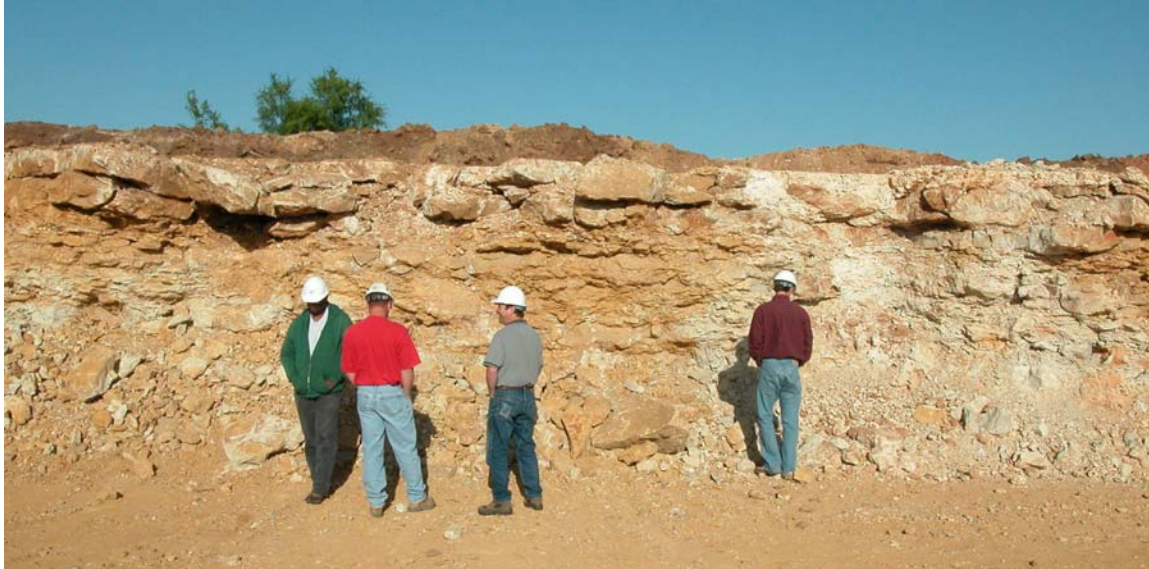
Figure 1. Working Face at the Baird Quarry Shows a Thin (2 foot) Resistant Unit at Top.

Another important technique for evaluating aggregate quality, with respect to selective quarrying, is to examine natural exposures of the rock outside the quarry because disintegration/natural weathering may not coincide with results of the Sulfate Soundness Test (Loughlin, 1928).

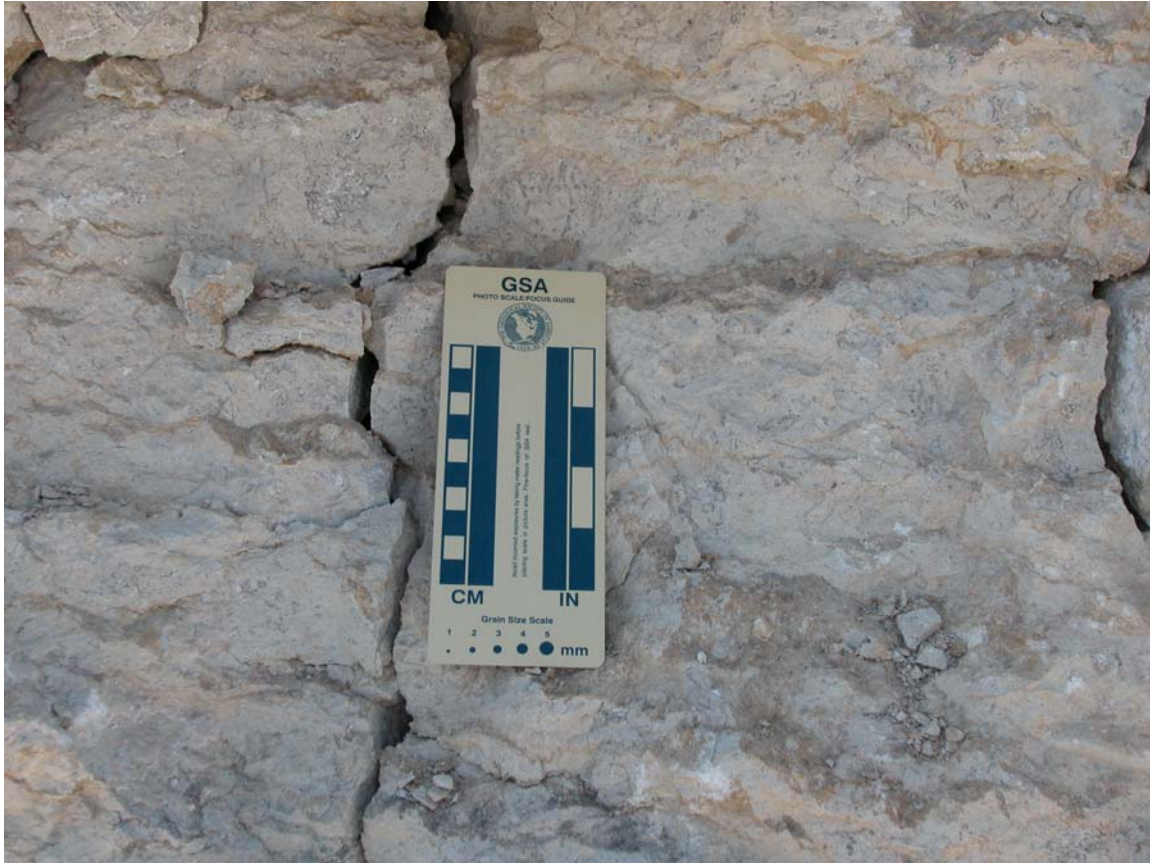
Figure 2. The Semihorizontal Tan Lines in the Top One-Third of the Image are Stylolites from the Black Quarry.

One textural and mineralogical property that affects aggregate strength and durability is the formation of stylolites - irregular suturelike boundaries (Figure 2). The stylolites form from insoluble materials (i.e., clay minerals, organic matter, and quartz) that are dispersed in a carbonate sediment becoming concentrated along a thin band due to dissolution of the calcite

from increased pressures generated by burial. The stylolites form perpendicular to the principal stress and are generally horizontal in flat-lying limestones. [Verhoef and van de Wall \(1998\)](#) report durability problems with limestone blocks containing stylolites composed of expansive clay minerals (smectite).

Clay mineral content is more difficult to identify in the field. The easiest identification is made at the working face of the quarry by looking for stylolites ([Figure 2](#)) and less resistant units. One simple test for individual aggregates is to place the aggregate into a glass of water to soak. If the aggregate breaks apart or slakes, then there is a potential problem with clay minerals.

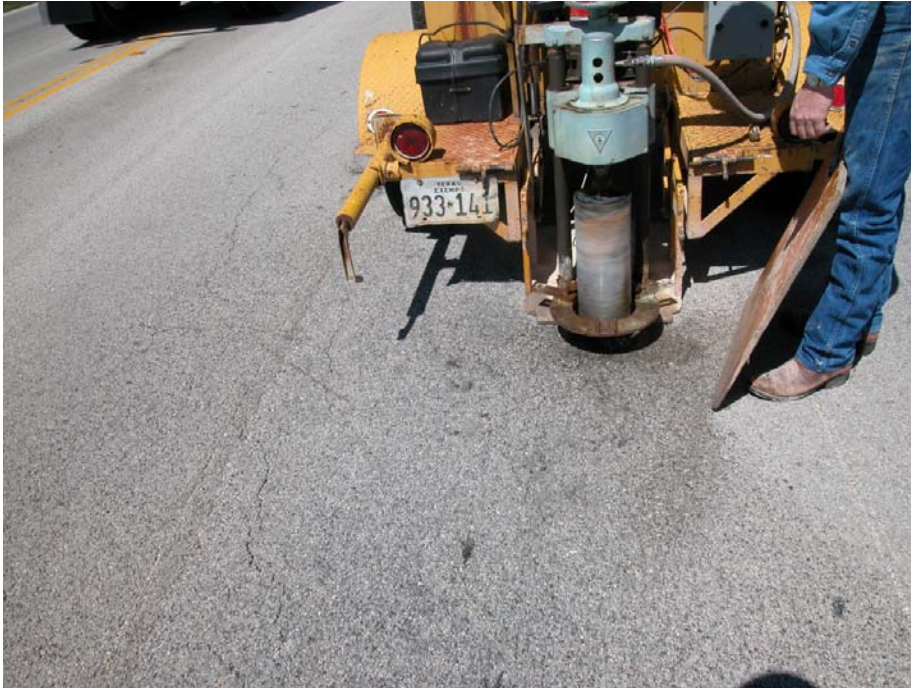
Figure 3. Drilling Cores from US-84.

The researchers focused on the surface course, but full-depth cores were collected from different locations in the roadway. Cores were collected using TxDOT’s mobile coring drill from the northbound outside lane in both counties (Figure 3). Cores were collected from all positions of a lane (e.g., center, left wheelpath, and right wheelpath) and from both damaged and undamaged parts of the lane.

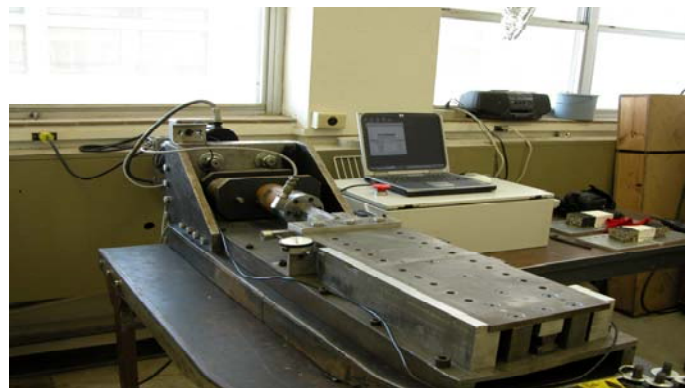
Figure 4. TTI Overlay Tester.

The TTI overlay tester was designed by Germann and Lytton in the late 1970s to simulate the opening and closing of joints or cracks, which are the main driving force inducing reflection crack initiation and propagation (Germann and Lytton, 1979). The key part of the apparatus, as

shown in [Figure 4](#), consists of two steel plates, one fixed and the other movable in a horizontal direction, to simulate the opening and closing of joints or cracks in the old pavements beneath an overlay. There are two overlay testing machines at TTI: one is a small overlay tester for a specimen size of 375 mm (15 inch) long by 75 mm (3 inch) wide with variable height; the other is a large overlay tester for a larger size specimen of 500 mm (20 inch) long by 150 mm (6 inch) wide with variable height. Both overlay testers have been successfully used to evaluate the effectiveness of geosynthetic materials on retarding reflection cracking. These applications indicate that the overlay testers have the potential to characterize the reflection cracking resistance of asphalt mixtures.

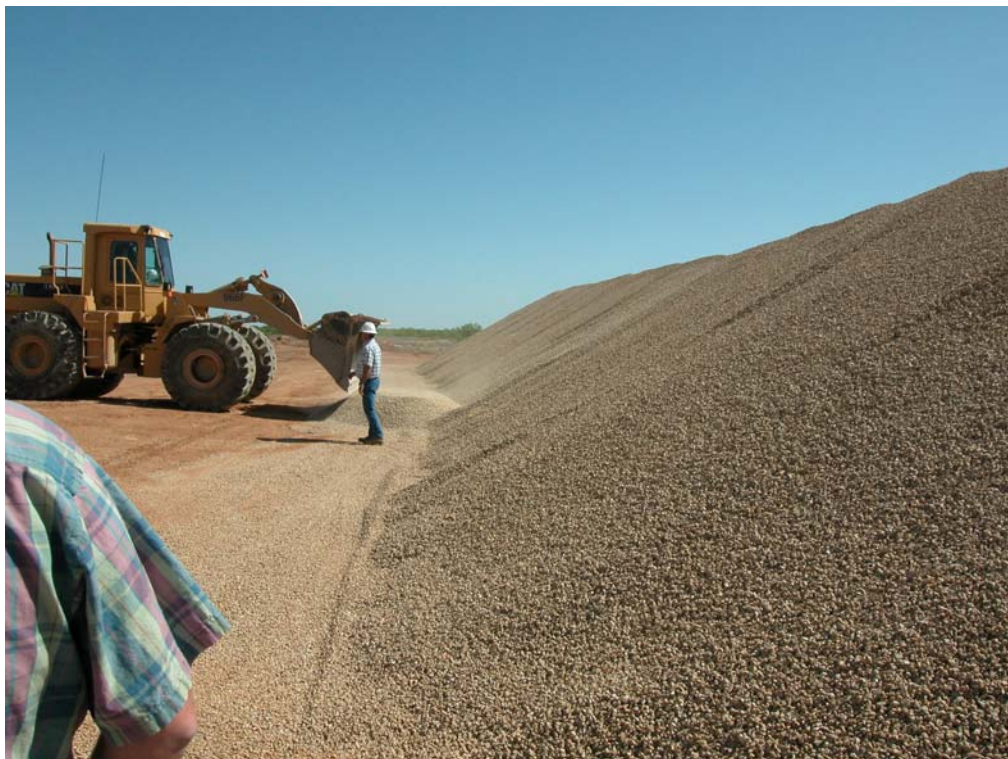
Figure 6. Grade 3 Stockpile at the Baird Quarry in the Abilene District.

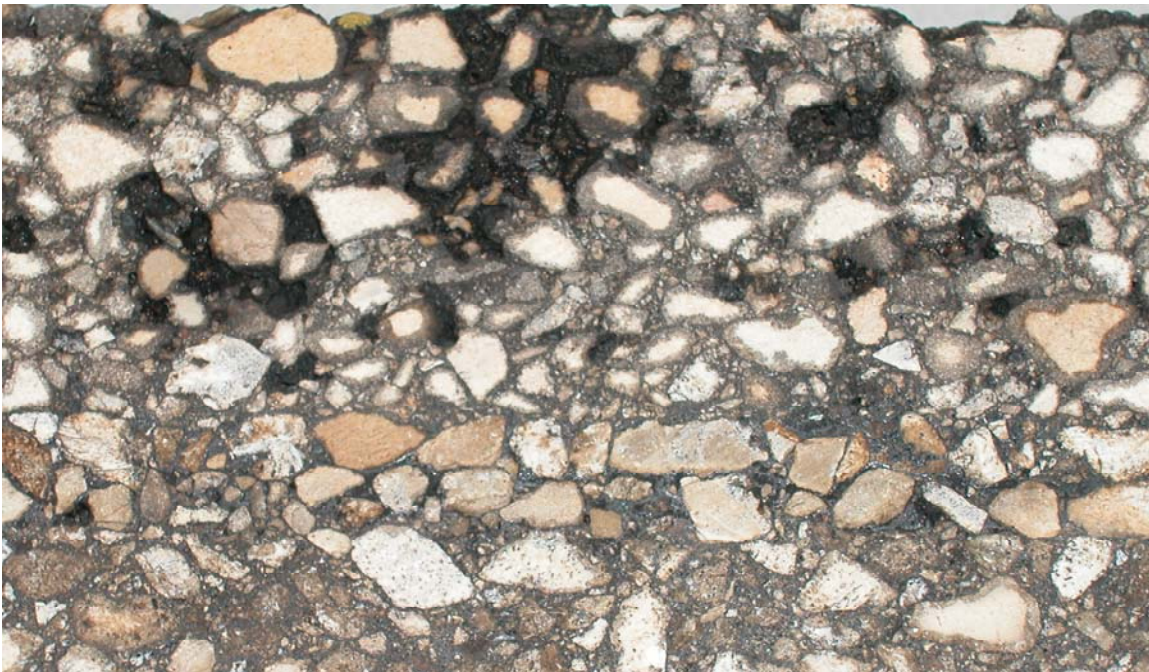
Figure 7. Sample from US-84 in Tyler County Showing Aggregates with a Lot of Absorbed Asphalt.

Visual observation of the cores revealed that some of the cores had cracks at the surface that propagated into the lower asphalt layer as well as the base layer. Some of the cores had cracks limited only to the top layer. This suggests the possibility of both top-down cracking (due to a poor surface layer) and bottom-up cracking (due to a poor base). After coring and/or sawing the top layer, the researchers noticed a significant percentage (approximately 5 percent) of absorbent coarse aggregates. Some aggregates absorbed asphalt throughout the entire aggregate (Figure 7).

The Overlay Tester results are indicative of brittle asphalt typically observed in an aged pavement. The aging of asphalt and, hence, mastic (due to overabsorption as observed in [Figure 7](#)) made the mastic brittle, which may have caused the loss of tensile strength and resulted in a low number of cycles to failure ([Table 5](#)). Results from Charles Glover, reported in [Chapter 2](#), seem to correlate with this interpretation.

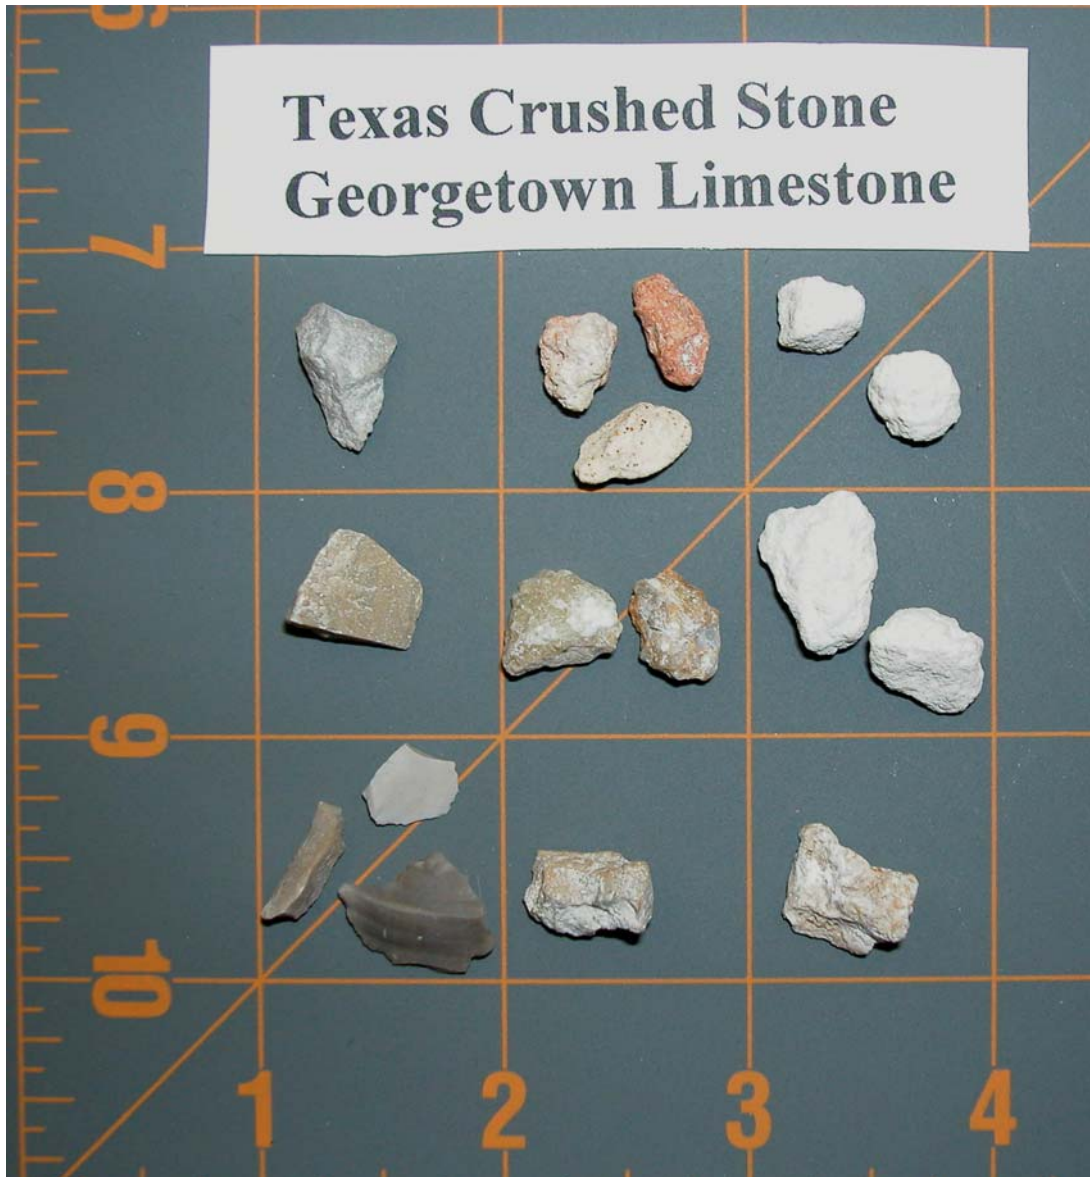
Figure 8. Aggregates from the Same Stockpile Showing Variations in Porosity, Angularity, and Mineralogy.

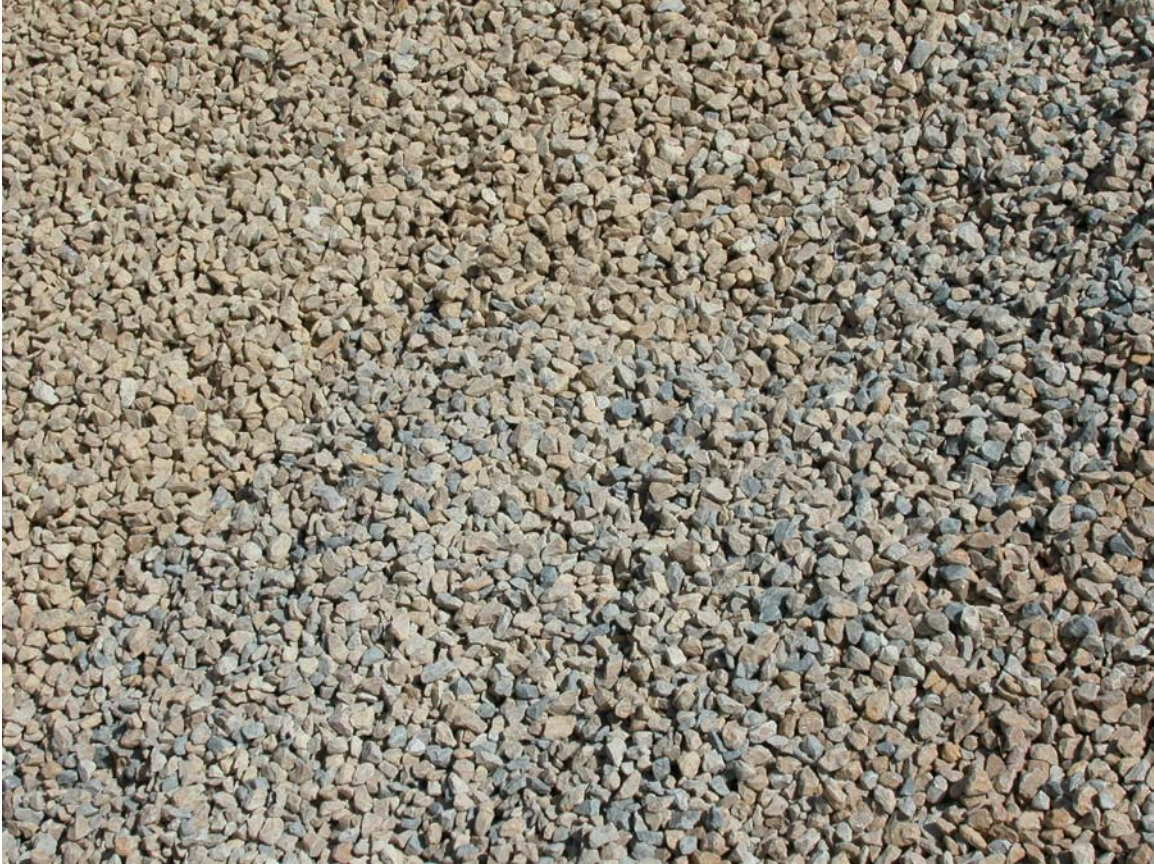
Figure 9. Segregation of Aggregate Types (Gray and Pink) in a Stockpile at the Baird Pit in the Abilene District.

A stockpile of grade 3 aggregate from the Baird Pit in the Abilene District does not show a variation in gradation, but the aggregate type changes drastically from one part of the stockpile to another. The change in aggregate type is obvious by the color variations in this stockpile (Figure 9). The upper left corner of Figure 9 shows a pink, fossiliferous limestone, and the middle of the image shows a mix of the pink limestone and a gray, more organic rich limestone.

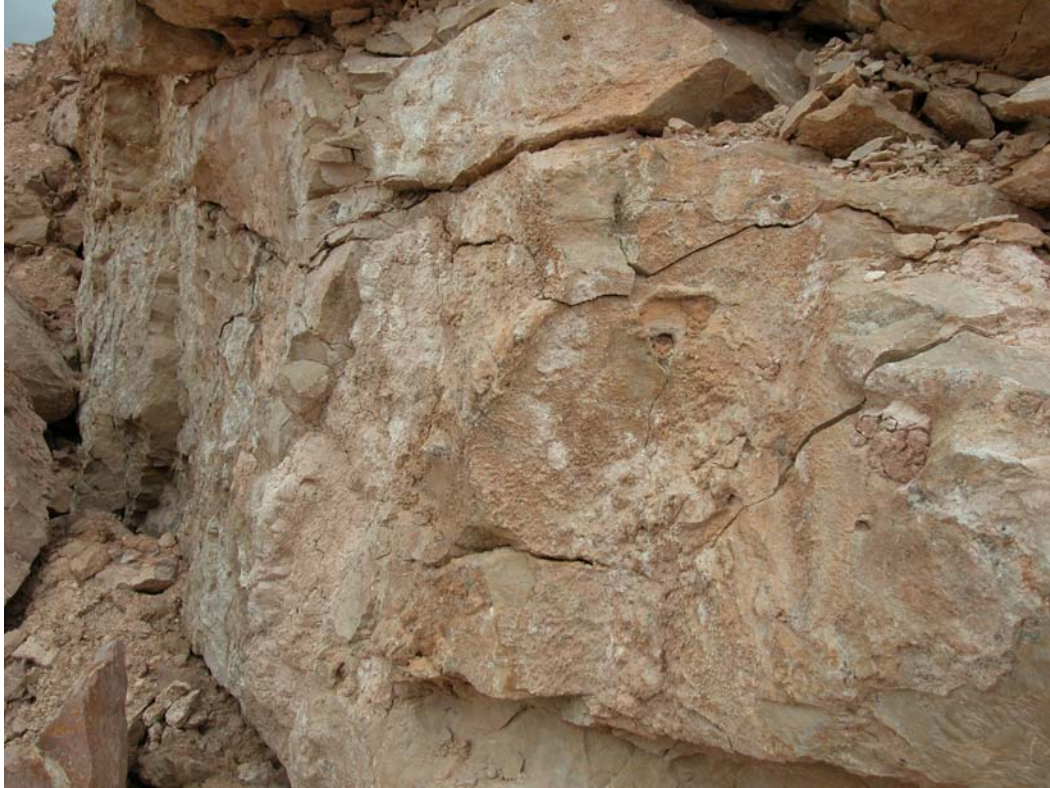
Figure 10. Vertical Fracture at the Price Clements Pit Showing Grayish Orange-Pink Clay Attached to a Pale Yellowish Brown Limestone Block.

Another way to identify clay minerals is to look for highly weathered rocks. Clays often concentrate in these weathered zones. The vertical fracture/joint in [Figure 10](#) is a good example of differential weathering. Along the face of the fracture, there are more fines/clays (grayish orange-pink) that are a product of weathering of the preexisting strata. The pale yellowish brown limestone is the fresh rock. Rock quarried along the fractures will have more deleterious clay minerals and yield a poorer quality aggregate. Soaking the aggregate and use of a washer will help to remove some of the poorer quality material associated with the fractures.

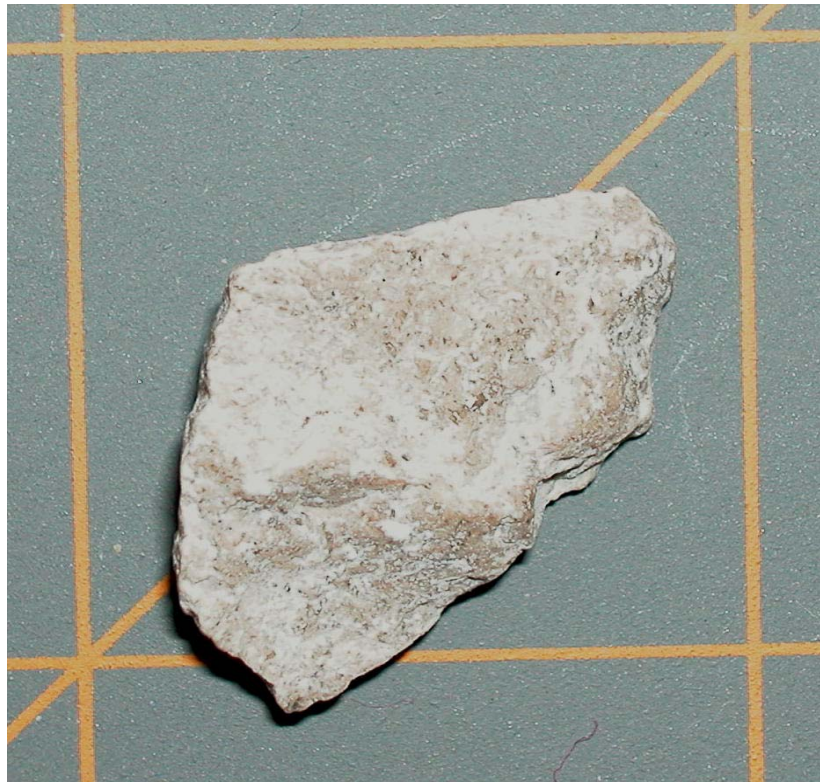
Figure 11. (Top) Thin-Section Photomicrograph of a Limestone Aggregate from the Vulcan Black Pit Showing No Pores. (Bottom) Macroscopic Image of the Same Limestone Aggregate (Note Angularity).

The next three figures illustrate good, moderate, and poor quality aggregates, respectively, which are all composed of a single mineral (calcite). The difference in quality is related to the texture. [Figure 11](#) shows textural properties of a good quality aggregate. The top image is a thin-section photomicrograph of a limestone (CaCO_3) aggregate from the Vulcan Black Pit: it does not have any visible pores, as evidenced by the lack of blue-dyed epoxy. The fossil fragments (light colored) in this limestone are still preserved. The darker areas are micrite (lime mud) that bind the fossil fragments together. This rock makes a strong, angular, nonabsorptive aggregate as evidenced in the bottom image.

From looking at [Figures 11-13](#), one can easily see how important textural variations are in affecting aggregate quality. Two ways to easily distinguish these three aggregate types are visual observation of aggregate angularity (as observed by Ed Morgan) and absorption of water.

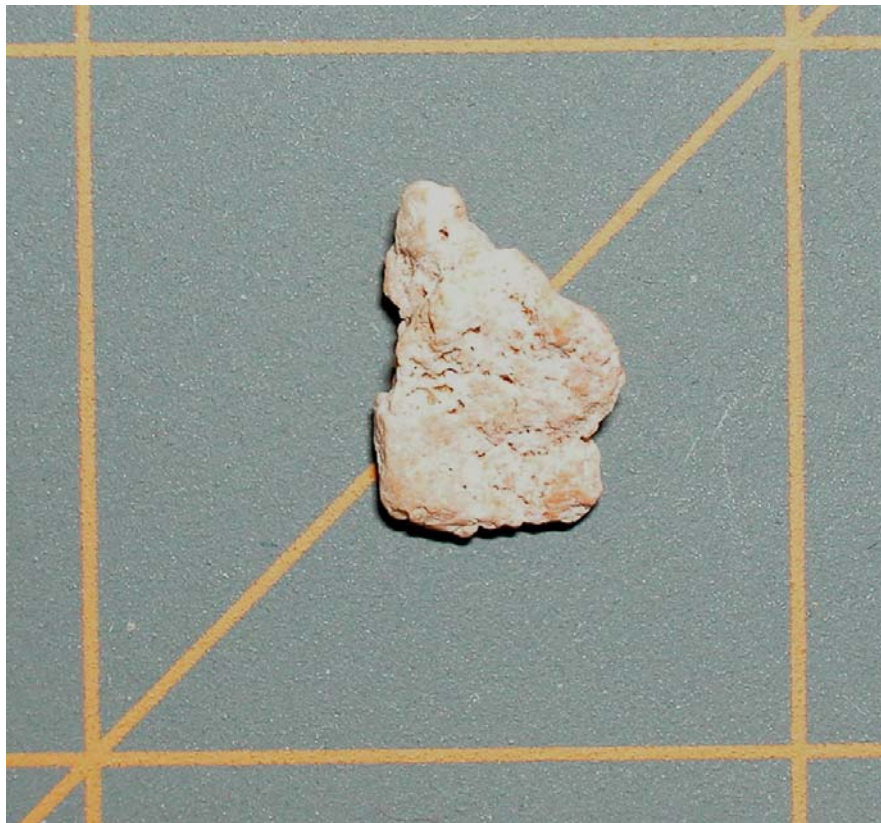
Figure 12. (Top) Thin-Section Photomicrograph Showing Moldic Pores (Blue) in a Limestone Aggregate from the Centex Yearwood Pit. (Bottom) Macroscopic Image of the Same Limestone Aggregate (Note Pits in Surface).

The aggregate represented by the images in [Figure 12](#) is from the Centex Yearwood Pit. It is not as strong as the aggregate in [Figure 11](#) because it has numerous large pores (blue-dyed epoxy) that were generated by the dissolution of fossil fragments. This is called moldic porosity. These pores are not well connected and they are large so there is not a lot of water absorption. The bottom image shows the aggregate. It has more rounded edges than the aggregate in [Figure 11](#) and it also has little pits all over the surface. The pits are the moldic pores observed in the

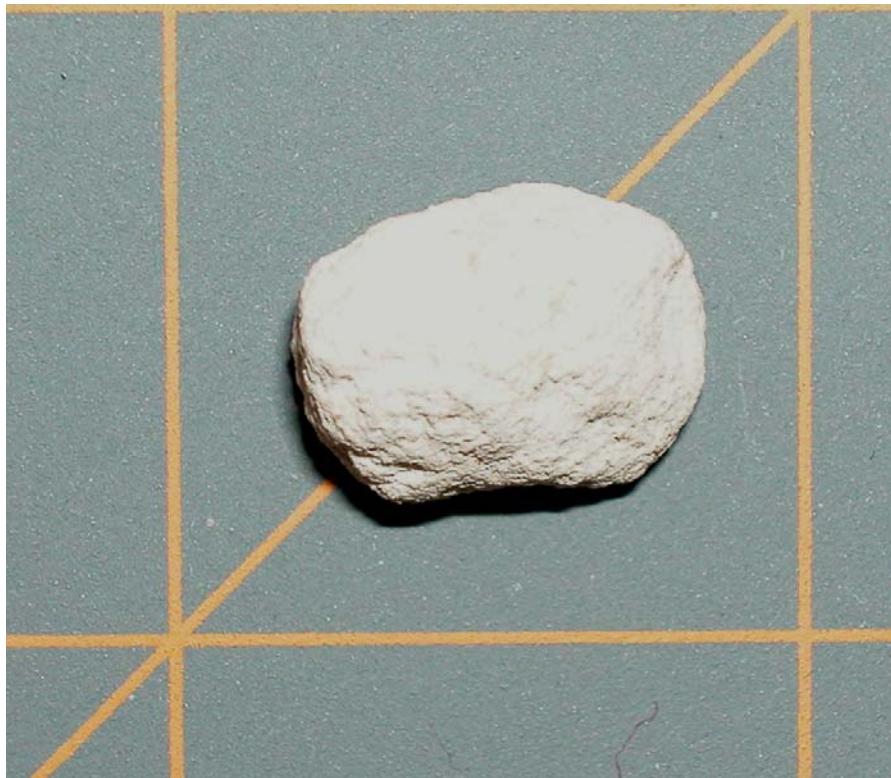
Figure 13. (Top) Thin-Section Photomicrograph Showing Intergranular Pores (Blue) in a Limestone Aggregate from the Centex Yearwood Pit. (Bottom) Macroscopic Image of the Same Limestone Aggregate (Note Roundness).

The images in [Figure 13](#) are of another aggregate from the Centex Yearwood Pit. This aggregate is also a limestone, composed of the mineral calcite (CaCO_3), but the texture is different. The top image shows a limestone with intergranular porosity (pores between the grains) that will absorb a large amount of water or asphalt. This pore network also makes the aggregate very weak. The bottom image shows how the aggregate particle has become well rounded after being crushed and transported. Ed Morgan, TxDOT construction geologist (pers. comm., 2003), concluded that poorer quality aggregates tend to be more rounded based on observations of aggregates from quarries around Texas.

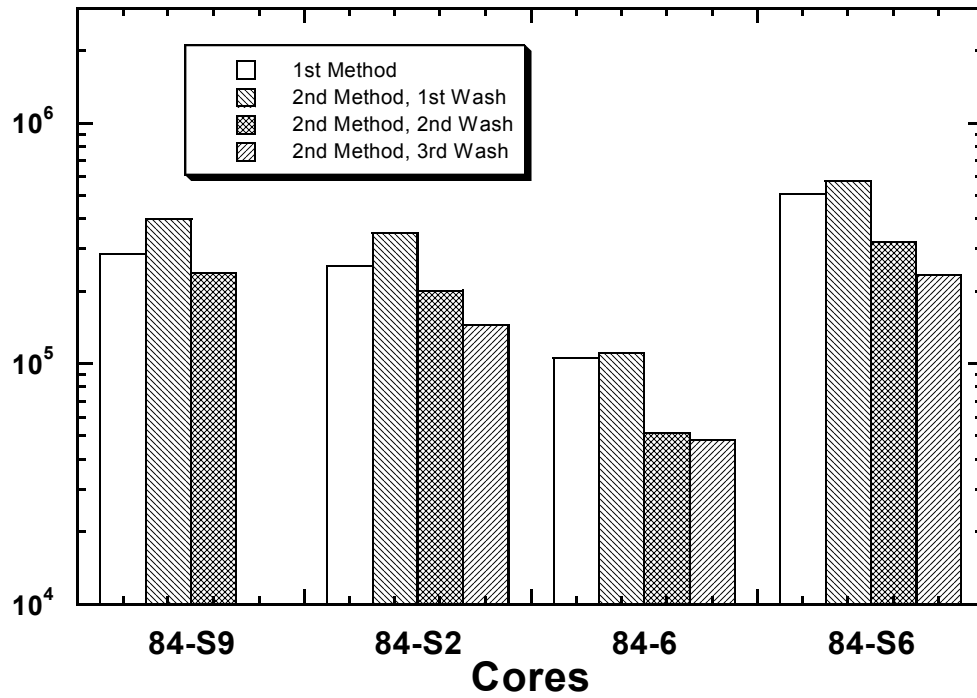
Figure 16. Zeroth Viscosity (η_0^* , poise) of Recovered Asphalt Binder.

that penetrated binder has a better flow property than the inter-binder, to some degree. In addition, it can be seen that specimen 84-S6 had the highest overall viscosity while specimen 84-6 had the lowest, one meaning it had less flow resistance associated with the binder. In fact, specimen 84-6 also had relatively low overall viscosity compared to specimens 84-S9 and 84-S2. From mixture design information, specimen 84-6 is based on PG 64-22 and the rest of the S-series cores are based on PG 70-22 asphalt binder. The difference based on asphalt binder could very well be an important factor for explaining flow behavior of asphalt in each series.

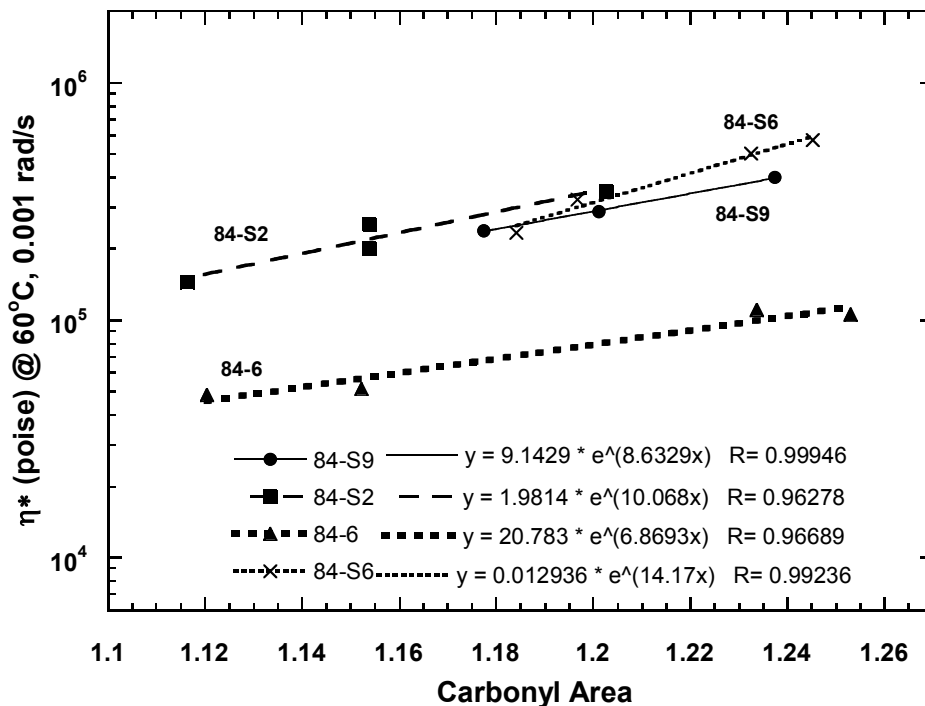
Figure 19. Hardening Susceptibility of US-84 Cores.

between those two binders. To answer this question, the concept of hardening susceptibility was used to verify differences in composition of each binder. Since each binder has a unique linear relationship between logarithm of viscosity ($\ln \eta$) and carbonyl area, a plot of carbonyl area versus $\ln \eta$ should highlight inconsistencies, if any, between the asphalt binders. Figure 19 was constructed to ascertain whether there is a linear relationship for asphalt binders from each core. From the hardening susceptibility perspective, no matter at what temperature and how long asphalt binder is aged, a linear relationship should still hold. As can be seen from Figure 19, data from each core form an acceptable linear relationship, as indicated by R-value. With this information, the overall composition of penetrated binder and inter-binder are not significantly different from each other.

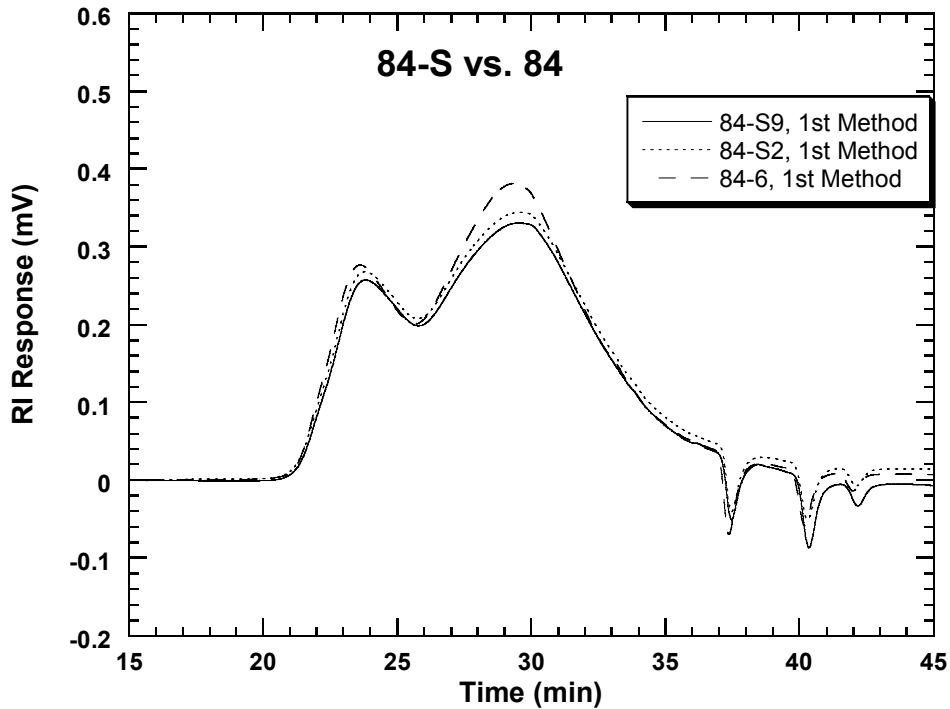
Figure 20. Comparison of RI Response between 84-S Series and 84 Series.

Other evidence that can confirm composition differences between inter-binder and penetrated binder is refractive index response from SEC. Figure 14, shows the refractive index response of each wash for the same core is consistent in terms of curve shape. Any inconsistency would cause the curve to be different in shape, as illustrated in Figure 20. Because the 84-S series and the 84 series were designed based on different asphalt binders, refractive index responses for these two series are quite distinguishable. The refractive index response of the 84 series is shifted slightly to the left of that of the 84-S

series. This refractive index disparity indicates that the 84 series has larger molecular size than 84-S series asphalt binder.
