1. Report No. FHWA/TX-04/0-4577-1		2. Government Accession No.		3. Recipient's Catalog No.	
4. Title and Subtitle EVALUATION OF NON-NUCLEAR DENSITY GAUGES FOR HMAC: YEAR 1 REPORT				5. Report Date October 2003

# **EVALUATION OF NON-NUCLEAR DENSITY GAUGES FOR HMAC: YEAR 1 REPORT**

Report 0-4577-1  
Project Number 0-4577  
Project Title: Further Development of NDT Devices to Identify Segregation in HMAC

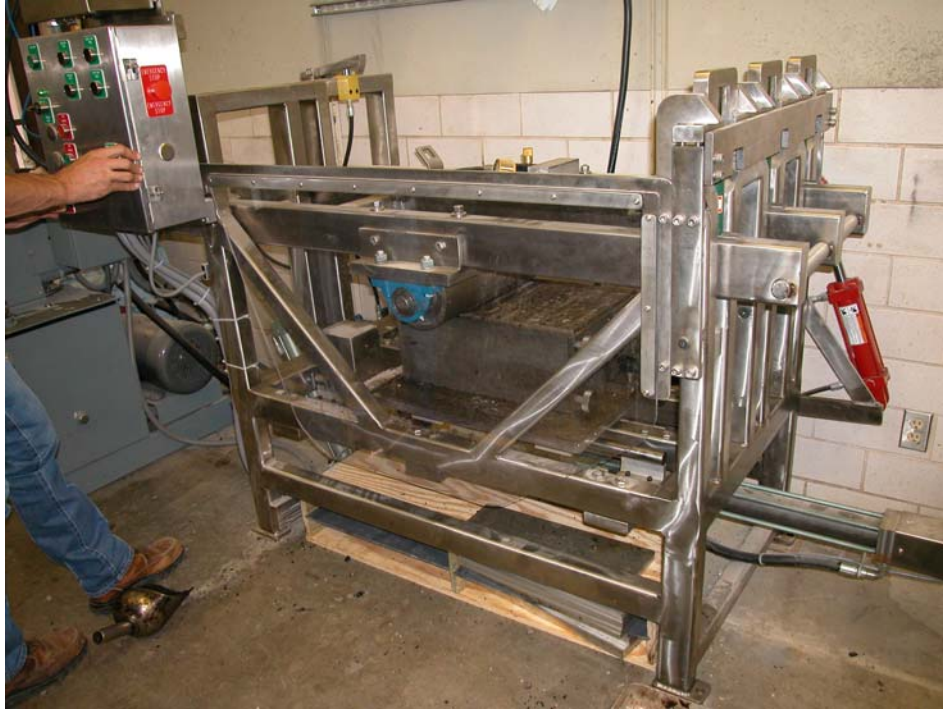
**Figure 1.1. Preparation of Laboratory Slabs with Linear Kneading Compactor.**

To accomplish these goals, researchers selected two mix types (1 inch SFA and Type C) from which they prepared HMA slabs in the laboratory with a linear kneading compactor, shown in [Figure 1.1](#). [Table 1.1](#) shows the mixture designs for these mixes. For each mix type, project

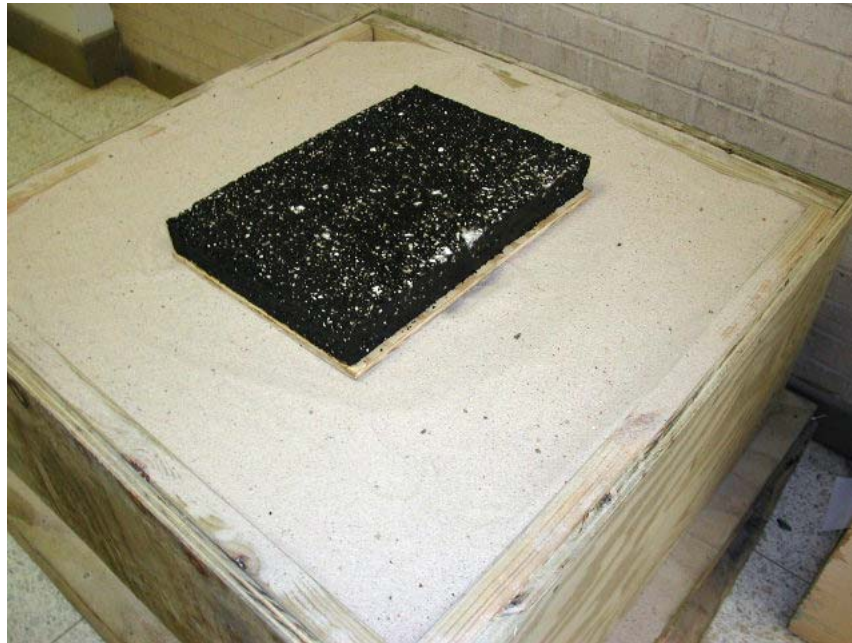
**Figure 1.2. Laboratory Slab on Sand Box for Density Testing.**

To conduct testing, each slab was placed on a sand test box (3 ft. × 3 ft. × 1.5 ft.), as shown in [Figure 1.2](#), after compaction. As the slabs cooled, researchers measured the slab temperature with an infrared temperature gun and then measured the densities of the slabs with the various density devices as described below:

- PQI and Pavetracker: Researchers collected four readings with the device in the center of the slab by rotating the device 90° between readings. The average of the four readings was recorded as one measurement.
- Nuclear gauge: Due to its size, researchers collected two 1-minute readings with the nuclear gauge rotated 180° between readings. The average of the two readings was recorded as one measurement. The test slabs were not large enough to rotate the nuclear gauge 90° between readings.

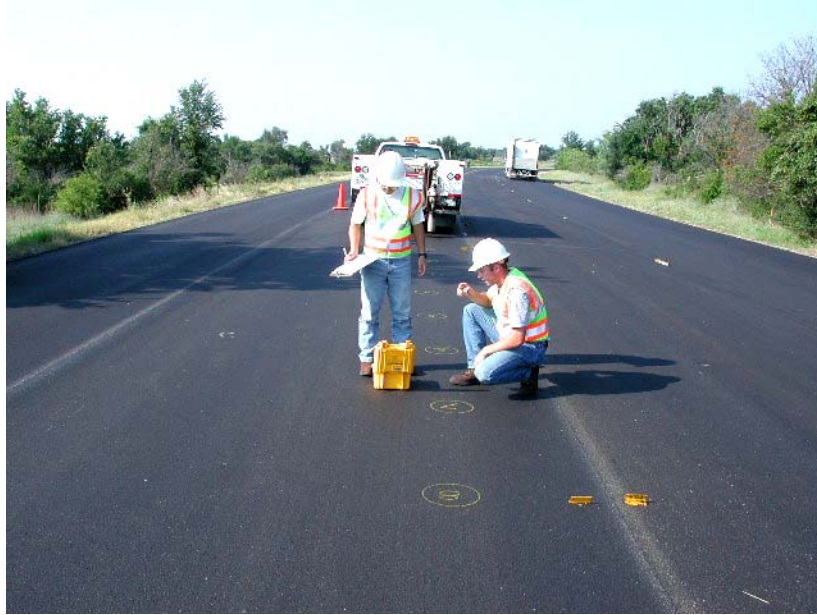
**Figure 3.1. US 281 Test Site.**

The test site on US 281 was 25 miles north of Stephenville, Texas, and was a 2 inch layer of Type D mix with JMF as shown in [Table 3.1](#). Researchers tested the northbound lane and performed calibrations with five cores on June 30, 2003. Although no visible segregation was present, on July 1, researches performed a density profile in the northbound lane 1000 ft north of the calibration site. There was no joint profile due to working conditions and time constraints. The profile was tested using default gauge settings and then retested with calibrated gauges. [Figure 3.1](#) shows the site of the density profile testing.

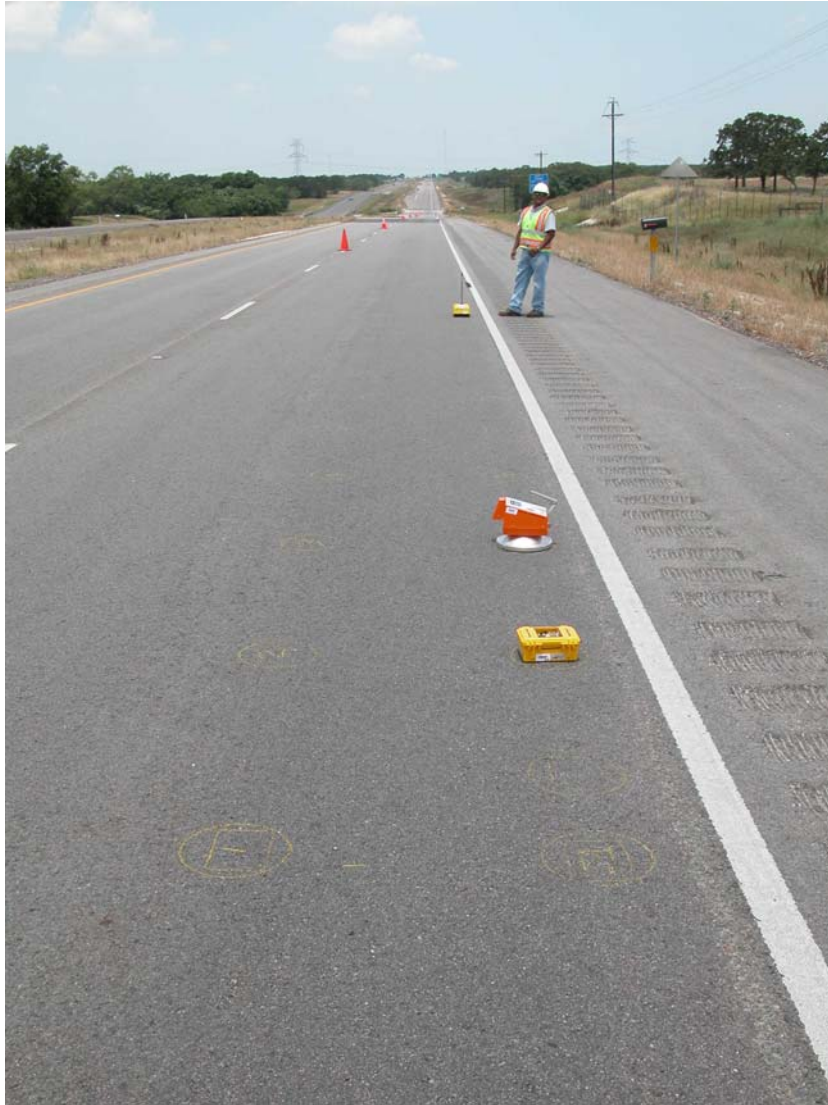
**Figure 5.1. Location of Testing on SH 6.**

The test site was located just north of Riesel, Texas in the outside northbound lane and consisted of a 2 inch layer of Type C mix with a JMF as shown in [Table 5.1](#). On June 3, researchers performed a density profile with the uncalibrated gauges. The density profile consisted of 11 locations spaced 5 ft. apart. At each location, readings were taken in the center of the lane and at the corresponding joint location. [Figure 5.1](#) shows the location of the testing.
