Project 0-4588
Seminar: 0-4588-P2
Effect of Voids in Grouted, Post-Tensioned
Concrete Bridge Construction

Texas Department of Transportation, Austin, Texas
February 26, 2009

TAMU / TTI Researchers: David Trejo (RS), Mary Beth Hueste (Co-RS),
Paolo Gardoni, Ken Reinschmidt, and Stefan Hurllebaus

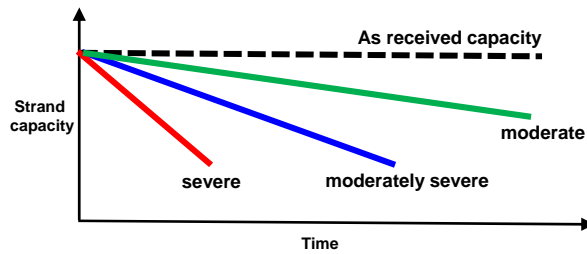
- Strand exposure conditions are affected by the presence of voids and tendon damage
- The rate of corrosion and the tension capacity loss of the strands increase as the severity of the exposure conditions increase

A conceptual schematic showing the capacity loss of strands

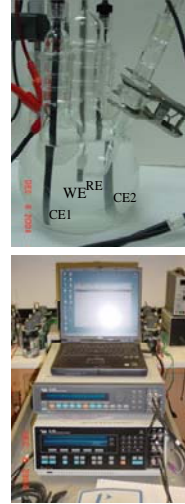
- The cyclic polarization test setup is shown below

Notes
 CE - Counter electrode (Graphite rod)
 RE - Reference electrode (Saturated Calomel electrode with 0.241 V vs SHE)
 WE - Working electrode (ASTM A416 steel wire)

Test setup for cyclic polarization test (not to scale)

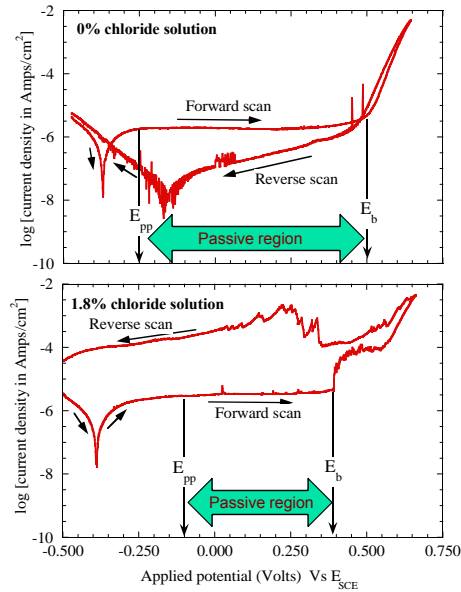
- As the chloride concentration increases, the breakdown potential, E_b , decreases and the passivation potential, E_{pp} , increases.
- Negative and positive hysteresis were observed with 0 and 1.8% chloride solutions, respectively.

- The passive region decreases as the chloride concentration increases
- The presence of chlorides can cause an increase of ~ 3 orders of magnitude in the corrosion rate
- Repassivation does not occur when chlorides are present

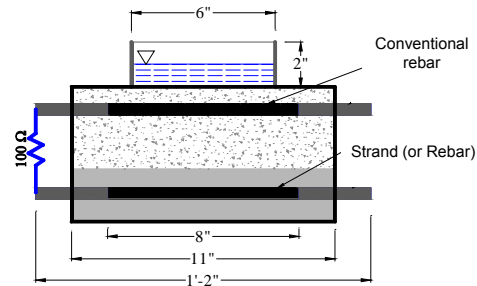
Modified ASTM G109 Test shows that no significant galvanic corrosion occurs between the conventional reinforcement and strands

- 20 specimens with strands at bottom and 20 specimens with conventional rebar at bottom were prepared and evaluated
- These specimens were then exposed to wet-dry cycles with 0 and 9% chloride solutions for 10 months

• No significant galvanic corrosion occurs between the conventional reinforcement and prestressing strands

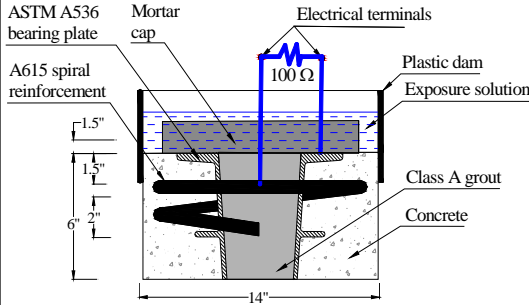
Bearing-plate Test shows that significant galvanic corrosion can occur between the conventional reinforcement and bearing plates

- 20 specimens with conventional spiral reinforcement and cast iron bearing plates were prepared
- These specimens were then exposed to wet-dry cycles with 0 and 9% chloride solutions for 10 months

- Galvanic corrosion can occur between the conventional reinforcement and bearing plate and between the prestressing strand and bearing plate.
- Coating the bearing plate surface with a dielectric material may be beneficial

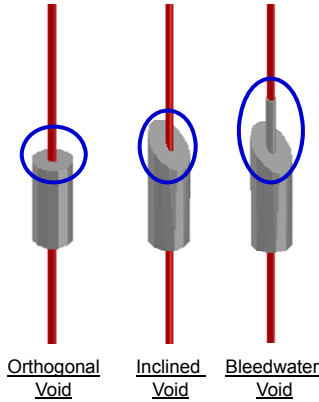
Void types were simulated by forming grout-air-strand interfaces that represent field conditions

- **Parallel voids** - typically found in the horizontal portion of a tendon in a PT girder
- **Orthogonal voids** - typically found in the PT columns with vertical profile
- **Inclined and bleedwater voids** - typically found in the inclined tendons at the anchorage zones of a PT girder

- Orthogonal, inclined, bleedwater void types have statistically similar effects on the tension capacity of strands
- The localized corrosion associated with these void types (typically located at girder anchorages and columns) are more severe than the parallel void type (typically located at the midspan of a girder)

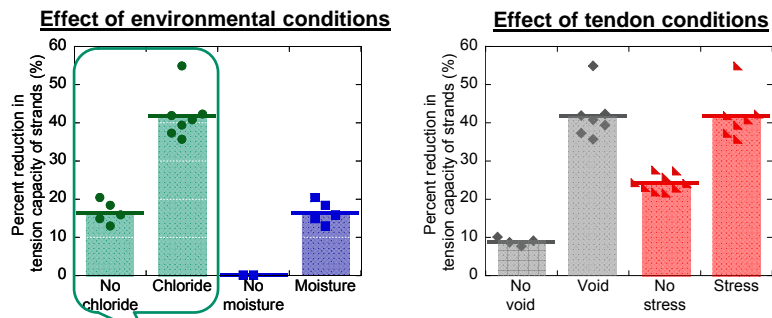
The presence of chlorides can reduce the strand capacity by an additional ~25% in 21 months

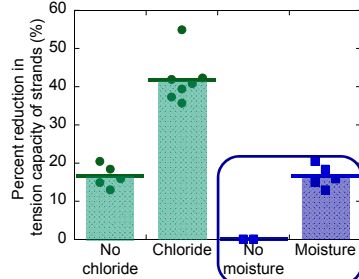
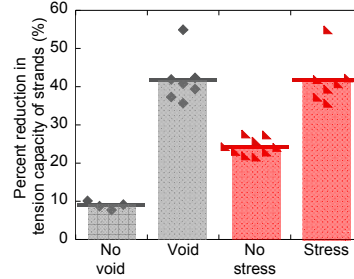
Effect of environmental conditions

Effect of tendon conditions

The presence of moisture can reduce the strand capacity by an additional ~17% in 21 months

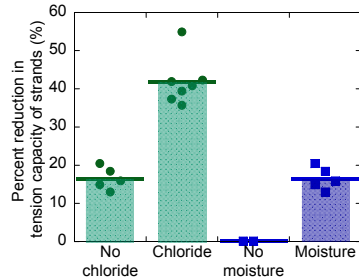
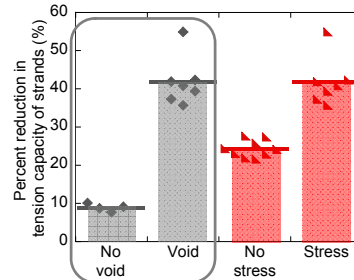
Effect of environmental conditions

Effect of tendon conditions

The presence of voids can reduce the strand capacity by an additional ~33% in 21 months

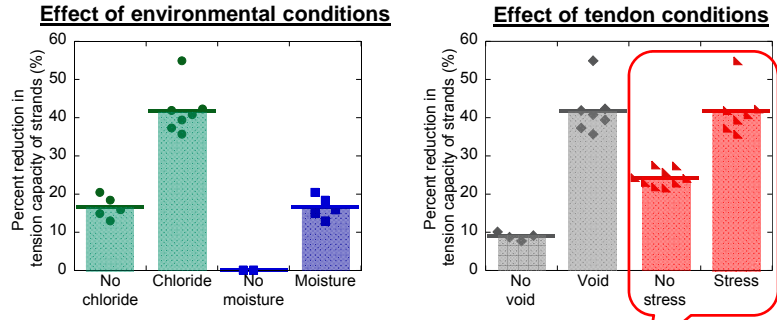
The presence of stress can reduce the strand capacity by an additional ~17% in 21 months

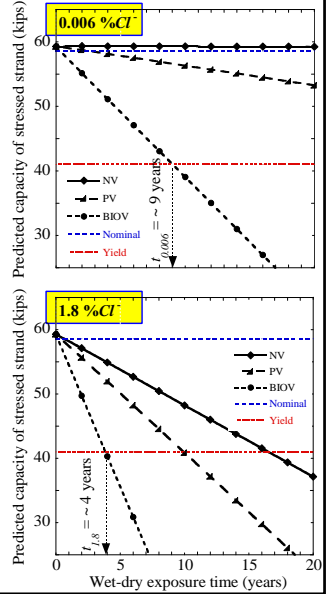
- Tension capacity of tendons can drop below the yield capacity in very young ages, if voids, water, or chlorides are present inside the tendons
- The time estimates obtained from the capacity models are consistent with the tendon failures observed in Florida and Virginia
- The effects of this tension capacity loss on the structural reliability were assessed

The plots shown are based on the assumption that there is a 2 months of wet time in every year

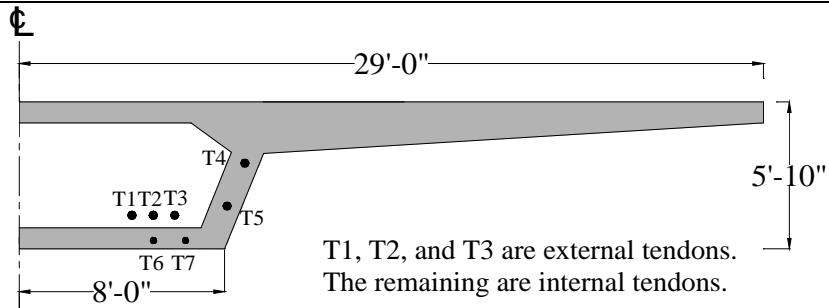
Cross-section of a typical segmental box girder with 14 tendons and a span of 100 feet

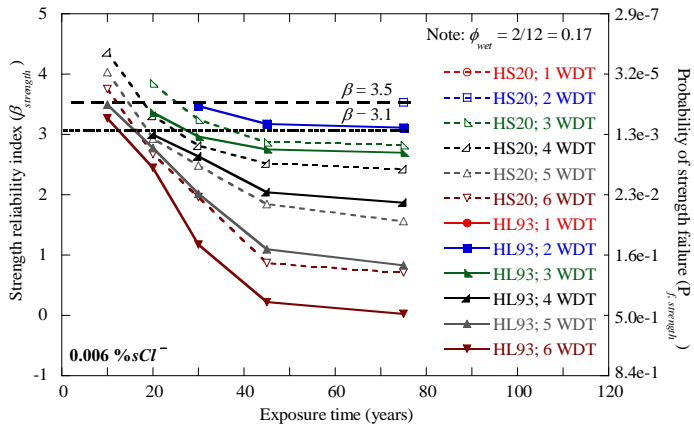
Safety can decrease if water infiltrate the voided tendons

- Bridge tendons with voids exposed to severe moisture conditions lead to a severe reduction in strength reliability

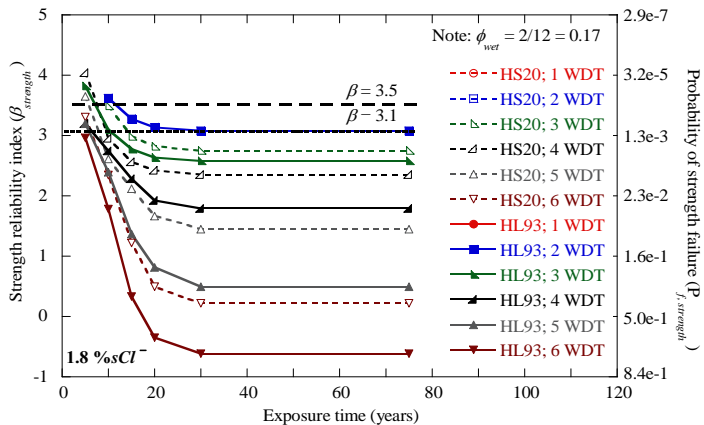
Safety can further decrease if water and chlorides infiltrate the voided tendons

- Bridge tendons with voids exposed to severe moisture and chloride conditions lead to a severe reduction in strength reliability

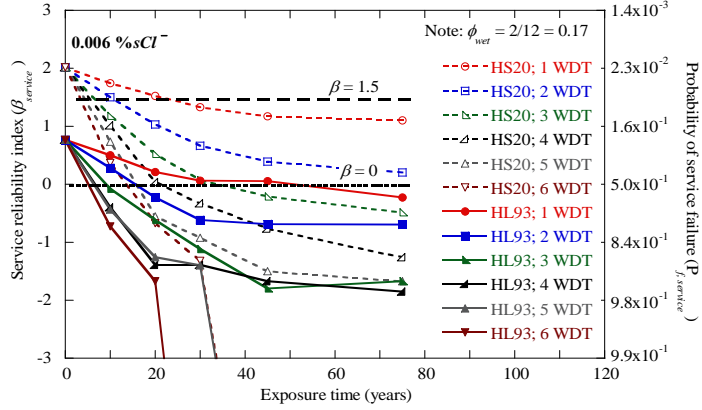
Serviceability can decrease if water infiltrate the voided tendons

- Bridge tendons with voids exposed to severe moisture conditions lead to a severe reduction in service reliability

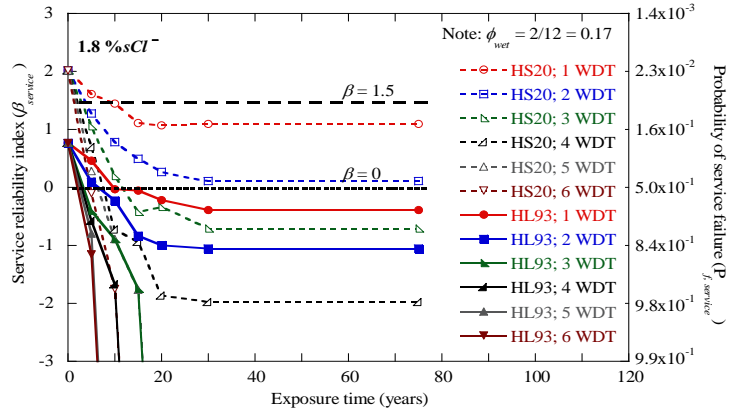
Serviceability can further decrease if water and chlorides infiltrate the voided tendons

- Bridge tendons with voids exposed to severe moisture and chloride conditions lead to a severe reduction in service reliability

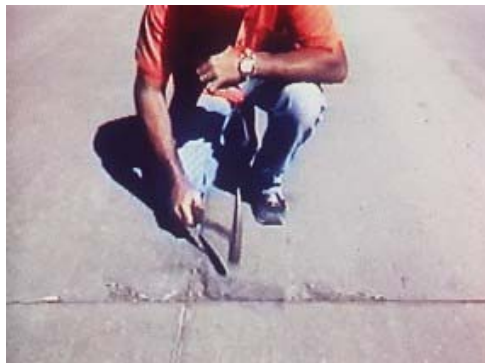
- The literature shows that the sounding inspection method is commonly used to detect delaminated areas in concrete structures
- The sounding inspection method is subjective

Detecting delaminated areas in concrete bridge decks

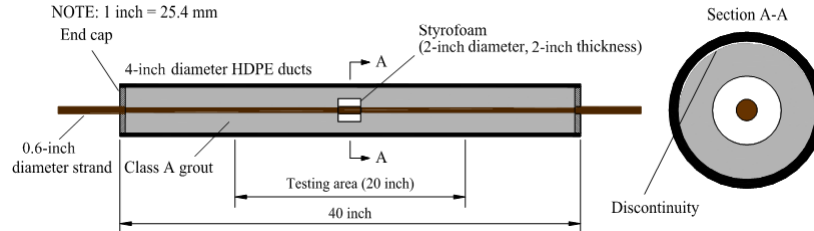
- 16 specimens were designed and fabricated
- Voids were simulated using different size of plastic balls and styrofoam

The schematic of small scale specimen including styrofoam void and strand

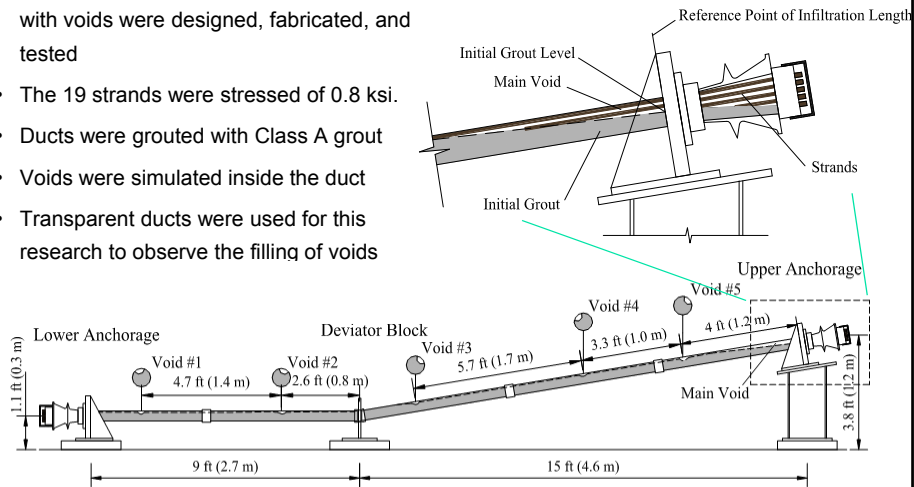
- 16 prototype external tendon specimens with voids were designed, fabricated, and tested
- The 19 strands were stressed of 0.8 ksi.
- Ducts were grouted with Class A grout
- Voids were simulated inside the duct
- Transparent ducts were used for this research to observe the filling of voids

Note: For clarity the 19 strands inside the acrylic duct are not shown.

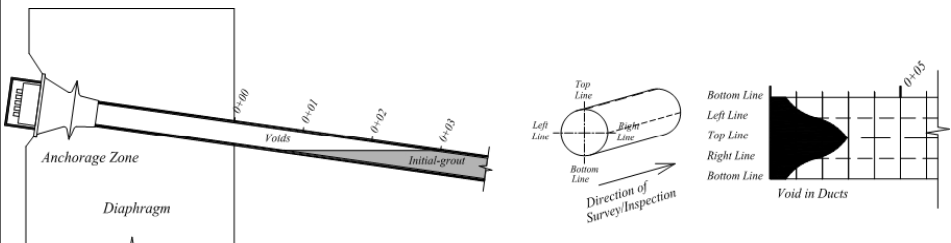
- The test methodology
 - uses a steel tapping hammer to identify the presence of voids in PT ducts
 - identifies voids by detecting a high pitch sound while tapping
 - uses subjective assessment of noise pitch
- The information is recorded on the “unrolled drawing” as shown:

Marking void profiles using sounding inspection on unrolled drawing form

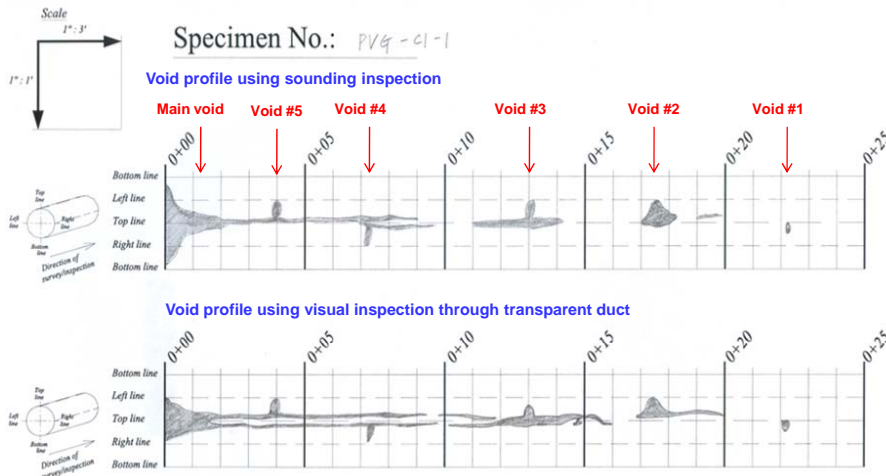
The void profiles obtained using sounding and visual inspections were compared

- The sounding inspection method can identify voids

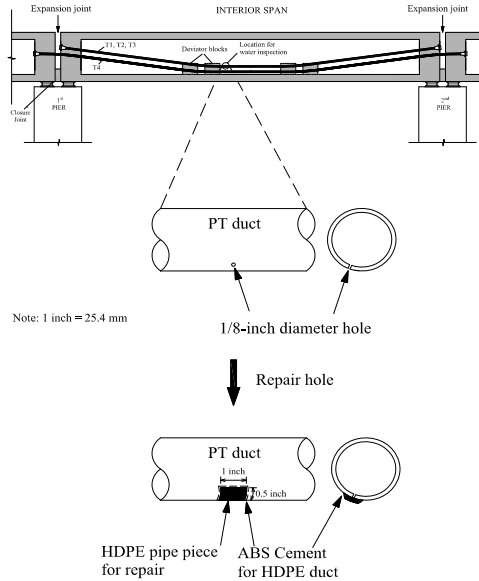
- Test procedure
 - **Using a dremel tool with a copper wire bit (1/8-inch diameter)**, drill the duct at the bottom of the lowest point of tendon
 - If water drains from the hole in the tendon, the solution can be collected to assess chlorides or other aggressive ions
 - Repair the hole
 - For more in-depth assessment, additional holes can be selected to identify water and/or chlorides in external tendon

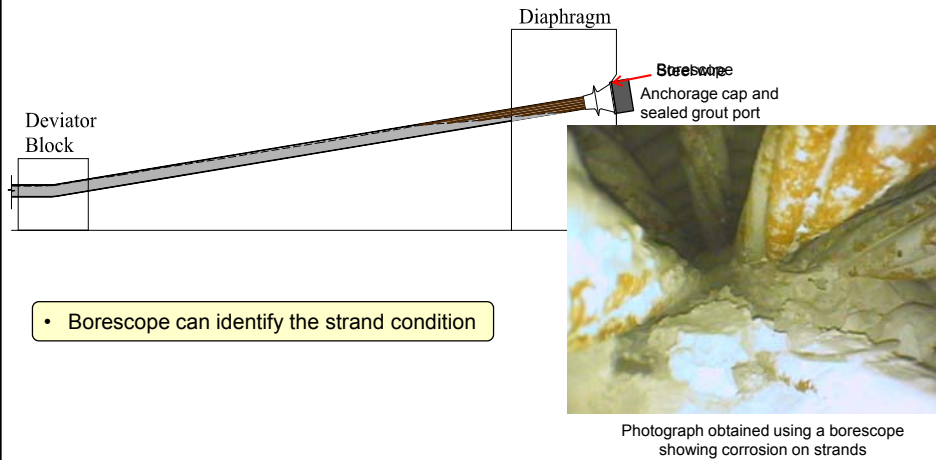
To identify the condition of the strands a borescope can be used

- Test procedure
 - Open the sealed grout port at anchor plate
 - Check the existence of voids inside the anchor plate using steel wire
 - Identify strand conditions inside the anchor plate using borescope

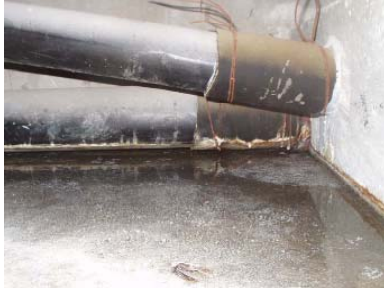
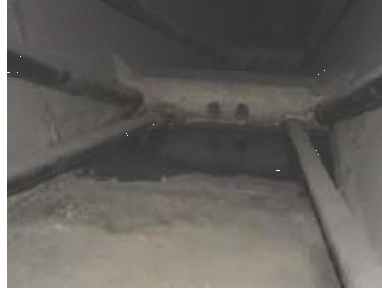
- Standing water/moisture inside the box girder

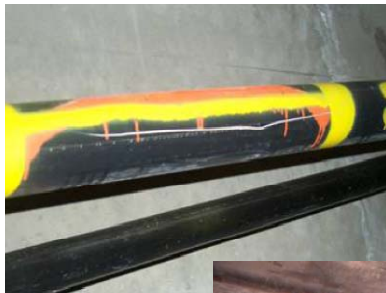
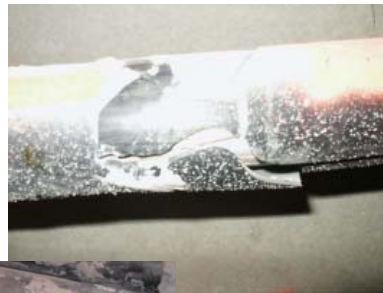
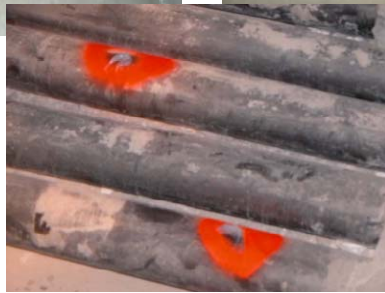
- Cracked/broken PT duct and holes on duct

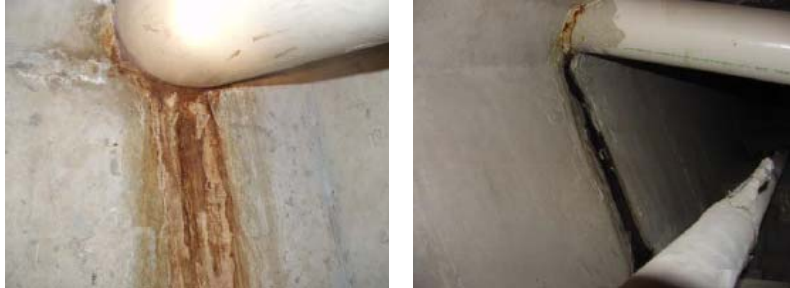
- Cracked/broken drainage pipe

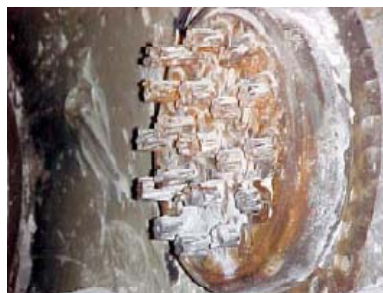
To identify potential damaging conditions in PT systems, the presence of exposed anchorage plates should be identified

- Exposed anchorage plate

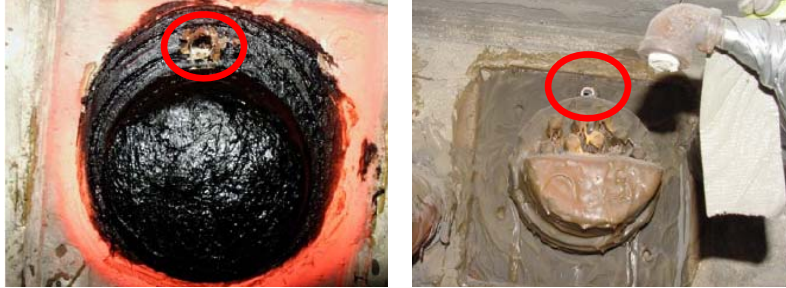
- Open grout port

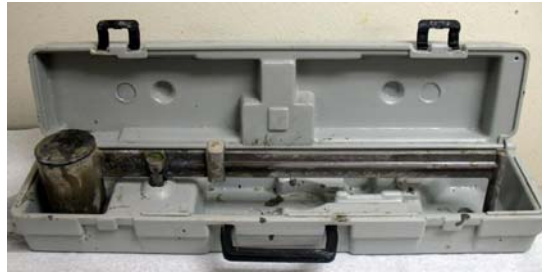
Baroid Mud Balance Apparatus

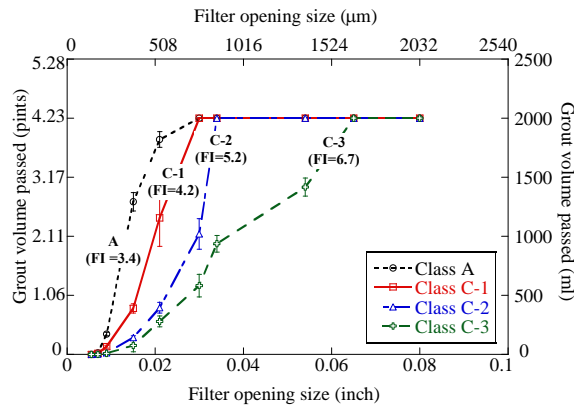
- Different commercially available Class C grouts can have different fillability indices
- It is recommended to include fillability test in DMS-4670 specification to well characterize the Class C grouts

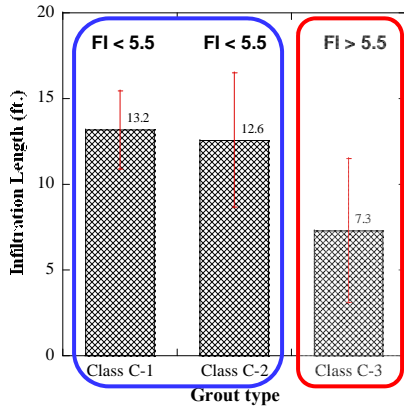
- C-3 grout does not meet Fillability Index (FI) requirement
- C-1 and C-2 grouts with larger FI can infiltrate deeper into the voids than C-3 grout

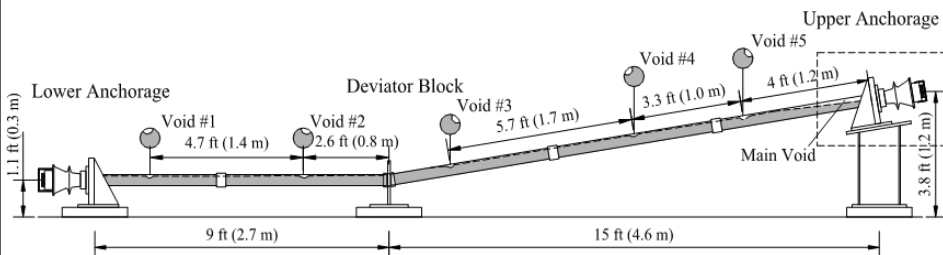
Note: For clarity the 19 strands inside the acrylic duct are not shown.

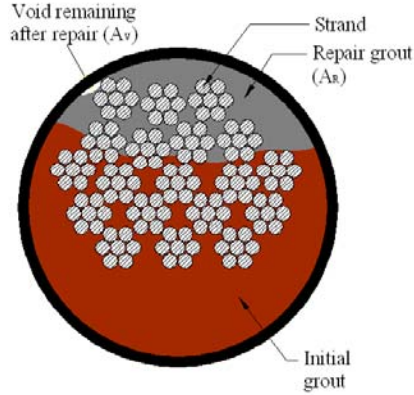
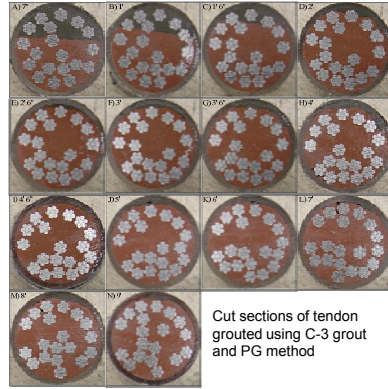
- Sections were cut at every 6 inches up to 5 ft from reference point and at every 12 inches thereafter
- Void percent $(A_v/A_R) \times 100$ was estimated to compare the performance of repaired grout
- The minimum values of the repaired area in cut sections were evaluated to compare filling capability

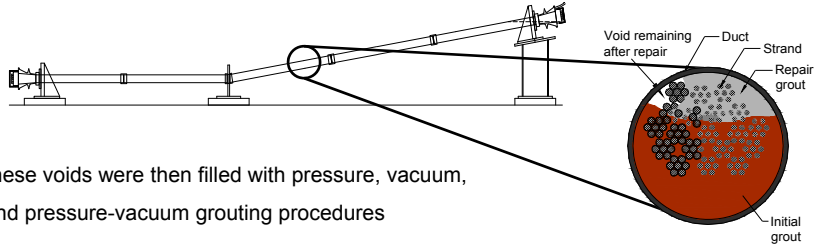
- These voids were then filled with pressure, vacuum, and pressure-vacuum grouting procedures
- **Pressure grouting** requires less preparation time (more constructable) but was found to leave voids unfilled (lower fillability)

Tendon cross-section showing strands, possible remaining voids, and initial and repair grout
(LOWER FILLABILITY)

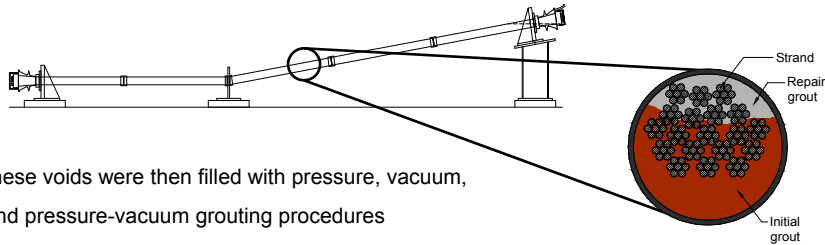
Tendon cross-section showing strands, and initial and repair grout
(BETTER FILLABILITY)

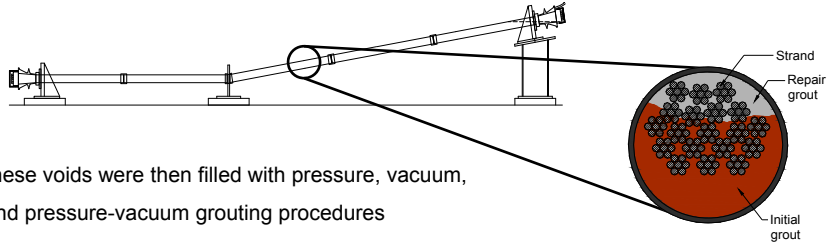
Tendon cross-section showing strands, and initial and repair grout (BETTER FILLABILITY)

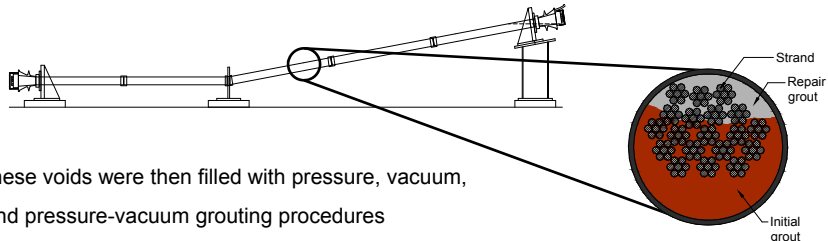
Tendon cross-section showing strands, and initial and repair grout (BETTER FILLABILITY)

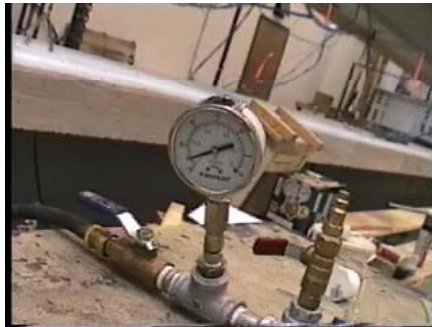
Test using VG method

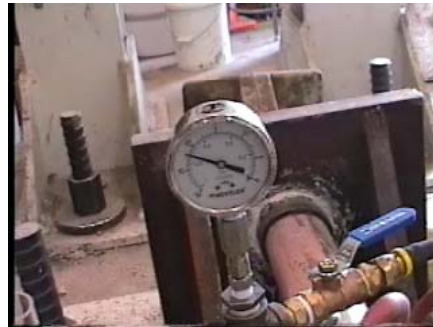
Test using PVG method

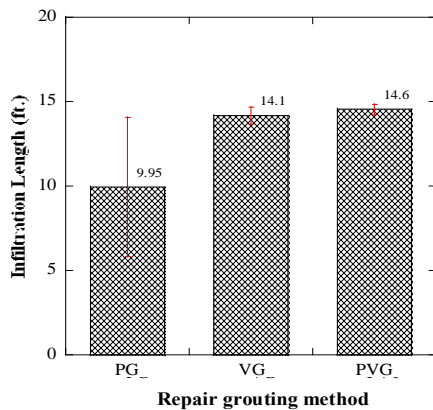
- Based on the ANOVA, at a 0.05 level of significance, the hypothesis that the mean infiltration lengths are all the same as different repair grouting method cannot be rejected
- That is, there is no statistically significant evidence to conclude that different repair grouting methods have different infiltration lengths
- However, the PG method seems to have less infiltration length than others

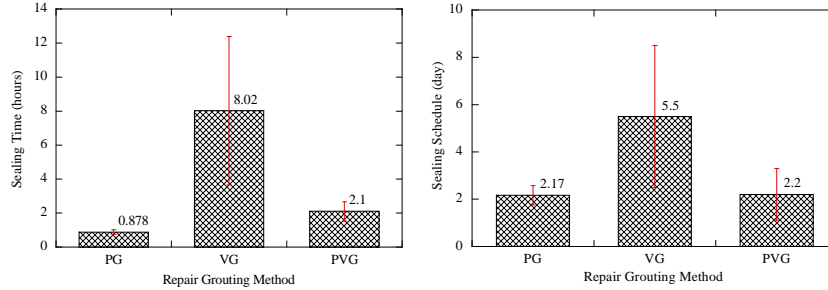
- Voids after repair are assessed in cut sections
 - Based on the ANOVA, at a 0.05 level of significance, the hypothesis that the mean sealing time is all the same as different repair grouting methods can be rejected.
 - That is, there is statistically significant evident to conclude that different grouting methods need different sealing time.
 - From the SNK test, the sealing time of the VG method have more preparation time than others.
